U.S. Department
of Transportation
**Federal Railroad
Administration**

Evaluation of Damaged Tank Car Structural Integrity

1. Report No. DOT/FRA/ORD-88/02		2. Government Accession No.		3. Recipient's Catalog No.	
4. Title and Subtitle Evaluation of Damaged Tank Car Structural Integrity			5. Report Date January 1988

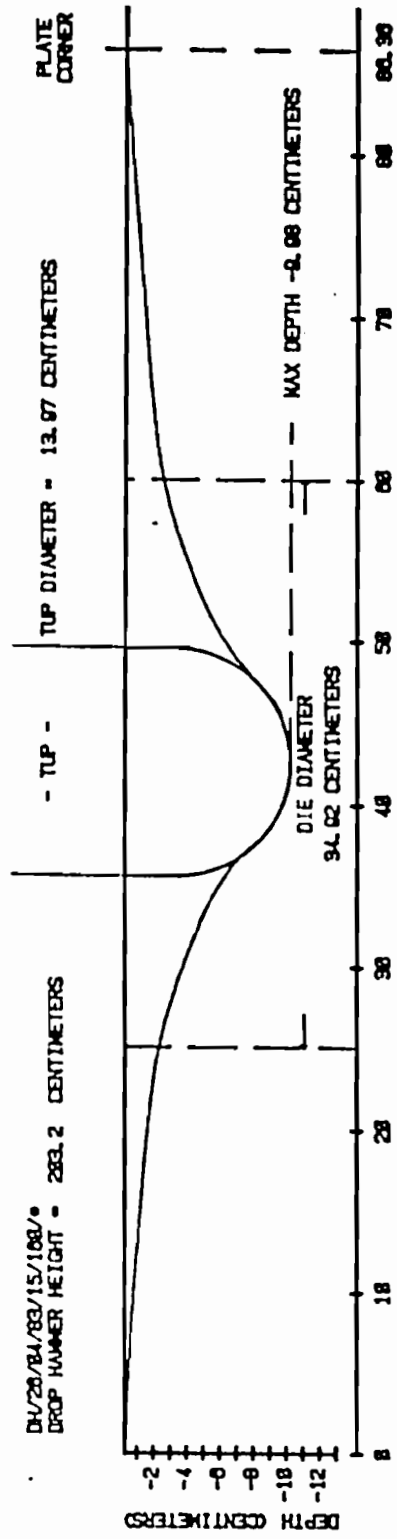
Various mechanical techniques were also used to measure deformation on the 68 specimens. These measurements were restricted to methods that could easily be used in the field and consisted of measuring the depth and radius of curvature of each deformed area. Figure 2 is an example of plots that were made previously¹ of dent depth versus position.

Figure 2. Dial micrometer measurement of dent depth.

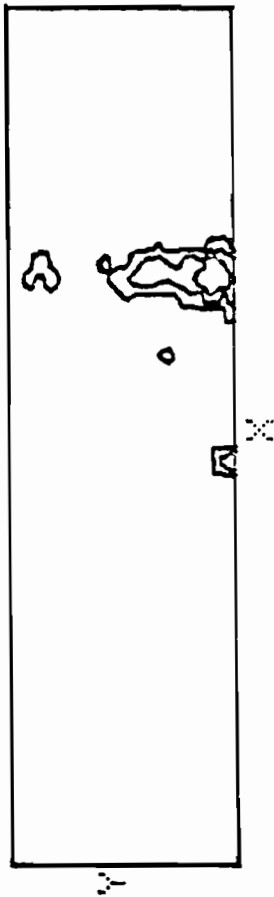
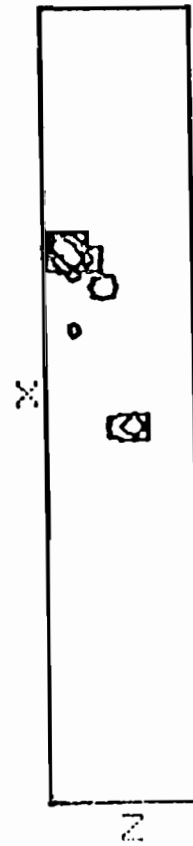
Figure 3. Typical contour plots generated by a computer-controlled ultrasonic imaging system showing images of cracks in the metal (three dimensions): (a) plan view, (b) cross-sectional view parallel to rolling direction, and (c) cross-sectional view transverse to rolling direction. (Plate #DH-25-04-83-18-160)

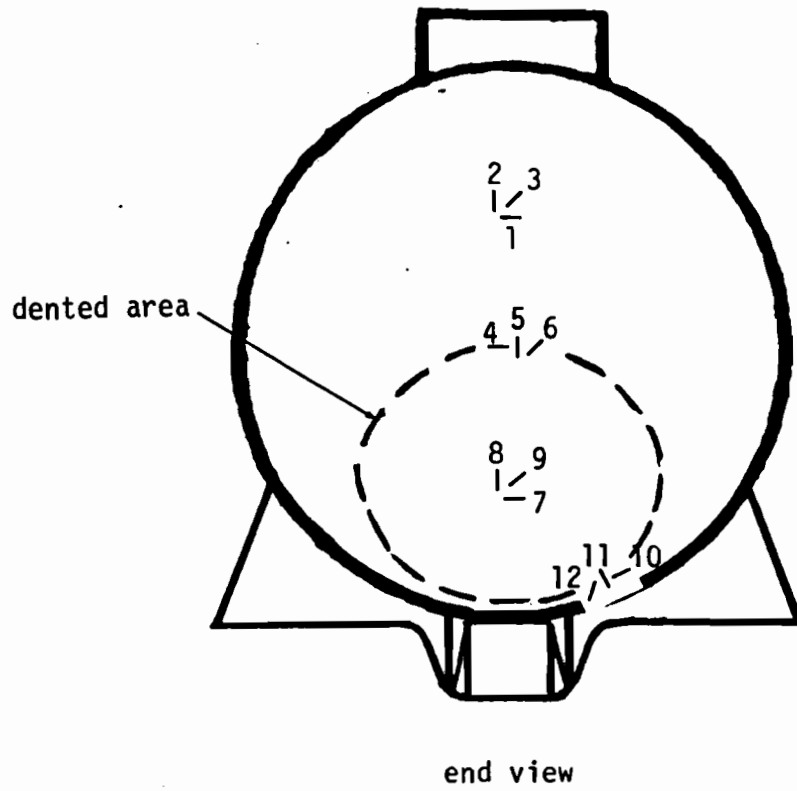
Figure 27. Locations of the strain gauges.

The strain gauges were located in or adjacent to the damaged region in the dome, see Figure 27, since this is where failure was expected if the 1/5 scale tanks represented the conditions of an actual tank car. Since the failures occurred in the cylindrical portion of the tank at a substantial distance from the damaged areas, the strain gauge data are of limited use. The results for Tank #401A are summarized as follows:

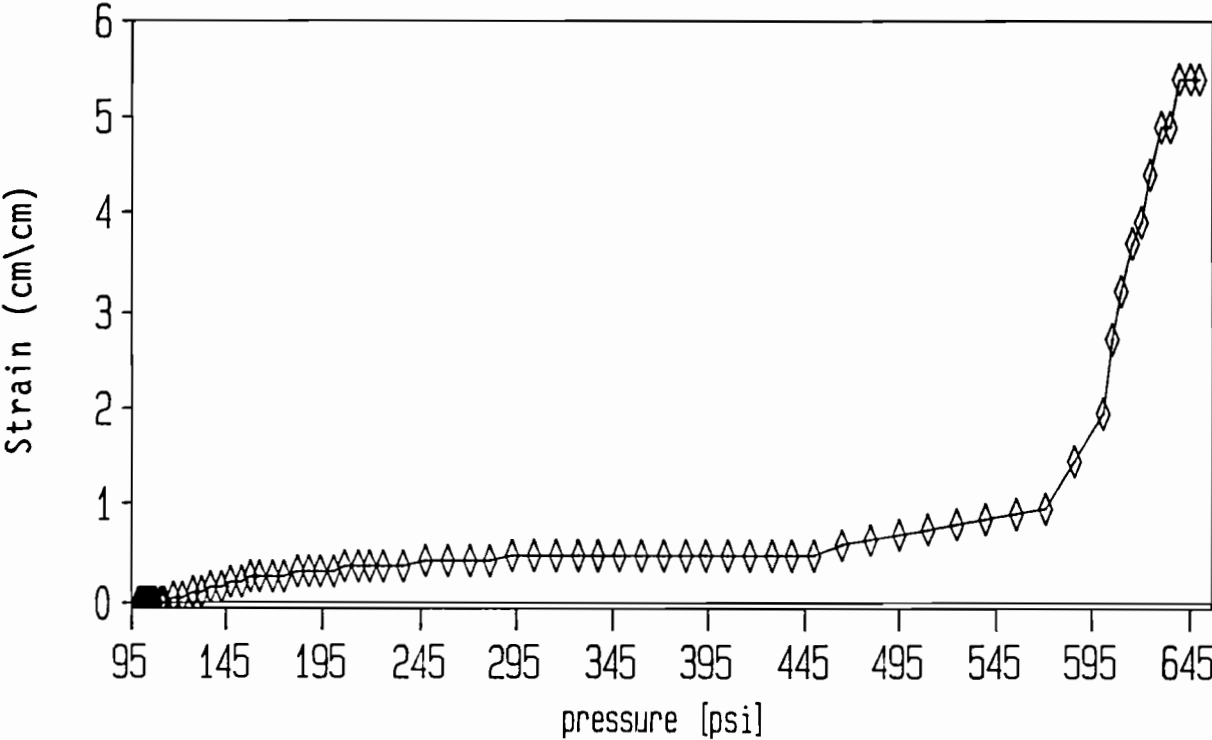
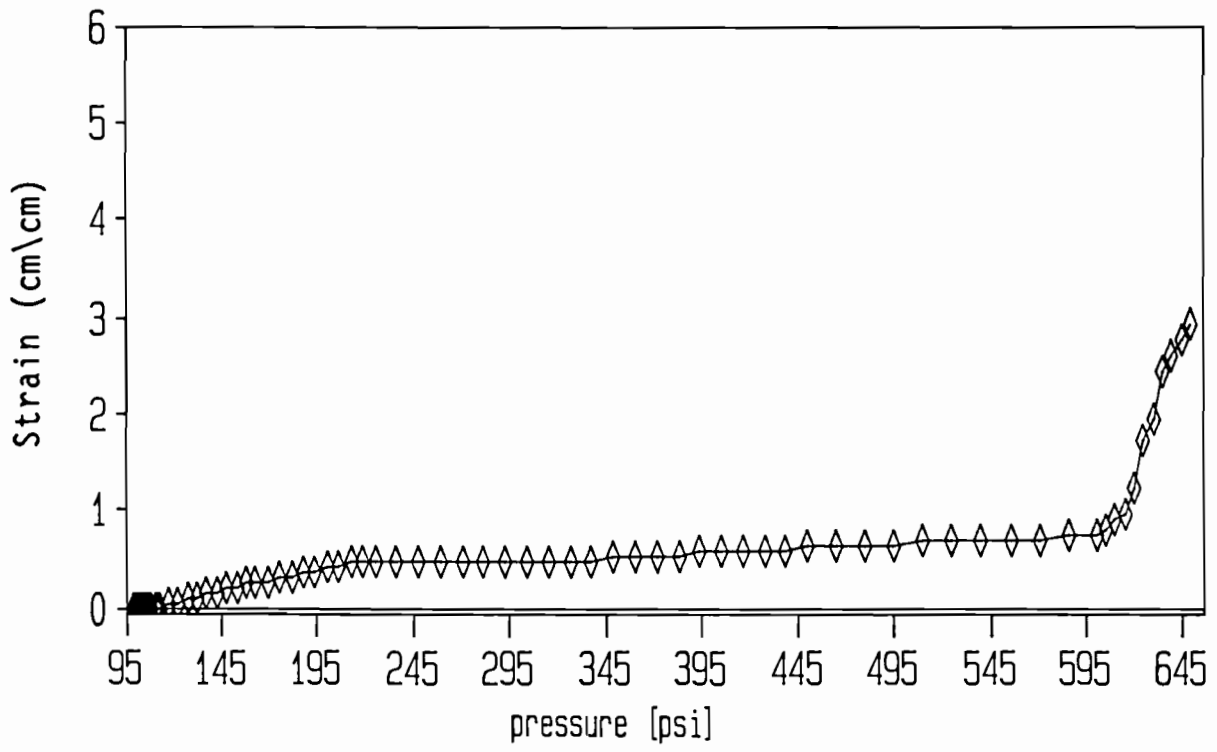
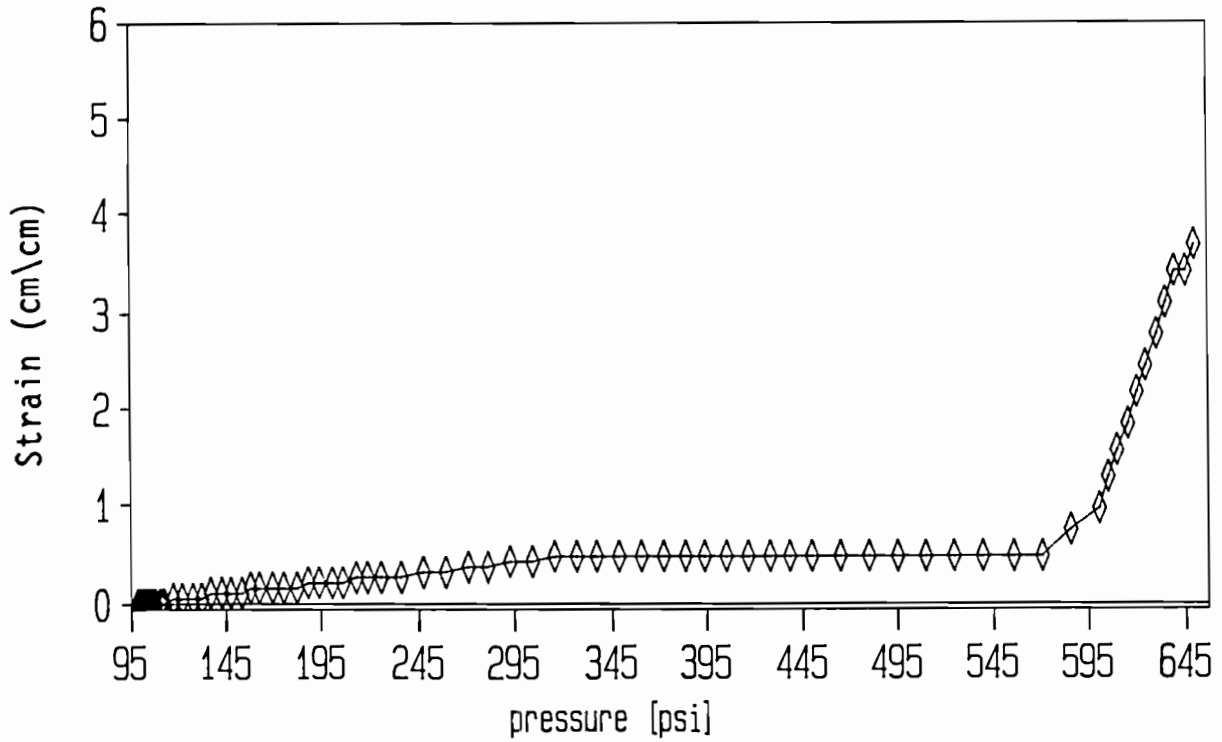
- Gauges 1-3, the strain ranged from 3% to 5%.
- Gauges 5-7, the strain was initially compressive due to the damaged area being forced back to its original position at which time some tensile strain (reduction in compressive strain) occurred.
- Gauges 8-10, substantial peak strains on the order of 40%-50% occurred followed by decreasing tensile strain.
- Gauges 11-12, substantial compressive strains of nominally 65% were observed.

Figure B-1. Tank #401A, Strain Gauge #1.

Figure B-2. Tank #401A Strain Gauge #2.

Figure B-3. Tank #401A Strain Gauge #3.

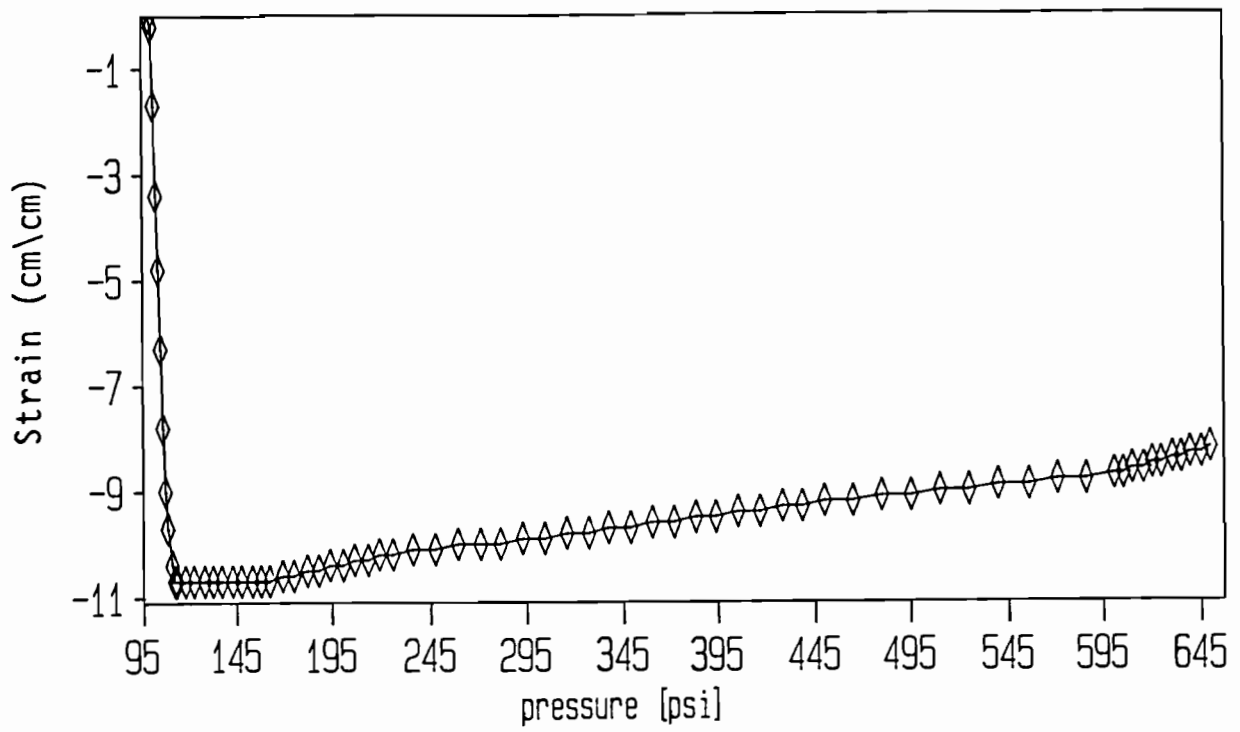
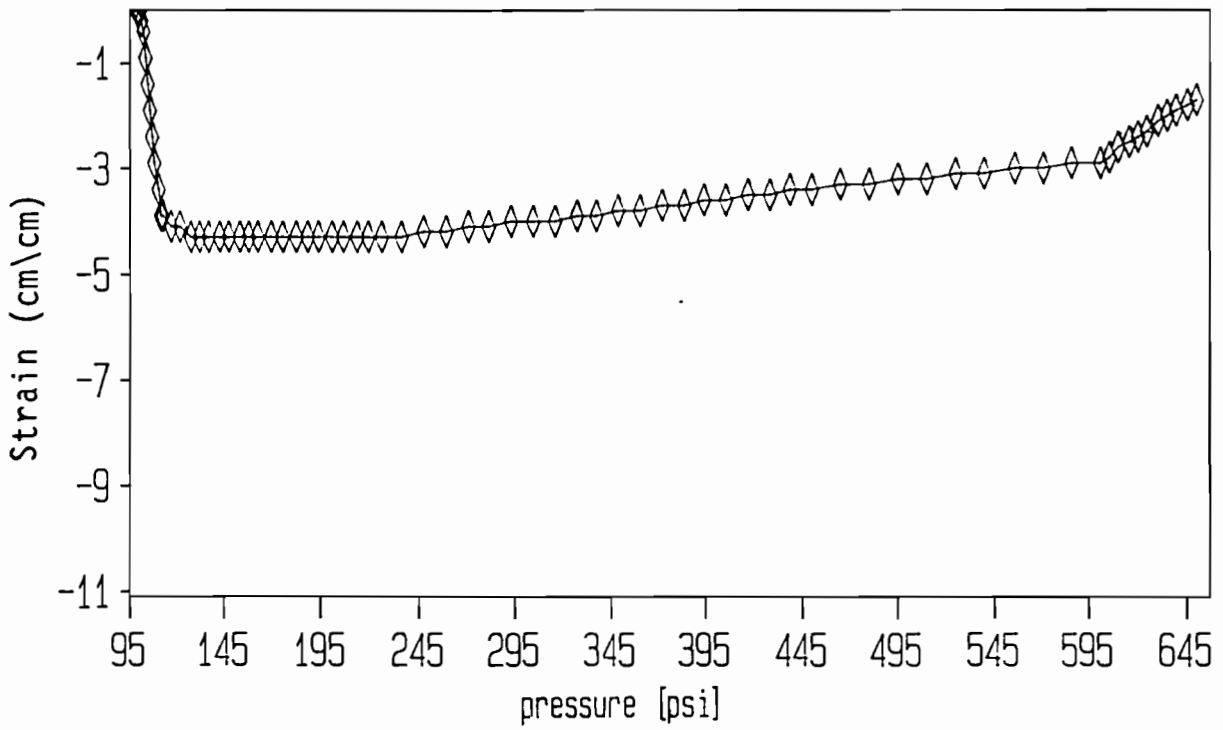
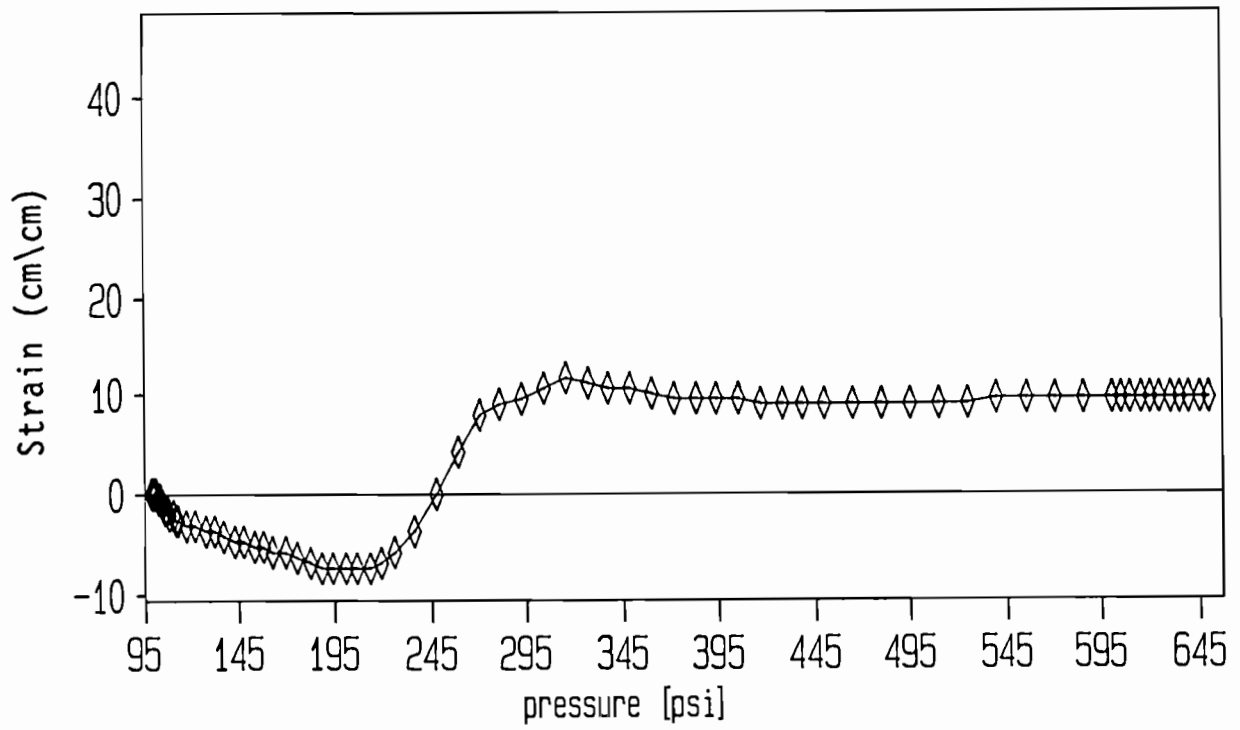
- Gauges 1-3, the strain ranged from 3% to 5%.
- Gauges 5-7, the strain was initially compressive due to the damaged area being forced back to its original position at which time some tensile strain (reduction in compressive strain) occurred.
- Gauges 8-10, substantial peak strains on the order of 40%-50% occurred followed by decreasing tensile strain.
- Gauges 11-12, substantial compressive strains of nominally 65% were observed.

Figure B-4. Tank #401A Strain Gauge #5.

Figure B-5. Tank #401A Strain Gauge #6.

Figure B-6. Tank #401A Strain Gauge #7.

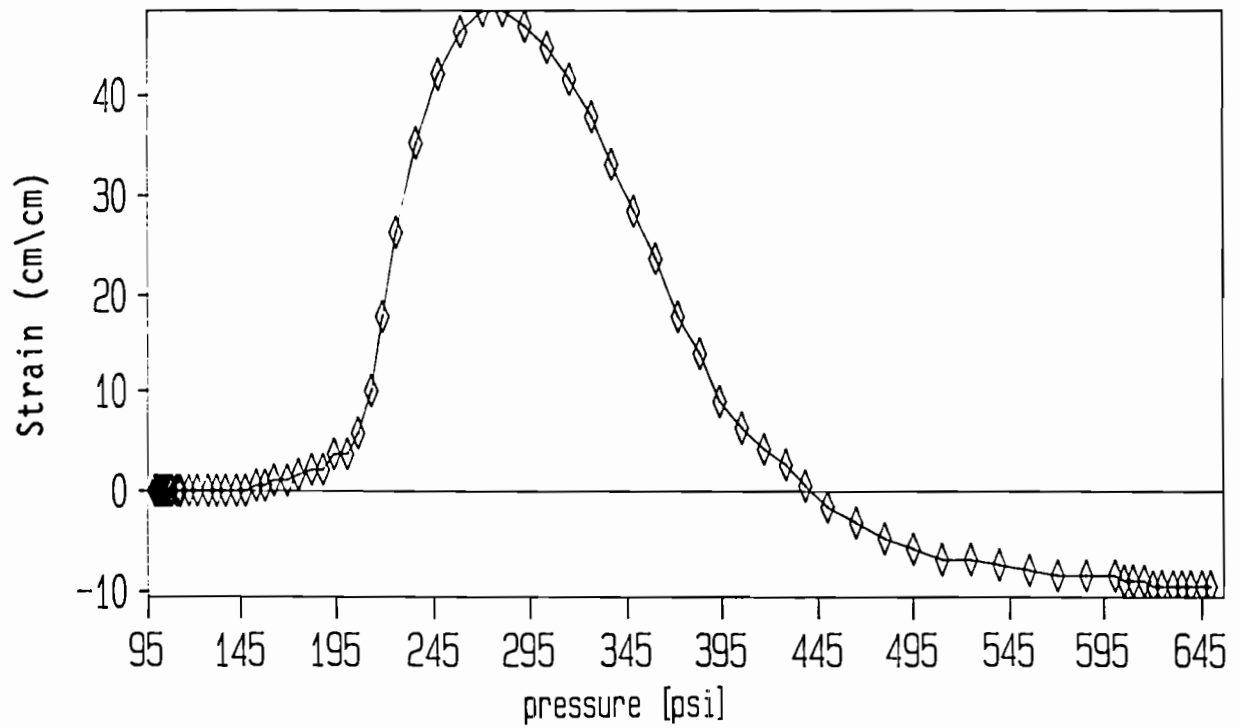
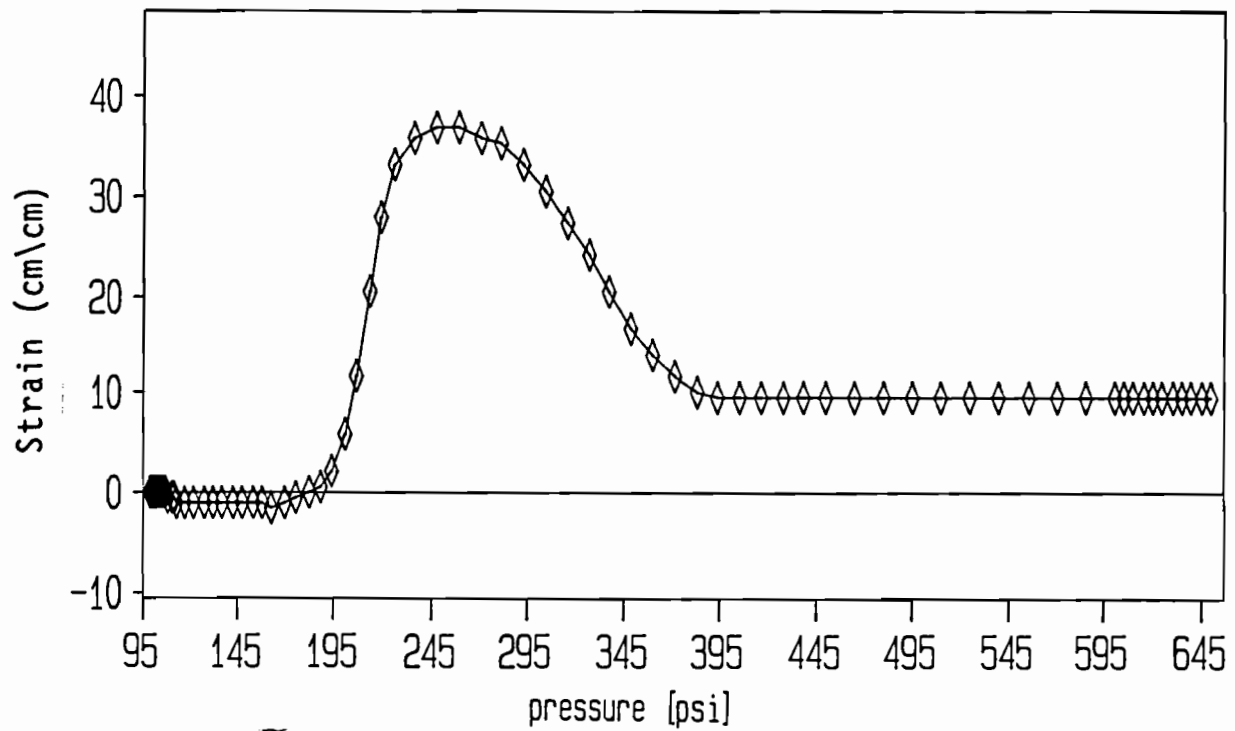
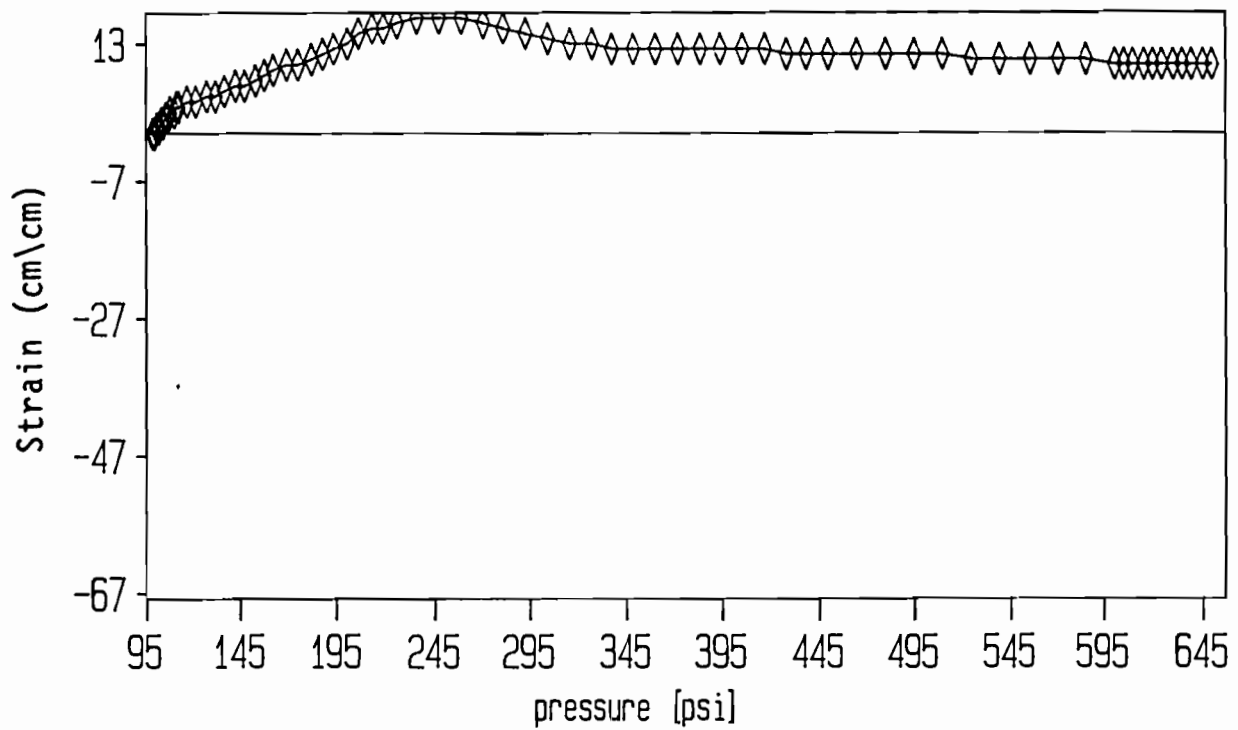
The peak strain of 40%-50% observed for Gauges 8-10 is considerably greater than the average value associated with failure in the cylindrical section. At this time it is not possible to explain why Gauges 8-10 showed the substantial decrease in tensile strain.

Figure B-7. Tank #401A Strain Gauge #8.

Figure B-8. Tank #401A Strain Gauge #9.

Figure B-9. Tank #401A Strain Gauge #10.

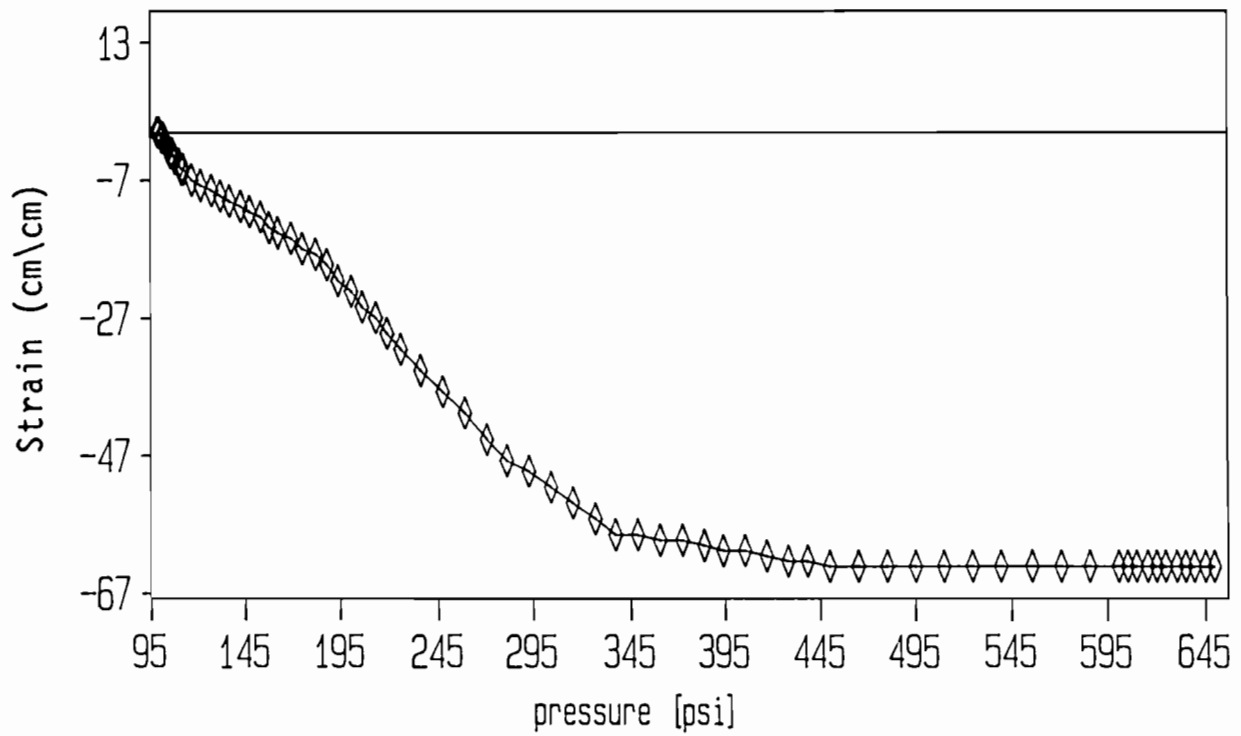
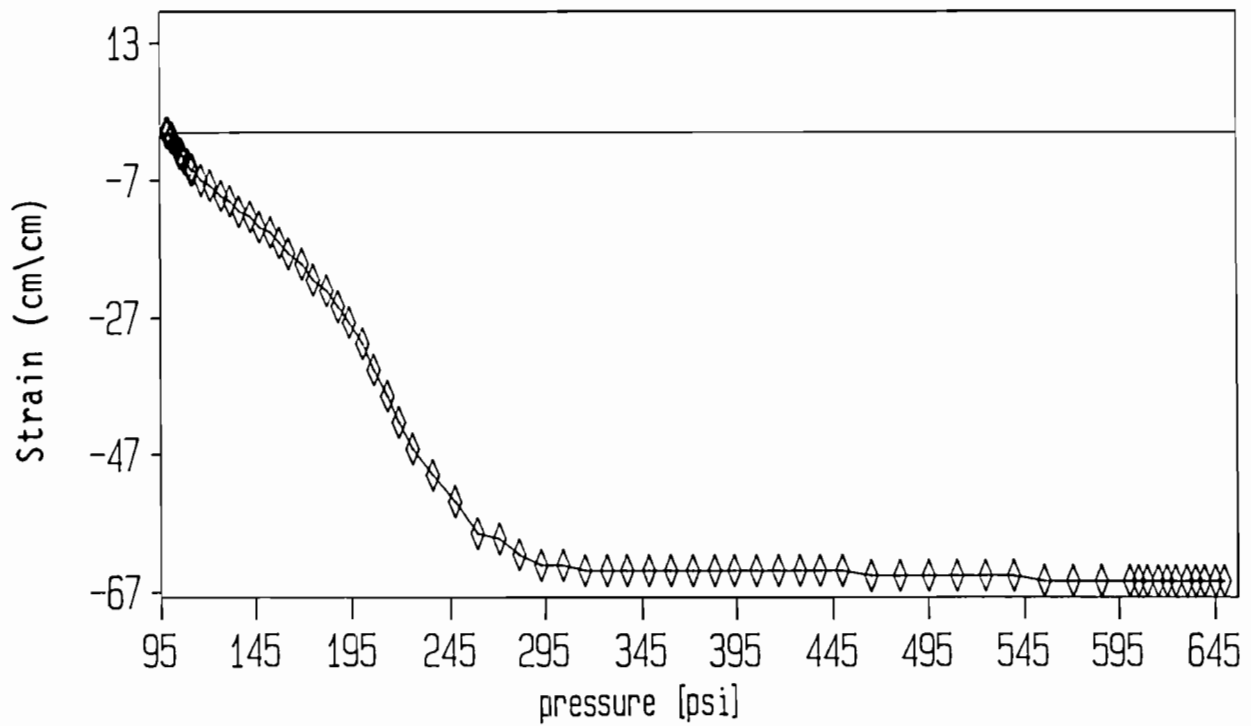
Figure B-10. Tank #401A Strain Gauge #11.

Figure B-11. Tank #401A Strain Gauge #12.
