Experimental Study of Various Techniques to Protect Ice-Rich Cut Slopes

Construction Report

July 2013

INE/AUTC 13.07

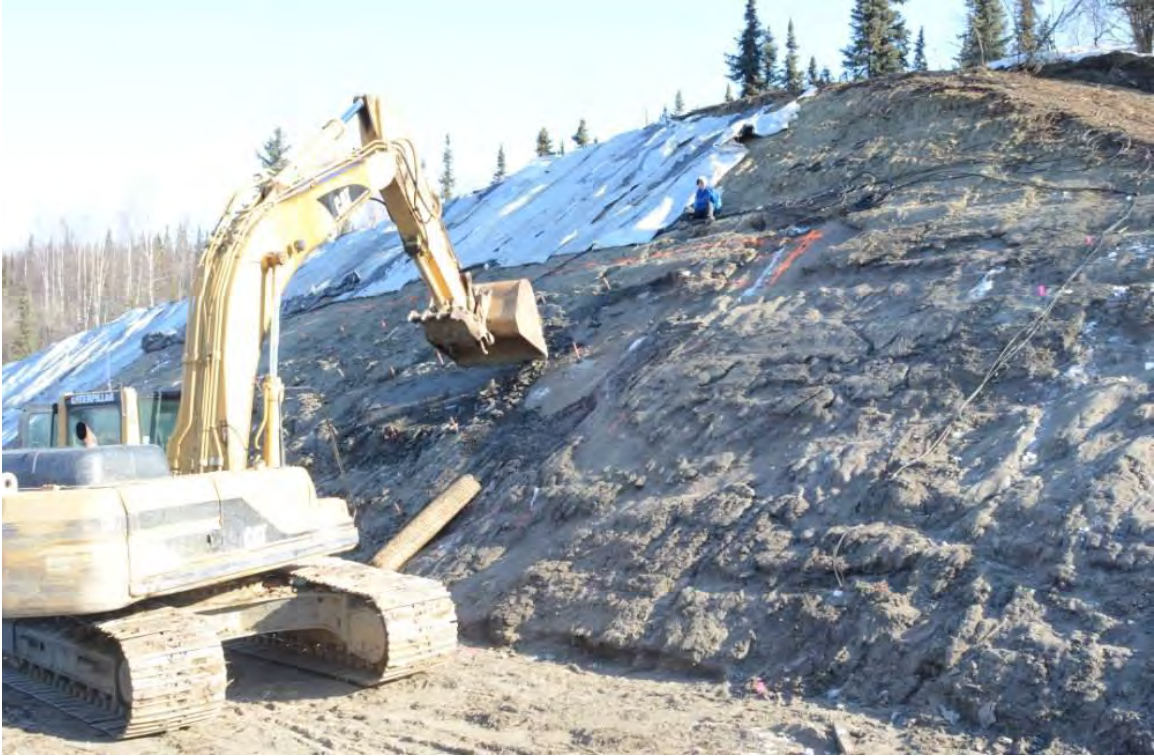
As mentioned previously, significant erosion was observed after the drilling process on the slope as shown in Figure 4.7. The eroded, uneven slope surface quickly became unsuitable for placement of the coconut erosion control matting and the Tecco-mesh. It was necessary that both of these treatments be placed on a smooth ground surface to prevent air circulation between treatment matting and the cut slope surface. Such air circulation would reduce the thermally protective effects of both treatment types. Therefore, prior to placement of the coconut (Section B) and Tecco-mesh (Section C) slope coverings, the bucket of a large backhoe excavator was used to smooth out the uneven surface of the cut slope. This operation is shown in Figure 4.13. Then Sections B and C were seeded. Figure 4.14 shows a small area of the cut slope after seeding.

Figure 4.13 Re-smoothing the cut slope surface

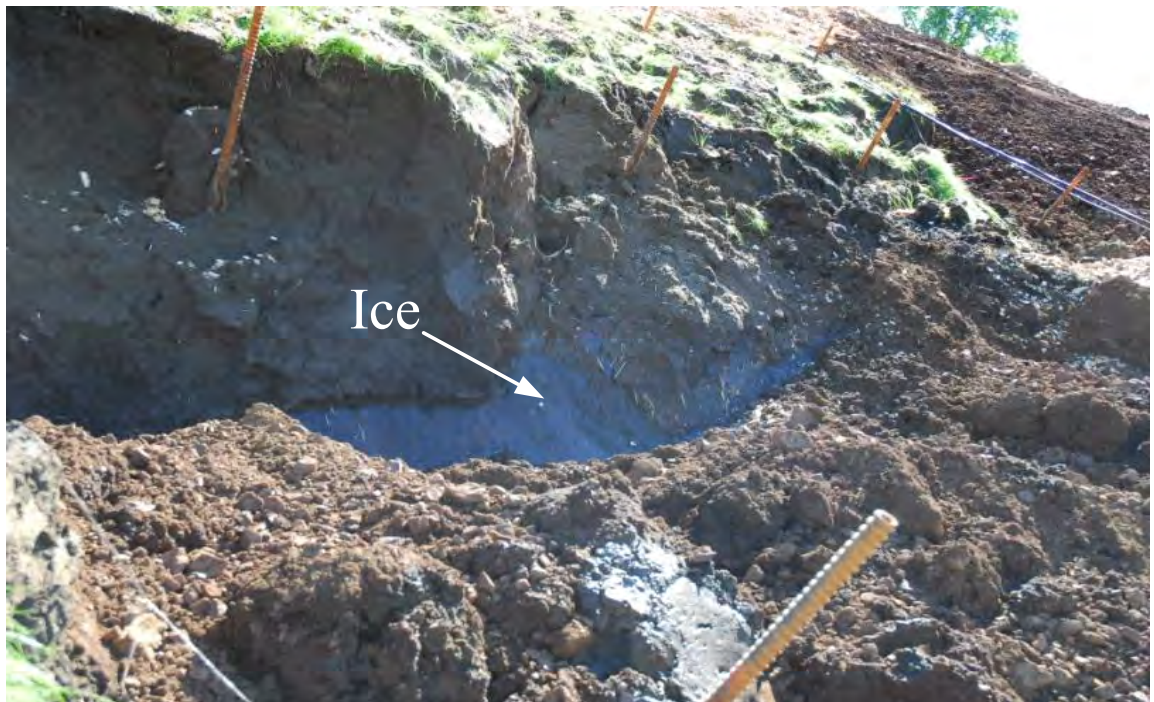
According to the recommendations listed above, on June 17th 2013, Tecco-mesh and the coconut erosion control blankets at Section C were removed which is shown in Figure 6.5. The great loss of volume in Section C can be seen especially where massive ice is exposed as shown in Figure 6.6. Crushed rock was hauled to the test site. Then, an excavator was used to cover Section C with crushed rock (see Figure 6.7). The hollow rebar anchors were left intact during these repairs to serve as survey and photogrammetric reference points. Figure 6.8 shows the cut slope after completion of repairs on June 17th 2013.

Figure 6.6 Massive ice in Section C

- Extend the rock blanket material (control section material) across that section. During this process, leave as many of the Tecco-mesh anchors in place as possible. It was thought that thaw-related problems would initially continue given the very high ice content of some of the cut slope material, and that the rock blanket would conform to slope surface as it receded. The rock blanket would provide some degree of insulation and serve as a filter to keep silt from running into the ditch. Initial failure of the project's standard design thickness of blanket material, due to loss of massive ice volume, would require placement of additional blanket material.

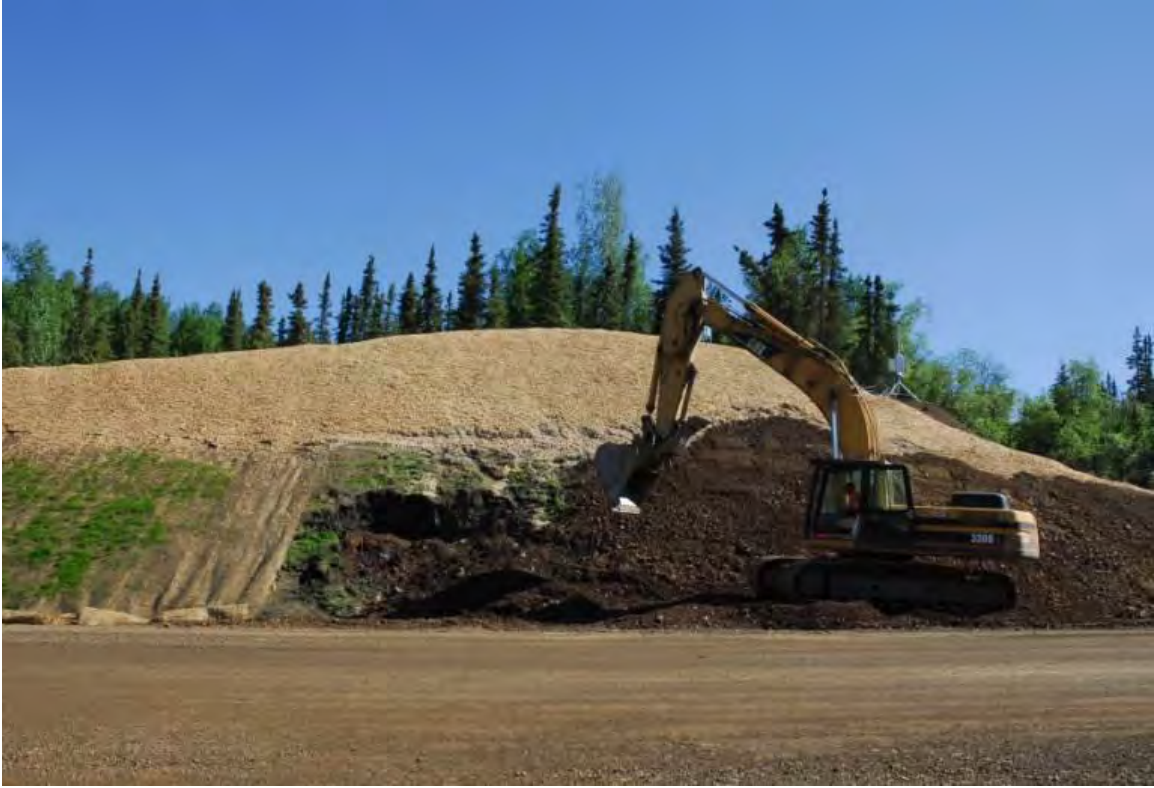
Figure 6.7 Covering Section C with crushed rock

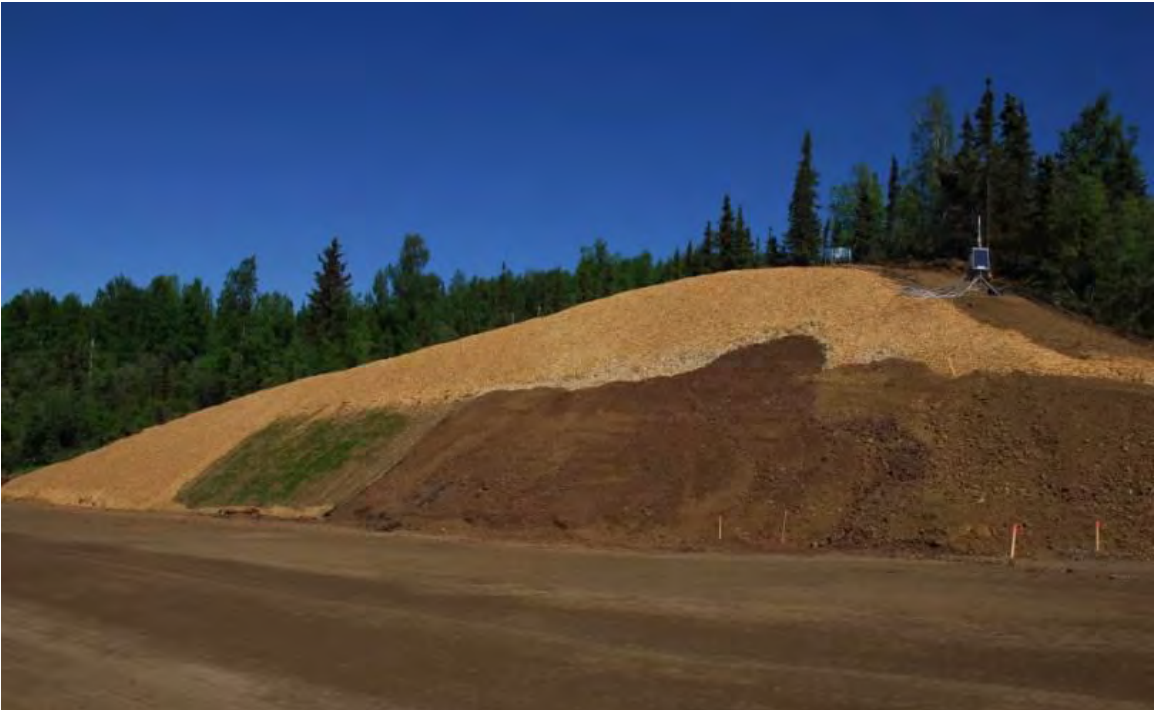
Figure 6.8 Cut slope after construction on Section C

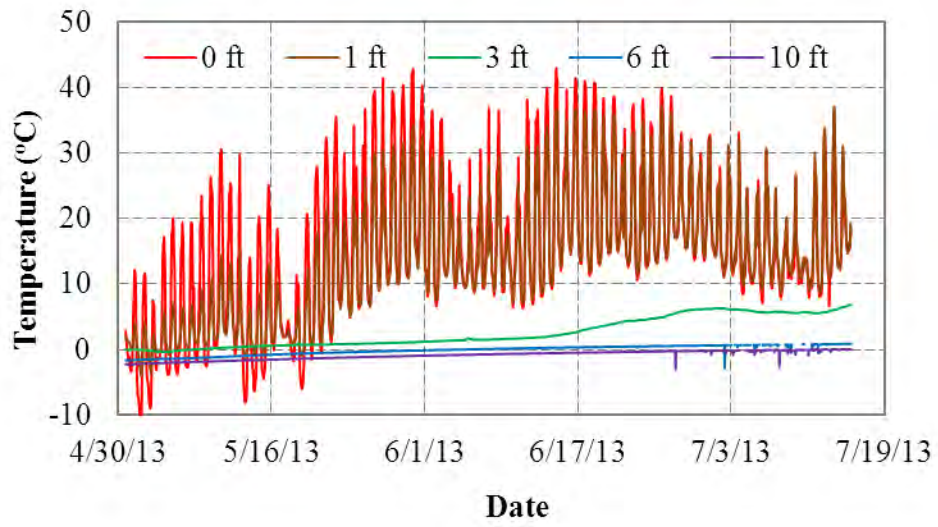
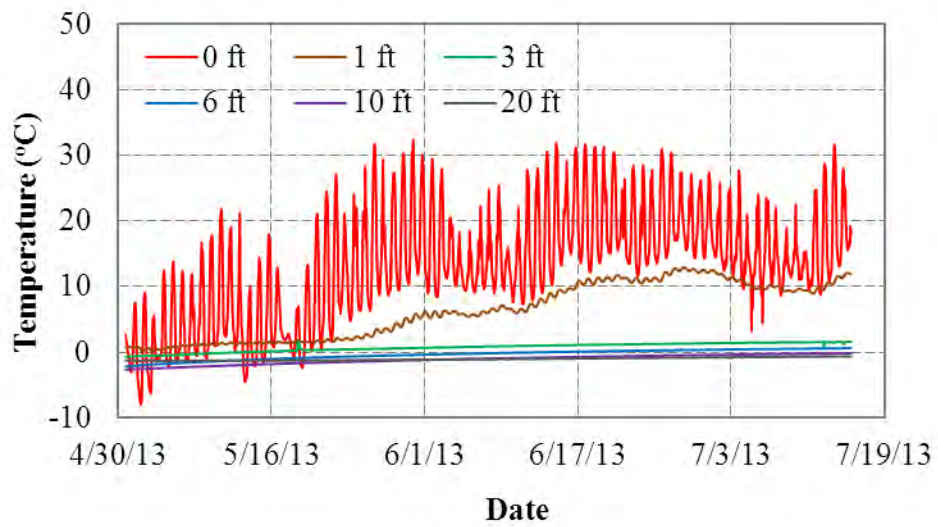
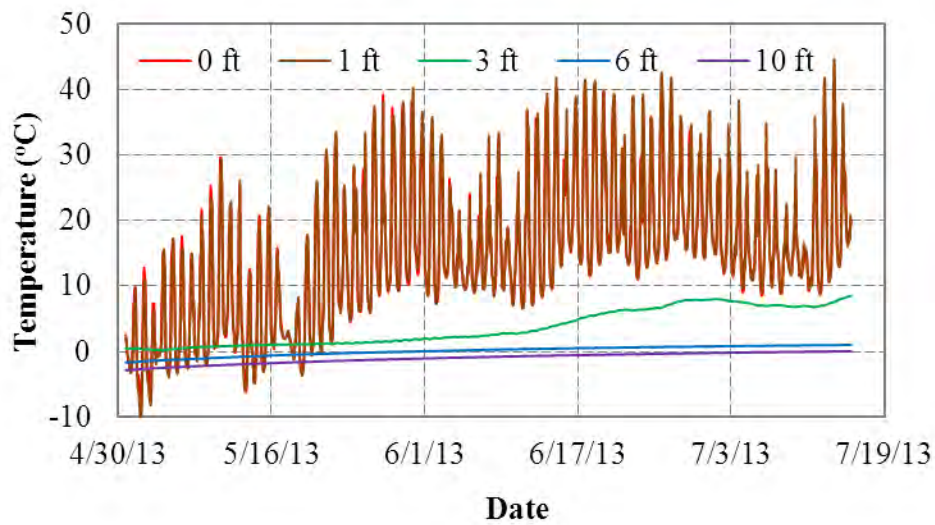
Figure 7.11 Temperature variations in Section B

Similar to the temperature variation in Section A, due to the air temperature increase, temperatures increased throughout the monitoring period at different depths as can be seen in Figure 7.11. At the slope surface, the temperature changes closely followed the air temperature variation. Also, the temperature variations for the bottom, middle, and top of the section were consistent with one another due to the thickness uniformity of the coconut blanket except the temperatures at the middle with depth of 1 and 3 feet. At one foot below the slope surface in this section, especially for the temperatures at the top and bottom of this slope, the soil temperature changes closely followed the daily air temperature variation. Compared to the layer of wood chips, the coconut blanket (as expected) offered essentially no insulative benefit. Three feet below the slope surface of this section, soil temperature changes smoothly followed the long term increase in air temperature — in a much damped response compared to the soil at a one foot depth.

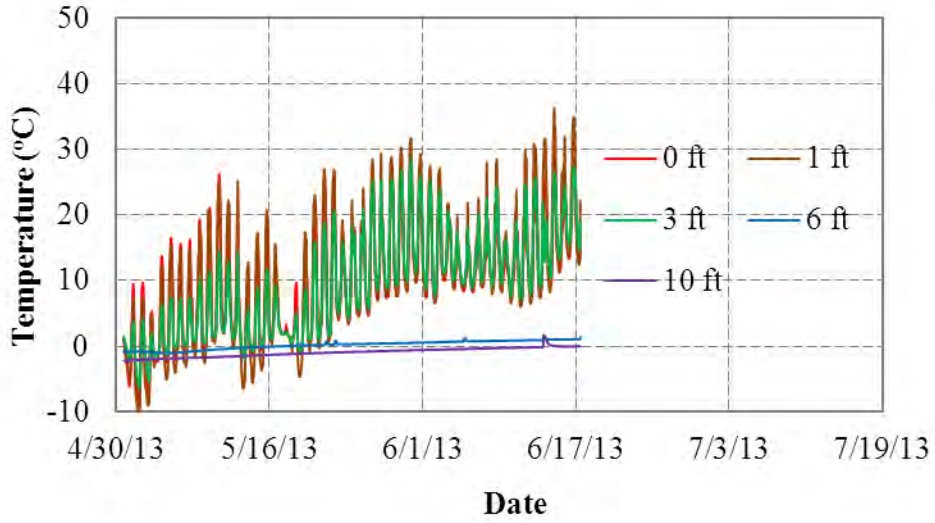
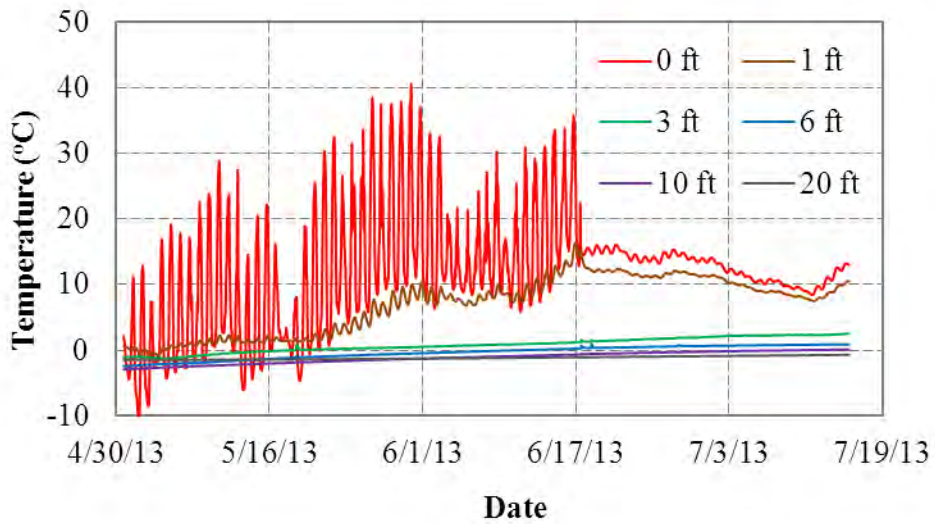
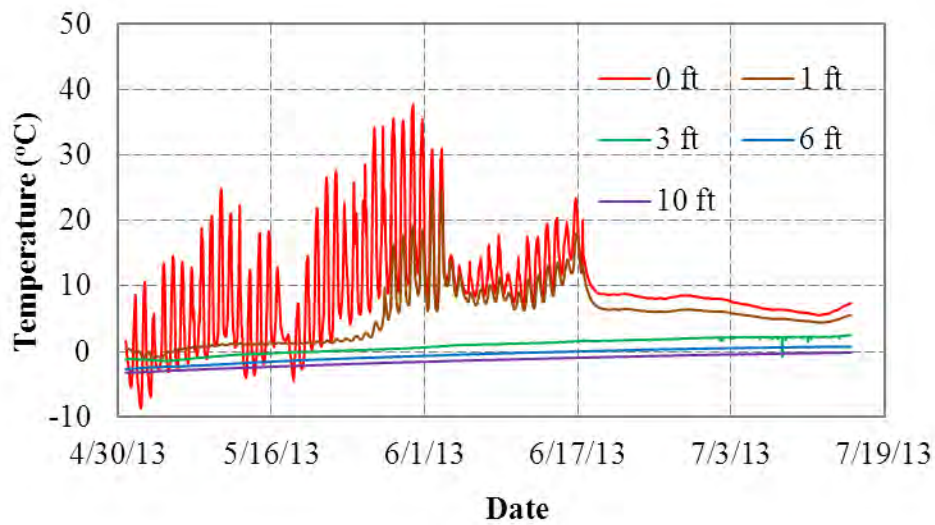
Figure 7.12 Temperature variations in Section C

Figure 7.12 shows the temperature changes at the bottom, middle, and top of Section C (Tecco-mesh + coconut blanket) at different depths (0, 1, 3, 6, 10, and 20 ft). Temperature variations at different depths are presented in different colors. Due to thaw-related slope failures in this section, the Tecco-mesh and coconut blanket were removed and replaced by crushed rock on June 17th, 2013. The crushed rock layer used for this purpose was of variable thickness due to

the uneven surface of the damaged slope. The thickness of the rock blanket ranged from about one to three feet. All temperature sensors located at the bottom of Section C stopped working after the June 17th repair work.

Before the major repair work on June 17th, 2013, temperature variations within Section C were generally similar to those of Sections A and B as seen in Figure 7.12. Due to the air temperature increase, soil temperatures increased throughout the monitoring period at different depths. At the slope surface and one foot below, temperatures followed the daily air temperature variation. Compared to the wood chip section (Section A), the coconut blanket together with the Teccomesh offered essentially no insulative benefit as expected. After the replacement of the Teccomesh and coconut blanket with a rock blanket, temperature sensors at the original slope surface and originally one foot below indicated that a period of cooling occurred. No such period of cooling was seen in Sections A or B.

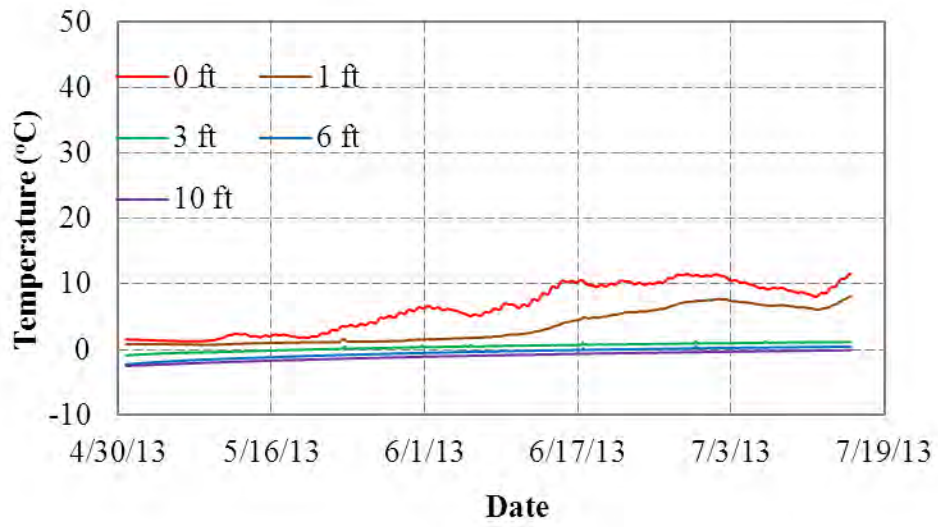
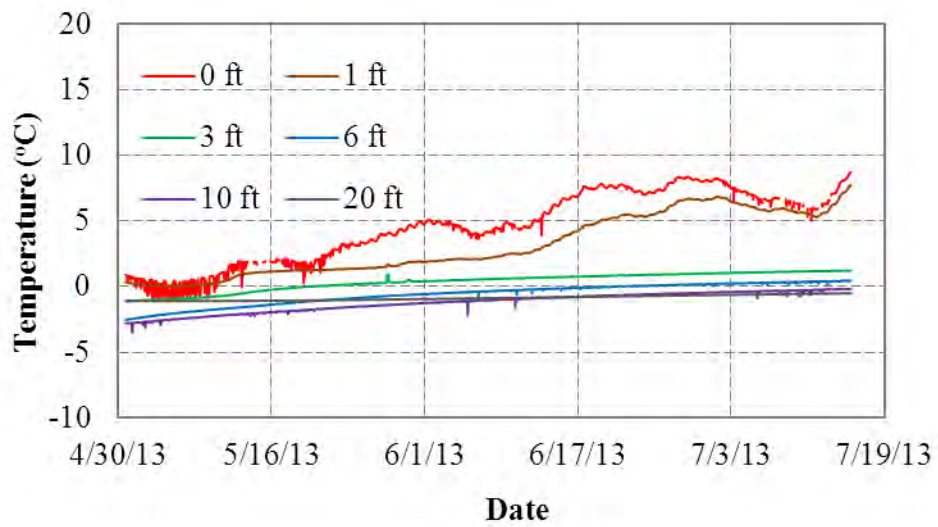
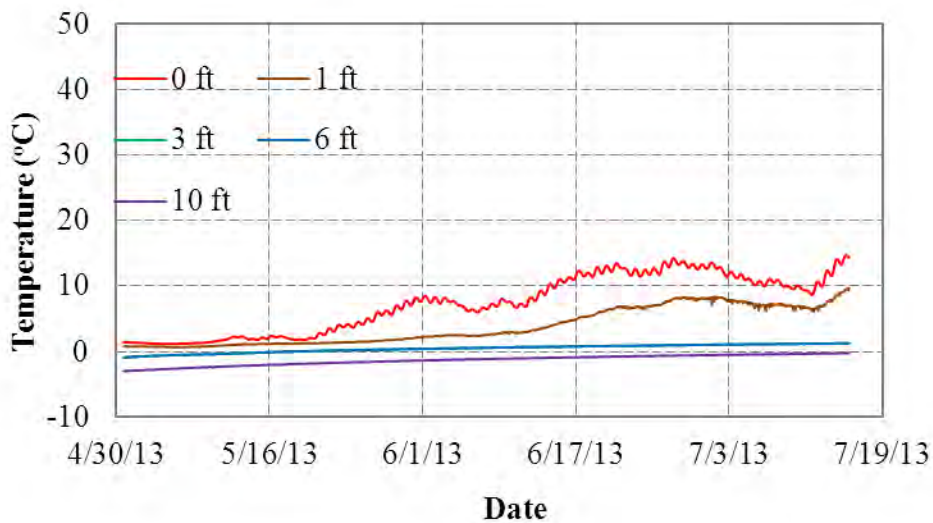
Figure 7.13 Temperature variations in Section D

Figure 7.13 shows the temperature changes at the bottom, middle, and top of Section D (crushed rock) at different depths (0, 1, 3, 6, 10, and 20 ft). At the top of Section D, no temperature data was obtained from the sensor at 3 feet due to malfunctioning. Due to erosion in Section D, associated with repairs and placement of crushed rock in Section C, more crushed rock was also placed in Section D.

Figure 7.13 shows the soil temperature variations in Section D. Soil temperature variations at the original slope surface and one foot below follow the pattern as for Sections A through C except that the soil temperature response is damped by overlying rock blanket. At 3, 6, 10, and 20 feet below the slope surface, temperatures slightly increased throughout the measurement period. Figure 7.13 indicates that soil 10 feet or more below the original slope surface remained frozen throughout the monitoring period reported here. Sensors installed above the 10 foot depth in Section D indicated thawing with time.

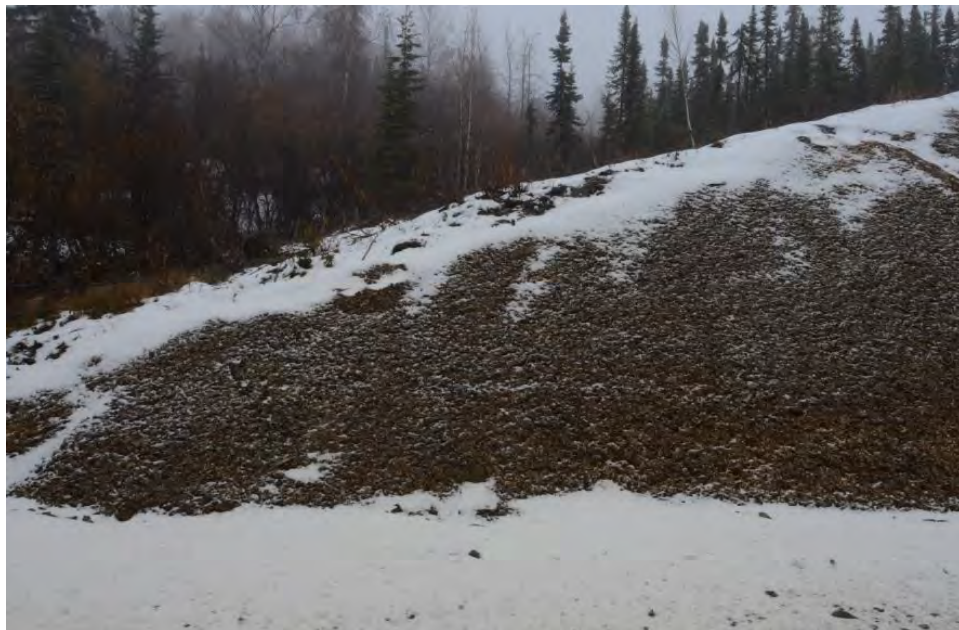
Figure 7.25 Section A with more wood chips on September 27th, 2013

A record of the cumulative surface volume changes for Section A between April 26th and September 27th, 2013 is shown in Figure 7.22. In Figure 7.22, volume changes are indicated on various dates between April 26th and September 27th, 2013. A volume increase relative to the slope face condition on April 26th is shown as a positive value in the figure. A volume decrease relative to April 26th would be shown as a negative value in the Figure 7.22. Figures 7.23 and 7.24 are photos of Section A on April 26th and April 30th, respectively. Figure 7.22 indicates that the volume along the Section A slope face actually increased (varying between 8 and 12 m³) during this period. Part of the increase is because additional wood chips were applied over Section A after April 26th. Another reason is the light snow cover on Section A that was added between April 26th and 30th. After April 30th, there were small fluctuations in the volume of material added to the surface of Section A. These fluctuations are attributed to animal activity on the slope. Observation of this section identified no significant erosion throughout the 2013 monitoring period. This is indicated by the excellent condition of the slope on September 27th indicated in the Figure 7.25 photo.

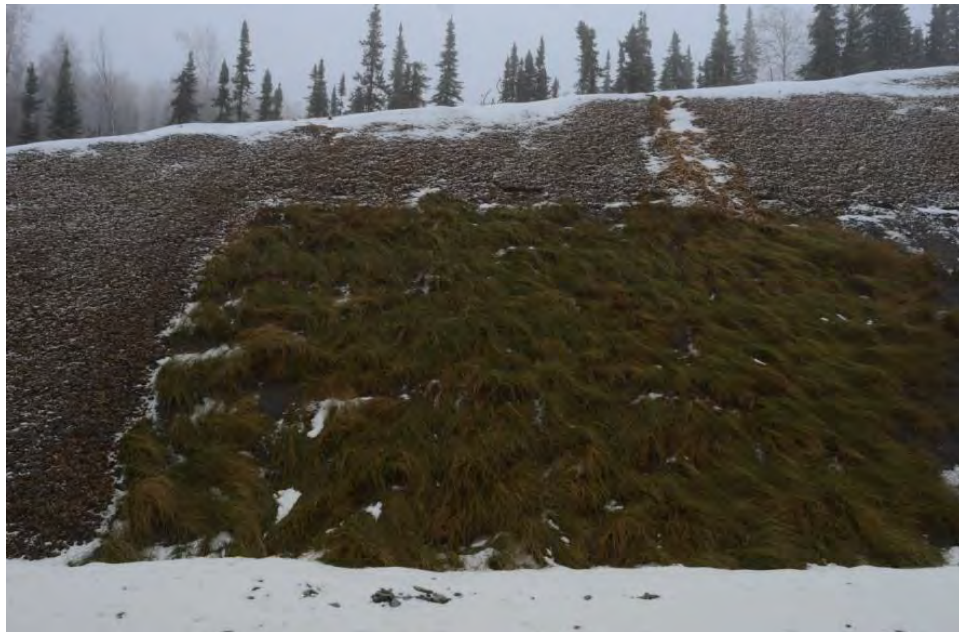
Figure 7.30 Section B on September 27th, 2013

shown in Figures 7.28 and 7.29 which are photos of this section captured on July 15th and August 8th respectively. Figure 7.30 is a photo showing the surface of Section B on September 27th. This fall-time photo shows that the grass has wilted. This wilting process was detected as a surface volume loss during the fall season and is shown in Figure 7.30.

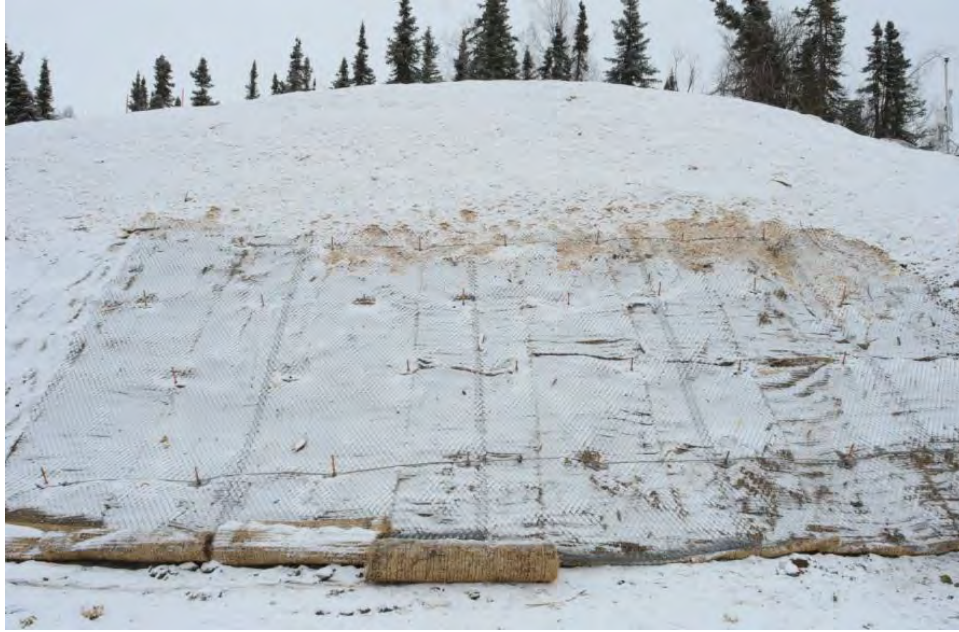
Figure 7.32 Section C on April 30th, 2013

photogrammetric record, April 26th, measurements indicated a small surface volume increase due to the snow cover shown in Figure 7.32. During the period between about April 30th and June 13th a rather large volume of icy soil (and massive ice) materials, originally located beneath the Tecco-mesh slope cover, were lost to runoff and thaw-consolidation. Photogrammetric measurements, as indicated in Figure 7.31, keyed on the surface of the Tecco-mesh, and therefore provided no indication of the volume loss that was occurring under the Tecco-mesh. Figure 7.33 shows obvious signs of the actual condition of the cut slope face under the Tecco-mesh by June 13th. Obviously, the deterioration process of the cut slope face under the Tecco-mesh was not detected by the photogrammetric process! On June 17th, the Tecco-mesh and coconut blanket on this section were removed and replaced by crushed rock as shown in Figure 7.34. This significant slope surface volume change (due to the added crushed rock) was captured by the subsequent set of photogrammetric measurements, and is indicated on the right hand side of Figure 7.31. Figure 7.35 shows the appearance of Section C on September 27th, the end of the monitoring period for this report. Figure 7.31 indicates than an attenuation of thaw-related volume change was occurring in Section C prior to the September 27th date.

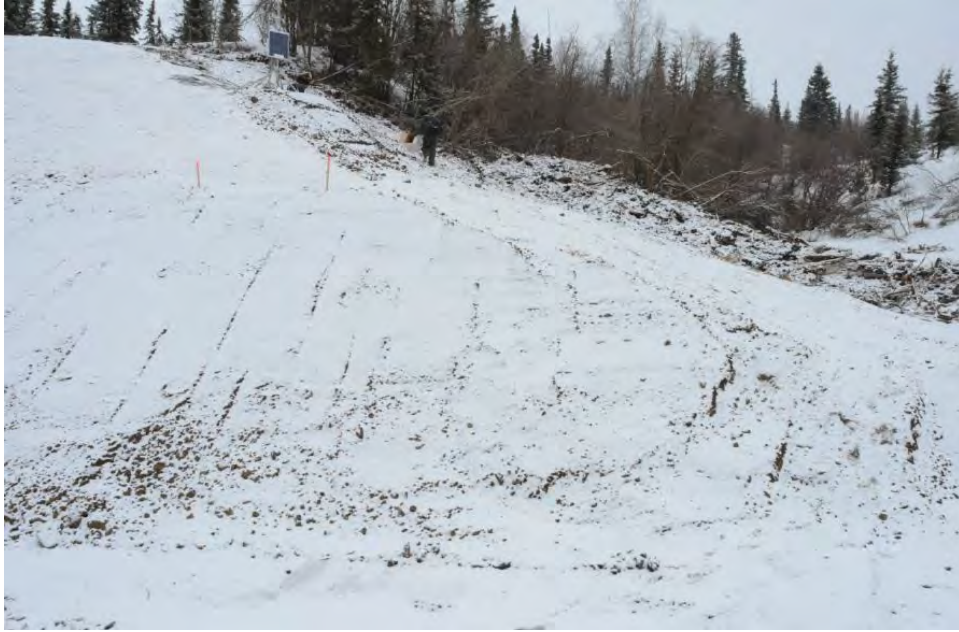
Figure 7.37 Section D on April 30th, 2013

Section D (originally constructed with a crushed rock blanket) serves as the control section for the Experimental Feature. Figure 7.36 indicates that a more or less continual loss of slope surface volume has occurred through September 27th. The initial small volume increase at the surface of Section D was because of the late April snowfall shown in the Figure 7.37 photo. Loss of surface

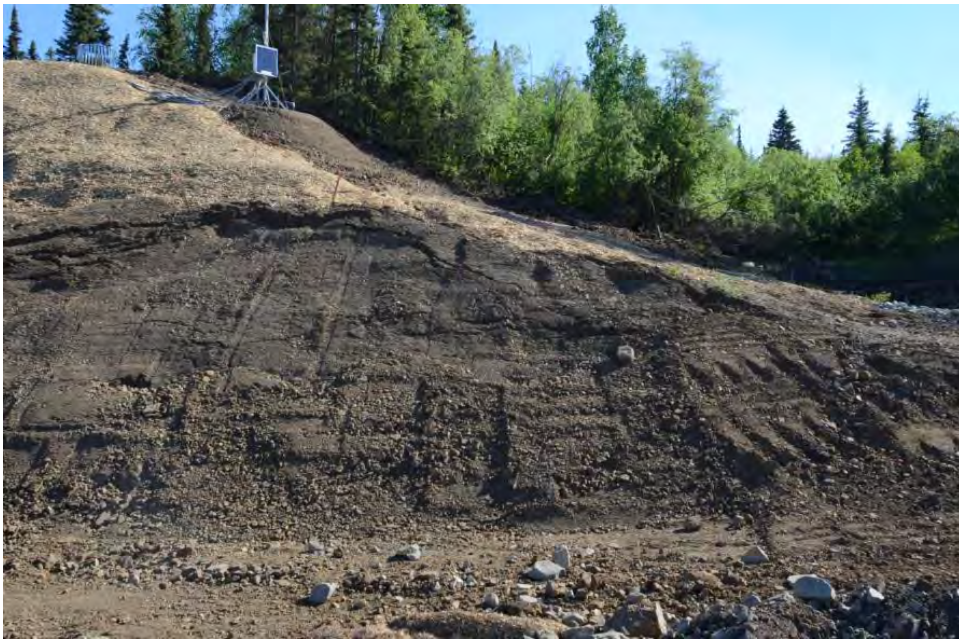
Figure 7.38 Section C on June 13th, 2013

volume (through erosion and/or thaw-consolidation) continued through June 13th. Figure 7.38 shows the condition of the slope face on June 13th. Then, on June 17th, a volume of rock material was added to the surface of Section D during Section C repairs (also see the Figure 7.39 photo). The immediate surface volume increase due to this addition of material in Section D is plotted in Figure 7.36. After placement of additional crushed rock on June 17th, the loss of surface volume continued through the end of the monitoring period for this report on September 27th. The condition of the slope at that time is shown by the Figure 7.40 photo. Figure 7.36 indicates that the surface volume loss rate for Section D had not much attenuated prior to September 27th, 2013.
