# DEVELOPMENT OF MODIFIED TxDOT SINGLE-POST SKID-MOUNTED SIGN SUPPORT

## Test Report 0-6968-R3

TEXAS A&M TRANSPORTATION INSTITUTE  
COLLEGE STATION, TEXAS

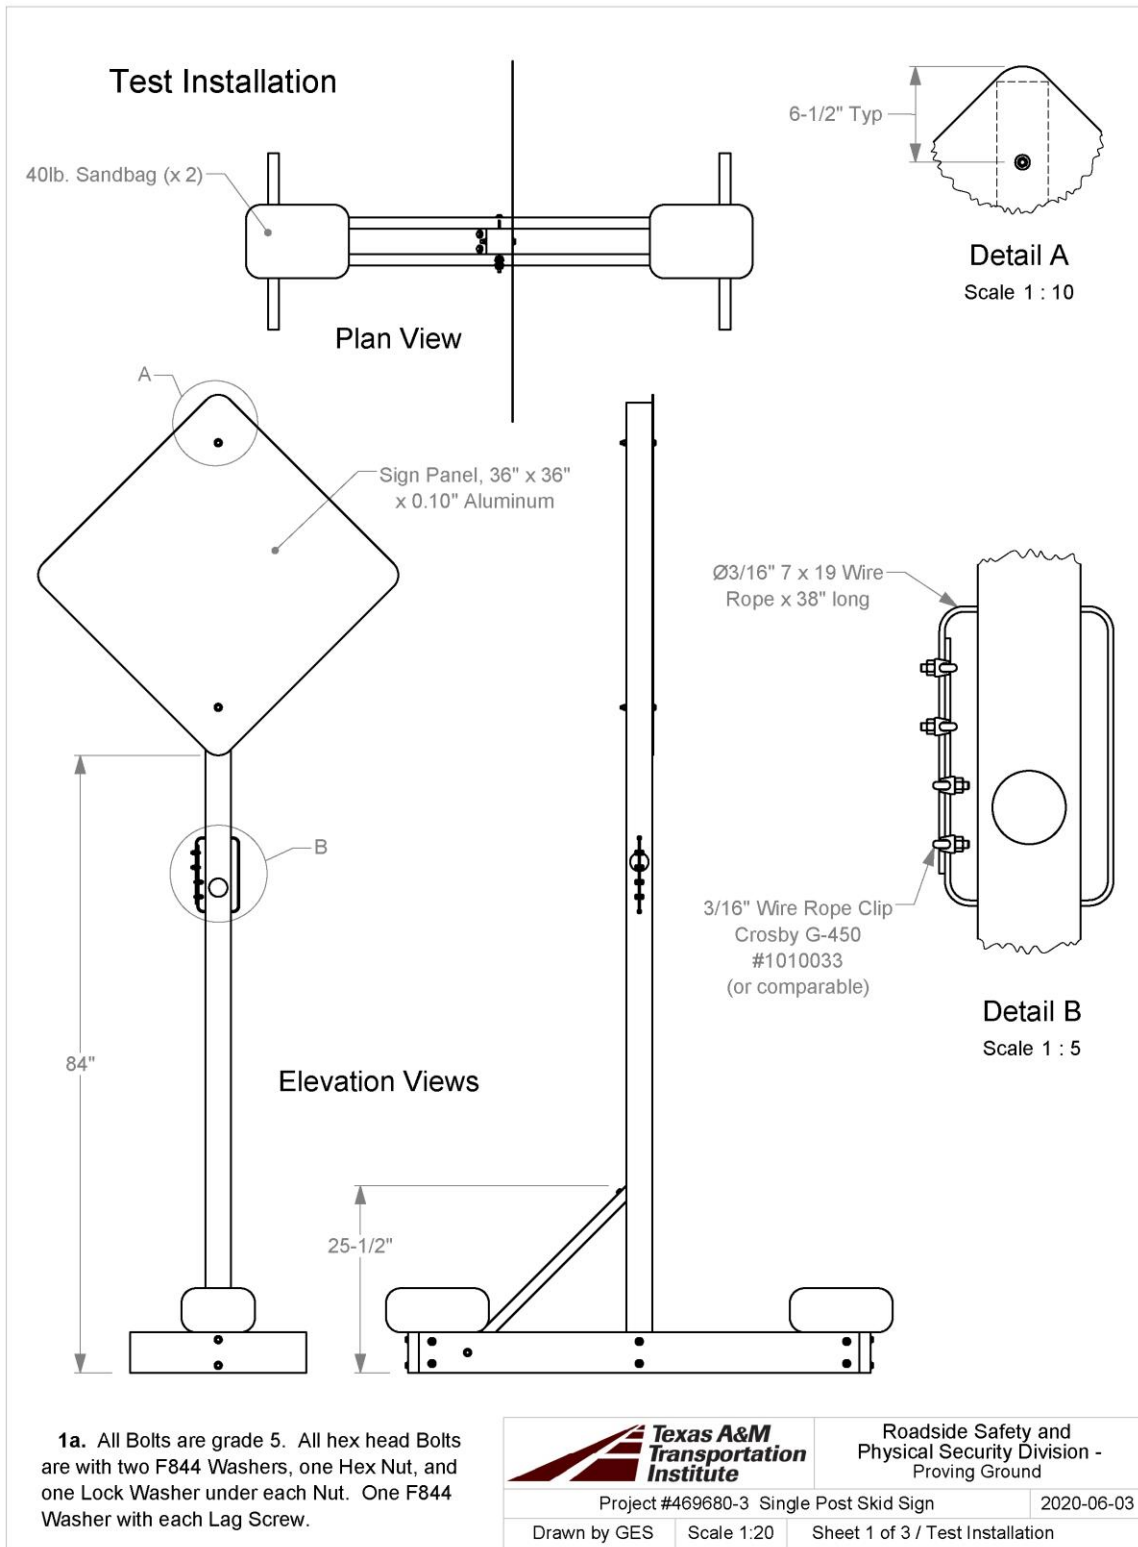
**Figure 4.1. Modified TxDOT Single Skid-Mounted Sign Support Details (Original) for Crash Test 469680-03-2.**

During Crash Test No. 469680-03-2, the sign panel contacted the roof of the 2270P vehicle, sliced a 22-inch-long hole in the roof, and penetrated the occupant compartment over the driver’s seat. Film analysis indicated that while the tether cable prevented the fractured segments of the support post from separating, the amount of slack in the cable delayed its effectiveness in influencing the trajectory of the connected segments. A decision was made to reduce the length of the tether cable and remove the excess slack to more quickly engage the hinge mechanism provided between the two fracture segments of the support post. *MASH* Test 3-72 at 90 degrees was repeated on the redesigned single skid-mounted sign support, as described in the next chapter.

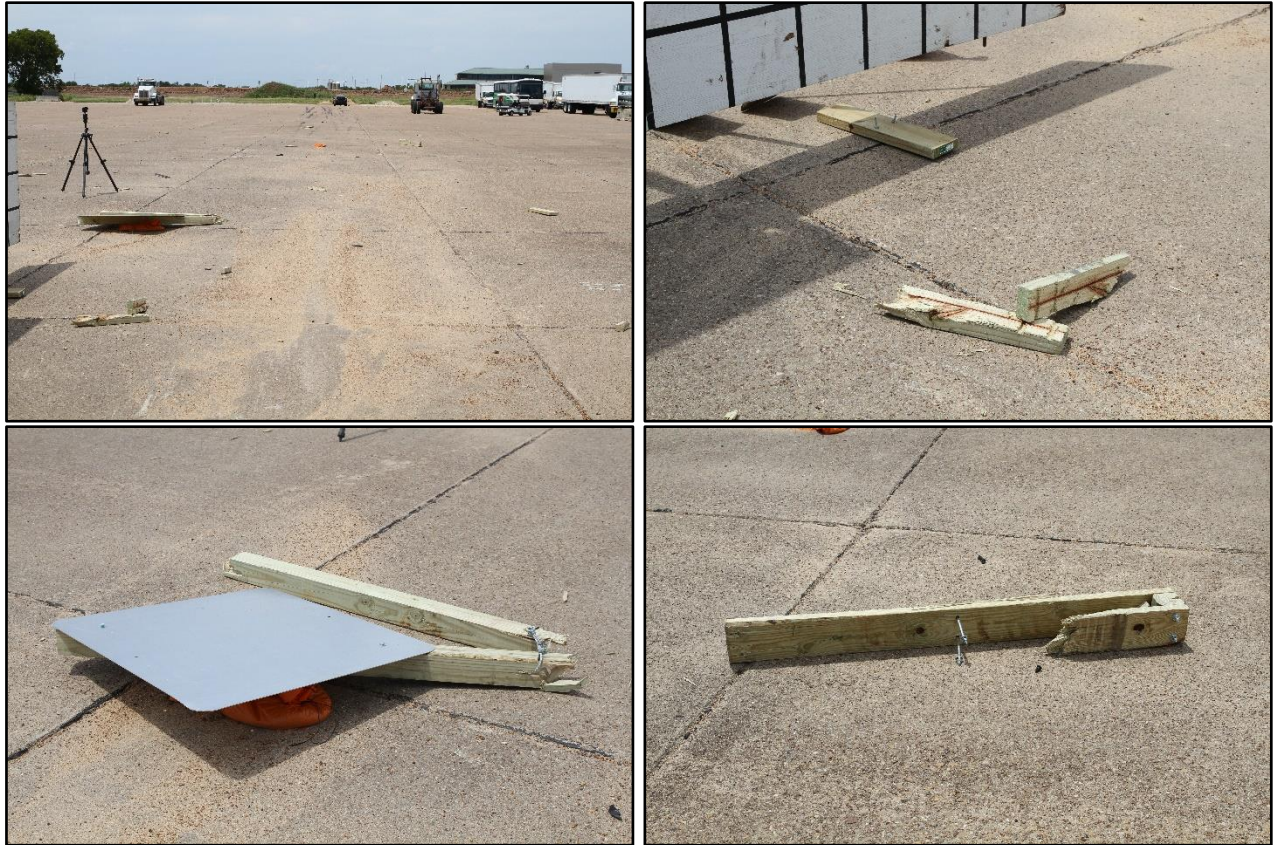
**Figure 8.3. Modified TxDOT Single Skid-Mounted Sign Support after Test No. 469680-03-1.**

Figure 8.3 shows the damage to the modified TxDOT single skid-mounted sign support. The sign support broke apart into multiple pieces, and the debris field was 19 feet to the left, 12.5 feet to the right, and 142 feet downstream of impact. The section of post attached to the sign landed 22 feet downstream and 5 feet left of impact.

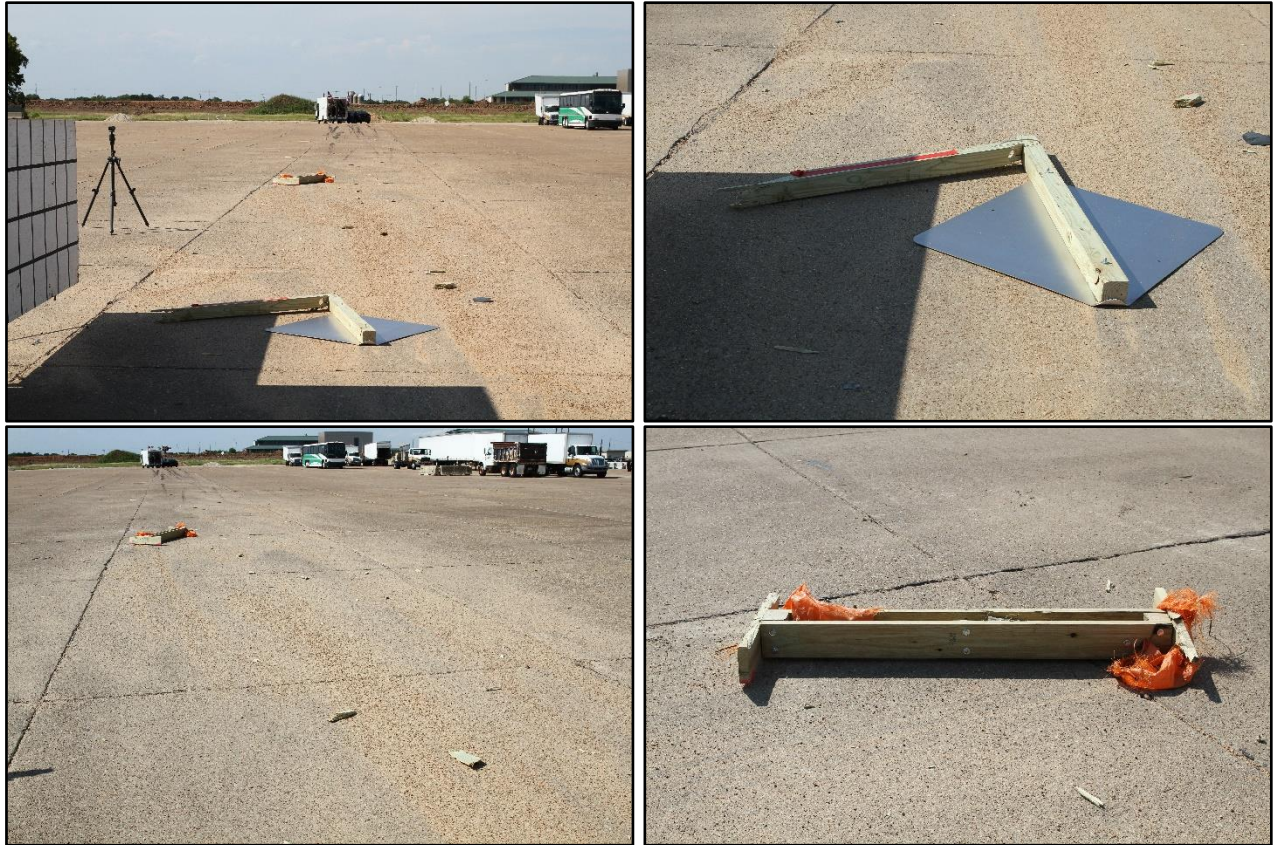
**Figure 9.3. Modified TxDOT Single Skid-Mounted Sign Support after Test No. 469680-03-3.**

Figure 9.3 shows the damage to the modified TxDOT single skid-mounted sign support. The sign panel and attached post segments landed 10 ft downstream and 3 ft to the left of impact. The base came to rest 65 ft downstream and 5 ft to the left of impact, and a 32-inch-long section of the wood brace landed 167 ft downstream and 6 ft to the left of the vehicle impact path.

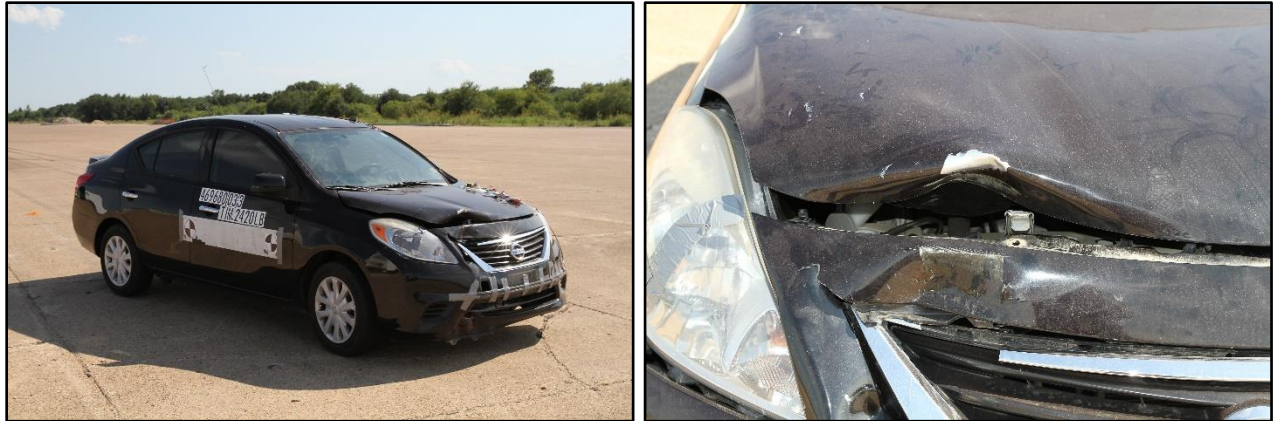
Figure 9.4. Test Vehicle after Test No. 469680-03-3.

Figure 9.4 shows the damage sustained by the vehicle. The front bumper and grill sustained a 24-inch  $\times$  4-inch  $\times$  1.0-inch deformation 13 inches to the right of the centerline of the vehicle. There was also a 4-inch  $\times$  4-inch deformation in the hood, which was also pushed rearward 2.0 inches. The lower radiator support was deformed. A small dent was noted in the oil pan; however, no fuel tank damage was observed. Maximum exterior crush to the vehicle was 1.0 inch in the front plane to the right of the centerline at bumper height. No occupant compartment deformation or intrusion was noted. Figure 9.5 shows the interior of the vehicle. Tables G.2 and G.3 in Appendix G.1 provide exterior crush and occupant compartment measurements.

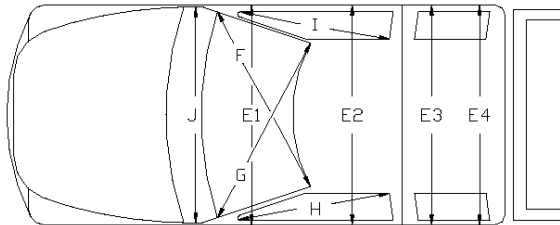
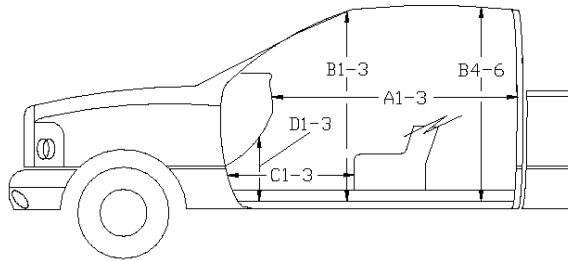
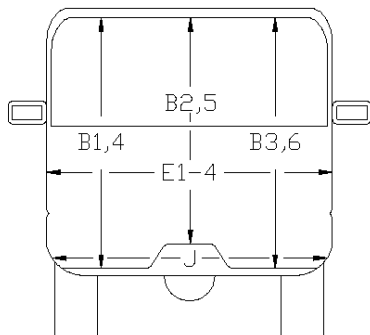
**Vehicle Roof Penetrated over Driver Seat**

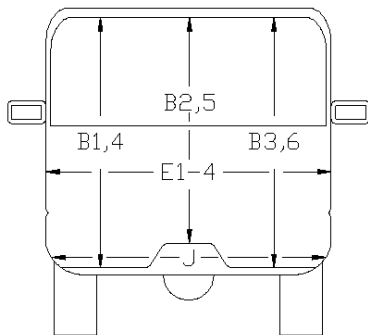
**Vehicle Roof Penetrated over Driver Seat**
