Evaluation of Roadway Concrete Barriers and Materials

Vista Shahriari, M.S.
Pavana Prabhakar, Ph.D.
Jose A. Pincheira, Ph.D.

University of Wisconsin – Madison
Department of Civil and Environmental Engineering

WisDOT ID no. 0092-19-03

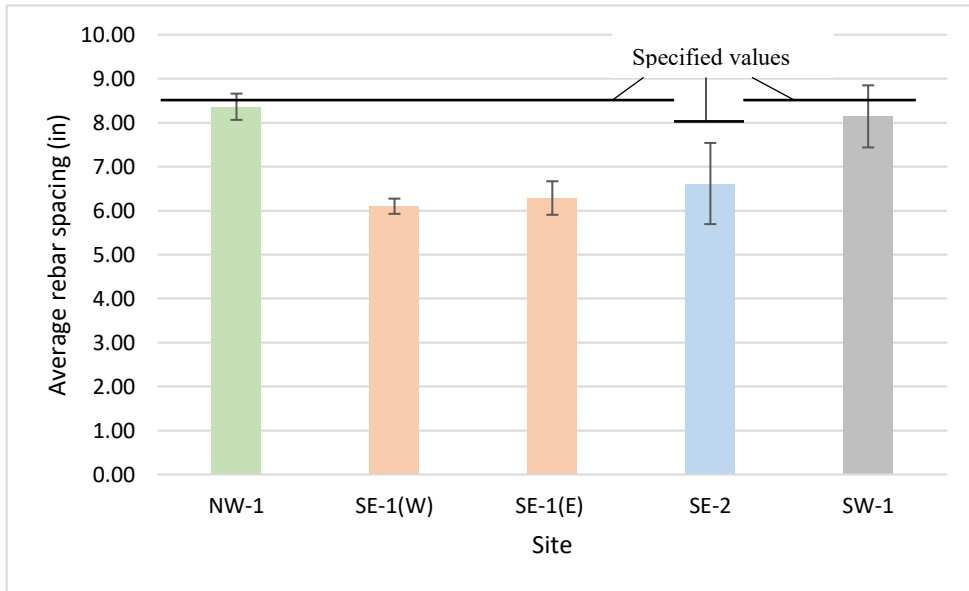
Figure 7.5: Average measured rebar spacing at different sites based on the GPR data

The average measured side cover at each site is shown in Figure 7.4. It can be seen that the actual bar cover is almost two times the specified value in most visited sites. This larger than specified concrete cover may be in part responsible for wider cracks on the barrier surface. The average measured rebar spacing at each site is shown in Figure 7.5. As shown in the figure, the average rebar spacing in all barriers was less than the specified value, particularly in sites SE-1 and SE-2.

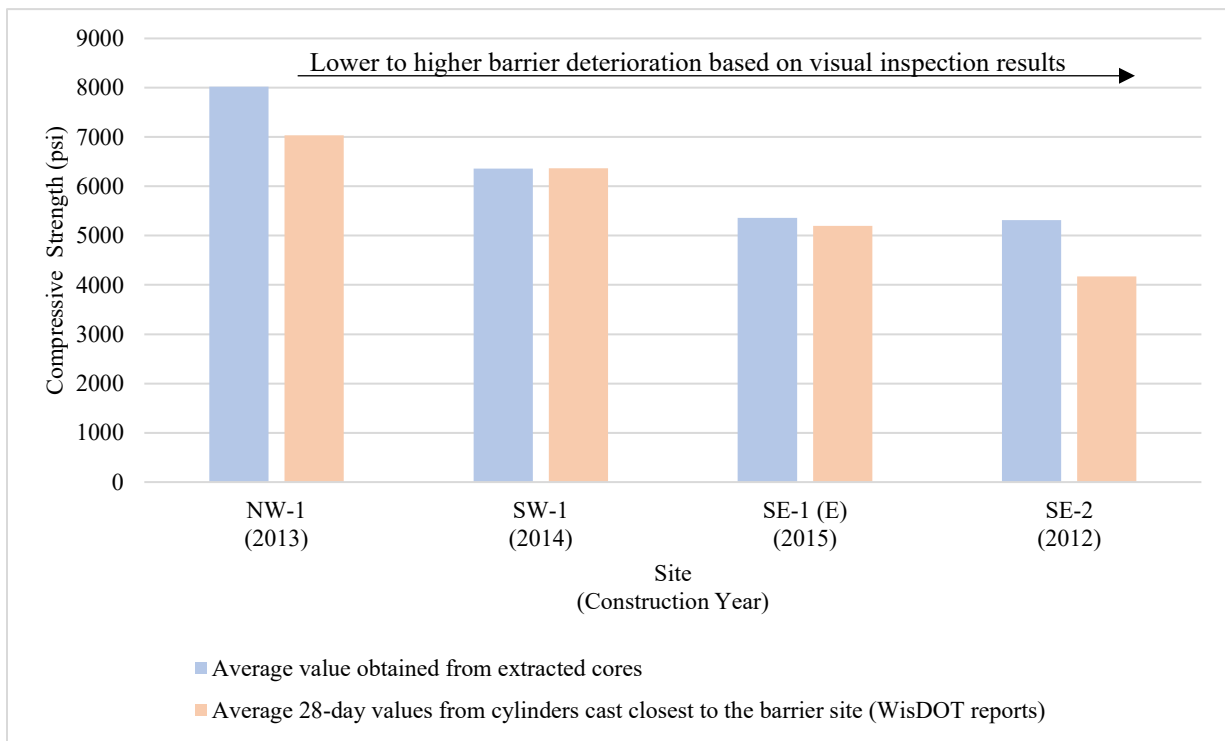
Figure 8.6: Measured compressive strength of the concrete

Results of the compressive strength tests performed in 2020 on the cores extracted in 2019 as part of this project are compared with the cylinder test data from reports by WisDOT (Figure 8.6). By comparing the results of this test with the visual inspection ranking, it can be seen that barriers that show less deterioration have concrete with higher compressive strength. In addition, the level of deterioration increases as the compressive strength decreases (Figure 8.6). More discussions about the results of this test are provided in section H.7 of Appendix H.
