Report No. UT-21.23

SALT LAKE CITY AIRPORT PARKING GARAGE VISUAL INSPECTION REPORT

Utah Department of Transportation
Research & Innovation Division

**Final Report
August 2021**

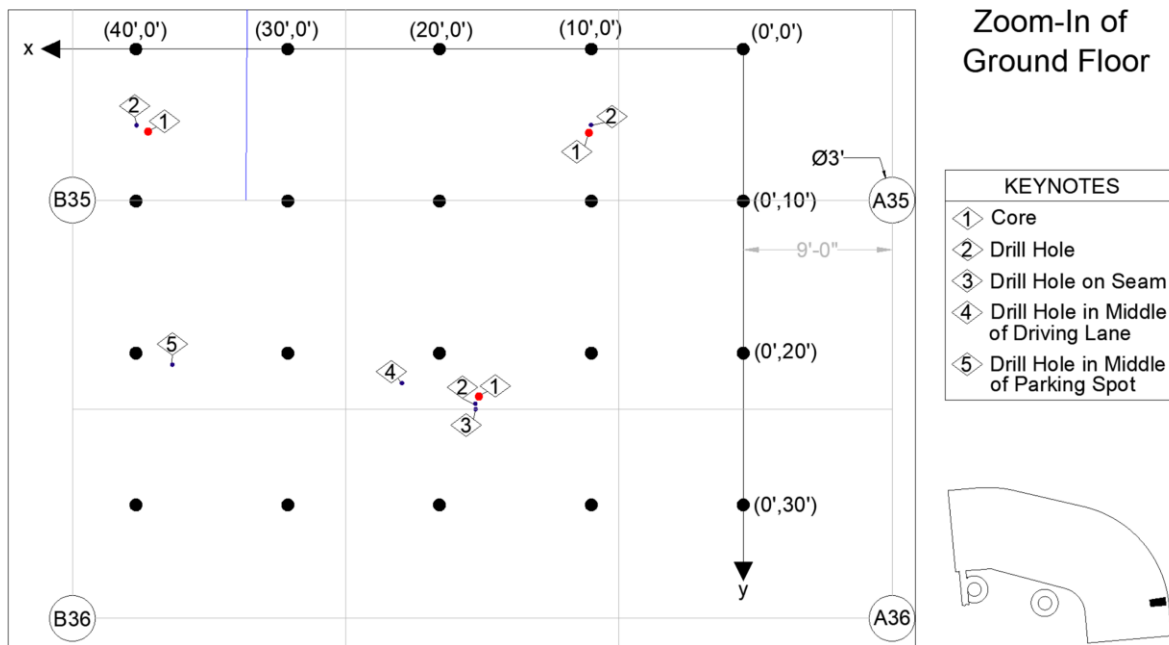
Figure 2-2 Zoomed-in view of data sampling area taken on the plain unreinforced concrete on the ground floor. The black dots were for Schmidt hammer readings; red dots for core sample locations; blue dots for chloride drilled sample locations; gray lines were saw-cut joints; and top-down cracking (blue line).

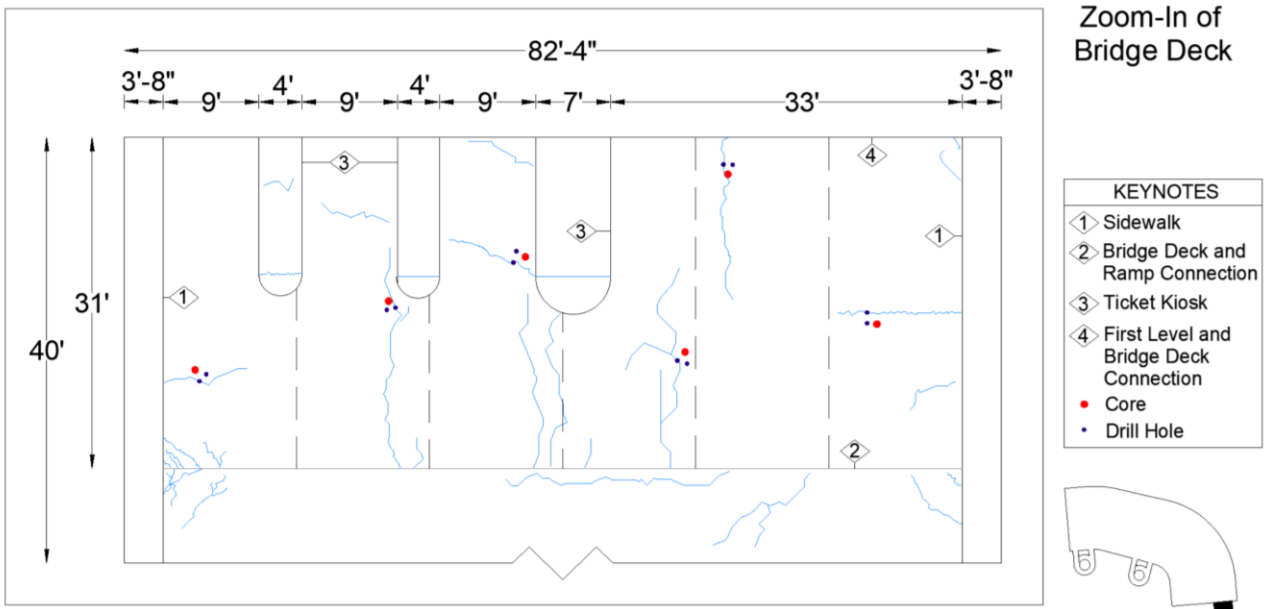
Figure 3-11 First floor entrance bridge detailed analysis site showing black dashed lines for the lane grid setup, red dots for core sample locations, blue dots for chloride-drilled sample locations, and top-down cracking (blue lines).

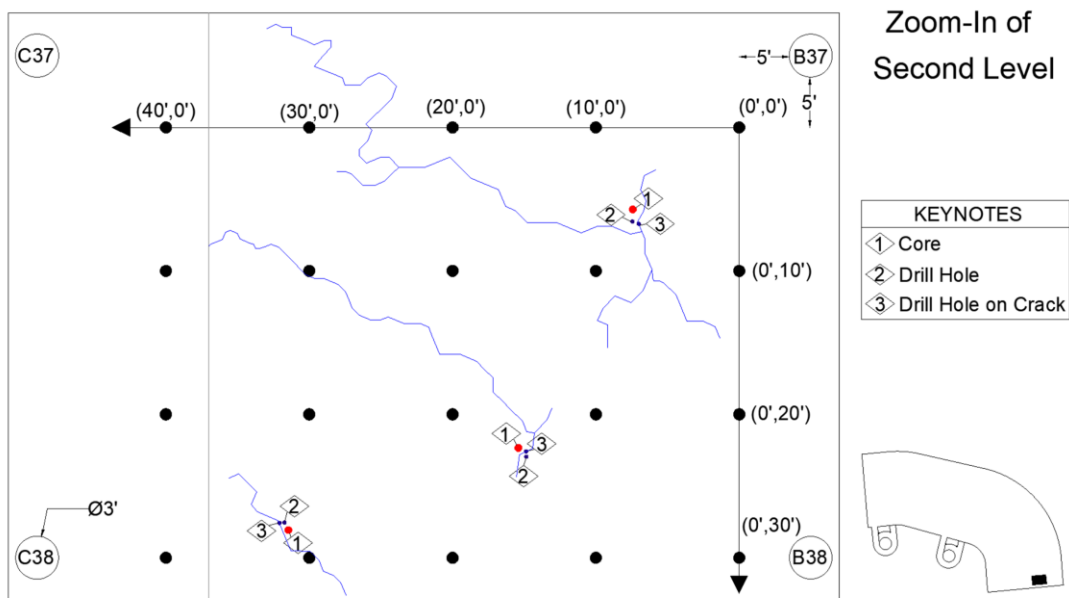
Figure 3-12 Second floor detailed analysis site showing the black dots for Schmidt hammer, cover depth, and VEI readings; red dots for core sample locations; and blue dots for chloride-drilled sample locations; and top-down cracking (blue lines).

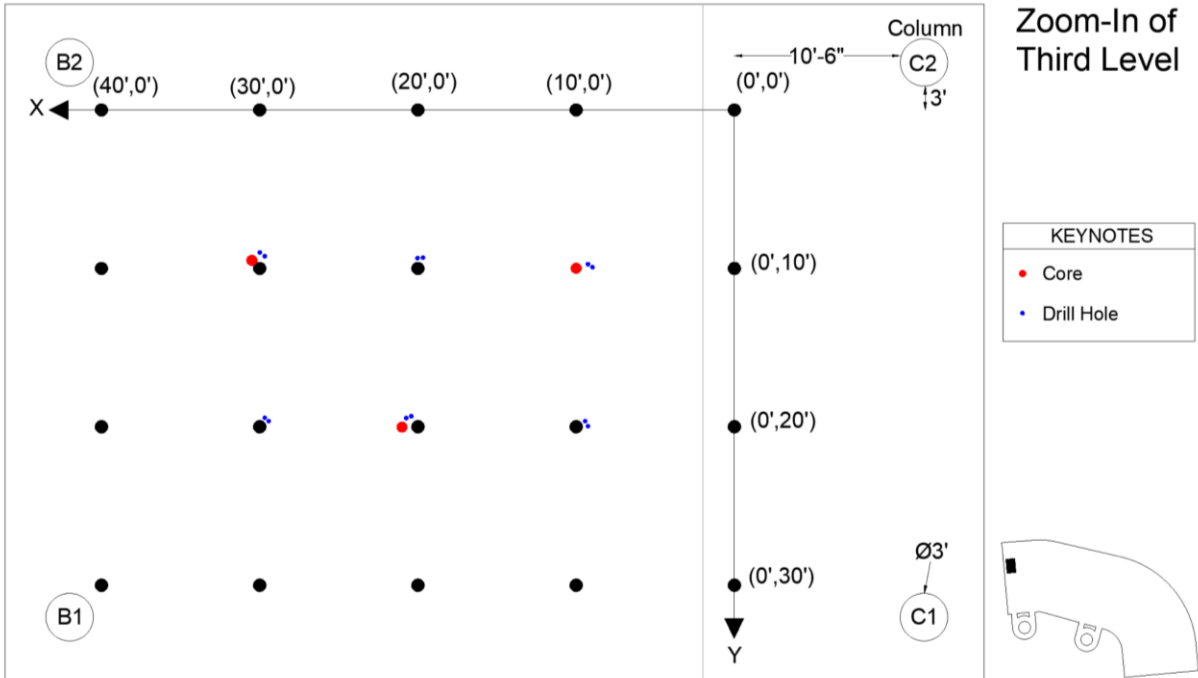
Figure 3-13 Third (top, covered) floor detailed analysis site showing black dots for Schmidt and cover depth readings, red dots for core sample locations, and blue dots for chloride-drilled sample locations. There were no cracks found in this site.

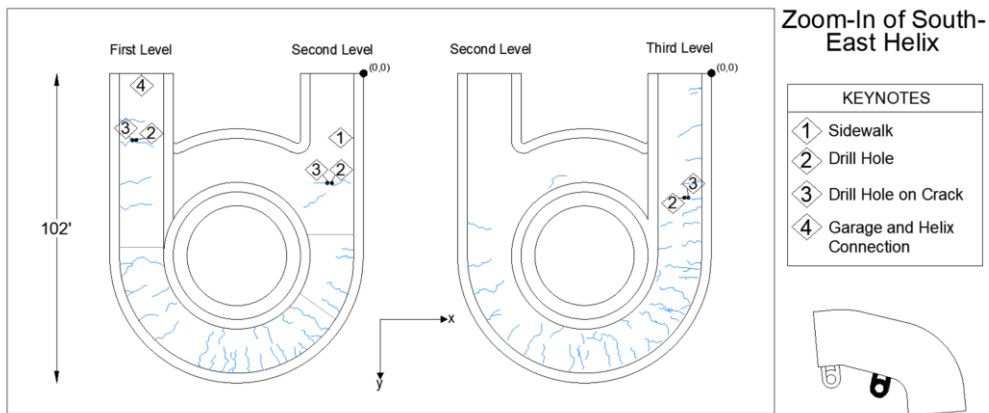
Figure 3-14 Helix (upward traffic, covered) floor detailed analysis site showing blue dots for chloride-drilled sample locations, and top-down cracking (blue lines). No cores were taken on the helix because of the inclined surface.
