Protecting Piers of Overhead Structures from Degradation Due to Snow and Ice Chemical and Material Usage Phase II

Project ID Number: 106177

April 2021

Final Report

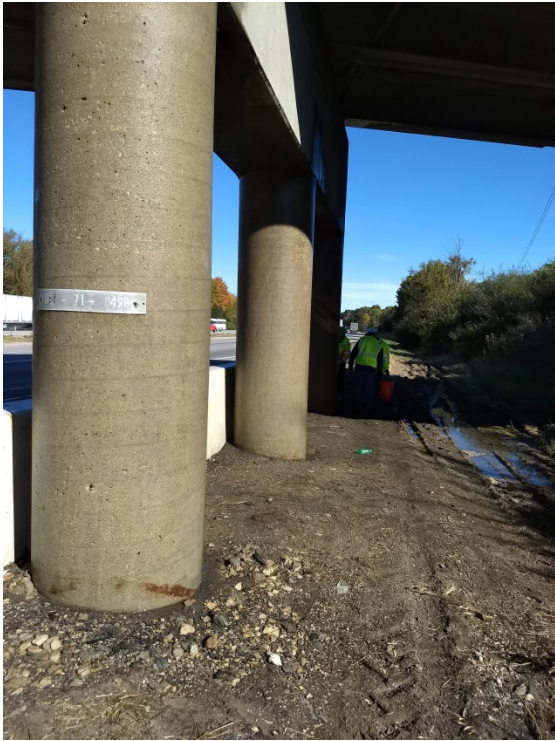
Figure C1 shows the DEL 71-498 bridge just prior to application of the coating. The southbound pier had a large spall on the center column where the reinforcing bar was exposed (Figure C2). Other than power washing the columns prior to application, no other surface preparation was used. The columns were washed just before application because the Creative Material primer is applied to wet surfaces. The product comes in two parts and was mixed according to manufactures' instruction. It was applied with paint rollers. In the spalled area, foam paint brushes where used to apply the material. The temperature varied between 40-50°F. The material has a pot life of about 1 hour.

Figure C 1 -DEL 71 498 before coating

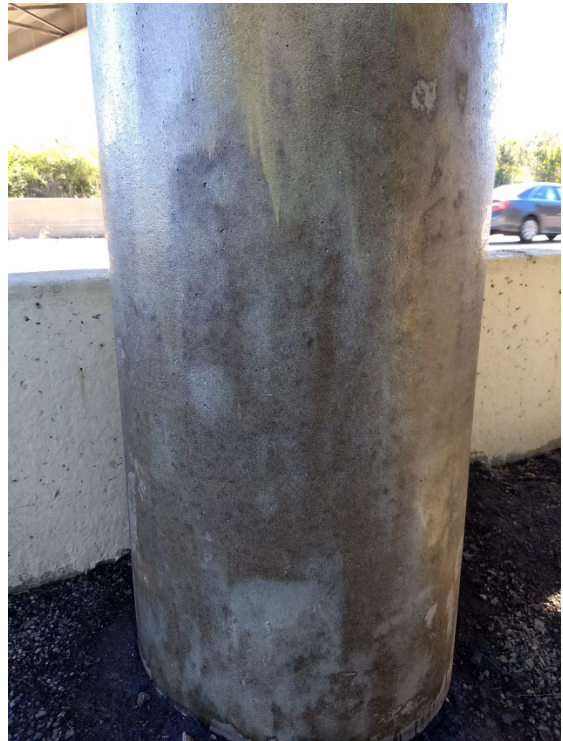
The primer was applied to the both the southbound and northbound pier columns on DEL 71-498. It took 1.5-2 hours for the primer to dry enough that the top coat could be applied. After the first application of the primer to the DEL 71-498 bridge, the research team noted a "mottled" appearance (Figure C3) in the primer. The manufacturer advised that this was probably due to differences in porosity in different areas of the concrete. A second coat was applied. Since this coat would not dry within before the ODOT work crews had to leave for the day, the top coating was delayed until 10/25/2018. The manufacturer said this was allowable as long as the top coat was applied within 24 hours.

Figure C 2 - Column with first coat of primer applied.

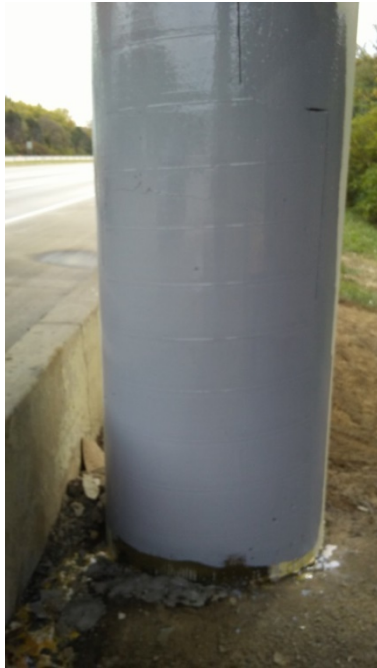
The Creative Materials product was used to coat a patch on the center column of the eastbound shoulder pier of the Gantz Road bridge over I-270 (FRA 270-960). The primer was applied on 10/25 and the top coat was applied on 10/26. Figure C4 shows the patch.

Figure C 4 Creative Material product applied on patch FRA 270 960

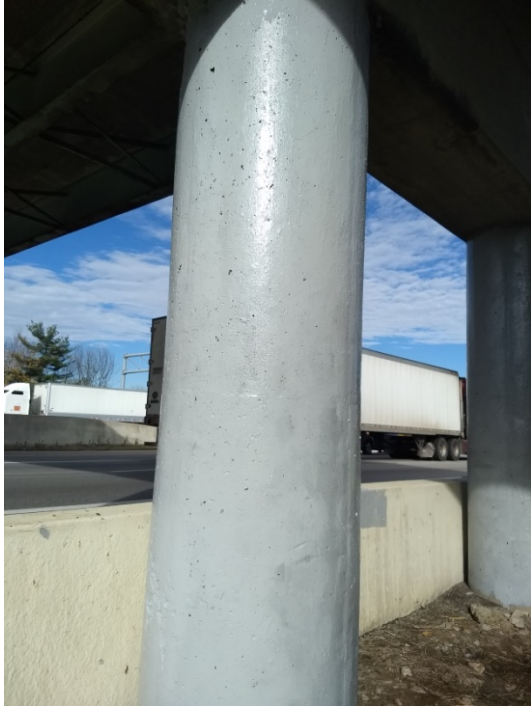
The Citadel material was applied to the northbound shoulder and southbound shoulder pier columns of the bridge over I-71 at Berkshire Road (DEL 71-1093) and the patch on the west column of the eastbound shoulder pier of the Gantz Road bridge (FRA 270 960) on November 7, 2018. Because this material must be applied to a dry surface, ODOT crews power washed the areas the day before application. The temperature was not recorded but the weather conditions were similar to those on October 25/26. Figures C5 shows the DEL 71-1093 bridge after coating. DEL 71-1093 also had a large spall on the center column of the southbound shoulder pier (Figure C6) Except for the previously cited problem that the summer rather winter material was supplied, there were no issues with application of this product. Figure C7 shows the coated patch on FRA 270-960.

Figure C 6 - - DEL 71-1093 with coating

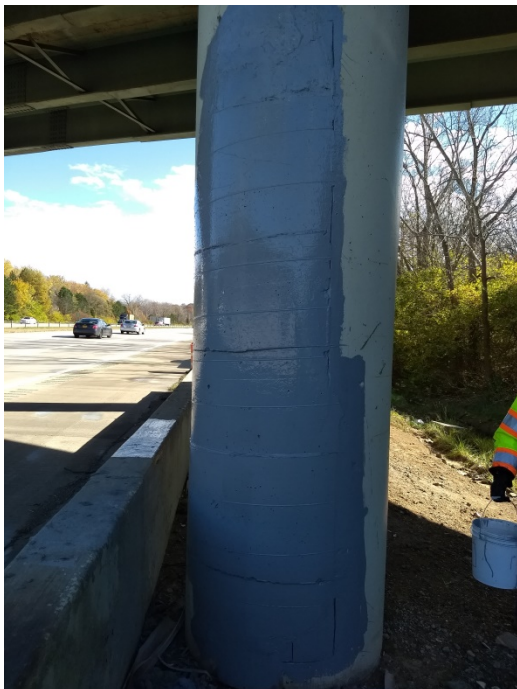
Figure C 7- Patch on FRA 270 960 coated with Citadel product

The patches on the FRA 270 960 (Gantz Road) bridge were evaluated. Visual inspection showed that the coatings appeared intact and looked the same as when they were installed. However, when the “V” notch test was applied, both materials easily peeled off the patch. It was noted that patching material was very dense and smooth. It seemed that the lack of adhesion was due to the smoothness of the surface. Recall that the manufacturers recommend roughening the surface by sandblasting or some other method. That may have helped adhesion in this case. However, there was no sign of deterioration in the patch and the lack of adhesion was only apparent when an overt attempt was made to remove the material. Figures C8-11 show the results.
