JRC2021-1075

UPDATED FUEL TANK PUNCTURE SURVEY: 1995-2020

Karina Jacobsen

Volpe National Transportation Systems Center
United States Department of Transportation
Cambridge, Massachusetts, USA

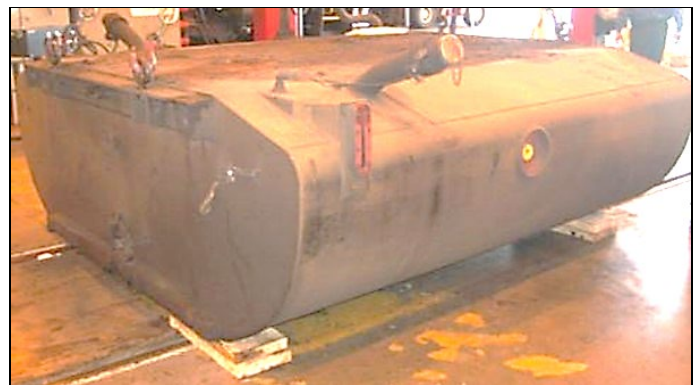
Figure 9. Concord, MA, Locomotive Fuel Tank

On September 5, 2010, an Amtrak commuter train traveling through Concord, Massachusetts received a warning in the locomotive cab that fuel was being lost. The train was taken out of service. Upon inspection, a puncture was discovered on the bottom surface of the locomotive fuel tank [7]. The locomotive was transported to Massachusetts Bay Transportation Authority's Boston Engine Terminal in Somerville, MA.

The fuel tank involved in the puncture incident is shown in Figure 10. A detailed inspection determined a single puncture in the center lobe of the bottom of the tank; the size, shape and location are shown in the photos of Figure 11. As there had been nothing unusual about the commuter rail operation when the damage occurred, it was presumed that a piece of debris may have been kicked up and struck the bottom of the fuel tank. Striation marks that spanned from front to back of the tank led up to the puncture indicating that an impact object dragged along it until it puncture the bottom surface at the location adjacent to the internal baffles.

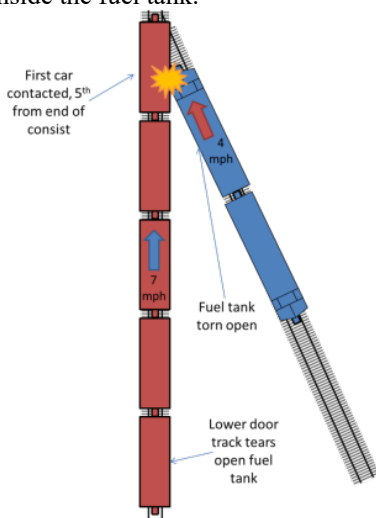
Figure 14. Schematic of Raking Impact in Oak Island Yard in Newark, NJ

On April 28, 2012, two coupled CSX locomotives rolled down a siding and into a switch, sideswiping a freight consist traversing the main line. This incident occurred in the Oak Island Rail Yard in Newark, New Jersey. As illustrated in Figure 15, the impact scenario created an oblique raking impact between the two trains. The main line freight train was traveling at around 7 mph with the fifth to last freight car of the consist on the switch at the moment the runaway two-locomotive consist rolled through the switch at about 4 mph. The impact caused the locomotives of the runaway consist to derail and the outside rail of the siding rolled outward. As the freight train continued along the tracks, the right side doortrack of a boxcar (the last freight car) impacted the left side of the lead runaway locomotive fuel tank, dragging along the tank [9] and piercing into it. As can be seen in Figure 16, the fuel tank puncture extends along nearly the entire length of the tank. The end sheet at the lead end of the fuel tank, presumably the primary impact point, was torn away from the side sheet of the fuel tank at its weld. The door track of the trailing freight car was broken with part of it recovered from inside the fuel tank.

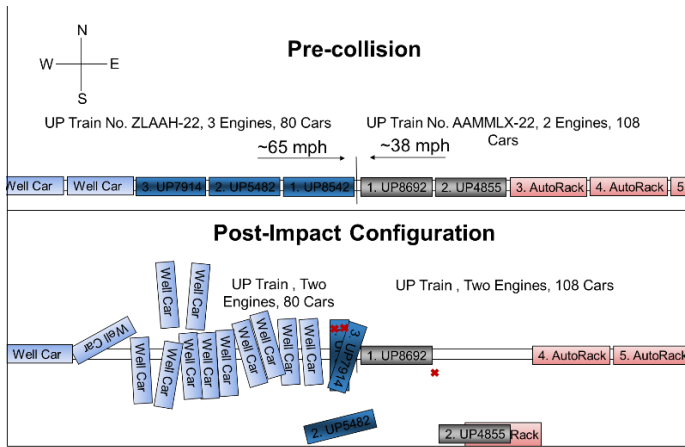
Figure 16. Illustration of Goodwell, OK, Train Accident Pre- and Post- Collision (Positions Estimated and Dimensions Not to Scale)

On June 24, 2012, two UP freight trains collided head-on in Goodwell, Oklahoma at a closing speed of nearly 100 mph. The eastbound train was traveling at about 65 mph, made up of three locomotives and 80 cars and operated by an engineer and conductor in the lead locomotive cab. The westbound train was traveling at about 38 mph, made up of two locomotives and 108 cars and operated by an engineer and conductor in the lead locomotive cab. During the high speed impact event, the three locomotives leading the eastbound train derailed along with the preceding 24 cars. The two locomotives leading the westbound train derailed along with eight other cars of the westbound train. The post-collision scene consisted of the westbound train in a large pile-up with nearly two dozen cars in large scale lateral buckling, as shown in Figure 17. Not shown in the schematic is the large debris field caused by cargo carried in derailed freight cars. The conductor of the westbound train was able to jump from the train just prior to the collision [10]. The remaining three crew were killed.

As is seen in other accidents, fuel tank punctures are common in collisions and derailments where the railcars go into large scale lateral buckling. As cars roll over and begin to pile up, the fuel tank becomes more exposed to impacts from other railcars or debris. The accident in Goodwell, Oklahoma highlights this. Multiple locomotive fuel tanks ruptured, released diesel fuel and led to a fire that burned for more than 24 hours. Three of the five freight locomotive fuel tanks were punctured as shown in Figures 18, 19, 20 and described below.

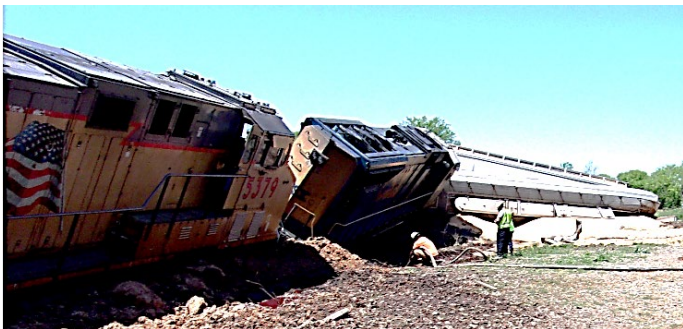
Figure 24 UP Locomotive 5379

On April 9, 2019, a Union Pacific freight train collided with a tractor-trailer at a grade crossing near Caspiana, Louisiana. The freight train consisted of three locomotives and 106 loaded freight cars. During the impact, the three lead locomotive derailed along with the preceding 20 freight cars. The locomotives plowed through gravel and dirt coming to rest at an angle partially down an embankment with their underframes buried in the gravel and mud. As the locomotives derailed, the preceding freight cars experienced large scale lateral buckling causing at least the eight of them to pile up and spilling their contents, mostly grain and dirt. Figure 24 shows the final position of the lead locomotives. Figure 25 shows a photo looking back along the consist with the second and third locomotives at an angle along the embankment and the trailing freight cars having rotated nearly 90 degrees from their original position of travel. The fuel tank of the lead locomotive was breached, most likely from impacting or dragging across a rigid
