Federal Railroad
Administration

Research Results

RR08-17
December 2008

Gas Pressure Welds and Hollink Slot Welds Testing at the Facility for Accelerated Service Testing

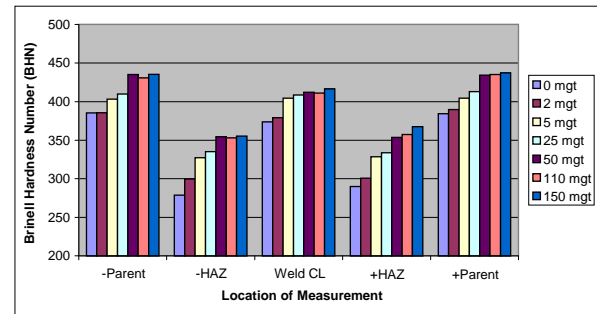
Figure 3. GPW Average Running Surface Hardness Measurements.

centerline. Figure 3 shows the measured readings for each location and tonnage through 150 MGT.

At 150 MGT, the TTCI rail flaw detector car indicated a flaw in GPW No. 08. On the gage face of the weld at a depth of 0.3 inch, examination revealed 3- by 1-inch internal shelling. The weld was loosely barred with a special insulated bar to allow for monitoring of flaw growth. Within 5 MGT, the flaw developed a vertical component near the weld centerline comprising approximately 6 percent of the railhead region. After a total of 15 MGT from the first detection, the shell grew to 5 inches long by 1.75 inches wide and the vertical component had grown to 17 percent of the railhead. The weld was removed at 165 MGT.
