Evaluation of Roadway Worms/Distortions

Final Report

Prepared by:
Applied Research Associates, Inc.
430 W 5th Street, Suite #700
Panama City, Florida 32401
850-914-3188 / 850-914-3189 Fax

Contract No. BE491

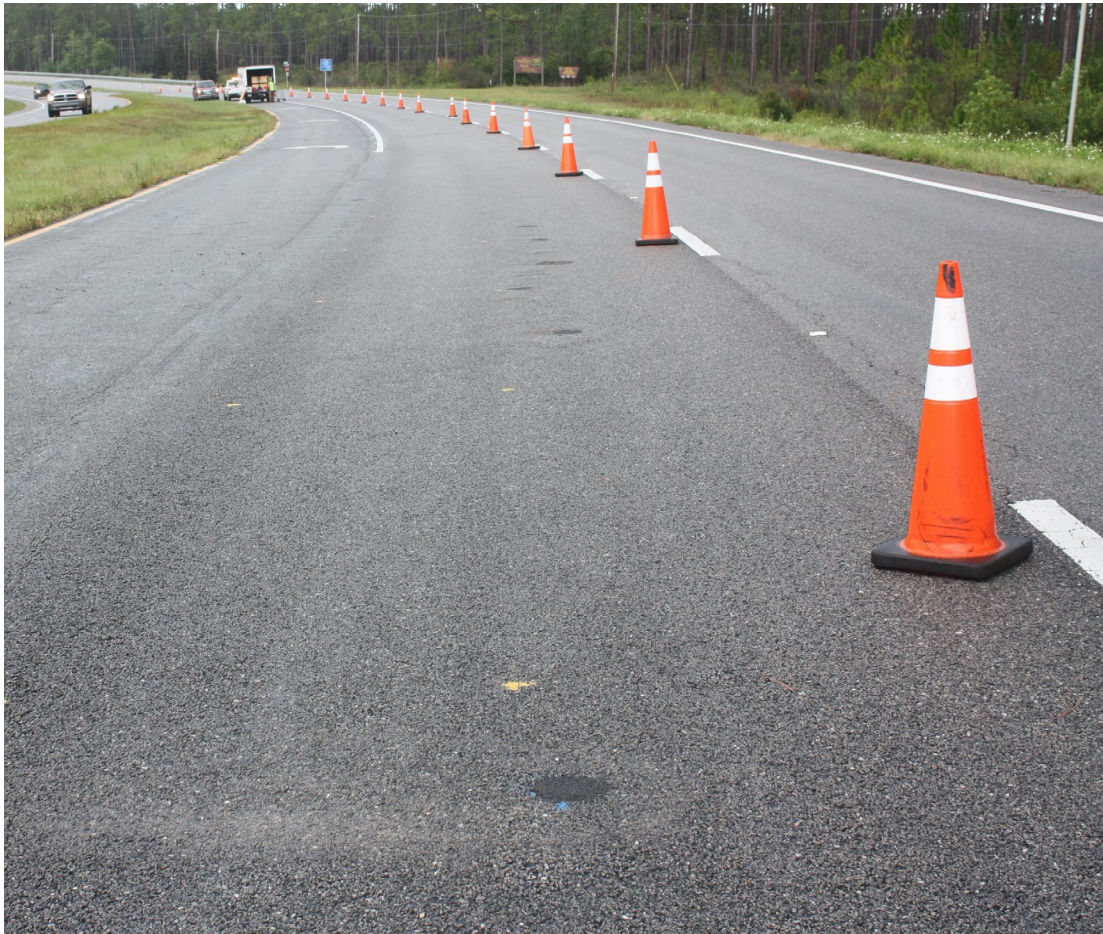
Figure 3-3. SR 79 Roadway Overview

No separate, discrete area was available for a control section. The selected control section with no visible surface worm distress was limited to a 310-ft segment that begins 243 ft south of the northern test section boundary and ends 553-ft south of the northern test section boundary. The worm distresses are prominent in magnitude and density, occurring as both round and roughly rectangular in shape (Figure 3-4). The roadway surface is an open-graded friction course (OGFC). The worm distresses ranged in height from approximately 0.25 to 0.5 in. The area of the project studied is composed of a superelevated section of roadway where worm distresses increase in density with lanes at lower elevation. The most severe worm distresses were observed in the turning lane at the lowest elevation point. No standing water or drainage issues were observed.

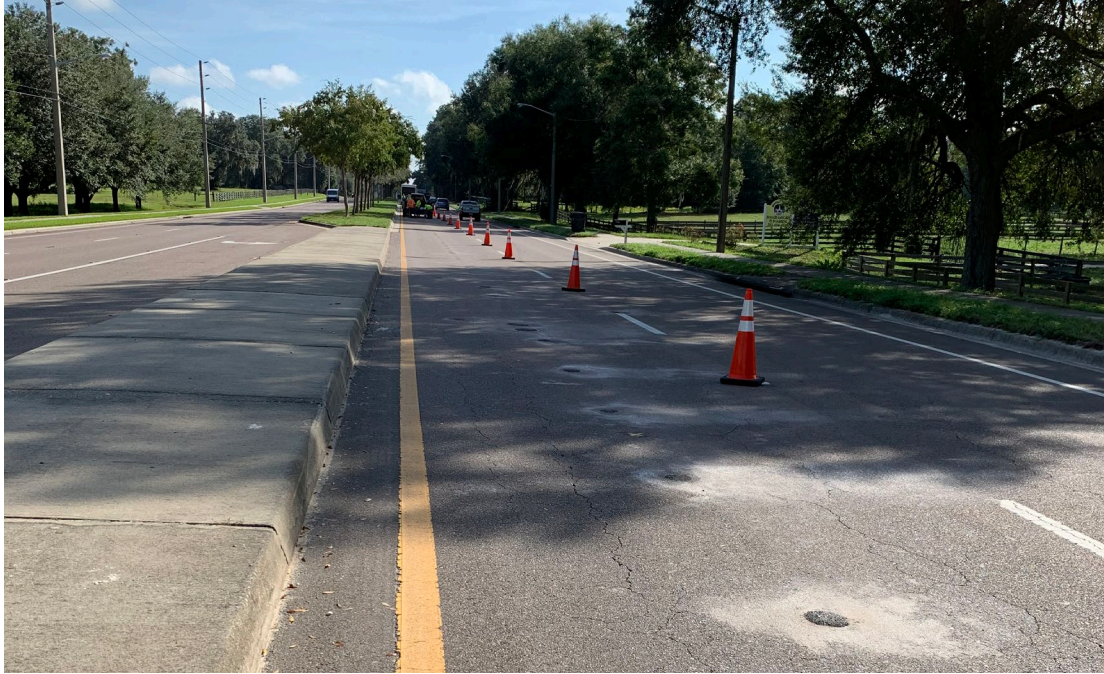
Figure 3-5. SR 26 Roadway Overview

Worms are present in un-trafficked areas of the lane but primarily between the wheel paths. A greater density of the worm distress is present where the longitudinal crack component of block cracking occurs (Figure 3-6). The research team originally assumed the presence of cracking would provide relief for the mechanism causing worms; however, this does not appear to be the case. Worms occur on the site despite there being a substantial amount of age-related cracking on the pavement surface. The roadway consists of 12-ft lanes and a divided median. Curb and gutter are present throughout. A cross-slope drains water from the inside lanes to the outside lanes. The cross-slope ranges from 1.3% to 2.3% in the worm section and 0.8% to 2.9% in the control section. No standing water or drainage issues were observed.

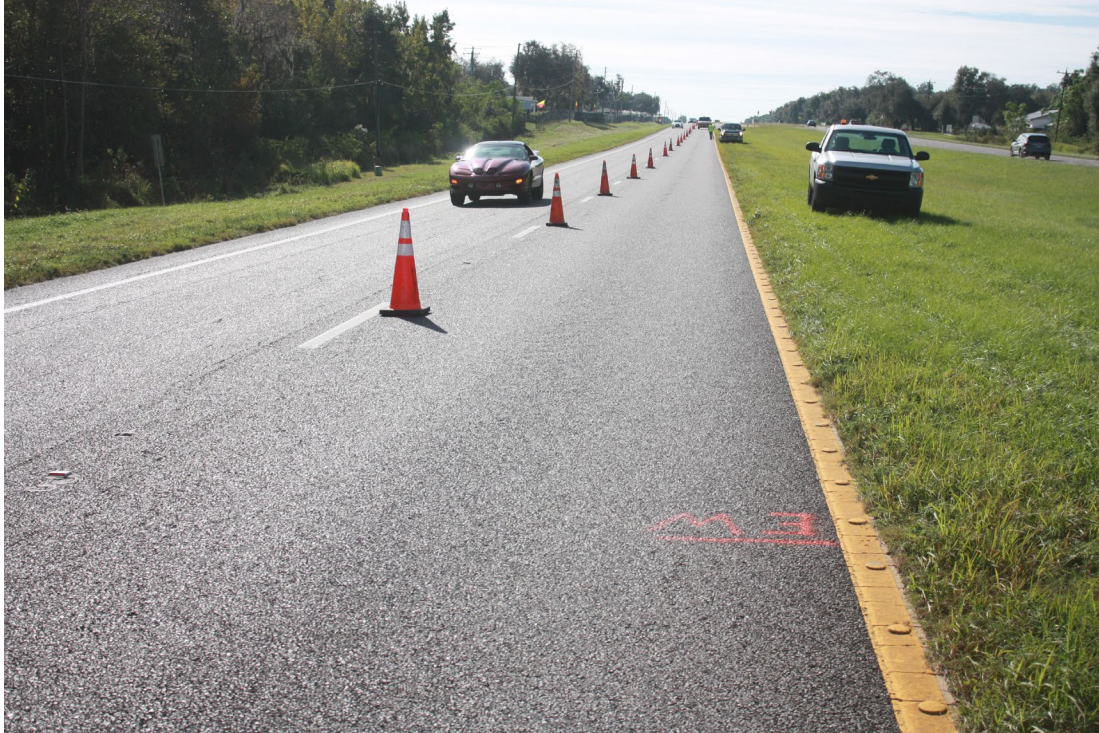
Figure 3-9. US 17 Roadway Overview

The worm distresses occur both as round and roughly rectangular in shape (Figure 3-10). The roadway surface is an OGFC. The worm distresses ranged in height from approximately 0.25 to 0.5 in. The control section is at a higher elevation on a vertical curve. The severity of worm distress increases in areas of lower elevation. The roadway consists of two 12-ft lanes. The centerline is crowned. Cross slopes range from 1.1% to 3.1% in the worm section and 1.2% to 2.6% in the control section. No standing water or drainage issues were observed.

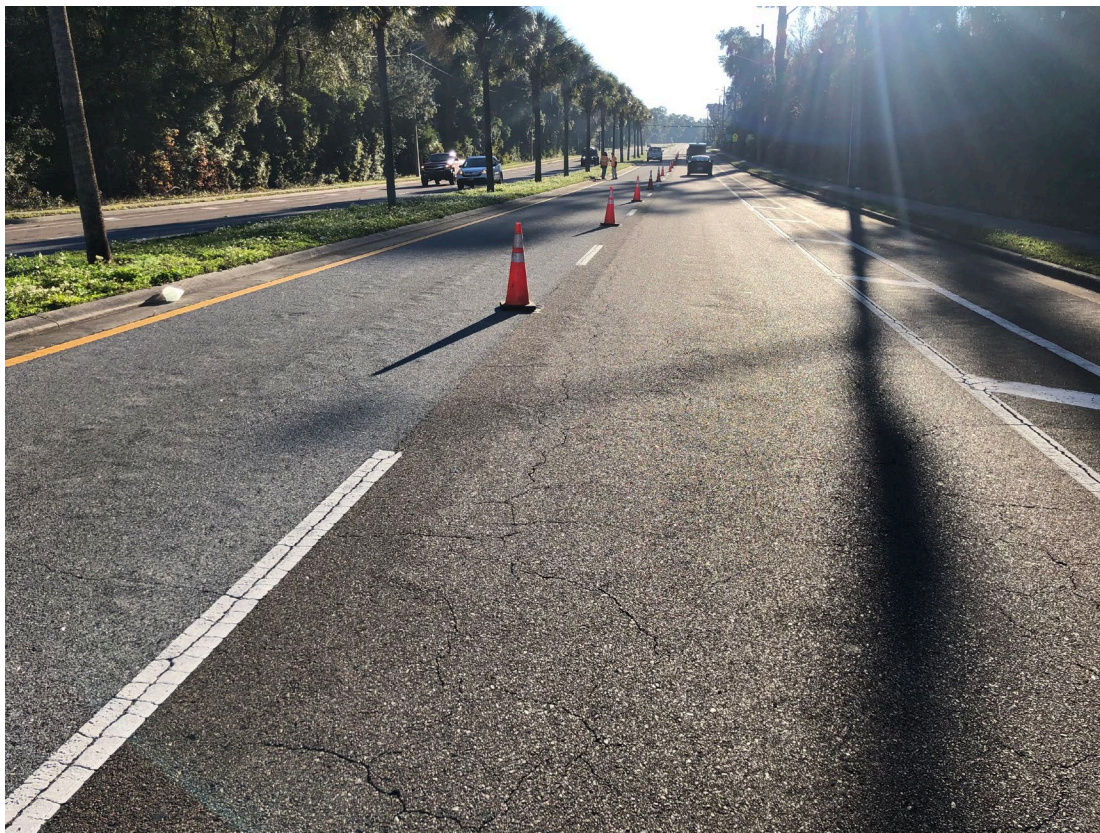
Figure 3-11. SR 20 Roadway Overview

This roadway features two different dense-graded asphalt (DGA) surface mixes. Both lanes exhibit worm distresses, indicating worm distress may not necessarily be being associated with factors related to the top AC lift. Worm distresses are not considerably severe (< 0.25 in tall) and occur infrequently. No worm distresses were observed over 390 ft of the 581-ft test section. Figure 3-12 presents a close-up of a worm distortion on the left edge of the worm section. The roadway consists of 12-ft travel lanes, with a 5-ft gore area separating the mainline from a 6-ft parking lane. Curb and gutter are present throughout. A cross-slope drains water from the inside lanes to the outside lanes. The cross-slope ranges from 1.6% to 2.7% in the worm section and 1.9% to 2.8% in the control section. No standing water or drainage issues were observed.

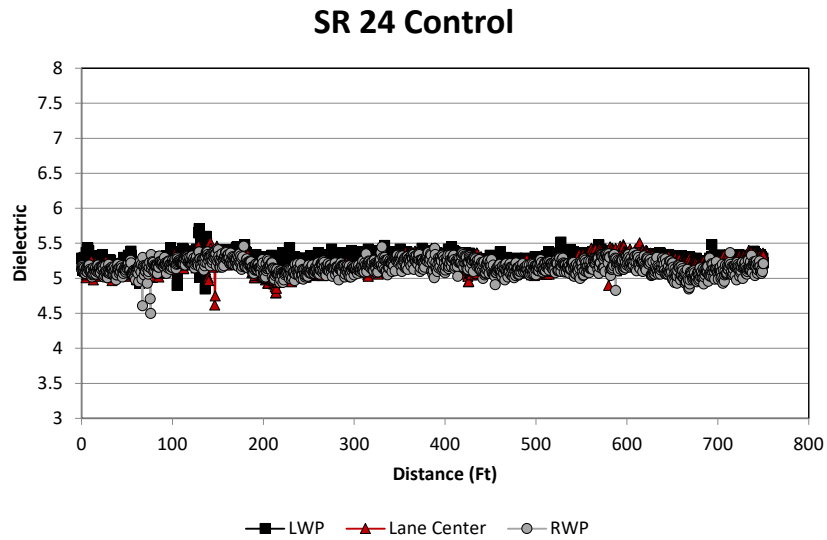
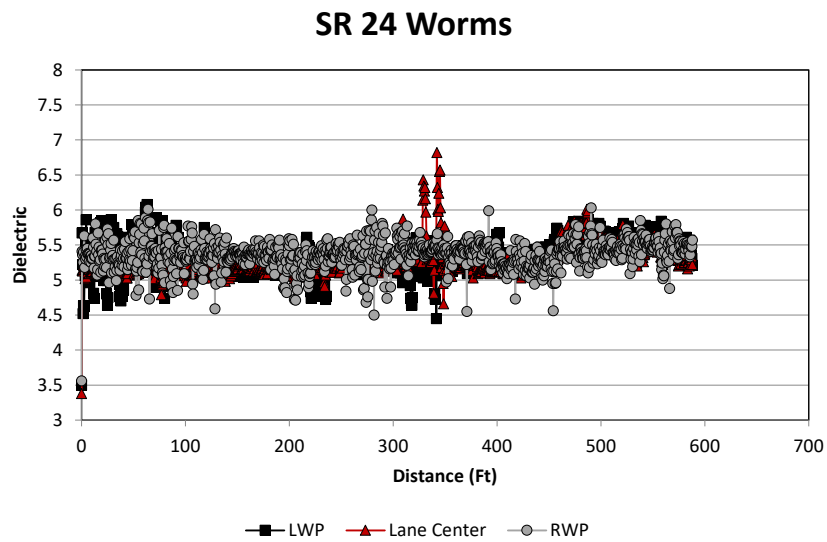
Figure 4-1. Dielectric Profiles from SR 24 (a) Control and (b) Worm Sections

With the exception of SR 79, the PaveScan GPR data was collected from both the control and the worm sections of all field sites. The PaveScan data was collected with a total of three GPR antennas located at both wheel paths (outside antennas were positioned four feet from pavement edge lines) and at the lane center. Figure 4-1 through Figure 4-4 show the dielectric profiles collected from the respective sections using PaveScan. These figures clearly show that the dielectrics from worm sections exhibit higher variability (i.e., inconsistency) compared to the control sections. Moreover, these figures generally indicate that the highest variability within the worm sections is observed from the lane center. This indicates that the wheel paths of worm sections may have been compacted by the driving traffic, leaving more inconsistency in the lane center where lower density may exist. The variability or inconsistency in the SR 20 worm section was less pronounced than the other three roadways; however, this observation was consistent across all sites.

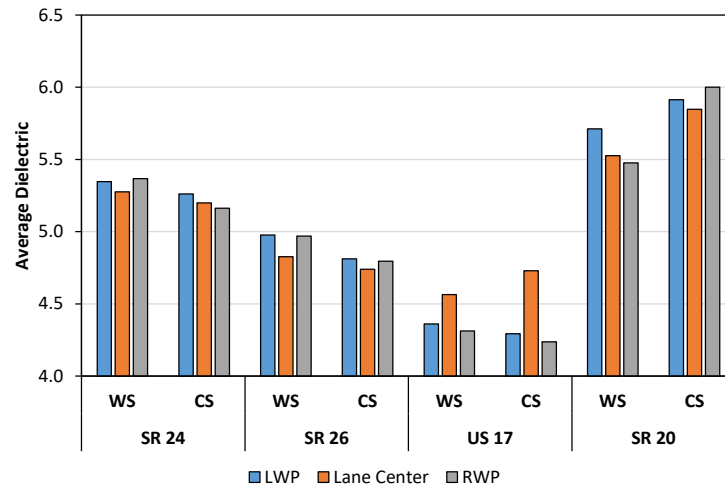
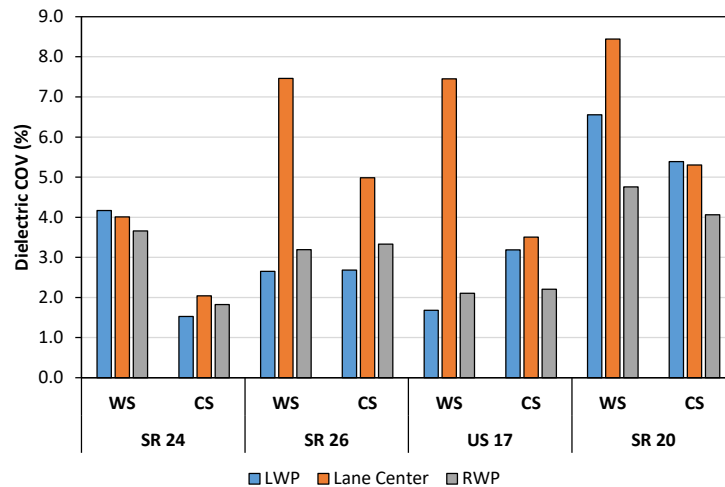
Figure 4-5. Dielectric Summaries: (a) Mean and (b) COV

Figure 4-5 shows a summary (i.e., mean and coefficient of variation [COV]) of the dielectrics obtained from the respective field sites. Figure 4-5(a) shows that higher mean dielectric values are seen in the worm sections of SR 24 and SR 26, while the trend is reversed for US 17 and SR 20. As such, the trend of the mean dielectric values is not quite conclusive. However, Figure 4-5(b) clearly shows that the worm sections generally exhibit higher variability, especially within the lane center where the asphalt was not compacted by traffic.

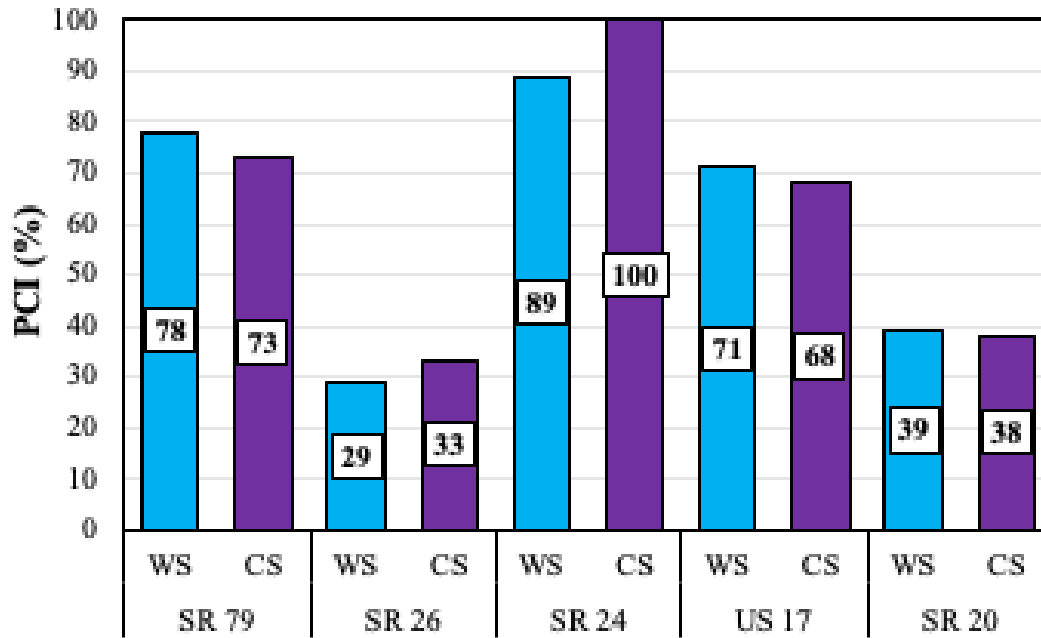
Figure 4-6. Overall PCI

The overall PCI values for the five roadway sections evaluated in this study are presented in Figure 4-6 and range from 29 to 100. Contrary to expectations, three of the five worm sections (SR 79, US 17, and SR 20) exhibited higher PCI values than the control sections. The difference in PCI between worm and control sections was minimal and ranged from 1 to 5 PCI points on SR 79, SR 26, US 17 and SR 20. The largest difference in condition was observed between worm and control sections of SR 24, where the control section carried a PCI of 11 points greater than the worm section. The SR 24 roadway was also in the best overall condition of the five projects, according to PCI. The only distress observed in the SR 24 control section was 16 ft of low-severity longitudinal and transverse (L&T) cracking. In contrast, there was 375-ft of L&T cracking in the worm section. A total of four distress types were observed across all the projects: L&T cracking, alligator cracking, rutting, and block cracking. All block cracking and rutting observed was of low severity. Low-severity and medium-severity L&T cracking and

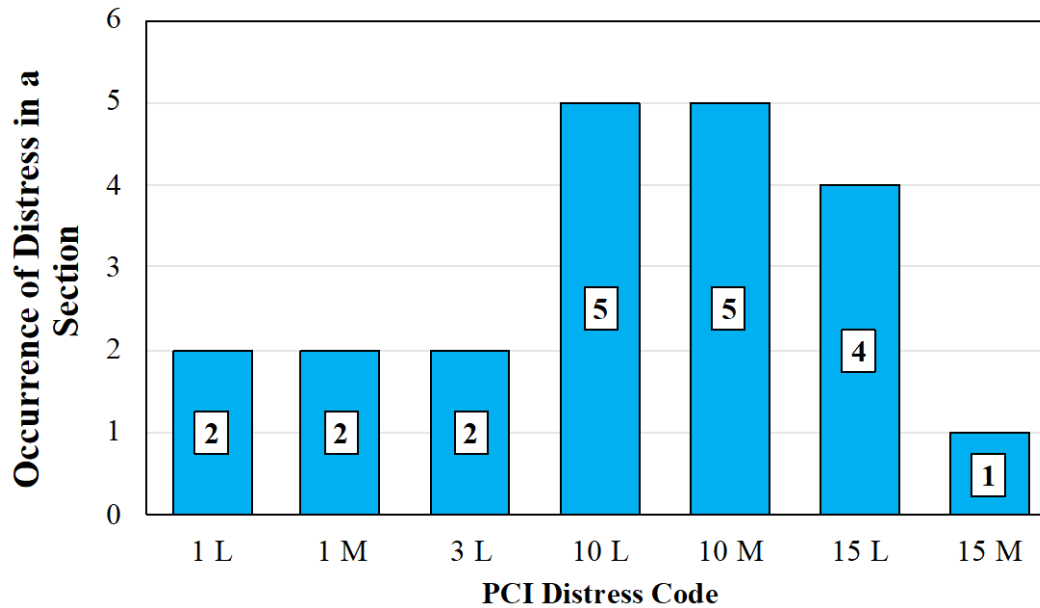
Figure 4-7. Worm Section Distress Occurrence

alligator cracking were also observed on each roadway. Histograms provided in Figure 4-7 and Figure 4-8 show the occurrence of distress types and severity over worm and control sections, respectively. Low, medium and high distress severities are indicated by “L”, “M”, and “H” designations on the x-axis. Table 4-1 provides a key for referencing distress codes. These data show that the same distresses generally occurred in both worm and control sections. Two exceptions were the occurrence of low-severity block cracking in the SR 26 worm section, where the control section did not exhibit block cracking, and the occurrence of medium-severity L&T cracking in worm sections on SR 24 and US 17, where the control sections only exhibited low-severity L&T cracks.

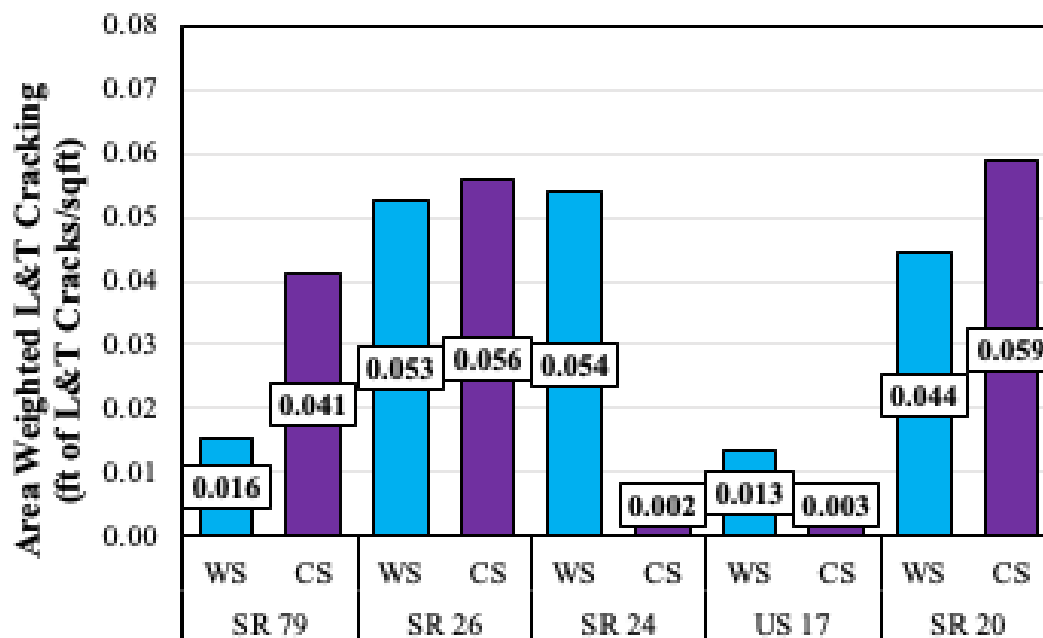
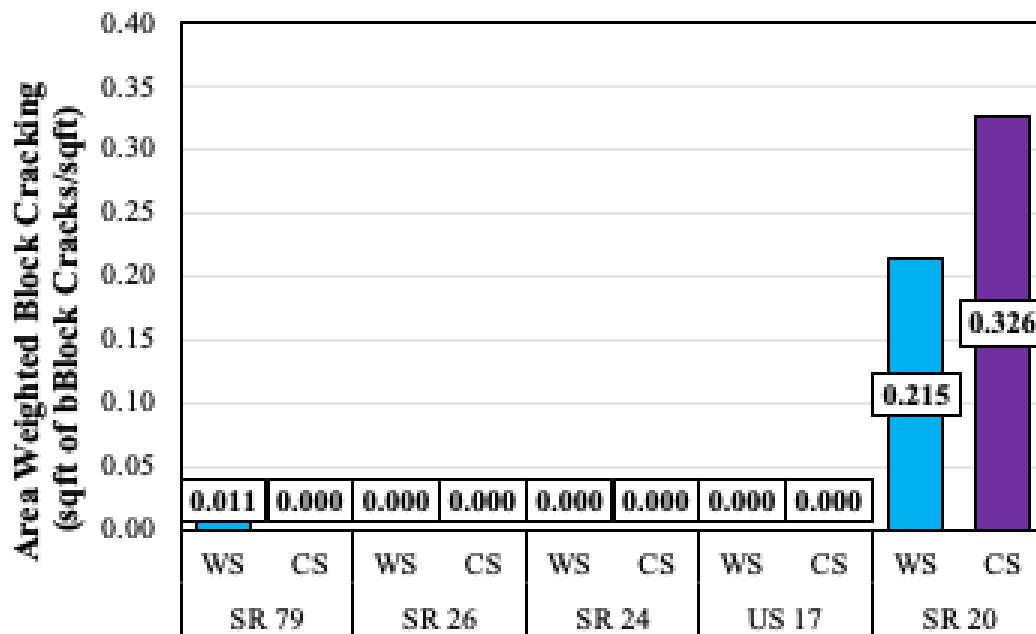
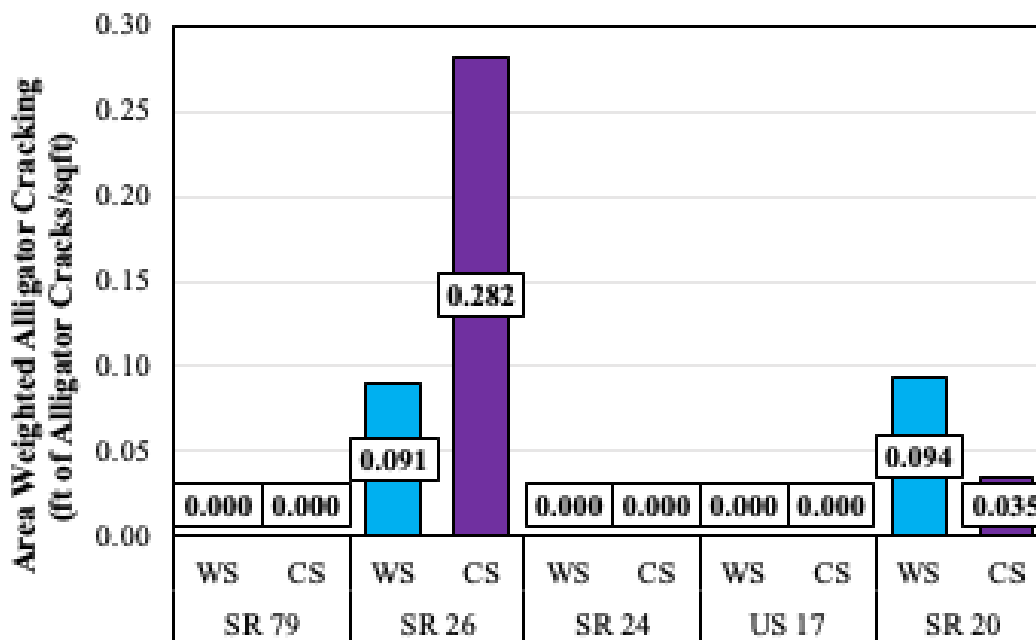
Area weighted averages for L&T cracking, block cracking, and alligator cracking are provided in Figure 4-9, Figure 4-10, and Figure 4-11, respectively. Low- and medium-severity distress quantities were combined for these computations. These figures show the occurrence of block cracking and alligator cracking was not consistent across each site and may not be a major contributing factor to the occurrence of worm distress. The rate of L&T cracking observed on the control sections of SR 24 and US 17 was considerably minimal. Taken together, the absence of worm distress in the control sections of SR 24 and US 17 may have an association with the absence of surface cracking. A possible interpretation of this finding is that cracking may be a prerequisite for the mechanism(s) causing worm distress. Control sections for SR 79, SR 26, and SR 20 all exhibit as much or more cracking than the worm sections; therefore, L&T cracking is not sufficient to cause blistering but may be necessary.

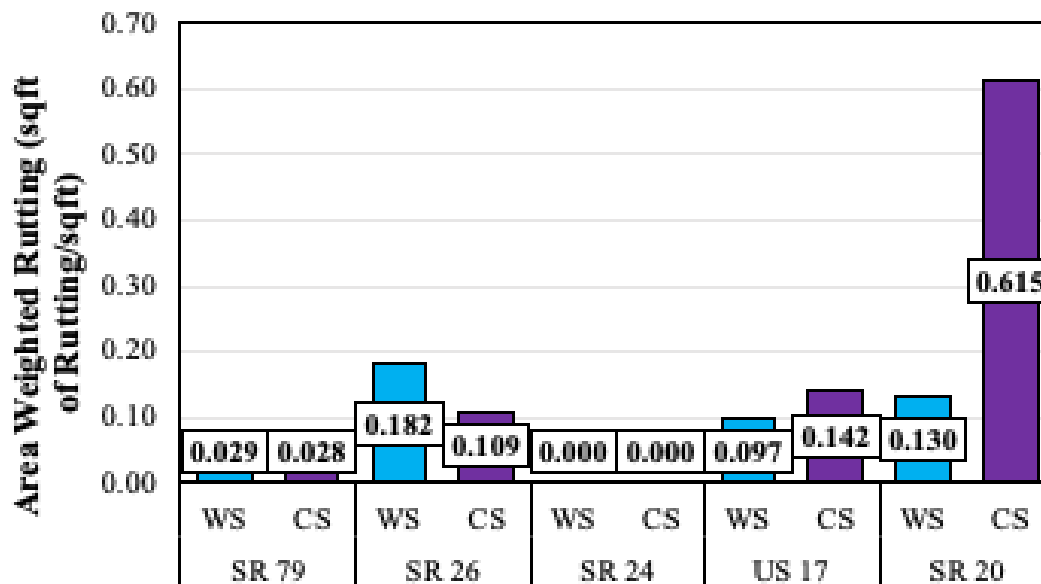
Figure 4-12. Area Weighted Rutting

Rutting was also computed as an area weighted average and is provided in Figure 4-12. No rutting occurred on SR 24. Rutting was considerably greater in the control section of SR 20, which is supported by higher air voids measured and presented in Section 4.2.3. Rutting was not consistently higher or lower in worm sections on the remaining three projects and does not appear to be associated with worm distress.

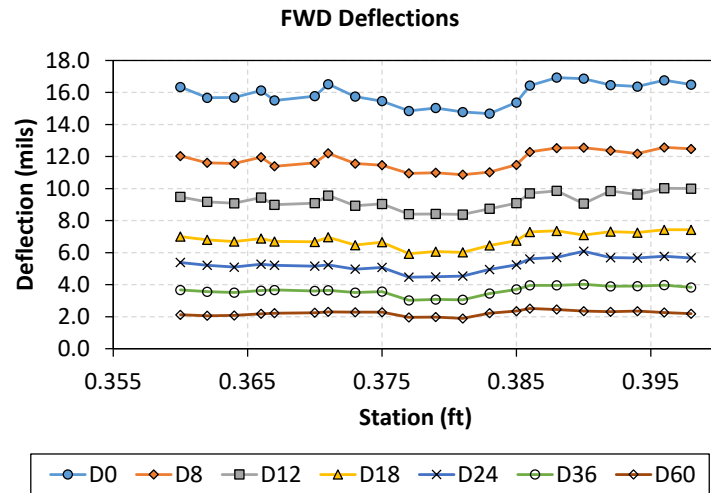
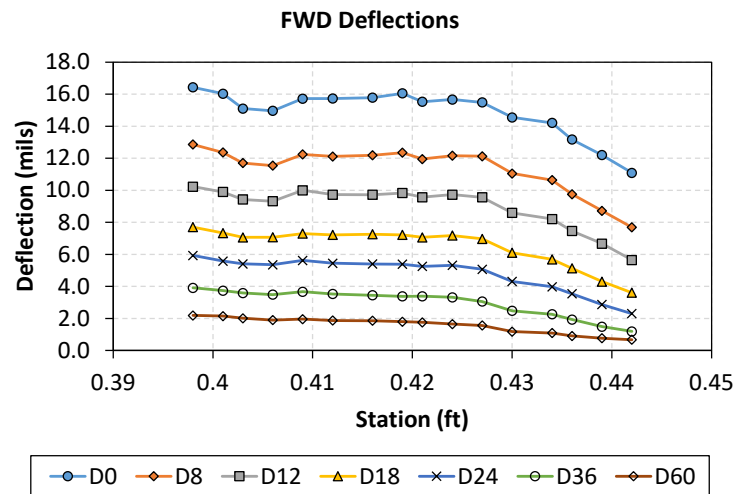
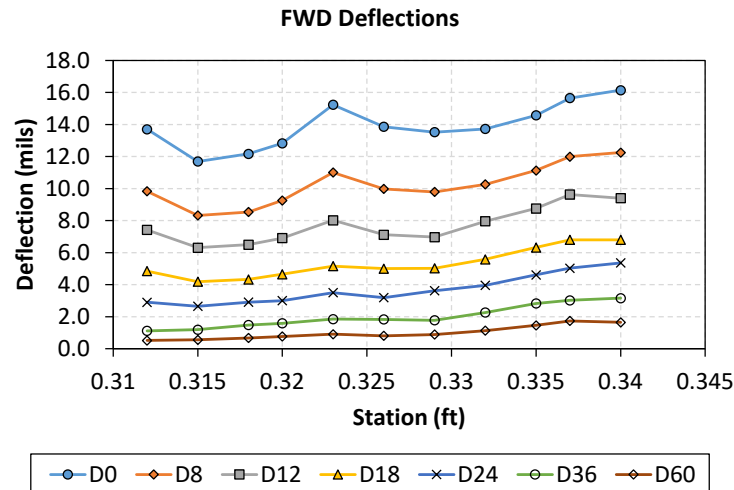
Figure 4-14, Figure 4-15, and Figure 4-16 show the raw FWD deflections under the 9,000-lb target load, collected from the control, worm section no. 1, and worm section no. 2, respectively. These figures generally show the deflections follow relatively consistent trends within each section, indicating that no subsurface anomalies (or an abrupt pavement change) exist within these sections.

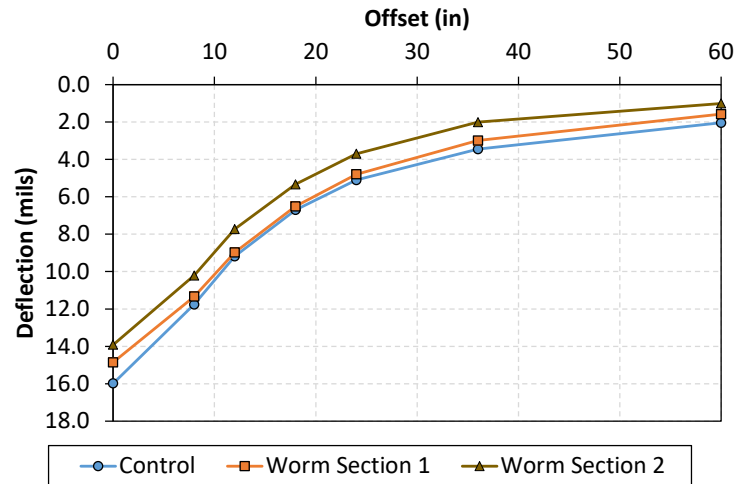
Figure 4-17. Average FWD Deflection Basins from SR 79

Figure 4-17 shows the average deflection basins obtained from each section, with the summary statistics of the deflections, provided in Table 4-2. The figure shows that the shape of the deflection basins is relatively consistent among all three sections. Table 4-2 shows that despite the comparable average deflection basins, both worm sections exhibit higher variability as indicated by the standard deviation and COV. Worm section no. 2 showing the lowest average deflections may be attributed to a stiffer subgrade or embankment material below this particular section.

The control section also shows the highest deflections, especially for the FWD sensor directly below the load plate (D0). While such higher D0 may be attributed to a weaker AC layer, it is also possible that the pavement temperature in the control section was higher than the worm sections during the FWD testing. Higher D0 within the control section may also be attributed to weaker foundation layers (i.e., base and subgrade). Although backcalculating the dynamic modulus master curve of the AC layer and shifting the master curve to a reference temperature may allow for a fair assessment of the AC modulus, the FWD temperature sensor malfunctioned at the time of FWD testing on SR 79 and, hence, backcalculation was not conducted for the FWD data from SR 79. Instead, the AC dynamic modulus needed for the pavement performance assessment was obtained from laboratory testing of field-retrieved cores.

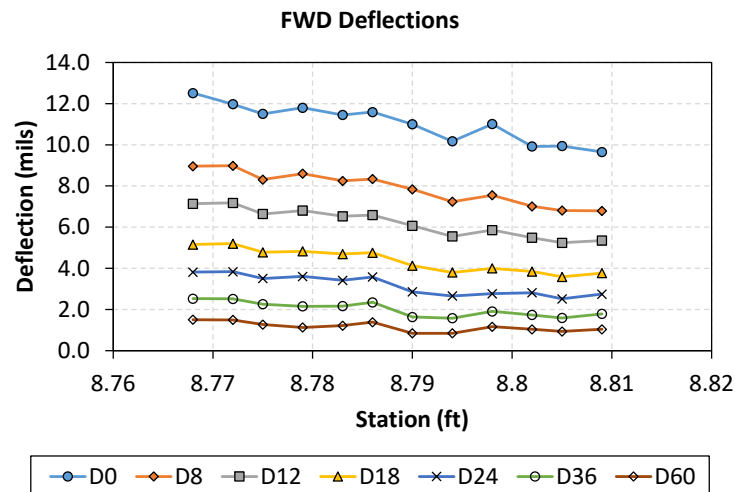
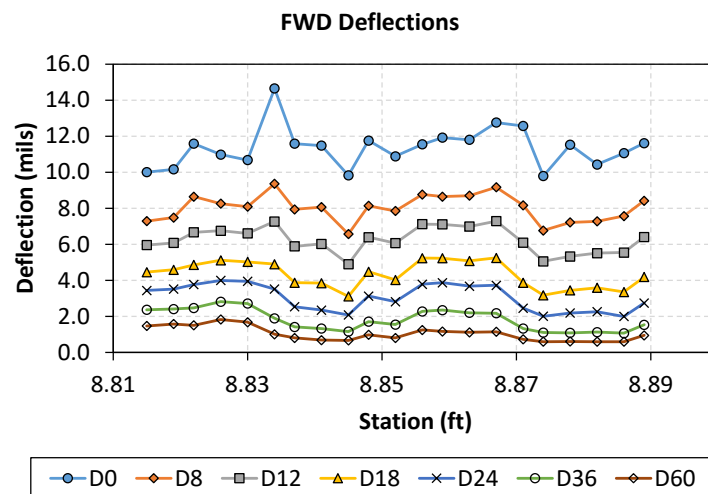
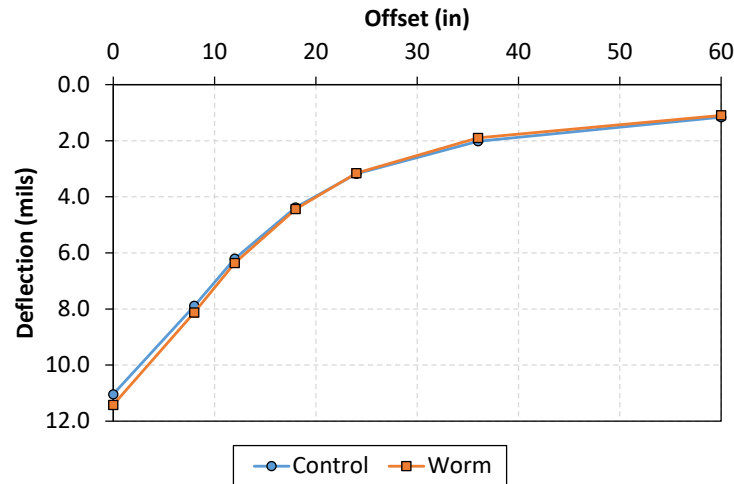
Figure 4-18 and Figure 4-19 show the raw FWD deflections under the 9,000-lb target load, collected from the control and worm sections of SR 26, respectively. Figure 4-20 shows the average deflection basins, with the summary statistics of the deflections provided in Table 4-3. Figure 4-20 and Table 4-3 show that the average deflections from the control and the worm sections were comparable, with the worm section showing slightly higher deflections. The deflections from the worm section also show slightly higher variability (Table 4-3).

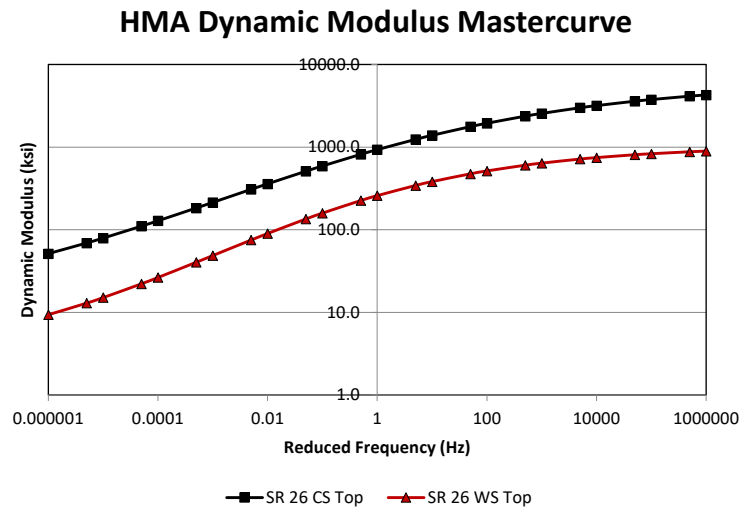
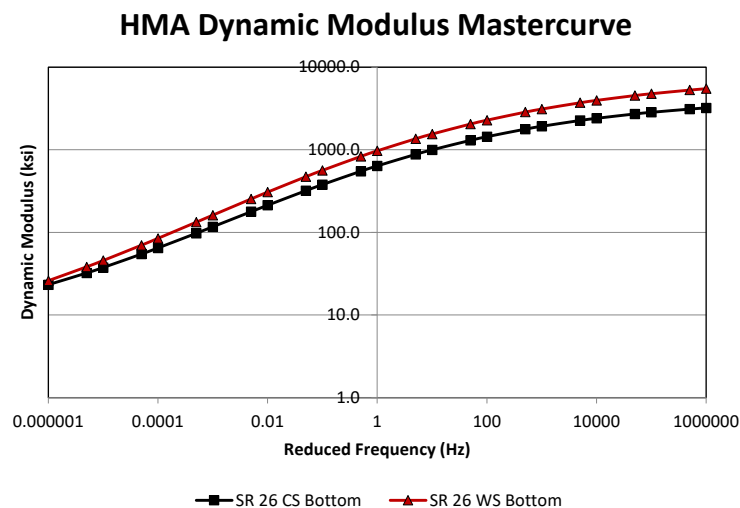
Figure 4-21 and Figure 4-22 show the backcalculated AC dynamic modulus master curve shifted to a reference temperature of 50 °F (10 °C) for the top and the bottom AC lifts, respectively. The backcalculated dynamic modulus values of the AC layer at 10 Hz as well as the backcalculated modulus of the interface bond and the unbound layers (i.e., base and subgrade) are summarized in Table 4-5. The table clearly shows that when the AC modulus was shifted to a common reference temperature, the top AC lift within the worm section showed significantly lower modulus compared to the control section. This trend is reversed for the lower AC lift. The table also shows that the control section has a slightly stronger bond between the top and the bottom AC lifts.

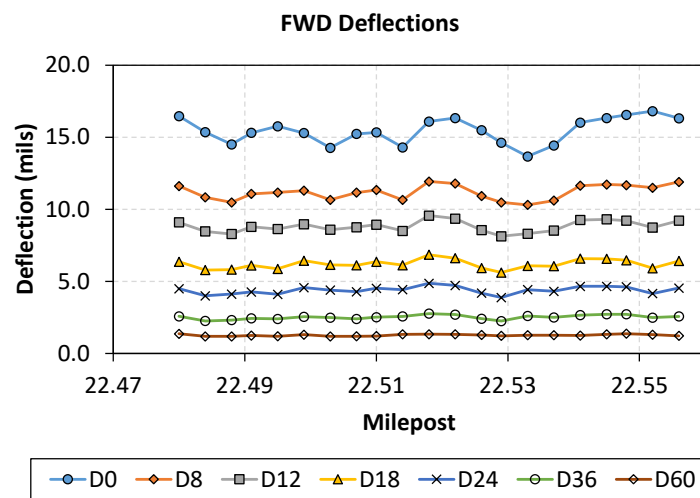
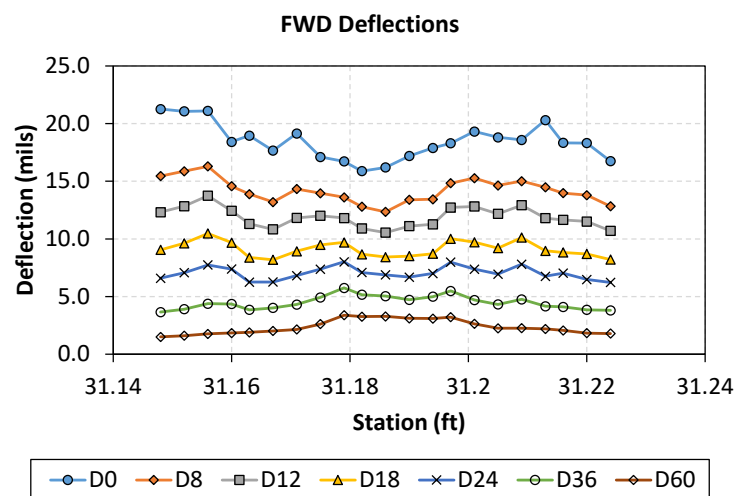
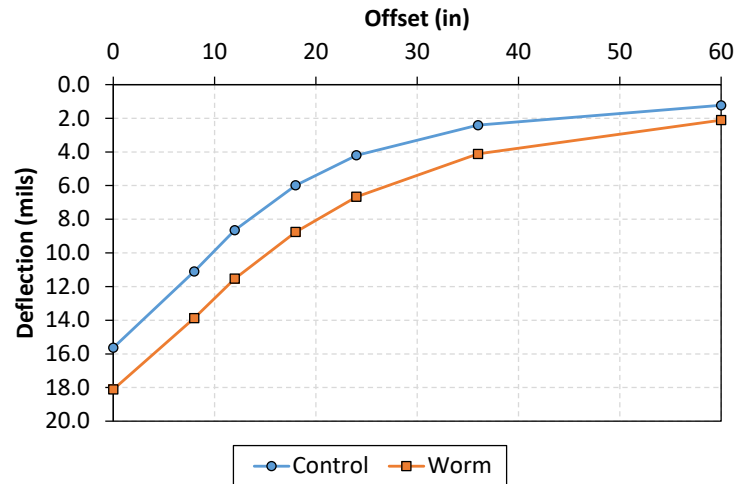
Figure 4-23 and Figure 4-24 show the raw FWD deflections under the 9,000-lb target load, collected from the control and worm sections of SR 24, respectively. Figure 4-25 shows the average deflection basins, with the summary statistics of the deflections provided in Table 4-6. Figure 4-25 and Table 4-6 indicate that the worm section shows not only higher deflections, but also higher variability within the measured deflections.

Table 4-7 summarizes the pavement surface temperature during FWD testing. As seen from the table, the control section temperature was significantly higher (i.e., approximately 24 °F higher) than the worm section temperature. In other words, the worm section showed higher deflections, despite the lower temperature. This indicates that the AC layer in the worm section may show significantly lower modulus when the AC dynamic modulus from both sections are evaluated at the same temperature.

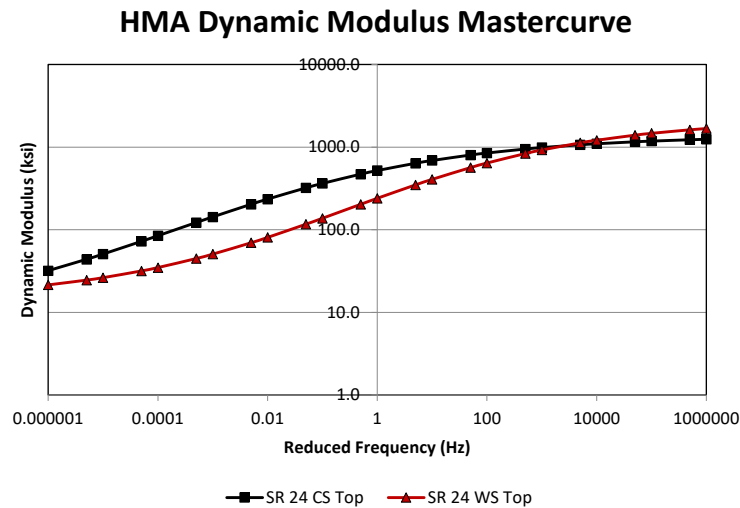
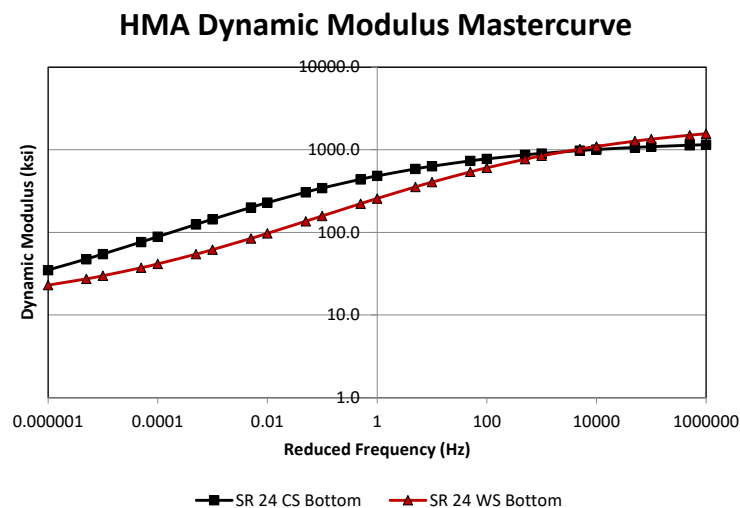
Figure 4-26 and Figure 4-27 show the backcalculated AC dynamic modulus master curve shifted to a reference temperature of 50 °F (10 °C) for the top and the bottom AC lifts, respectively. The backcalculated dynamic modulus values of the AC layer at 10 Hz as well as the backcalculated modulus of the interface bond and the unbound layers (i.e., base and subgrade) are summarized in Table 4-8. The table clearly shows that at the respective FWD testing temperature, the AC within the worm section showed higher modulus. Nonetheless, when the AC modulus was shifted to a common reference temperature, the AC within the worm section showed significantly lower modulus. The table also shows that the control section has a significantly stronger bond between the top and the bottom AC lifts.

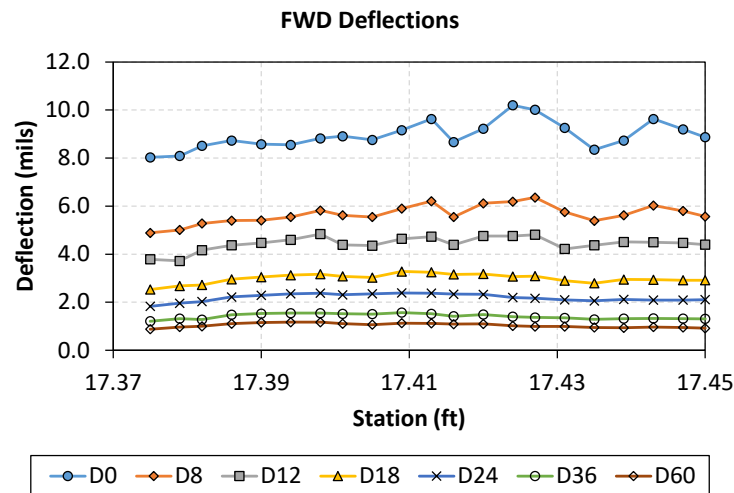
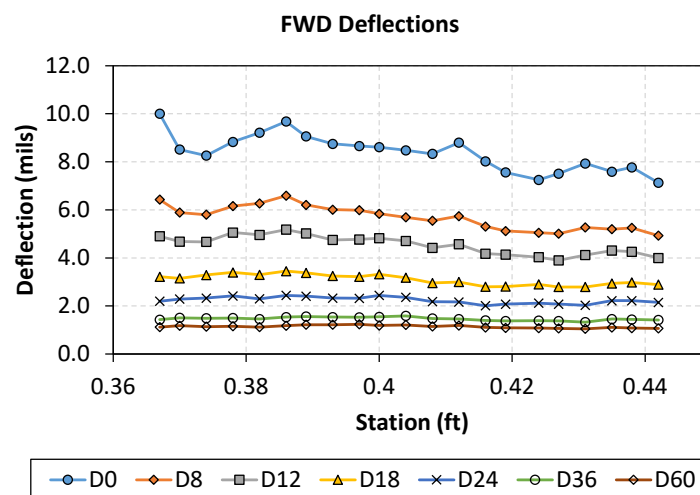
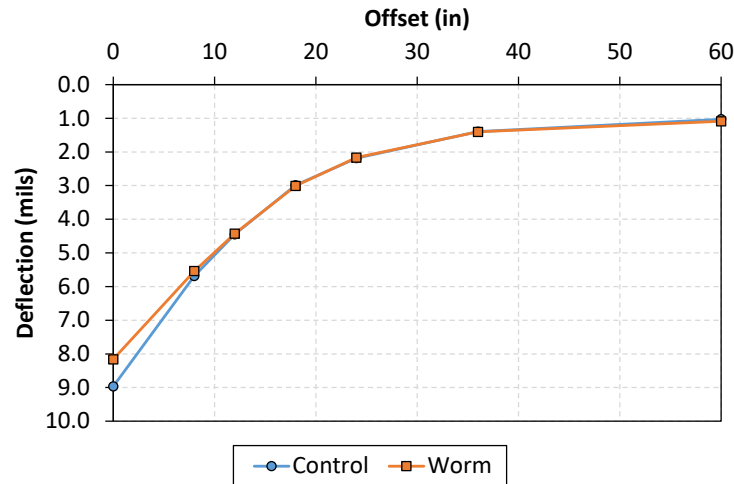
Figure 4-28 and Figure 4-29 show the raw FWD deflections under the 9,000-lb target load collected from the control and worm sections of US 17, respectively. Figure 4-30 shows the average deflection basins, with the summary statistics of the deflections provided in Table 4-9. Figure 4-30 and Table 4-9 show that the average deflections from the control and the worm sections were comparable, with the worm section showing higher variability within the deflections.

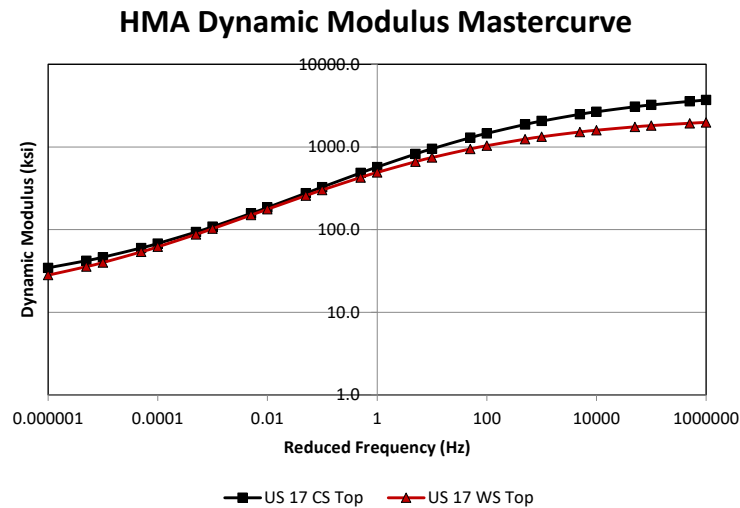
Figure 4-31. Backcalculated Dynamic Modulus Master Curves for US 17 Top Lift AC Layer

Figure 4-31 and Figure 4-32 show the backcalculated AC dynamic modulus master curve shifted to a reference temperature of 50 °F (10 °C) for the top and the bottom AC lifts, respectively. The backcalculated dynamic modulus values of the AC layer at 10 Hz as well as the backcalculated modulus of the interface bond and the unbound layers (i.e., base and subgrade) are summarized in Table 4-11. The table clearly shows that when the AC modulus was shifted to a common reference temperature, both the top and bottom AC lifts within the worm section showed lower modulus compared to the control section. The modulus of the interface bond and the unbound layers were comparable to each other.

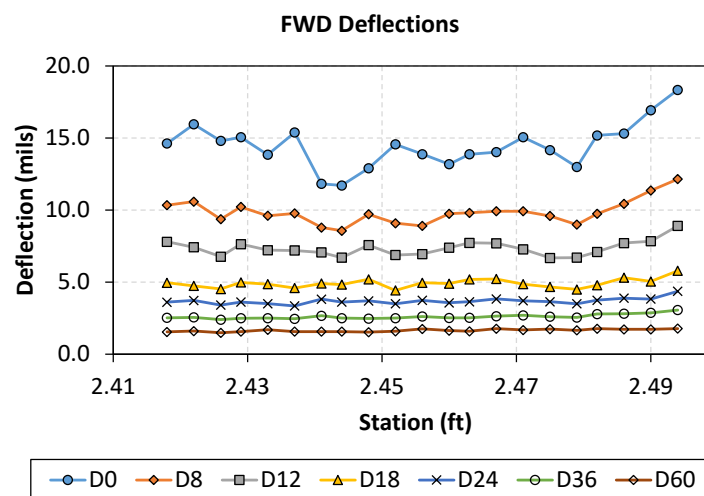
Figure 4-34. FWD Deflections from SR 20 Worm Section

Figure 4-33 and Figure 4-34 show the raw FWD deflections under the 9,000-lb target load, collected from the control and worm sections of SR 20, respectively. Figure 4-35 shows the average deflection basins, with the summary statistics of the deflections provided in Table 4-12. Figure 4-35 and Table 4-12 indicate that the worm section shows not only higher deflections, but also higher variability within the measured deflections.

Table 4-13 summarizes the pavement surface temperature during FWD testing. As seen from the table, the control section was under higher temperature (i.e., approximately 12 °F higher) than the worm section. In other words, the worm section showed higher deflections, despite the lower temperature. This indicates that the AC layer in the worm section may show significantly lower modulus when the AC dynamic modulus from both sections are evaluated at the same temperature.

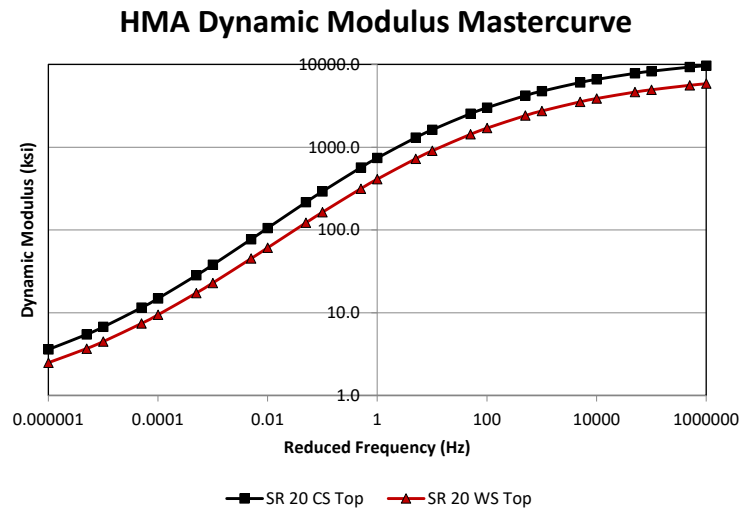
Figure 4-36. Backcalculated Dynamic Modulus Master Curves for SR 20 Top Lift AC Layer

Figure 4-36 and Figure 4-37 show the backcalculated AC dynamic modulus master curve shifted to a reference temperature of 50 °F (10 °C) for the top and the bottom AC lifts, respectively. The backcalculated dynamic modulus values of the AC layer at 10 Hz as well as the backcalculated modulus of the interface bond and the unbound layers (i.e., base and subgrade) are summarized in Table 4-14. The table clearly shows that at the respective FWD testing temperature, the modulus of the AC was comparable between the control and the worm section. Nonetheless, when the AC modulus was shifted to a common reference temperature, the AC within the worm section showed significantly lower modulus for the top lift.

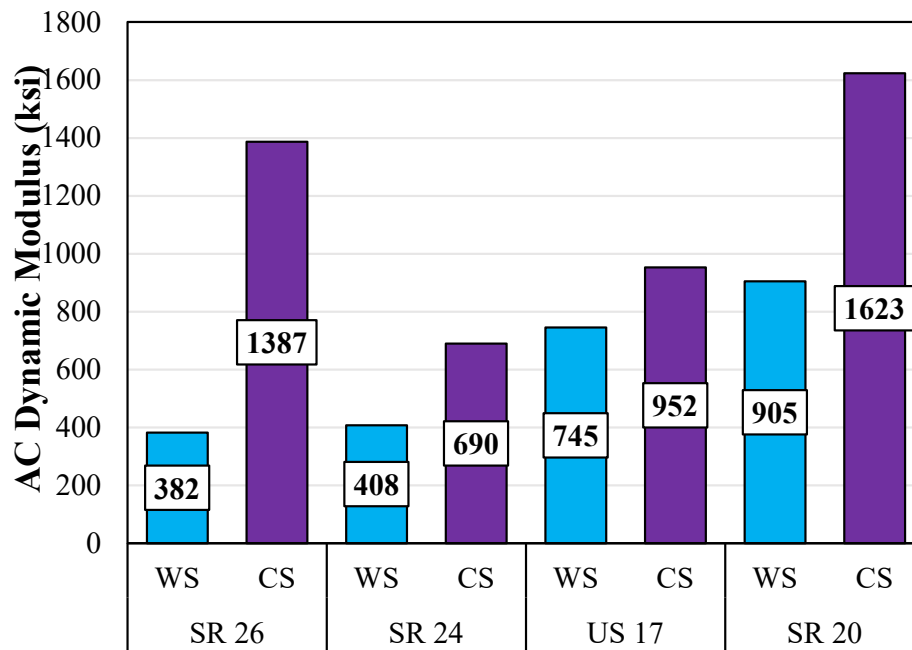
Figure 4-38. FWD Backcalculated Dynamic Modulus of Top Lift AC at 50°F and 10 Hz

Figure 4-38 shows the average backcalculated dynamic modulus of the top lift AC for all sections. Note that these dynamic modulus values correspond to 10 Hz at a reference temperature of 50 °F. Although the modulus values span a wide range, the figure clearly shows that the worm sections exhibit lower modulus compared to their control counterparts. The reduction in modulus ranges from 21.8% (from US 17) to 72.5% (from SR 26).

the bottom lift AC compared to the control section. Furthermore, the SR 26 worm section was the only section in which the top lift AC exhibited significantly lower (i.e., almost five times lower) modulus compared to the bottom lift (see Figure 4-38 and Figure 4-39). The outcome of such a drastic difference in AC modulus is that the bottom lift AC does not undergo a significant amount of “bending” and most of the strains occur within the weaker, top lift AC. As an example, Figure 4-120 and Figure 4-121 show the simulated vertical and transverse (i.e., horizontal) strains for the bottom of the SR 26 top lift AC. For all three strains, tension is positive and compression is negative in the charts. These figures clearly show that while the vertical, compressive strain increased significantly, the tensile strain almost diminished within the worm section (i.e., no bending).

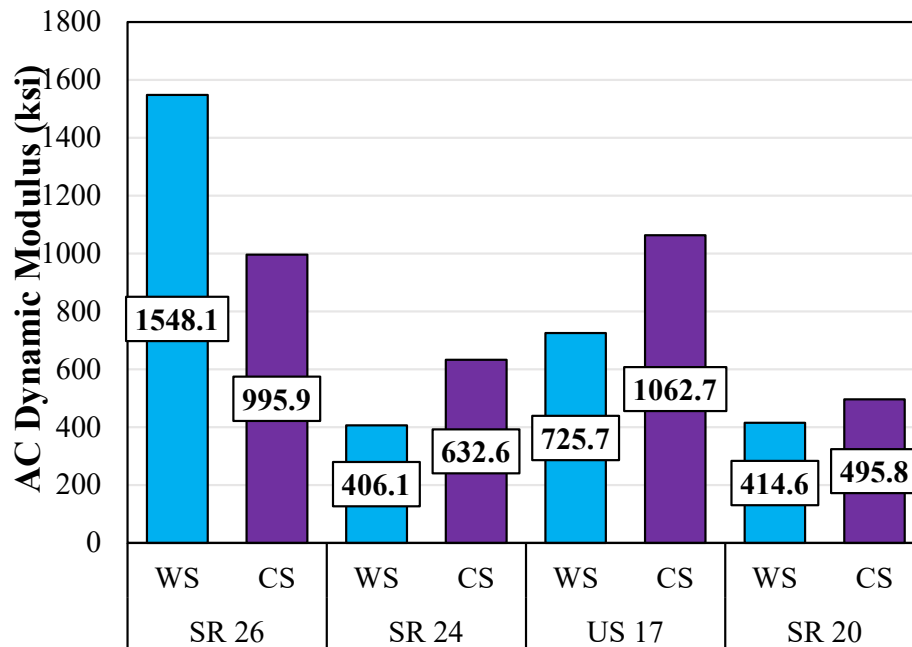
Figure 4-39. FWD Backcalculated Dynamic Modulus of Bottom Lift AC at 50°F and 10 Hz

Similarly, Figure 4-39 shows the average backcalculated dynamic modulus (at 10 Hz and at 50 °F) of the bottom lift AC for all sections. With the exception of SR 26, the worm sections showed lower dynamic modulus compared to the control sections, with the reduction ranging from 16.4% (from SR 20) to 35.8% (from SR 24).
