Evaluation of Roadway Worms/Distortions

Final Report

Prepared by:
Applied Research Associates, Inc.
430 W 5th Street, Suite #700
Panama City, Florida 32401
850-914-3188 / 850-914-3189 Fax

Contract No. BE491

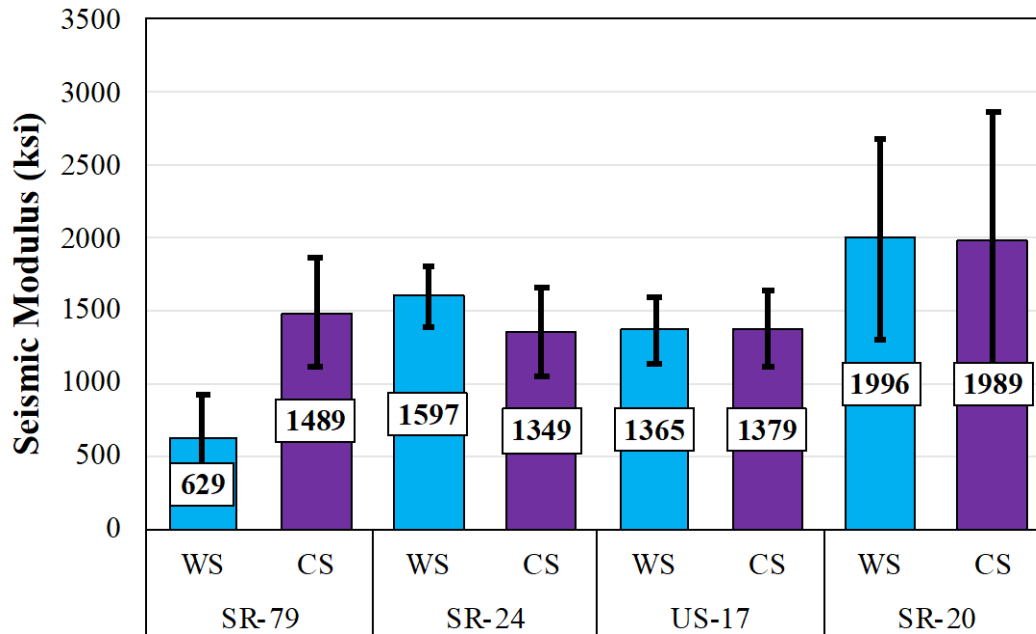
Figure 4-46. AC PSPA Moduli

Figure 4-46 shows a summary of the AC modulus obtained from PSPA testing. The PSPA data for SR 26 was not recoverable due to a corrupted database file. It should be noted that the AC modulus from PSPA is obtained at a significantly higher frequency than the FWD, and a direct comparison between the FWD and PSPA modulus may not always be reasonable. The PSPA modulus generally indicates that the AC modulus between the control and the worm sections did not exhibit a significant difference, with the exception of SR 79. The worm section of SR 79 showed a significant (i.e., approximately 58%) reduction in the AC modulus compared to the control section.

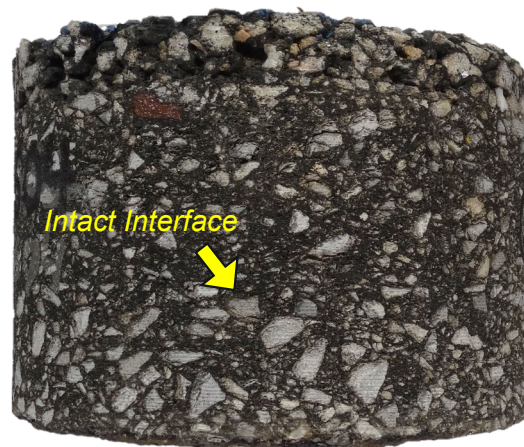
Figure 4-48. SR 79 MP 0.391 Control Section Core – Typical Core

All cores collected from SR 79 were intact. Typical field cores are presented in Figure 4-47 through Figure 4-50. Delamination between the bottom two structural asphalt layers was observed more frequently in worm section cores. Some segregation of aggregate was evident on the bottom AC lift. AC layer thicknesses were consistent between the worm and control sections. The overall AC layer thickness and individual lift thicknesses are presented in Figure 4-51.

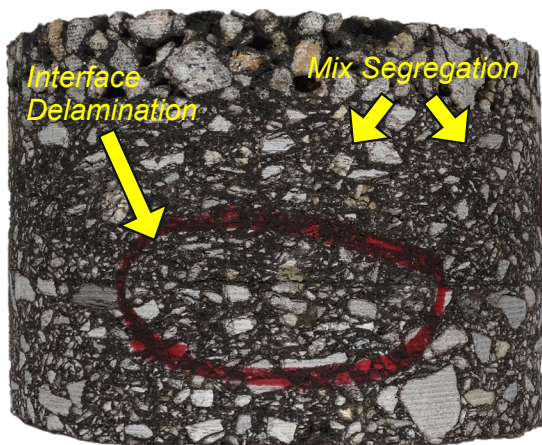
Figure 4-49. SR 79 MP 0.321 Worm Section Core – Structural AC Layer Delamination and Segregation

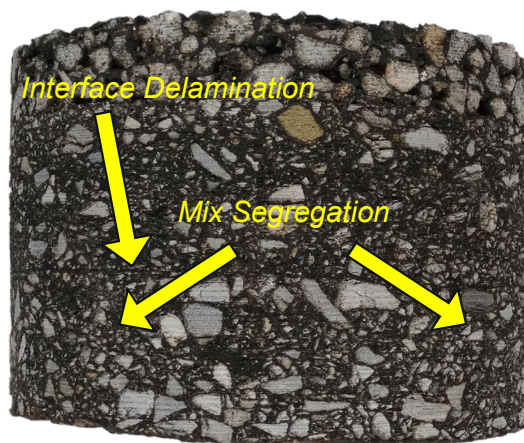
Figure 4-50. SR 79 MP 0.357 Control Section – Structural AC Layer Delamination and Segregation

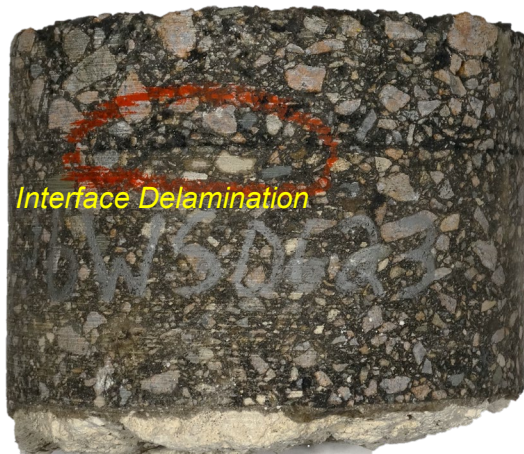
All cores collected from SR 26 were intact. Typical field cores are presented in Figure 4-52 through Figure 4-55. Voids in the pavement structure were noted in both the top two DGA layers for control and worm section cores. The greatest concentration of voids was at the interface of these two layers in the worm section, especially at the bottom of the surface course. The stripped aggregate at this subject interface, shown in Figure 4-52, could be indicative of water traveling along the interface. SR 26 AC layer thicknesses are presented in Figure 4-56. Surface mix lift thicknesses were within 0.1-in agreement on average. The bottom lift AC was 0.6-in thicker in the worm section.

Figure 4-54. SR 26 MP 8.879 Worm Section Core – Upper Layer Delamination

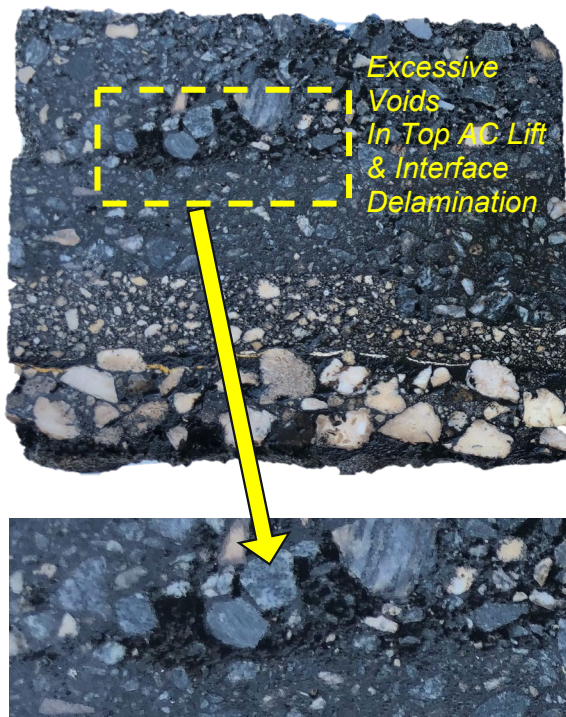
All cores collected from SR 24 were intact. Typical field cores are presented in Figure 4-57 through Figure 4-60. Like the SR 26 cores, the SR 24 cores exhibit considerable voids at the interface of the surface course and underlying layer. These voids are primarily at the bottom of the top layer, but it appears water may have entered the pavement structure and weathered material on both sides of the interface over time. SR 26 AC layer thicknesses are presented in Figure 4-61. Layer thicknesses between worm and control groups are in good agreement.

Figure 4-57. SR 24 MP 31.207 Worm Core Cross Section – Paving Lane Joint with Voids at Bottom of Friction Course

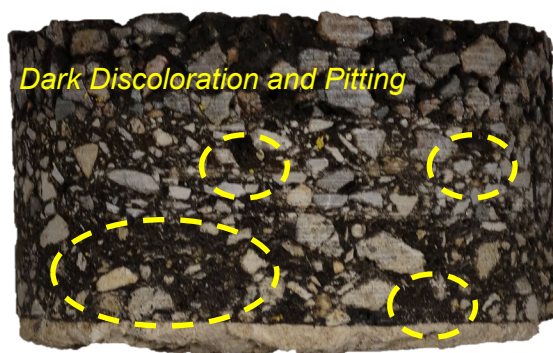
All cores collected from US 17 were intact. Typical field cores are presented in Figure 4-62 through Figure 4-65. Voids, segregation, and cracking were observed in the top DGA layer of worm section cores. Discoloration and pitting were also observed in both control and worm section layers. These defects are mostly concentrated in the top DGA layer. Figure 4-62 presents the cross section of a worm distress that was cored and sectioned, showing a crescent shaped fracture pattern consistent with the profile of a worm distress. The AC layer interfaces appear to be undamaged/not delaminated. US 17 AC layer thicknesses are presented in Figure 4-66. The composite asphalt structure is 1-in thicker than the control asphalt, on average.

Figure 4-65. US 17 Control Core at MP 17.432 – High Air Voids in All Layers

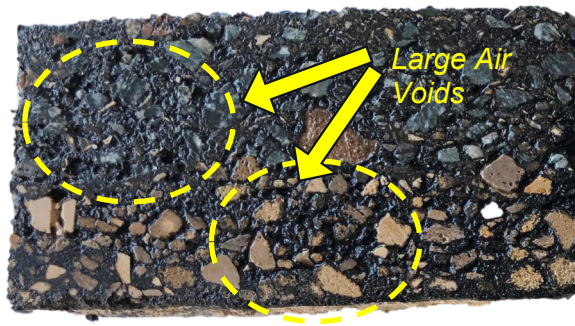
One worm section core broke at the interface during drilling/extraction in the field. The remainder of the 59 cores were collected intact. Typical field cores are presented Figure 4-67 through Figure 4-70. Voids were concentrated around the layer interface in both worm and control sections; however, these voids were more severe in the worm cores. The overall AC layer thickness and individual lift thicknesses are similar for the worm and control cores and are presented in Figure 4-71.

Figure 4-67. SR 20 MP 2.511 Worm Section Paving Lane Joint Cross-Section Showing Large Air Voids in Both AC Layers

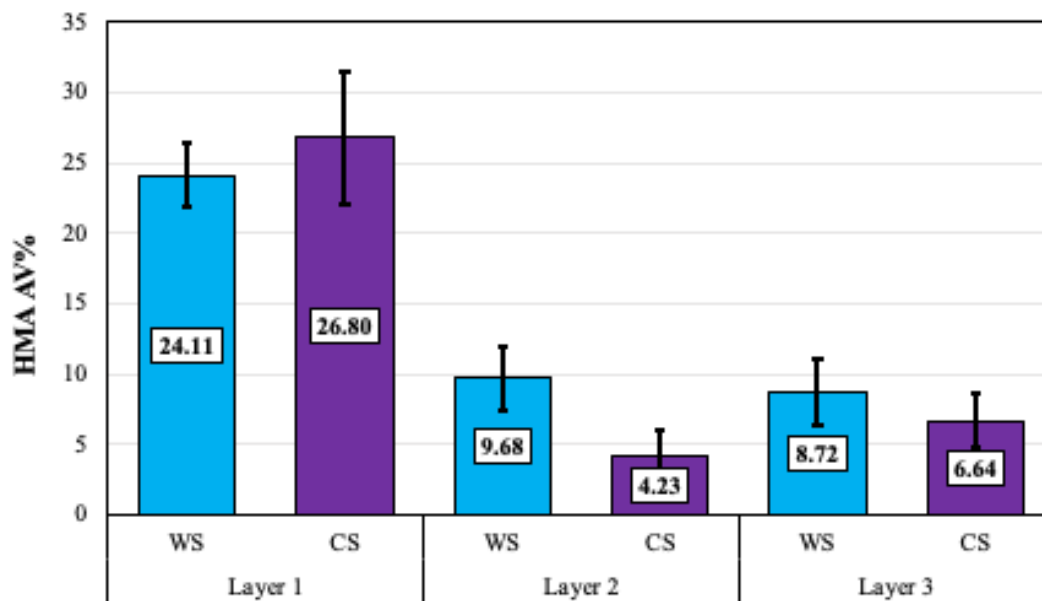
Figure 4-83. SR 79 AC Field Core Air Voids

Figure 4-83 through Figure 4-87 present the average air void content for field cores. It was determined after testing the first site (SR 79) that OGFC was likely not a contributing factor to the development of worm distresses; therefore, the US 17 OGFC was not tested. The air void content of DGA materials ranged from 3.63% to 14.13%. In the upper two DGA layers of each project, 90% of the AC tested on the five projects exhibited air voids in excess of the 4% target. The worm section AC contained greater air voids than the control section in 7 of the 10 subject layers.

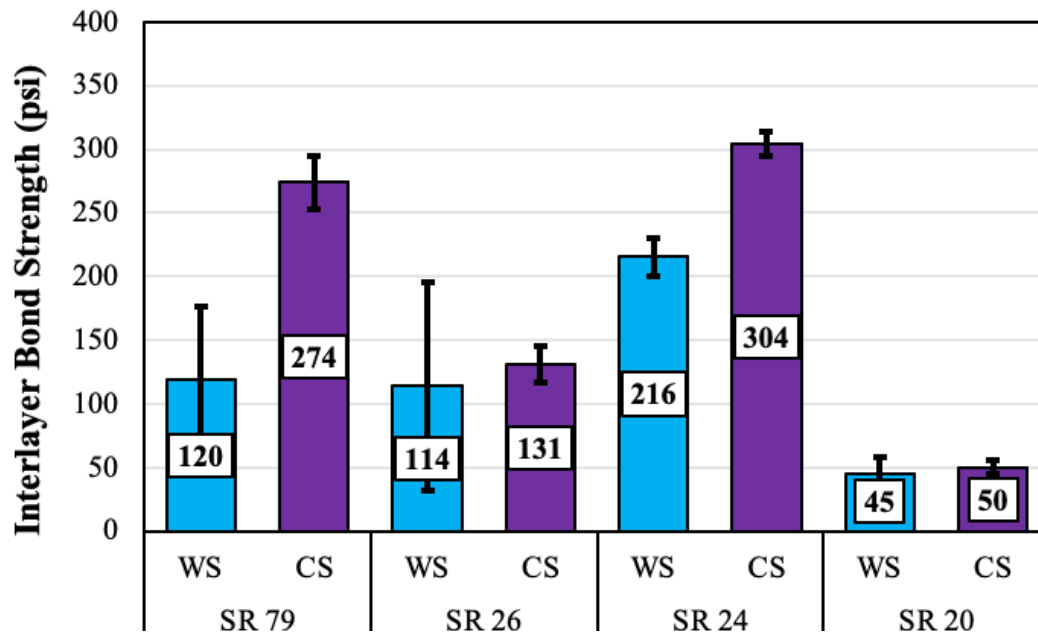
Figure 4-88. Interlayer Bond Strength Results

A total of 58 bond strength tests were performed to assess the interlayer bond strength of the top two dense-graded AC layers of each project. Bond test results are presented in Figure 4-88. The test results show the presence of worm distress is consistent with a reduction in interlayer bond strength. Overall, a total of 31 cores could not be tested due to material failure and not necessarily bond failure. During the initial testing of cores retrieved from SR 79, five consecutive cores failed in the AC material outside of the interface (within the AC mixture itself), resulting in invalid tests. The material failures occurred both in cores sampled from the control and worm-distressed sections. It was observed that the cores did not have interfaces that were truly in plane with the surface of the roadway. To account for this skew, the gap between the shear and reaction frames was increased from 0.25 to 0.375 in to promote better layer interface alignment within the gap. The 0.375-in gap spacing was maintained for all interlayer bond strength tests. Failures in the AC mix continued to occur on cores sampled from all five sites,

possibly indicating a loss of durability, stiffness, and strength of the AC at the subject interface. Of the 58 tests performed, 14 failures were observed in the top AC layer, 8 failures were observed in the bottom layer, 30 cores sheared at the interface, and 5 cores exhibited fractures in both the upper and lower AC layers. No core samples from US 17 fractured along the interface. Both AC layers at the interface were considerably deteriorated; however, the lower layer exhibited the most severe pitting and voids. A close-up of these distresses along the interface are shown on a typical worm section core in Figure 4-89.

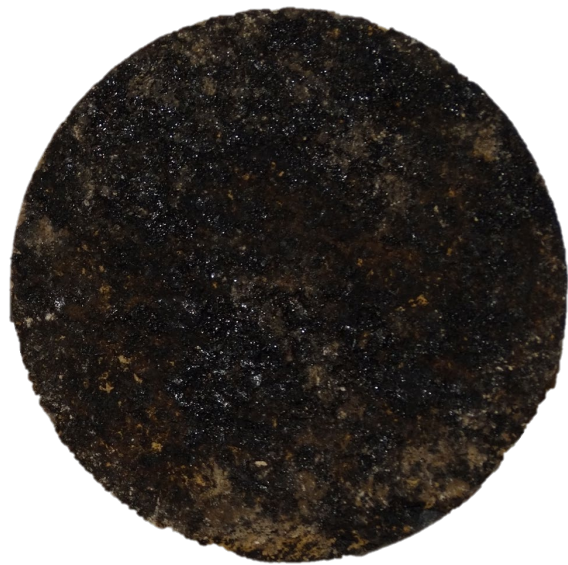
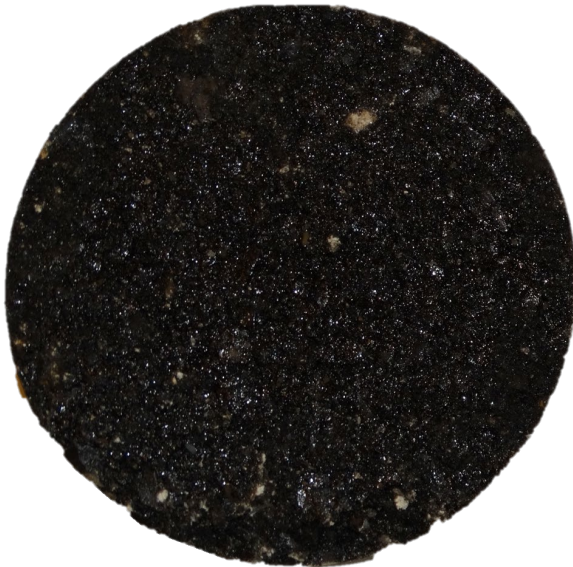
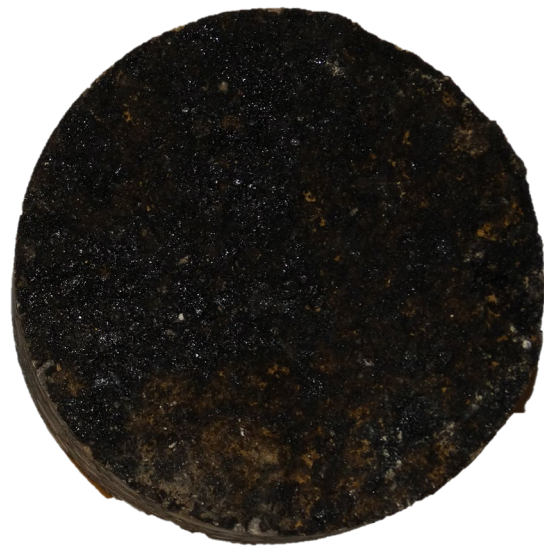
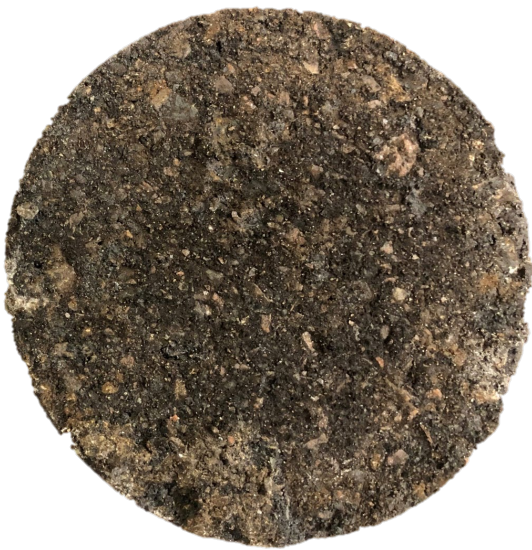
Figure 4-90. SR 79 Example AC Layer Interfaces

- SR 79
 - Control Section: Uniform tack coat on interfaces.
 - Worm Section: Inconsistent tack coat coverage; approximately 30% to 40% of tack material missing or has brown color that resembles an unbroken or re-emulsified tack coat.

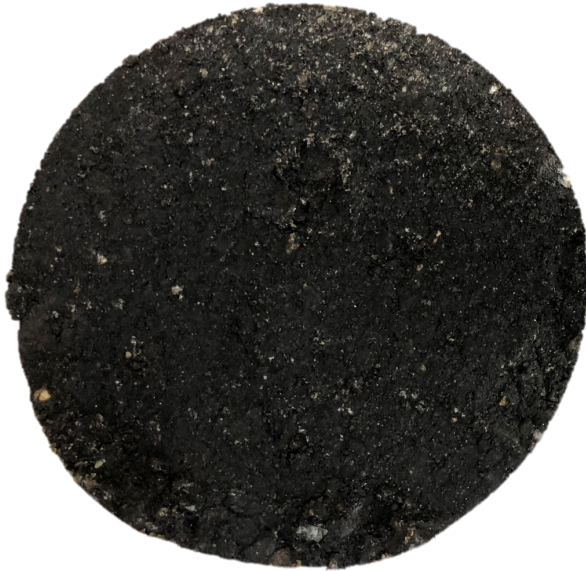
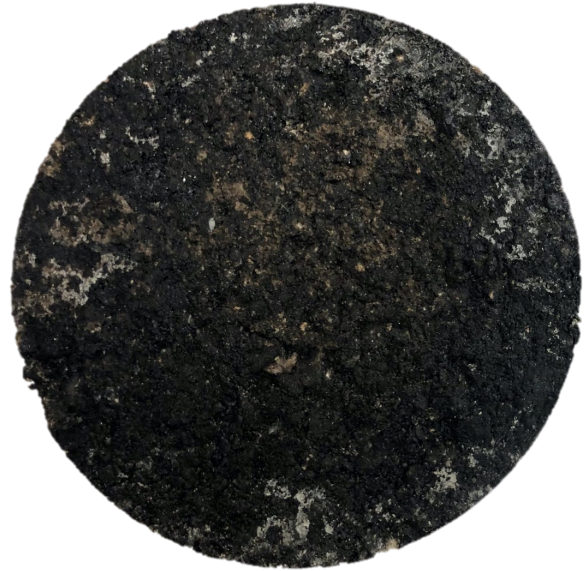
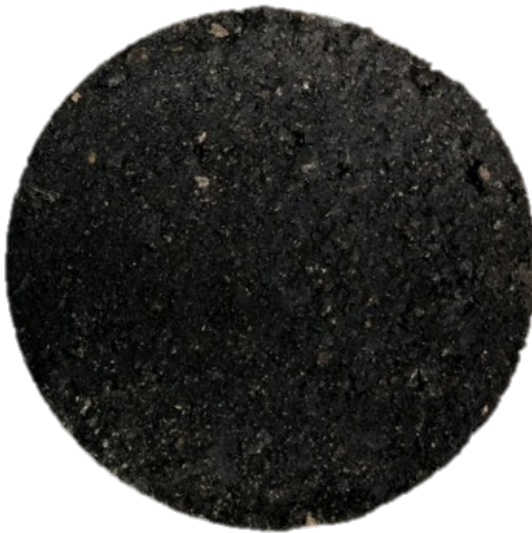
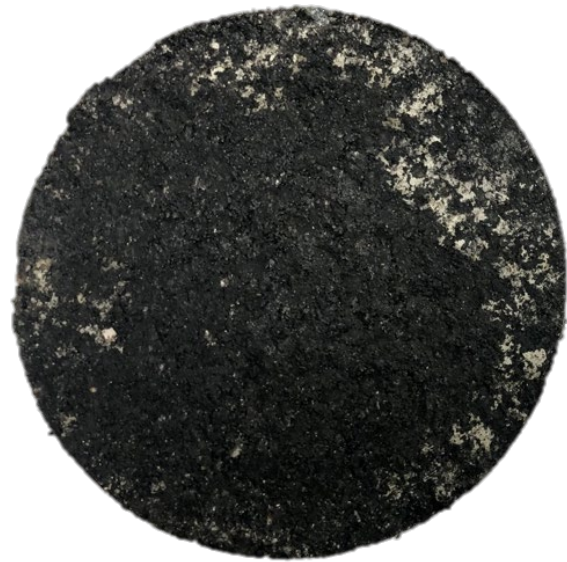
Figure 4-92. SR 24 Example AC Layer Interfaces

- SR 24
 - Control Section: Uniform tack coat on interfaces.
 - Worm Section: Missing tack coat; appearance may indicate trapped water between layers has stripped tack in areas and left behind white stains.

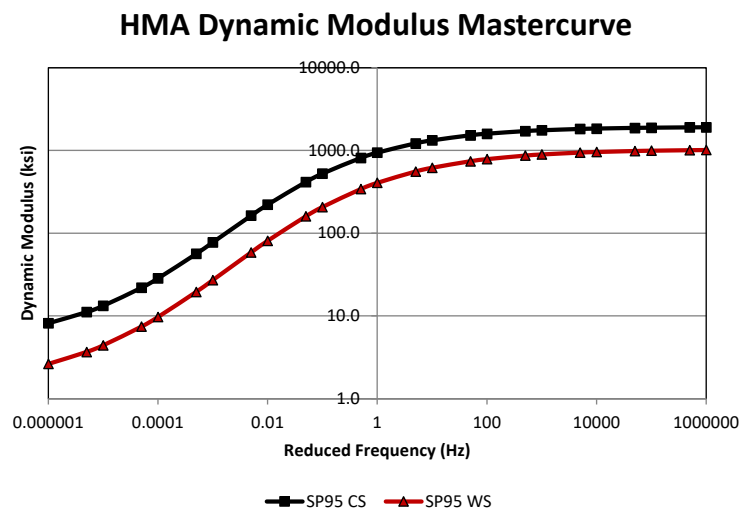
Figure 4-104. Dynamic Modulus Master Curves for the Top Lift of SR 79 AC (SP 9.5) at a Reference Temperature of 50 °F

Figure 4-104 and Figure 4-105 show the AC dynamic modulus master curves for SR 79 at a reference temperature of 50°F (10°C) for the top and the bottom AC lifts, respectively. Similar to the trends of the FWD backcalculated dynamic modulus master curves, the worm section shows significantly lower modulus for the top lift AC (Figure 4-104). More specifically, the top lift AC modulus was found to be 1,323 ksi and 618 ksi for the control and worm sections, respectively. This corresponds to a 53% reduction in AC modulus for the worm section, which is in agreement with the PSPA data discussed previously (Figure 4-46). The bottom lift AC from the worm section is also showing lower modulus compared to the control section (Figure 4-105), although the difference is not as significant—approximately 26% reduction from control section modulus of 1,703 ksi to worm section modulus of 1,257 ksi.

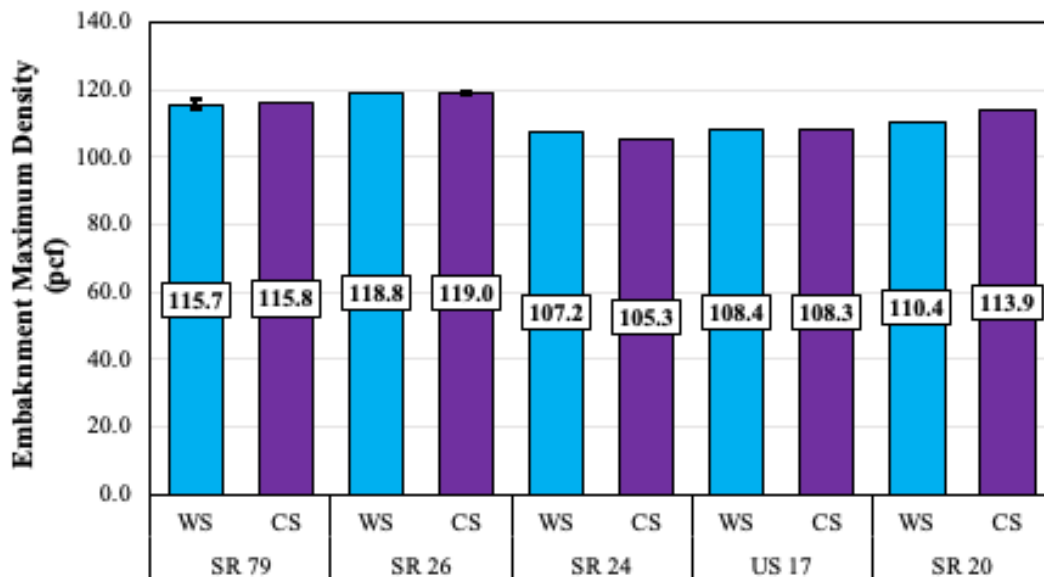
Figure 4-114. Laboratory Embankment Maximum Density Results

Maximum density of embankment materials from the proctor test are presented in Figure 4-114. The average maximum density of all materials ranged from 105.3 pcf to 119.3 pcf. No bias in the data was observed between worm and control groups.

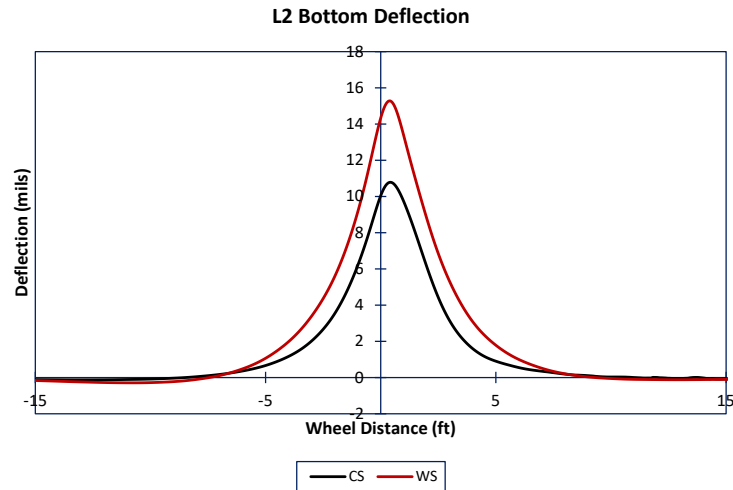
Figure 4-116. ViscoWave Simulated SR 24 Deflection at the Bottom of AC

The same pavement structures used for FWD backcalculation (see Section 4.1.3) were used for simulating the pavement response under a moving load with ViscoWave. The load was modeled as a single tire with 9,000 lbs uniformly distributed over a circular, 8-in diameter contact area. The speed of the moving load was fixed at 50 mph. As an example of the ViscoWave simulation results, Figure 4-116 shows the pavement deflection simulated at the bottom of SR 24 AC. Similarly, Figure 4-117, Figure 4-118, and Figure 4-119 show the longitudinal, transverse, and vertical strains simulated at the bottom of the AC layer, respectively. Clearly, these figures show that the lower AC modulus and the lower bond modulus in the worm section contributed to the increased pavement response (deflection and strains).

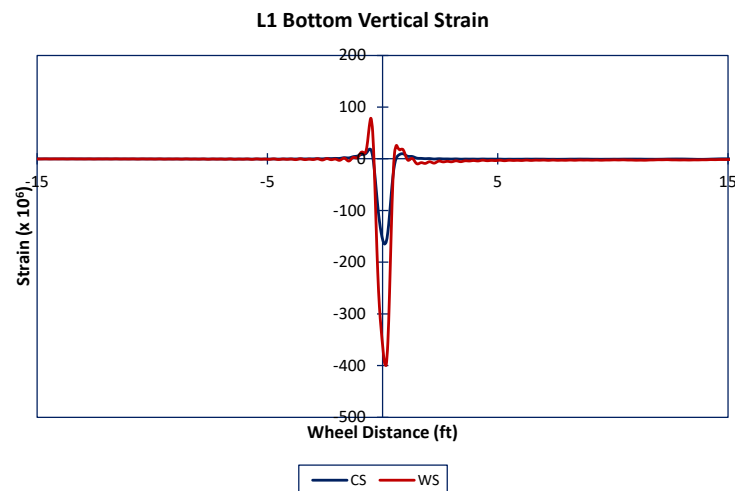
Figure 4-120. ViscoWave Simulated SR 26 Vertical Strain at Bottom of Top Lift AC

the bottom lift AC compared to the control section. Furthermore, the SR 26 worm section was the only section in which the top lift AC exhibited significantly lower (i.e., almost five times lower) modulus compared to the bottom lift (see Figure 4-38 and Figure 4-39). The outcome of such a drastic difference in AC modulus is that the bottom lift AC does not undergo a significant amount of “bending” and most of the strains occur within the weaker, top lift AC. As an example, Figure 4-120 and Figure 4-121 show the simulated vertical and transverse (i.e., horizontal) strains for the bottom of the SR 26 top lift AC. For all three strains, tension is positive and compression is negative in the charts. These figures clearly show that while the vertical, compressive strain increased significantly, the tensile strain almost diminished within the worm section (i.e., no bending).

As seen from the above, the negligible amount of tensile strain observed within the top lift AC of the SR 26 worm section is responsible for the higher amount of N_f value shown in Table 4-24. On the other hand, it is believed that the increased vertical strain within the top lift AC may cause increased rutting within the AC layer. As such, the vertical strain at the mid-depth of each AC lift was simulated and the rut depth progression was predicted using the MEPDG methodology. Figure 4-122 and Figure 4-123 show, as an example, the predicted rut depth for the SR 26 control and worm sections, respectively. Figure 4-122 shows that the rutting within the control section is relatively minimal and most of the rutting is contributed to the bottom lift AC. Conversely, Figure 4-123 shows that the rut depth within the worm section grows relatively rapidly, and the rutting is mostly confined to the top lift AC (i.e., the weaker AC layer).

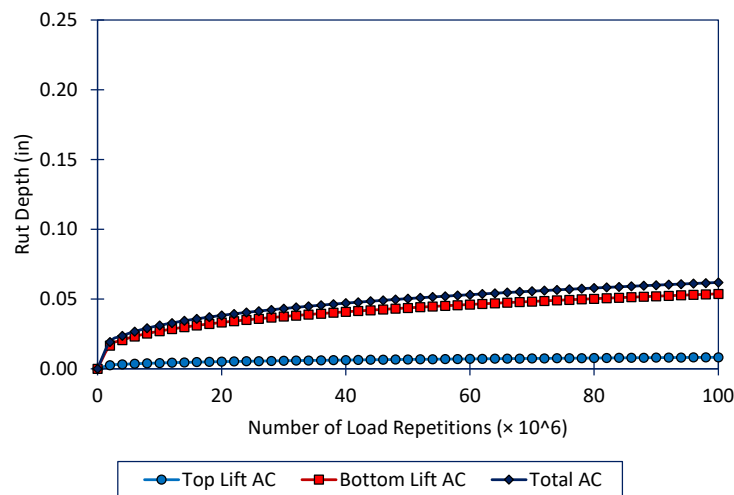
Figure 4-122. Rut Depth Predicted for SR 26 Control Section

From the rut depth progression curves (such as those shown above), the pavement life under rutting was obtained for each of the sites. The rutting pavement life was defined as the number of load repetitions (N_f) until a total AC rut depth of 0.25 in is achieved. Table 4-25 summarizes these N_f values as well as the estimated life reduction for the worm sections.

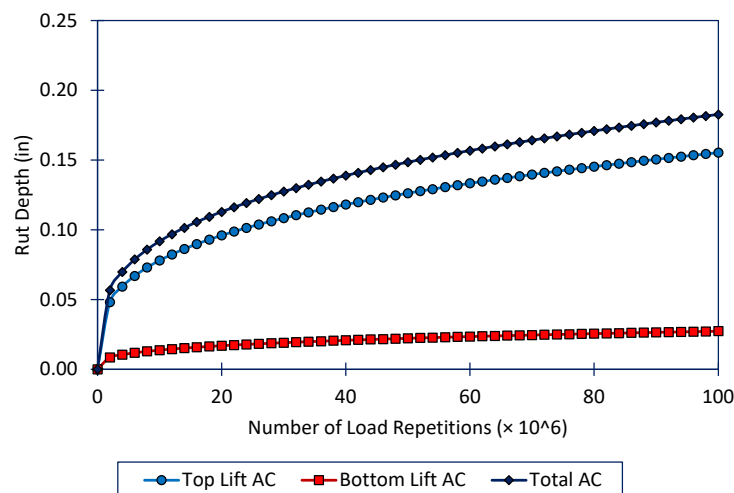
Figure 4-123. Rut Depth Predicted for SR 26 Worm Section

The above table clearly shows that the worm distress may have a significant effect on pavement life based on rutting, which ranges from a 7% to 97% reduction. The most significant life reduction was observed from SR 26.
