Bridge Deck Repair Investigation and Quantity Estimation

APPLIED RESEARCH &
INNOVATION BRANCH

COLORADO
Department of Transportation

University of Colorado Denver Inspection of Bridge Decks Utilizing Ground Penetrating Radar

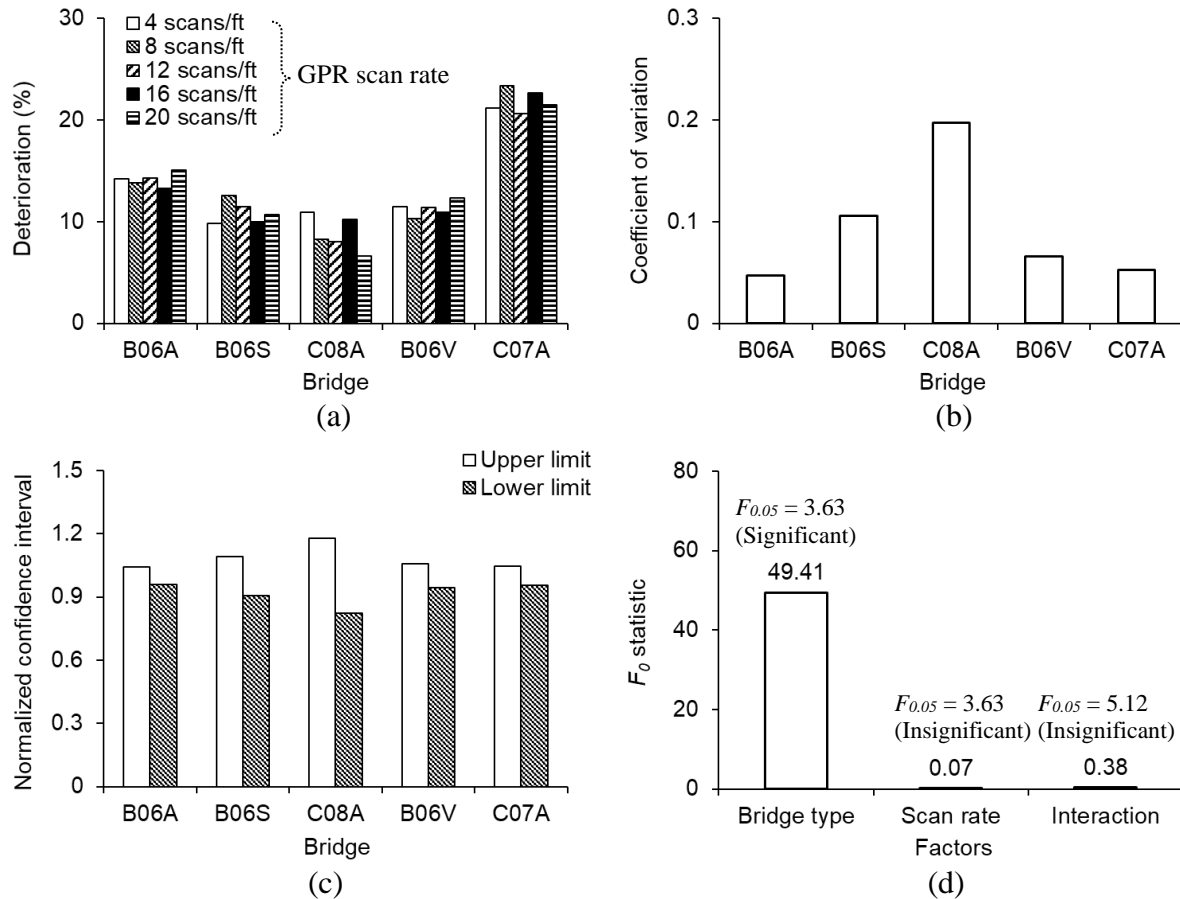
Fig. 6. Sensitivity analysis of ground-penetrating radar: (a) scanned data for deterioration; (b) coefficient of variation; (c) confidence interval; (d) factorial analysis

The percent deterioration of the decks with the scan rate is graphed in Fig. 6(a). There was no correlation between the scanning frequency and the deteriorated area. Considering the COV

values positioned between 0.047 and 0.203 (Fig. 6(b)), the degree of scatter in the GPR readings appeared reasonable. It is noted that the standard GPR test for bridge decks (ASTM D6087 (ASTM 2008)) does not state an acceptable range of accuracy; hence, further research is recommended. As an alternative for evaluating the sensitivity of the measured GPR data, confidence intervals were calculated at a level of 95% (Meeker et al. 2017)

where μ and σ are the mean and standard deviation of the data, respectively, and n is the number of GPR repetitions per bridge. The confidence intervals of the decks were normalized by their means for comparison and are given in Fig. 6(c). The lower and upper levels of C08A (0.82 and 1.18, respectively) enveloped all other cases, meaning that $\pm 20\%$ of the GPR data can be tolerable within the 95% confidence intervals. Figure 6(d) exhibits the results of factorial analysis, which clarifies the statistical significance of the GPR properties. An F_0 statistic is calculated (Montgomery 2013) and compared against the corresponding threshold limit (a confidence level of 95% was used for consistency, $F_{0.05}$): if F_0 is greater than $F_{0.05}$, the factor is regarded to be significant; otherwise, insignificant. The value of $F_0 = 49.41$ in the bridge type factor ($> F_{0.05} = 3.63$) attests that the GPR readings were dominated by the bridge configurations; on the other hand, the scanning rate was not a significant factor ($F_0 = 0.07 < F_{0.05} = 3.63$). The interaction between these two factors (bridge type and scanning rate) was not significant either ($F_0 = 0.38 < F_{0.05} = 5.12$). That is, the GPR-based deterioration was bridge-specific and the scanning rate was not a critical factor from a statistical perspective.

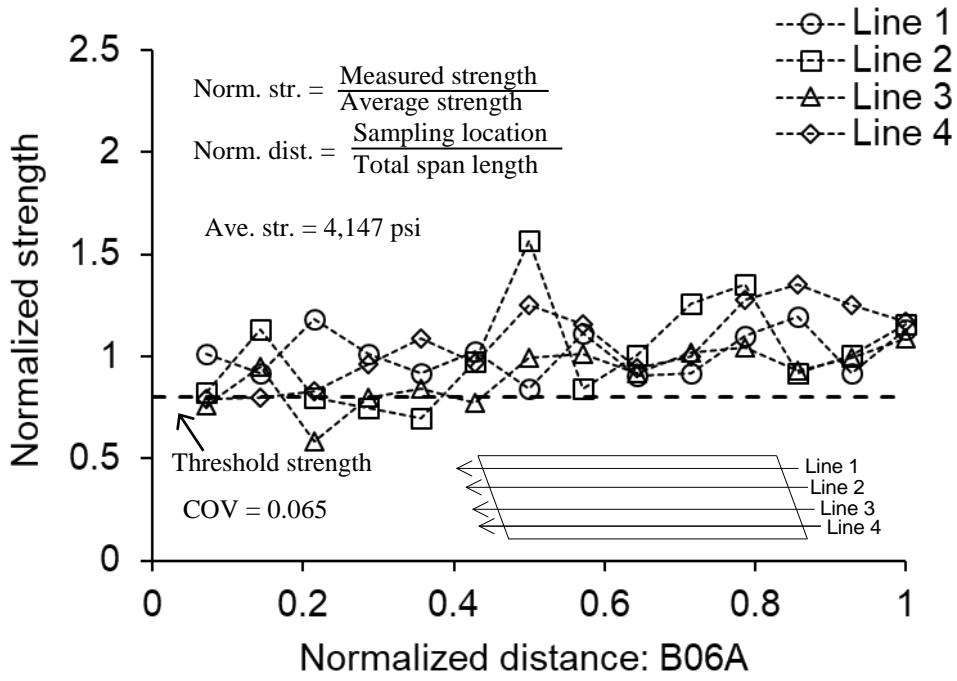
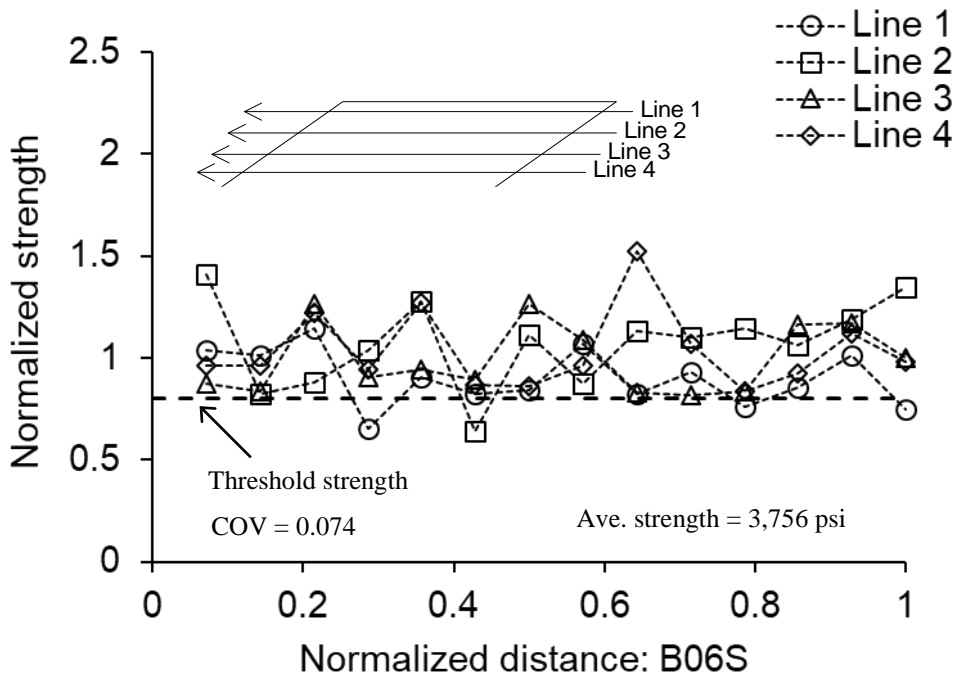
Fig. 7. Rebound hammer data: (a) B06A; (b) B06S

Figure 7 shows the compressive strength of the deck concrete. For the purpose of comparison, the strength and span length of the individual bridges were normalized by corresponding average strength and total span, respectively. The line numbers indicated in Figs. 7(a) to (d) represent the repeated strength measurements along the decks, contingent upon superstructure size and accessibility at the time of rebound hammering. The strength variation of the deck concrete was acceptable, as supported by the coefficient of variation ranging from $COV = 0.061$ to 0.131 : an archetypal COV for structural concrete is 0.125 (Nowak and Collins 2013). Conforming to the published literature that defines a degradation threshold for hardened concrete (Elmenschawi and Brown 2010; Khoshraftar et al. 2013; Guo et al. 2014), a 20% reduction of the average strength was set as the limit. The percentage of the measured values below the threshold was then multiplied by the deck area of each bridge to estimate the quantity of deterioration. As shown in

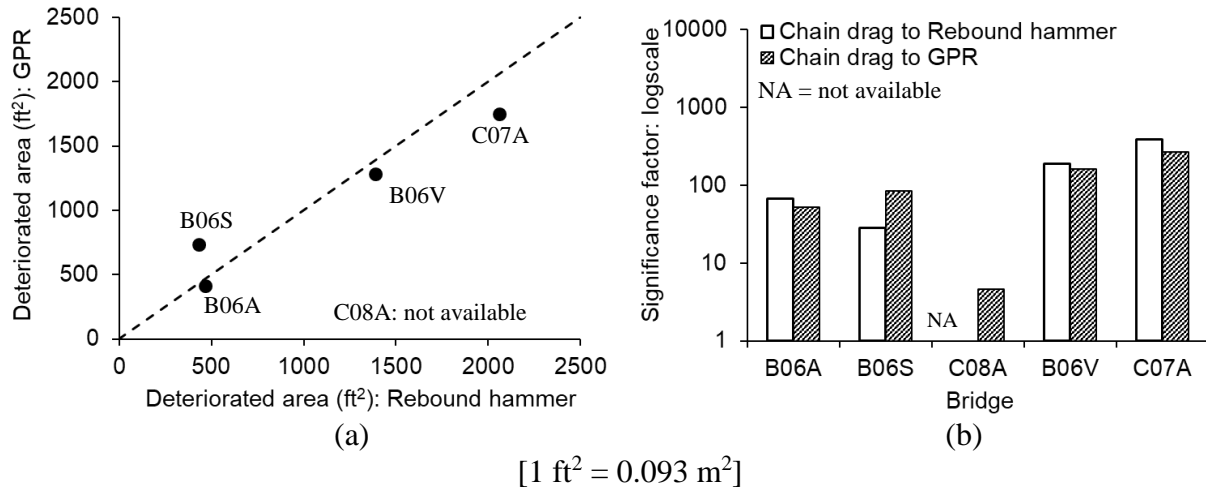
Fig. 8. Evaluation of rebound hammer results: (a) average deterioration; (b) significance factor

Fig. 8(a), a linear trend was noticed between the deteriorated areas determined from the GPR and rebound hammering, and the coefficient of correlation (Eq. 2) was $P_{cor} = 0.967$ (1.0 = perfect correlation)

where A_A and A_B are the areas detected by methods A and B (either chain drag vs. rebound hammer or chain drag vs. GPR in this section), respectively, and A_{deck} is the total deck area. As shown in Fig. 8(b), all factors were classified into the *highly significant* ($I > 15$) and *moderately significant* ($5 < I < 15$) categories. This necessitates isolating concrete delamination from the deteriorated regions.

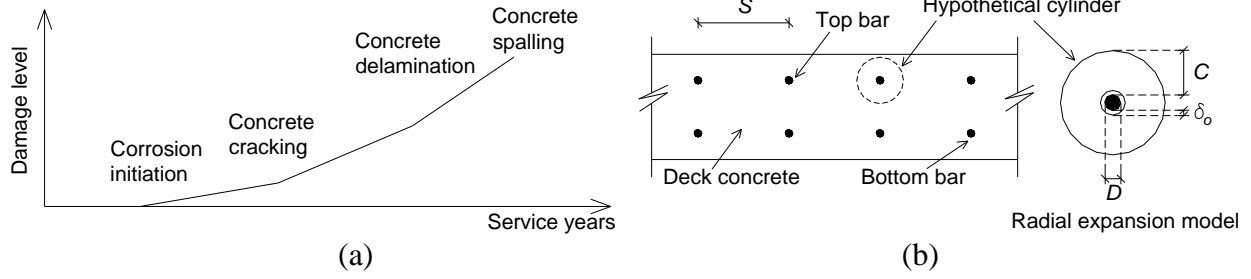
Fig. 9. Deterioration of bridge deck: (a) progression of damage; (b) analytical model

Since repairs are conducted when concrete delamination occurs, delaminated areas need to be extracted from a GPR map that represents deteriorated concrete. Figure 9(a) depicts a schematic diagram concerning the progressive degradation of a corrosion-damaged bridge deck. In accordance with analytical modeling and computational simulations, the regions of delaminated concrete are predicted and compared against repaired areas.

As illustrated in Fig. 9(b), the radial expansion of deck concrete due to rebar corrosion, δ , may be obtained by (ElMaaddawy and Soudki 2007)

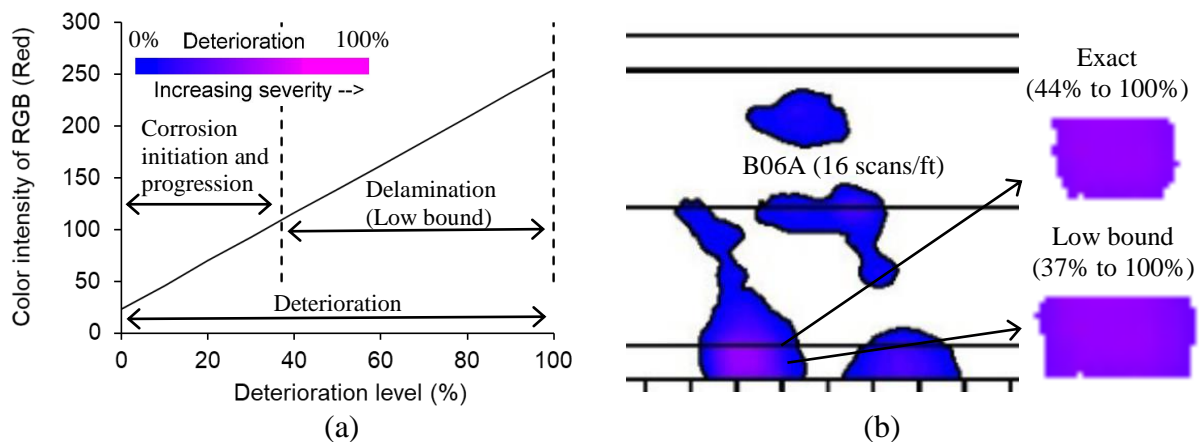
Fig. 10. Agent-based modeling: (a) calibration of RGB color code; (b) extracted delaminated areas at exact and low bound levels for B06A

Preprocessing: The deterioration of the GPR contours was decoded in RGB model space, comprising a combination of Red, Green, and Blue, so that the condition of the bridge decks was numerically linked with the scale bar (Fig. 10(a), inset). The intensities of these colors varied from 0 to 255; for instance, a value set of (255, 0, 0) means red. After completing a calibration process (Fig. 10(a)), the GPR maps of the individual decks were imported to a two-dimensional space in the Netlogo platform. This computer program is specialized in simulating the decentralized response of a discrete agent, called *patch*, that is controlled by a preset rule. The principle and applications of Netlog are provided elsewhere (Wilensky 1999). The dimensions of the imported images were defined and a grid system was assigned to envelop each deck. In doing so, the number of image pixels became equal to the number of the patches; accordingly, one agent represented one pixel with a specific color in the RGB space.

recognized individual pixel colors, and the intensities of Red were attained in the RGB space to identify the calibrated deterioration levels (Fig. 10(b)). Then, the number of the patches was counted within a designated color range and multiplied by a single pixel size to determine the delaminated areas of the decks.

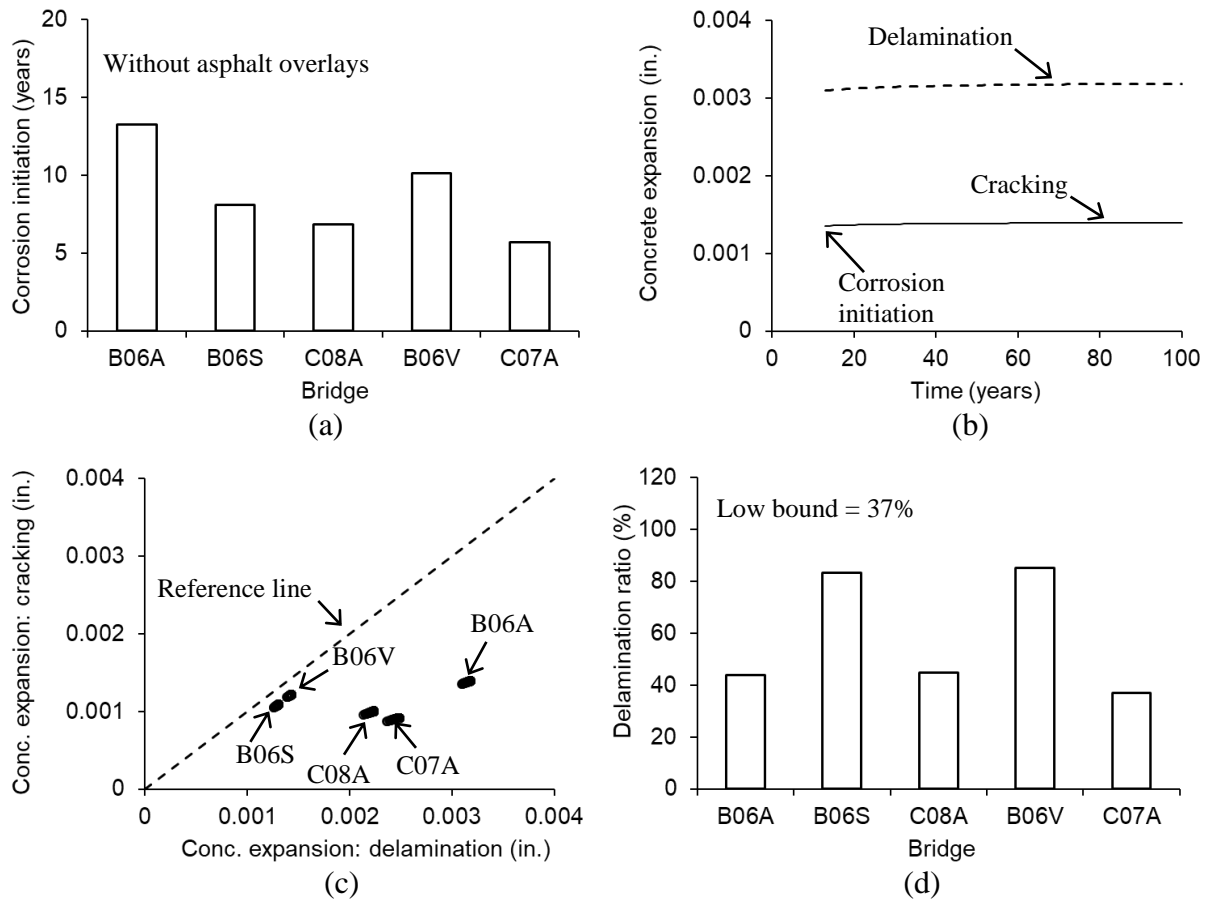
Fig. 11. Corrosion-induced damage: (a) corrosion initiation time; (b) concrete expansion due to corrosion at cracking and delamination for B06A; (c) comparison among bridges; (d) average delamination ratio for 100 years

Figure 11(a) exhibits the corrosion initiation years of the bridge decks, based on the cover depth of the reinforcement measured by GPR (Table 3). The corrosion of B06A commenced at 13.2 years, while that of C07A began at 5.7 years. These predicted results are conservative because the asphalt overlays listed in Table 3 were not taken into consideration in the empirical model. A comparison between the radial expansions at the cracking and delamination (δ_{cr} and δ_{del} , respectively) of B06S is provided in Fig. 11(b), along with the average concrete strength determined by the rebound hammer tests (Fig. 7). After the onset of corrosion at 8.1 years, the radial expansions marginally increased and the gap between the cracking and delamination was maintained up to 100 years. It is important to note that the deck concrete was not subjected to cracking and delamination as soon as the rebar corrosion initiated, whereas the predictions in Fig. 11(b) indicate possible expansion patterns over time (the ratio between these expansions is the above-defined delamination ratio, λ). Compared with the concrete expansion at cracking, additional rust-induced pressures were required for delamination, as given in the skewed data in Fig. 11(c): the strength of C08A was not measured so it was assumed to be the average of the other four bridges' strengths. The difference between the cracking and delamination was a function of the bridge configuration (Fig. 11(d)), and the δ_{cr}/δ_{del} ratios ranged from 37% to 100%. This observation points out that the delamination of the concrete deck can be approximated above 37% of the deterioration intensity in the GPR scale (Fig. 4(a)). In other words, 0% to 36% of the GPR scale represents the initiation of corrosion and progression (Fig. 10(a)); for that reason, the chain drag did not detect the concrete damage within this range (human ear can only perceive an audible range of 1 to 3 kHz, Gucunski et al. 2013) and thus the repair work was not available.

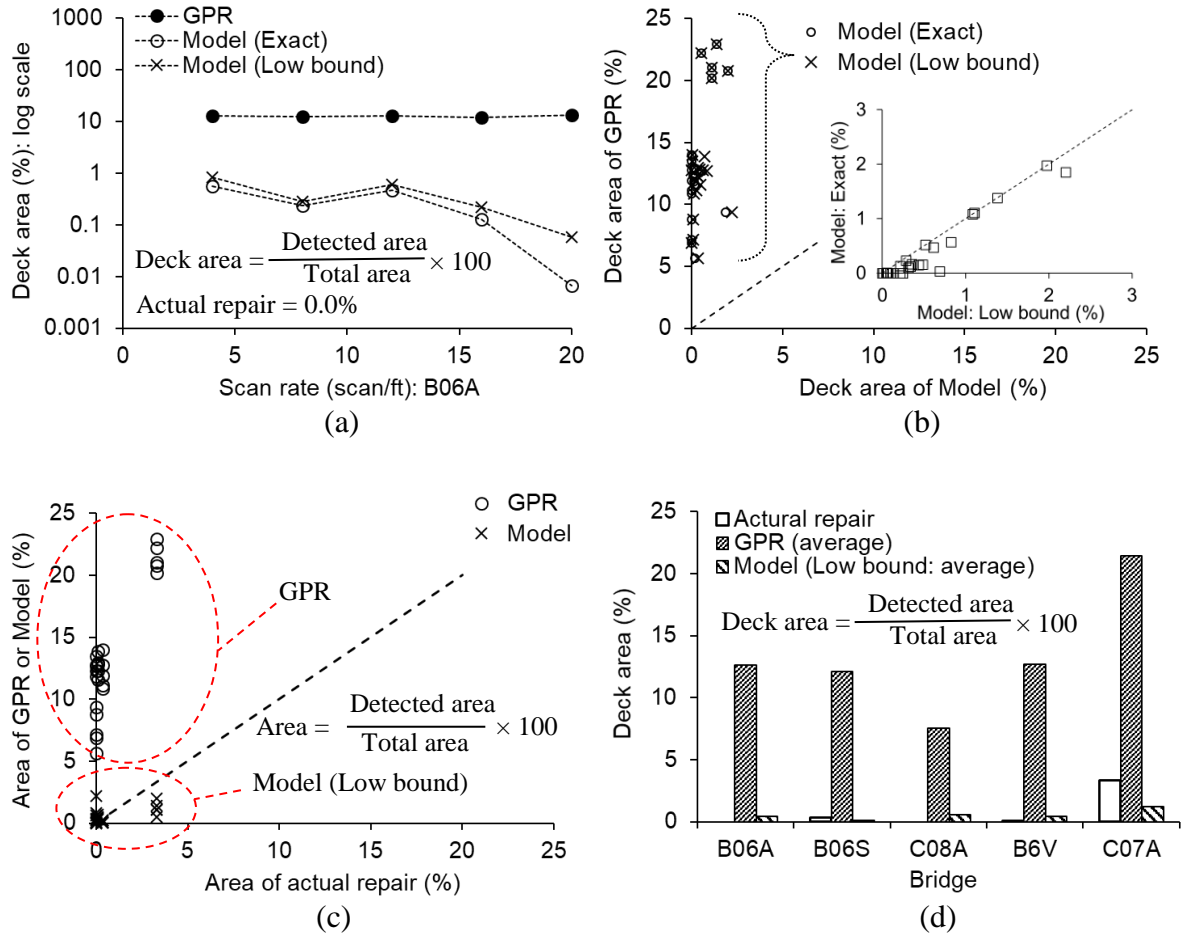
Fig. 12. Evaluation of delaminated area: (a) deck area with scan rate for B06A; (b) comparison between GPR and model; (c) comparison among actual repair, GPR, and model; (d) average comparison

A comprehensive evaluation of the GPR and model-based delamination is shown in Fig. 12. The average responses of the models with the Exact and Low bound levels were comparable (Fig. 12(a)), although their scan-rate-dependent values fluctuated due to the inconsistency of the GPR contours (Table 4). As evidenced in Fig. 12(b), the normalized deck areas associated with GPR were substantially larger than those with the models. There were minor discrepancies between the Exact and Low bound results (Fig. 12(b), inset); therefore, the Low bound model covering all the five bridges (Fig. 11(d)) was adopted for the estimation of the delaminated areas. The degree of deviation from the actual repair is clearly discernable in the Model and GPR (Figs. 12(c) and (d)). From an application standpoint, the dissimilarity between the Model and actual repair is

negligible because the accuracy of chain drag is affected by numerous factors with a large COV of 40% (Scott et al. 2003; Maser 2004).

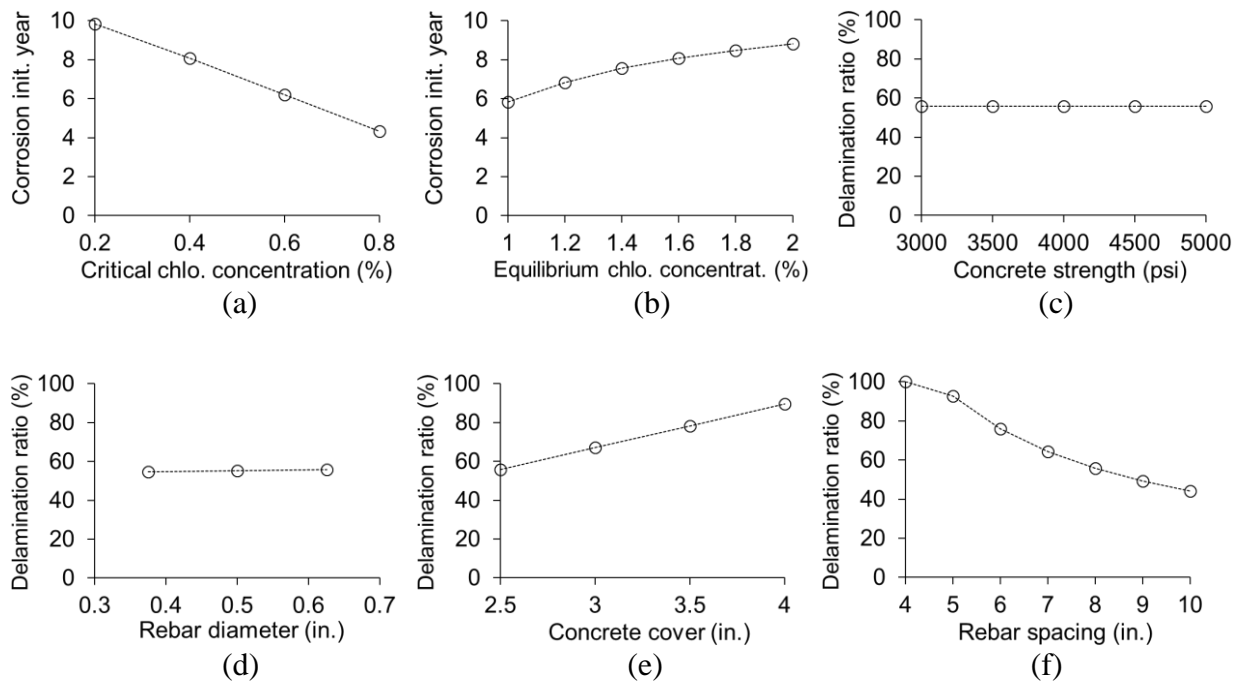
Fig. 13. Parametric study: (a) critical chloride concentration; (b) surface chloride concentration; (c) concrete strength; (d) rebar diameter; (e) concrete cover; (f) rebar spacing

The sensitivity of constituent parameters in the analytical model is described in Fig. 13. The default properties for the chloride-induced corrosion were taken as presented earlier (Eq. 9), and those for the delamination ratio (λ) were as follows (values for all other variables in Eqs. 12 to 14 remained unchanged): compressive strength of concrete = 4,000 psi (27 MPa), diameter and spacing of No. 5 rebar = 0.625 in. (15.9 mm) and 8 in. (203 mm), respectively, and service period = 100 years. The corrosion initiation year (t_i) linearly decreased with the increased critical chloride concentration (C_{cr} , Fig. 13(a)); in contrast, the year gradually rose when the equilibrium

chloride (C_o , Fig. 13(b)) went up. Despite the difficulty in accurately inferring the onset of corrosion, the practical range of the C_{cr} and C_o terms implies that bridge decks under ordinary circumstances begin to corrode between 5 and 10 years, which is corroborated by previous studies (Hopper et al. 2015; Li 2019). Unlike the concrete strength (3,000 psi (20 MPa) to 5,000 psi (35 MPa)) and rebar diameter (0.25 in. (6.35 mm) to 0.625 in. (15.9 mm), No. 3 to No. 5) showing insignificant effects on the delamination ratio of the deck (Figs. 13(c) and (d)), the concrete cover for the top rebars (2.5 in. (64 mm) to 4.0 in. (102 mm)) and rebar spacing (4 in. (102 mm) to 10 in. (254 mm)) were dominant parameters that altered the delamination ratio (Figs. 13 (e) and (f)). Within the simulation ranges of these parameters, the resultant delamination ratios were above the ratio of 37% at the Low bound level (Fig. 11(d)). Thereby, a rounded ratio of 40% is suggested when interpreting GPR data for delamination of concrete decks; namely, the scale bar of a GPR map can be decomposed into the initiation and progression of corrosion (0% to 39%), accompanied by concrete cracking, and the delamination of the concrete (40% to 100%).

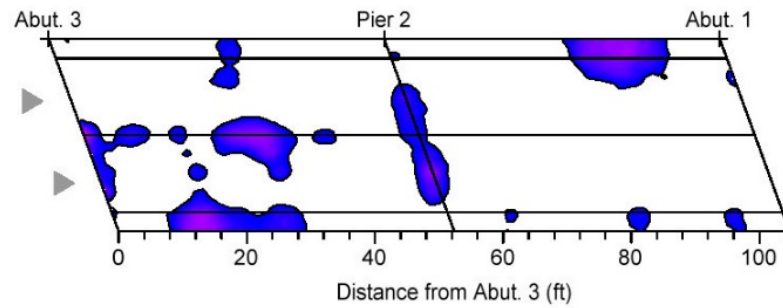
Direction of traffic</p> | <p>Deck</p> <table border="1"> <tr> <td>Conc. Deterioration (%)</td> <td>14.2</td> </tr> <tr> <td>Conc. Deterioration (s.f)</td> <td>446</td> </tr> </table> | Conc. Deterioration (%) | 14.2 | Conc. Deterioration (s.f) | 446 | <p>Bridge ID: B-06-A (4 scans/ft) US 40 WB over Fortification Creek</p> <p>Analyzed by: IN Reviewed by: SB Completed: 9/14/18</p> <p>Sheet 1 of 1</p> |
| Conc. Deterioration (%) | 14.2 | | | | | | |
| Conc. Deterioration (s.f) | 446 | | | | | | |

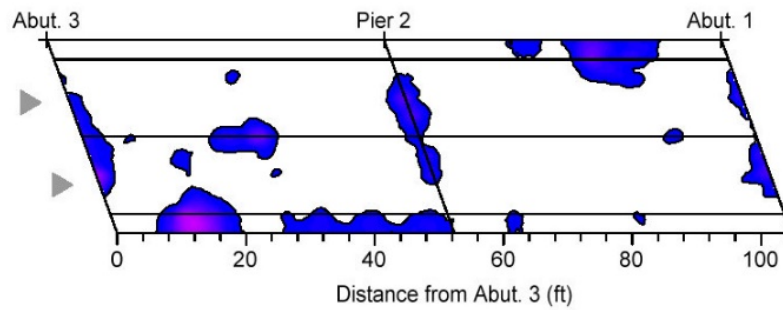
| Concrete Condition Legend | Orientation | Quantity Summary | General Information | | |
|---|--|--|--|---|---|
| <p>Deterioration</p> <p>Condition not detectable by GPR</p> | <p>Orientation</p> <p>Direction of traffic</p> | Deck | <p>Bridge ID: B-06-A (8 scans/ft)</p> <p>US 40 WB over Fortification Creek</p> | | |
| | | <table border="1"> <tr> <td>Conc. Deterioration (%)</td> <td>13.8</td> </tr> <tr> <td>Conc. Deterioration (s.f)</td> <td>432</td> </tr> </table> | Conc. Deterioration (%) | 13.8 | Conc. Deterioration (s.f) |
| Conc. Deterioration (%) | 13.8 | | | | |
| Conc. Deterioration (s.f) | 432 | | | | |
| | | | <p>Sheet 1 of 1</p> | | |

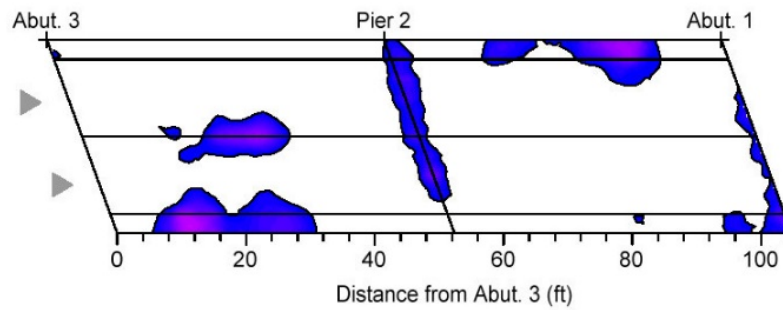
| Concrete Condition Legend | Orientation | Quantity Summary | General Information | | |
|--|---|--|---|---|---|
| <p>Deterioration</p> <p>Increasing severity --></p> <p> Condition not detectable by GPR</p> | <p></p> <p> Direction of traffic</p> | Deck | <p>Bridge ID: B-06-A (12 scans/ft)</p> <p>US 40 WB over Fortification Creek</p> | | |
| | | <table border="1"> <tr> <td>Conc. Deterioration (%)</td> <td>14.3</td> </tr> <tr> <td>Conc. Deterioration (s.f)</td> <td>449</td> </tr> </table> | Conc. Deterioration (%) | 14.3 | Conc. Deterioration (s.f) |
| Conc. Deterioration (%) | 14.3 | | | | |
| Conc. Deterioration (s.f) | 449 | | | | |
| | | | Sheet 1 of 1 | | |

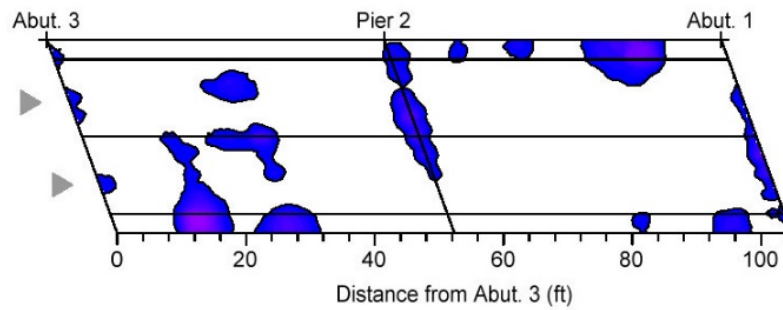
| Concrete Condition Legend | Orientation | Quantity Summary | General Information | | |
|--|---|--|---|---|---|
| <p>Deterioration</p> <p>Increasing severity --></p> <p> Condition not detectable by GPR</p> | <p></p> <p> Direction of traffic</p> | Deck | <p>Bridge ID: B-06-A (16 scans/ft)</p> <p>US 40 WB over Fortification Creek</p> | | |
| | | <table border="1"> <tr> <td>Conc. Deterioration (%)</td> <td>13.3</td> </tr> <tr> <td>Conc. Deterioration (s.f)</td> <td>417</td> </tr> </table> | Conc. Deterioration (%) | 13.3 | Conc. Deterioration (s.f) |
| Conc. Deterioration (%) | 13.3 | | | | |
| Conc. Deterioration (s.f) | 417 | | | | |
| | | | <p>Sheet 1 of 1</p> | | |

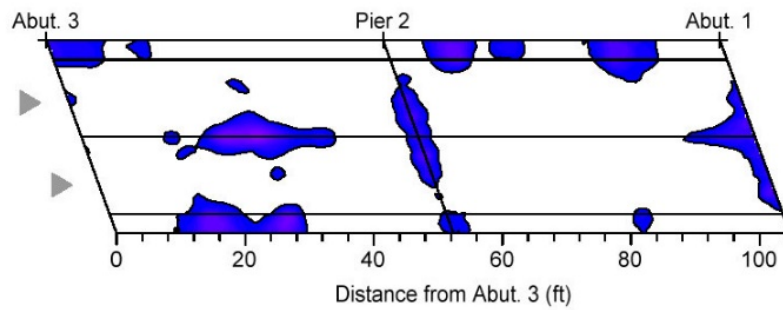
| Concrete Condition Legend | Orientation | Quantity Summary | | General Information |
|---|---|---|---|--|
| <p>Deterioration</p> <p>Condition not detectable by GPR</p> | | Deck | Conc. Deterioration (%) | 15.1 |

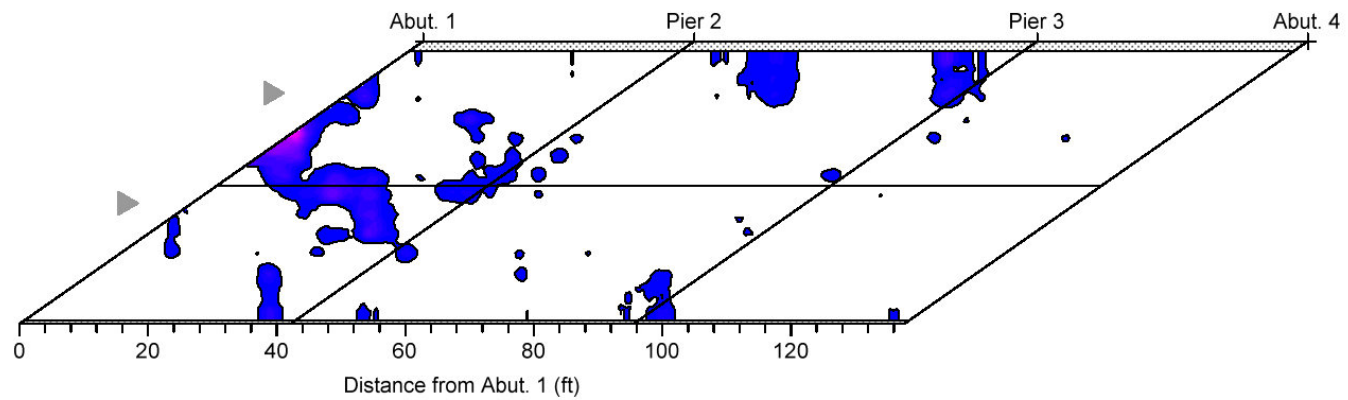
| Concrete Condition Legend | Orientation | Quantity Summary | General Information | | | | |
|--|---|---|---|---|---|---|--|
| <p>Deterioration</p> <p>Increasing severity --></p> <p> Condition not detectable by GPR</p> | <p> Direction of traffic</p> | <p>Deck</p> <table border="1"> <tr> <td>Conc. Deterioration (%)</td> <td>9.8</td> </tr> <tr> <td>Conc. Deterioration (s.f)</td> <td>555</td> </tr> </table> | Conc. Deterioration (%) | 9.8 | Conc. Deterioration (s.f) | 555 | <p>Bridge ID: B-06-S (4 scans/ft) US 40 EB over Fortification Creek</p> <p>Analyzed by: IN Reviewed by: SB Completed: 9/14/18</p> <p>Sheet 1 of 1</p> |
| Conc. Deterioration (%) | 9.8 | | | | | | |
| Conc. Deterioration (s.f) | 555 | | | | | | |

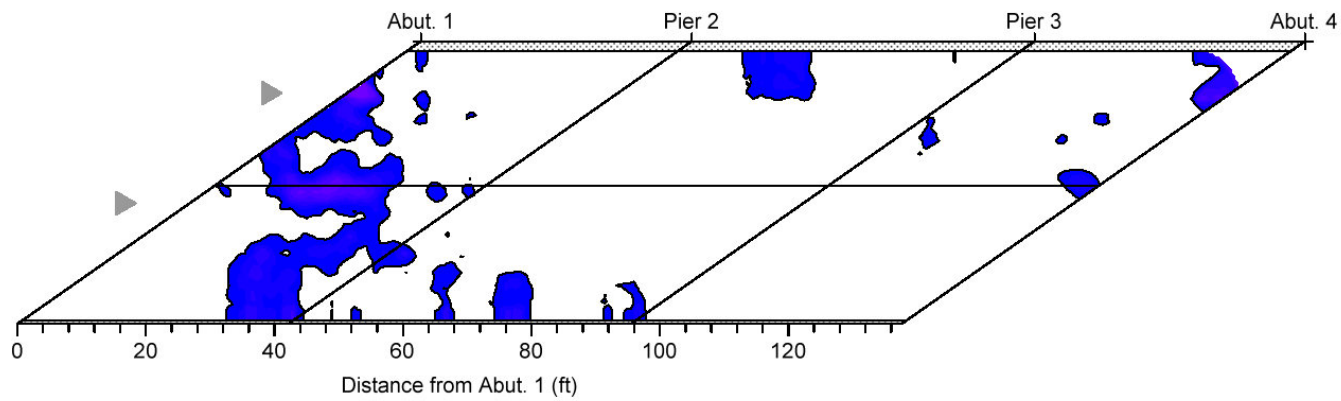
| Concrete Condition Legend | Orientation | Quantity Summary | General Information | | | | |
|---|---|--|---|---|---|---|---|
| <p>Deterioration</p> <p>Condition not detectable by GPR</p> | <p>Direction of traffic</p> | <p>Deck</p> <table border="1"> <tr> <td>Conc. Deterioration (%)</td> <td>12.6</td> </tr> <tr> <td>Conc. Deterioration (s.f)</td> <td>717</td> </tr> </table> | Conc. Deterioration (%) | 12.6 | Conc. Deterioration (s.f) | 717 | <p>Bridge ID: B-06-S (8 scans/ft) US 40 EB over Fortification Creek</p> <p>Analyzed by: IN Reviewed by: SB Completed: 9/14/18</p> |
| Conc. Deterioration (%) | 12.6 | | | | | | |
| Conc. Deterioration (s.f) | 717 | | | | | | |
| | | | Sheet 1 of 1 | | | | |

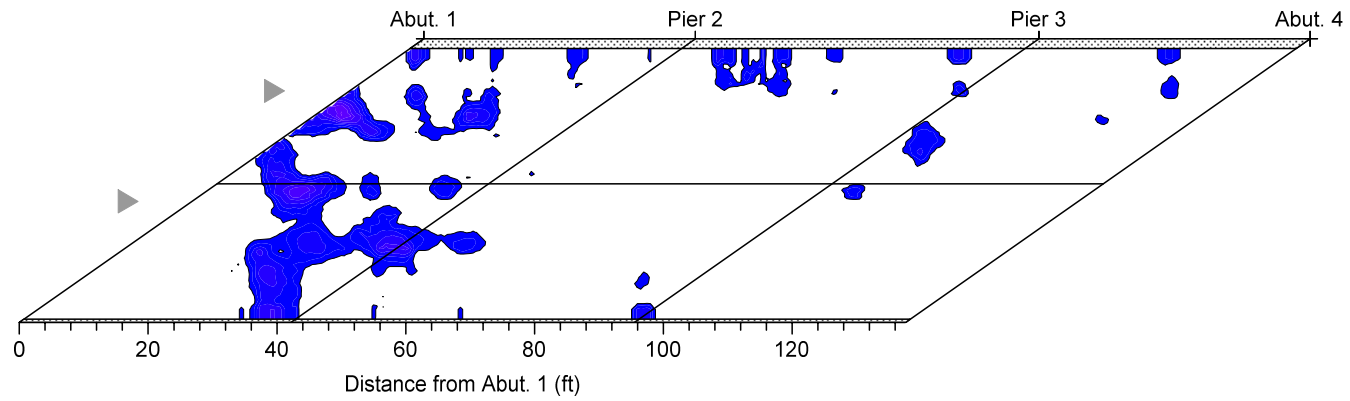
| Concrete Condition Legend | Orientation | Quantity Summary | General Information | | | | |
|--|---|--|---|---|---|---|--|
| <p>Deterioration</p> <p>Increasing severity --></p> <p> Condition not detectable by GPR</p> | <p> Direction of traffic</p> | <p>Deck</p> <table border="1"> <tr> <td>Conc. Deterioration (%)</td> <td>11.5</td> </tr> <tr> <td>Conc. Deterioration (s.f)</td> <td>654</td> </tr> </table> | Conc. Deterioration (%) | 11.5 | Conc. Deterioration (s.f) | 654 | <p>Bridge ID: B-06-S (12 scans/ft) US 40 EB over Fortification Creek</p> <p>Analyzed by: IN Reviewed by: SB Completed: 9/14/18</p> |
| Conc. Deterioration (%) | 11.5 | | | | | | |
| Conc. Deterioration (s.f) | 654 | | | | | | |
| | | | <p>Sheet 1 of 1</p> | | | | |

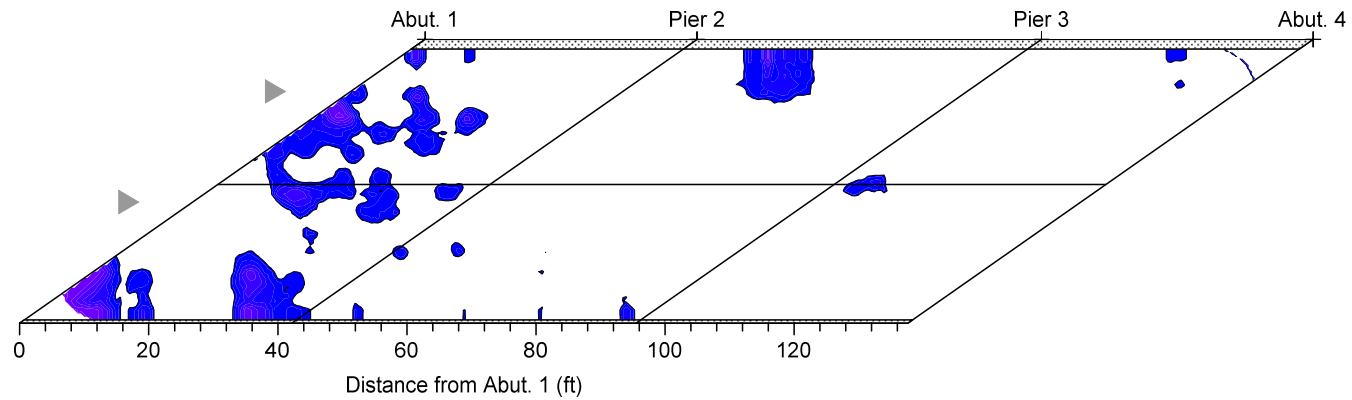
| Concrete Condition Legend | Orientation | Quantity Summary | General Information | | | | |
|--|---|--|---|---|---|---|---|
| <p>Deterioration</p> <p>Increasing severity --></p> <p> Condition not detectable by GPR</p> | <p></p> <p> Direction of traffic</p> | <p>Deck</p> <table border="1"> <tr> <td>Conc. Deterioration (%)</td> <td>10.0</td> </tr> <tr> <td>Conc. Deterioration (s.f)</td> <td>572</td> </tr> </table> | Conc. Deterioration (%) | 10.0 | Conc. Deterioration (s.f) | 572 | <p>Bridge ID: B-06-S (16 scans/ft) US 40 EB over Fortification Creek</p> <p>Analyzed by: IN Reviewed by: SB Completed: 9/14/18</p> <p>Sheet 1 of 1</p> |
| Conc. Deterioration (%) | 10.0 | | | | | | |
| Conc. Deterioration (s.f) | 572 | | | | | | |

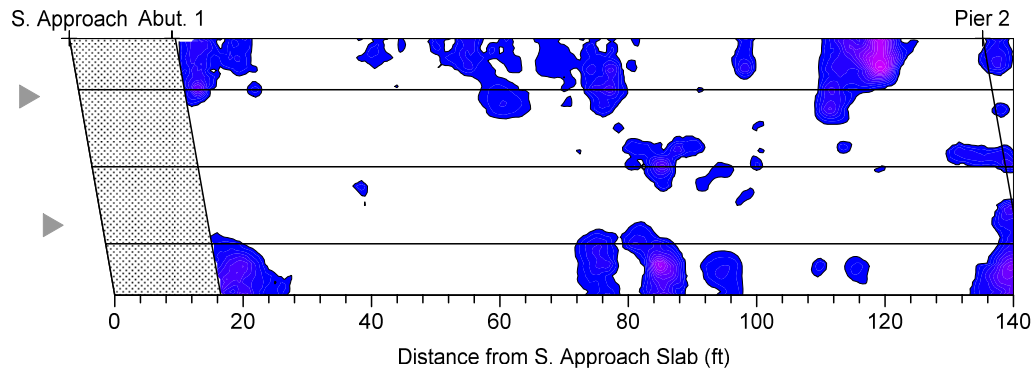
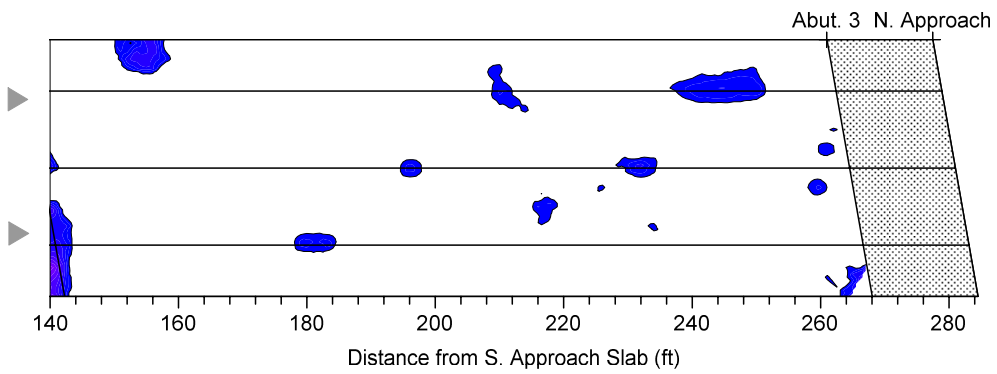
| Concrete Condition Legend | Orientation | Quantity Summary | General Information |
|--|---|---|--|
| <p>Deterioration</p> <p>Increasing severity --></p> <p> Approach Slab</p> | <p></p> <p> Direction of traffic</p> | Deck | <p>Bridge ID: B-06-V (4 scans/ft)</p> <p>SH 394 over Yampa River</p> <p>Analyzed by: IN</p> <p>Reviewed by: SB</p> <p>Completed: 9/14/18</p> |
| | | <p>Conc. Deterioration (%) 11.5</p> <p>Conc. Deterioration (s.f) 1158</p> | <p>Sheet 1 of 1</p> |

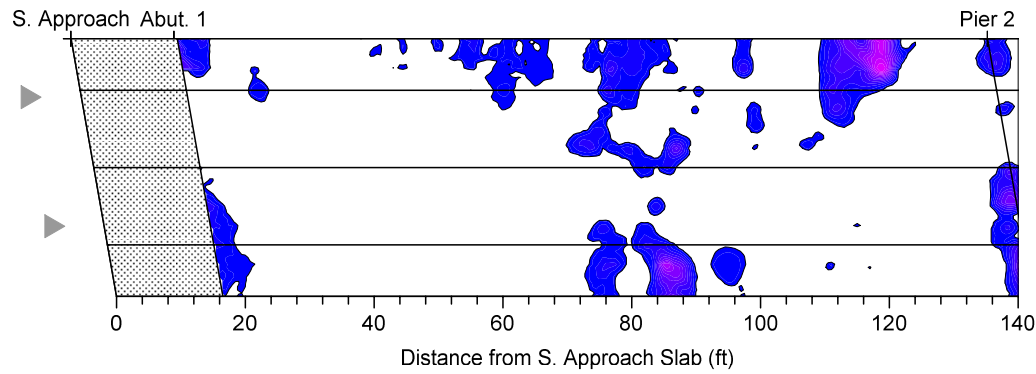
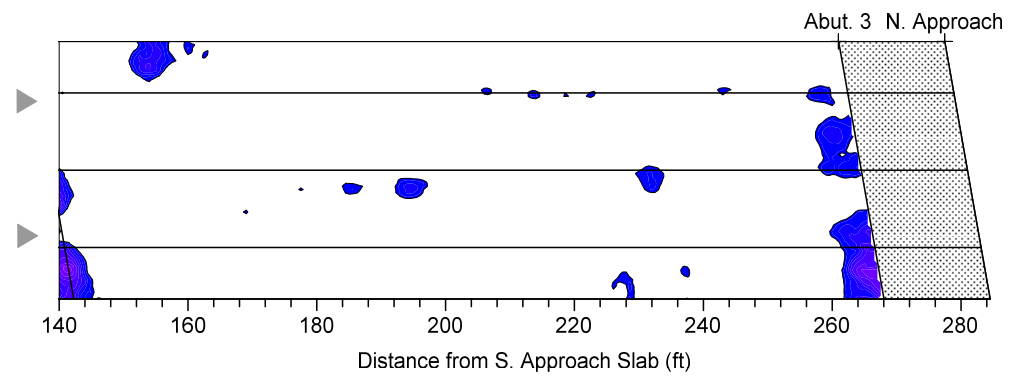
| Concrete Condition Legend | Orientation | Quantity Summary | General Information | | |
|--|---|---|---|---|---|
| <p>Deterioration</p> <p>Increasing severity --></p> <p> Approach Slab</p> | <p> Direction of traffic</p> | Deck | Bridge ID: B-06-V (8 scans/ft) SH 394 over Yampa River | | |
| | | <table border="1"> <tr> <td>Conc. Deterioration (%)</td> <td>10.3</td> </tr> <tr> <td>Conc. Deterioration (s.f)</td> <td>1030</td> </tr> </table> | Conc. Deterioration (%) | 10.3 | Conc. Deterioration (s.f) |
| Conc. Deterioration (%) | 10.3 | | | | |
| Conc. Deterioration (s.f) | 1030 | | | | |
| | | | Sheet 1 of 1 | | |

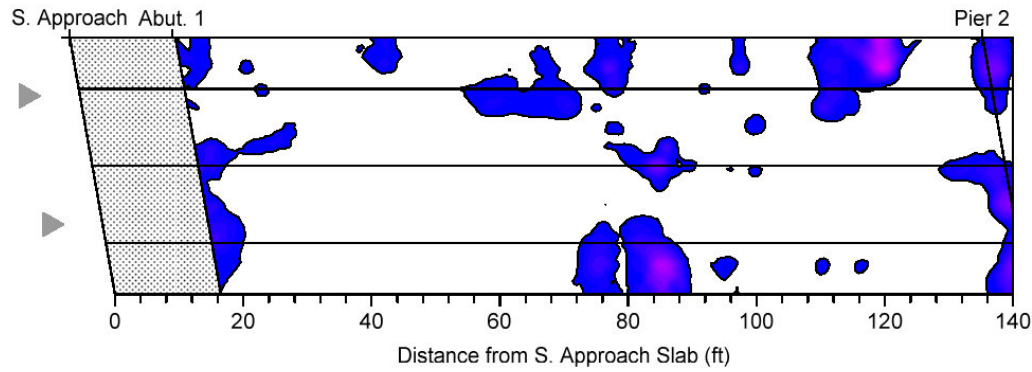
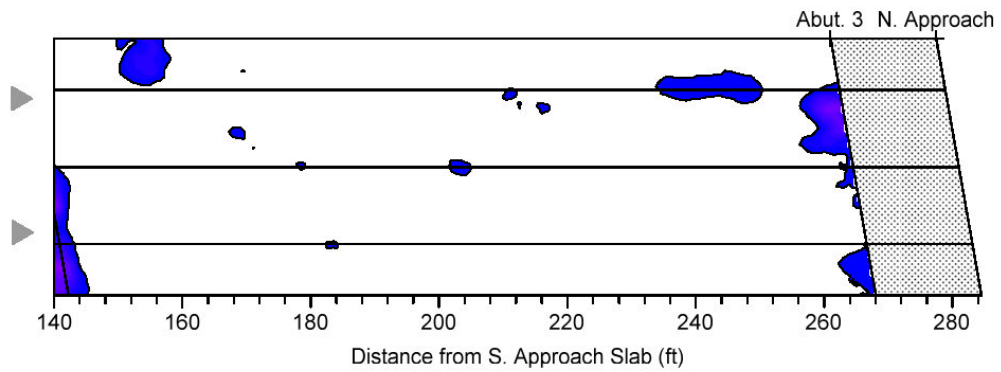
| Concrete Condition Legend | Orientation | Quantity Summary | General Information | | |
|--|---|---|--|---|---|
| <p>Deterioration</p> <p>Increasing severity --></p> <p> Approach Slab</p> | <p> Direction of traffic</p> | Deck | <p>Bridge ID: B-06-V (12 scans/ft) SH 394 over Yampa River</p> <p>Analyzed by: IN Reviewed by: SB Completed: 9/14/18</p> | | |
| | | <table border="1"> <tr> <td>Conc. Deterioration (%)</td> <td>11.4</td> </tr> <tr> <td>Conc. Deterioration (s.f)</td> <td>1150</td> </tr> </table> | | Conc. Deterioration (%) | 11.4 |
| Conc. Deterioration (%) | 11.4 | | | | |
| Conc. Deterioration (s.f) | 1150 | | | | |

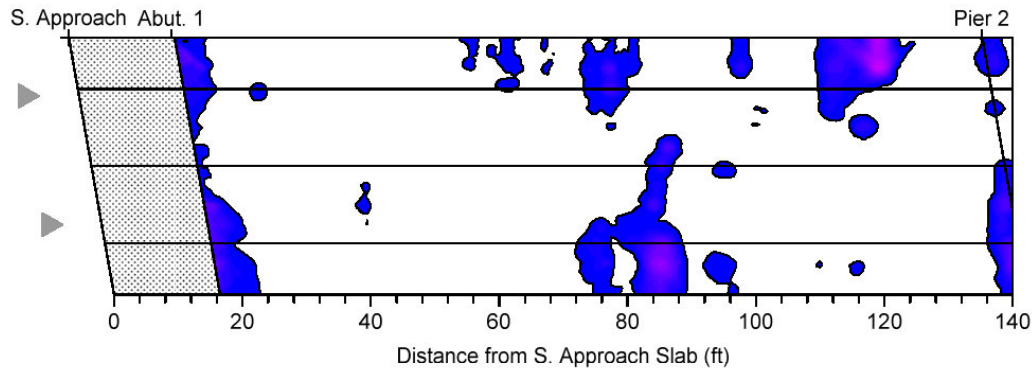
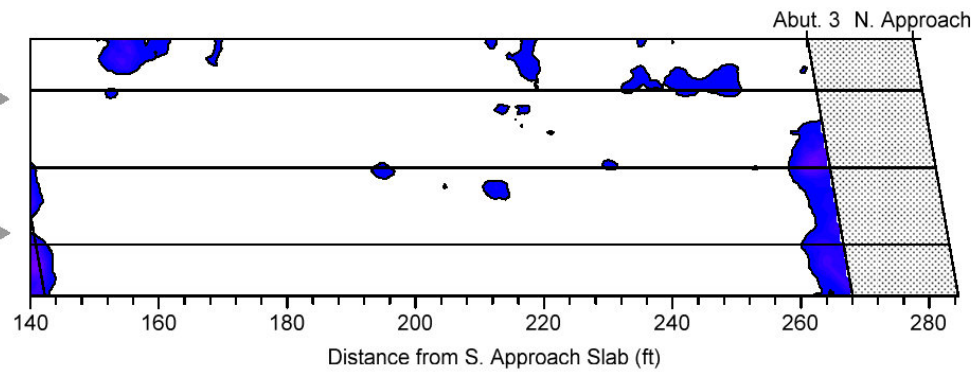
| Concrete Condition Legend | Orientation | Quantity Summary | General Information | | |
|--|---|---|--|---|---|
| <p>Deterioration</p> <p>Increasing severity --></p> <p> Approach Slab</p> | <p> Direction of traffic</p> | Deck | <p>Bridge ID: B-06-V (16 scans/ft) SH 394 over Yampa River</p> <p>Analyzed by: IN Reviewed by: SB Completed: 9/14/18</p> | | |
| | | <table border="1"> <tr> <td>Conc. Deterioration (%)</td> <td>10.9</td> </tr> <tr> <td>Conc. Deterioration (s.f)</td> <td>1096</td> </tr> </table> | | Conc. Deterioration (%) | 10.9 |
| Conc. Deterioration (%) | 10.9 | | | | |
| Conc. Deterioration (s.f) | 1096 | | | | |

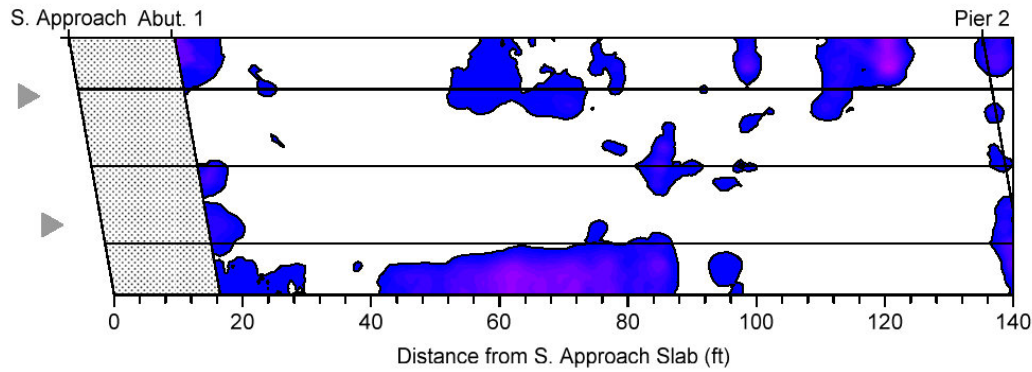
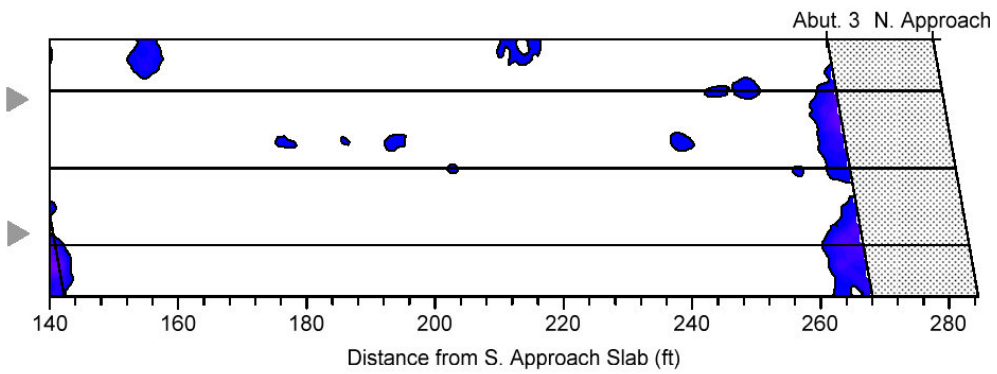
| Concrete Condition Legend | Orientation | Quantity Summary | General Information | | |
|--|---|---|--|---|---|
| <p>Deterioration</p> <p>Increasing severity --></p> <p> Approach Slab</p> | <p> Direction of traffic</p> | Deck | Bridge ID: B-06-V (20 scans/ft) SH 394 over Yampa River | | |
| | | <table border="1"> <tr> <td>Conc. Deterioration (%)</td> <td>12.3</td> </tr> <tr> <td>Conc. Deterioration (s.f)</td> <td>1238</td> </tr> </table> | Conc. Deterioration (%) | 12.3 | Conc. Deterioration (s.f) |
| Conc. Deterioration (%) | 12.3 | | | | |
| Conc. Deterioration (s.f) | 1238 | | | | |
| | | | Sheet 1 of 1 | | |

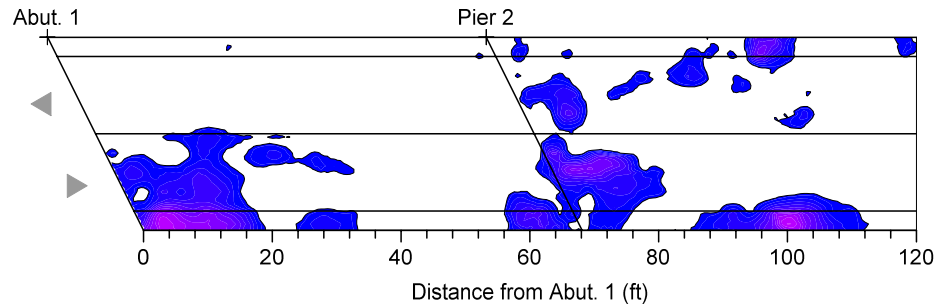
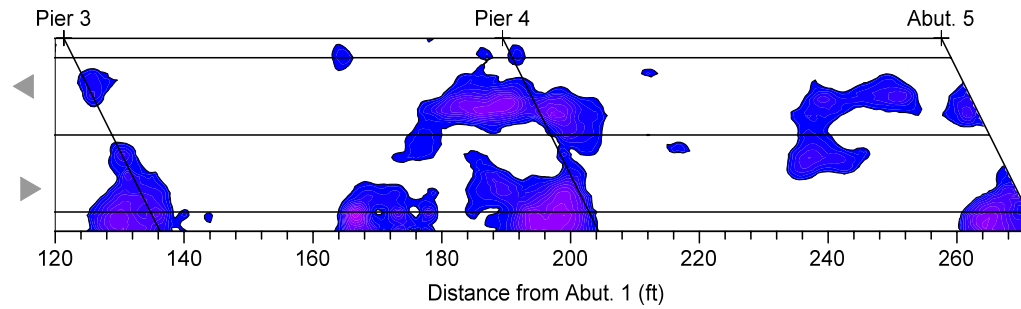
| Concrete Condition Legend | Orientation | Quantity Summary | General Information | | |
|--|--|---|--|---|---|
| <p>Deterioration</p> <p>Increasing severity --></p> <p> Condition not detectable by GPR</p> | <p>Orientation</p> <p>Direction of traffic</p> | Deck | Bridge ID: C-07-A (4 scans/ft) US 40 over Yampa River | | |
| | | <table border="1"> <tr> <td>Conc. Deterioration (%)</td> <td>21.2</td> </tr> <tr> <td>Conc. Deterioration (s.f)</td> <td>1732</td> </tr> </table> | Conc. Deterioration (%) | 21.2 | Conc. Deterioration (s.f) |
| Conc. Deterioration (%) | 21.2 | | | | |
| Conc. Deterioration (s.f) | 1732 | | | | |
| | | | <p>Sheet 1 of 1</p> | | |

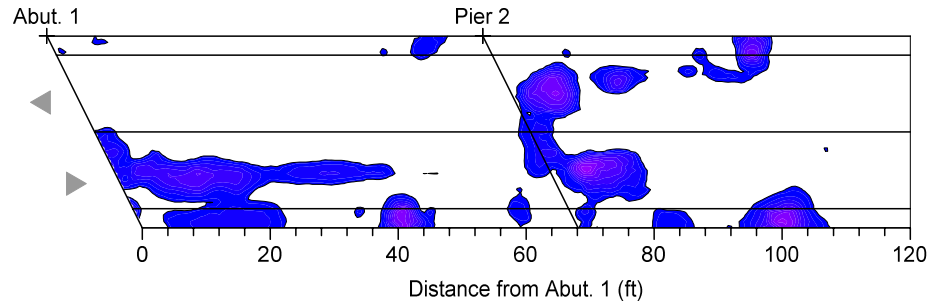
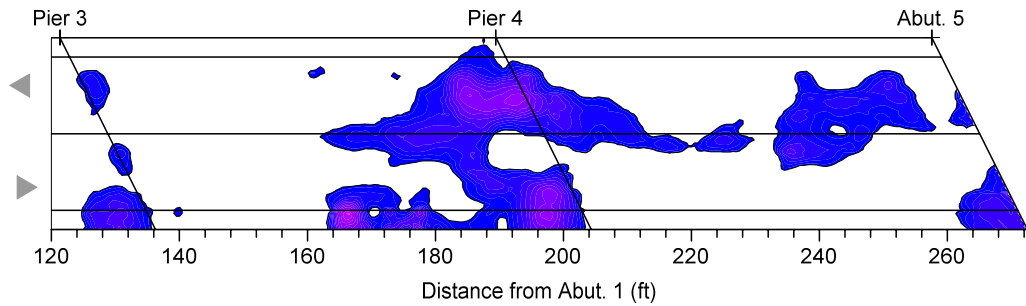
| Concrete Condition Legend | Orientation | Quantity Summary | General Information | | |
|--|---|---|--|---|---|
| <p>Deterioration</p> <p>Increasing severity --></p> <p> Condition not detectable by GPR</p> | <p></p> <p> Direction of traffic</p> | Deck | Bridge ID: C-07-A (8 scans/ft) US 40 over Yampa River | | |
| | | <table border="1"> <tr> <td>Conc. Deterioration (%)</td> <td>23.4</td> </tr> <tr> <td>Conc. Deterioration (s.f)</td> <td>1908</td> </tr> </table> | Conc. Deterioration (%) | 23.4 | Conc. Deterioration (s.f) |
| Conc. Deterioration (%) | 23.4 | | | | |
| Conc. Deterioration (s.f) | 1908 | | | | |
| | | | Sheet 1 of 1 | | |

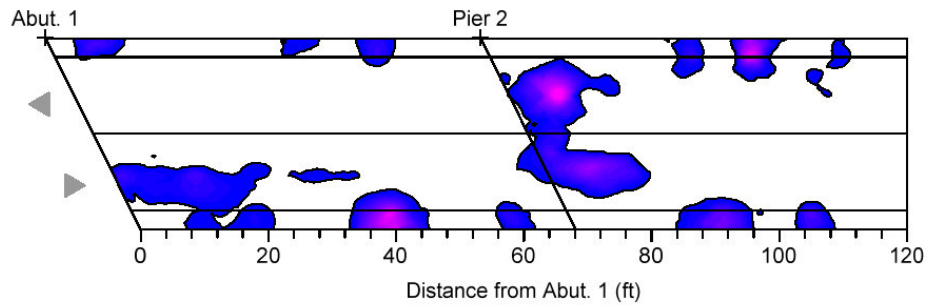
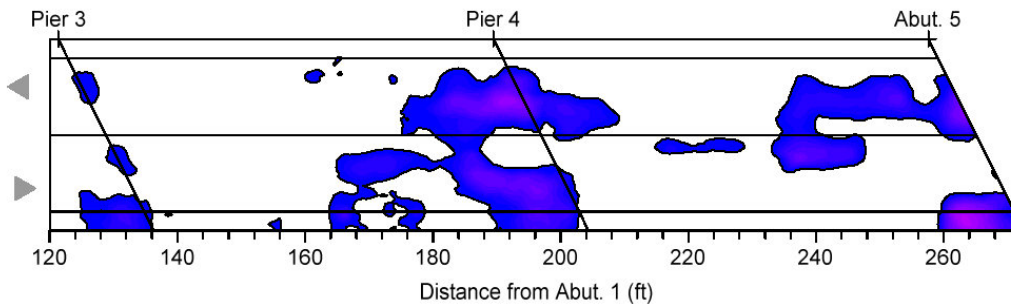
| Concrete Condition Legend | Orientation | Quantity Summary | | General Information | |
|--|---|---|---|---|---|
| <p>Deterioration</p> <p>Increasing severity --></p> <p> Condition not detectable by GPR</p> | <p></p> <p> Direction of traffic</p> | Deck | Conc. Deterioration (%) | 20.6 | Bridge ID: C-07-A (12 scans/ft) US 40 over Yampa River |
| | | | Conc. Deterioration (s.f) | 1685 | Analyzed by: IN Reviewed by: SB Completed: 9/14/18 |
