Bridge Deck Repair Investigation and Quantity Estimation

APPLIED RESEARCH &
INNOVATION BRANCH

COLORADO
Department of Transportation

University of Colorado Denver Inspection of Bridge Decks Utilizing Ground Penetrating Radar

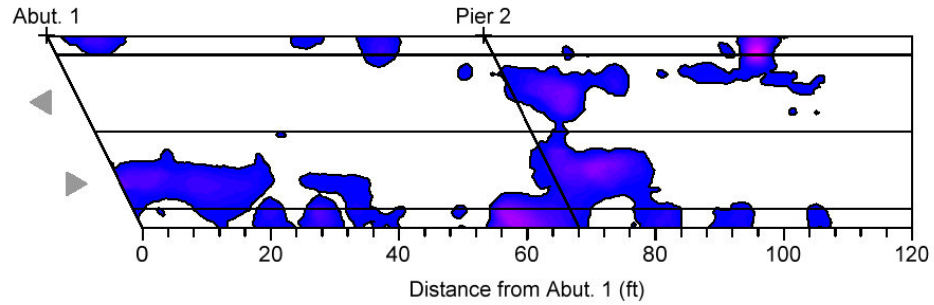
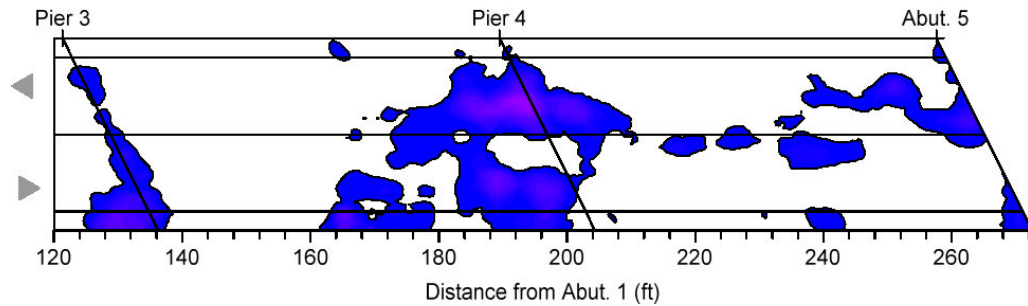
| Concrete Condition Legend | Orientation | Quantity Summary | General Information | | |
|--|---|---|---|---|---|
| <p>Deterioration</p> <p>Increasing severity --></p> <p> Condition not detectable by GPR</p> | <p></p> <p> Direction of traffic</p> | Deck | <p>Bridge ID: C-07-A (16 scans/ft) US 40 over Yampa River</p> <p>Analyzed by: IN Reviewed by: SB Completed: 9/14/18</p> | | |
| | | <table border="1"> <tr> <td>Conc. Deterioration (%)</td> <td>22.7</td> </tr> <tr> <td>Conc. Deterioration (s.f)</td> <td>1853</td> </tr> </table> | | Conc. Deterioration (%) | 22.7 |
| Conc. Deterioration (%) | 22.7 | | | | |
| Conc. Deterioration (s.f) | 1853 | | | | |

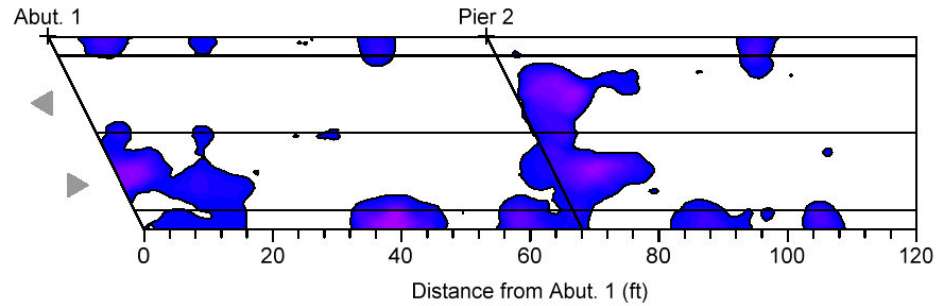
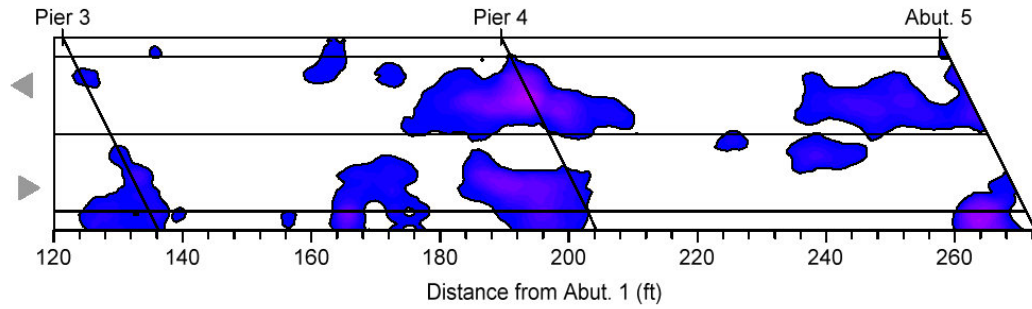
| Concrete Condition Legend | Orientation | Quantity Summary | General Information | | |
|--|--|---|---|---|---|
| <p>Deterioration</p> <p>Increasing severity --></p> <p> Condition not detectable by GPR</p> | <p>Orientation</p> <p>Direction of traffic</p> | Deck | Bridge ID: C-07-A (20 scans/ft) US 40 over Yampa River | | |
| | | <table border="1"> <tr> <td>Conc. Deterioration (%)</td> <td>21.5</td> </tr> <tr> <td>Conc. Deterioration (s.f)</td> <td>1756</td> </tr> </table> | Conc. Deterioration (%) | 21.5 | Conc. Deterioration (s.f) |
| Conc. Deterioration (%) | 21.5 | | | | |
| Conc. Deterioration (s.f) | 1756 | | | | |
| | | | <p>Sheet 1 of 1</p> | | |

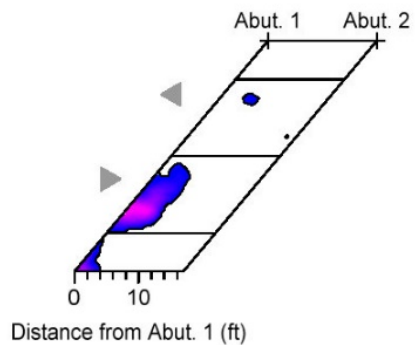
Direction of traffic</p> | <p>Deck</p> <table border="1" data-bbox="1115 1252 1430 1339"> <tr> <td>Conc. Deterioration (%)</td> <td>10.9</td> </tr> <tr> <td>Conc. Deterioration (s.f)</td> <td>63</td> </tr> </table> | Conc. Deterioration (%) | | 10.9 | Conc. Deterioration (s.f) | 63 | <p>Bridge ID: C-08-A (4 scans/ft) US 40 over Shelton Ditch</p> <p>Analyzed by: IN Reviewed by: SB Completed: 9/14/18</p> <p style="text-align: center;">Sheet 1 of 1</p> |
| Conc. Deterioration (%) | 10.9 | | | | | | | |
| Conc. Deterioration (s.f) | 63 | | | | | | | |

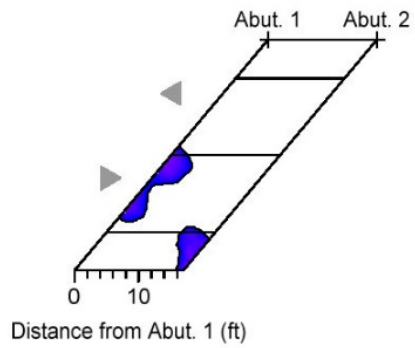
Direction of traffic</p> | <p>Deck</p> <table border="1" data-bbox="1117 1258 1423 1339"> <tr> <td>Conc. Deterioration (%)</td> <td>8.3</td> </tr> <tr> <td>Conc. Deterioration (s.f)</td> <td>48</td> </tr> </table> | Conc. Deterioration (%) | | 8.3 | Conc. Deterioration (s.f) | 48 | <p>Bridge ID: C-08-A (8 scans/ft) US 40 over Shelton Ditch</p> <p>Analyzed by: IN Reviewed by: SB Completed: 9/14/18</p> <p>Sheet 1 of 1</p> |
| Conc. Deterioration (%) | 8.3 | | | | | | | |
| Conc. Deterioration (s.f) | 48 | | | | | | | |

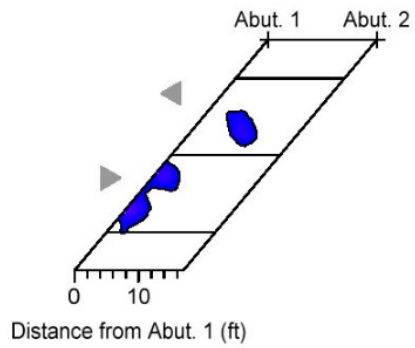
Direction of traffic</p> | <p>Deck</p> <table border="1" data-bbox="1117 1258 1423 1339"> <tr> <td>Conc. Deterioration (%)</td> <td>8.1</td> </tr> <tr> <td>Conc. Deterioration (s.f)</td> <td>47</td> </tr> </table> | Conc. Deterioration (%) | 8.1 | Conc. Deterioration (s.f) | 47 | <p>Bridge ID: C-08-A (12 scans/ft) US 40 over Shelton Ditch</p> <p>Analyzed by: IN Reviewed by: SB Completed: 9/14/18</p> <p>Sheet 1 of 1</p> |
| Conc. Deterioration (%) | 8.1 | | | | | | |
| Conc. Deterioration (s.f) | 47 | | | | | | |

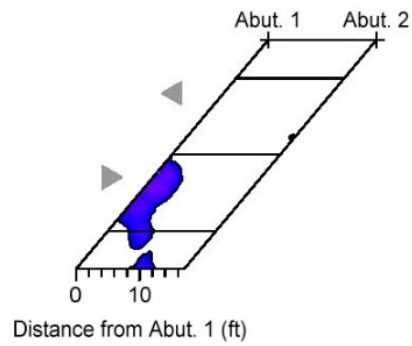
Direction of traffic</p> | <p>Deck</p> <table border="1"> <tr> <td>Conc. Deterioration (%)</td> <td>10.3</td> </tr> <tr> <td>Conc. Deterioration (s.f)</td> <td>59</td> </tr> </table> | Conc. Deterioration (%) | 10.3 | Conc. Deterioration (s.f) | 59 | <p>Bridge ID: C-08-A (16 scans/ft) US 40 over Shelton Ditch</p> <p>Analyzed by: IN Reviewed by: SB Completed: 9/14/18</p> <p align="center">Sheet 1 of 1</p> |
| Conc. Deterioration (%) | 10.3 | | | | | | |
| Conc. Deterioration (s.f) | 59 | | | | | | |

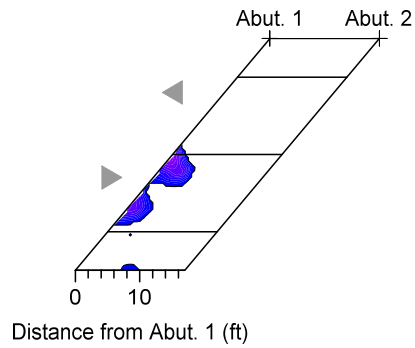
Direction of traffic | <p>Deck</p> <table border="1"> <tr> <td>Conc. Deterioration (%)</td> <td>6.6</td> </tr> <tr> <td>Conc. Deterioration (s.f)</td> <td>38</td> </tr> </table> | Conc. Deterioration (%) | | 6.6 | Conc. Deterioration (s.f) | 38 | <p>Bridge ID: C-08-A (20 scans/ft) US 40 over Shelton Ditch</p> <p>Analyzed by: IN Reviewed by: SB Completed: 9/14/18</p> <p style="text-align: center;">Sheet 1 of 1</p> |
| Conc. Deterioration (%) | 6.6 | | | | | | | |
| Conc. Deterioration (s.f) | 38 | | | | | | | |
