1. Title and Subtitle
**Forensic Evaluation of Pavement Structure:
Ponderosa Drive in East Baton Rouge Parish**
2. Author(s)
Qiming Chen, Ph.D., P.E., Nicholas Ferguson, P.E., Moses Akentuna, Ph.D., P.E., Saman Salari, P.E., Gavin Gautreau, P.E., Samuel Cooper, III, Ph.D., P.E.

5. Report No.
FHWA/LA.17/21-01TA-P
6. Report Date
January 2022
7. Performing Organization Code
LTRC Project Number: 21-01TA-P
8. Type of Report and Period Covered
Technical Assistance Report
August 2020-August 2021

Forensic Evaluation of Pavement Structure: Ponderosa Drive in East Baton Rouge Parish

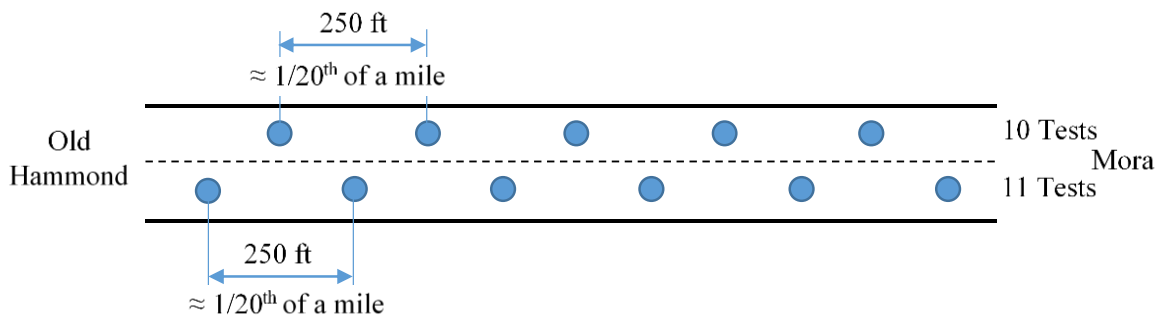
Figure 6. FWD testing locations/frequency

Figure 6 shows the FWD testing locations/frequency used in this investigation.

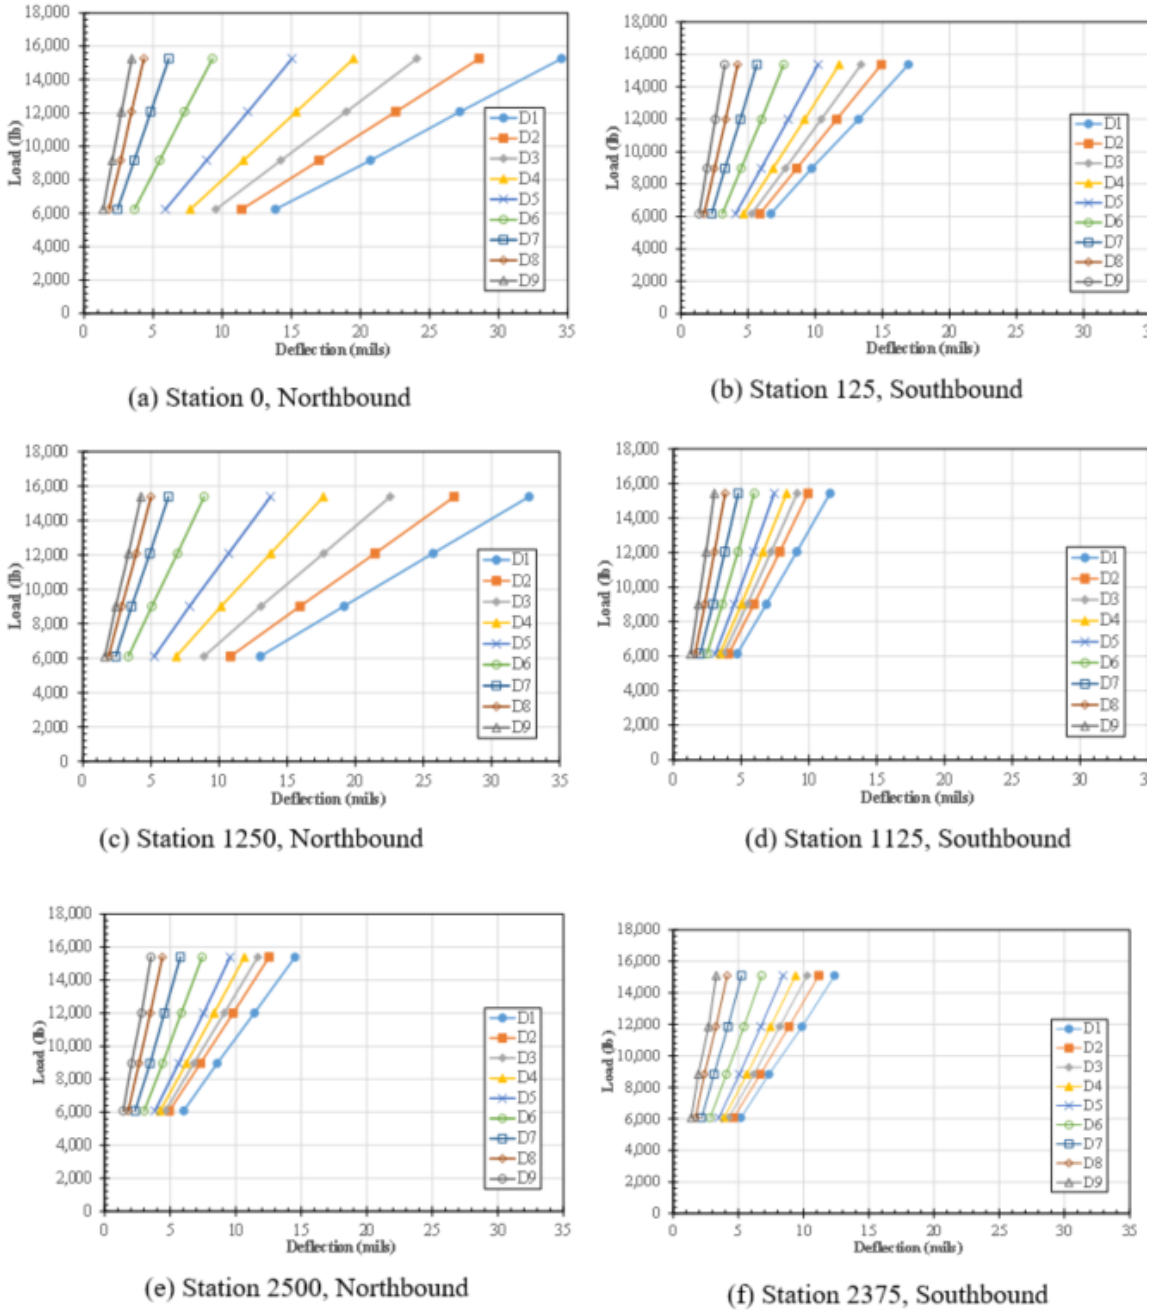
Figure 8. FWD load versus sensor deflection

In addition to general data checks, FWD deflection data were checked for linearity. Figure 8 compares the load versus sensor deflection for selected locations in both North and Southbound lanes. The measurements show the data is good for linear analysis.

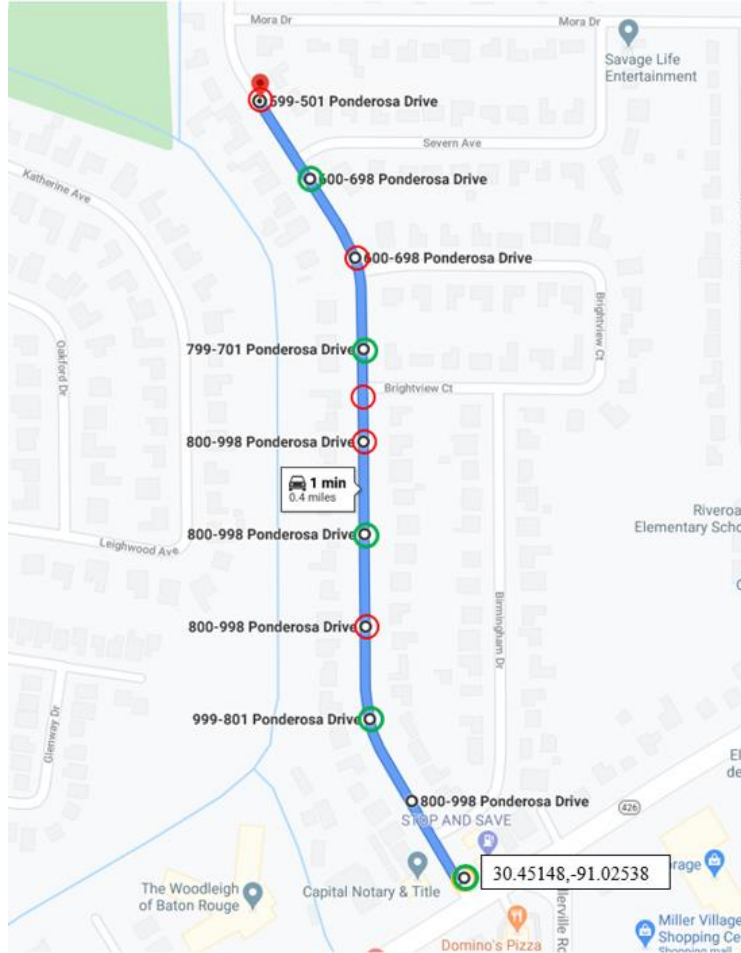
Figure 11. Preliminary map for Ponderosa Project

Based on the FWD tests, LTRC’s pavement research group identified 10 locations along the pavement section, which were classified as “good” and bad “spots” based on the severity of the distress and the moduli of base and subgrade layers. These 10 locations were marked for further investigations by the Geotechnical and Asphalt groups. Figure 11 shows a map of 10 preliminary forensic investigation zones; good zones are denoted by the green circles and bad zones by red circles.

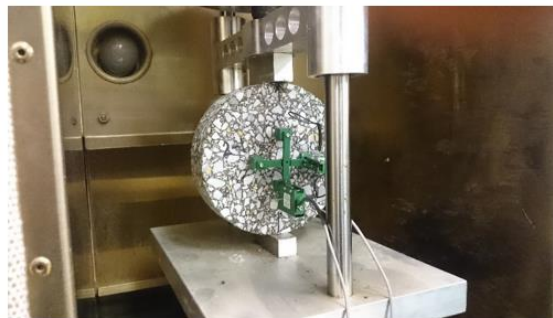
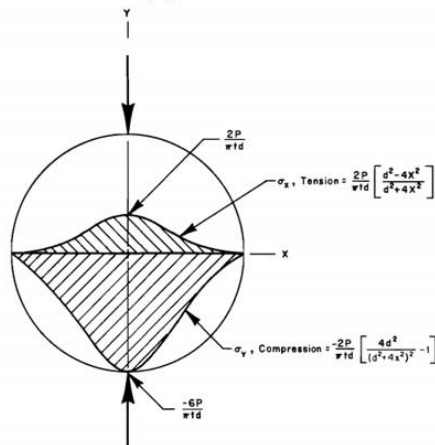
Figure 19. (a) IDT $|E^*|$ test setup and (b) stress distribution along X-axis

The IDT |E*| test was conducted according to AASHTO TP 131, “Proposed Standard Test Method for Determining the Dynamic Modulus of Asphalt Mixtures Using the Indirect Tension Test” [3]. The IDT|E*| test applies a sinusoidal compressive stress to the diametric axis of an unconfined cylindrical field core specimen; see Figure 19. This test was conducted at three temperatures: -10, 10, and 30°C (14, 50, and 86°F). For each test temperature, asphalt mixture specimens were tested at five loading frequencies: 10, 5, 1, 0.5, and 0.1 Hz. The compressive stress applied to the test specimen results in tensile stress and strain along the horizontal axis of the specimen. A target tensile strain level of 40 to 60 microstrain was maintained to keep the specimens in the linear viscoelastic region. The dynamic modulus was computed using the following equation:

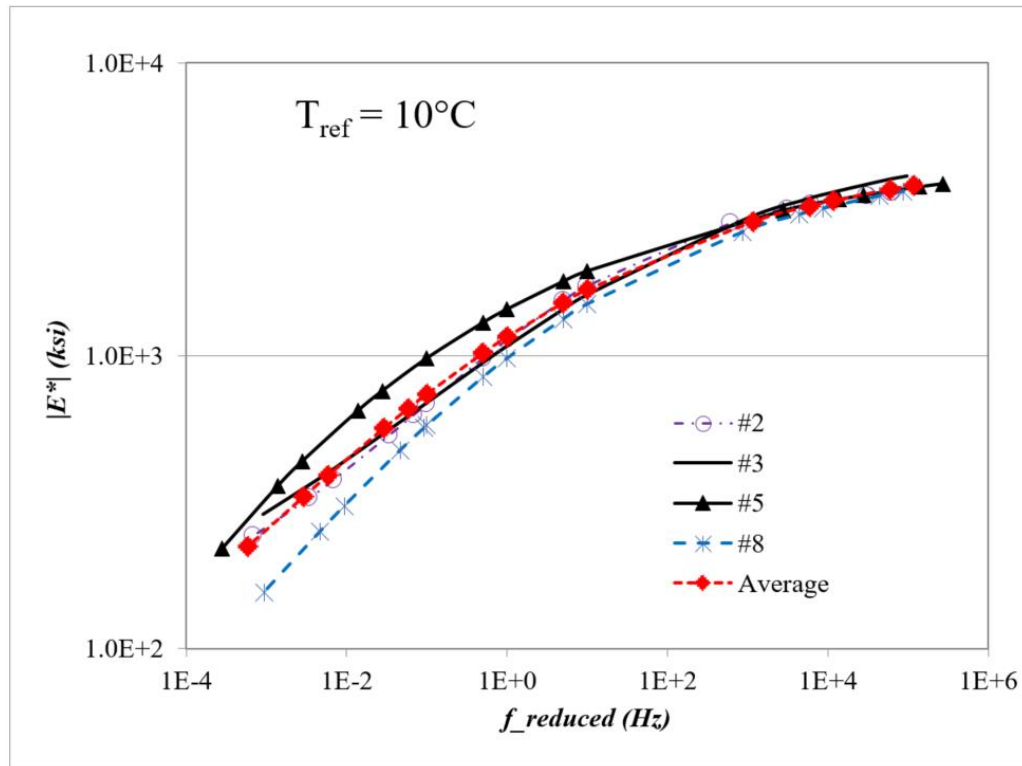
Figure 20. Dynamic modulus master curves

Figure 20 presents the dynamic modulus master curves for asphalt field cores obtained from the pavement section evaluated. The master curves were constructed at a reference temperature of 10°C. It is noted that the dynamic modulus for the pavement section evaluated is within the range of values reported by other researchers for Louisiana level 2 asphalt mixtures ([5]- [6]). Figure 21 shows the $|E^*|_{54.4^\circ\text{C}, 5\text{Hz}}$ values for the test section evaluated. It is worth noting that $|E^*|_{54.4^\circ\text{C}, 5\text{Hz}}$ values were extrapolated from the dynamic modulus master curves. The $|E^*|_{54.4^\circ\text{C}, 5\text{Hz}}$ parameter is a good indicator of mixture rutting performance [7]. Higher $|E^*|_{54.4^\circ\text{C}, 5\text{Hz}}$ values indicate higher rutting performance and vice versa. For the field cores evaluated, $|E^*|_{54.4^\circ\text{C}, 5\text{Hz}}$ values were found to be higher than values reported by Mohammad et al. after characterizing commonly used level 1 and 2 asphalt mixtures in Louisiana [7]. This observation is attributed to the fact the asphalt layer was placed in 2014 and may have undergone substantial level of long-term aging [8].
