Technical Report Documentation Page

| 4. Title and Subtitle<br>Materials Selection for Concrete Overlays: Information Survey<br>Review and Evaluation of Existing Concrete Overlays in Texas | | | | 5. Report Date<br>October 2010; Revision April 2011 | |
| 7. Author(s)<br>Dong hyun Kim, Manuel Trevino, David P. Whitney, David W.<br>Fowler, Raissa Ferron | | | | 8. Performing Organization Report No.<br>0-6590-1 | |

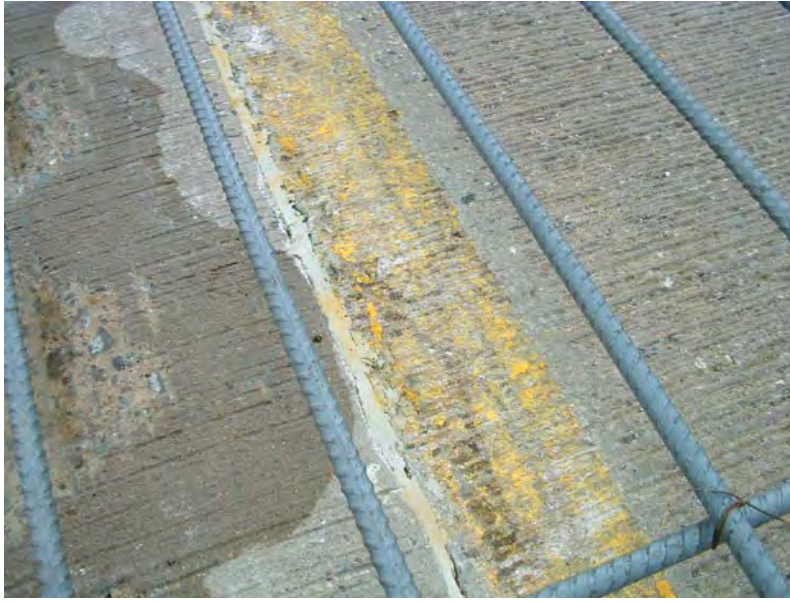
*Figure 8.5: After the removal of the yellow stripe*

The surface was roughened up and cleaned before the BCO placement. However, the survey team noticed that the yellow pavement stripe was still intact, which raised a concern for the possibility of the stripe acting as a debonder. Therefore, the contractor was asked to remove the yellow stripe and thoroughly clean the surface again before the construction began. Figure 8.4 shows the pavement before the yellow strip was removed, and Figure 8.5 shows it after removal.

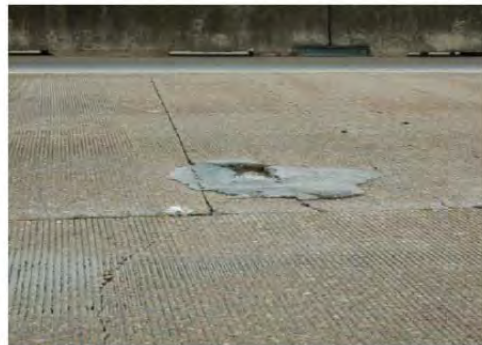
AC patch with failure

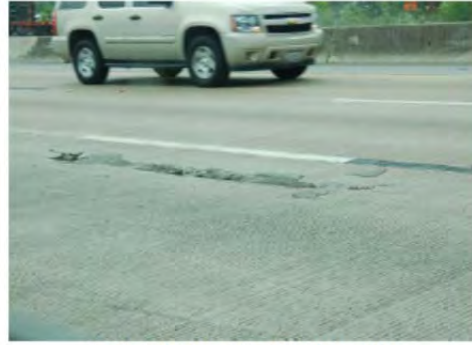
Punchout

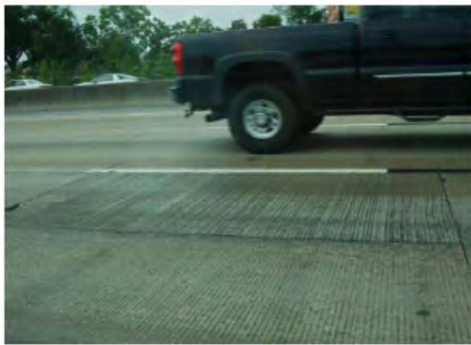
AC Patch, longitudinal cracks

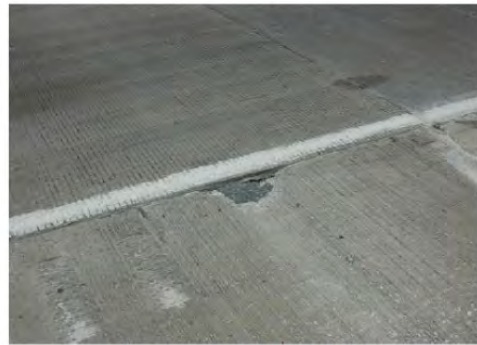
PCC patch

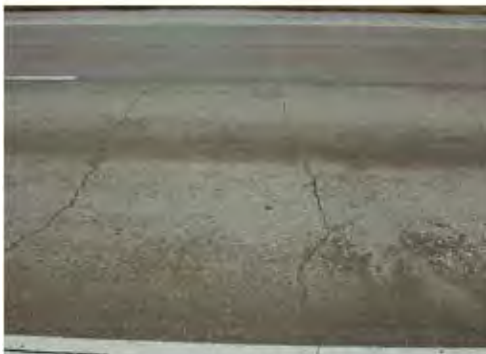
Picture 3  
Transverse cracks

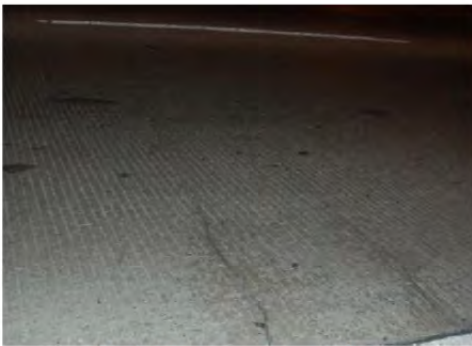
Typical transverse cracks

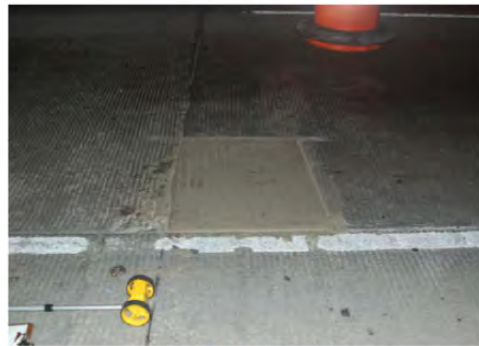
Small PCC patch
