DOT/FAA/TC-21/17

Bonded Repairs to Composite Wing Panel Structure: Phase 2, Baseline Study

July 2021

Final report

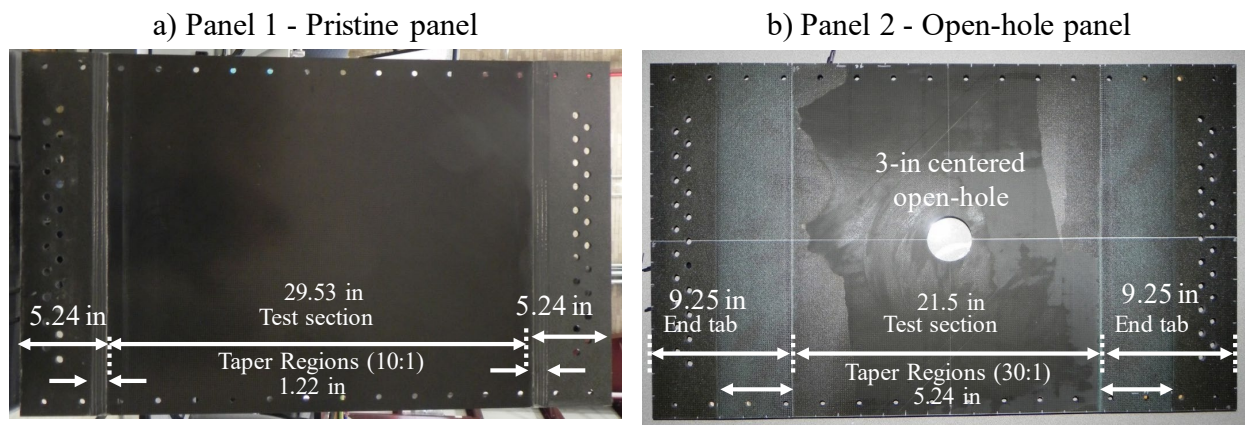
Figure 2. (a) Panel 1 - pristine panel; (b) Panel 2 - open-hole panel

During the testing of the pristine panel (panel 1), it was noticed that delaminations and strain concentrations were initiating along the tapered regions of the panel (near the end tabs). To mitigate this issue in subsequent tests, the design of the panel was updated from a 10:1 ratio to a 30:1 ratio. Further discussion of this change, and the results that spurred it, are provided in the results section of this report. Images displaying this change in tab end dimensions are provided in Figure 2, where the initial tab is for the pristine panel, and the updated for the open-hole panel. Detailed engineering drawings of the panels are provided in appendix A.

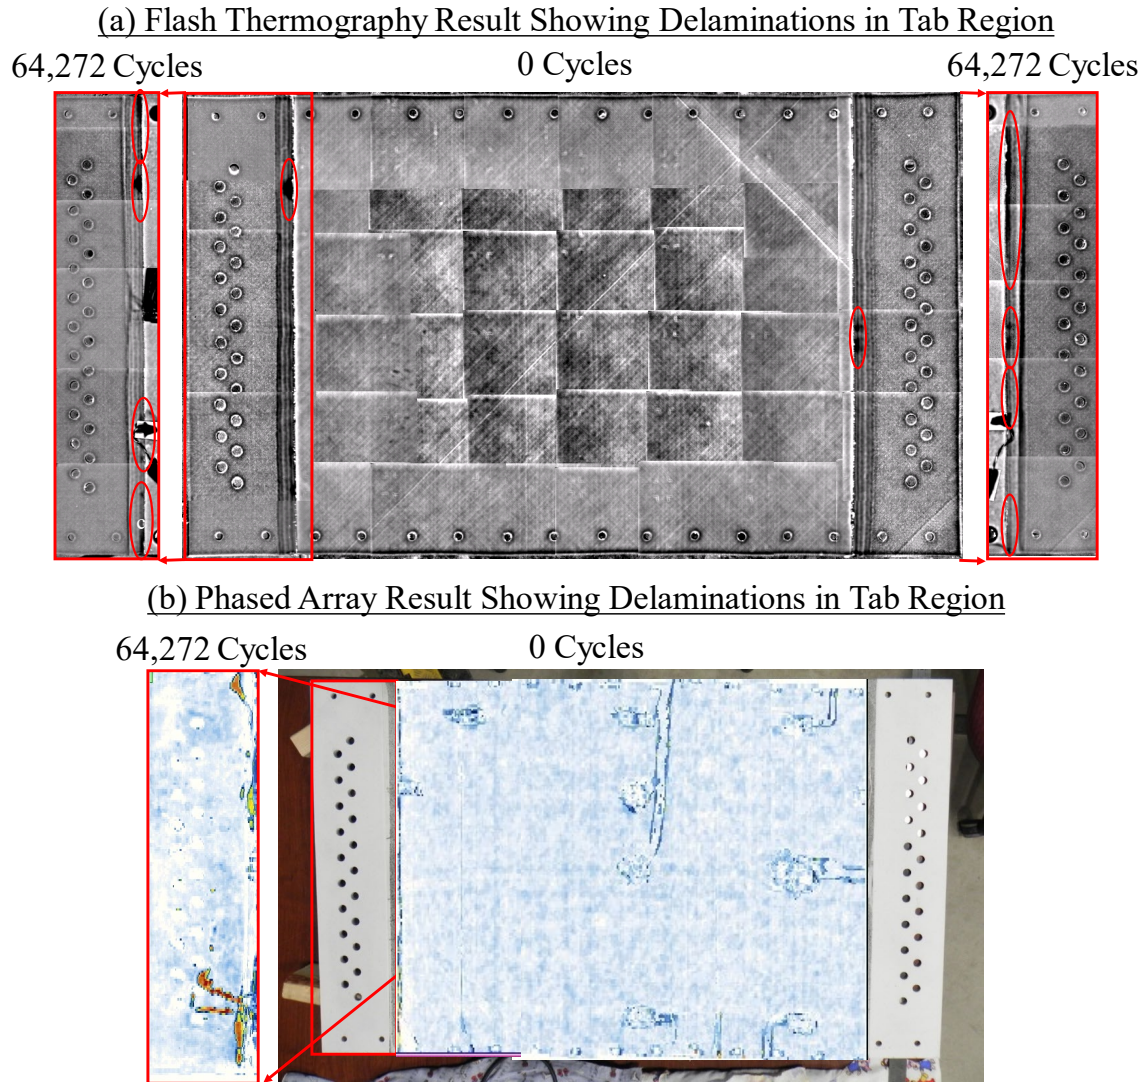
Figure 22. Flash thermography and phased array results in the tab regions of panel 1

The structural integrity of panel 1 was maintained through fatigue testing with no signs of damage in the test section. However, NDI inspections indicated the development and slow growth of disbonds between the panel and the end tabs during fatigue. Figure 22 shows the flash thermography and phased array ultrasonic results of the pristine panel, captured prior to the panel installation, and results of the end tabs captured after approximately 64,272 fatigue cycles. As shown, multiple disbonds developed less than halfway through 165,000 cycles in multiple sections of the end tab-main panel transition region. Overall, these disbonds had no effect on the load transfer to the test section.

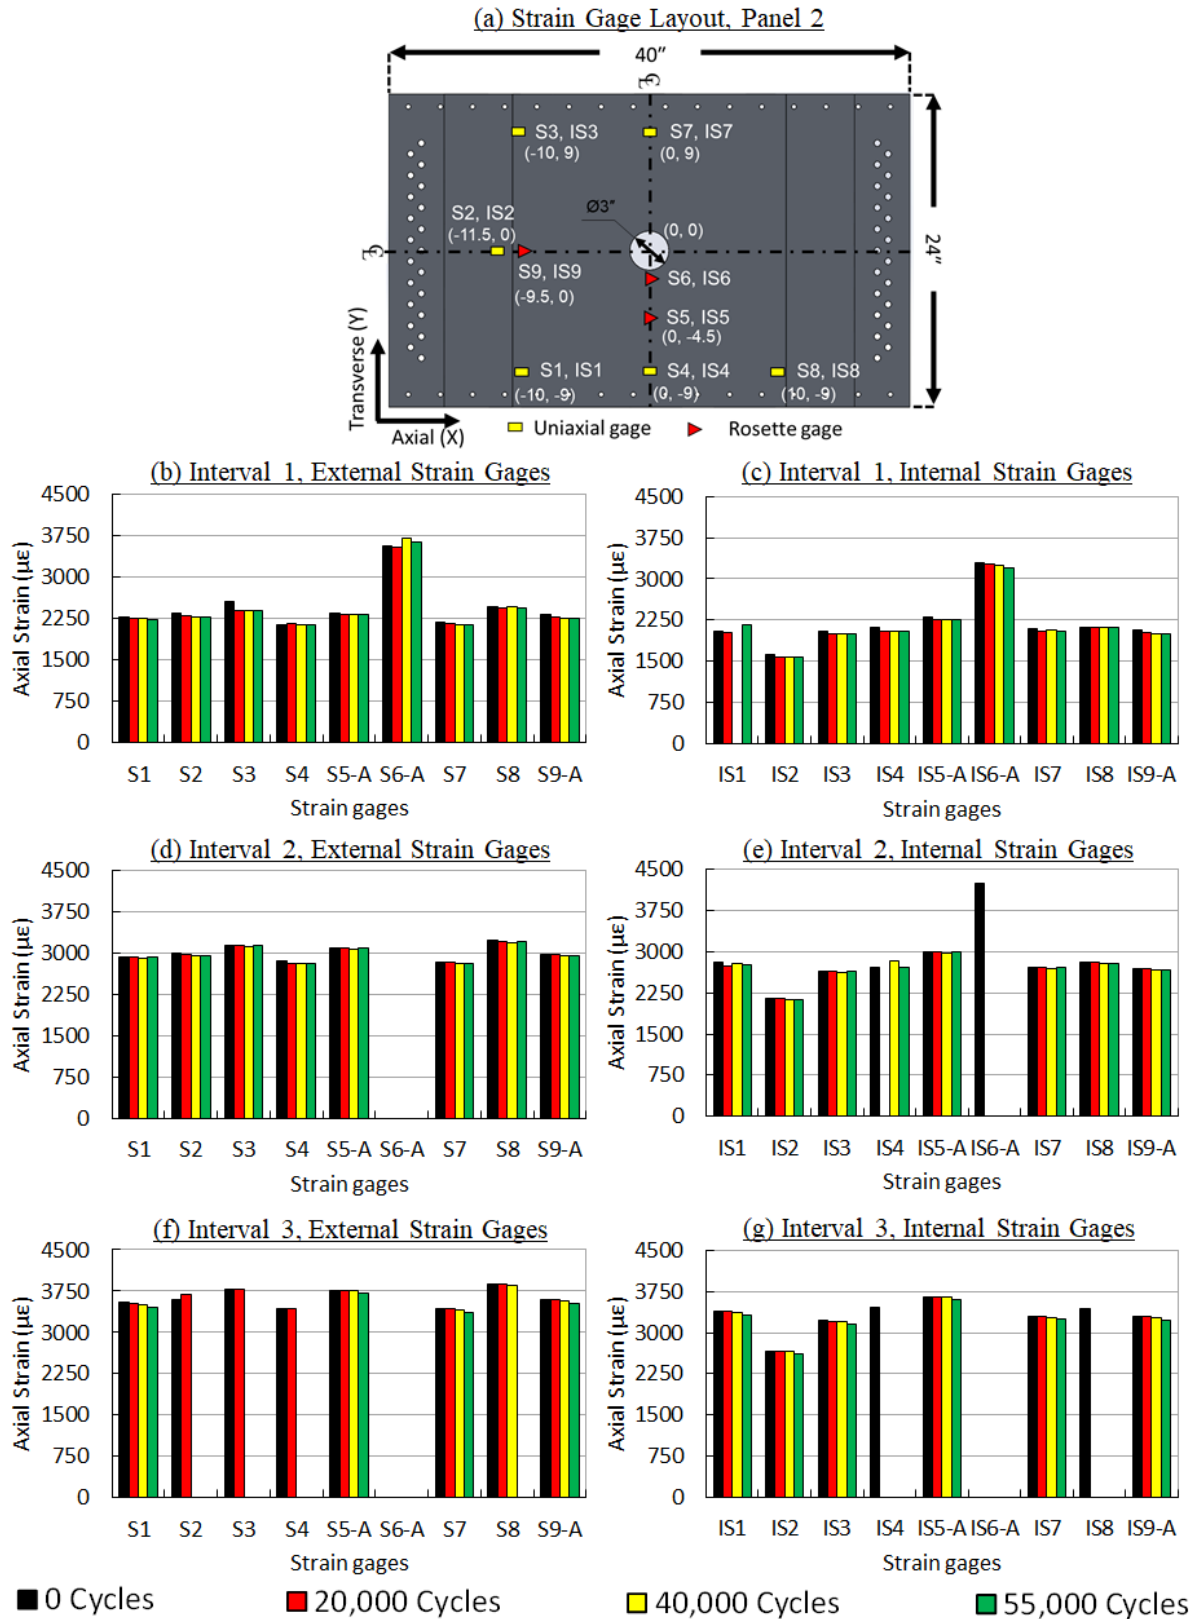
Figure 26. Strain gage results captured throughout panel 2 fatigue test

Strains measured during strain surveys for each fatigue interval are provided in Figure 26 for panel 2. As shown, strain values were consistent in-phase for all strain gages across the board, indicating the local delaminations, present along the hole edges, did not impact the far-field strain distributions. Some exceptions, fluctuations in values, can be attributed to relocation of strain gages, which happened after strain gages failed.

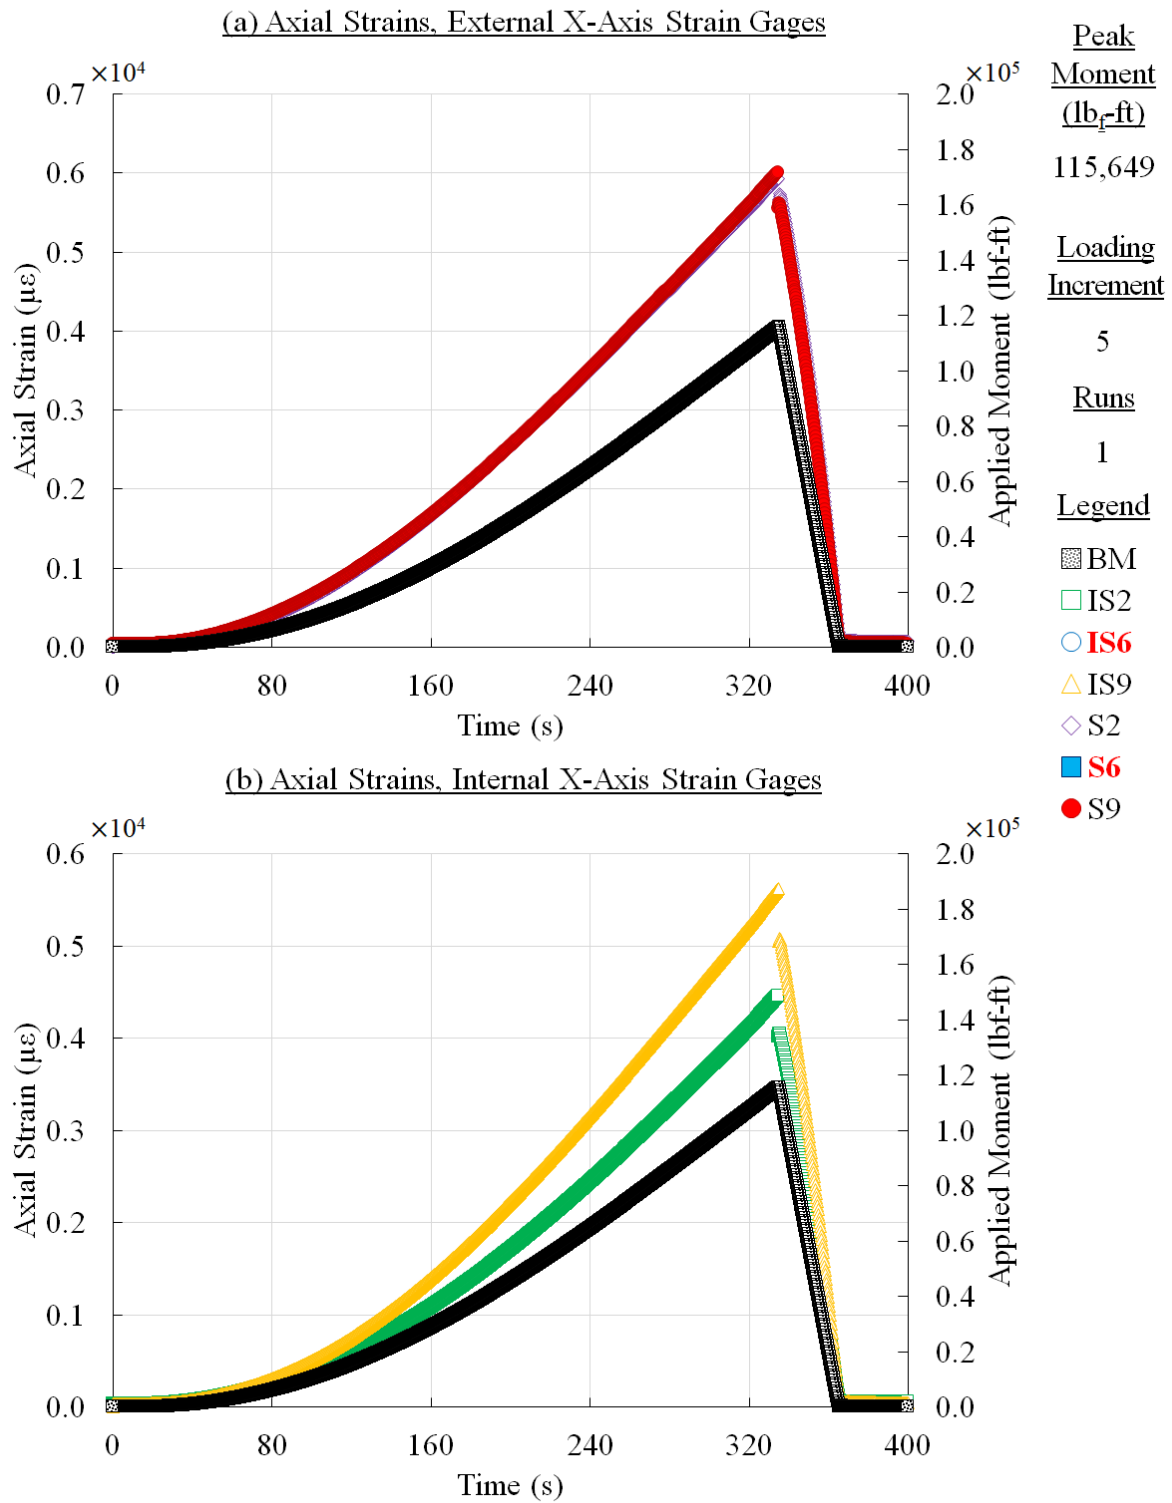
Figure 127. Panel 2 residual strength test results, loading increment 5 (final failure)

In the final load increment, the panel was quasi-statically loaded to failure. The panel failed through the net section at an applied moment of 116,535 lbf-ft, comparing well to the prediction of 104,734 lbf-ft (as obtained by K_t -based analysis). The damage growth from the hole in the transverse direction was quite rapid and the strain redistribution was evident from DIC results, as shown in Figure 31. This figure also shows the visual image and the NDI results captured by flash thermography and phased array after failure, which were all able to capture the breaking of

CFRP Panel 2 – Open-Hole – Results of Residual Strength Loading Increment # 5

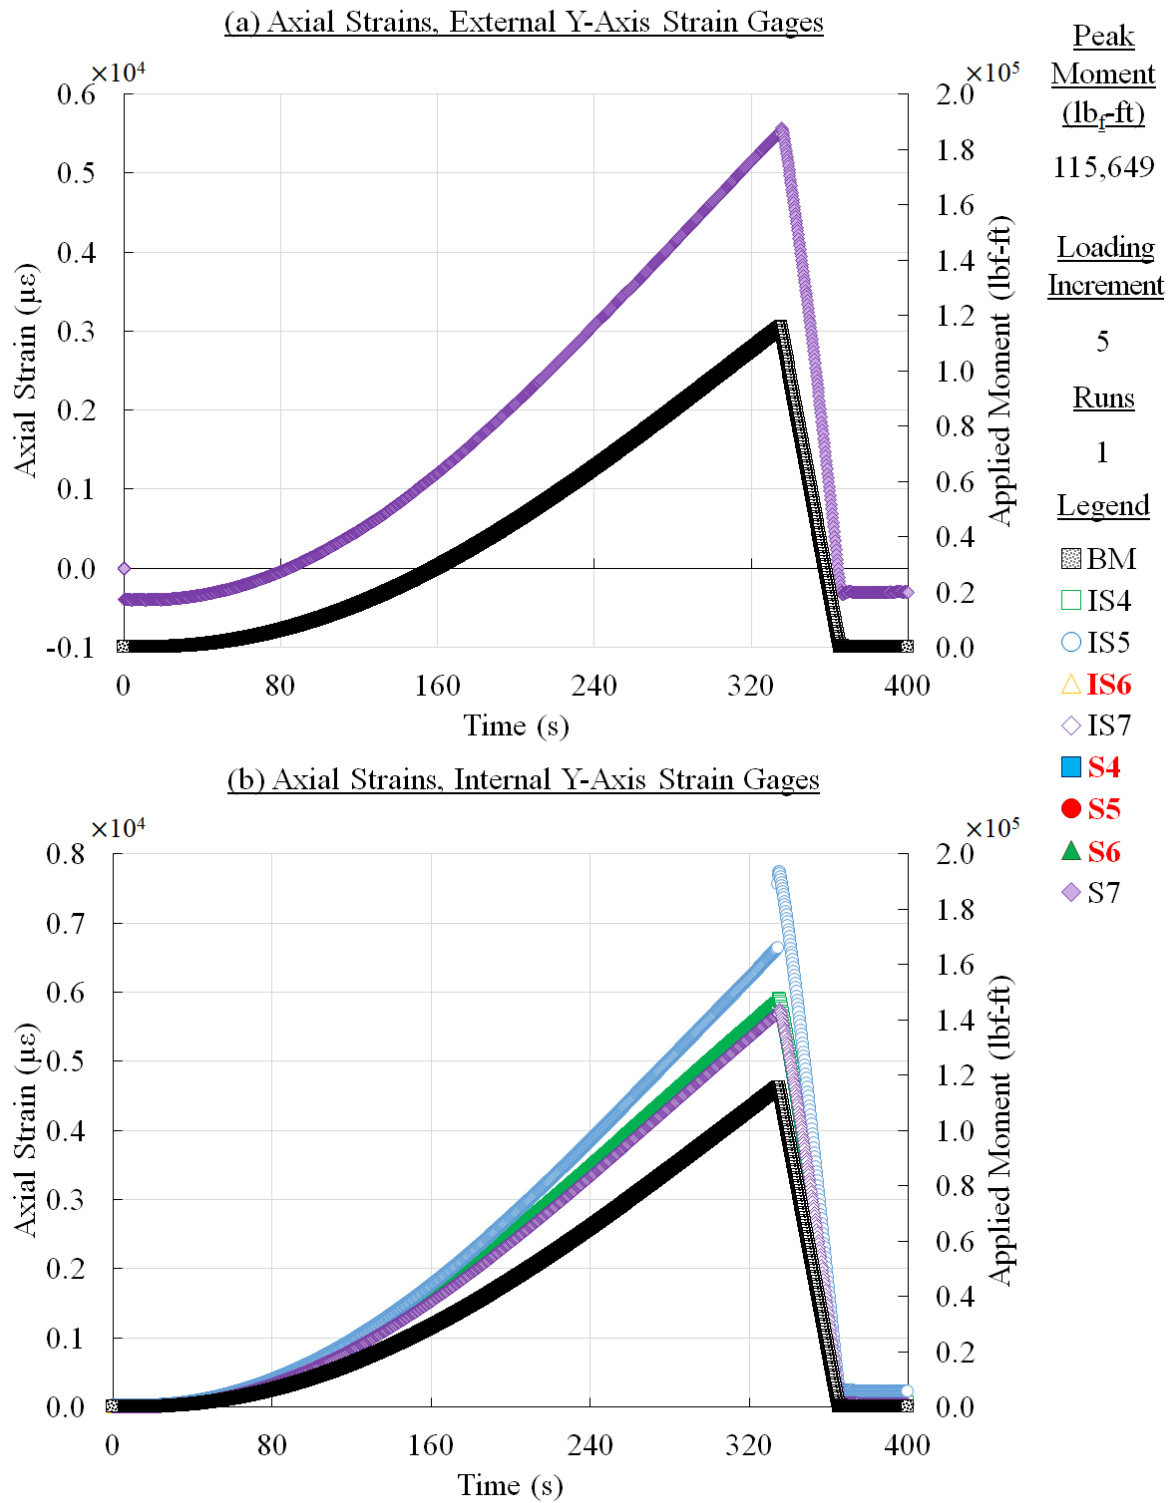
Figure 128. Panel 2 residual strength test results, loading increment 5 (final failure)

CFRP Panel 2 – Open-Hole – Results of Residual Strength Loading Increment # 5

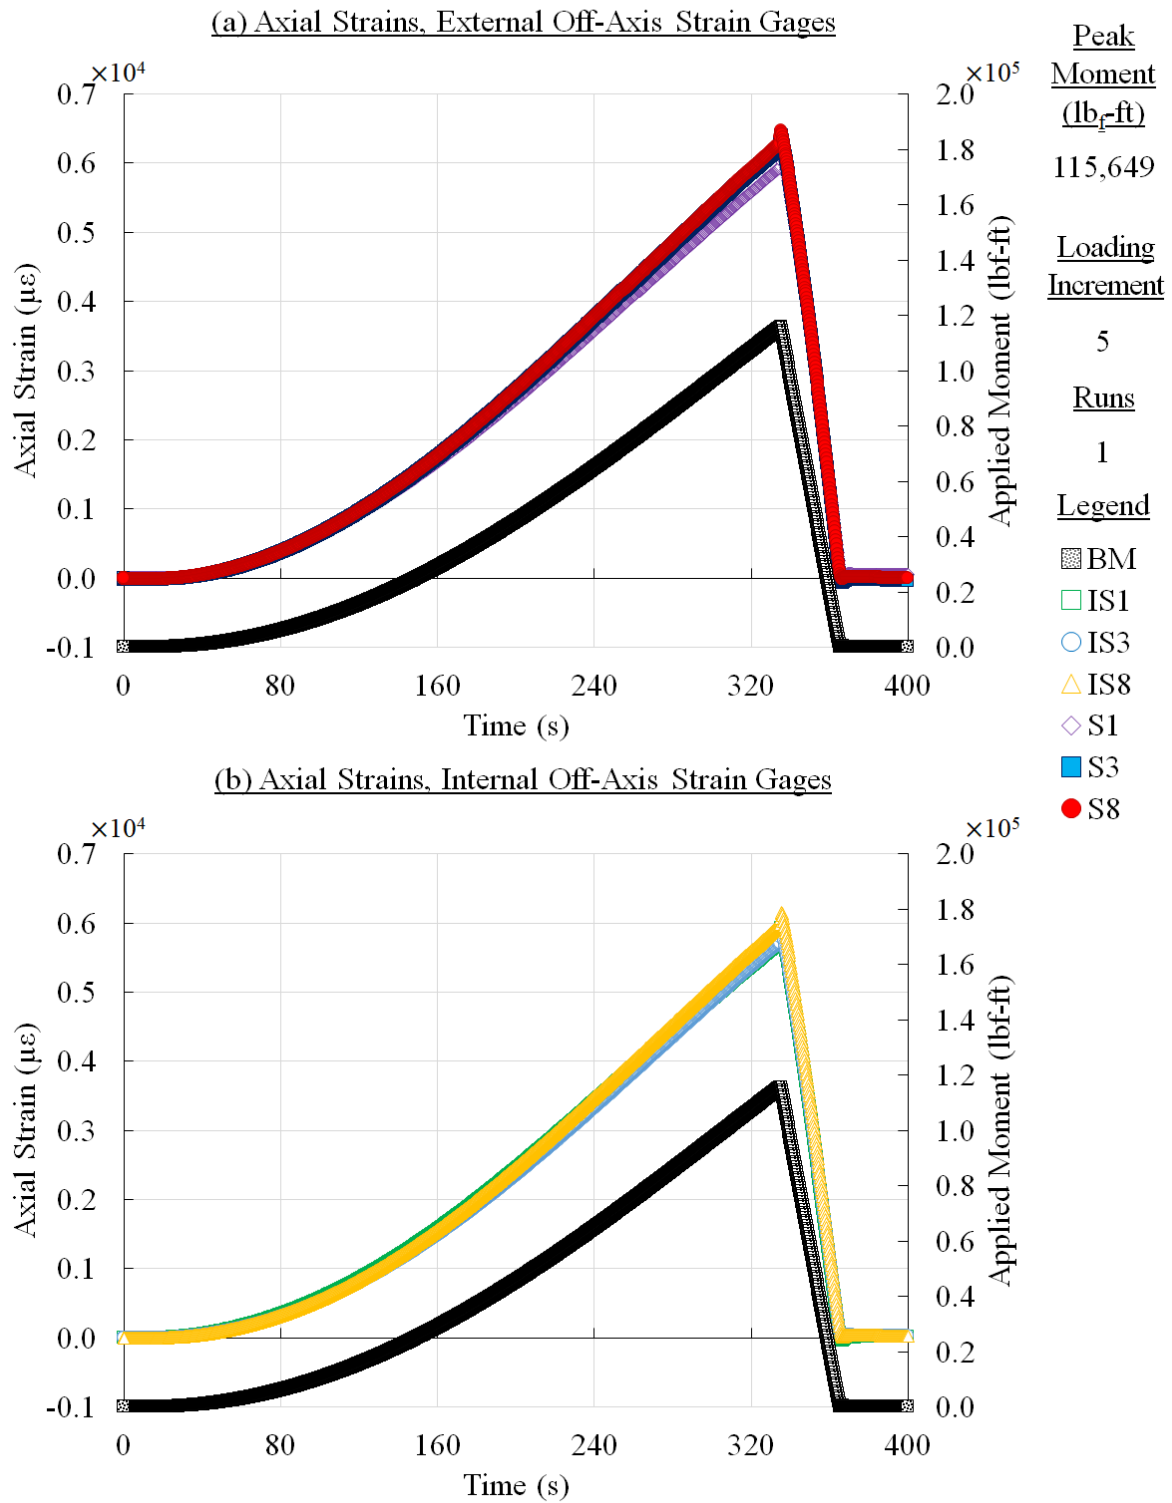
Figure 129. Panel 2 residual strength test results, loading increment 5 (final failure)

CFRP Panel 2 – Open-Hole – Results of Residual Strength Loading Increment # 5

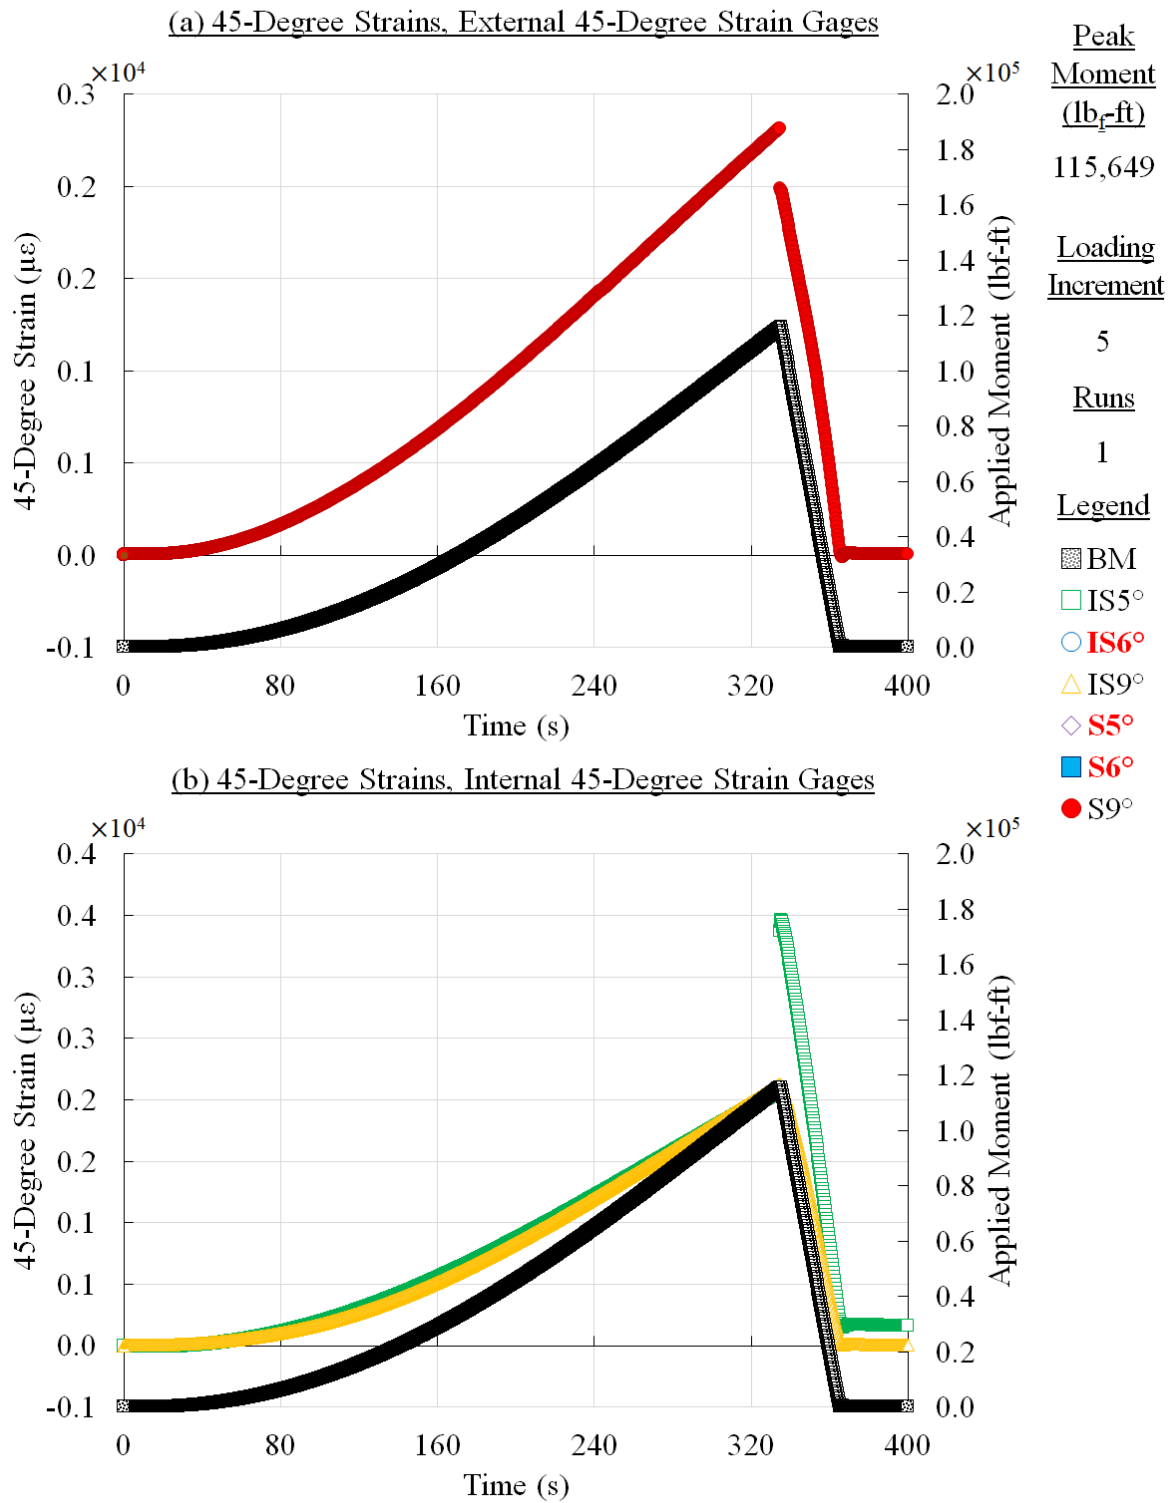
Figure 130. Panel 2 residual strength test results, loading increment 5 (final failure)

CFRP Panel 2 – Open-Hole – Results of Residual Strength Loading Increment # 5

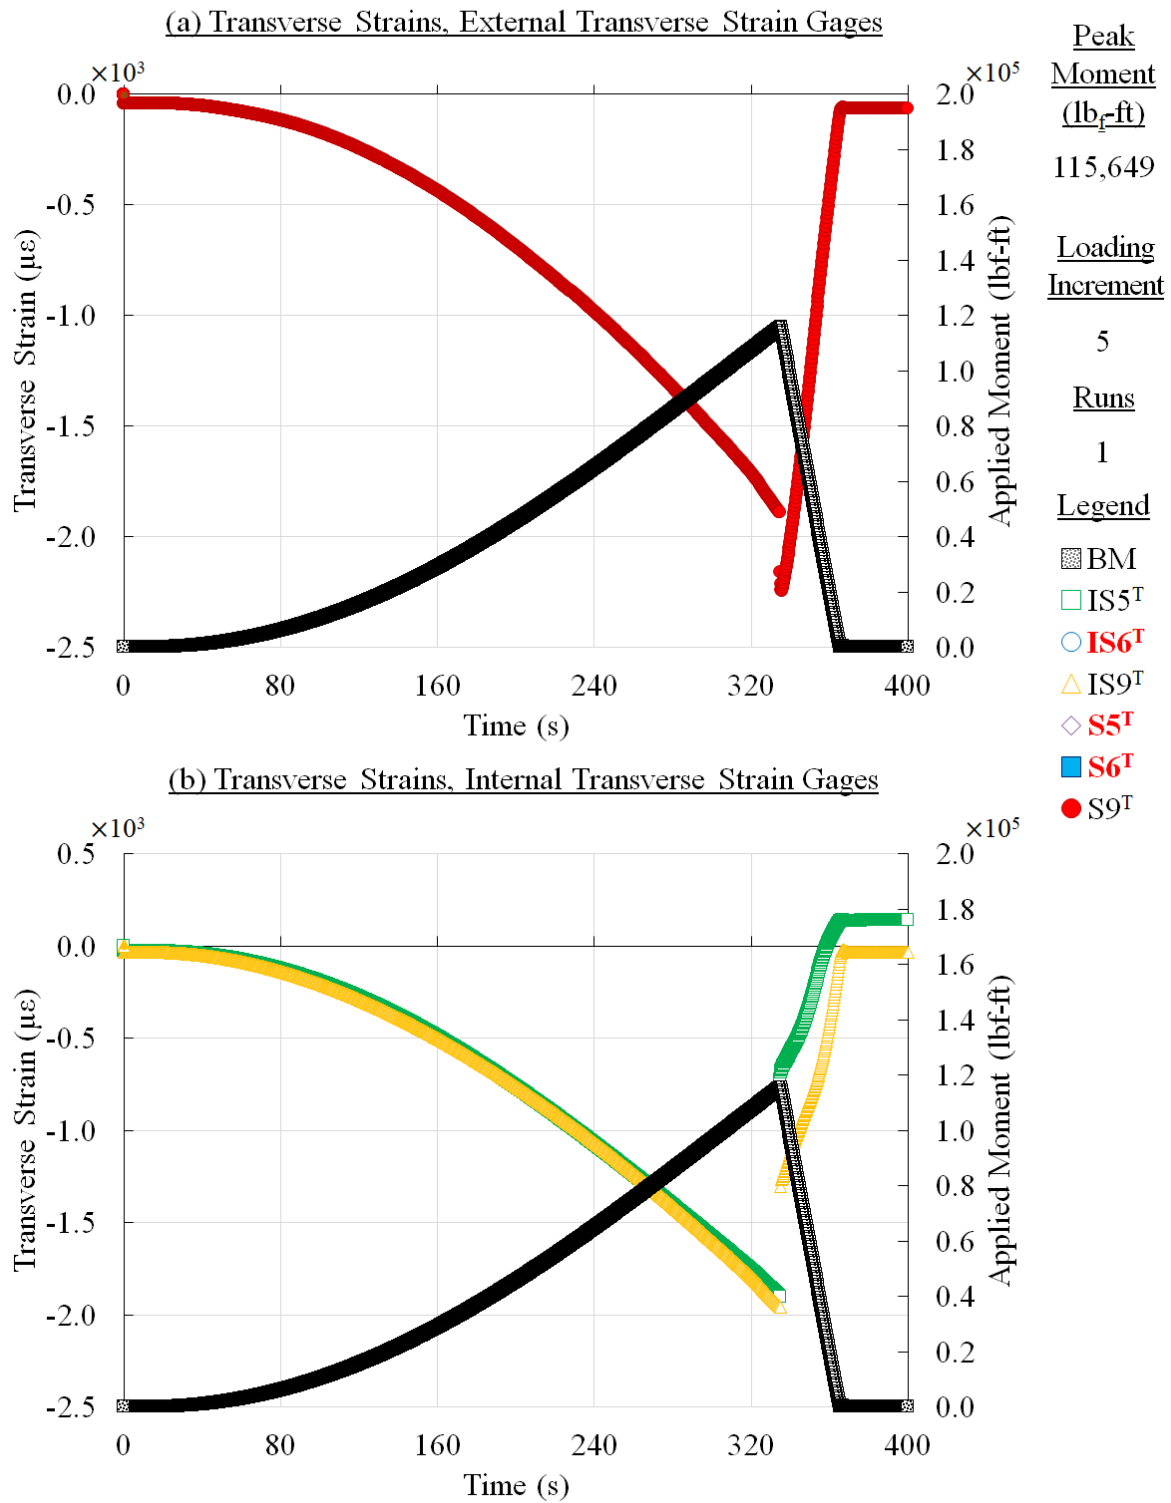
Figure 131. Panel 2 residual strength test results, loading increment 5 (final failure)

CFRP Panel 2 – Open-Hole – Results of Residual Strength Loading Increment # 5

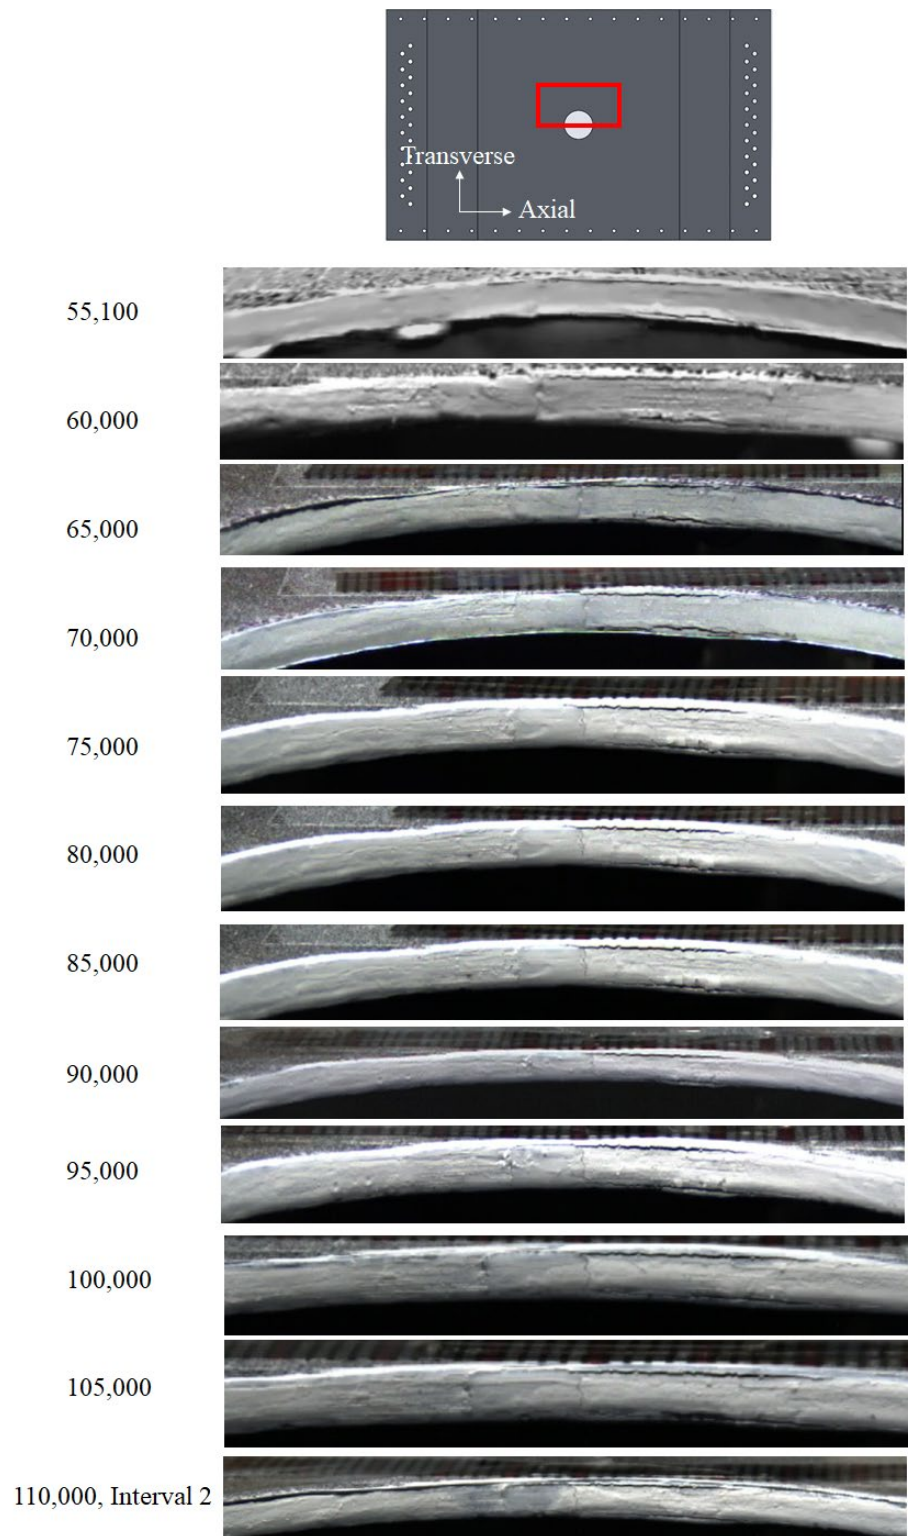
Figure 144. Panel 2 fatigue test, visual results for positive transverse hole edge (interval 2)

Close up images of the positive transverse edge of panel 2 hole for intervals 2 and 3 are shown in Figure 144 and Figure 145 and for the negative transverse edge in Figure 146 and Figure 147. Figure 148 shows the top view images of the hole in panel 2. Wide field of view and narrow field of view images of the hole during residual strength test are shown in Figure 149 and Figure 150.

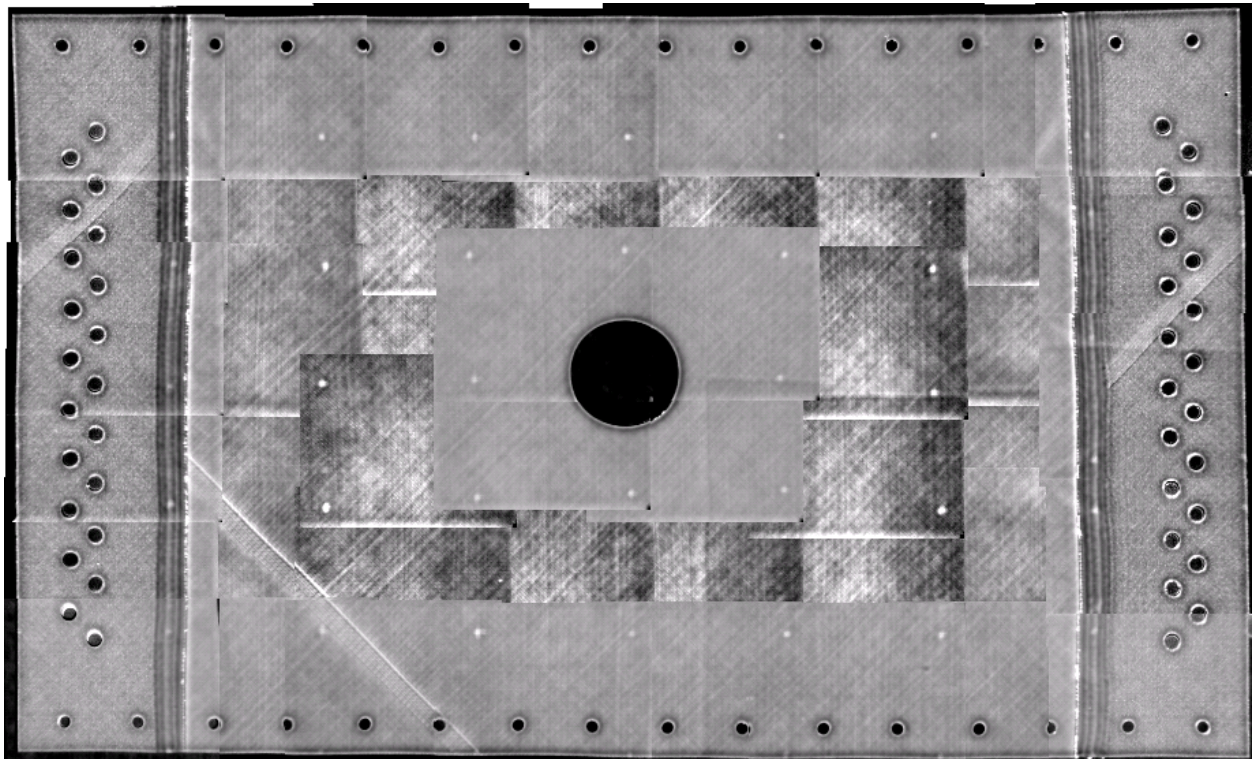
Figure 151. Flash thermography results captured for the open-hole panel before fatigue

Figure 151 shows the baseline thermography images of whole panel 2. The thermography images of the center hole captured during panel 2 fatigue test and residual strength test are shown in Figure 152 and Figure 153, respectively.

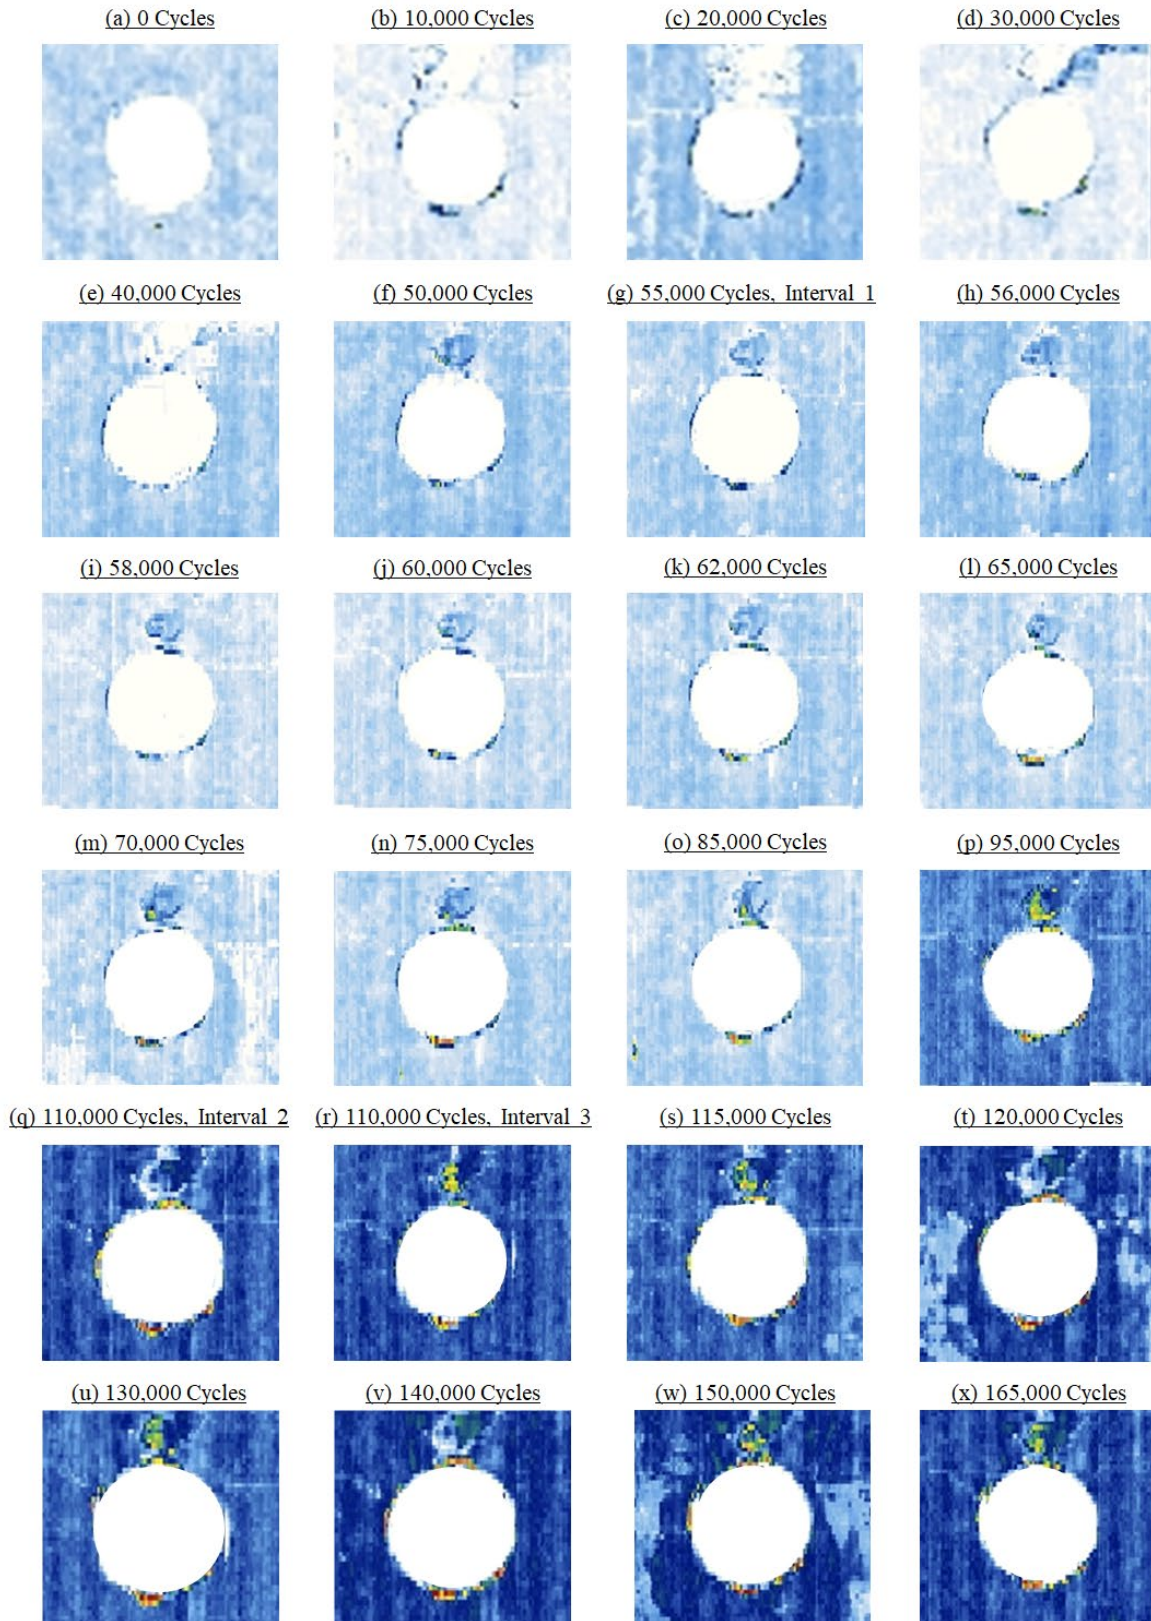
Figure 154. Phased array ultrasonic results (amplitude) for panel 2 throughout fatigue

Phased array results captured for the open-hole panel during fatigue are provided in Figure 154 and Figure 155, while phased array results captured during residual strength are provided in Figure 156 and Figure 157.

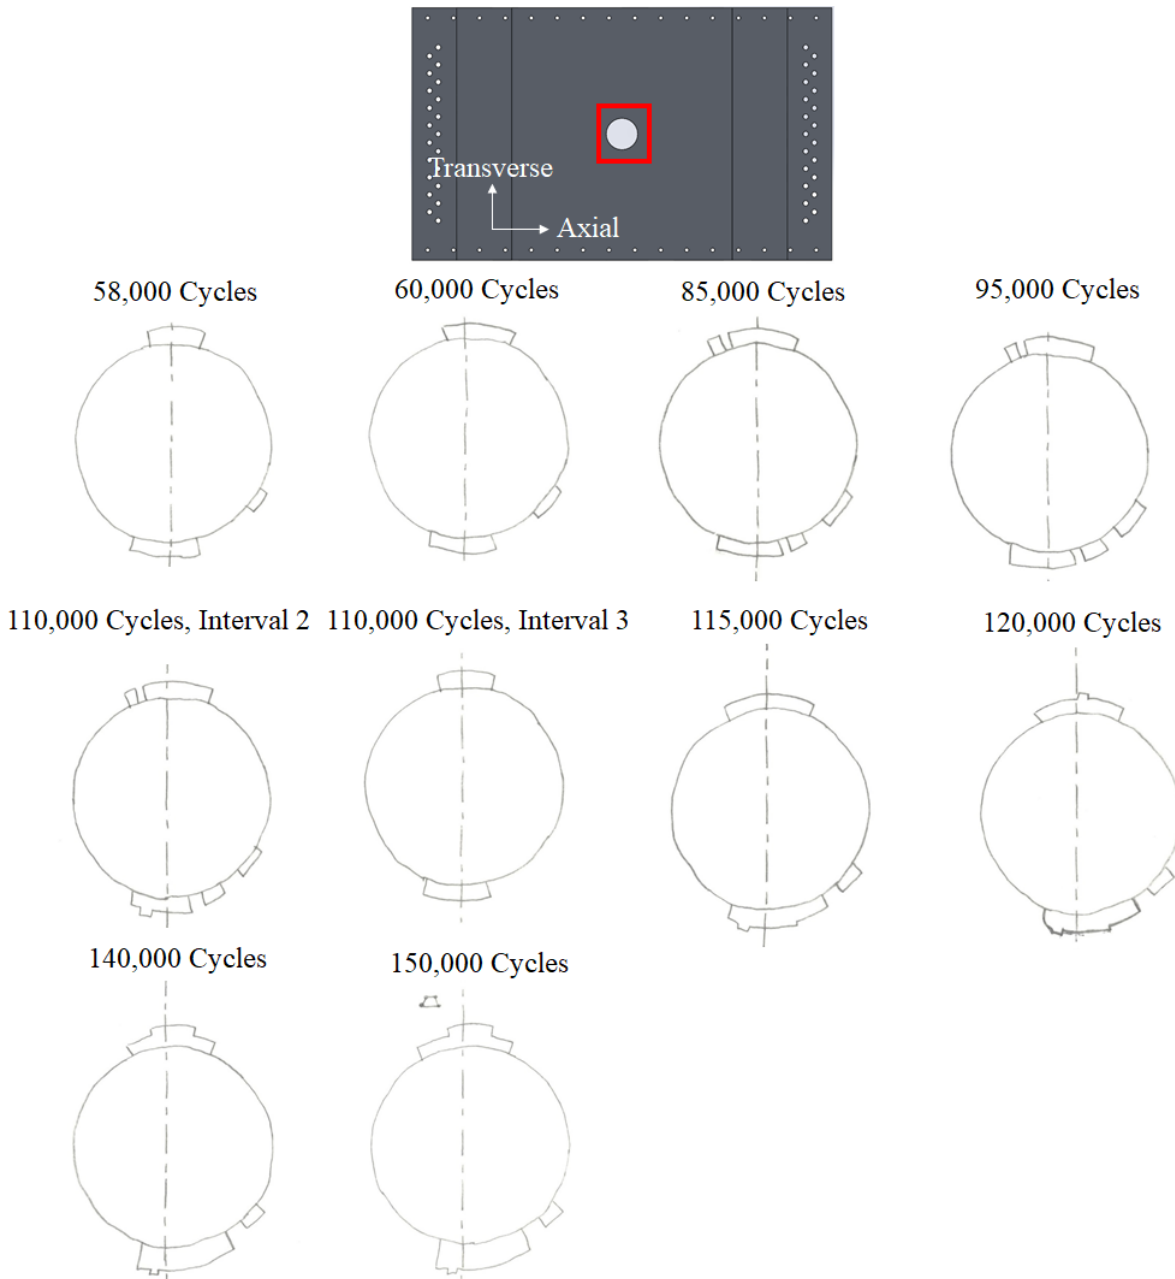
Figure 158. Pulse-Echo ultrasonic results captured for panel 2 throughout fatigue

Figure 158 shows the schematic of delaminations at the hole edges outlined using pulse-echo inspection of panel 2.
