FINAL REPORT

Effects of Service Life of Aluminized Steel Corrugated Pipe with Visible and Not Visible Coating Deficiencies within the Lock System

FDOT Contract Number: BDV25-977-62

July 2021

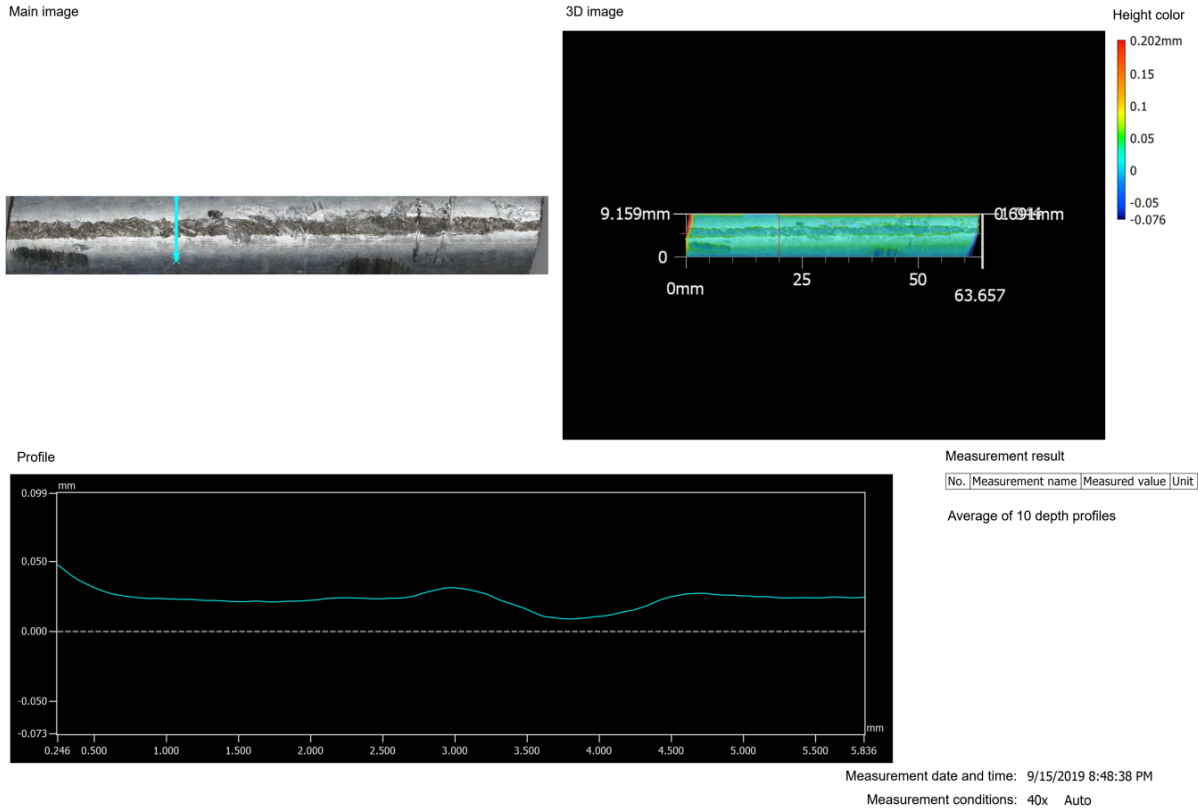
Figure 3.2. Surface analysis results of a coating scrape along the corrugation of an aluminized pipe.

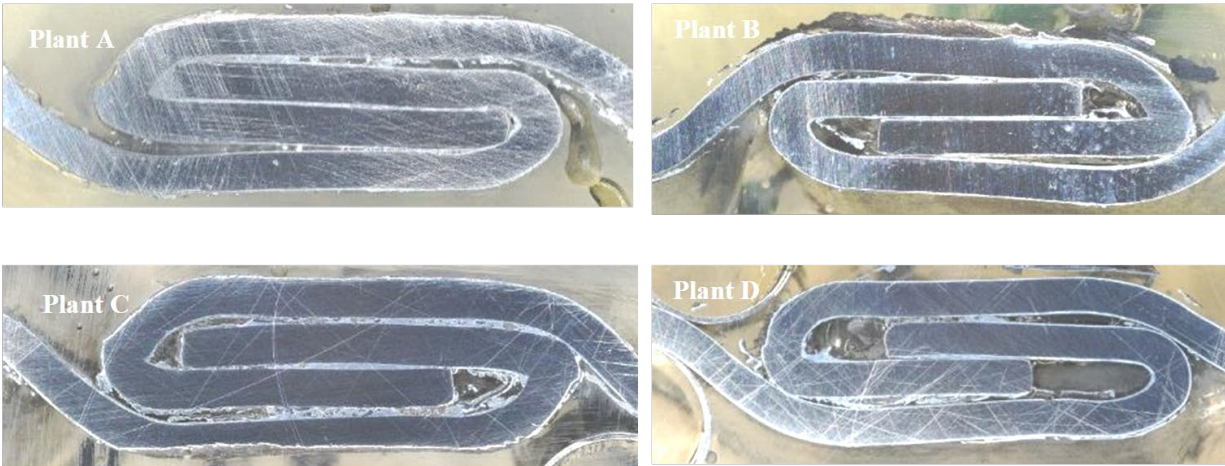
Even though each plant followed the same standard to form drainage pipes, the lock-seams from each plant differed in terms of the way that the two sheets locked together. For some plants the lock-seam was looser than others. Figure 3.8 and Figure 3.9 show the different shapes and looseness of the lock-seams from each plant for both the aluminized and galvanized steel pipes, respectively.

Figure 3.9. Galvanized steel pipe lock-seams from four different manufacturers.

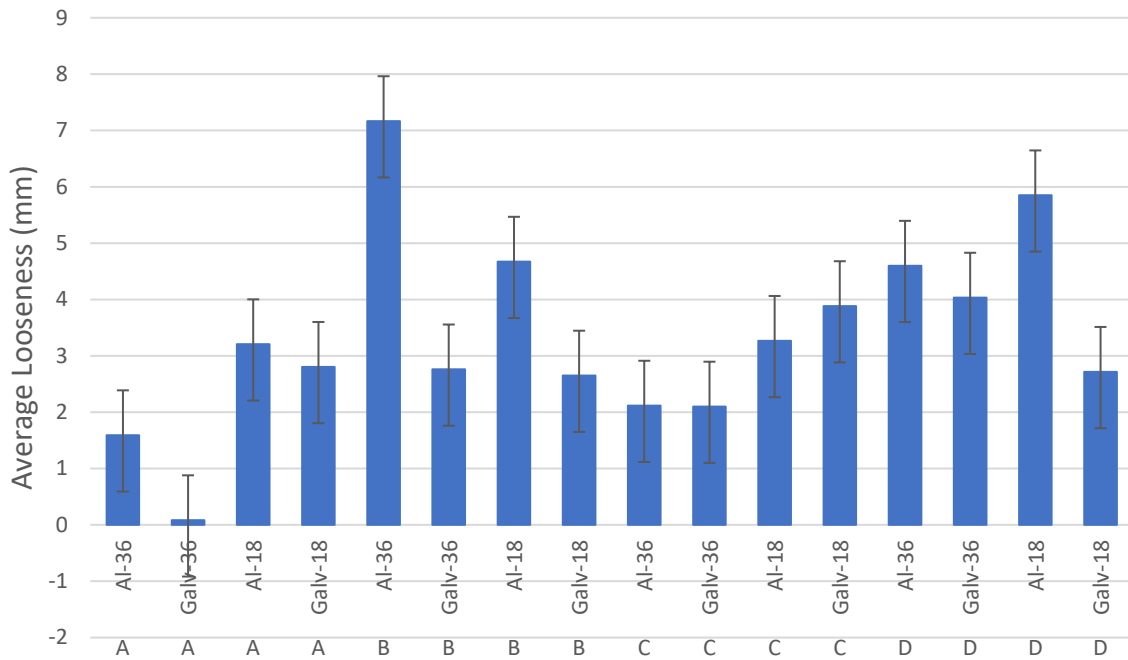
Figure 3.10 shows the average looseness of the lock-seams quantified according to the method provided in Figure 3.3, for each metal type and manufacturer analyzed. The maximum average looseness was found in aluminized steel pipes from Plant B, which was 7.2 mm with a standard deviation of 0.7 mm. Loose lock-seams may result in leaks in the pipes and will have a role on the durability of the lock-seams. The looseness of the lock-seams will be used to select best and worst cases for further electrochemical testing by immersion experiments.

Figure 3.10. Average Looseness of Lock-Seam in millimeters from plants A, B, C and D.

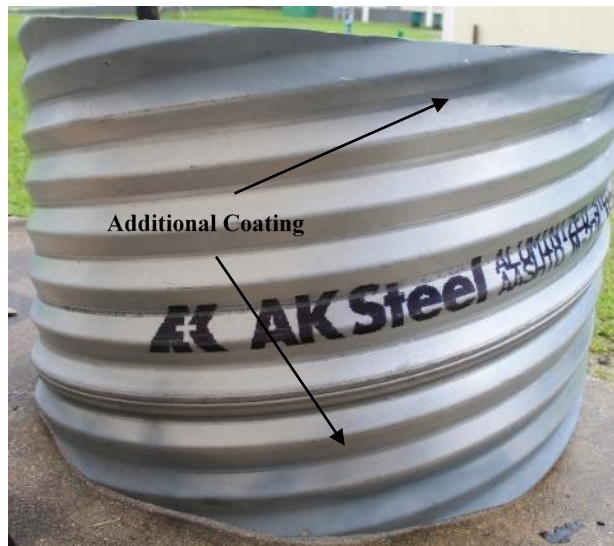
The pipes from Plant D were additionally sprayed to protect the coating from further damage as shown in Figure 3.20 which shows the spray-coated metal pipes.

Figure 3.20. Additional spray-coated pipe in an aluminized steel pipe from Plant D.

The additional coating of the sides of the pipe affected the quantification and detection of visible coating defects in the pipe. Despite this metallographic samples obtained still showed coating defects within the lock-seam of the pipes and pre-existing corrosion pits were observed on both aluminized and galvanized steel pipes. Figure 3.21 shows an example of a coating defect observed within the lock-seam of one of the pipes. In this particular case, there is a break in the outer coating layer but little visible damage to the intermetallic layer.

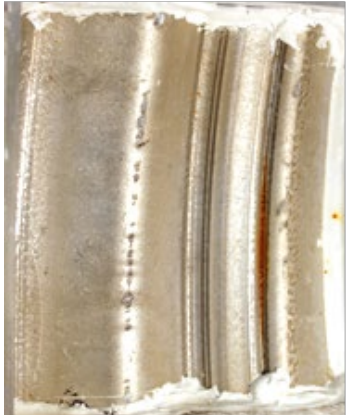
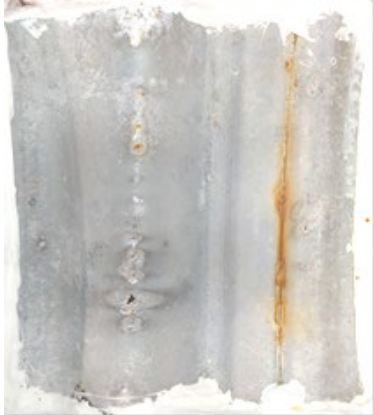
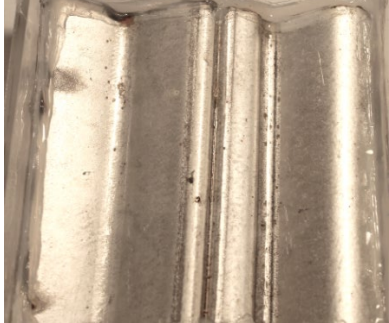
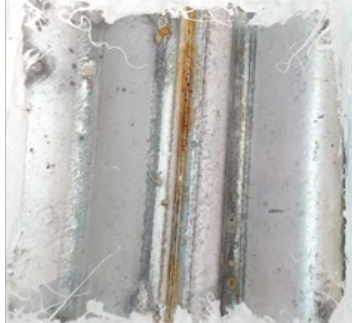
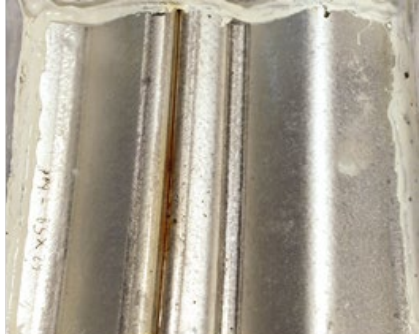
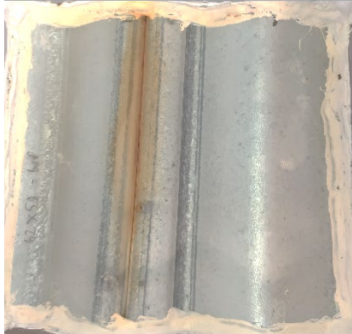
Aluminized steel samples cut from plant A and B pipes are presented in Figure 4.3 and those of plant C and D are presented in Figure 4.4. After 51 days of immersion, the plant A specimens show clear signs of steel corrosion products at the mouth of the lock-seams, and this occurs more in the mild case. There are no signs of aluminum corrosion products at this stage of exposure indicating that the aluminum does not seem to provide any protection to exposed steel defects as was the case with the galvanized steel specimens. However, at the end of the exposure period (227 days), there is clear presence of general aluminum corrosion and in some cases aluminum corrosion around defects suggesting some protection ability after a certain exposure period. Similar results were observed for plants B, C, and D. This agrees with prior work which showed that initially the aluminum remains passive in natural waters until there is either a brief period where the bulk solution pH or local cathodic activity at the coating surface results in alkalization. Additionally, there were also some cases in which the aluminum corrosion products were localized and surrounded small defects.

Figure 4.3. Aluminized steel long-term immersion samples at 51 days (left column) and after 227 days (right column) of immersion in aggressive and mild solutions for Plants A and B.

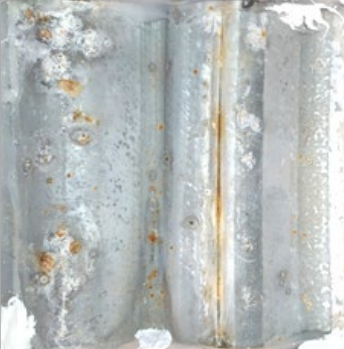
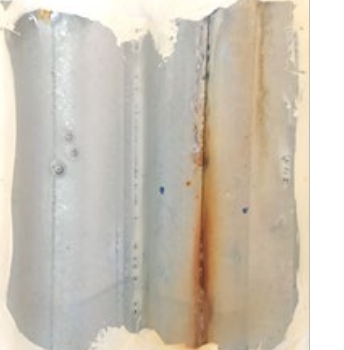
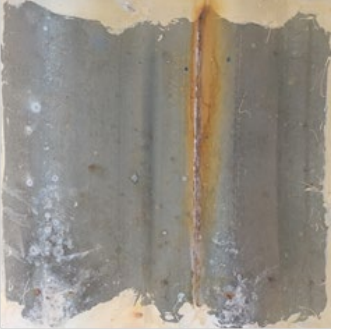
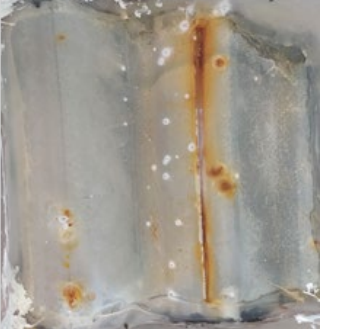
Figure 4.4. Aluminized steel long-term immersion samples at 51 days (left column) and after 227 days (right column) of immersion in aggressive and mild solutions for Plants C and D.
