# Durability and Inspection of Hybrid Composite Beams

Final Report VTRC 20-R7

**DURABILITY AND INSPECTION OF HYBRID COMPOSITE BEAMS**

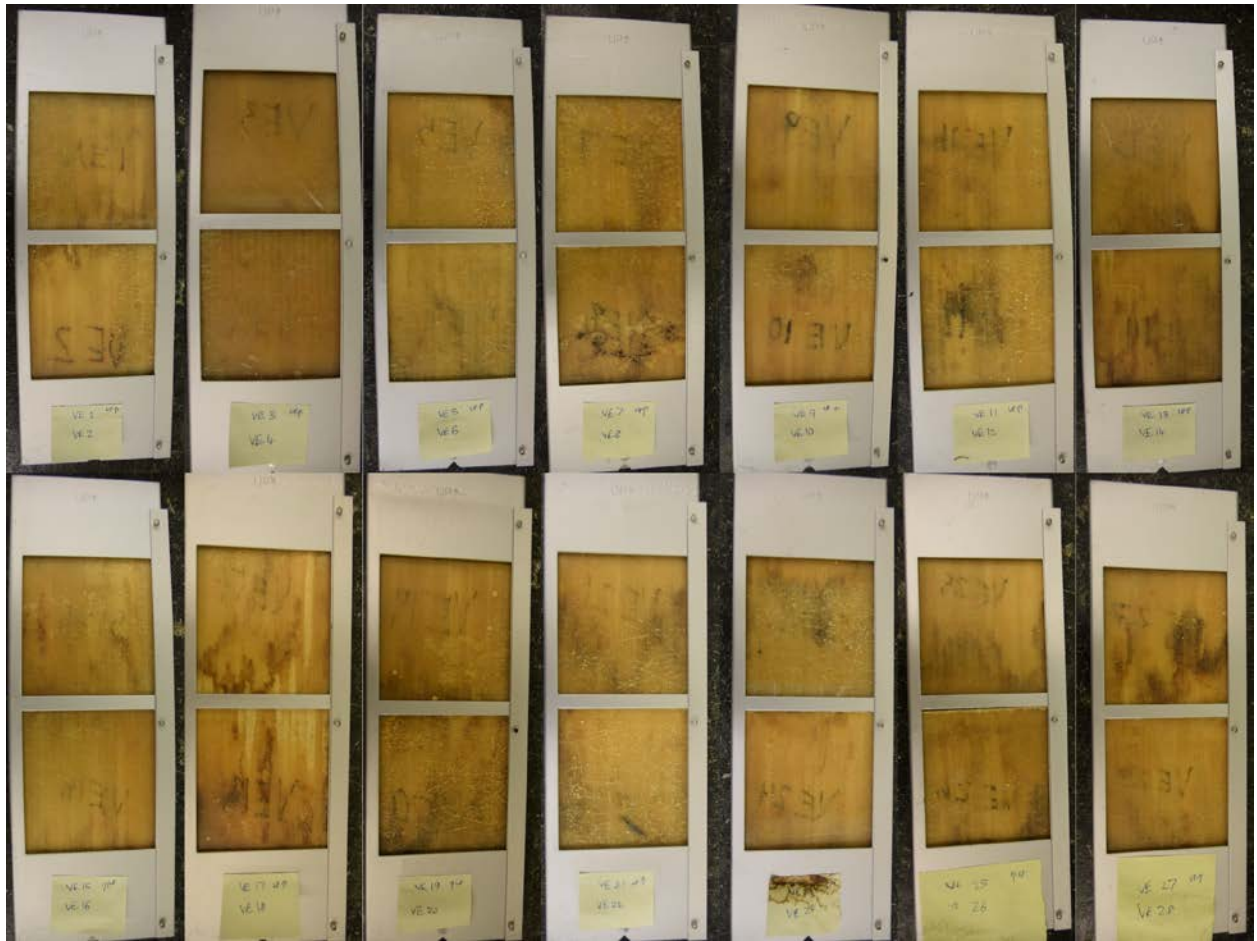
**Figure 11. Laboratory Specimens at 920 Hours of Aging by Ultraviolet Radiation**

Figures 10 through 12 show the laboratory specimens at 0 hr, 920 hr, and 2,000 hr of UV aging, respectively. Visually, the specimens appear to become darker. However, no damages such as pitting, cracking, or crumbling were observed except on Specimen 8, which developed a burn on the surface at 920 hr (Figure 11). This black spot can be observed to grow bigger at the end of 2,000 hr of UV aging (Figure 12). This might have been because of the presence of a thin delamination from the load testing at Virginia Tech. Based on this, there was a suspicion that the accelerated exposure might be too aggressive in the later stages of the degradation and might not represent the actual conditions of the field structures, so the aging was stopped at this stage.

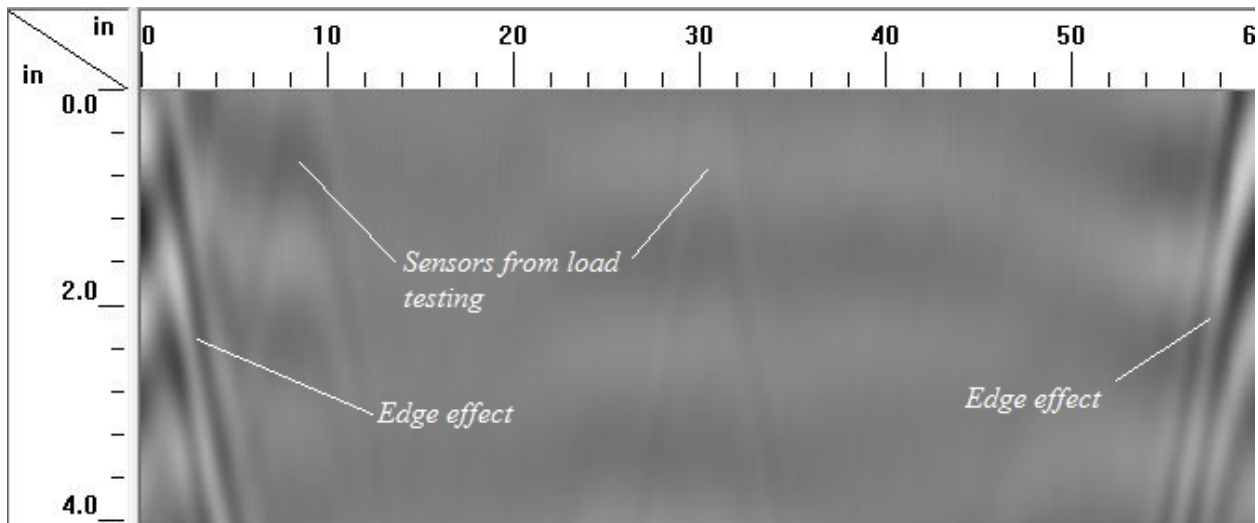
Figure 25 shows a GPR scan in the longitudinal direction of the HCB in the middle. The x-axis shows the longitudinal spatial length of the scan, and the y-axis shows the depth. Then, moisture was applied using a brush on the same section for a 12-in length from the edge. Figure 26 shows the GPR scan with the 12-in-long moisture signature clearly. It can be noted that the edge effect in the form of hyperbolas appears more prominent than the presence of water.

**Figure 25. Ground Penetrating Radar Scan of Bottom Flange With No Moisture**

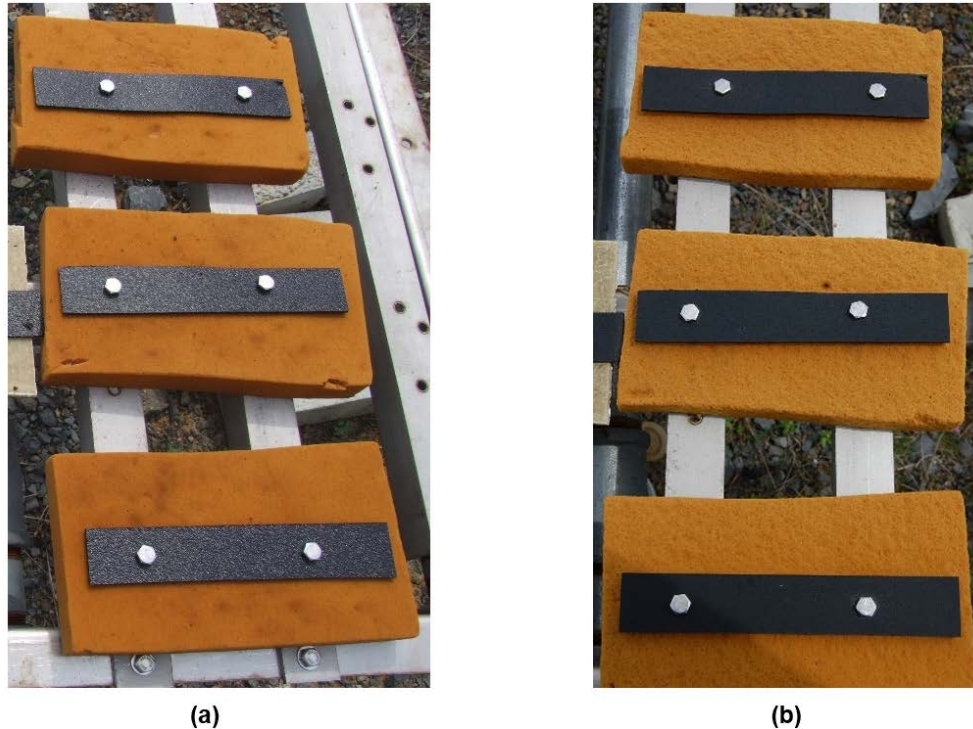
Delamination of the glass layer was observed along a cut edge (Figure 33) in one sample, which was probably attributable to moisture penetrating the sample and expanding and contracting during seasonal cycles of freezing and thawing. Most of the specimens, however, visually seemed to have performed well and did not show signs of substantial degradation. This response was especially surprising for the foam specimens (Figure 35) since this component of the composite beam was somewhat protected from the weather because it was placed inside the fiberglass shell that makes up the beam.

**Figure 35. Comparisons of Foam Specimens: (a) initially; (b) after 1 year and 8 months**

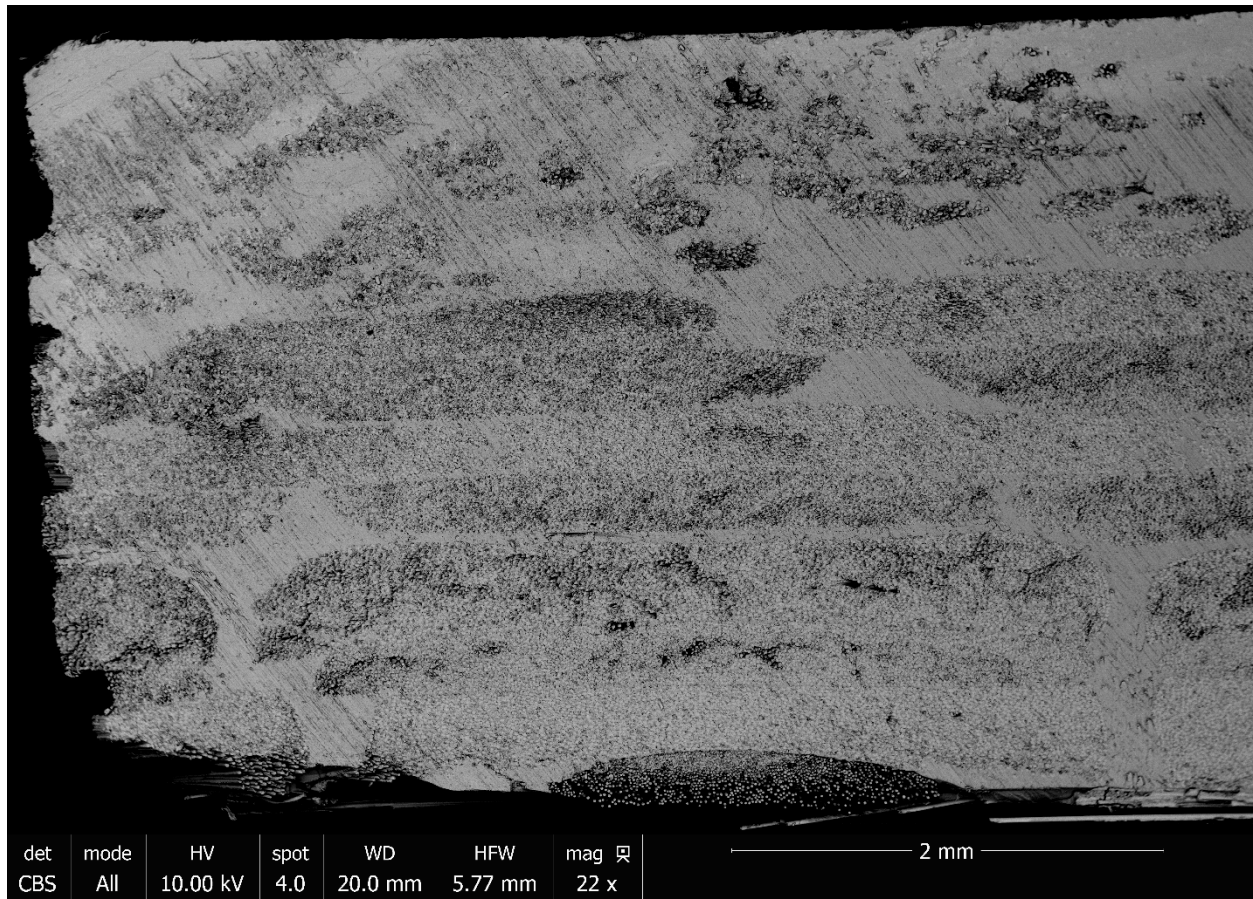
This technique uses a scanning electron microscope to produce extremely high-resolution images of specimens. SEM focuses a beam of electrons on to the scanning surface. The electrons interact with the atoms and produce signals proportional to the topography of the sample surface. Resolution of the SEM can be from 1 to 20 nm ( $4 \times 10^{-5}$  to  $7.8 \times 10^{-4}$  mils) depending on the instrument. Figure 40 shows an SEM image of the polished surface of the same sample from Figure 39. Although the SEM image provided more details and confirmations about fiber mat layers, it was still difficult to determine the fiber orientations.

**Figure 40. Scanning Electron Microscope Image of Highly Polished Fiber-Reinforced Polymer Sample**

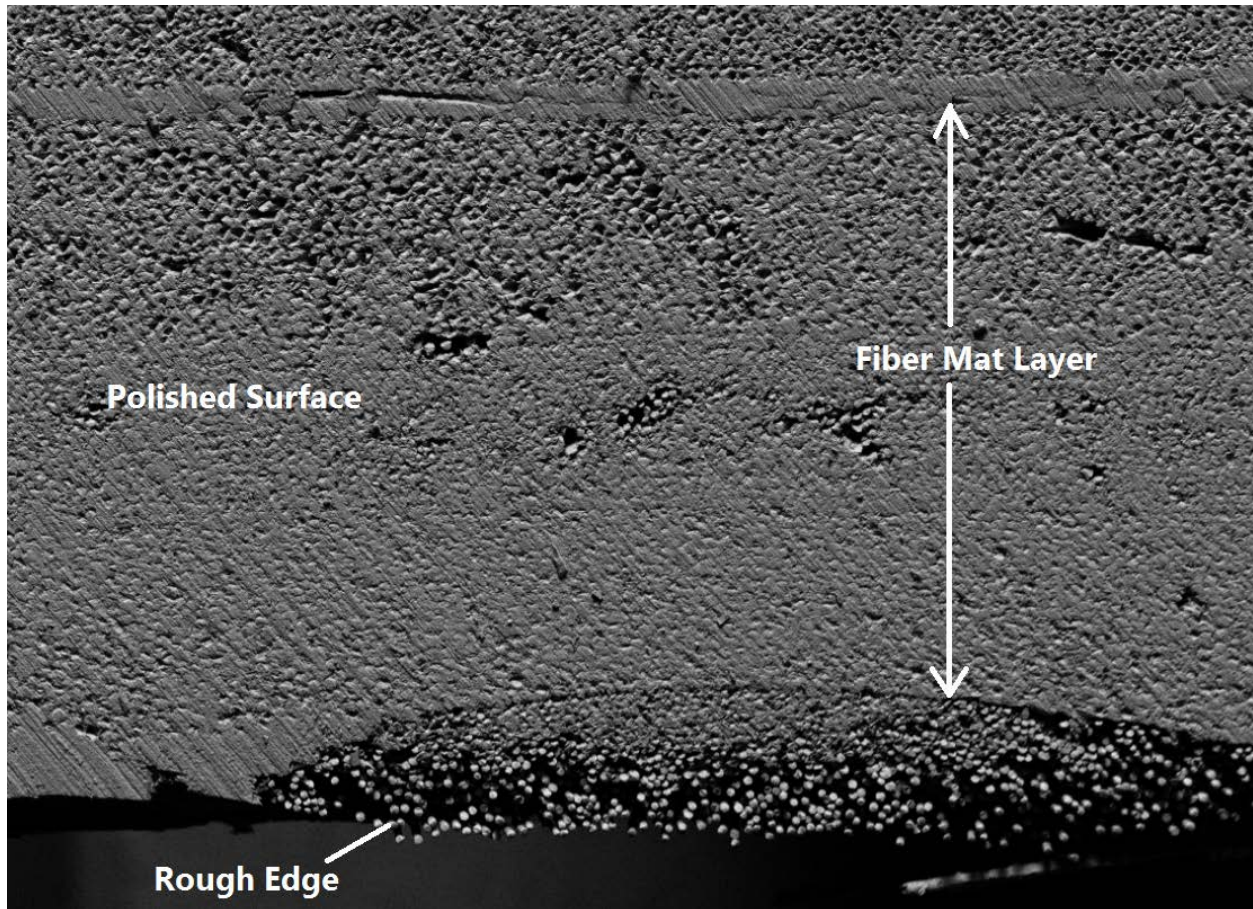
A magnified portion of Figure 40 is shown in Figure 41. The fiber layers can be easily identified; however, as stated before, the fiber orientations appear vague. In the same image, the bottom surface of the sample shows some rough edges that were not polished well. It was ironically more useful in identifying the fiber strands and orientation. The rough clump of fibers runs perpendicular to the plane of the image, as indicated by the circular cross section of the individual fiber strands. It was found that unpolished specimens also provided less reliable visualization of the resin.

**Figure 41. Magnified Scanning Electron Microscope Image of Polished and Rough Edges**

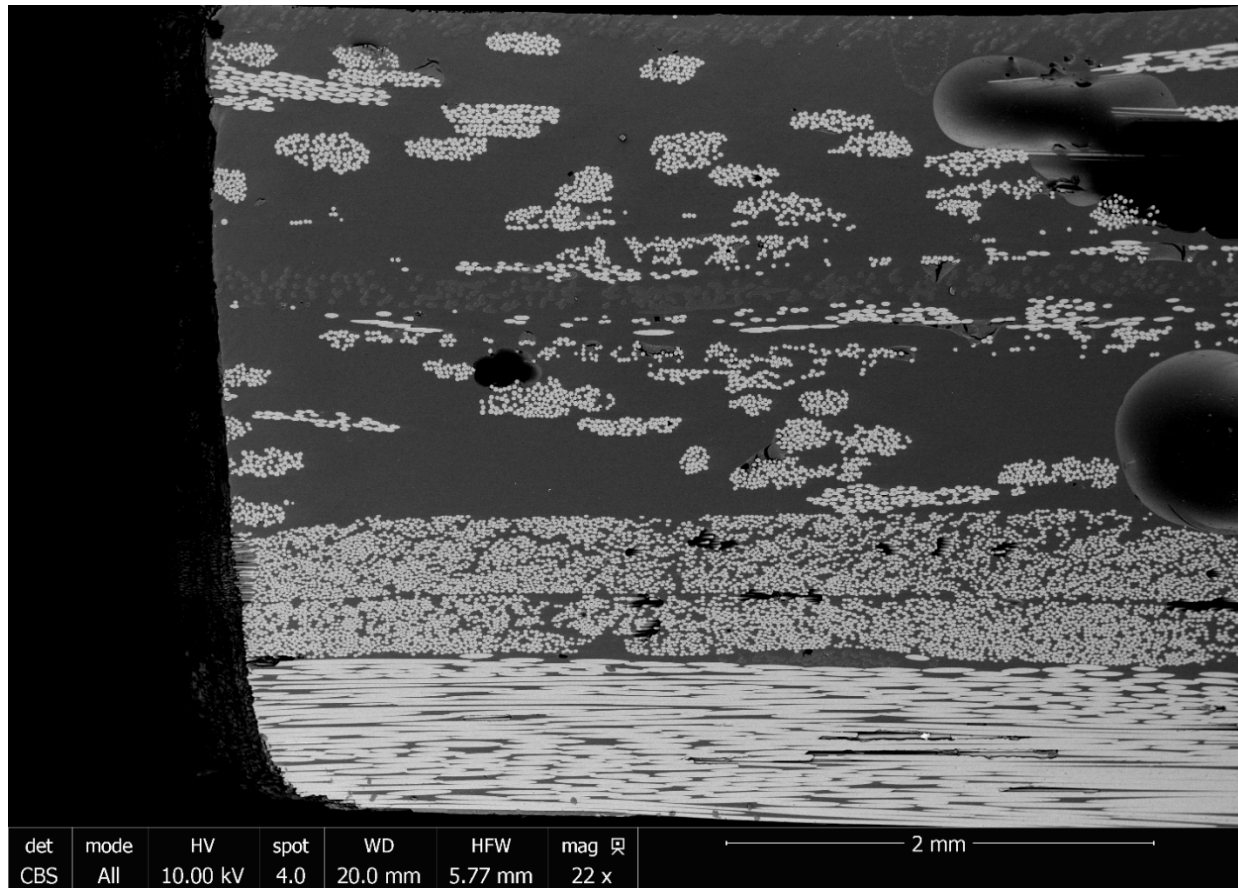
Therefore, further specimens were polished mildly, to remove dirt and foreign material, before SEM imaging was performed, as shown in Figure 42. However, the outer layer of FRP (top two-thirds thickness of Figure 42) showed irregular and scarce fiber content without a particular orientation. It is possible that there were fiber mats in this layer, but was not visible on the surface.

**Figure 42. Scanning Electron Microscope Imaging of Mildly Polished Sample**

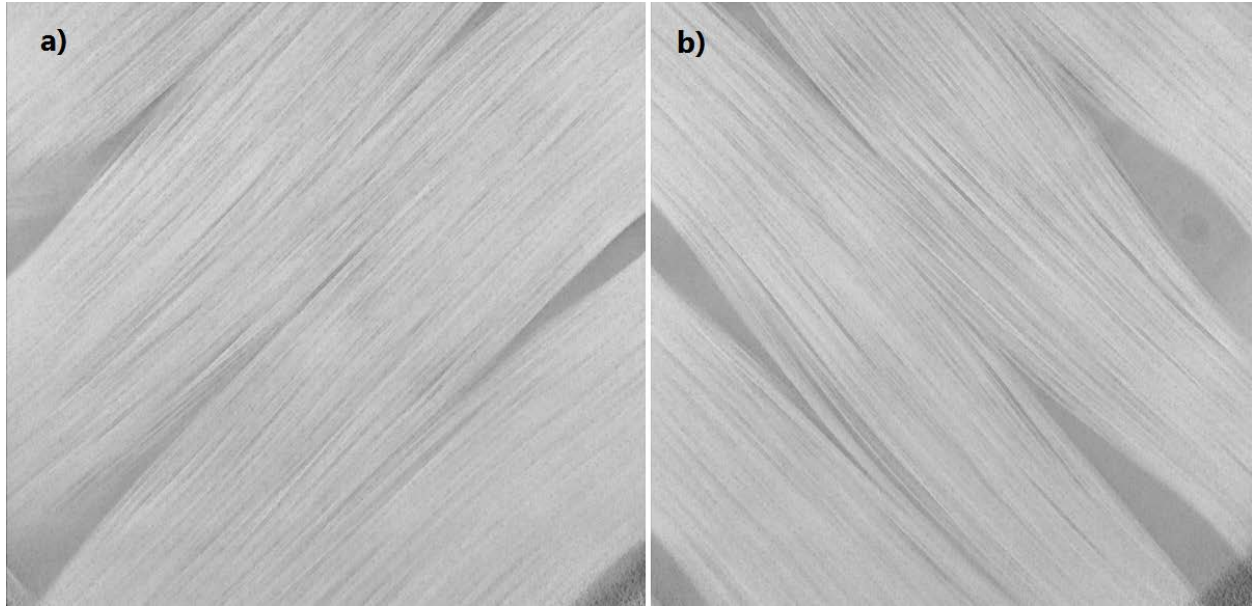
Figure 43 shows images of the longitudinal sections with distinct visualization of the fiber mat orientations. The resolution was more than adequate, displaying particles as small as fiber strands. The outer layer of the FRP sample was scanned to check for actual fiber content, as shown in Figure 44. There were random fiber clumps present in the outer resin layer, but there were no fiber mats. These could have been residues from the fiber mats. Thus, their influence on the tensile strength is miniscule.

**Figure 43. X-ray Computed Tomography Imaging of Fiber Mats: (a) at 45 degree angle; (b) at 135 degree angle**

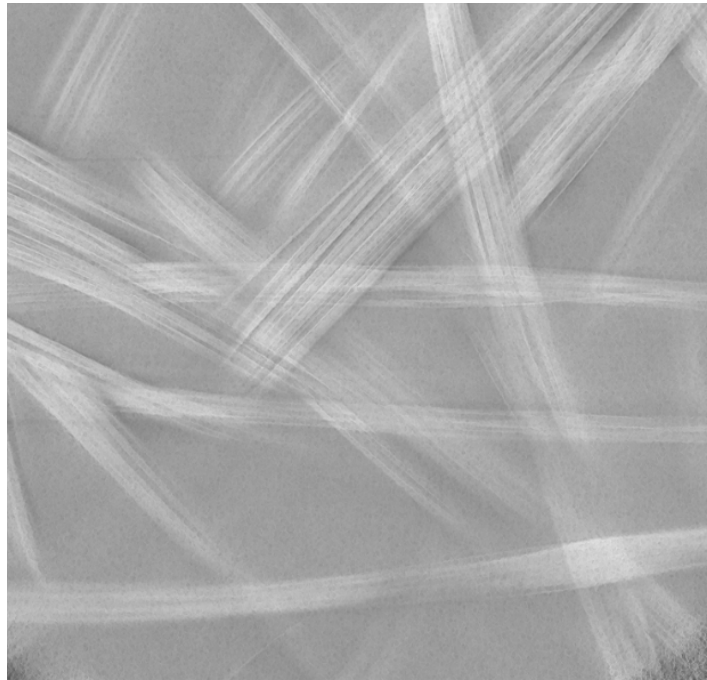
**Figure 44. X-ray Computed Tomography Imaging of Random Fiber Clumps at Outside Layer of Fiber-Reinforced Polymer**

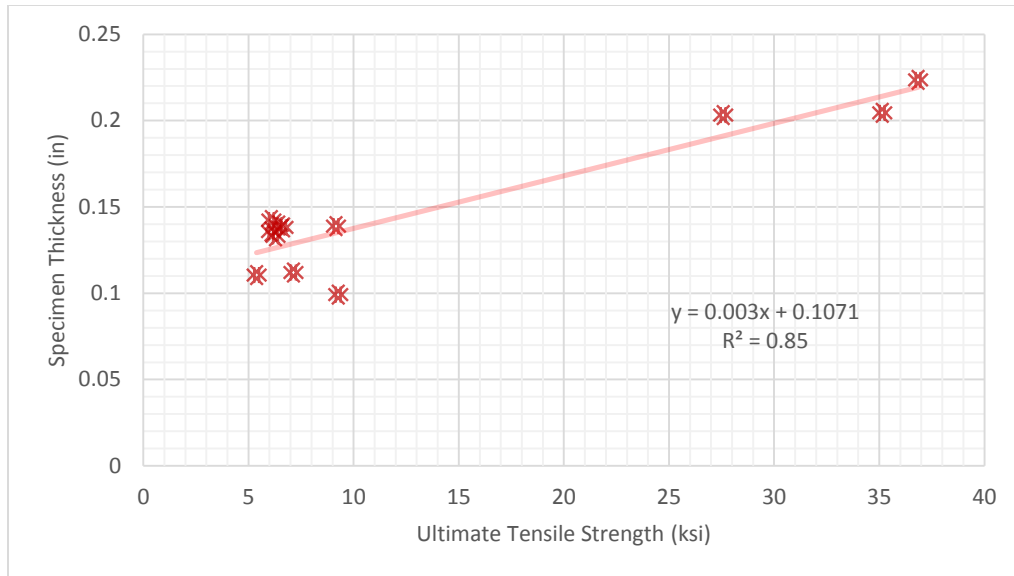
**Figure 46. Relationship Between Specimen Thickness and Ultimate Tensile Strength**

On average, the thickness of the LO# specimen was 65% greater than that of the rest of the specimens; however, their average tensile strength was about 374% greater. By evaluating the SEM images of the cross sections, it was found that most of the tensile fiber content started at about 0.09 in (2.25 mm) from the outside surface of the FRP specimens. This indicates for the sake of the inspection that if scraping damage is limited to the outer 2 mm or so, the strength of the material will not decrease significantly. However, this finding might apply only to this case, since FRP construction may not be precise enough to have the exact cross section in every beam.

In addition, it was established earlier that the FRP shell acts as an important load-bearing member; thus, the fiber content in the shell, being the principal tensile load-carrying material, must be preserved for structural integrity and expected load-carrying performance. Thus, any fiber exposure must be sealed because of resin degradation as soon as possible for durability.
