# Best Practices for Pavement Restoration of Open Cut Utility Installations/Repairs on Local Roadways in Ohio

Prepared by Mary Robbins, Roger Green, Teruhisa Masada, and Dane Redinger (Resource International, Inc.)

June 2019

Final Report

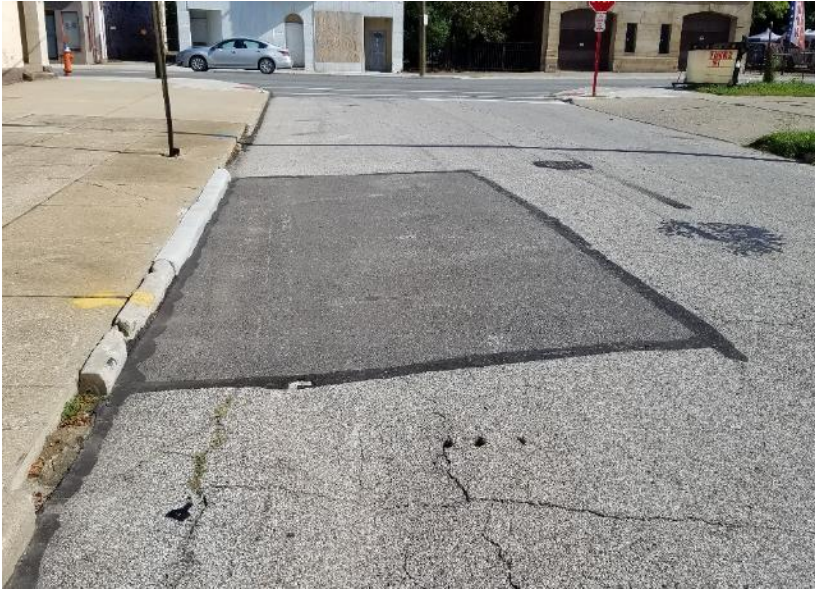
**Figure 28 Repair on Pepper Ave.**

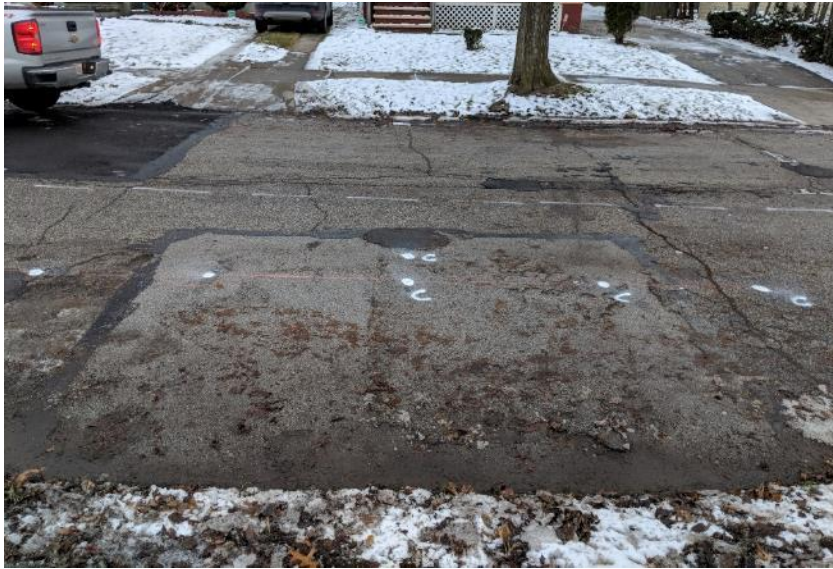
**Figure 32 Repair on Terminal Ave.**

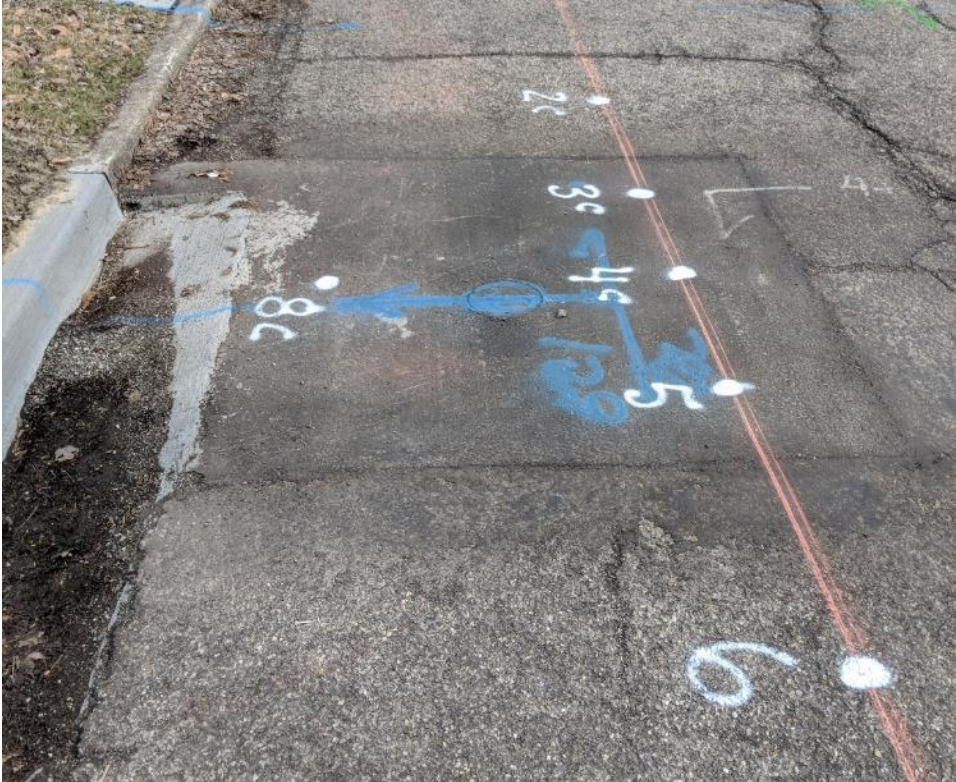
Figure 35 Repair at 50 E. Jeffrey Place.

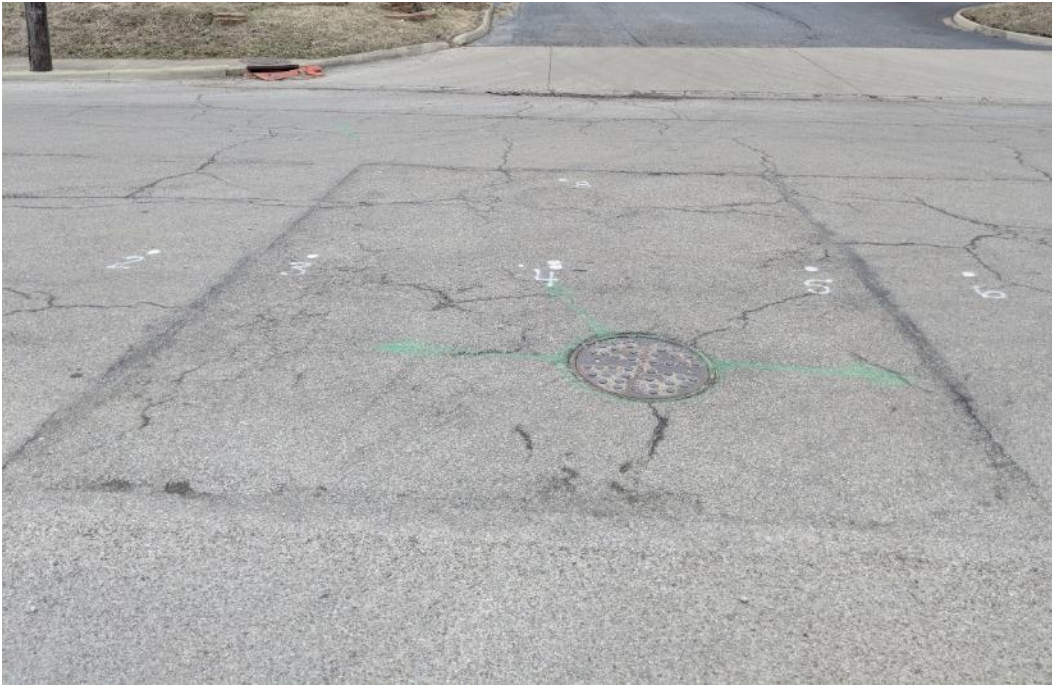
Figure 36 Repair at 1576 Old Leonard Ave.

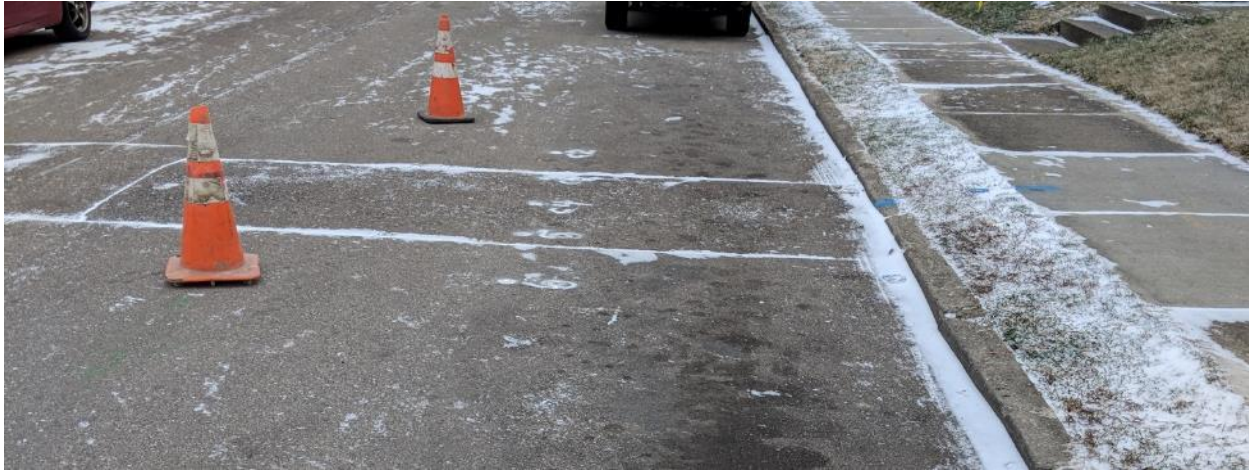
**Figure 40 Repair on 66 S. Sperling Ave.**

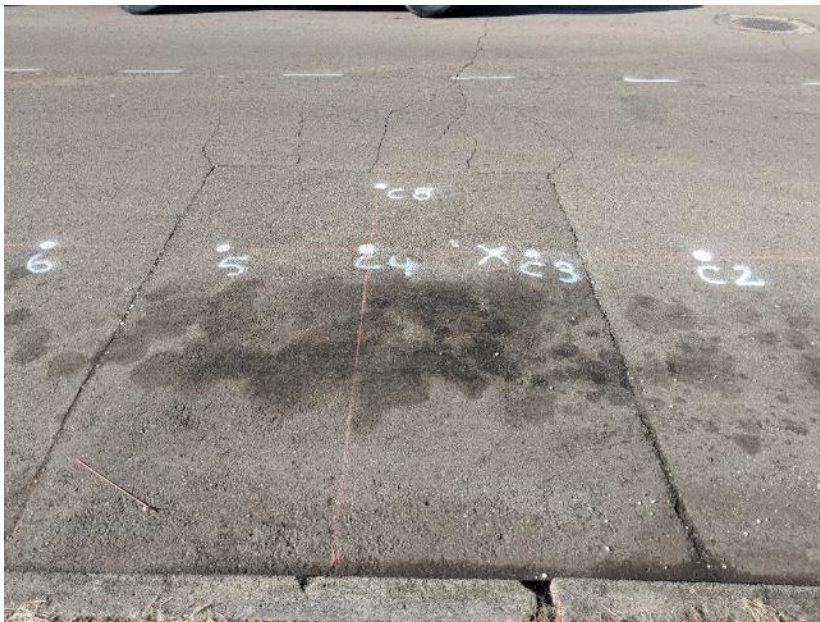
**Figure 41 Repair on 74 S. Sperling Ave.**

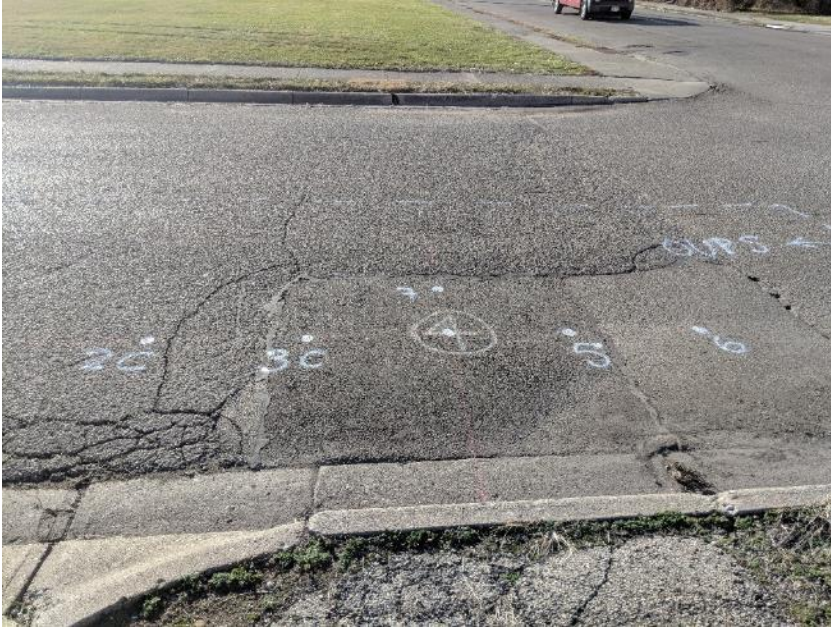
Figure 42 Repair on N. Torrence at Springfield.
