# FINAL PROJECT REPORT #00059416

## Durability of GFRP Bar Reinforcement Extracted from In-service Concrete Structures

**Participating Consortium Member:**  
Missouri University of Science and Technology

Dr. John J. Myers, Ph.D., P.E., (PI)  
Ali Al-Khafaji, P.E.

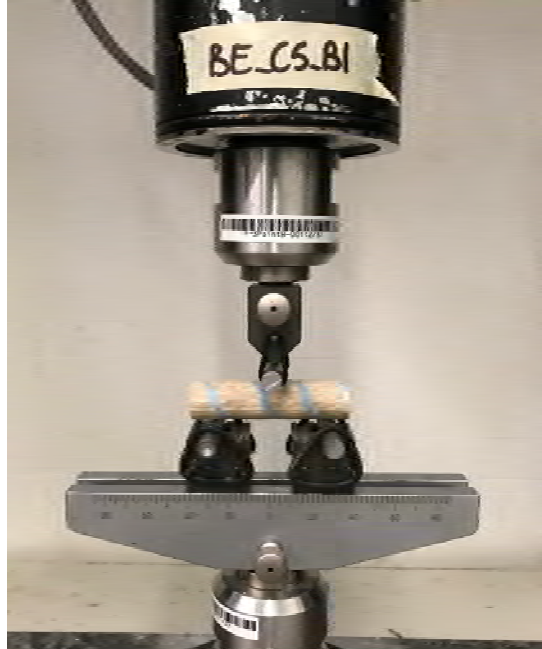
*Fig. 47–Modified horizontal shear test setup for short bars*

Due to the size of the specimens of Bettendorf Bridge, the bars were not tested according to ASTM D4475. The anvils available at the University of Miami did not fit the specimens properly, and an alternative test set up was attempted (Fig. 47). The failure mode of the specimens was not acceptable for horizontal shear, and therefore the results are invalid and were not included in Table 11.

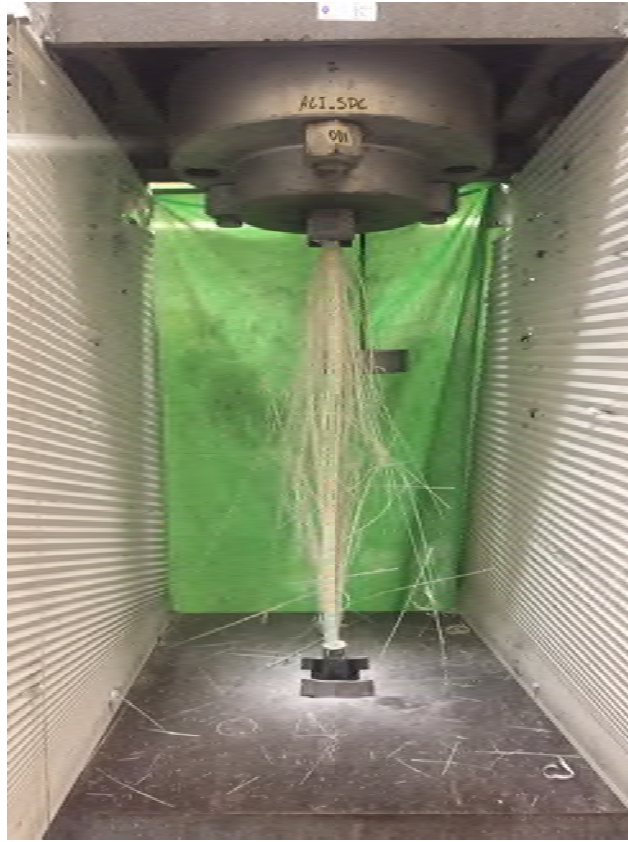
*Fig. 54–Pristine GFRP tension failure*

Ten #5 pristine bars were tested for tension capacity at the University of Miami as described in Section 4.1.8.2. The test set up is shown in Fig. 53 and the results of the test is shown in Table 19. The average peak load was 36,989 lbs. (164,535 N), which is similar the manufacture's specification dated 2002. The results of the tension test for each bar is shown in Appendix VI. All bars failed as shown in Fig. 54.

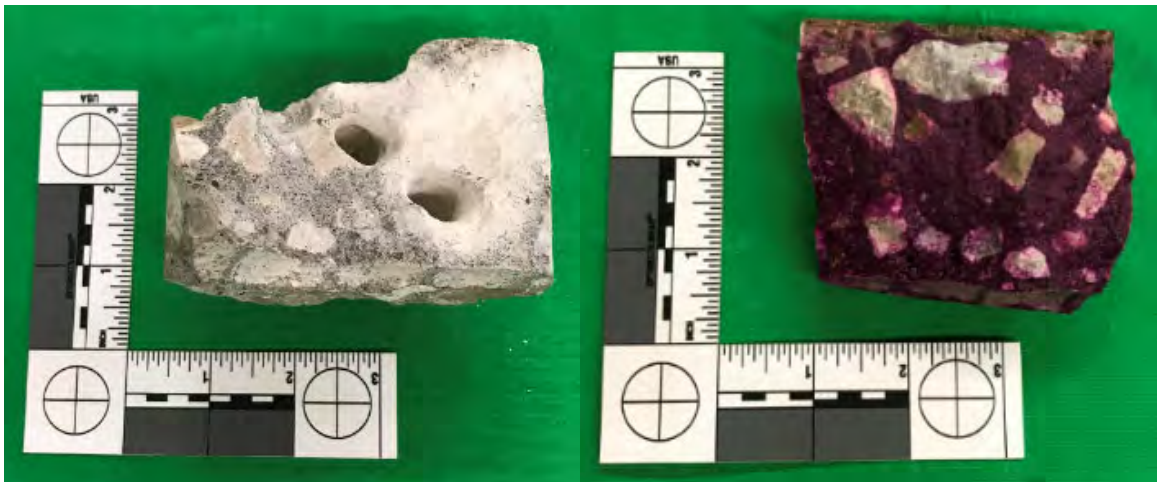
*Fig. 59–Cuyahoga Core 4 pH test with phenolphthalein*

The pH of the samples varied between 9 and 13. The lowest average pH for was 10 for Roger's Creek and McKinleyville Bridge, while the highest average pH was 12.2 for Cuyahoga and Gills Creek Bridge. The average results for each bridge can be observed in Table 23. *Fig. 59* shows a sample tested with phenolphthalein indicator solution for Cuyahoga Bridge and *Fig. 60* its corresponding pH based on color range.

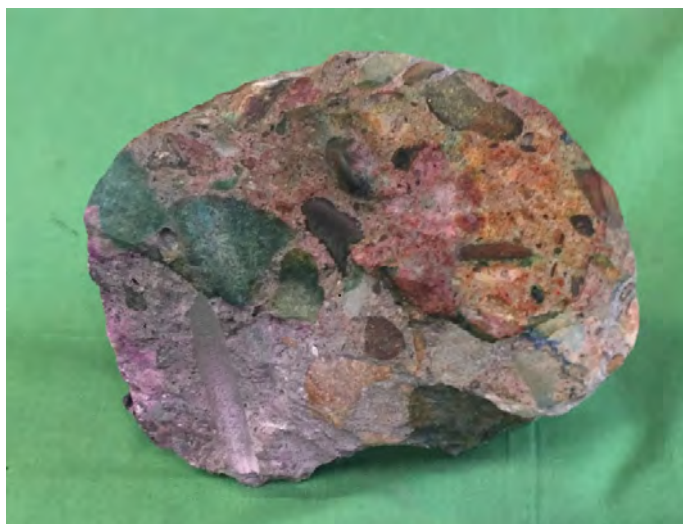
*Fig. 61—McKinleyville pH range using the rainbow indicator*

Fig. 61 shows a sample tested with the rainbow indicator. The test results for the individual bridge are shown in Appendix IV.

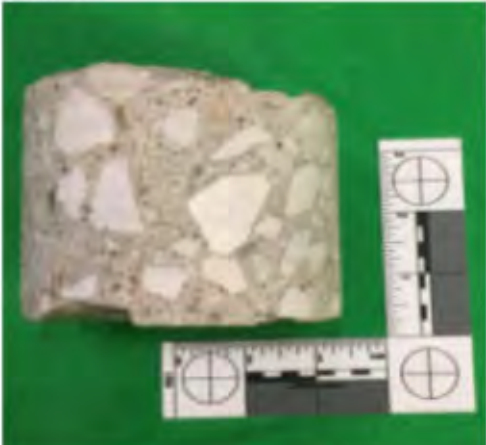
| Core | Height<br>(in) | Diameter<br>(in) | Clear cover<br>(in) | Notes | Picture |
|---|---|---|---|---|---|
| BE_C1 | 2.75 | 3.75 | | Missing steel<br>-- rebar | |

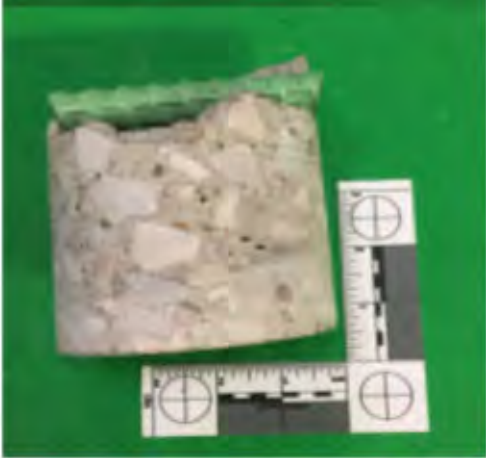
| Core | Height<br>(in) | Diameter<br>(in) | Clear cover<br>(in) | Notes | Picture |
|---|---|---|---|---|---|
| BE_C2 | 2 | 3.75 | | Steel rebar, core<br>has hole in<br>-- center | |

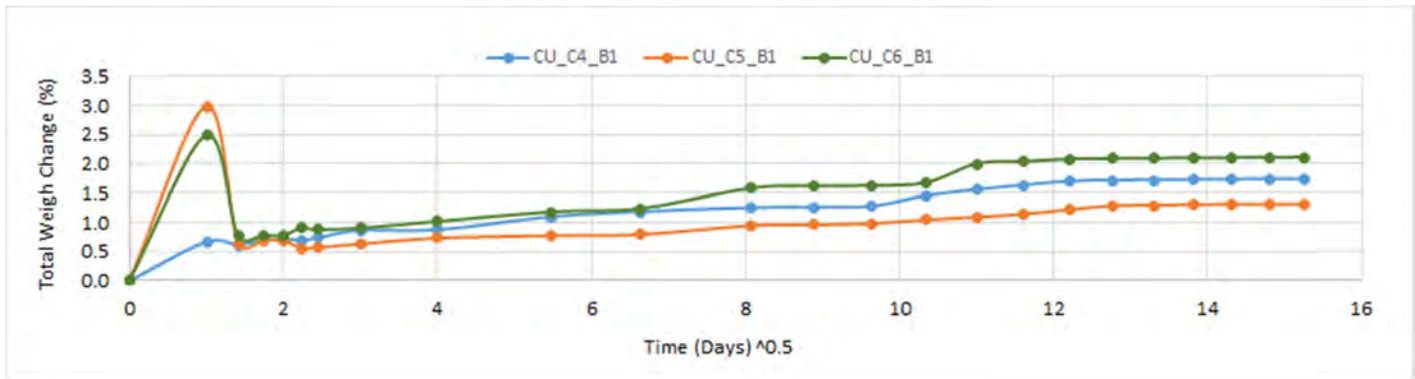
According to ASTM D570, any observation as to warping, cracking or change in appearance of the specimens should be reported. Between 30 and 44 days into uptake testing, CU\_C4\_B1 and CU\_C6\_B1, lost a little piece of helical wrap around 7 mg and 5 mg respectively. In addition to

losing a piece of helical wrap, some residue was noticed in all of the specimens' containers after 6 weeks of testing.

Fig 9. Cuyahoga moisture uptake vs. square root of time – MST

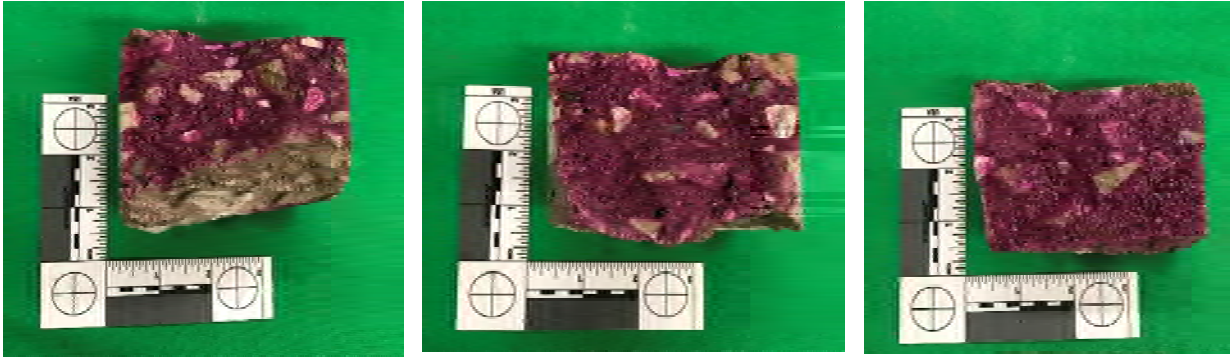
Carbonation depth was determined for three concrete samples from the *Bettendorf Bridge*. The results are shown in *Fig. 11*. Pictured samples are oriented such that the exposed surface (typically bridge deck) of the core is at the top of the image.

*Fig. 11. Bettendorf carbonation depth results*

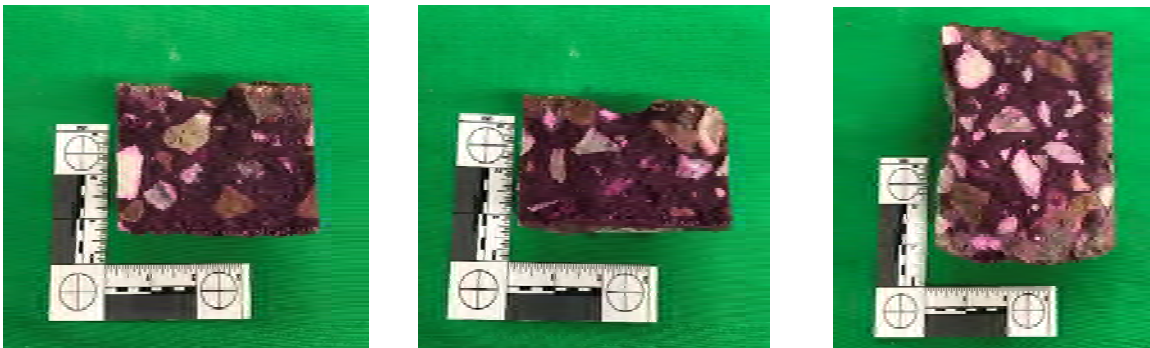
Carbonation depth was determined for three concrete samples from the *Cuyahoga Bridge*. The results are shown in *Fig. 12*. Pictured samples are oriented such that the exposed surface (typically bridge deck) of the core is at the top of the image.

*Fig. 12. Cuyahoga carbonation depth results -UM*

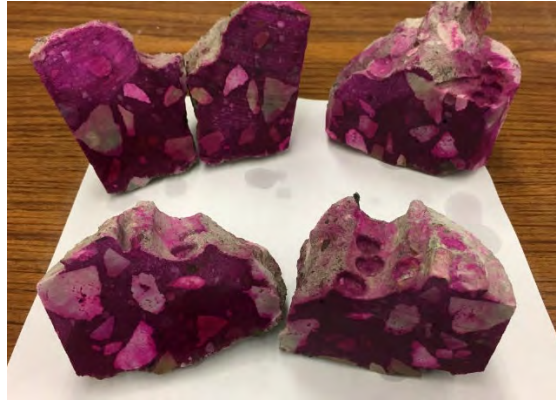
Carbonation depth tests were also performed at Missouri S&T for the *Cuyahoga Bridge*. The results are shown in *Fig. 13*.

*Fig. 13. Cuyahoga carbonation depth results -S&T*

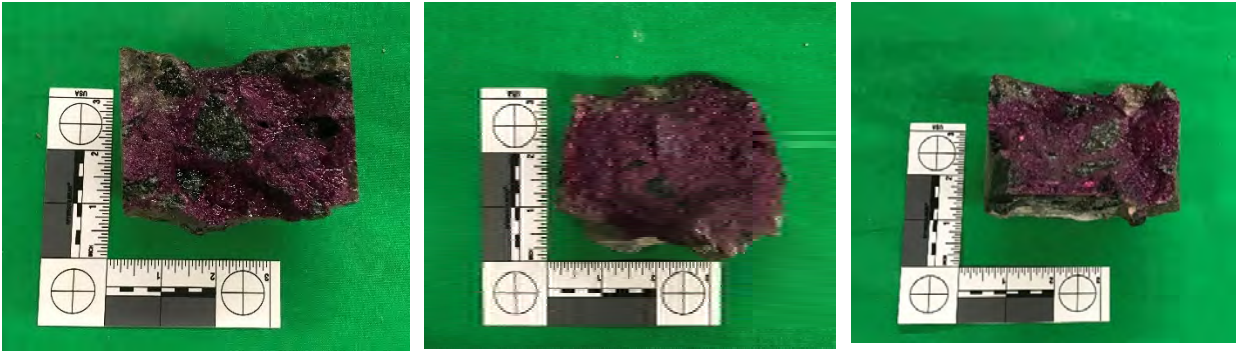
Carbonation depth was determined for three concrete samples from the *Gills Creek Bridge*. The results are shown in *Fig. 14*. Pictured samples are oriented such that the exposed surface (typically bridge deck) of the core is at the top of the image.

*Fig. 14. Gills Creek carbonation depth results*

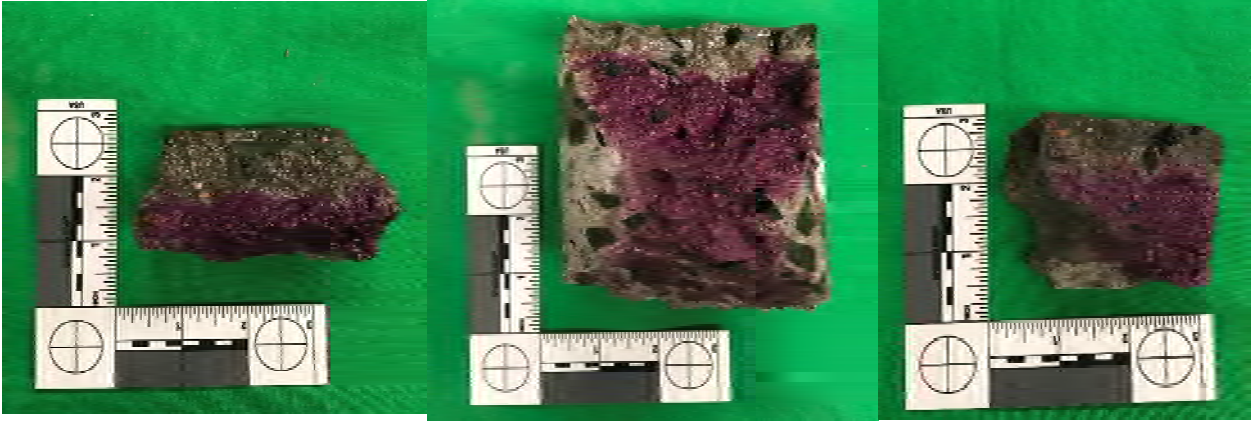
Carbonation depth was determined for three concrete samples from the *O'Fallon Park Bridge*. The results are shown in *Fig. 15*.

Fig. 15. O'Fallon Park carbonation depth results

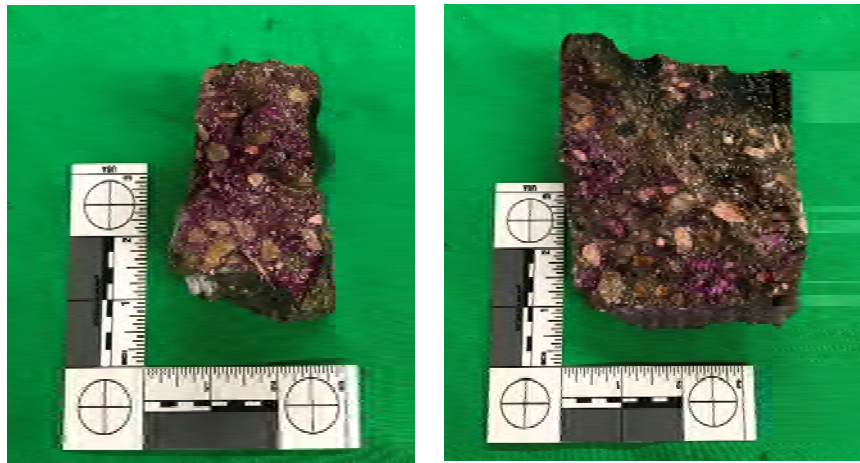
Carbonation depth was determined for two concrete samples from the *Salem Ave Bridge*. The results are shown in Fig. 16. Pictured samples are oriented such that the exposed surface (typically bridge deck) of the core is at the top of the image.

Fig. 16. Salem Ave carbonation depth results

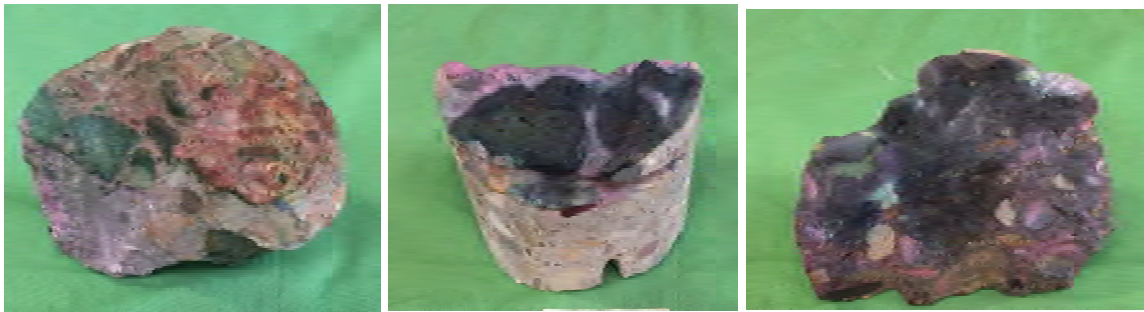
Fig. 30. McKinleyville pH test

All the core samples were tested with the rainbow indicator and the value varied between samples and location of where the indicator was applied. *McKinleyville Bridge* samples indicated a pH of 13 in the inside of the concrete sample and a pH between 7 and 13 on the outside face of the concrete core, as seen in Fig. 30.

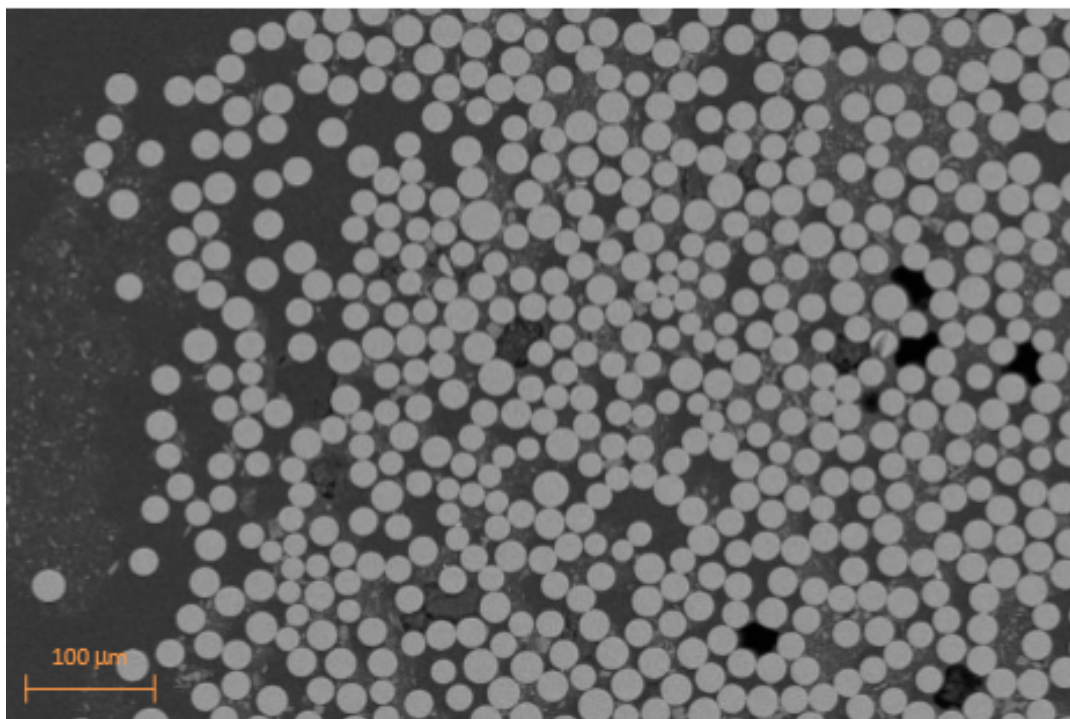
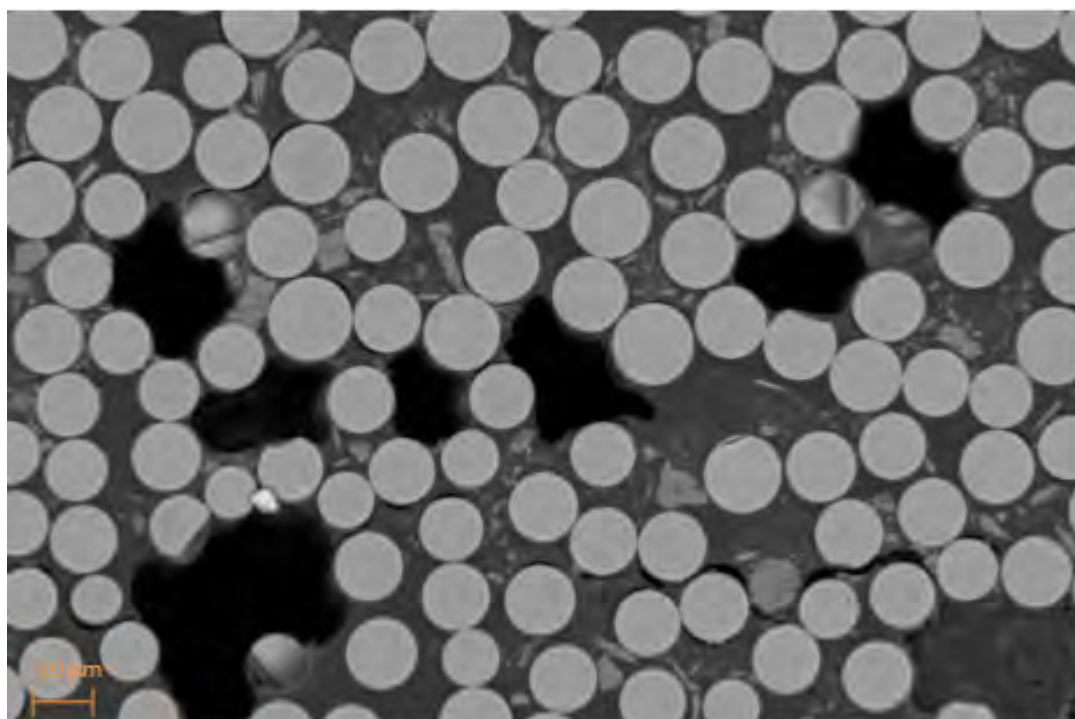
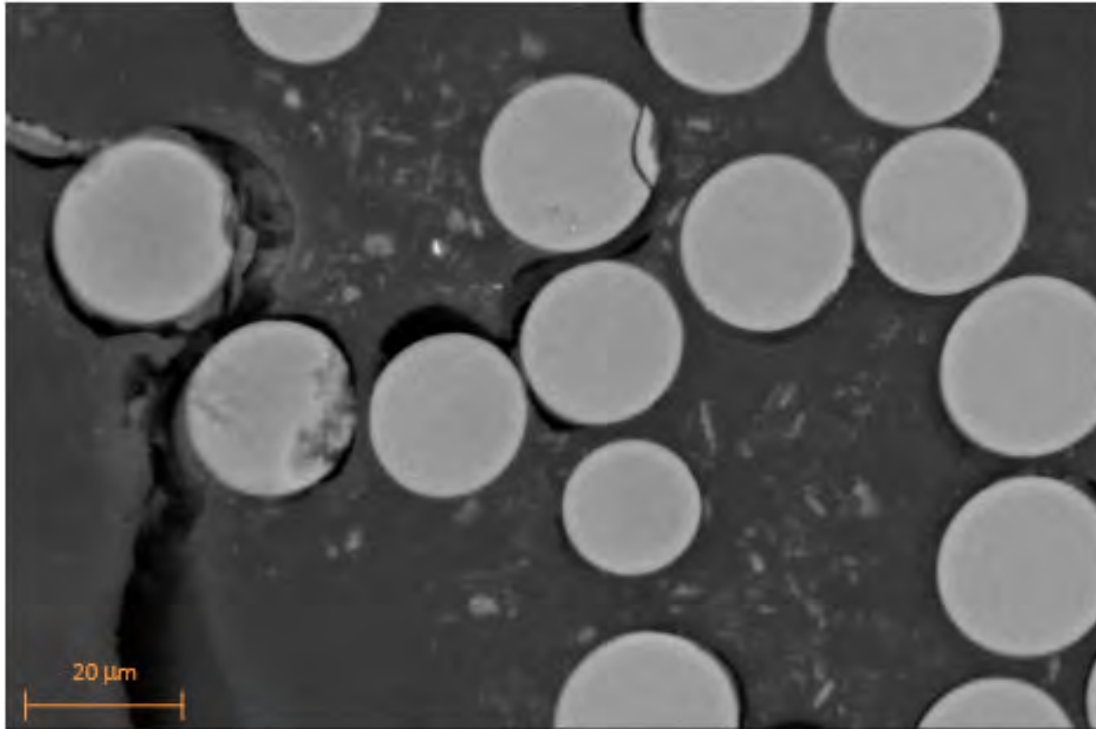
The fibers evidently affected (192 out of 352,000 fibers) were estimated from counting fibers with obvious signs of damage in 1 quadrant, multiplied by 4. The extrapolation for affected fibers (412 out of 352,000 fibers) was estimated from counting fibers with obvious signs of damage and fibers with polishing artifacts in 1 quadrant, multiplied by 4. This quantity is much less than expected or predicted by accelerated test methods, The results of each bar is shown in Fig. 28 through Fig. 31.

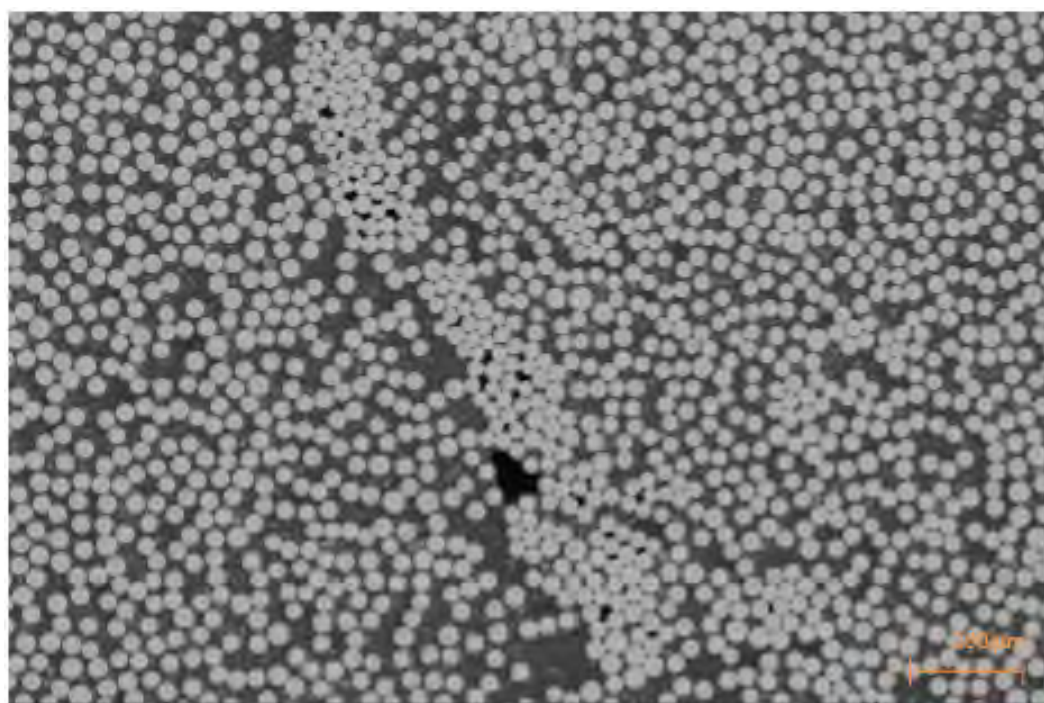
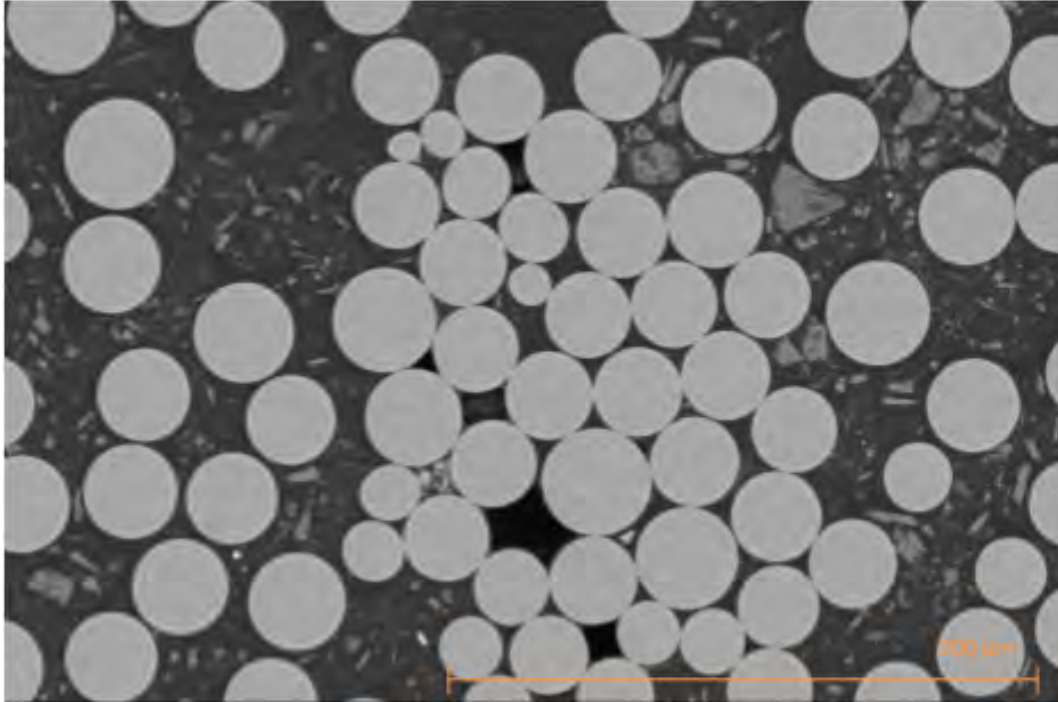
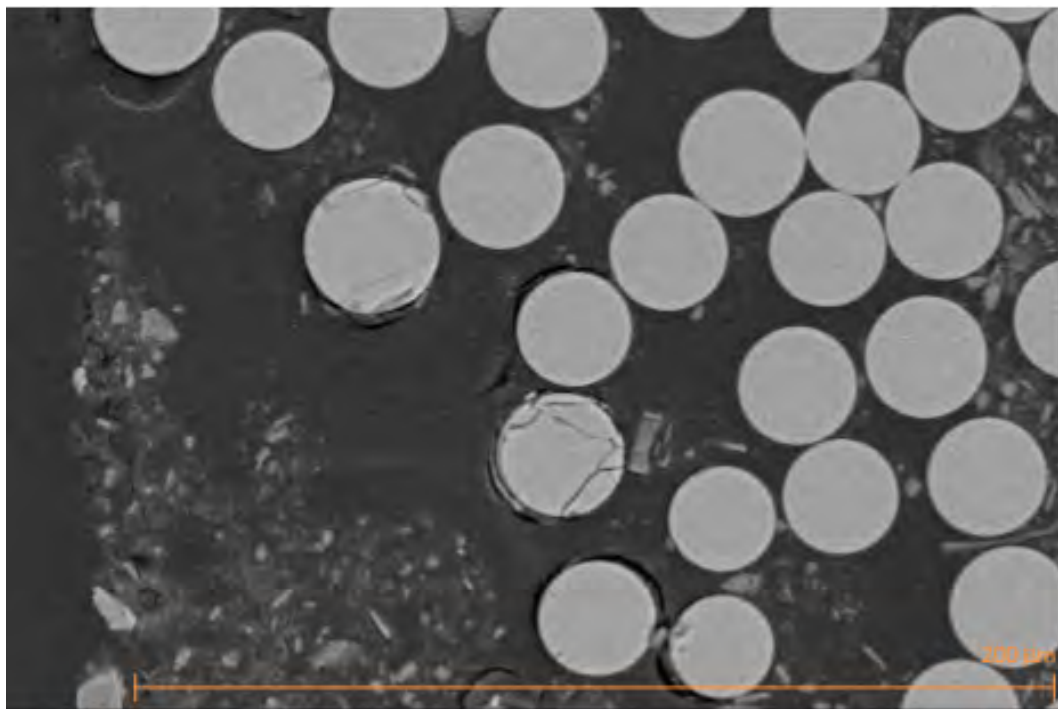
SEM imaging for *Cuyahoga Bridge* was performed at Owens Corning. GFRP rebar extracted from Cuyahoga bridges show some damage on 0.05 to 0.12 % of the glass fibers. This is much less than expected or predicted by accelerated test methods, and has a negligible impact on mechanical properties. The affected fibers were typically on the outer edge of the rebar. The results of each bar is shown in Fig. 32 through Fig. 35.

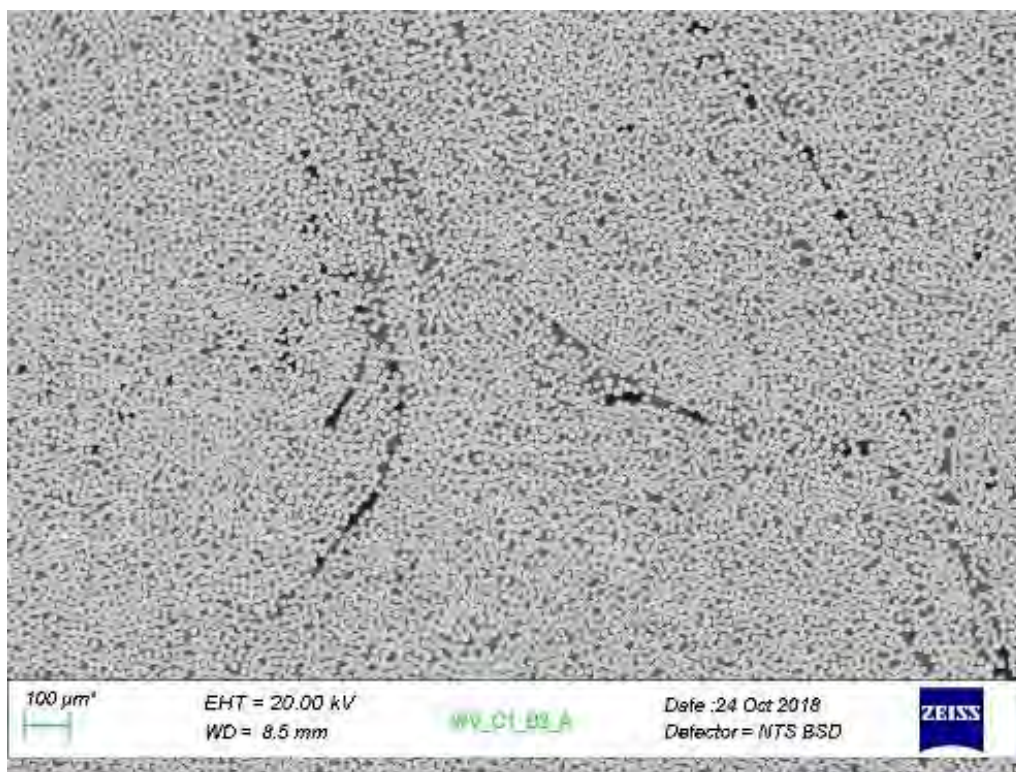
SEM imaging for *McKinleyville Bridge* was performed at Owens Corning. Nearly no negatively affected fibers were observed on the interior or exterior of in-service rebar. The few negatively affected fibers appear to have physical damage from specimen preparation as they are near resin voids. The SEM images of each bar is shown in Fig. 36 through Fig. 80.

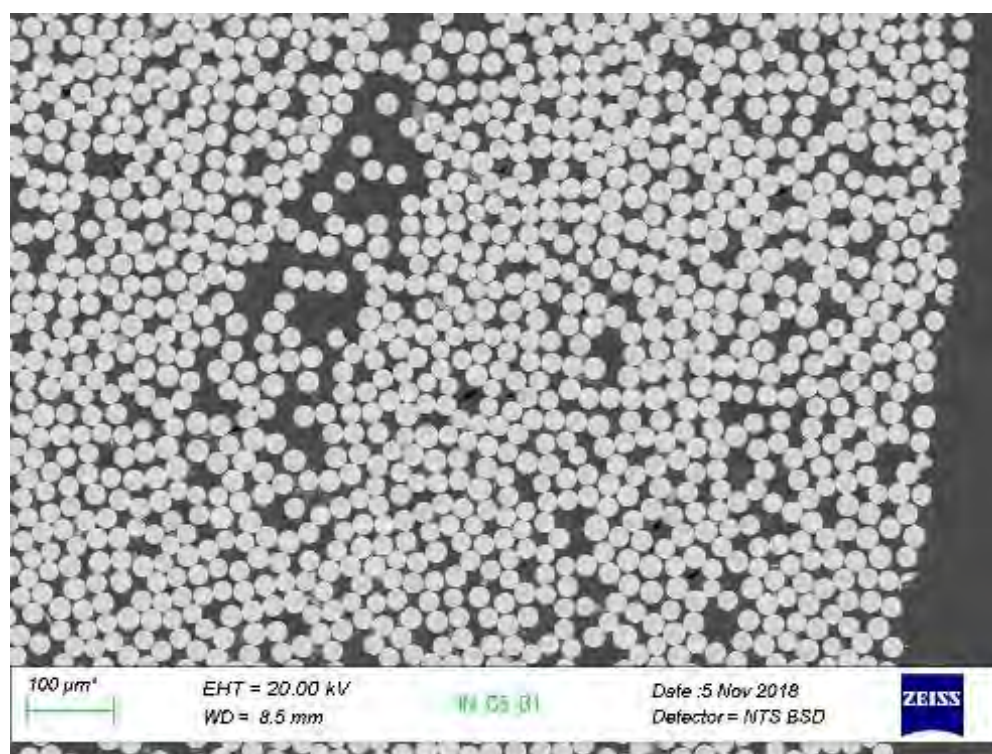
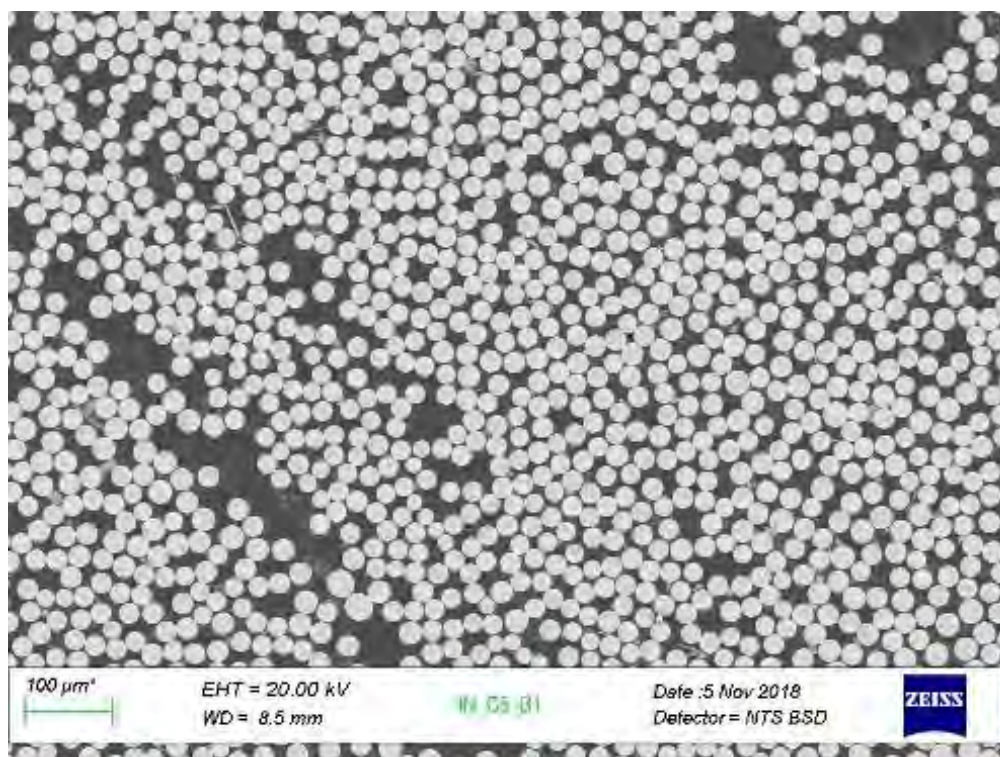
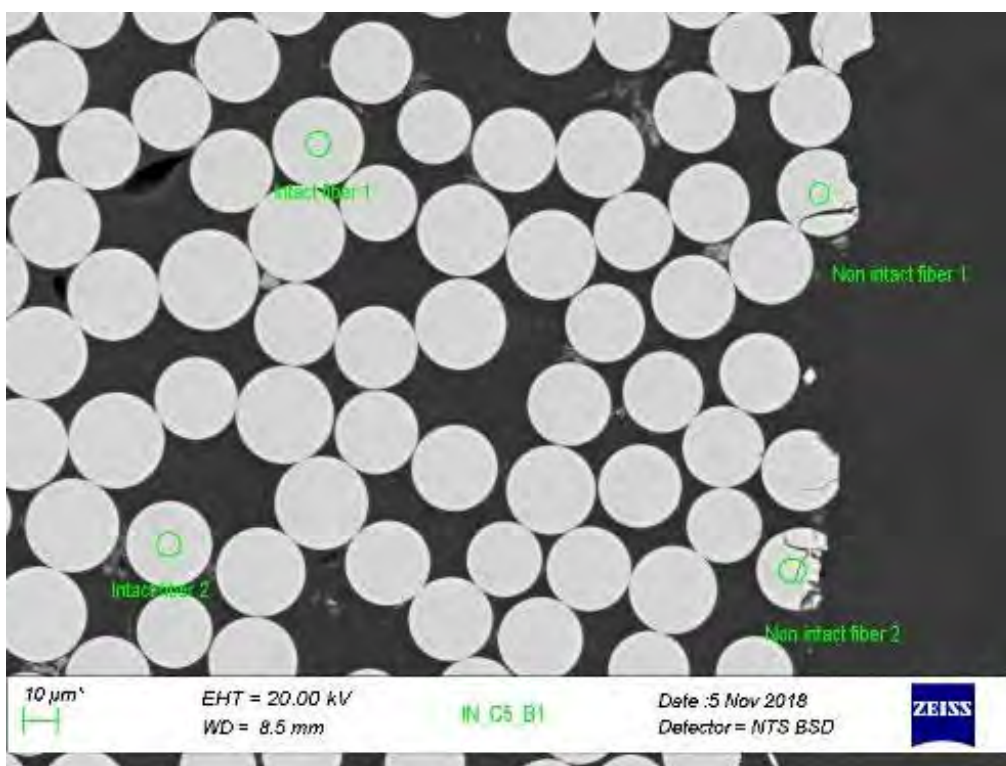
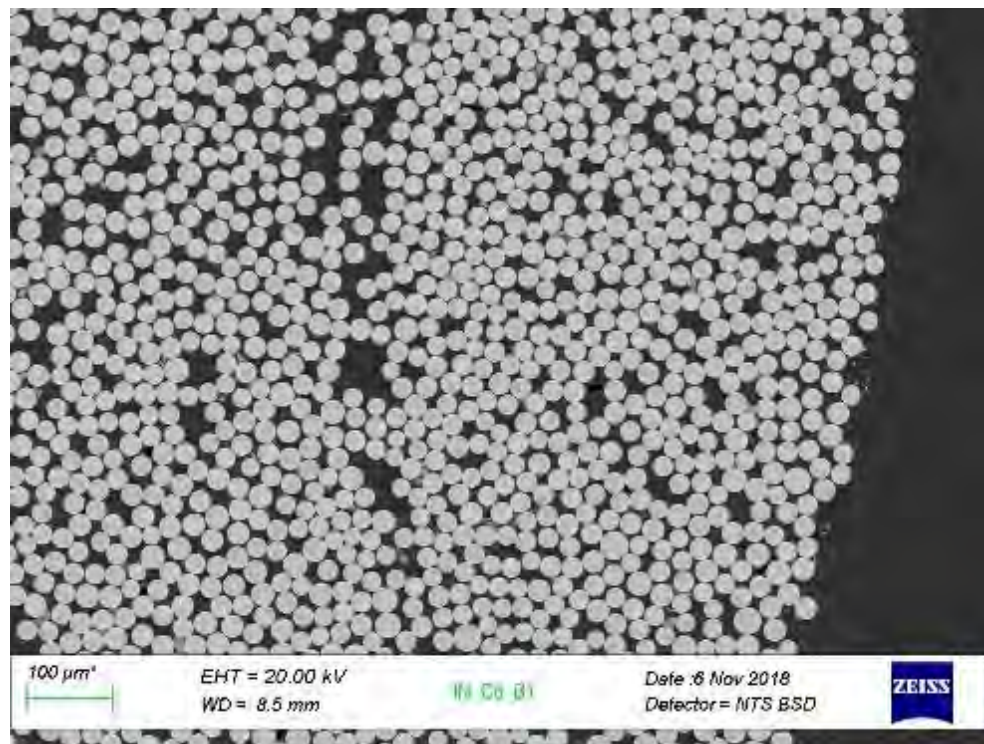
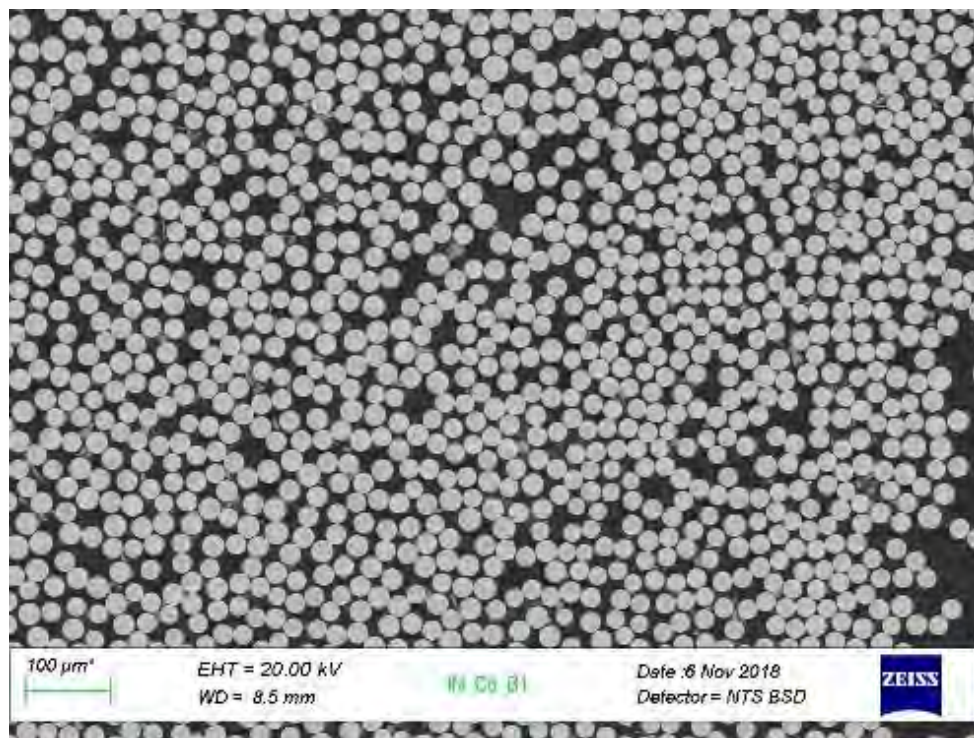
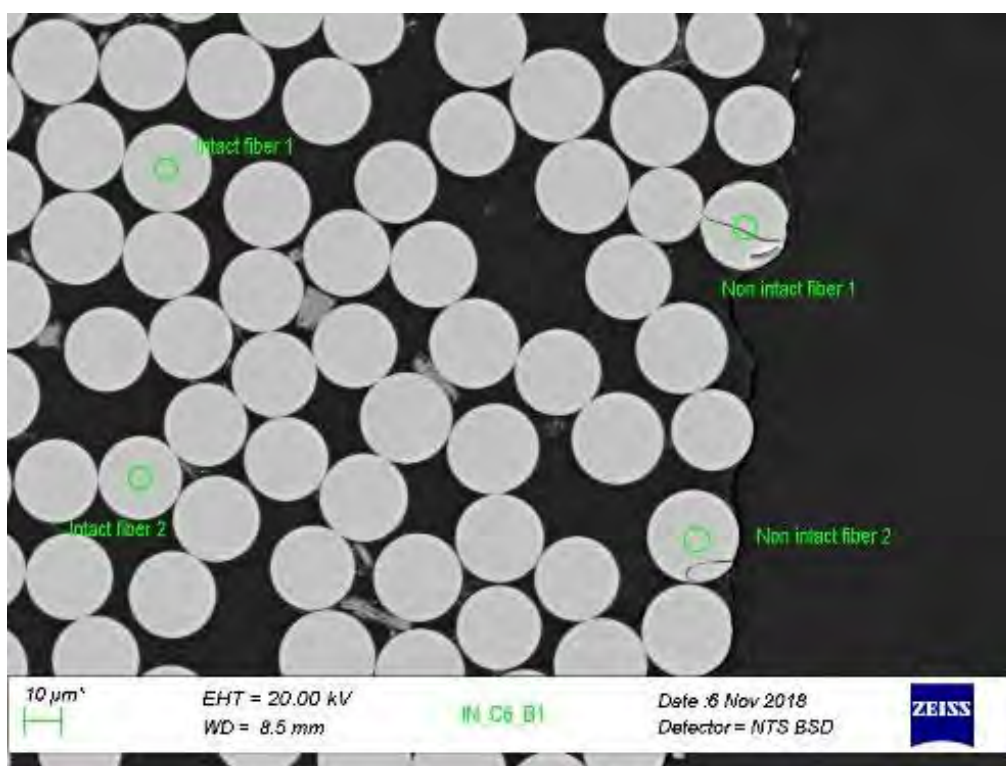
SEM imaging for *Thayer Road Bridge* was performed at Owens Corning. A few negatively affected fibers were observed but appeared to be isolated on the outer perimeter of in-service rebar. The affected fibers only indicated physical damage, likely from manufacturing process. Extrapolated damage was not visible in this sample. Swirls observed in optical microscopy can be seen in low magnification images and are related to resin rich areas. The SEM imaging of each bar is shown in Fig. 81 through Fig. 98.

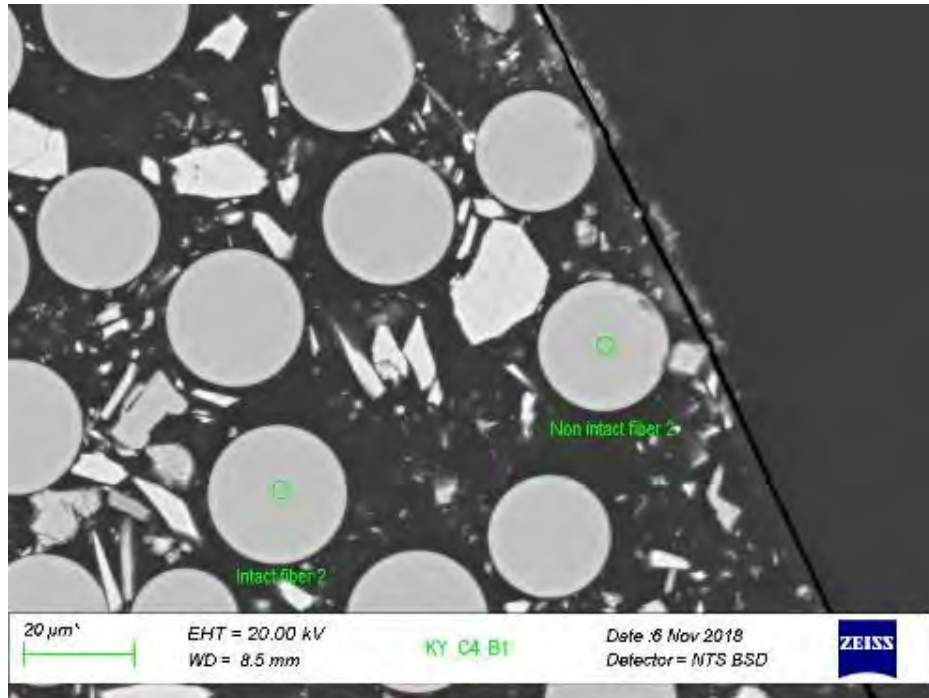
SEM imaging for *Roger's Creek Bridge* was performed at Owens Corning. The fibers from *Roger's Creek Bridge* showed some evidence of being negatively affected by concrete exposure. Of the few negatively affected, they were located on the exterior or near large cracks. The number of affected fibers is expected to be similar or less than the Cuyahoga or Gills Creek samples. The SEM imaging of each bar is shown in Fig. 99 through Fig. 109.

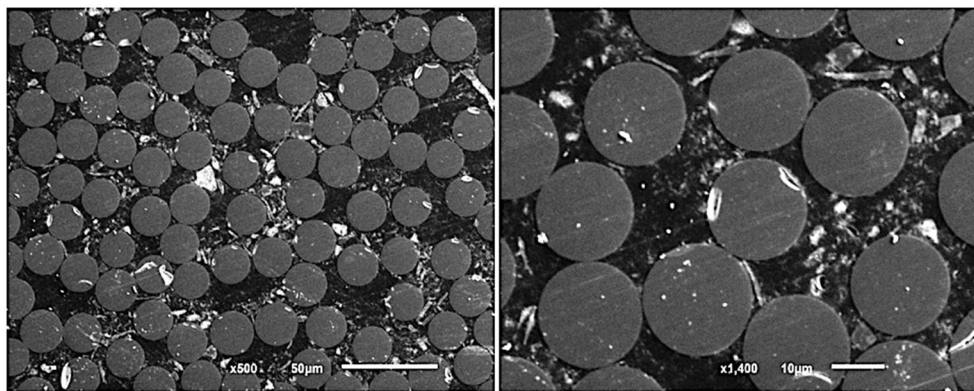
SEM imaging for *Southview Bridge* was performed at the University of Miami. The results of each bar is shown in Fig. 114 through Fig. 110. SEM analysis suggests that there was no apparent sign of deterioration in the GFRP coupons. No damage was observed in the matrix and at the matrix-fiber interface. Glass fibers appeared to be intact without no loss of cross-sectional area.

Fig. 114. SEM images of GFRP bar after 11 years of service in Southview Bridge at magnifications of 500x (left) and 1400x (right)

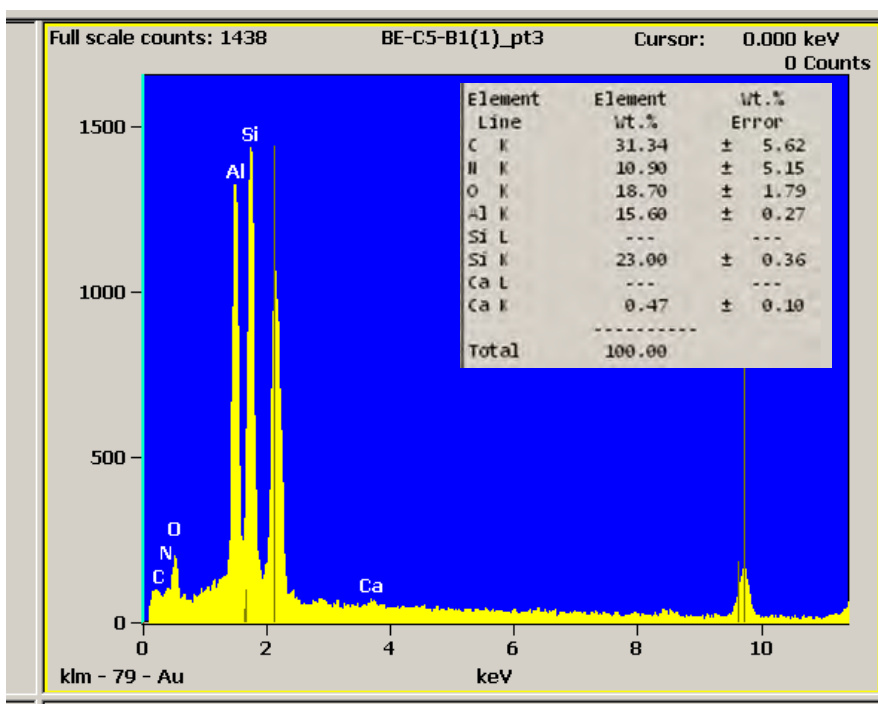
Fig. 119. BE\_C5\_B1-1 pt.3 gold not included. Presence of C, O and N and yielded high aluminum.

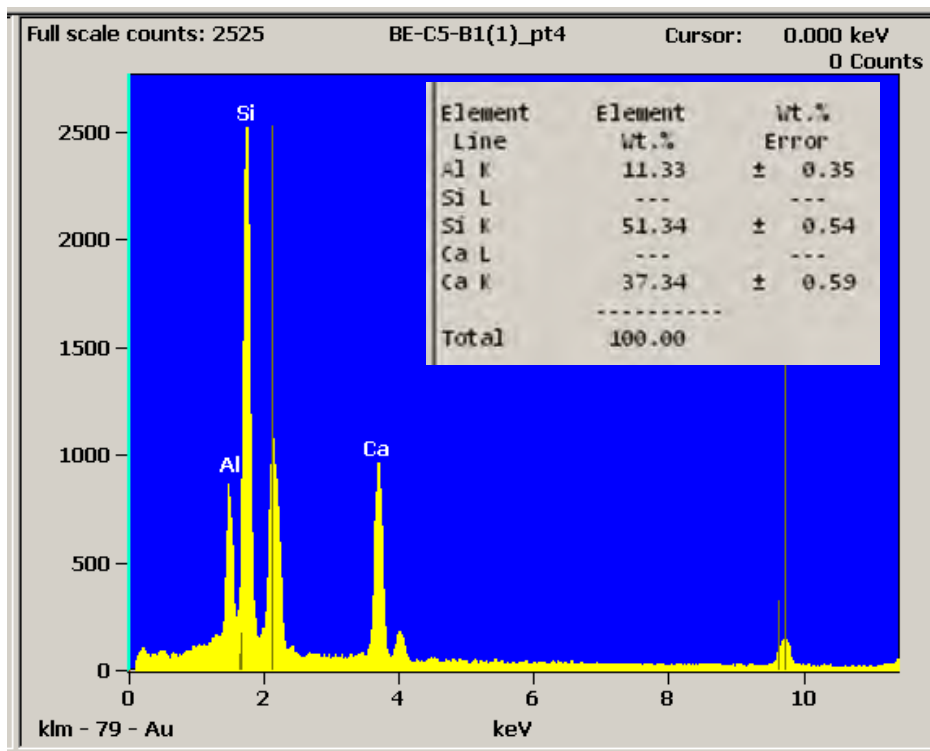
Fig. 120. BE\_CE\_B1-1 pt. 4 gold not included. Yielded Al, Si and Ca.

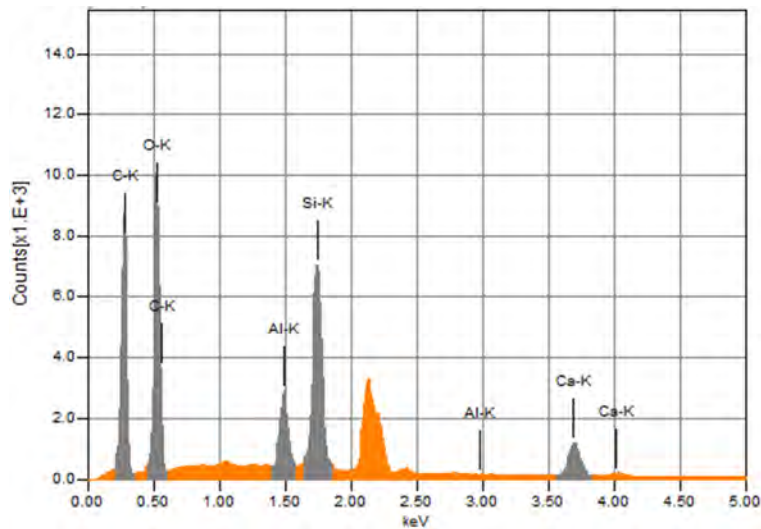
EDS for *Walker Box Culvert Bridge* was performed at the University of Miami using the method described in Section 4.1.5. The result of EDS analysis is shown in Fig. 146. Si, Al, Ca (from glass fibers) and C (from the matrix) were the predominant chemical elements in the extracted samples. No apparent sign of any chemical attack was observed in the bars.

Fig. 146. Result of the EDS analysis performed on GFRP samples extracted from Walker Bridge

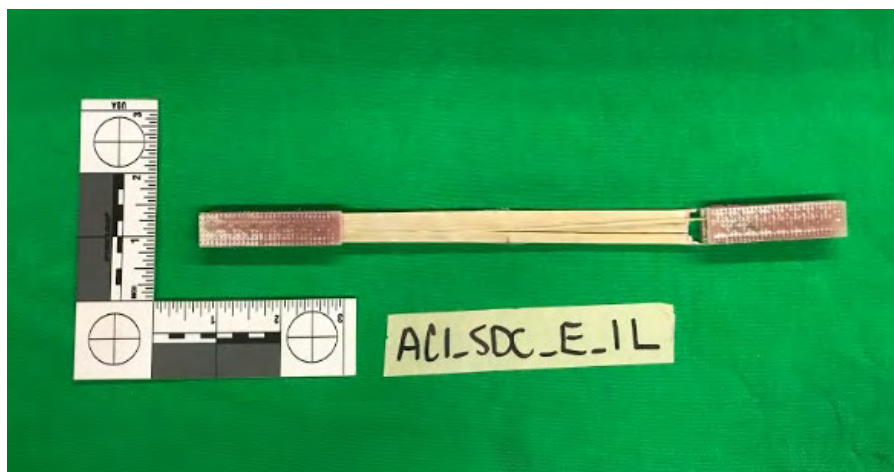
Fig. 4. E\_1L after failure

Sierrita de la Cruz Creek coupon 1 from the left side of the rebar failed at the lateral grip on the top at a peak load of 2,732 lbs. (12 kN) and a peak strain of  $10,000 \times 10^{-6}$ . The coupon before testing and test set up are shown in Fig. 2 and Fig. 3, respectively. The failed coupon and the stress strain curve are shown in Fig. 4 and Fig. 5, respectively. The strain values were recorded with both strain gauges and extensometer; however, the extensometer was removed at 2,500 lbs. Therefore, the stress strain curve uses the values obtained from the strain gauge. A summary of the tensile test results is shown in Table 1.

Since the failure of this coupon happened at the location of the tab, the test is rejected.

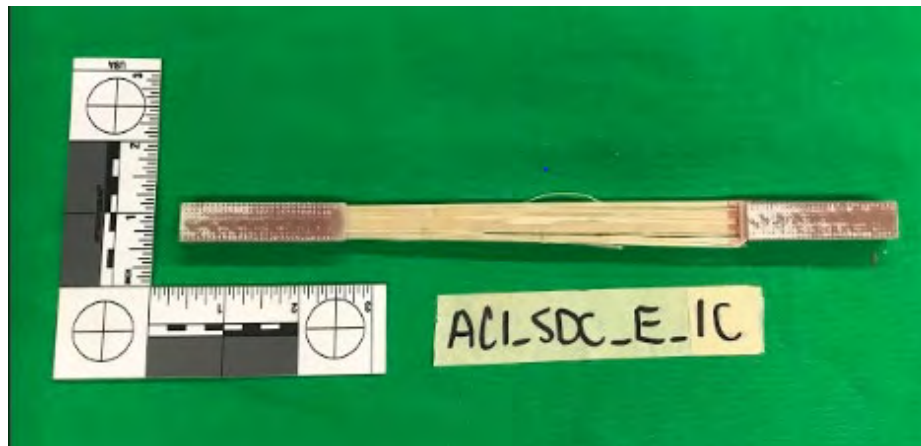
*Fig. 7. Coupon E\_1C after failure*

Sierrita de la Cruz Creek coupon 1 from the center of the rebar failed with the splitting of gage at various points at a peak load of 4,140 lbs. (18 kN) and a peak strain of  $12,300 \times 10^{-6}$ . The coupon before testing and after failure are shown in Fig. 6 and Fig. 7, respectively. The strain values were recorded with both strain gauges and extensometer; however, the extensometer was removed at 3,500 lbs. Therefore, the stress strain curve uses the values obtained from the strain gauge. The strain gauge recorded inaccurate values at stresses higher than about 77,000 psi. The stress strain curve for this bar is shown in Fig. 8. A summary of the tensile test results is shown in Table 2.

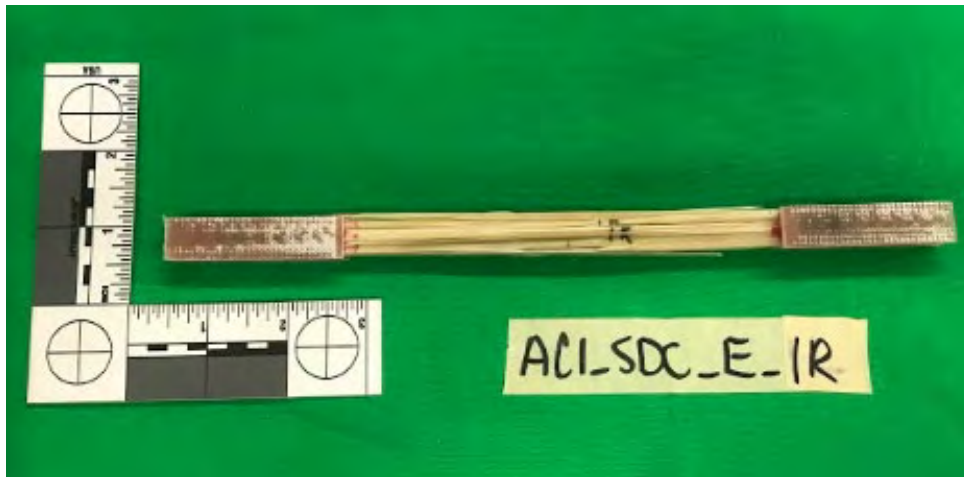
*Fig. 10. Coupon E\_1R after failure*

Sierrita de la Cruz Creek coupon 1 from the of the right side of the rebar failed with the splitting of gage at various points at a peak load of 5,038 lbs. (22kN) and a peak strain of 12,000x10<sup>-6</sup>. The coupon before testing and after failure are shown in Fig. 9 and Fig. 10, respectively. The strain values were recorded with both strain gauges and extensometer; however, the extensometer was removed at 2,250 lbs. Therefore, the stress strain curve uses the values obtained from the strain gauge. The strain gauge recorded inaccurate values at stresses higher than about 90,000 psi. The stress strain curve for this bar is shown in Fig. 11. A summary of the tensile test results is shown in Table 3.

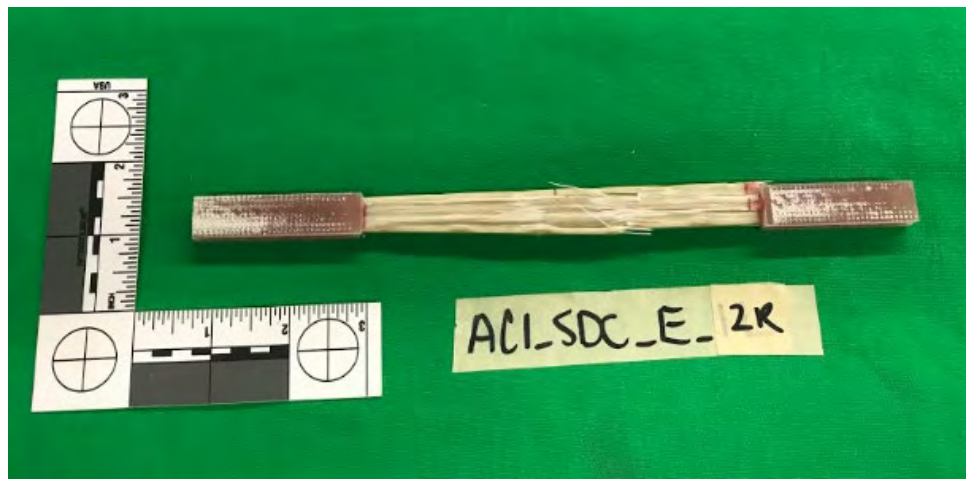
Sierrita de la Cruz Creek coupon 2 from the right side of the rebar failed with the splitting of gage at various points at a peak load of 4,597 lbs. (20 kN) and a peak strain of 13,000x10<sup>-6</sup>. The coupon before testing and after failure are shown in Fig. 18 and Fig. 19, respectively. The strain values were recorded with both strain gauges and extensometer; however, the extensometer was removed at 3,500 lbs. Therefore, the stress strain curve uses the values obtained from the strain gauge. The stress strain curve for this bar is shown in Fig. 20. A summary of the tensile test results is shown in Table 6.

*Fig. 19. Coupon E\_2R after failure*
