# FINAL PROJECT REPORT #00059416

## Durability of GFRP Bar Reinforcement Extracted from In-service Concrete Structures

**Participating Consortium Member:**  
Missouri University of Science and Technology

Dr. John J. Myers, Ph.D., P.E., (PI)  
Ali Al-Khafaji, P.E.

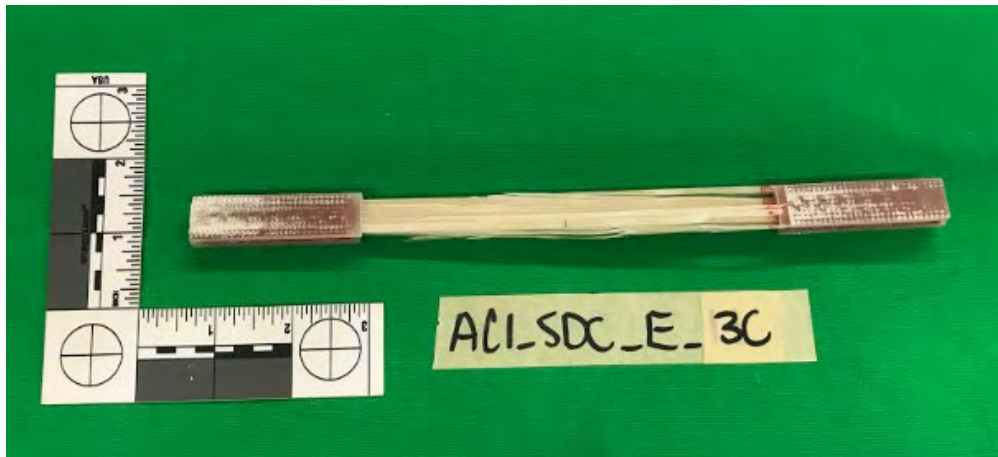
Sierrita de la Cruz Creek coupon 3 from the center of the rebar failed with the splitting of gage at various points at a peak load of 4,621 lbs. (21 kN). The coupon before testing and after failure are shown in Fig. 24 and Fig. 25, respectively. Due to test issues, the strain for this bar could not be recorded, however, a stress curve is shown in Fig. 26. A summary of the tensile test results is shown in Table 8.

*Fig. 25. Coupon E\_3C after failure*

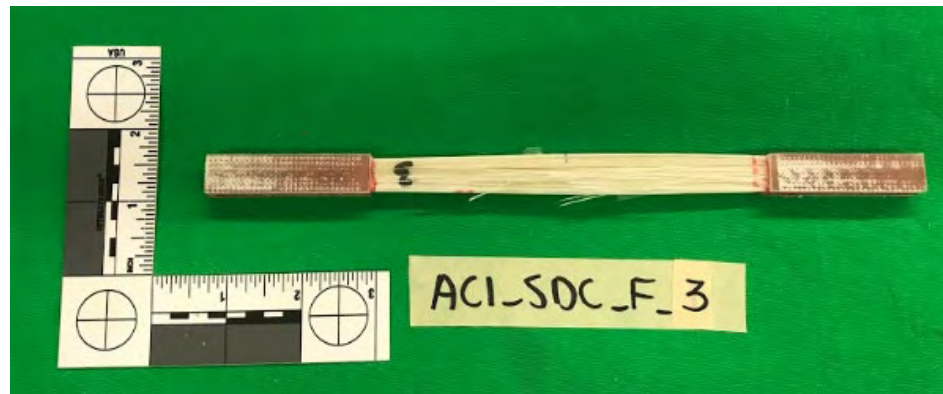
Pristine coupon 3 failed with the splitting of gage at various points at a peak load of 4,894 lbs. (12 kN) and peak strain of  $15,000 \times 10^{-6}$ . The coupon after failure is shown in Fig. 35. The strain values were recorded with both strain gauges and extensometer; however, the extensometer was removed at 4,000 lbs. Therefore, the stress strain curve uses the values obtained from the strain gauge. The stress strain curve for this bar is shown in Fig. 36. A summary of the tensile test results is shown in Table 12.

Fig. 35. Coupon F\_3 after failure

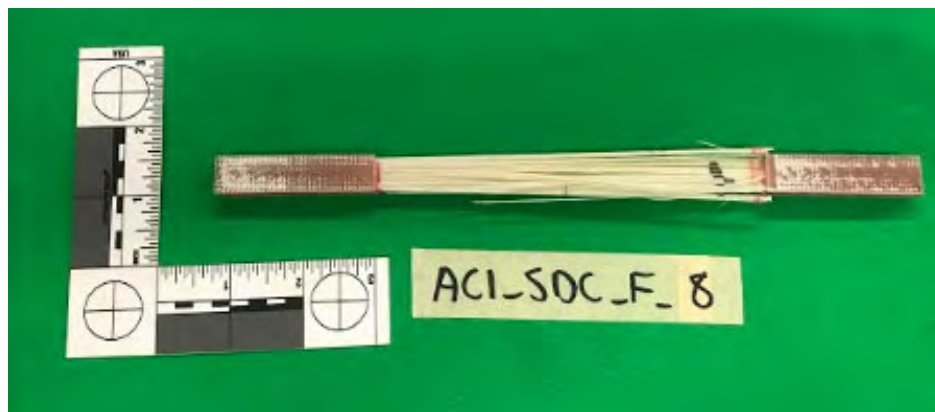
Pristine coupon 8 failed with the splitting of gage at various points at a peak load of 4,609 lbs. (20 kN) and a maximum strain of  $15,900 \times 10^{-6}$ . The coupon after failure is shown in Fig. 45. The stress strain curve for this bar is shown in Fig. 46. The strain values were recorded with both strain gauges and extensometer; however, the extensometer was removed at 4,000 lbs. Therefore, the stress strain curve uses the values obtained from the strain gauge. A summary of the tensile test results is shown in Table 17.

Fig. 45. Coupon F\_8 after failure

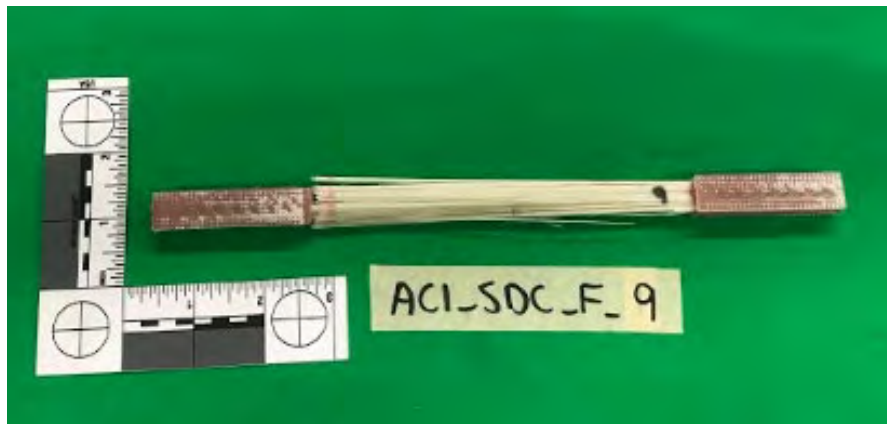
Pristine coupon 9 failed with the splitting of gage at various points at a peak load of 5,207 lbs. (23 kN) and a maximum strain of  $15,600 \times 10^{-6}$ . The coupon after failure is shown in Fig. 47. The stress strain curve for this bar is shown in Fig. 48. The coupon before testing and test set up are shown in Fig. 2 and Fig. 3, respectively. The failed coupon and the stress strain curve shown in Fig. 4 and Fig. 5, respectively. The strain values were recorded with both strain gauges and extensometer; however, the extensometer was removed at 4,000 lbs. Therefore, the stress strain curve uses the values obtained from the strain gauge. A summary of the tensile test results is shown in Table 18.

Fig. 47. Coupon F\_9 after failure

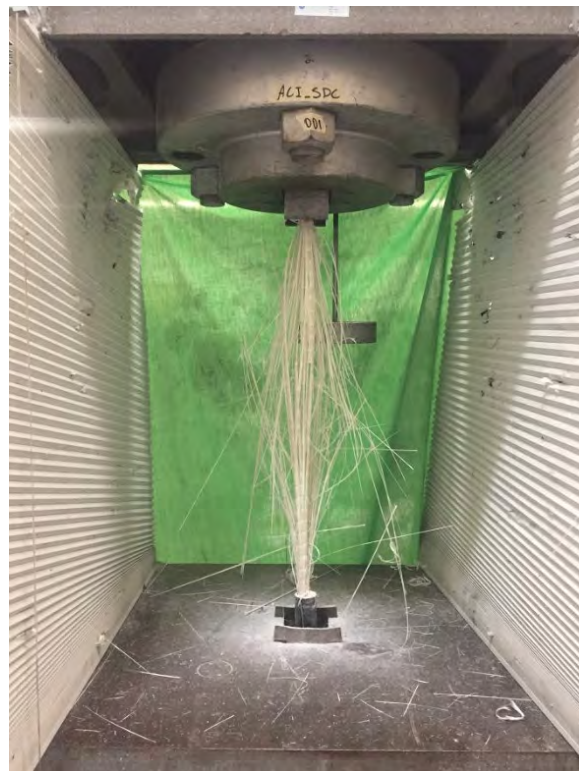
Pristine bar 001 failed at a peak load of 37,312 lbs. (166 kN). The test set up is shown in Fig. 51 and the bar after failure is shown in Fig. 52. The extensometer was removed at a load of 11,620 lbs., and therefore, the maximum strain could not be determined. The stress strain curve for this bar is shown in Fig. 53. A summary of the tensile test results is shown in Table 21.

*Fig. 52. Bar 001 after failure*

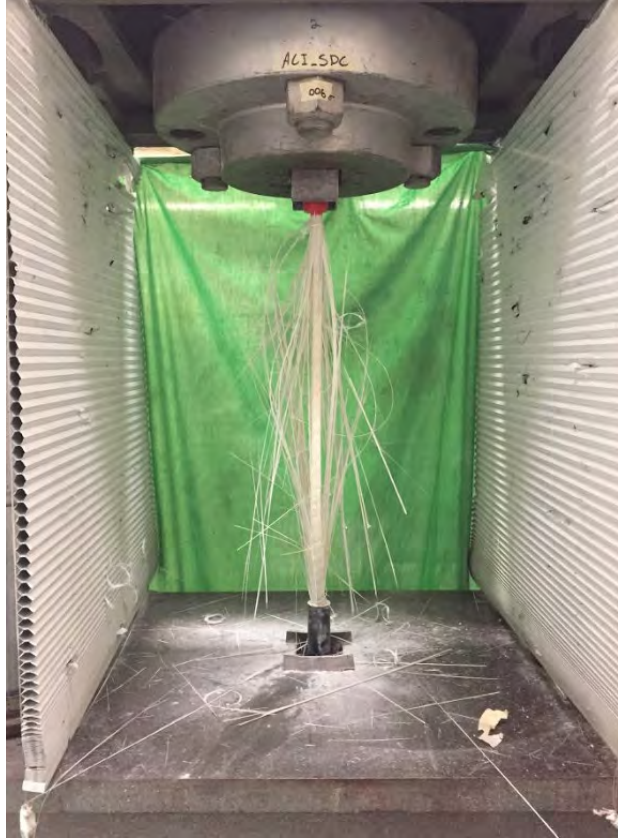
Pristine bar 006 failed at a peak load of 35,264 lbs. (157 kN). A photograph of the bar after failure is shown in Fig. 60. The extensometer was removed at a load of 13,360 lbs., and therefore, the maximum strain could not be determined. The stress strain curve for this bar is shown in Fig. 61. A summary of the tensile test results is shown in Table 26.

*Fig. 60. Bar 006 after failure*

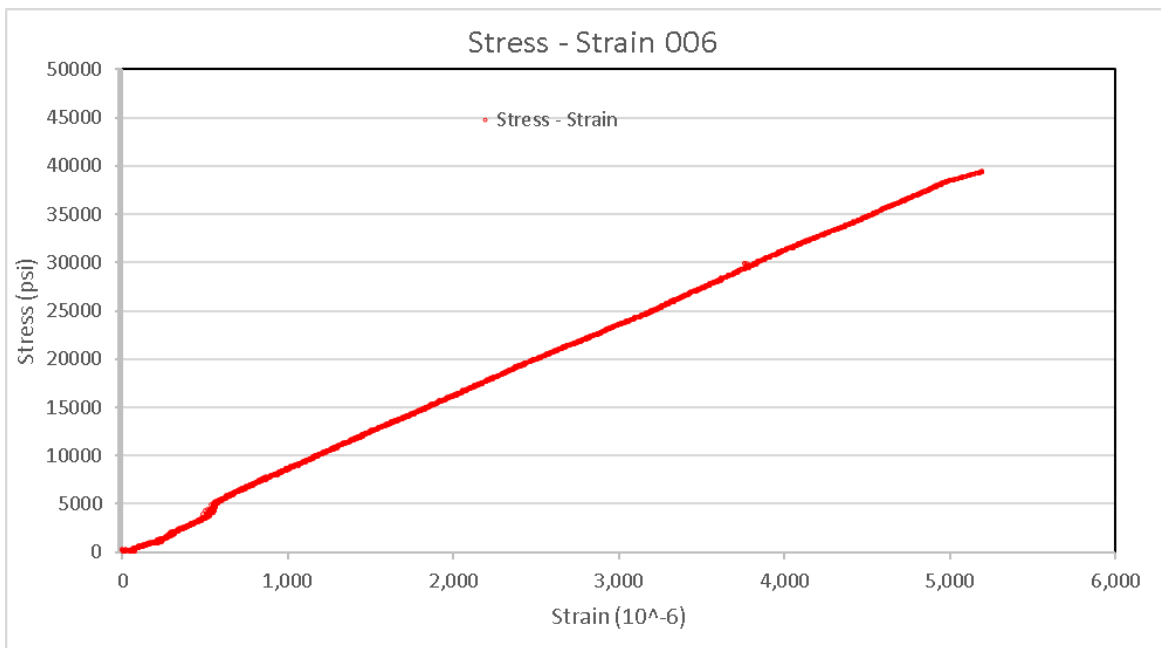
*Fig. 61. Stress strain curve for bar 006*

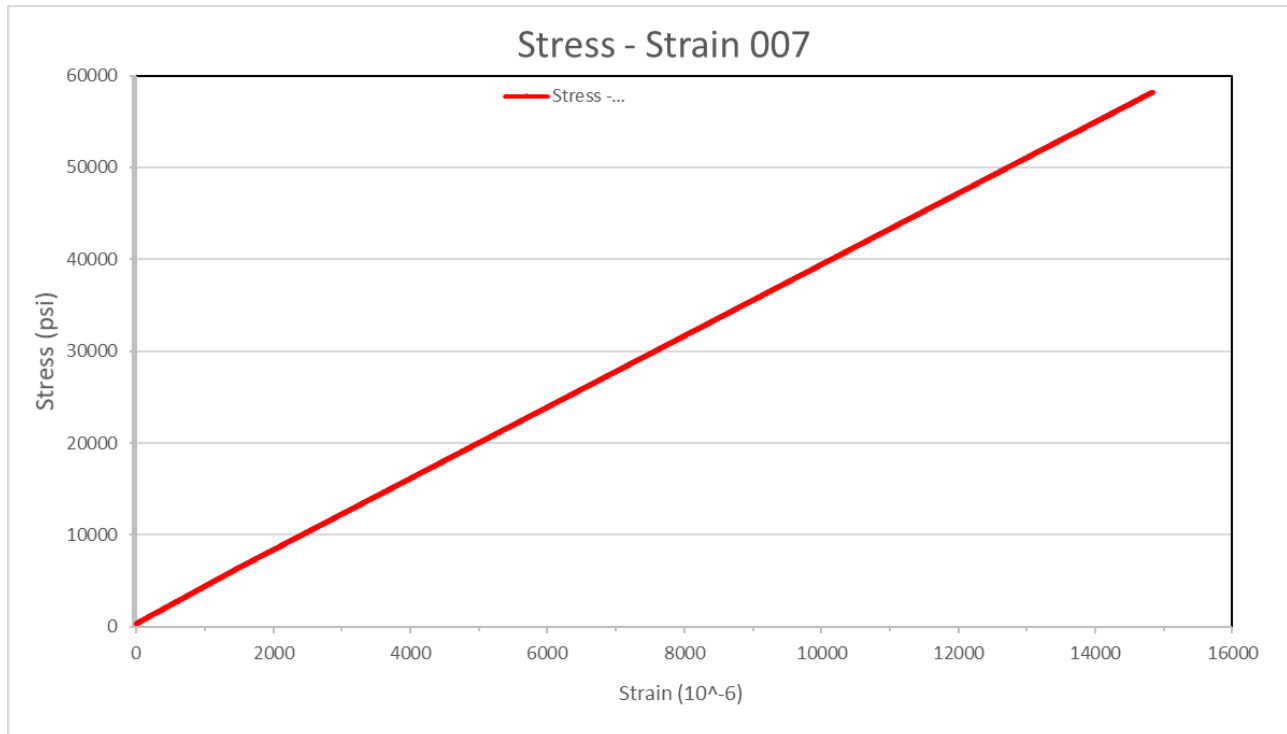
Pristine bar 007 failed at a peak load of 37,488 lbs. (167 kN). The extensometer was removed at a load of 14,130 lbs., and therefore, the maximum strain could not be determined. The stress strain curve for this bar is shown in Fig. 62. However, the recorded strain values are considered invalid due to the high magnitude, which is outside the range of strain for a #5 GFRP rebar. The A summary of the tensile test results is shown in Table 27.

Fig. 62. Stress strain curve for bar 007

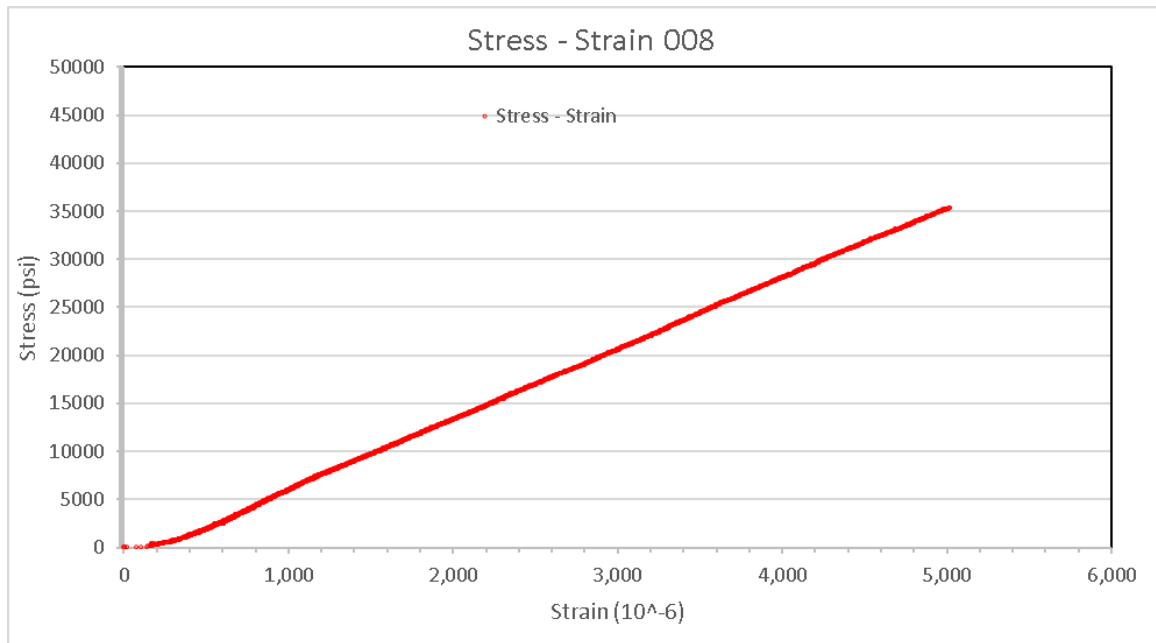
Fig. 64. Stress strain curve for bar 008

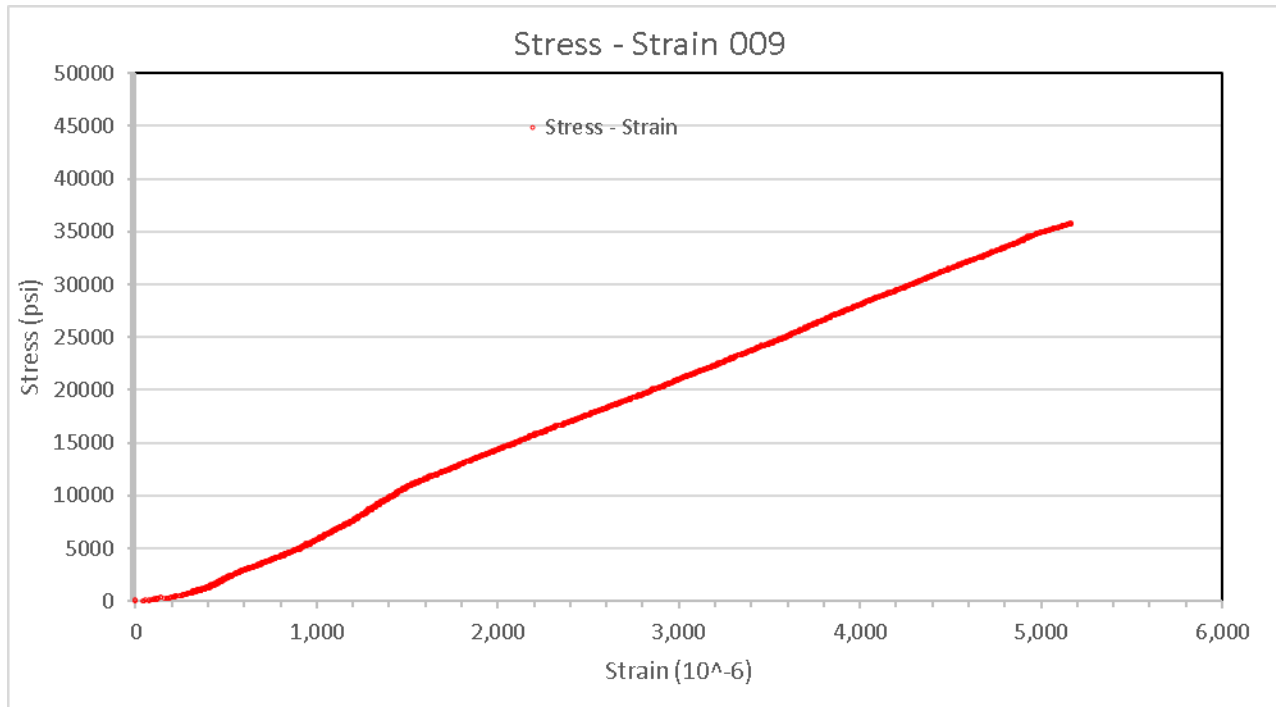
Pristine bar 009 failed at a peak load of 36,576 lbs. (164 kN). The extensometer was removed at a load of 12,250 lbs., and therefore, the maximum strain could not be determined. The stress strain curve for this bar is shown in Fig. 65. A summary of the tensile test results is shown in Table 29.

Fig. 65. Stress strain for bar 009

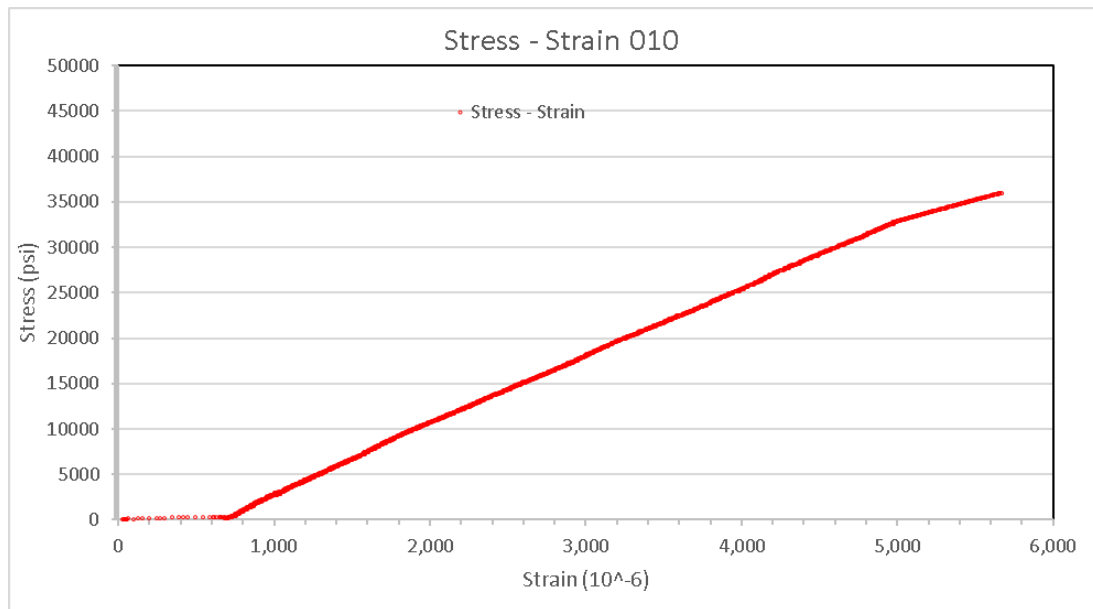
*Fig. 67. Stress strain curve for bar 010*
