APPENDIX A: AASHTO PROVISIONAL STANDARDS FOR CRACK SEALANT TESTS

APPENDIX T: PERFORMANCE EVALUATION OF NEWLY-INSTALLED CRACK SEALING PROJECTS (PHASE 3)

APPENDIX U: PERFORMANCE EVALUATION OF OLD CRACK SEALING PROJECTS (PHASE 4)

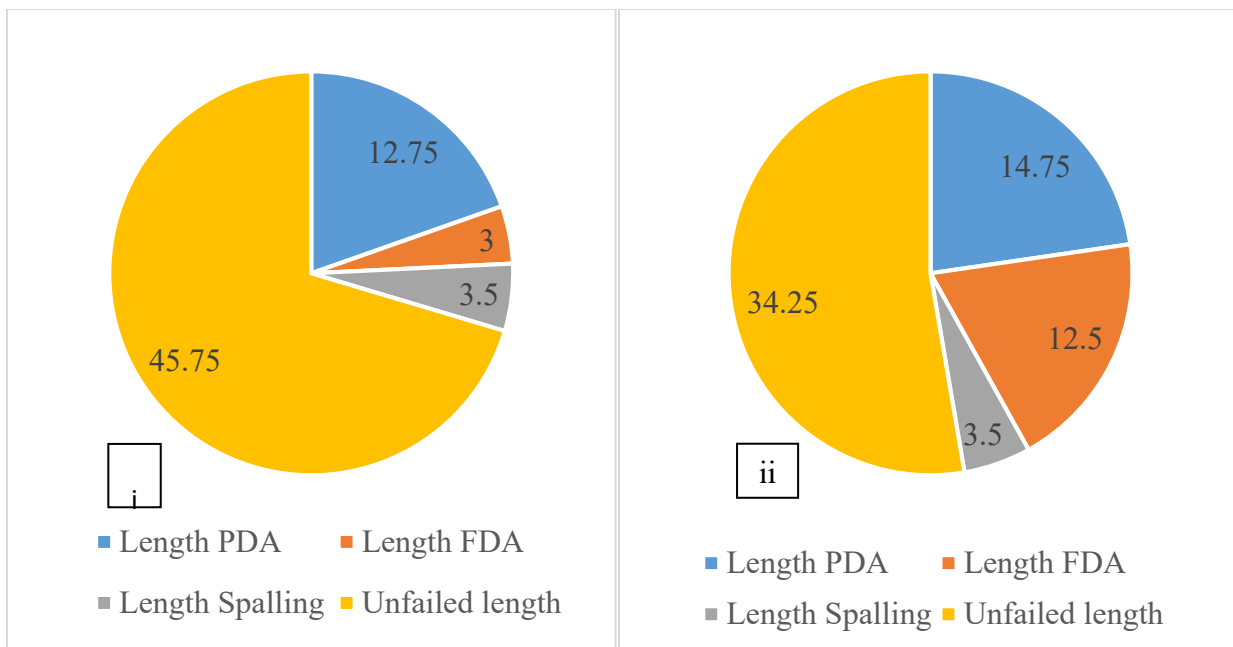
Seal Performance at Site D after First Winter (i) and Second Winter (ii)

Site D Performance (end of 2nd Winter)						
Crack ID	crack length	Length PDA	Length FDA	Length Spalling	Unfailed length	Performance Index
D-1	13	12	0	0	1	53.8
D-2	13	2	3	0	8	69.2
D-3	25	1.5	0	0	23.5	94.2
D-4	13	0.5	5	0	7.5	56.3
D-5	13	0	2.5	3.5	7	53.8
D-6	13	0.25	2	0	10.75	83.7
D-7	38	0	0	0	38	100.0
D-8	10	1.25	0	0	8.75	93.8
sum	65	14.75	12.5	3.5	34.25	63.4

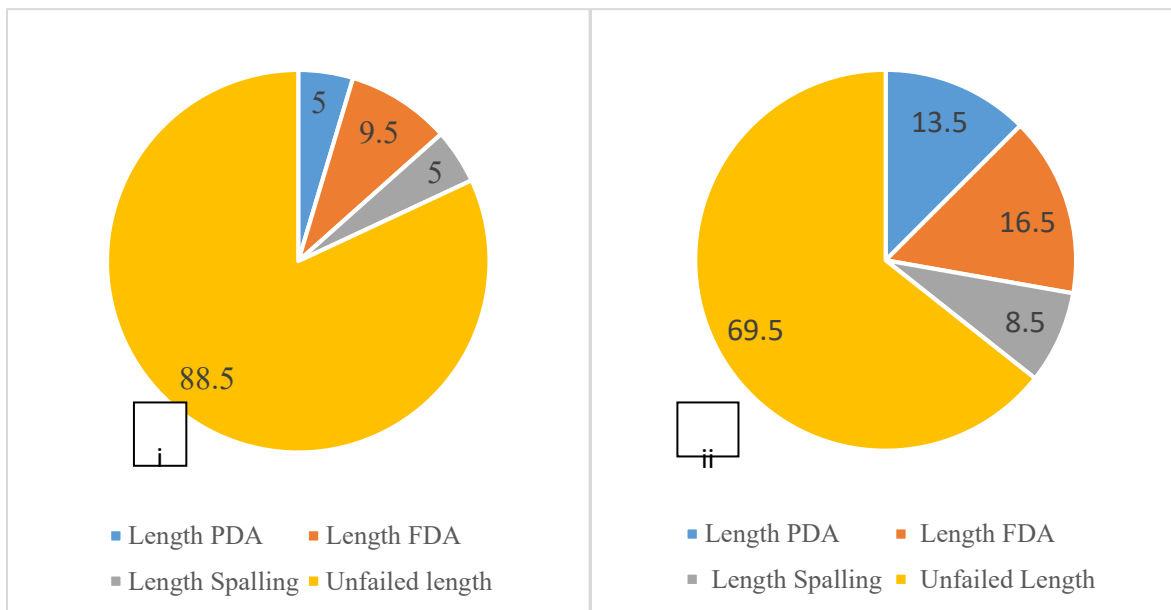
Seal Performance at Site E after First Winter (i) and Second Winter (ii)

Site E Performance (end of 2nd Winter)						
Crack ID	crack length	Length PDA	Length FDA	Length Spalling	Unfailed length	Performance Index
E-1	12	1.5	3	1.5	6	56
E-2	12	1.5	3	0	7.5	69
E-3	12	2	3	2	5	50
E-4	12	0	1	0	11	92
E-5	90				90	x
E-6	12	1	3	1.7	7	63
E-7	12	1	3	1	7	63
E-8	12	3	0	0.5	8.5	83
E-9	12	0.5	0	2	9.5	81
E-10	12	3	0.5	0.5	8	79
sum	108	13.5	16.5	8.5	69.5	71

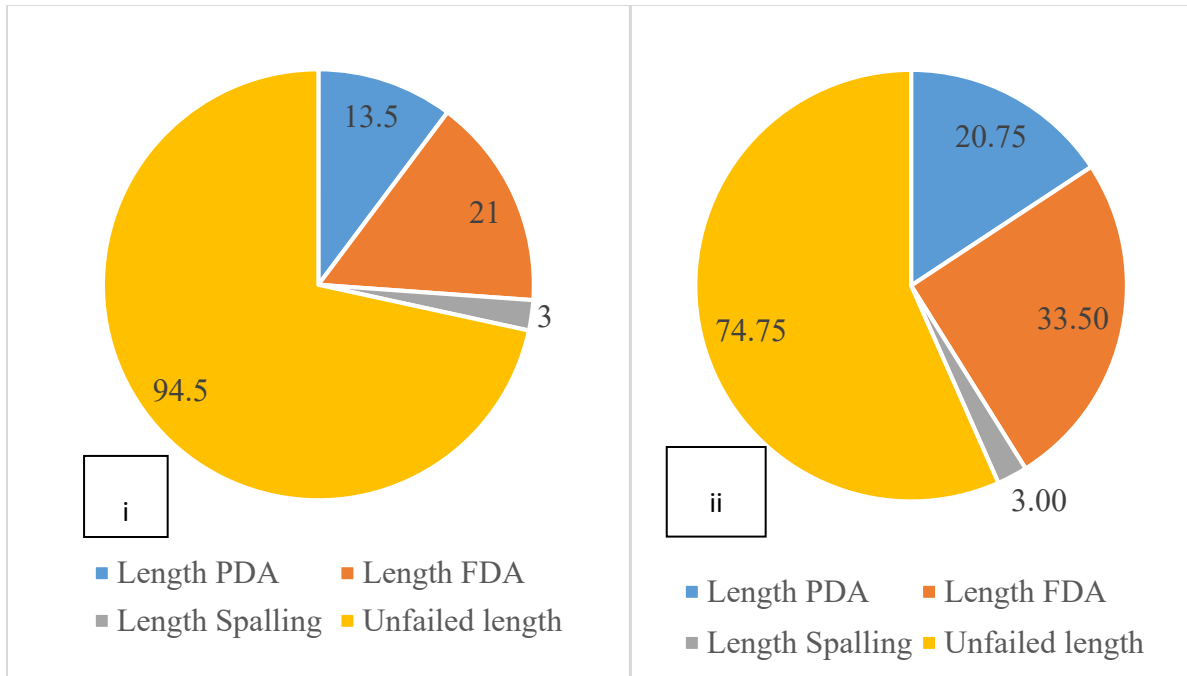
Seal Performance at Site F after First Winter (i) and Second Winter (ii)

Site F Performance (end of 2nd Winter)						
Crack ID	crack length	Length PDA	Length FDA	Length Spalling	Unfailed length	Performance Index
F-1	15	0.75	5.50	3.00	5.75	41
F-2	14	2	8	0	4	36
F-3	14	1.5	3	0	9.5	73
F-4	25	2	5	0	18	57
F-5	100				100	
F-6	14	0	10	0	4	29
F-7	14	1.5	1.5	0	11	84
F-8	100				100	
F-9	24	4	0	0	20	92
F-10	12	9	0.5	0	2.5	58
sum	132	20.75	33.50	3.00	74.75	59

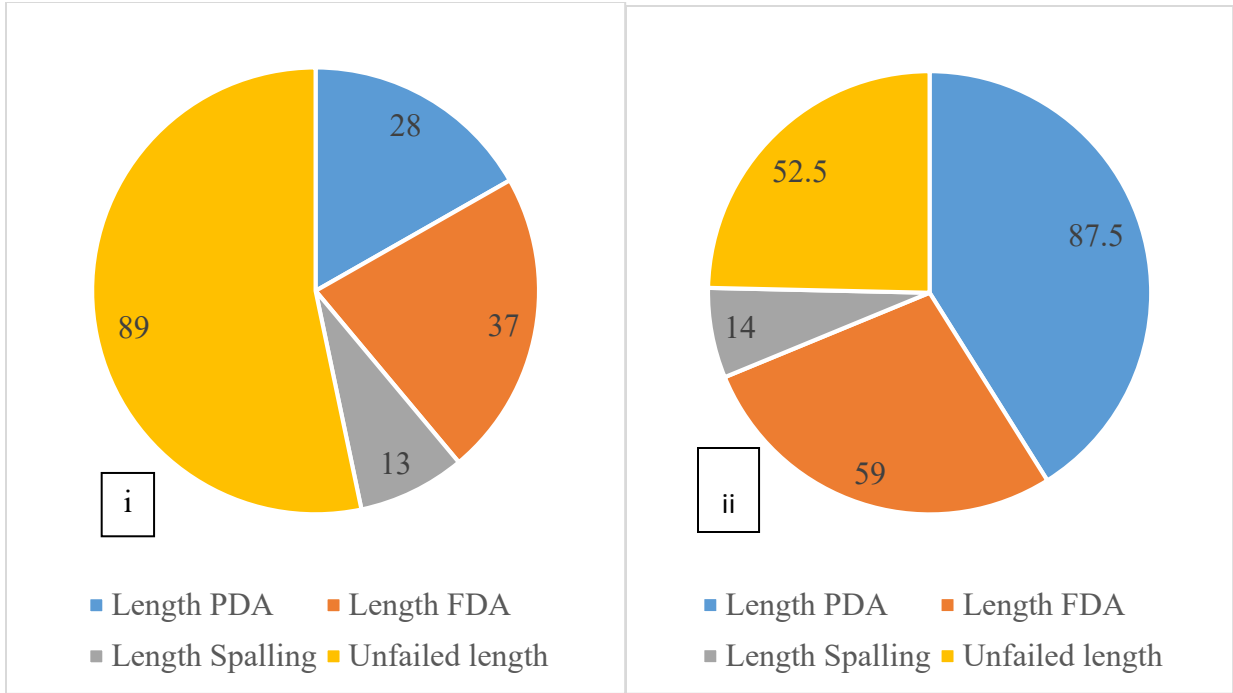
Seal Performance at Site G after First Winter (i) and Second Winter (ii)

Site G Performance (end of 2nd Winter)						
Crck ID	crack length	Length PDA	Length FDA	Length Spalling	Unfailed length	Performance Index
G-1	12	2	3	6	1	17
G-2	12	8	4	0	0	33
G-3	12	3	2	3	4	46
G-4	12	12	0	0	0	50
G-5	12	12	0	0	0	50
G-6	12	9	3	0	0	38
G-7	12	7.5	1	0	3.5	60
G-8	12	0	8	0	4	33
G-9	6	0	0	0	6	100
G-10	25			0	25	NA
G-11	12	0	12	0	0	0
G-12	12	0	7	0	5	25
G-13	3	3	0	0	0	50
G-14	12	9	3	0	0	38
G-15	12	0	8	4	0	0
G-16	12	0	6	1	5	42
G-17	12	10	2	0	0	42
G-18	12	12	0	0	0	50
G-19	12	0	0	0	12	NA
G-20	12	0	0	0	12	NA
sum	213	87.5	59	14	52.5	40

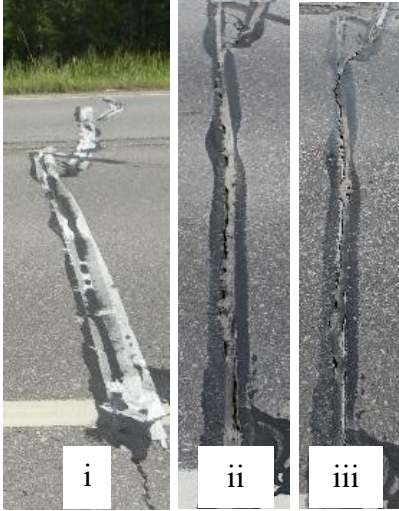
<p>Three photographs of road damage. Image i shows a large, irregular pothole with exposed aggregate. Image ii shows a deep, narrow longitudinal crack. Image iii shows a similar deep longitudinal crack.</p></div>	<div>

Photographic performance documentation of Site G. G-1-i shows crack G-1 immediately after being sealed. G-1-ii and G-1-iii show Crack G-1 during the first and second winter since seal installation. This same sequence follows for Cracks G-3, G-4, G-5, G-6, G-7, G-8, G-9, G-10, G-11, G-13, G-14, and G-16. Photos i, ii, and iv of cracks G-15 and G-15 show the seal immediately after installation and during the first and second winter since installation, while photo iii shows a close-up of seal failure in each crack. Crack G-17 shows images before, after and during the first and second winter.

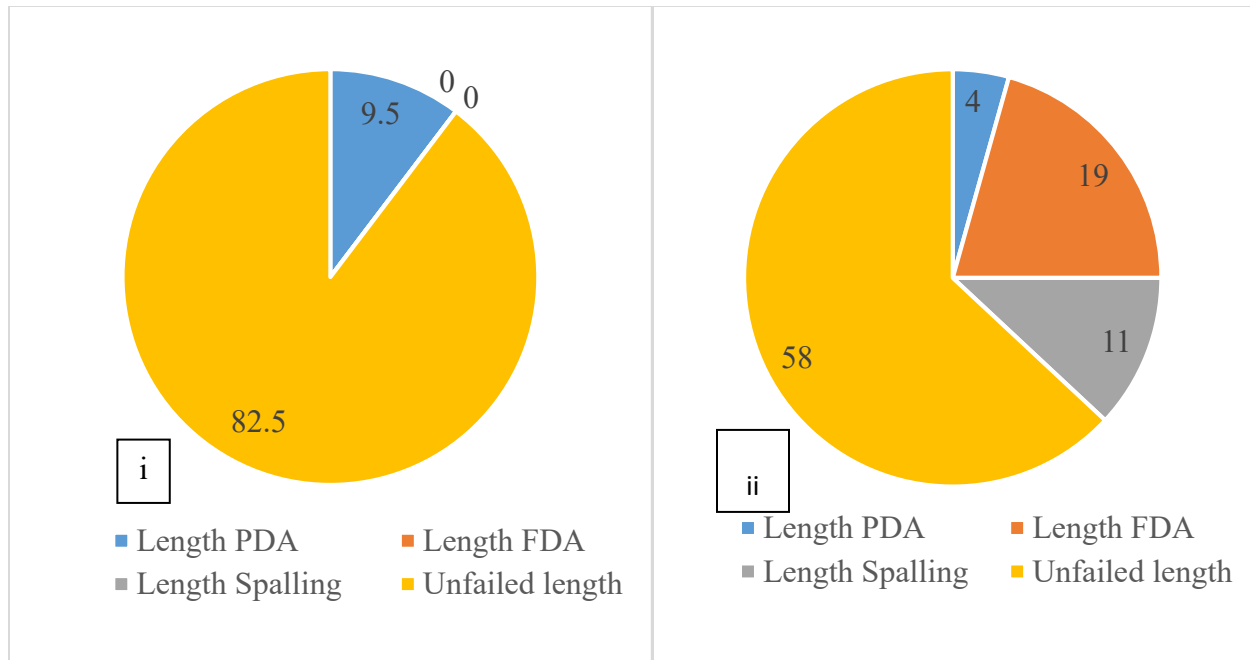
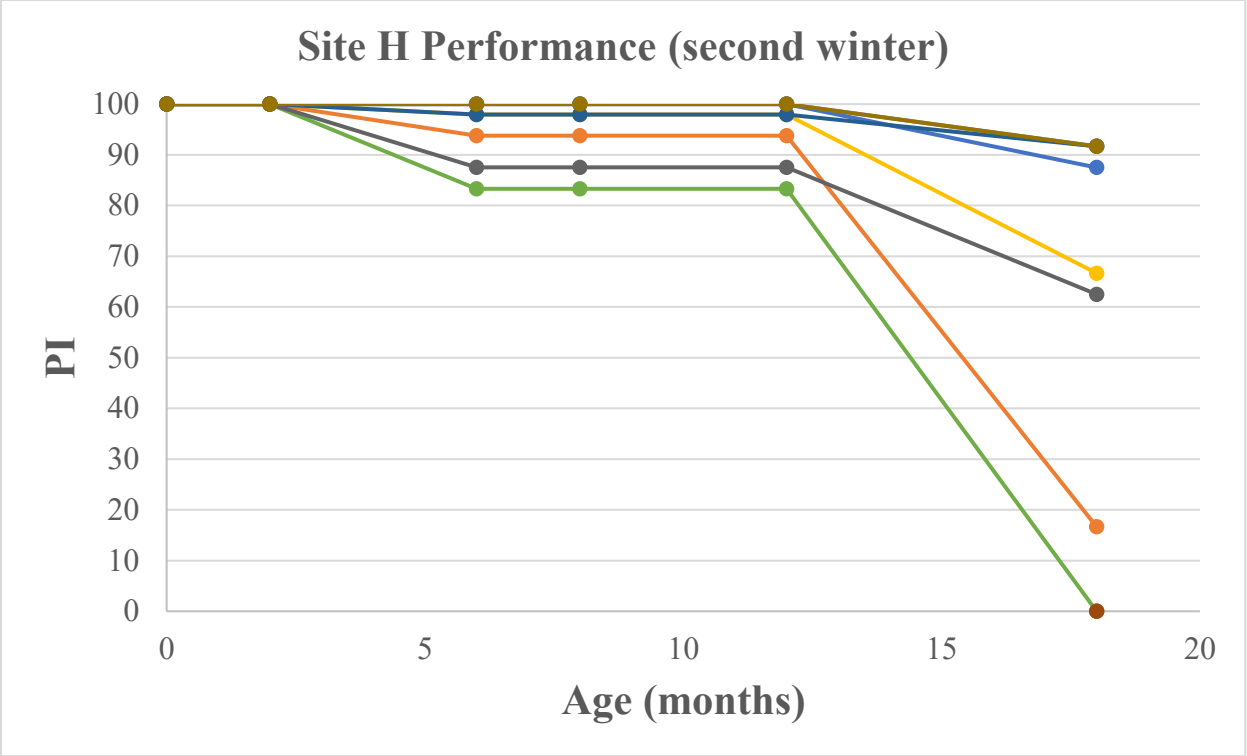
Performance Index of Site H after Second Winter

The site contains ten documented cracks. Eight of these ten are transverse, while the other two lies along lane joint and were left unsealed. The severity of the cracks at this site was low. The tables and figures below within this subsection, Site H, provide details of the seal performance for the ten cracks considered in Site H.

Site H Performance (end of 2nd Winter)						
Crack ID	crack length	Length PDA	Length FDA	Length Spalling	Unfailed length	Performance Index
H-1	12	0	1	0	11	91.67
H-2	12	2	3	6	1	16.67
H-3	30	0	0	0	30	0.00
H-4	12	0	4	0	8	66.67
H-5	12	0	0	0	12	87.50
H-6	12	0	8	4	0	0.00
H-7	12	2	0	0	10	91.67
H-8	30	0	0	0	30	0.00
H-9	8	0	3	0	5	62.50
H-10	12	0	0	1	11	91.67
sum	92	4	19	11	58	63.54

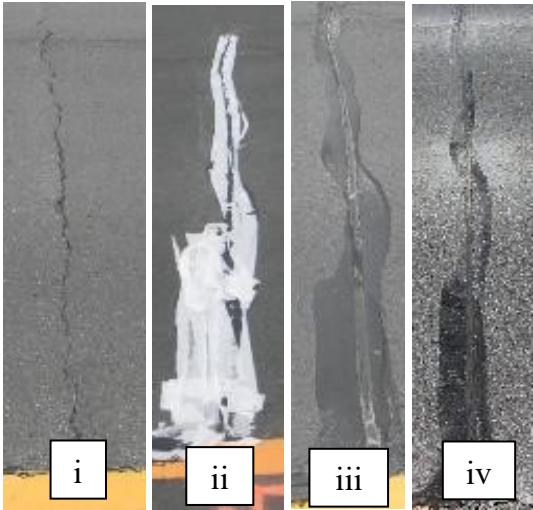
<p>H-1</p>	<p>H-2</p>

Photographic documentaion of site H performance. Photos i, ii, iii, and iv show cracks H-1, H-2, and H-6 before, after, and during the first and second winter. Photos i and ii show cracks H-3 and H-8, left unsealed, during the first and second winter. Crack H-4 is represented by photos immediately after sealing, a close up during the first winter, and overviews of the first and second winter. Crack H-5 is represented by four photos taken immeditaly after being sealed, during the first summer, and the first and second winter. Crack H-7 is represented immeditaely after being sealed, then during the first and second winter. Cracks H-9 and H-10 are depicted by photos taken before being sealed, then during the first and second winters.

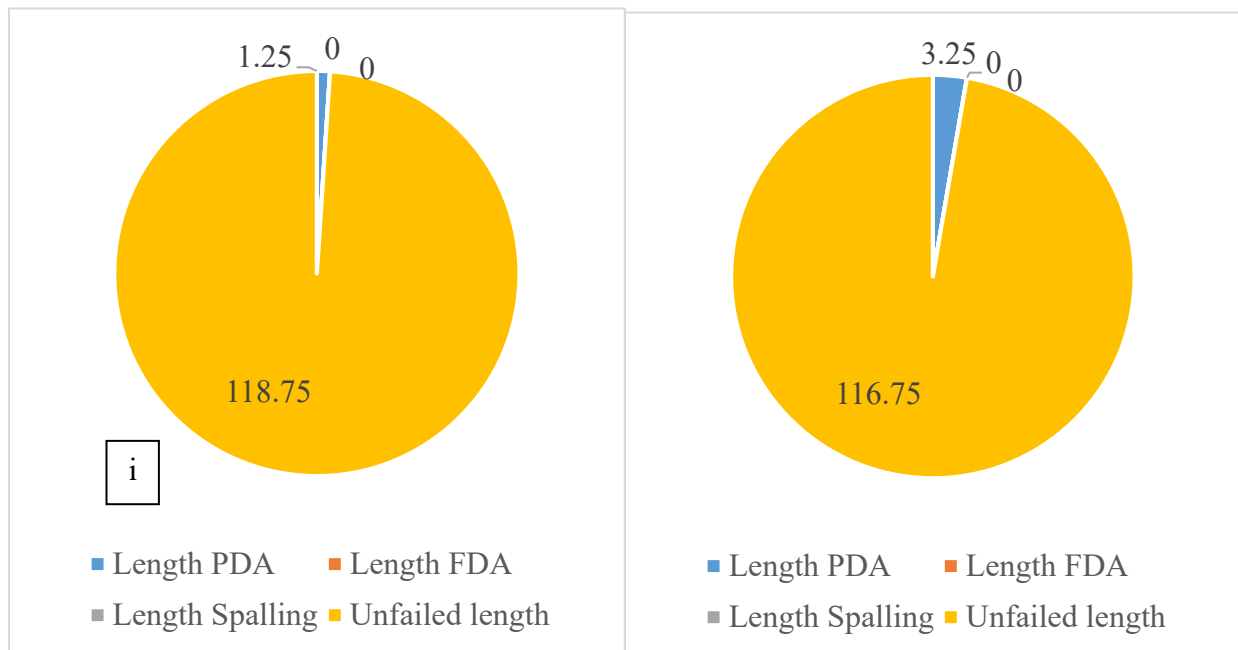
Site I Clean-and-Seal Performance during First Winter (i) and Second Winter (ii)

Site I Performance (2nd Winter) (clean-and-seal)						
Crack ID	crack length	Length PDA	Length FDA	Length Spalling	Unfailed length	Performance Index
I-1	12	1	0	0	11	96
I-2	12	0.5	0	0	11.5	98
I-3	12	0	0	0	12	100
I-4	12	0	0	0	12	100
I-5	12	0	0	0	12	100
I-6	12	0.5	0	0	11.5	98
I-7	12	0.5	0	0	11.5	98
I-8	12	0.5	0	0	11.5	99
I-9	12	0.25	0	0	11.75	100
I-10	12	0	0	0	12	98
sum	120	3.25	0	0	116.75	99
Site I Performance (2nd Winter) (rout-and-seal)						
I-11	12	2.5	0	0	9.5	90
I-12	12	1	0	0	11	96
I-13	12	1.5	0	0	10.5	94
I-14	12	0	0	0	12	100
I-15	12	0.5	0	0	11.5	98
I-16	12	0	0	0	12	100
I-17	12	0	0	0	12	100
I-18	12	0	2	0	10	83
I-19	12	0	0	0	12	100
I-20	12	0	0	0	12	100
sum	120	5.5	2	0	112.5	96

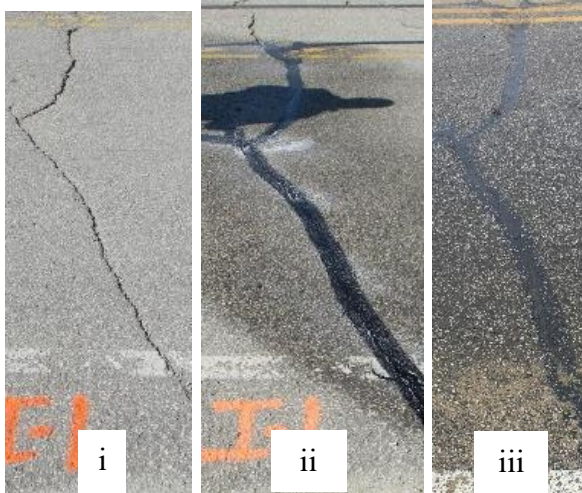
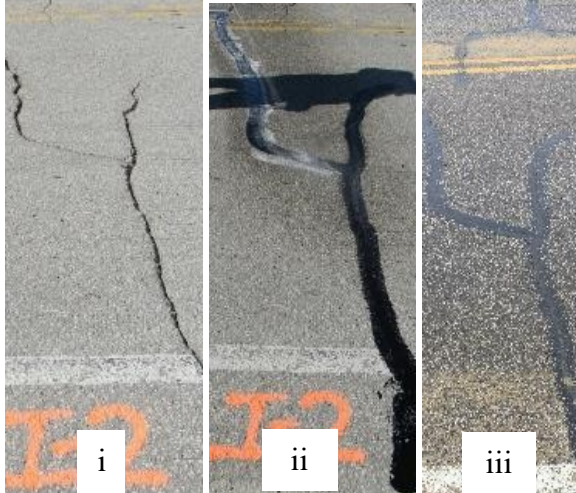
I-1	I-2

Photographic Performance Documentation of Site I. I-1-i Shows Crack I-1 prior to being Sealed. I-1-ii Shows Crack I-1 immediately after being Sealed. I-1-iii Shows Crack I-1 after the First Winter since being Sealed. This same sequence of photos follows for cracks I-2 through I-20.

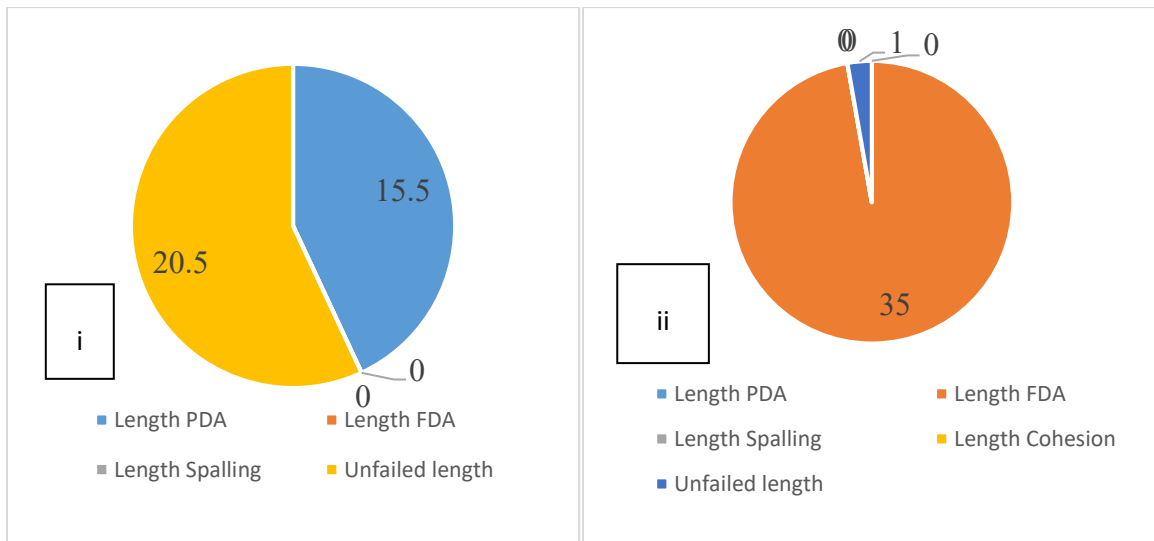
Site M Clean-and-Seal Performance after First Winter (i) and Second Winter (ii)

Site inspections following installation have shown that this site is experiencing about 25% of the total length of the seal to be suffering from partial-depth adhesion failure. Three cracks with rout-and-seal have performed slightly better than the other three with clean-and-seal.

Site M Performance (end of 2nd Winter)							
Crack ID	crack length	Length PDA	Length FDA	Length Spalling	Length Cohesion	Unfailed length	Performance Index
Clean-and-Seal							
M-1	12	0	12	0	0	0	0.00
M-2	12	0	11	0	0	1	12.00
M-3	12	0	12	0	0	0	5.50
sum	36	0	35	0	0	1	5.83
Rout-and-Seal							
M-4	12	0	10.75	0	0	1.25	3.00
M-5	12	0	10.75	0	0	1.25	20.50
M-6	12	0	9.5	0	0	2.5	0.00
sum	36	0	31	0	0	5	7.83

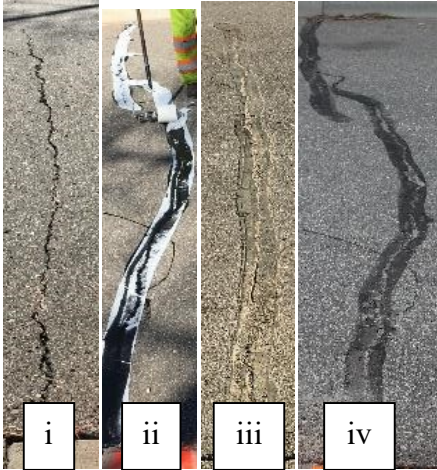
Photographic performance documentation of Site M. M-1-i Shows Crack M-1 prior to being sealed. M-1-ii shows Crack M-1 immediately after being sealed. M-1-iii and M-1-iv show Crack M-1 at the end of its first and second winter after being sealed. M-1-This same sequence of photos follows for cracks M-2, M-3, M-4, M-5, and M-6.

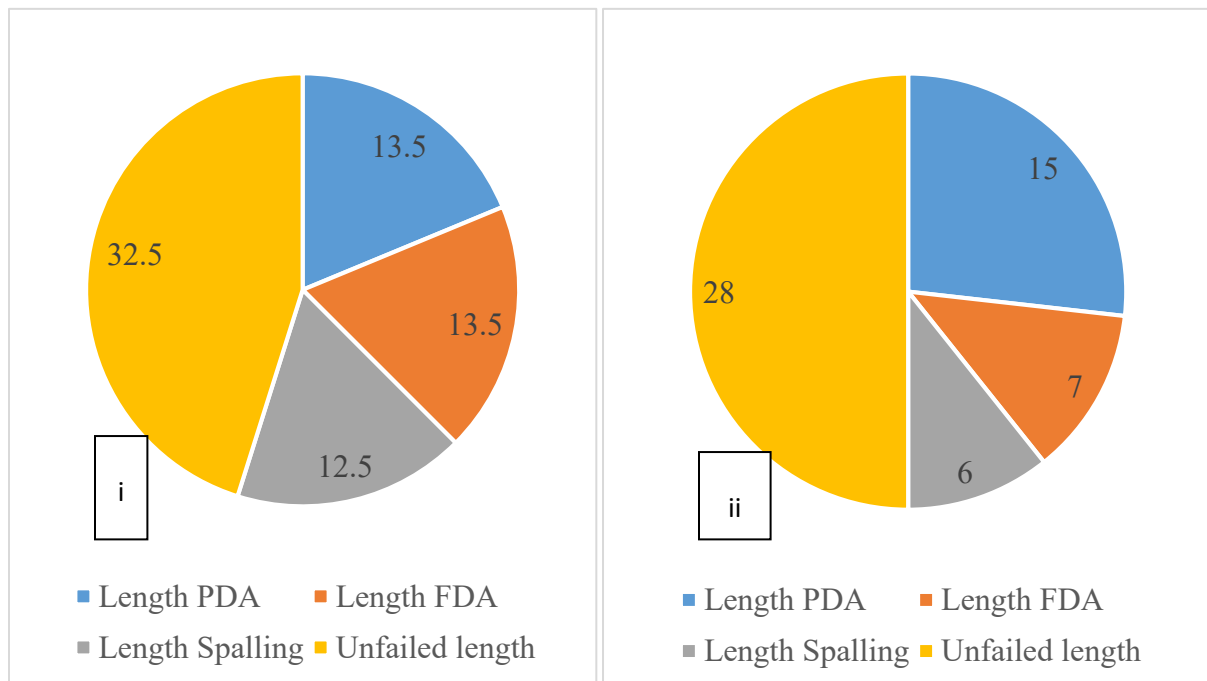
Site N Clean-and-Seal Performance After First Winter (i) and Second Winter (ii)

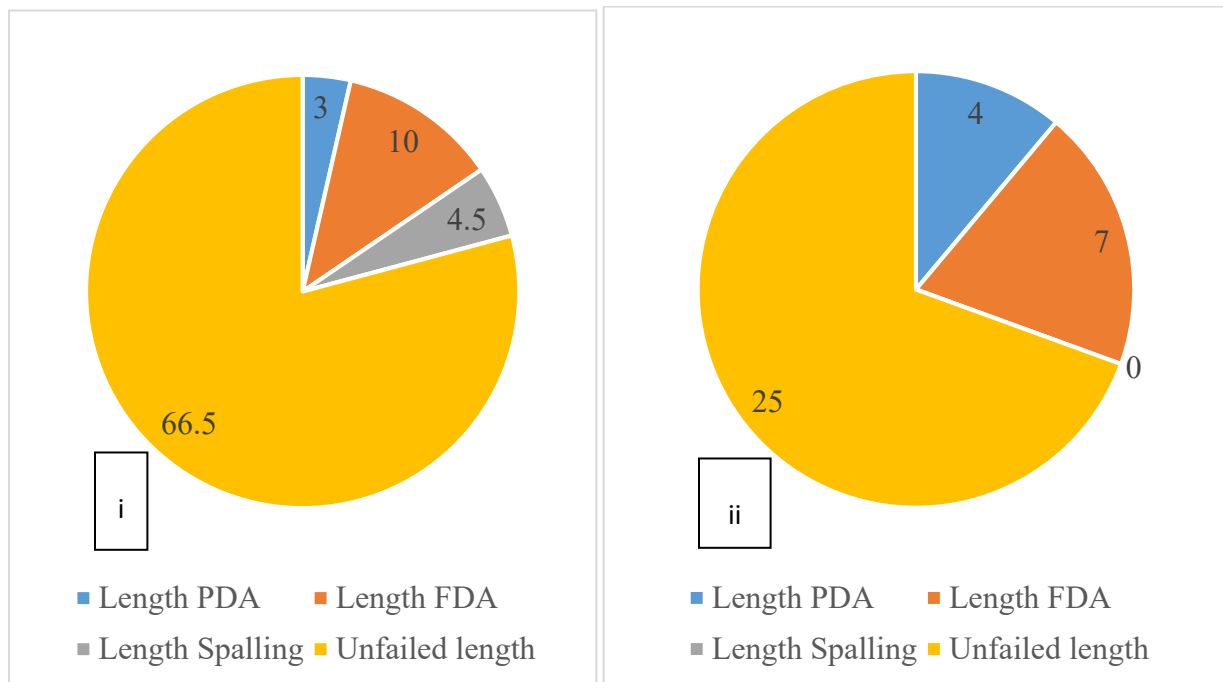
Site N Rut-and-Seal Performance After First Winter (i) and Second Winter (ii)

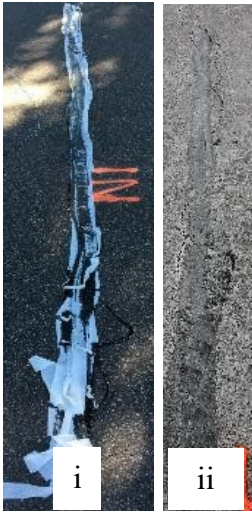
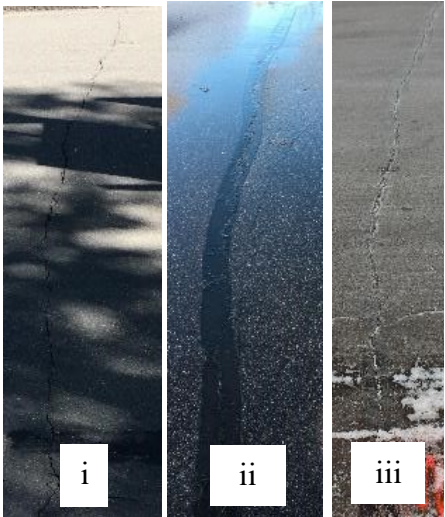
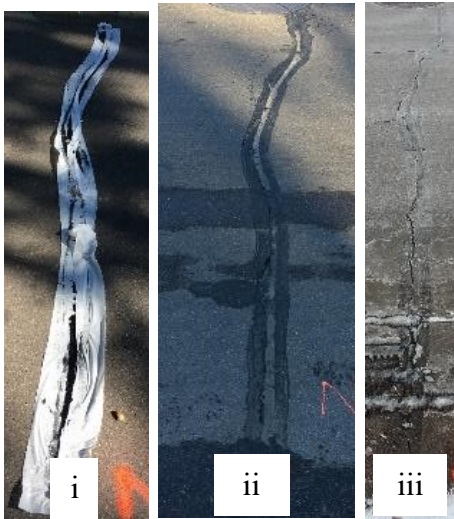
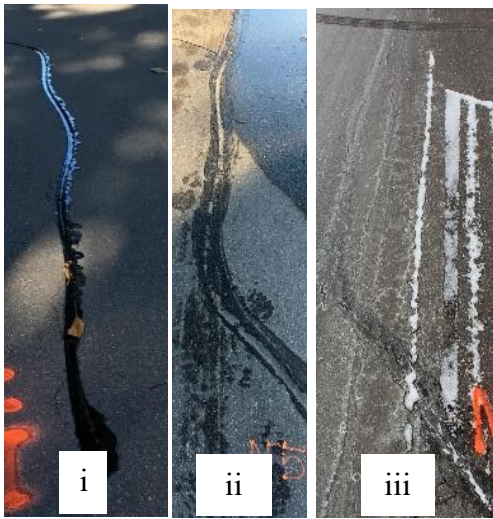
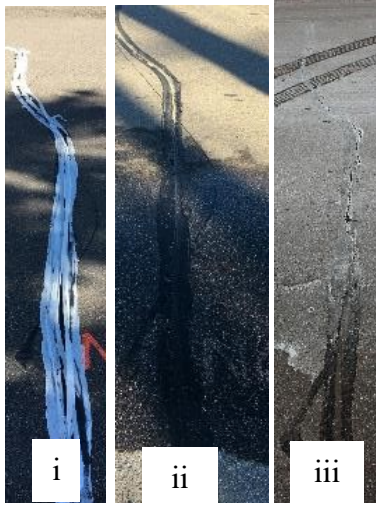
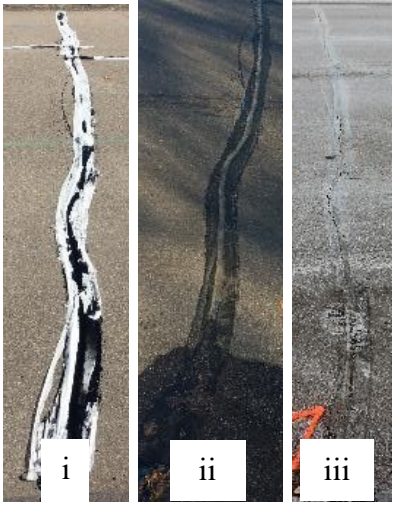
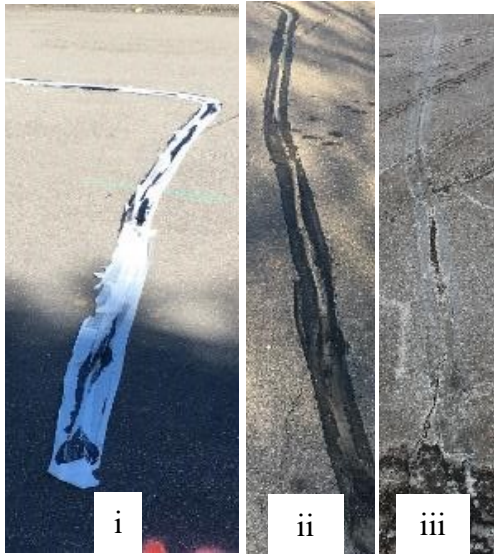
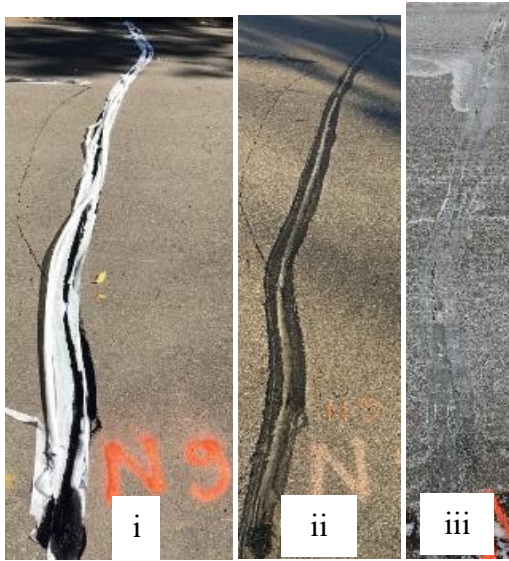
Photographic performance documentation of Site N. N-4-i shows Crack N-4 immediately after being sealed. N-4-ii and N-4-iii show crack N-4 after the first and second winter since being sealed. This same sequence follows for cracks N-5, N-6, N-7, N-8, N-9, and N-10. and N-11. N-1-i and N-2-ii show crack N-1 after being sealed and during the second winter. N-3-i shows Crack N-3 before being sealed. N-11-i shows immediately after being sealed and during the first winter.

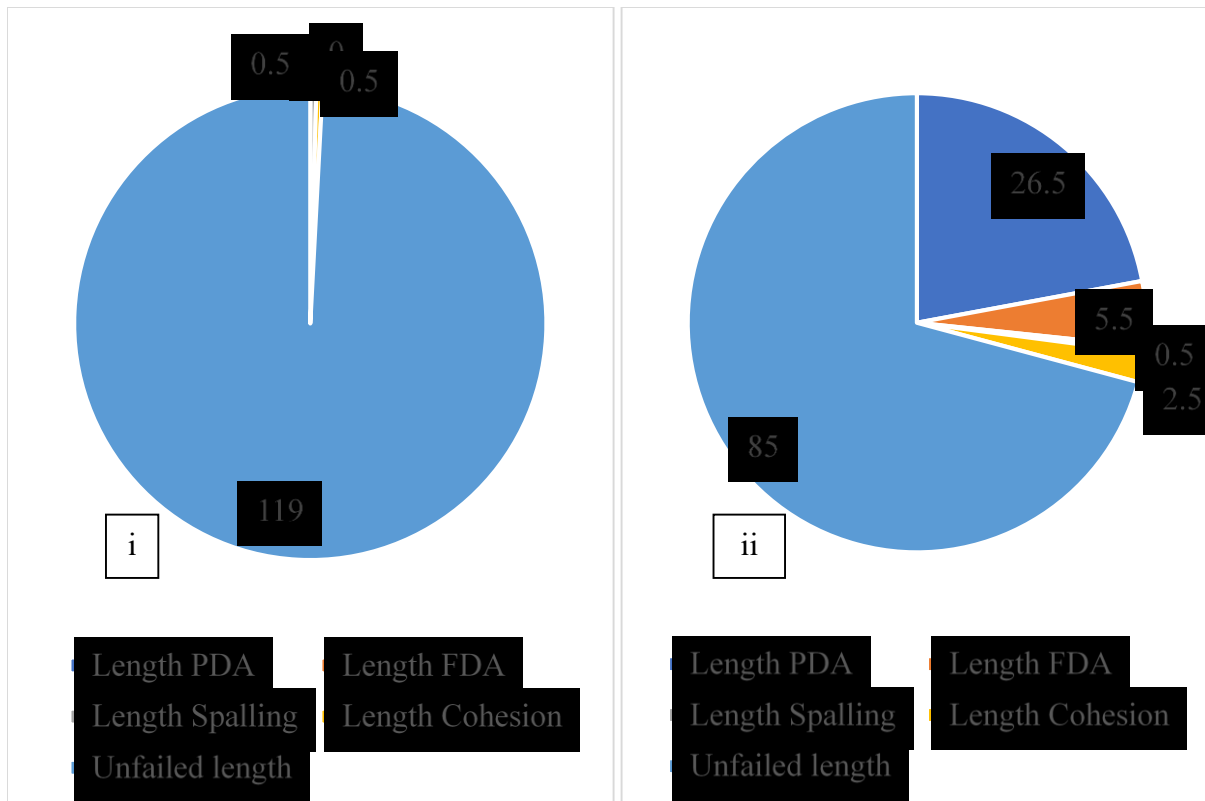
Site O Clean-and-Seal Performance After First Winter (i) and Second Winter (ii)

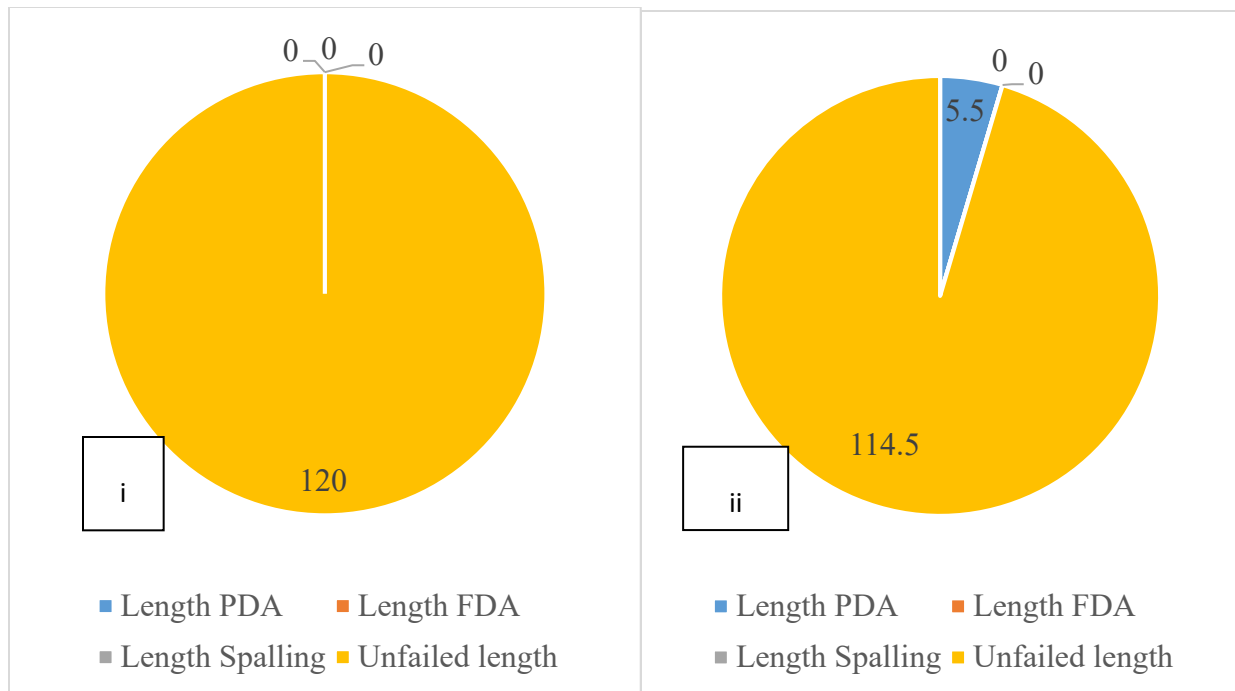
Site O Rout-and-Seal Performance After First Winter (i) and Second Winter (ii)

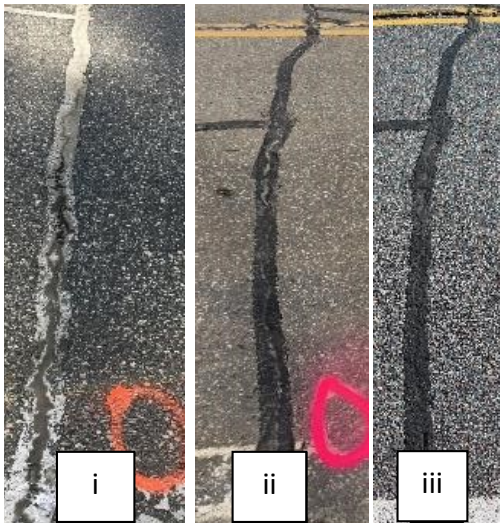
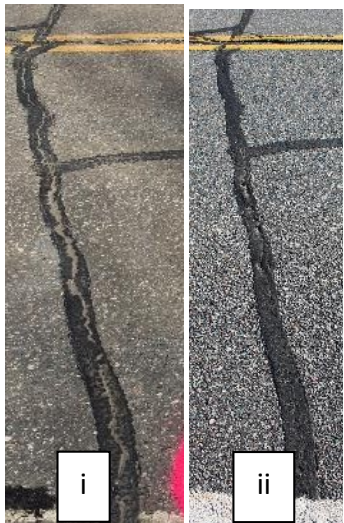
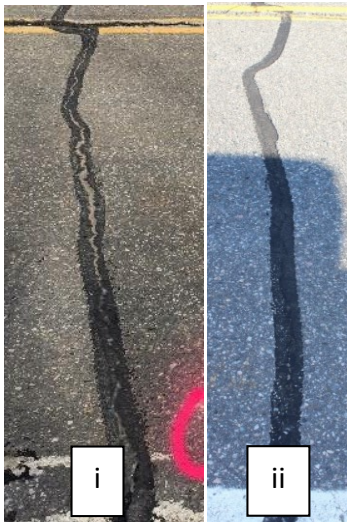
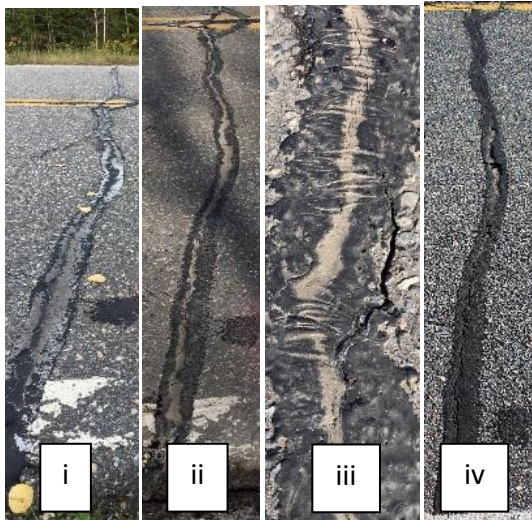
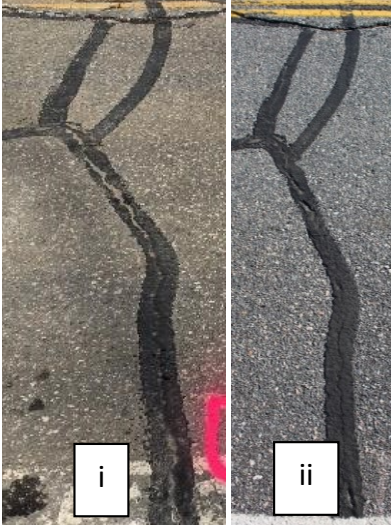
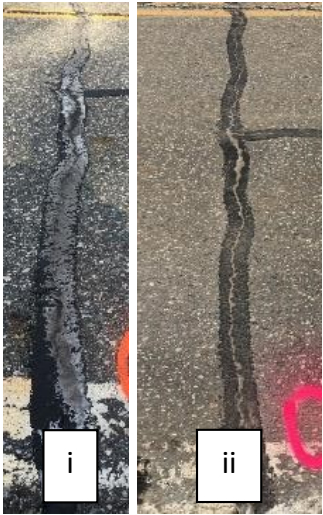
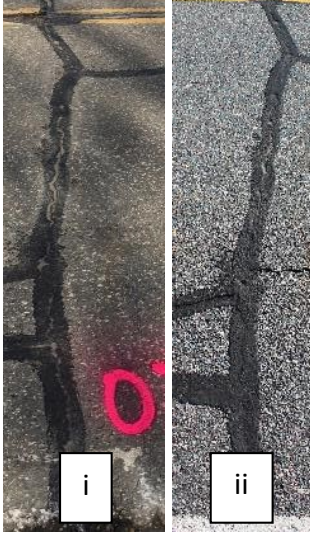
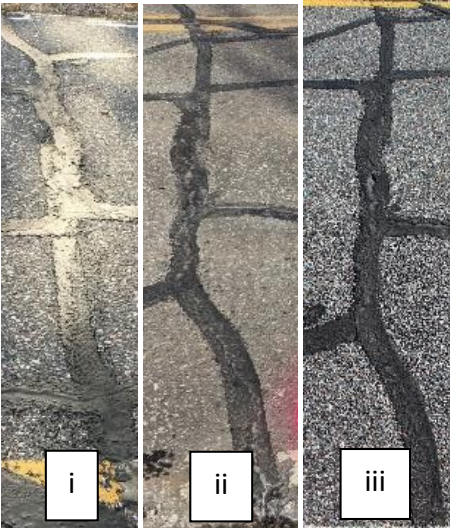
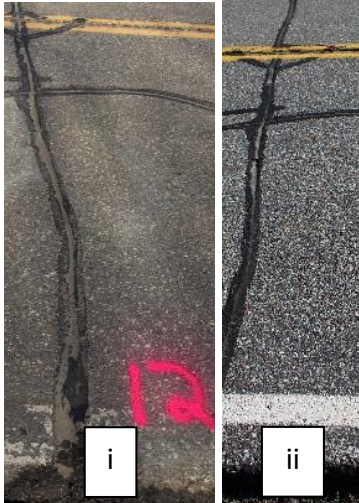
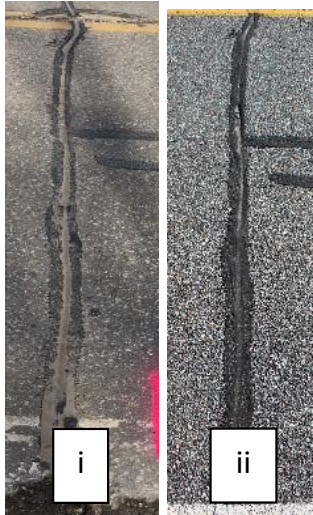
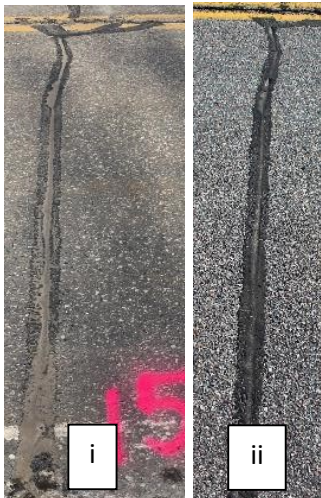
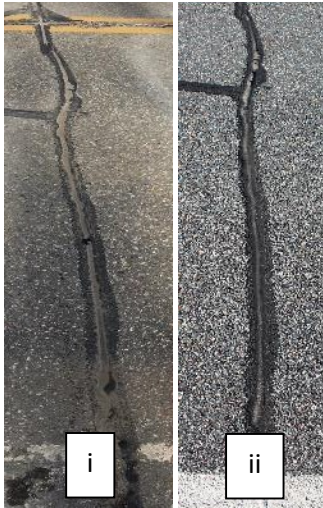
Photographic documentation of seal performance at Site O. O-2-i and O-2-ii show Crack O-2 during the first and second winter after being sealed. This same sequence follows for Cracks O-3, O-5, O-6, P-7, O-9, O-11, O-12, O-13, O-14, O-15, O-16, O-17, O-19, and O-20. Cracks O-1, O-8, and O-10 are shown a week after being sealed, then during the first and second winter. Crack O-4 is shown in this same manner, with the addition of a close-up of a spalling failure in image O-4-iii.

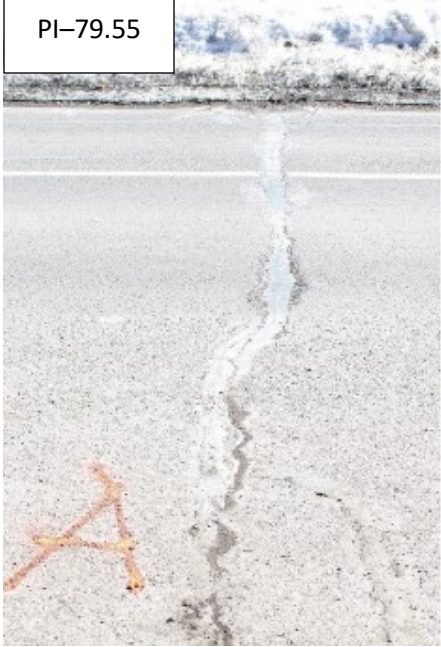
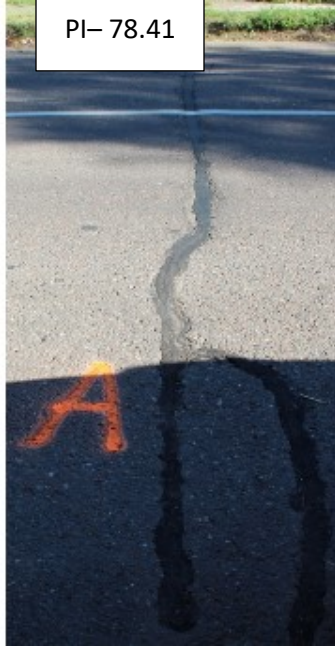
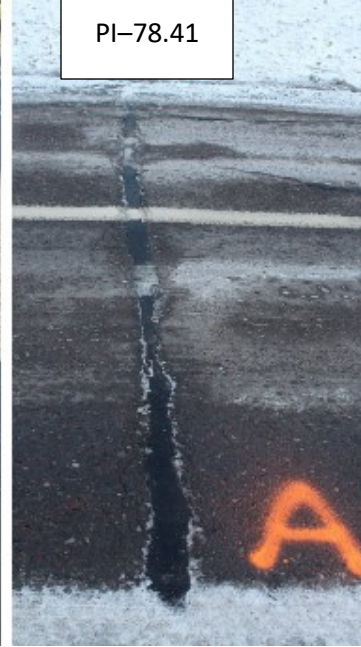
(e) Site A: 3rd St:21st AE to 1st AE, Duluth; Crack Sealing Year - 2014

PI-79.55

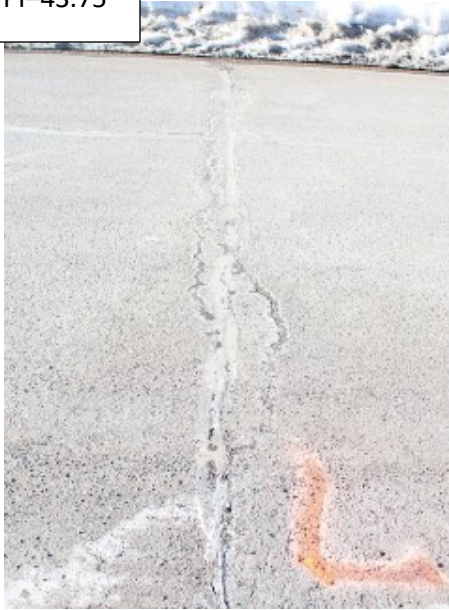
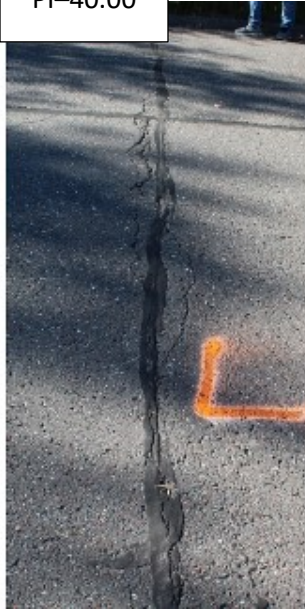
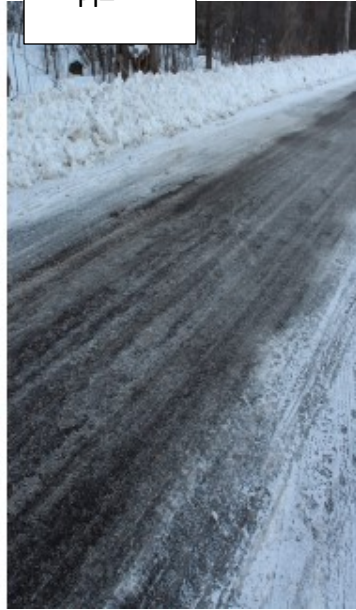
(a) Site L: 1st St.: 24- 26 AE., Duluth; Crack Sealing Year – 2016; **Snow Cover

PI-43.75

PI-40.00

PI-**

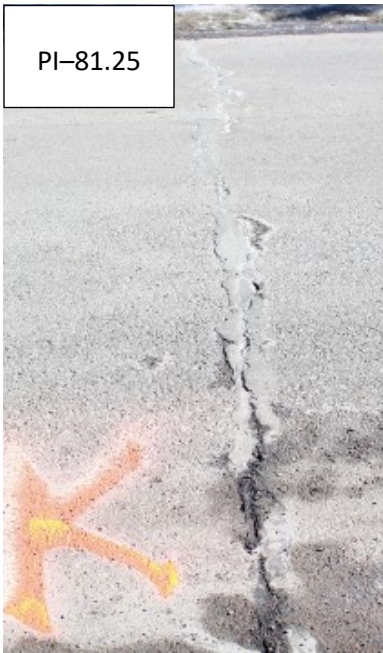
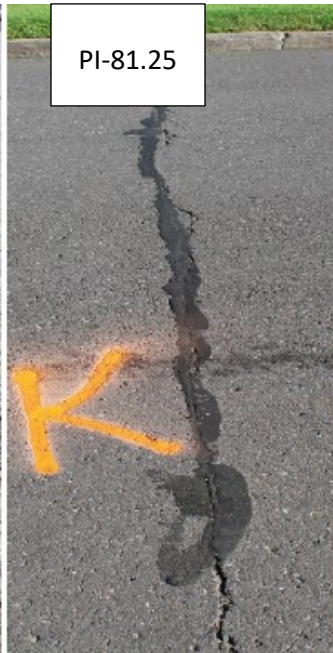
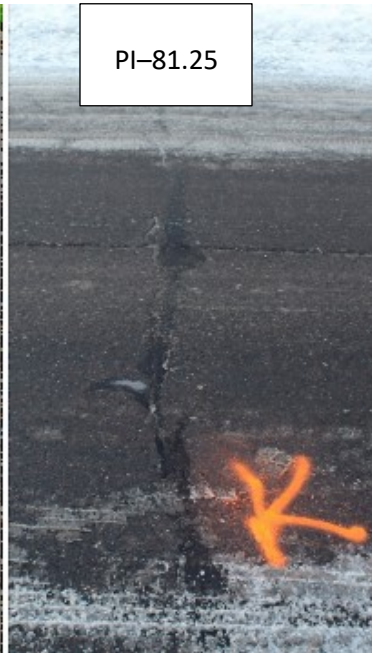
(b) Site K: 2nd St.: 24-26 AE, Duluth; Crack Sealing Year – 2016

PI-81.25
