**Preservation of Missouri
Transportation Infrastructures:
Non-Destructive Testing of FRP Materials
and Installation, Gold Bridge**

**UTC
R96**

In 2003 the Missouri Department of Transportation contracted to retrofit five county bridges with FRP materials. This paper deals with non-destructive testing of FRP material performance of the Dallas County Bridge P-0962, codenamed the "Gold Bridge"

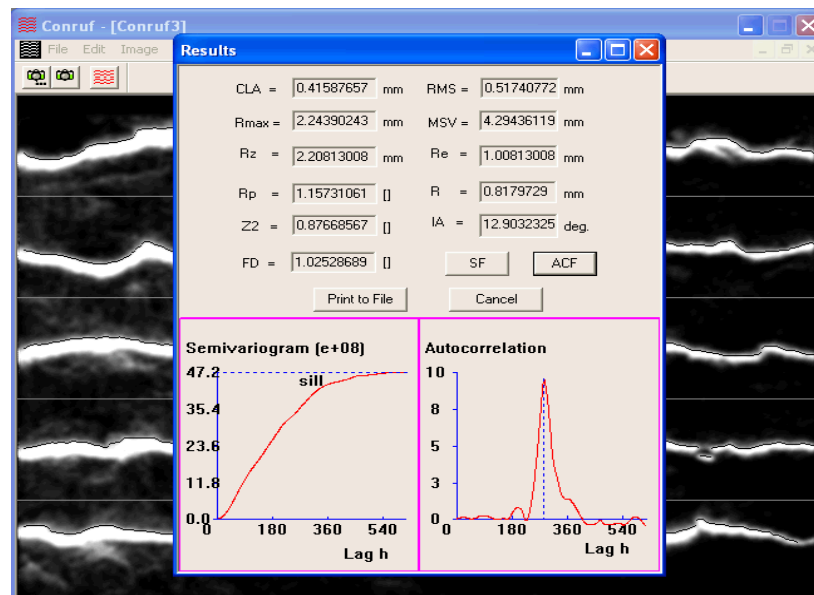
Figure 1.4: Sample roughness outputs for the profilometer.

The video signal is transmitted to a laptop computer via coax cable or wireless video. At the computer the signal is digitized by a PCMCIA digitizing card or framegrabber. The profiles are analyzed to produce varying roughness measures (Figure 1.4).

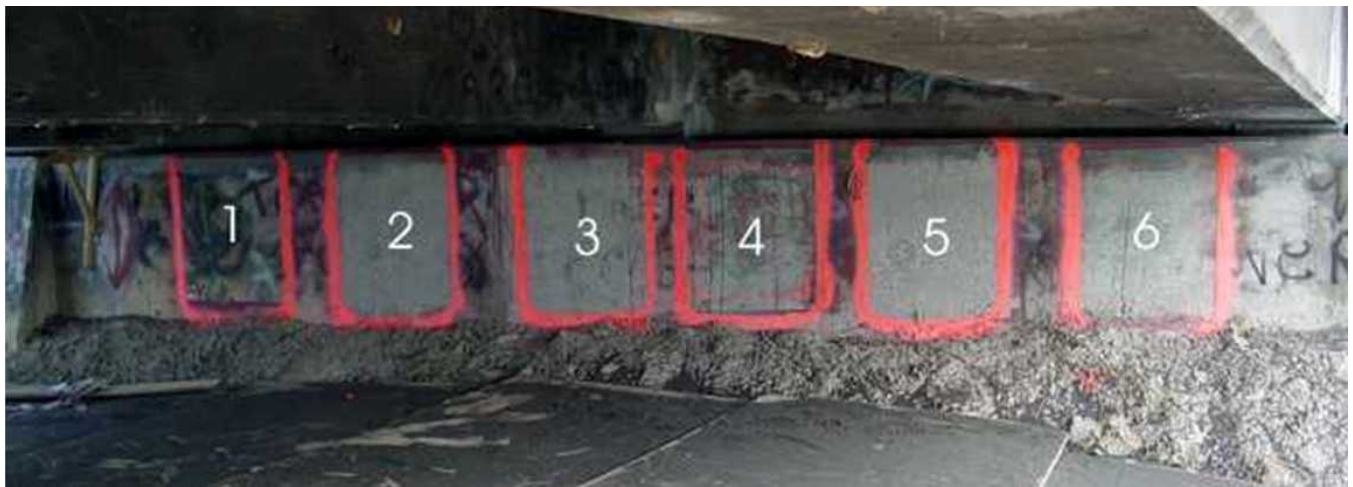
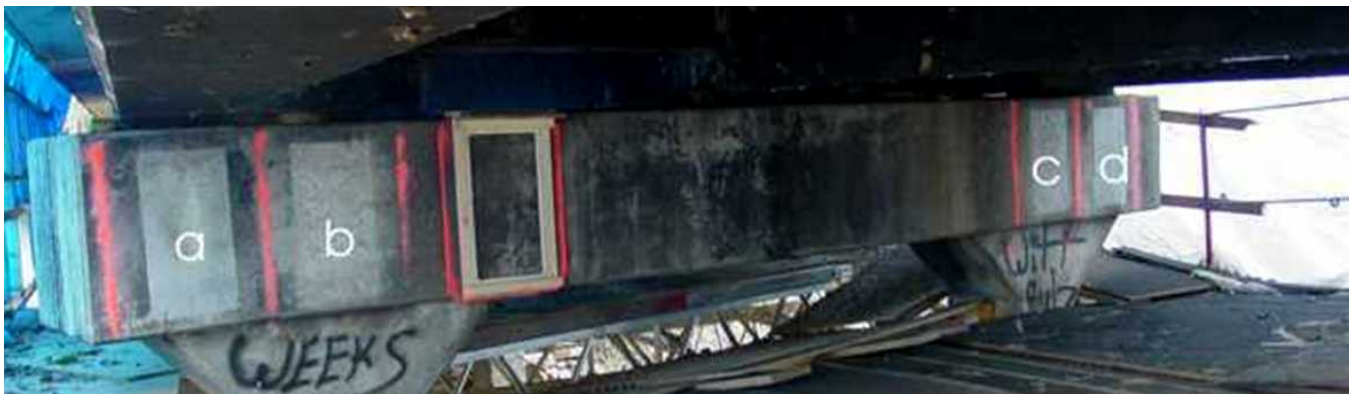
Figure 1.6: Location of the test panels on the abutment (top) and the bent (bottom).

Roughness measurements after sand blasting (Figure 1.5) were made in two different areas, under the bridge deck and on the test panels where test FPR panels with forced delaminations were planned to be installed (Figure 1.6).

The roughness values of the locations for the abutment and bent panels were also measured (Tables 1.2, 1.3). For the abutment patches the sand blasting instructions were not well executed and the roughness measured reflected that. For the bent patches the instructions were executed correctly. The end of the bent around patches c and d later underwent unrelated masonry repair, and so the roughness numbers in Table 1.3 are no longer relevant.

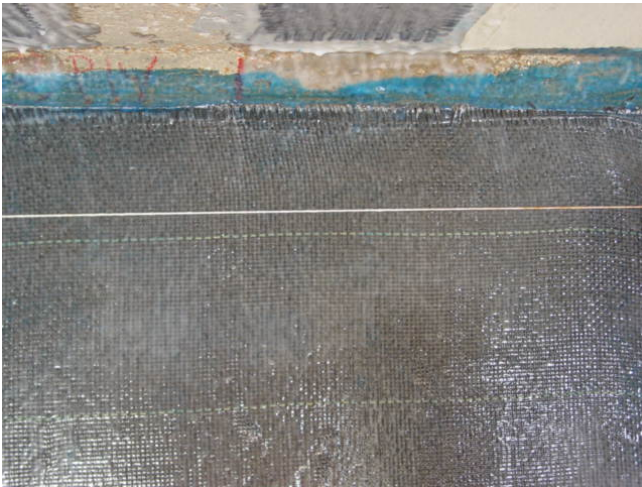
Figure 2.2: FRP sheets with yellow tracer and overlain by white chord.

A method of measuring the installation alignment of the FRP sheets was developed. FRP sheets were ordered with an embedded tracer woven into the fabric, and were installed using transparent epoxy (Figure 2.1). Then a chord is simply stretched in the correct alignment, and imaged with a digital camera. (Figure 2.2). Using imaging software, the angle between the tracer and the chord is measured to determine if there is greater than 5° misalignment (Figure 2.3).

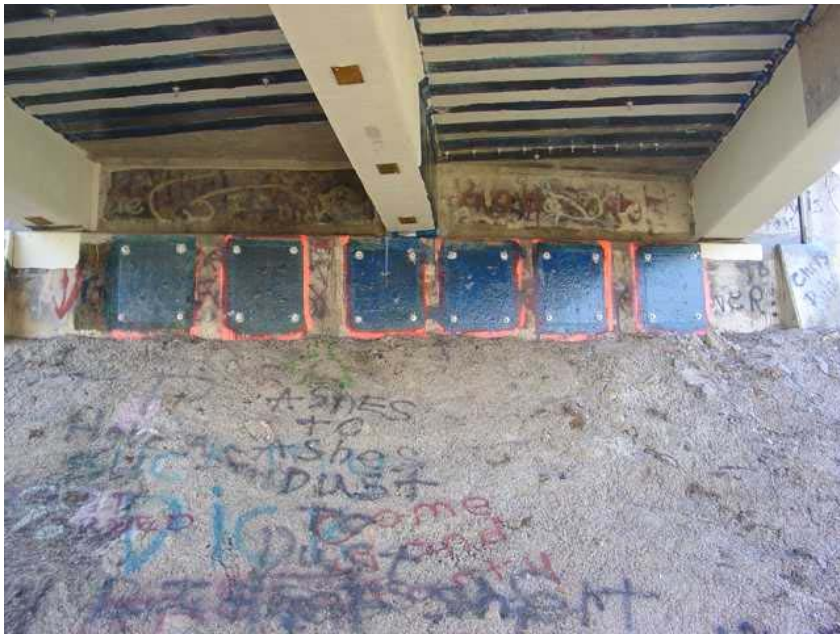
Figure 3.3: Panels for delamination on south abutment.

Test sections of FRP materials were applied on one abutment and one bent (Figure 1.6, 3.3). These locations were sandblasted to specified differing roughnesses (Figure 1.5), and roughness was characterized prior to FRP sheet installation. FRP sheets were installed (Figure 3.3) and before the epoxy was allowed to cure, delaminations were forced under the sheets installed in these test sections by air injection (Figure 3.4). These delaminations were measured periodically using impact echo testing (Figure 3.5). To make repeat measurements easier a grid of yellow dots on 1” centers was painted over the FRP material (Figure 3.6)

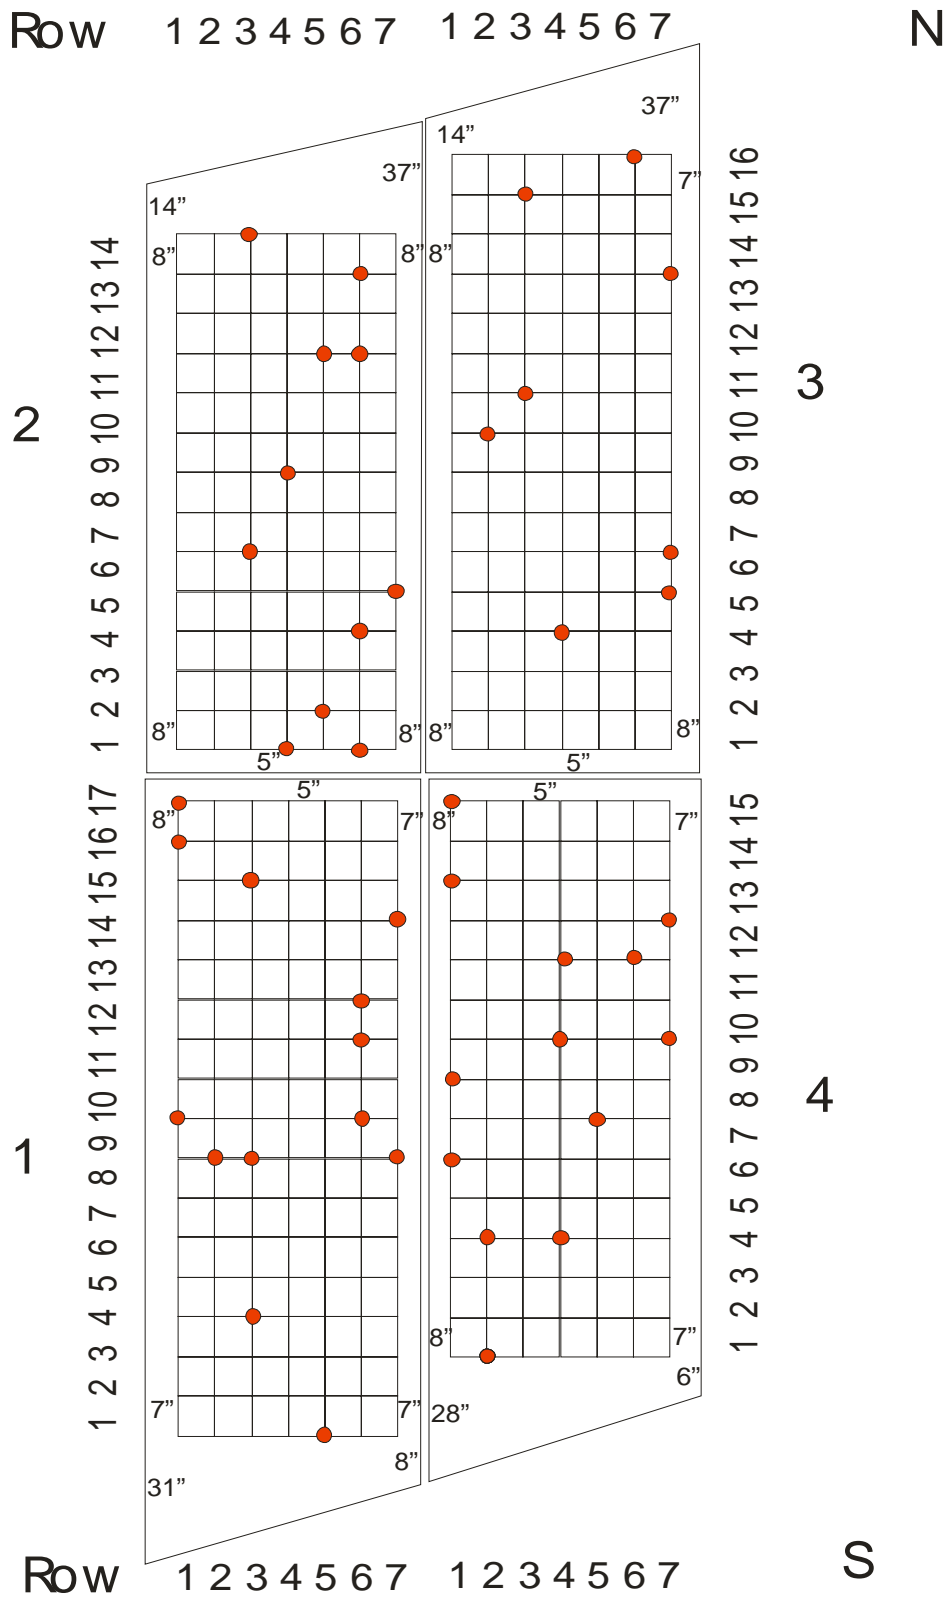
Figure 4.3: Location of pull-off plugs.

A total of 45 plugs were installed. Plug plan locations and corresponding concrete surface roughness are shown in Figure 4.3, and in Appendix 3 with corresponding underlying surface roughness. The installation process is shown in Figure 4.4.

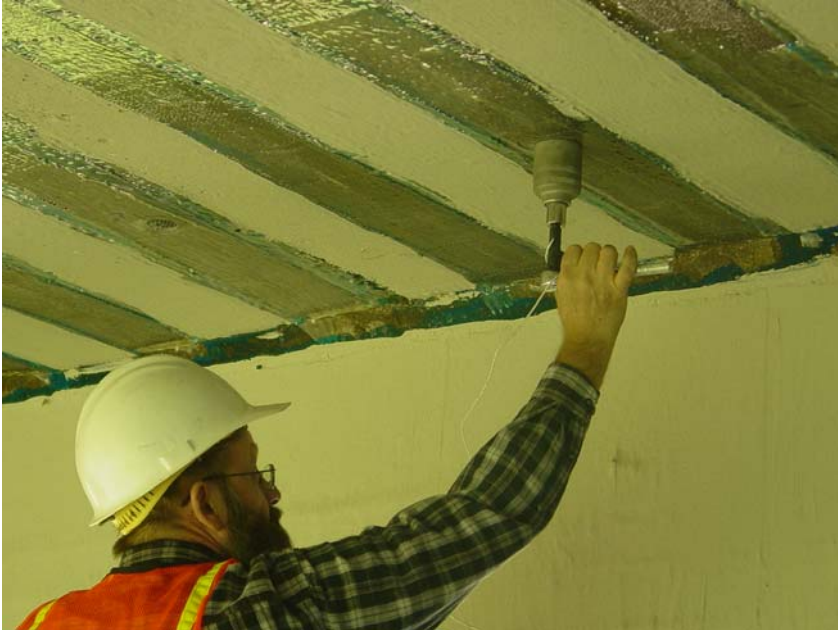
Figure 4.5: Pull-off test on the deck plugs.

To determine an appropriate test load rate about 20 plugs were laminated to FRP test sections in non-critical areas and were pull tested to failure. The average pull-off value was 450 in-lbs of torque on the instrument. For subsequent tests, the maximum pull-off force applied was one-half of that load or up to 225 in-lbs. Figure 4.5 shows a test being conducted. If failure occurred, the failure load was recorded and the failure mechanism. As many of the plugs that did fail did so along the FPR/covering epoxy layers, during early test the failed area was tested using the impact echo tester to determine whether or not delamination between the concrete substrate and FRP also may have occurred (Figure 4.6). In every case checked this did not happen.

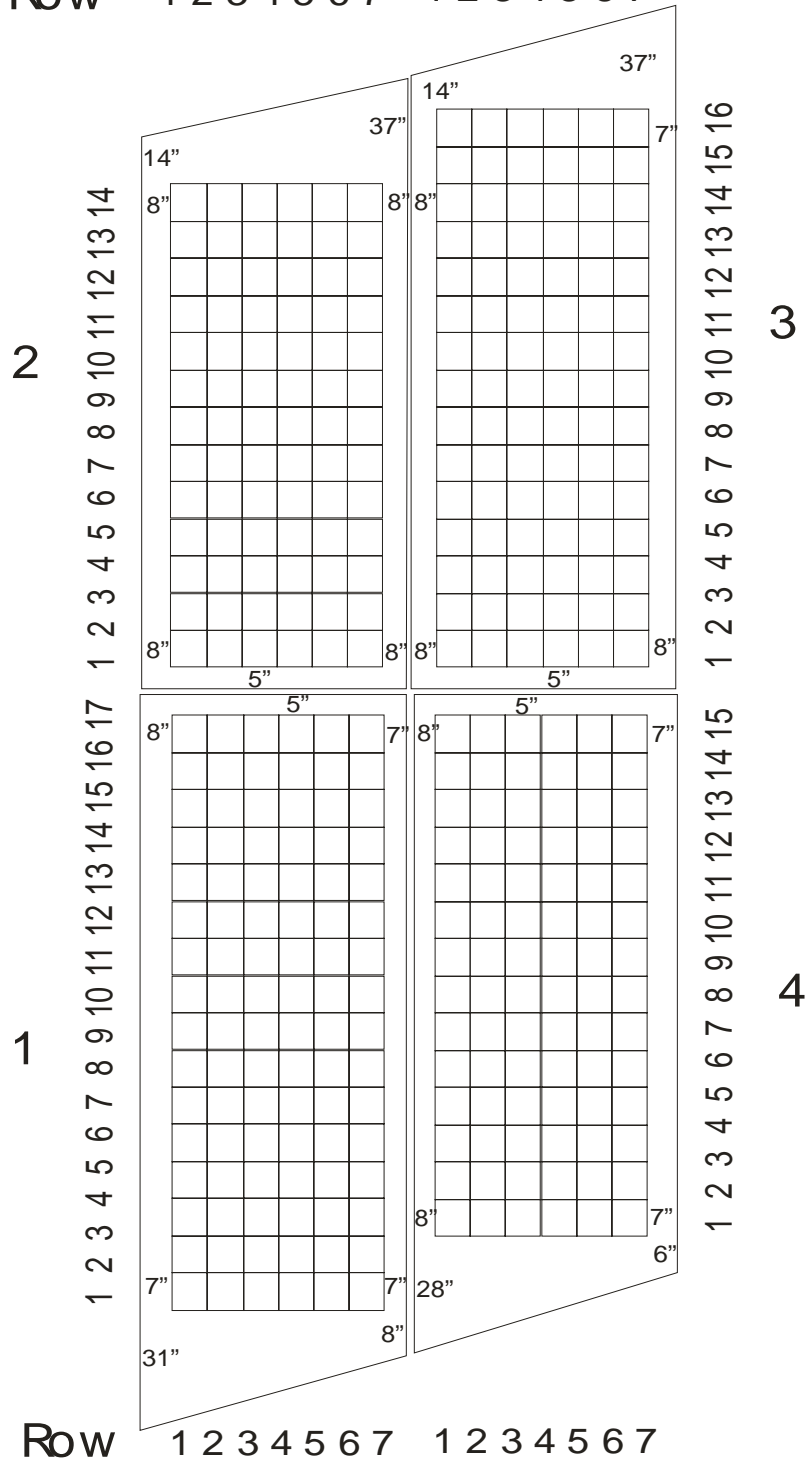
Grid on bridge deck.

Under the bridge deck, which was sand blasted with no specific instructions, measurements were made along on a 1' by 1' grid that was marked with chalk line (Figure 1.3, Appendix 1). Measurements along nodes were recorded to 1) Determine if optimum roughness has been achieved, 2) Determine a relationship between roughness should future delamination take place, and 3) Selection locations of varying roughnesses for installing

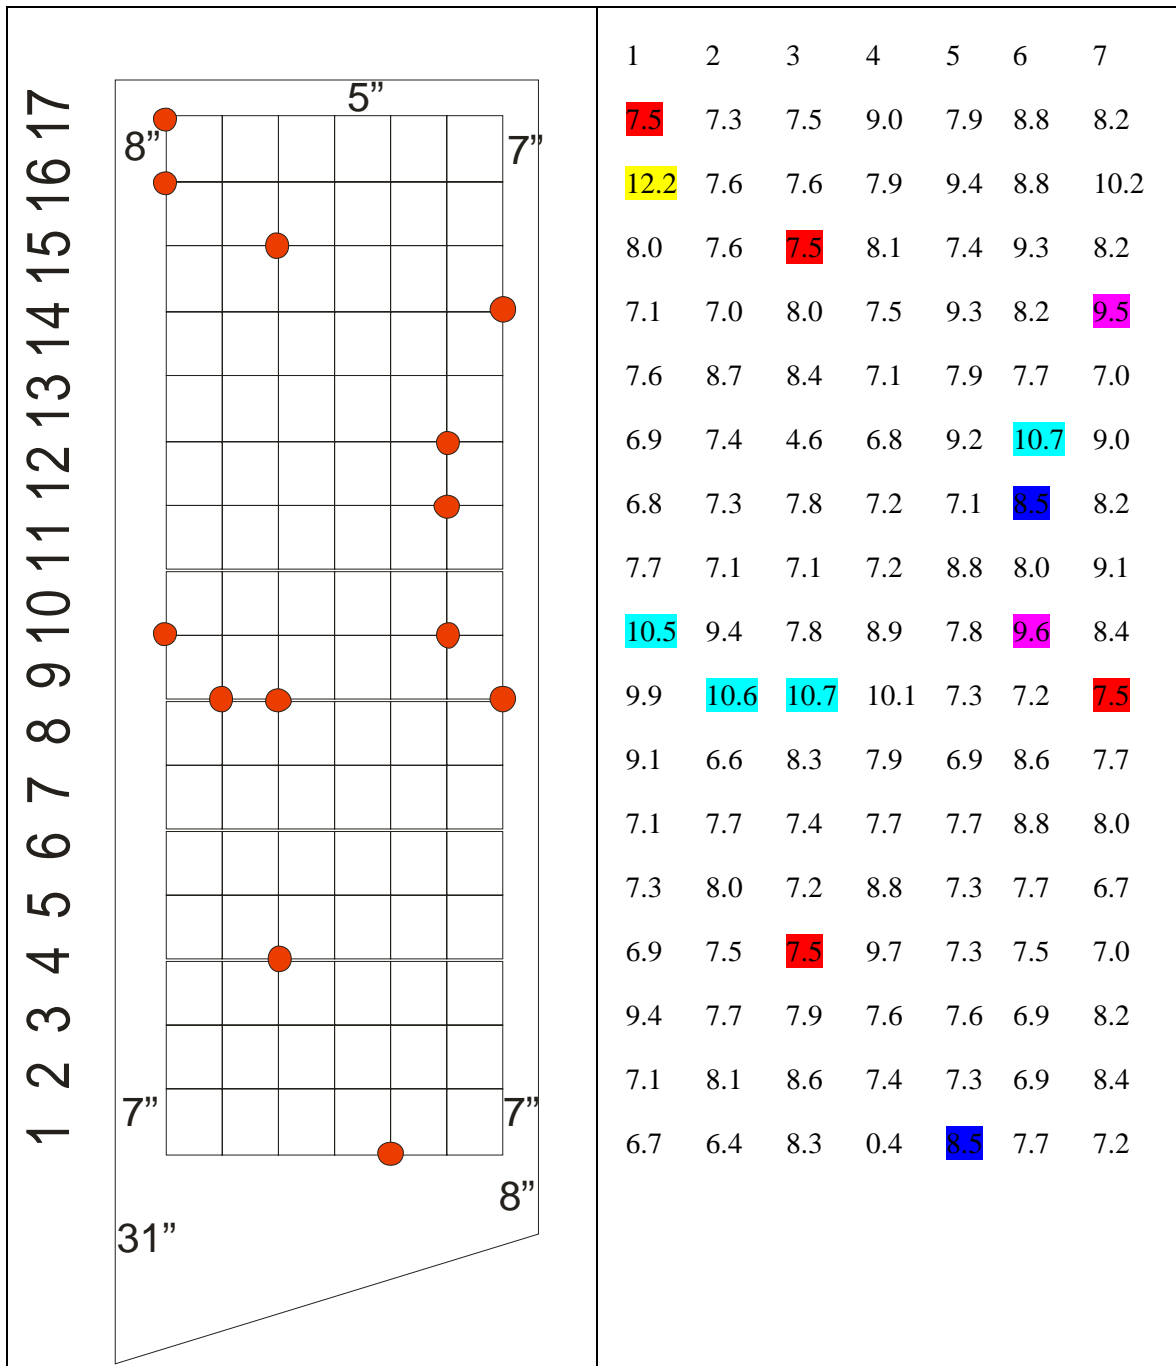
Deck area 1. Location of pull-off plugs, with corresponding underlying roughness, Ia, (Micro-average inclination angle).

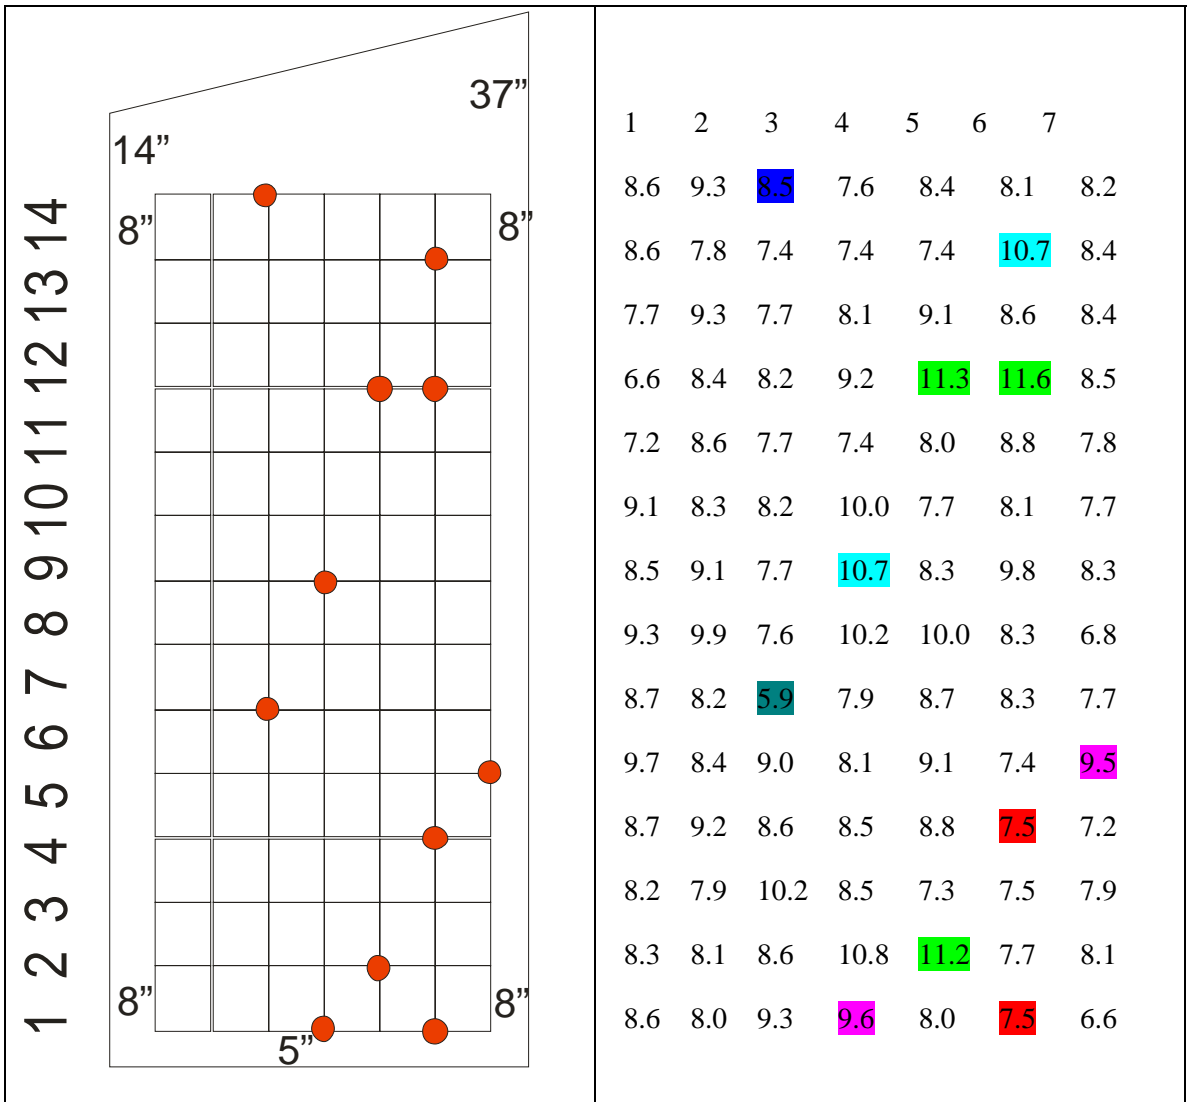
Deck area 2. Location of pull-off plugs, with corresponding underlying roughness, Ia, (Micro-average inclination angle).

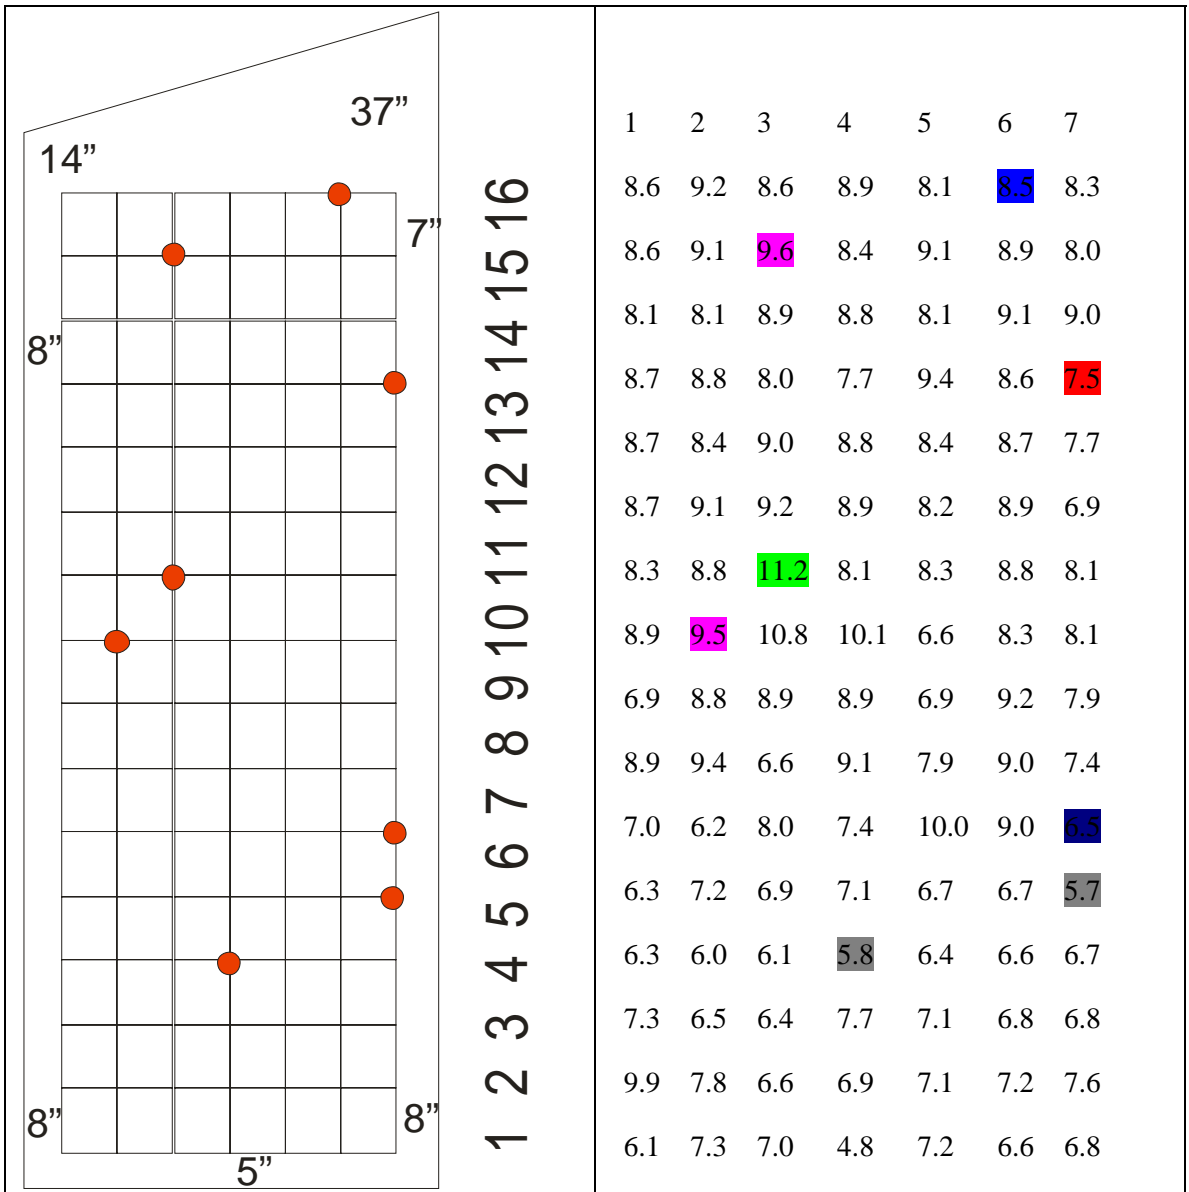
Deck area 3. Location of pull-off plugs, with corresponding underlying roughness, Ia, (Micro-average inclination angle).

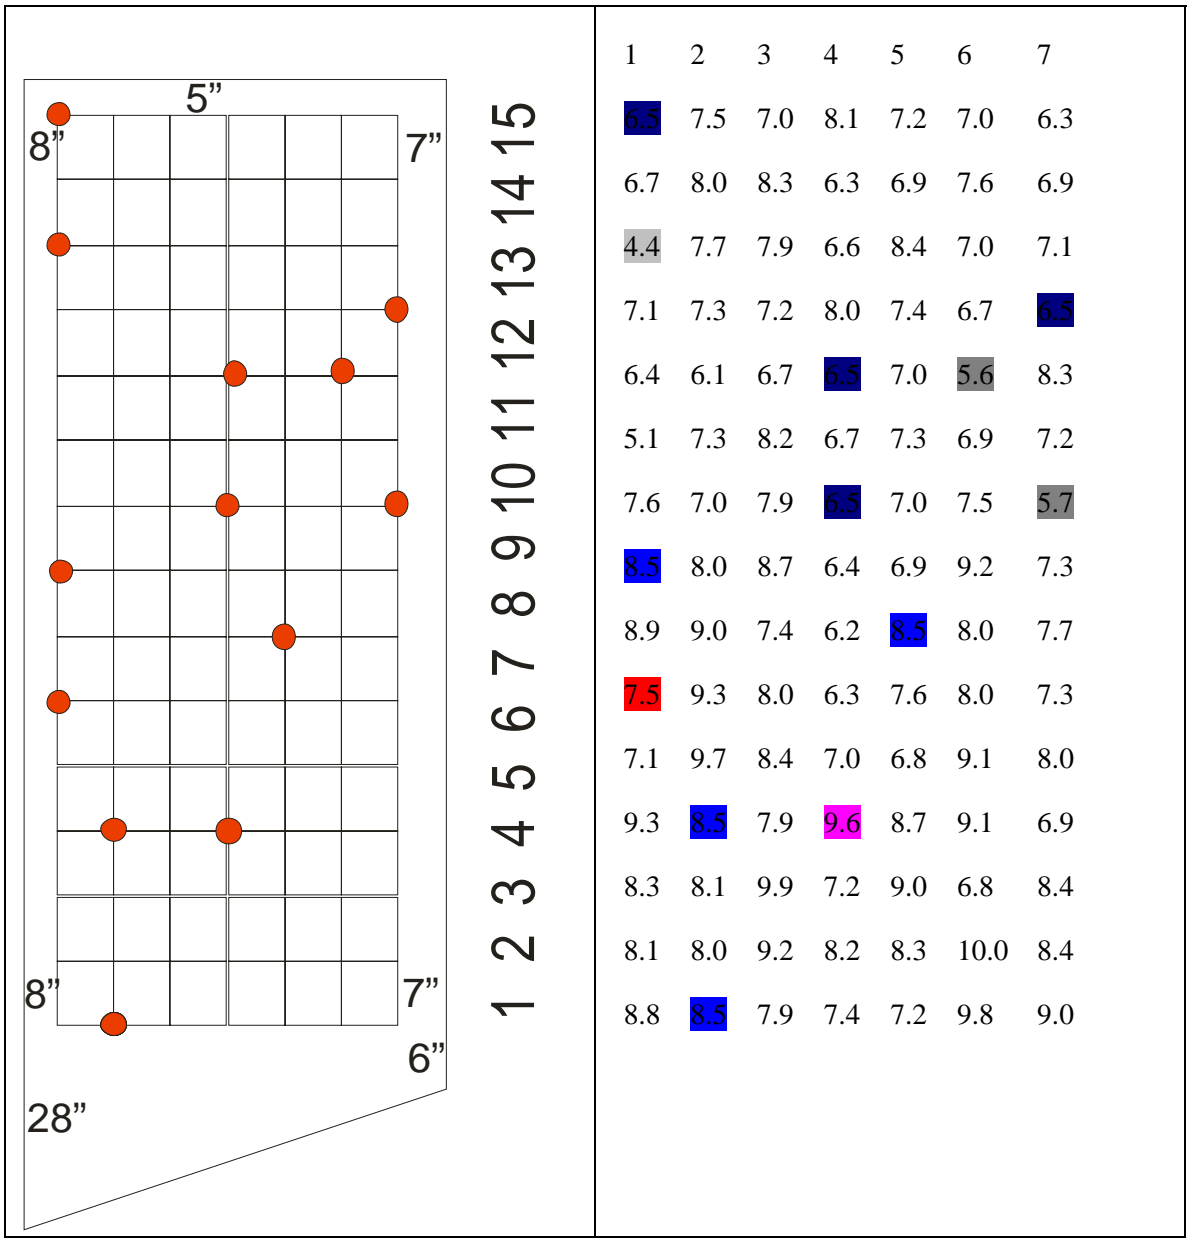
Deck area 4. Location of pull-off plugs, with corresponding underlying roughness, Ia, (Micro-average inclination angle).
