**PAVEMENT EVALUATION
I-265 JEFFERSON COUNTY
MP 15.0-19.0**

**Research Report
KTC-03-22/FR-122-03-1f**

Pavement Evaluation, I-265 Jefferson County MP 15.0 - 19.0

November 2003

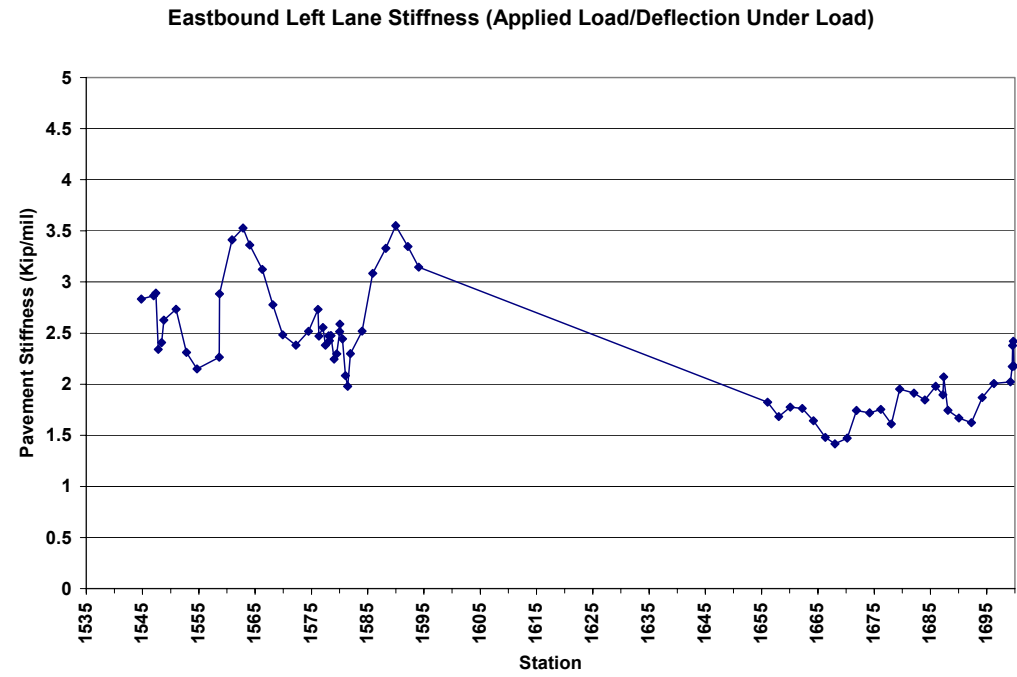
Figure 8a. Pavement Stiffness

To obtain a measure of the structural condition of the pavement, pavement stiffness was determined along the length of the project. Pavement stiffness is defined as the applied load from the FWD in kilo pounds (kips) divided by the measured deflection under the load in mils (thousandths of an inch) under the load. The result is a overall measure of the stiffness of the pavement structure. These results are given in Figures 8a, 9a, 10a, and 11a. It may be seen from these figures that there is considerable variability along the project, with stiffness values ranging from 4.5 to 1.5 kips/mil. In general, the areas which exhibited the lower stiffness values have exhibited more distress in terms of mid-panel cracking and slab settlement.

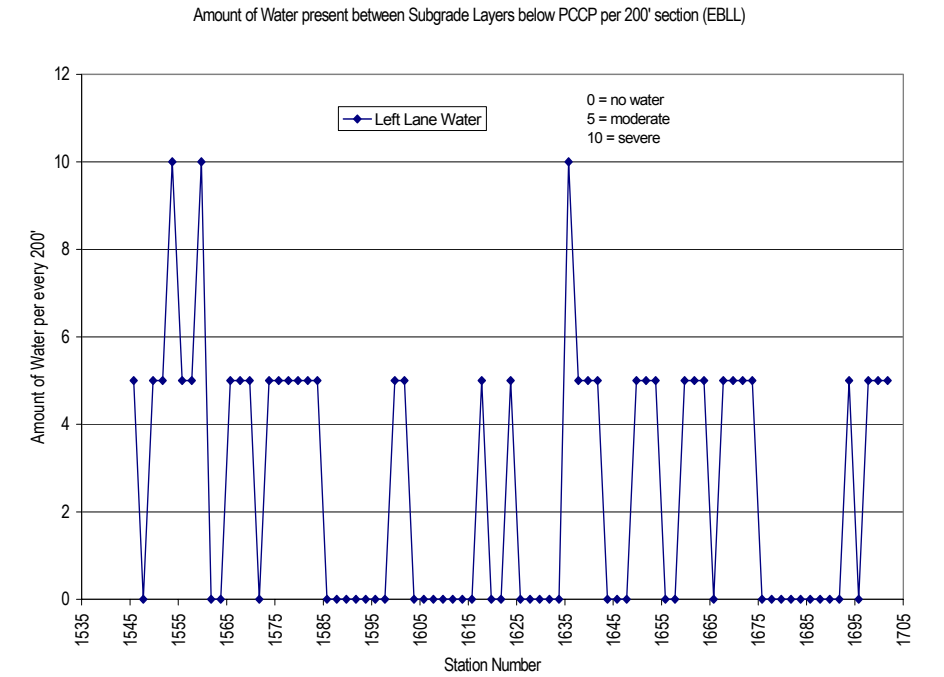
Figure 8e. Subgrade Water

Once a visual threshold was established for the amount of water present in the DGA layer, a rating was given to every 200 feet in both the right and left lanes of both the east and west bound directions. Ten points were given to the sections with severe water, five points were given to the sections with moderate water, and zero points were given to the sections with little or no water. In order to determine how each 200-foot section varied along the route all water ratings were graphed. Figures 8e and 9e show the left and right lanes of the eastbound direction, and figures 10e and 11e show the left and right lanes of the westbound direction, respectfully. It appears that edge drains should be installed along this section of I-265 to help drain the subgrade/DGA layer. However, if providing edge drains throughout the entire project is not possible, it is suggested that subgrade drainage be provided to those areas that have a rating of ten.

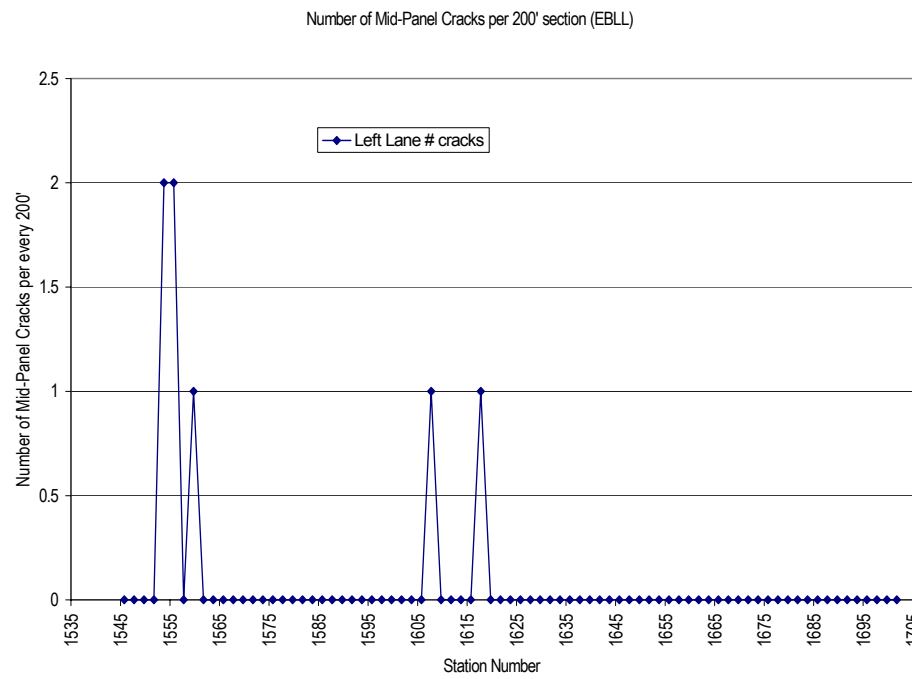
Figure 8d. Mid-Panel Cracking

An attempt was made to identify the number of mid-panel cracks for each 200-foot section. This was preformed by doing a visual survey of each lane and counting the cracks. No attempt was made to determine the severity of the cracks. Figures 8d, 9d, 10d, 11d, show the number of cracks observed for each 200-foot section for the eastbound left lane, eastbound right lane, westbound left lane, westbound right lane, respectfully.
