Galvanized and Aluminized Pipe Durability Field Review and Evaluation

Kansas State University Transportation Center

Final Report

September 2019

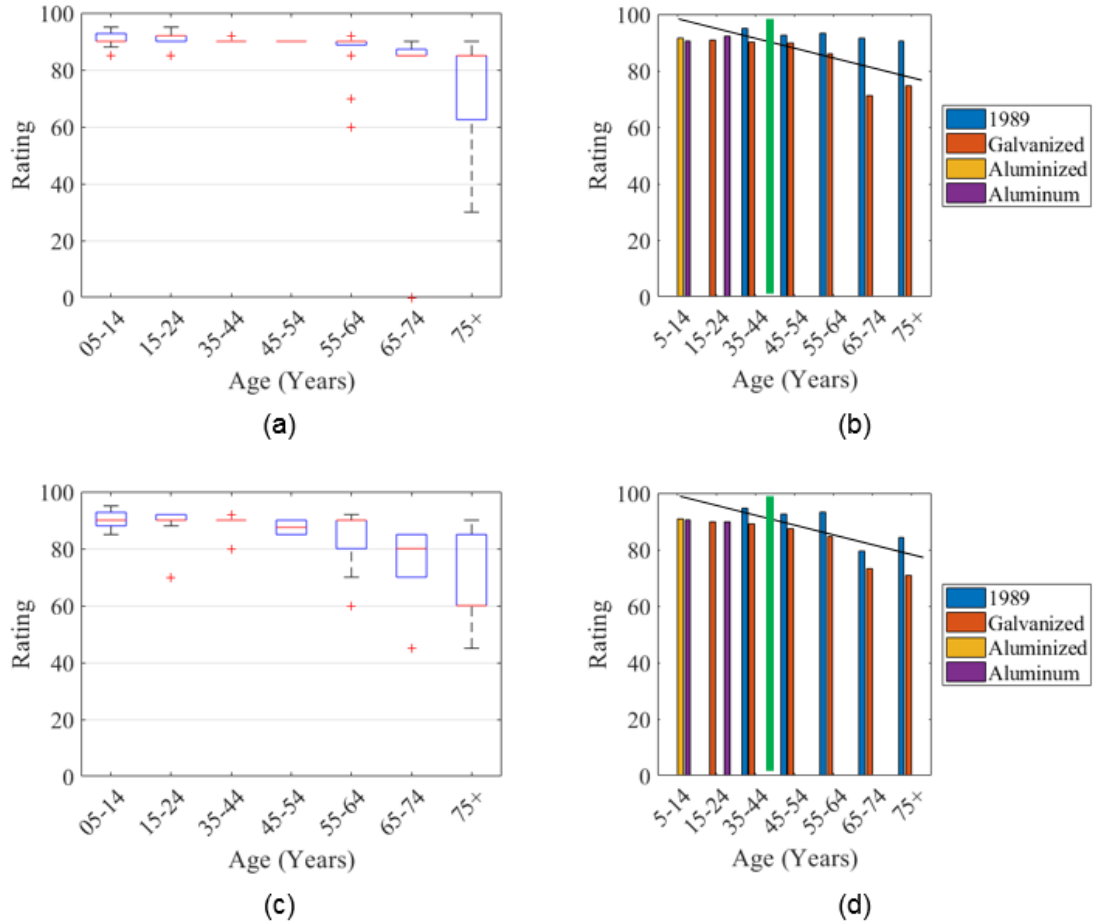
Figure 4.4: Crown and Side Observations: a) Crown Rating in 2018; b) Average Crown Rating in 2018 and 1989; c) Side Ratings in 2018; d) Average Side Rating in 2018 and 1989

The crown and side ratings are summarized in Figure 4.4. Figure 4.4(a) and 4.4(c) are box and whisker plots of the observed ratings to show the distribution and observe trends in deterioration of all CMP surveyed in 2018. The upper and lower boxes are the first and third quartiles of the data and the line in the box is the second quartile (median). A horizontal line only (i.e., 25–34 years) indicates there was no variability in the data. There were no CMP surveyed in the 25–34 range and two were surveyed in the 44–55 range. The large distribution of data in the 65–74 year range highlight why the average ratings are lower in this age group than the oldest CMP. One 65-year-old CMP in Jefferson County has completely failed and three more have a zero rating on two or more surveyed locations (i.e., crown, side, invert, or exterior). Only seven CMP were surveyed in this age group, so the average rating is greatly influenced. Figure 4.4(b) and 4.4(d) show the average crown and side ratings for this study and for CMPs surveyed in this study that were also in Stratton et al. (1990). There is a general trend of deterioration with age in Figure 4.4(b) and 4.4(d), shown with a best-fit line. This was expected since these areas of the CMP are primarily exposed to atmospheric corrosion only. On average, no rusting was observed on the crown or side of CMPs less than 65 years old.

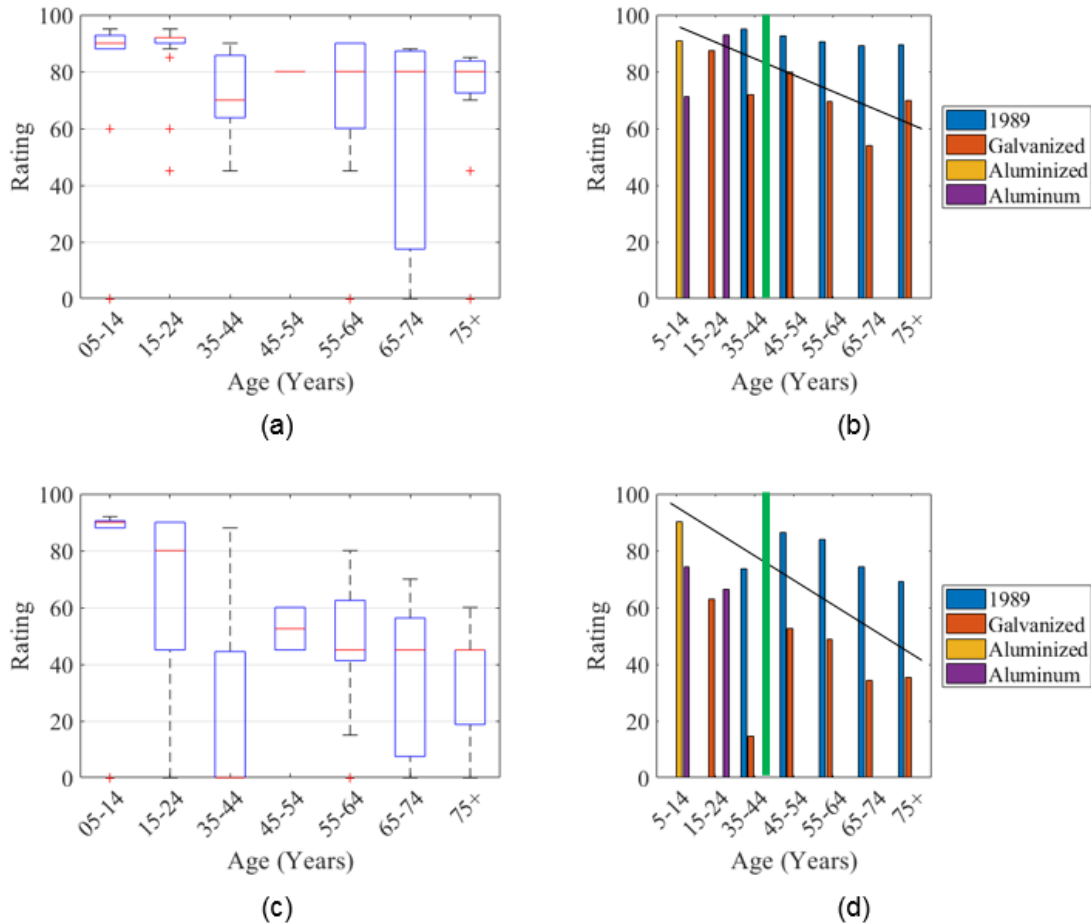
Figure 4.5: External and Invert Observations: a) External Rating in 2018; b) Average External Rating in 2018 and 1989; c) Invert Ratings in 2018; d) Average Invert Rating in 2018 and 1989

Figure 4.5 shows the external and invert CMP ratings. Again, Figure 4.5(a) and 4.5(c) show the variability in the 2018 ratings; however, the external and invert appear to be influenced by more than just the age of CMP. The change in KDOT policy in 1974 was identified as a cause of accelerated deterioration by Stratton et al. (1990); the green line in Figure 4.5(b) represents CMP installed before/after this policy change. Although CMPs 41 years and older were part of the pre-1974 group, all surveyed CMP in the 35–44 year range were 39 years old. The difference in external rating in Figure 4.5(b) between 1989 and 2018 appears to be greater after the 1974 policy change, despite the fact that the CMP are younger. This indicates higher deterioration rates. This is also true in the 65–74 range, where the average rating in 2018 was the lowest, but again one of

the six CMP in this subset completely failed and this affects the average rating for the small sample size. The rate of deterioration will be quantified and discussed later in this chapter.

Figure 4.5(c) and 4.5(d) also indicate deterioration rates were not only attributable to age in the CMP inverts. The invert showed the most corrosion damage of all CMP locations and these data were also the most variable, as shown in Figure 4.5(c). Furthermore, unlike the average external, side, or crown ratings, the average invert rating indicated increased deterioration of CMP installed after 1989, or what would correspond to recommendations by Stratton et al. (1990).

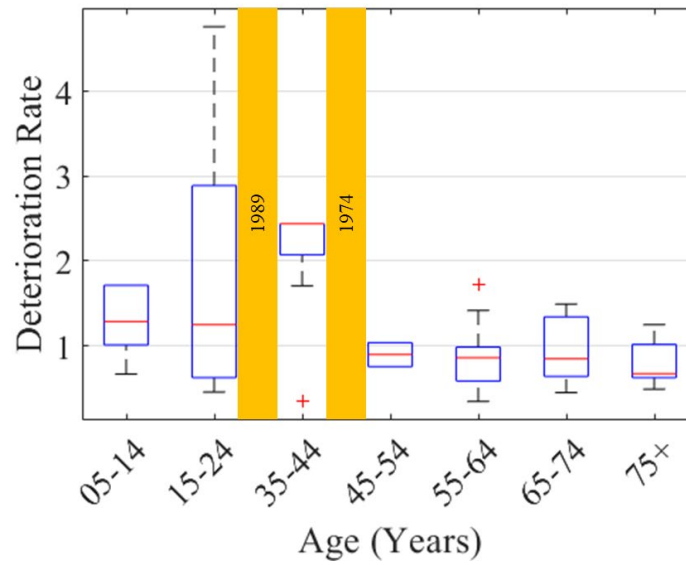
Figure 4.6: Invert Deterioration

Figure 4.6 shows the distribution of the CMP deterioration, where deterioration, D , was determined as:

Table 4.3 also includes the averages of these data. A larger number indicates a faster deterioration rate in the invert. The increased invert deterioration in Figure 4.5 for CMP installed since 1994 (youngest CMP surveyed in this study after the Stratton et al. [1990] recommendations) is also apparent in Figure 4.6, specifically for CMP that are 15–24 years old. The vertical lines indicate the 1974 change in policy to a thinner CMP installed and after the Stratton et al. recommendations.

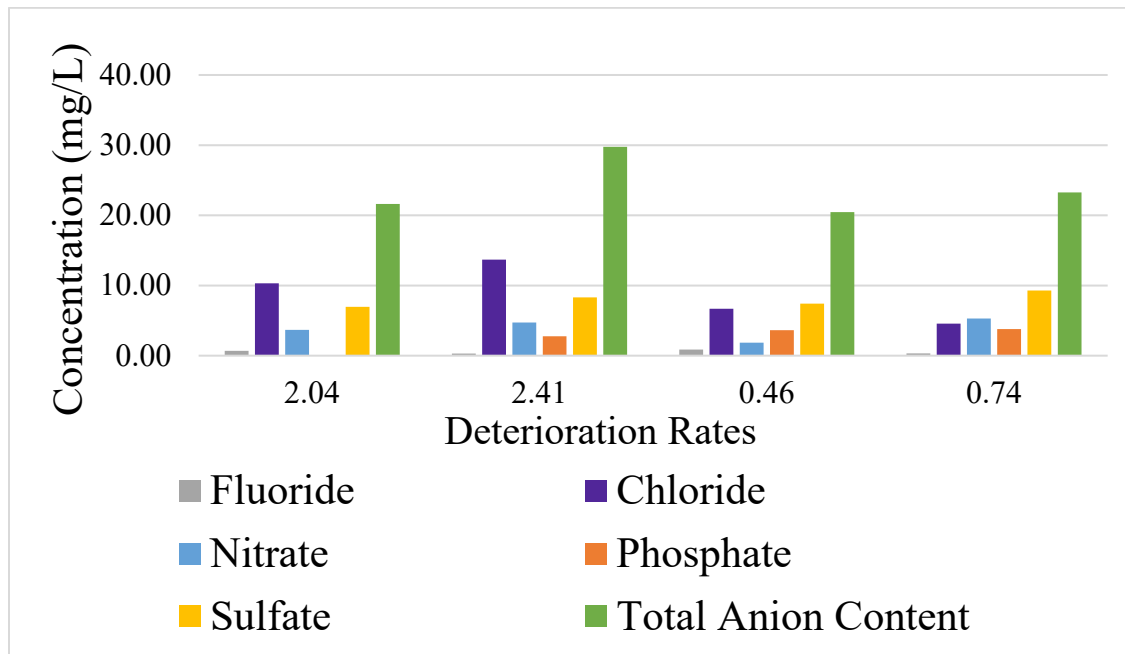
**Figure 4.7: Laboratory Leachate Testing**

An initial laboratory leachate test was conducted to determine the basic corrosion agents in the soil. Results of ion concentrations of soil slurry in deionized water are shown in Figure 4.7; the deterioration rates from Table 4.4 differentiate the samples. The initial study of anion presence in the soil suggests that chloride salts (purple bar) have the most significant influence on corrosion mechanisms in the soil pore fluid. Additionally, the pH of the leachate was measured over three days as described in the methodology. The leachate pH is shown in Figure 4.8.

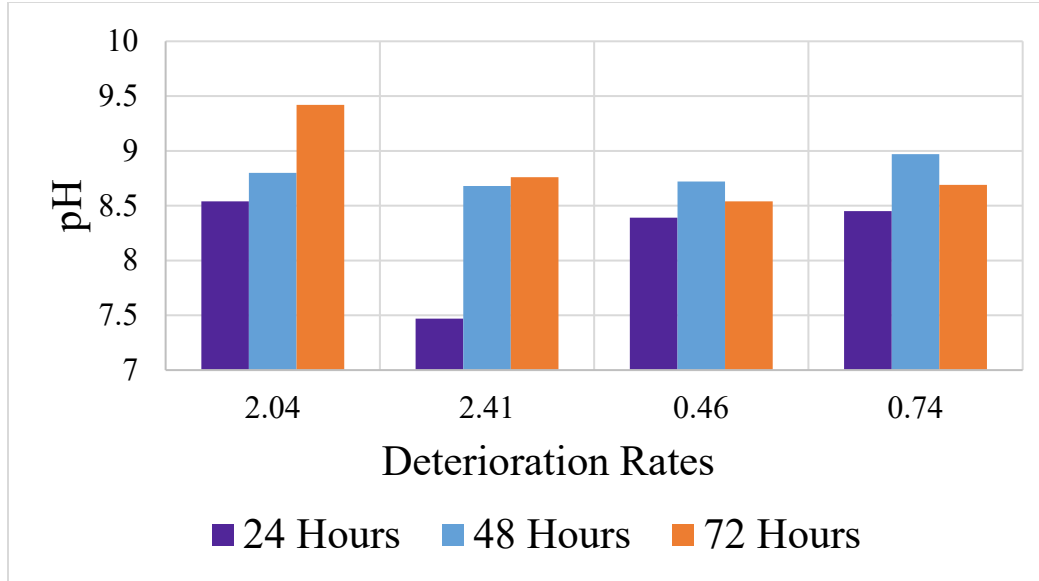
Figure 4.8: pH of Leachate

The pH measurements of the leachate samples were compared to the invert CMP deterioration per sample. The change of pH for each bath was compared by finding the standard deviation S_{pH} for each sample location. The standard deviation S is:

deterioration rate may prove to be a stronger indicator of deterioration than that of a typical resistivity test in the field.
