# Optimized Taconite-Based Pavement Repair Compound and Deployment System

**Lawrence Zanko, Principal Investigator**

Natural Resources Research Institute  
University of Minnesota-Duluth

Research Project  
Final Report 2019-46

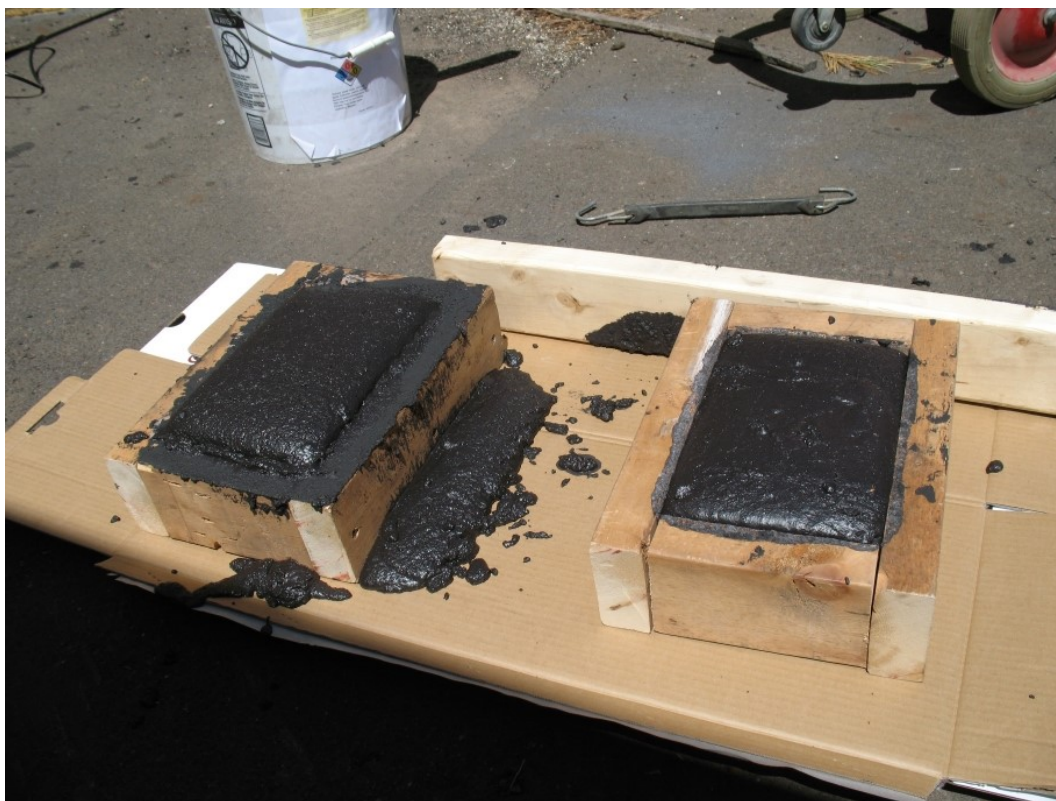
The repair compound continued to expand at the 13-minute mark (Fig. 2.11) and firmed at 17 minutes. The compound was likely “drivable” at the 23-minute mark.

**Figure 2.10 Filled forms (May 24, 2017).**

The expansion suggested that the repair compound could have “de-gassed” further before pouring to reduce in-repair expansion. Follow-up testing focused on techniques for reducing expansion to achieve a more wear-resistant repair.

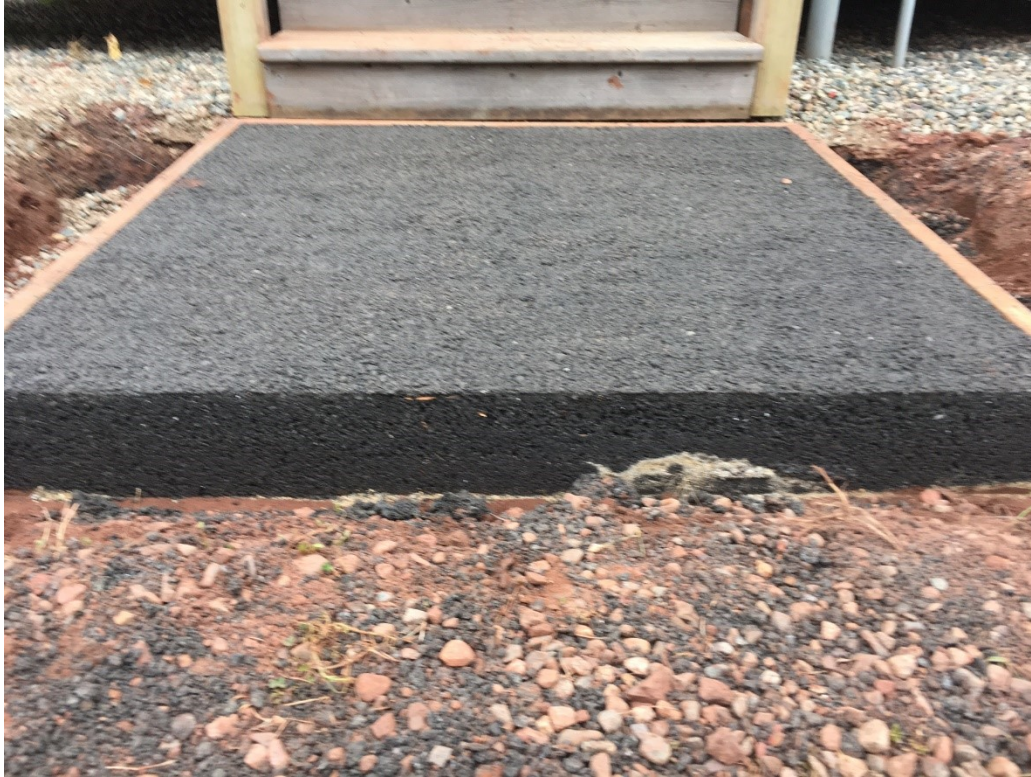
Figure 2.11 Sidewalk slab made from coarser lean ore formulation (October 2016).

- While its initial appearance looked good, the surface of the slab made from lean ore is breaking up. Its reactive aggregate gradation was probably too coarse and would likely have benefited from containing a higher percentage of finer reactive aggregate supplemented with concentrate.
- The slab made from the much finer tailings, baghouse fines, and concentrate formulation remains solid, with its surface exhibiting no break-up.

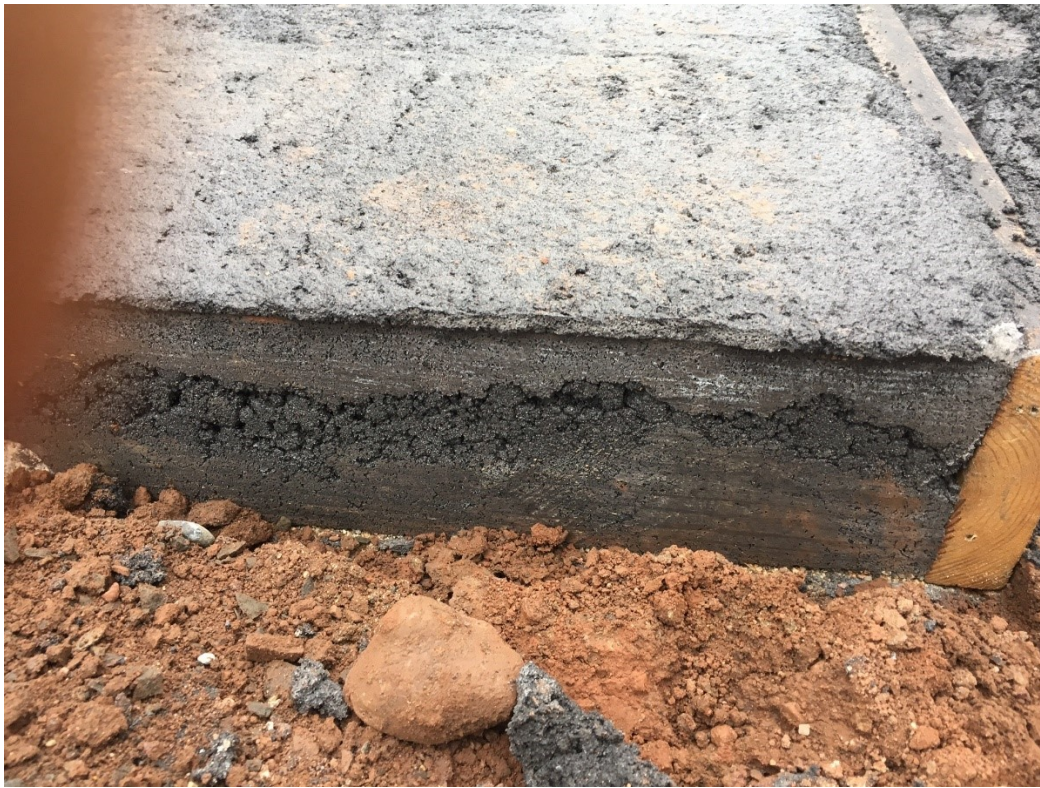
Figure 2.12 Sidewalk slab made from fine formulation (October 2016).

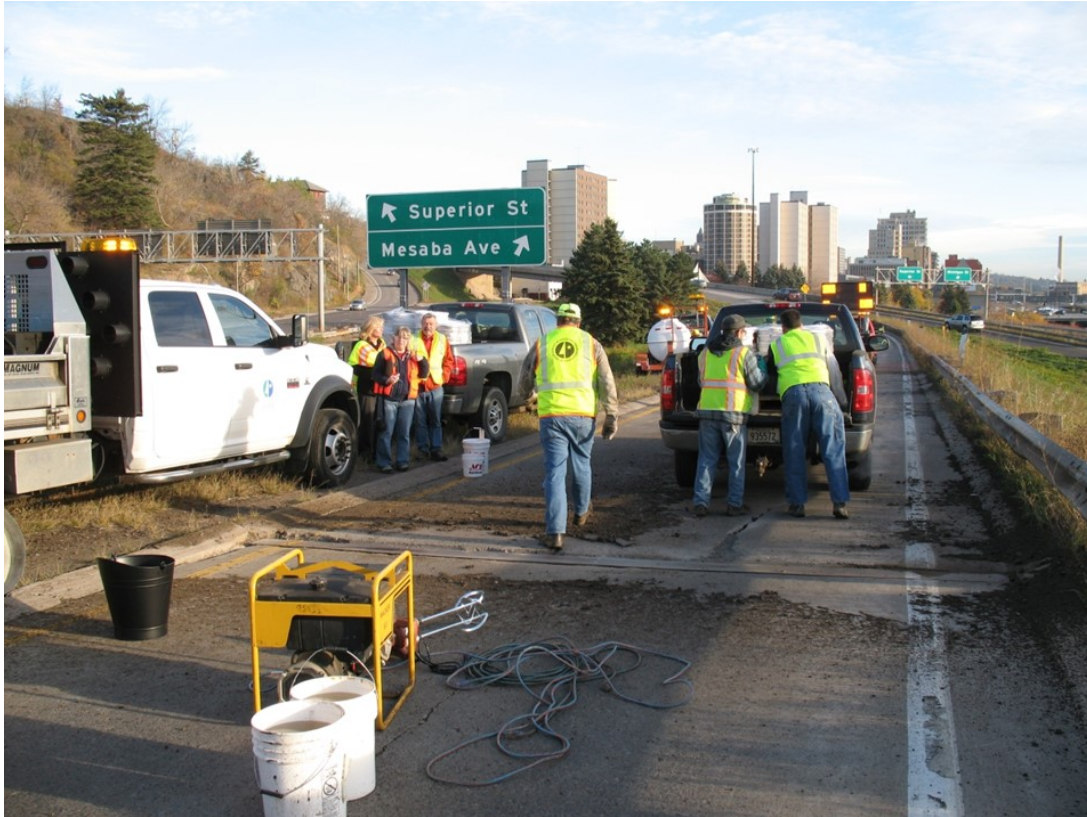
Figure 2.14 Initial field trial: Mesaba Avenue, Duluth - November 2, 2016.

The condition of the repairs was observed and documented following installation, revealing that the formulation needed further modification to improve performance and optimize set times relative to ambient pavement and air temperatures. Excessive expansion of the compound following placement in the repair can lead to a weaker product, especially at the surface. Abrasion and deterioration of the repairs occurred within a week, as Figure 2.17 shows, especially where the repair was thin and shallow. The repair compound is better suited for deeper/thicker repairs. Formulation modification is underway and continuing, as described previously.

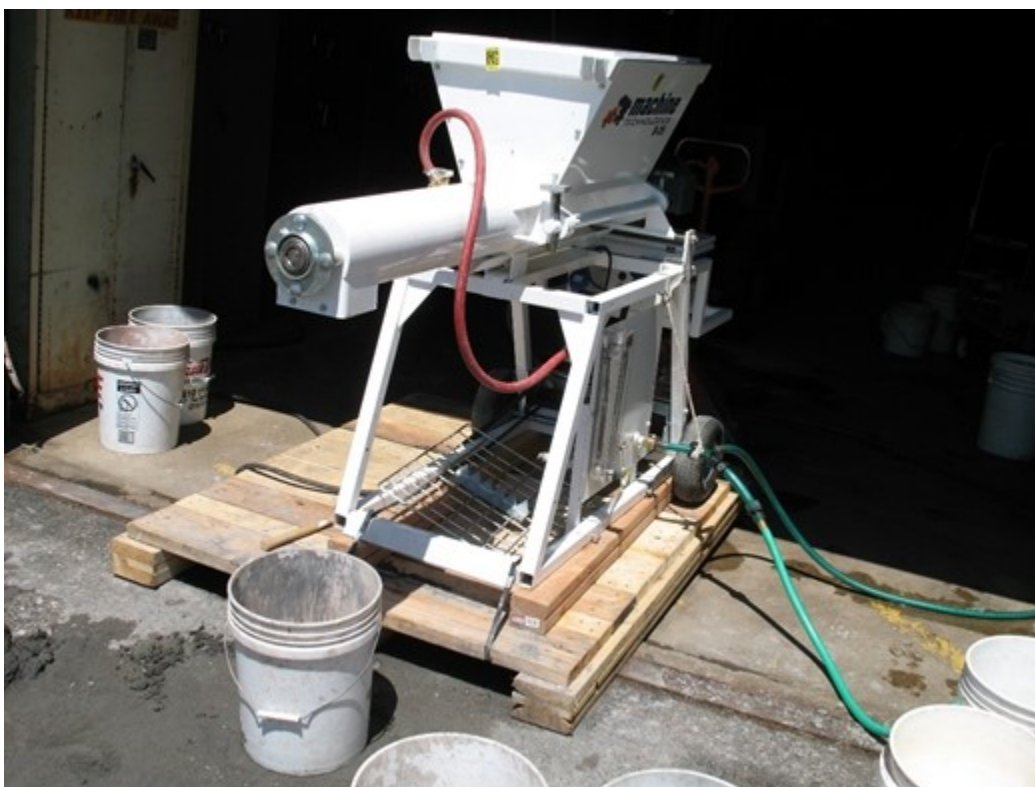
Figure 2.19 Continuous mixer test at NRRI, July 5, 2017.

The July 5, 2017, test proved unsatisfactory from a repair compound and equipment operation standpoint. A partial contributing factor was likely the high ambient temperature, which accelerated the repair compound's set time. Therefore, follow-up lab work in July and August focused on improving the repair compound formulation and mixing procedure. This work led to the development of a revised formulation and mixing procedure which resulted in a repair compound that behaved more predictably, with lab set times ranging from 15 to 40 minutes, depending on the ambient temperature conditions and liquid activator strength.

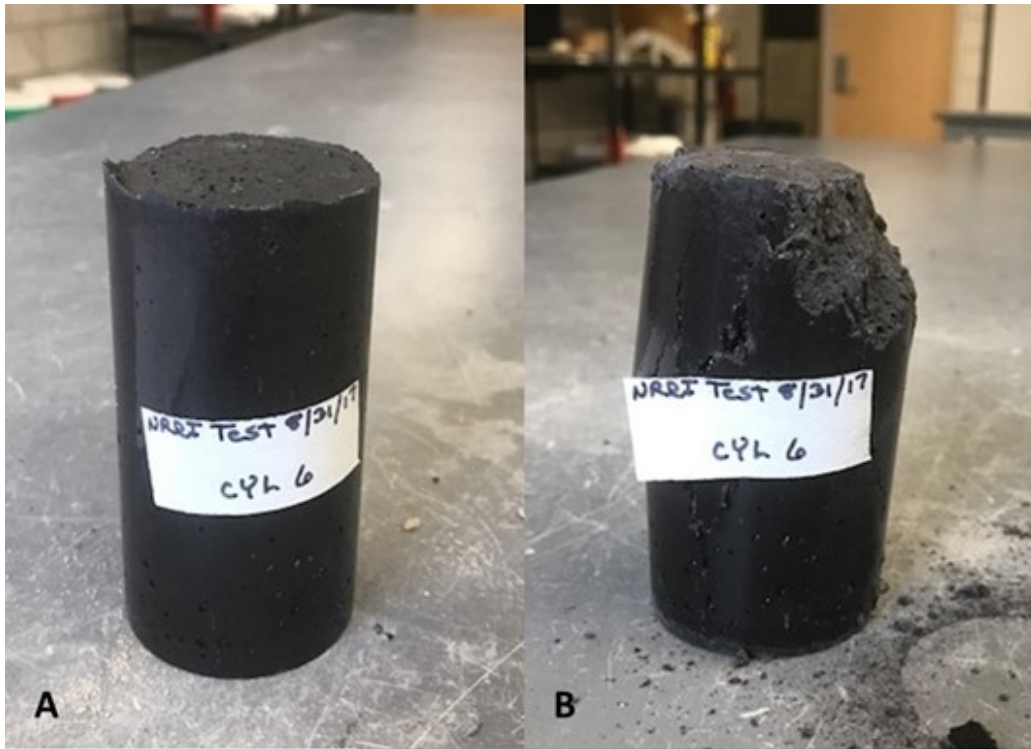
Fifteen (15) 2"-diameter x 4"-tall specimen cylinders were filled with the 8/31/2017 repair compound prepared in the paddle mixer and delivered to UMD's Department of Civil Engineering for uniaxial compressive strength testing at 1, 3, 7, 14, and 28 days. All tests were done in triplicate, except for one, which was a duplicate. Figure 2.21 shows before (A) and after (B) examples. Additional specimen cylinders made from previous formulation recipes were included for comparison. Compressive strength declined steadily from 1 to 3 to 7 days, then remained relatively flat from 7 to 28 days (Fig. 2.22).

Figure 2.20 2" x 4" test cylinders, before (A) and after (B) uniaxial compressive strength testing.

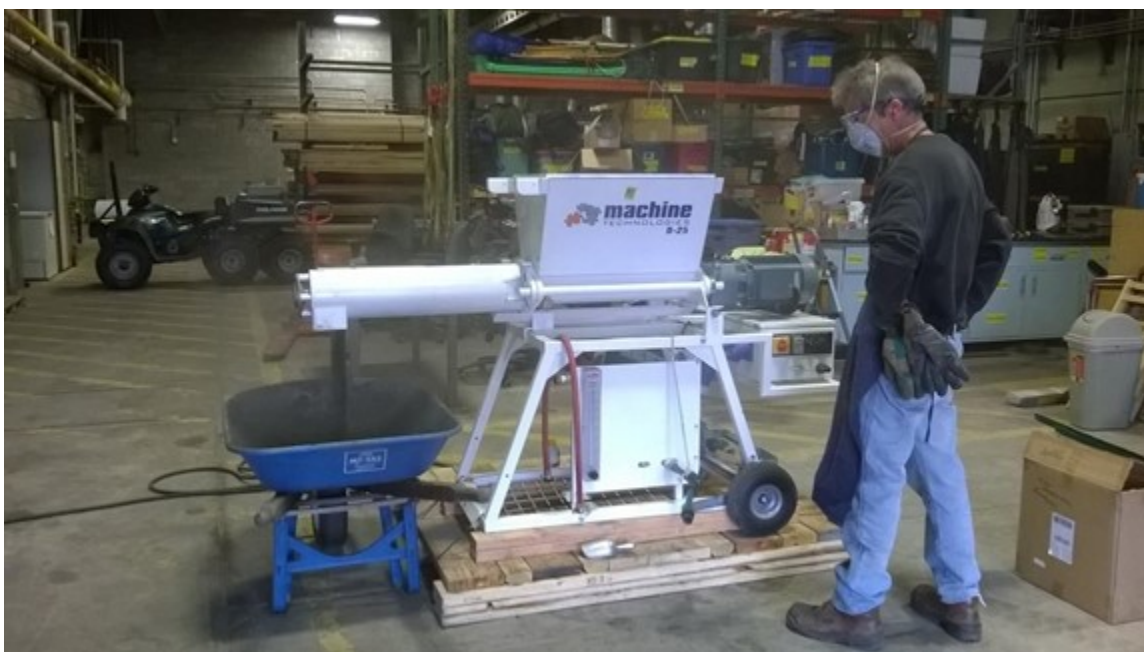
**Figure 2.23 Testing throughput of dry reactive aggregate in continuous mixing device, October 5, 2017.**

While the test was successful, it also re-confirmed this particular piece of equipment's operational challenges to the investigators. Primary concerns included: 1) the necessity of detaching, cleaning, and re-attaching the auger between batches; and 2) matching the right proportion of liquid activator to dry components on the fly. While technically doable, both actions add operational complexity to a process that should be kept as simple and straightforward as possible for a maintenance crew. Furthermore, if either (or both) is done incorrectly, delays and/or unsatisfactory repairs could be the result. The test also showed that the hopper must contain enough material to completely cover the mixing tines and

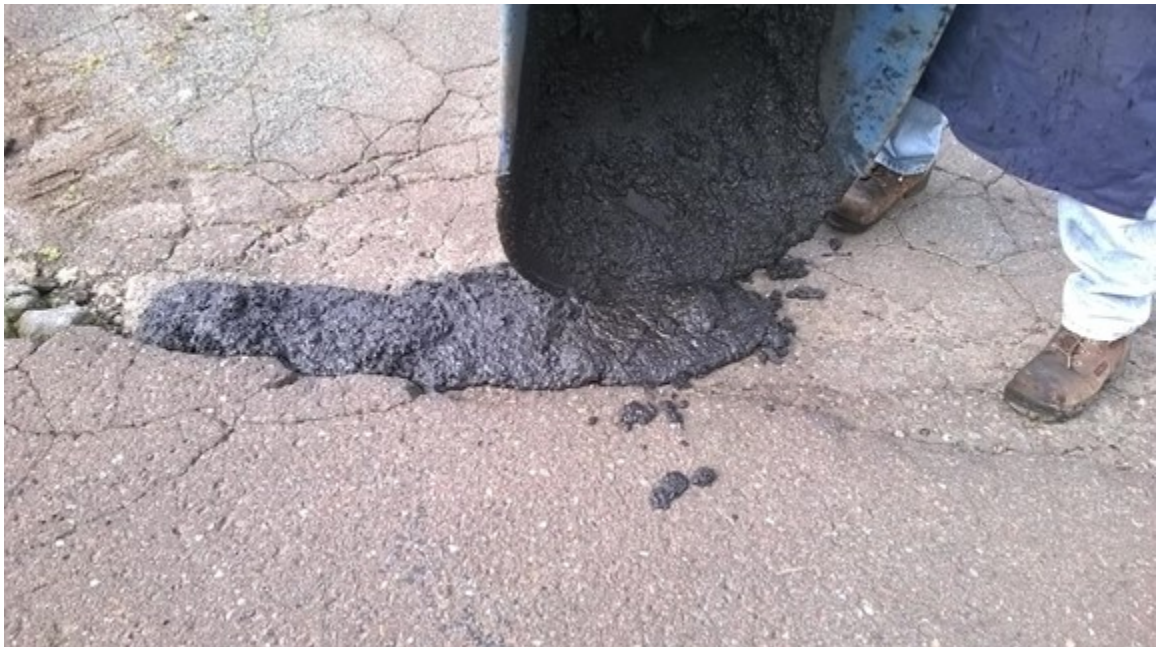
Figure 2.26 Pouring October 5, 2017, test repair in NRRI parking lot.

Following pouring, the mixture was workable and “screedable” for about two minutes before it started to firm. The total time from initial mixing in the paddle mixer to a “drivable” (set) repair was about 15 to 18 minutes. The air and the pavement temperatures were about 60 ° F. The investigators have concluded that the cooler the ambient air and pavement temperatures, the longer the workability and set time. Under warmer conditions, the workability and set time would be somewhat shorter. The condition of this and other project test repairs was followed and documented throughout Task 2 and is presented in Section 3.

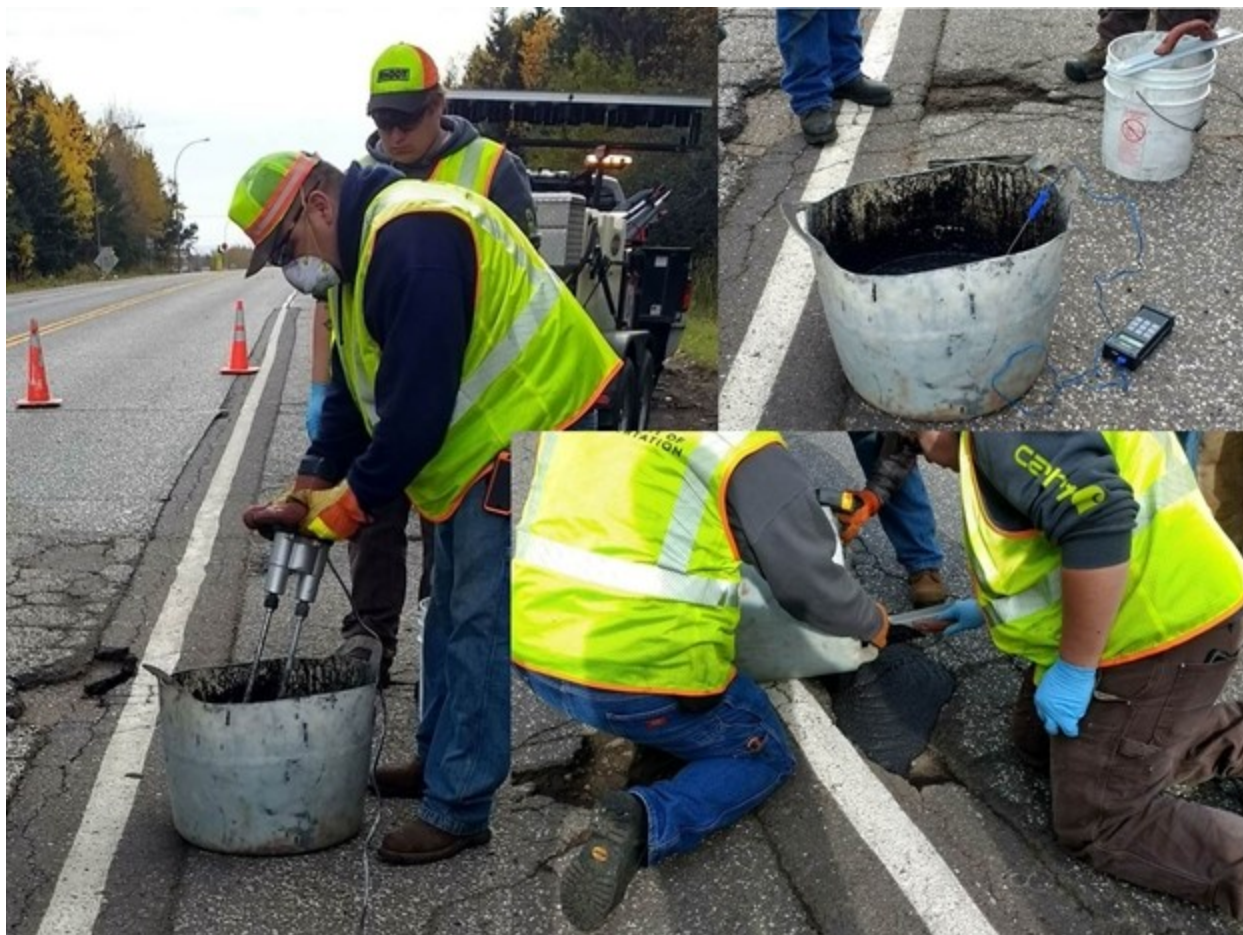
**Figure 2.32 MnDOT crew preparing and installing repair compound, October 18, 2017.**

All repairs were estimated to be drivable within 15 to 20 minutes. The entire field deployment test went smoothly and gave the investigators additional insights and ideas. Importantly, the field results closely matched what the NRRI's preliminary lab and parking lot tests had predicted.

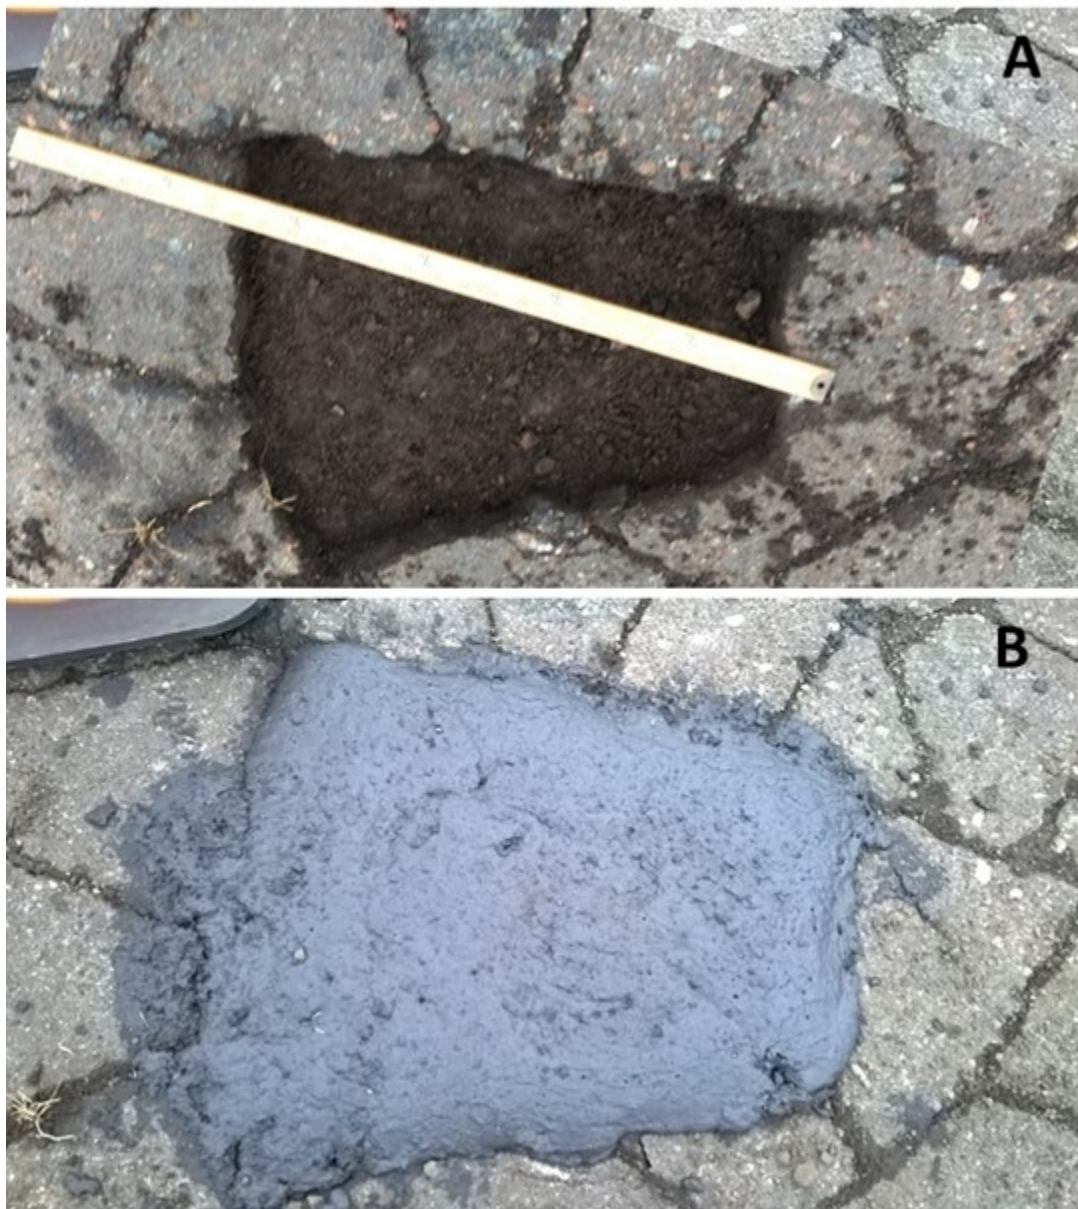
**Figure 2.35 October 31, 2017, cold temperature pothole repair test at NRRI; before (A) and after (B).**

On October 31, 2017, the first larger-scale cold temperature test repair was performed in the NRRI rear parking lot by removing a section of alligatored asphalt pavement to “make” a pothole. The hole measured approximately 14 in wide x 20 in long x 2 in deep. Because only a single layer of asphalt was put down in this section of the parking lot, the base of the hole was compacted gravel, not asphalt. Figure 2.36 shows the pothole pre- (A) and post- (B) repair. The pavement temperature was 32 ° F (0 ° C), the liquid activator 45 ° F, and the dry reactive aggregate components 38 ° F. The center of the repair

firmed up in about 30 minutes but was softer nearer the edges. The edges began firming up in about 45 minutes. Overall, the repair took about 60 minutes to reach a drivable state.

As reported previously, this was the first larger-scale cold temperature test repair performed in the NRRI rear parking lot. The pavement temperature was 32 ° F (0 ° C), the liquid activator 45 ° F, and the dry reactive aggregate components 38 ° F. The hole measured approximately 14 in wide x 20 in long x 2 in deep. The base of the hole was compacted gravel, not asphalt (see Fig. 2.36). To reiterate, the center of

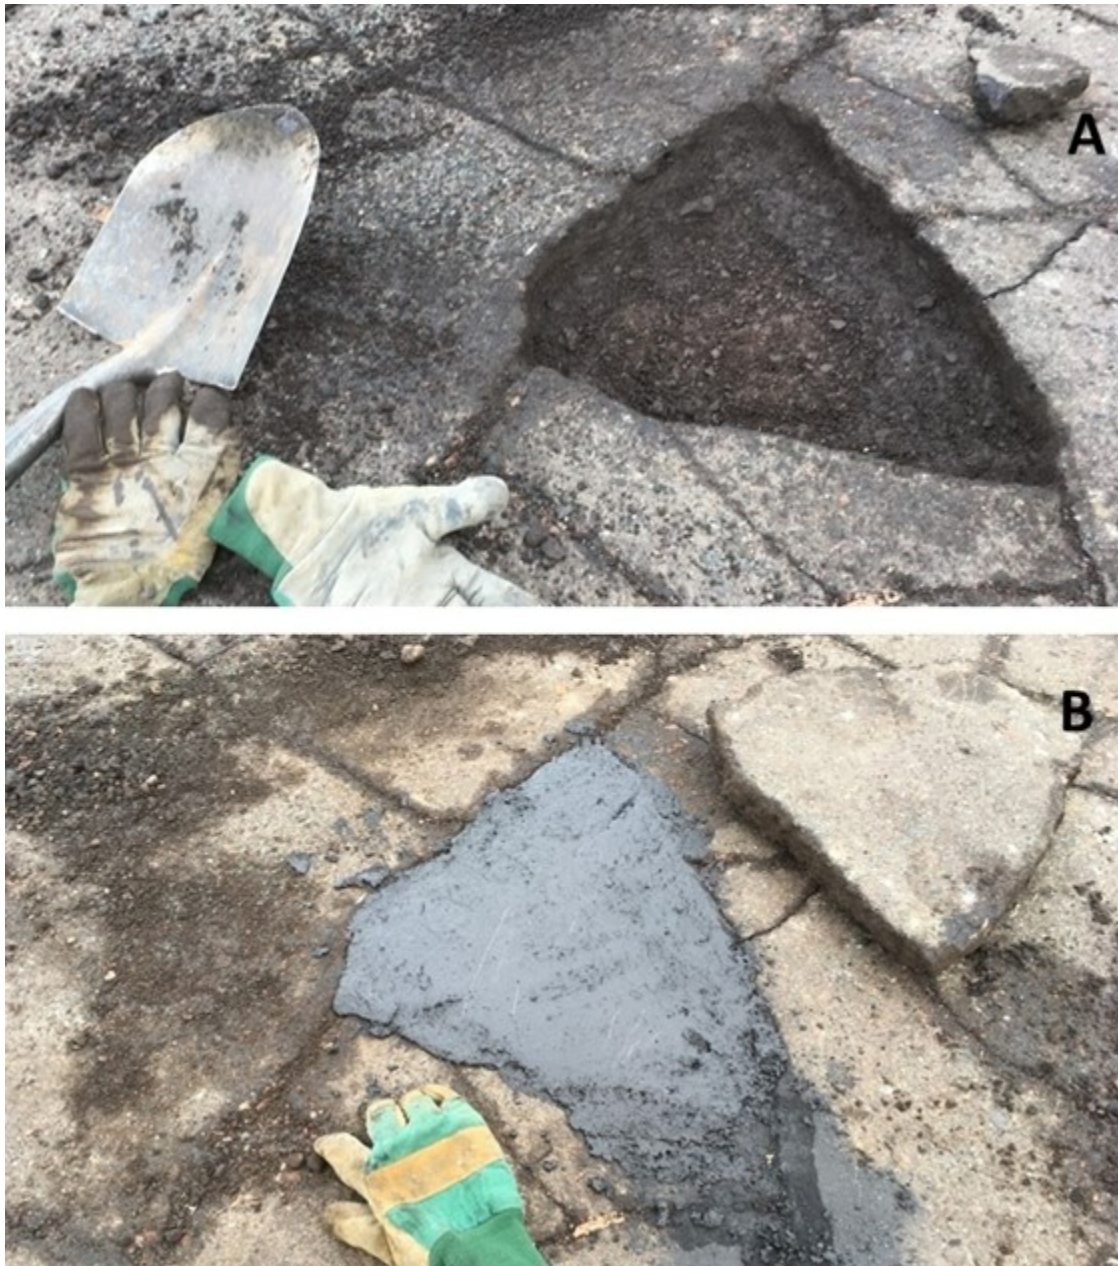
**Figure 2.36 November 20, 2017, cold temperature pothole test at NRRI; before (A) and after (B).**

A second cold weather repair was done on November 20, 2017. An 18 in to 24 in x 2 in-deep triangular pothole was again “made” in the NRRI rear parking lot (Fig. 2.37). Some asphalt remained near the perimeter at the bottom of the hole, while gravel was exposed at the hole’s center. The repair was made when the ambient temperature was in the mid-30s ° F. Frost was also visible in the bottom of the hole. This time, the dry and liquid components were mixed for two minutes in a five-gallon bucket at their ambient (indoor) temperature of 61 ° F; the bucket was then placed outside and monitored for

The bucket was wheeled to the pothole and poured at the 10-minute mark. The temperature of the bottom of the hole was 37 ° F. The mixture was soft and workable for about 2 minutes, and a temperature probe was inserted at the 12-minute mark. The repair temperature peaked at about the 15-minute mark. The center of the repair was firm at about 19 minutes but still somewhat soft at the edges. It was estimated that the repair was probably drivable at about the 35-minute mark.

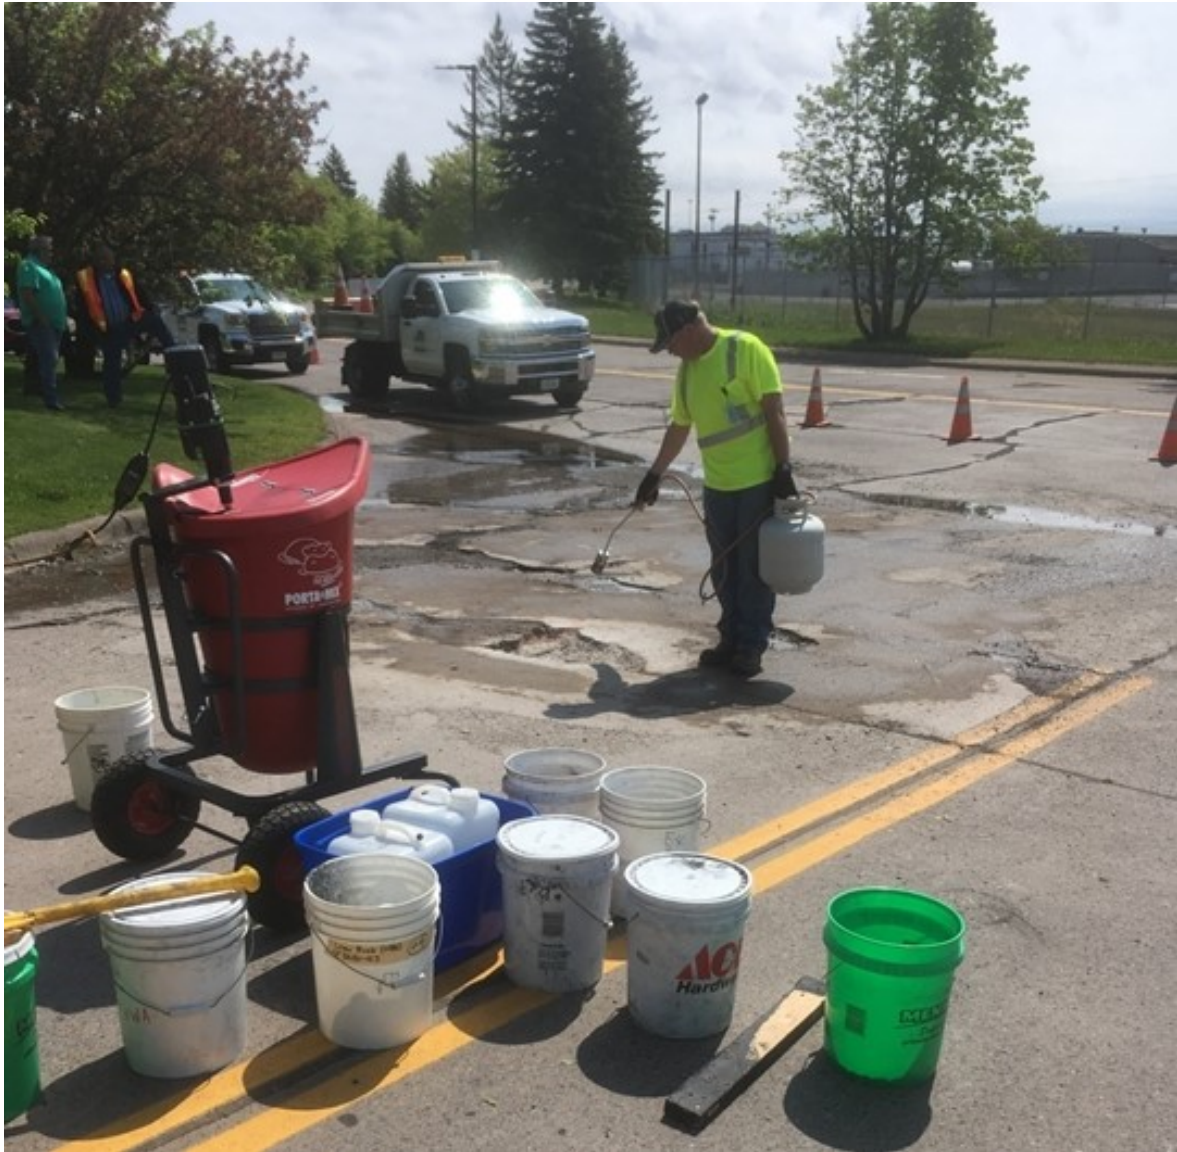
**Figure 2.41 Pothole repair setup and preparation, June 6, 2018, Duluth field trial location.**

Zanko and Drazan used shovels and hoes to remove loose material from the holes and to make vertical to slightly inclined edges for the potholes. The slight incline (edge bottom being in further than the top) allows for a stronger bond between repair materials and the surrounding road. Duluth public employees

prepped each pothole by removing loose gravel, dirt, and debris, flushed out excess water with a leaf blower, and dried the potholes with a propane torch (Fig. 2.42).

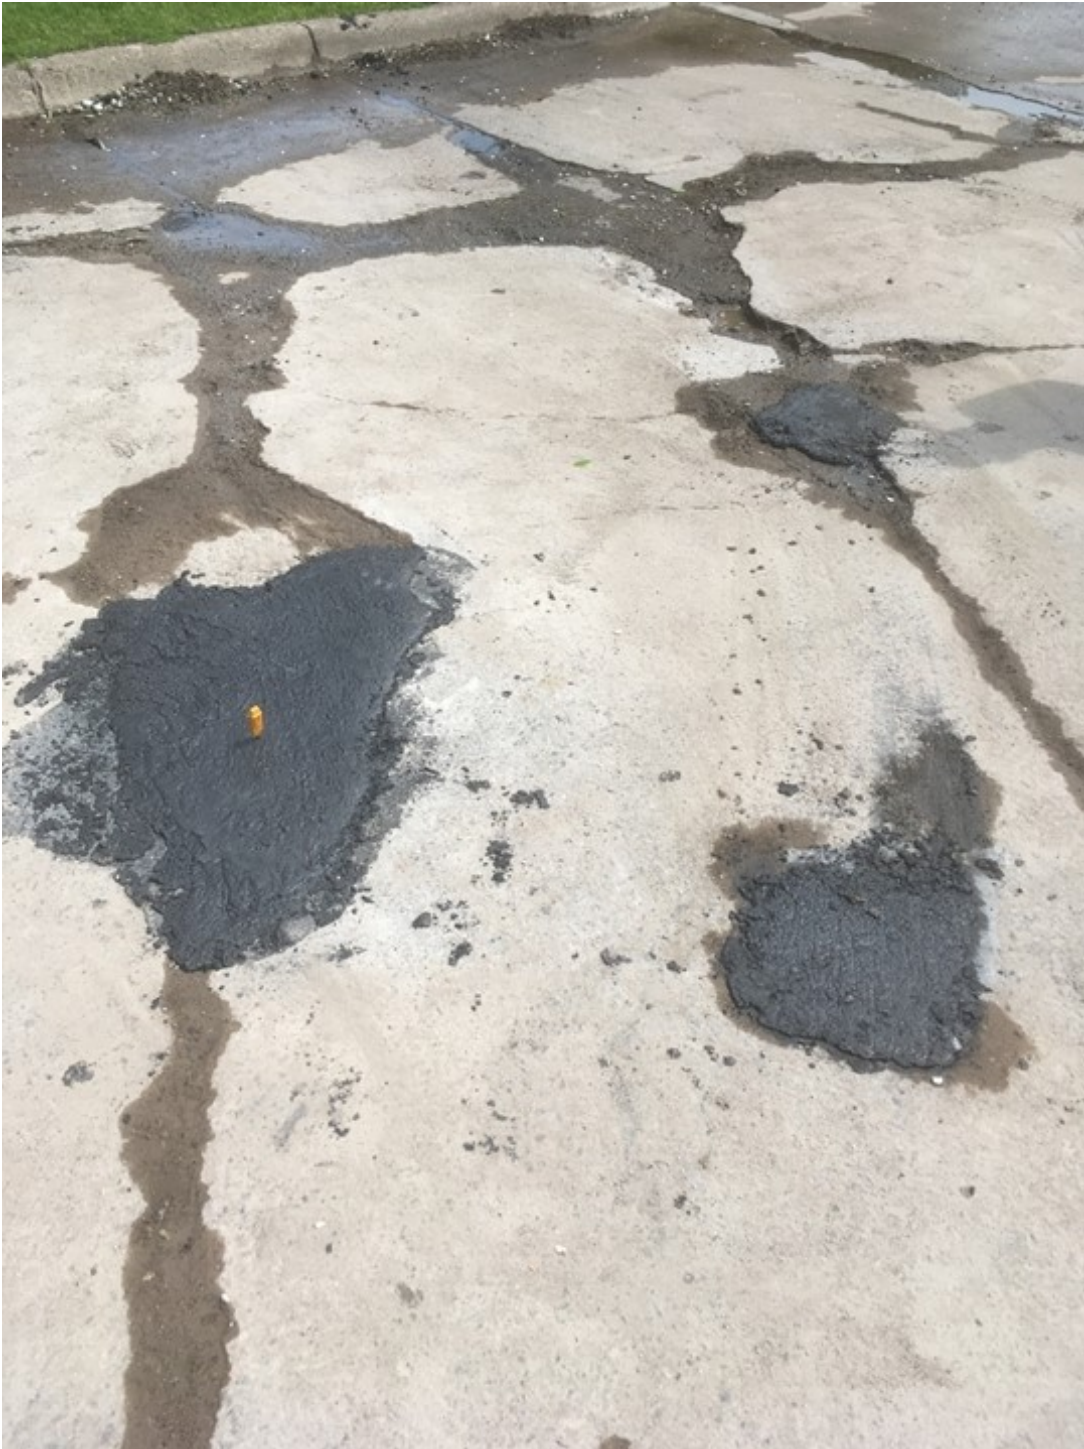
**Figure 2.42 Finished Batch 2 repairs: June 6, 2018, Duluth field trial location.**

Batch 2 contained activator liquid (27 lb) and reactive mineral material (150 lb), which included a small amount (15 lb) of a mineral byproduct fines additive. Again, the liquid activator was poured into the Mega Hippo first and mixed for approximately 30 seconds. For Batch 2, the byproduct mineral fines (15 lb) were poured into the Mega Hippo containing the liquid activator and mixed for another approximately 30 seconds until well mixed. The reactive mineral material was poured into the mixer using two (2) five-gallon buckets containing 50 lb and 35 lb of material, respectively. This mixer was run for approximately 1.5 minutes. The lid and spin blade were removed, while the spin blade was placed into a five-gallon bucket containing water for cleaning. The Mega Hippo was transported to the large pothole. Zanko used the tilt-and-pour method as Drazan used a paddle to spread and remove the mixer from the Mega Hippo. The Batch 2 mixture looked and moved more thickly than Batch 1. The mixture was thicker and slightly clumpy coming out of the Mega Hippo. The thicker consistency of the Batch 2 mixture was likely attributable to the additional byproduct mineral fines. Batch 2 timed at approximately 15 minutes from the addition of the reactive mineral material to the Mega Hippo mixer to setting, and approximately 10 minutes from being poured into the pothole to setting. The setting of the pothole repair compound seemed to move more quickly in comparison to the smaller pothole. No

inconsistencies of setting/drying were noticed for Batch 2. The pothole repair increased in temperature more quickly than the small pothole (approximately 5 minutes) to reach 101 ° F and plateau. Excess mixer material from Batch 2 was used to fill smaller potholes adjacent to the large pothole (Fig. 2.43). These were not monitored as closely since they were not prepped as scrupulously as the first two pothole repairs.

The performance and condition of the remaining repairs at the Chestnut Street and Truck Center Drive field trial location has ranged from good to excellent. Two representative examples are shown in Figure 2.79 (June 6, 2018 repair) and Figure 2.80 (September 27, 2018 repair). Refer back to Figures 2.43 and 2.49 to view the respective freshly completed repairs.

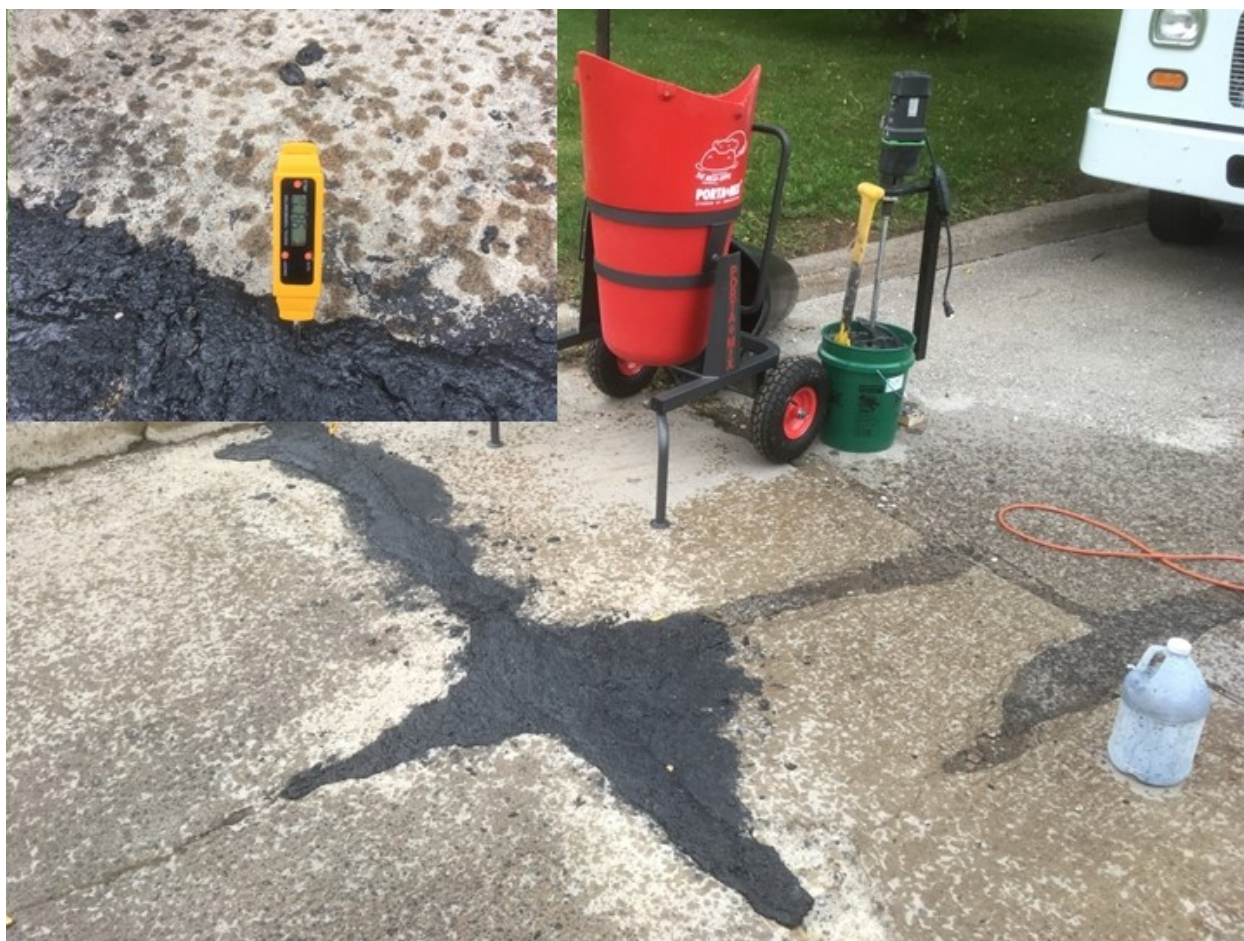
A combination field demonstration/media event with the city of Duluth took place on Thursday, September 27, 2018, using two updated repair formulations, again at the Chestnut Street and Truck Center Drive location (refer to Fig. 2.41). Repairs were again performed in the street's concrete pavement in linear failures that formed between panels. The failures were from 2- to 3-in (5 to 7.5 cm) deep and varied in width. Two (2) 50-lb batches of dry reactive mineral material were used to fill about 0.85 ft<sup>3</sup> of pavement failures. Each 50-lb batch was mixed with 9 lb of liquid activator (18% by weight). Following their placement, the two repair formulations set to a probable drivable state within about 15 minutes. The air temperature was 59 ° F (15 ° C). The internal temperature of the repairs peaked at about 100 ° F (38 ° C), which coincided with a "drivable" set. The temperature and set time result correlated well with prior laboratory testing. Figure 2.49 shows the final repair, with the inset showing the temperature.

**Figure 2.48 Completed repair: September 27, 2018, Duluth field trial location (inset showing curing temperature).**

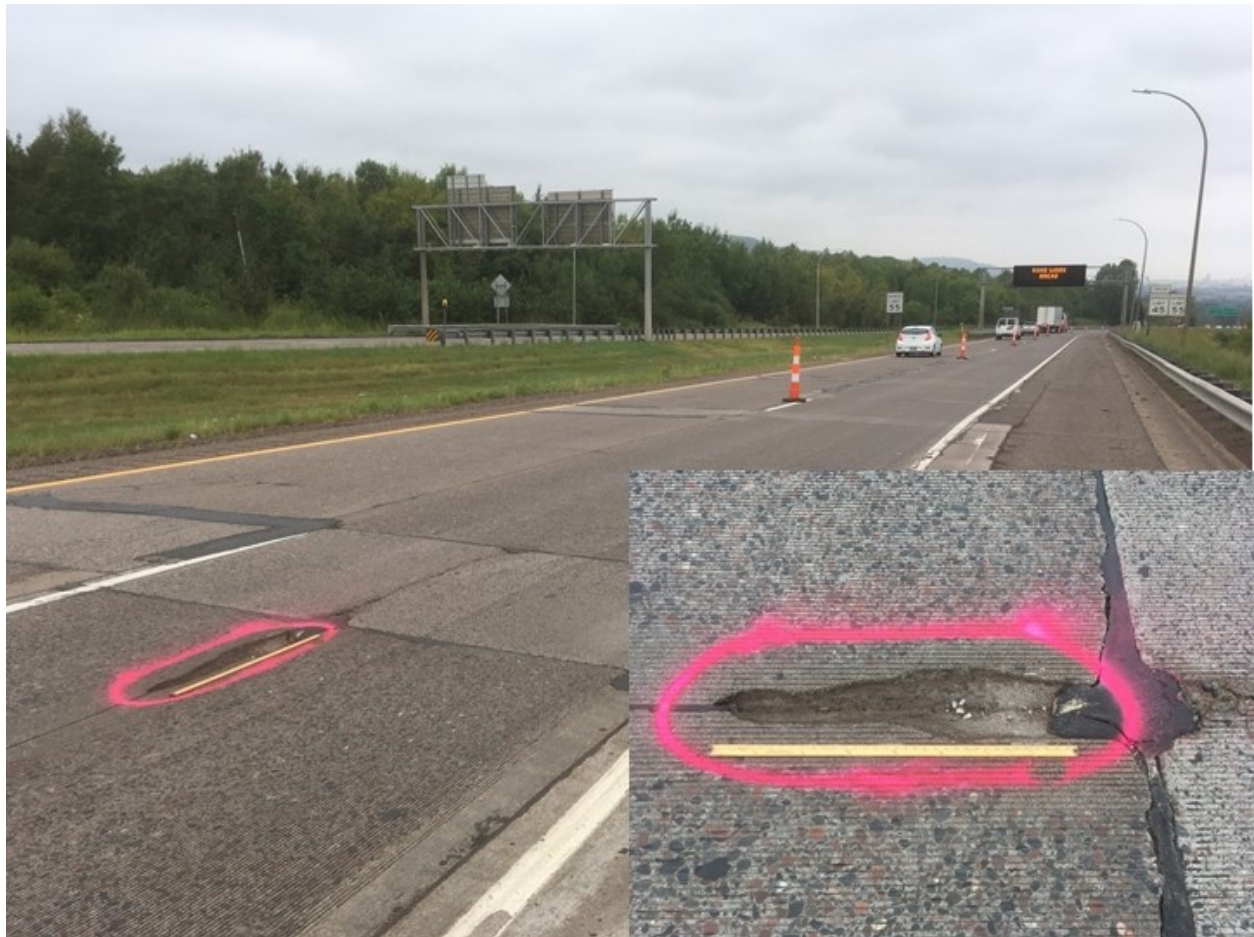
In late August 2018, prospective repair locations on the Thompson Hill to Central Avenue portion of I-35 in Duluth were discussed with MnDOT D1 personnel and were identified, photographed, and marked for potential future repair (Fig. 2.53). It was originally thought those repairs would be done in the fall of

**Figure 2.52 Potential southbound I-35 repair: Thompson Hill, Duluth (inset shows detail).**

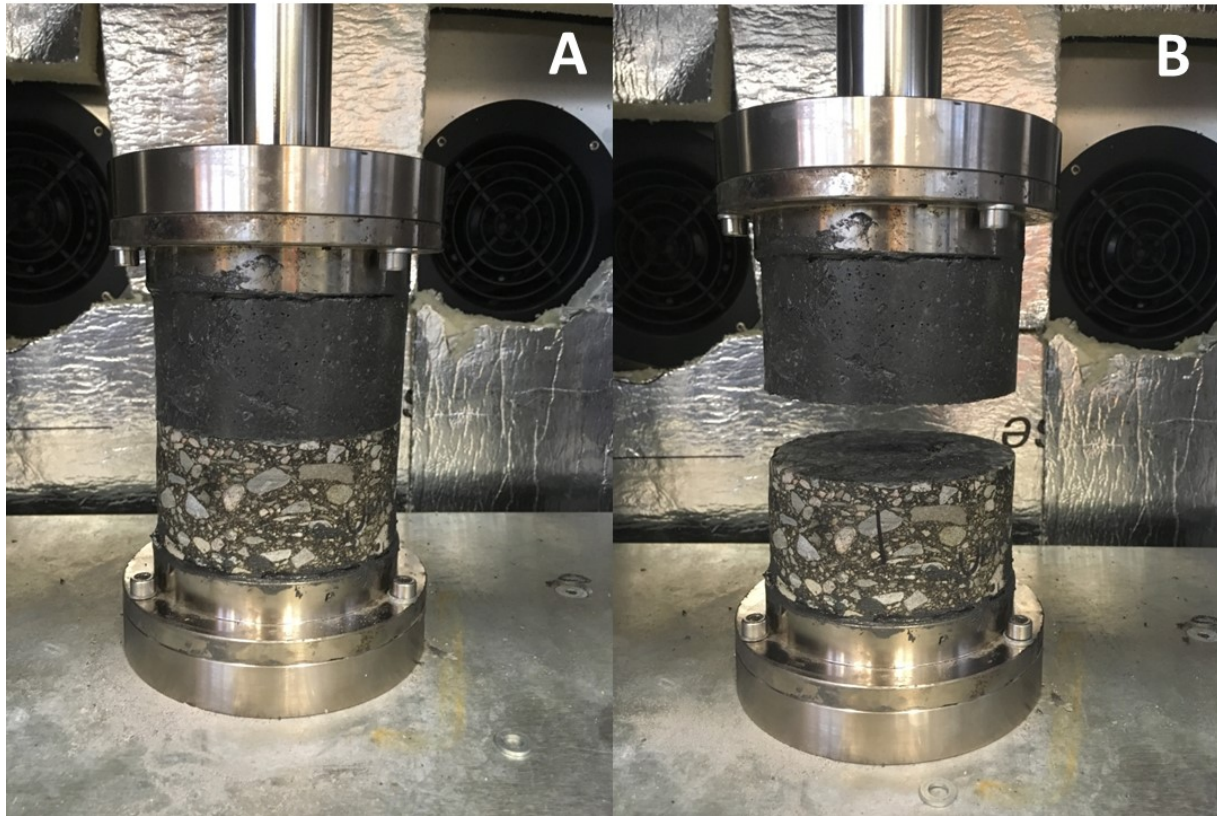
**Figure 2.55 Bond strength testing apparatus and specimen (road patch material topping asphalt pavement core): before (A) and after (B).**

As reported by the UMD postdoc investigator, two of the three samples broke at the interface, while one sample broke in the asphalt portion. The test was very quick (within a second), and the peak load to break the bond was around 3-4 kN (675-900-lb force). It was observed that the asphalt test specimens were probably too smooth (diamond-sawn face) and were not necessarily a good representation of real-world (field) conditions. A typical pavement (or pothole) would have a rougher surface texture.

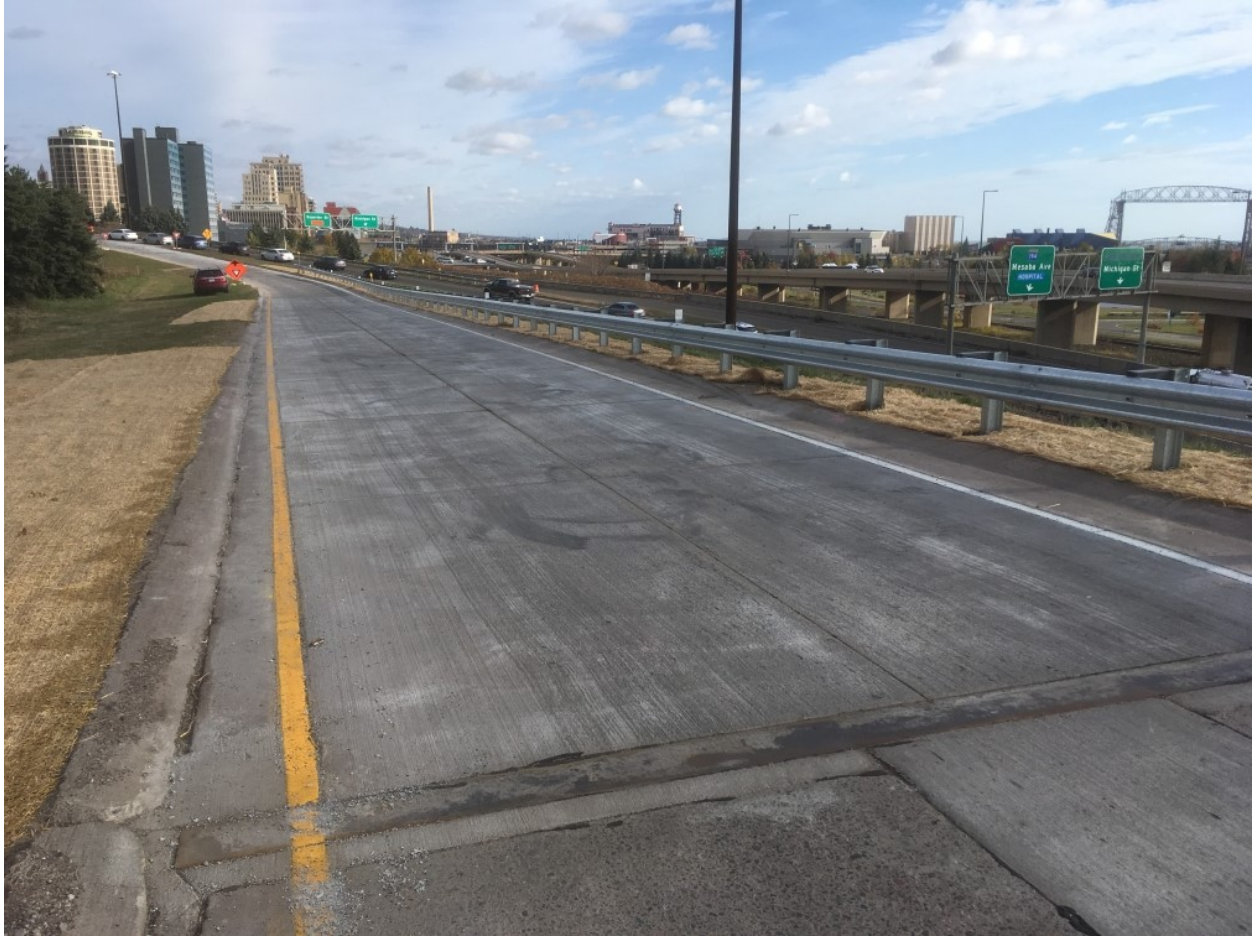
Figure 2.61 is informative because it suggests that the two repair types, in combination, could make for a good quality repair system. Nearly all of the repairs were paved over during a rehabilitation of Mesaba Avenue during the summer of 2018 (Fig. 2.62).

**Figure 2.61 Rehabilitated Mesaba Avenue pavement as of October 19, 2018.**

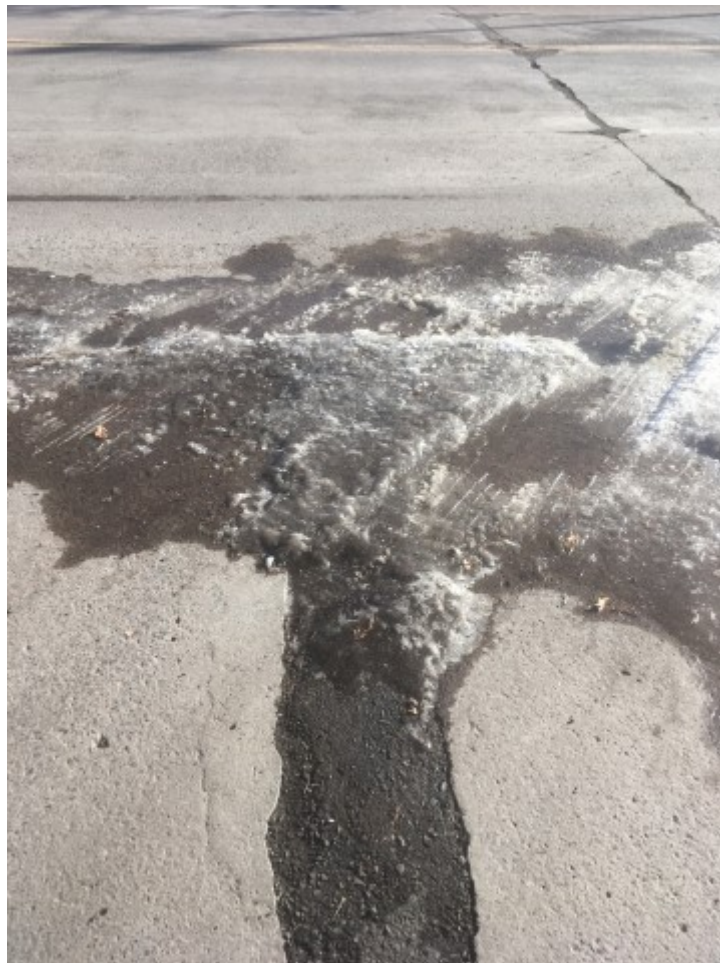
As Figure 2.75 shows, the condition of the repair on October 2, 2018, was good. A follow-up inspection on November 17 confirmed the problematic (wet) conditions at this location, which were present at the time of the June 7 installation. Aside from the location's slow drainage and tendency to pond precipitation, the location also received input of water from an "upstream" water leak originating on Truck Center Drive. As Figure 2.76 shows, the taconite-based repair was completely covered with ice on November 9, 2018.

**Figure 2.75 Ice-covered condition of June 7, 2018, Duluth field trial repair on November 17, 2018.**
