# Optimized Taconite-Based Pavement Repair Compound and Deployment System

**Lawrence Zanko, Principal Investigator**

Natural Resources Research Institute  
University of Minnesota-Duluth

Research Project  
Final Report 2019-46

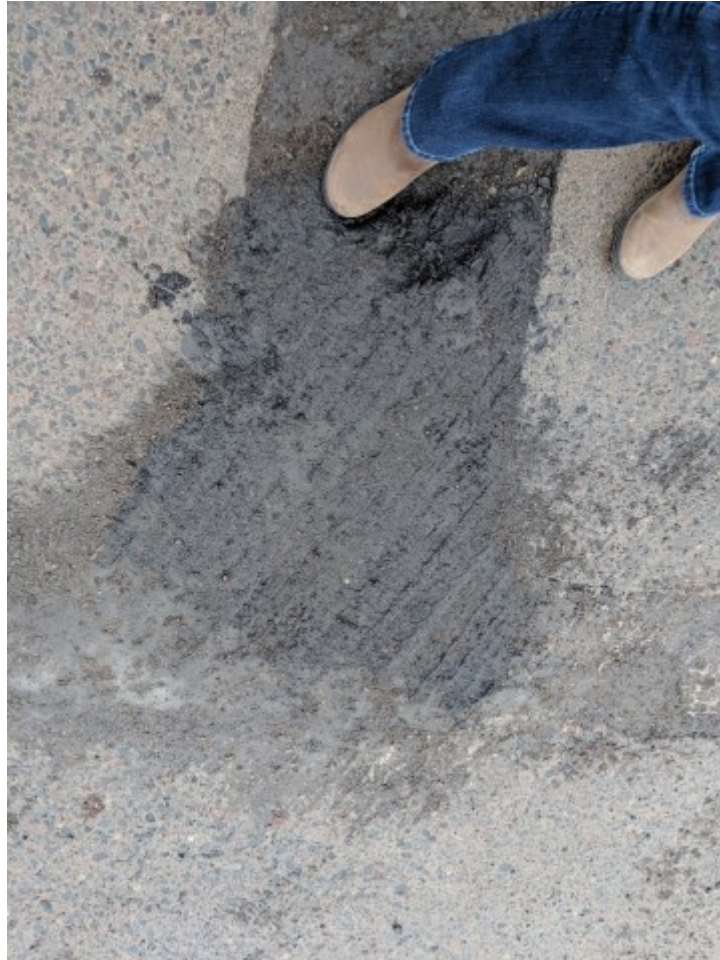
It was not until the next inspection took place – performed under drier conditions on December 12, 2018 – that the deteriorating condition of the repair was revealed (Fig. 2.77). As the tire tracks and footprint show, the surface of the repair had softened considerably in the intervening month.

**Figure 2.76 Condition of June 7, 2018, Duluth field trial repair on December 12, 2018, showing deterioration.**

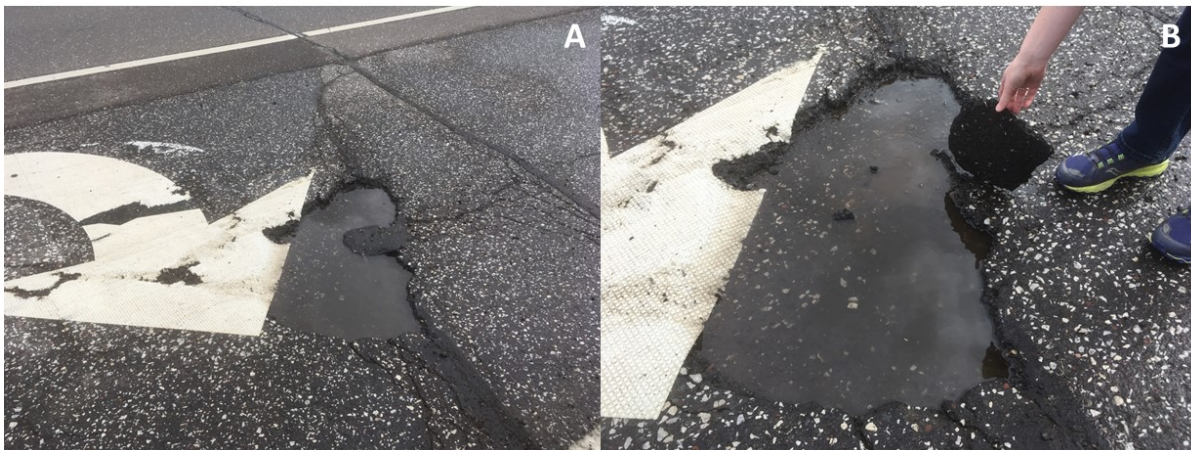
The size and condition of the target pothole was inspected on August 20, 2018, and is shown in Figure 2.84A and B. It appears delamination of the upper lift of asphalt pavement from the underlying lift led to the formation of the pothole. Note the loose piece of patch material remaining from an earlier repair (Fig. 2.84B). The dimensions of the pothole were measured, and its volume was estimated at 0.9 cubic feet.

**Figure 2.83** Pre-repair condition of pavement (A) and loose nature of remaining repair (B) in turn lane at the U.S. Highway 53 field trial location.

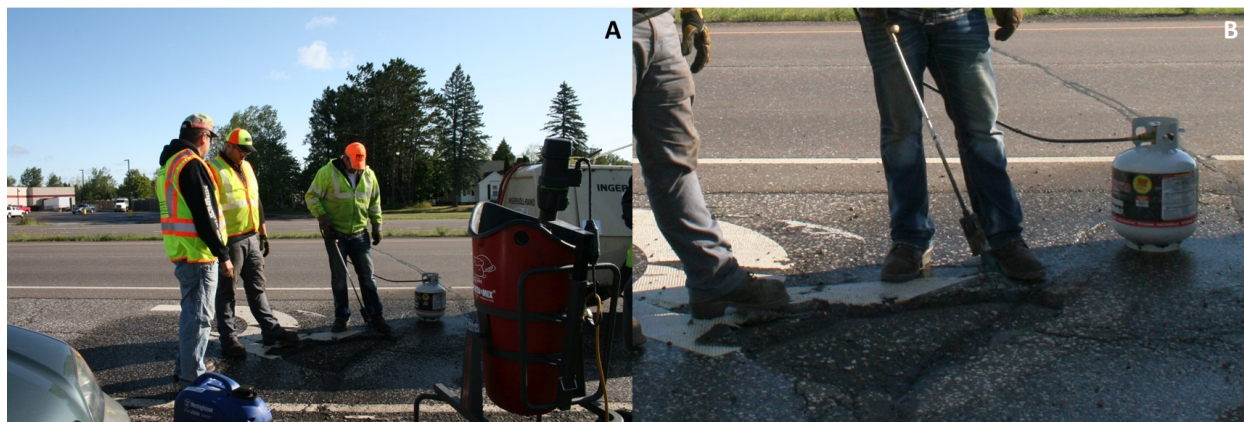
**Figure 2.84 MnDOT District 1 crew preparing pothole for repair (A) and driving moisture from the pothole with a propane torch (B).**

MnDOT District 1 personnel prepared the pothole by removing loose debris with high-pressure air and driving out excess moisture with a propane torch (weed burner) (Fig. 2.85A and B).

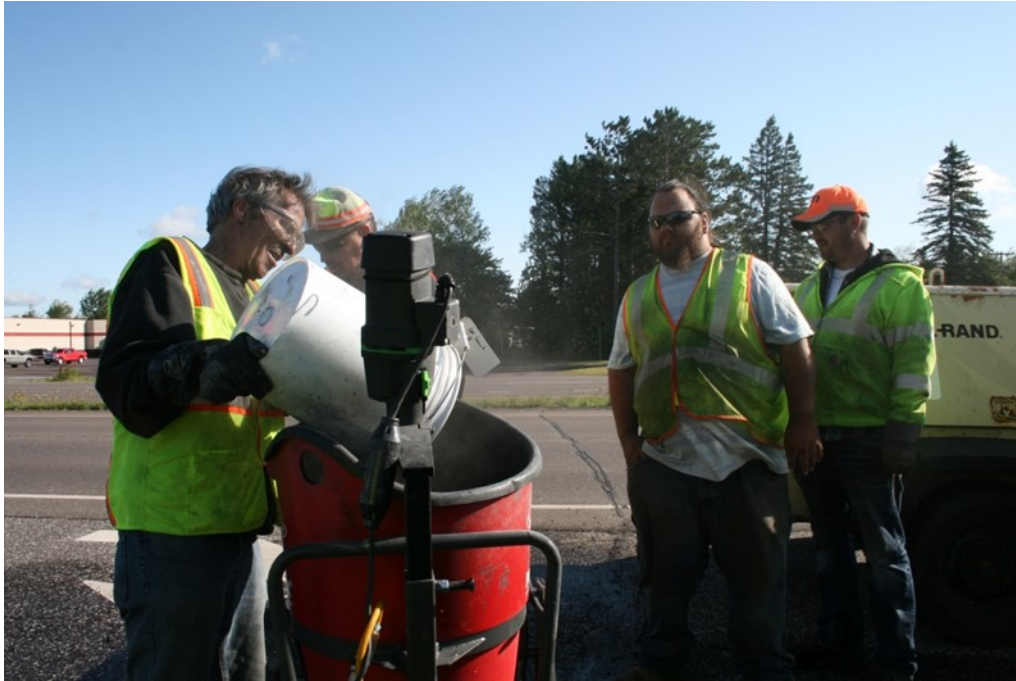
Figure 2.85 Adding and mixing repair compound components at the U.S. Highway 53 field trial location.

Mixing commenced by first placing 21.6 lb of liquid activator (18% of 120 lb) in the mixer’s flexible liner and starting the mixer. The two supplemental mineral components were then added to pre-mix with the liquid activator, followed immediately by the taconite components. (NOTE: Under normal circumstances, all dry mineral components would be pre-blended and added in 40-lb increments together.) The mixer was run for about 1 minute (Fig. 2.86). The mixing apparatus was then removed from the mixer, with the mixing blade end placed in a five-gallon bucket of water. This step makes the mixing end easy to clean and prevents the compound from hardening on the blades. The repair compound was allowed to “rest” for two more minutes as the exothermic reaction between the mineral components and liquid activator took place. A small amount of gas (hydrogen) is generated by the reaction and causes the mixture to expand slightly, like rising bread dough. A large plastic mixing spatula was used to give the repair compound a final “de-gassing” stir before tipping the “Mega Hippo” mixer to dispense the compound into the hole (Fig. 2.87). A short length of a wood 2 x 4 was used to spread and

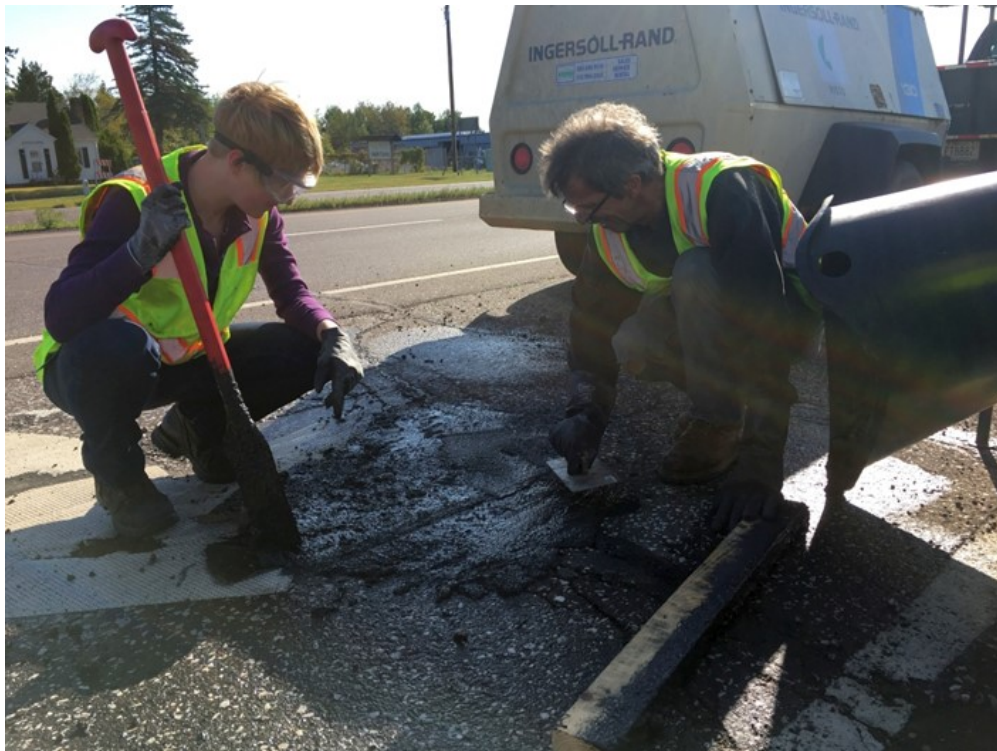
Figure 2.87 Finishing the completed repair at the U.S. Highway 53 field trial location.

level the compound, and a metal mortar spatula was used to smooth the repair's surface (Fig. 2.88). The repair began to set within 6 minutes of initial mixing and likely could have accepted traffic in about 10 minutes. Photographs taken with a thermal imaging camera before (Fig. 2.89A) and after (Fig. 2.89B) placing the repair compound to illustrate the exothermic nature of the reaction. The surface temperature of the repair compound at the time the image was taken had risen by 13.2 ° C (23.8 ° F), to 29.1 ° C (84.4 ° F).

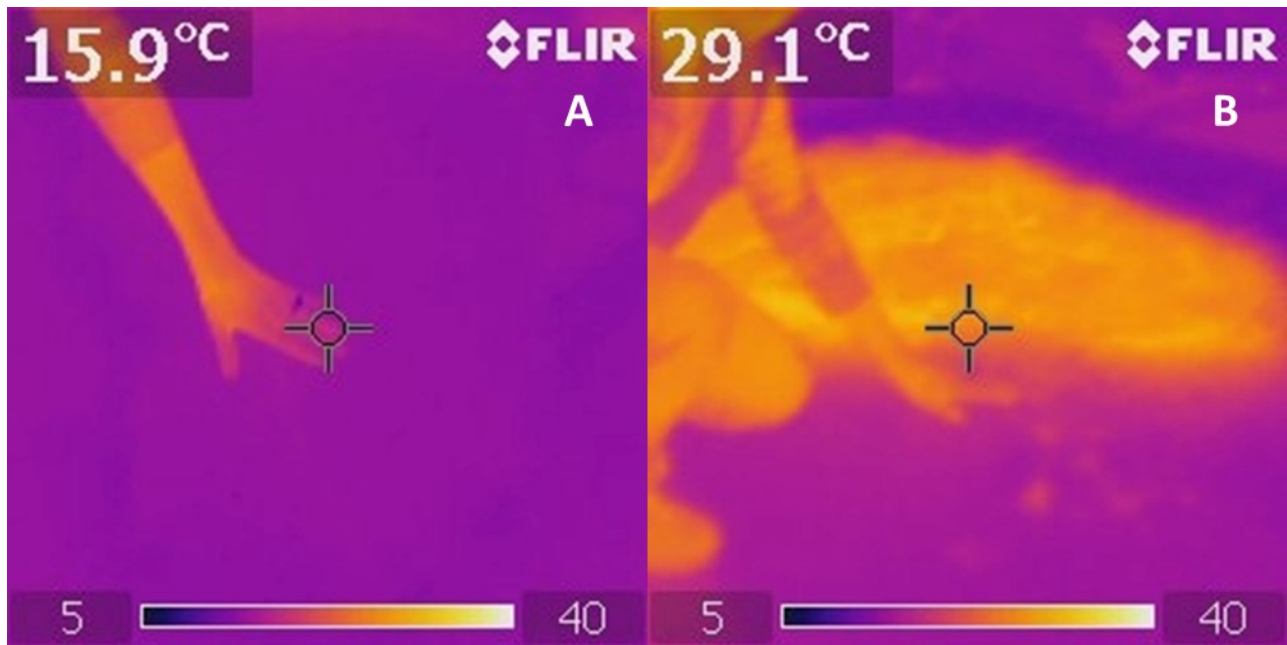
**Figure 2.88 Thermal images of temperature before (A) and after (B) repair compound placed at the U.S. Highway 53 field trial location.**

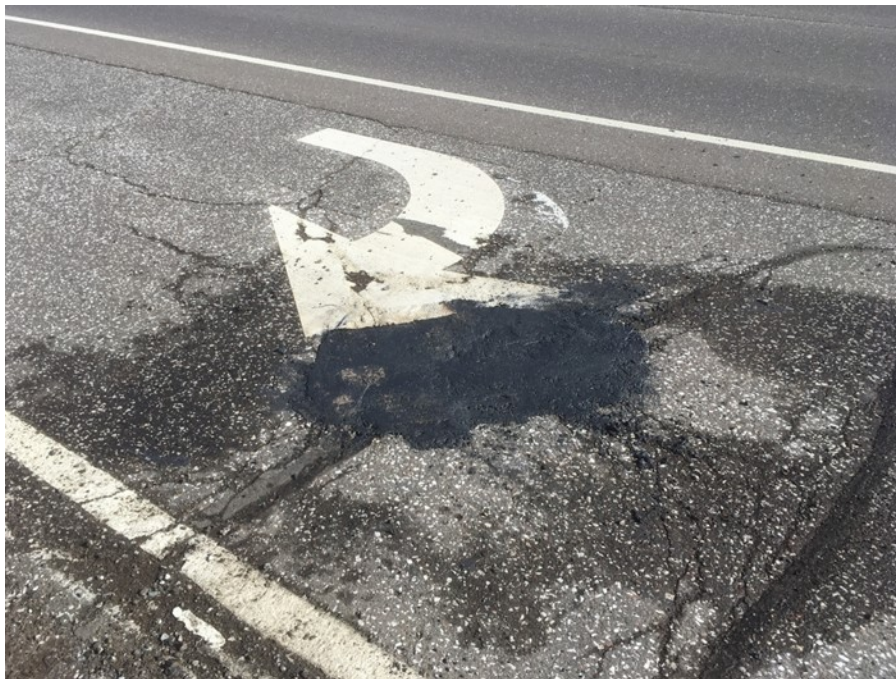
**Figure 2.89 Completed repair at the U.S. Highway 53 field trial location (August 29, 2019).**

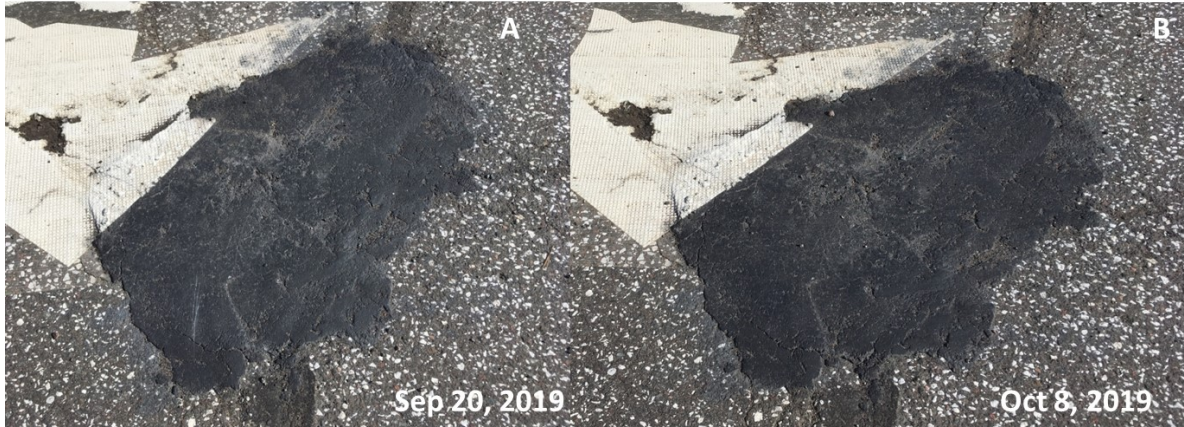
The finished August 29, 2019 repair is shown in Figure 2.90. The condition of the repair is shown on September 20 (Fig. 2.91A) and October 8, 2019 (Fig. 2.91B). The NRRI will continue to monitor and document the condition of the repair beyond the completion of this project.

Figure 2.90 Follow-up photographs of the August 29, 2019, U.S. Highway 53 field trial repair on September 20, 2019 (A) and October 8, 2019 (B).

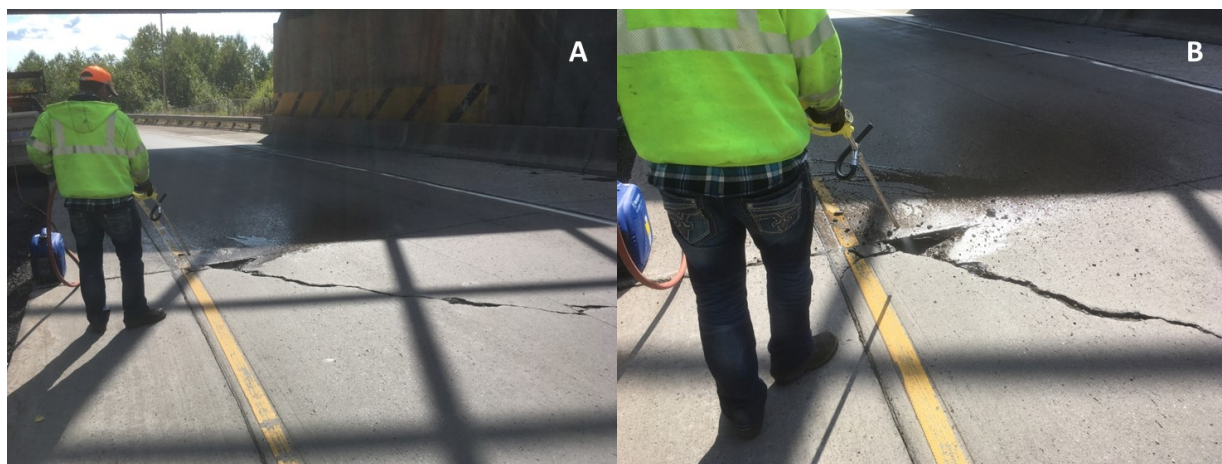
**Figure 2.92** MnDOT District 1 personnel removing loose debris from pothole with compressed air at U.S. Highway 2 and I-35 Thompson Hill field trial location (A); closer view (B) on August 29, 2019.

As before, MnDOT District 1 personnel provided traffic control prepared the pothole by removing loose debris with compressed air (Fig. 2.93A and 2.93B) and driving out excess moisture with a propane torch (weed burner).

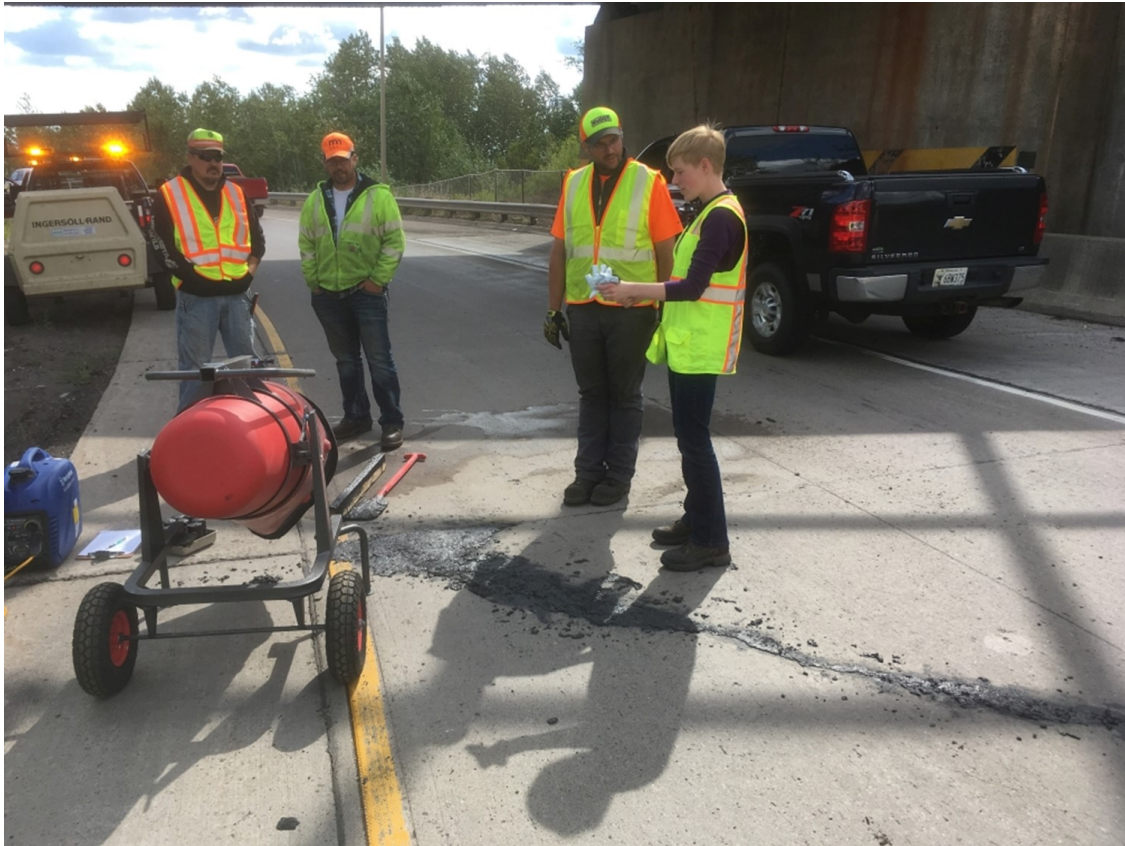
**Figure 2.93 Completed repair at U.S. Highway 2 and I-35 Thompson Hill field trial location, showing blue portable generator and “Mega Hippo” mixer on the left, and MnDOT District 1 crew with the NRRI’s Sara Post.**

The hole (and crack) required a single 40-lb batch of repair compound, which was combined with 7.2 lb of liquid activator (18% of 40 lb). The same repair compound formulation, mixing equipment, and mixing and deployment protocols were used as those employed at the Bullyan RV/U.S. Highway 53 location. The completed repair and equipment are shown in Figure 2.94, along with NRRI researcher Sara Post, P.E. (on the right) discussing the project with the MnDOT District 1 crew.

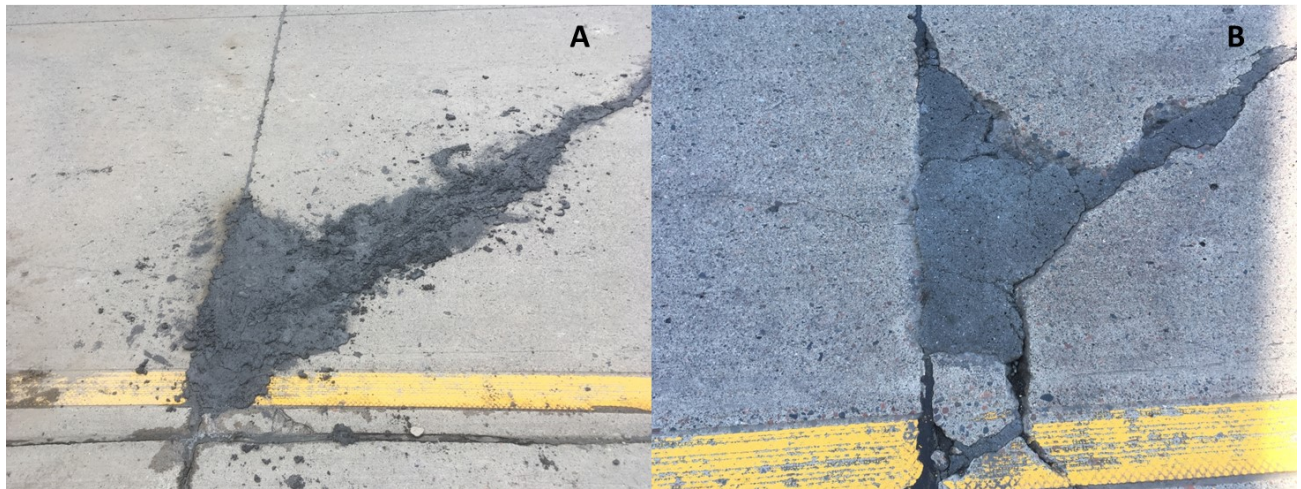
**Figure 2.94** Finished repair at U.S. Highway 2 and I-35 Thompson Hill field trial location on August 29, 2019 (A); and repair as of October 8, 2019 (B).

Figure 2.95 shows the finished repair on August 29, 2019 (Fig. 2.95A) and the condition of the repair as of October 8, 2019 (Fig. 2.95B). The roadway’s heavy traffic has worn away excess repair material that thinly coated the pavement. The NRRI will continue to monitor and document the condition of the repair beyond the completion of this project.

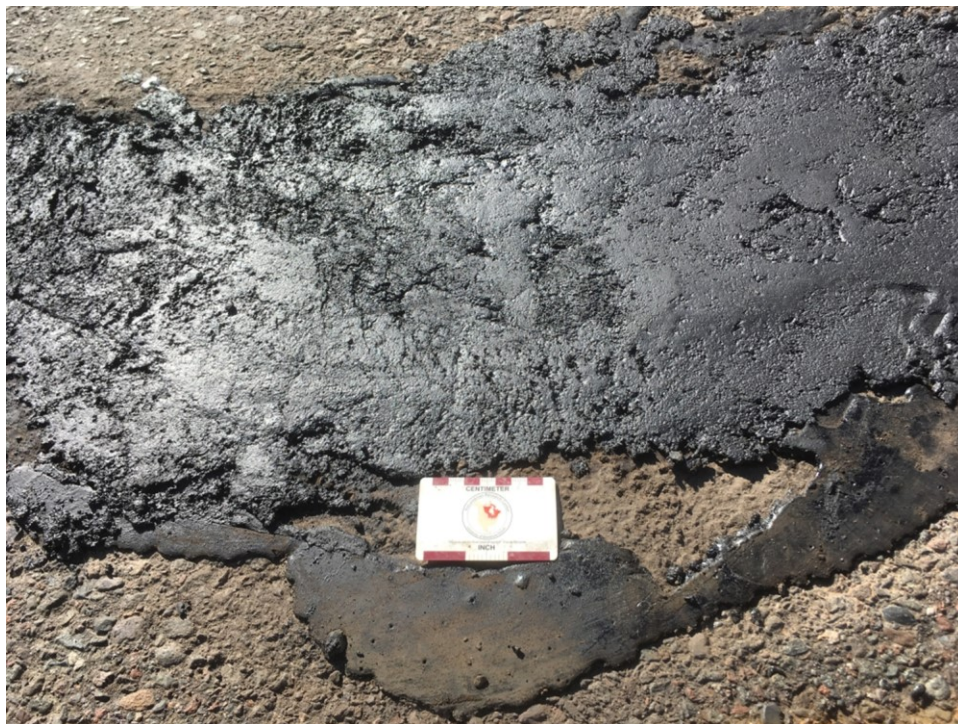
**Figure 2.99 Closeup of finished taxiway repair and adjacent mastic.**

began to set. Figure 2.99A and 2.99B show the repair, before and after. Figure 2.100 shows a closeup of the repair, with a scale placed between the new repair and adjacent mastic.

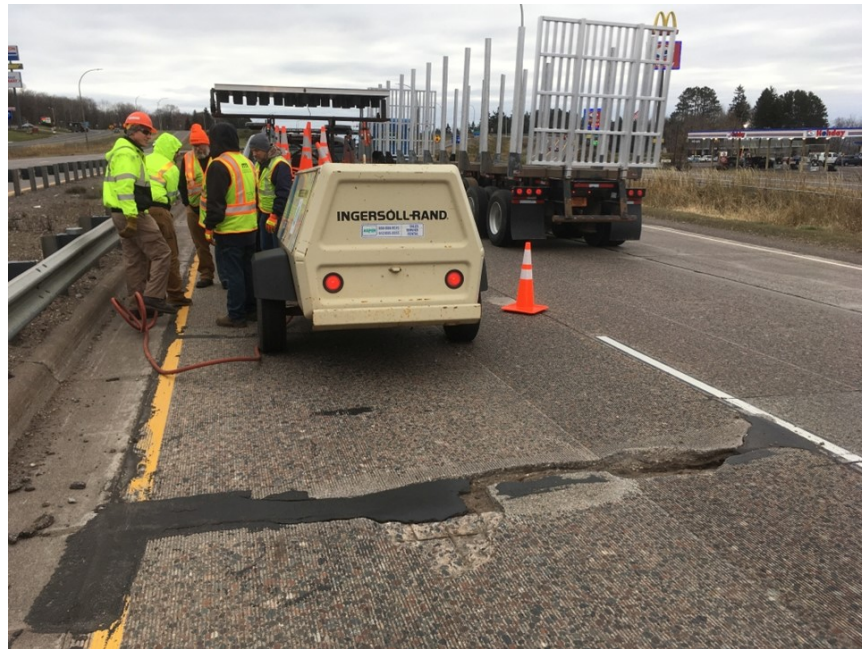
**Figure 2.103 MnDOT District 1 crew and equipment at Repair #1 location, southbound I-35 and Boundary Avenue test location (Hole 1 in foreground): October 31, 2019.**

MnDOT District 1 provided traffic control as well as personnel to clean out the holes with compressed air and assist with the repair process (Fig. 2.104). Hole 1 is visible in the foreground, prior to repair.
