Testing and Recommended Practices to Improve Nurse Tank Safety: Phase IV

U.S. Department of Transportation
Federal Motor Carrier Safety Administration

June 2022

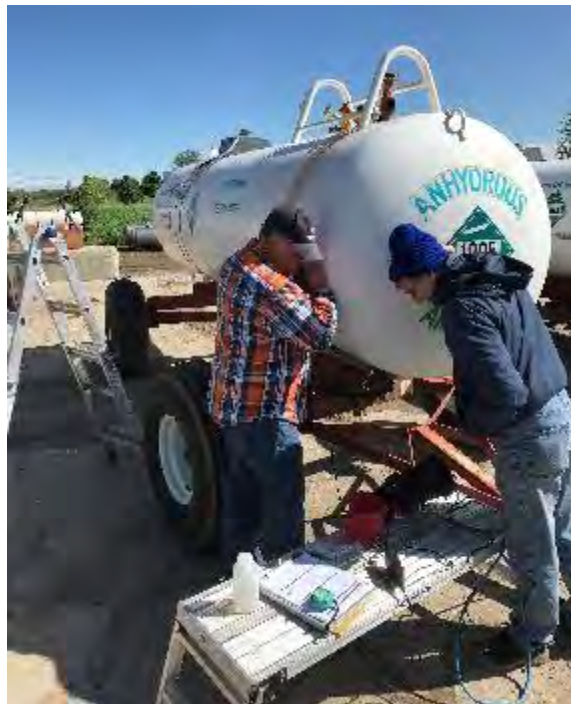
Figure 13. Photograph. Testing of the end cap weld.

In cooperation with owner Heartland Co-op, tanks were selected to fulfill requirements for the four different series. The tanks also had to be relatively easy for Heartland Co-op to locate and make available for testing—in most cases, this meant moving the tanks to their Slater, Iowa, location. Once there, the research team identified the positions of prior indications on the previously studied tanks. Then they conducted a complete ultrasonic examination of the welds using PA (as shown in Figure 13). Details of the specific unit employed for the PA exam and the operating conditions are found in Appendix B. It was not unexpected to discover that many prior indications found in 2015 were due to scattering from weld geometry rather than SCC.

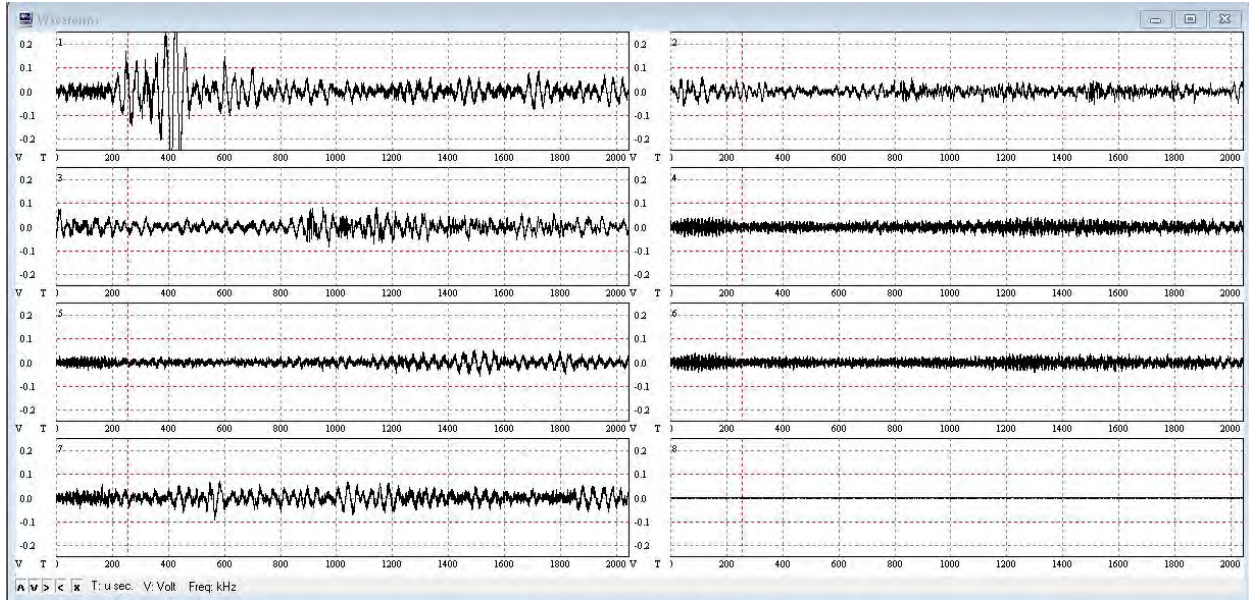
Figure 15. Screen. Readout of AE events. Transducers are indicated by number in the top left of each scan. The higher the signal the closer the event is to that transducer.

After completion of the hydro test, the research team analyzed the data output (see Figure 15). On occasion, no AE events were recorded, meaning no change at all occurred during the test. Therefore, no post-hydro PA examination was needed. More often, further analysis was needed to separate out extraneous noise caused from the metal flexing and expanding from noise that was potentially caused by crack formation or growth. This would typically require two to four days to complete. Once the analysis was completed, a summary of possible crack-related AE events was compiled. A time was then scheduled with Heartland Co-op to return and complete the post-hydro PA examination that concentrated on those areas identified by AE as having a significant event. This examination was usually completed quickly since specific locations were provided for the examination. This eliminated the need to redo PA testing of the entire tank.

It should be noted that just because a significant event was recorded this still did not necessarily mean a new crack had formed or an existing crack had grown. AE signals recorded by the transducers are examined to see if the signals detected are consistent with one another. For example, consider an event detected on the shell/head weld of a tank, which was the most common type of event recorded. Since there are three transducers positioned around the shell/head weld, each one of them has to record the signal. Additionally, the time lags between the pairs of transducers (e.g., T1/T2 and T1/T3) had to satisfy the wave velocity for sound traveling through the steel and be consistent with each other. Only if this is true would the recorded event be considered a valid “hit”.

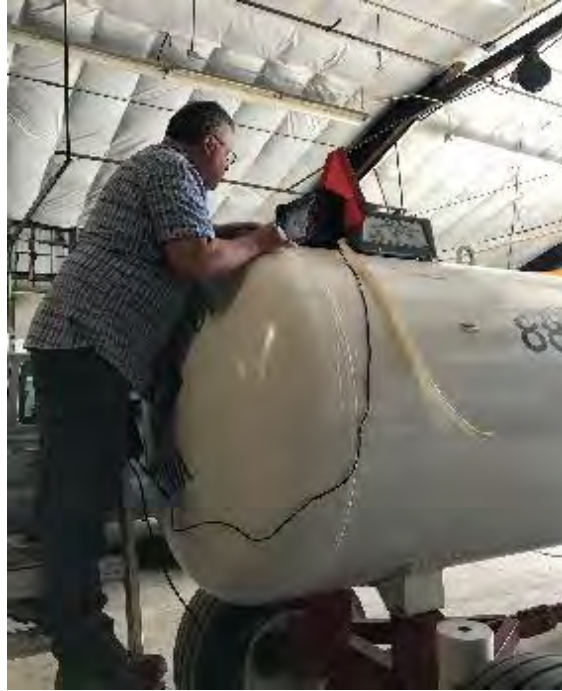
Figure 20. Photograph. Post-hydro ultrasonic examination of suspected crack growth/nucleation sites.

Figure 20 shows a post-hydro PA examination of a tank that showed AE events during the hydro test. Of the 16 tanks flagged for further examination, only 7 tanks were found to have measurable differences between the pre- and post-hydro ultrasonic examinations. These tanks are discussed in more detail below.

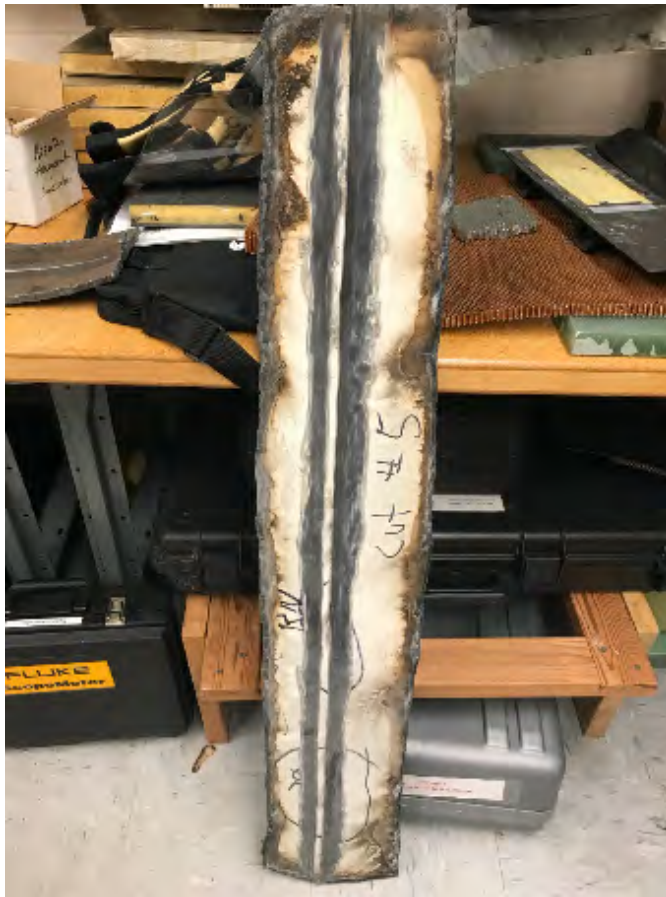
Figure 28. Photograph. Section 5 from tank #8161.

Five different areas were selected for sectioning and an example of one of the areas selected (section 5) is shown in Figure 28. The piece is shown leaning against a lab bench to provide scale. The AE and PA indications found within these sections are identified by the different section numbers used in Table 11. Sections removed from the tank were examined first in the as-received condition, and then again after they had been cleaned to better view the surface. An example of how a typical piece looked before and after cleaning is shown in Figure 29 and Figure 30.

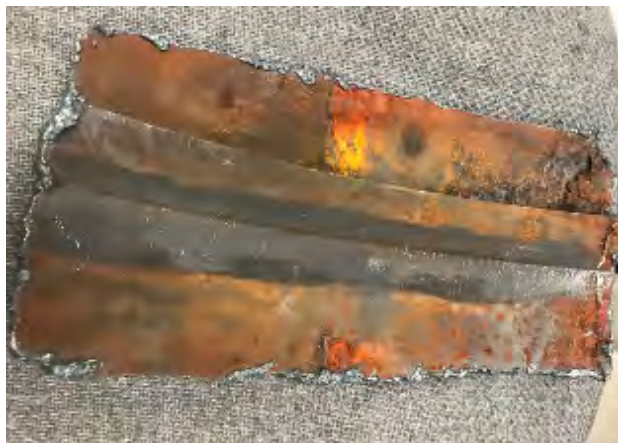
Figure 29. Photograph. Section 4 from tank #8161, before cleaning.

Before any further sectioning was carried out, the rough ends produced by flame cutting were removed so that magnetic particle (MP) imaging could be done. Although several indications had been flagged on these pieces using PA and AE, MP imaging revealed only two regions where cracks were evident. These regions were a through-crack in section 3 that resulted when the tank was overpressurized (see Figure 31), and a crack that was found in section 4 (see Figure 32).
