ARIZONA DEPARTMENT OF TRANSPORTATION

REPORT NUMBER: FHWA-AZ88-202-1

SMALL SIGN SUPPORT ANALYSIS

Phase I Crash Test Program

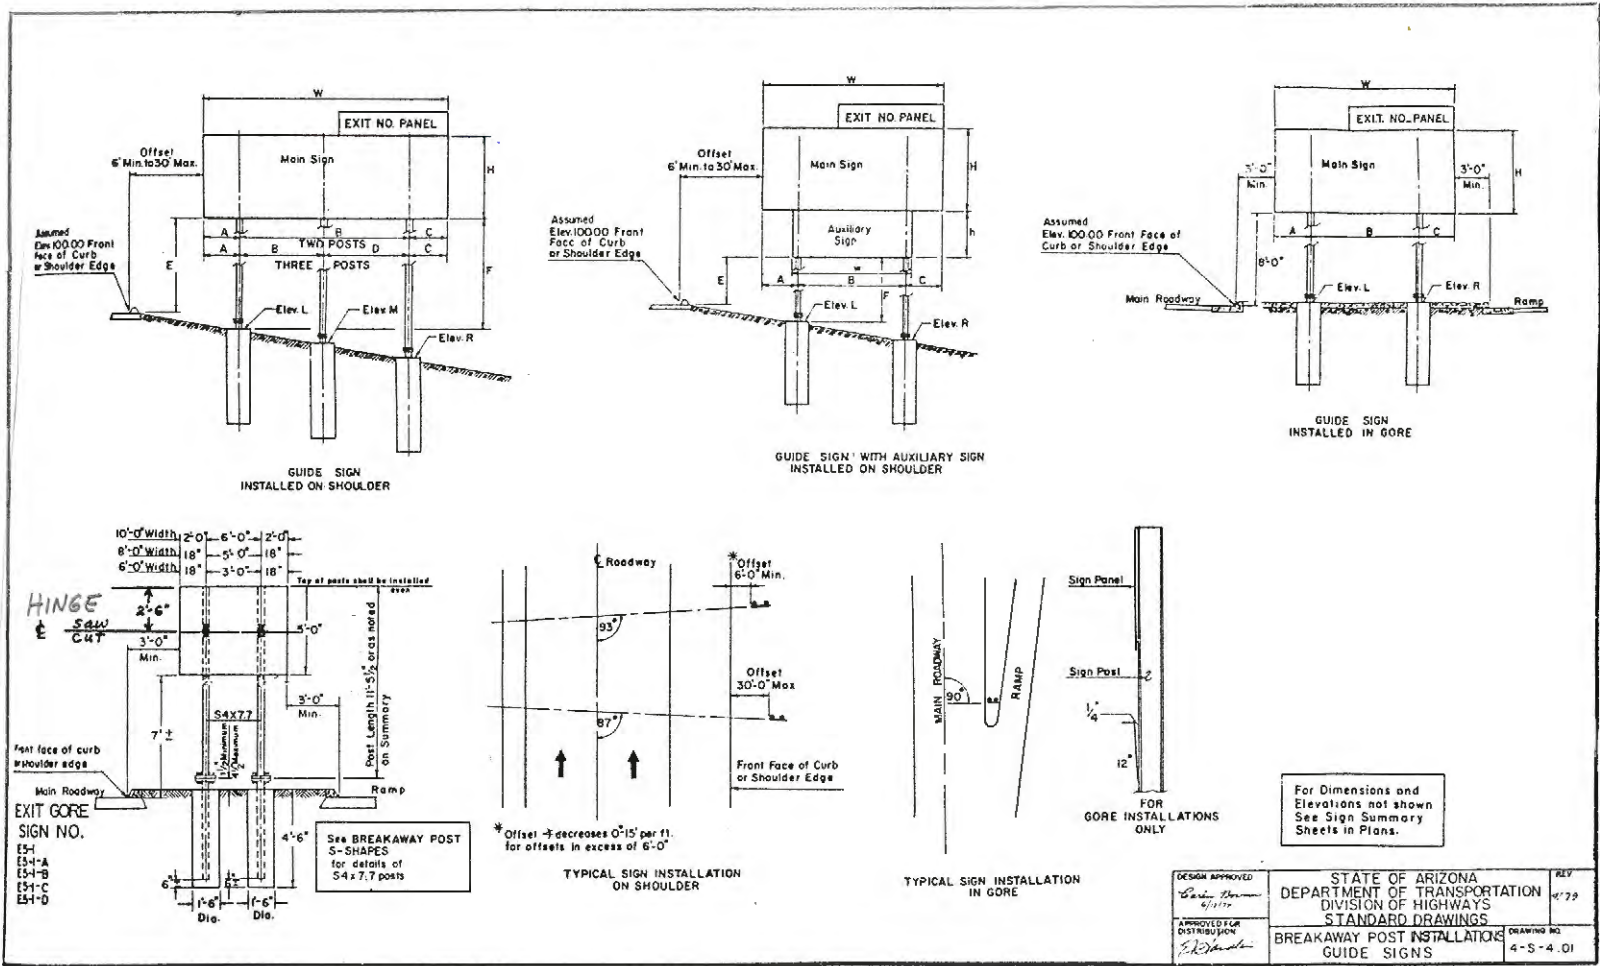
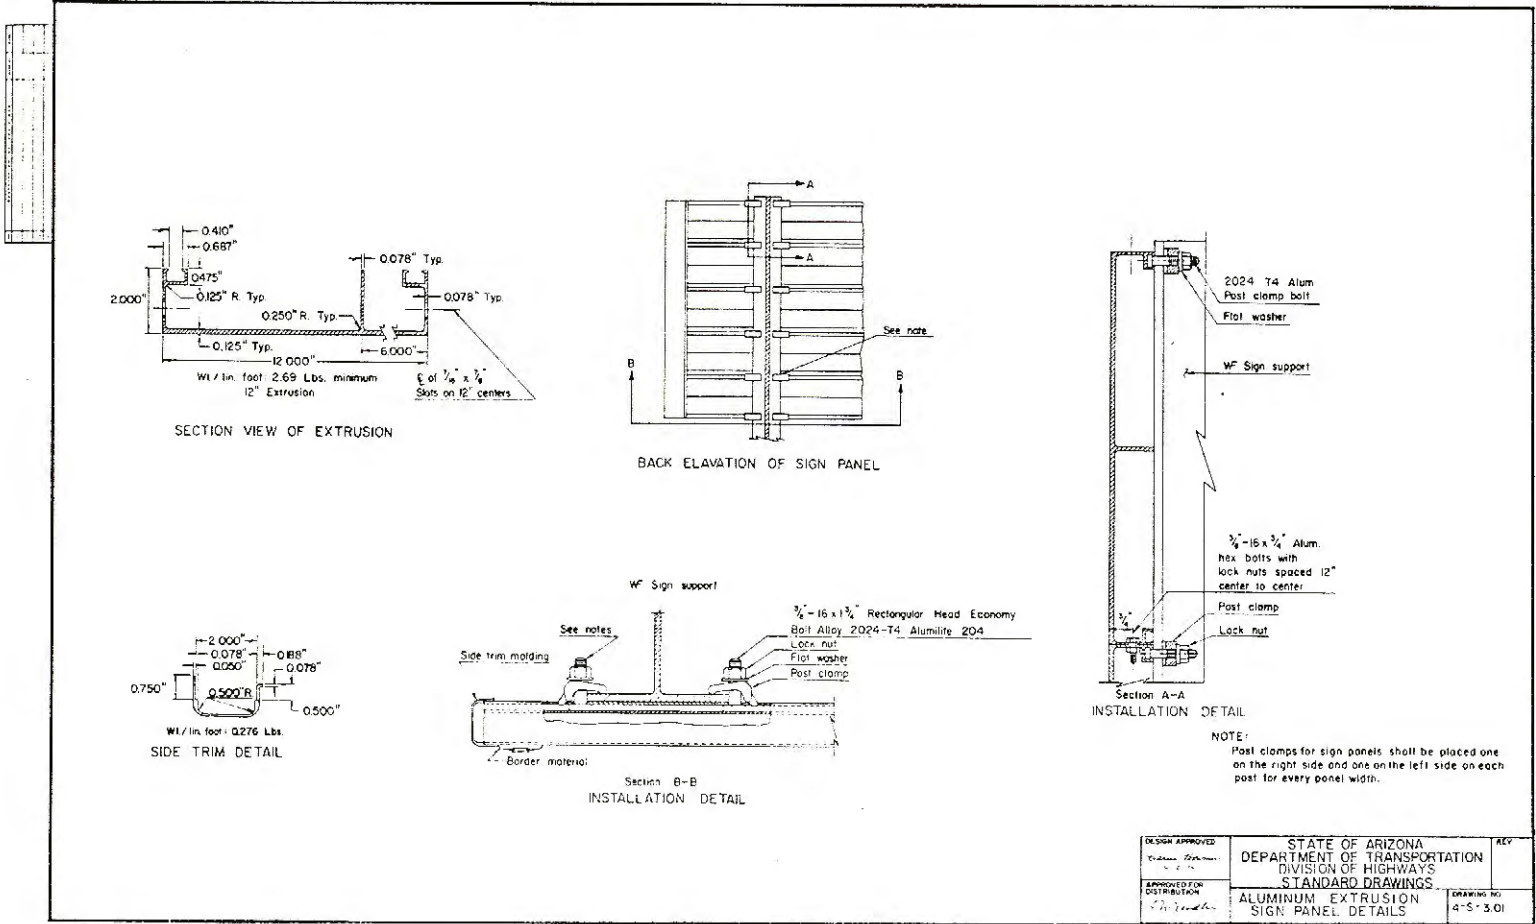
FIGURE A-2. SLIPBASE DESIGN, TESTS 1 AND 2

An 8 ft wide by 5 ft high extruded aluminum panel was mounted on the two S4 x 7.7 posts, with the lower edge of the panel approximately 7 ft above ground. The posts were spaced 5 ft apart. Note that the hinge was placed at the midheight of the panel as shown on the first sheet of Figure A-2, not as shown on the second sheet. It should also be noted that the hinge details differed from those shown on the second sheet. For the installations tested,

the sign post was not cut completely into as shown. The flange adjacent to the sign panel and the web was cut but the back flange was not cut. The "friction fuse plate" was installed as shown but there was no need for the "back plate".

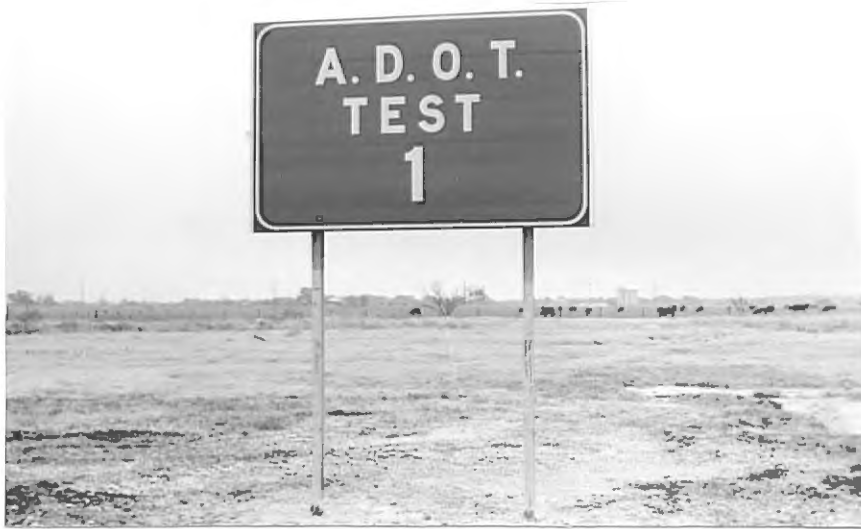
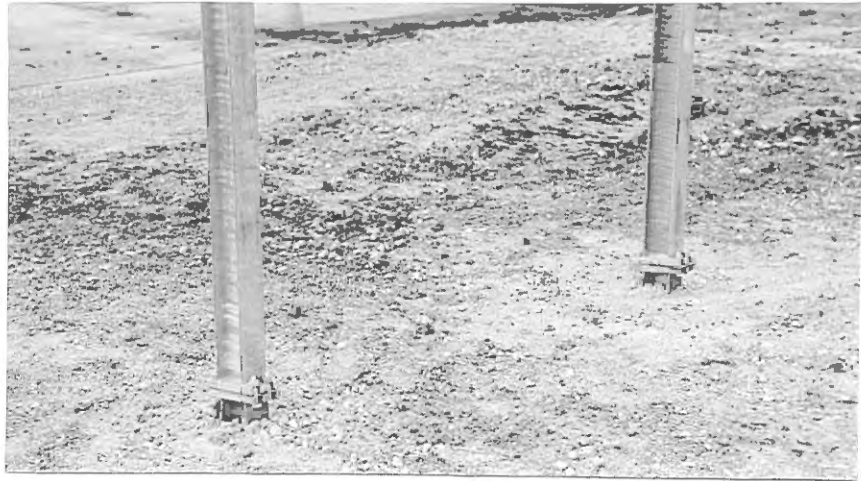
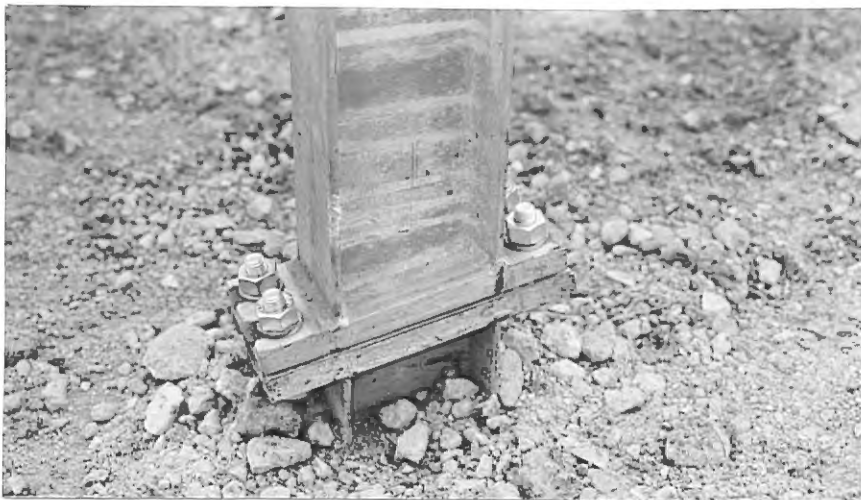
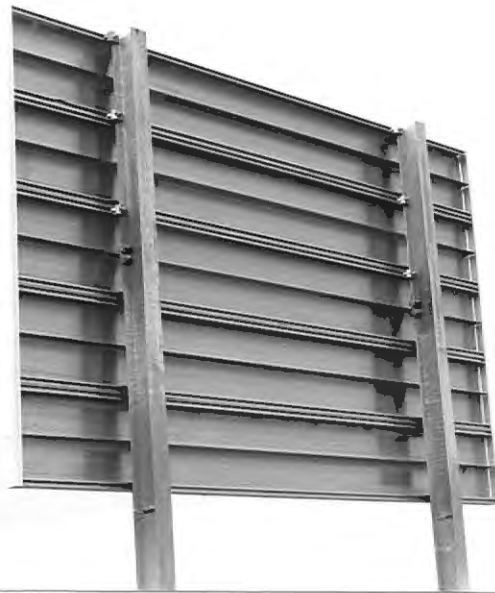
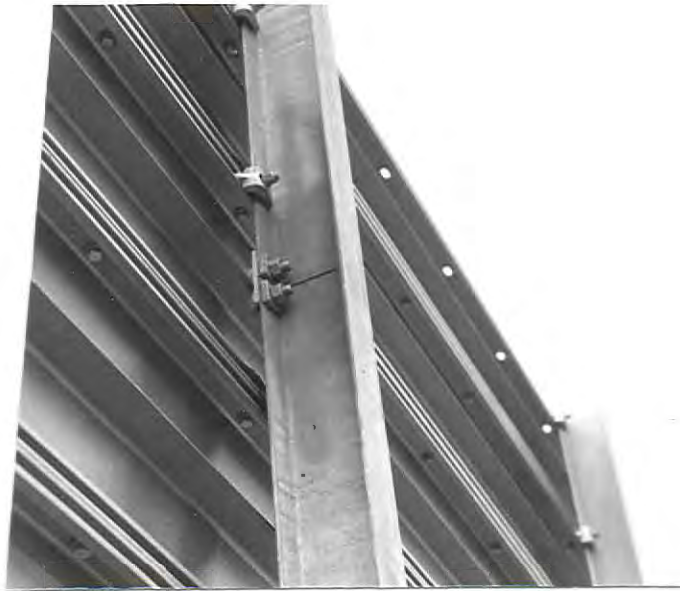
FIGURE A-3. SIGN INSTALLATION, TEST 1
(SAME AS TEST 2)

Shown in Figure A-2 (3 sheets) are details of the system evaluated in tests 1 and 2. Photos of the installation for test 1 are given in Figure A-3 (2 sheets).

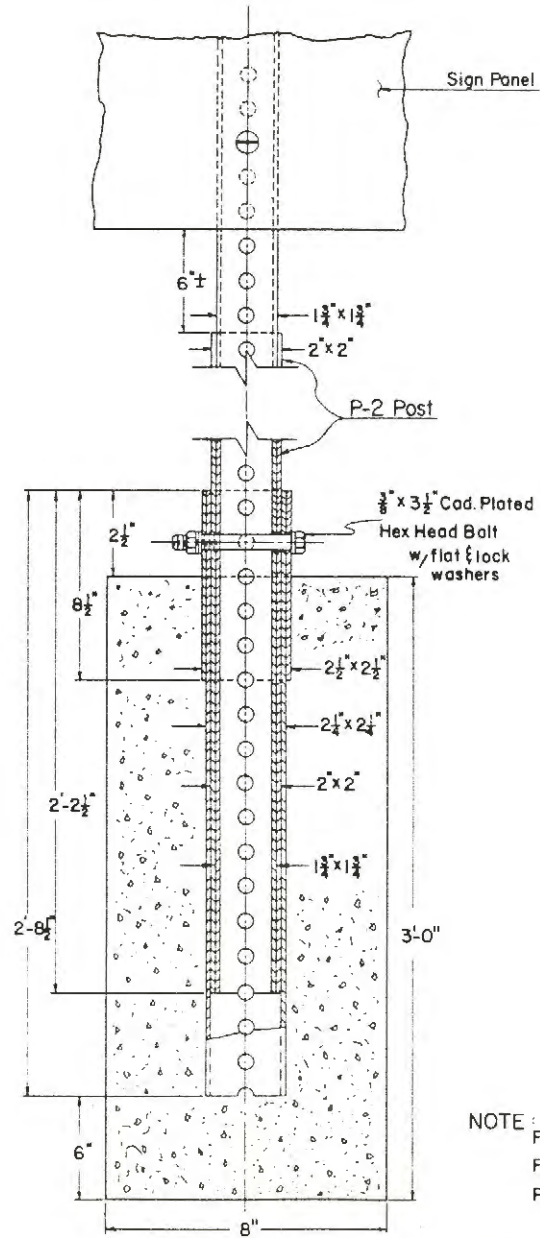
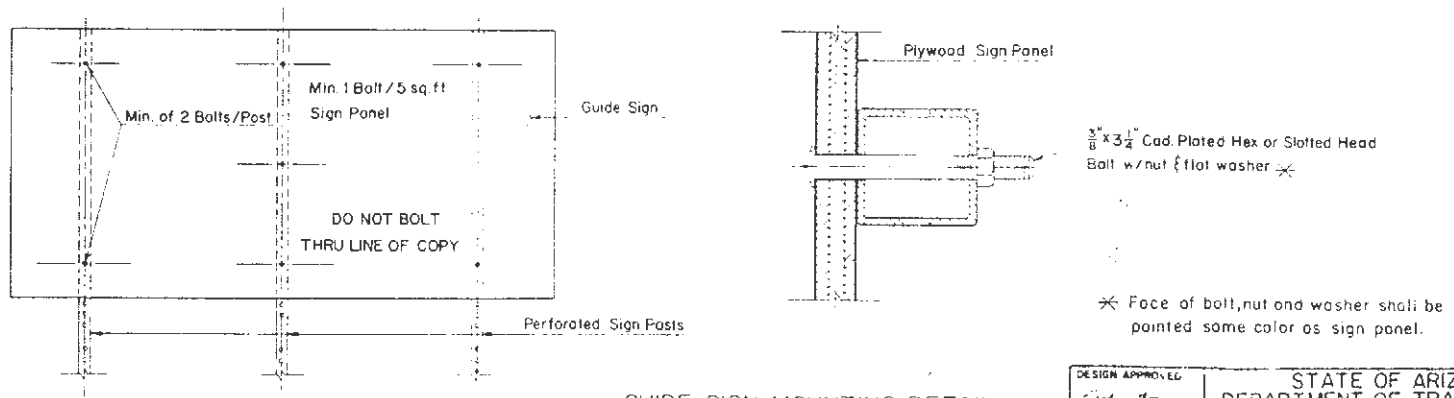
FIGURE A-6. SQUARE STEEL TUBE, MULTIPLE POSTS, TESTS 5, 6, 19, AND 20

In tests 5 and 6, a 6 ft wide by 5 ft high by 5/8 inch thick plywood (MDO) panel was mounted on three 1 3/4 inch square sign posts, with the lower edge of the panel approximately 5 ft above ground. Post spacing was 21 inches rather than the 25 inches called for in the plans (first sheet, Figure A-6). The smaller spacing was used so that the test vehicle would strike all three posts (vehicle width was approximately 51 inches). Three fasteners were used to attach the panel to each of the three posts. Attachment hardware was as shown on the second sheet of Figure A-6. Hardware specifications are given in the notes of Figure A-4. It is noted that a bolt for this specification is equivalent to an SAE Grade 1 bolt.

In tests 19 and 20, a 6 ft wide by 4 ft high by 5/8 inch thick plywood (MDO) panel was mounted on two 1 3/4 inch square sign posts, with the lower edge of the panel approximately 5 ft above ground. Post spacing was 40 inches rather than the 43 inches called for in the plans (first sheet, Figure A-6). The smaller spacing was requested by ADOT. Two fasteners were used to attach the panel to each post. Attachment hardware was as shown on the second sheet of Figure A-6. In tests 19 and 20, the bolts were SAE Grade 5 and the nuts were Grade 8.

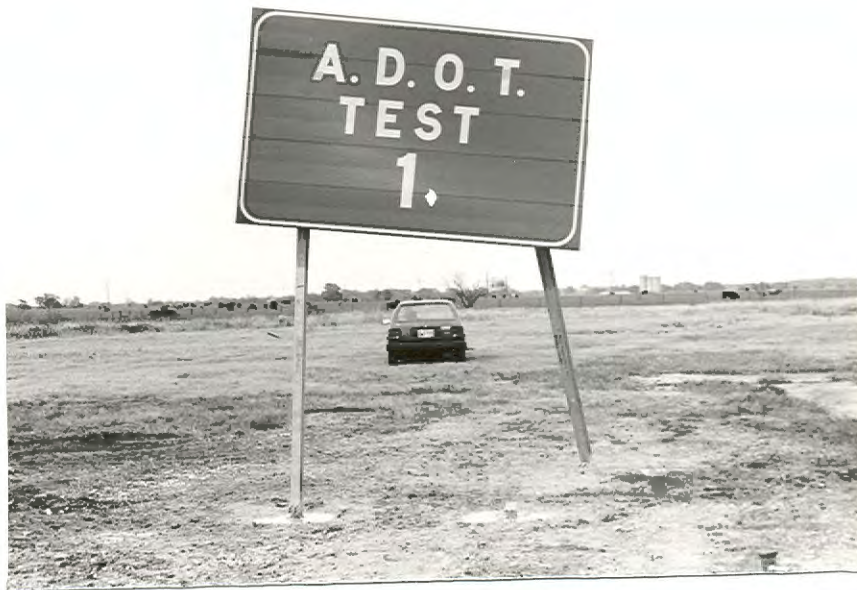
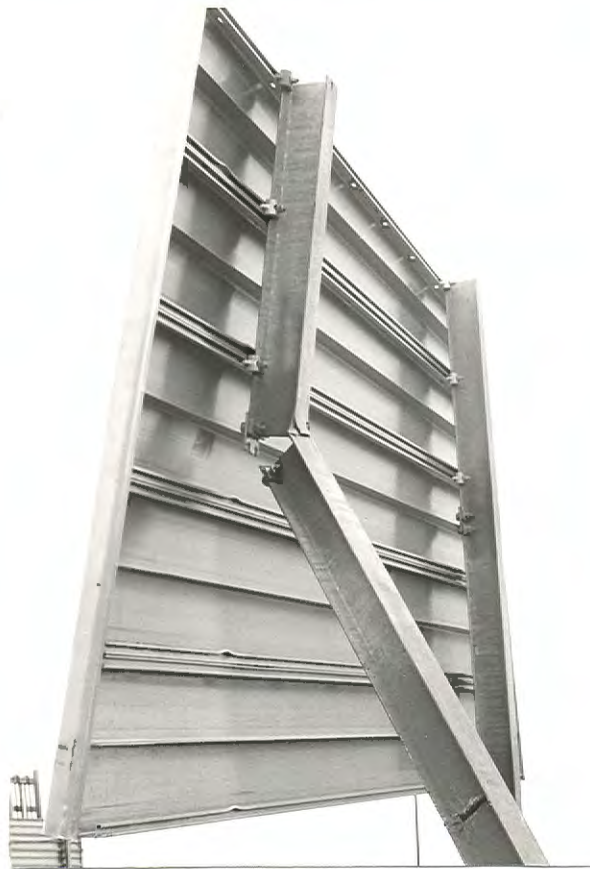
Photographs of the sign installation after the test are shown in Figures A-24 and A-25. Damage to the vehicle was minimal as shown in Figure A-26. The left front quarter was deformed and was crushed 1.0 in. at bumper height. Sequential photographs of the test are shown in Figure A-27.

FIGURE A-24. SIGN INSTALLATION AFTER TEST 1.

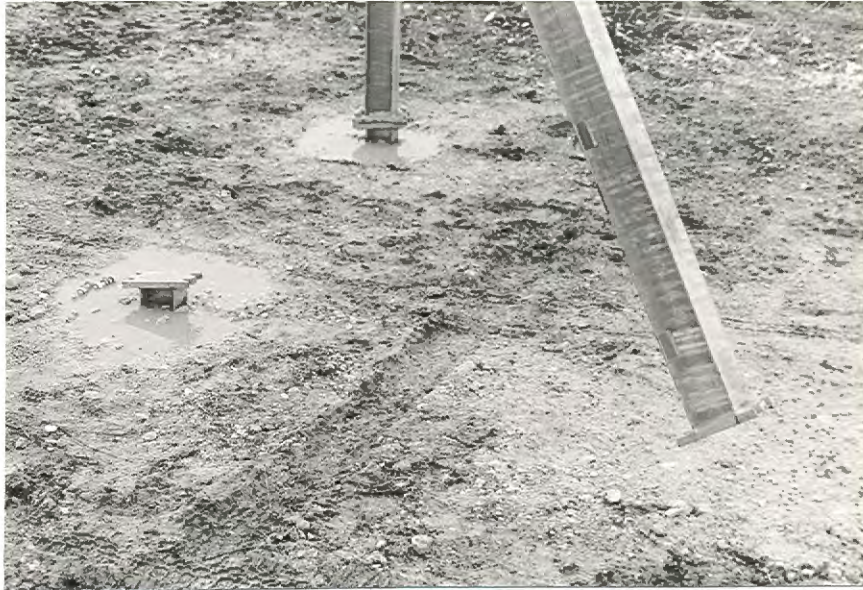
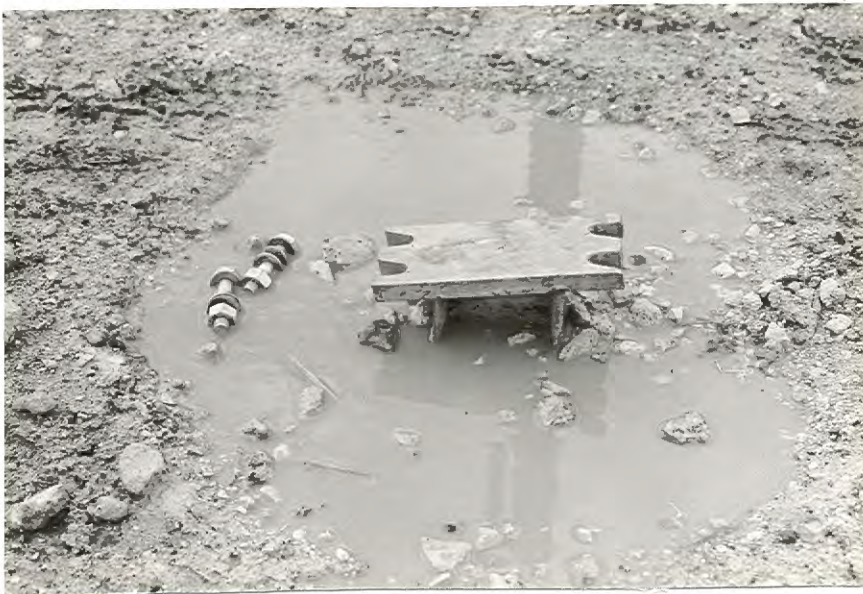
FIGURE A-25. BREAKAWAY BASE AFTER TEST 1.

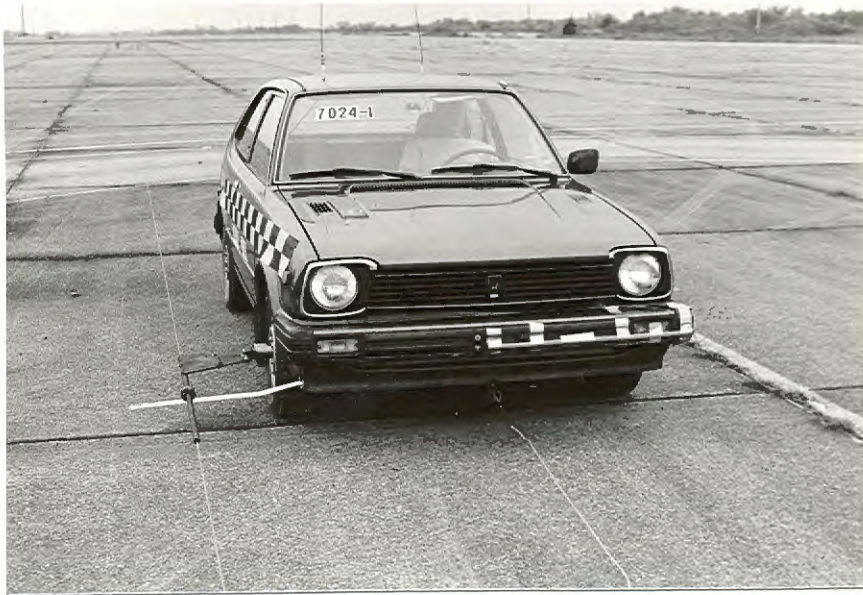
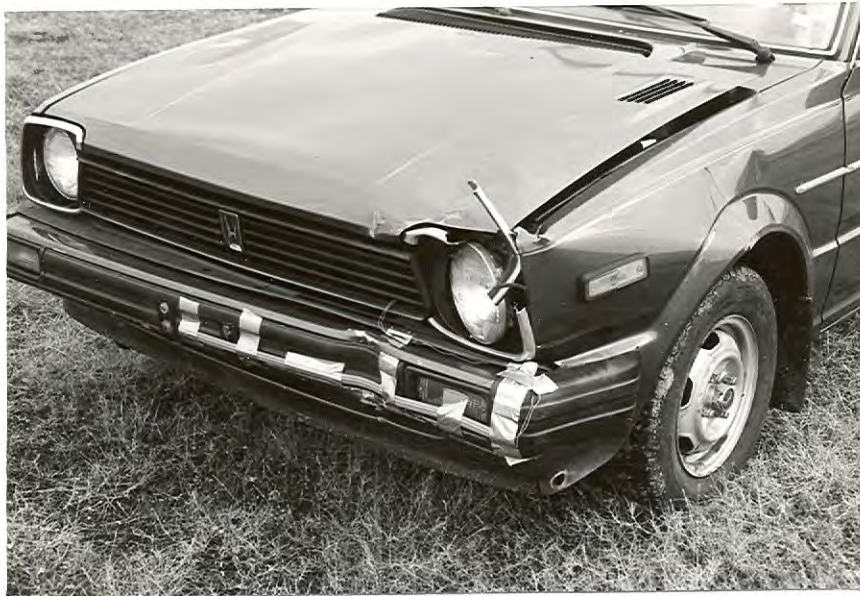
FIGURE A-26. TEST VEHICLE BEFORE AND AFTER TEST 1.

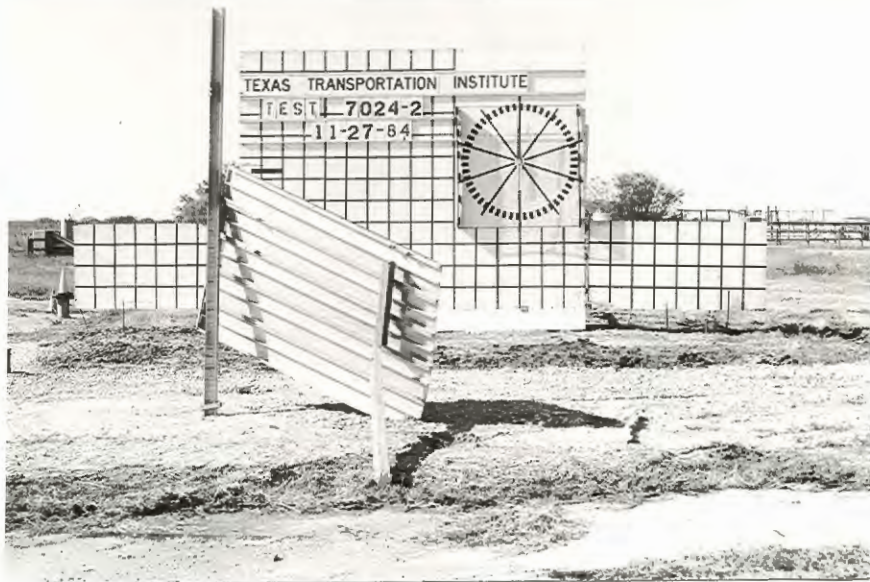
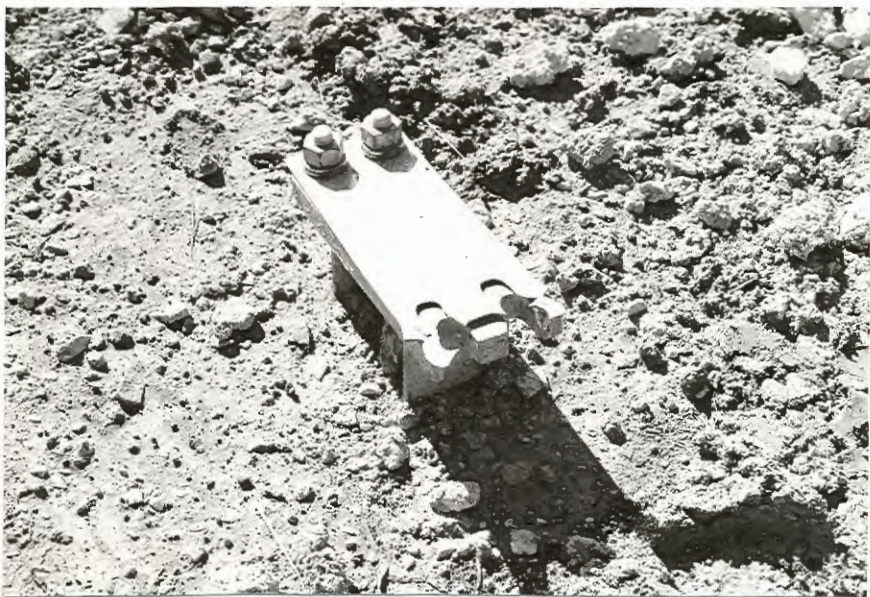
Photographs of the sign after the test are shown in Figures A-31 and A-32. The vehicle received minimal damage as shown in Figure A-33. The right front quarter received 2.0 in. crush at bumper height and 2.0 in. at hood height. Sequential photographs of the test are shown in Figure A-34.

FIGURE A-31. BREAKAWAY BASE AFTER TEST 2.

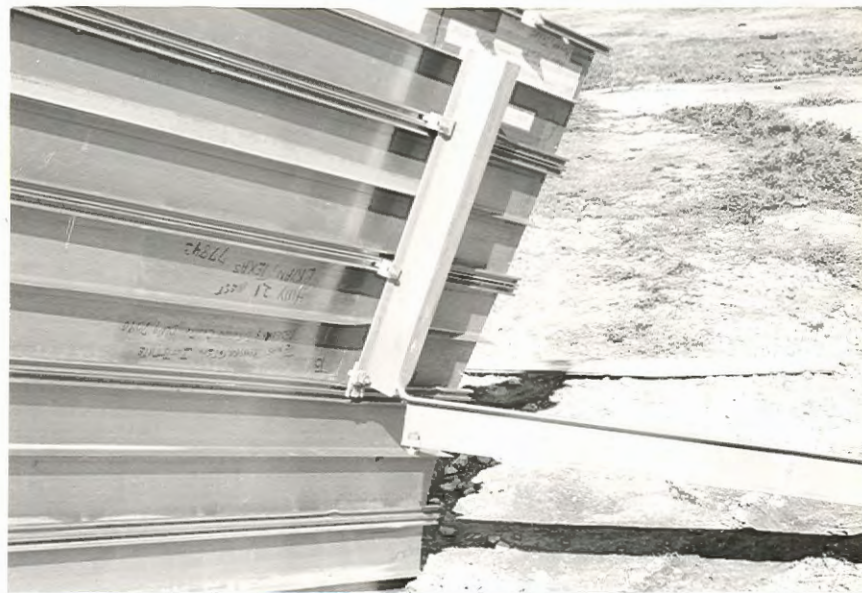
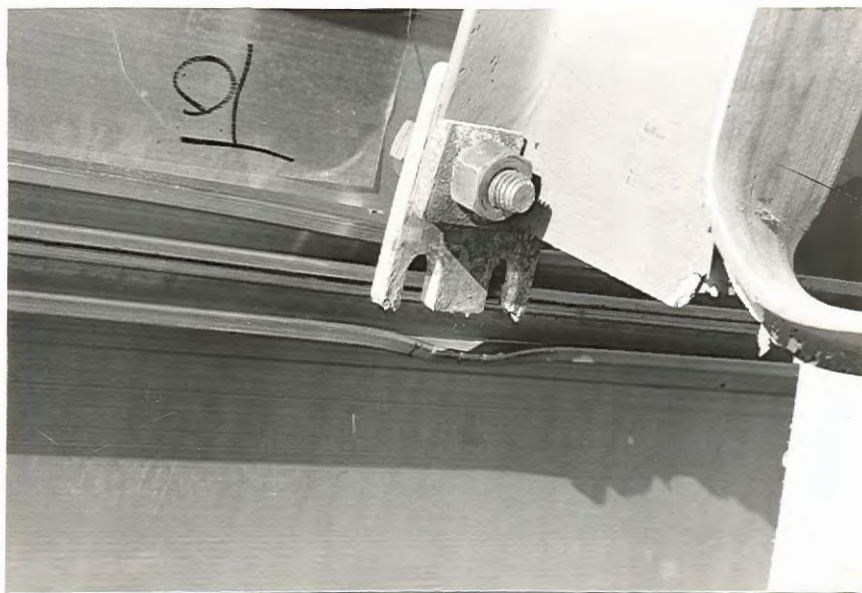
FIGURE A-32. HINGE AFTER TEST 2.

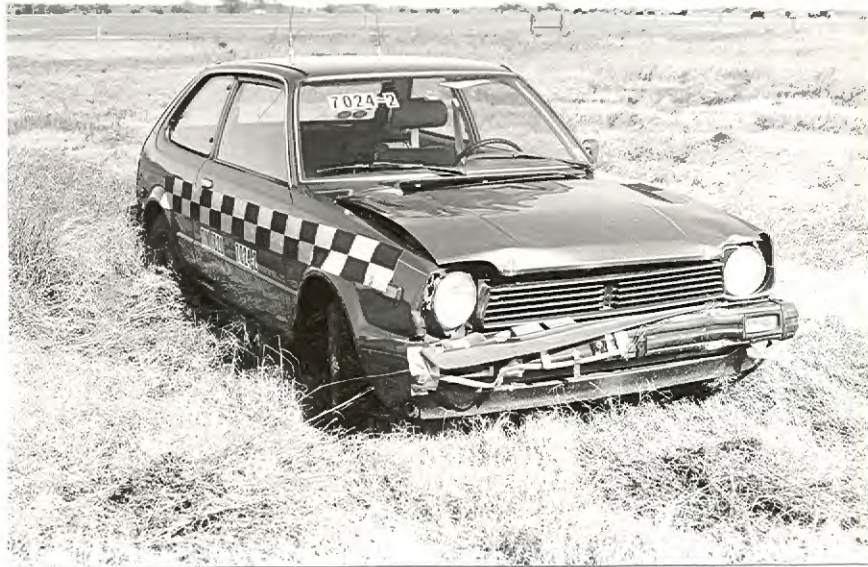
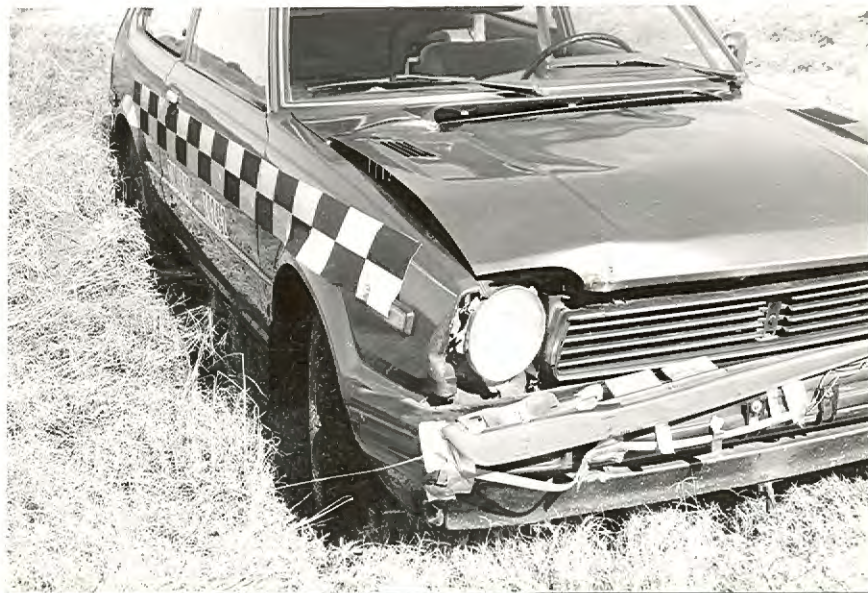
FIGURE A-33. TEST VEHICLE AFTER TEST 2.

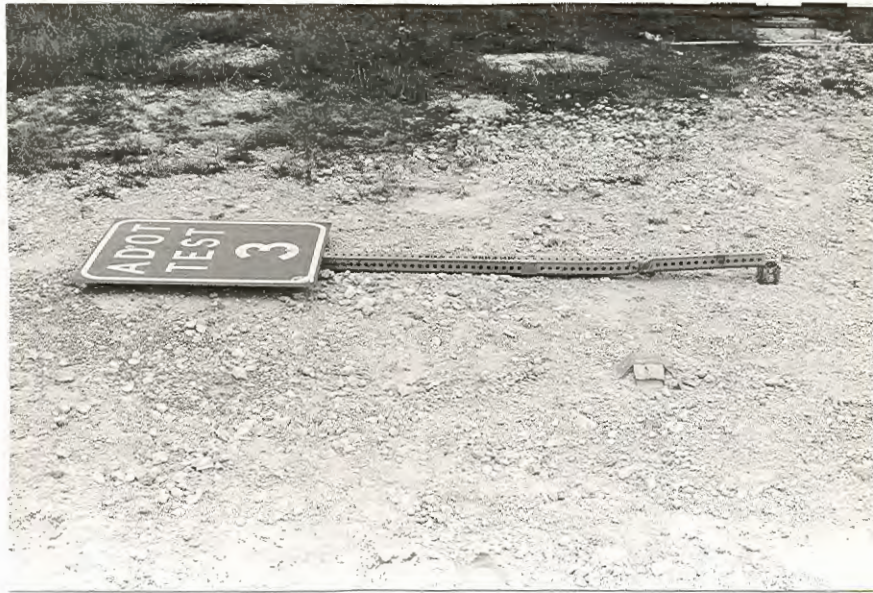
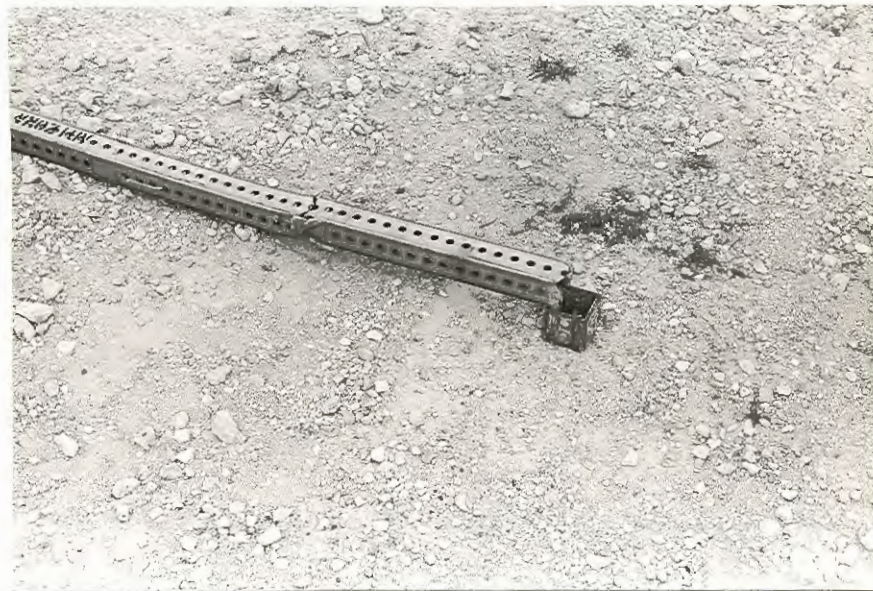
FIGURE A-38. TEST INSTALLATION AFTER TEST 3.

Approximately 0.025 sec after impact the support fractured at bumper height. The vehicle lost contact with the sign installation at 0.110 sec. Sequential photographs of the test are shown in Figure A-37. The support was fractured (but not completely separated) at the base and 16 in. above the ground as shown in Figure A-38. As shown in Figure A-39 the vehicle sustained minor scrapes to the bumper.

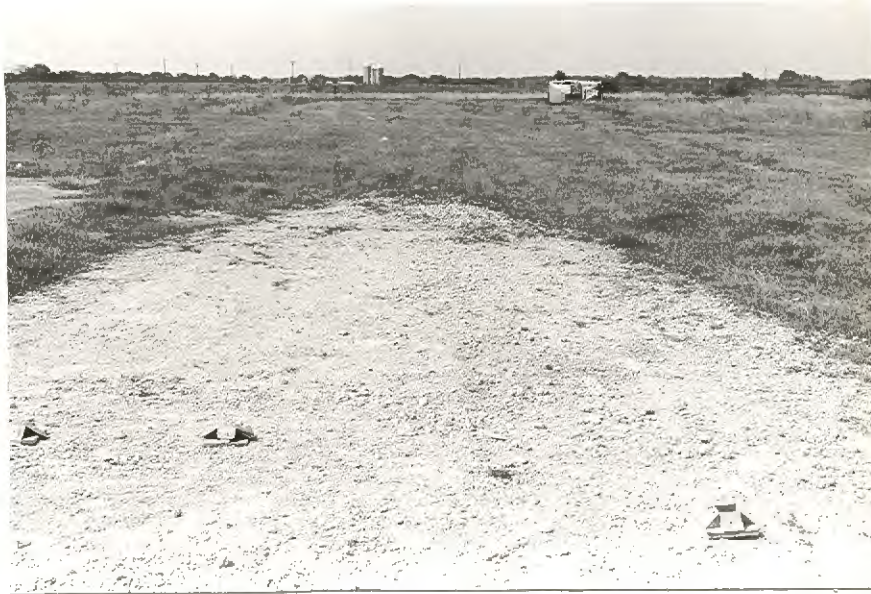
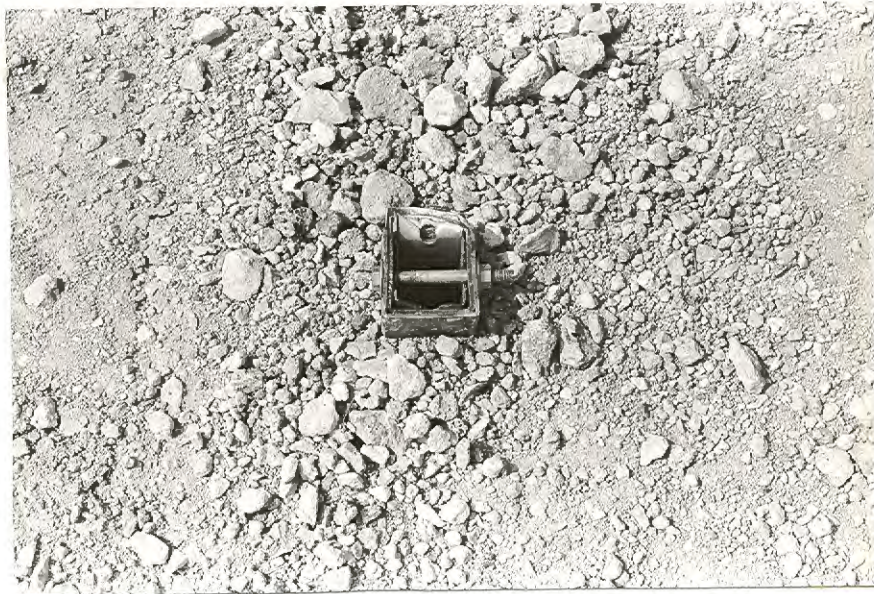
FIGURE A-43. TEST SITE AFTER TEST 4.

The support broke away at the base and was deformed as shown in Figures A-43 and A-44. The vehicle sustained a maximum crush of 3.0 in. at bumper height and the hood was scraped and dented. The windshield was cracked but not penetrated when the sign panel hit it. All other damage was due to post-test rollover. Photos of the vehicle after the test are shown in Figure A-45.

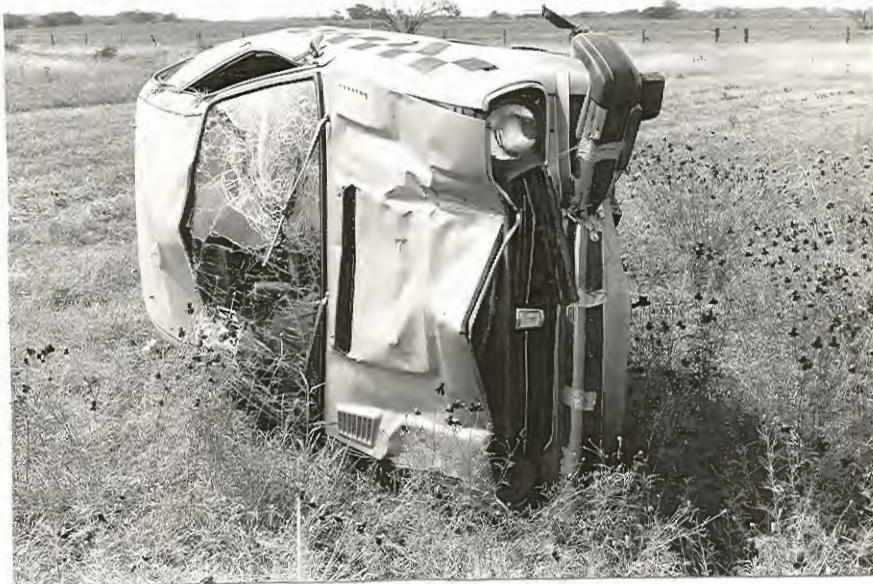
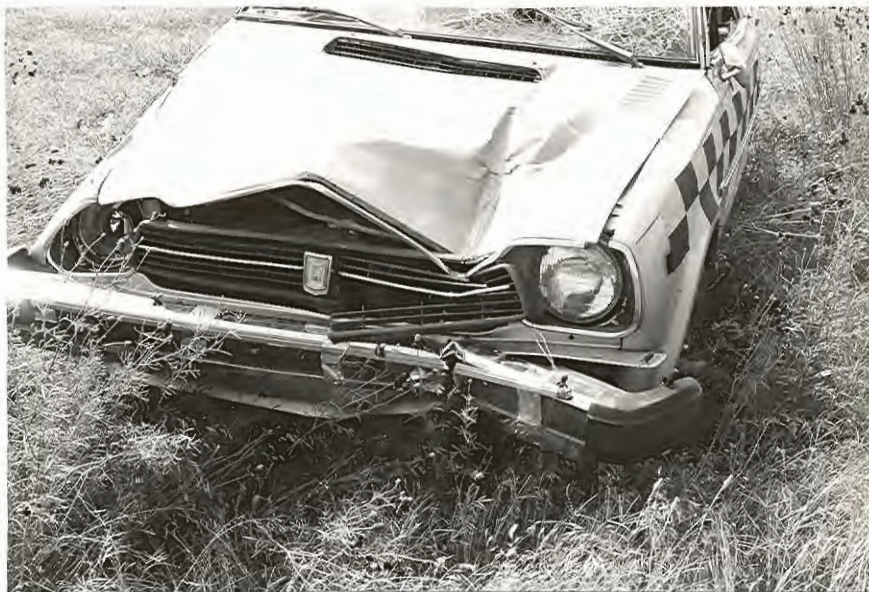
FIGURE A-45. VEHICLE AFTER TEST 4.

The vehicle remained upright and stable throughout the impact phase and up to the time of brake application. Rollover of the vehicle was considered to be totally due to unsymmetrical brake application in combination with soft soil and not induced by impact with the sign.

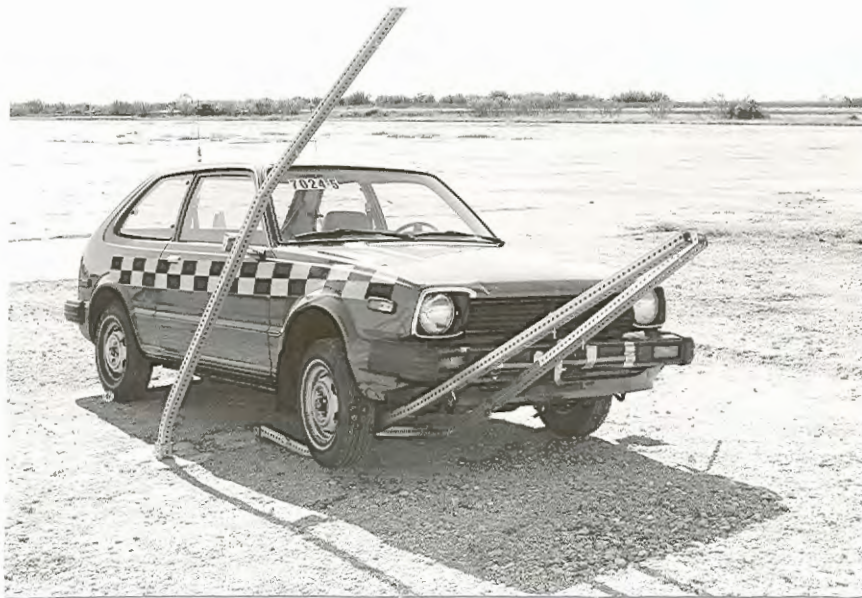
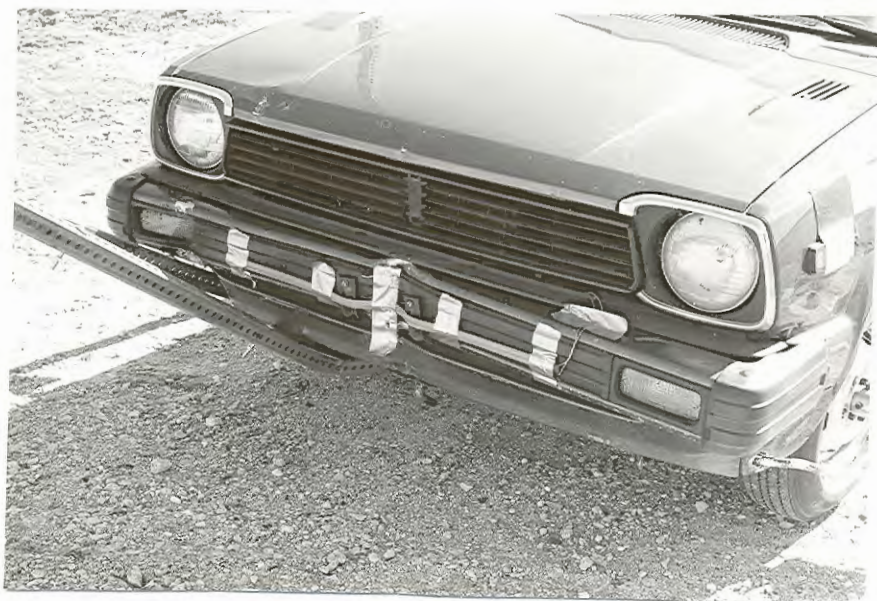
FIGURE A-50. TEST VEHICLE AFTER TEST 5.

The front of the vehicle was deformed as shown in Figure A-50. The right front quarter received 4.0 in. crush at bumper height. The center was crushed 2.0 in. at bumper height. The windshield was slightly cracked just below the mirror. Sequential photographs of the test are shown in Figure A-51.

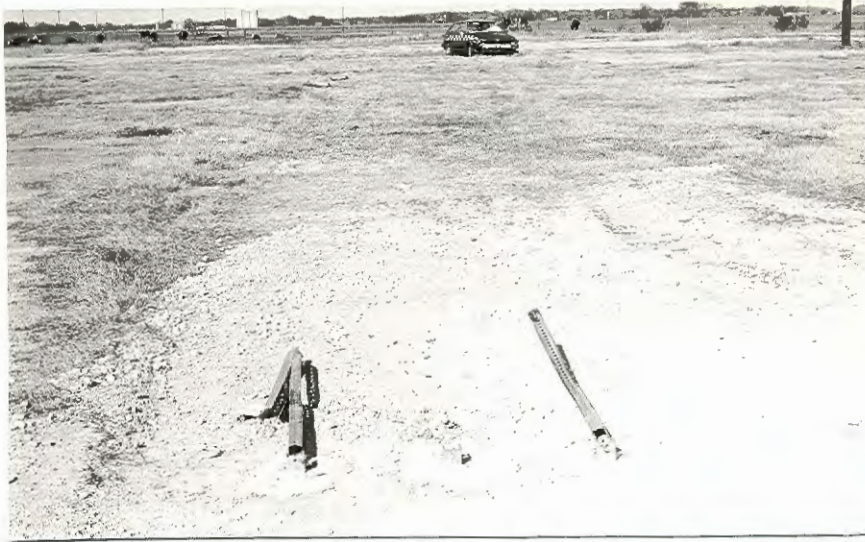
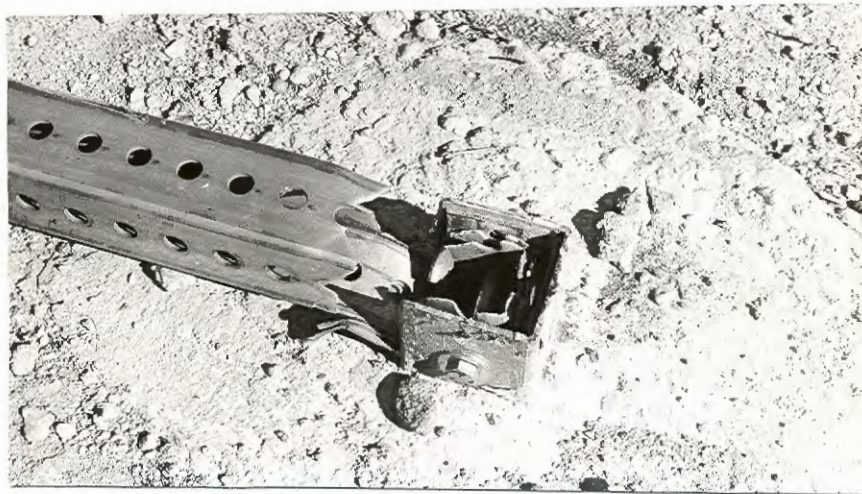
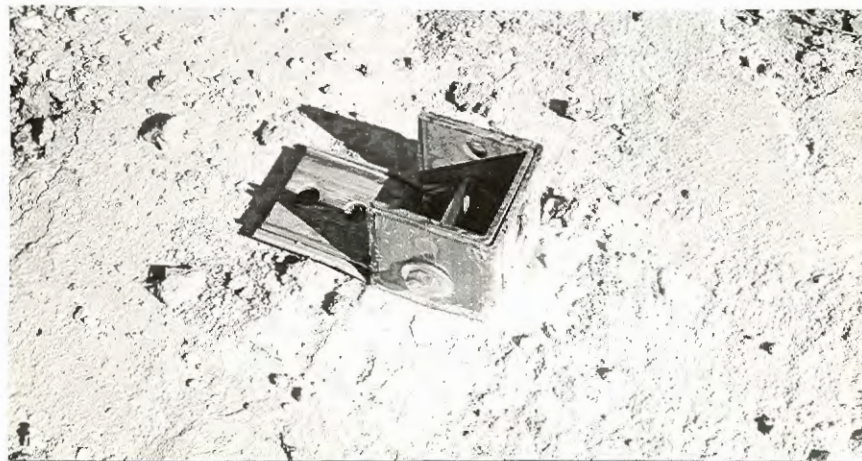
FIGURE A-55. SIGN INSTALLATION AFTER TEST 6.
(BASE)

Almost immediately after impact (0.002 sec), the supports began bending. At 0.022 sec the supports began to fracture and, as the vehicle continued forward, the supports deformed around the front of the vehicle. At 0.072 sec the sign panel hit the windshield knocking it loose from the upper molding. At 0.090 sec the dummy's head came through the opening between the windshield and the roof of the vehicle and by 0.162 sec the dummy's head was completely out of the vehicle. The vehicle exited the test area carrying the sign panel and parts of the supports. The vehicle came to rest approximately 156 ft behind and 18 ft to the right of the impact point.

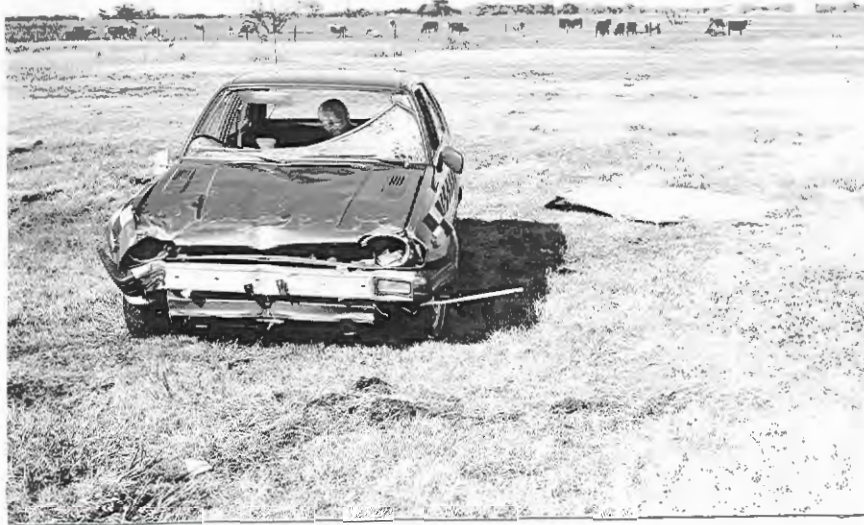
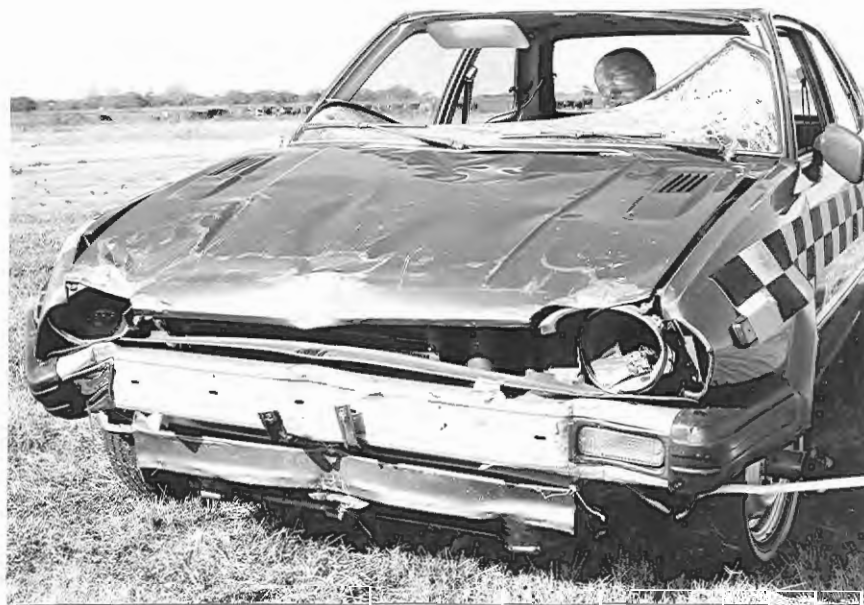
FIGURE A-57. TEST VEHICLE AFTER TEST 6.

The front of the vehicle was deformed and the windshield was broken as shown in Figure A-57. The right front quarter received 4.0 in. crush at bumper height. The center was crushed 1.0 in. at bumper height and 1.5 in. at hood height. Sequential photographs of the test are shown in Figure A-58.

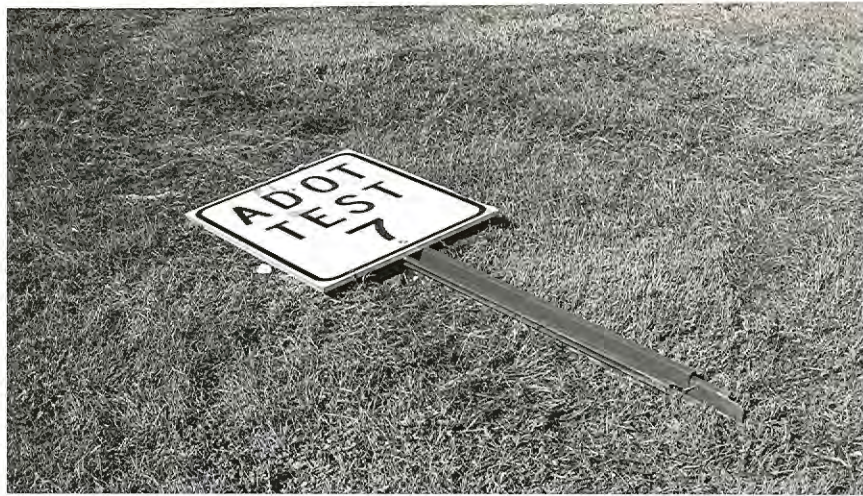
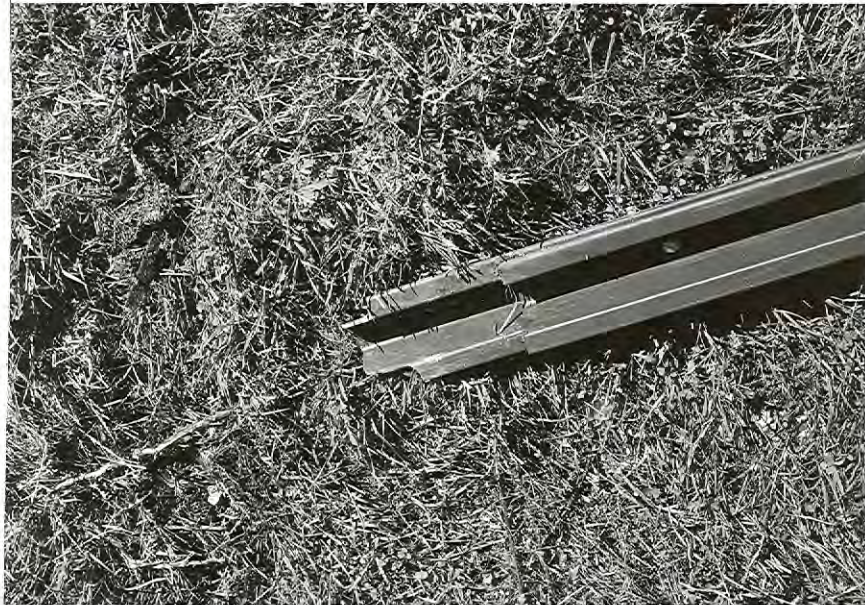
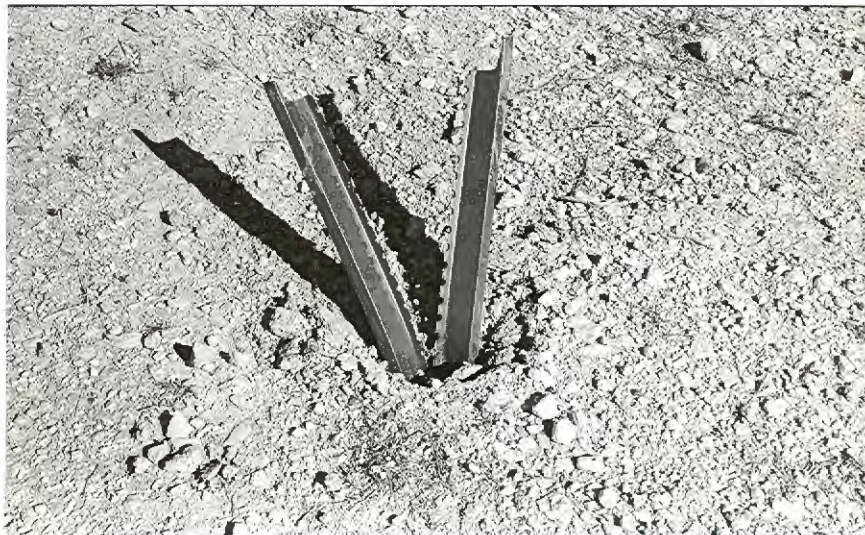
FIGURE A-62. SIGN INSTALLATION AFTER TEST 7.

The support was split from ground level to 14 in. above the ground. At this point the support was fractured as shown in Figure A-62. The vehicle received a maximum crush of 3.5 in. at bumper height and the left front corner of the bumper was bent forward. The roof was dented about 2 in. where the sign impacted. Photographs of the vehicle after the test are shown in Figure A-63 and sequentials of the crash are presented in Figure A-64.
