ARIZONA DEPARTMENT OF TRANSPORTATION

REPORT NUMBER: FHWA-AZ88-202-1

SMALL SIGN SUPPORT ANALYSIS

Phase I Crash Test Program

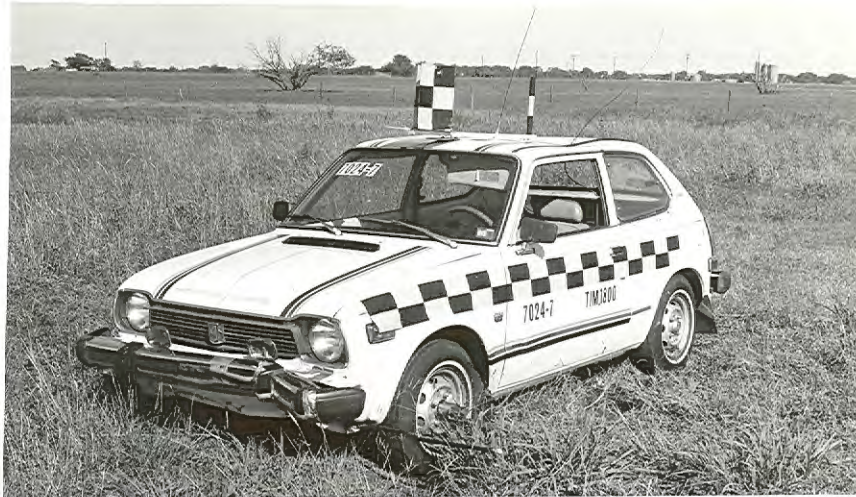
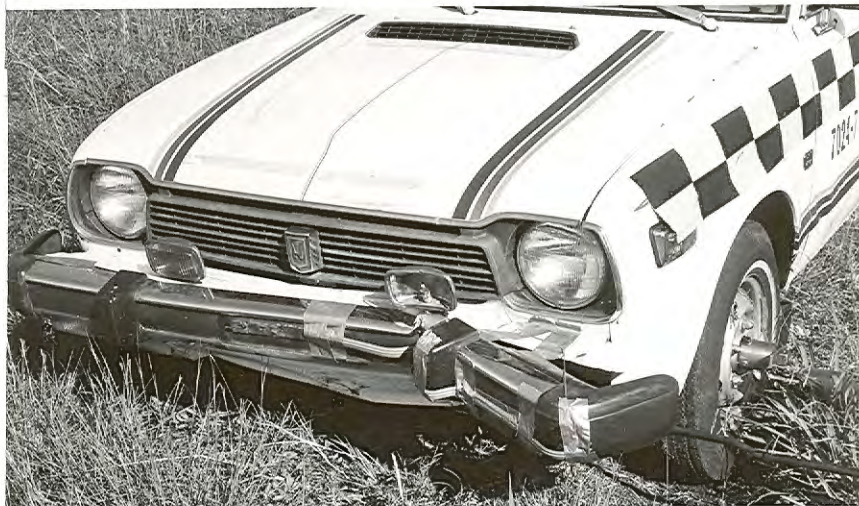
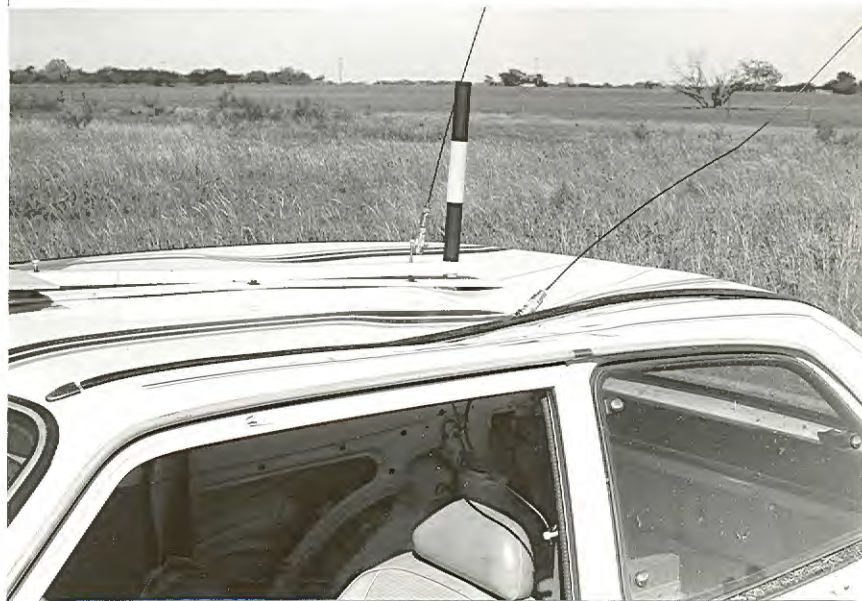
FIGURE A-63. TEST VEHICLE AFTER TEST 7.

The support was split from ground level to 14 in. above the ground. At this point the support was fractured as shown in Figure A-62. The vehicle received a maximum crush of 3.5 in. at bumper height and the left front corner of the bumper was bent forward. The roof was dented about 2 in. where the sign impacted. Photographs of the vehicle after the test are shown in Figure A-63 and sequentials of the crash are presented in Figure A-64.

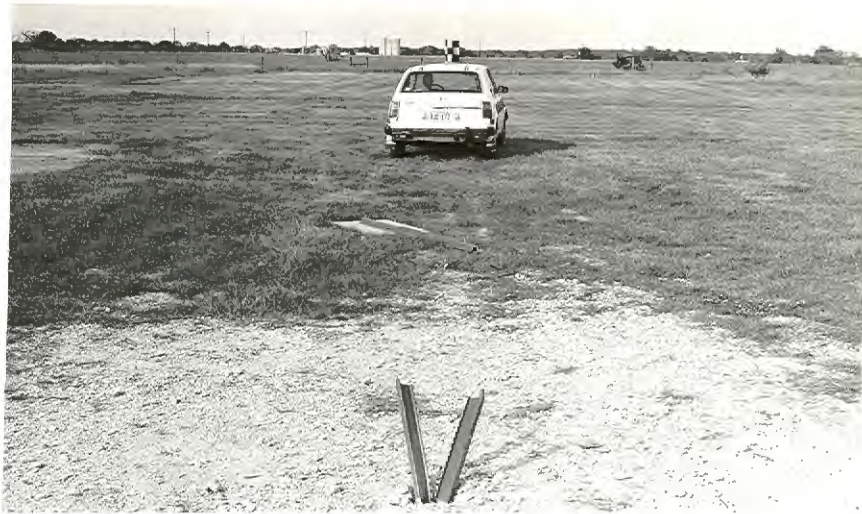
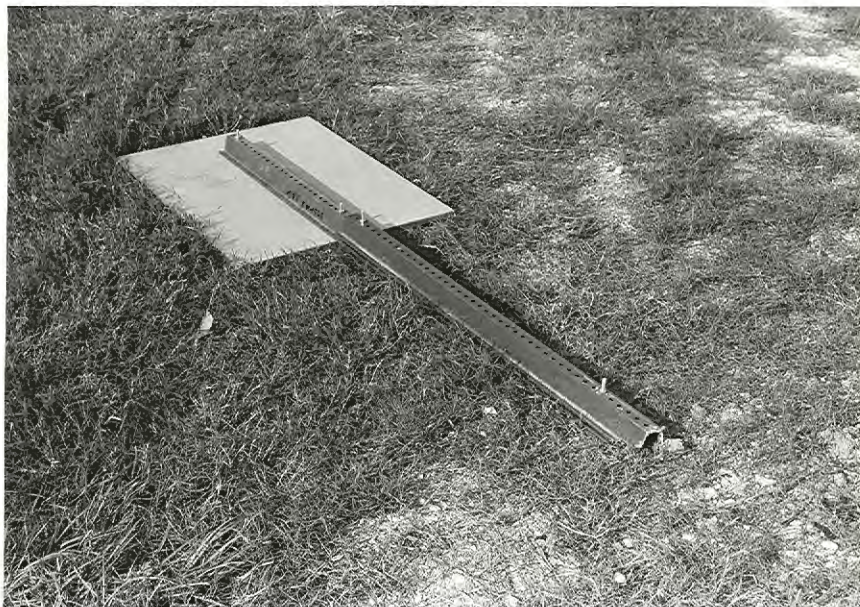
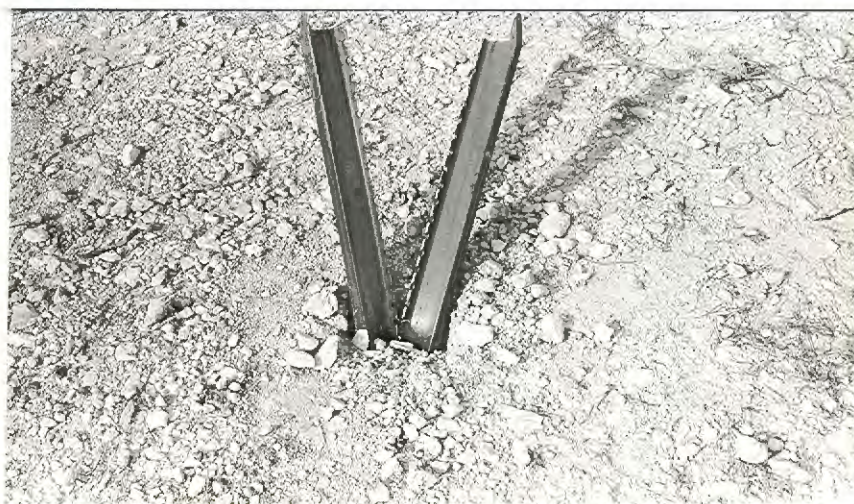
FIGURE A-68. SIGN INSTALLATION AFTER TEST 8.

The support was split from ground level to 16.5 in. above the ground. At this point the support was fractured as shown in Figure A-68. The vehicle received a minimal amount of damage. As shown in Figure A-69 there was a slight indentation in the bumper and the parking light was also broken. (Damage to the left side was due to the previous test.) Sequentials of the test are presented in Figure A-70.

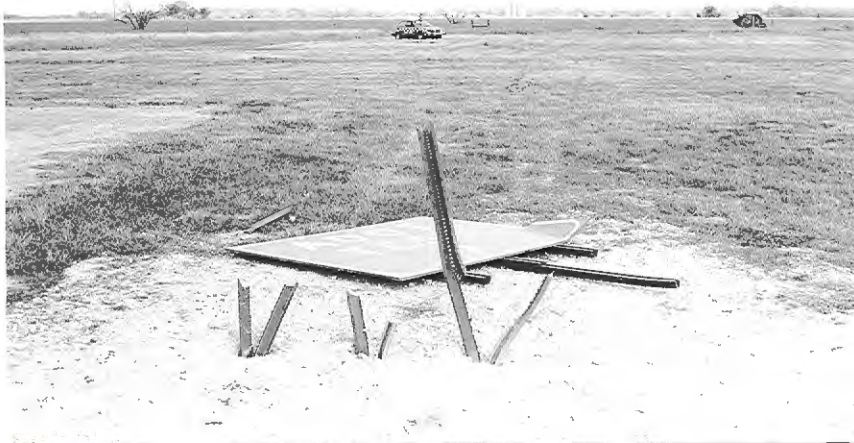
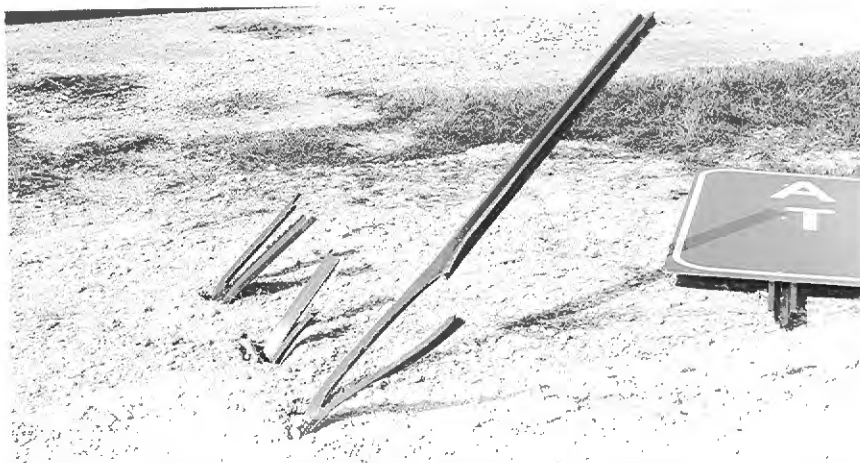
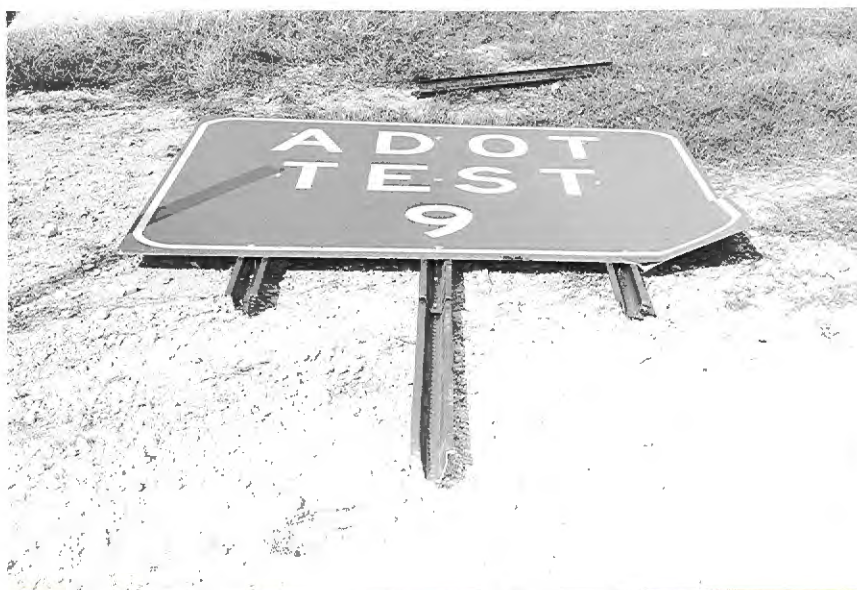
FIGURE A-74. SIGN INSTALLATION AFTER TEST 9.

The lower section of the left support was split longitudinally from ground level to 16.5 in. above the ground where it had fractured. The lower section of the center support was split from ground level to its fracture point of 12 in. As shown in Figure A-74 the right support split from ground level to 20 in. above the ground where only the right half fractured. The upper sections were relatively undamaged.

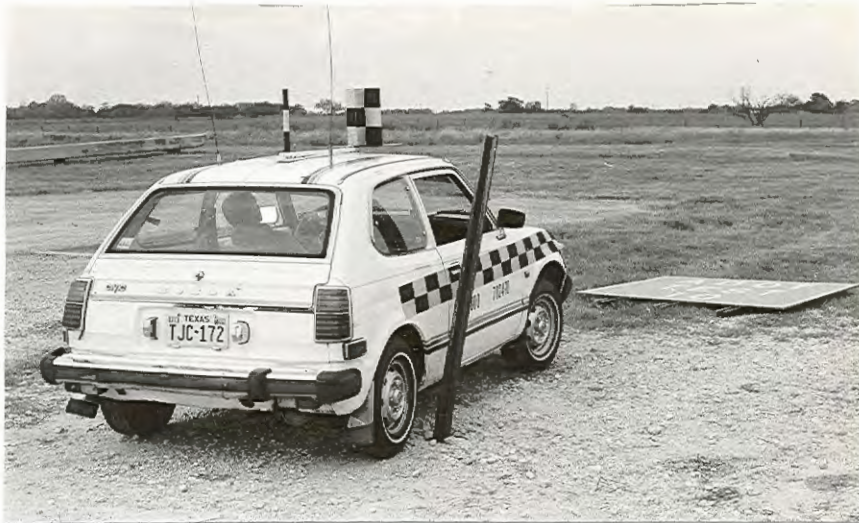
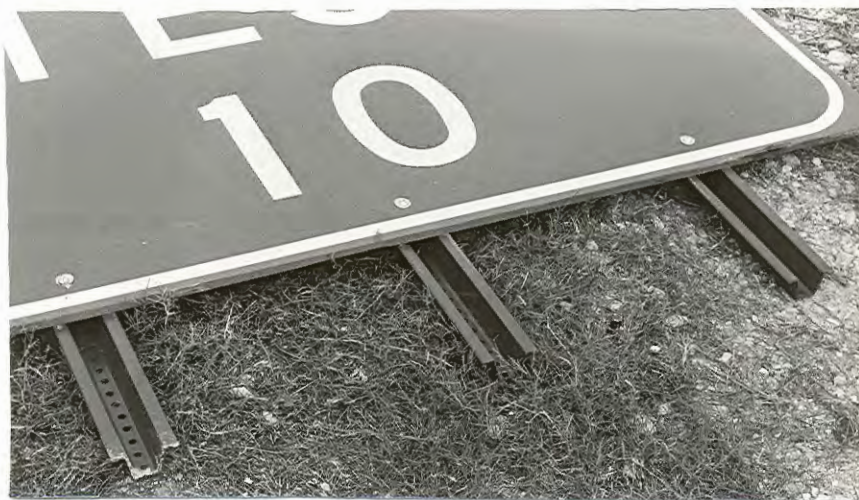
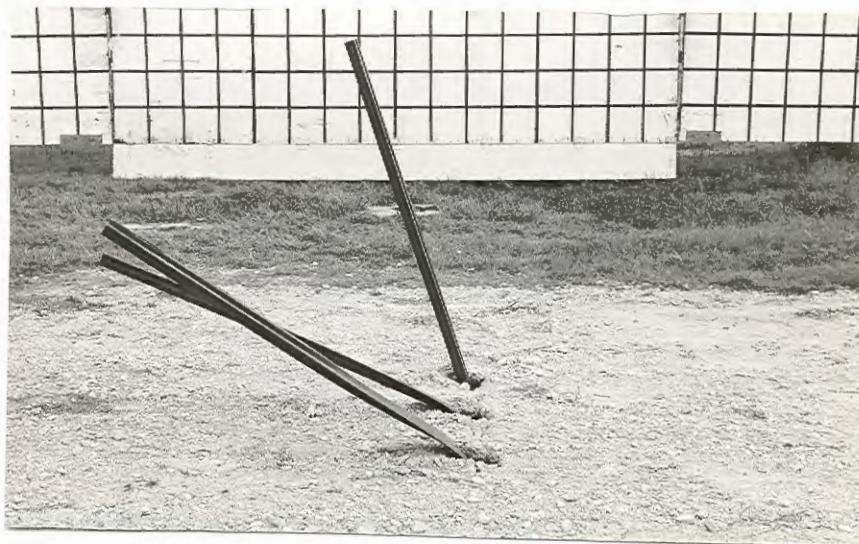
FIGURE A-79. SIGN INSTALLATION AFTER TEST 10.

Approximately 0.013 sec after impact the lower sections of the supports between ground level and the upper connection were bending and causing bending deformations at the upper connection. By 0.028 sec the top bolts in the connection failed and by 0.038 sec the lower bolts also failed. At 0.108 sec the vehicle began to ride up on the supports. The dummy's head hit the windshield just below the visor at 0.170 sec and at 0.210 sec the vehicle impacted the sign panel which had remained connected to the upper sections of the supports. Subsequently, the vehicle tilted to the left and came to rest directly over the left and center supports as shown in Figure A-79. The sign came to rest about 6 ft in front of the vehicle.

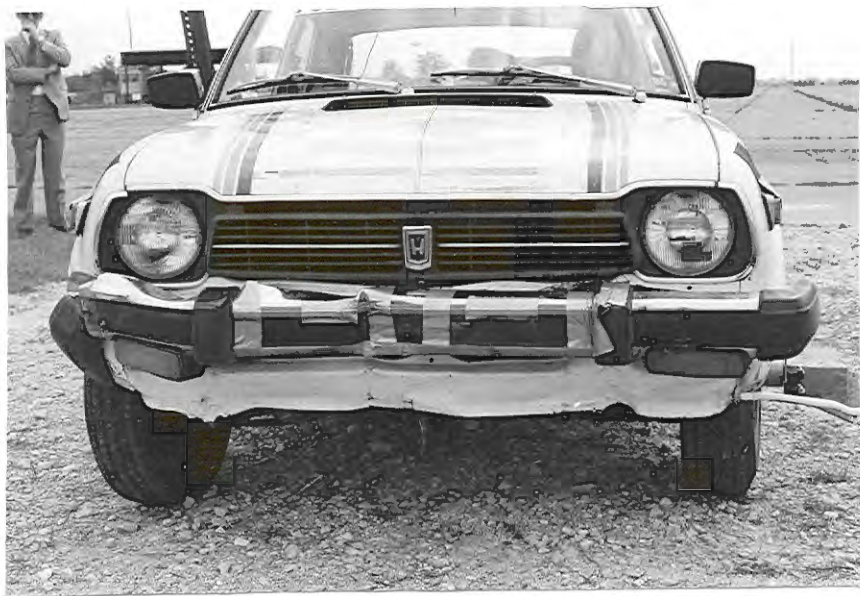
FIGURE A-80. TEST VEHICLE AFTER TEST 10.

The front of the vehicle was deformed as shown in Figure A-80. The right front quarter received 6.0 in. crush at bumper height. The center was crushed 2.0 in. at bumper height. The windshield was slightly cracked just below the visor and the visor was bent. Sequential photographs of the test are shown in Figure A-81.

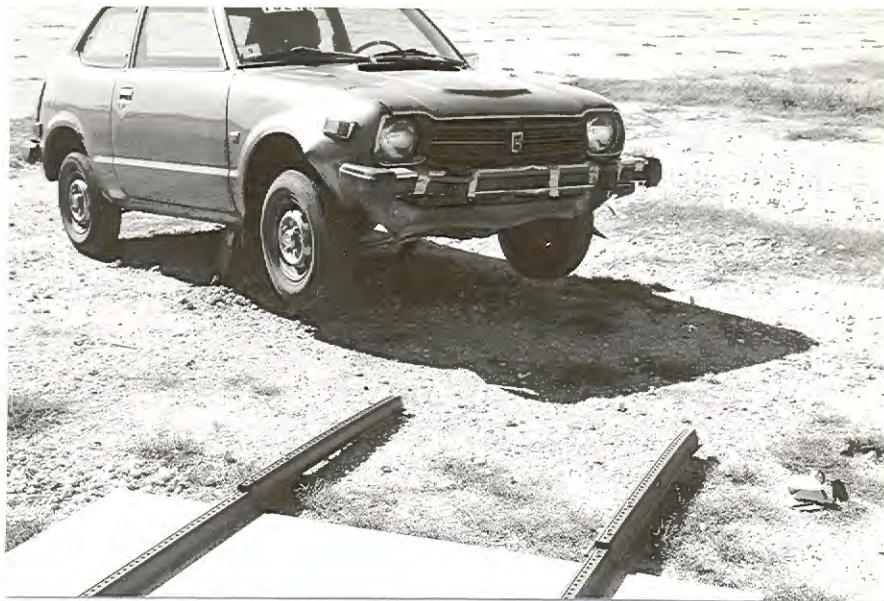
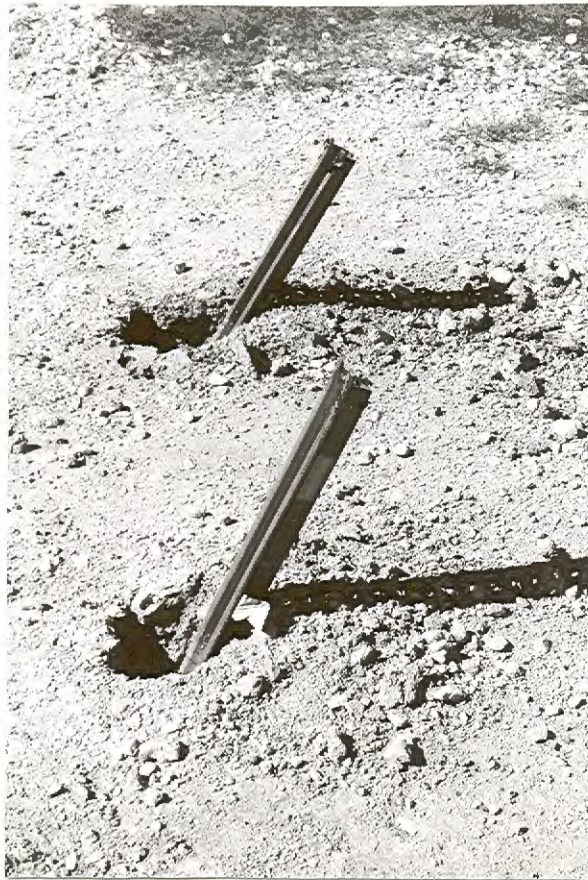
FIGURE A-85. SIGN INSTALLATION AFTER TEST 11.

The right support was fractured 19 in. above the ground and the left support was fractured 20 in. above the ground, as shown in Figure A-85. As shown in Figure A-86, the vehicle was elevated by the fractured supports. The front of the vehicle sustained minor scrapes and dents.

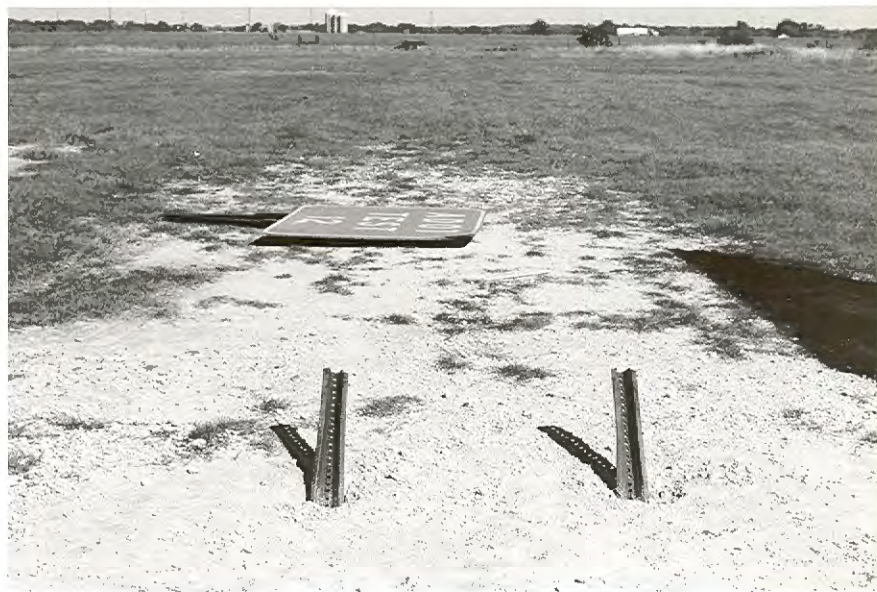
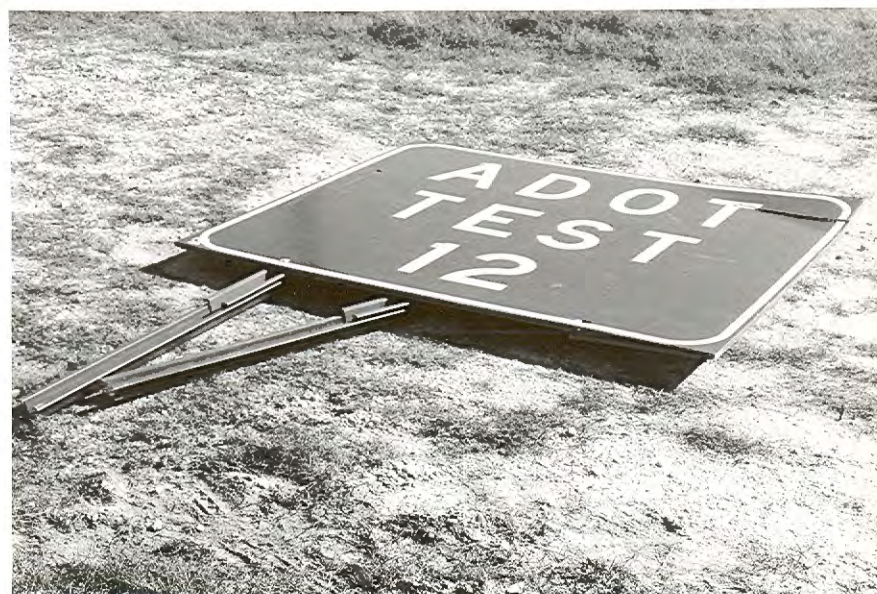
FIGURE A-90. SIGN INSTALLATION AFTER TEST 12.

The lower sections of the left and right supports fractured 17 in. above the ground. Damage to the sign supports is shown in Figure A-90. The front of the vehicle was deformed as shown in Figure A-91. The vehicle sustained minor dents. It remained upright and stable after impact.

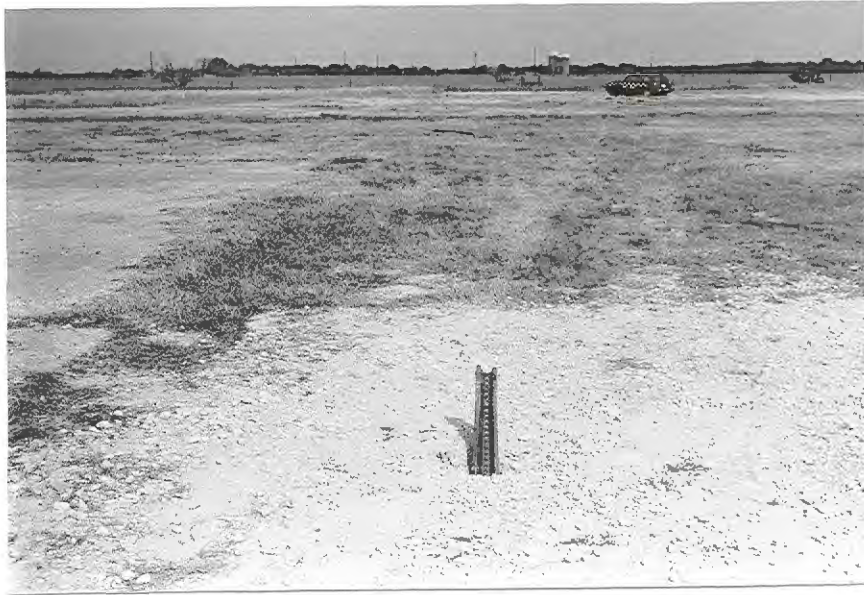
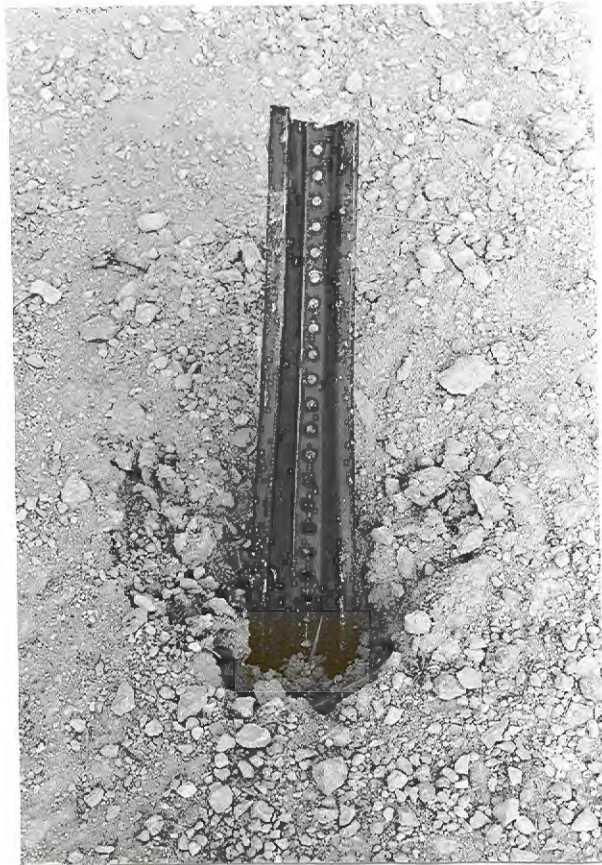
FIGURE A-95. TEST SITE AFTER TEST 13.

The lower section of the support was fractured 18 in. above the ground as shown in Figures A-95 and A-96. The vehicle received a maximum crush of 6.0 in. at bumper height and 2 in. at hood height. Photographs of the vehicle after the test are shown in Figure A-97 and sequentials of the test are presented in Figure A-98.

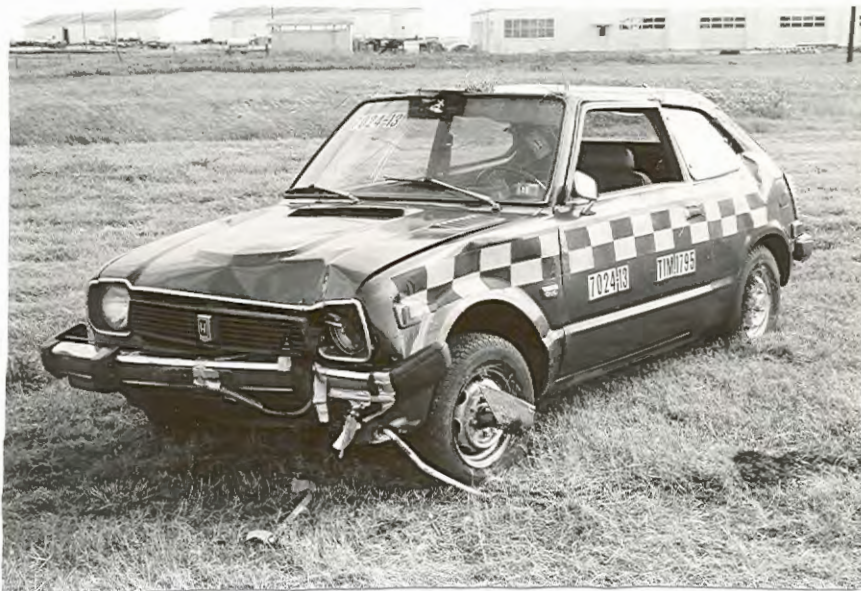
FIGURE A-97. TEST VEHICLE AFTER TEST 13.

The vehicle remained upright and stable throughout the initial test period. Post-test roll was attributed to unsymmetrical brake application and subsequent tipping of the vehicle when the tires rutted the grassy sod.

Post-test roll attributed to
unsymmetrical brake application
and soil condition.

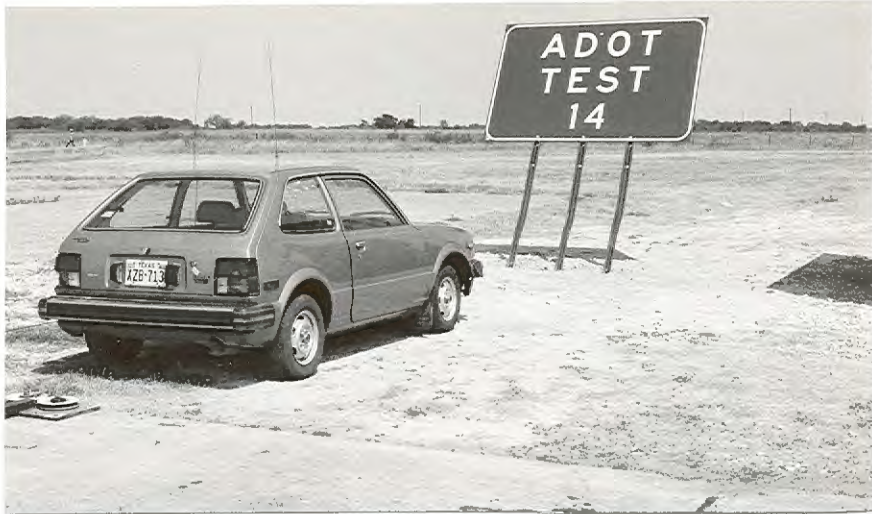
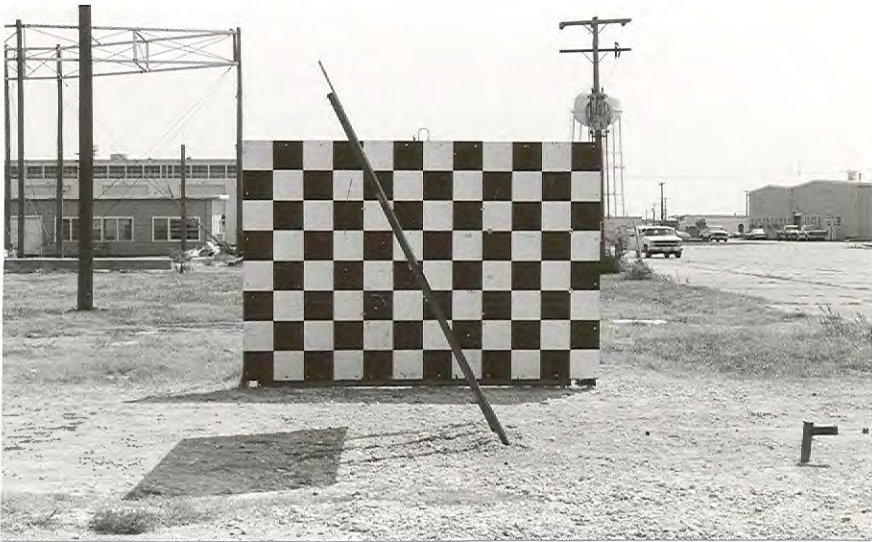
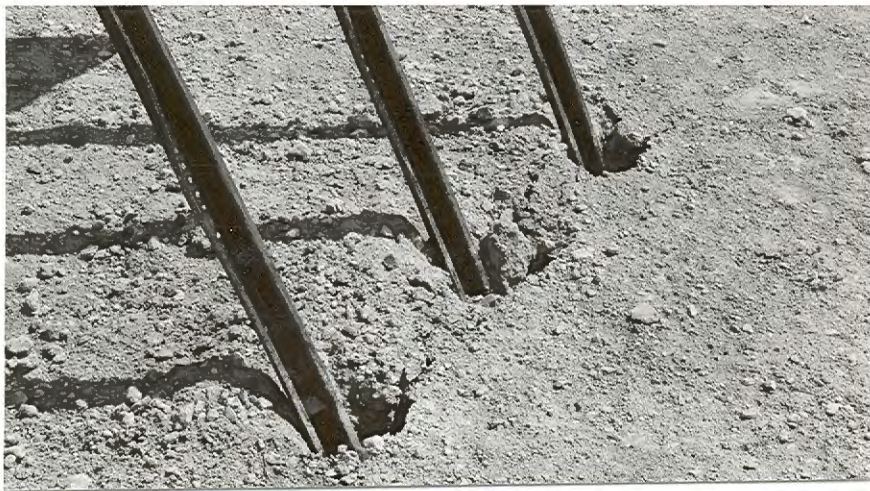
FIGURE A-102. TEST INSTALLATION AFTER TEST 14.

The sign installation was pushed back about 6.5 in. and was scratched and bent about 16 in. above the ground as shown in Figure A-102. As shown in Figure A-103, the vehicle sustained minor scrapes to the bumper with a maximum 1.5 in. crush at bumper height. Also the windshield was cracked.

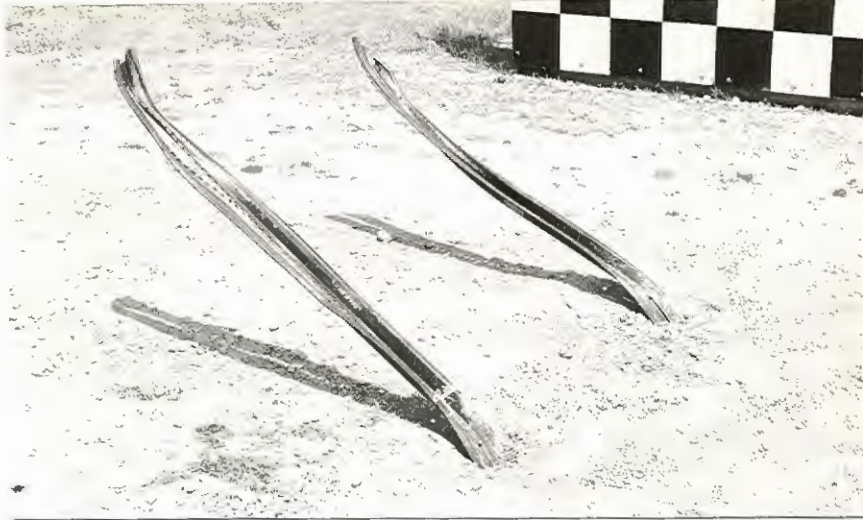
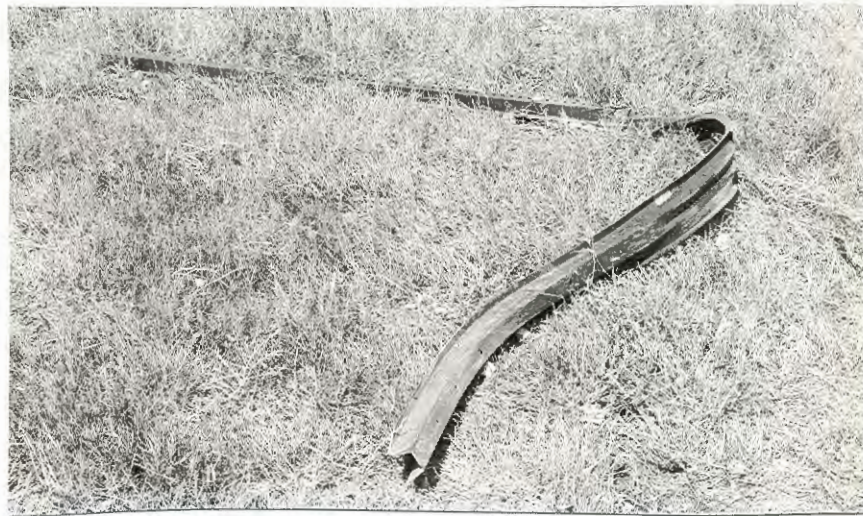
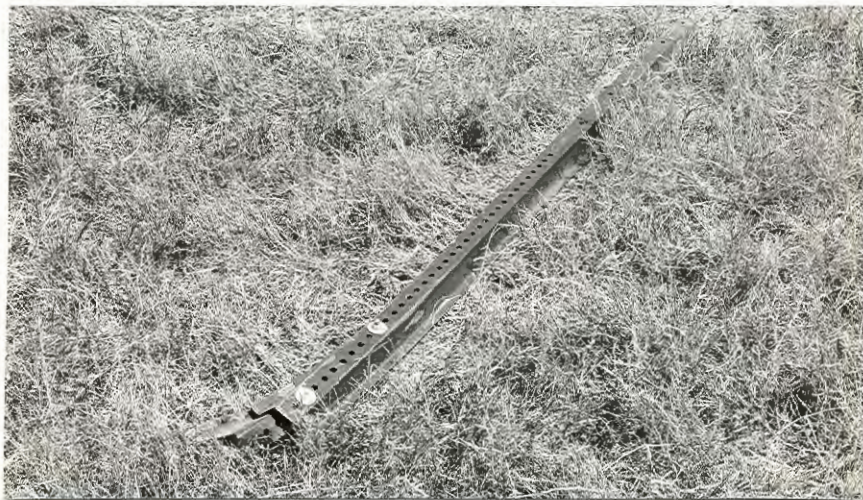
FIGURE A-106. TEST INSTALLATION AFTER TEST 15.

The lower sections of the left and right supports fractured 54 in. above the ground. The center support was pulled completely out of the ground. Damage to the sign supports is shown in Figure A-106.

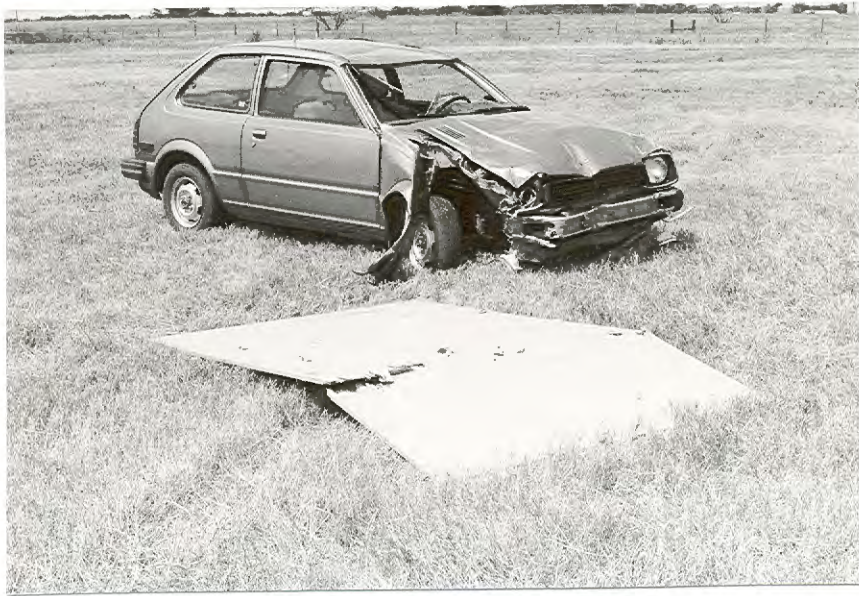
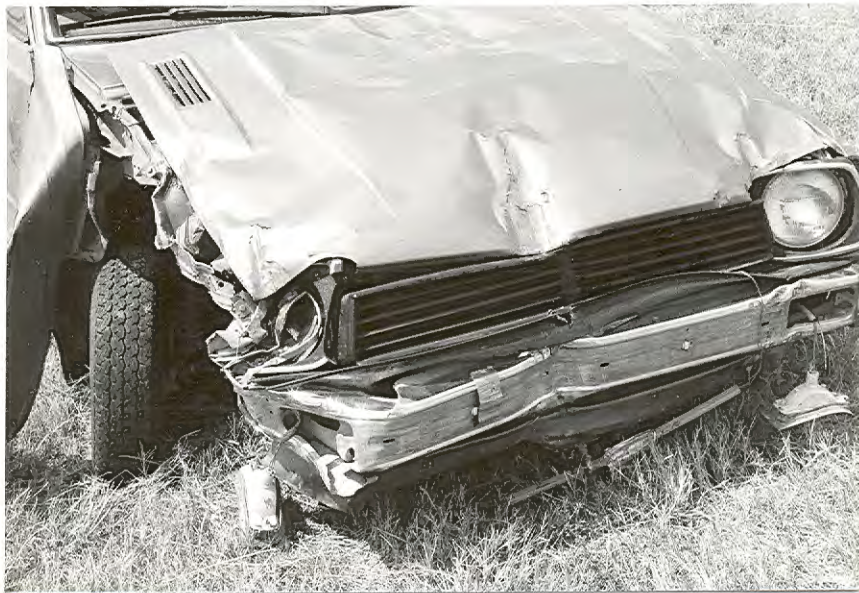
FIGURE A-107. VEHICLE AFTER TEST 15.

The front of the vehicle was deformed as shown in Figure A-107. The right front quarter received 10.0 in. crush at bumper height. The center was crushed 3.0 in. at bumper height and 1.0 in. on the left side. The windshield was also broken. Sequential photographs of the test are shown in Figure A-108.

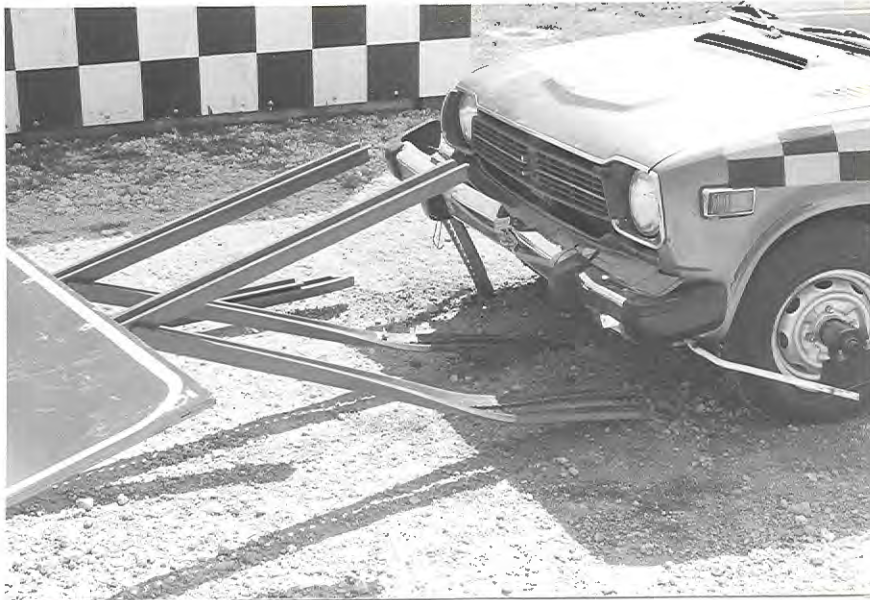
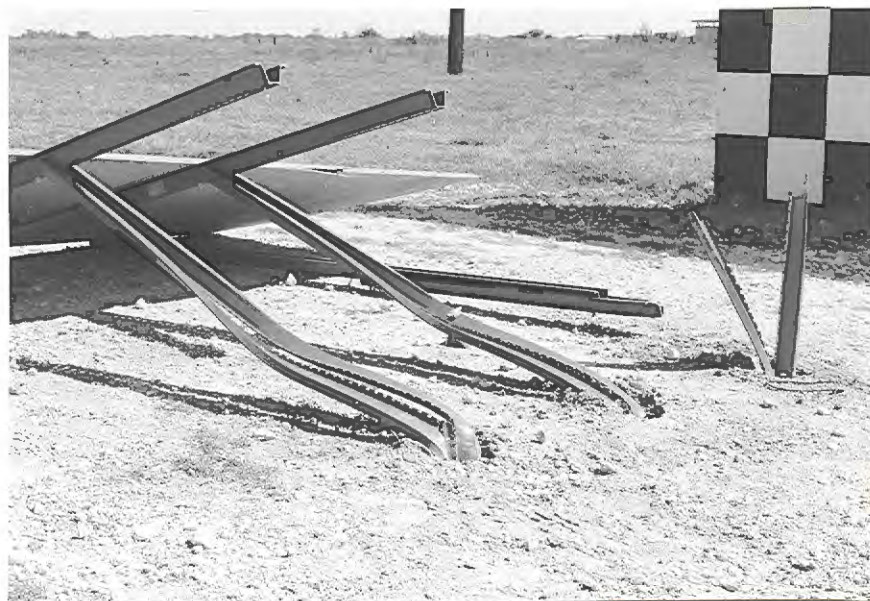
FIGURE A-112. TEST INSTALLATION AFTER TEST 16.

The sign installation was pushed to the ground as shown in Figure A-112. The lower section of the right support was split longitudinally and was fractured 19 in. above the ground. The lower sections of the center and left supports were split longitudinally.

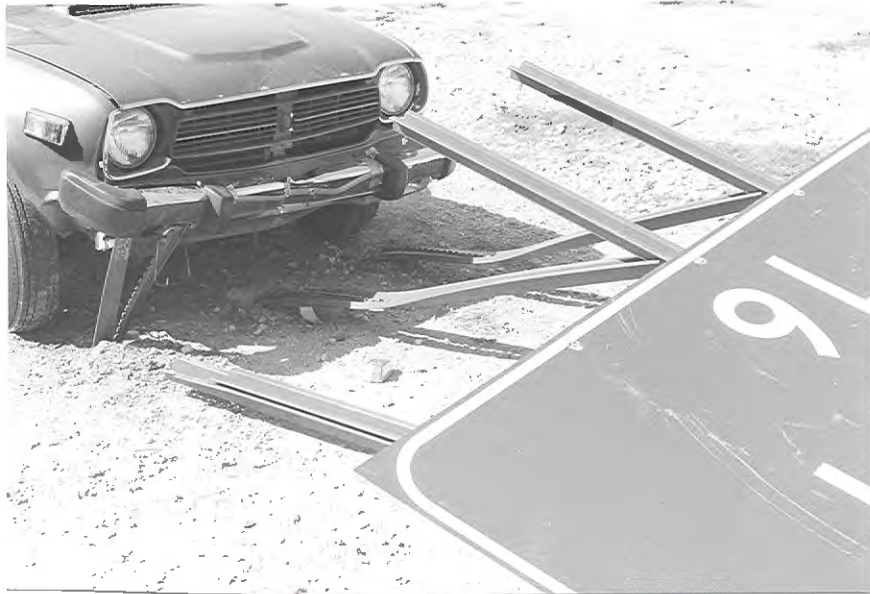
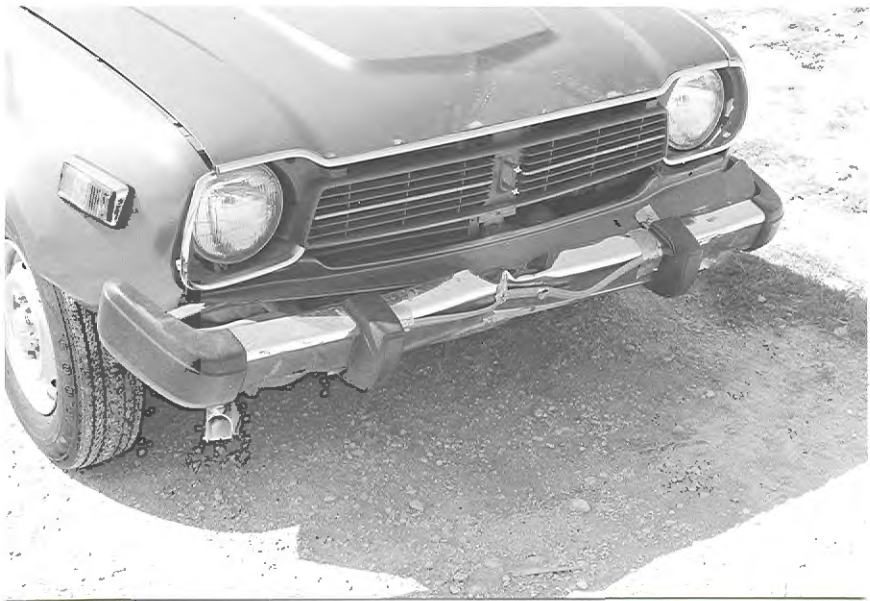
FIGURE A-113. VEHICLE AFTER TEST 16.

The vehicle received minor damage as shown in Figure A-113. There was a maximum vehicle crush of 4 in. at bumper height.

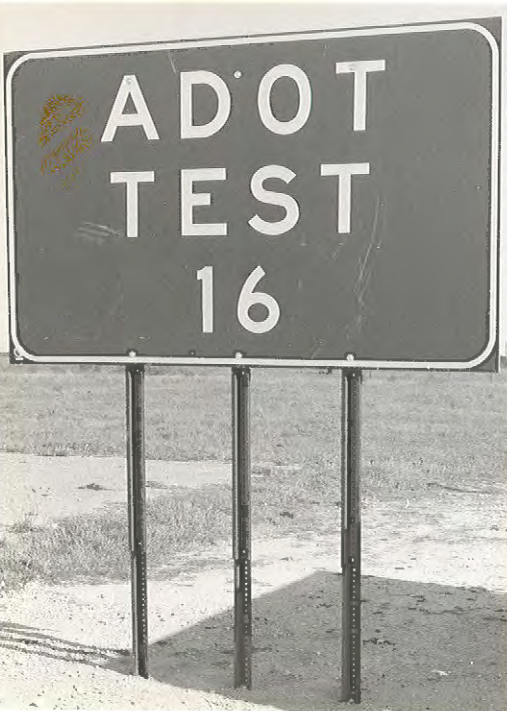
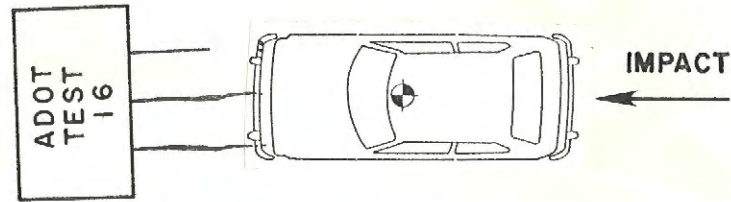
FIGURE A-114. SUMMARY OF RESULTS FOR TEST 16.

The results of the test are summarized in Figure A-114. Change in the vehicle's velocity was 19.0 mph and change in momentum was 1,534 lb-sec. Longitudinal occupant impact velocity was 22.4 fps and the maximum 0.010-second average occupant ridedown acceleration was -3.6 g.

Test No.	7024-16	Impact Speed.	20.0 mph (32.2 kph)
Date	9/24/85	Change in Velocity.	19.0 mph (30.6 kph)
Test Article	Sign installation	Change in Momentum.	1,534 lb-sec
Support.	Three 3 lb High Carbon Billet Steel Supports	Occupant Impact Velocity	
Vehicle.	1979 Honda Civic	Longitudinal.	22.4 fps (6.8 m/s)
Vehicle Weight		Lateral	None
Test Inertia	1,772 lb (804 kg)	Occupant Ridedown Accelerations	
Gross Static	1,955 lb (888 kg)	Longitudinal.	-3.6 g
Vehicle Damage Classification		Lateral	N/A
TAD.	12FD1	Maximum Vehicle Crush	
SAE.	12FDLW1	Bumper Height	4.0 in. (10.2 cm)

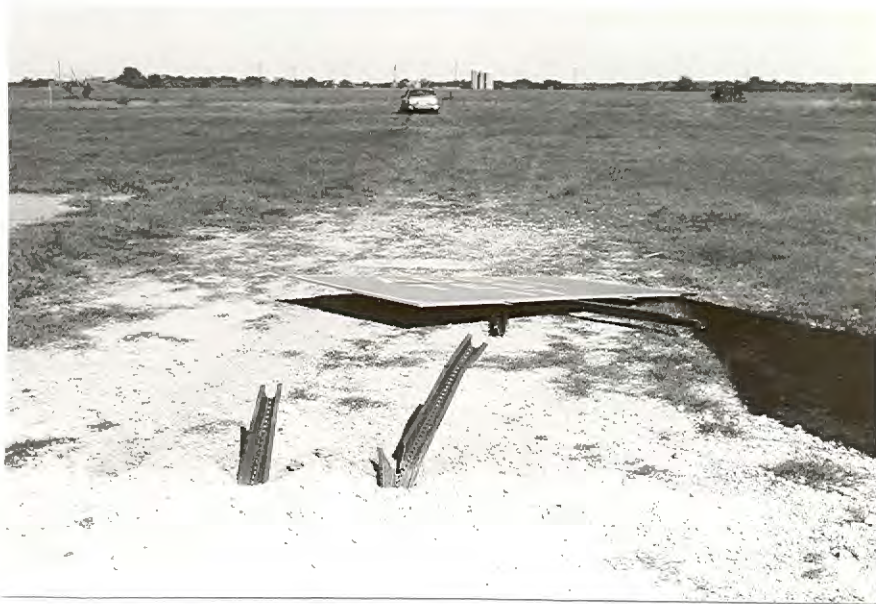
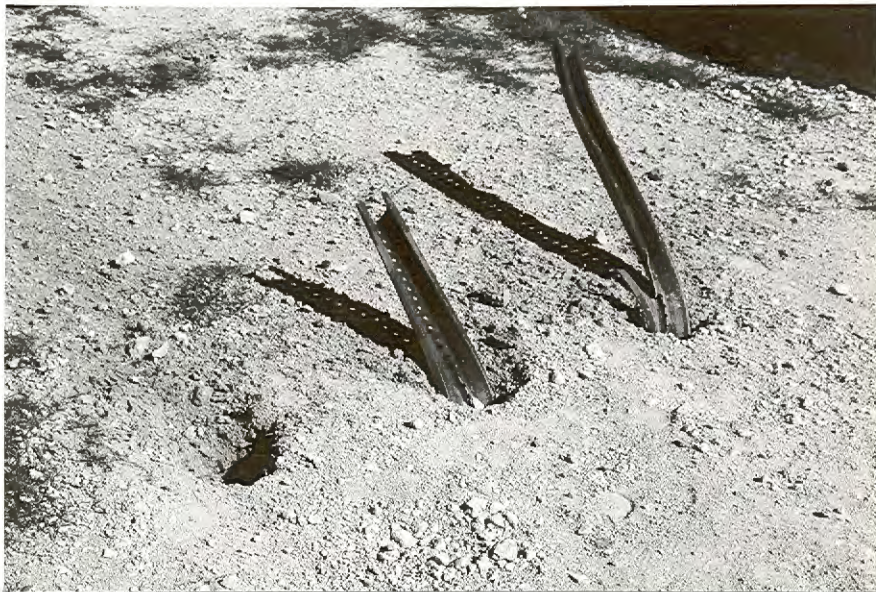
FIGURE A-117. SIGN INSTALLATION AFTER TEST 17.

The lower section of the center support fractured at 17 in. and the right support fractured 33 in. above the ground. The left support was pulled completely out of the ground. Damage to the sign supports is shown in Figure A-117.

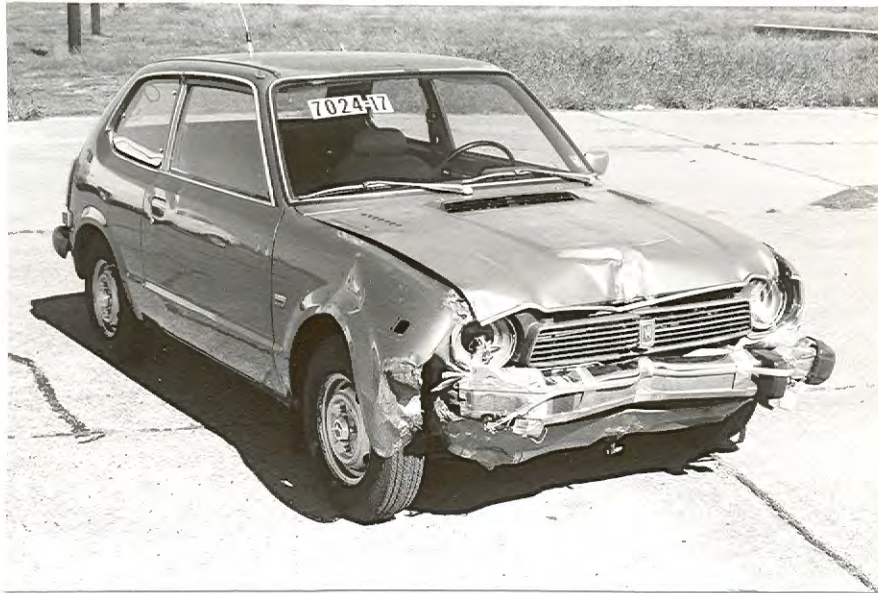
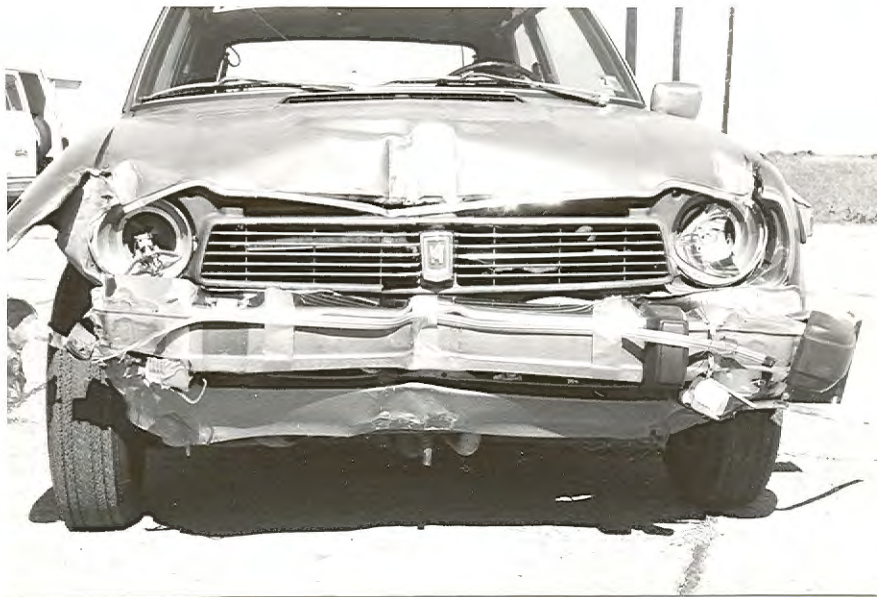
FIGURE A-118. VEHICLE AFTER TEST 17.

The front of the vehicle was deformed as shown in Figure A-118. The right front quarter received 5.0 in. crush at bumper height. The center was crushed 5.5 in. at bumper height, and 10.0 in. on the left side.

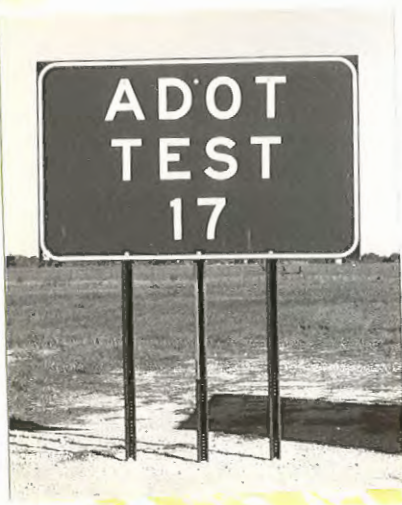
FIGURE A-119. SUMMARY OF RESULTS FOR TEST 17.

Test results are shown in Figure A-119. Change in the vehicle's velocity was 12.9 mph and change in momentum was 1,058 lb-sec. Longitudinal occupant impact velocity was 12.8 fps and the maximum 0.010-second average ridedown acceleration was -2.0 g.

Test No.	7024-17	Impact Speed.	62.0 mph (99.8 kph)
Date	11/07/85	Change in Velocity.	12.9 mph (20.8 kph)
Test Article	Sign Installation	Change in Momentum	1,058 lb-sec
Support.	Three posts of 3 lb High Carbon Billet Steel	Occupant Impact Velocity	
Vehicle.	1979 Honda Civic	Longitudinal.	12.8 fps (3.9 m/s)
Vehicle Weight		Lateral	None
Test Inertia	1,800 lb (817 kg)	Occupant Ridedown Accelerations	
Gross Static	1,965 lb (892 kg)	Longitudinal.	-2.0 g
Vehicle Damage Classification		Lateral	N/A
TAD.	12FD1	Maximum Vehicle Crush	
SAE.	12FDEW1	Bumper Height	10.0 in. (25.4 cm)

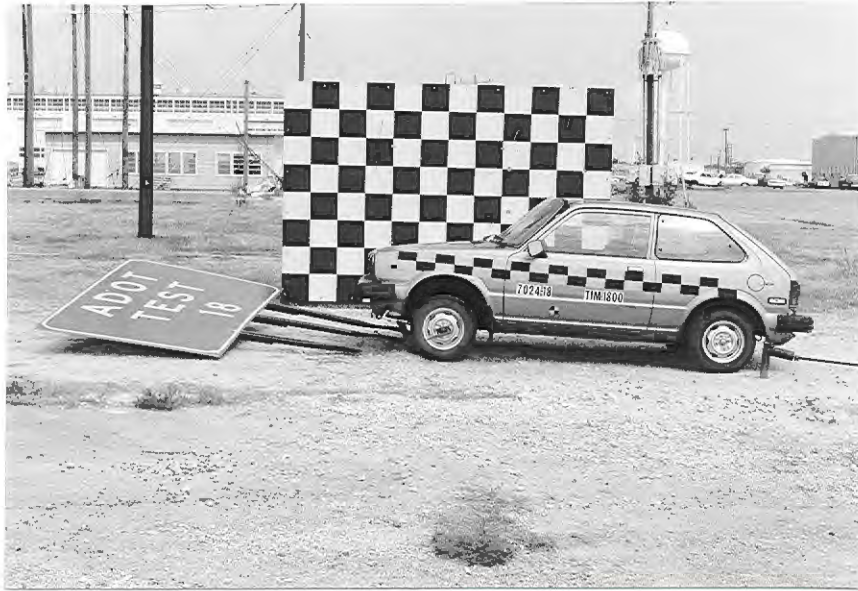
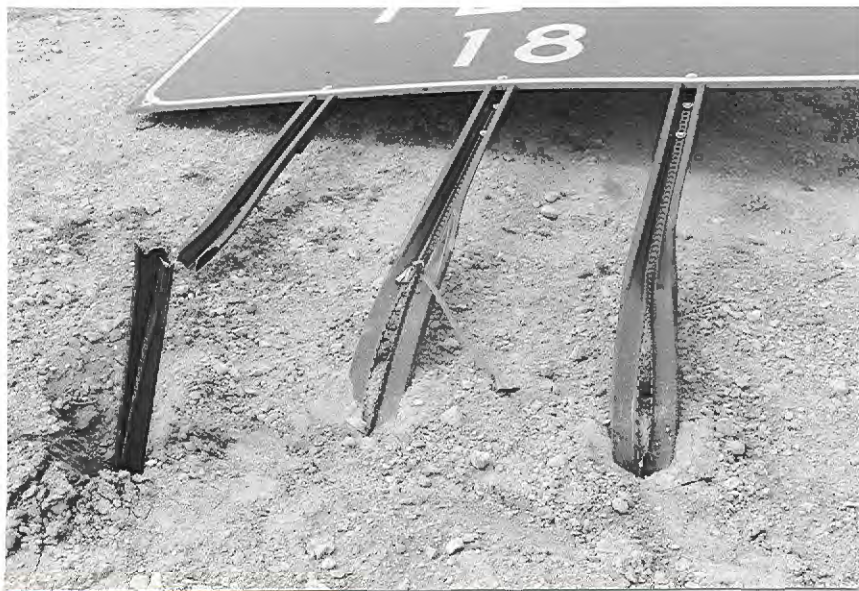
FIGURE A-122. TEST INSTALLATION AFTER TEST 18.

The left support was fractured 19.5 in. above the ground as shown in Figure A-122. The center and right supports were split longitudinally but did not fracture. As shown in Figure A-123, the vehicle sustained minor scrapes to the bumper and a broken windshield.

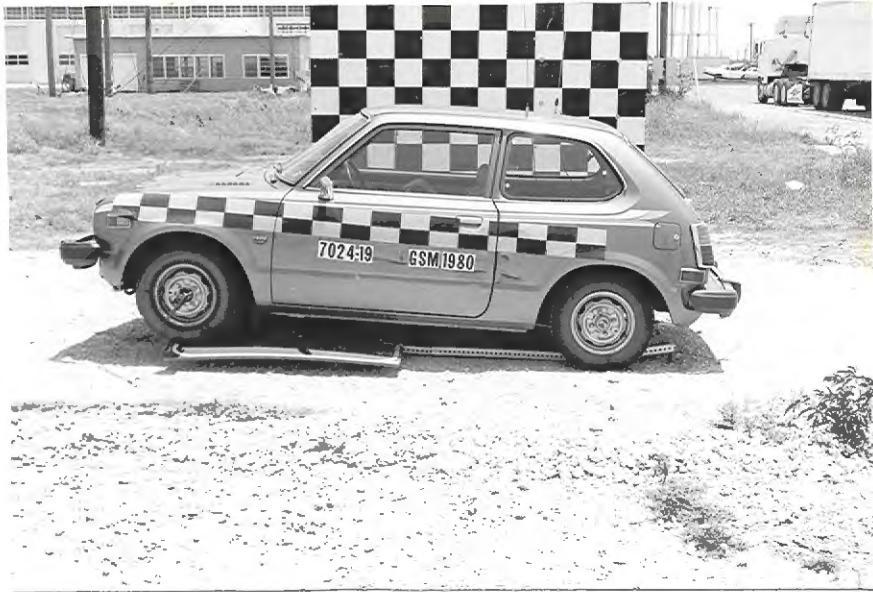
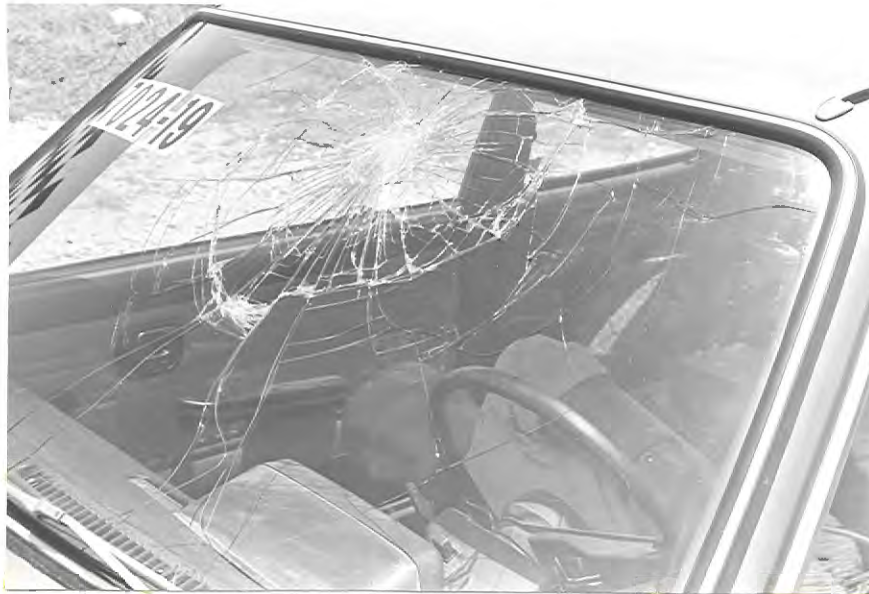
FIGURE A-126. TEST VEHICLE AFTER TEST 19.

As shown in Figure A-128, the supports were fractured at the base. The left support also had a slight fracture about 16.0 in. above the ground. The vehicle (see Figure A-126) received minor scrapes on the bumper with a maximum crush of 4.5 in. on the right side at bumper height. The windshield was also cracked.
