ARIZONA DEPARTMENT OF TRANSPORTATION

REPORT NUMBER: FHWA-AZ88-202-1

SMALL SIGN SUPPORT ANALYSIS

Phase I Crash Test Program

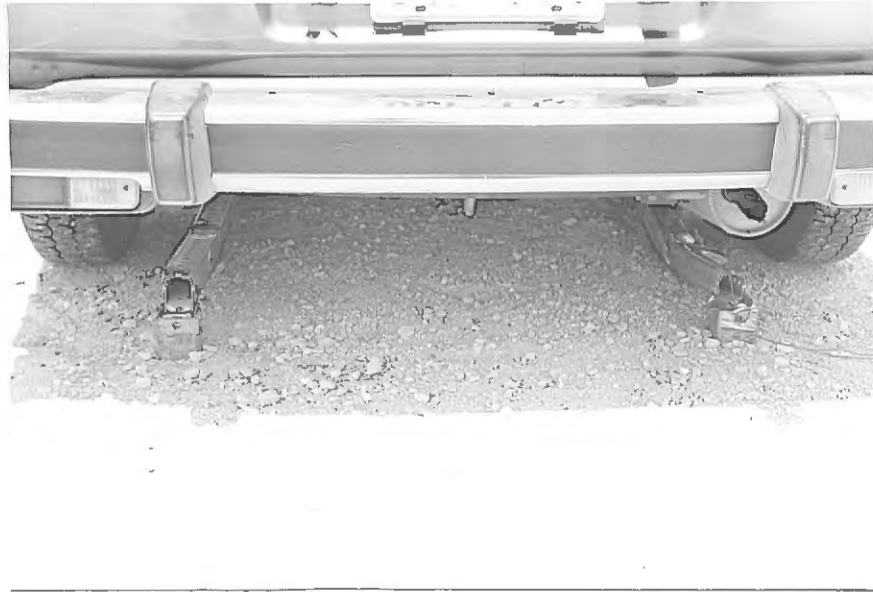
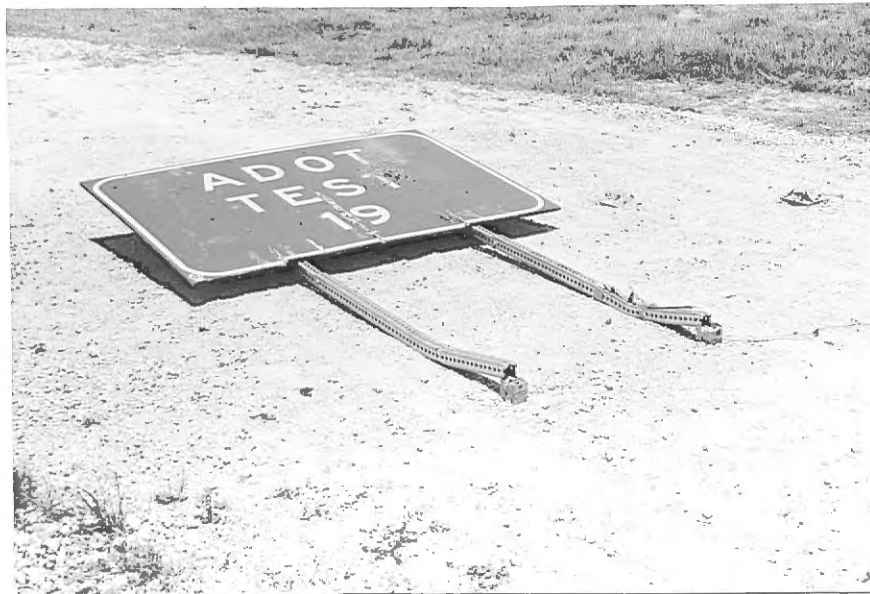
FIGURE A-128. TEST INSTALLATION AFTER TEST 19.

As shown in Figure A-128, the supports were fractured at the base. The left support also had a slight fracture about 16.0 in. above the ground. The vehicle (see Figure A-126) received minor scrapes on the bumper with a maximum crush of 4.5 in. on the right side at bumper height. The windshield was also cracked.

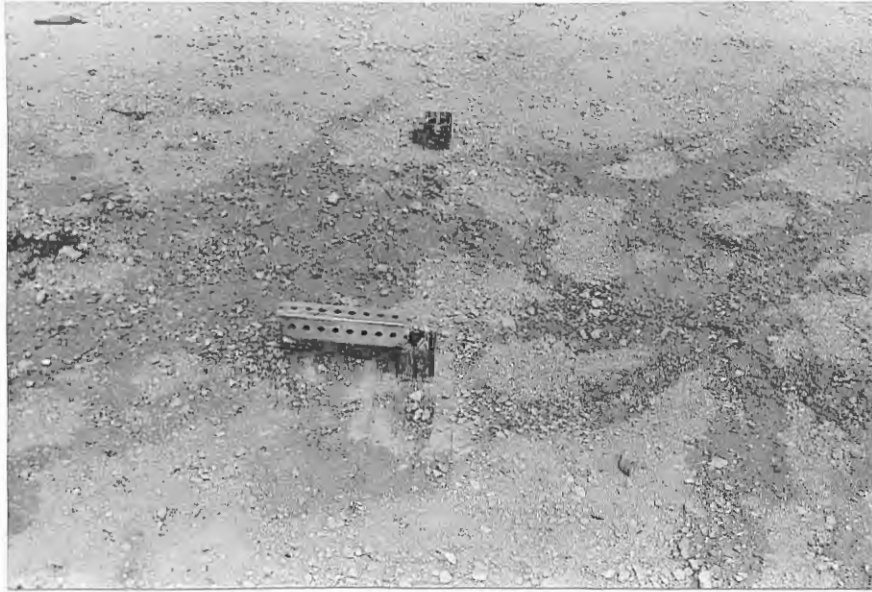
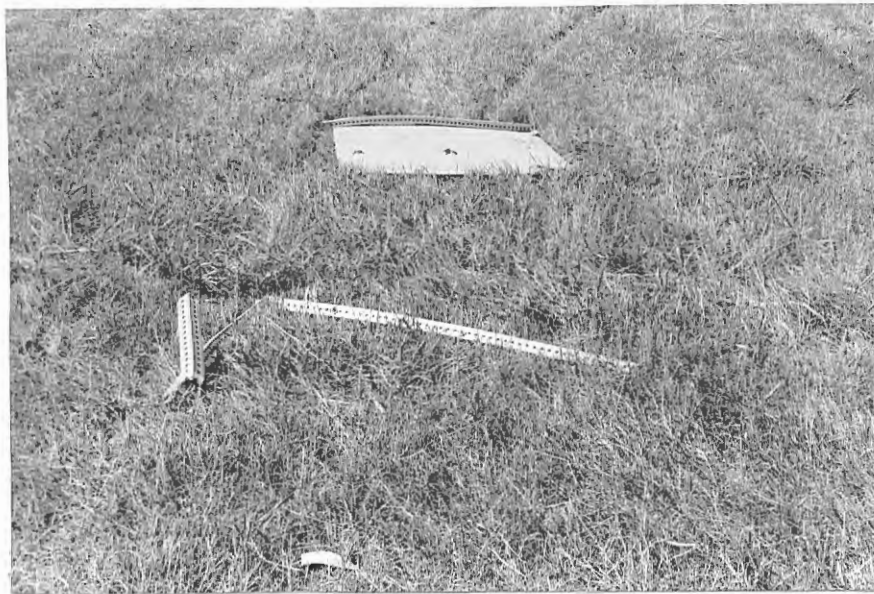
FIGURE A-132. SIGN INSTALLATION AFTER TEST 20.

As shown in Figure A-132 (two sheets), the left support separated about 10 in. above the ground and the right support separated at the base. The vehicle sustained a maximum crush of 3 in. at bumper height on the right side. The hood was scraped and dented, and the windshield was knocked out. Photographs of the vehicle after the test are shown in Figure A-133.

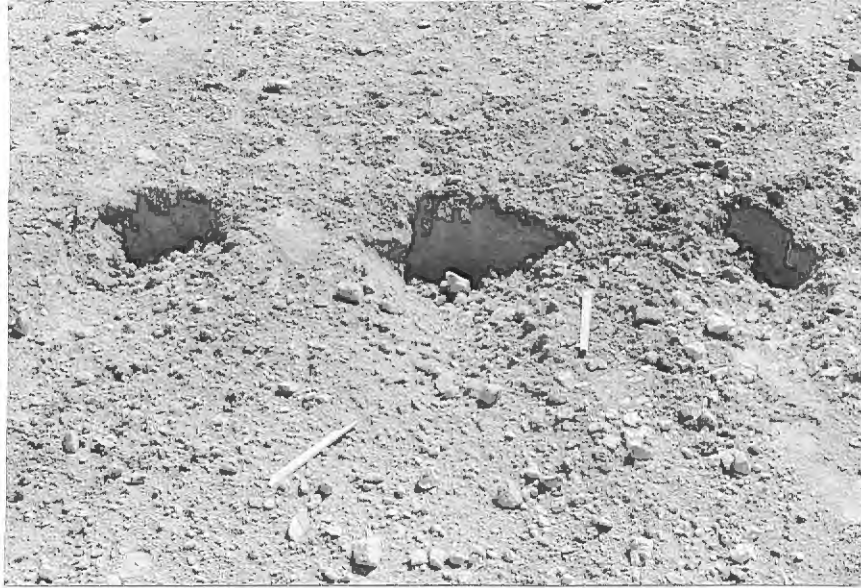
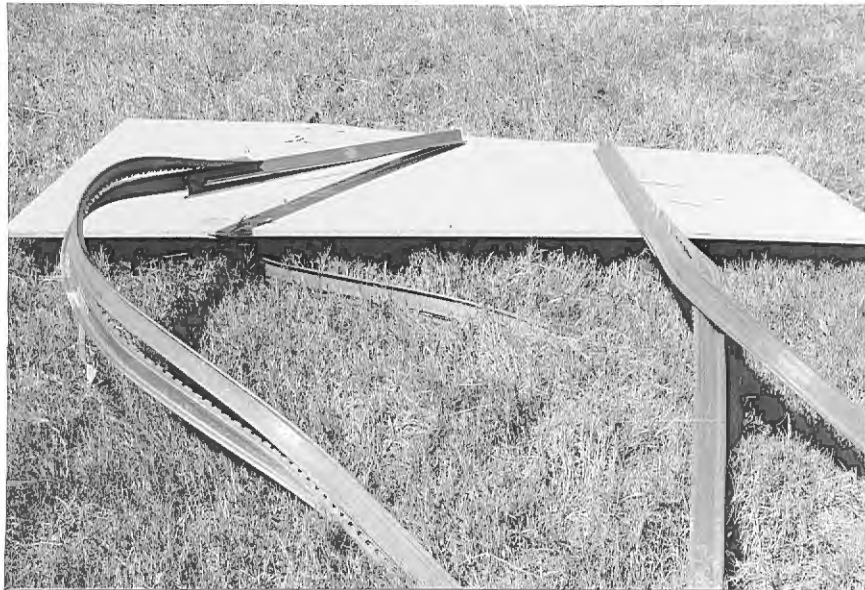
FIGURE A-136. SIGN INSTALLATION AFTER TEST 21.

The sign installation was pulled out of the ground. The supports were split and twisted. Damage to the sign supports is shown in Figure A-136.

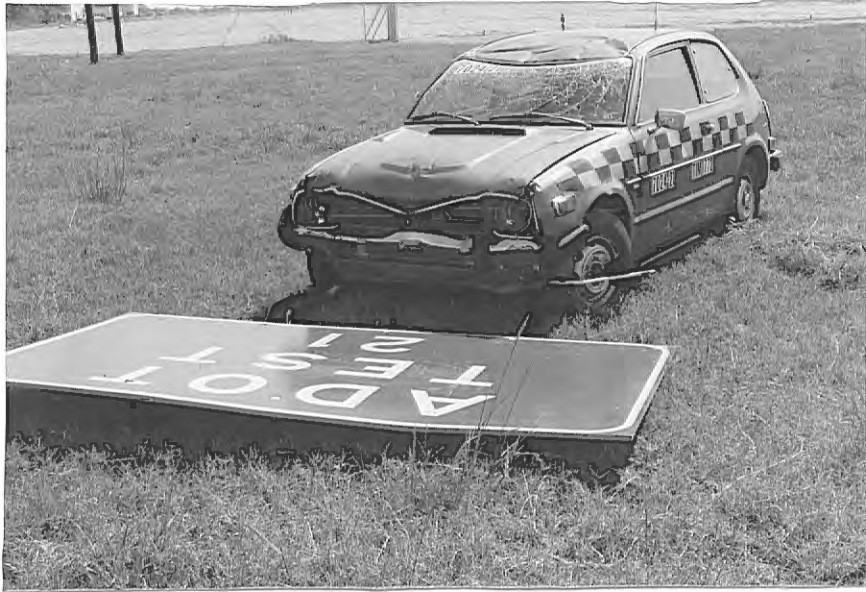
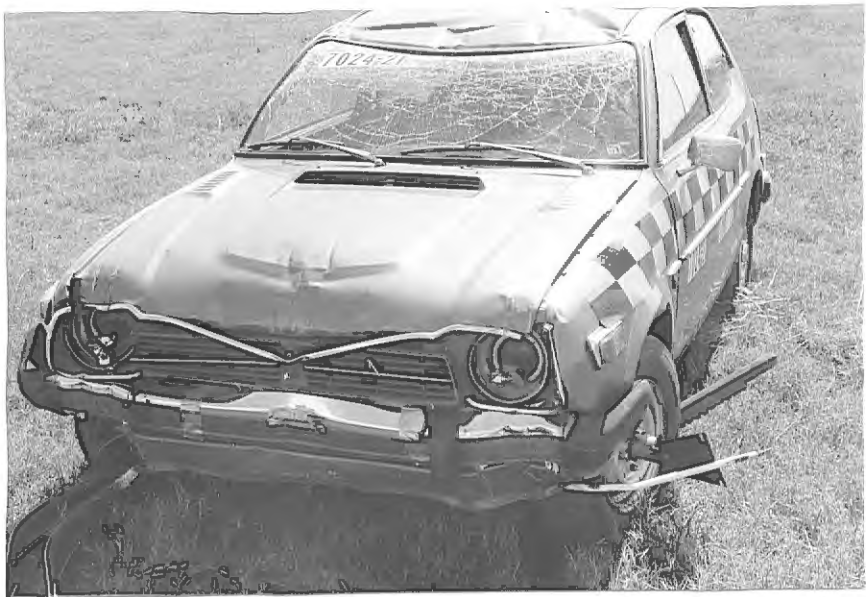
FIGURE A-137. VEHICLE AFTER TEST 21.

The front of the vehicle was deformed as shown in Figure A-137. The left front quarter received 6.0 in. crush at bumper height. The center and right side was crushed 3.0 in. at bumper height. The windshield also was broken. Sequential photographs of the test are shown in Figure A-138.

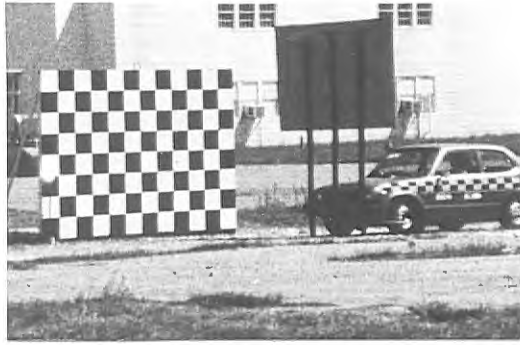
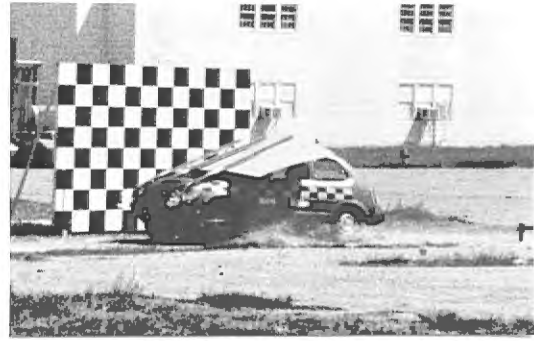
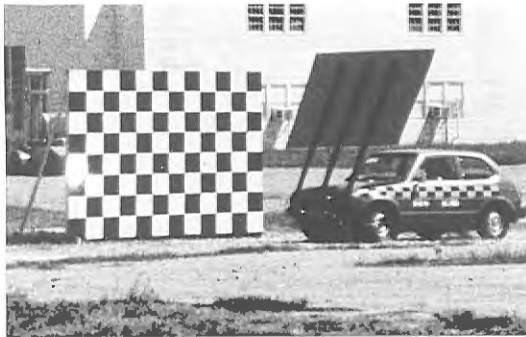
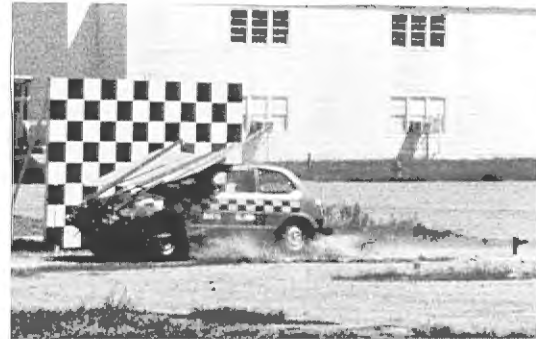
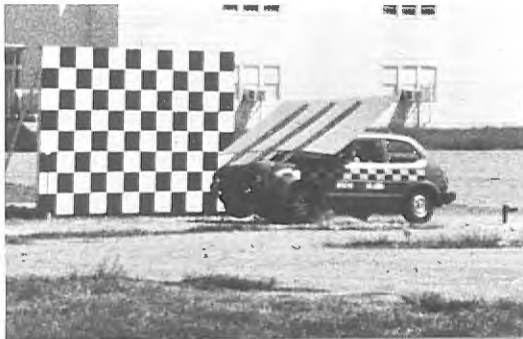
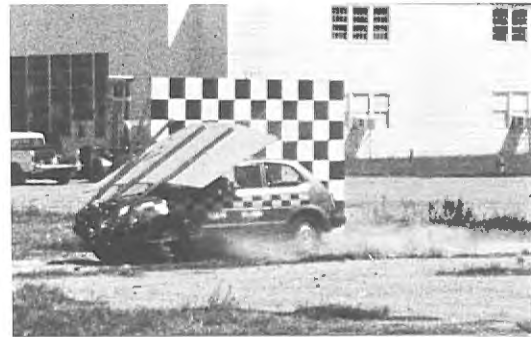
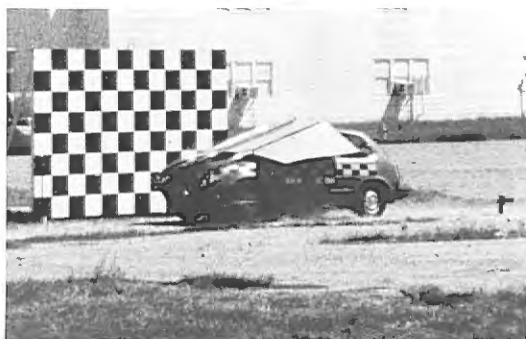
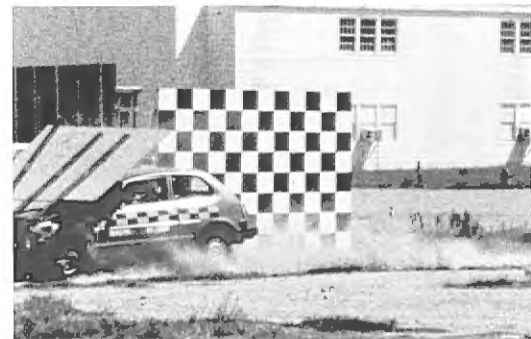
FIGURE A-138. SEQUENTIAL PHOTOGRAPHS FOR TEST. 21.

Shortly after impact the supports began to deform around the front of the vehicle and by 0.063 sec the front wheels left the ground. By 0.089 sec the supports had bent sufficiently to cause the sign panel to hit the hood and windshield. The whole sign installation pulled out of the ground and rode with the vehicle which traveled 175 ft directly behind the impact point.

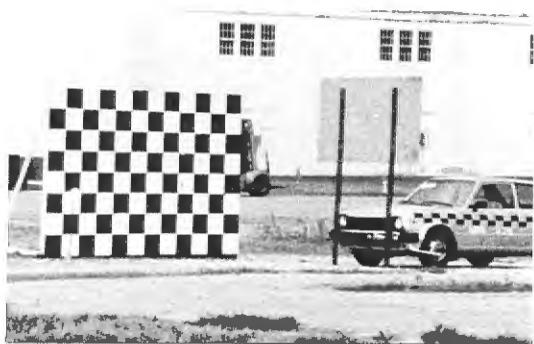
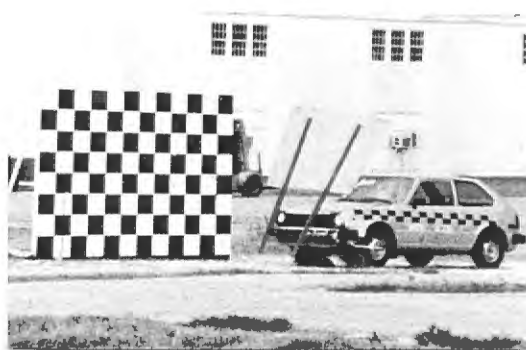
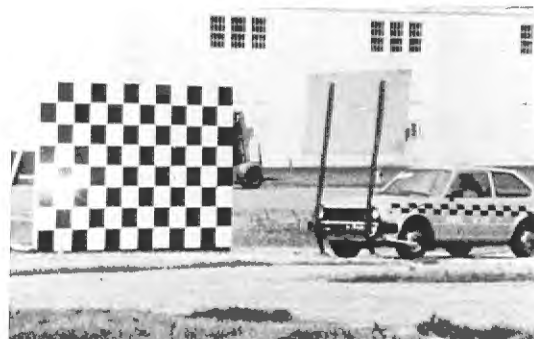
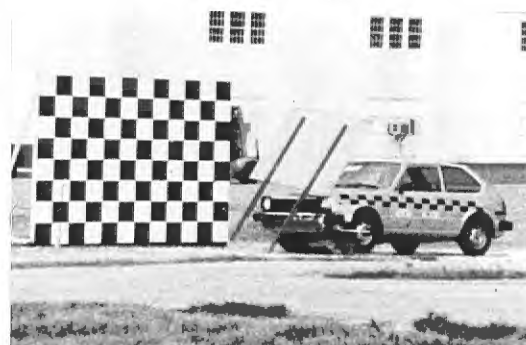
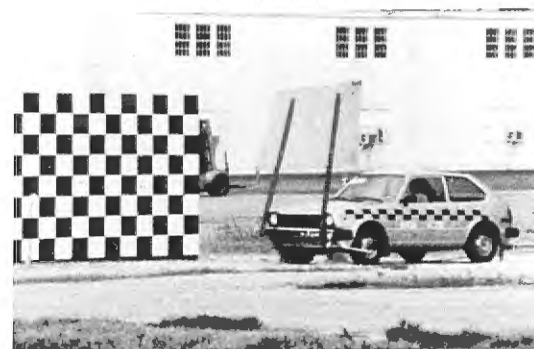
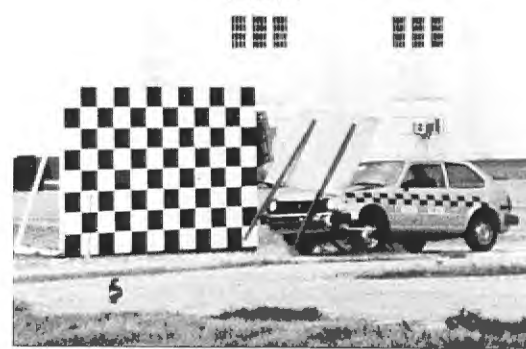
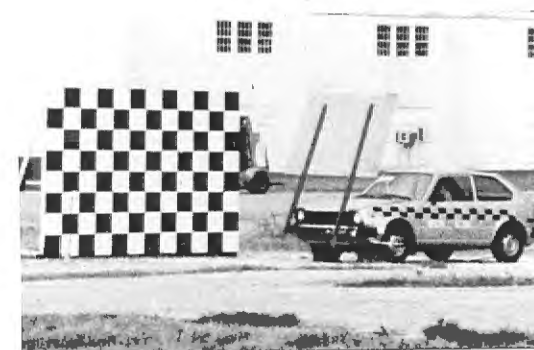
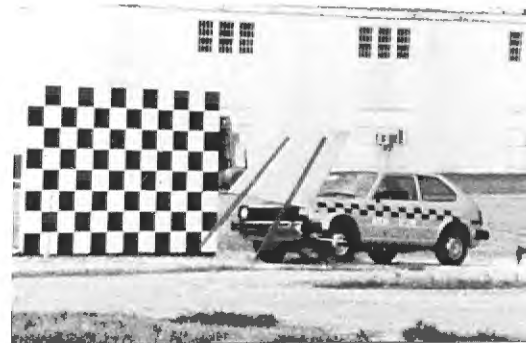
FIGURE A-141. SEQUENTIAL PHOTOGRAPHS FOR TEST 22.

Approximately 0.054 sec after impact the right support fractured, and at 0.077 sec the left support fractured. The vehicle lost contact with the sign installation at 0.197 sec. Shortly thereafter the sign panel fell on the hood and slid to the ground. Sequential photographs of the test are shown in Figure A-141.

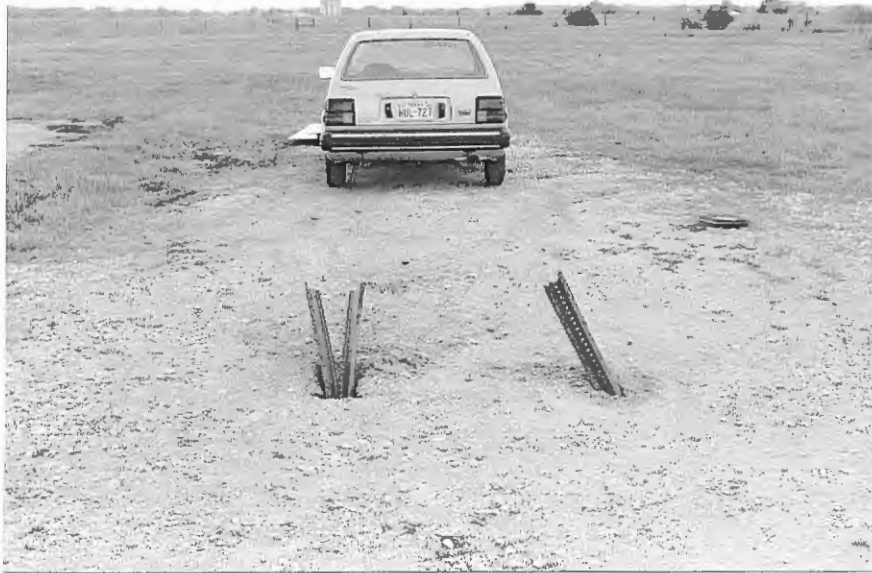
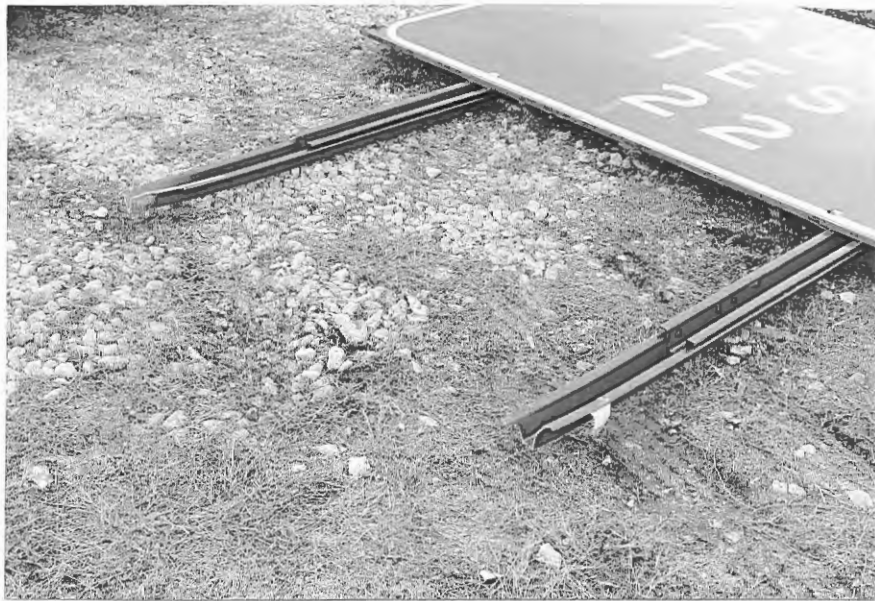
FIGURE A-142. SIGN INSTALLATION AFTER TEST 22.

The right support was fractured 19 in. above the ground and the left support was fractured 20 in. above the ground as shown in Figure A-142. As shown in Figure A-143, the vehicle sustained minor scrapes to the bumper and hood.

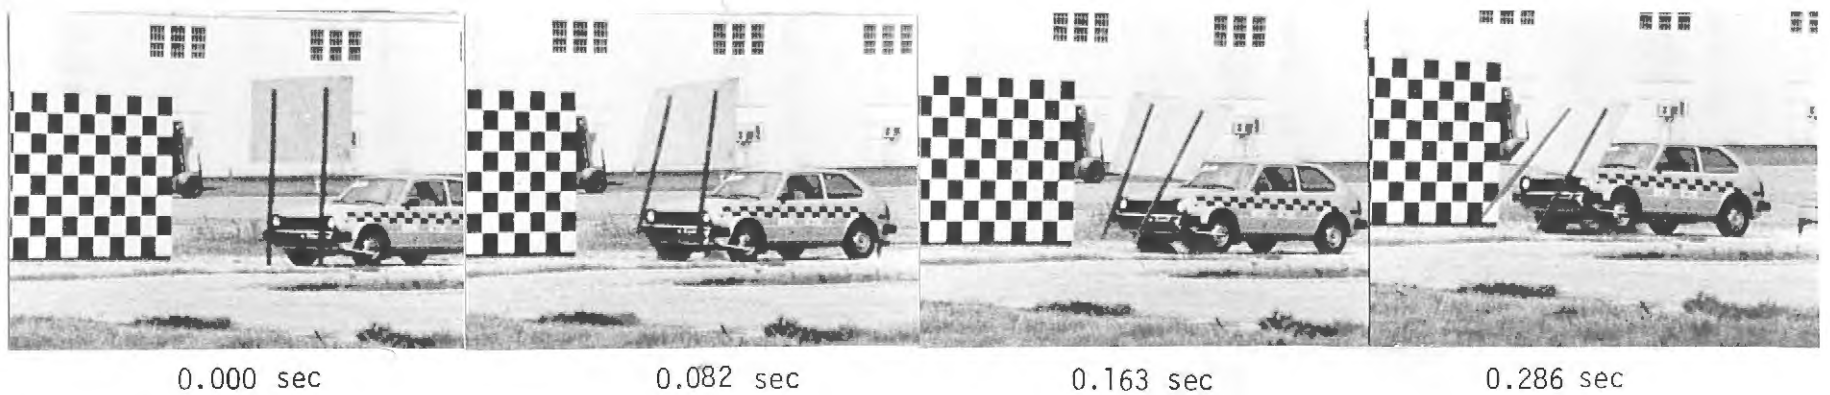
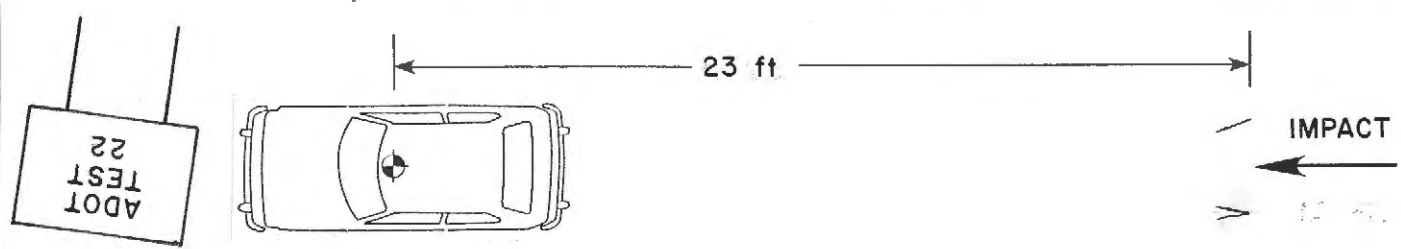
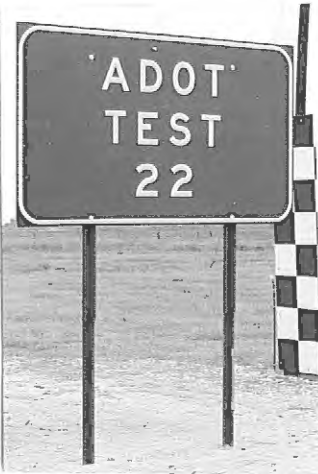
FIGURE A-144. SUMMARY OF RESULTS FOR TEST 22.

The results of the test are summarized in Figure A-144. Change in the vehicle's velocity was 6.4 mph and change in momentum was 534 lb-sec. Longitudinal occupant impact velocity was 10.1 fps and the maximum 0.010-second average occupant ridedown acceleration was -1.9 g.

Test No.	7024-22	Impact Speed.	20.0 mph (32.2 kph)
Date	9/12/85	Change in Velocity.	6.4 mph (10.3 kph)
Test Article	Sign installation	Change in Momentum.	534 lb-sec
Support.	Two 3 lb High Carbon Billet Steel Supports	Occupant Impact Velocity	
Vehicle.	1980 Honda	Longitudinal.	10.1 fps (3.1 m/s)
Vehicle Weight		Lateral	None
Test Inertia	1,833 lb (832 kg)	Occupant Ridedown Accelerations	
Gross Static	2,003 lb (909 kg)	Longitudinal.	-1.9 g
Vehicle Damage Classification		Lateral	N/A
TAD.	12FD1	Maximum Vehicle Crush	
SAE.	12FDEW1	Bumper Height	0.0 in. (0.0 cm)

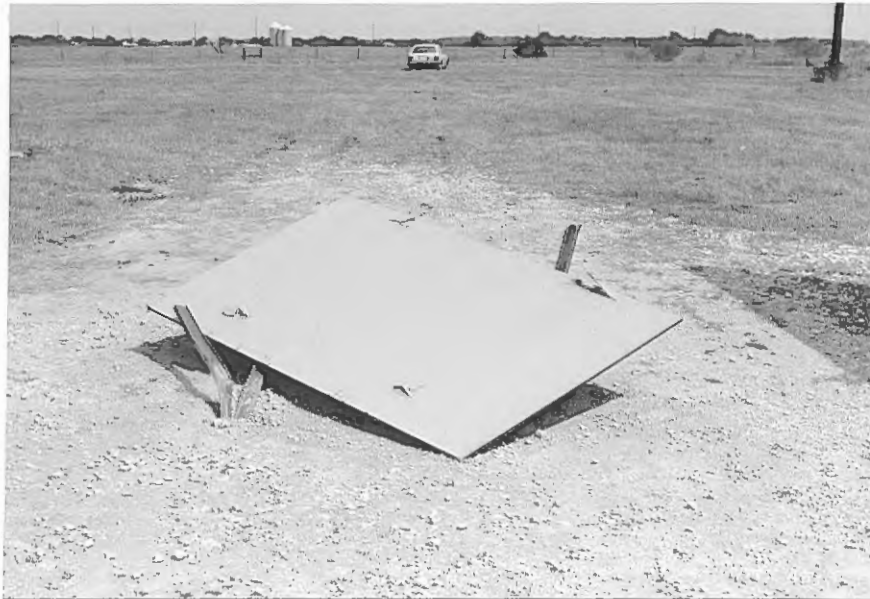
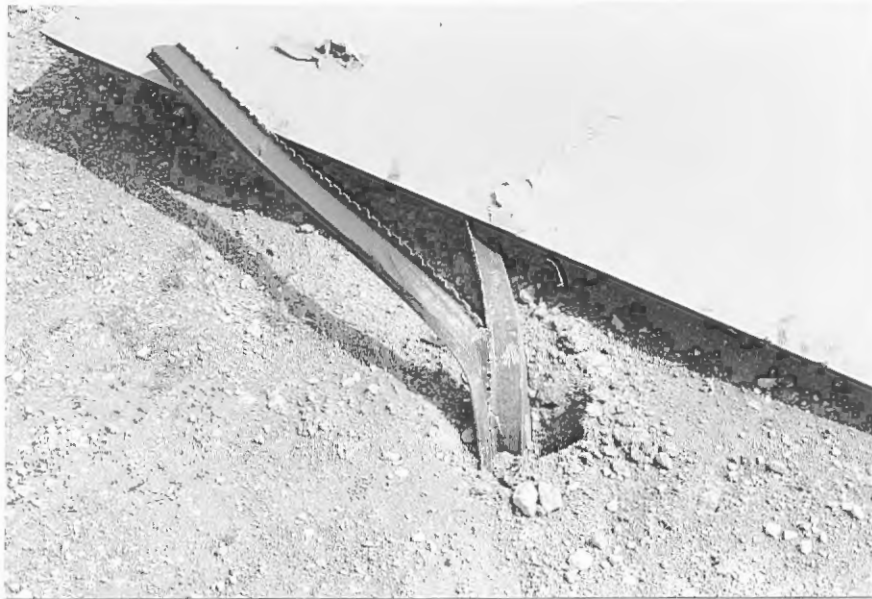
FIGURE A-147. SIGN INSTALLATION AFTER TEST 23.

The lower section of the left support fractured 35 in. above the ground and the right support fractured 38 in. above the ground. The upper sections of the supports rode with the vehicle for approximately 145 ft. Damage to the sign installation is shown in Figure A-147.
