Strategies to Reduce Burro-Vehicle Collisions in the Lake Pleasant Area

SPR-753
June 2022

Published by:
Arizona Department of Transportation
206 South 17th Avenue
Phoenix, AZ 85007
in cooperation with
Federal Highway Administration

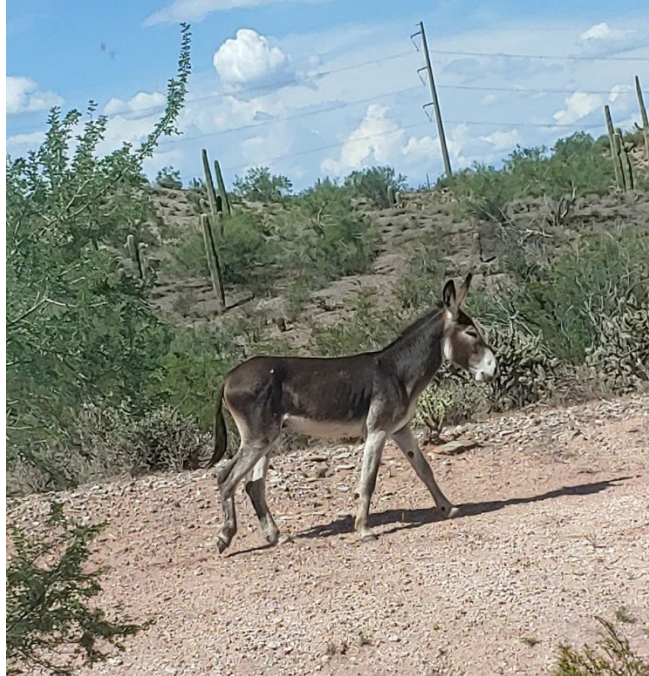
BVCs hot spots are strongly associated with ROW access points (Figure 56), which allow burros to cross fences and enter ROW. Burros were shown to access ROW through unfenced sections of highway, through gaps in ROW fence, under raised bottom wires, through unguarded driveways and intersections, and across sediment-filled crossing guards. Each of these access points is discussed below followed by a discussion of gate design and burro interactions.

Figure 56. Burro Jack That Entered a Fenced ROW Through an Access Point

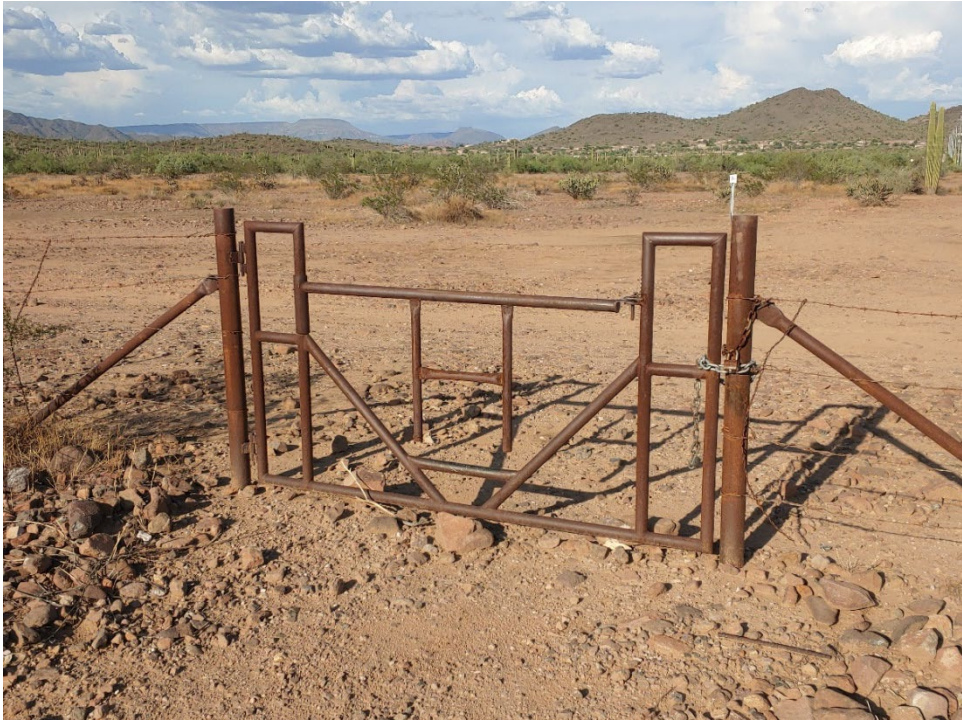
Single-arm gate designs (Figure 64) or designs including large apertures within the structure such as equestrian gates (Figure 65) present a potential burro passage route similar to a raised bottom wire. Anecdotally, a research biologist from AGFD noted that equestrian gate designs with a bar close to ground level and an aperture directly above were observed to allow burro passage (Colin Beach, personal communications, October 5, 2018). Staff at the Ben Avery Shooting Facility added welded metal to two equestrian gates previously observed to allow burro passage to close these apertures (Figure 66). As noted in the case study in Chapter 4, no collared burros were documented crossing the fence after modification.

Figure 66. Modified Equestrian Gate to Prevent Burro Passage Through Aperture

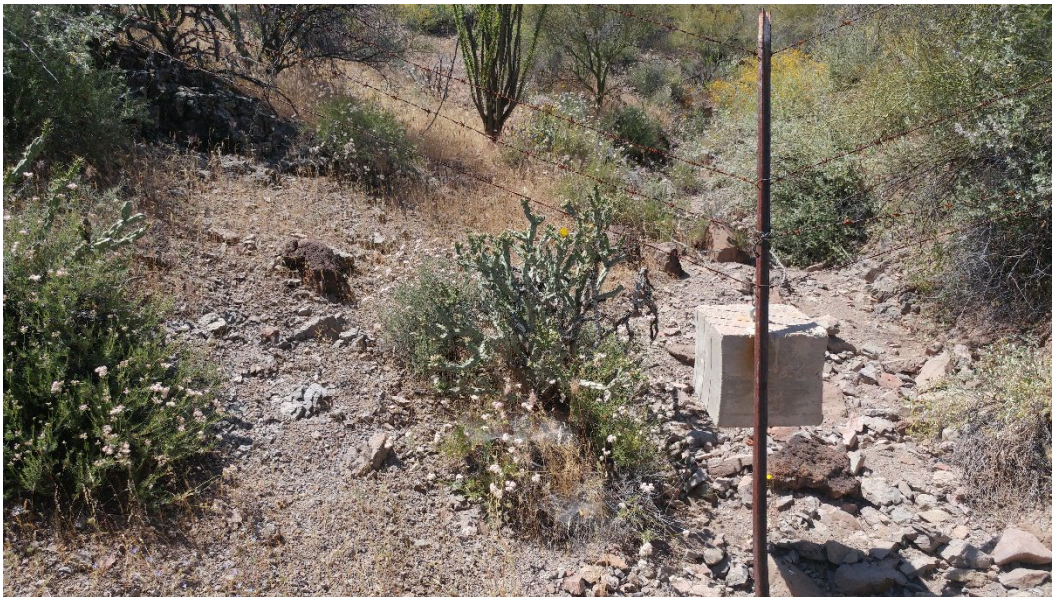
Figure 68. Deadweight Hang Anchoring a Fence Post Where ROW Fence Spans a Wash

- Install a deadweight hang (a heavy object attached to the fence) intended to pull the fence closer to ground level and anchor fence posts (Figure 68).
- Install additional wires beneath the standard four strands (Figure 69).
- Span the gap with a single fence span and hanging material cut to length beneath the fence (Figure 70).
- Shorten fence spans that traverse steep topography so the fence posts are installed and anchored as close to the top and toe of a slope as possible and wire hung between the posts runs parallel to the ground.

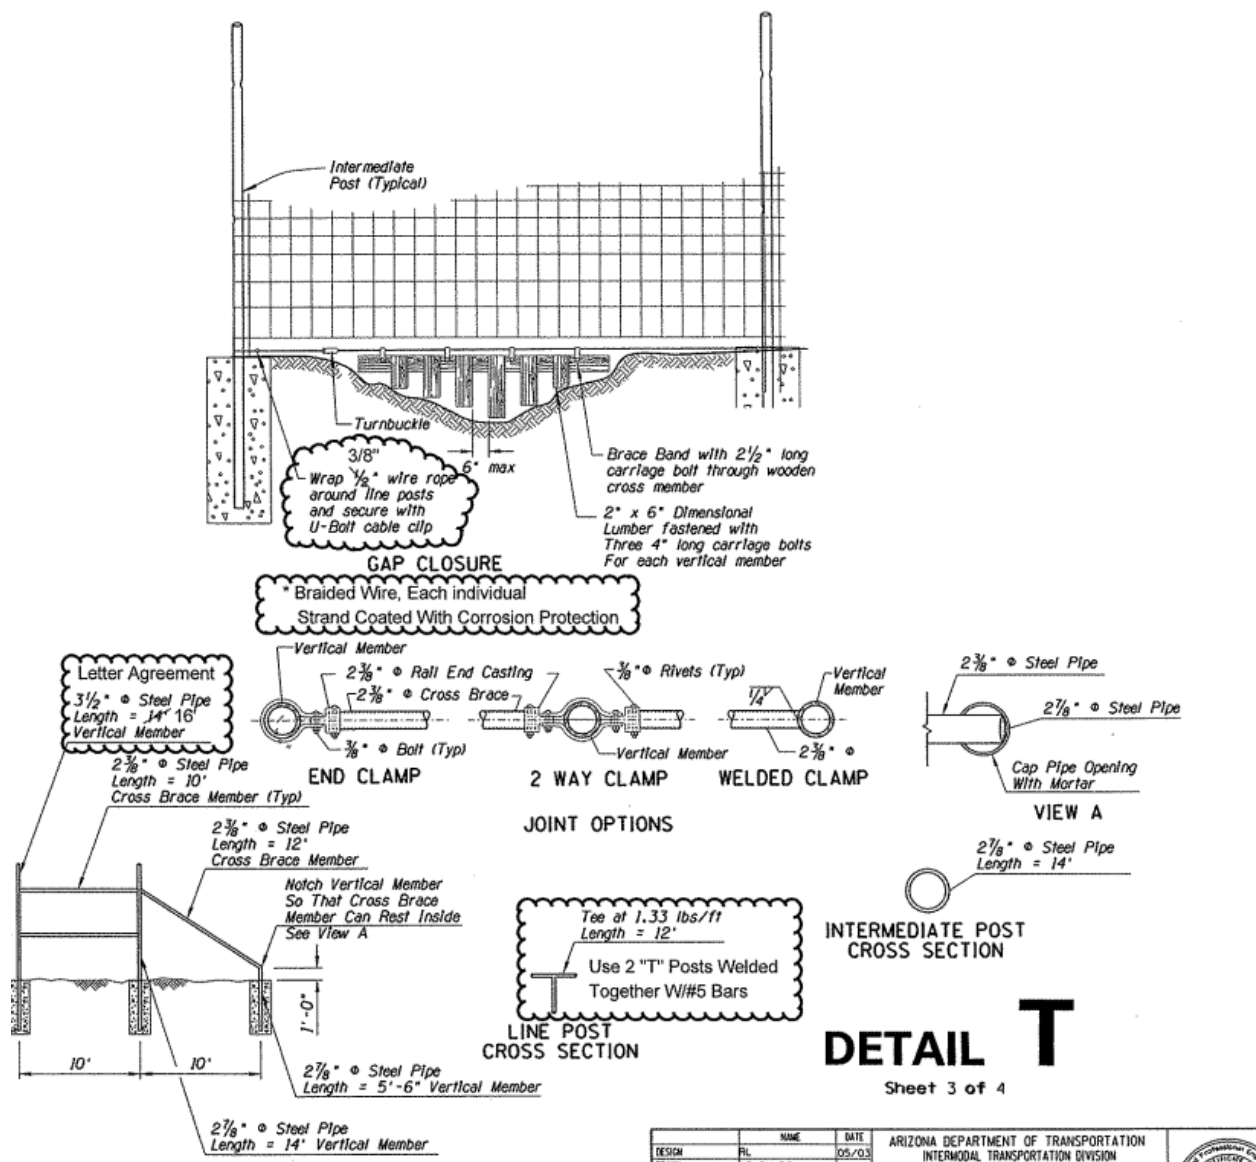
Figure 70. Detail of Fence Design for Spanning Uneven Topography

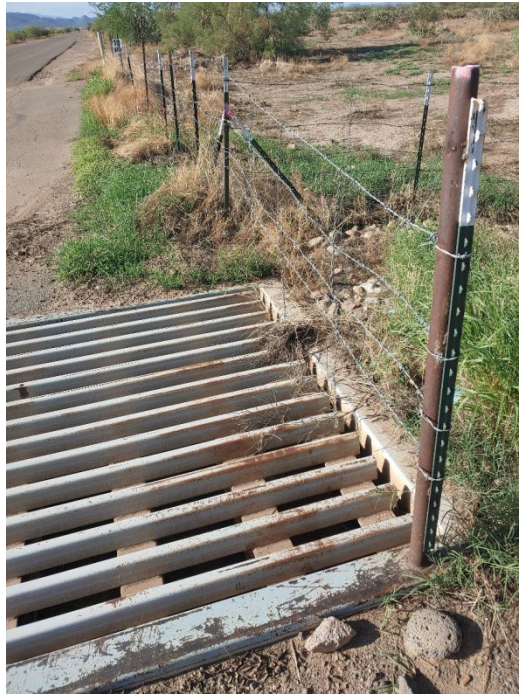
Figure 72. Wing Fence at a Crossing Guard Tie-In

- Install wing fencing along the edge of crossing guards to minimize the possibility of cross-jumps (Gagnon et al. 2020) (Figure 72).
- Tie in ROW fence and wing fence within crossing guard vaults to prevent burros from traversing vault ledges (Gagnon et al. 2020) (Figure 73).
- Add angle iron along the vault ledge or use rubber bumpers to reduce access to the vault ledge (Gagnon et al. 2020).
- Clear crossing guard vaults before sedimentation levels reach 50 percent depth.
- Survey crossing guard sedimentation levels annually.

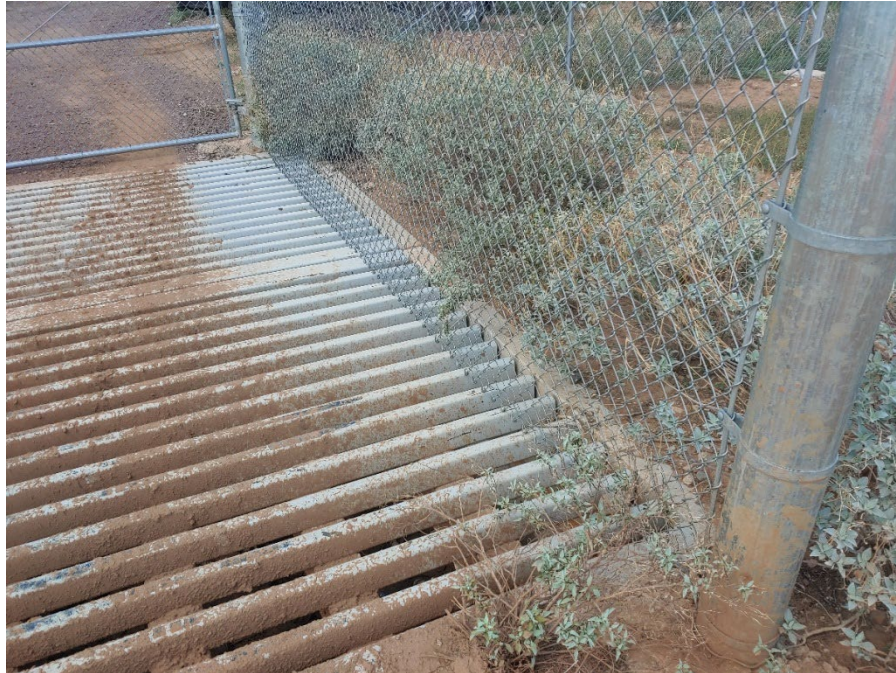
Figure 73. Chain-Link Wing Fence Tied in Within Crossing Guard Vault

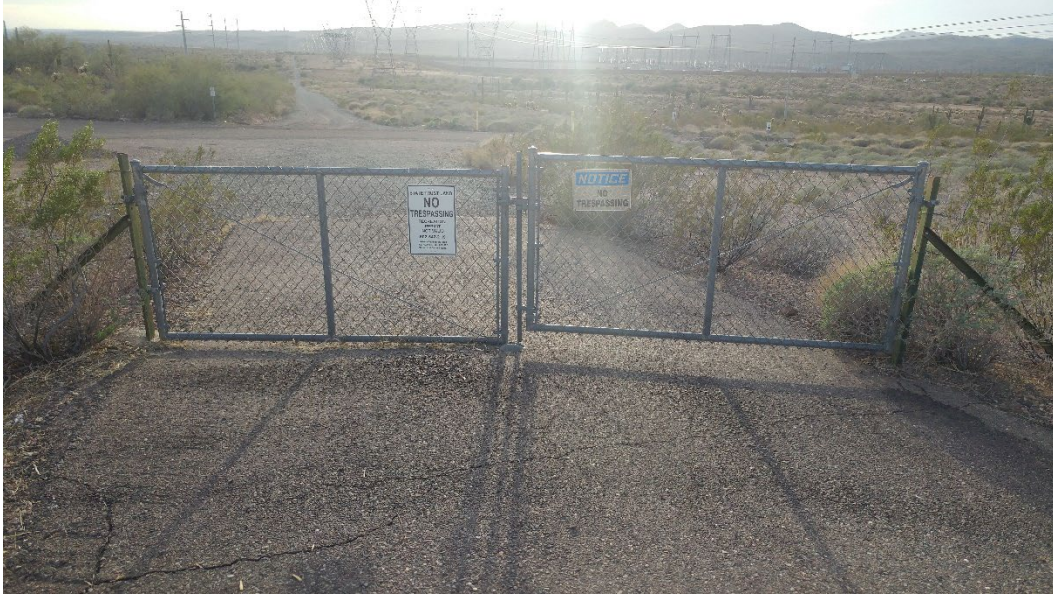
Figure 74. ADOT Type 1 Double Gate

- Install ADOT type 1 single or double gates (Figure 74) according to ADOT fence detail specifications at all gate locations in burro habitat.
- Use ADOT type 2 ranch-style gates only in low-traffic locations where they are already in place (Figure 75). Type 2 gates can be difficult to close or easily damaged and become unusable.

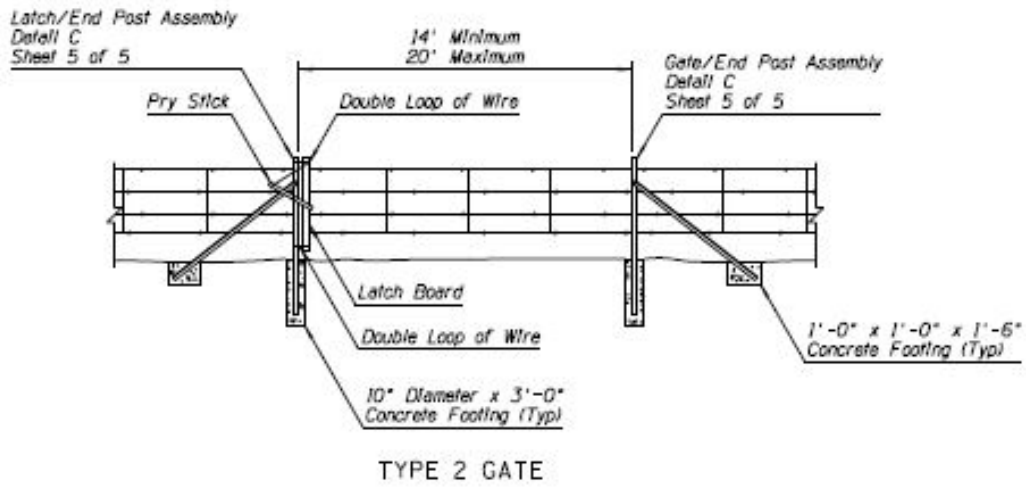
Figure 75. Type 2 Ranch-Style Gate Standard Drawing

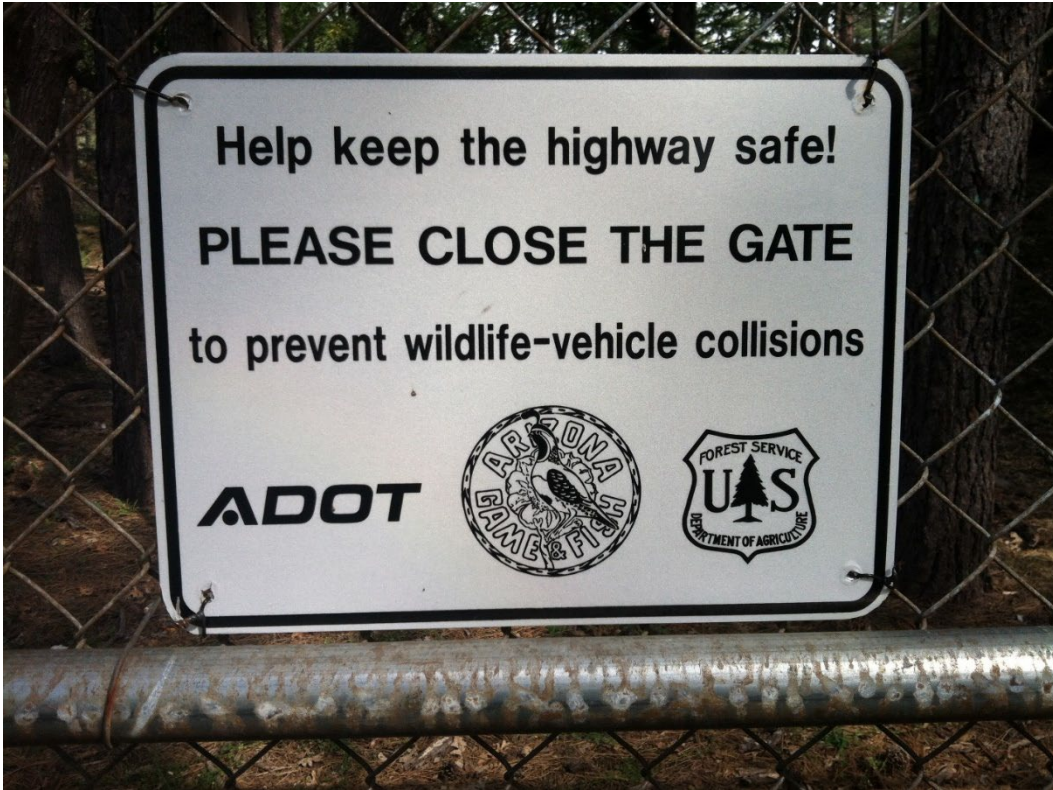
Figure 76. Sign to Reduce the Incidence of Unclosed Gates

- Consider installing informative signage or crossing guards where gates are consistently left open. AGFD has successfully worked with ADOT to develop and install informative signs in areas with wildlife exclusionary fences along SR 260 and I-17 (Figure 76).

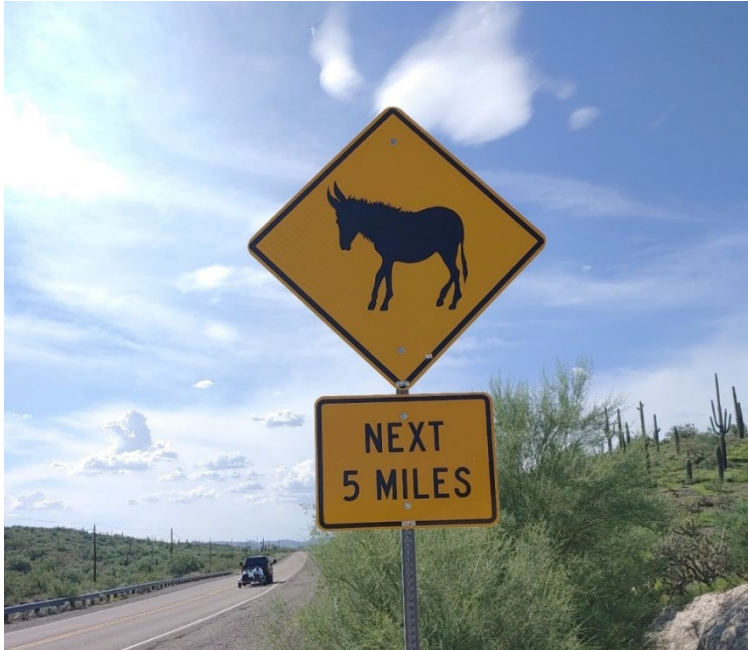
Figure 78. Burro Warning Signage

- Where fence installation options are limited, consider installing warning signage (Figure 78), reducing speed limits, or increasing visibility by clearing vegetation from either side of the highway. Static warning signs, however, have shown inconclusive results for reducing wildlife-vehicle collisions due to motorist complacency over time, which may be the case for burros (Found and Boyce 2011; Rytwinski et al. 2016). Seasonal warning signs have shown more promise for wildlife and could work for burros if targeting seasonal movement and collision peaks from October through January (Sullivan et al. 2004; Hardy et al. 2006; Donaldson and Kweon 2019).

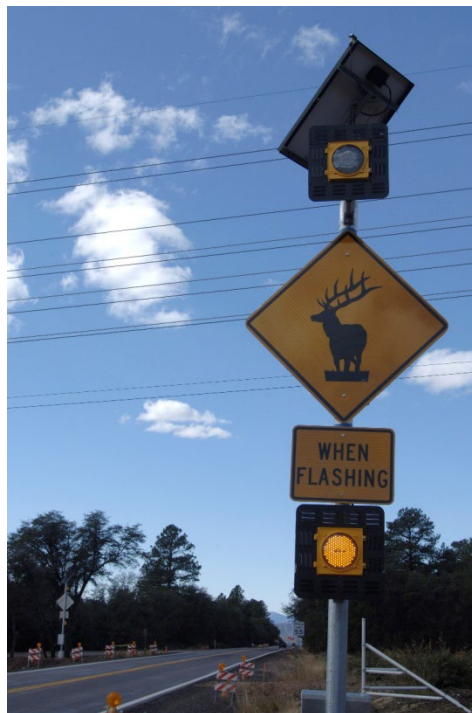
**Figure 79. Elk Crossing Alert Signage
Triggered by a Detection System
at an Elk Crosswalk**

- At at-grade crossings, in rugged terrain, and within areas of high human disturbance, consider terminating fence with detection systems and/or alert signage (Figure 79) or adding wildlife guards at the ends of the fence. Previous studies have shown that these strategies can reduce the number of ungulates entering the ROW, which may translate to similar outcomes for burros (Huijser et al. 2008; Gagnon et al. 2015; Siemers et al. 2015; Gagnon et al. 2019).
