MDOT State Study 287—Evaluation of Ground Penetrating Radar as a Tool in Designing Maintenance and Rehabilitation Projects in Mississippi

Report Date: 12/18/2019

BURNS COOLEY DENNIS, INC.

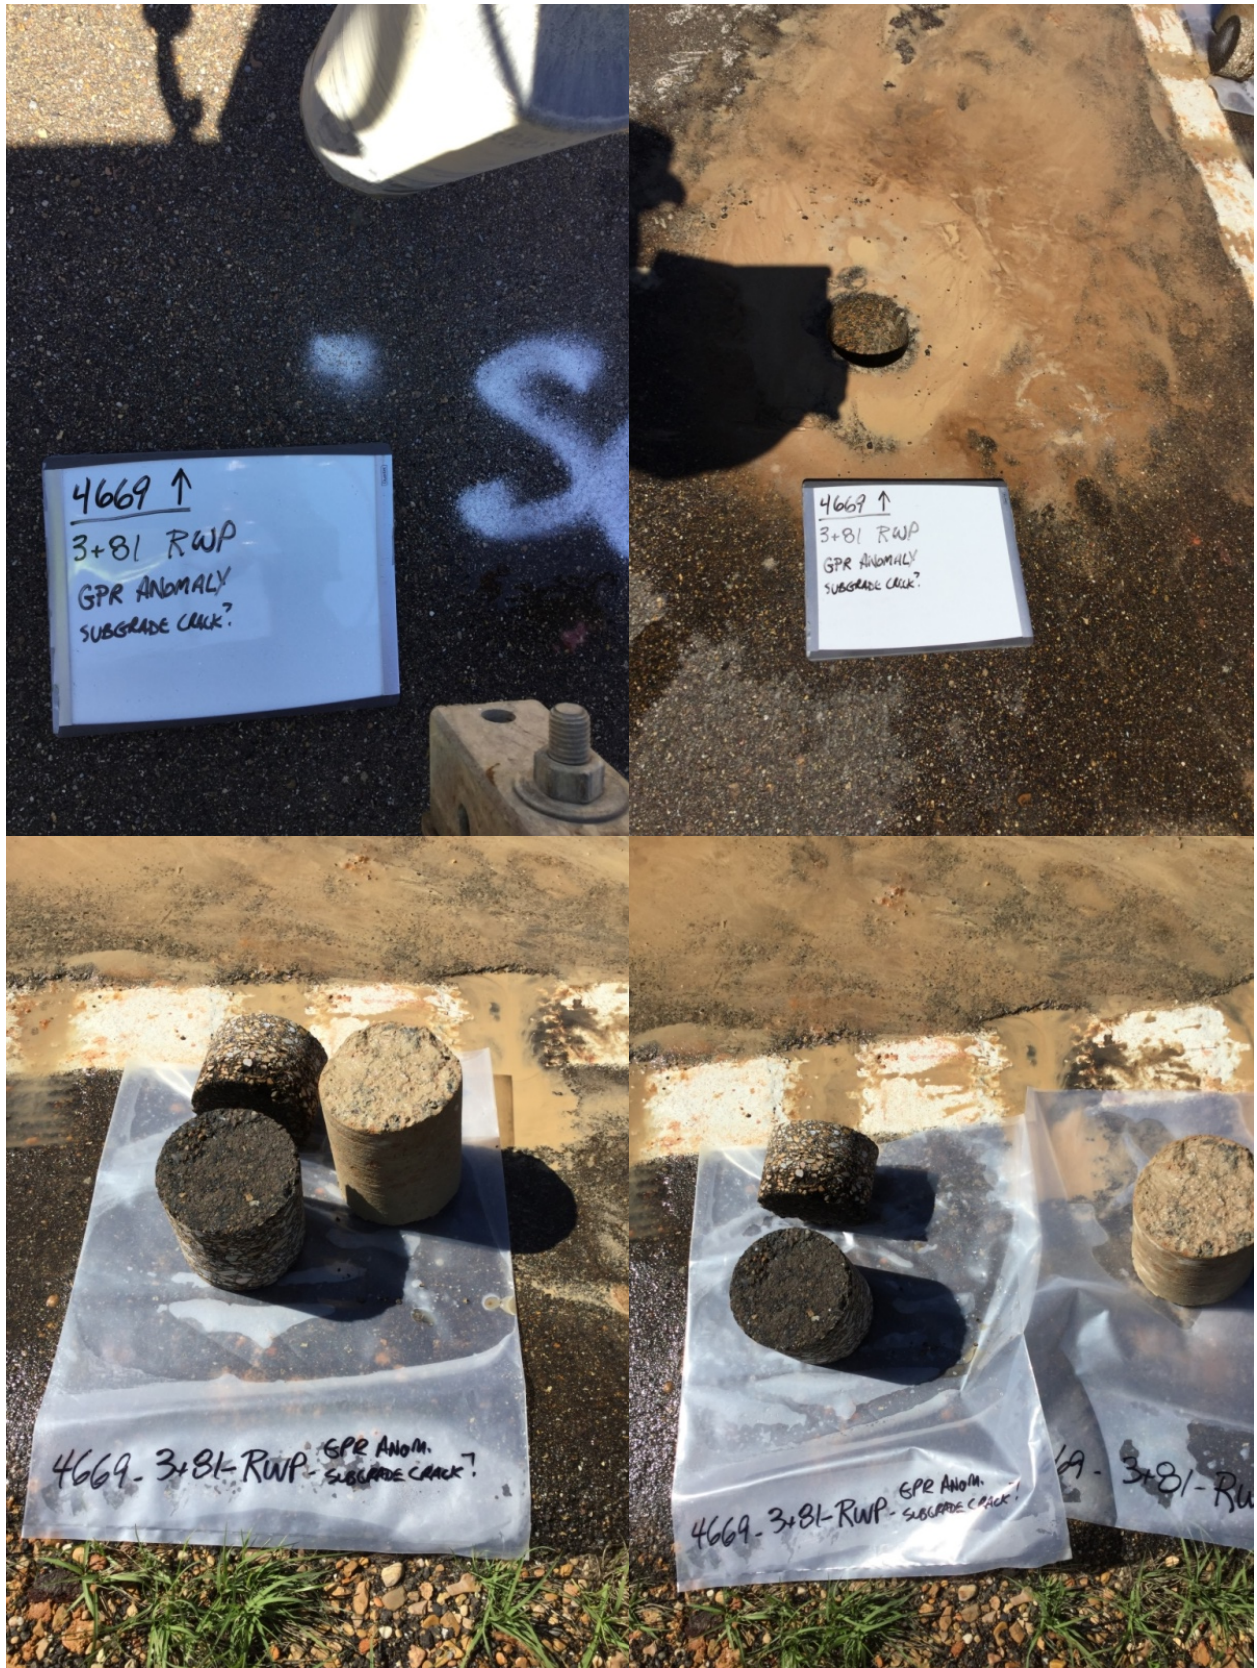
Figure 6: Core Cut at Station 3+81 – Section 4669

Figure 5 illustrates the GPR trace for an anomaly located in the right wheel path (RWP) at Station 3+81. As shown in Figure 5, a parabola indicating an anomaly was identified near the bottom of the HMA layer extending downward into the structure. A core was cut at this location (Figure 6). Evaluation of the core did not indicate the cause of the anomaly. A second core was not cut due to time constraints. Whether the anomaly was a false-positive or the core was cut in the wrong location is not known.

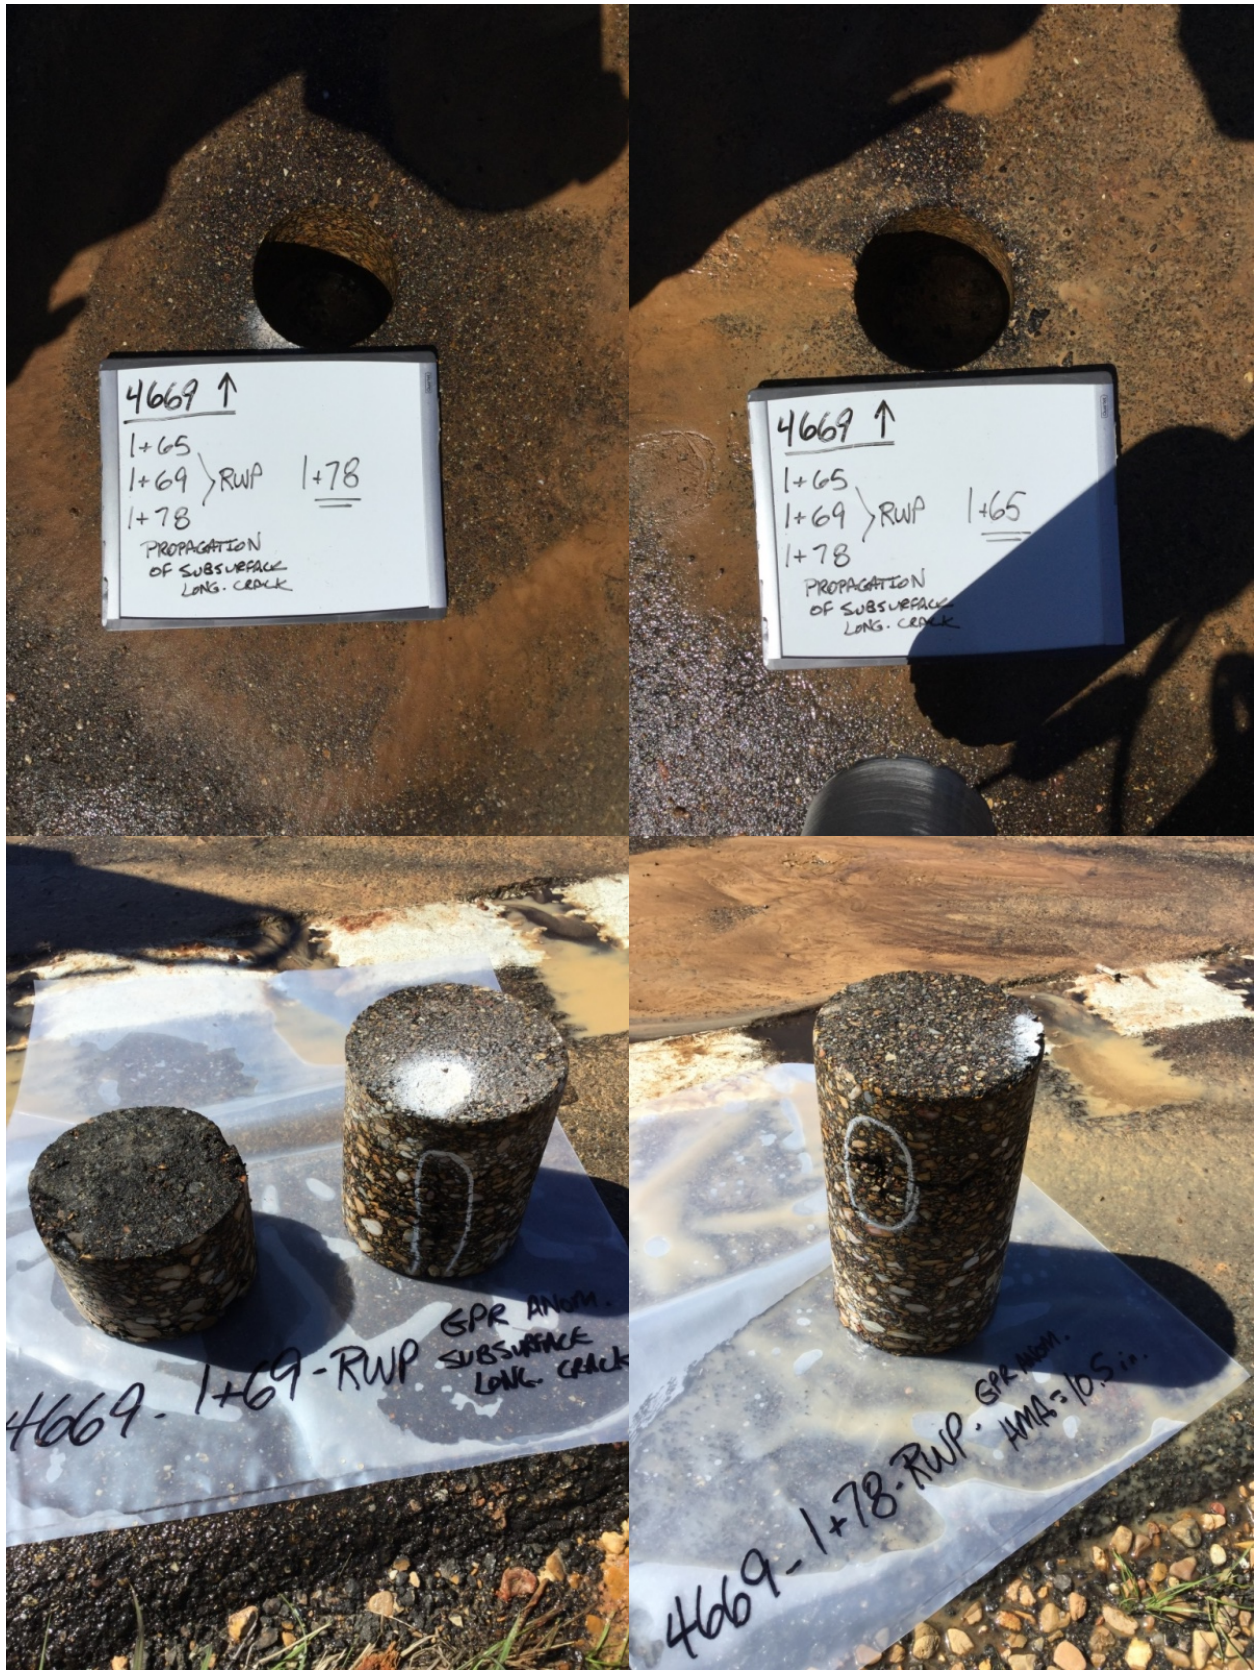
Figure 11: Cores Cut at Stations 1+69 and 1+78 – Section 4669

Note: Companion Transverse Scans were performed at 1+78, 1+69, and 1+65 to further pin-point the presence and position of the observed anomaly. Voids were observed in the 1+78 and 1+69 cores.

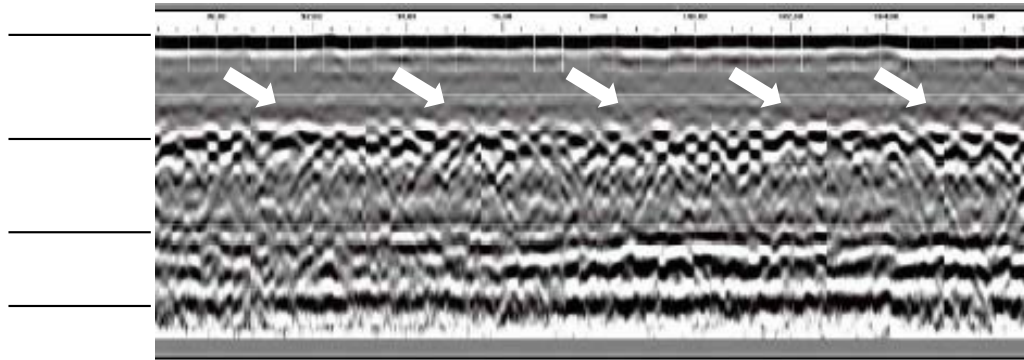
Figure 31: RWP Trace from Section 5244 near Station 1+00

Another occurrence of potential CSM fatigue is illustrated within Figure 31. This trace is from the RWP of section 5244 near station 1+00. The pavement structure within section 5244 only included a single layer of CSM. As shown in the figure, the potential occurrence of fatigue within the CSM layer is different in appearance within Figure 31 than in Figures 29 and 30.

Within Figure 31, a series of parabolas beginning at the CSM/HMA interface is the characteristic that suggests fatigue cracking. The large number of parabolas distort the interface between the CSM and HMA layers.

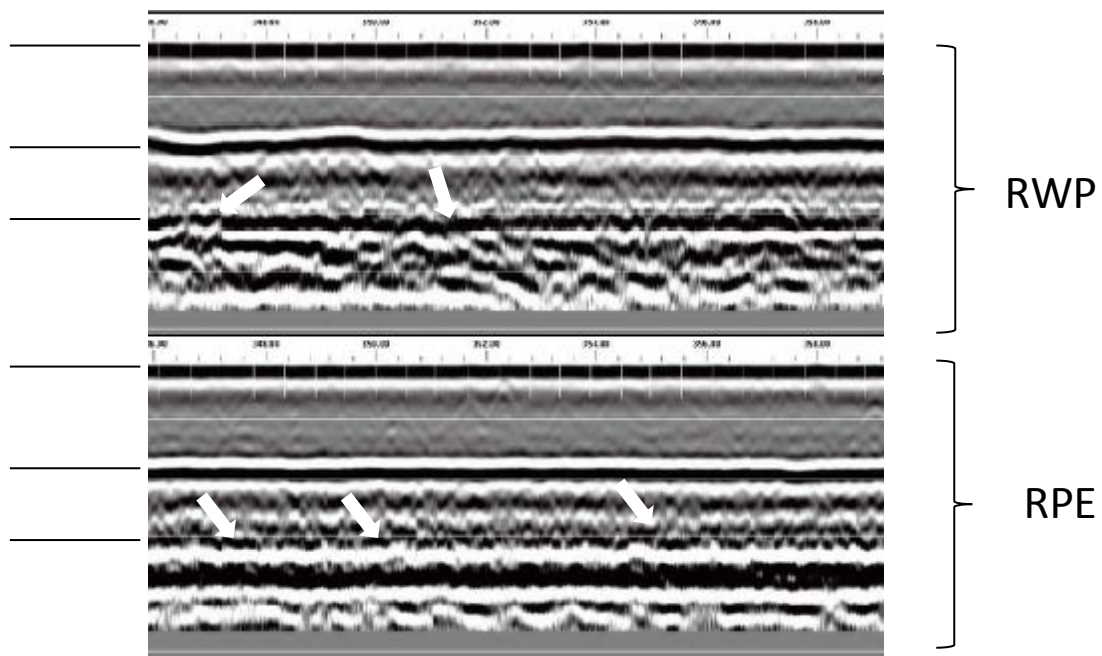
Figure 32: RWP and RPE Traces from Section 5249 near Station 3+50

The final presented occurrence of possible fatigue within the CSM layer is illustrated within Figure 32. These traces show the RWP and RPE of section 5249 near station 3+50. As shown in the figure, the interface between the CSM and subgrade is distinct for the RPE, while within the RWP trace the interface is broken in areas. This may suggest CSM fatigue within the RWP.

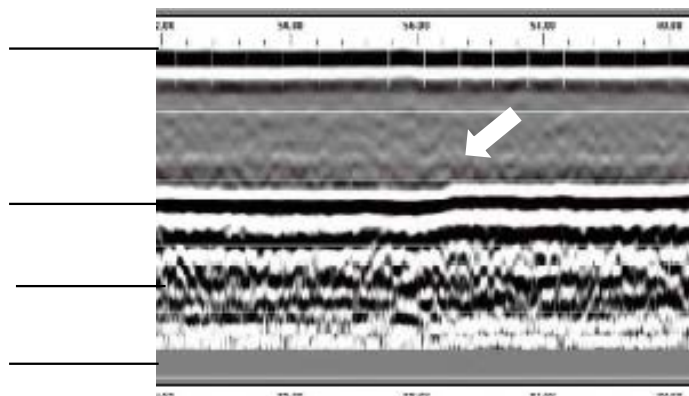
Figure 33: RWP Trace from Section 4588 near Station 0+56

While evaluating the five full 500-ft traces for the 16 sections, a number of observations were categorized as interesting. Though some may or may not specifically affect a M&R design, they are presented to illustrate the potential of the GPR to identify potential issues within the pavement. The first interesting observation is from the RWP near station 0+56 within section 4588, which is shown in Figure 33. As shown in the figure, the thickness of the HMA layer changes (white arrow). Based upon the trace, the thickness of the HMA changed approximately 1 inch.

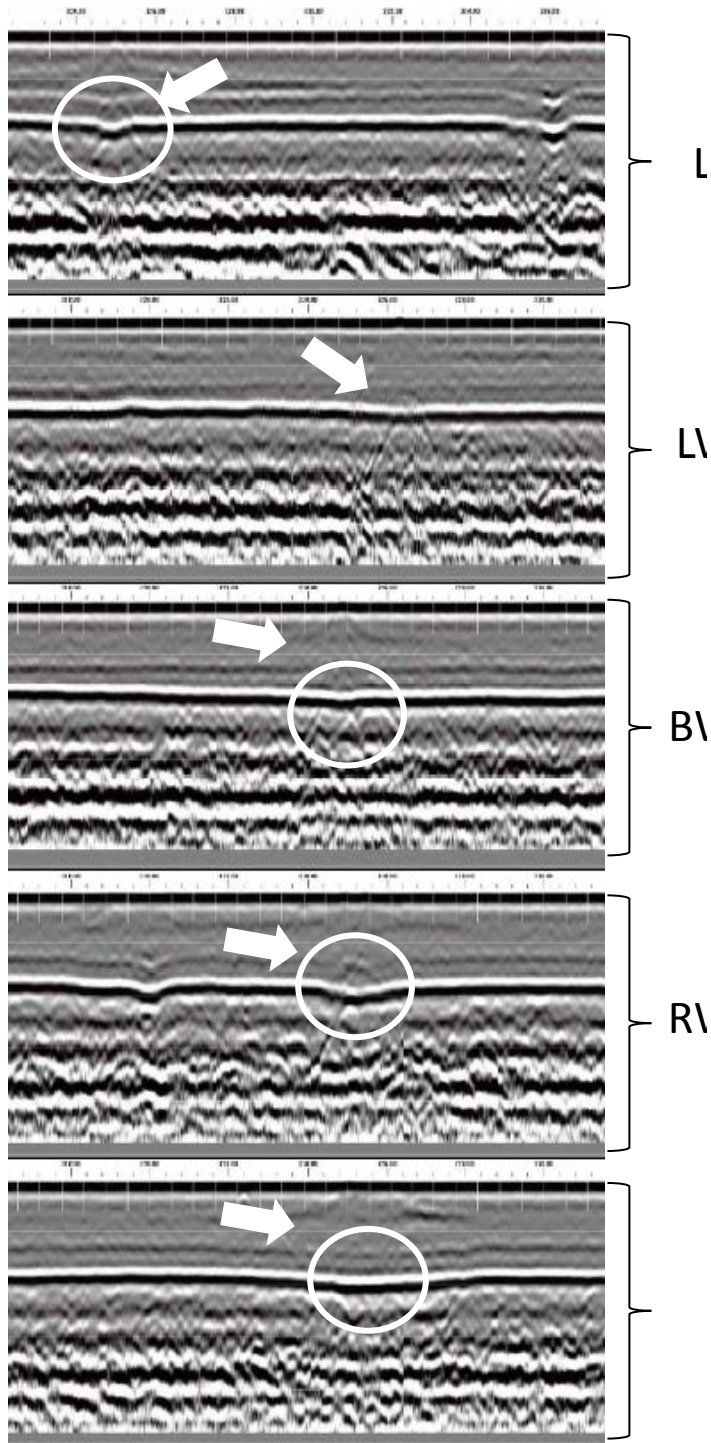
Figure 34: Five Traces from Section 4782 near Station 3+30

Another interesting observation comes from section 4782. A transverse crack existed near station 3+30 that extended across the entire lane. As shown within Figure 34, which shows all five traces near 3+30, the transverse crack was identified by the GPR across the entire lane width (white arrows). Another interesting observation about the traces is that there are the characteristic concave shapes at the HMA/CSM interface that was described previously (white circle). This transverse crack was selected in the field for coring. Figure 35 presents photos of the pavement surface, the transverse crack, the full depth core, and the surface of the CSM within the core hole. As shown within Figure 35, a crack existed within the CSM layer (which has been hypothesized for the characteristic concave shape) and the crack extended through the entire HMA layer. This may suggest that when the characteristic concave shape is located at the top of the CSM layer and the crack is visible at the surface, the crack is full depth within both the CSM and HMA.

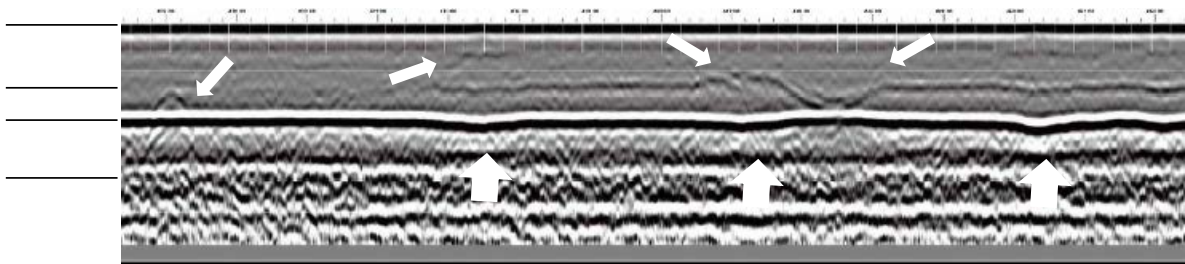
Figure 36: BWP Trace from Section 4782 near Station 3+35

Section 4782 provided another interesting observation from the GPR traces. Figure 36 presents a BWP trace near station 3+35. As shown on the left side of the figure, an anomaly exists within what is believed to be the limestone (LMS) drainage layer. The top of the anomaly (parabola) appears to be right at the interface between the LMS drainage layer and HMA. It is

unclear whether this is potentially a crack within the underlying CSM that is propagating upward through the LMS Drainage layer, a discontinuity within the LMS drainage layer or some foreign matter. Intuitively, it would not be a crack propagating through the LMS Drainage layer into the HMA; therefore, the likely cause is a discontinuity or foreign material within the LMS Drainage layer. Secondly, there is a dark horizontal line that begins about a third of the distance from the left of the trace that extends to the right edge of the trace. At about the half-way point of the trace, the dark horizontal line goes downward then comes back up. When it begins, this dark horizontal line would be near the interface between the HMA and LMS drainage layer. It is unclear why this dark horizontal line is within part of the trace and not the other. It is also unclear why the dark horizontal line would drop and then rise within the trace. The larger white arrows oriented upwards show the characteristic small concave shape at the interface of the HMA and LMS Drainage layer which may be indicating cracks within the CSM layer.

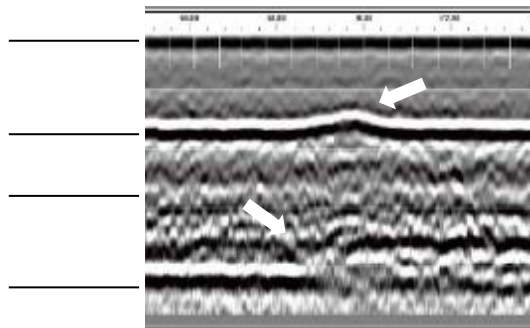
Figure 37: RPE Trace from Section 4834 near Station 0+70

Section 4834 also provided a unique trace. Figure 367 presents a trace from the RPE near station 0+70. As shown within this figure, the interface between the HMA and CSM has an isolated convex shape. It is also interesting that the interface between CSM2 and the subgrade changes (lower white arrow) almost directly below the convex shape. The change in this interface may indicate distress within one or both CSM layers.

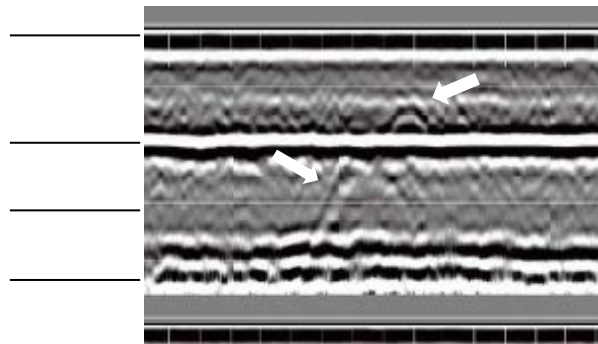
Figure 38: LWP Trace from Section 5210 near Station 0+24

Figure 38 presents a trace from the LWP of section 5210 near station 0+24. This trace shows two parabolas (anomalies). One parabola is within the HMA layer while the other parabola is within the CSM1 layer. The interesting part of this trace is that the two parabolas appear to be offset by a short distance. During the field work within SS No. 263, there were a number of instances where a transverse crack existed within the HMA surface. Based upon the appearance of the transverse crack in the field, it was assumed that the transverse crack had reflected from a crack within the CSM layer; however, after coring a crack was not observed within the CSM layer. The trace within Figure 38 potentially suggests that the reflected crack within the HMA may not always be directly above the crack within the CSM layer.

A number of interesting observations from the GPR traces were provided. The offset parabolas within Figure 38 appear to provide some explanation for the reason that some CSM cracks were not observed when they were expected. The issues highlighted within Figures 39 and 39 do suggest something happening below the HMA layer that would need further investigation.

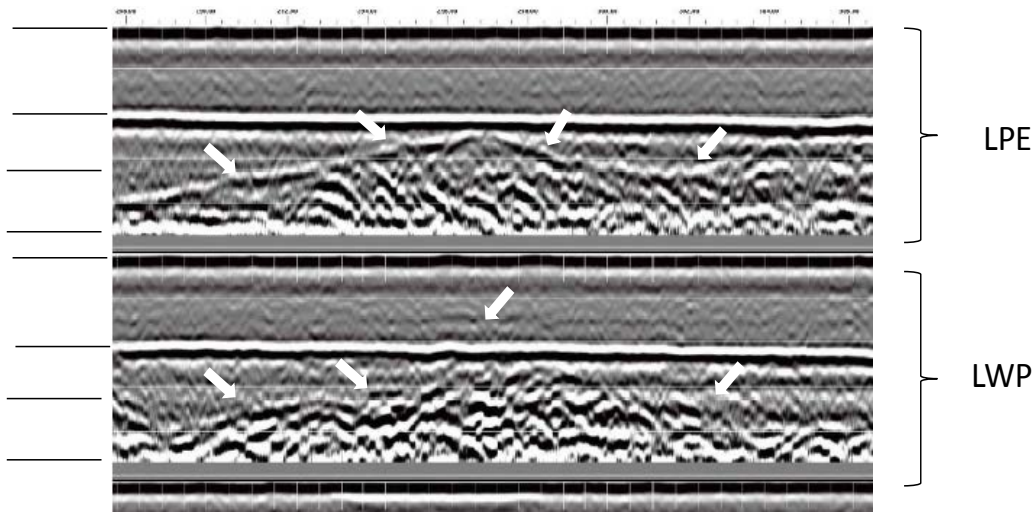
Figure 39: LPE and LWP Traces from Section 5230 near Station 2+96

Figure 39 presents a trace from section 5230 near station 2+96. This figure illustrates the LPE and LWP traces at the location. Based on the figure, the interface between the two CSM layers was very inconsistent within the LPE trace. The LWP trace also shows this inconsistency within the CSM layers; however, it is not as distinct. It is unclear why the interface between the two CSM layers would be so inconsistent. One possibility is that within this area, the construction of the CSM layers was inconsistent. On the LWP trace, a white arrow within the HMA layer shows a small area having differing/alternating shades of gray. This area may indicate a small area of stripping.

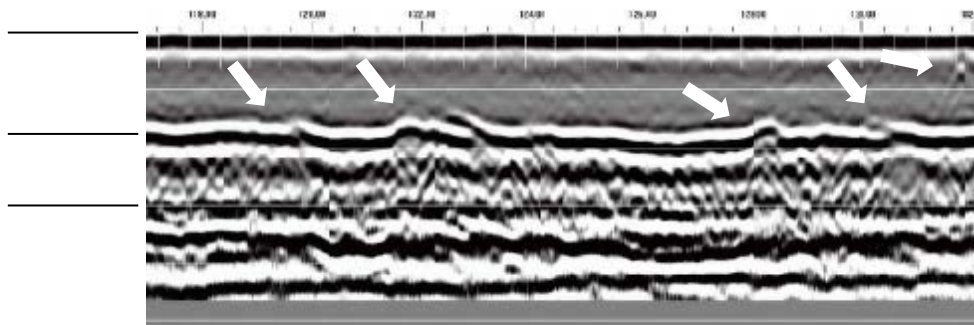
Figure 40: RPE Trace from Section 5249 near Station 1+25

The final interesting observation presented herein is presented within Figure 40. This figure shows the RPE trace from Section 5249 near station 1+25. As shown in the figure, the interface between the HMA and CSM is very inconsistent. It's unclear whether subsurface distresses are distorting the interface or whether the HMA layer thickness is variable in this area.

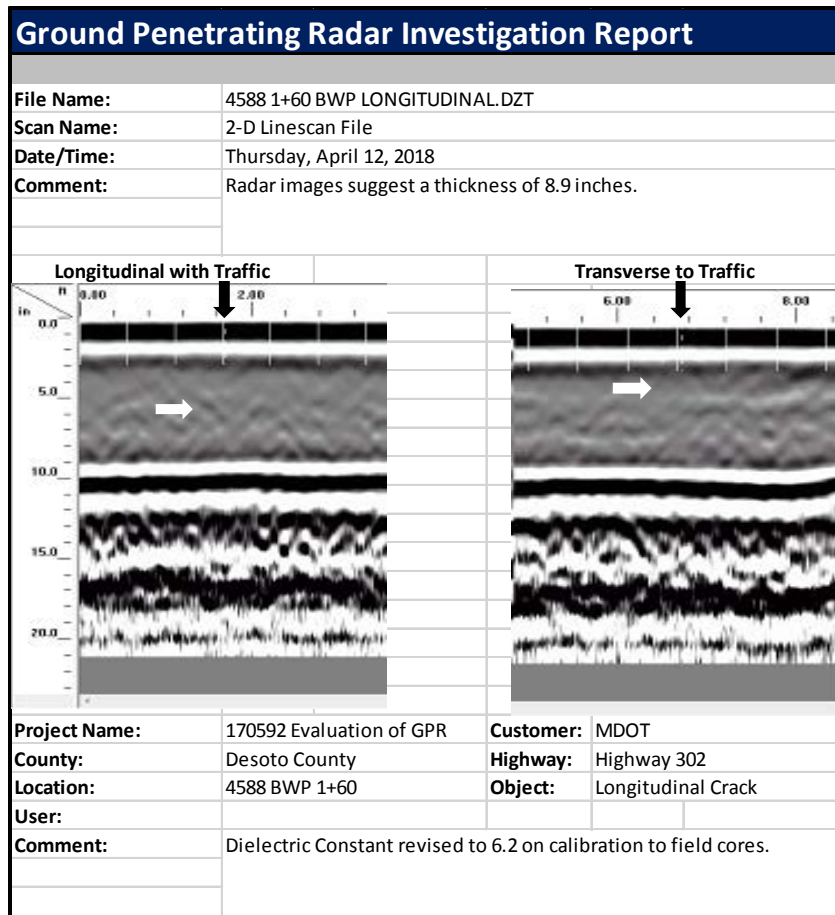
Figure 41: GPR Trace for Longitudinal Crack - Section 4588, Station 1+60

Figure 41 illustrates the GPR trace for a longitudinal crack within Section 4588 near station 1+60. Black arrows shown on the figure are superimposed onto the trace to signify the location of the visible crack at the pavement surface. For longitudinal cracks, generally speaking, the GPR trace transverse to the direction of traffic would show the distress better than the longitudinal GPR trace. The transverse to traffic trace is on the right side of Figure 41, while the longitudinal trace is on the left. As shown in the figure, very little can be discerned from either the transverse or longitudinal traces related to the surface distress. Figure 42 is a collage of photographs from the location depicted by the traces within Figure 40. Photos within Figure 42 are for the pavement surface and the core obtained from the location. As shown within Figure 42, the longitudinal crack is a low severity crack which appears to have initiated at the top of the pavement surface. As shown in the lower right portion of Figure 42, the crack only extends a short distance into the HMA layer.

As shown in Figure 41, very little can be discerned from the traces related to the longitudinal crack that was visible at the surface of the pavement. One potential reason the GPR trace did not indicate the crack is the fact a ground coupled GPR was utilized for this testing. According to Scullion and Saarenketo (3), it can be difficult to obtain quantitative information near the pavement surface when using a ground coupled system. Figure 42 shows that the crack was low severity and did not propagate but a short distance into the pavement.

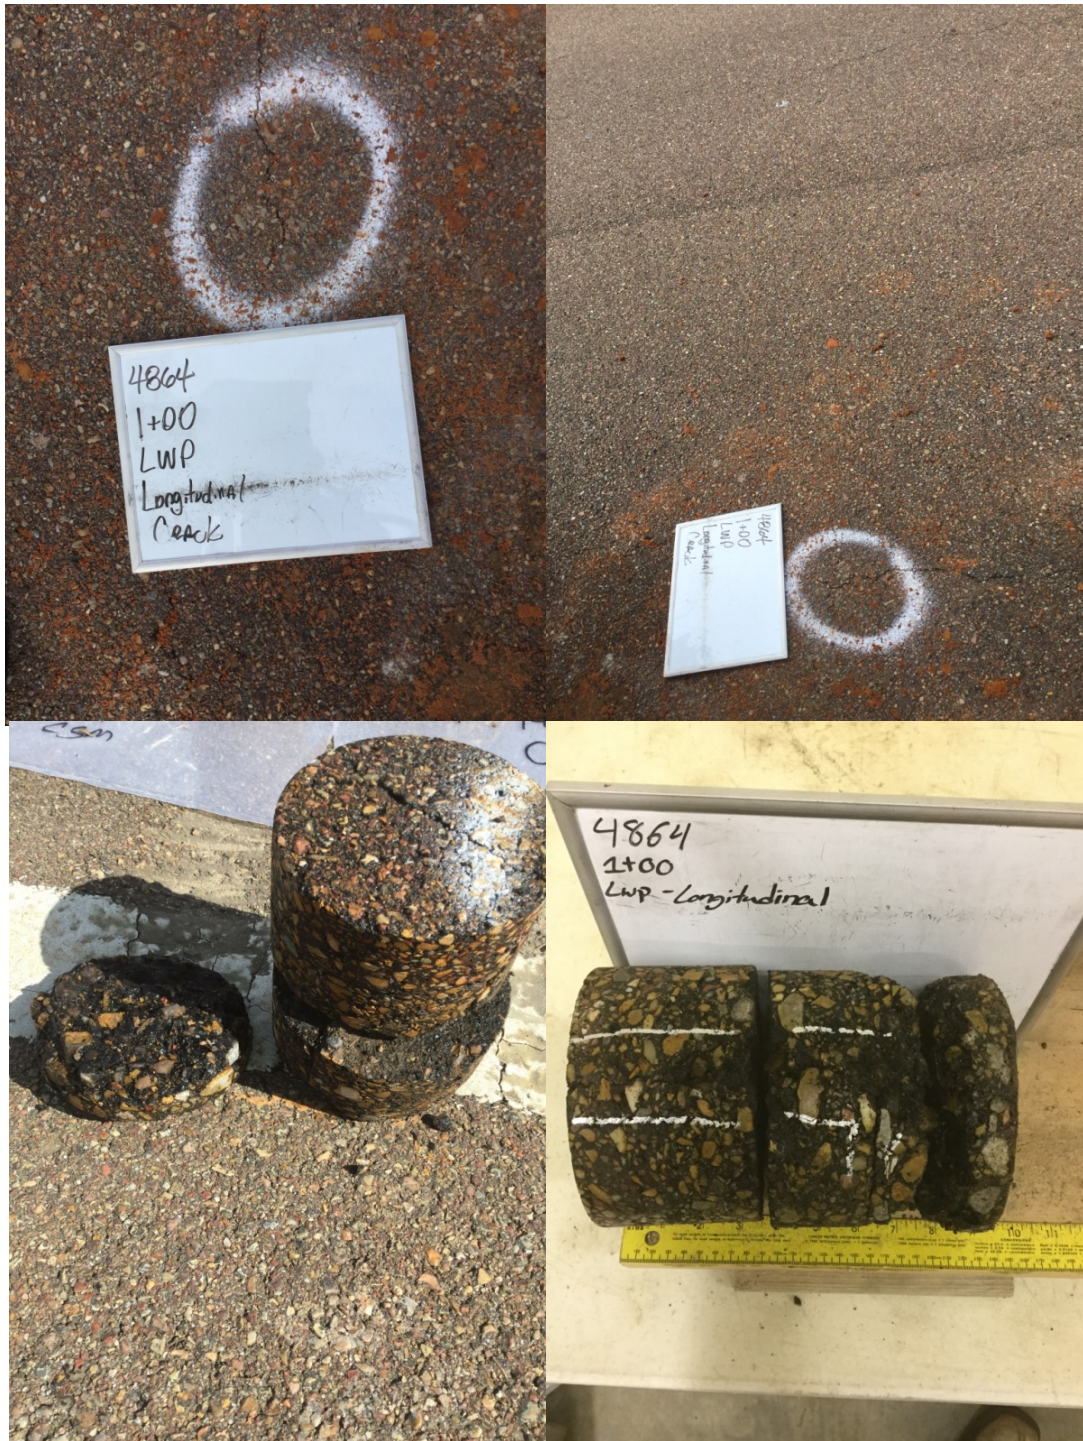
Figure 44: Pavement Surface and Core for Longitudinal Crack - Section 4864, Station 1+00

Figure 43 illustrates the longitudinal and transverse traces for a longitudinal crack within Section 4864 near station 1+00. Unlike Figure 41, the GPR traces within Figure 43 do show anomalies related to the longitudinal crack. Within the transverse trace, a characteristic parabola is shown near the top of the pavement. Within the longitudinal trace, anomalies are also shown at approximately mid-layer and near the bottom of the layer.

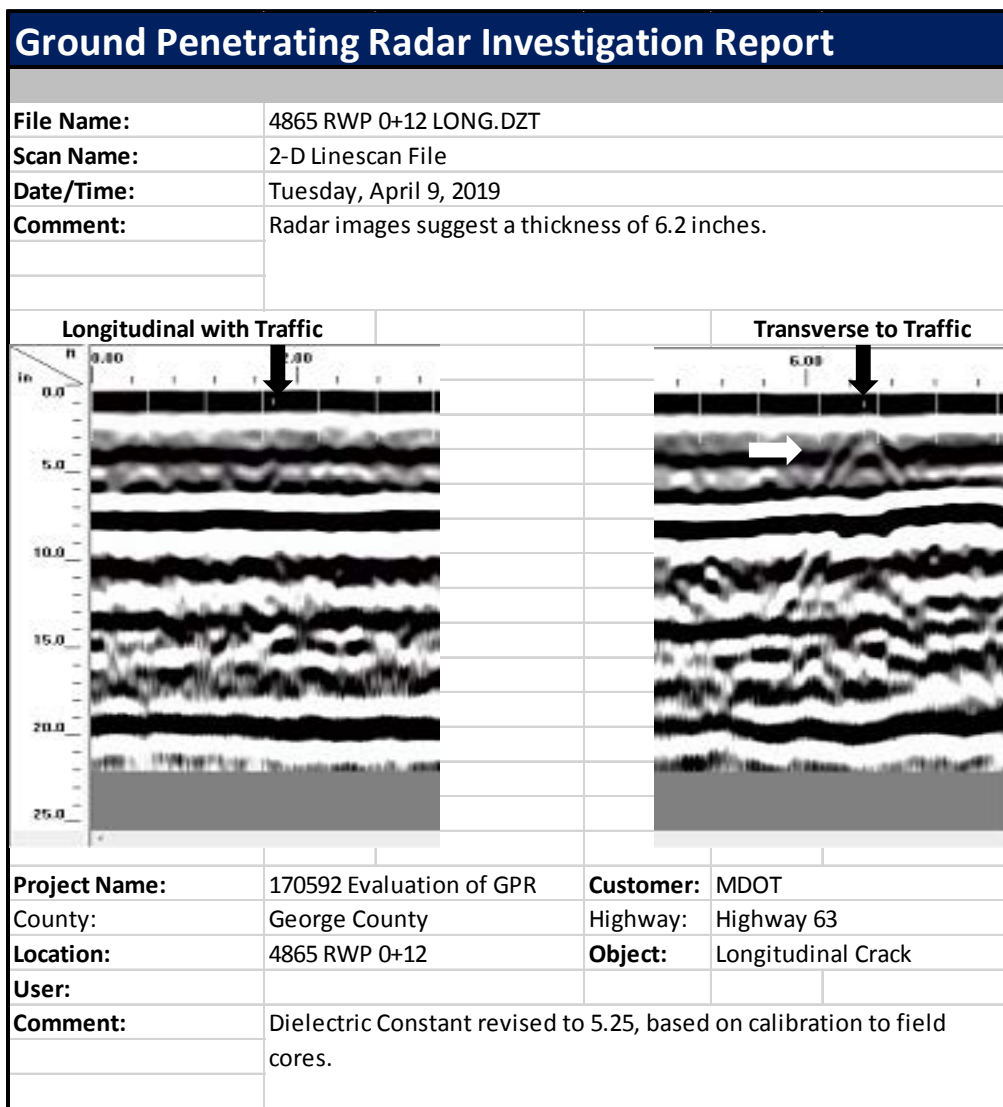
Figure 45: GPR Trace for Longitudinal Crack - Section 4865, Station 0+12

GPR traces for a longitudinal crack within Section 4865 near station 0+12 are illustrated within Figure 45. As shown within this figure, the transverse GPR trace shows a characteristic parabola indicating the longitudinal crack. Figure 46 illustrates the pavement surface and core obtained at this location. The photograph of the core shows that the longitudinal crack does

not extend through the entire layer of HMA. The crack extends from the surface of the pavement to just below the mid-point of the HMA. Interestingly, the small concave shape discussed previously appears at the interface of the HMA and underlying layer. As stated previously, it was hypothesized that this small concave shape could be a crack within an underlying CSM layer. For the longitudinal crack described in Figures 45 and 46, there was an underlying CSM layer. However, as shown within the lower left photograph of Figure 46, there was not a crack in the location that the core was cut.

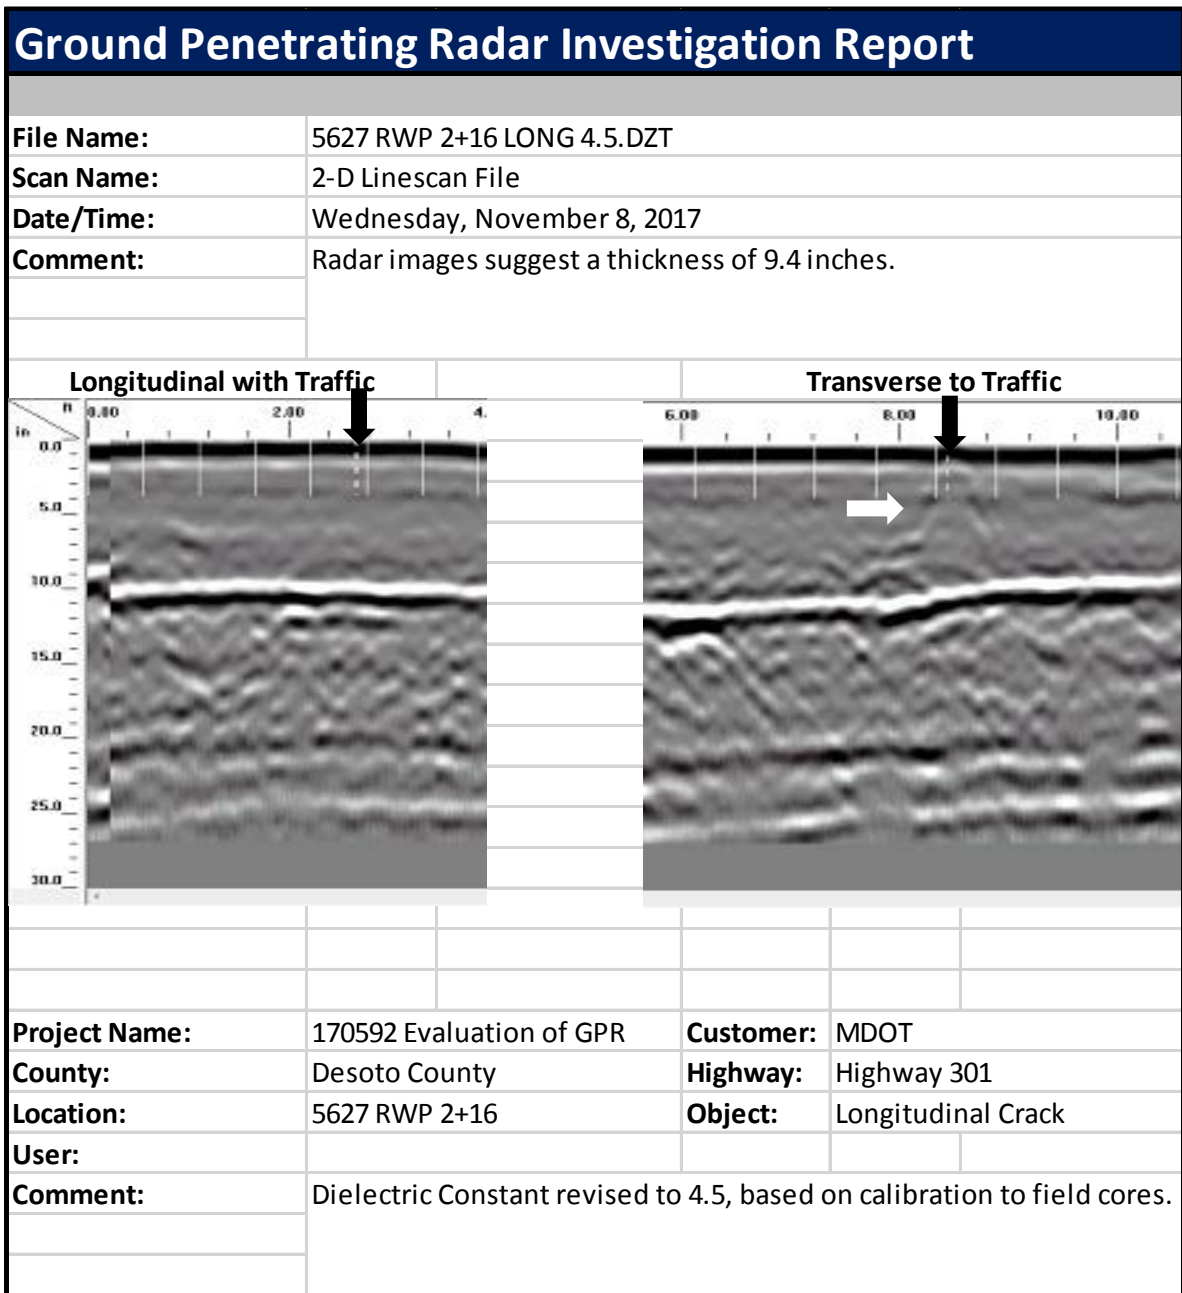
Figure 47: GPR Traces for Longitudinal Crack - Section 5627, Station 2+16

Figure 47 presents the last example of GPR traces for longitudinal cracks. These traces are from Section 5627 near station 2+16. As shown within the figure, the transverse GPR trace shows the characteristic parabola indicating the longitudinal crack. Figure 48 presents photographs of the pavement surface and core from this location. The longitudinal crack is

moderate to high severity at the pavement surface. However, the photograph of the core shows that the crack extends only about 4 in. into the pavement.

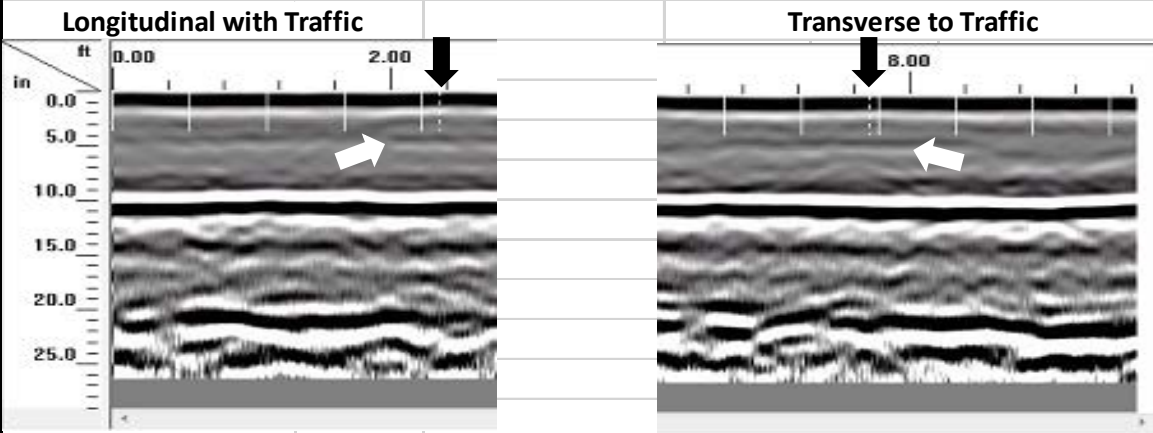
Figure 49: GPR Traces for Transverse Crack - Section 3163, Station 3+91

Figure 49 presents the longitudinal and transverse GPR traces for a transverse crack within Section 3163 near station 3+91. Being a transverse crack, the GPR traces within the longitudinal direction would generally provide a better indication of the distress. As shown within the longitudinal trace (left trace), a faint parabola exists at the location of the crack. Another characteristic within both the longitudinal and transverse traces are shaded, gray lines (see white arrows on traces) at a depth of about 5 in. It was hypothesized earlier in this report that these shaded, gray lines could indicate stripping or delamination.

File Name:	3163 BWP 3+91 TRANS.DZT
Scan Name:	2-D Linescan File
Date/Time:	Tuesday, December 12, 2017
Comment:	Radar images suggest a thickness of 9.1 inches

Project Name:	170592 Evaluation of GPR	Customer:	MDOT
County:	Franklin County	Highway:	Highway 84
Location:	3163 BWP 3+91	Object:	Transverse Crack
User:			
Comment:	Dielectric Constant revised to 4.8, based on calibration to field cores.

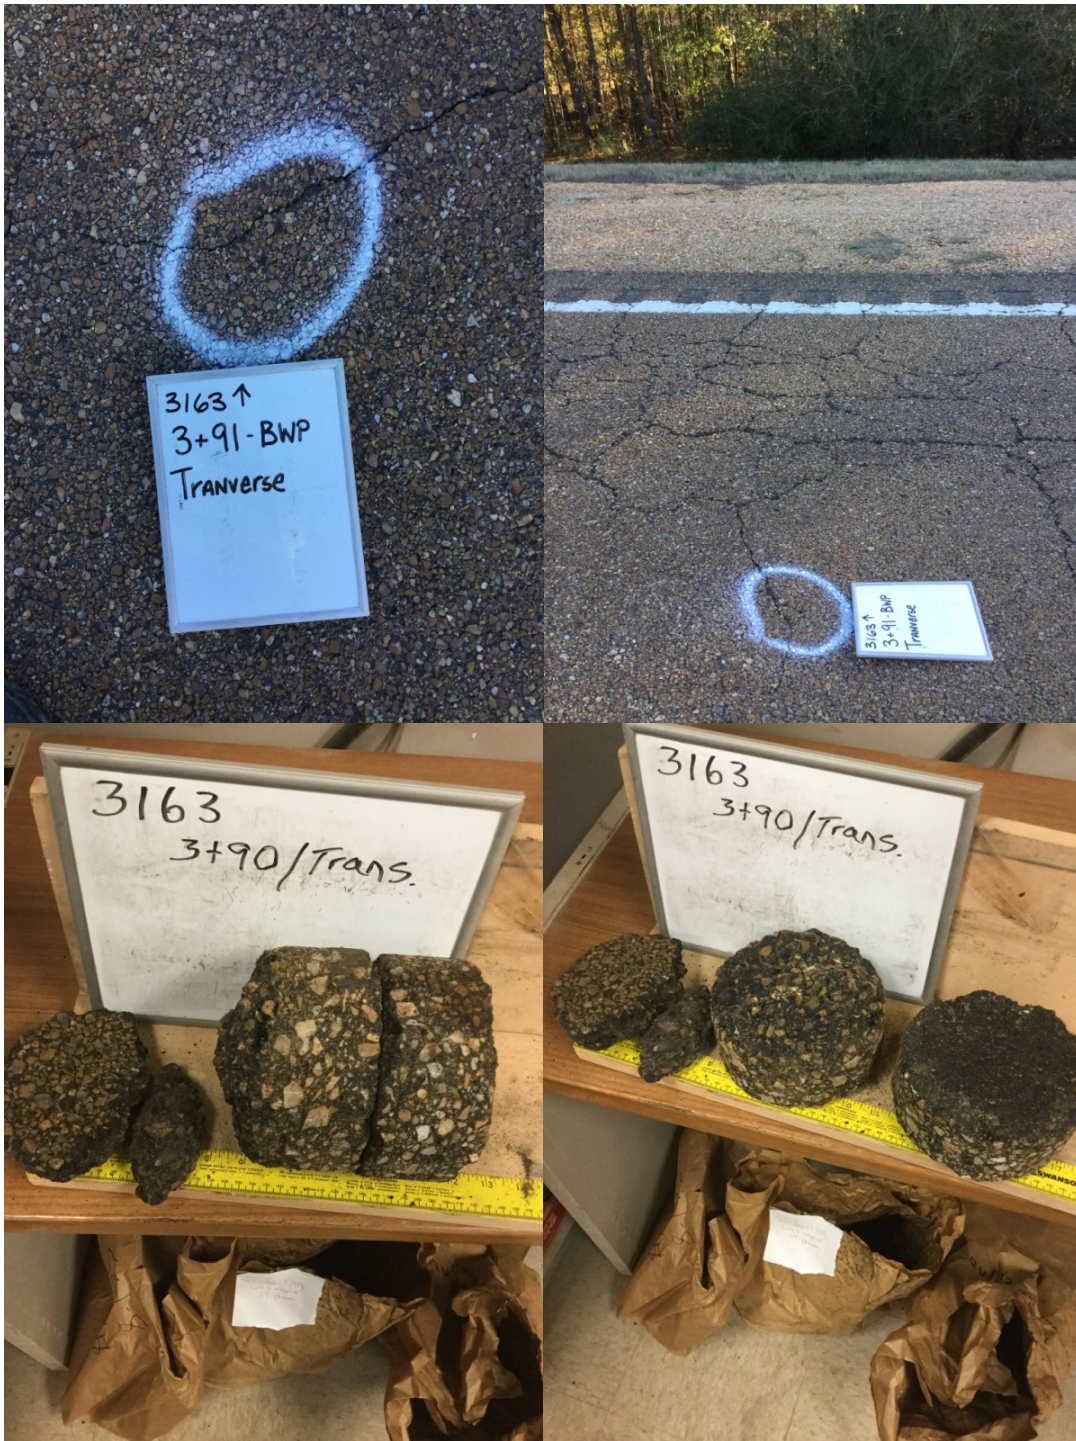
Figure 50: Pavement Surface and Core for Transverse Crack - Section 3163, Station 3+91

Figure 50 presents photographs of the pavement surface and the core obtained from this location. As shown in Figure 50, the transverse crack had a low severity. The core from this location shows that the crack was top-down and extended only an inch or two into the pavement. Delamination and stripping had occurred below the surface layer of HMA as well as just above the bottom layer of HMA.

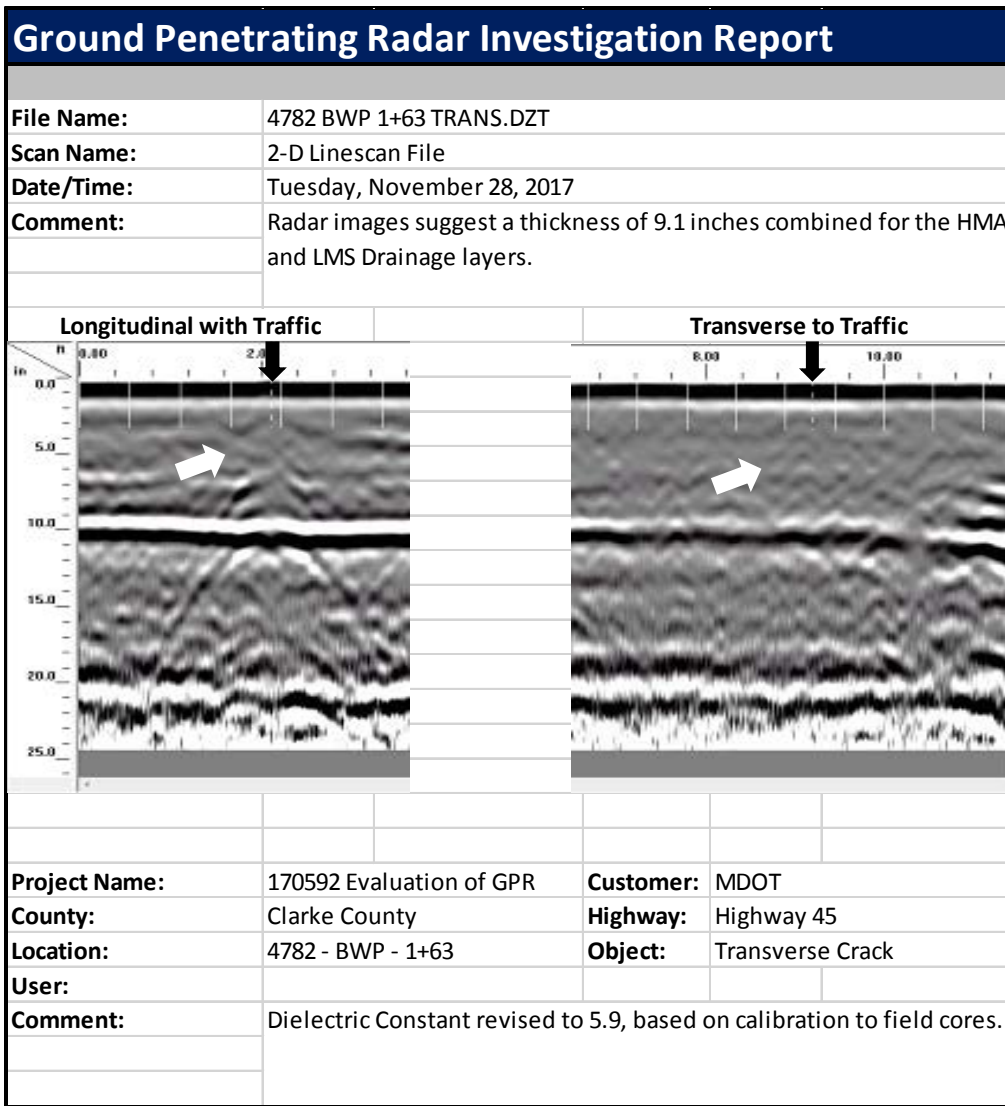
Figure 51: GPR Traces for Transverse Crack - Section 4782, Station 1+63

Figure 51 illustrates the GPR traces for a transverse crack within Section 4782 at station 1+63. Within the longitudinal trace, a distinct parabola exists below the visible distress. Additional anomalies are below the top parabola including a parabola near the interface between the HMA and underlying CSM layer.

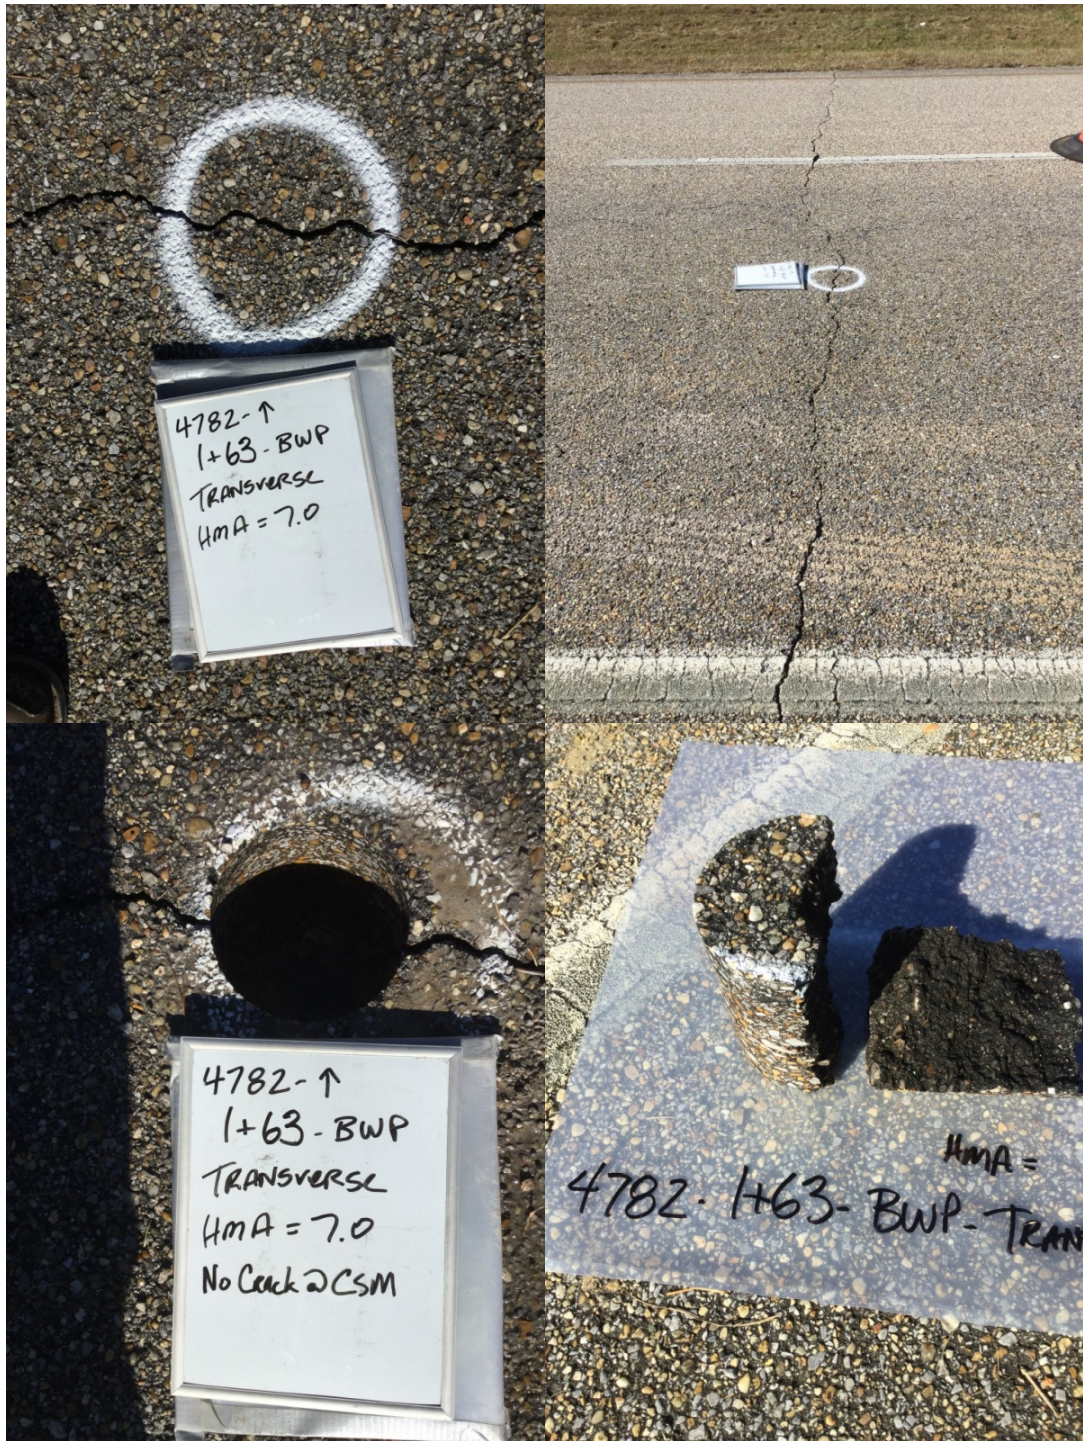
Figure 52: Pavement Surface and Core from Transverse Crack - Section 4782, Station 1+63

Figure 52 presents photographs of the pavement surface and core obtained at the location of the Figure 51 GPR traces. As shown in this figure, the transverse crack extended across the entire pavement lane. The core cut from this location (bottom right photograph of Figure 52) shows that the crack extended through the entire HMA layer. However, a crack was not found within the CSM layer at the location of the core.

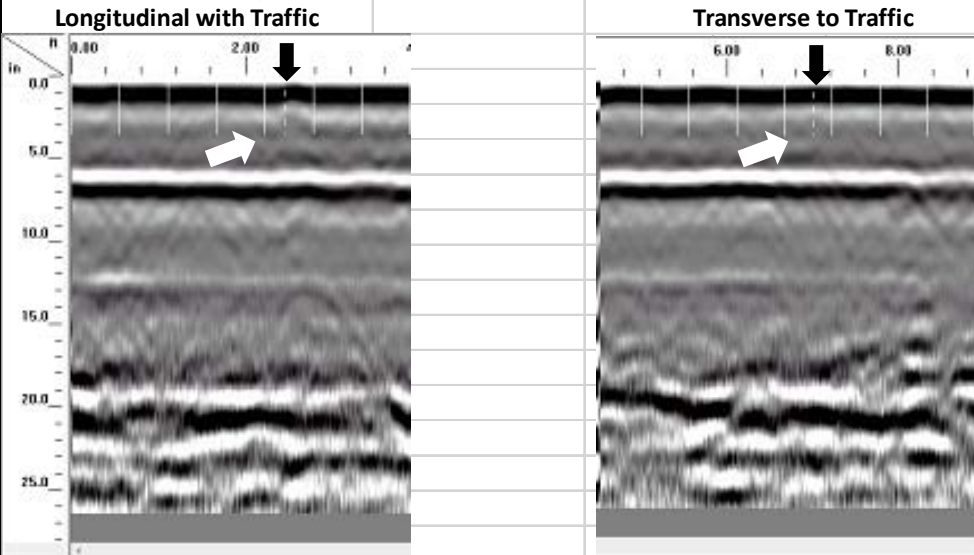
Figure 53: GPR Traces for Transverse Crack - Section 4784, Station 0+15

GPR traces of a transverse crack from Section 4784 near station 0+15 are illustrated within Figure 53. The longitudinal trace shows an anomaly directly under the location of the distress. The parabola is somewhat faint, but does exist.

File Name:	4784 BWP 0+15 TRANS.DZT
Scan Name:	2-D Linescan File
Date/Time:	Wednesday, November 29, 2017
Comment:	Radar images suggest a thickness of 5.7 inches

Project Name:	170592 Evaluation of GPR	Customer:	MDOT
County:	Clarke County	Highway:	Highway 45
Location:	4784 BWP 0+15	Object:	Transverse Crack
User:			
Comment:	Dielectric Constant revised to 5.1, based on calibration to field cores.
