MDOT State Study 287—Evaluation of Ground Penetrating Radar as a Tool in Designing Maintenance and Rehabilitation Projects in Mississippi

Report Date: 12/18/2019

BURNS COOLEY DENNIS, INC.

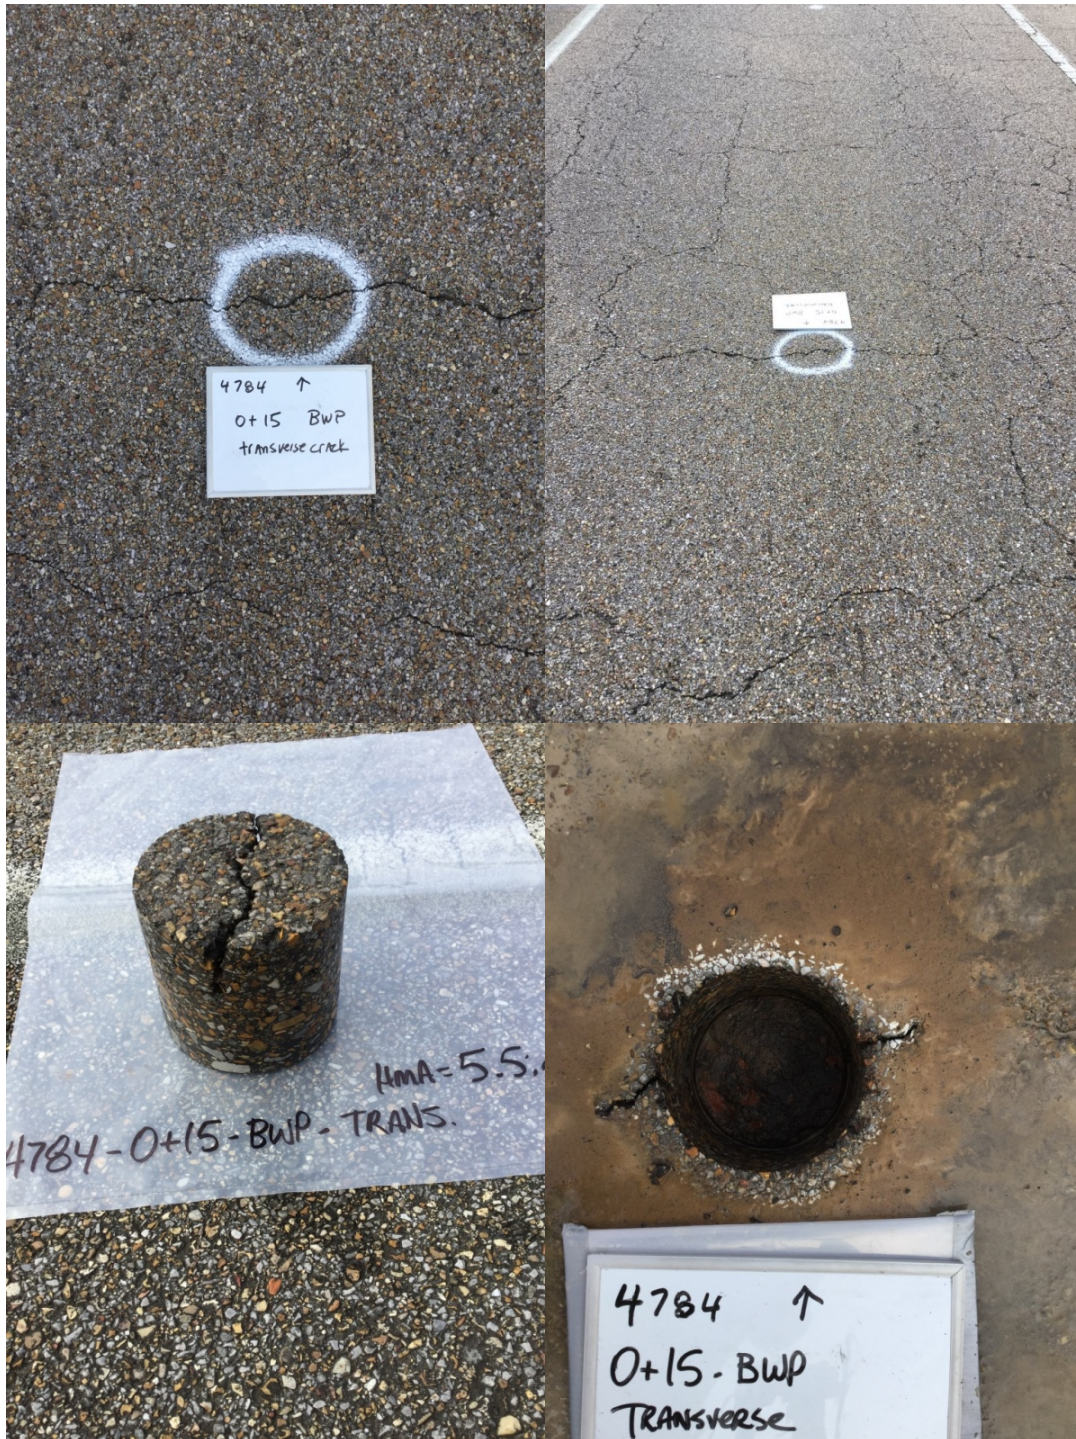
Figure 54: Pavement Surface and Core from Transverse Crack - Section 4784, Station 0+15

Figure 54 presents photographs from station 0+15 of Section 4784. As shown within these photos, the transverse crack was low severity and was BWP. Based on the photograph of the core, the transverse crack was top-down that extended through about half of the HMA layer. The CSM layer below the HMA did not have a crack at the location the core was obtained.

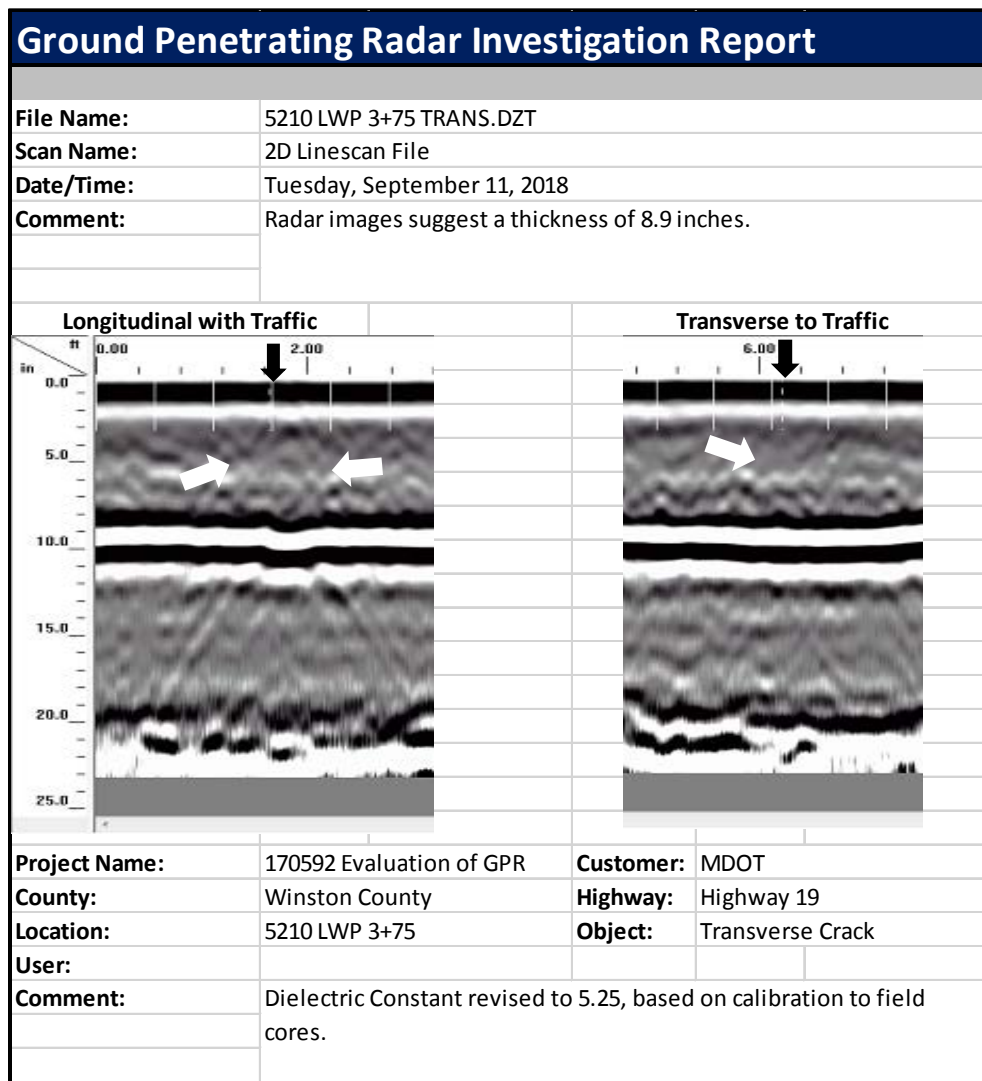
Figure 55: GPR Traces for Transverse Crack - Section 5210, Station 3+75

The final example of comparing visible transverse cracks to GPR traces is from Section 5210 near station 3+75. Longitudinal and transverse GPR traces at this location are presented in Figure 55. This figure shows an anomaly under the location of the surface distress as shown by the white arrows on the longitudinal trace. Additionally, the longitudinal trace indicates some

further distresses below the surface. This observation is based upon the various dark and light shaded lines below the surface (as shown by the white arrows). The various dark and light lines also show up in the transverse trace. Also, of note, the characteristic concave shape exists at the interface between the HMA and CSM layer within the longitudinal trace.

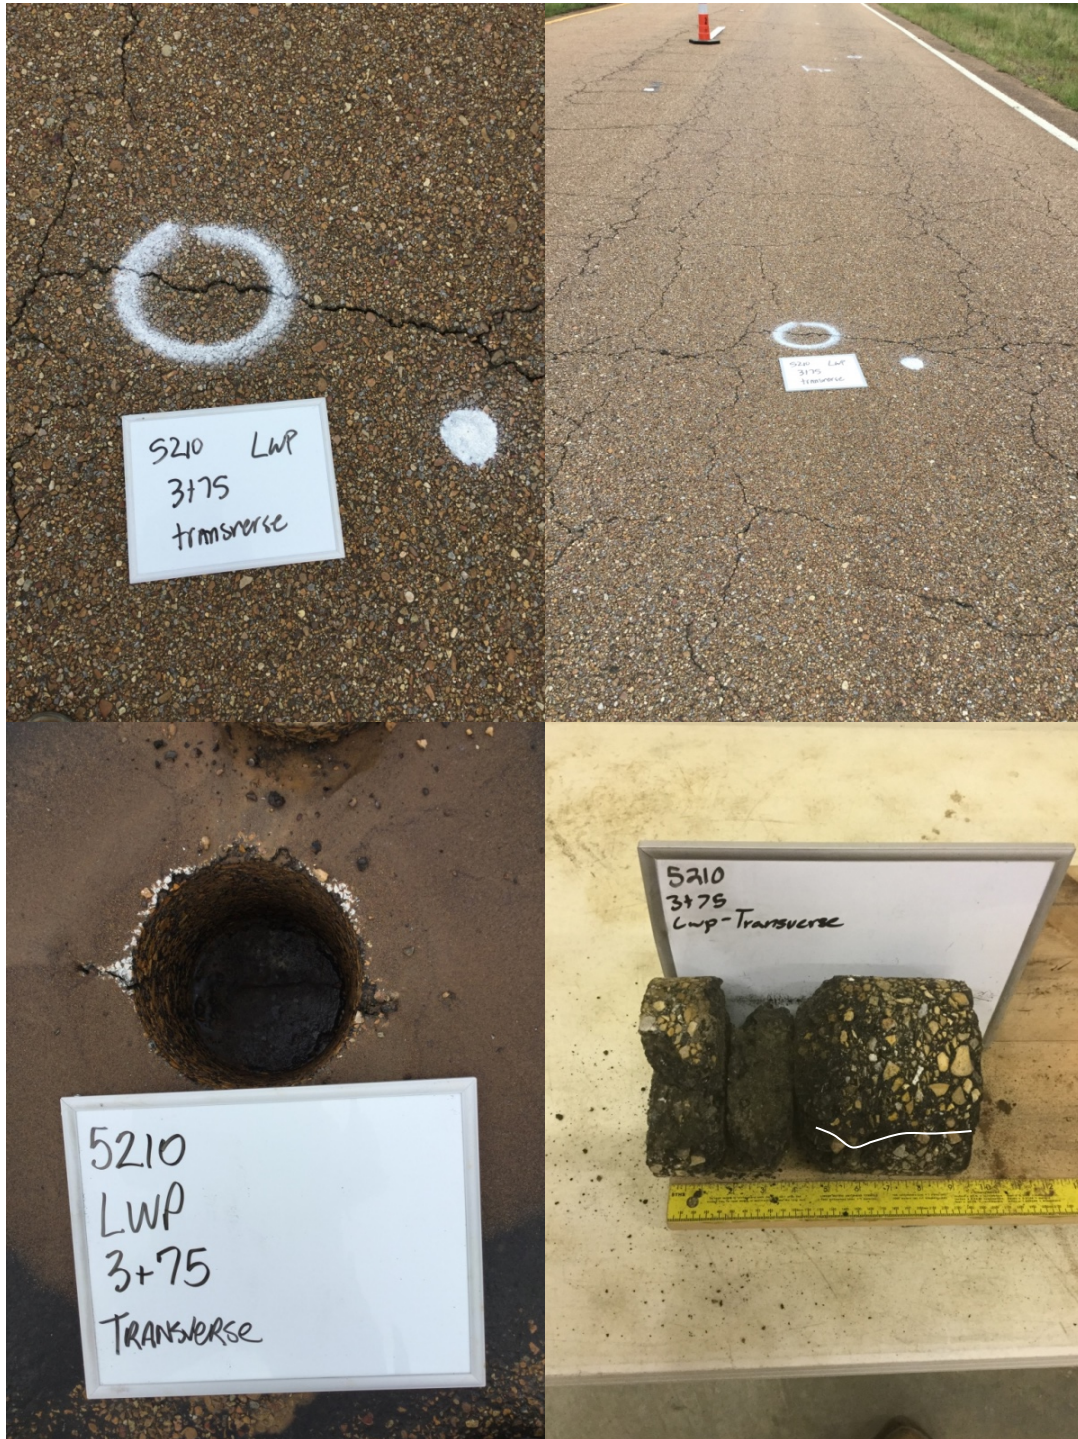
Figure 56: Pavement Surface and Core from Transverse Crack - Section 5210, Station 3+75

The pavement surface and core obtained from Section 5210 is illustrated within Figure 56. This figure shows that the crack is low to moderate severity and is BWP. Based upon the core, stripping had occurred within the middle portion of the HMA layer. The transverse crack extended from the pavement surface to the bottom of the HMA layer. Additionally, there was a crack within the CSM layer at the core location. Therefore, the various dark and light shaded lines did appear to indicate stripping (and possibly delamination) and the concave shape did appear to indicate a crack within the CSM layer.

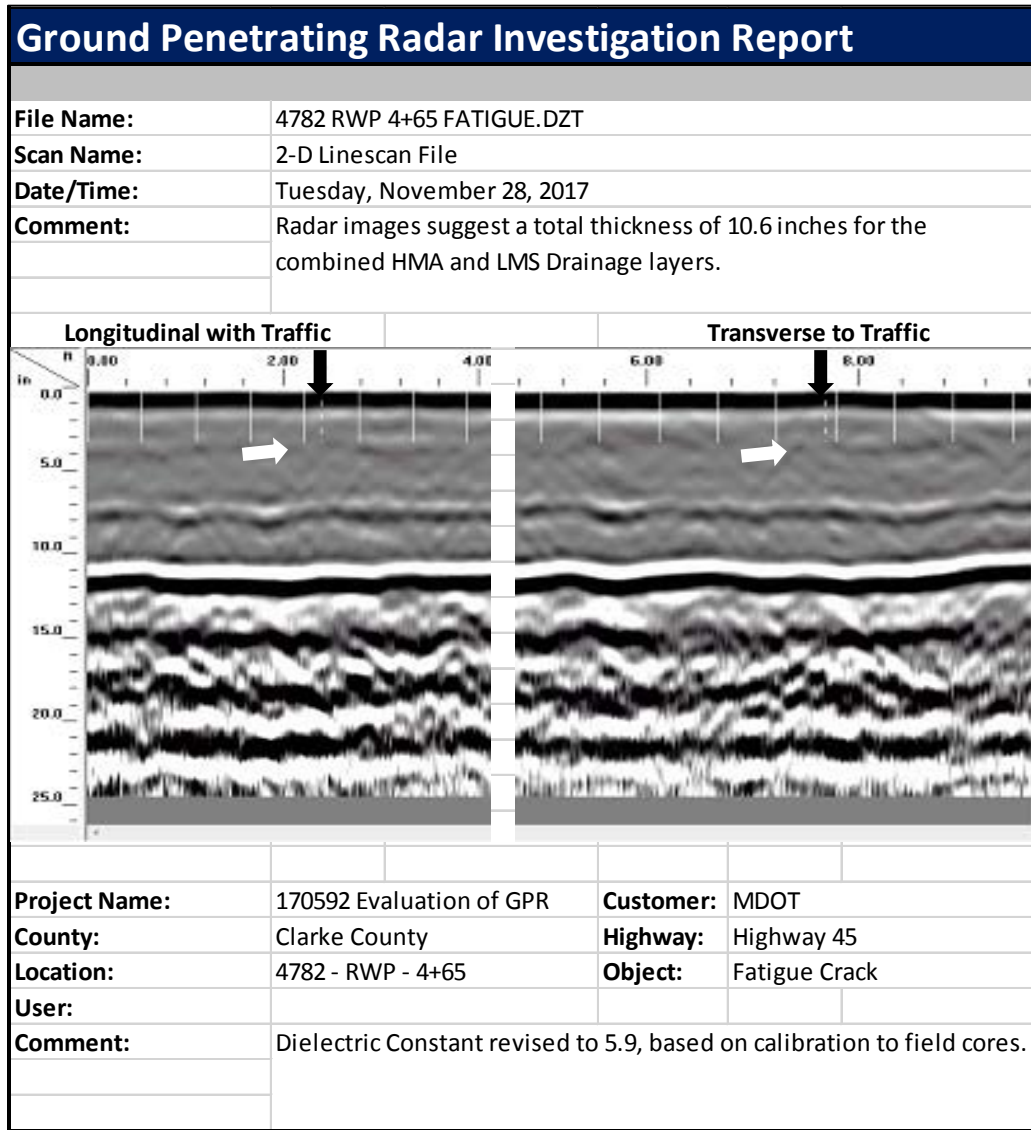
Figure 57: GPR Traces for Fatigue Cracks - Section 4782, Station 4+65

Figure 57 shows the longitudinal and transverse GPR Traces for fatigue cracks observed within Section 4782 near station 4+65. Based upon the traces, very little can be discerned from the longitudinal trace. However, there are some anomalies below the surface within the transverse trace, though they are faint.

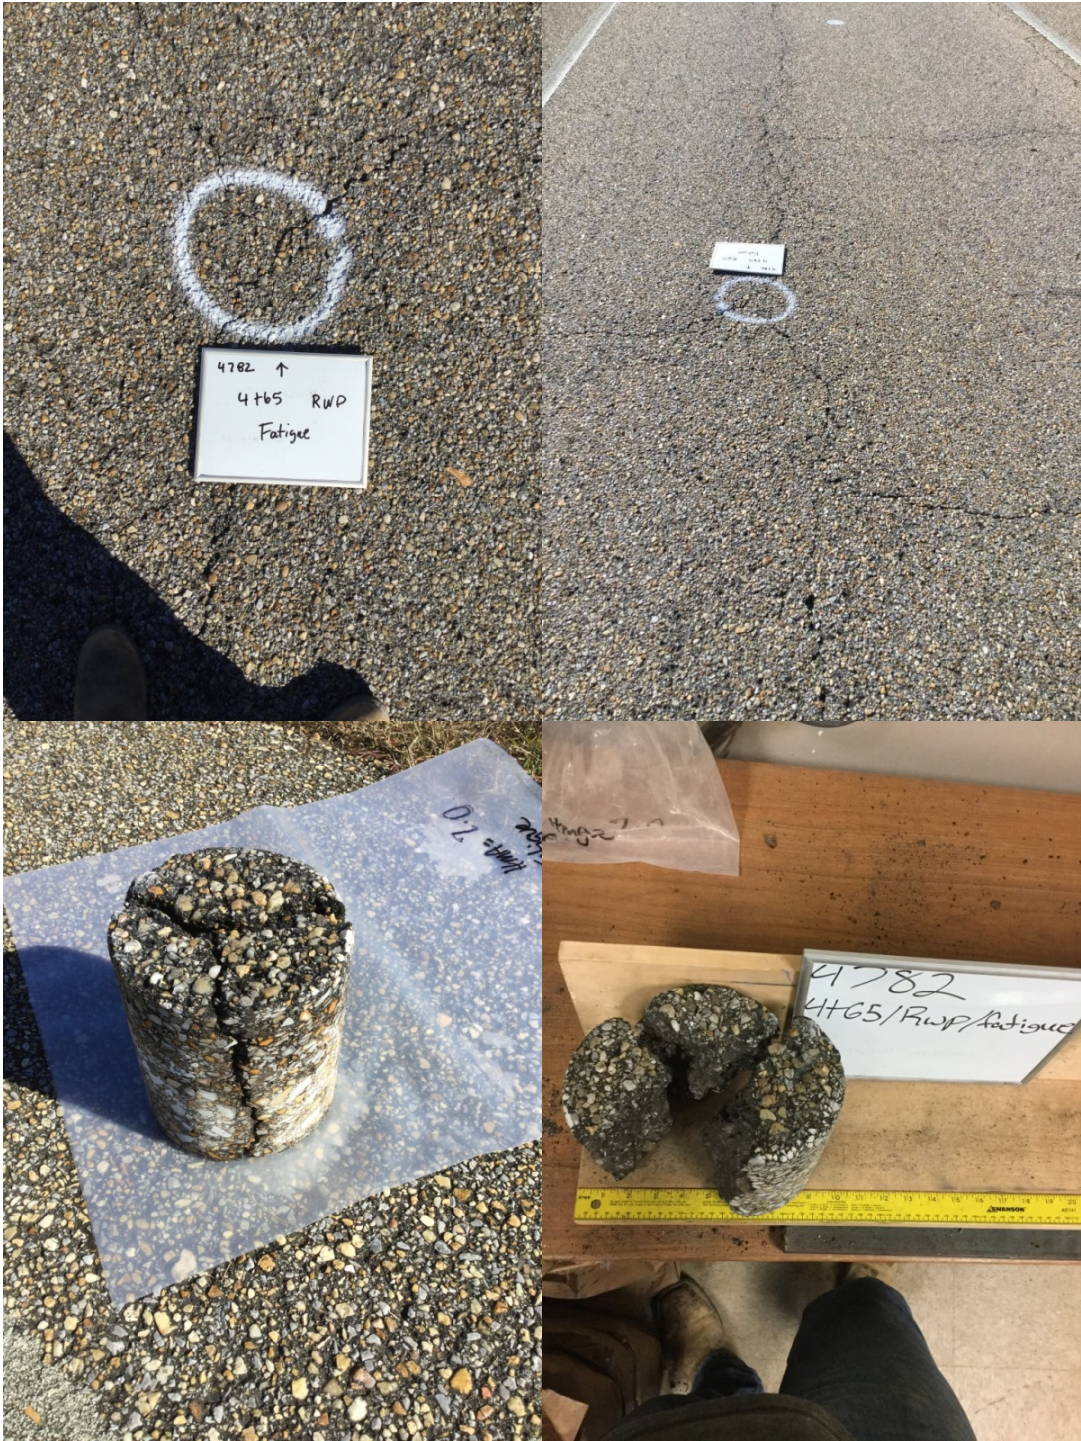
Figure 58: Pavement Surface and Core from Fatigue Cracks - Section 4782, Station 4+65

Figure 58 presents photographs of the pavement surface and a core cut from within Section 4782 at station 4+65. The fatigue cracking in this area is generally a longitudinal crack at the edge of the wheel path with secondary transverse cracks. As shown in Figure 58, the core was cut at the intersection of the longitudinal crack and one of the secondary transverse cracks. Both of these cracks would be considered low severity. The core revealed that both the longitudinal and transverse cracks extended through the entire HMA layer.

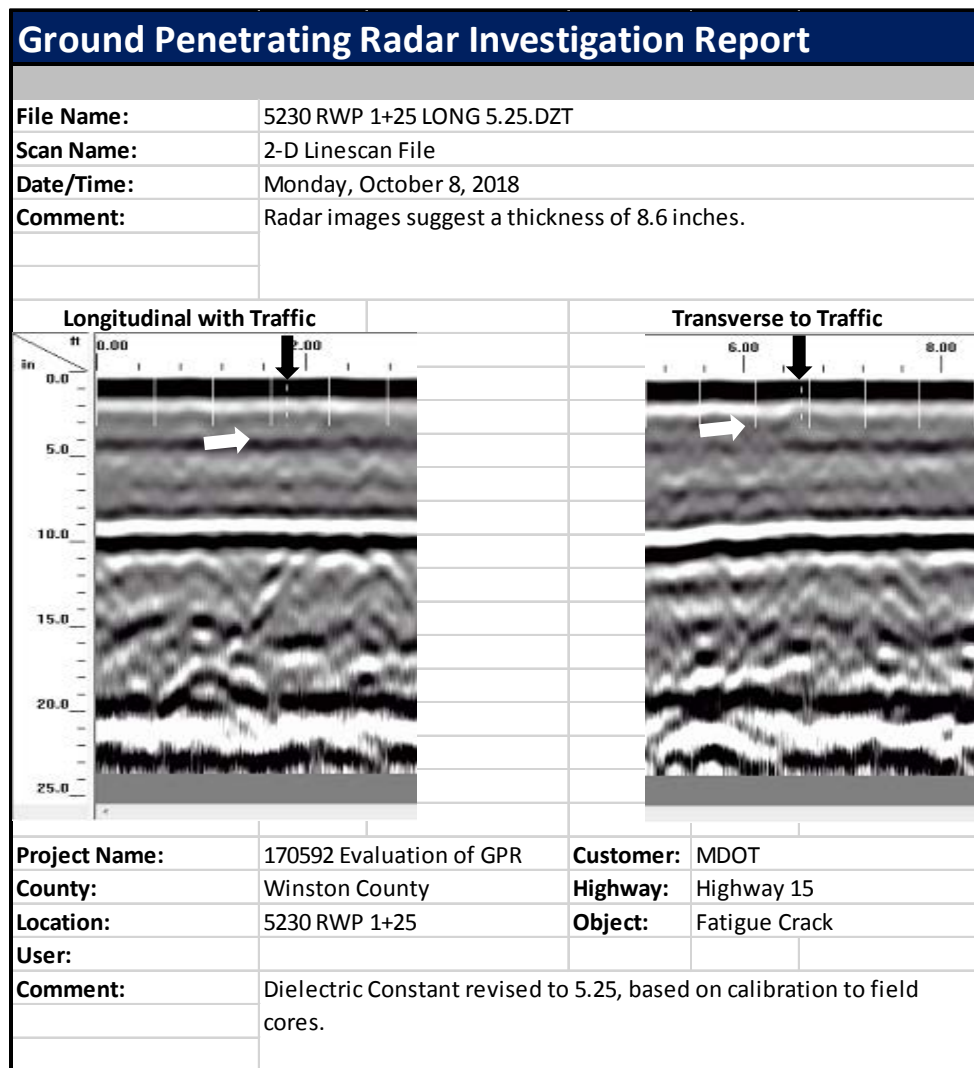
Figure 59: GPR Traces for Fatigue Cracks - Section 5230, Station 1+25

Figure 59 presents the GPR traces for fatigue cracking within Section 5230 near station 1+25. The transverse to traffic trace does appear to show an anomaly near the pavement surface (as designated by the white arrow). Interestingly, both traces show a dark shaded line at a depth of about 4 in.

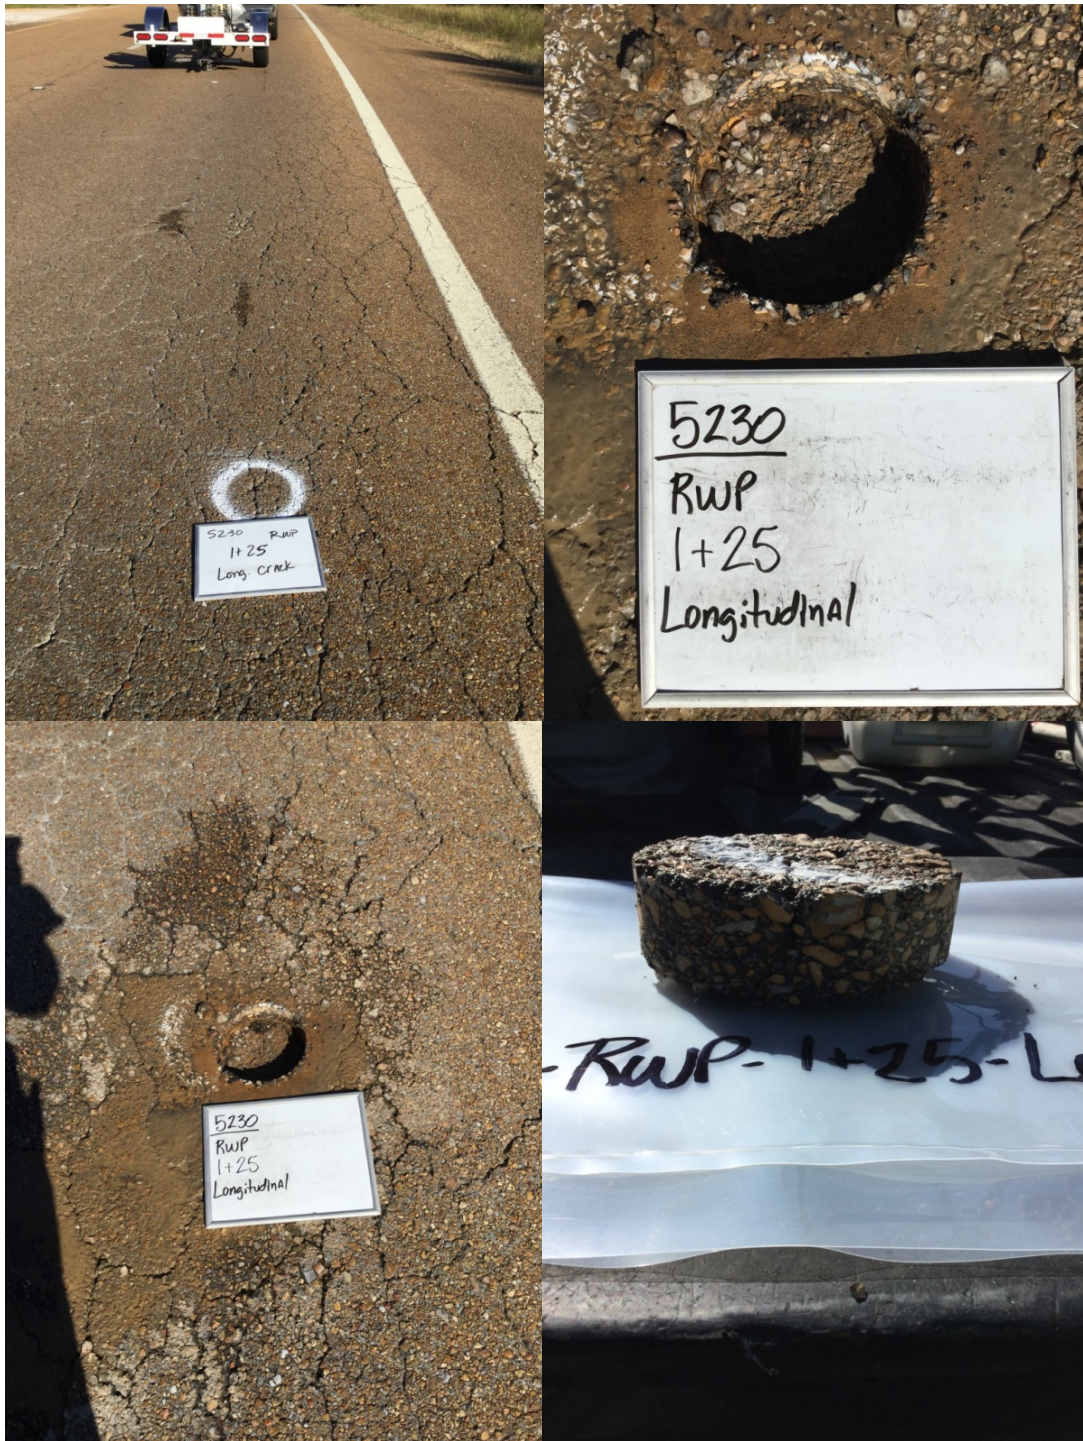
Figure 60: Pavement Surface and Core from Fatigue Crack - Section 5230, Station 1+25

Photographs of the pavement surface and core cut from Section 5230 are presented within Figure 60. As shown within this figure, the pavement surface has the appearance of classical “alligator” cracking and are low to moderate severity. However, the core cut from the pavement indicated that the cracks only extended through the first layer of HMA. Therefore, these cracks are top-down or bottom-up from the bottom of the surface layer. The core also shows delamination and some stripping at the bottom of the HMA surface layer.
