**RP 270**

# **Development of an Inventory and Inspection Database Framework for Asset Management of MSE Walls**

Idaho Transportation Department

July 2019

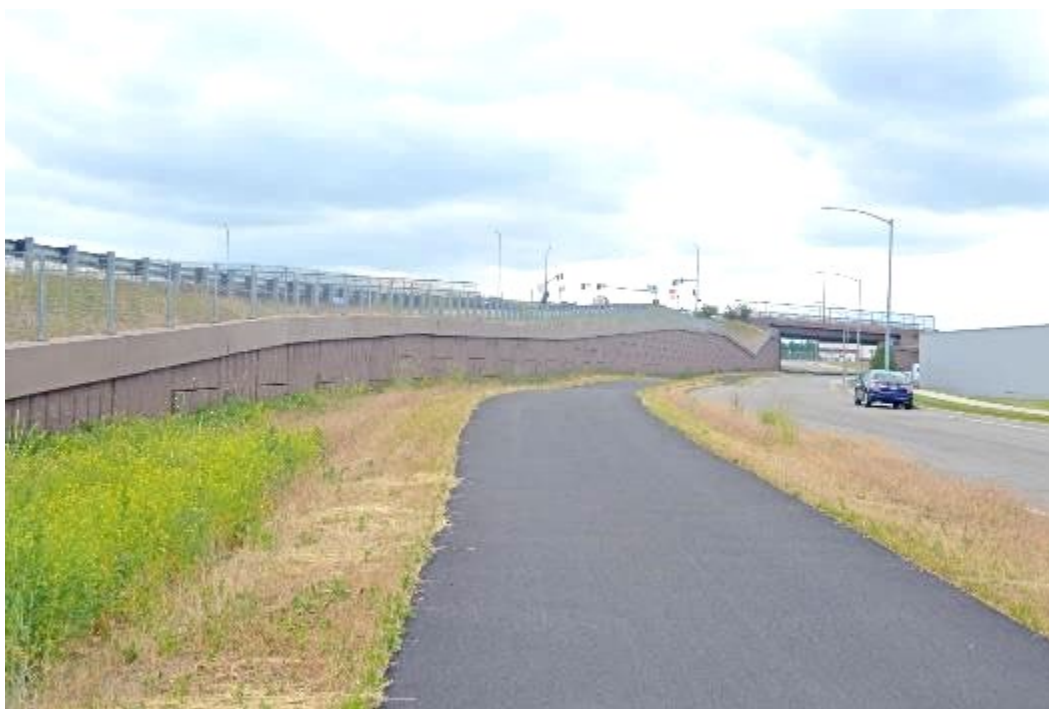
The 960-foot long, concrete panel, MSE wall at MP 1.03 on the eastbound exit-ramp coming off I-90 was inspected with a view to evaluating the three selected inspection procedures. This MSE wall was constructed in 2012 and uses rectangular concrete panels and metallic reinforcement strips. The panels are 9.7 (W) × 4.7 (H) feet in size and have a patterned finish which has been painted dark brown. Figures 5 and 6 show the setting of the wall and a typical panel with some bulging.

The inspection was started at the western end (L = 0 feet) and looked for “blemishes” in the wall appearance moving in an eastward direction. Overall the wall is in excellent condition, with only minor items. There is some slight bulging of 1.0 to 1.5 inches in the panels located at 330, 396, and 464 feet from the western edge of the wall. Also, three panels had broken corners at 580 (2 panels) and 658 feet. It appeared that the corners at 580 feet were broken during construction, but the one at 658 feet appears to be the result of “crushing” caused by rotation of panel. A summary of the results according to the three inspection procedures is presented in Tables 24 to 26.

**Figure 5. I-90 MSE Wall along the EB Off-ramp near MP 1.03**

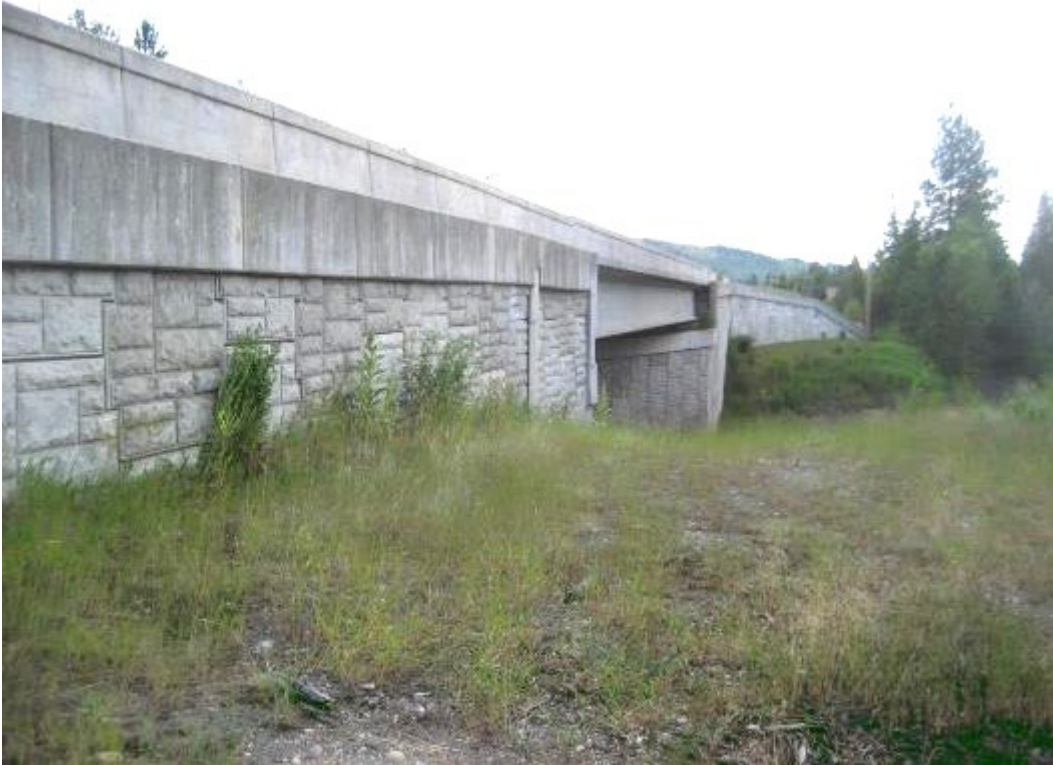
The concrete paneled, wing-walls for the Westmond railroad bridge at MP 465.04 on US-95 were constructed in 2004. The NW wing-wall located at the north abutment of the SB carriageway was inspected for damage. The wall extends about 110 feet to the abutment face and has an average height of about 10 feet. The last 20 feet plunges into the railroad cut, reaching a maximum height of about 35 feet. The wall uses cruciform-shaped concrete panels with maximum dimensions of about 53 (H) × 68 (W) inches. The panels have a cut-stone finish. The setting of this MSE wall is shown in Figure 7, along with a distressed panel in Figure 8.

**Figure 7. Westmond Bridge Wingwall at US-95 SB, North Abutment**

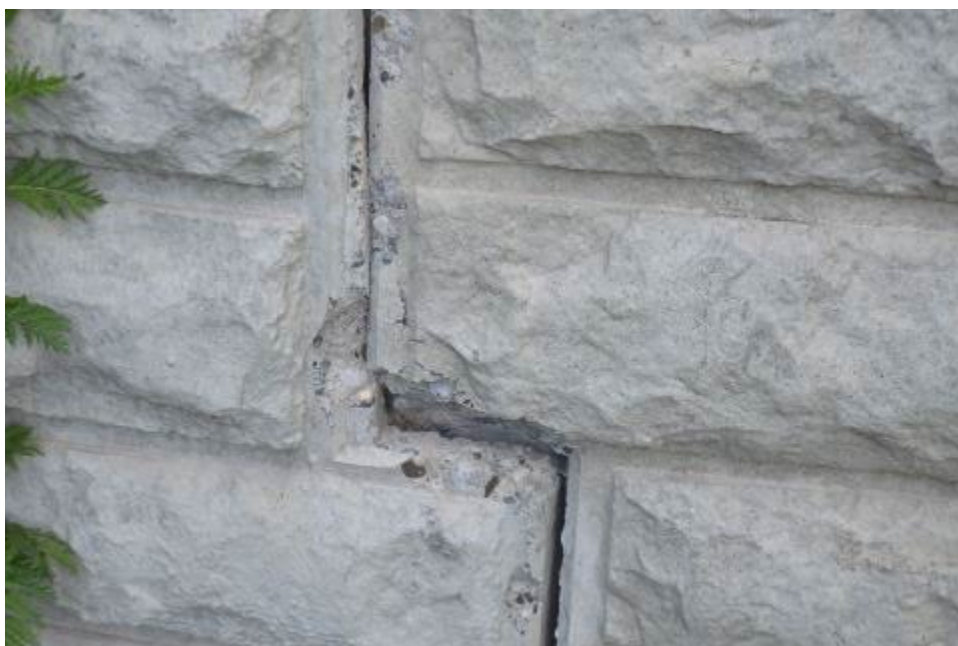
Distance, L (feet)	Notes
20	Panel has rotated clockwise; joint ranges from nearly closed to 1-inch width
25	Panel has rotated clockwise; joint ranges from nearly closed to 1-inch width
30	Panel has rotated clockwise; joint ranges from nearly closed to 1-inch width (see Figure 9)
40	Panel is damaged due to crushing (see Figure 10)
45	Panel corners are damaged
60	Panel corners damaged; some crushing; vertical joint is nearly 1.5 inches wide
85	Vertical joint has widened to nearly 1.5 inches
90	MSE Wing wall ends; from 90-110 feet, wall is part of abutment
110	Bearing wall damaged; part of panel crushed and cracked (see Figure 8)

**Figure 10. Crushed Panel at L = 40 feet**

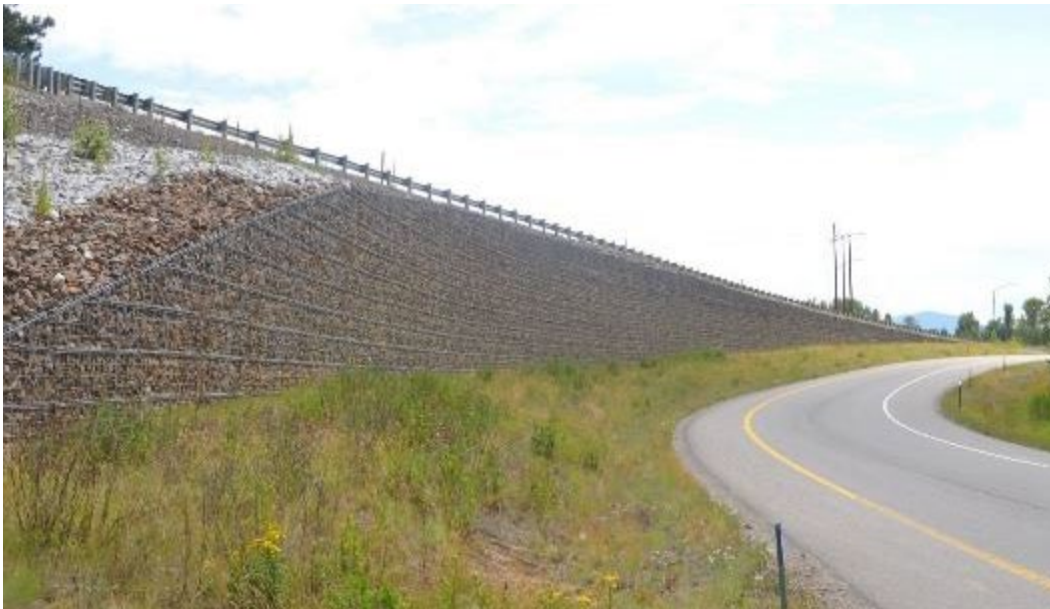
With no problems observed, it can be concluded that the wall is performing as expected.

**Figure 11. Wire-Gabion MSE Wall at MP 475, SB US-95 in Sandpoint**

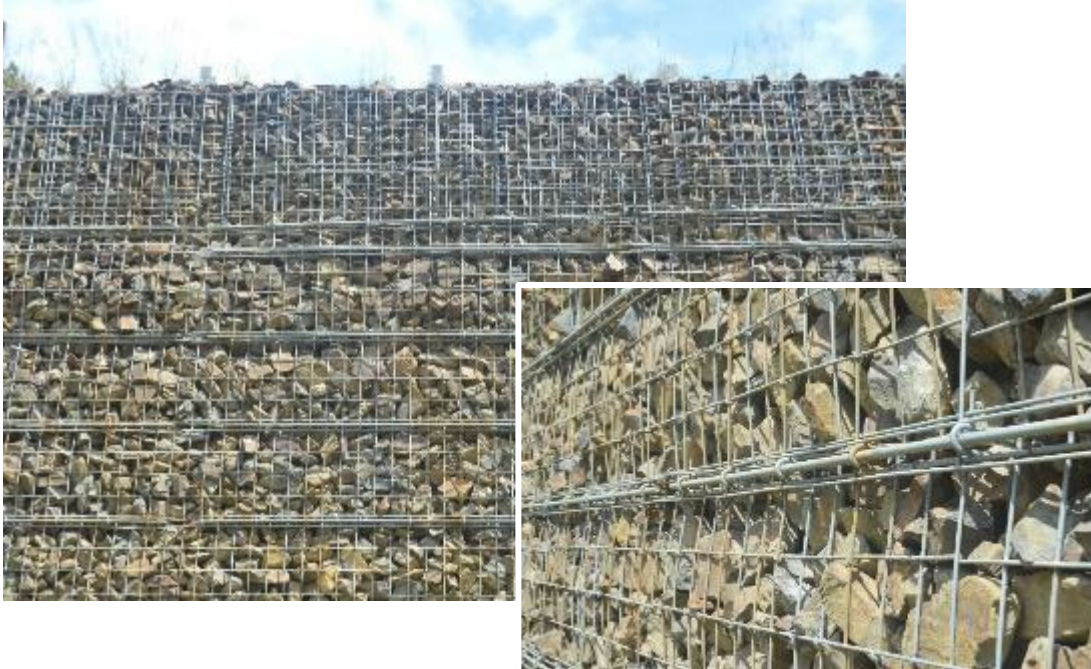
**Figure 12. Wire-Gabion Configuration and Large Rockfill**

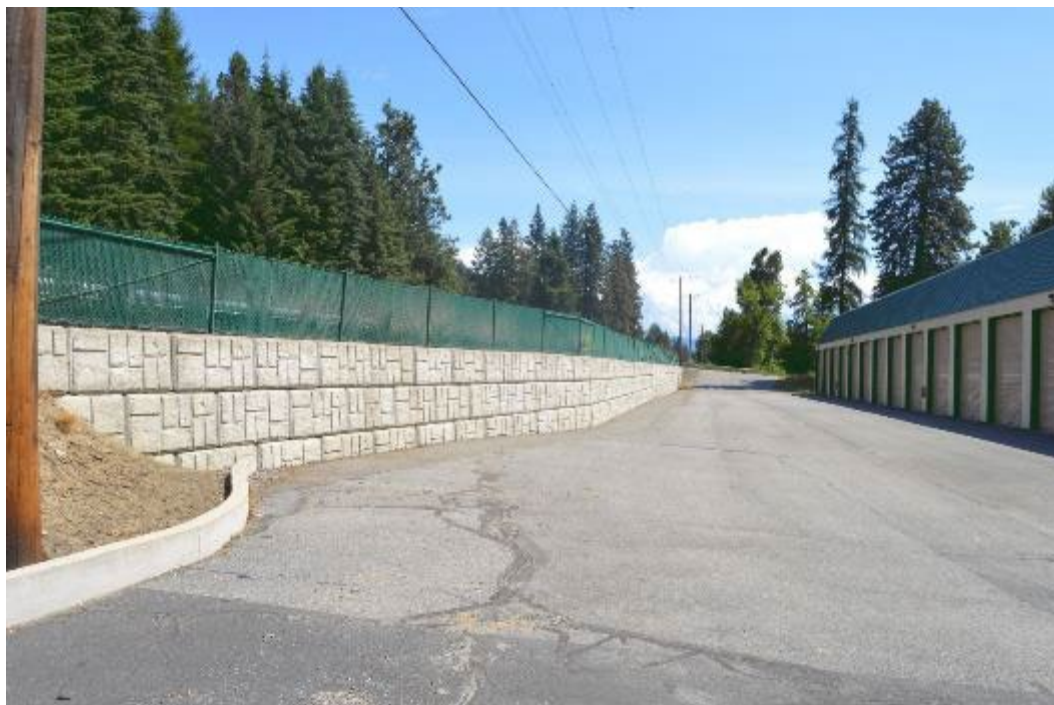
This is a 330-foot long, MSE concrete block wall which supports the SB lane of SH-200 near Trestle Creek. This wall was constructed in 2013 and consists of stacked concrete blocks as shown in Figures 13 and 14. The maximum height of this wall is 8.5 feet. The inspection revealed no problems with alignment, settlement, or block degradation. There was some minor staining, but there were no obvious signs of leaking backfill or drainage problems. The completed inspection forms are included in Appendix B.

**Figure 13. Concrete Block Wall near Trestle Creek, SB SH-200**

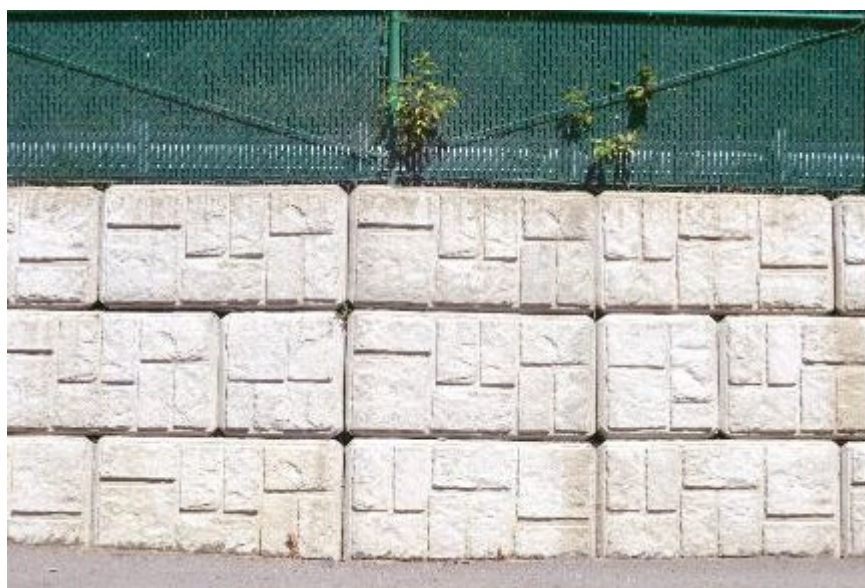
**Figure 14. Concrete Block with “Cut-Stone” Finish used for Trestle Creek Wall**

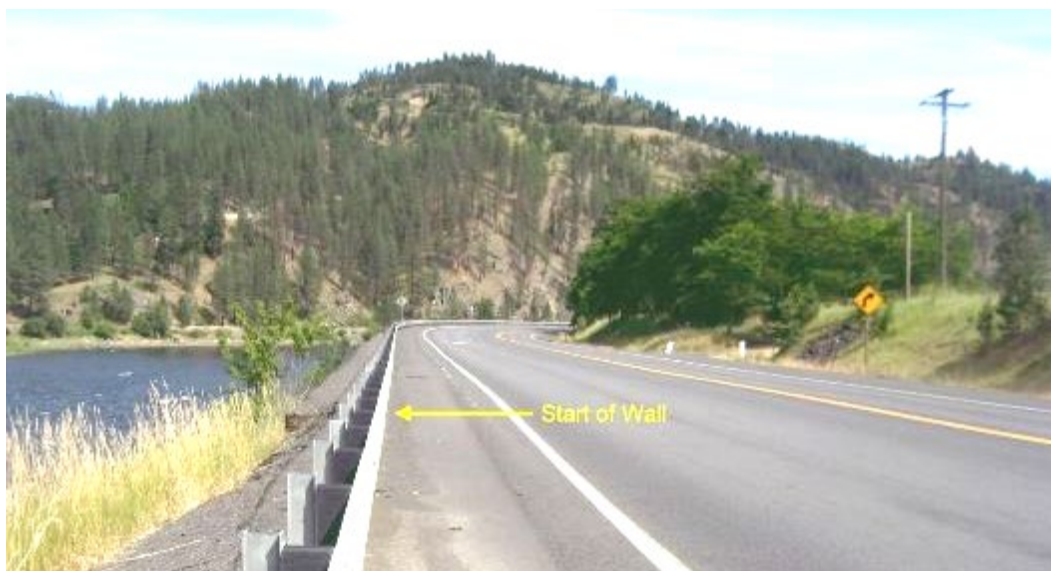
**Figure 15. Western Wire Gabion MSE Wall at MP 53.00, WB US-12**

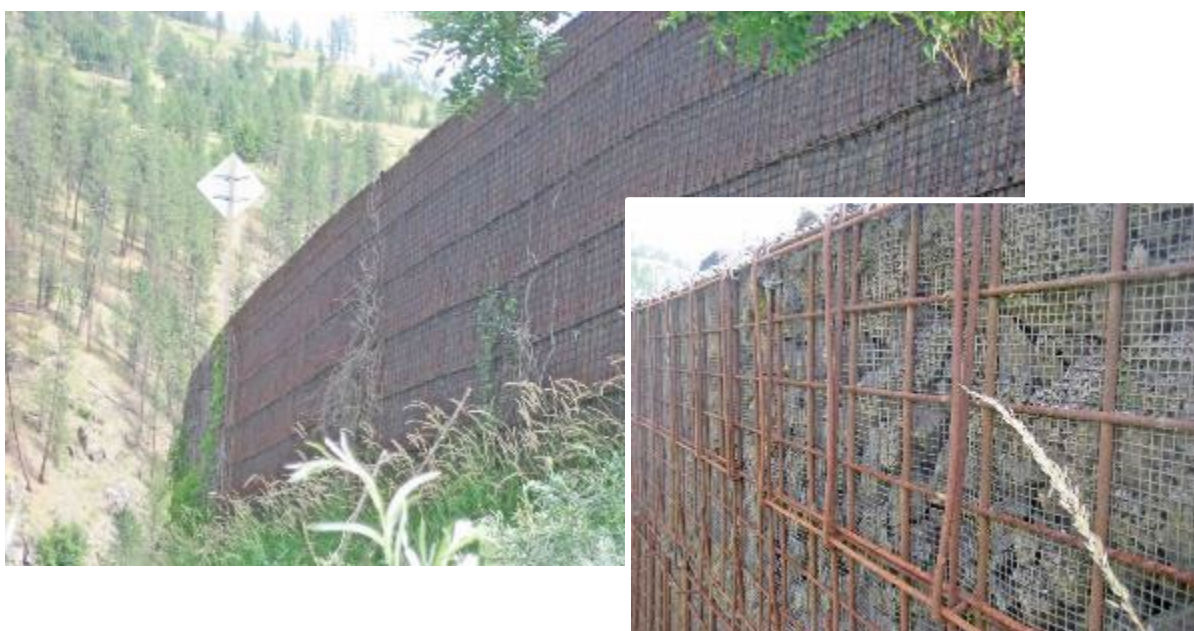
**Figure 16. View of Western Wall and Corten-steel Gabions from Clearwater Riverbank**

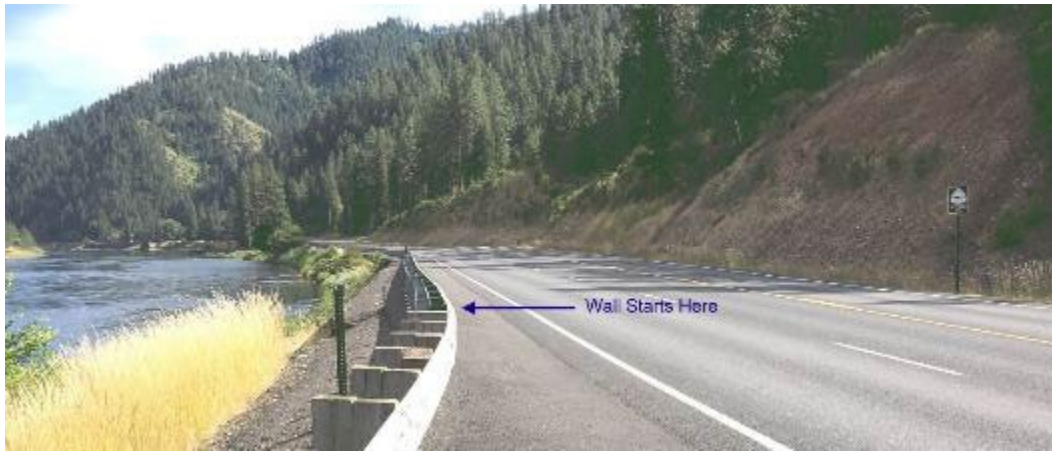
Figures 17 and 18 show the start of the eastern wall at MP 53.59, which is about 650 feet long and has a maximum height of about 15 feet. As in the western wall, a woven geosynthetic mesh is used to retain the finer gabion backfill, as shown in Figure 18. These gabions are also made of Corten-steel which has developed the typical rust coating.

Only the edges of the wall could be accessed for inspection due to the steep, vegetated terrain next to the Clearwater River. There were no signs of excessive corrosion or leakage of gabion fill materials, and no adverse observations noted during the site visit.

**Figure 17. Eastern Wire Gabion MSE Wall at MP 53.59, WB US-12**

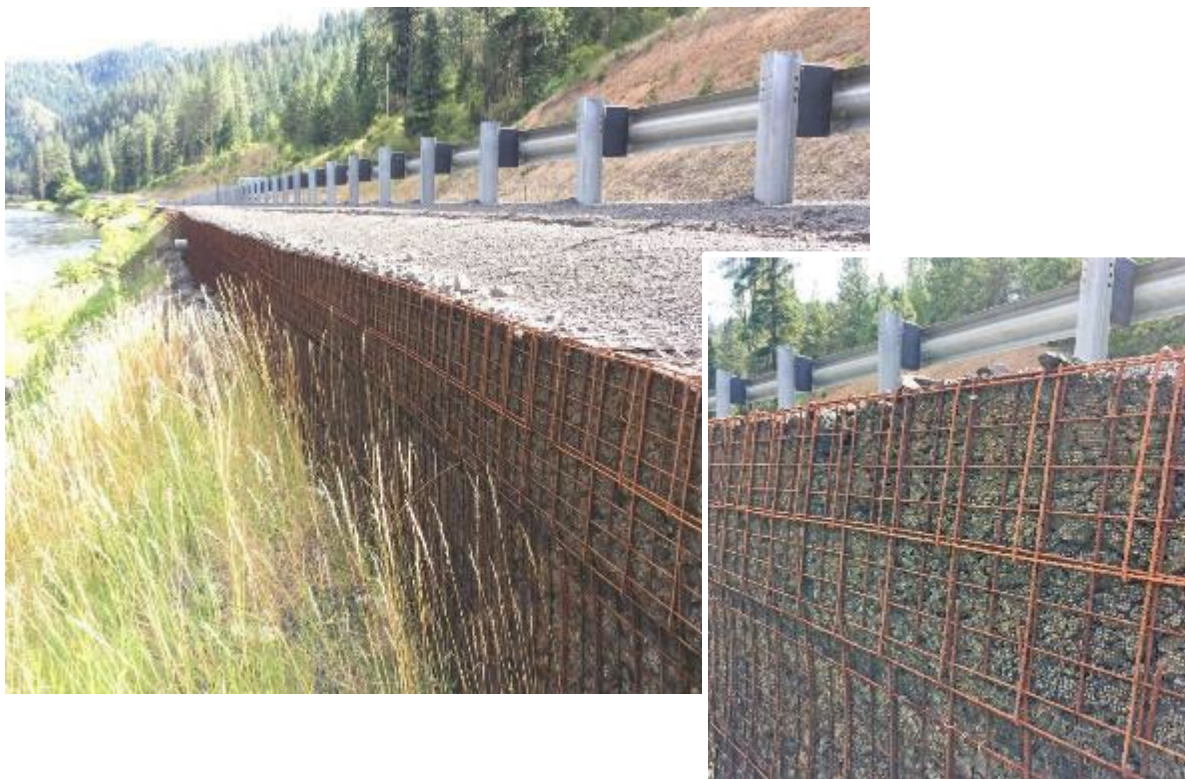
**Figure 18. View of Eastern Wall and Corten-steel Gabions from Clearwater Riverbank**

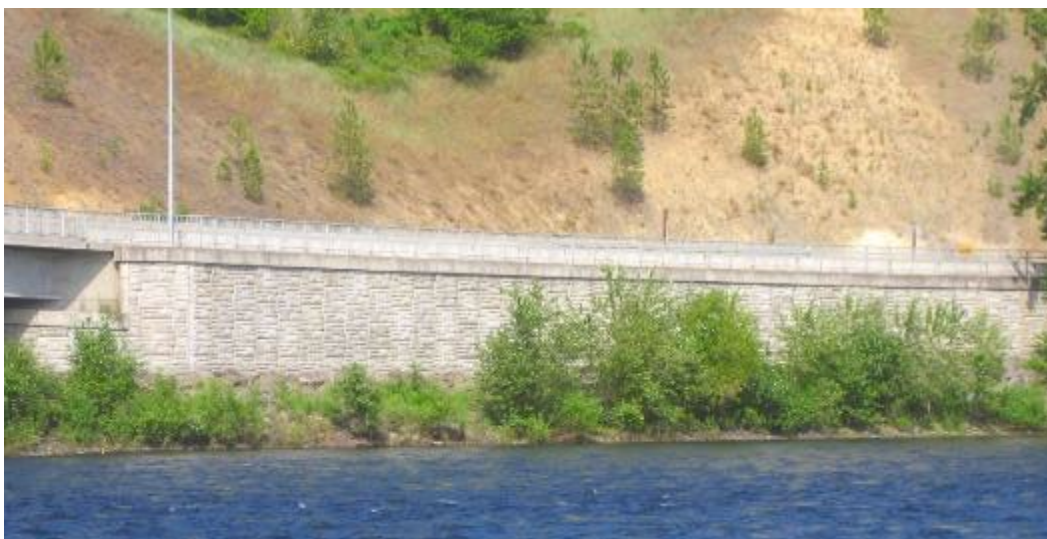
Overall the MSE wall is in good condition, with only minor staining, no obvious distress in the concrete panels, and all panel joints have uniform spacing. The rip-rap (up to 3-feet in diameter) placed at the base of the wall is performing well as there were no obvious signs of erosion due to scour. The wall did not have any vegetation growth in the panel joints and only limited vegetation growth on the road side of the coping. The inspection forms for this MSE wall are not included as the wall is performing very well and no adverse features were observed during the field investigation.

**Figure 19. View of Kamiah Bridge Eastern MSE Wall, EB US-12, from across the River**

This wall is an excellent candidate for future condition surveys performed by sUAV (“drone”) technology due to its inaccessibility adjacent to the Clearwater River.

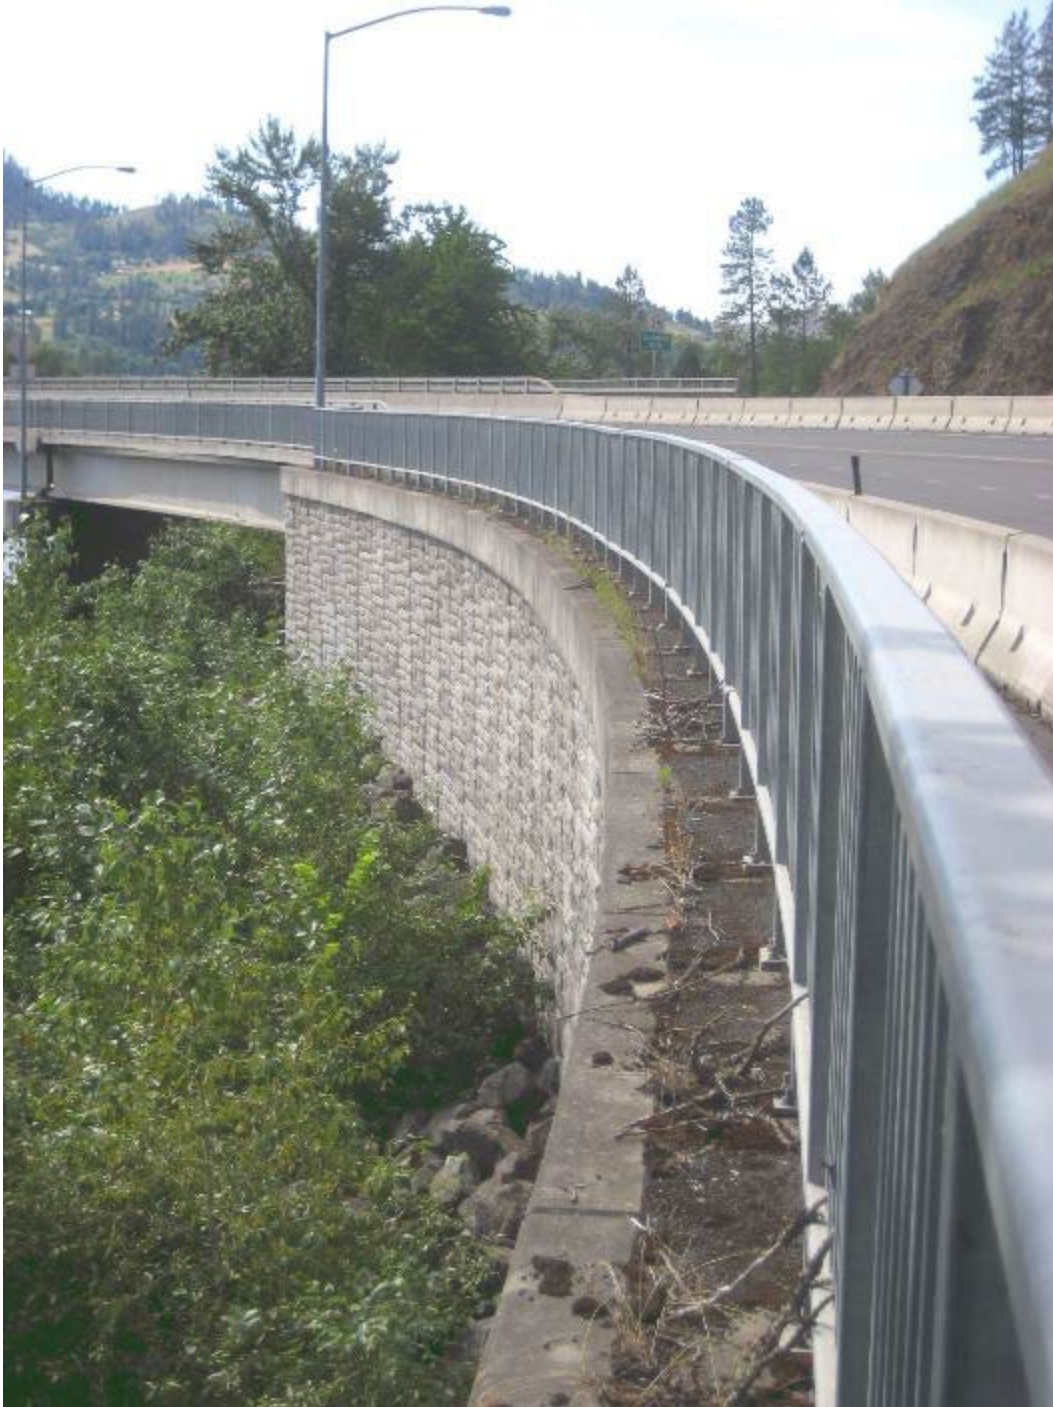
**Figure 20. Closer View of Eastern MSE Wall of Kamiah Bridge from the Deck**

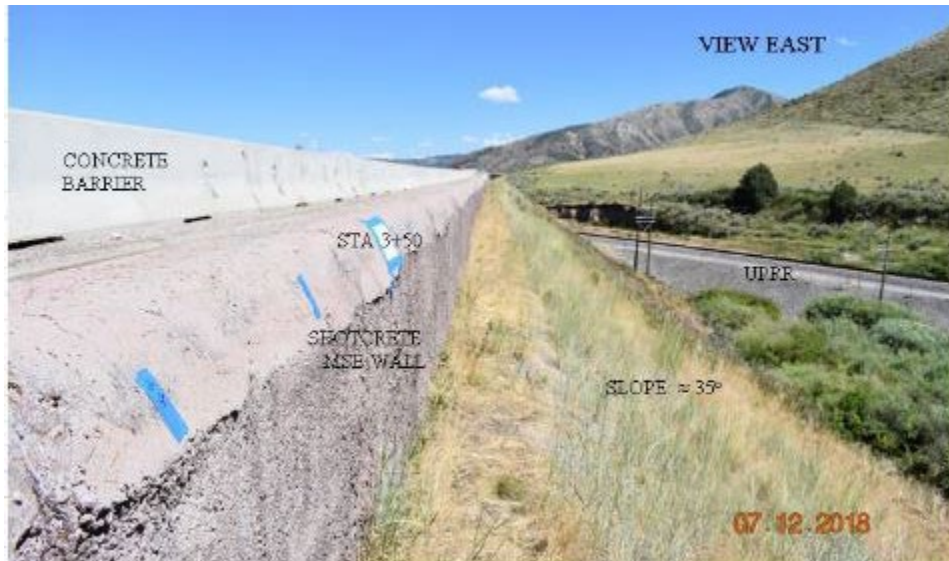
1. HL to  $\frac{1}{32}$  in. wide vertical cracks in shotcrete (see Figures 24 and 25).
  - few cracks up to  $\frac{1}{16}$  in. wide.
  - shrinkage cracks primarily along construction joints.
  - cracks present in 46 out of 80 panels: (58%).
  - damage levels: acceptable - no concern.
2. Animal burrows in one area at base of wall.
3. No ground cracks in embankment supporting MSE wall.
4. Discontinuous transverse separations/cracks on ends of approach slab.

Figure 24. Steel-fiber Reinforced Shotcrete MSE Wall at Topaz Bridge, US-30

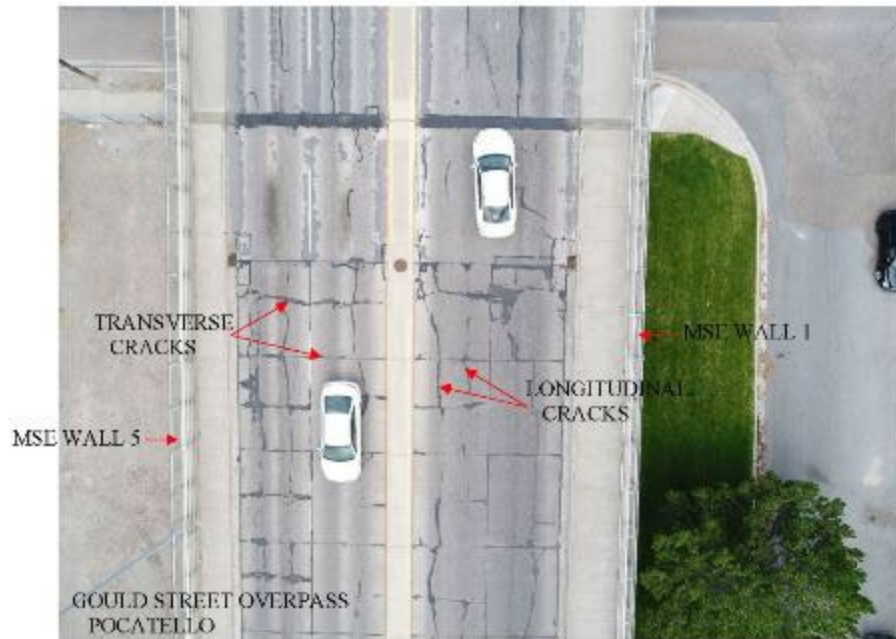
Figure 35. sUAV Pavement Survey above MSE Wall 5 along E. Gould Street Overpass

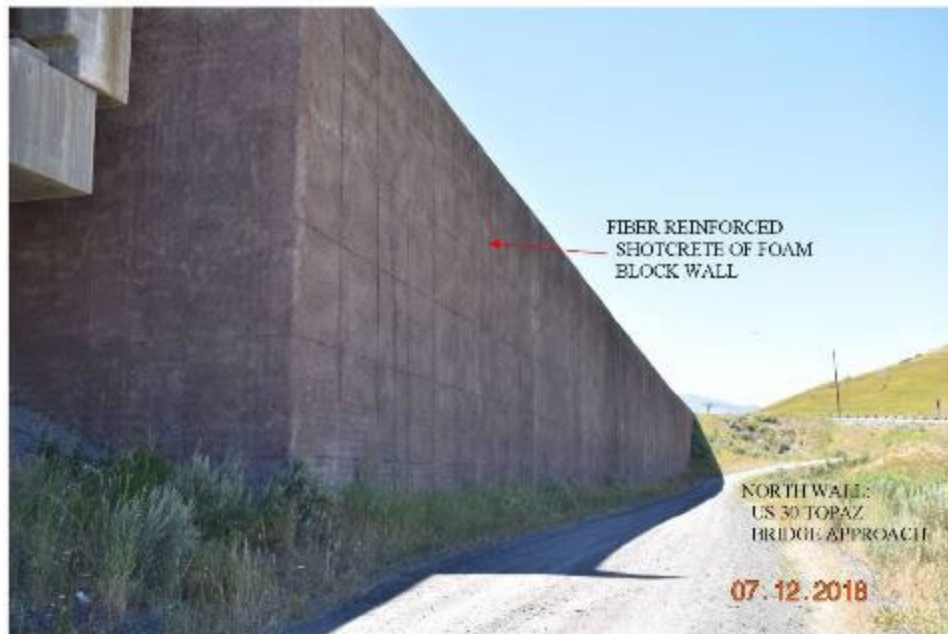
Figure 36. sUAV Survey of 30-ft High North Wall of Topaz Bridge Approach

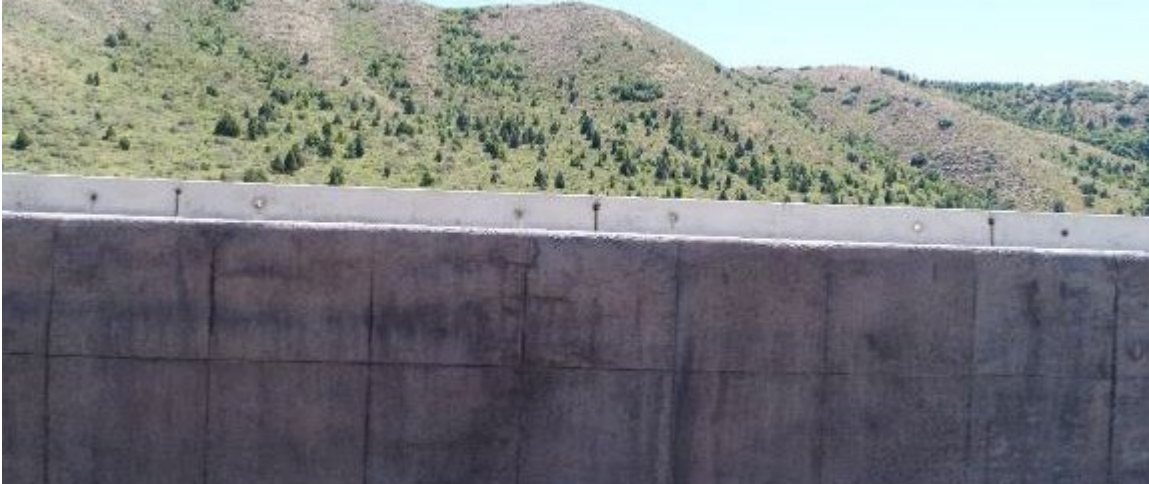
**Figure 37. sUAV Survey Photo at Top of 30-Ft High North Wall of Topaz Bridge, US-30**

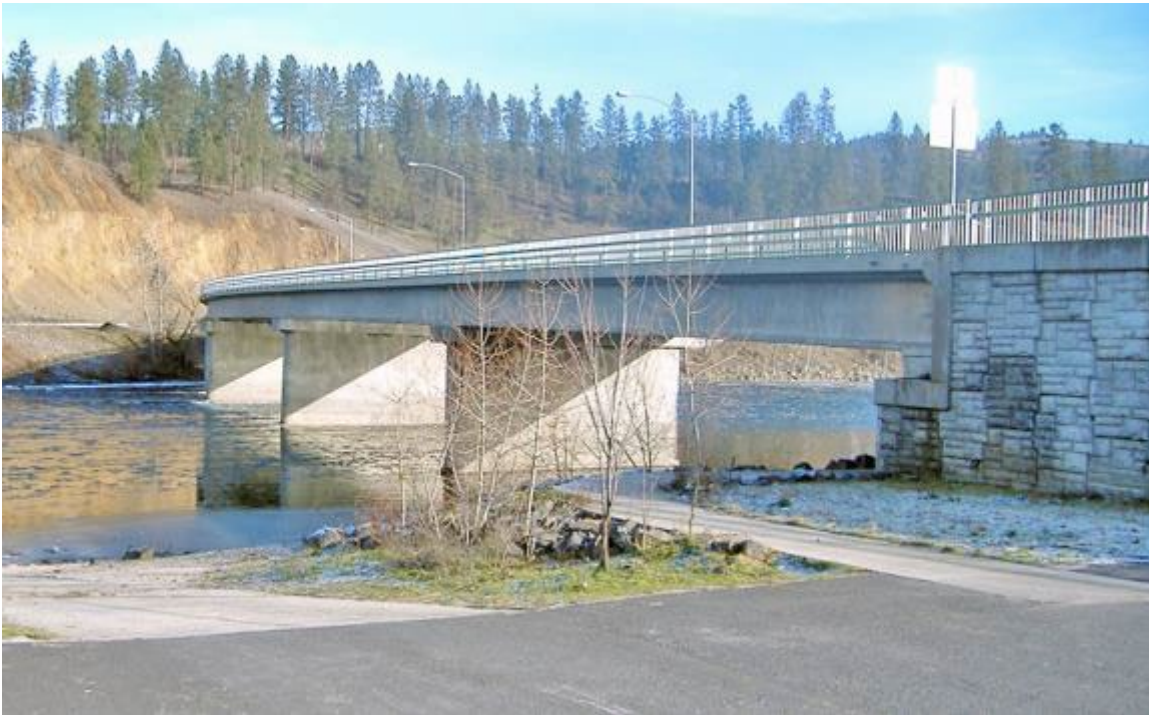
An MSE wall on the north side of the eastern abutment of Kamiah Bridge supports the WB lane of US-12. A boat ramp is located on the north side of the wall, which is 280 feet long and has a maximum height of about 16 feet. Cruciform-shaped concrete panels support the reinforced fill, as shown in the photo in Figure 38. This photograph was found on a website by “chance” and added to the inventory. Unfortunately, as the location of this MSE wall was not known during the visit to Kamiah Bridge, its condition was not surveyed for this project. The photograph reveals some staining and the concrete panels do not appear to show any deterioration. However, its condition can only be confirmed by an actual site inspection.

**Figure 38. North MSE Wall at Eastern Abutment of Kamiah Bridge, MP 66.69, WB US-12**

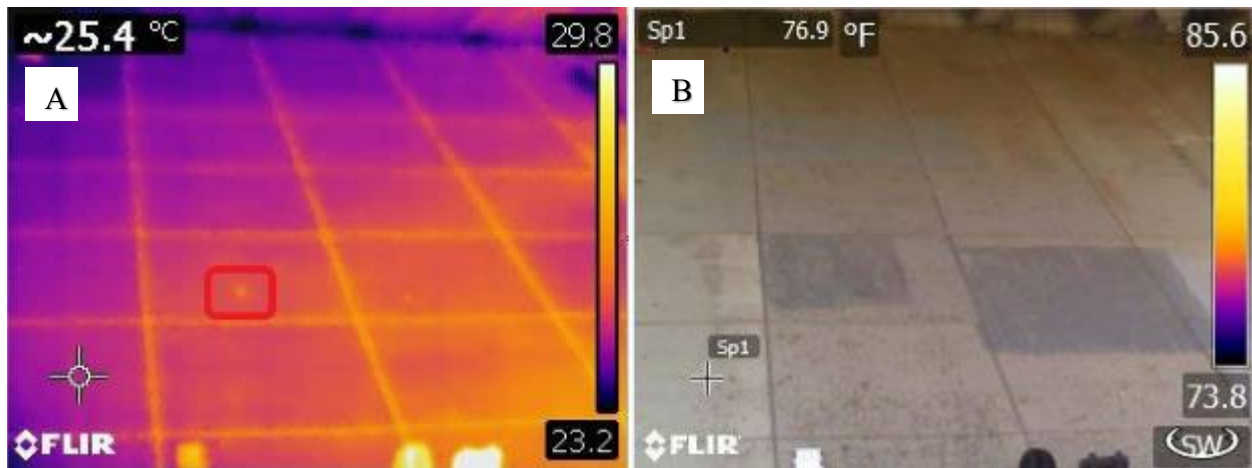
**In the first case**, the thermal and visual images were taken on the surface of concrete slabs in front of a bridge (Site D3-2) in Garden City, Idaho (see Figure 41). A sub-surface anomaly, a possibly a void, will act as an insulator and does not let the heat to transfer to the lower parts of the concrete slab. This is because the anomaly has a lower thermal conductivity compared with an intact concrete section. Therefore, heat accumulates on top of the anomaly and temperature of the surface is elevated compared with the adjacent area of intact concrete. This behavior allows detection of anomalies within 1 inch of the concrete surface using infrared thermography.

**Figure 41. Site name: D3-2, Type of image: A: Thermal image, B: Visual image**

In the visual image of Figure 41B, two areas of the slab have been coated. Even though no anomaly is visible on the surface, there is a 2-degree Fahrenheit difference between the area on top of the anomaly shown in the red box in the thermal image (Figure 41A) and the surrounding area. The results indicate the presence of a shallow anomaly. This area was also investigated using an ultrasonic testing device. The ultrasonic test results also indicated the presence of an anomaly. Unfortunately, there was no time, sufficient resources, or permission to core the concrete to verify and determine the exact nature of the suspected anomaly.

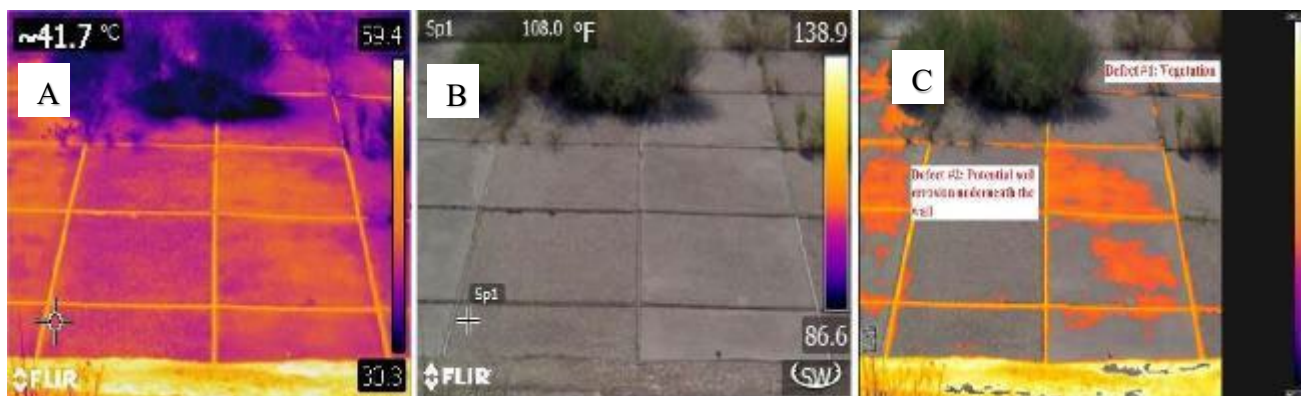
**Figure 42. Site name: D3-1, Type of image: Thermal image, B: Visual image, C: Processed image**

**In the second case**, the thermal and visual images of concrete slabs were taken at another site along a side road (D3-1) in Boise (see Figure 42). The thermal image in Figure 42 indicates a potential larger than in the Garden City site.

In the processed image in Figure 42C, there is a 5-degree Fahrenheit temperature difference between the surfaces above a potential anomaly and the adjacent concrete. Temperature threshold of 106 degrees of Fahrenheit is used to construct the processed image. No visible surface deterioration that could cause a temperature gradient, such as leaching, was detected on the surface of these slabs.

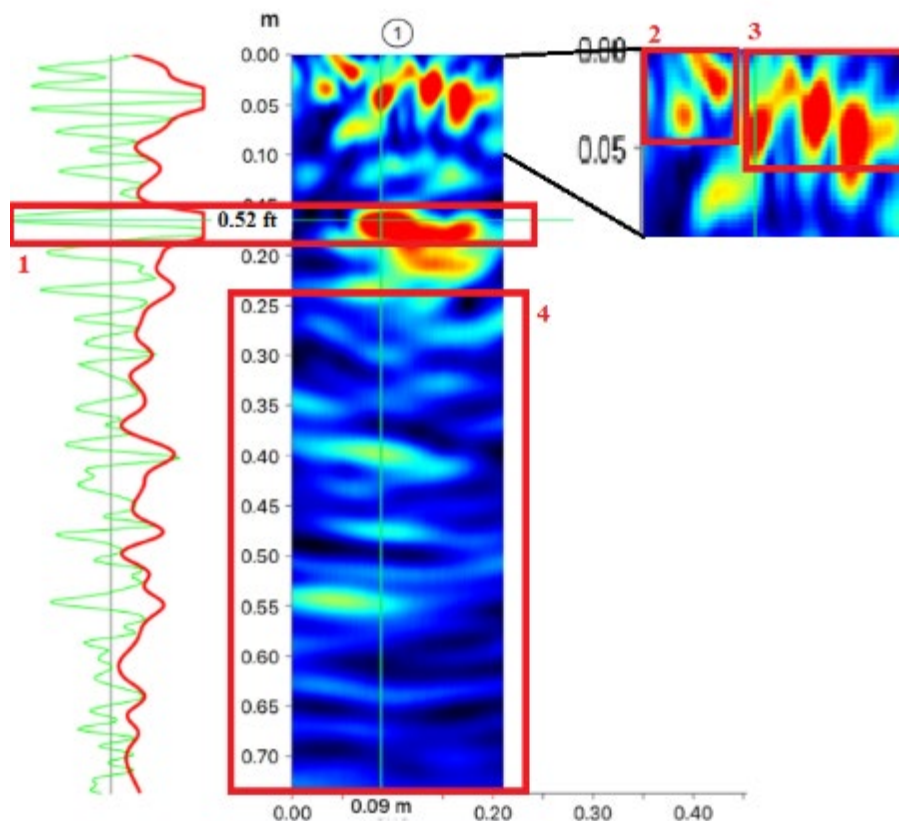
**Figure 46. A-scan (left) and B-scan (right) of potential delaminated area in Site D3-2 concrete slab**

The results of the BSU ultrasonic study are illustrated in Figure 46. The measurements were made at Site D3-2 in an area of the concrete apron where a potential delamination was first identified using infrared thermography. The y-axis in Figure 46 is the distance inside the face of the concrete (0.00 m in the plot) whereas the x-axis is the lateral distance along the slab.

The first peak in the A-scan plot is an indicator of the inward distance of a potential delamination with respect to the surface of the slab. The anomaly is displayed in the upper red area of the B-scan. Using the ultrasonic scan, the delamination identified first in the thermal image (Figure 41) is estimated to be 0.01 (0.4 inch) to 0.03 meters (1.1 inches) below the concrete surface (see Box 2). It also appears that

there are more than one defect present in deeper sections of the wall (see Box 3). The deepest anomaly is located approximately 0.05 meter or around 2 inches beneath the surface of the wall.

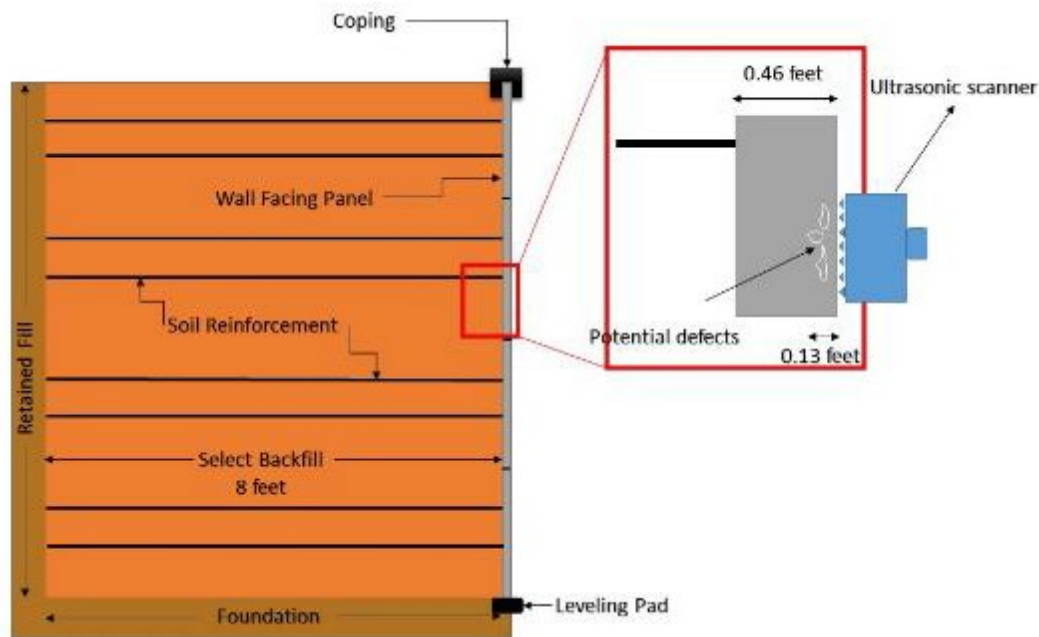
**Figure 48. Schematic of MSE wall and results of the Ultrasonic scan**

inside the surface of the wall. The scattered nature of the readings is an index of multiple defects on the same horizon. A schematic drawing of an MSE wall is shown in Figure 48. The ultrasonic survey does not provide any information about the presence of defects or reinforcement in the backfill.

Based on general design criteria of MSE walls<sup>(1, 46, 47)</sup>, the typical thickness of an MSE wall panel is 5.5 in. (0.456 feet). This value is very close to the thickness of the wall determined at Site 3D-3 based on the ultrasonic readings (5.5 in. or 0.46 feet). This relationship is an indicator of the sensitivity of the ultrasonic tests in determining the thickness of MSE wall panels. In addition, the ultrasonic tests indicate the presence of defects approximately 1.6 in. (0.13 feet) beneath the outside surface of the wall. Verification of the presence and distance of the defects should be confirmed by either destructive tests (such as coring), other nondestructive tests such as a hammering test and/or large-scale laboratory tests on concrete slabs cast with voids.

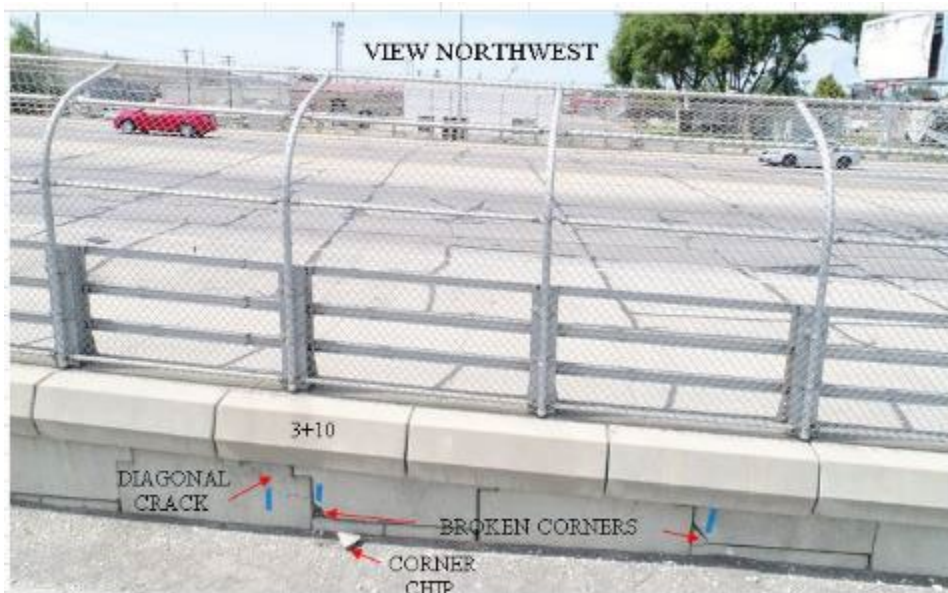
Figure 50. Photo of Gould Street Overpass, Wall 4, taken with sUAV

#	CONDITIONS	Yes, No, N/A
TOP OF THE WALL		
16.	Is there settlement at the top of the wall?	No
17.	Are there any open cracks in the concrete coping (not hairline cracks)? If yes, record the approximate maximum crack width.	No
18.	Have the construction joints in the concrete coping opened up?	No
19.	Is there a gap larger than 1 inch between the approach slab and the approach pavement? If yes, record the approx. max. gap size.	Sealed
20.	At abutments, has the joint between the wall coping and the abutment opened up more than two inches?	No
21.	Comments: - Concerns: see Condition Survey - piping of sand and silt along the face of the bridge abutment - one location - Other Observations/Measurements: - broken corners: 7 MSE Wall panels

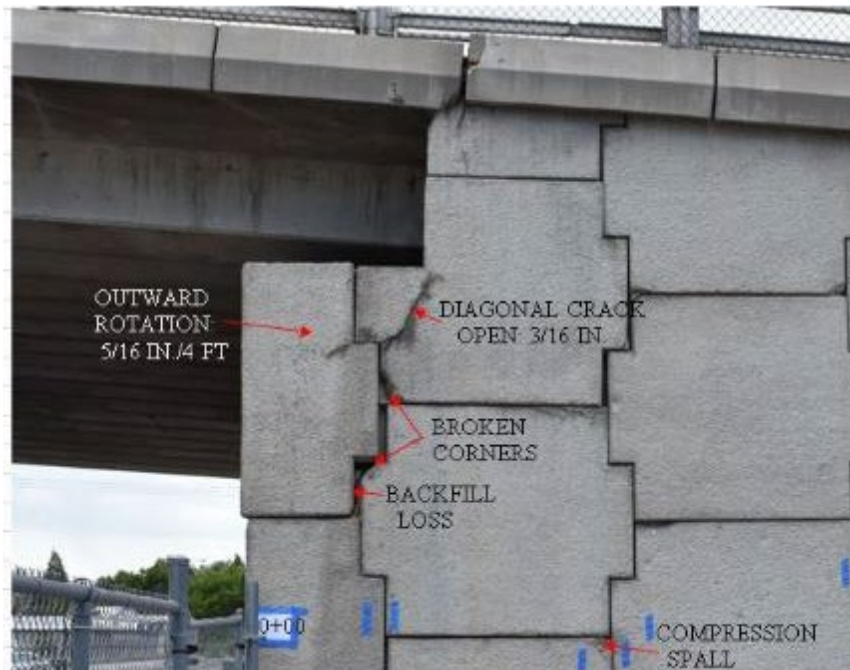
Figure 56. Photo of Gould Street Overpass, Wall 5, taken by sUAV

STATION	ORIENTATION	HEIGHT	LENGTH	WIDTH
0+02	DIAGONAL			
SEVERE WALL DAMAGE AT ABUTMENT				
MSE BACKFILL LOSS				
STATION	BACKFILL			
1+01.1	Fine Sand			
1+16.6	Fine Sand

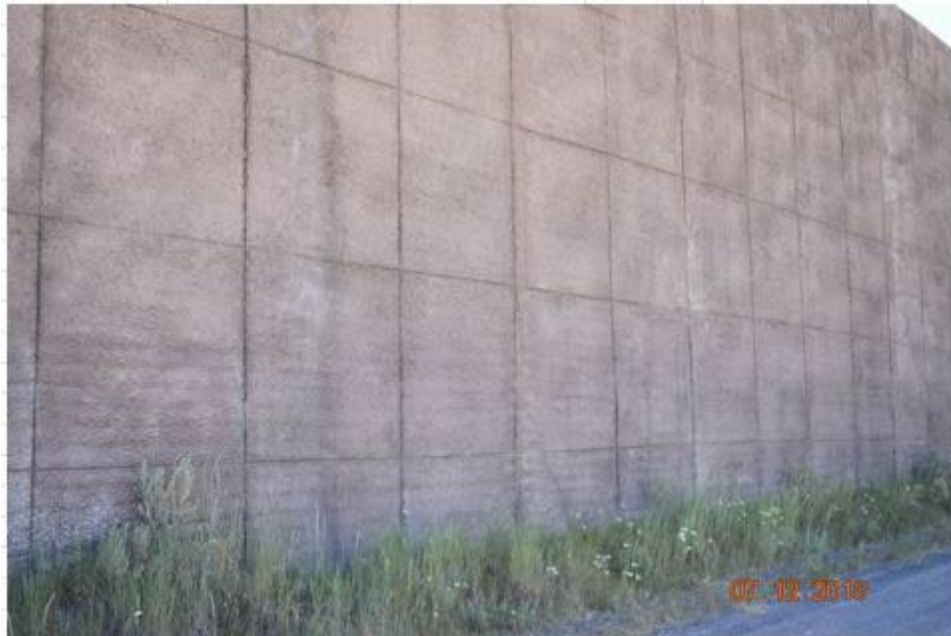
Figure 65. sUAV Photo of Fiber Shotcreted Geofoam Blocks, N. Wall, W. Abutment, Topaz Bridge

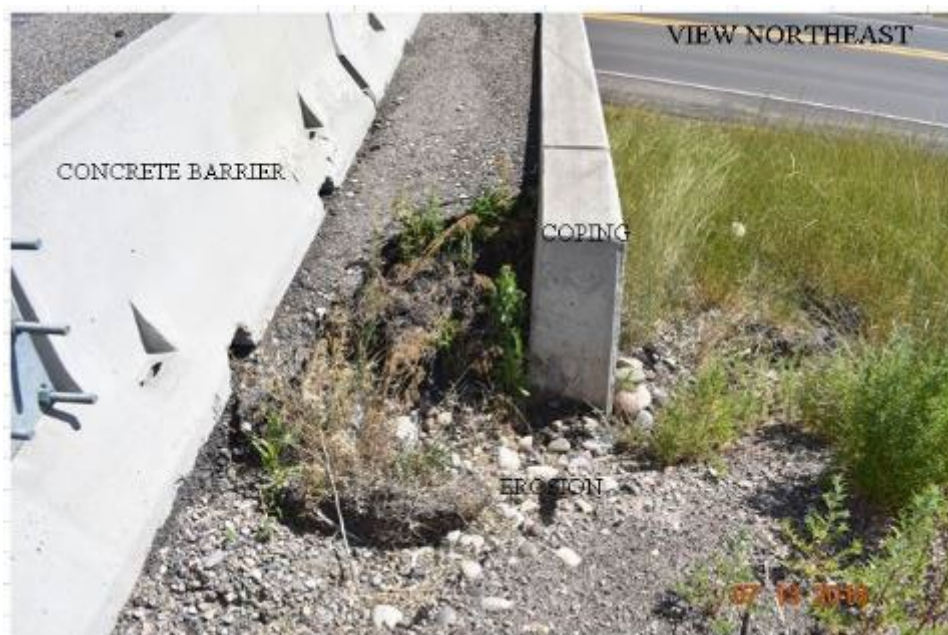
STATION	LOCATION	WIDTH	DEPTH	LENGTH
0+00	West End/South Wall			
	West Abutment	2.6 ft	1.2 ft	3.7 ft
	East End/South Wall			
	East Abutment	1.7 ft	0.5 ft	2.0 ft

Figure 77. Erosion Channel at Edge of South Wall, West Abutment, US-20, St Leon Exit

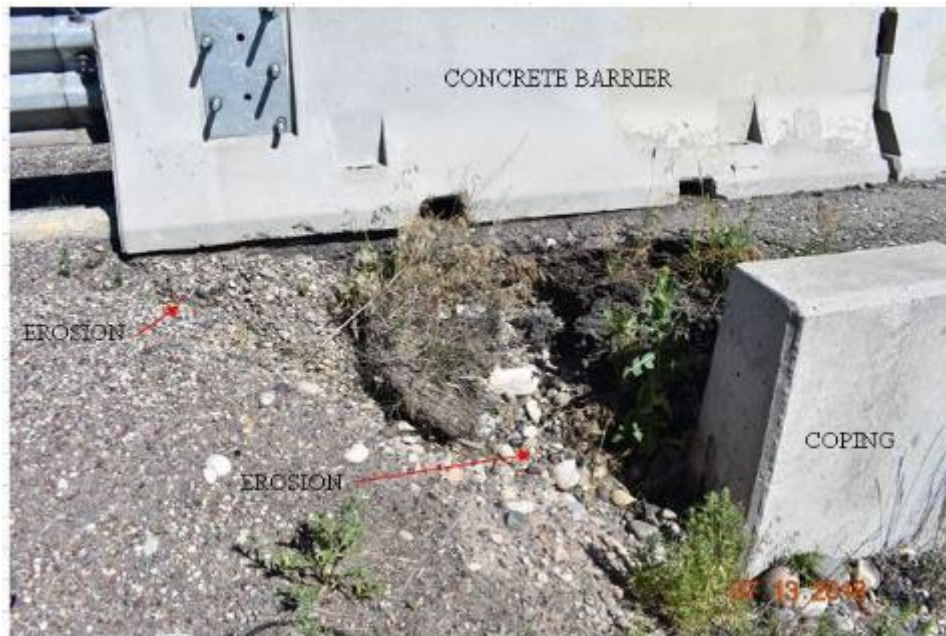
Figure 78. Erosion Channel at Edge of South Wall, West Abutment, US-20, St Leon Exit

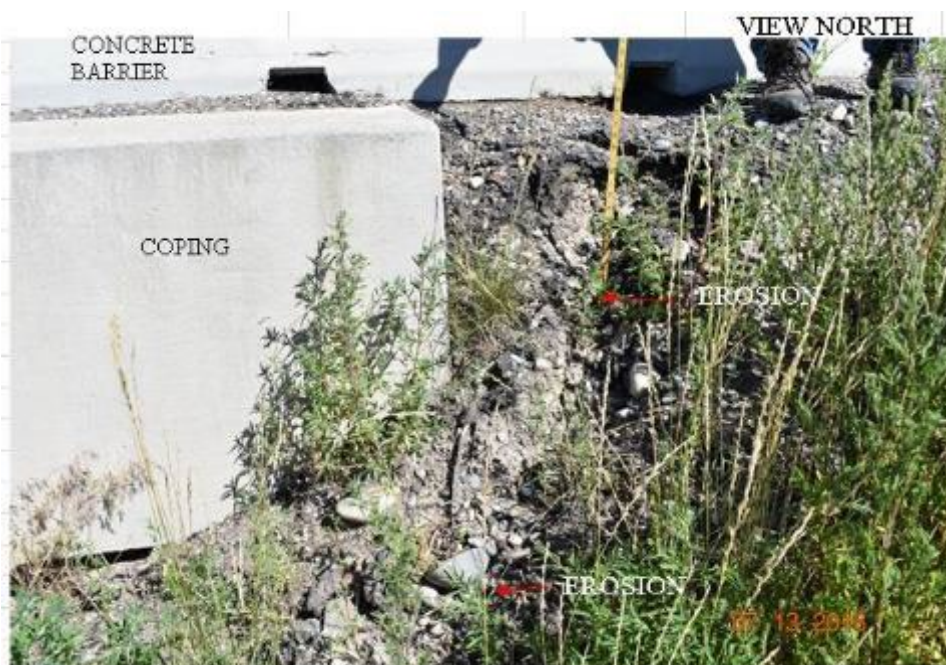
Figure 79. Erosion Channel at Edge of South Wall, West Abutment, US-20, St Leon Exit

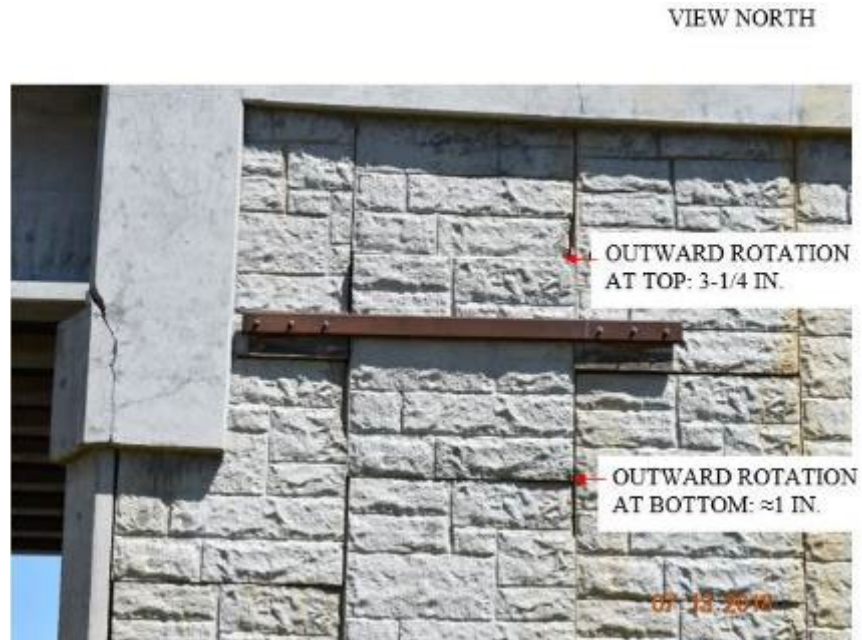
MAJOR OFFSET/ROTATION IN  
TWO PANELS NEAR ABUTMENT  
OFFSET: 1 TO 3-1/4 IN.  
STEEL CHANNEL BRACE

Figure 86. Close-up View of Displaced South MSE Wall, East Abutment of SH-33 Exit at US-20
