**RP 270**

# **Development of an Inventory and Inspection Database Framework for Asset Management of MSE Walls**

Idaho Transportation Department

July 2019

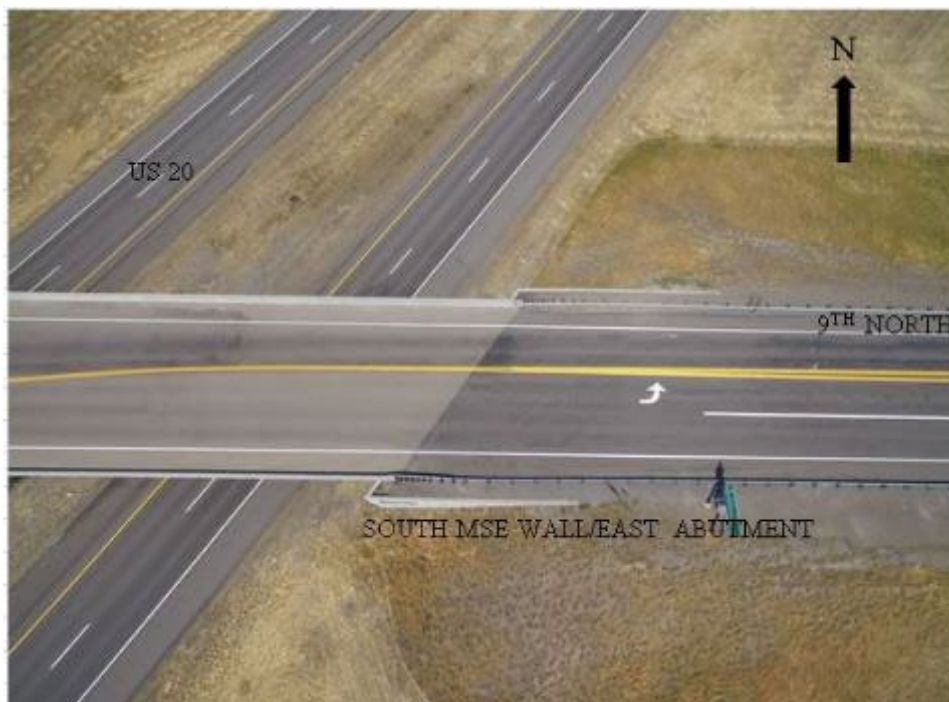
Figure 91. sUAV Photo of Pavement Surface near S. MSE Wall, E. Abutment of SH-33 Exit at US-20
