TREASURY DEPARTMENT
UNITED STATES COAST GUARD

NAVIGATION AND VESSEL INSPECTION CIRCULAR NO. 11-63

Subj: LSTs as unmanned barges; structural reinforcement and drydocking; hull inspection requirements

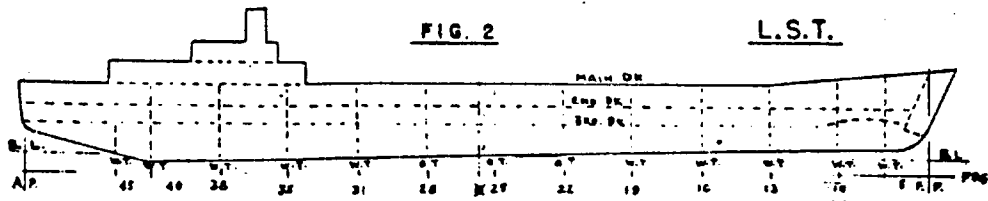
FIG. 3 ELEVATION

STRAP REINFORCEMENT OF SHELL LAPPED BUTTS, FRGS. 13-35 INCL.

- (1) Existing lapped butts in shell and deck plating at Frames 13-35 inclusive shall either be reinforced by the fitting of scalloped doubler straps as shown in Fig. 3, or be modified as shown in Fig. 4. Where the reinforcement shown in Fig. 3 is used, existing welds in the lapped butts, both internal and external, must be sound with no significant localized wastage in the plating adjacent to the welds. This is especially important at the internal welds of the butts in the bottom plating (Fig. 3). Where such wastage is apparent the bottom butts shall be reworked in accordance with the method shown in Fig. 4.
