**DOT/FAA/TC-22/17**

# **Bonded Repairs of Composite Wing Panel Structure: Phase 3, Bonded Repair Size Limits Study for Solid Laminates with Double- Sided Scarf Panels**

June 2022

Final report

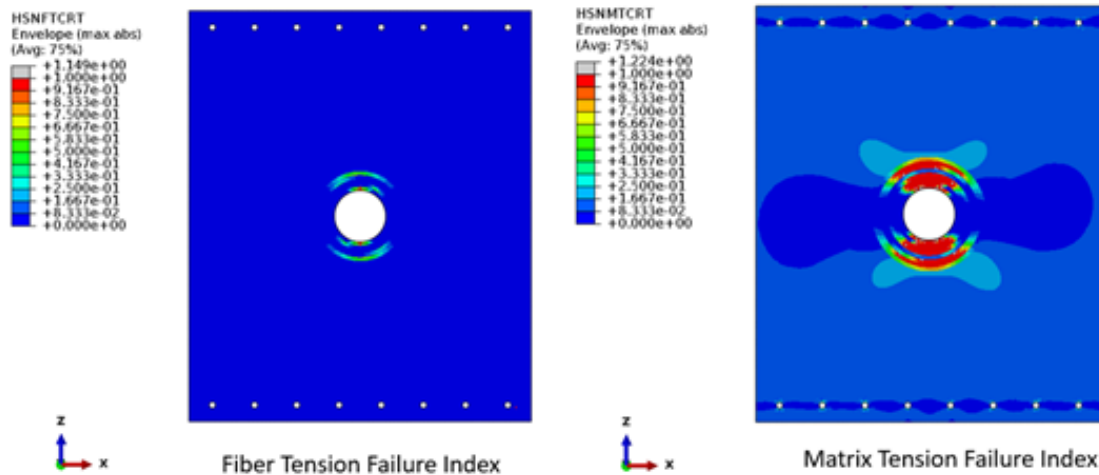
Figure 9. The PFA approach to predict residual strength for panels 7 & 8 at the onset of final failure

Figure 9 shows the matrix and fiber tensile failure index contours at ultimate load for the double-sided 30:1 scarf panel (only the damaged regions were shown). The predicted failure onset load was 11,400 lbs for vertical actuators, correlating well with the test results shown in Table 2.

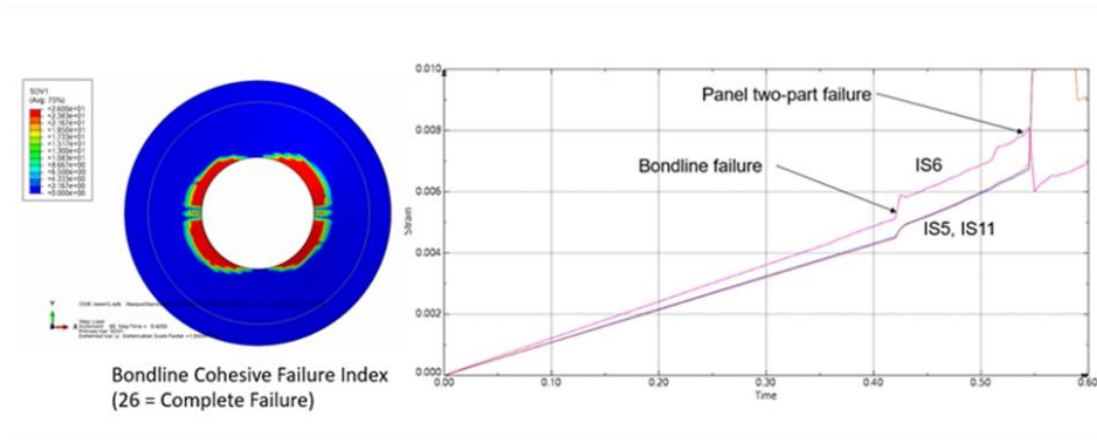
Figure 10. Adhesive failure index contour at 5300  $\mu\epsilon$  and the simulated SG results (IS6, IS5 & IS11)

One of the most significant findings during this phase of testing was that one remaining perfectly bonded patch did not improve the residual strength at all (see results from Table 2). From a free-body analysis under tensile loading, one can hypothesize that due to the prying moment induced by the eccentricity from the pristine region to the scarfed region, the peel stress in the bondline would be high and caused premature failure of the bondline and hence deemed the patch entirely ineffective. This hypothesis was confirmed by PFA analysis of the double-sided scarf with single-sided repair patch, panels 9 thru 11. In this model, adhesive bondline was modeled with 3-D cohesive elements with damage initiation and progression properties derived from fundamental tests (static tension, shear, Mode-I & II fracture energy measurements using double cantilever beam (DCB) and end notch flexure (ENF) tests). Table 3 lists such properties for the adhesive used. Figure 10 shows the adhesive failure index contour at 5300  $\mu\epsilon$  and on the right are simulated axial strain histories as a function of applied load fraction. Both the initiation of bondline failure and final two-part failure strains at gage IS6 (at the center of patch on the interior side) correlate with test results very well. So is the final failure mode (Figure 11).

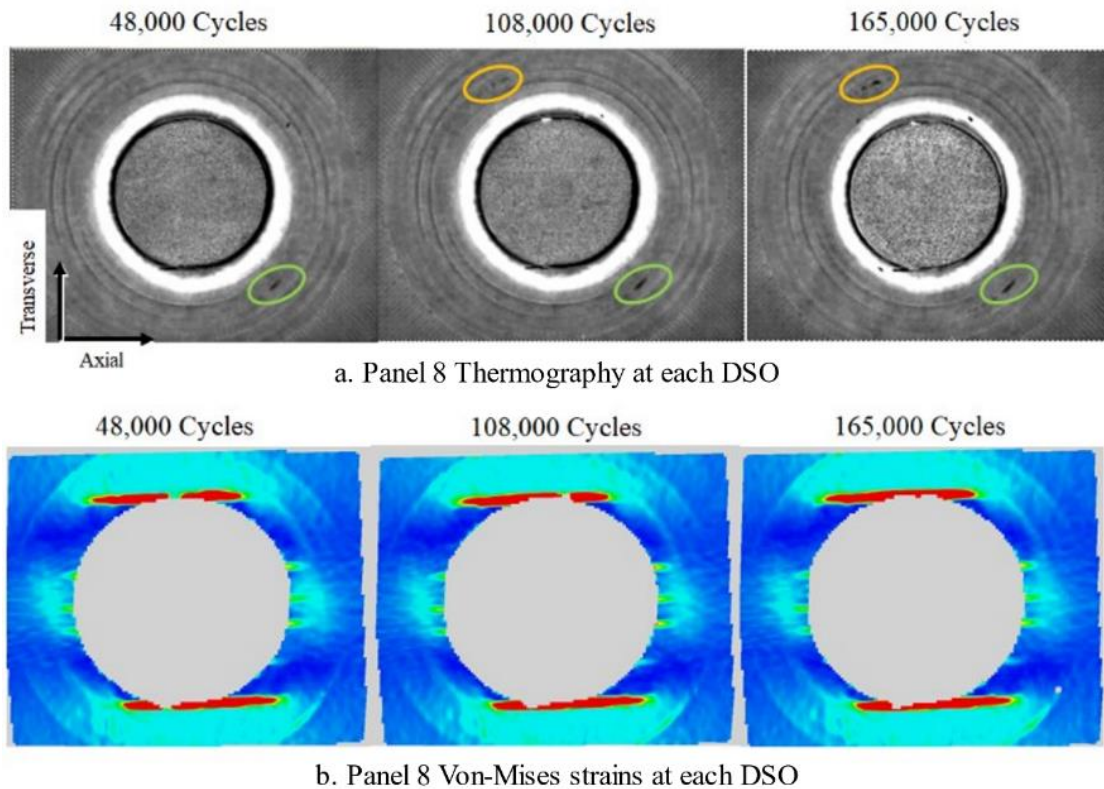
Figure 17. Panel 8 a) thermography images and b) von-Mises strains at each DSG

After the initial strain surveys, panel 8 was subjected to three DSGs, i.e. 165,000 fatigue cycles at target maximum far-field strain of  $2,200 \mu\epsilon$  (average of strain gage S1 and S3) and  $R=0.1$ . No strain redistribution was observed during the fatigue cycles as shown by DIC and strain gage results in Figure 16, where the strains remained relatively similar throughout fatigue. During the tests, the panel was also inspected using a flash thermography system and the inspection results indicted a few small delaminations at 5 o' clock and 11 o' clock locations (Figure 17b). These delaminations were too small to have any effect on the durability of the scarf. In addition, the crack in the middle ply ( $0^\circ$  ply) along the inner edges of the scarf did not grew due to fatigue, as shown in Figure 17. Overall, the double-sided scarf panel was able to sustain 3 DSGs without any new damage formation or growth.

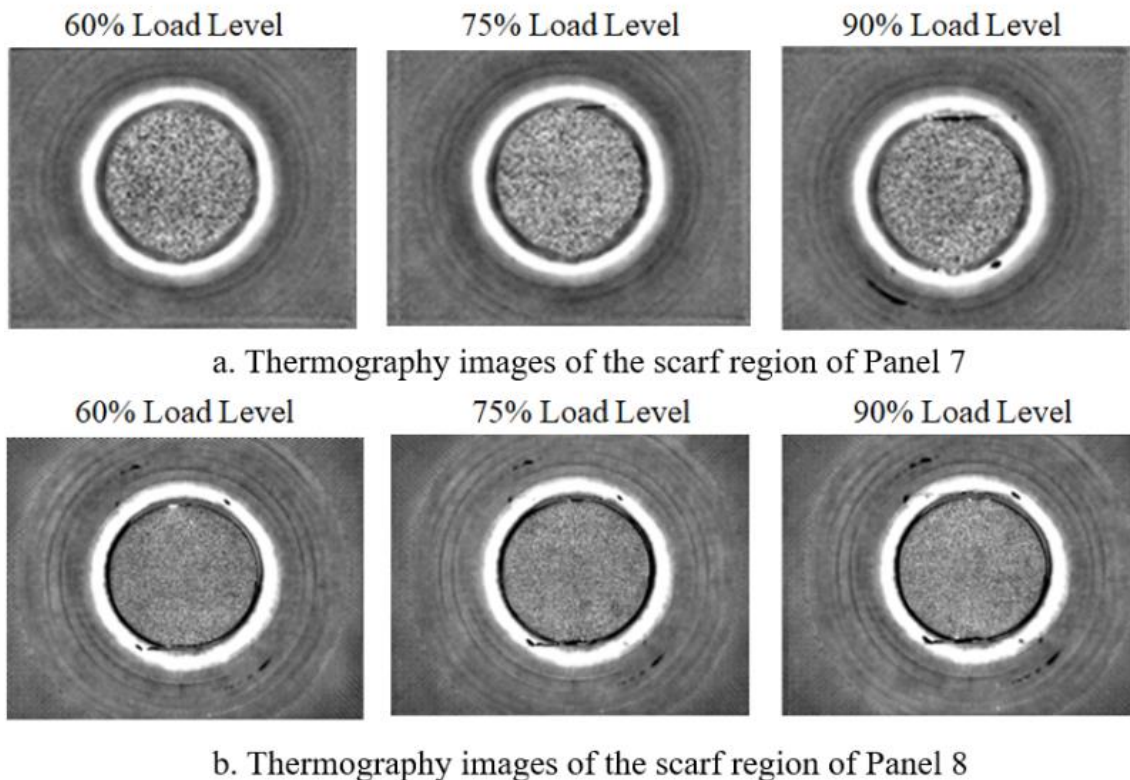
Figure 18. Thermography results in the scarf region for a) panel 7 and b) panel 8

Both DIC system and thermography inspections showed that at each load increment, the results of panels 7 and 8 were very similar. The comparison of thermography and von-Mises strain images for both the panels are shown in Figure 18 and Figure 19, respectively. Both the panels showed minimal crack growth at the 6 o' clock and 12 o' clock locations, as shown in Figure 18. The delaminations in the 5<sup>th</sup> ply (first 0° ply from the top) were at the 11 o' clock and 5 o' clock locations in panel 8, as compared to the 1 o' clock and 7 o' clock locations in Panel 7, shown by thermography images in Figure 18 and DIC results in Figure 19.

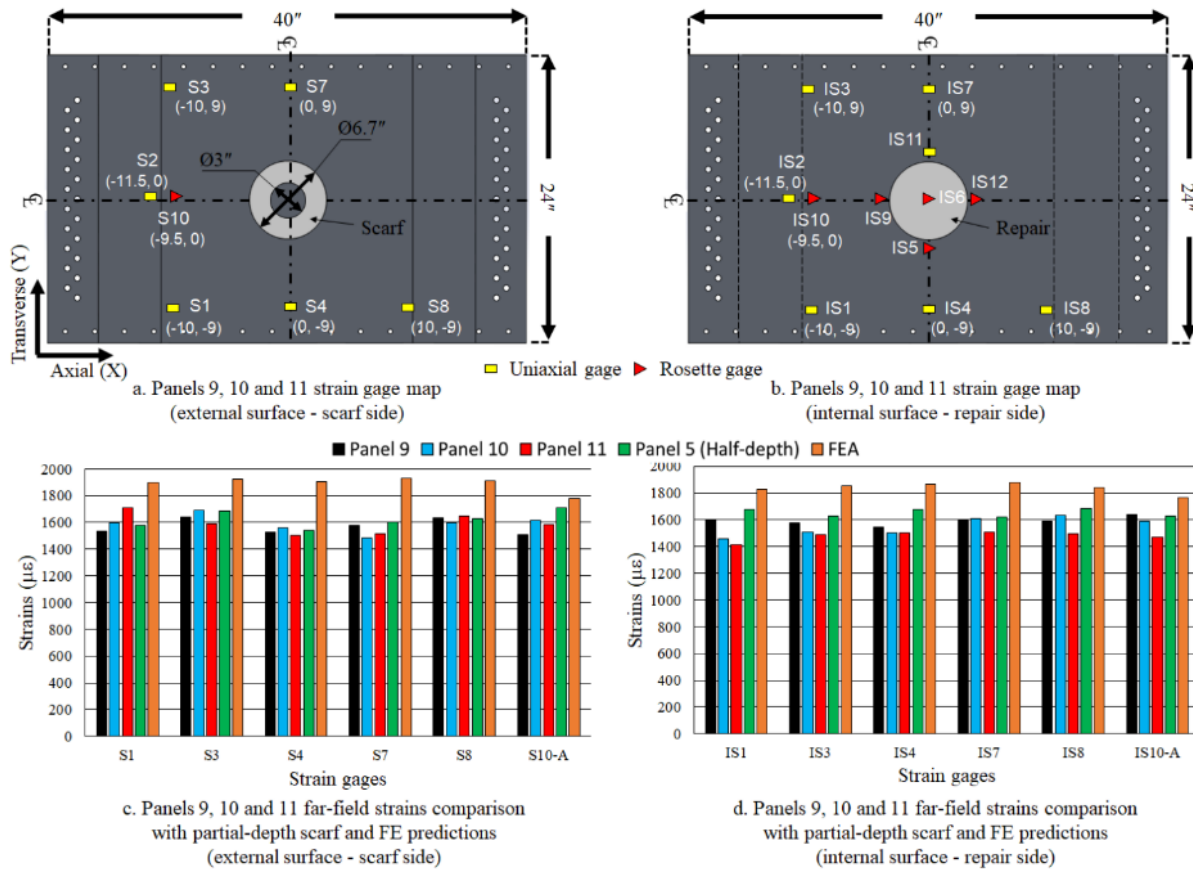
Figure 22. Far-field axial strains in panels 9 and 10 measured during initial strain surveys

The offset between the scarf and the patch in panel 9 did introduce local stress concentration in the inner edge of the scarf, but the effect of this offset was very local and did not affect the far-field strains in the panel, as shown in Figure 22. As shown in the figure, the axial strains measured using strain gages for panels 9, 10 and 11 were very similar for the same strain survey load-levels. Also shown is an excellent comparison of strains between the in double-sided scarf panel with single-sided repair patch (panels 9, 10 and 11) and half-depth scarf panel 5 during strain survey loading. Although for panels 9, 10 and 11 the load transfer from the parent material to the patch will not be as smooth and continuous as panel 5 due to the bondline (Figure 5), a good bond is able to transfer the load perfectly. Thus at strain survey loads, the double-sided scarf with single sided patch configuration works as the half-depth scarf configuration and shows similar strain distribution.

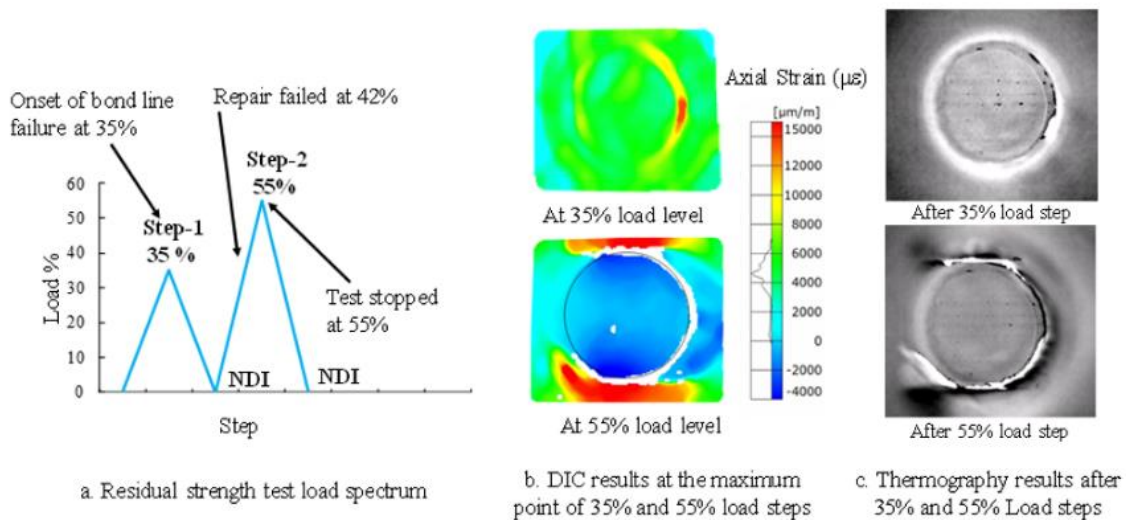
Figure 23. Panel 9 residual strength test; a) load spectrum, b) DIC, c) thermography results

After the initial strain surveys, residual strength tests were performed to panels 9, 10 and 11. The panels were loaded quasi-statically in a saw-tooth profile, increasing the load level up to the predicted critical loads of panel 3 with failed (cavity) half-depth scarf (168,611 ft-lbf), which was considered as 100%. During loading, damage formation was monitored visually using high-magnification cameras and DIC. After each loading, the scarf and its vicinity were inspected using thermography. For panel 9, the target of the first load increment was 60% of the half-depth scarf panel 3 predicted critical load, but the damage was first detected visually at 35% load level in the form of edge delamination (first 0° ply) along the scarf inner-edge, at the 3 o'clock position. As the delamination was detected, the test was unloaded, and thermography inspection was conducted to document the delamination. The panel was then reloaded to higher load level and at 42% load level (72,983 ft-lbf), the patch unexpectedly failed. The test was subsequently stopped at 55% load level (92,954 ft-lbf) to save the panel for future inspections. Since the patch had failed, further loading the panel would have caused catastrophic failure of the panel. Figure 23 shows the schematic of loading profile, DIC results at the peak loads and thermography results after each unloading.

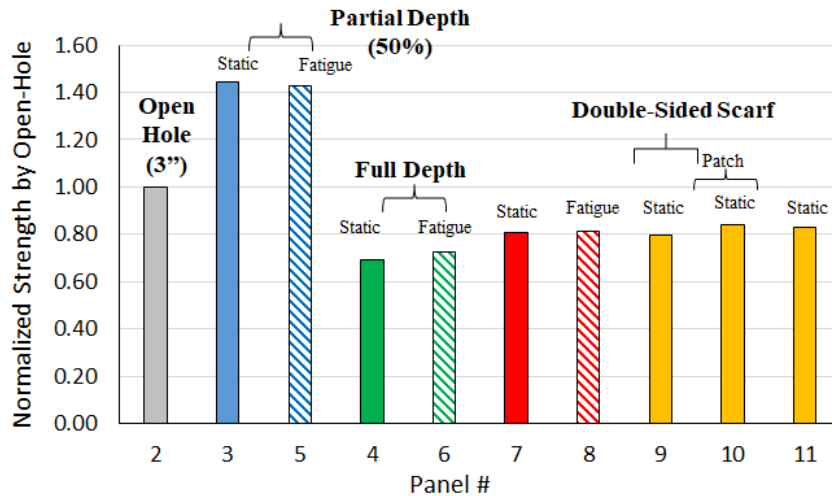
Figure 29. Comparison of strength of all the panels

The goal of panels 7 and 8 tests was to study the effect of fatigue on the residual strength of the panels with double-sided scarfs without any patches. For panels 9, 10 and 11 test, the target was to measure the effectiveness of panels with double-sided scarfs that are partially repaired (single-sided patch) in restoring the strength when compared to the panels with half-depth scarfs. In order to compare the effectiveness, the strengths of panels 7 - 11 are plotted in Figure 29. These strengths are normalized by the strength of an open-hole panel tested in phase 2 (Neel, et al., 2020). In addition, the figure also shows the normalized strength of panels with half-depth scarf (panels 3 and 5) and full-depth scarf (panels 4 and 6) tested in phase 3 (Neel R. C.-M., 2021). As seen in the figure, the strength of panels 9, 10, and 11 was similar to that measured in panels 7 and 8, indicating that within the scope of this research, the single-sided patch was not effective at all in restoring strength. Bondline failure of the repair patch occurred in panels 9 – 11 at the same load level as net section failure observed for the double-sided scarf panels 7 and 8. In addition, the comparison of strengths of panels 9, 10, and 11 with half-depth scarf panels 3 and 5 shows the inability of the single-sided repair patch to be as effective as panel with half-depth scarf. The strength of panel 8 as compared to panel 7 shows that subjecting the panel with double-sided scarf to 3 DSGs had no effect on its residual strength.
