Bridge Deck Surface Profile Evaluation for Rapid Screening and Deterioration Monitoring

FINAL REPORT
September 2022

Submitted by: Adriana
C. Trias-Blanco
Assistant Professor

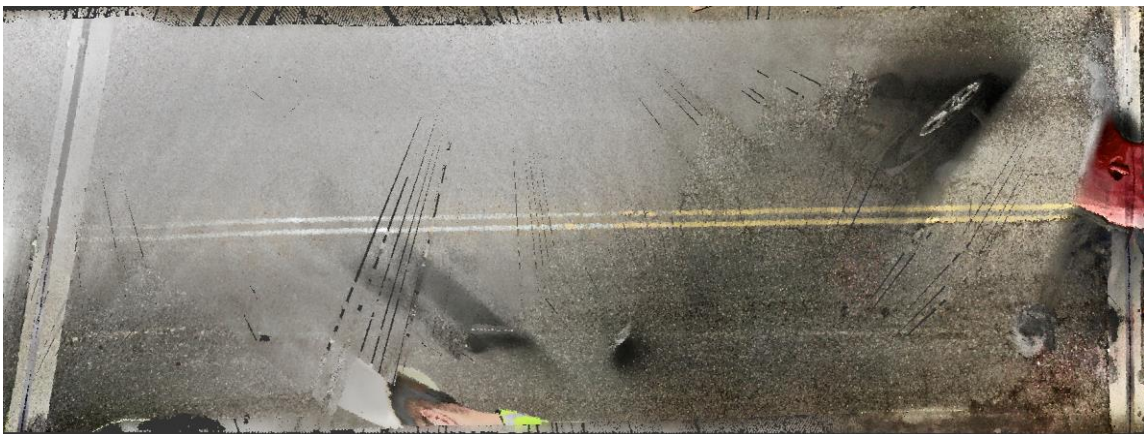
Figure 17. Structure 0954163 - RGB image of the deck's top surface.

Bridge 0954163 presented a rutting of approximately 36% of the total deck area. The arrows in Figure 15 indicate the presence of rutting on the scanned deck. While the grayed areas on Figure 16, represent the approximated rutting area on the deck. The percentage of rutting area was estimated by adding the grayed squares and dividing this amount by the total number of squares that cover the area of the deck, multiplied by 100. Figure 17 presents a plan view of the top surface of the deck as reference.

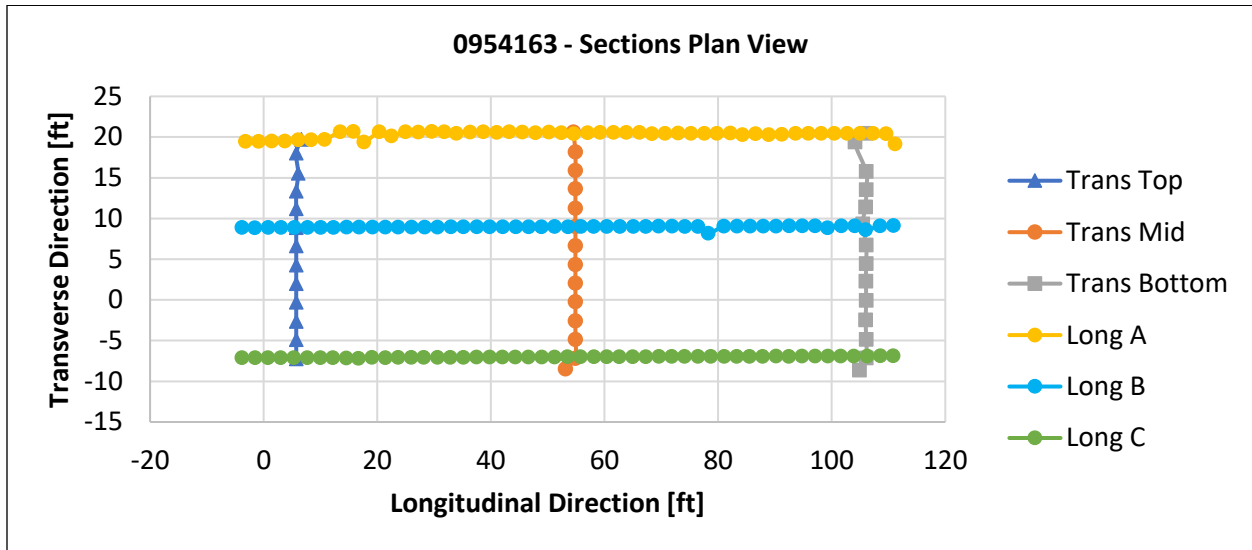
Figure 18. Structure 0954163 - Sections Plan View.

The longitudinal cross sections generated for this structure show several low points as indicated in Figure 20, which are areas where water is more likely to sit for longer periods accelerating the damage of the reinforcing steel. Additionally, the longitudinal slope was estimated to be of 0.5% slowing the water drainage. From Figure 21, the transverse cross section slope is estimated to be between 0 to 0.8%, which is below the recommended 2%. The plan view presented on Figure 18 indicates the location of the longitudinal and transverse section within the deck.

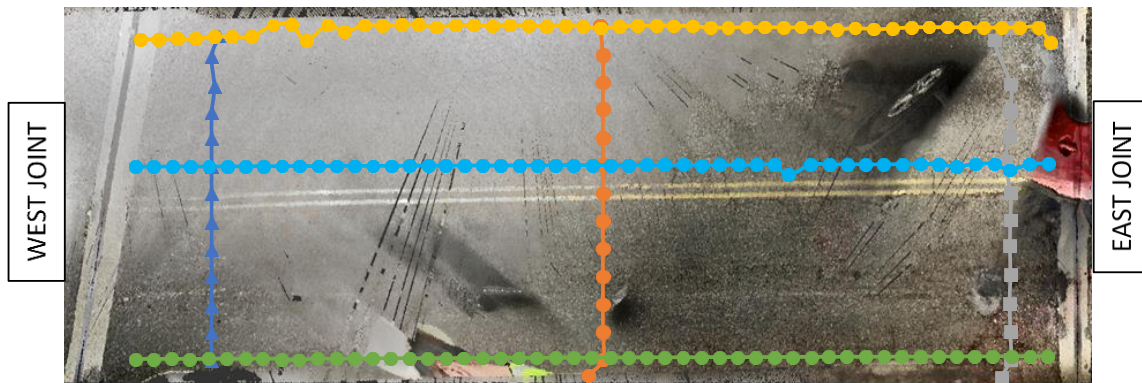
Figure 19. Structure 0954163 - Reference of cross section location.

Cross sections along the transverse and longitudinal directions were generated by creating slices of the point cloud of the deck. The misalignment seen on the plan views do not represent deformations or potential errors, but variations in X or Y coordinate of the selected points. The location of each cross section is presented in Figure 18, where Long A, Long B, and Long C are the cross section on the longitudinal direction, while Trans Top, Trans Mid, and Trans Bottom are the cross sections on the transverse direction. While Figure 19 presents an approximate location of each of the aforementioned cross sections within structure 0954163.

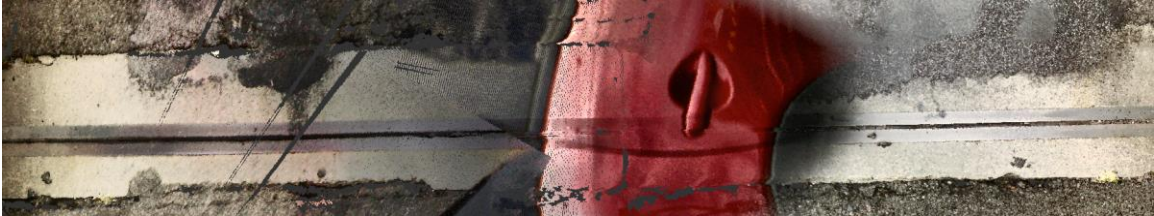
Figure 22. Structure 0954163 - East joint: (a) Elevation, (b) RGB.

Additional analysis was performed at the location of the joints. LiDAR was capable of detecting the surface of the deteriorated joints. Figure 22 helps visualize the condition of the East joint and the surrounding area, while Figure 24 presents information for the West joint. The lines present on these and other images are originated due to the passing of cars/trucks during data collection, which generates a gap in the point cloud. Following the scope of work of this project, the analysis of the joints will be limited to measuring approximated area of damage. Following the same percent area estimation for calculating the presence of rutting, the East joint presented 18% of deteriorated area, as seen in Figure 23. Similarly, the West joint of the bridge deck presented 39% of deteriorated area, as seen in Figure 25.

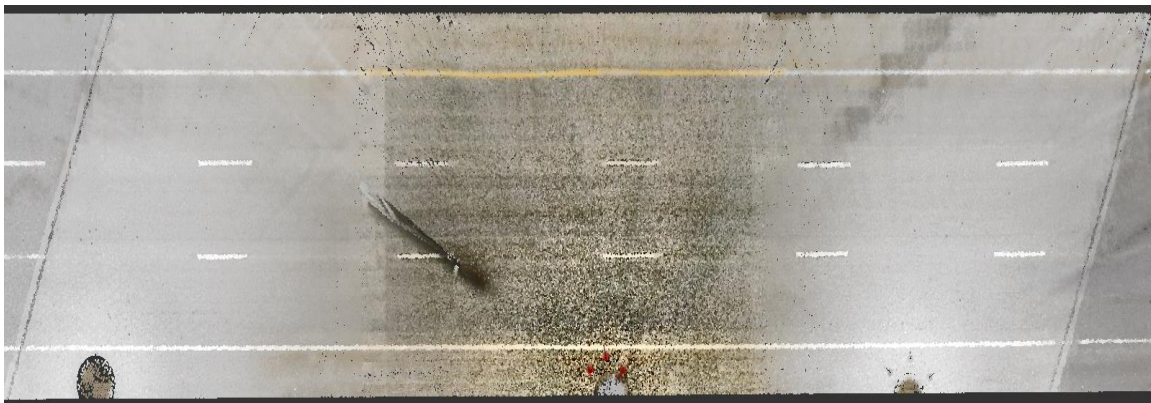
Figure 34. Structure 361632N - RGB image of the deck's top surface.

The elevation map presented in Figure 33, combined with the longitudinal slope estimated from Figure 37 which was estimated to be between 1 to 1.5%, indicate the presence of proper surface conditions for water to run off the deck without difficulty. Moreover, the transverse slope estimated from Figure 38 was found to be approximately 2%. Structure 361632N does not present clear evidence of potential areas susceptible to early deterioration. It is important to indicate that, based on the findings of Figure 37, the first half (upstream) of the deck presents lower slope than the second half of the deck, this could alter the performance as water sits longer on flatter areas causing faster deterioration. Figure 34, presents an RGB view of the deck's top surface.

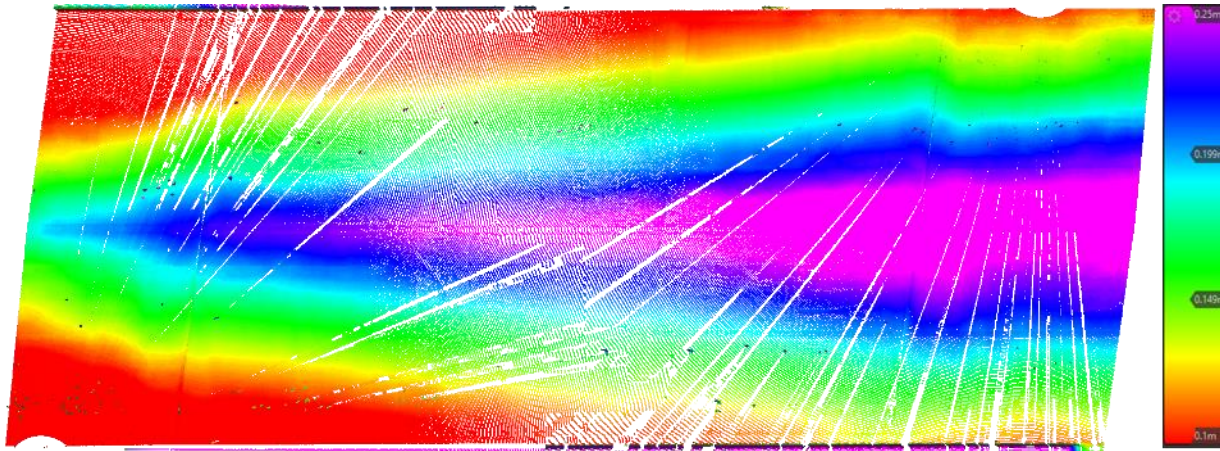
Figure 39. Structure 18G0701 - Elevation map.

Structure 18G0701 is a newly constructed deck. It can be seen from Figure 39, Figure 43, and Figure 44 that the deck has proper slope for drainage on both the longitudinal and transverse directions. It is important to highlight that some low points were found along the deck as seen in Figure 43, this can be areas of concern in the long term. The plan view presented on Figure 41 indicates the location of the longitudinal and transverse section within the deck. Figure 40, presents an RGB view of the deck's top surface.

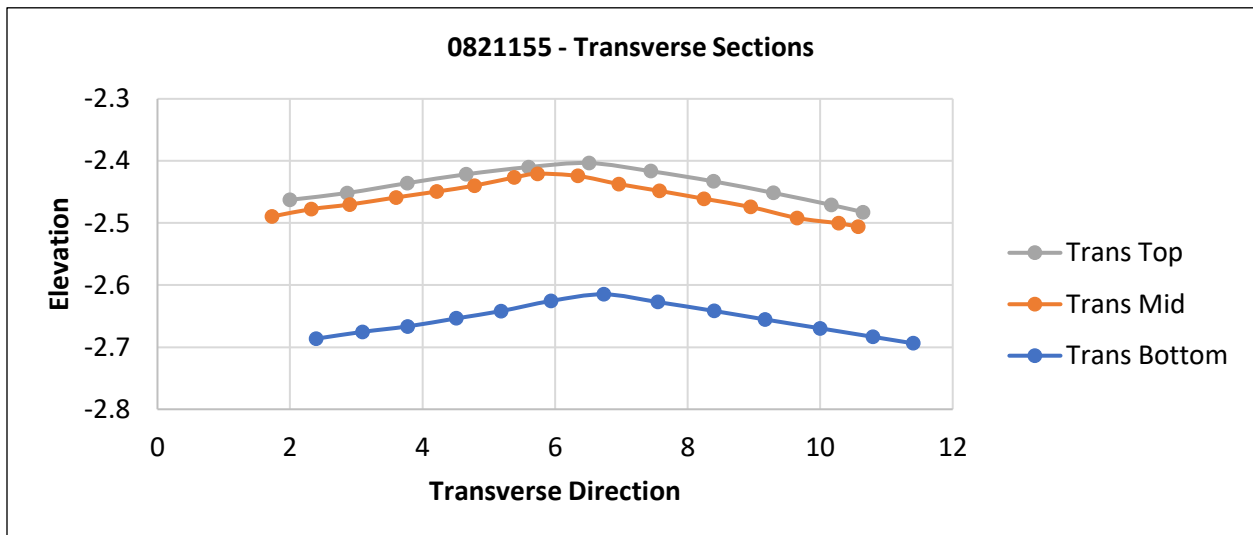
Figure 50. Structure 0821155 - Transverse Sections.

Structure 0821155 is a newly constructed structure. It can be seen from the left side of Figure 45 and Figure 49, the presence of a flatter region, which can be an area of concern if the long term. The transverse cross section slope of the deck is approximately 1.4%, slightly below the recommended 2%, this was estimated from the data found on Figure 50. Figure 46, presents an RGB view of the deck's top surface.

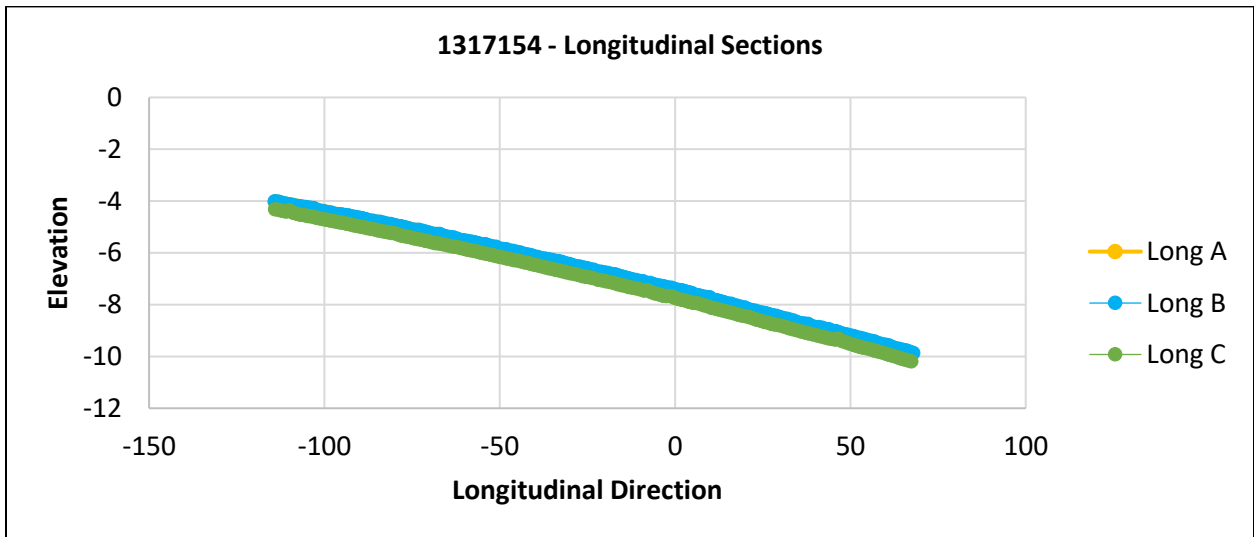
Figure 55. Structure 1317154 - Longitudinal Sections.

Structure 1317154 presents a uniform longitudinal slope of approximately 3% as seen and estimated from Figure 51 and Figure 55. The transverse slope estimated from Figure 56 is approximately 1.6%, slightly below the recommended 2%. There is not a clear area of concern where early deterioration would occur. It is important to highlight the low transverse slope found on this deck. The plan view presented on Figure 53, indicates the location of the longitudinal and transverse section within the deck, where Long A, Long B, Long C, and Long D are the cross section on the longitudinal direction, while Trans Top, Trans Mid, and Trans Bottom are the cross sections on the transverse direction. Figure 54 presents an approximate location of each of the aforementioned cross sections within structure 0821155.

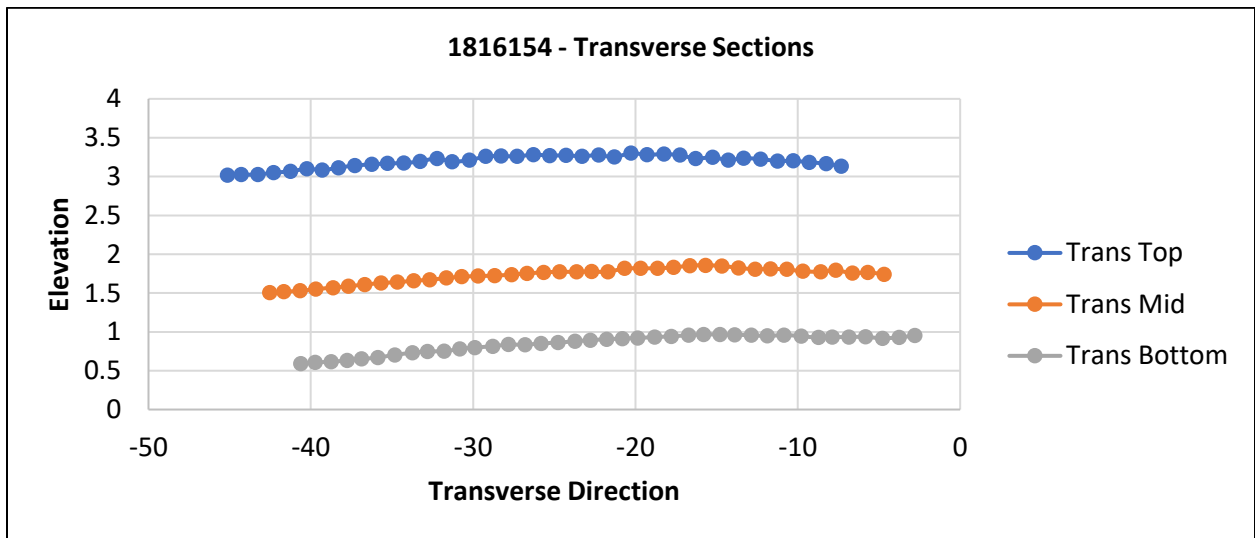
Figure 62. Structure 1816154 - Transverse Sections.

Structures 1816154 and 1816155 will be compared in this section, since these structures were included on this project as a case study presented by NJDOT. The twin bridges originally presented different levels of deck condition (3 for 1816155, and 6 for 1816154) which was a concern since the structures see the same level of traffic and have same dimensions of their structural components. Figure 58 and Figure 63 show the elevation maps of the top surface of the structures. Both structures present a longitudinal slope of approximately 2.3%, which can be estimated from Figure 61 and Figure 66. Structure 1816154 presents a transverse slope between 1 and 1.3% (see Figure 62), while structure 1816155 presents a uniform transverse slope of 1.3% (see Figure 65).

It is important to mention that during the data collection of Structure 1816155 a construction work was being performed on the premises of the bridge, which obstructed part of the deck and limited the access of the research team. For this, only half of the deck was available for data collection. From Figure 62 and Figure 67, the presence of mild rutting can be seen throughout all transverse directions, this can indicate the potential location of areas where water sits for longer periods of time, increasing the possibility of early deterioration. Based on the information gathered from the analyzed point cloud data, there is no clear evidence of the cause on the difference in condition stage between structures 1816154 and 1816155. The main evidences of deck damage found on the top surface of bridge decks were rutting and low points of vertical curvature. These aspects presented clear correlation with the deterioration stage of the deck.
