Rapid Seismic Repair of Column to Footing Connections – Phase 2

Alaska Department of Transportation & Public Facilities

1. AGENCY USE ONLY (LEAVE BLANK)		2. REPORT DATE May 31, 2022		3. REPORT TYPE AND DATES COVERED FINAL REPORT, Jan. 2019 through May 2022
4. TITLE AND SUBTITLE Rapid Seismic Repair of Column to Footing Connections – Phase 2			5. FUNDING NUMBERS

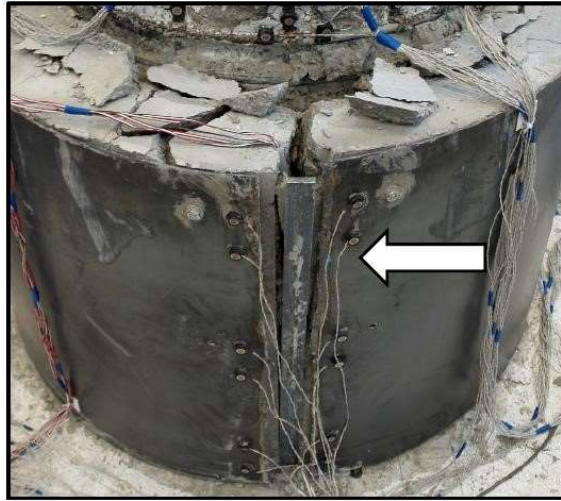
While this test started off well, the repair suffered an early failure due to rupture of the weld in the steel sleeve, which is shown in Figure 2.5. This failure led to conclusions that the use of a welded connection requires careful cutting and surface preparations for the thin sleeve. This was one reason that a mechanically bolted connection was investigated in this project. Despite the weld rupture, which was initiated during ductility 3, an analysis of the repair was conducted up to that point. For the two new anchorage mechanisms, the bar with the headed stud showed no signs of debonding. Although it was believed that this would have continued if the weld had not ruptured, the headed stud required so much labor for installation it was recommended only if complete bar anchorage was absolutely necessary. As for the bars that had the surrounding concrete removed,

Figure 2.5: Weld Failure during Repair #5 (Krish, 2018).

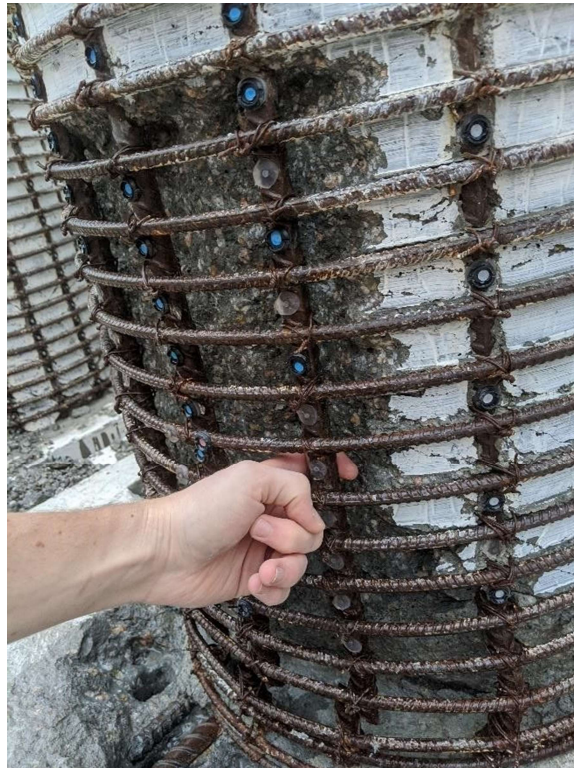
Figure 3.5: Removal of Concrete Around the Perimeter of Fractured Bars.

within the height of the repair should be removed. This ensures that the fresh repair grout will completely surround the fractured bar and is a necessity to fully anchor the bar within the repair. An example before and after of this step is shown in Figure 3.4. On the left, the damaged column is shown with large cracks near the base being evidence of the loose concrete that needs to be removed. For this column, the three frontmost bars were fractured during the original test, so within the height of the repair the concrete around the bars was removed, which can be seen on the right. Although the exact depth for concrete removal around the fractured bars has not been studied in this project, it is recommended to remove at least a the nominal maximum aggregate size around the bar (shown in Figure 3.5).

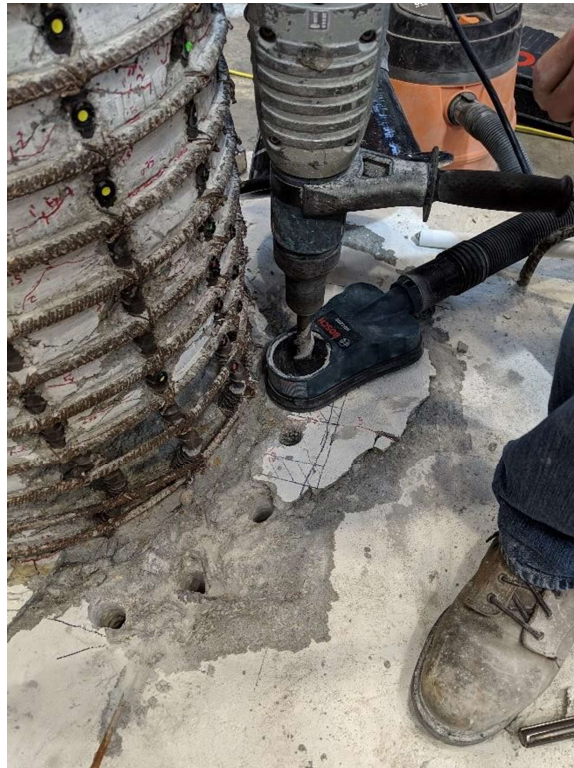
Figure 3.6: Drilling Holes into Footing for Repair Bars.

The repair design will determine the number, size, and approximate locations of the new longitudinal repair bars. The first step in placing these bars is to drill holes into the footing. This should be done according to the manufacturer's specifications of the grout or epoxy used to anchor the bars (Step 4). For the repairs in this project, the No. 8 bars required a 1-1/8" drill bit, and the drilling depth was limited to 15 inches due to the footing being 18 inches deep. This step is shown in Figure 3.6.

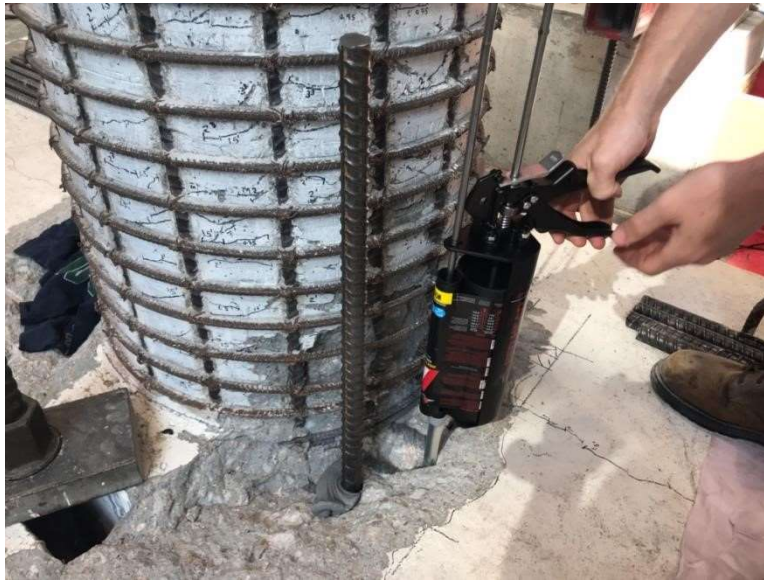
Figure 3.7: Anchorage of Repair Bars in Footing via Epoxy.

Once the holes have been prepped, the next step is to partially fill the holes with the epoxy. The bar is then slowly pushed into the hole while being twisted to prevent air bubbles and provide the best bond for the epoxy. For this project, nothing needed to be done to ensure the bars stayed vertical while the epoxy set due to a small hole tolerance and a viscous epoxy. Injection of the epoxy into the hole, as well as a completed bar is shown in Figure 3.7.

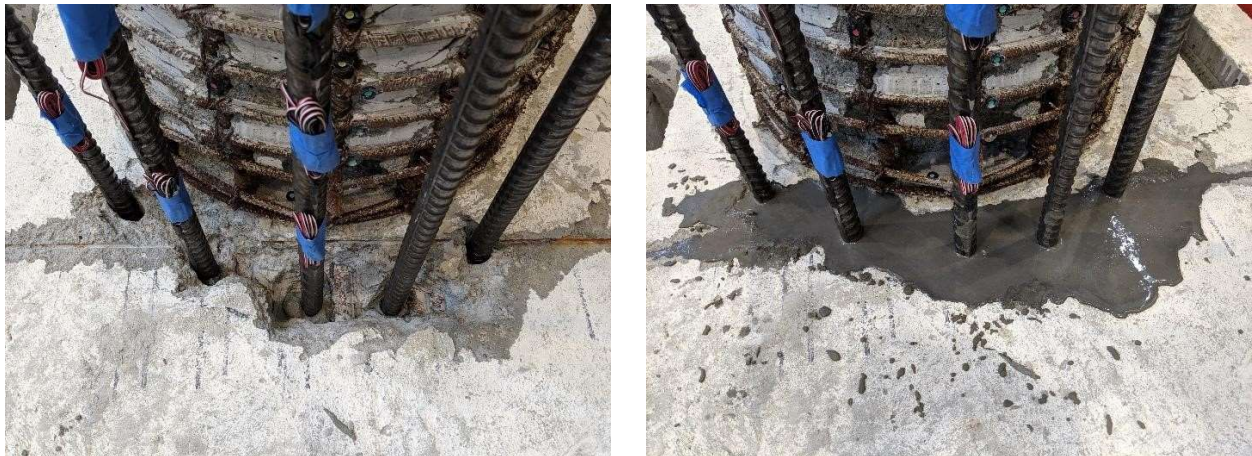
Figure 3.8: Use of Grout to Provide a Level Base for the Steel Sleeve.

For a column plastic hinge to form the extreme level of damage this repair is intended for, there will possibly be some amount of surface damage to the footing concrete near the joint. This damage can make it difficult to create a seal at the bottom of the sleeve and leveling may be needed. With the bars now in place and the epoxy set, any rapid set grout or concrete can be poured to create a level surface of the footing. Figure 3.8 shows an example of this step before (left) and after (right) levelling.

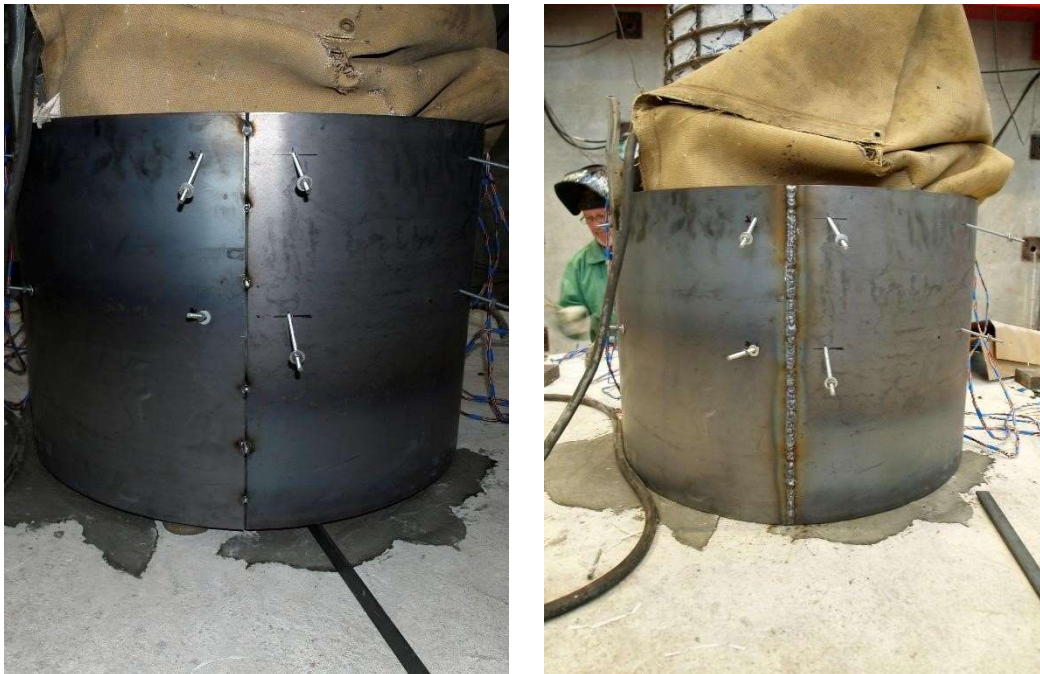
Figure 3.9: Use of Tack Welds (left) then Butt Weld (right) for Welded Connection (Krish, 2018).

For this connection, the steel sleeve is comprised of two semi-circular plates. These plates are placed around the column, then tack welded in place with a backer bar to align the connection. Once this is done, the entire height of the sleeve is butt welded, essentially creating a continuous ring around the column. This process was thoroughly studied by Krish (2018) and is shown in Figure 3.9.

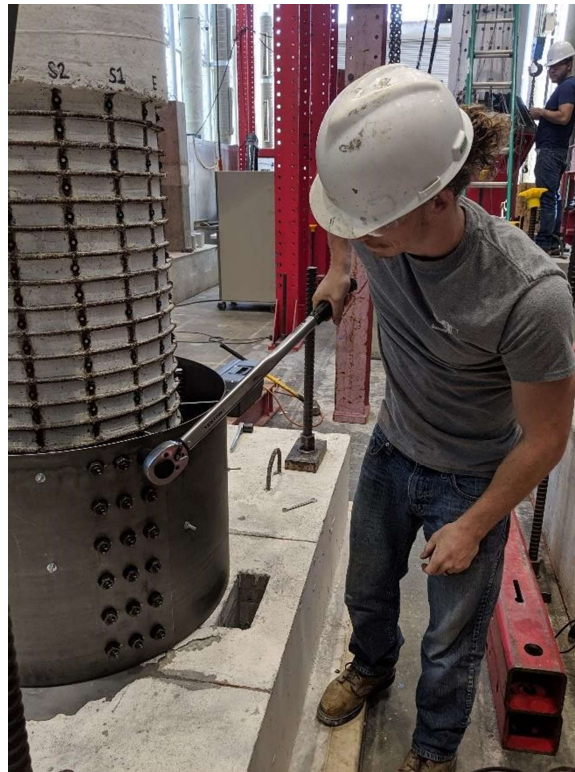
Figure 3.10: Pre-tensioning of Bolts via Calibrated Torque Wrench.

As previously discussed, the replacement of the welded connection with a bolted connection was the primary objective in the early stages of this research. For this connection, the steel sheet is cut to be slightly larger than a semi-circle. Consequently, when the two pieces are placed around the column they overlap on both ends, leaving room for the pieces to be bolted together. From the experimental tests, using this connection necessitates the use of pretensioned bolts to prevent slip at the plates. In the lab, this was done using a calibrated torque wrench, however any reliable method of bolt pre-tensioning can be used as long as slip of the plates can be prevented. The use of the calibrated torque wrench to tighten the bolts is shown in Figure 3.10, and the design for the sleeve, bolts and pre-tensioning can be found in Chapter 5.

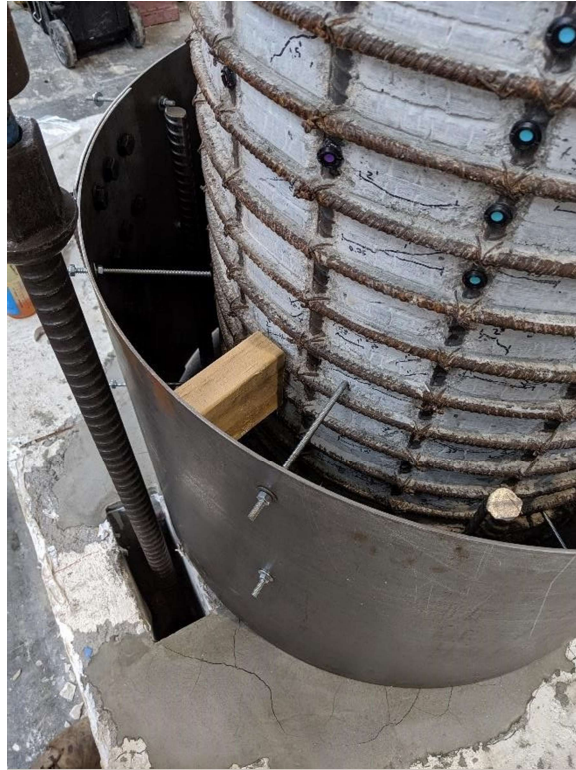
Figure 3.11: Centering of Steel Sleeve around the Column.

the column. Using nuts and washers, the length of the rod could be adjusted so that the sleeve was secured to the column, then the 2x4s were removed. Both the 2x4 spacers and 1/4" threaded rods can be seen in Figure 3.11. It should be noted that there are likely other methods of accomplishing this, but regardless of the process the sleeve should be uniformly spaced and secured so that it will not shift throughout the remainder of the construction process.

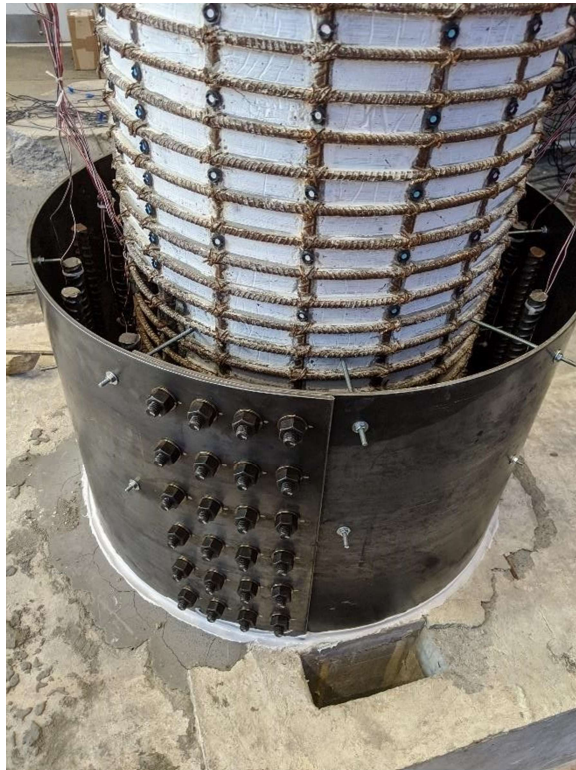
Figure 3.12: Silicone Sealant (White) shown at the Base of the Sleeve.

Before grout can be poured into the repair, it is recommended that a water-tight seal be made at the base of the sleeve to prevent leakage. This is easily done in the lab using a silicone sealant caulk, however in the field any method that prevents severe leakage of the repair grout should be sufficient. The white silicone sealant caulk used for this project can be seen at the base of the sleeve in Figure 3.12.

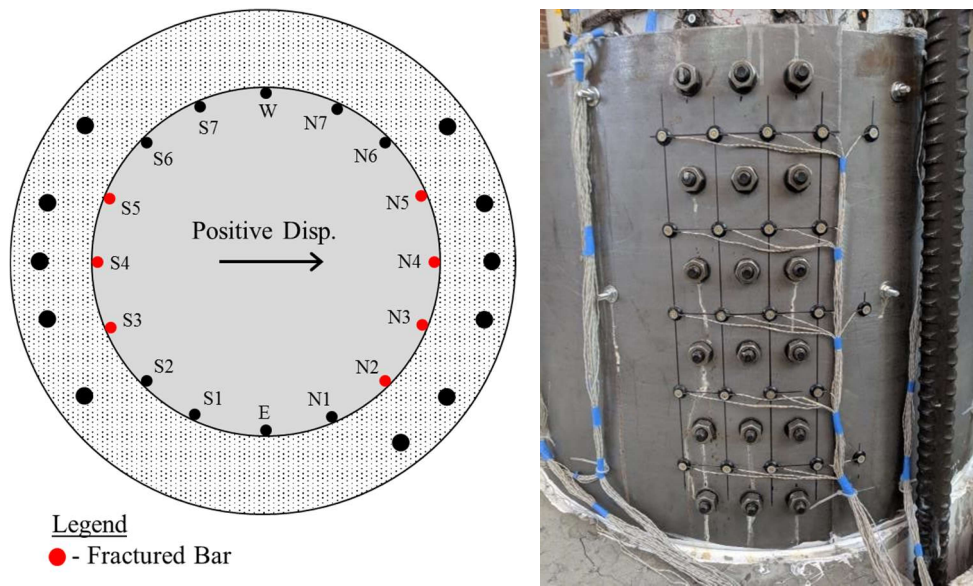
The use of a bolted connection is in-line with the repair philosophy of only using conventional materials that are readily available and serves to keep this a rapid repair. While designing this connection, it was realized that the force demand for the sleeve was not known, so a conservative design was chosen to inhibit a connection failure. To do this, it was assumed that the sleeve would yield up the entire height, which is easily equated to a concentric point load at the center of the sleeve height. This allowed for a connection design to be found where bolt bearing, bolt shear, and sleeve rupture would have a higher capacity than sleeve yielding. This design led to the use of 6 rows and 3 columns of ½" diameter ASTM F3125 Grade A325 bolts (which can be seen in Figure

4.2). The holes for these bolts were inadvertently oversized and drilled to 5/8” instead of 9/16”. As a note, the conservative design for this repair was later refined, and the updated design is described in Section 5.3.

Figure 4.2: Repair Cross Section and Bolt Configuration for Repair #1.

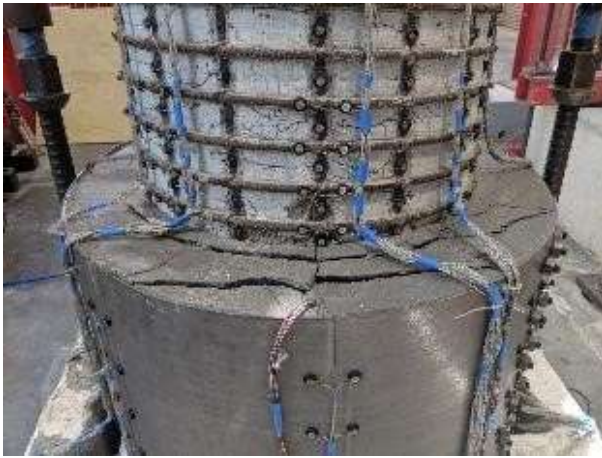
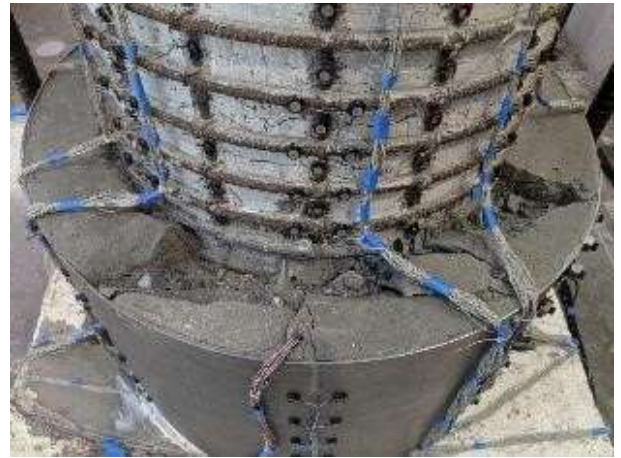
Figure 4.4: Cracking of the Top of Repair Grout (a) Before Removal of Loose Grout and (b) After.

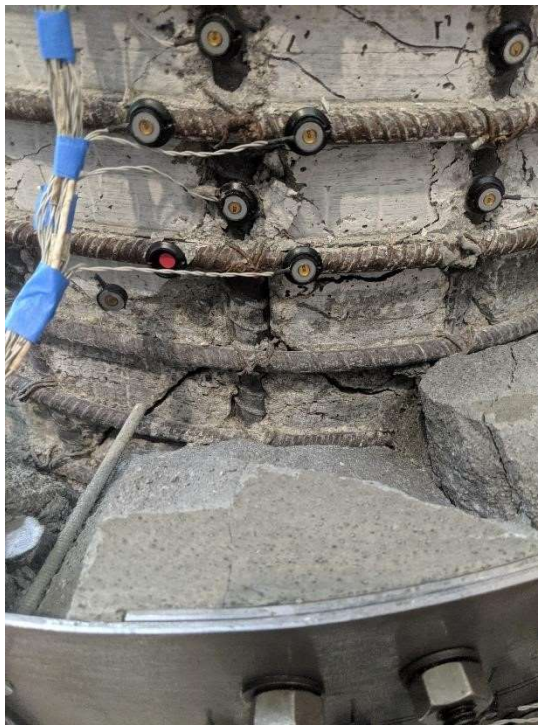
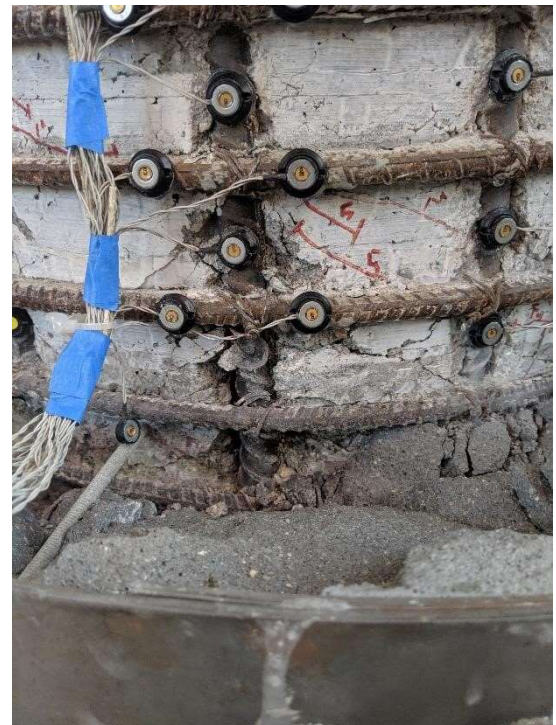
For this test, the column was subjected to the same displacement history as the original column test where $\Delta y' = 1.026$ in. and $\Delta y = 1.34$ in. Cracking of the grout at the top of the repair was initiated at the very first cycle ($1/4 F_y'$) as shown in Figure 4.3.a. When first yield (F_y') was reached, this crack had already become larger than the crack width ruler (>0.060 inches) (Figure 4.3.b). More cracks formed and all continued to widen, with minimal to no damage visible on the column above the repair on both sides of the column (Figure 4.4.a). At the end of the cycles at ductility 2, the loose grout was removed from the top of the repair (Figure 4.4.b). Since the three most extreme bars on each side were fractured, and likely debonded by now, there was still only minimal cracking or crushing of the concrete around these bars. However, during the first cycles at ductility 4, concrete crushing and cracking was found at the most extreme nonfractured bars (S2, S6, N1, and N6) which can be seen in Figure 4.5. Notably, the crushing and cracking primarily occurred just below the top of the repair,

as opposed to above the repair as expected. By the final cycles at ductility 4, buckling was observed for the S2, S6, N1, and N6 bars. In the 1st of the ductility 5 cycles, each of these bars were further buckled, and on the 2nd cycle, S6 fractured during the positive displacement, and N6 fractured on the negative displacement. At this point, the test was concluded. Figure 4.6 shows the repaired column's maximum displacement.

Figure 4.5: Concrete (a) cracking and (b) crushing visible during the 1st cycle at ductility 4.

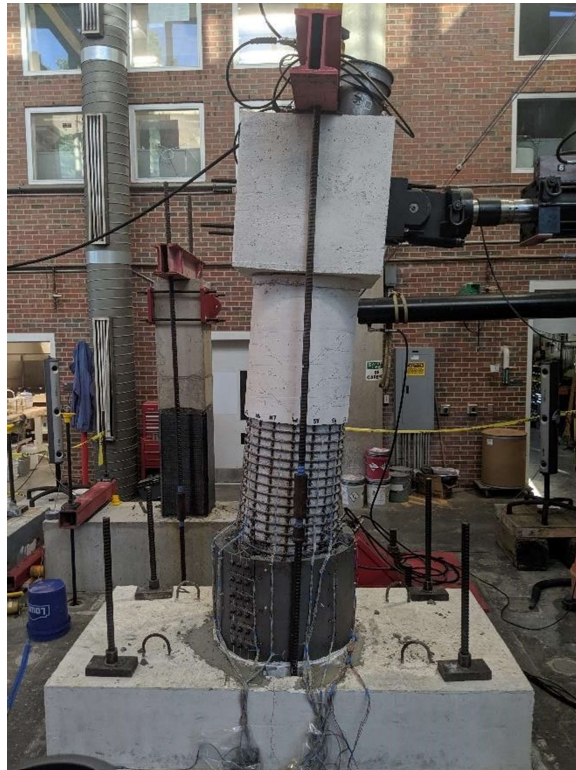
Figure 4.6: Maximum displacement and final cycle of test.

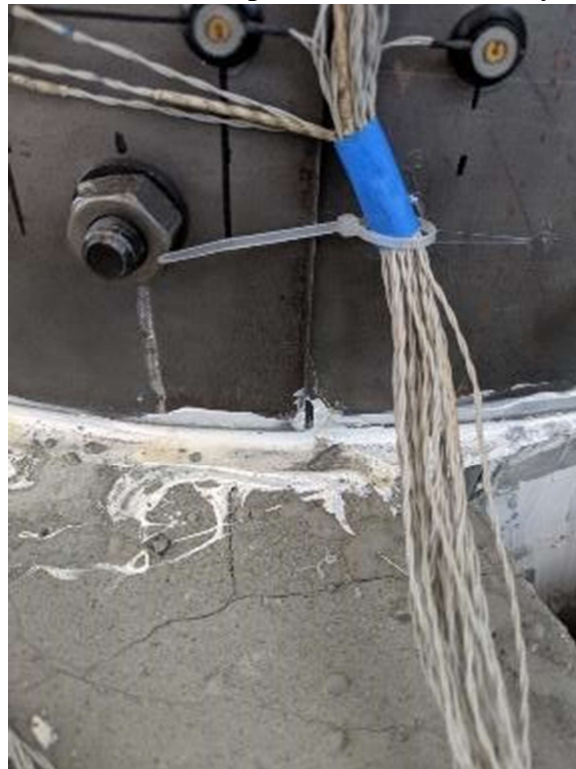
During the test, it was observed that the plates were slipping relative to each other. This was most noticeable at the base where the silicone was used to seal the sleeve and by the end of the test a visible gap had formed which is shown in Figure 4.7.

Figure 4.7: View of silicone sealant where gap formed due to plates slipping.

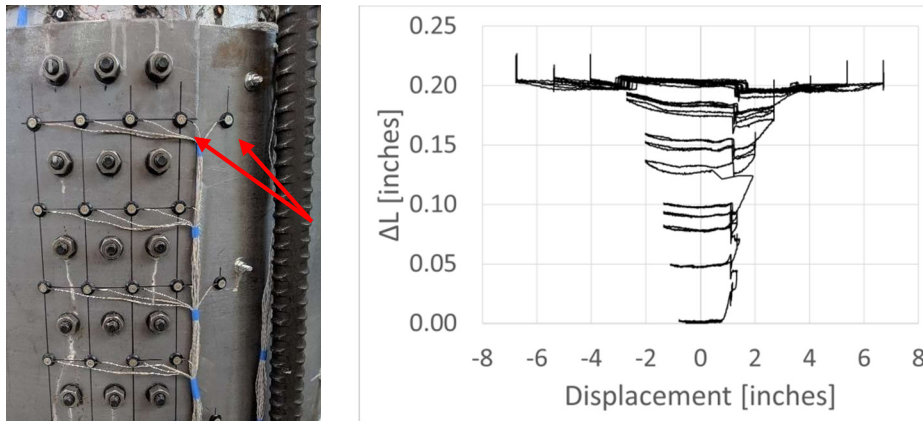
Using Optotrak data from LEDs on separate plates at the connection, plate slip can be monitored throughout the duration of the test. An example of two of these LEDs is shown on the left of Figure 4.9, and on the right is a plot of the length change between the two markers vs. the top displacement of the column. This data shows that the first push of the early cycles would cause the plates to slip, and there was almost no rebound. Eventually (at around 3 inches of displacement), enough of the bolts began to bear on the holes and there is minimal subsequent increase in slip. While some amount of this change in length would be due to the strain in the sleeve, it is believed that this would be minimal until the bolts were bearing on the holes. With no strain developing in the sleeve, the confining stresses from the sleeve would be minimal, which would diminish the anchorage effect of the fractured bars within the repair. While the oversized holes would have worsened this behavior, prevention of plate slip completely would theoretically lead to a behavior similar to a welded connection where there would be no slip.

Figure 4.9: Slip of Plates in Repair #1.

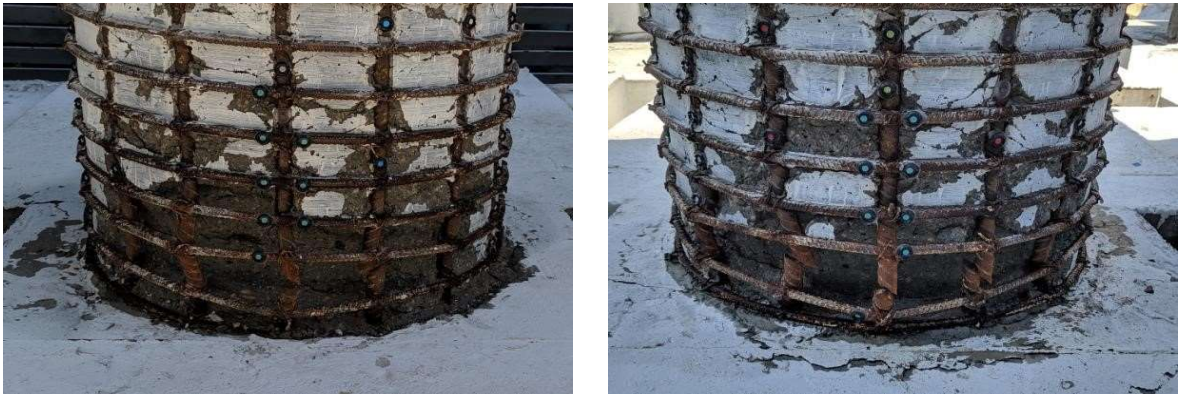
The column repaired for this test was nominally identical to the previous column aside from the longitudinal bars coming from a different steel mill. The original column test resulted in 5 bars being fractured and a significant amount of concrete spalled off. Although Repair #1 contained 7 fractured bars, the south sides of the columns from both tests contained 3 fractured bars and had 5 repair bars. This gives an optimal location for comparison of local strains between the two tests. The damaged state of the column prior to repair as well as the repaired cross section are shown in the following Figures 4.12 and 4.13. The properties for the original column, comparison column, and repair are summarized in Table 4.2.

Figure 4.12: Damaged column for Repair #2 on the North (left) and South (right) sides.

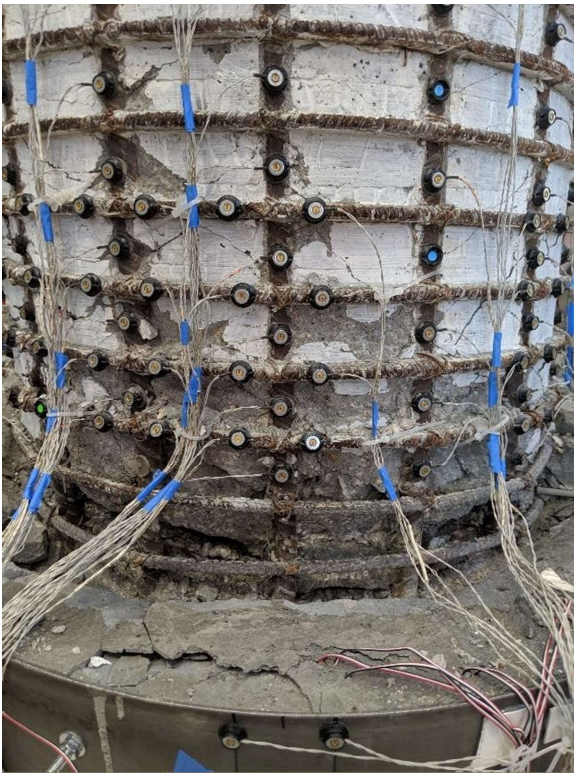
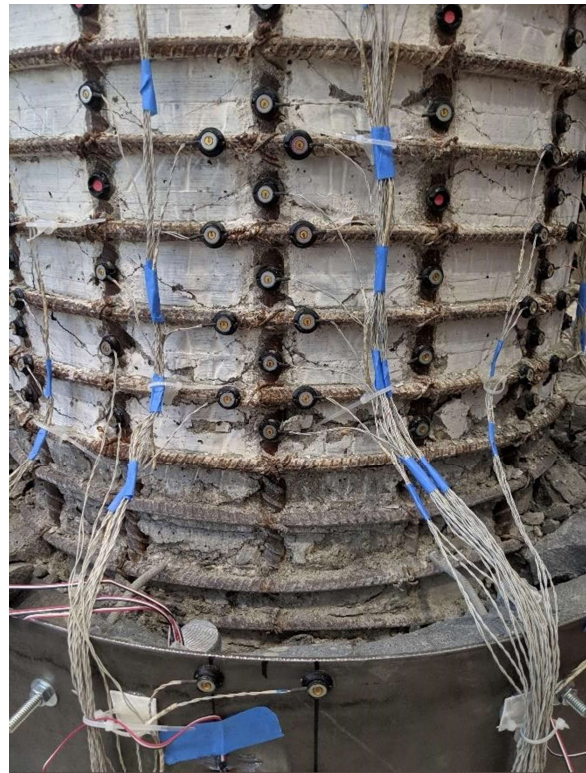
Nearing the end of the test, the north side of the column had a large amount of concrete crushing, while the south side had fairly little. A comparison of the concrete crushing on the two sides is shown in Figure 4.16.

This is likely due to the north side having less initial damage than the south (2 fractured bars vs 3). Buckling was first observed in N3 during the final cycle at ductility 4. On the first push cycle of ductility 5, N2 and N6 also buckled. When pulling back in the opposite direction N3 fractured and S2 and S6 buckled. In the second cycle at ductility 5 each of the buckled bars were further buckled but did not fracture. For the third cycle S2, N2, and N6 fractured. Though the column had completed all three cycles at ductility 5, the column was pushed one more time to fracture S6. At a displacement of 7.45 inches, S6 fractured and the test was concluded. A progression of buckling to fracture is shown in Figure 4.17 for N6, with other bars showing similar damage progression. Lastly, Figure 4.18 shows the column's displacement during the final cycle of ductility 5.

Figure 4.16: Damage comparison during ductility 5 on the North (left) and South (right) sides.

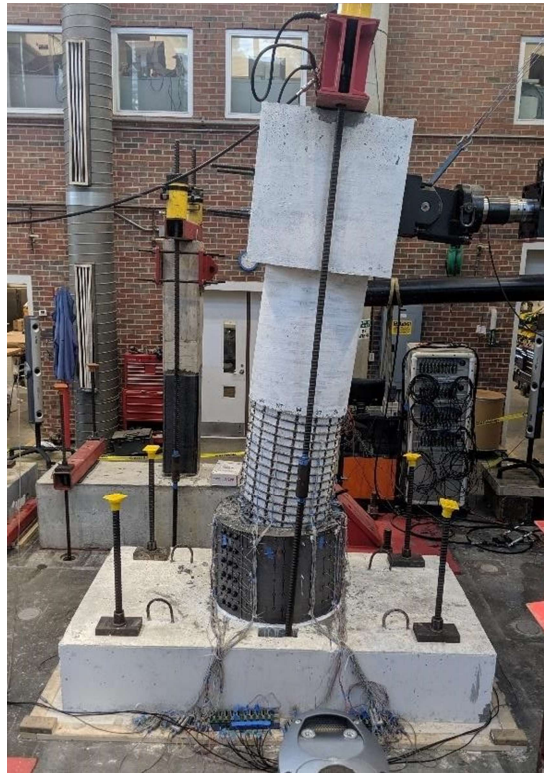
Figure 4.18: Column displacement during final cycle of ductility 5.

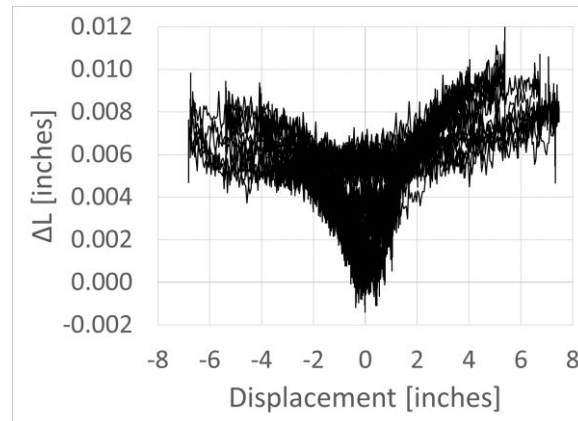
Using the same process as Repair #1, slip of the steel plates can be monitored using Optotrak LEDs on the two plates. Figure 4.21 shows that the maximum change in length of the two markers was around 0.01 inches. For comparison, Repair #1 had a maximum change in length of 0.20 inches. With this information, we can conclude that the pretensioned bolts succeeded in minimizing the plate slip. It is worth reiterating that the values above are the change in length of the two LEDs. For this reason, the values are not a direct measure of slip because strain within the sleeve would also contribute to the change in length. In other words, a change in length of 0.01 inches does not imply that the plate slipped 0.01 inches, because steel strain would also be

included in this. Further analysis would need to be done to determine actual slip length, but it must be less than 0.010 inches which is negligible.

Figure 4.21: Slip of Plates in Repair #2.

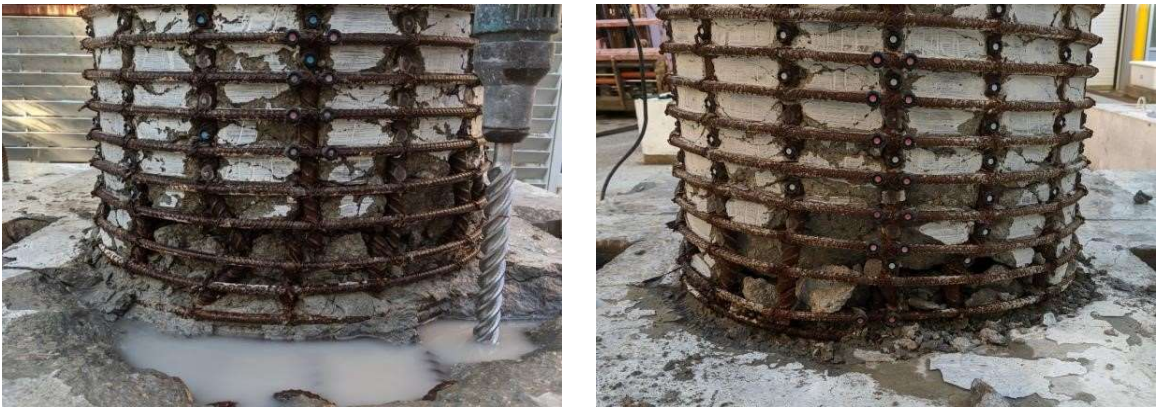
In the previous work by Krish (2018), one method of doing this was removing the concrete around the perimeter of the fractured bars within the height of the repair. This concrete is likely damaged from the original column test and bar fracture, so removing it makes it so that the repair grout will completely surround the bars which should improve their anchorage. When this was done by Krish (2018), it was found to slightly improve the peak strain that a bar could sustain before it would debond, but ultimately the bar still debonded; so in the interest of keeping the repair rapid the technique was not recommended. With the larger sleeve thickness expecting to improve the anchorage of the bars, the effectiveness of this technique was re-evaluated by chipping the concrete out on the North side and leaving the South side as it was. The damage after the original column test is shown in Figure 4.24. A comparison of the two sides after chipping is included Figure 4.25, and the

Figure 4.24: Damaged column for Repair #3 on the North (left) and South (right) sides.

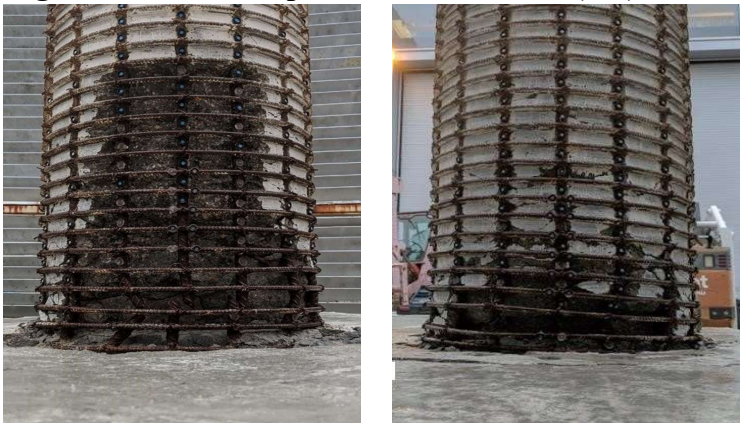
Figure 4.25: Repair conditions for the North (left) and South (right) sides.

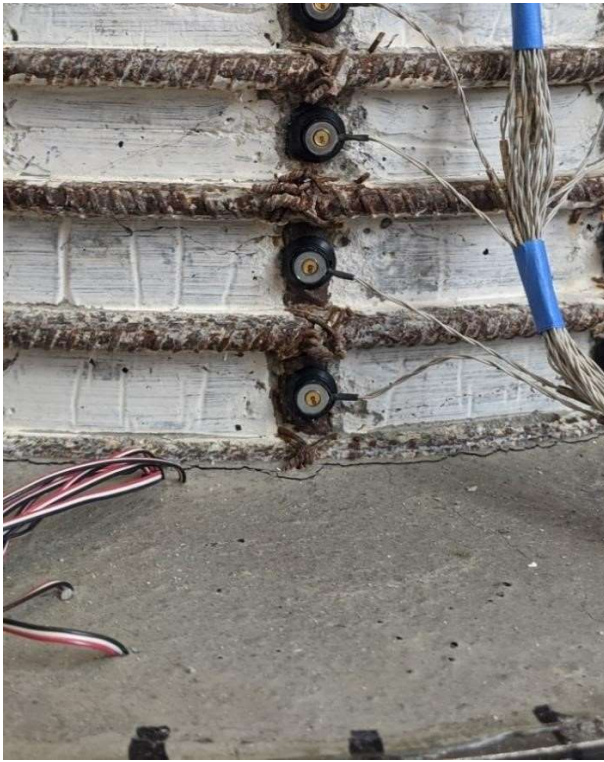
As with the two previous tests, cracking on the top of the repair occurred very early in the test, with a circumferential crack forming around the column at half of first yield ($1/2 F_y'$) which can be seen in Figure 4.27. During the cycles at ductility 1, minor flaking was observed on both sides of the column and it became clear that there was substantially more cracking on the south side of the column when compared to the north side. Figure 4.28 gives a comparison of the two sides while they are in tension and the cracks are most visible. As the test progressed, typical tension cracking and concrete crushing was seen in the column above the repair.

Figure 4.27: Circumferential cracks in grout at $\frac{1}{2} F_y'$ for the North (left) and South (right).

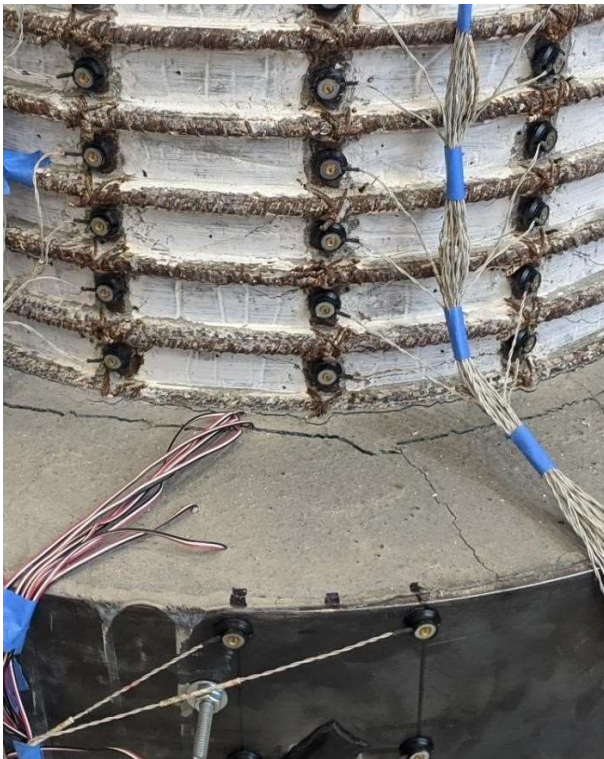
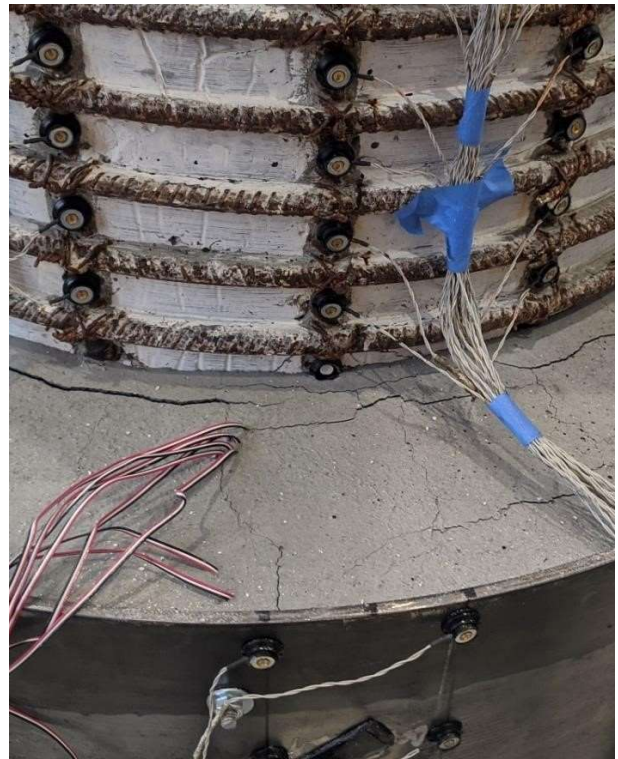
Figure 4.28: Comparison of cracking during ductility 1 for the North (left) and South (right).

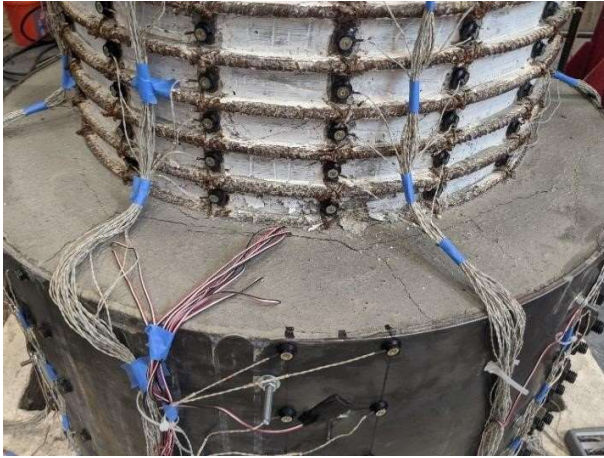
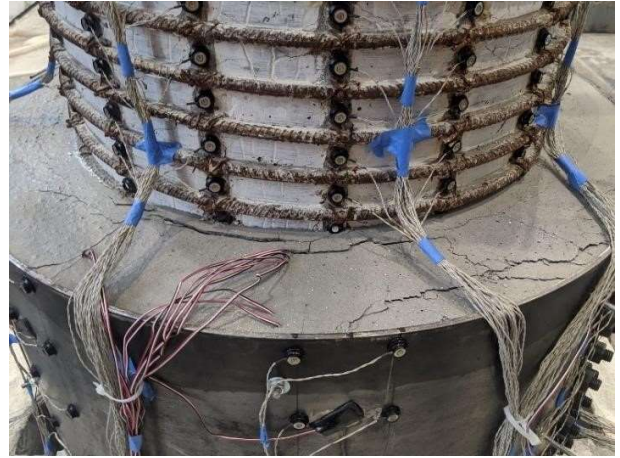
Figure 4.29: Damage Comparison after ductility 1.5 of the North (left) and South (right) sides.

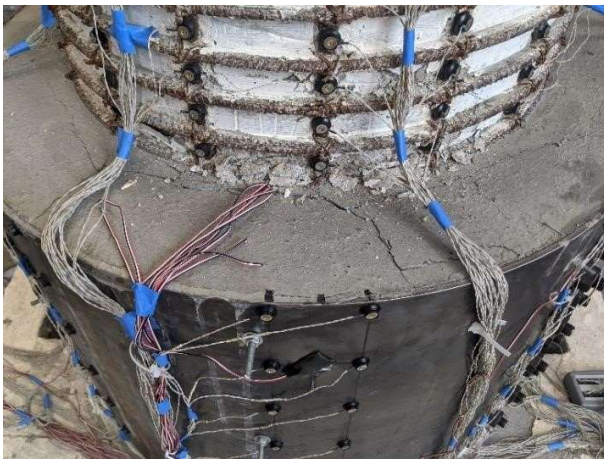
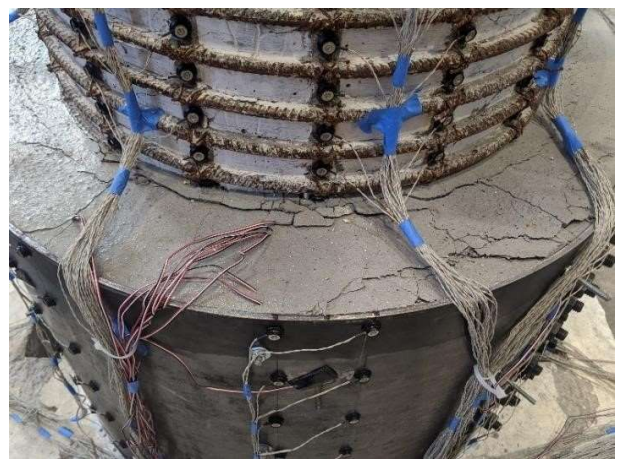
Figure 4.30: Damage Comparison after Ductility 2.

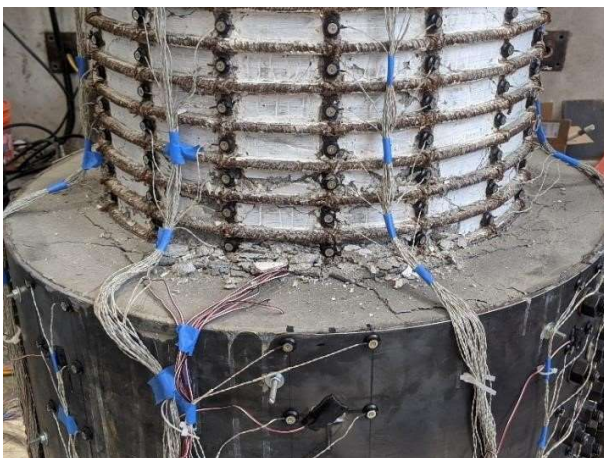
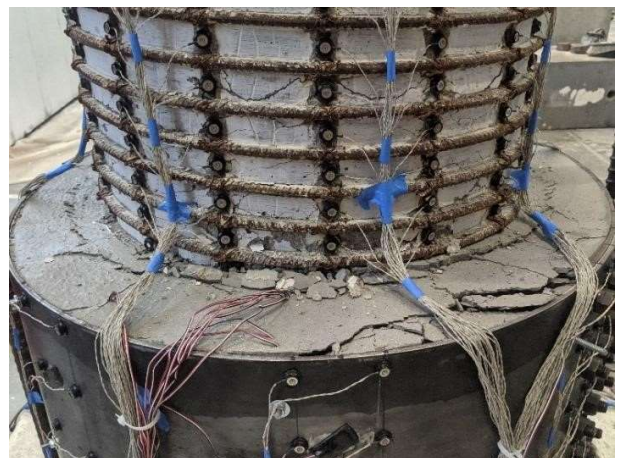
Figure 4.31: Damage Comparison after Ductility 3.

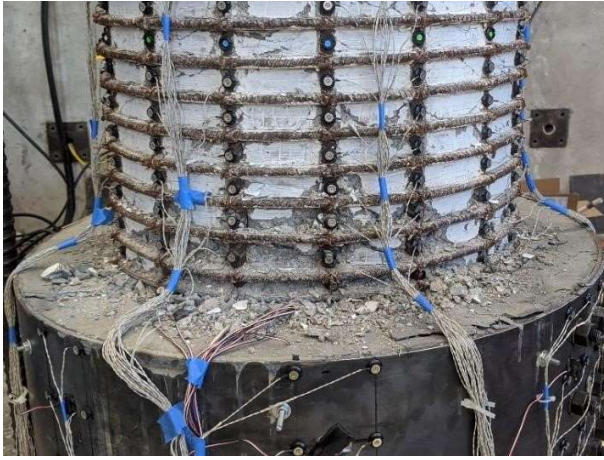
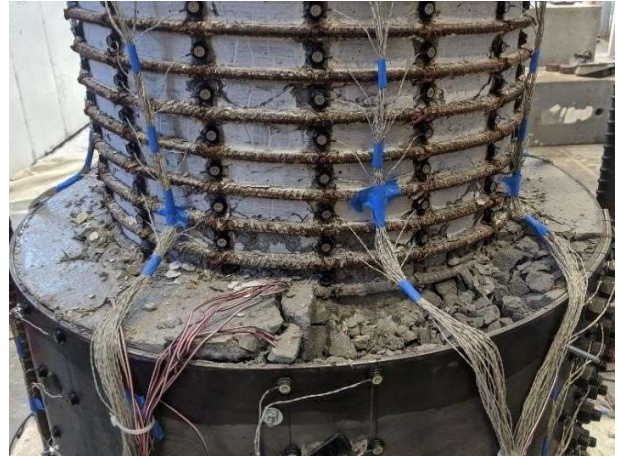
In the second cycle of ductility 4, buckling was observed in the 3 extreme bars (N3 to N5) on the north side. On the next cycle the 2 next extreme bars (N2 & N6) buckled, but there was still no visible buckling on the south side (though it is possible it buckled below the top of the repair grout). For the very first pull at ductility 5, N3 fractured followed shortly by N4. During the next pull cycle, N5 fractured and for the first time buckling was observed in S2 and S6. It was at this point that the large crack seen on the left of Figure 4.33 was noted. After this, one more push cycle was completed which fractured S2 and S6, the column was brought back to zero displacement and the test was complete.

Figure 4.32: Damage Comparison after Ductility 4.

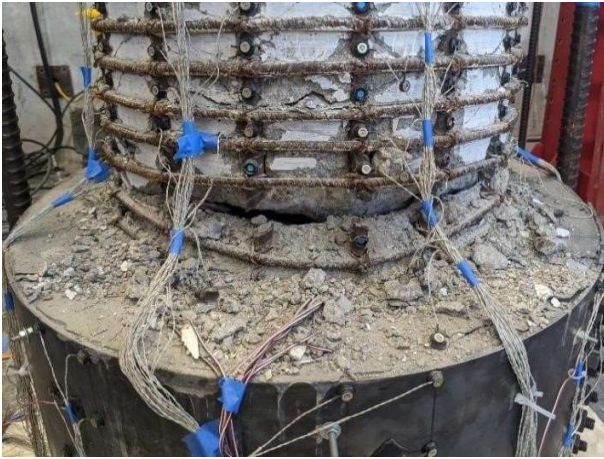
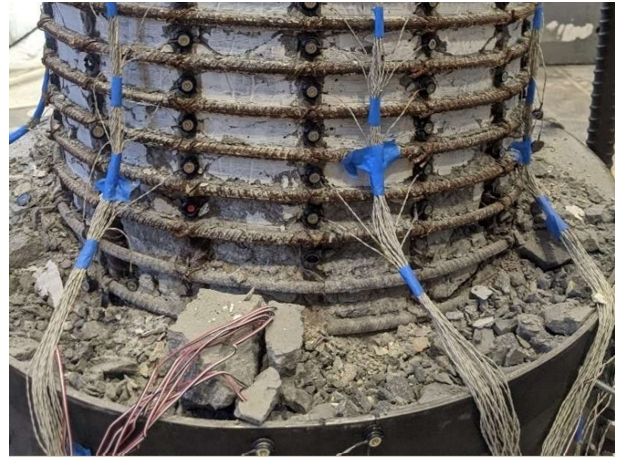
Figure 4.33: Damage Comparison during the final cycle of Ductility 5.

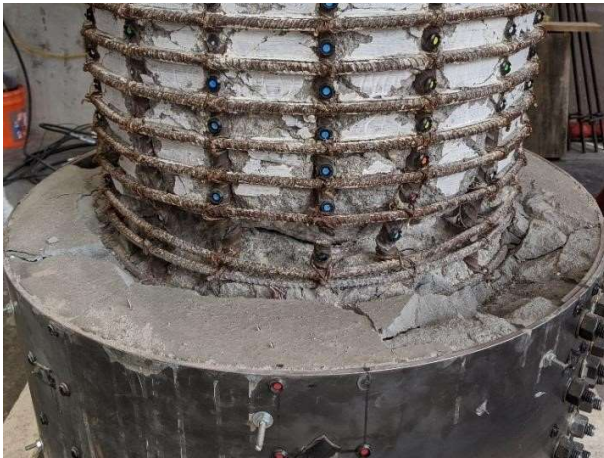
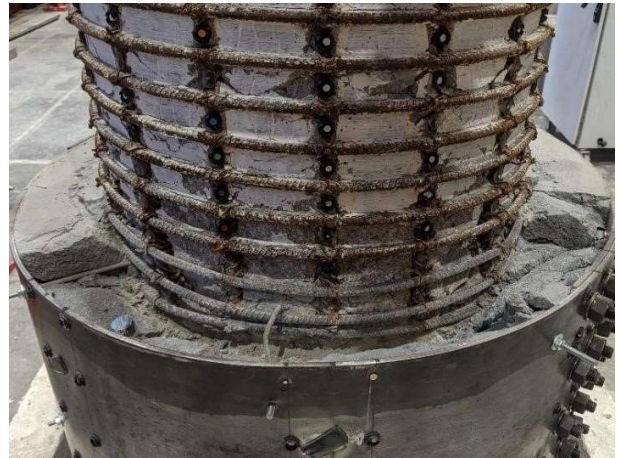
In summary, the south side performed similarly to what was seen in the previous test, but with slightly less damage. The three previously fractured bars (S3-S5) debonded, making the S2 and S6 the extreme bars that fractured in the repair test. The north side performance, however, was significantly different. For the first time ever, bars that had been fractured in the original tests (N3-N5) were fully anchored which led to them being re-fractured in the repair's relocated plastic hinge. It is worth emphasizing that not only did the North side have less damage to the repair, the relocated plastic hinge also formed completely above the top of the repair. For the previous two tests and the South side of this test, the relocated plastic hinge has appeared to be at or just below the top of the repair. It is believed that relocating the hinge above the repair is the ideal result for both capacity design and post-earthquake inspections.

Figure 4.34: Damage Comparison after the test with loose grout removed.

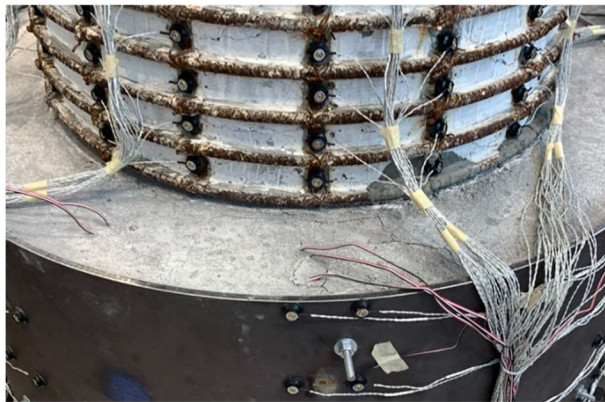
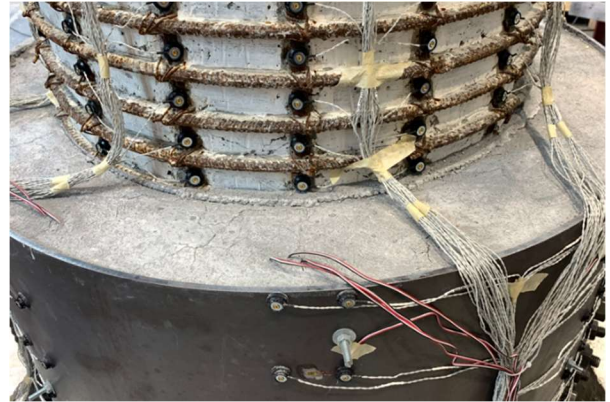
Figure 4.44: Damage Comparison after Ductility 1.5 of the North (left) and South (right) sides.

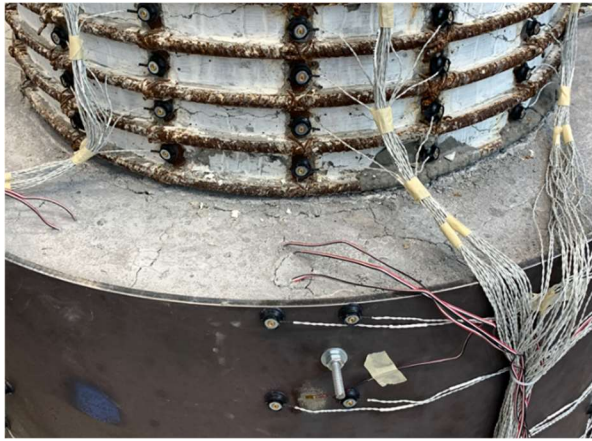
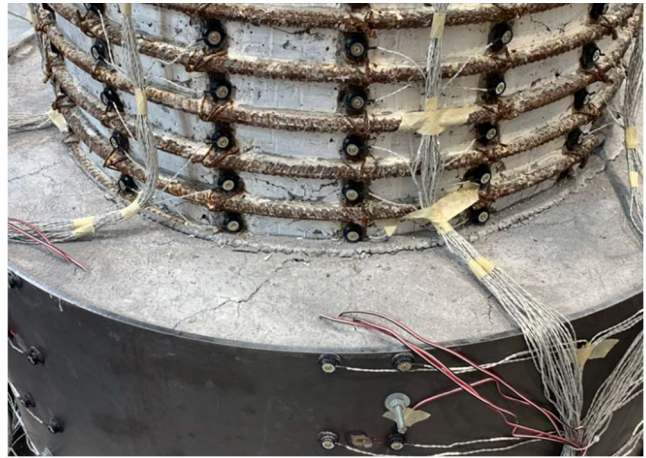
Figure 4.45: Damage Comparison after Ductility 2 of the North (left) and South (right) sides.

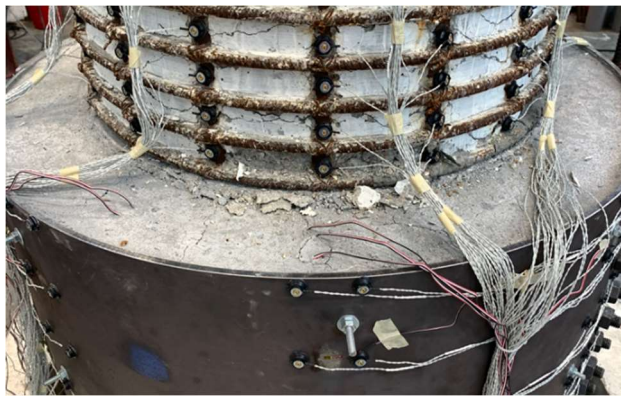
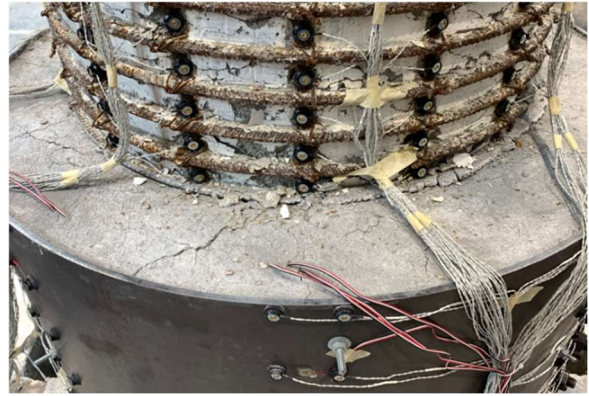
Figure 4.46: Damage Comparison after Ductility 3 of the North (left) and South (right) sides.

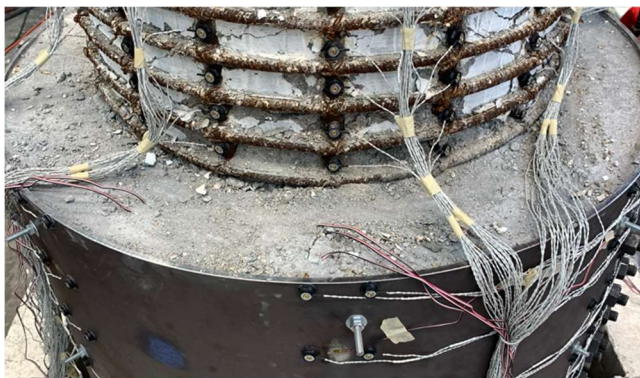
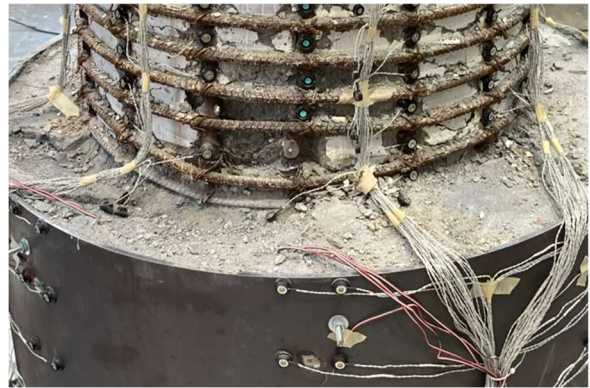
Buckling was observed during ductility 4 for the extreme bars on both sides of the column. On the South side, bars S4 and S5 buckled during the second cycle. On the North side, bars N4 and N5 buckled during the third cycle. The most extreme bars fractured on both sides of the column. S4 fractured on the South side during the third push of ductility 4, and N4 fractured on the first pull of ductility 5. Additionally, bars S3, S5, and S6 fractured in the cycles following the fracture of S4.

Figure 4.47: Damage Comparison after Ductility 4 of the North (left) and South (right) sides.

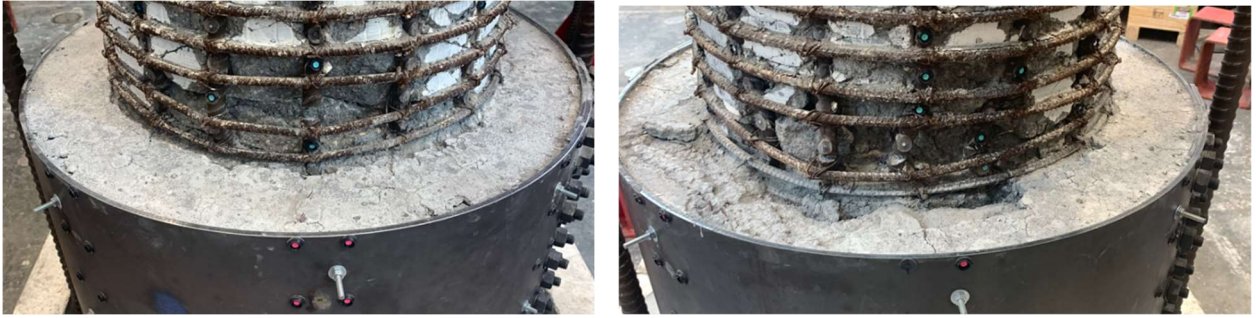
In summary, this repair showed full anchorage of previously fractured bars on both sides of the column. The chipping of weak concrete around fractured bars seems to be necessary to provide conditions in which the previously fractured bars do not debond. The similarity in damage to the top of the repair grout on each side indicates that chipping around bars that were not previously fractured does not provide additional benefits.

Figure 4.48: Damage Comparison after the test when all loose grout was removed of the North (left) and South (right) sides.
