Rapid Seismic Repair of Column to Footing Connections – Phase 2

Alaska Department of Transportation & Public Facilities

1. AGENCY USE ONLY (LEAVE BLANK)		2. REPORT DATE May 31, 2022		3. REPORT TYPE AND DATES COVERED FINAL REPORT, Jan. 2019 through May 2022
4. TITLE AND SUBTITLE Rapid Seismic Repair of Column to Footing Connections – Phase 2			5. FUNDING NUMBERS

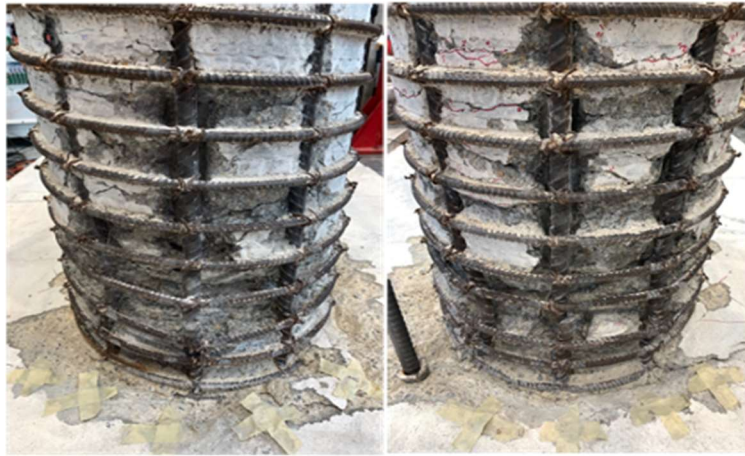
The initial damage condition of this column consisted of 1 fractured bar on the North side and 2 fractured bars on the South side. Based on the results of the previous tests, the concrete was chipped just around the fractured bars to improve bond conditions. Figure 4.53 shows the damage conditions for the North and South sides. For repairs using epoxy anchored bars in holes drilled in the footings, the number and size of bar is determined using the design outlined in Section 5.1 based on the number of bars that fracture in the original test. For this test with embedded couplers, the number and size of bar couplers that must be embedded is determined based on an assumed level of damage. The repair cross section was designed assuming no more than 3 longitudinal bars would fracture on each side of the column during the original test, resulting in 5 couplers placed in each side of the footing. Grade 80 threaded bars with a diameter of 0.75 inches were used with compatible couplers to construct the repair. Figure 4.54 shows the cross section and completed repair.

Figure 4.53: Repair conditions for the North (left) and South (right) sides.

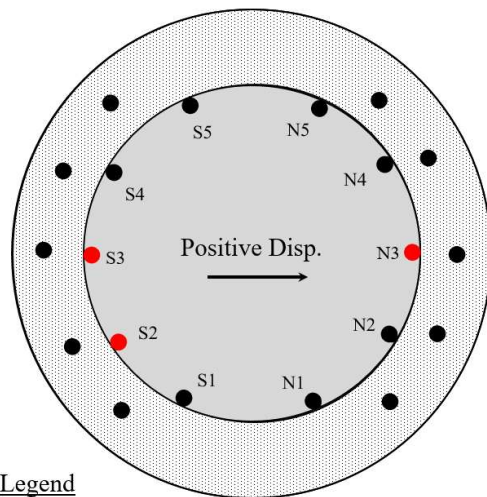
Legend

● - Fractured Bar

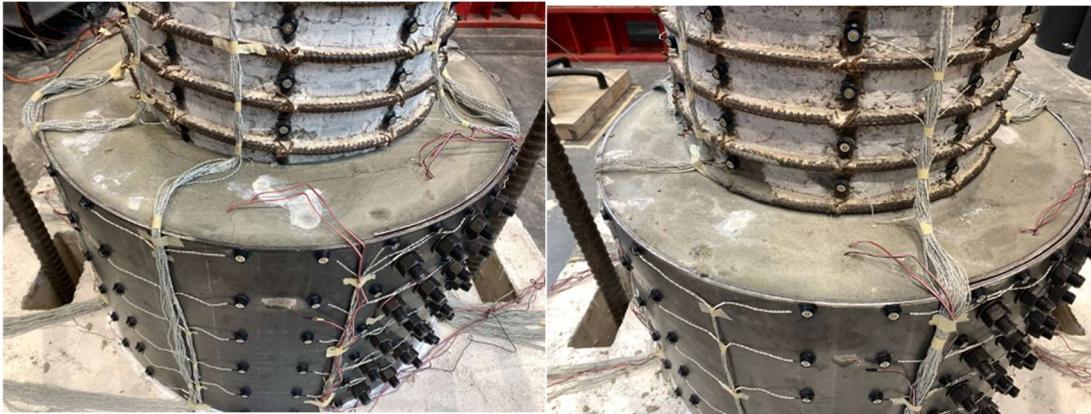
The first grout cracks appeared during the first yield cycle, and were diagonal through the top of the repair, radiating from the area where the core column chipping stopped. Circumferential grout cracks formed in the ductility 1 cycles. The original column cracks also widened in this cycle. Beginning in ductility 1.5, new column cracks formed above the repair. Column concrete crushing happened during ductility 3.

Figure 4.55: Damage after ductility 1 for the North (left) and South (right) sides.

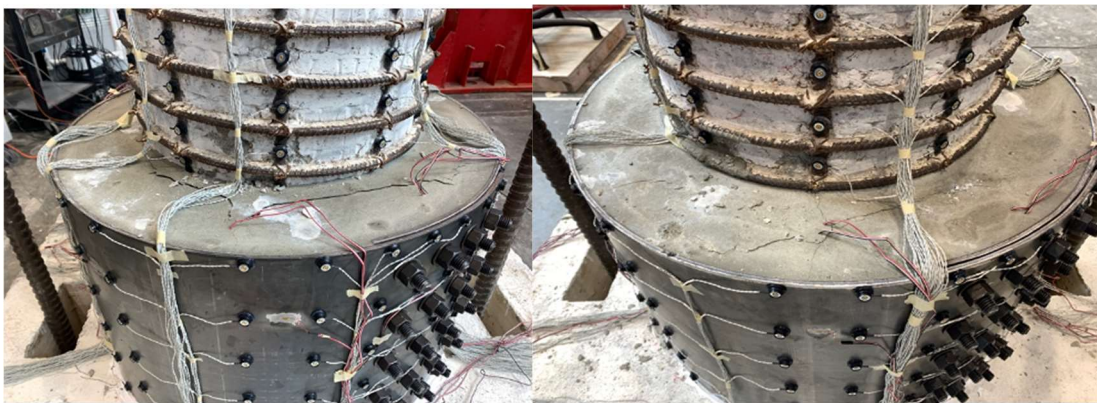
Figure 4.56: Damage after ductility 2 for the North (left) and South (right) sides.

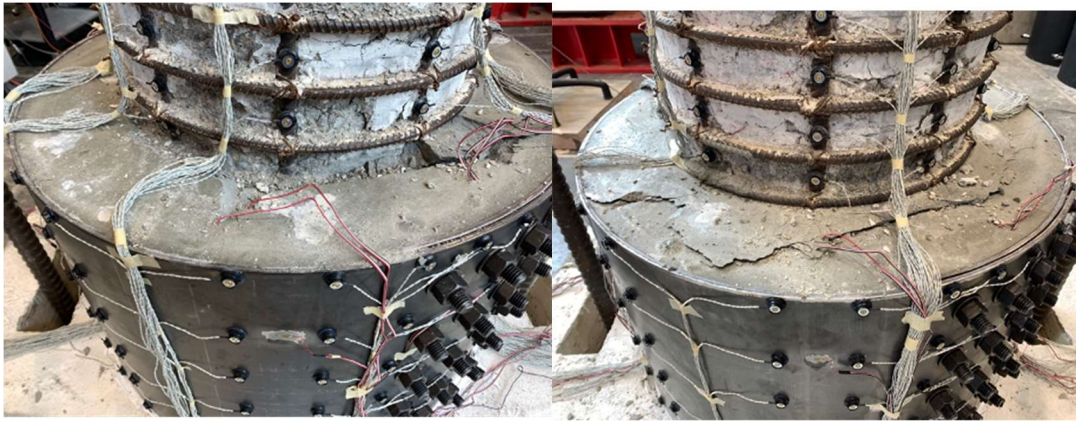
brought to zero displacement. Cracks in the repair grout closed in compression on the North and South side throughout the test. Starting in ductility 4, loose concrete and grout was removed. Buckling was observed during the second cycle of ductility 5 for the extreme bars on both sides of the column (bars S3 and N3). On the third cycle of ductility 5, N3 fractured. During the next push, S3 fractured before surpassing the ductility 5 displacement. The final damage condition consisted of bars N3 and S3 fractured in the relocated hinge, along with the buckling of N2.

Figure 4.57: Damage after ductility 4 for the North (left) and South (right) sides.

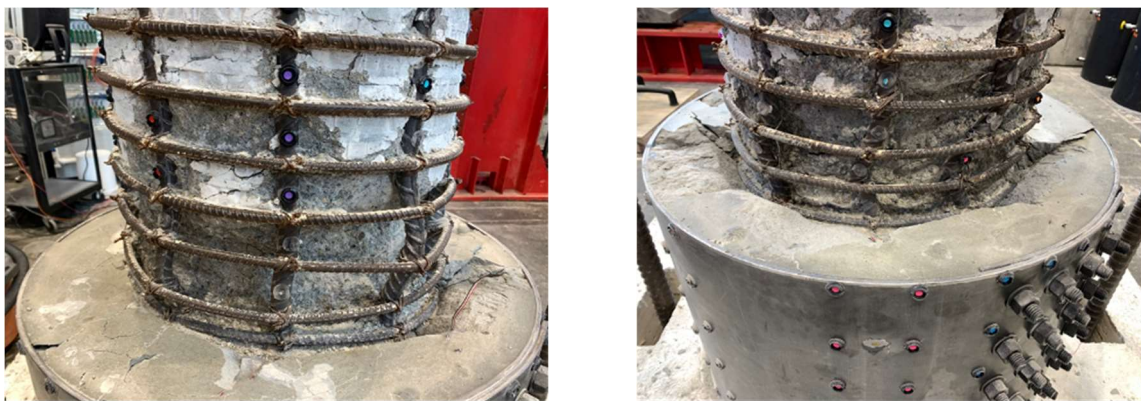
Figure 4.58: Damage Comparison after the test when all loose grout was removed of the North (left) and South (right) sides.

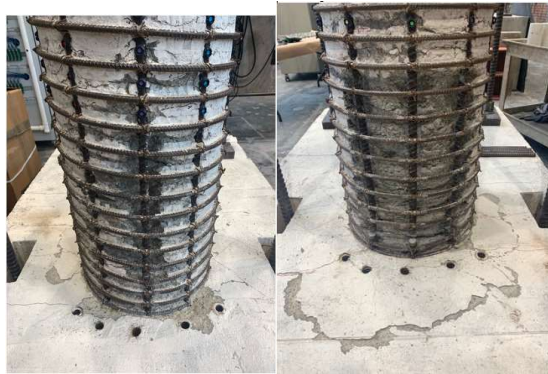
The initial damage condition of this column, shown in Figure 4.64, was one fractured bar on the North side and 3 fractured bars on the South side. The perimeter concrete was chipped around the fractured bars. The repair cross section is shown in Figure 4.65. In this design and the design of Repair #5, it was assumed that no more than 3 longitudinal bars would fracture on each side of the column, resulting in 5 couplers placed in each side of the footing during construction. For this repair, the actual damage of the original column was taken into account to decide how many bars would be placed in the couplers. On the South side, the assumed 3 bars fractured and therefore all 5 couplers were used. On the North side, only one bar fractured, so fewer repair bars could be used and still behave elastically according to the design, and two of the couplers were left empty.

Figure 4.64 Repair #6 damage state of the North and South sides.

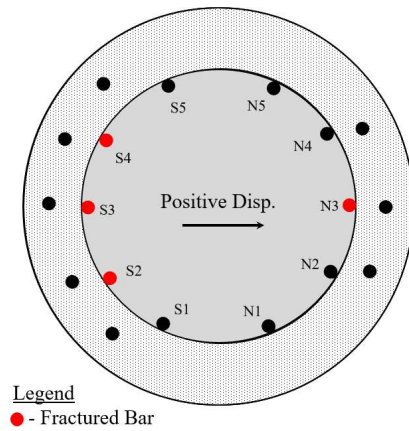
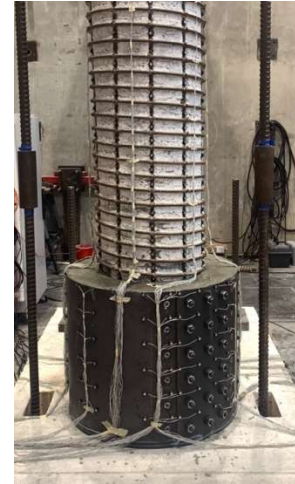
Figure 4.65: Repair #6 damage state of the (a) North and (b) South sides.

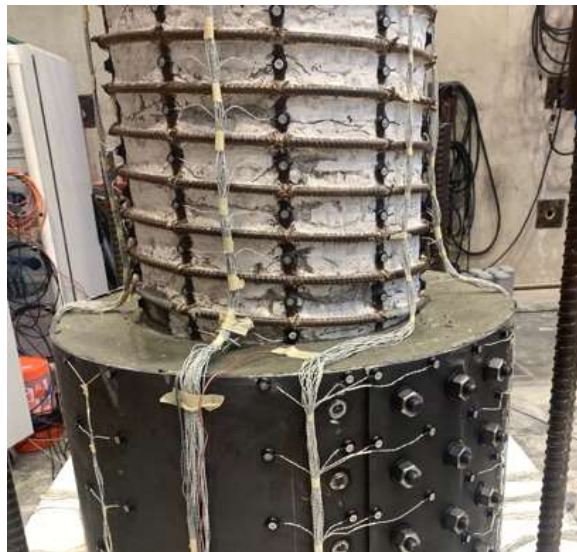
The first grout cracks appeared during the first yield cycle, and were diagonal through the top of the repair, radiating from the area where the core column chipping stopped. Circumferential grout cracks formed in the ductility 1 cycles. As you can see in Figure 4.66 the column exhibited large cracks in the new hinge region from the initial loading of the original test. These original column cracks also widened in the ductility 1 cycles. Beginning in ductility 1.5, new column cracks formed above the repair. Column concrete crushing happened during ductility 3.

Figure 4.66 Initial damage above repair.

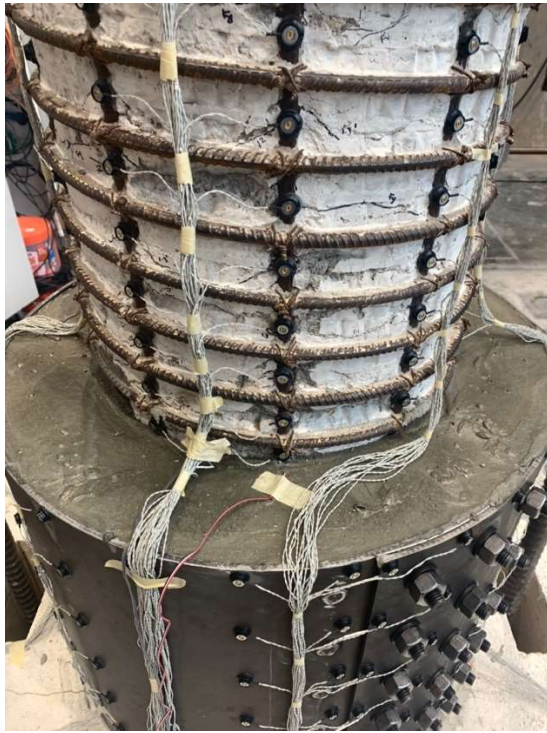
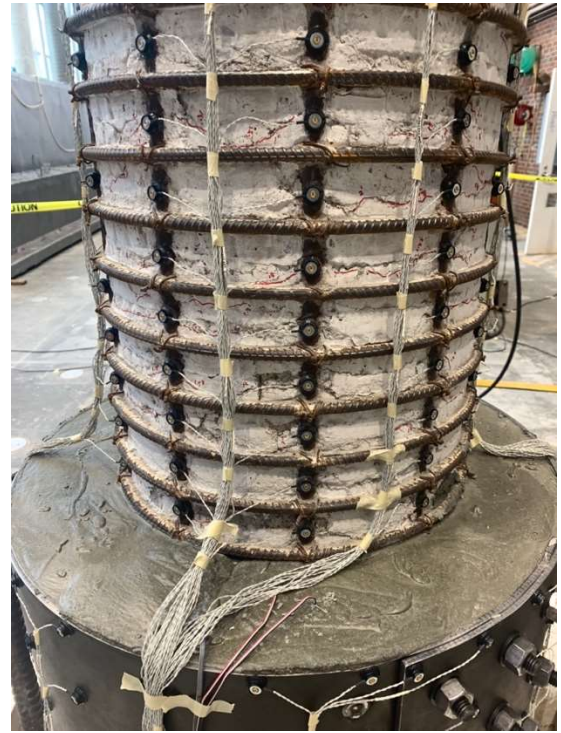
Figure 4.67: Damage During Ductility 1 of the North (left) and South (right) Sides.

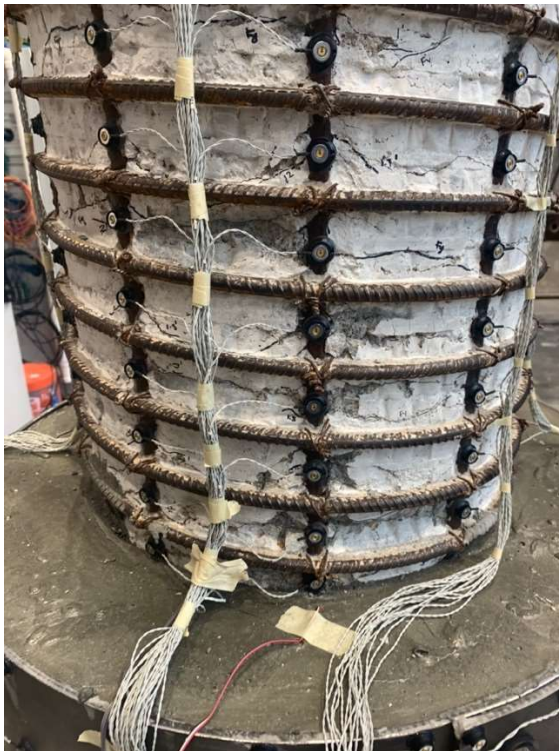
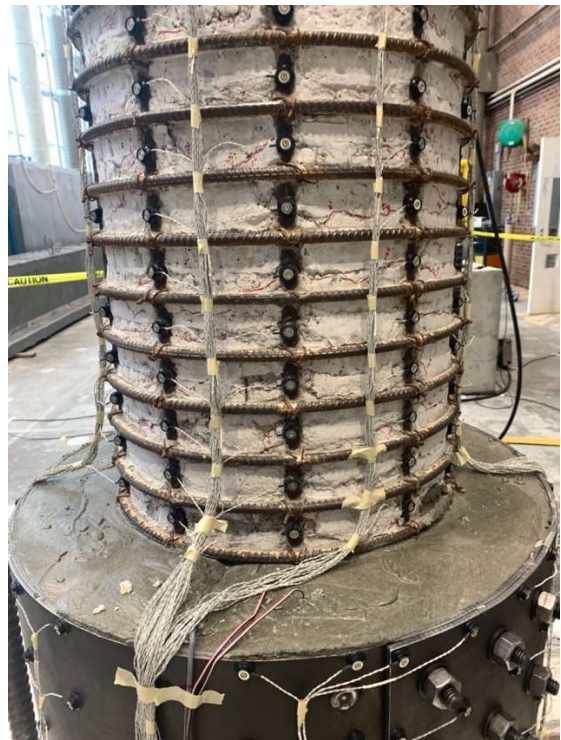
Figure 4.68: Damage During Ductility 1.5 of the North (left) and South (right) Sides.

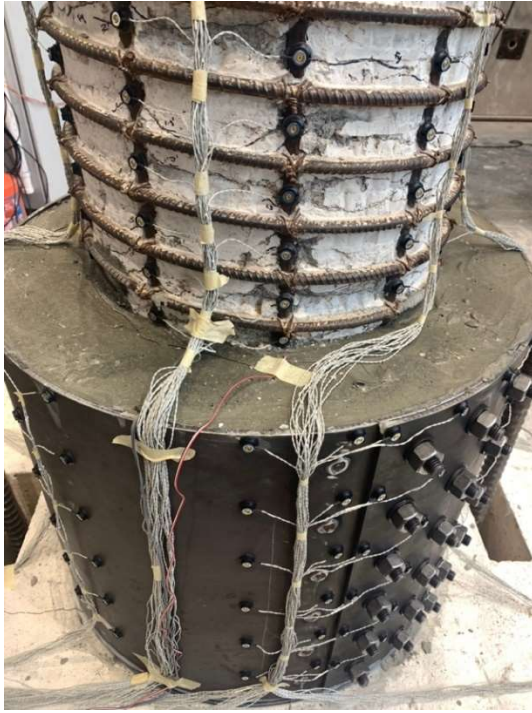
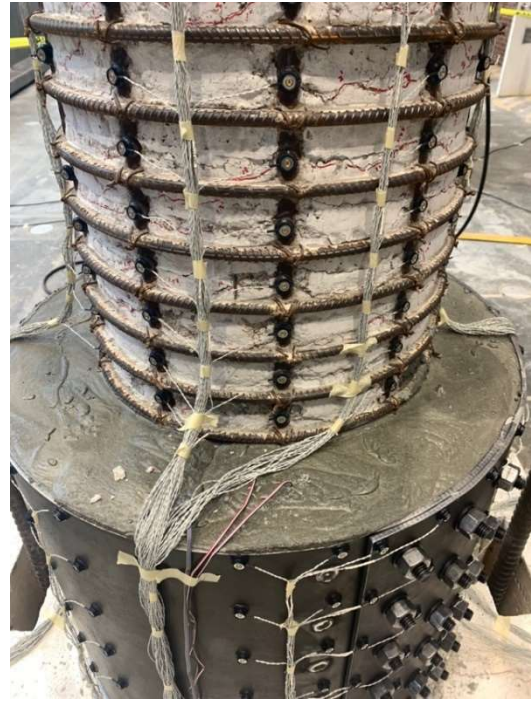
Figure 4.69: Damage During Ductility 2 of the North (left) and South (right) Sides.

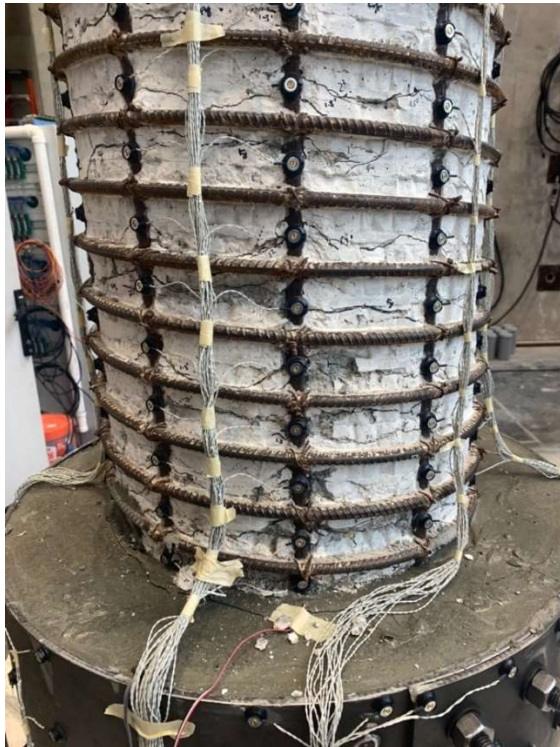
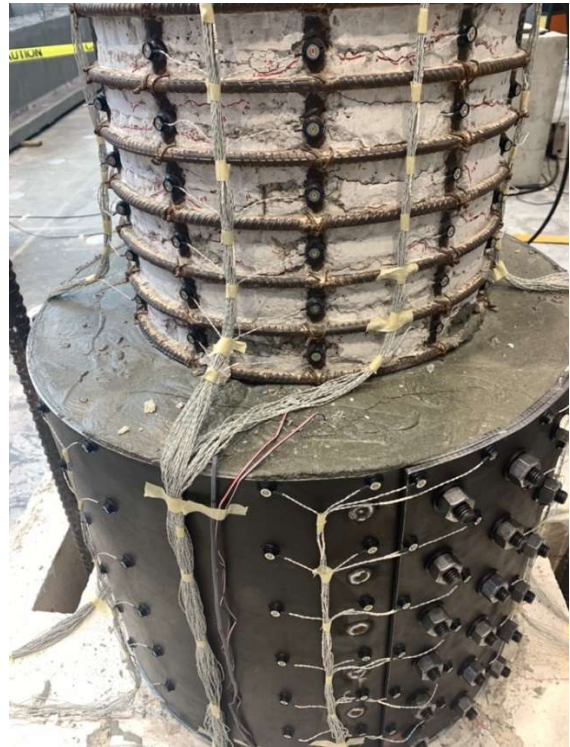
Figure 4.70: Damage During Ductility 3 of the North (left) and South (right) Sides.

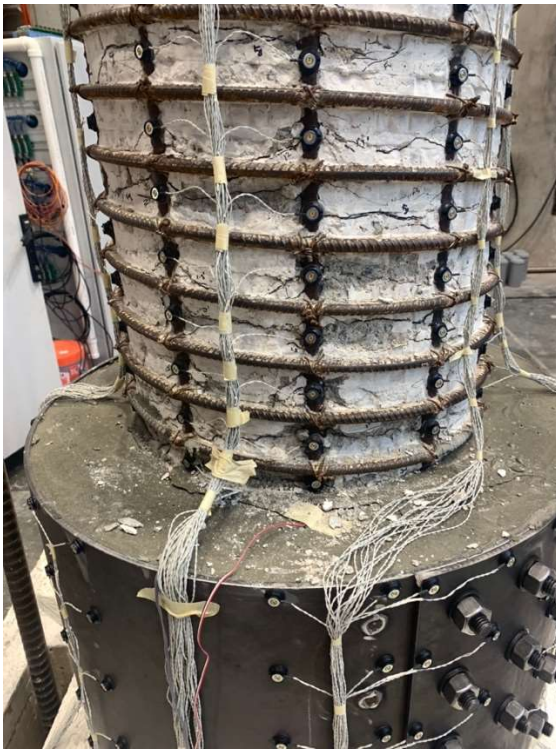
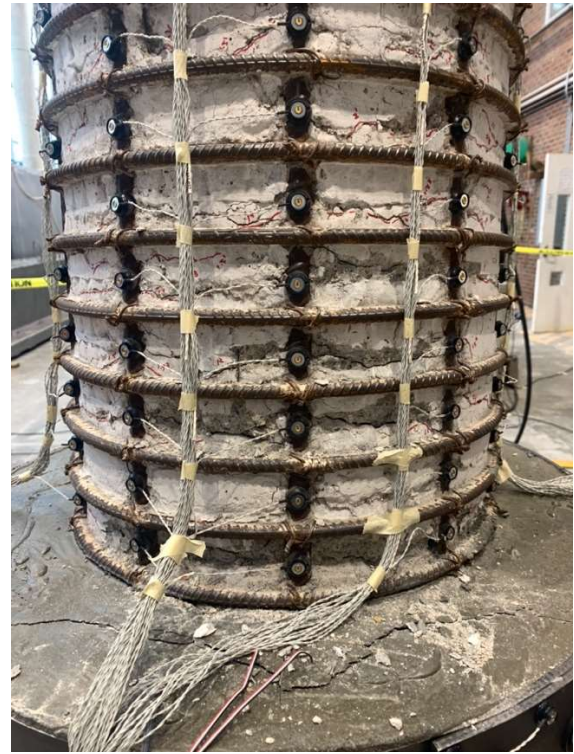
Figure 4.71: Damage During Ductility 4 of the North (left) and South (right) Sides.

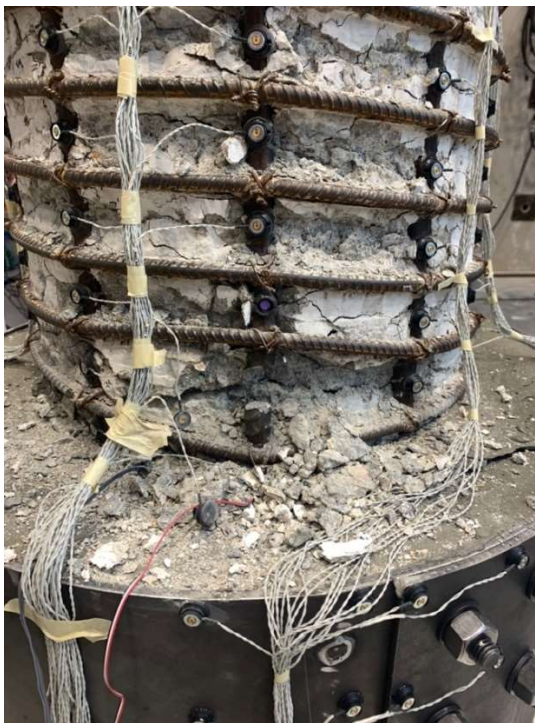
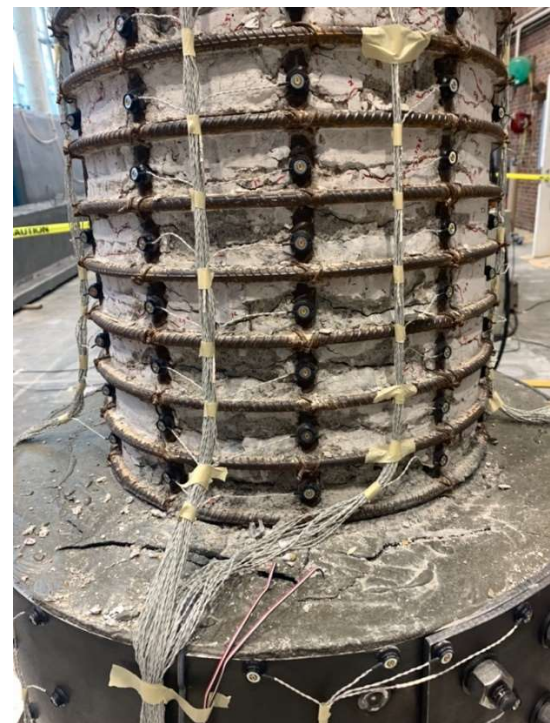
Buckling was observed during the second cycle of ductility 5 for the extreme bars on both sides of the column (bars S3 and N3). On the third cycle of ductility 5, N3 fractured. During the next push, S3 fractured before surpassing the ductility 5 displacement. In addition to N3 and S3 fracturing in the relocated hinge, N2 buckled.

Figure 4.72: Damage During Ductility 5 of the North (left) and South (right) Sides.

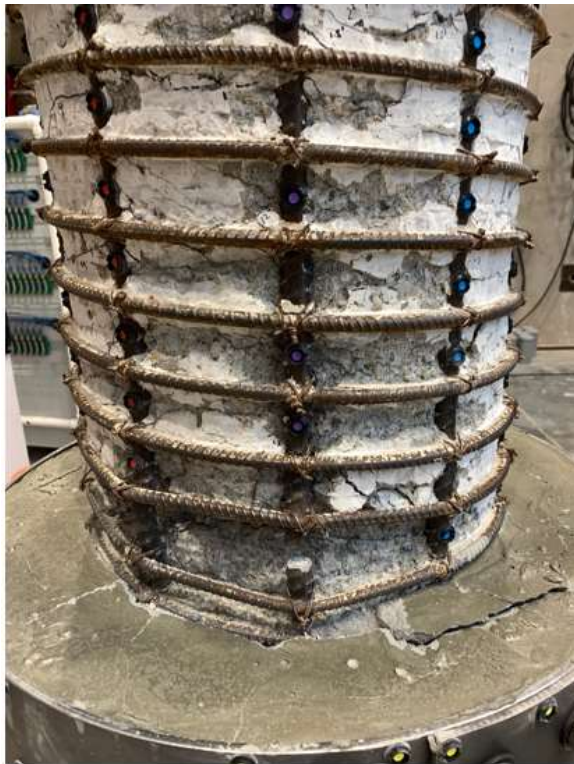
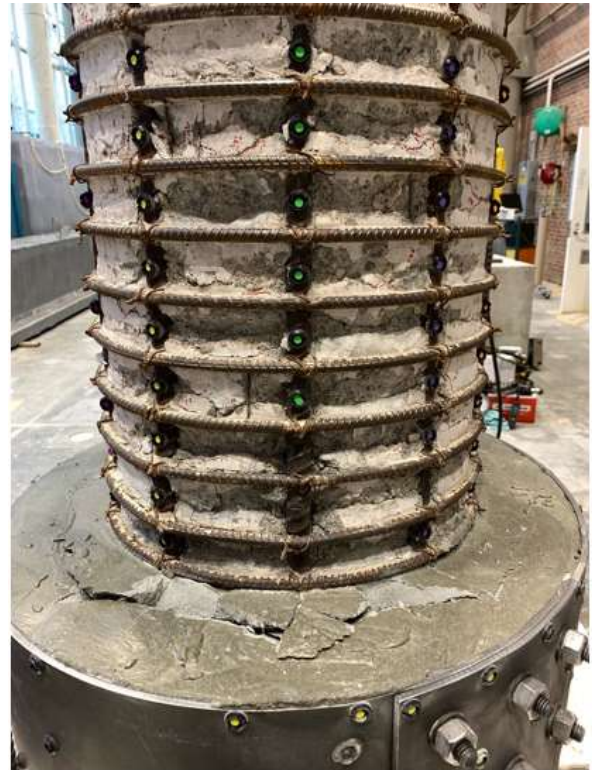
Figure 4.73: Damage after the test when all loose grout was removed of the North (left) and South (right) sides.

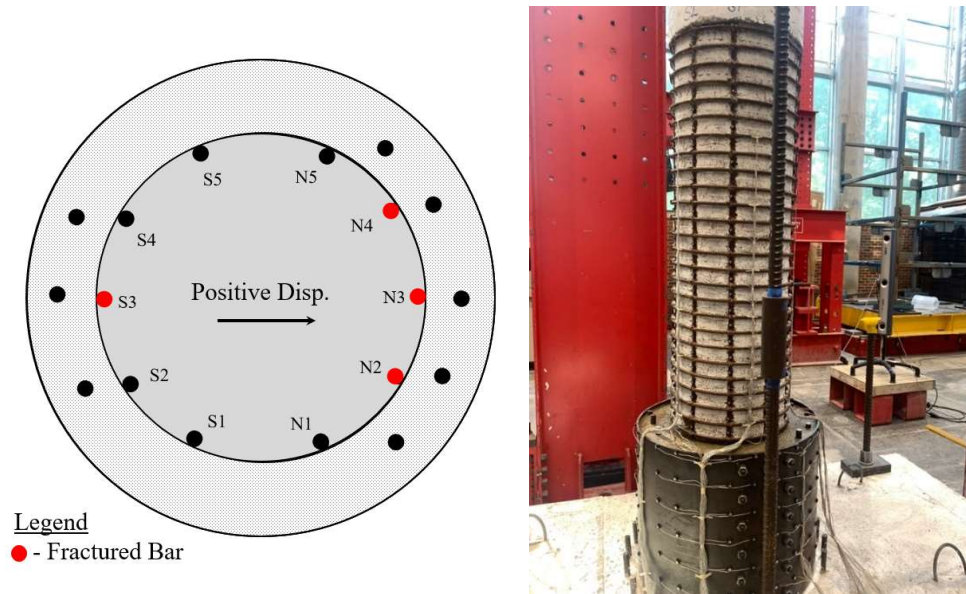
Figure 4.77: Repair Cross Section and Completed Repair.

6 bars were epoxy anchored into drilled holes in the footing. The strain from the previous test at the relocated hinge was less than the limit of 0.02 from Krish (2018). Epoxy grout was used as the backfill material and the completed repair is shown in Figure 4.77. The grout was poured to the same level as the top of the steel sleeve, but shrinkage resulted in a decreased height in addition to one large radial crack propagating through the entire height. Additional epoxy was poured into the crack, and after shrinkage the crack remained only at the surface. The properties for the original column and repair are summarized in Table 4.7.

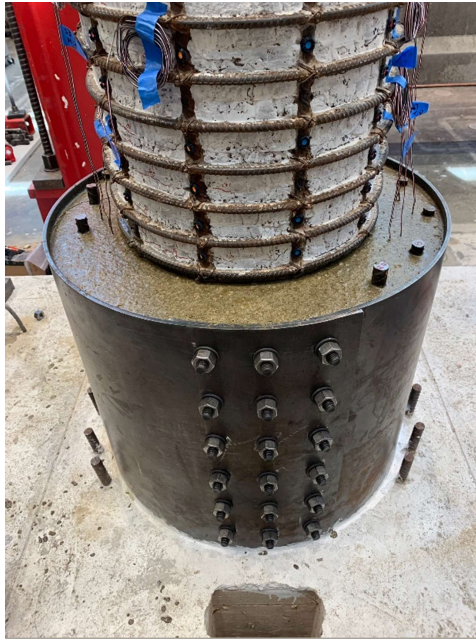
Figure 4.78: Initial Conditions

The original condition of the grout can be seen in Figure 4.78. The radial grout crack maintained the same size throughout the test, and no cracks formed in the grout for the majority of the test. One circumferential hairline crack formed on the South side during the first push of ductility 5. Cracks formed in the concrete at the interface between the column and repair during the first cycles of ductility 1; the original column cracks widened in these cycles. Beginning in ductility 1.5, new column cracks formed above the repair. Column concrete crushing happened during ductility 3. The damage progression is shown in Figures 4.80-4.85. Each picture was taken at the peak displacement for ductility cycle, with the shown side in tension.

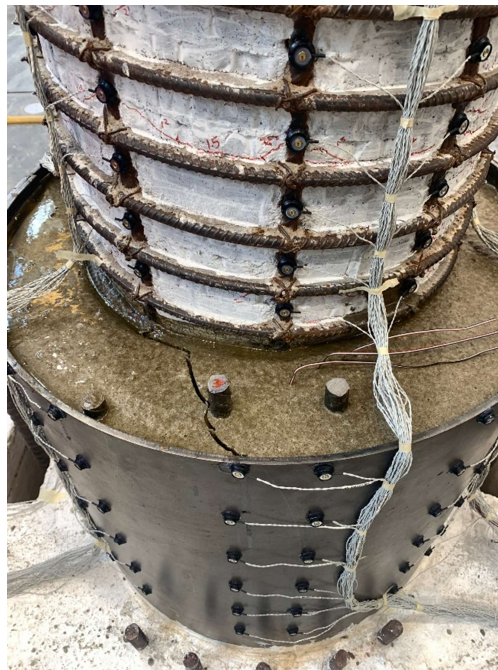
Figure 4.79: Initial Grout Crack

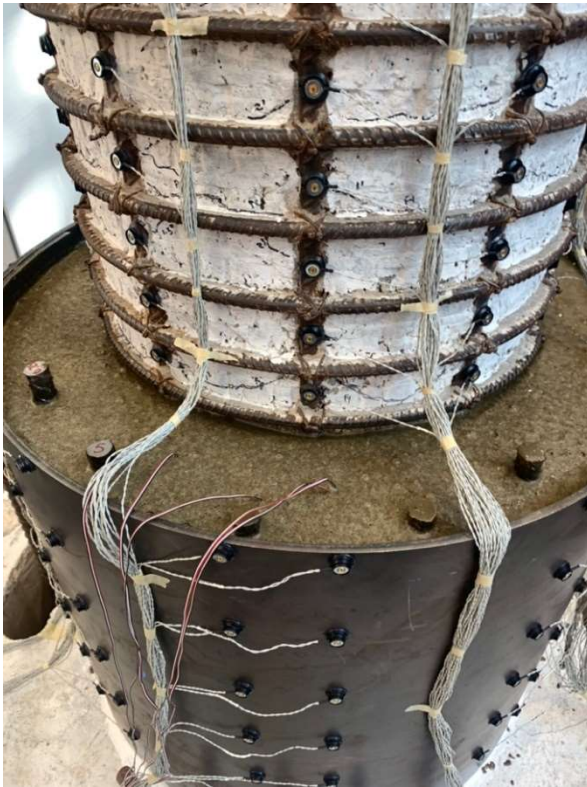
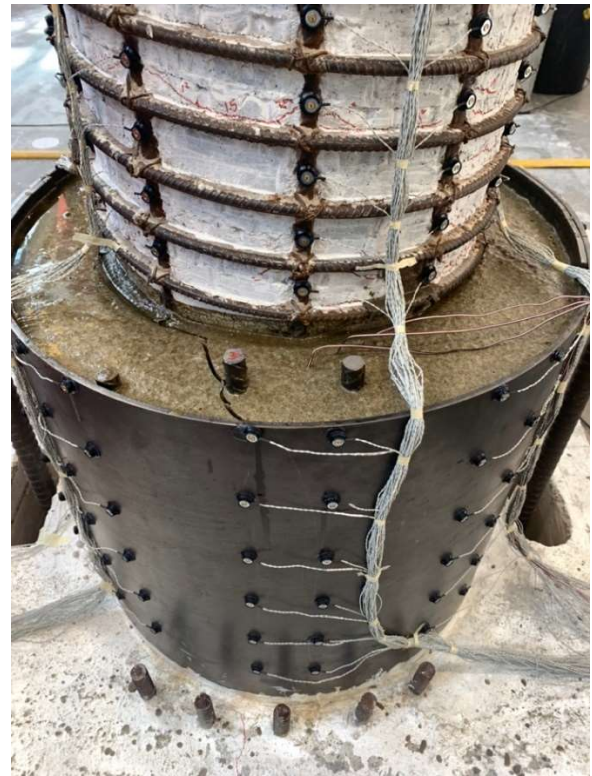
Figure 4.80: Damage During Ductility 1 of the North (left) and South (right) Sides.

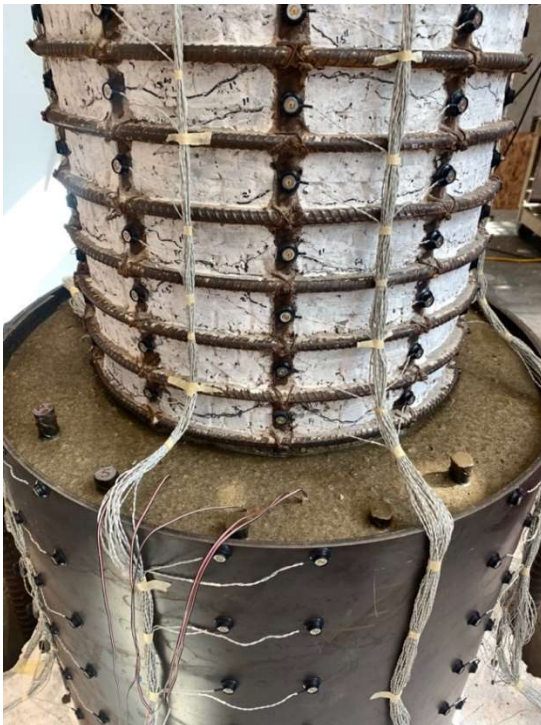
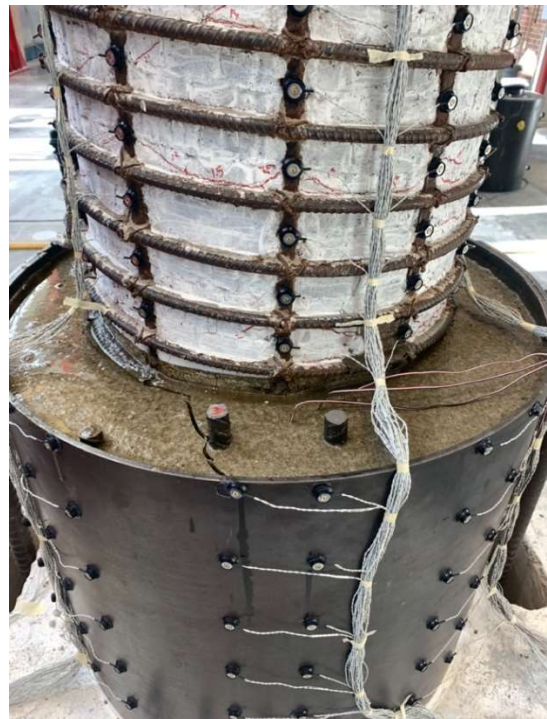
Figure 4.81: Damage During Ductility 1.5 of the North (left) and South (right) Sides.

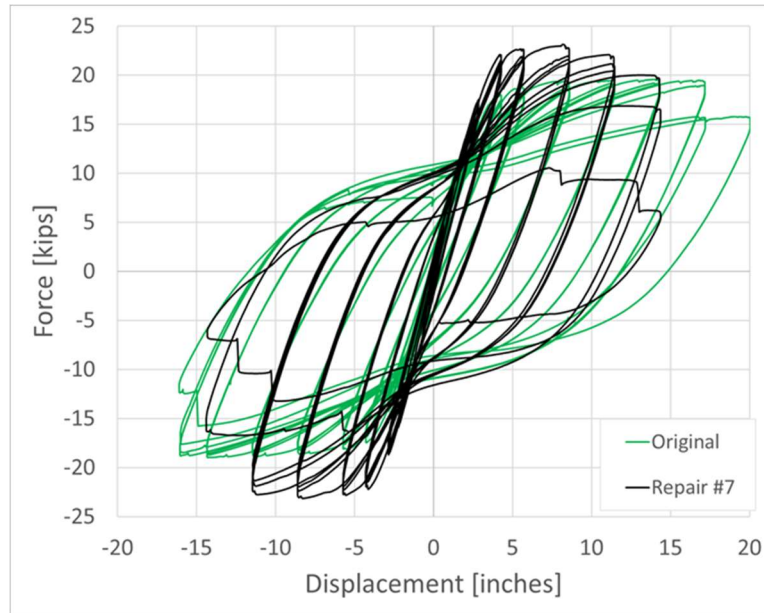
Figure 4.86: Force vs. Displacement of the Original and Repair Column Tests.

Figure 4.86 compares the force vs. displacement response of the repaired column with the original column. In this repair test, the repaired column was not able to reach the ductility level reached by the original column. The repaired column test ended after ductility 5. The original column failed at the third cycle of ductility 6.

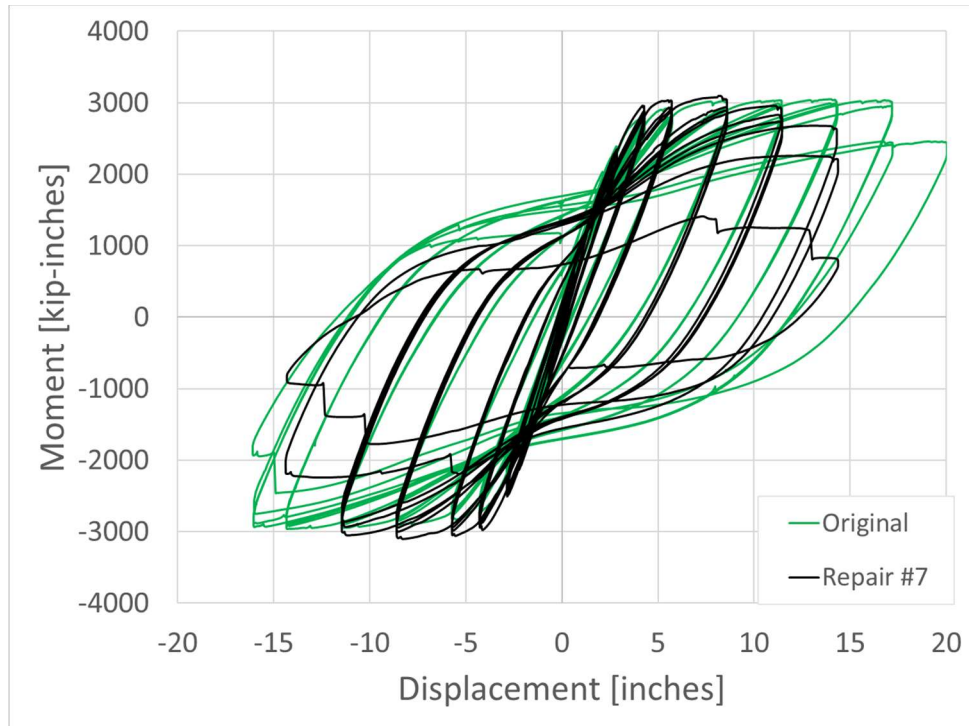
Figure 4.87: Moment vs. Displacement of the Original and Repair Column Tests.

The moment vs. displacement response is shown in Figure 4.87, and was produced following the procedure discussed in Section 4.3.4. The effective heights for the original column and repaired column are 156 inches and 134 inches, respectively. For the original column, the distance between the applied load and the top of the footing was 13 feet (156 inches). 4.81 shows that the performance of the repaired column is similar to that of the original column and even has similar stiffness. This is different from the previous repairs where the previous maximum strains above the repair are higher resulting in a softened response.

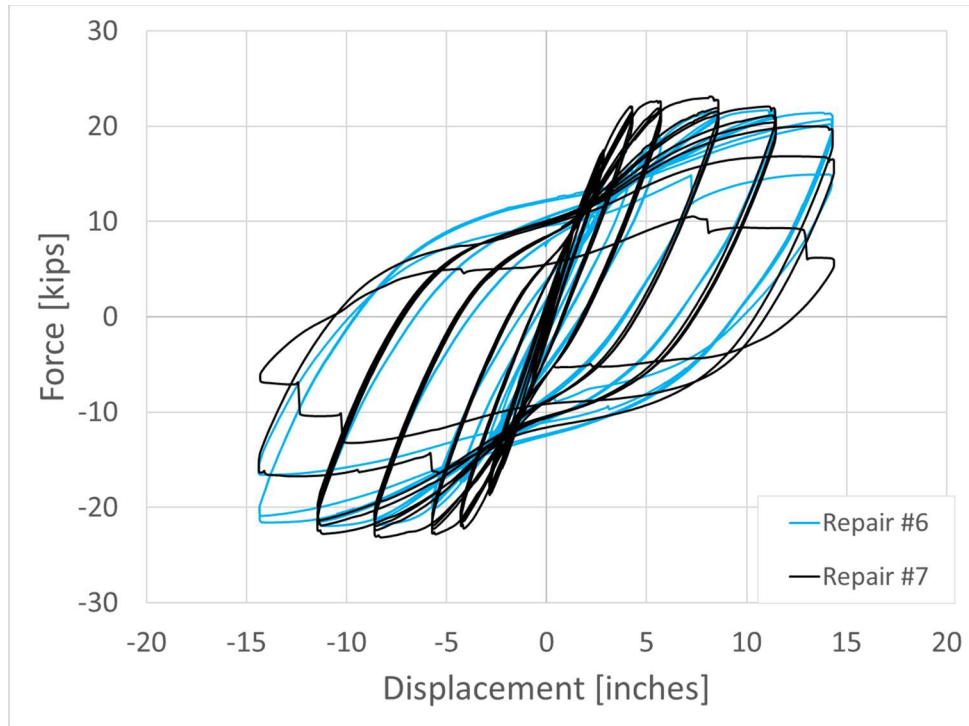
Figure 4.88: Force vs. Displacement of Repair #6 and Repair #7

A direct comparison between the force vs. displacement responses for Repairs #6 and #7 is shown in Figure 4.88. It is obvious that Repair #7 has a higher stiffness than Repair #6. The difference in damage conditions at the relocated hinge contribute to this difference in behavior. For Repair #6, the maximum strain from the original test above in the relocated hinge was 0.027, compared to 0.015 for Repair #7. As a reminder, the suggested maximum allowable strain in the relocated hinge is 0.02 based on the recommendations of Krish (2018).

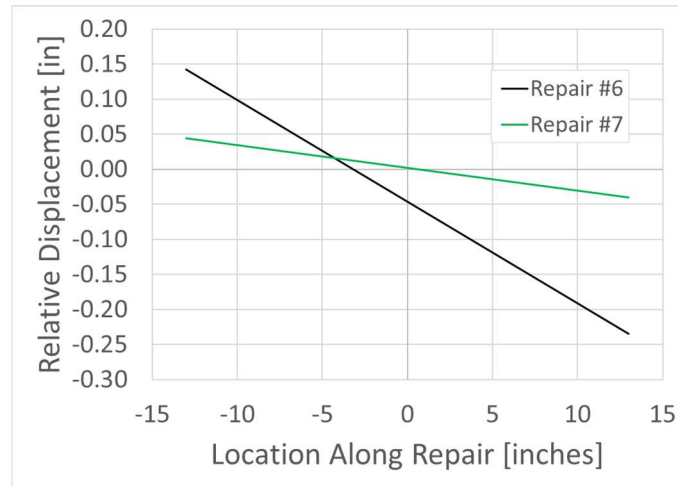
Figure 4.89: Repair Rotation at Ductility 4 for Repair #6 and Repair #7

A comparison of the strains on the repair bars is not available due to the heat generated by the epoxy grout during casting, which resulted in the strain gauges not working. Optotrak data from the exterior of the repair will be used to discuss the difference in repair performance. The LED markers allow for comparison of the repair rotation. The bottommost row of LED markers was used to trace the displacement relative to an LED on the fixed footing, and the line of best fit was used to determine the angle of repair rotation. Repair #6 (the cementitious grout comparison column) showed more repair rotation, which demonstrates that the epoxy grout did result in a more fixed condition.

One implication of this result is that less rotation of the repair leads to an increased flexural demand of the column section to reach the same displacement. The slope of the lines shown in Figure 4.89 at ductility 4 for Repairs #6 and #7 represents the angle of repair rotation. A comparison of the angle at the end of the first push cycle of each ductility level is shown for the two repairs in Figure 4.90. This decrease in repair rotation also suggests that the strain in the repair bars is less than Repair #6, and did not yield.

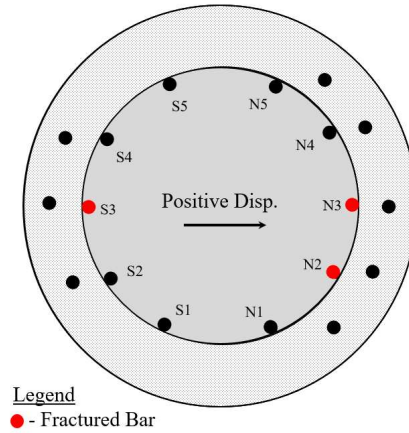
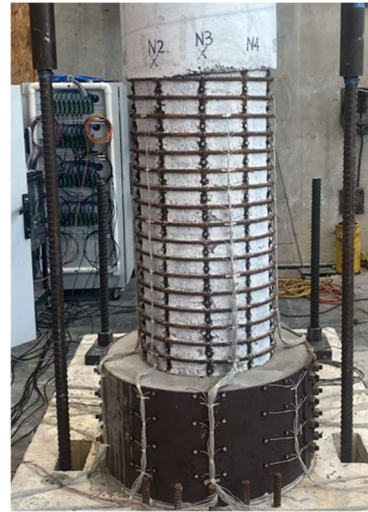
Figure 4.91: Cross section for Repair #8 and Completed Repair

The initial damage condition of this column consisted of 2 fractured bars on the South side and 1 fractured bar on the North side. The perimeter concrete was chipped around fractured bars. The repair reinforcement consisted of 8 Grade 80 No. 5 bars which were anchored using epoxy in drilled holes. The cross section for the repair is shown in Figure 4.91. The properties for the original column and repair are summarized in Table 4.8.

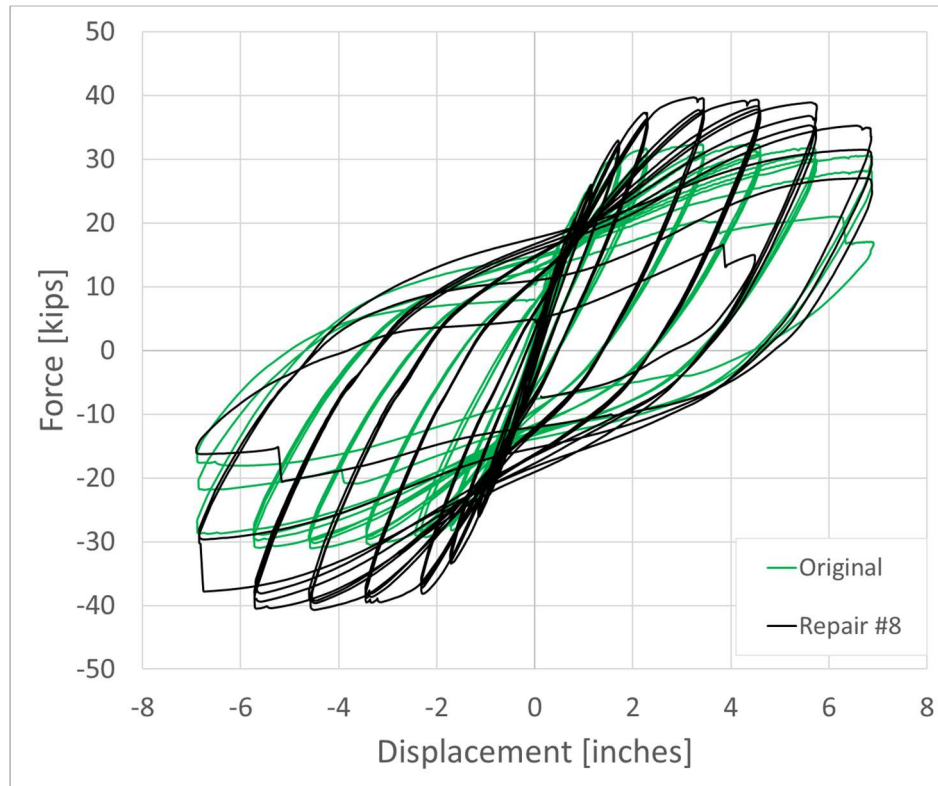
Figure 4.99: Force vs. Displacement of the Original and Repair Column Tests.

Figure 4.99 shows the force vs. displacement response in which this column reached the same displacement capacity as the original; the repair first experienced fracture during the first cycle of ductility 6, while the original completed an additional cycle before fracture. The repair response does display some strength degradation, especially after the extreme bar on the South side debonds during the second cycle of ductility 5.

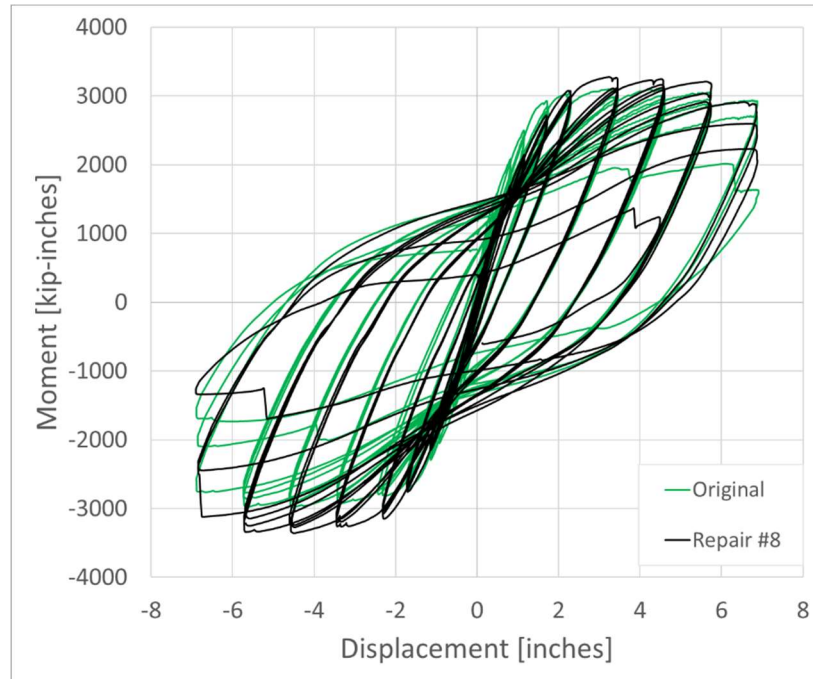
Figure 4.100: Moment vs. Displacement of the Original and Repair Column Tests.

Figure 4.100 shows the moment vs. displacement response where it can be seen that the repaired column had an increased moment capacity compared to the original column. However, the stiffness of the repaired column was lower, because decreasing the height of the repair results in higher levels of damage at the relocated hinge, resulting in lower stiffness.

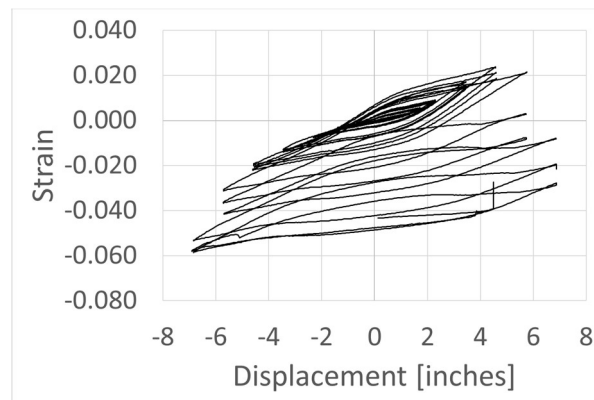
Figure 4.101: Strain History of S3 in Repair #8.

During the test, the most extreme bar on the North side (N3) buckled and fractured above the steel jacket. On the South side, however, S3 did not fracture and the test ended with the fracture of the next most extreme bar (S2). Figure 4.101 shows the strain history of S3, which shows the tensile strains decreasing in ductility 5, demonstrating that this bar debonded and stopped contributing to the strength of the repaired column. This is also apparent in the force vs. displacement response in Figure 4.99 as the difference in forces between the first and second push cycles of ductility 5.

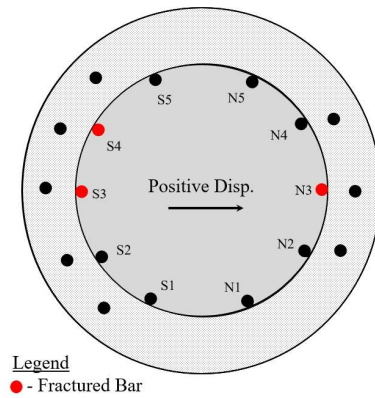
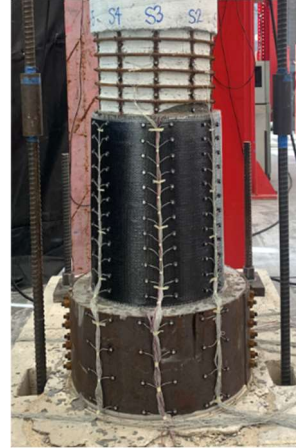
Figure 4.102: Cross Section for Repair #9.

The initial damage condition of this repair was 1 fractured bar on the North side and 2 fractured bars on the South side. The perimeter concrete was chipped around the fractured bars. The cross section and completed repair is shown in Figure 4.102. To compare the influence of the CFRP wrap with Repair #8, the repair height was 13.5 inches. Although 13.5 inches was not sufficient to anchor all of the previously fractured bars in Repair #8, the CFRP wrap could improve the bond conditions, while minimizing the increase in moment demand at the footing. The properties for the original column and repair are summarized in Table 4.9.

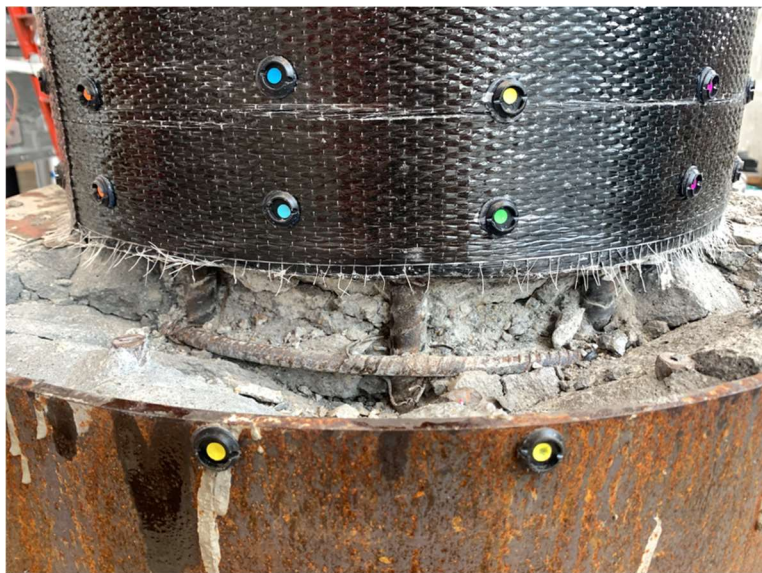
Figure 4.108: Removal of Grout to Locate Fracture Points.

Because of the presence of the CFRP wrap, the longitudinal bars were not visible during the test, and they could not be instrumented with Optotrak LEDs to obtain direct strain measurements. The inferences about longitudinal bar behavior throughout the progression of the test were based on the changes in force applied by the actuator. During the first cycle of ductility 8, there was a loud noise and drop in force which indicated a bar fracture on the South side. In the following pull, 3 distinct noises and drops in force occurred. After the test concluded, the grout at the interface between the steel repair and CFRP was removed to determine the fracture locations. All 4 bar fractures that were heard in the test were found approximately one inch below the FRP, as shown in Figure 4.108. The bars did not show any sign of buckling.

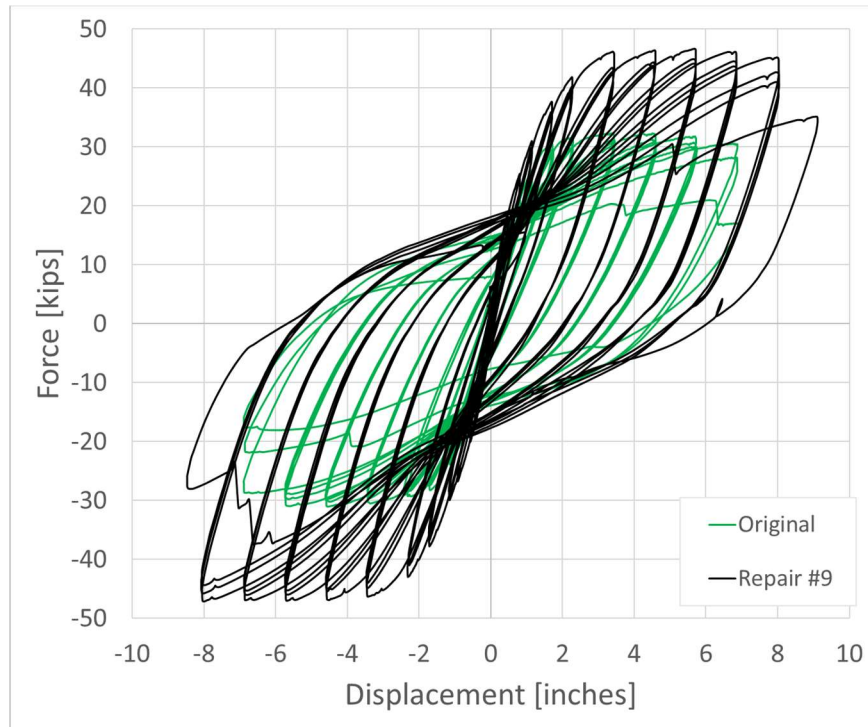
Figure 4.109: Force vs. Displacement of the Original and Repair Column Tests.

In Figure 4.109, the force vs. displacement response shows that the repair was able to maintain strength without degradation until bars began to fracture. In previous repairs where the original ductility capacity was met, the response softened before reaching the target ductility. The displacement capacity for this repair exceeded that of the original column. The original column completed 3 cycles at ductility

6, while the repaired column completed 3 cycles at ductility 7 and bars fractured during the first push and pull of ductility 8.

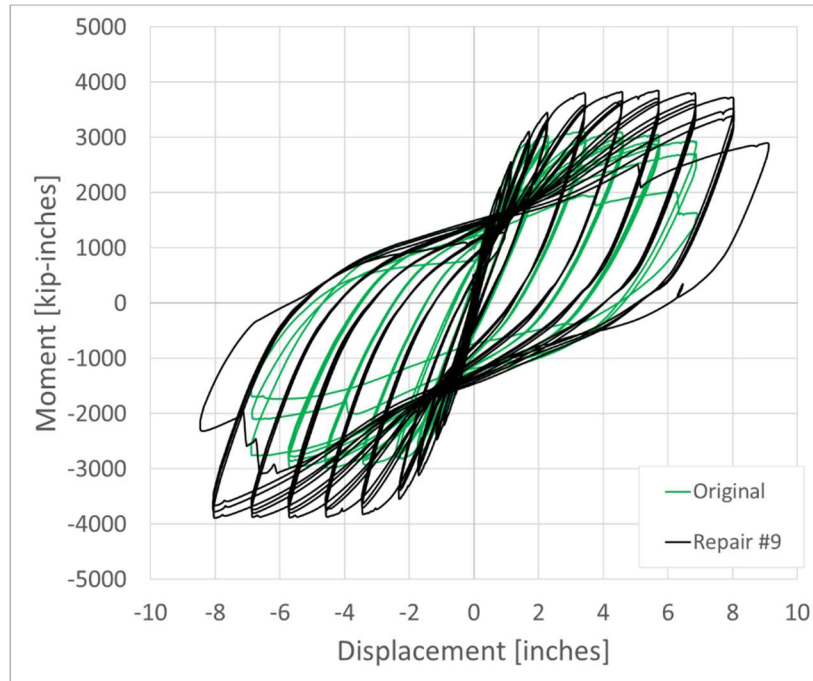
Figure 4.110: Moment vs. Displacement of the Original and Repair Column Tests.

It is evident in the moment vs. displacement response shown in Figure 4.110 that the moment is higher for the repaired column compared to the original. Part of the reason for this increased moment at the relocated hinge is the presence of the confined cover concrete. In the original column, the cover is blocked out to allow for instrumentation of the reinforcing steel, and the moment would theoretically be larger if the cover was included. Including the cover in the original column moment would reduce the difference in moments for the two tests, but the moment capacity would still increase because of the confinement from the CFRP wrap, which engages the concrete cover as well as increases the compressive strength and strain capacity of the concrete core.

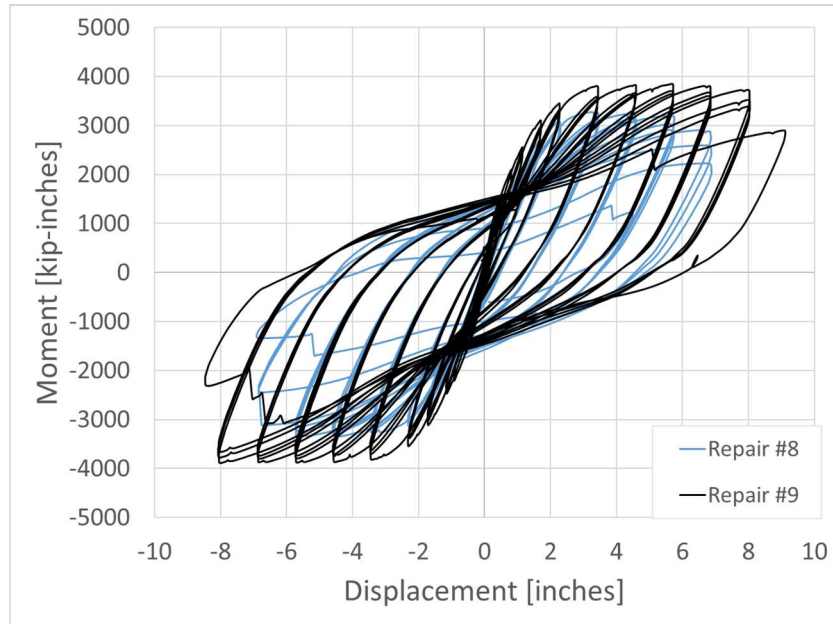
Figure 4.111: Moment vs. Displacement of Repair #8 and Repair #9.

Figure 4.111 provides a direct comparison of the moment vs. displacement response between Repairs #8 and #9. The repairs are nominally identical, except Repair #9 has the addition of the CFRP wrap. The main difference in response is the additional moment capacity from the engaged cover and increased strength of the confined core. The CFRP wrap did result in a larger displacement capacity than Repair #8, as well as a decrease in strength degradation at larger ductilities.
