Rapid Seismic Repair of Column to Footing Connections – Phase 2

Alaska Department of Transportation & Public Facilities

1. AGENCY USE ONLY (LEAVE BLANK)		2. REPORT DATE May 31, 2022		3. REPORT TYPE AND DATES COVERED FINAL REPORT, Jan. 2019 through May 2022
4. TITLE AND SUBTITLE Rapid Seismic Repair of Column to Footing Connections – Phase 2			5. FUNDING NUMBERS

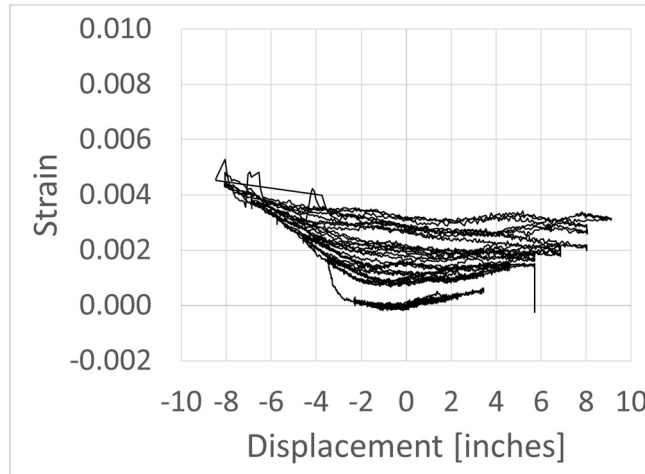
Figure 4.112: Hoop Strain History of CFRP wrap in Repair #9.

Figure 4.112 shows the strain history for the hoop strains in the FRP, calculated using Optotrak LEDs placed on the CFRP wrap. This is shown for the maximum measured hoop strain, which was found at the base of the CFRP wrap on the South side of the column. When the column is pulled to negative displacements, the South side of the column is in compression, resulting in larger dilation and therefore leading to larger strains. The maximum measured CFRP hoop strain was approximately 0.5%. The ultimate tensile elongation is determined by testing the CFRP in uniaxial tension, and experimentation shows that the true failure strain is reduced for hoop fibers. Considering the ultimate tensile elongation for the CFRP used in this repair is 1.7%, according to the manufacturer data sheet, and the efficiency factor of 0.55 (ACI 440.2R-08, 2008), the expected maximum CFRP hoop strain would be 0.935%. This suggests that the number of CFRP wrap layers could be reduced while still providing effective confinement, which was tested in Repair #10.

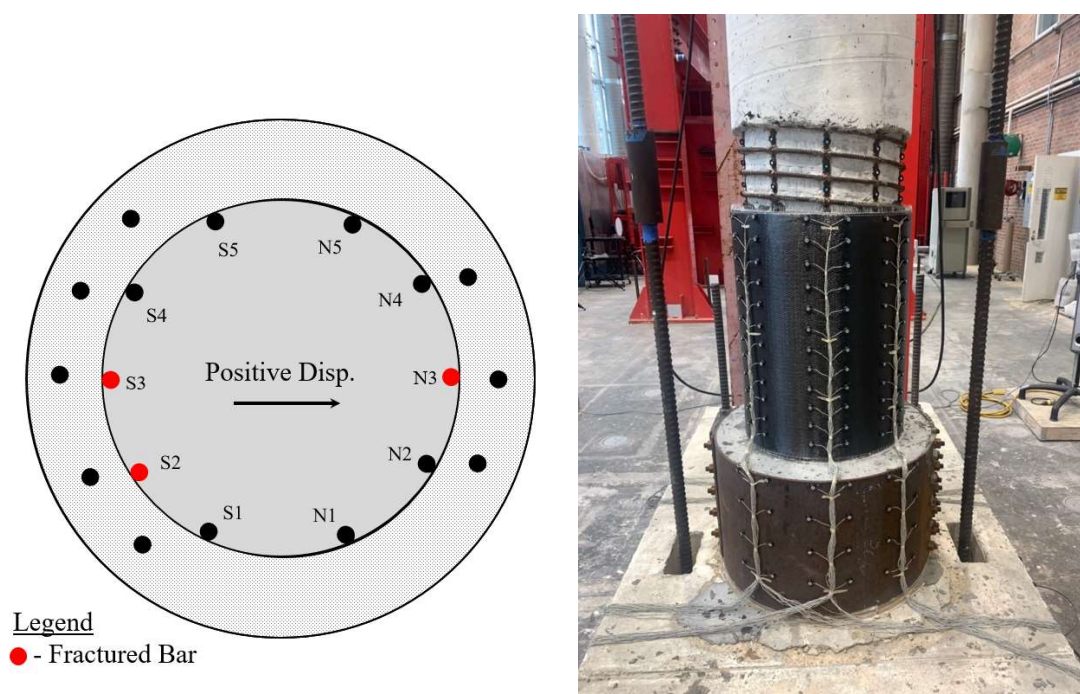
Figure 4.113: Cross section for Repair #10

The damage condition for this column was 1 fractured bar on the North side and 2 fractured bars on the South side. The perimeter concrete was chipped around the fractured bars. The cross section of the repair consisted of 8 Grade 80 No. 6 bars and is shown in Figure 4.113. To ensure that all of the previously fractured bars would remain anchored, the repair height was 0.9D, or 16.5 inches. The number of layers used for the CFRP wrap was reduced from 3 layers to 2 layers. The properties for the original column and repair are summarized in Table 4.10.

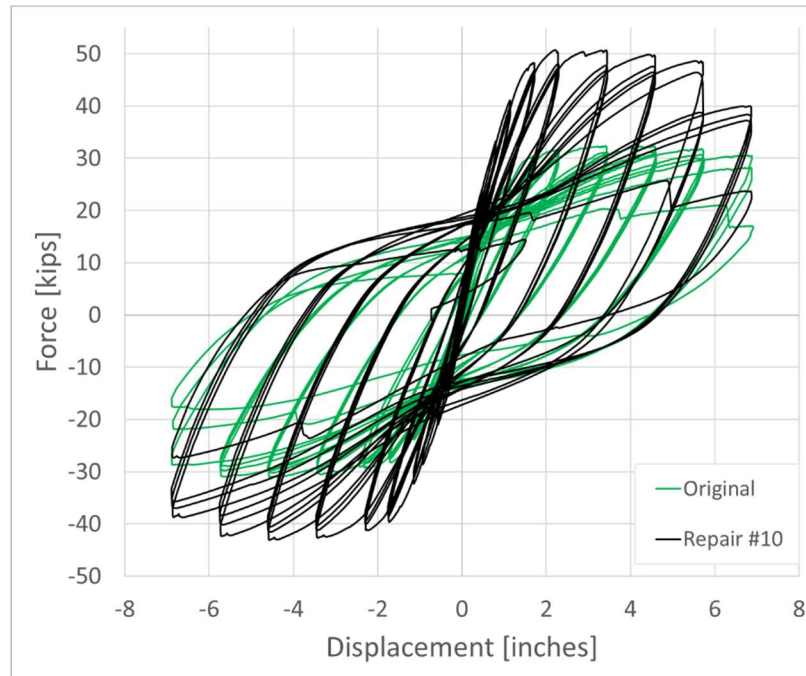
Figure 4.122: Force vs. Displacement of the Original and Repair Column Tests.

Figure 4.122 shows the force vs. displacement response for Repair #10. In this test, the first fracture for the repaired column occurred during ductility 5 while the original column had an ultimate displacement ductility of 6. Compared to Repair #9 which had an additional layer of the CFRP wrap, this column exhibits slightly more strength degradation, but still maintains most of its strength until bar fracture.

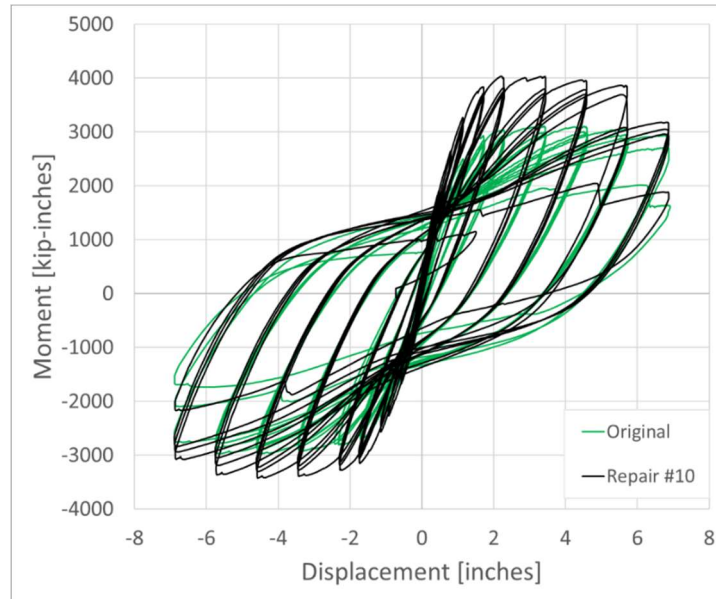
Figure 4.123: Moment vs. Displacement of the Original and Repair Column Tests.

Comparing the moment vs. displacement responses in Figure 4.108, the moment in the repair is significantly higher than the original column. This is because of the concrete cover that is now confined and providing additional capacity, as discussed in Section 4.9.4.

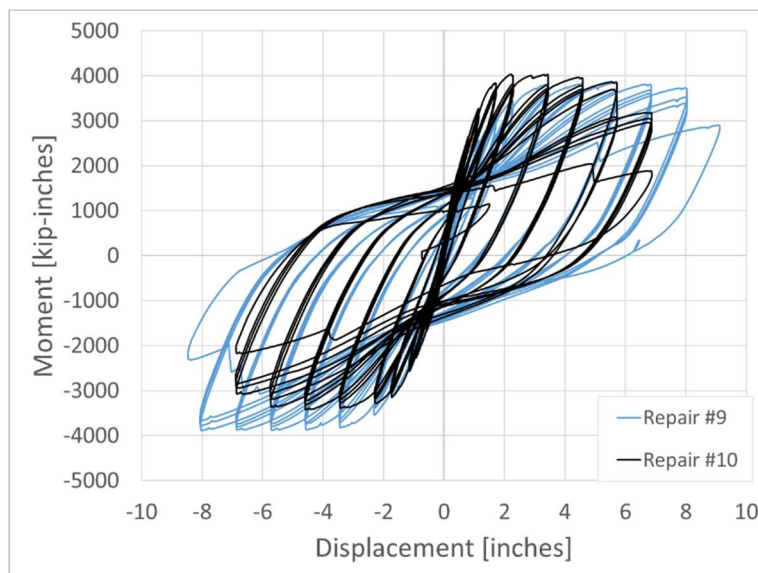
Figure 4.124: Moment vs. Displacement of Repair #9 and Repair #10.

The moment vs. displacement response is compared for Repairs #9 and #10 in Figure 4.124. Repair #9 used 3 layers of CFRP wrap and a repair height of 13.5 inches, while Repair #10 used 2 layers of CFRP wrap and a repair height of 16.5 inches. The influence of repair height should be negligible when comparing the moment response, although the increased stiffness of Repair #10 indicates that changing the repair height influences the stiffness. Repair #10 exhibits more strength degradation, and reaches a lower ductility level.

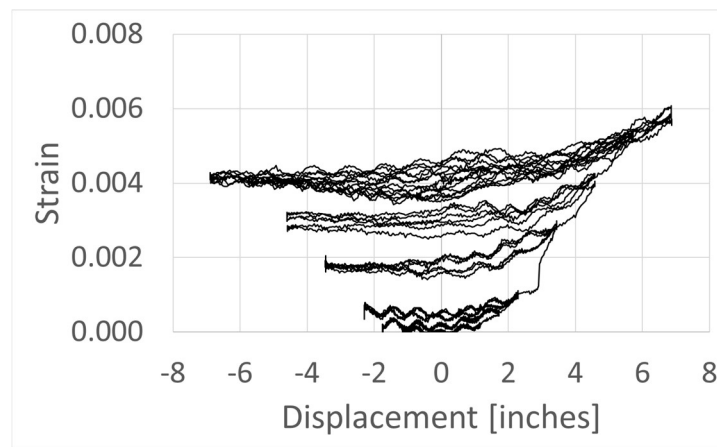
Figure 4.125: Hoop Strain History of CFRP wrap in Repair #10.

Figure 4.125 shows the strain history for the hoop strains in the FRP, calculated using Optotrak LEDs placed on the CFRP wrap. The maximum measured hoop strains were found at the base of the FRP on the North side. For positive displacements, the North side is in compression which causes more dilation and the strains to be higher than negative displacements. Using fewer layers of CFRP wrap did result in an increase in measured hoop strain compared to Repair #9. The maximum measured hoop strain was 0.006; this is 50% higher than the measured hoop strain at the same ductility level in Repair #9. However, the fewer layers were not able to prevent the reinforcement from buckling, which led to column failure at a ductility level less than the original column.

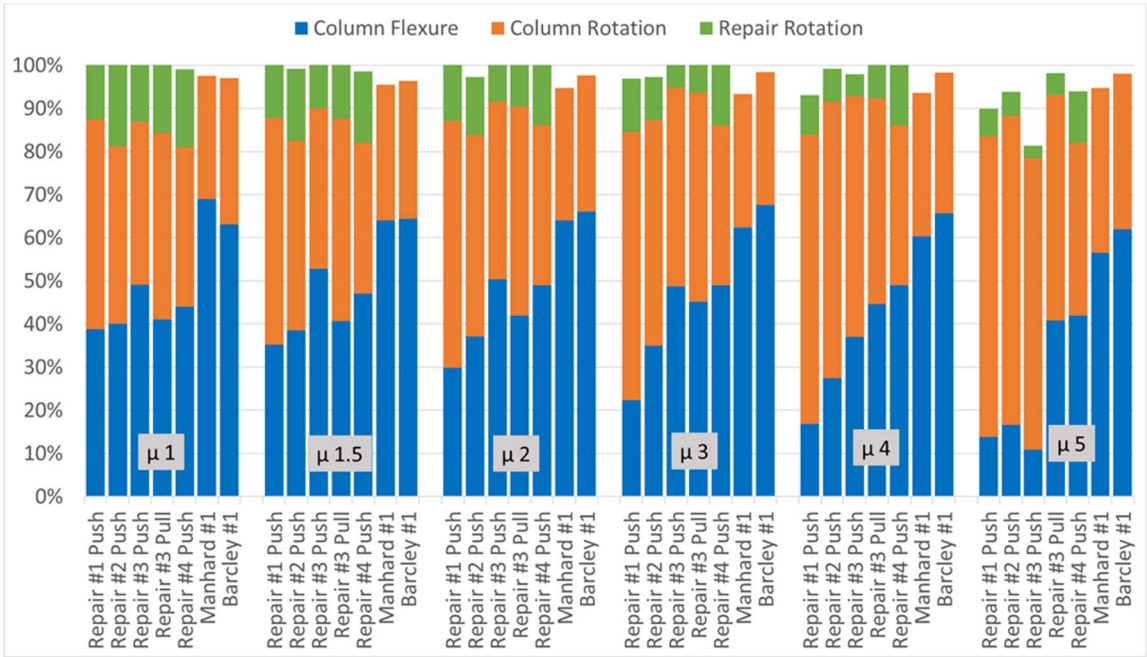
Figure 4.126: Proportional comparison of the components of deformation for 24" diameter columns.

Looking first at the two comparison columns on the far right of each ductility in Figure 4.114, it can be seen that flexural deformation accounts for about 60-65% of the column's displacement, with only a slight drop in proportion in the largest ductilities. In comparison, all of the repairs begin with flexural deformation accounting for about 45% of the displacement in ductility 1. For Repair #1 push cycles, this proportion steadily dropped through every cycle and was essentially replaced by column rotation. This is because the plate slip in this repair, which reduced confinement inside the repair, provided a weak anchorage of the column inside the repair making rotation easier. Repair #2 sought to improve this anchorage by using pre-tensioned bolts to prevent slip of the plates. It can be seen in Figure 4.114 that initially there is only a minor drop in the proportion of flexural deformation, but once the fractured bars debonded in ductility 3, the proportion rapidly drops and causes more column rotation as was seen with Repair #1.

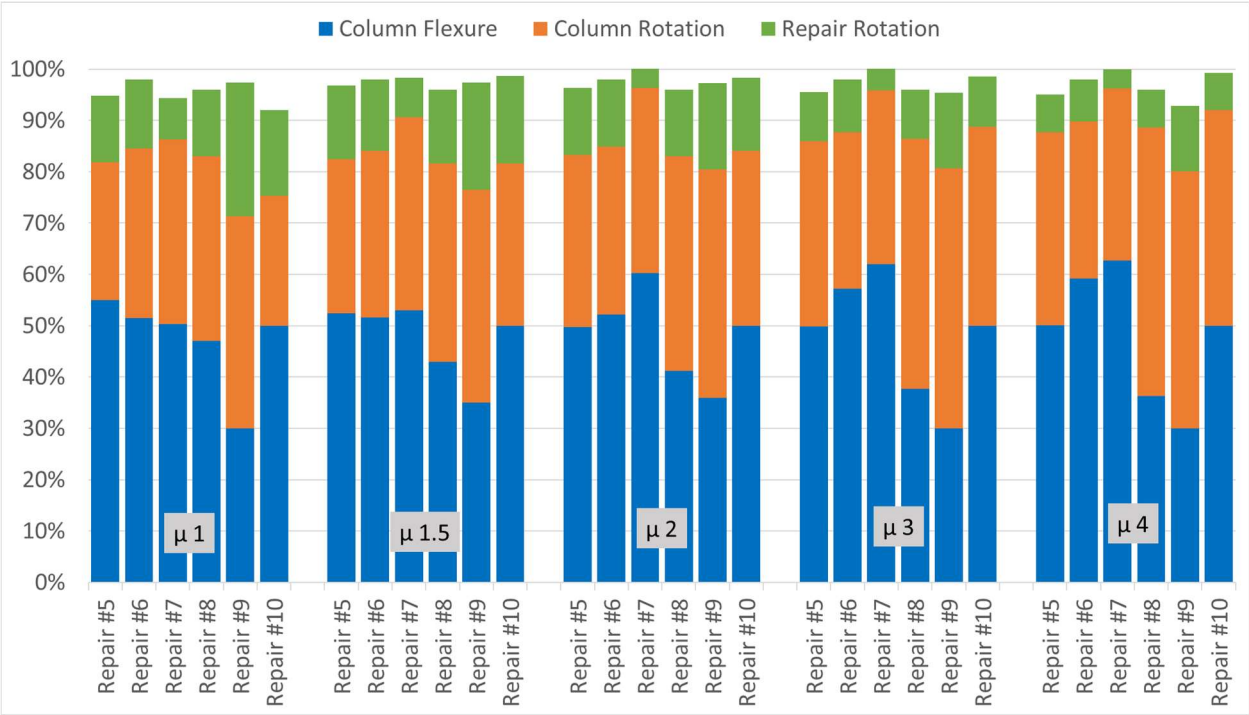
Figure 4.127: Proportional comparison of the components of deformation for 18" diameter columns

Figure 4.127 compares the components of deformation for the columns of 18" diameter. Repair #5 and Repair #6 compare columns of different heights. For Repair #6, which was 13 ft tall, the effective height considering the height of the repair was closer to the original column height; this results in proportions of flexure similar to what would be seen in an original column (around 60% at ductility 4). Repair #7 was also 13 ft tall and also exhibited a large proportion of column flexure. The contribution due to repair rotation was less for this repair, which used an epoxy grout, compared to all of

The difference between Repair #5 and Repair #8 was the height of the steel sleeve. For Repair #8, the height of the sleeve was decreased. While the amount of repair rotation remained similar, one previously fractured bar debonded in Repair #8, which resulted in a reduction of column flexure and increase in column rotation. Repair #9 was similar to Repair #8, with the addition of 3 layers of CFRP wrap. The flexural rotation was decreased for Repair #9, which shows that the displacement capacity can be increased with the addition of the CFRP wrap, because the section will have less flexural demand; however, the increased column rotation concentrates large strains at the base of CFRP wrap, which could limit the displacement capacity.

Repair #10 reduces the amount of CFRP layers from 3 (in Repair #9) to 2, and has an increased repair height. The response of Repair #10 can also be compared to Repair #5 which had the same repair height, but did not include the CFRP wrap. The behavior of Repair #10 is very similar to Repair #5, indicating that the 2 layers of CFRP were not sufficient to improve the behavior of the repaired column.

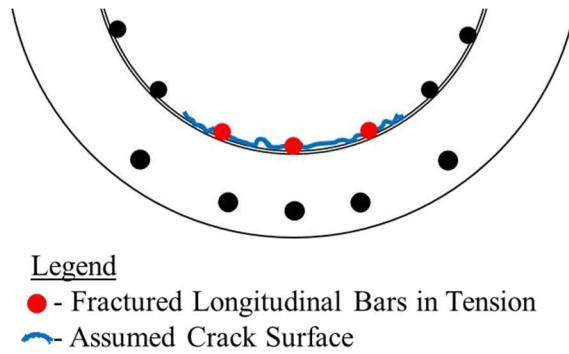
Figure 5.1: Assumed Crack Shape for Lap-Splice Failure.

The effects of confinement on the non-contact lap splice in the repair is likely to be the controlling factor in finding the required sleeve thickness. While Priestley's design method was intended for columns that were constructed using starter bars that extend from the footing and are lapped with column longitudinal bars in the plastic hinge, the splitting failure mechanism described is still considered to be the cause of the fractured bars debonding in this repair. In short, this mechanism assumes that a crack will form around the bars along the length of the splice and confining forces along the splice will act to anchor the bar through friction. If the force from the bar is too large, then the bar will slip at the crack and the lap-splice will fail. Based off the experimental tests, the splitting crack

surface is assumed to be along the radius of the column longitudinal bars which is shown in Figure 5.1 and can be calculated for each bar using Equation 5.1 where D' is the diameter of the spiral and n is the number of longitudinal bars. With this assumed crack shape, the required volumetric ratio for the steel sleeve can be found using Equation 5.2 according to Priestley's design and substituting Equation 5.1 and Equation 5.3 into Equation 5.2 results in the required thickness in Equation 5.4. This resulted in a required thickness of 0.20 inches for the columns in this repair and is why the 0.25 inch thick plate was used in Repair #3.
