Impact of Water/ Cementitious-Based Concrete Mix Design Specification Changes on Concrete Pavement Quality

July 2018

Research Project
Final Report 2018-25

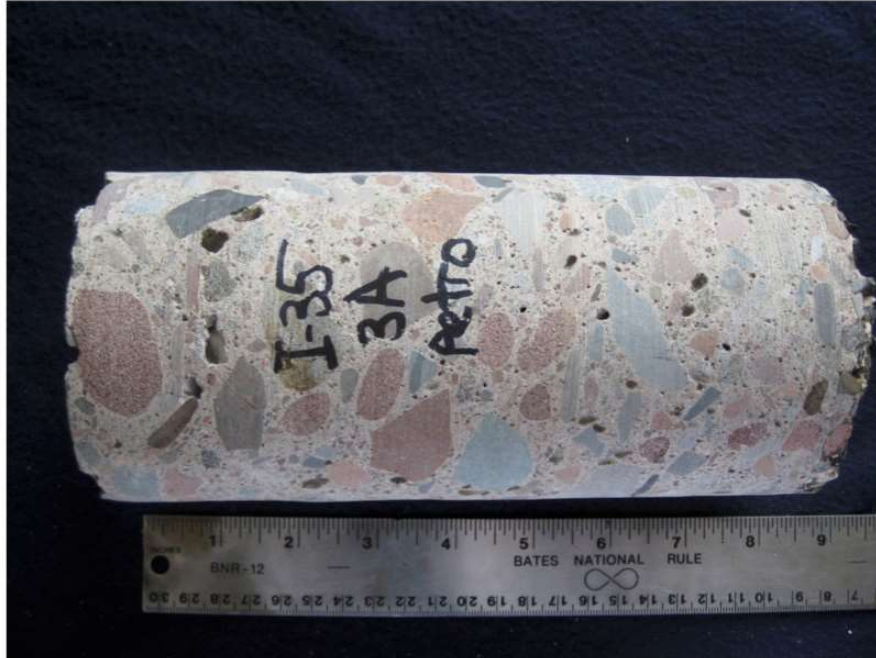
PHOTO: 7

SAMPLE ID: 0980-127, 3A **DESCRIPTION:** "Mid-panel" core sample selected for petrographic analysis.

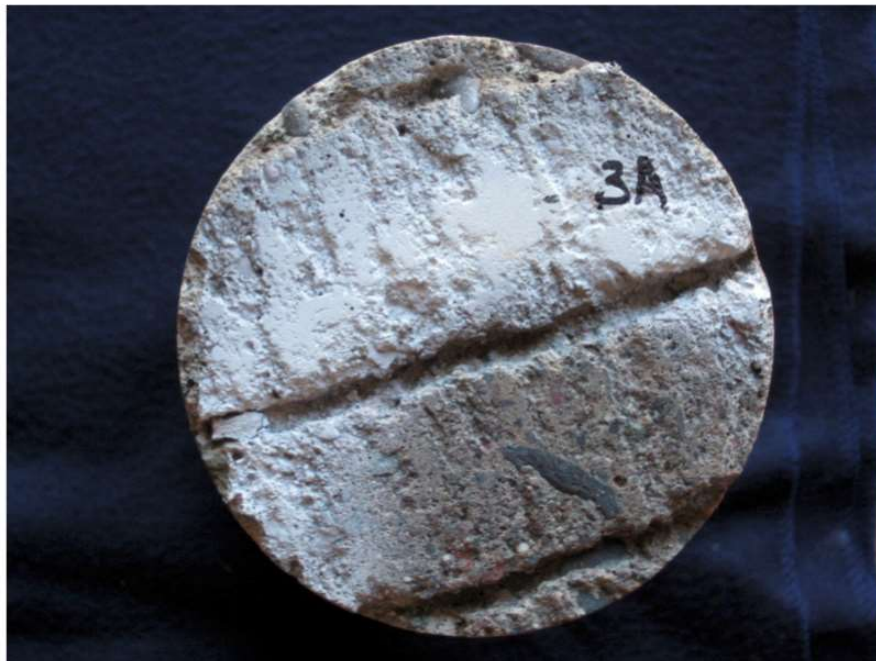
PHOTO: 8

SAMPLE ID: 0980-127, 3A **DESCRIPTION:** Rough screeded and tined top surface of the core with traffic wear exposing coarse aggregate surfaces.

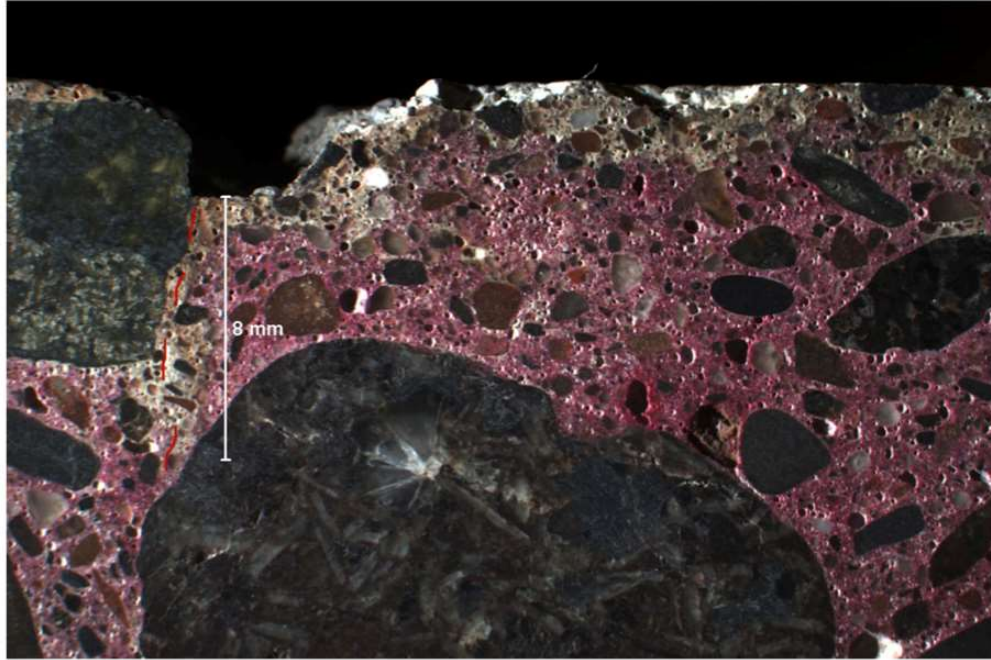
PHOTO:
98

SAMPLE ID: 0980-127, 3A **DESCRIPTION:** Carbonation (unstained paste) ranged from negligible up to 8mm depth from the top surface; along sub-vertical drying shrinkage microcracking mapped in red ink. A freshly sawcut and lapped cross section of core exposed to phenolphthalein pH indicator.
MAG: 5x

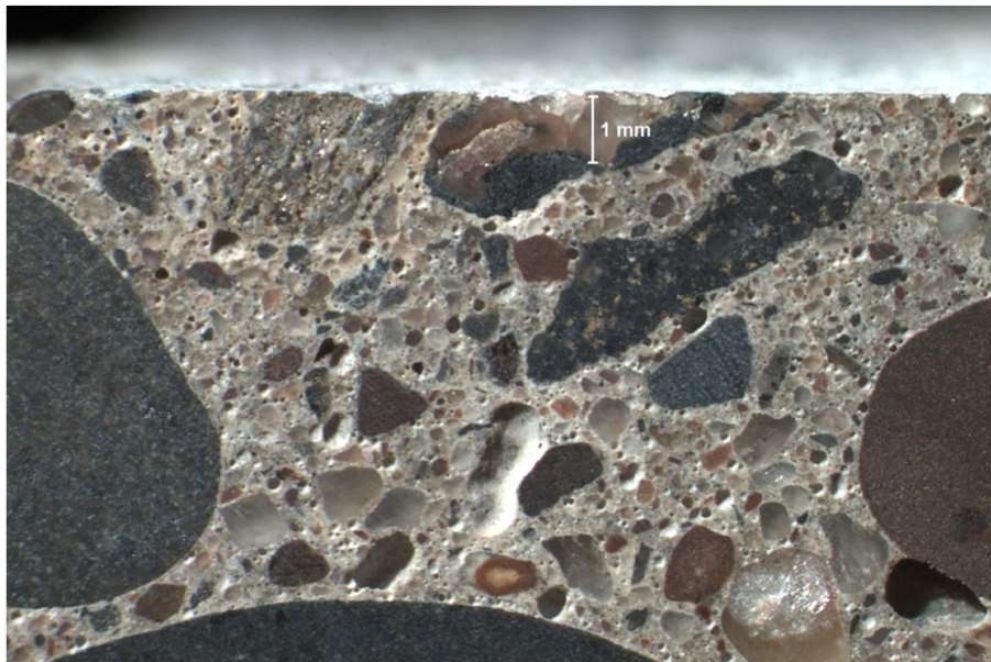
PHOTO:
99

SAMPLE ID: 0980-127, 3A **DESCRIPTION:** The air void system proximate to the top surface of the core is free of secondary ettringite.
MAG:

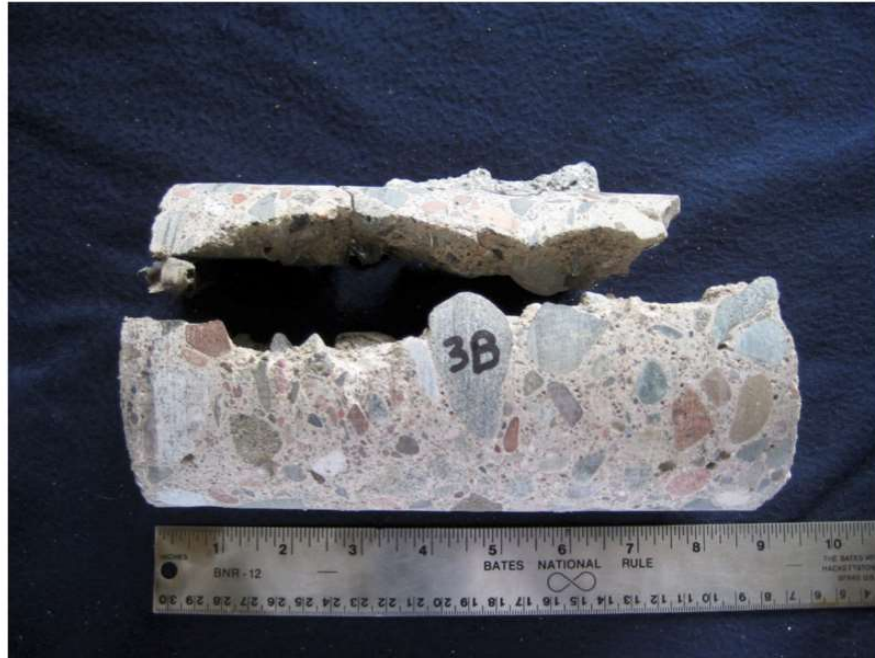
PHOTO: 9

3. **Reinforcement:** None observed.
4. **General Physical Conditions:** The core was taken directly through a severely distressed pavement joint. An unattached 90mm long and 10mm wide section of silicon joint sealant was included with the sample. The joint surfaces are vertically scaled/spalled away, leaving an up to approx. 25mm (1") diameter void in the joint between 35 and 85mm depth from the top surface. The void is approx. 10mm wide between 85 and 120mm depth; with some thinner paste loss and residual interlock between the two halves of core below 120mm depth. Concentrated sub-vertical microcracks (incipient spalling) were observed generally within the paste-only and within 12mm of the distressed joint surface between the top and bottom surfaces of the core. A few schist aggregate particles and softer graywackes exhibit spalling and some internal microcracking.

SAMPLE ID: 0980-127, 3B **DESCRIPTION:** Severely distressed joint core sample selected for petrographic analysis.

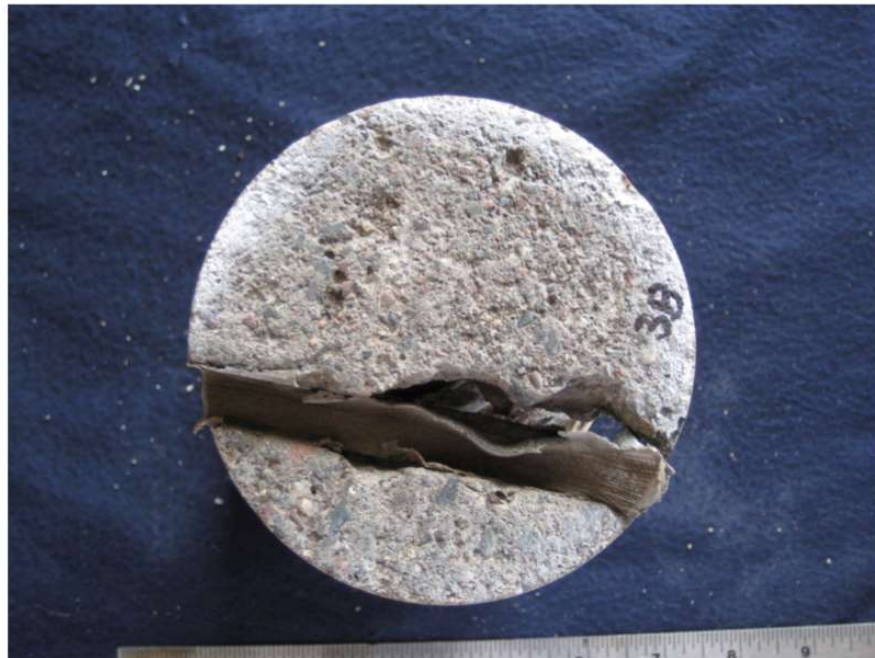
PHOTO:
10

SAMPLE ID: 0980-127, 3B **DESCRIPTION:** Rough screeded top surface of the core with mortar erosion/traffic wear exposing some coarse aggregate surfaces. Note compromised sealant.

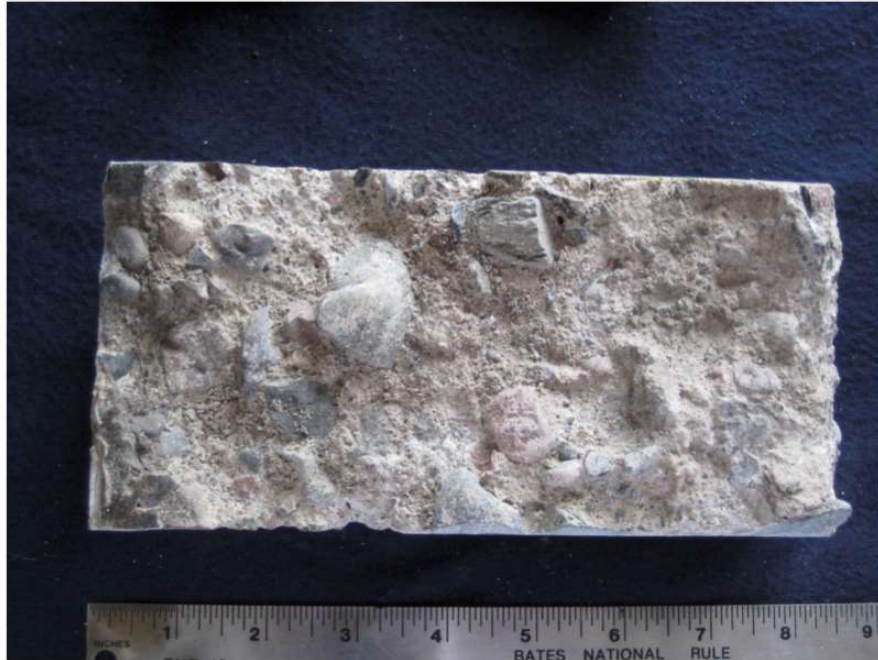
PHOTO:
11

- Joint: One side of the core exhibits evidence of the first sawcut to 53mm depth before severe vertical scaling/spalling exposes larger coarse aggregate fairly clean of paste below. A second "reservoir" sawcut is evident to 33mm depth. The adjacent sawcut surfaces on the other side of the joint are missing and completely spalled away. Some loose sand and apparent fine concrete debris line the joint plane.

SAMPLE ID: 0980-127, 3B **DESCRIPTION:** Severely distressed joint plane exhibits mostly sound aggregates protruding from distressed paste.

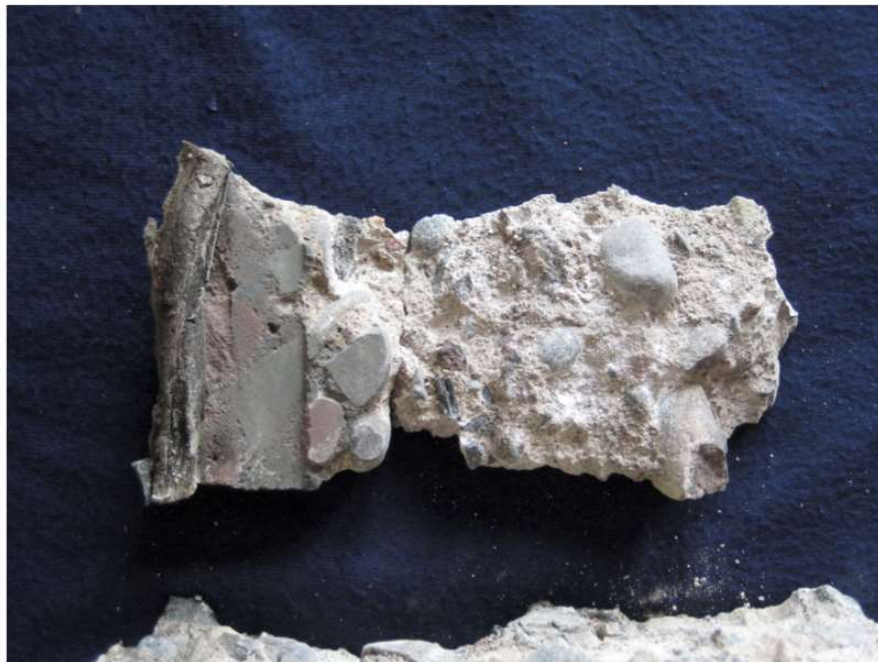
PHOTO:
12

SAMPLE ID: 0980-127, 3B **DESCRIPTION:** The other side of the severely distressed joint exhibits much of the original sawcut joint and a loosely adhered silicon sealant.

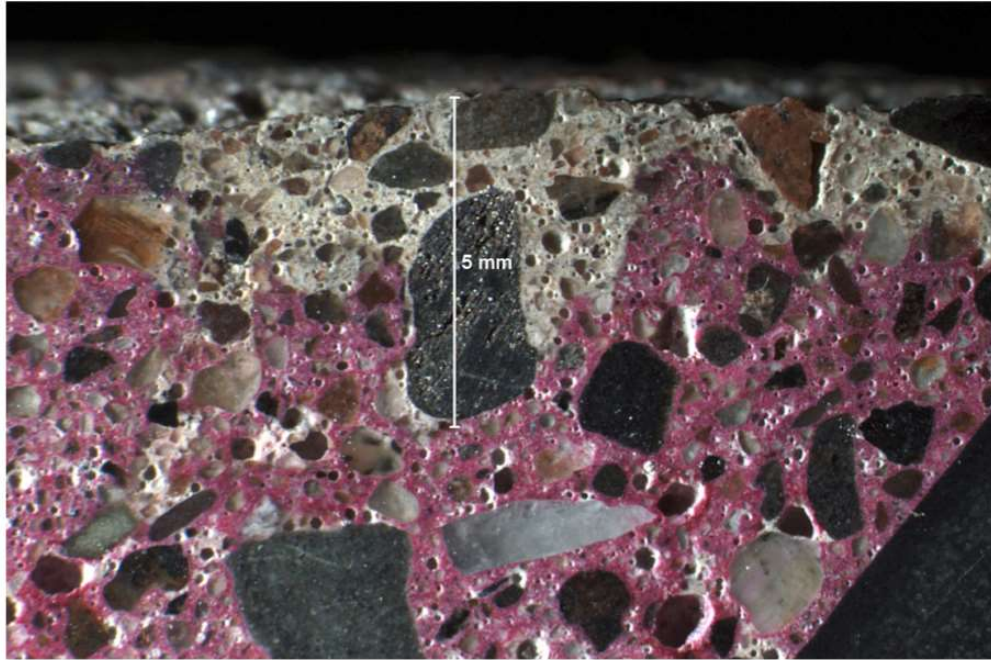
PHOTO:
100

SAMPLE ID: 0980-127, 3B **DESCRIPTION:** Carbonation (unstained paste) ranged from negligible up to 5mm depth from the top surface.
MAG: 5x

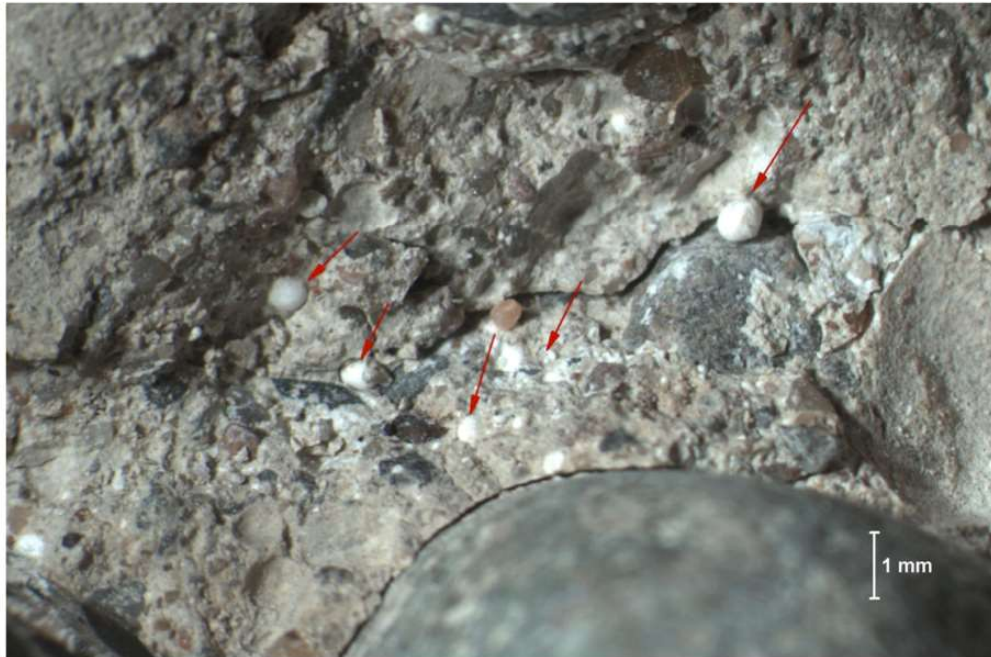
PHOTO:
101

SAMPLE ID: 0980-127, 3B **DESCRIPTION:** Ettringite-filled air voids present on the spalled joint surface of the core.
MAG: 10x

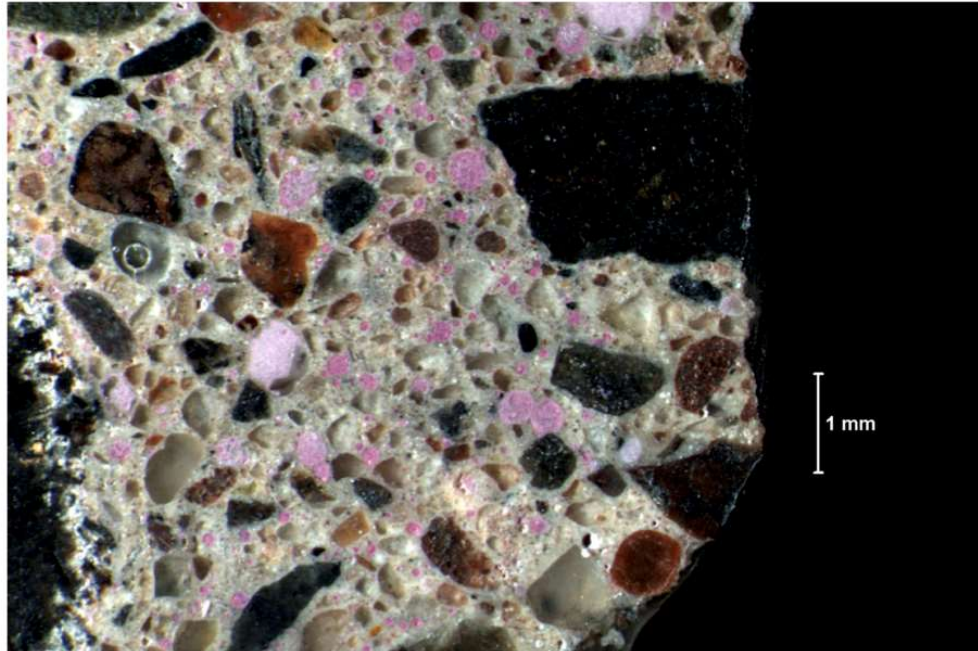
PHOTO:
102

8. Secondary deposits: White, generally acicular grown ettringite along with some clear platelets of portlandite fills most of the finer entrained sized air voids scattered throughout the paste from the top partly carbonated 7mm of paste through the depth of the core. Void fillings become less abundant with distance greater than approx. 25mm from the distressed joint surface. A few rare "mats" of white ettringite partly fill incipient spalls on the joint plane.

SAMPLE ID: 0980-127, 3B **DESCRIPTION:** Most of the entrained air void spaces proximate to the distressed joint plane is filled with secondary ettringite; stained purple.
MAG: 15x

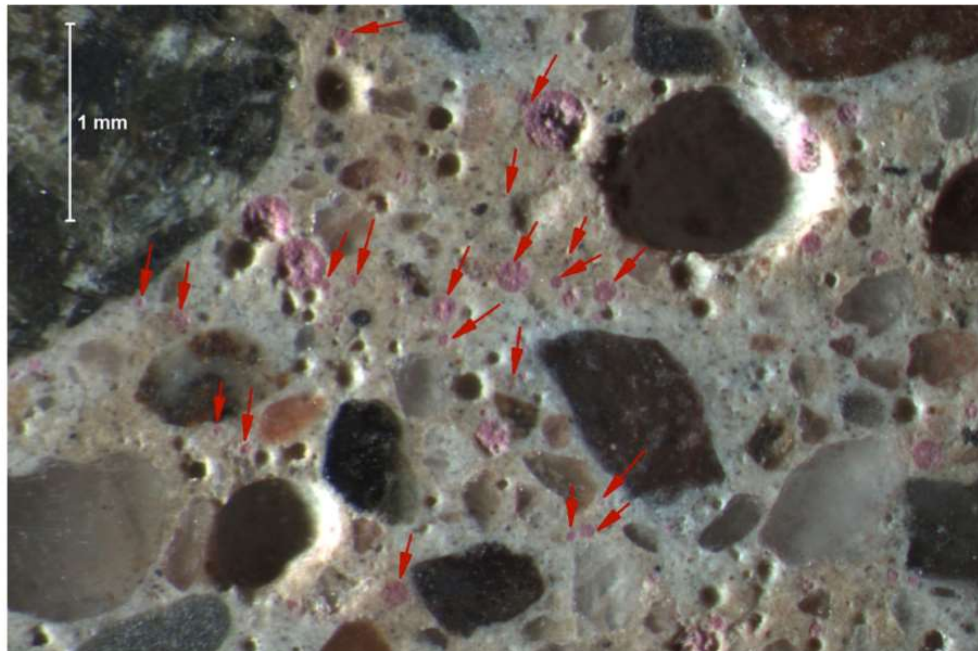
PHOTO:
103

SAMPLE ID: 0980-127, 3B **DESCRIPTION:** Ettringite-filled air void spaces (stained) at 38mm depth in the concrete and 30mm depth from the joint plane.
MAG: 10x

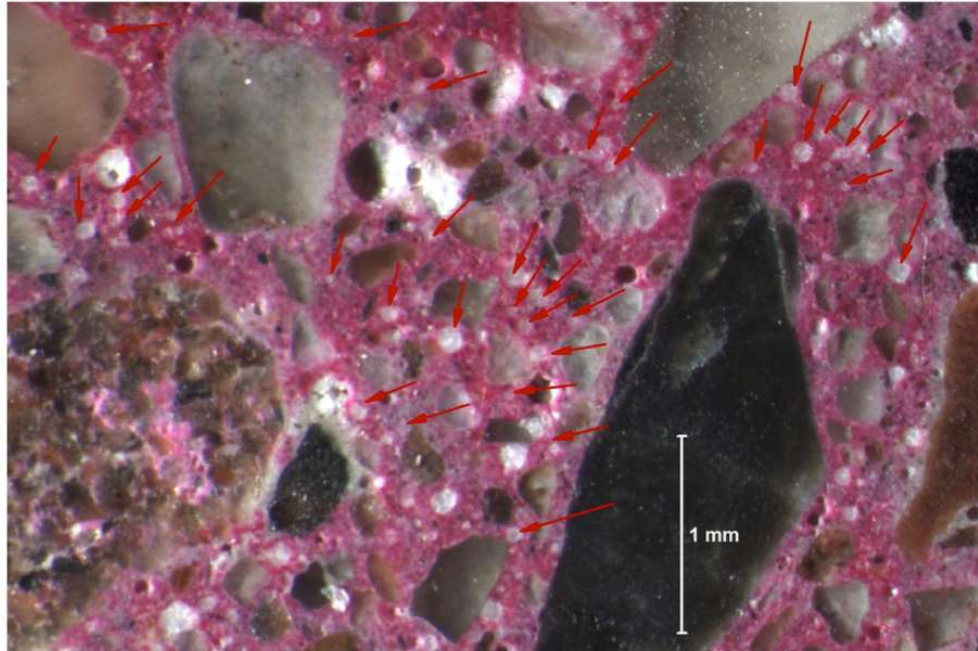
PHOTO:
104

SAMPLE ID: 0980-127, 3B **DESCRIPTION:** Most of the entrained air void spaces at 180mm depth in the core and 45mm from the distressed joint plane is filled with secondary ettringite; in phenolphthalein-stained paste.
MAG: 30x

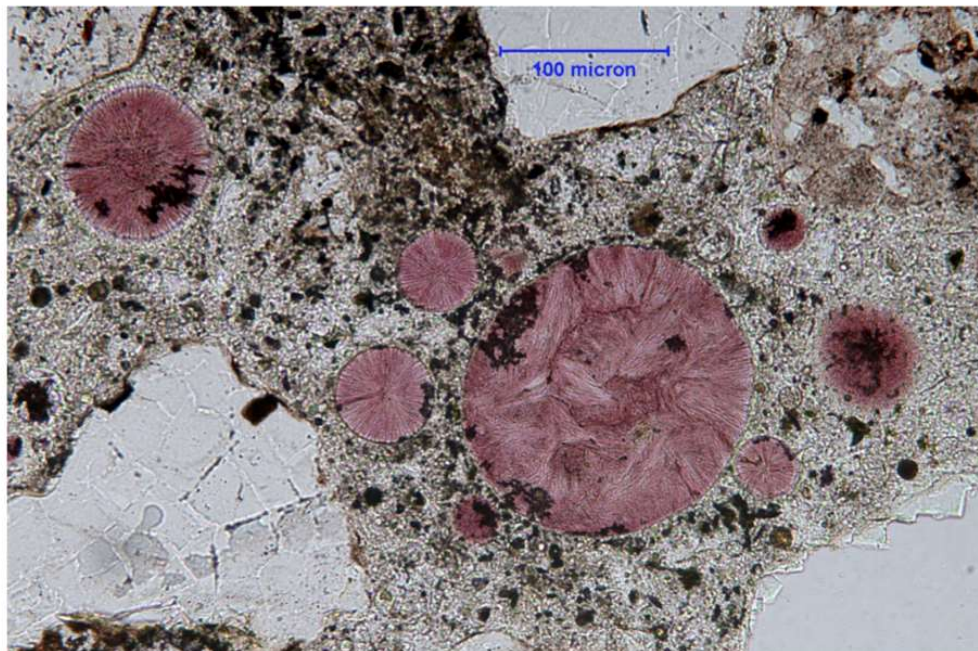
PHOTO:
105

SAMPLE ID: 0980-127, 3B **DESCRIPTION:** Ettringite-filled air void spaces (stained) in thin section of concrete adjacent to the joint plane; under plane polarized light.
MAG: 200x

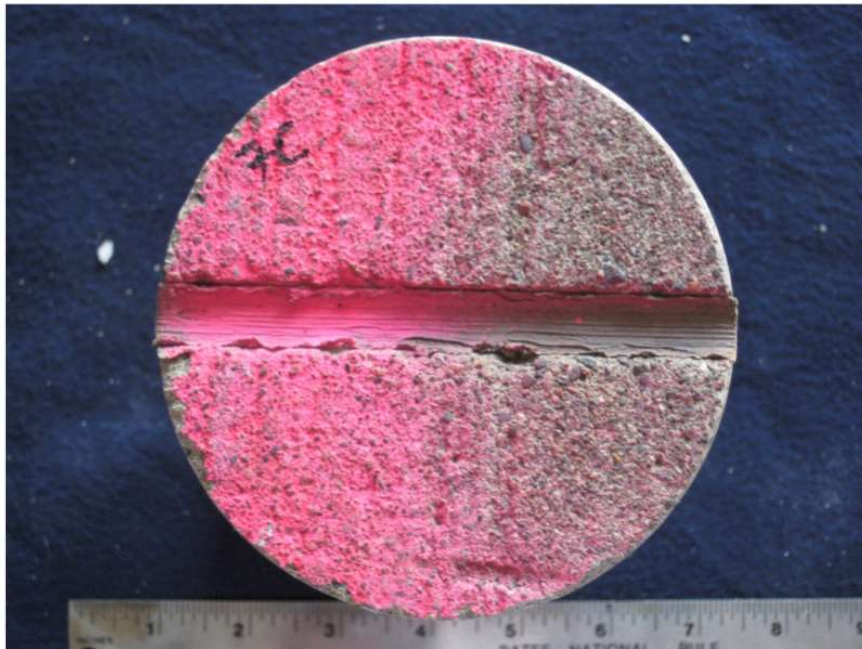
PHOTO:
38

SAMPLE ID: 3805-67, 7C
silicone sealant.

DESCRIPTION: Rough screeded and jointed top surface of the core with

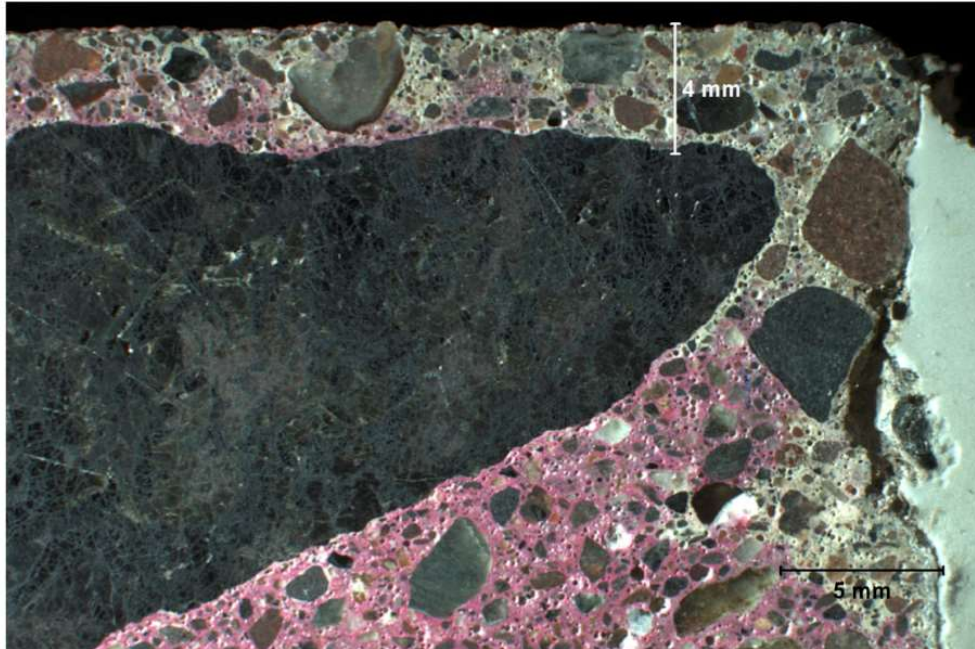
PHOTO:
118

SAMPLE ID: 3805-67, 7C **DESCRIPTION:** Carbonation (unstained paste) ranged from negligible up to 4mm from the top surface (in this view).
MAG: 5x

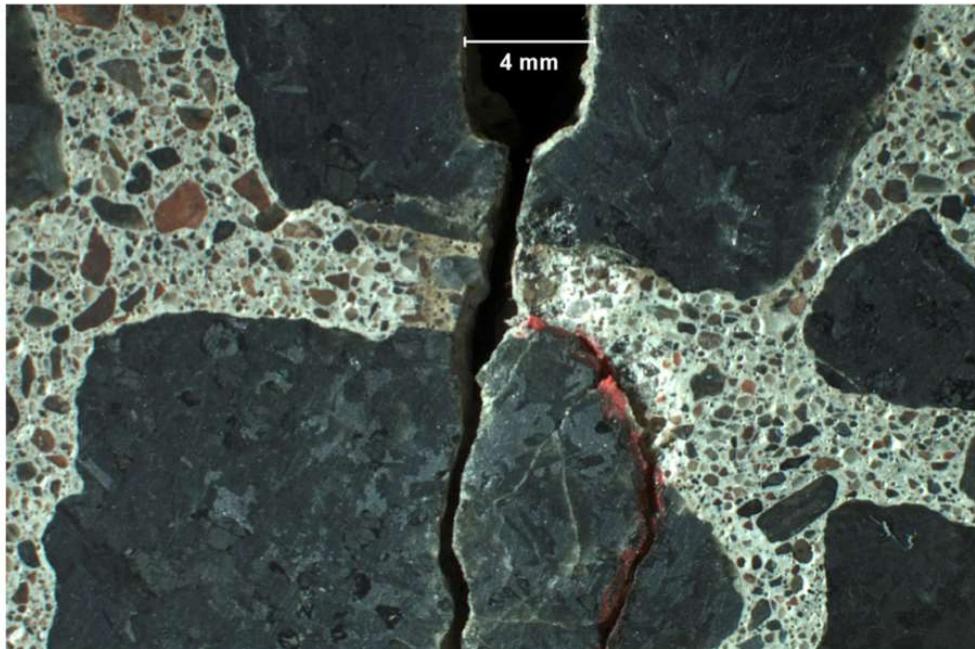
PHOTO:
119

SAMPLE ID: 3805-67, 7C **DESCRIPTION:** The relatively tight, un-distressed joint proceeds through a coarse aggregate particle below the sawcut.
MAG: 5x

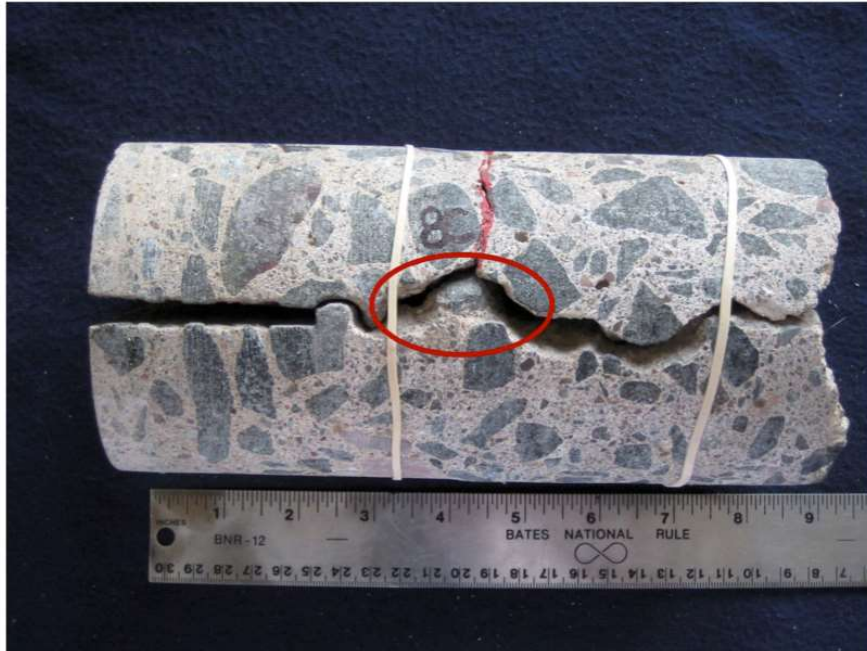
PHOTO:
39

SAMPLE ID: 3805-67, 8C **DESCRIPTION:** Overall view of the jointed core utilized for petrographic analysis. The top surface is left. Developing "tunneling" is marked in red.

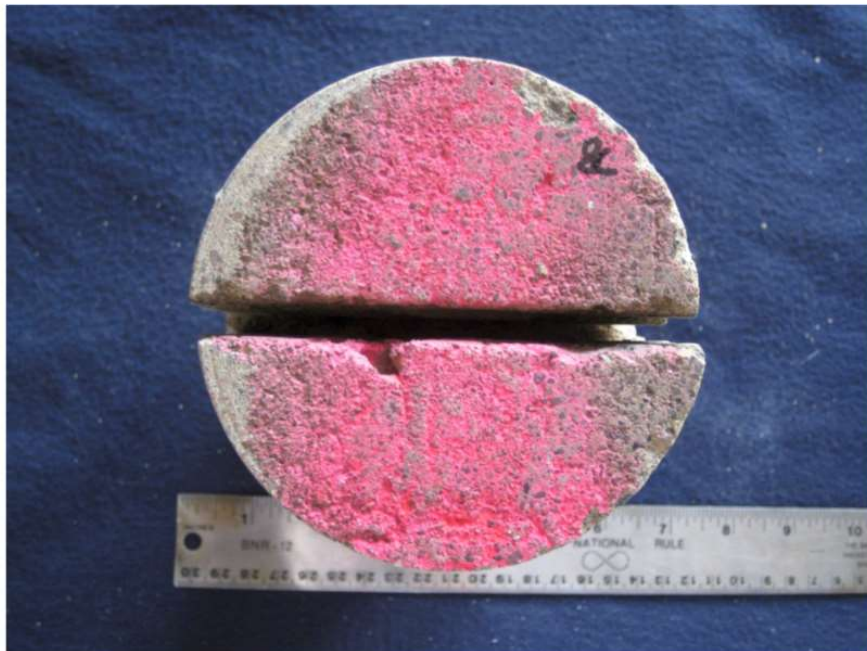
PHOTO:
40

SAMPLE ID: 3805-67, 8C **DESCRIPTION:** Rough screeded and (un-sealed) jointed top surface of the core.

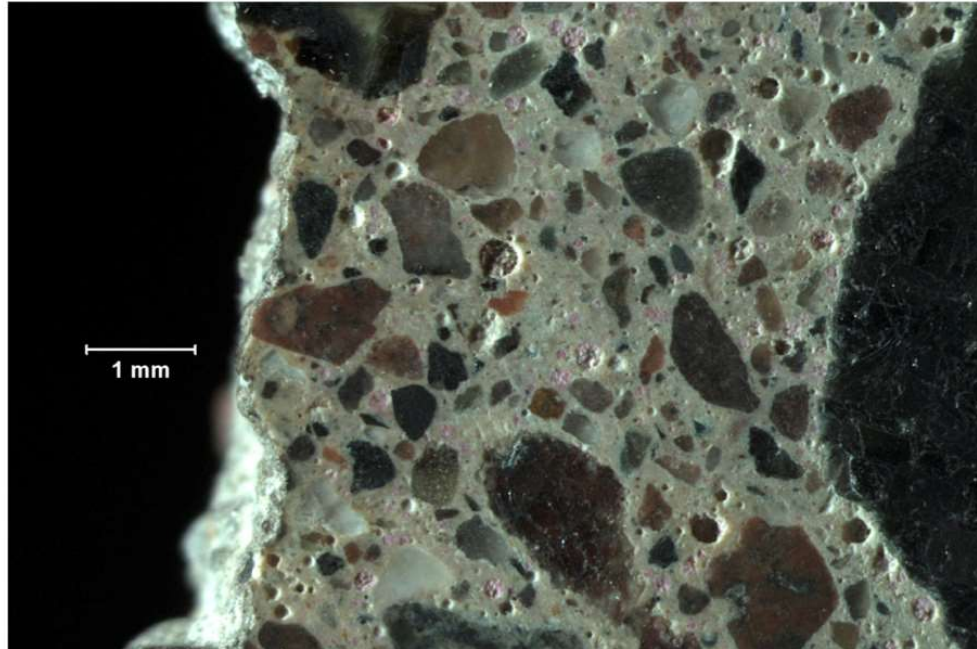
PHOTO:
120

SAMPLE ID: 3805-67, 8C **DESCRIPTION:** Air void system below 45mm depth from the top surface and at the distressed joint plane appears low in volume.
MAG: 15x

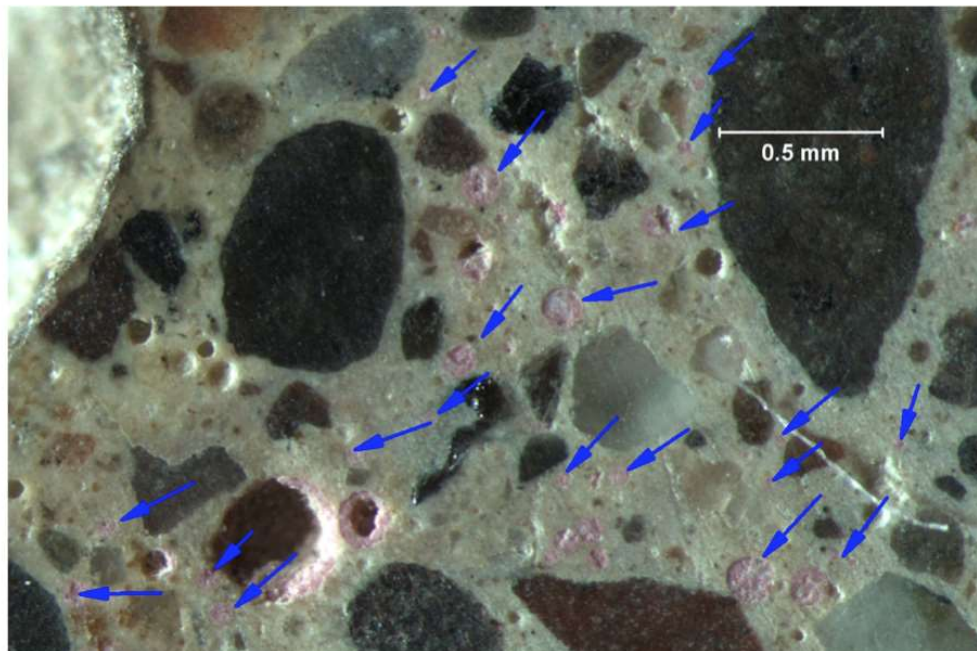
PHOTO:
121

SAMPLE ID: 3805-67, 8C **DESCRIPTION:** Most of the finest entrained air voidspaces proximate to the distressed joint plane (left) are filled with (stained) secondary ettringite.
MAG: 50x

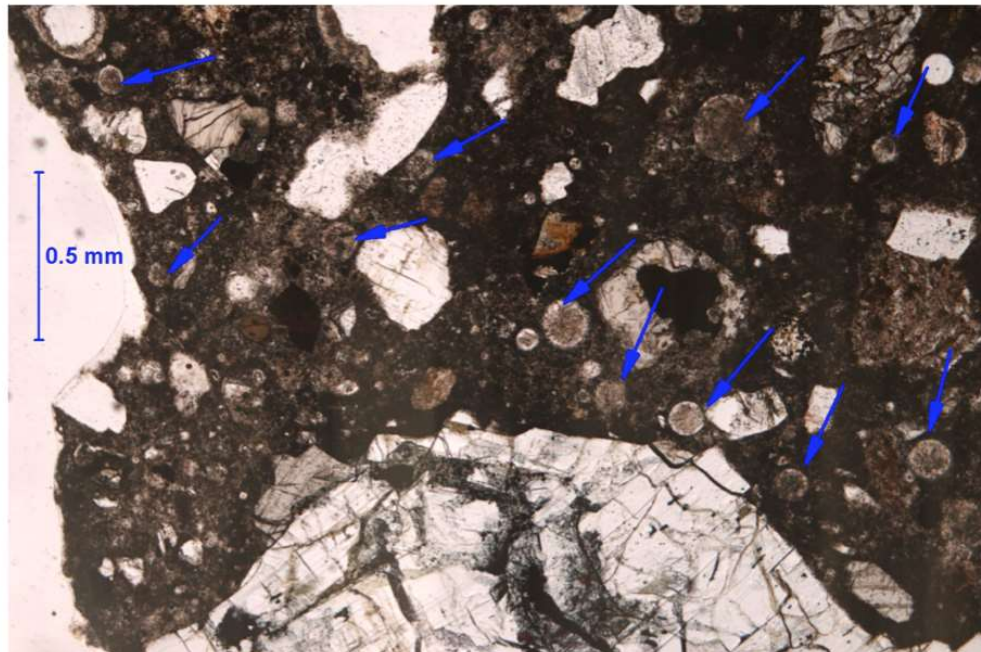
PHOTO:
122

SAMPLE ID: 3805-67, 8C **DESCRIPTION:** Air void system along the distressed joint surface is filled with secondary ettringite (arrows); in thin section under plane polarized light.
MAG: 40x

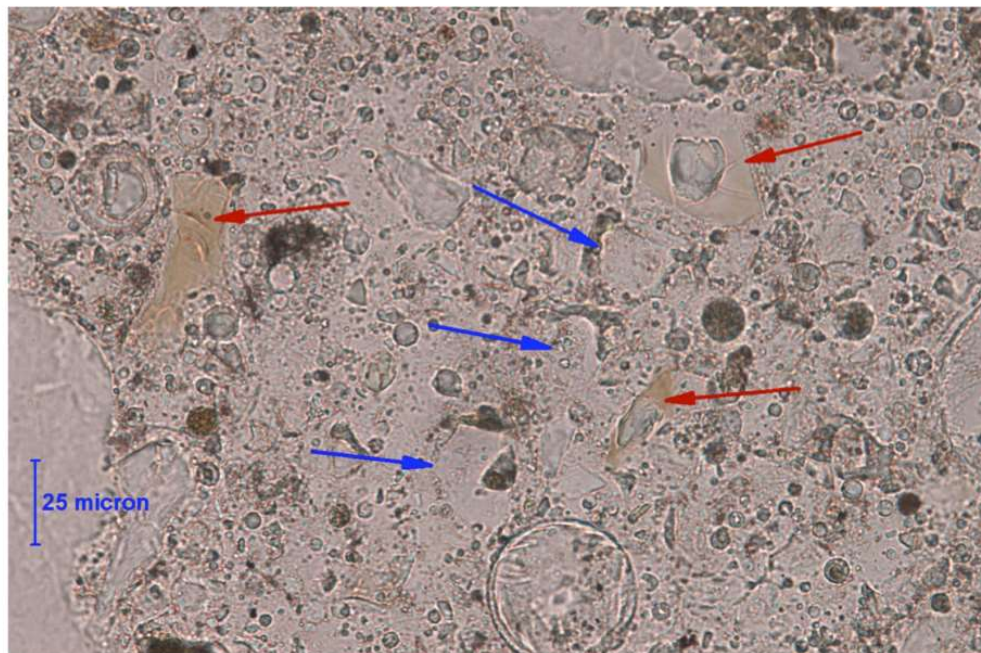
PHOTO:
123

SAMPLE ID: 3805-67, 8C **DESCRIPTION:** Fully hydrated alite portland cement clinker relicts (blue arrows) and well to fully hydrated slag cement grains (red) in thin section of concrete paste under plane polarized light.
MAG: 400x

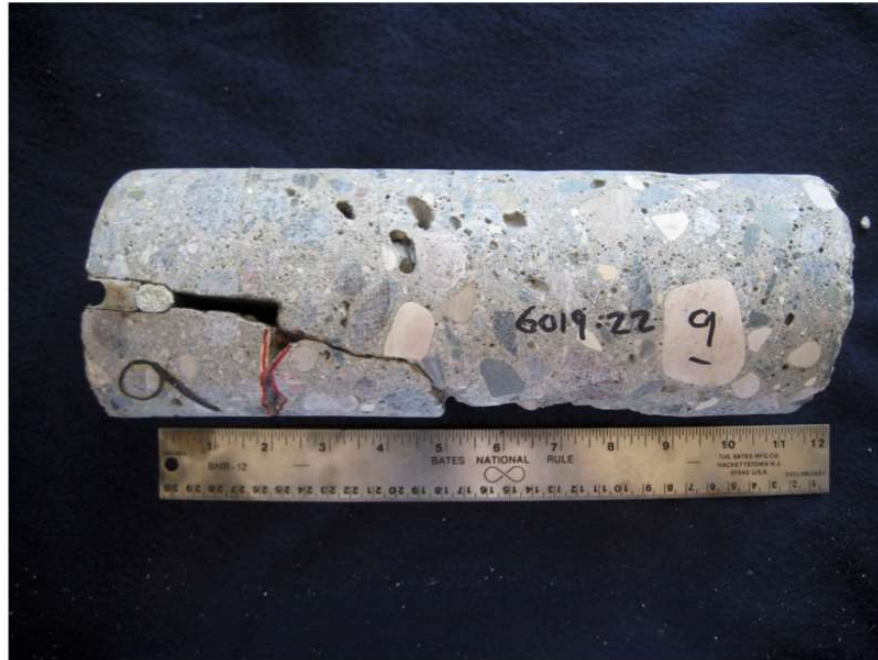
PHOTO:
59

SAMPLE ID: 6019-22, 9 **DESCRIPTION:** Overall view of the jointed core utilized for petrographic analysis. The top surface is left.

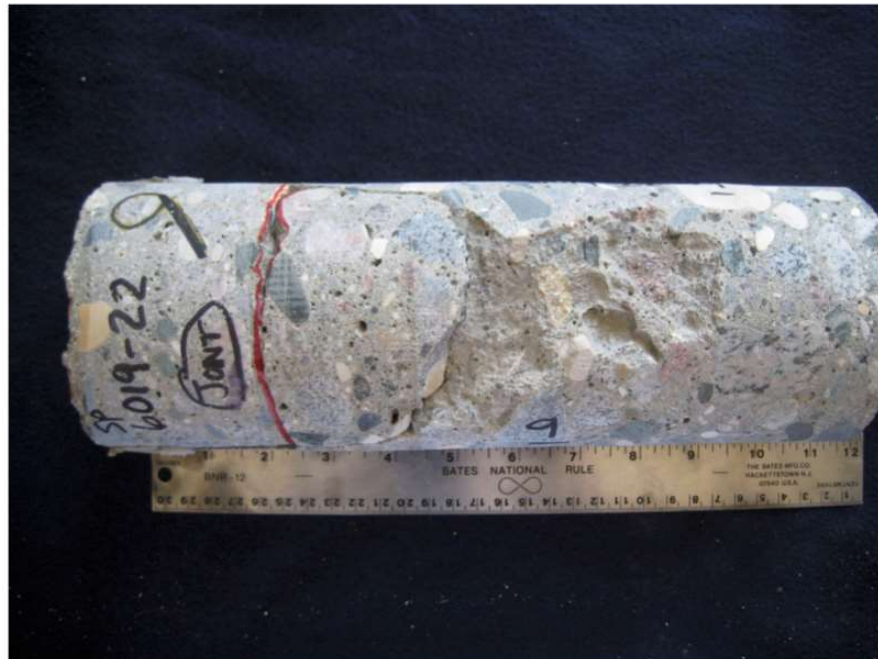
PHOTO:
60

SAMPLE ID: 6019-22, 9 **DESCRIPTION:** Joint crack plane exposed at depth in the core.

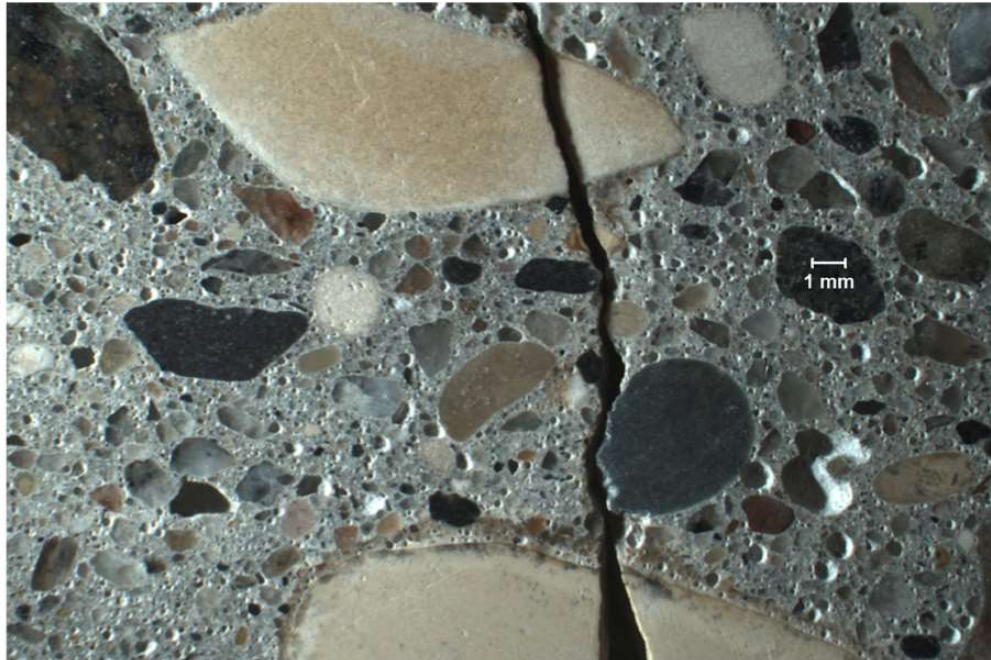
PHOTO:
140

SAMPLE ID: 6019-22, 9
aggregates below the sawcut.
MAG: 5x

DESCRIPTION: Relatively tight, un-distressed joint crack proceeds through coarse

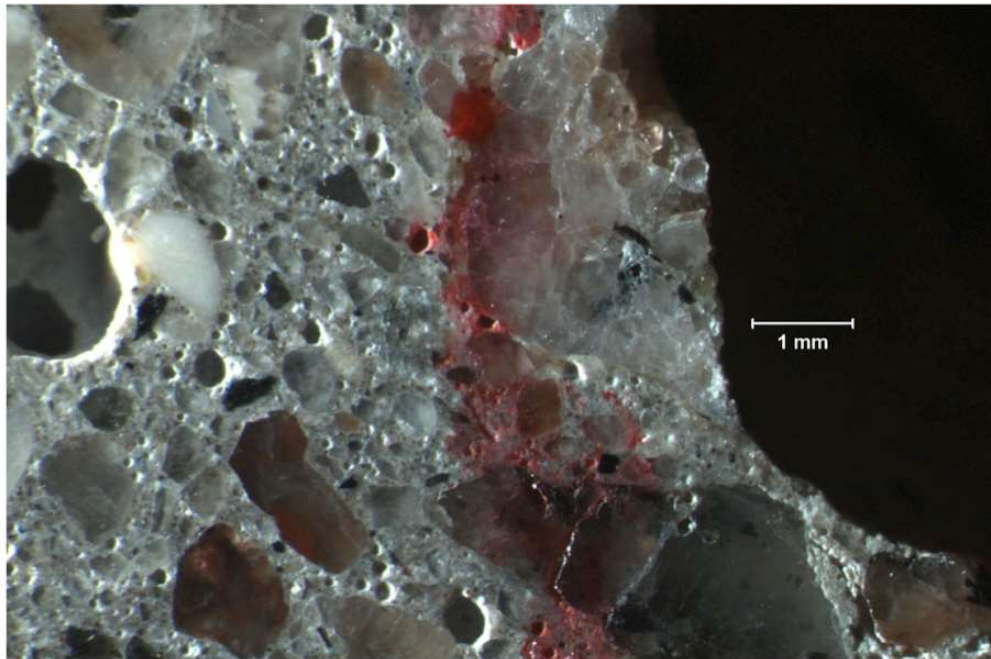
PHOTO:
141

SAMPLE ID: 6019-22, 9
base of the sawcut control joint.
MAG: 100x

DESCRIPTION: Ettringite lined or filled entrained air voidspaces are concentrated at the

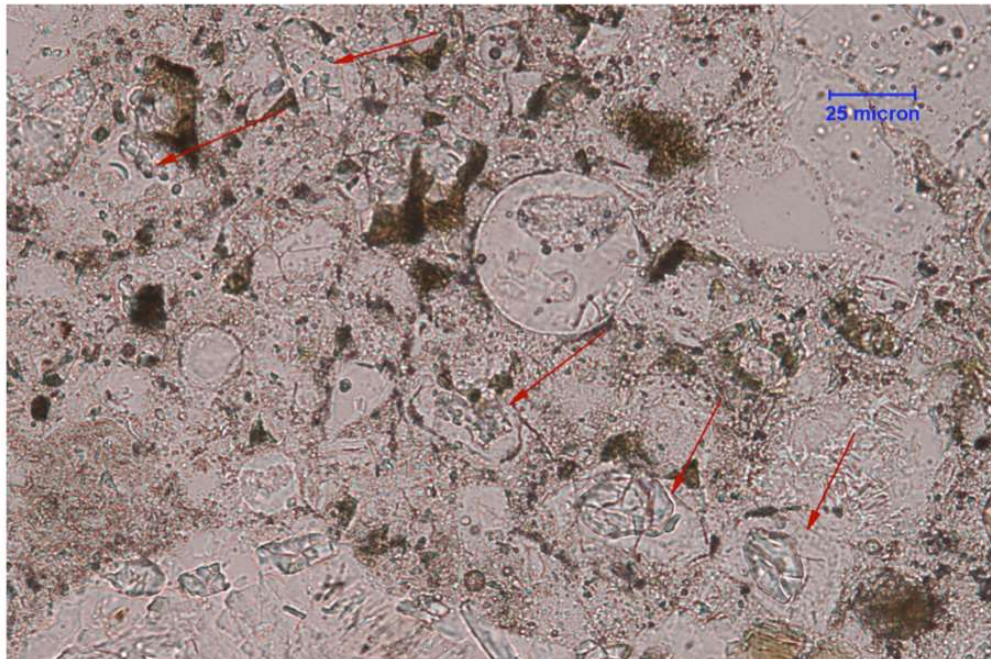
PHOTO:
143

SAMPLE ID: 6019-22, 9 **DESCRIPTION:** Well hydrated alite portland cement clinker particles in thin section of concrete paste under plane polarized light. Note spherical flyash pozzolan particles.
MAG: 400x

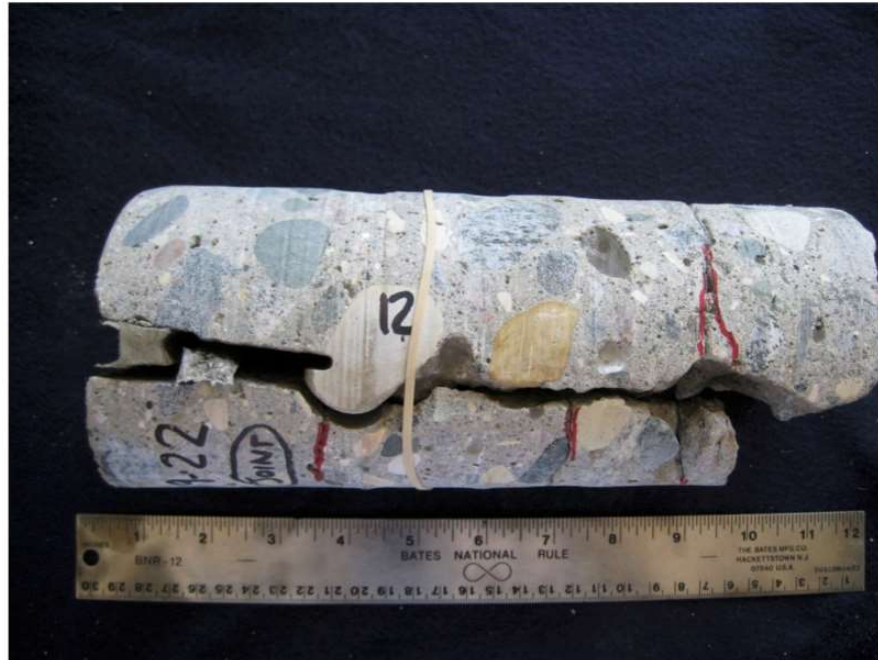
PHOTO:
63

SAMPLE ID: 6019-22, 12 DESCRIPTION: Overall view of the jointed core utilized for petrographic analysis. The top surface is left. Note failed silicon sealant.

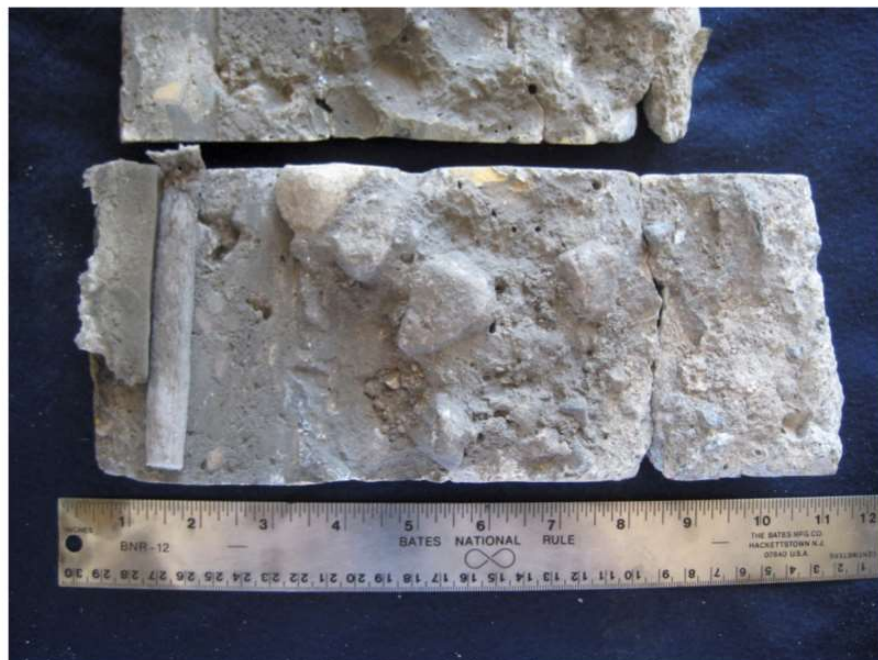
PHOTO:
64

SAMPLE ID: 6019-22, 12 DESCRIPTION: Joint plane exhibits loss of paste and exposure of sound coarse aggregates.

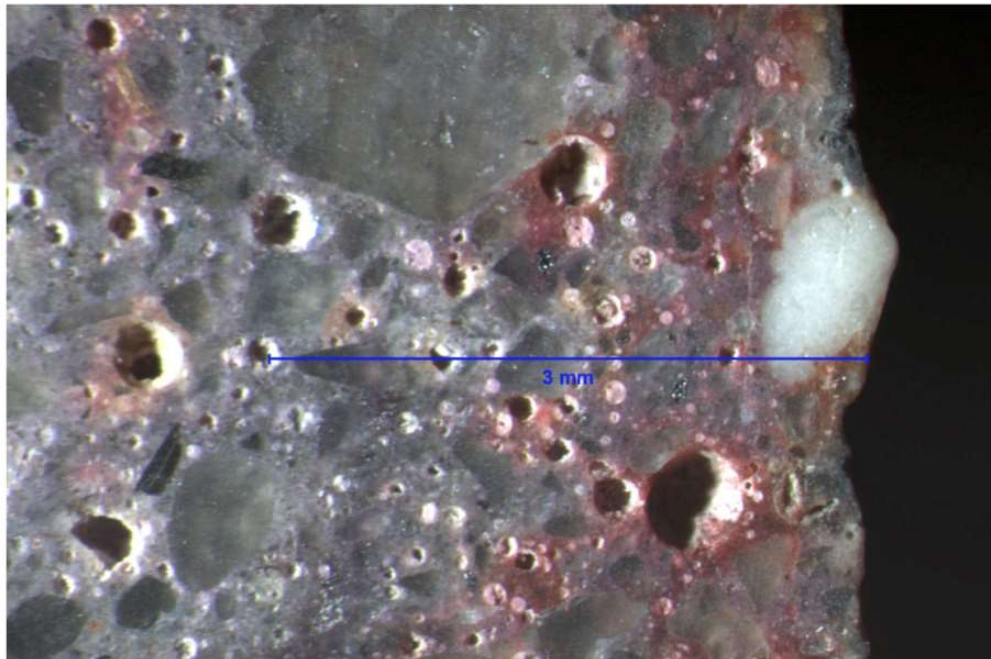
PHOTO:
145

SAMPLE ID: 6019-22, 12 **DESCRIPTION:** Fine entrained-sized air void spaces directly adjacent to the joint crack plane are mostly filled with secondary ettringite; at 203mm depth from the top surface.
MAG: 30x

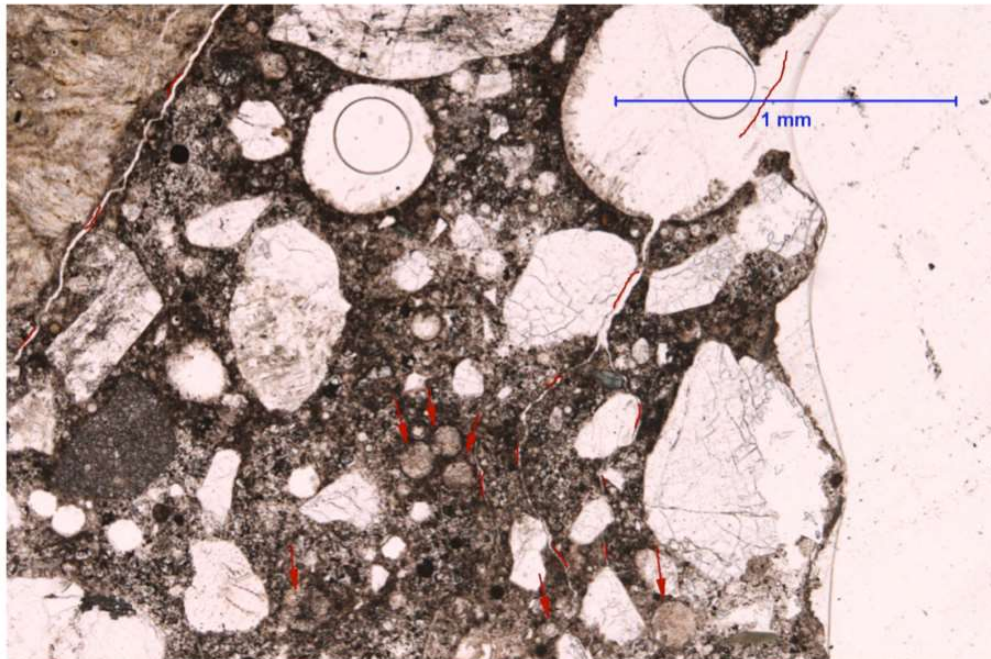
PHOTO:
147

SAMPLE ID: 6019-22, 12 **DESCRIPTION:** Fine entrained-sized air void spaces directly adjacent to the joint crack plane are mostly filled with secondary ettringite (red arrows); in thin section under plane polarized light at 145mm depth from
MAG: 40x the top surface.

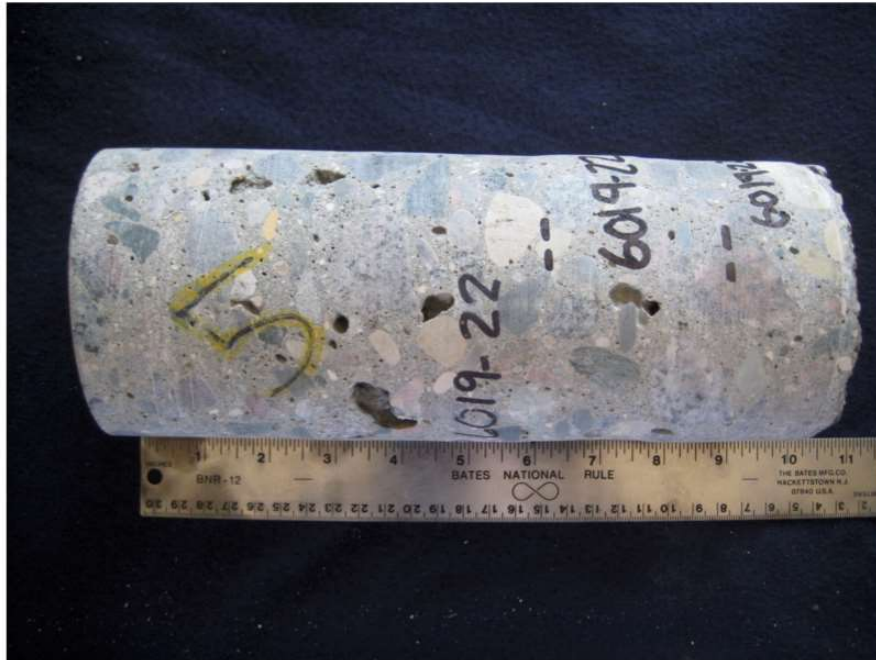
PHOTO:
55

SAMPLE ID: 6019-22, 5
permeability. The top surface

DESCRIPTION: Overall view of the mid-panel core utilized for rapid chloride is left.

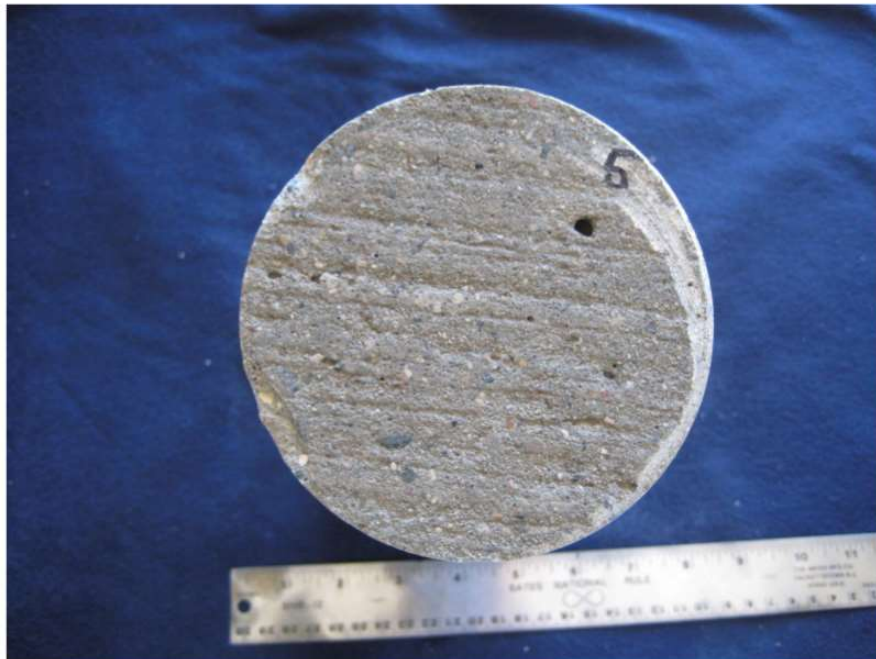
PHOTO:
56

SAMPLE ID: 6019-22, 5
erosion.

DESCRIPTION: Fairly rough screeded top surface of the core with minor mortar
