Impact of Water/ Cementitious-Based Concrete Mix Design Specification Changes on Concrete Pavement Quality

July 2018

Research Project
Final Report 2018-25

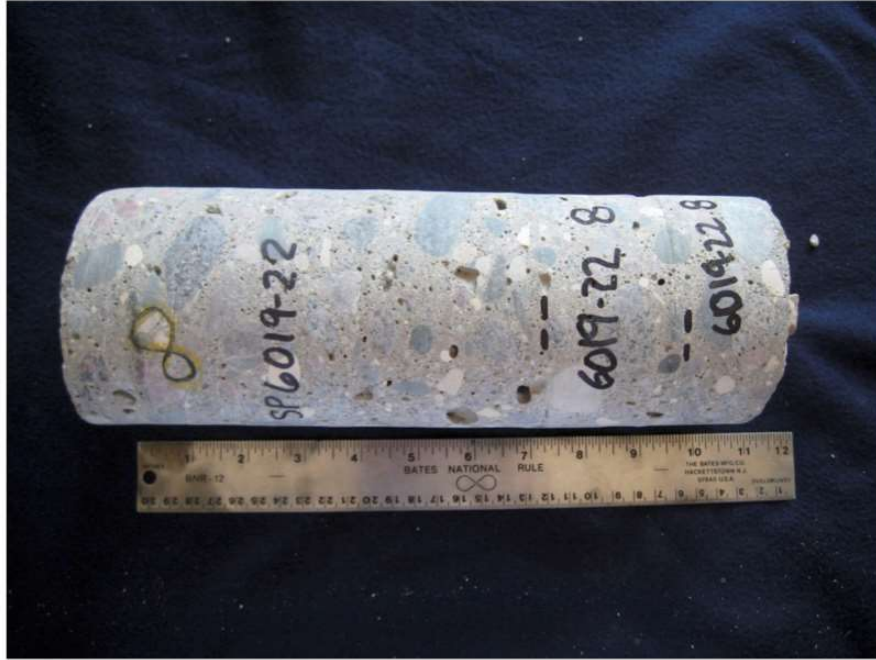
PHOTO:
57

SAMPLE ID: 6019-22, 8 **DESCRIPTION:** Overall view of the mid-panel core utilized for rapid chloride permeability. The top surface is left.

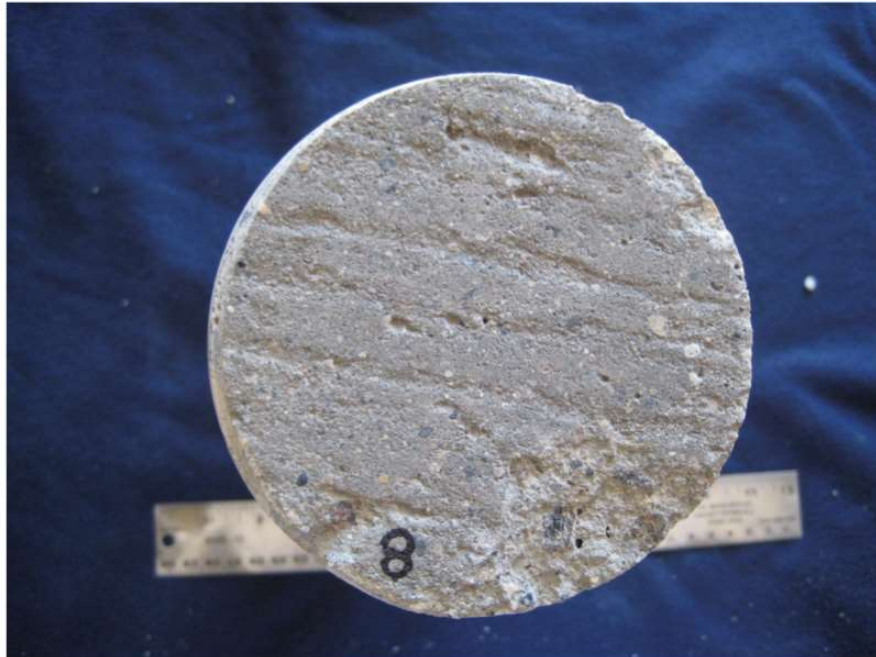
PHOTO:
58

SAMPLE ID: 6019-22, 8 **DESCRIPTION:** Fairly smooth screeded top surface of the core with traffic wear.

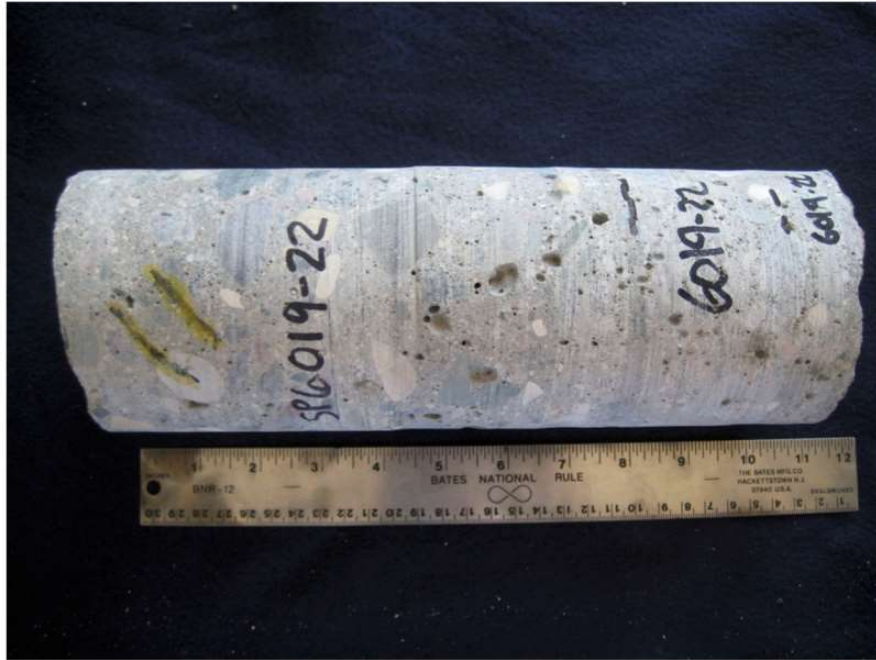
PHOTO:
61

SAMPLE ID: 6019-22, 11 **DESCRIPTION:** Overall view of the mid-panel core utilized for rapid chloride permeability. The top surface is left.

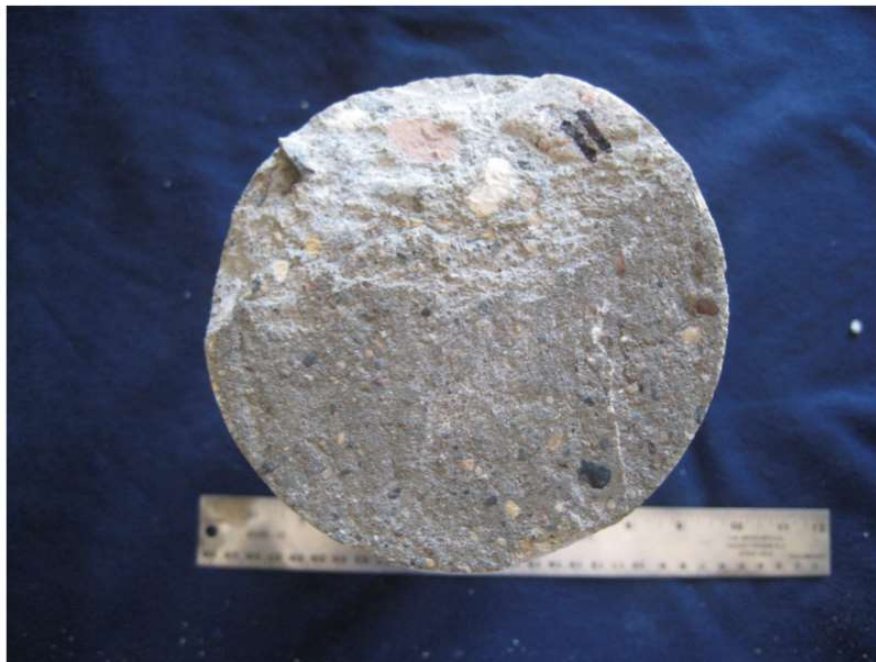
PHOTO:
62

SAMPLE ID: 6019-22, 11 **DESCRIPTION:** Rough screeded top surface of the core; with some spalling apparently created during sampling.

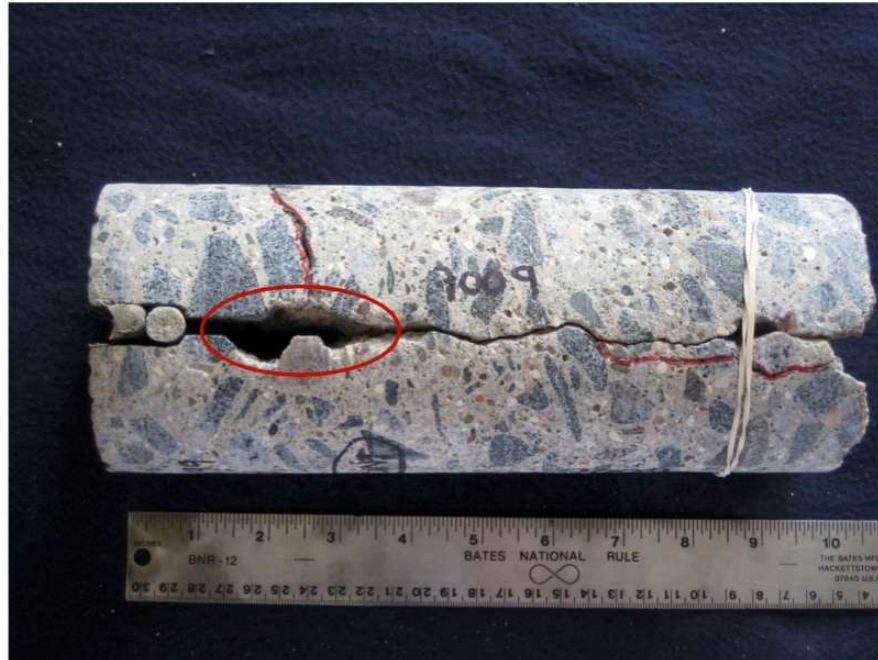
PHOTO:
75

SAMPLE ID: 7380-199, 7009 **DESCRIPTION:** Overall view of the jointed core utilized for petrographic analysis. Note developing tunneling at the base of the sawcut. The top surface of the core is left.

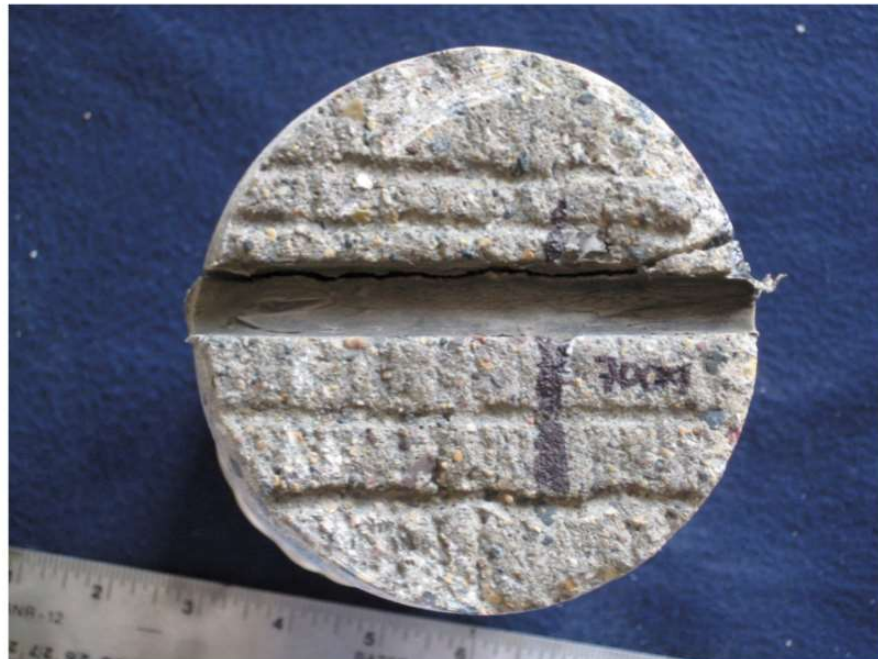
PHOTO:
76

SAMPLE ID: 7380-199, 7009 **DESCRIPTION:** Top surface of the core exhibiting a compromised sealant.

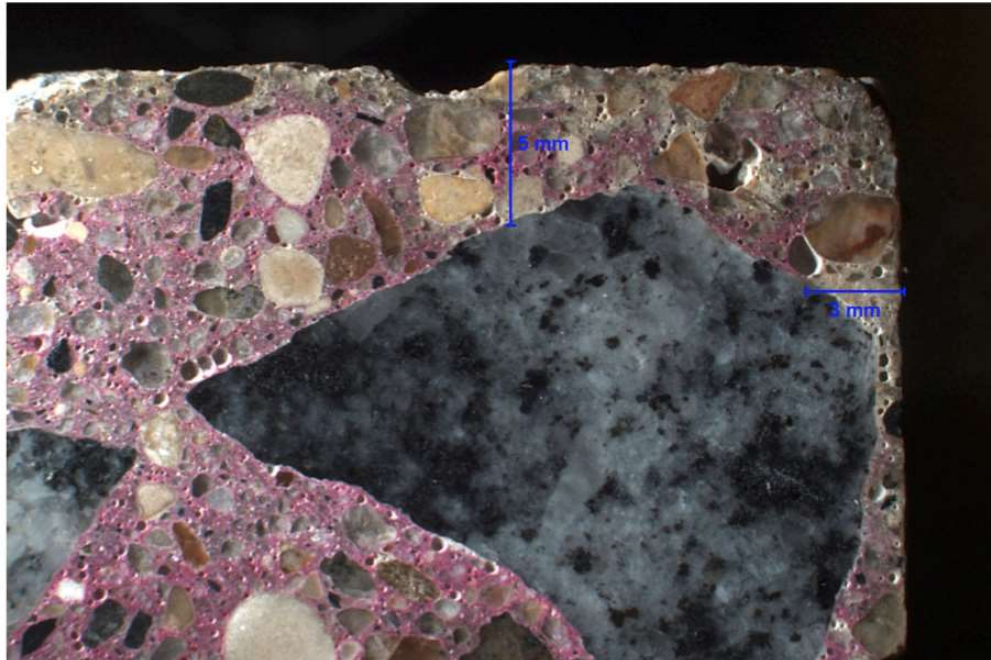
PHOTO:
154

SAMPLE ID: 7380-199, 7009 **DESCRIPTION:** Carbonation (unstained) proceeds up to 5mm depth from the top surface and up to 3mm depth from the sawcut joint surface; in this view of sawcut and lapped cross section of core exposed to phenolphthalien pH indicator.
MAG: 5x

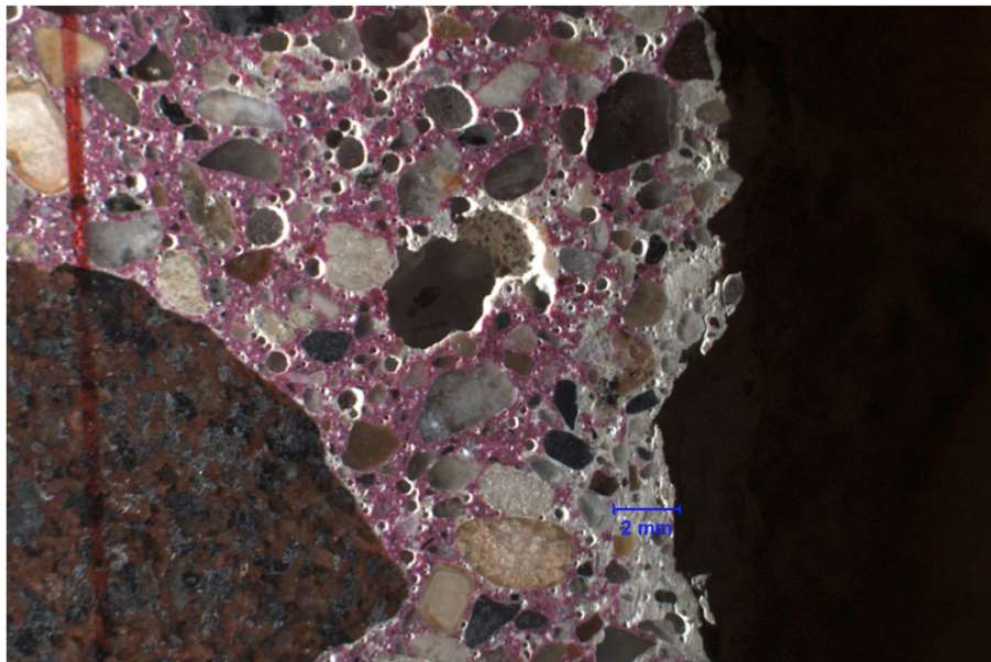
PHOTO:
155

SAMPLE ID: 7380-199, 7009 **DESCRIPTION:** Carbonation (unstained paste) proceeds up to 2mm depth from the distressed joint plane at 100mm depth in the core.
MAG: 5x

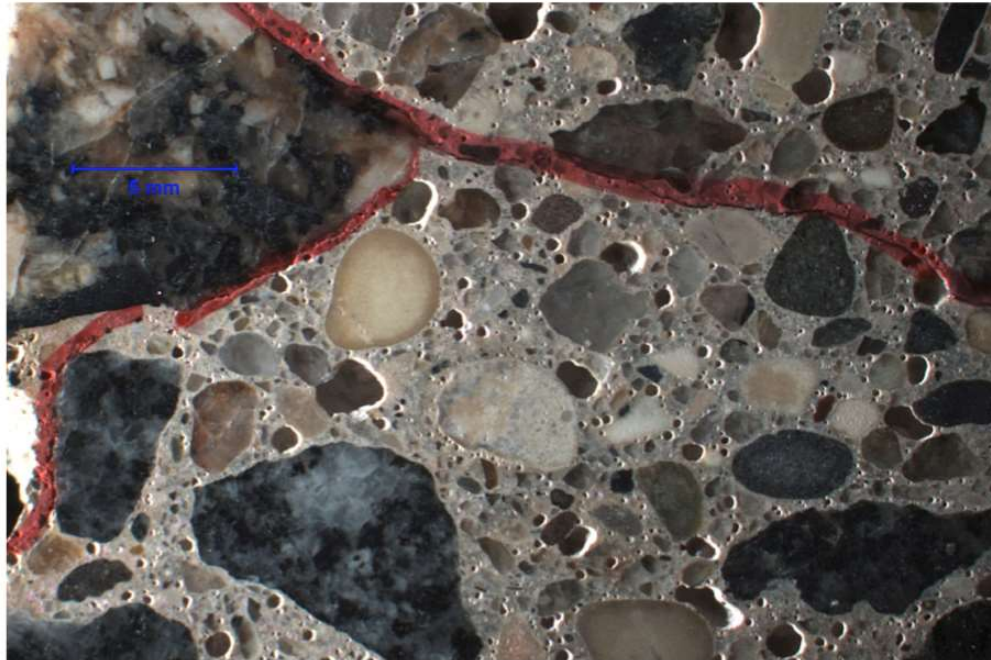
PHOTO:
156

SAMPLE ID: 7380-199, 7009 **DESCRIPTION:** Overall view of air void system at 60mm depth in the core. Not loss of fine air void spaces on left 1/3 of image from secondary ettringite fillings.
MAG: 5x

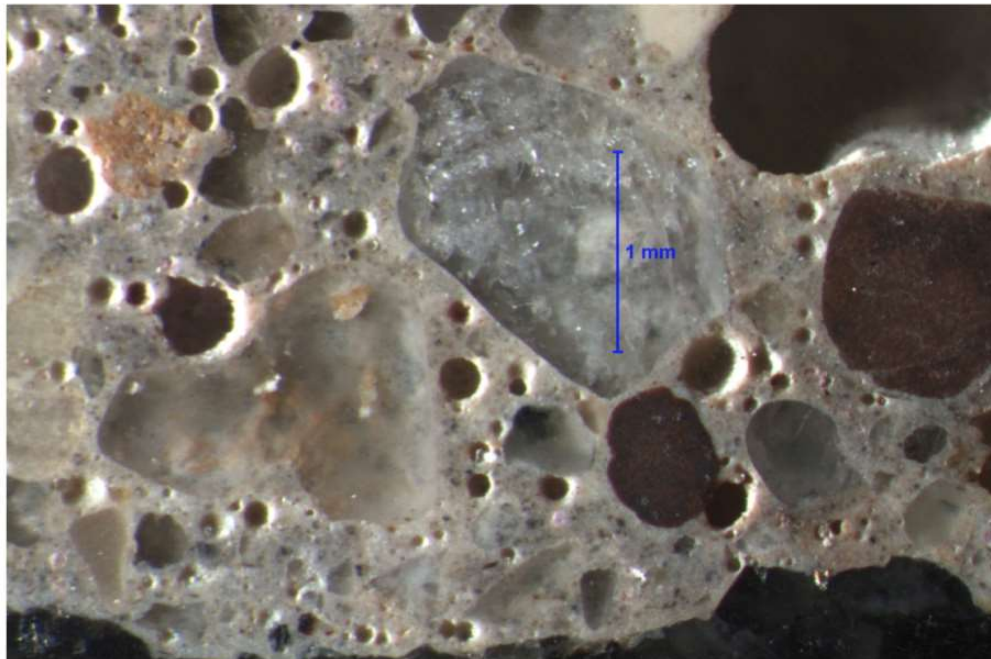
PHOTO:
157

SAMPLE ID: 7380-199, 7009 **DESCRIPTION:** Air void system at 70mm depth in the core and 45mm depth from the distressed joint plane.
MAG: 30x

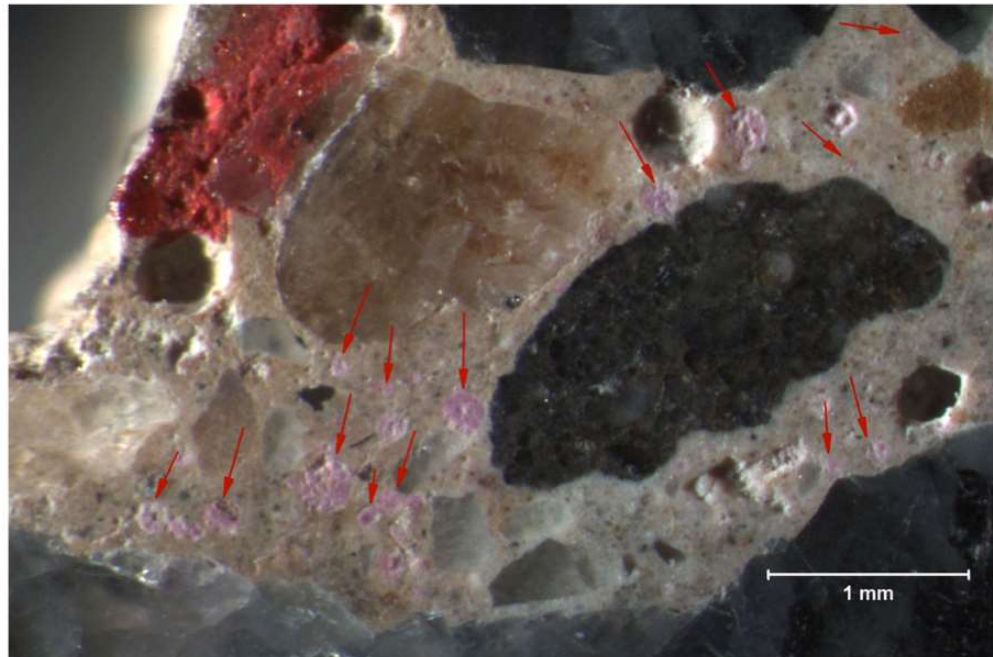
PHOTO:
159

SAMPLE ID: 7380-199, 7009 **DESCRIPTION:** Air void system at 70mm depth in the core and at the distressed joint plane (L). Note stained ettringite-filled voidspaces marked with arrows.
MAG: 30x

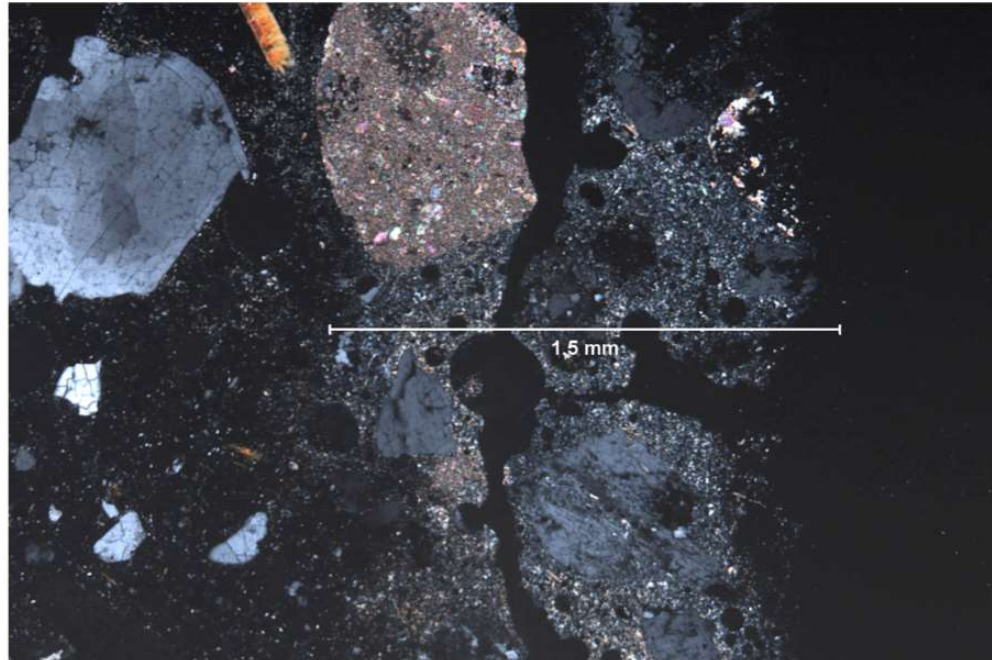
PHOTO:
160

SAMPLE ID: 7380-199, 7009 **DESCRIPTION:** Overall view of brightly colored carbonated paste to 1.5mm depth from the distressed joint plane; in thin section of concrete under cross polarized light.
MAG: 40x

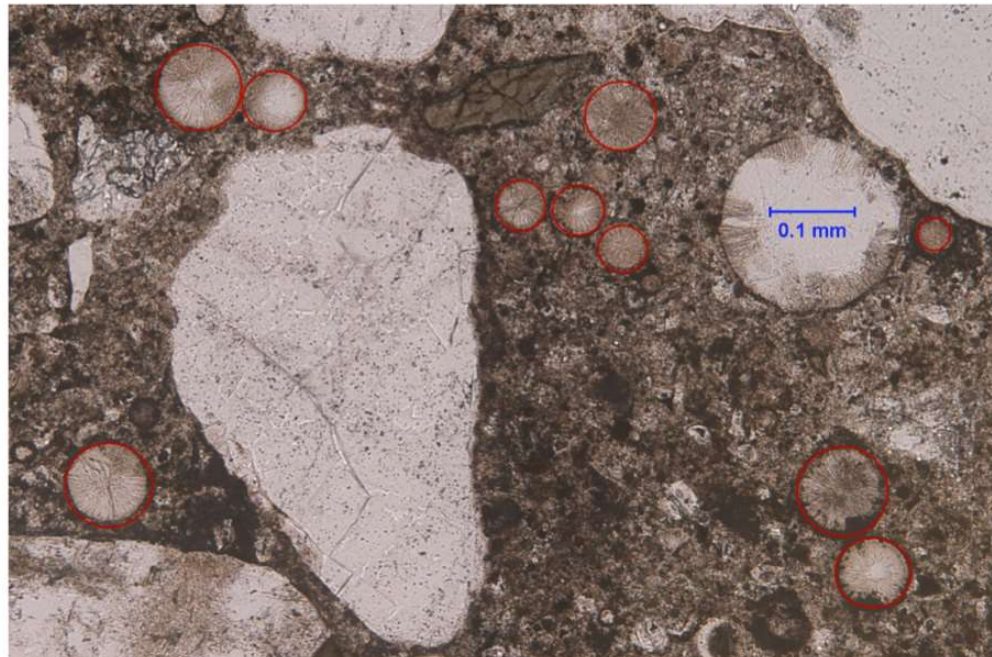
PHOTO:
161

SAMPLE ID: 7380-199, 7009 **DESCRIPTION:** Ettringite-filled voidspaces, outlined in red, in thin section of concrete paste adjacent to the distressed joint plane, under plane polarized light.
MAG: 100x

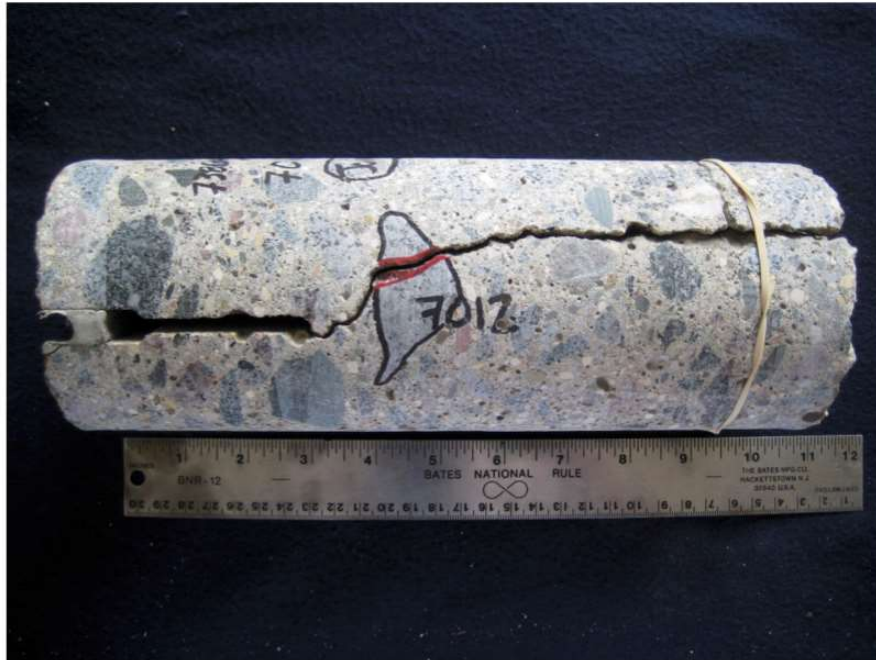
PHOTO:
77

SAMPLE ID: 7380-199, 7012 **DESCRIPTION:** Overall view of the jointed core utilized for petrographic analysis. Note joint crack bisecting a coarse aggregate particle outlined in black marker. The top surface of the core is left.

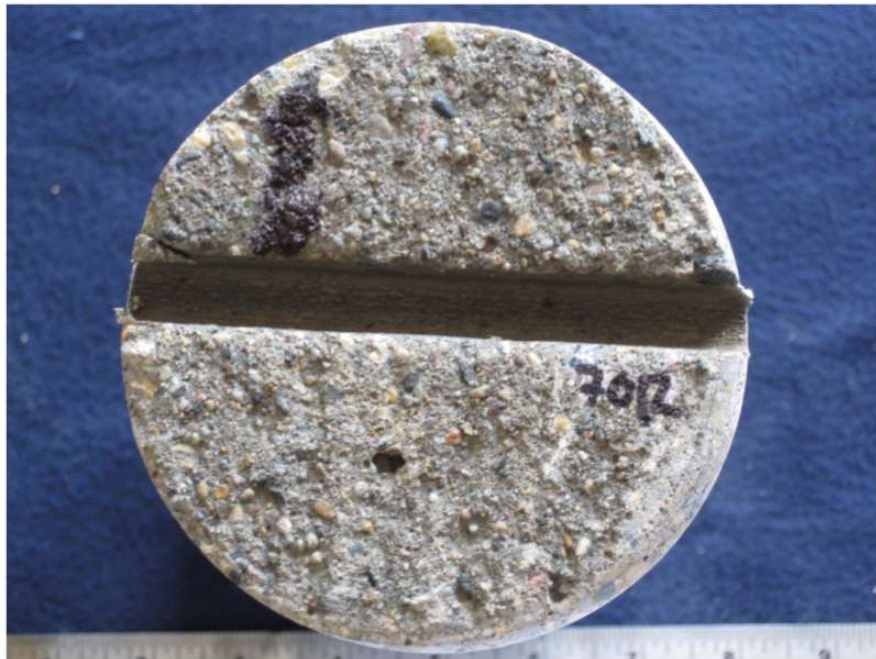
PHOTO:
78

SAMPLE ID: 7380-199, 7012 **DESCRIPTION:** Top surface of the core exhibiting an intact sealant.

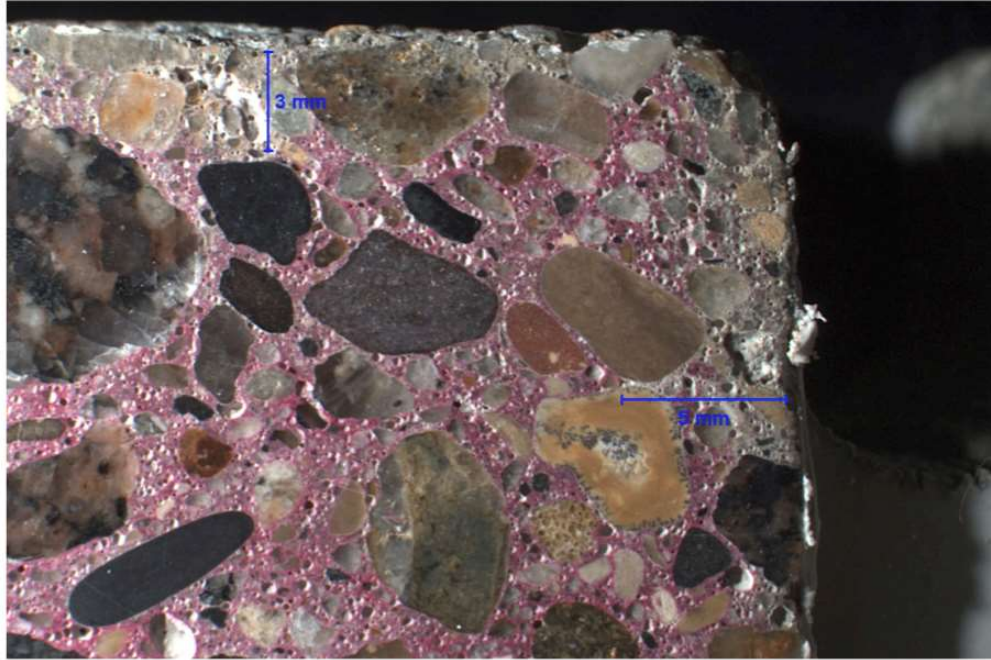
PHOTO:
162

SAMPLE ID: 7012, 7380-199 **DESCRIPTION:** Carbonation (unstained) ranged from negligible up to 3mm depth from the top surface and ranged from negligible up to 5mm depth from the sawcut joint surface; in this view of sawcut and lapped cross section of core exposed to phenolphthalien pH indicator.
MAG:5x

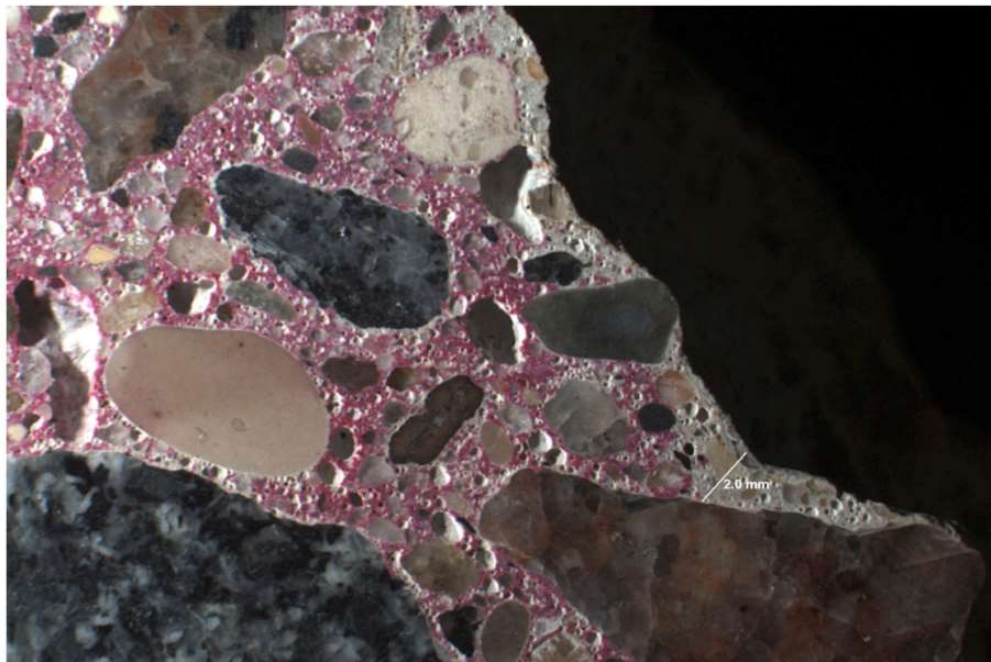
PHOTO: 163

SAMPLE ID: 7012, 7380-199 **DESCRIPTION:** Carbonation (unstained paste) proceeds up to 2mm depth from the stressed joint plane at 105mm depth in the core.
MAG: 5x

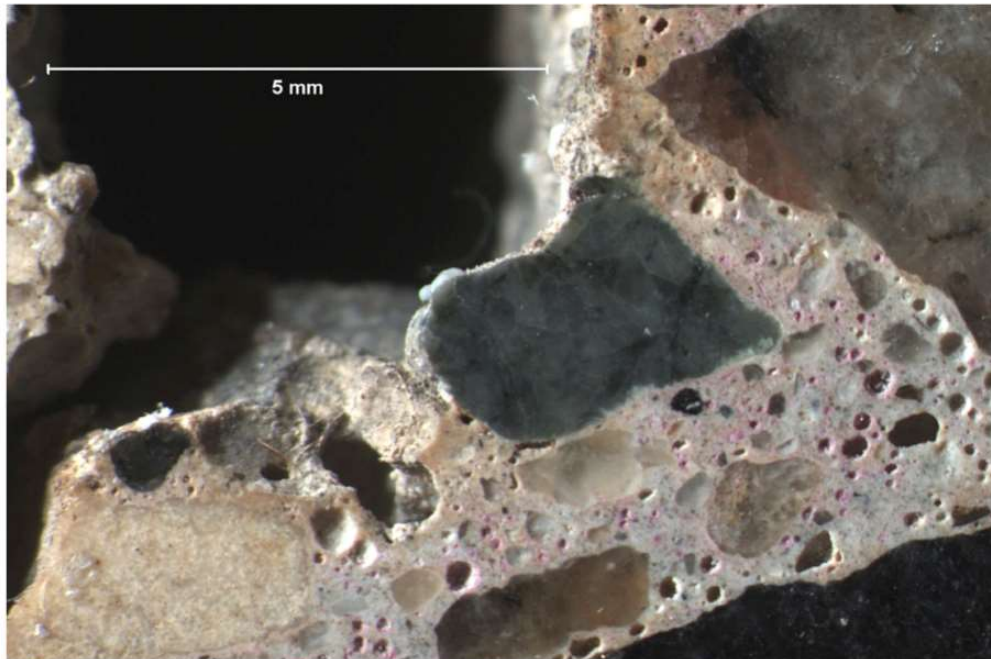
PHOTO:
165

SAMPLE ID: 7380-199, 7012 **DESCRIPTION:** A concentration of magenta-stained, ettringite-filled voidspaces at the base of the sawcut control joint.

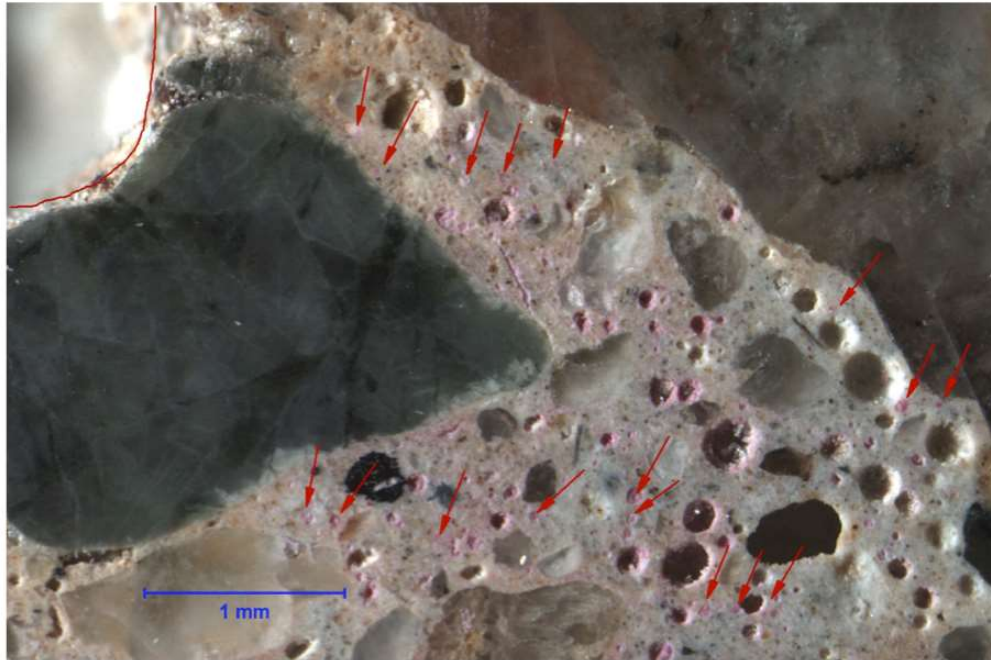
PHOTO:
166

SAMPLE ID: 7012, 7380-199 **DESCRIPTION:** Closer view of fine, ettringite-filled voids at the base of the sawcut.

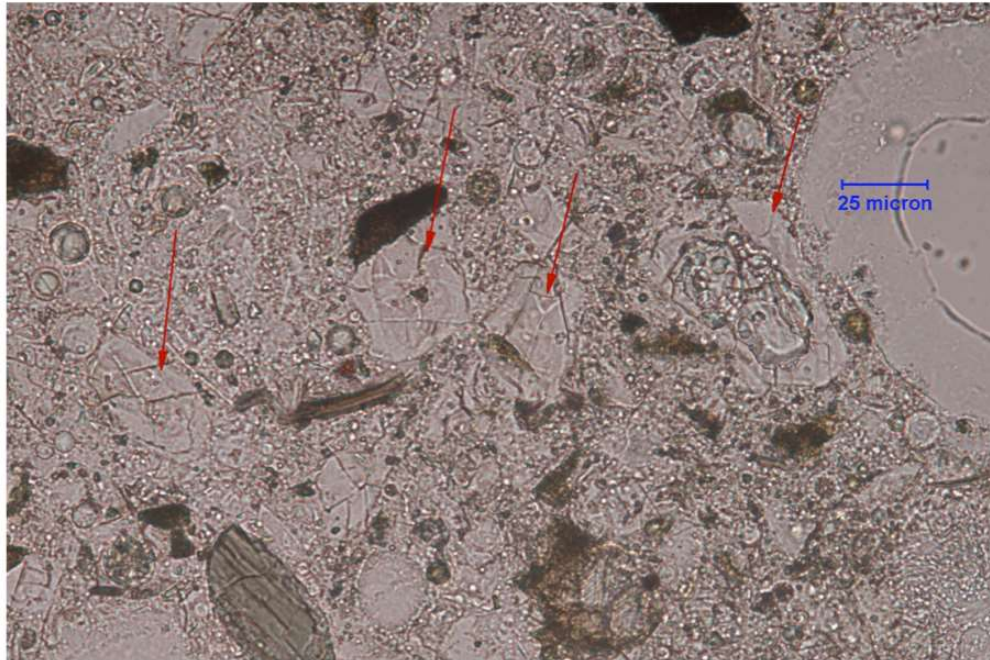
PHOTO: 168

SAMPLE ID: 7380-199, 7012 **DESCRIPTION:** Well to fully hydrated alite portland cement clinker particles in thin section of concrete paste under plane polarized light. Note abundant spherical flyash pozzolan particles.
MAG: 400x

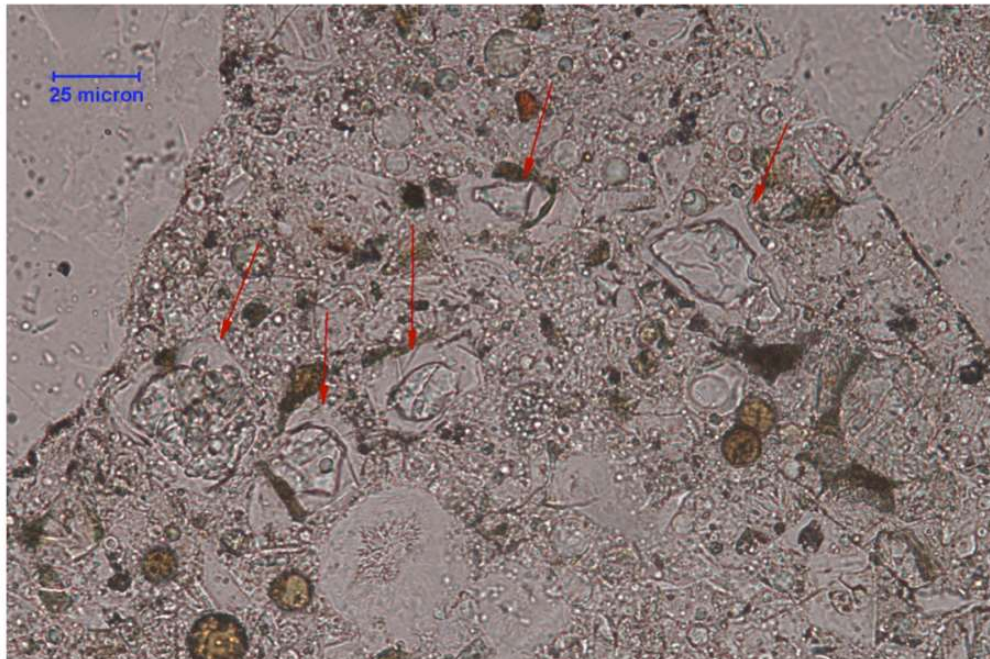
PHOTO: 169

SAMPLE ID: 7380-199, 70012 **DESCRIPTION:** Well hydrated alite portland cement clinker particles in thin section of concrete paste under plane polarized light. Note abundant spherical flyash pozzolan particles.
MAG: 400x

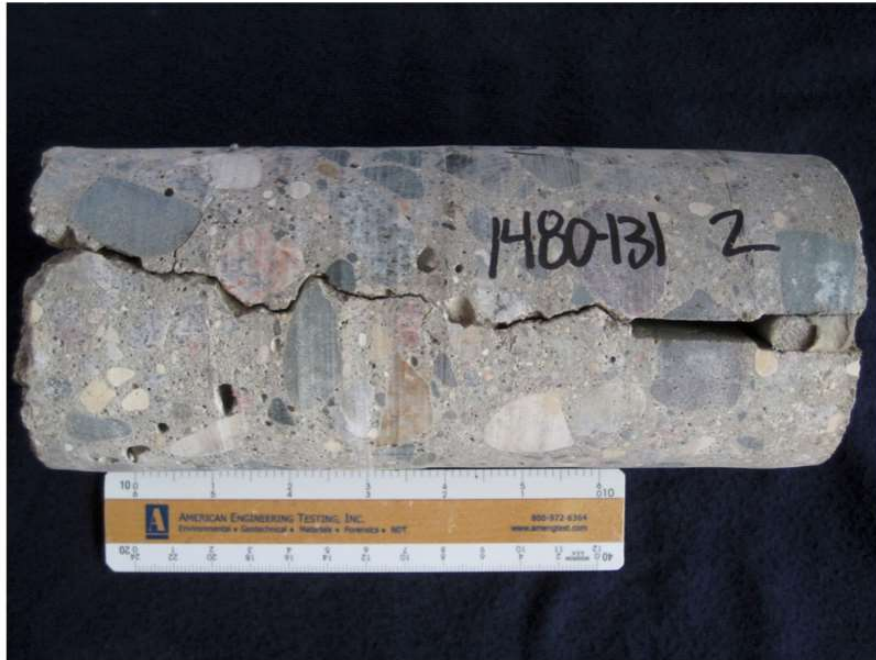
PHOTO: 1

SAMPLE ID: 1480-131, 2 **DESCRIPTION:** Jointed core sample utilized for petrographic analysis.
Top surface is right.

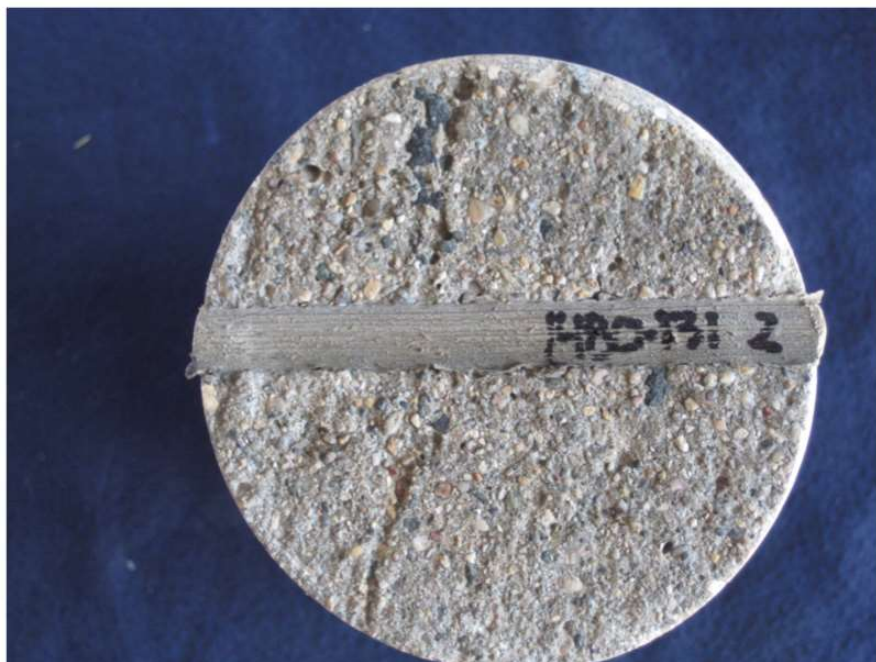
PHOTO: 2

SAMPLE ID: 1480-131, 2 **DESCRIPTION:** Rough screeded and mortar eroded top surface of the core with intact silicone joint sealant.

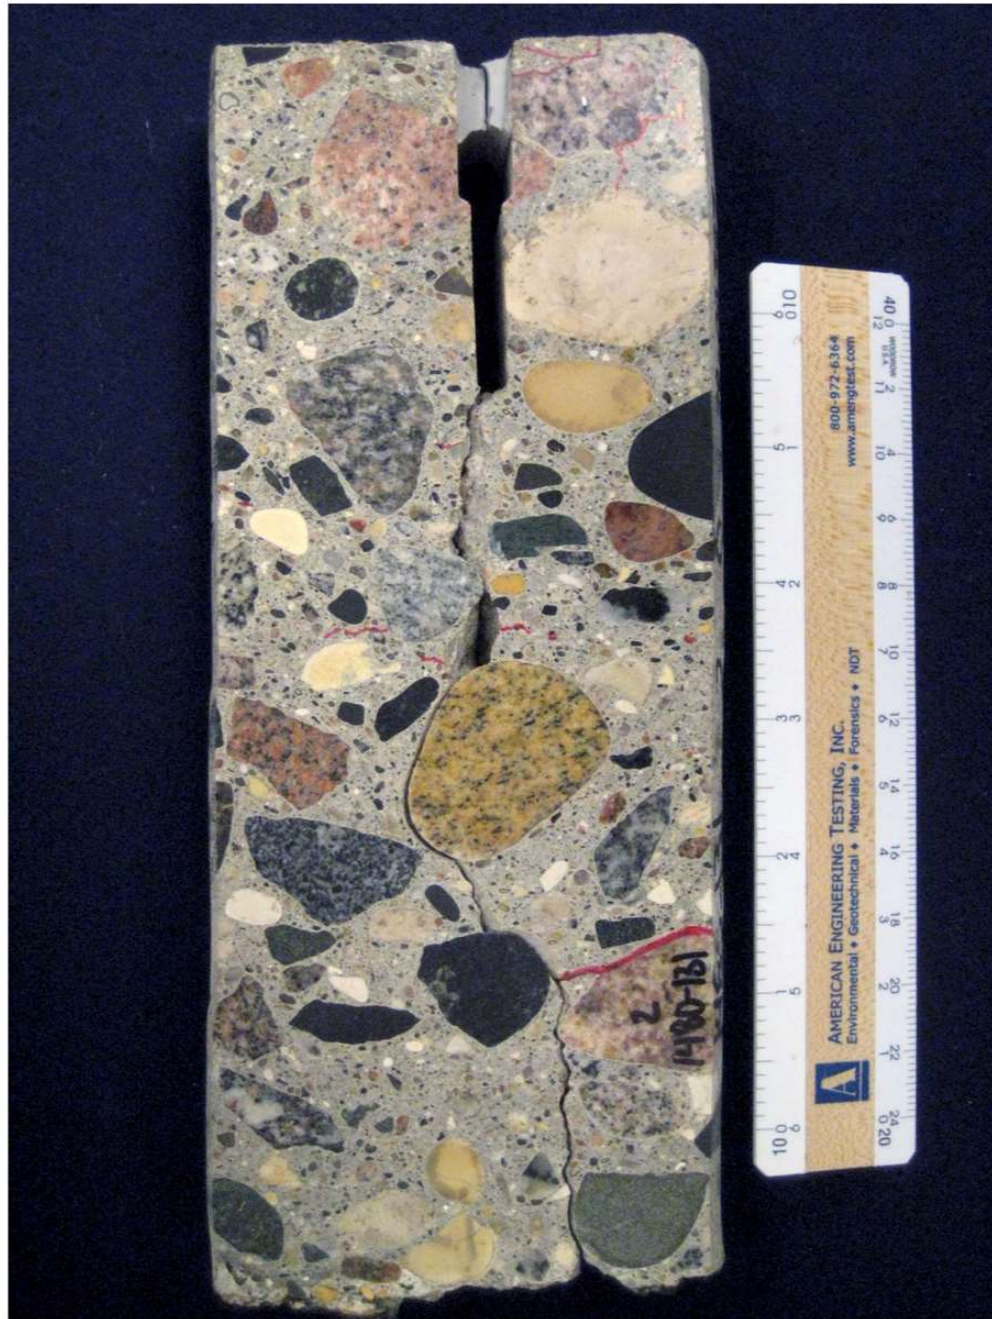
PHOTO:
57

SAMPLE ID: 1480-131, 2 **DESCRIPTION:** Sawcut and lapped cross section of core. The core exhibits tight interlock and no distress of the joint crack.

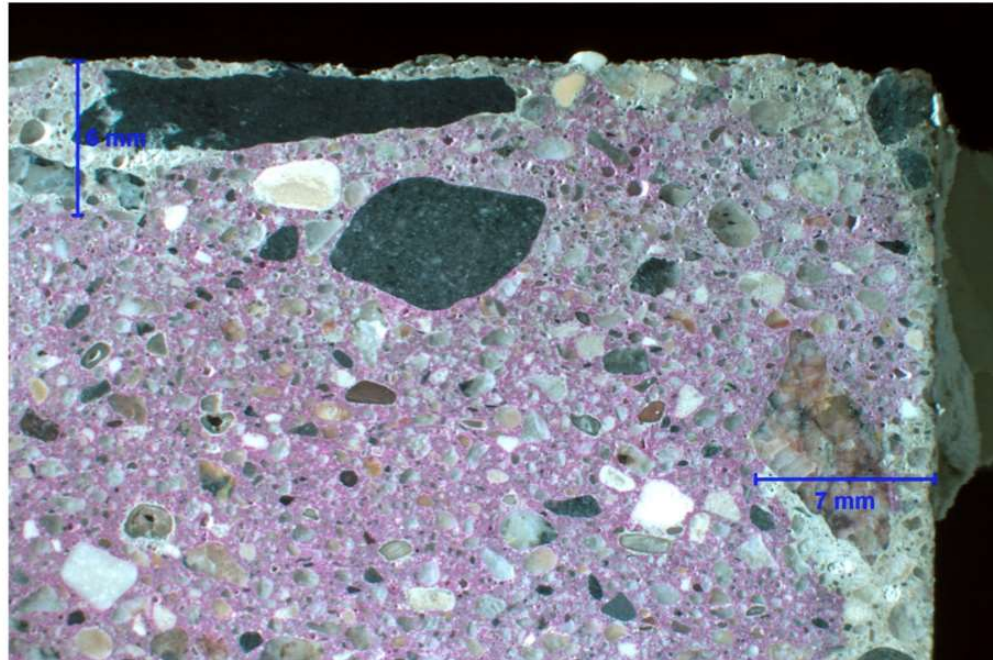
PHOTO: 76

SAMPLE ID: 1480-131, 2 **DESCRIPTION:** Carbonation (unstained paste) ranged from negligible up to 6mm depth from the top surface and negligible up to 7mm depth from the sawcut joint face.
MAG: 5x

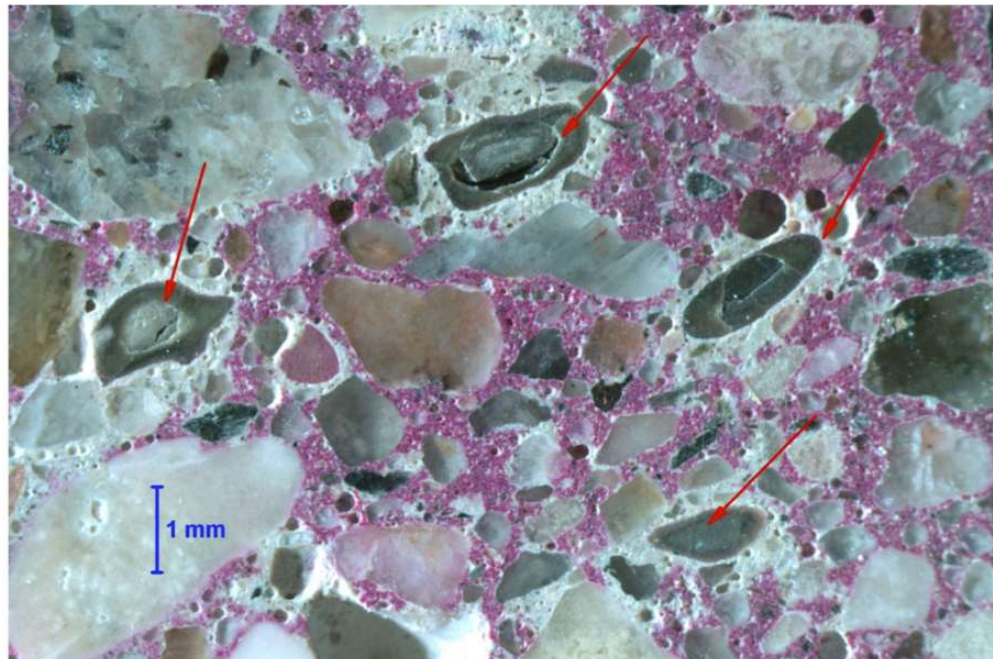
PHOTO: 77

SAMPLE ID: 1480-131, 2 **DESCRIPTION:** Four alkali silica reactive shale fine aggregate particles at depth in the sawcut and lapped cross section of core.
MAG: 15x

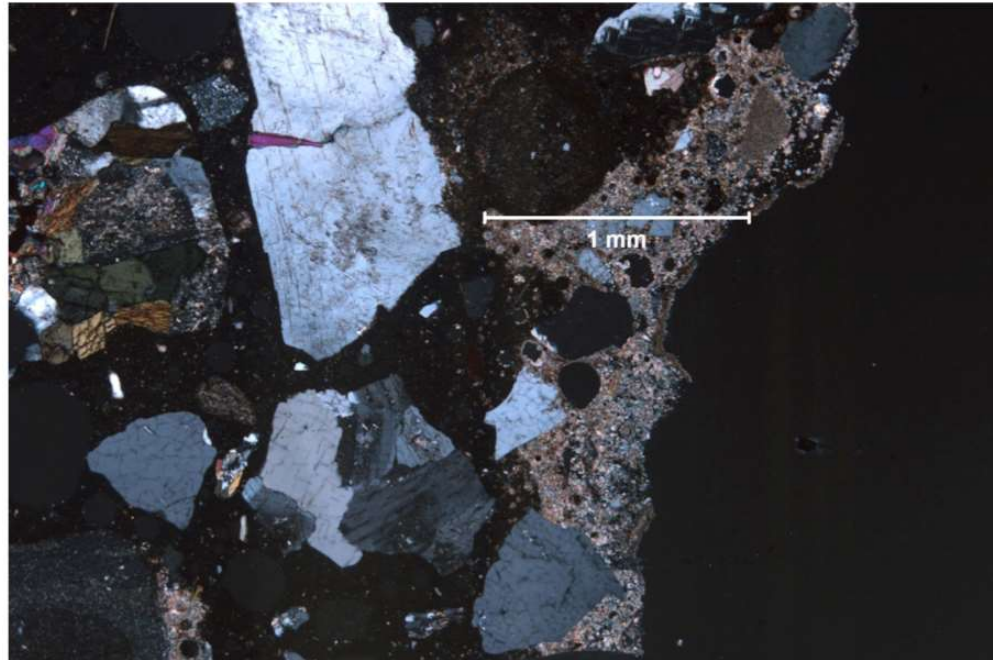
PHOTO: 78

SAMPLE ID: 1480-131, 2 **DESCRIPTION:** Carbonation (brightly colored paste) proceeded to 1mm depth from the joint crack plane (black, isotropic) on the right side of the image. Thin section of concrete at mid-depth in the joint under cross polarized light.
MAG: 40x

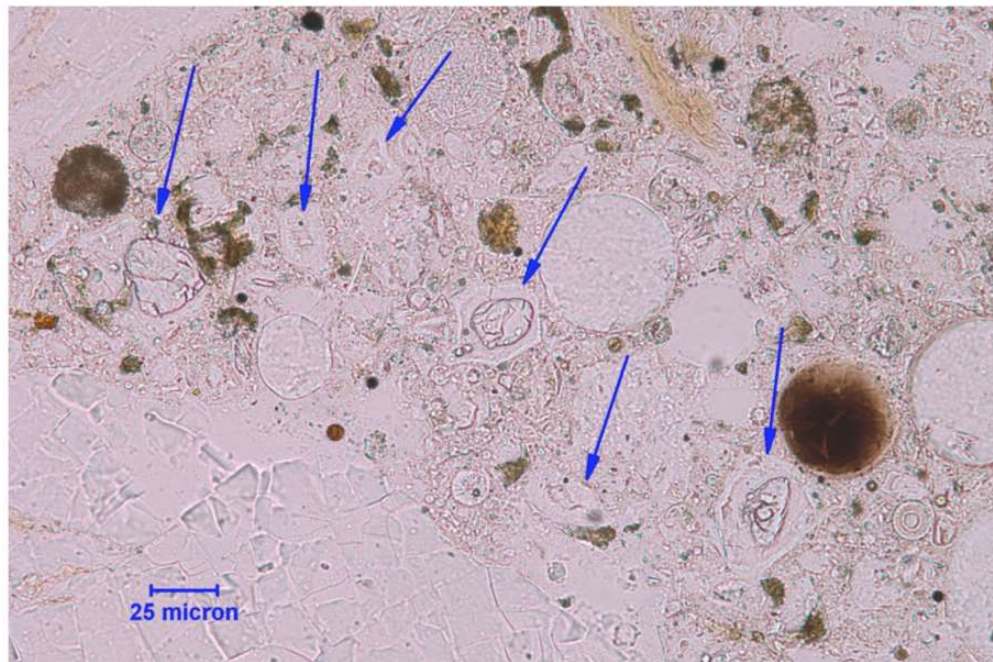
PHOTO: 79

SAMPLE ID: 1480-131, 2 **DESCRIPTION:** Well to fully hydrated alite portland cement clinker particles (arrows) in thin section of concrete paste under plane polarized light. Note abundant spherical flyash pozzolan particles,
MAG: 400x

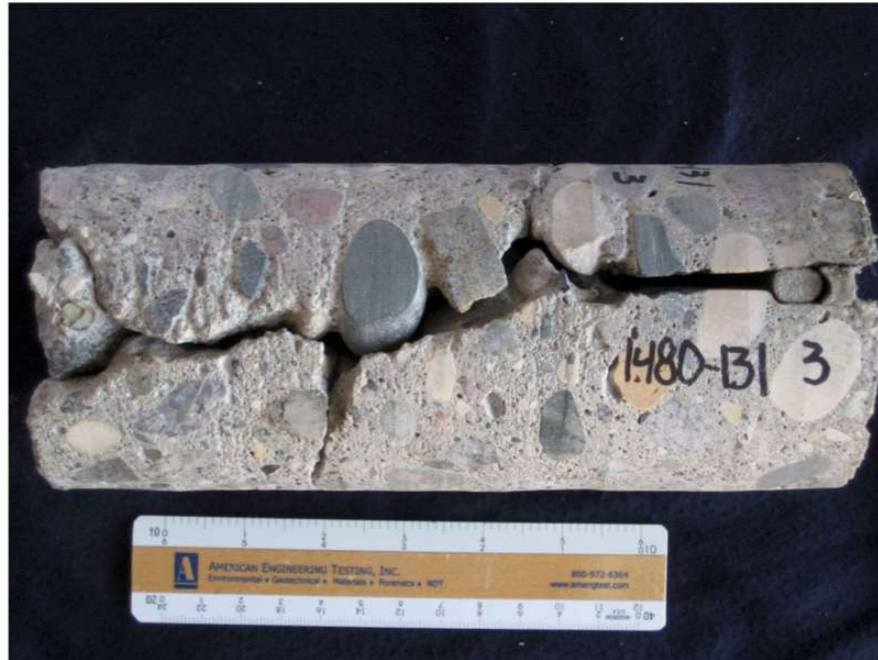
PHOTO: 3

SAMPLE ID: 1480-131, 3 **DESCRIPTION:** Jointed core sample utilized for petrographic analysis. Note some mass lost along the length of the joint. The top surface is right.

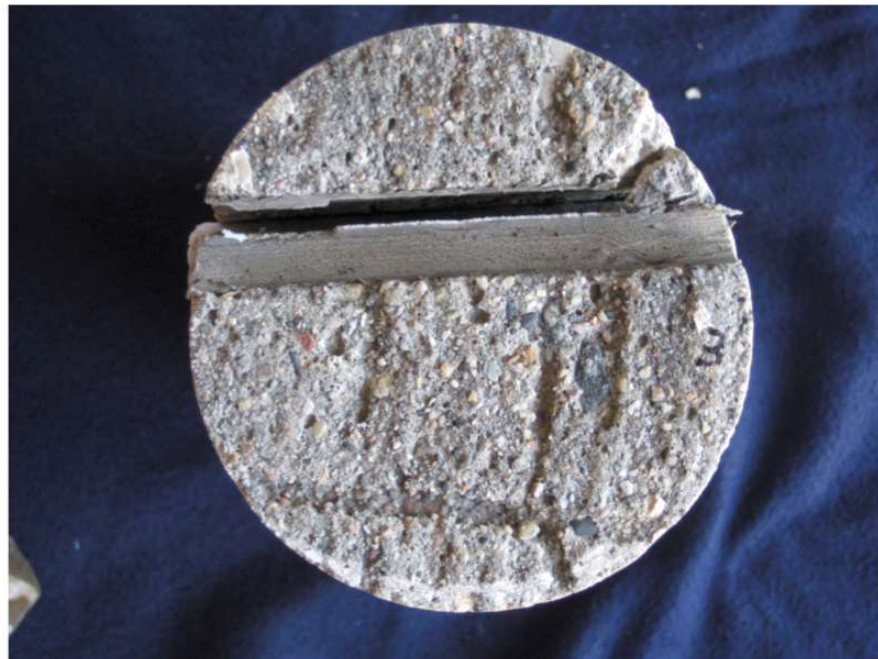
PHOTO: 4

SAMPLE ID: 1480-131, 3 **DESCRIPTION:** Rough screeded and tined top surface of the core with mortar erosion. Note failed silicone joint sealant.

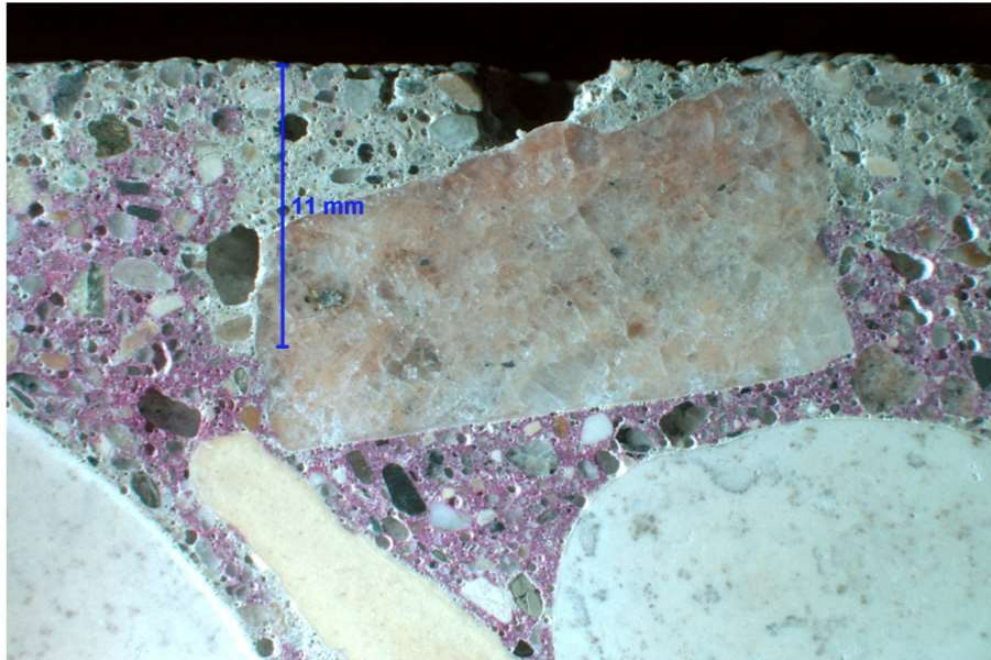
PHOTO: 80

SAMPLE ID: 1480-131, 3 **DESCRIPTION:** Carbonation (unstained paste) ranged from 1mm up to 11mm depth from the top surface of the core.
MAG: 5x

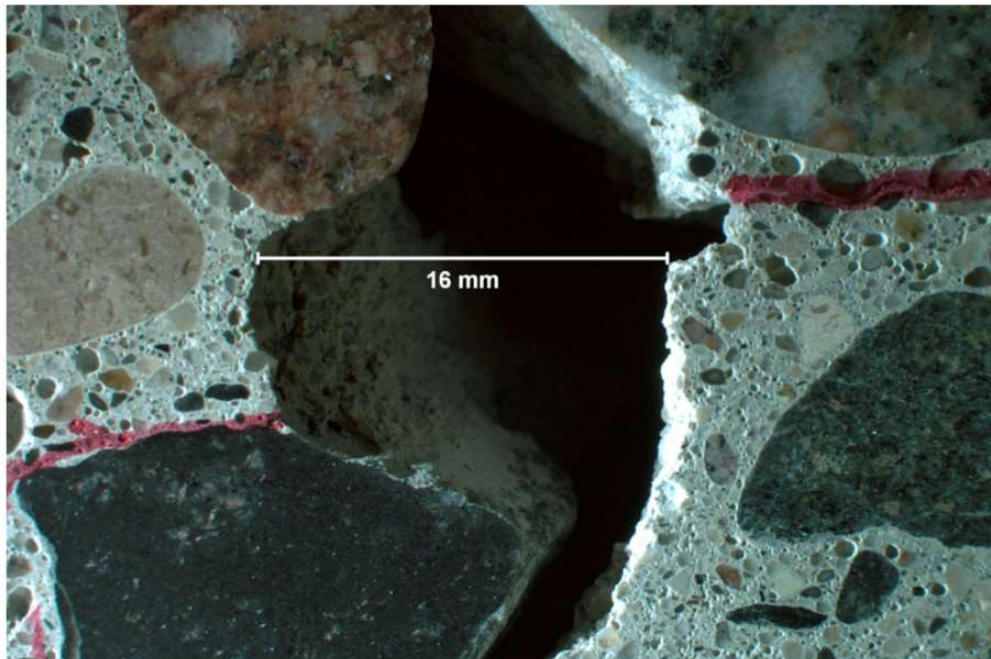
PHOTO: 81

SAMPLE ID: 1480-131, 3 **DESCRIPTION:** 16mm of mass loss between the two side of the joint crack at below 80mm depth in the joint.

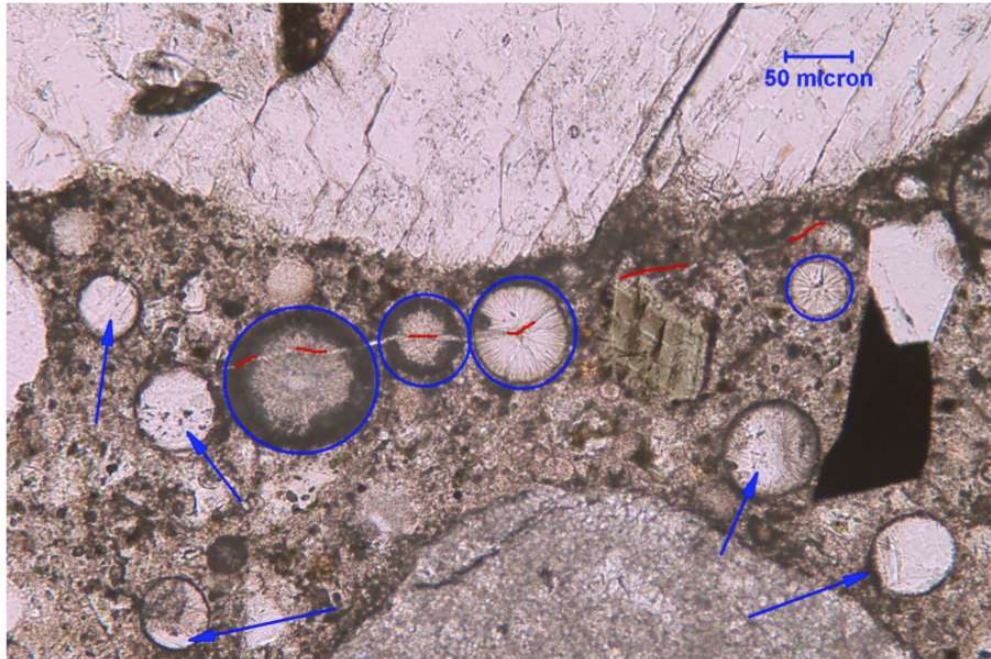
PHOTO: 83

SAMPLE ID: 1480-131, 3 **DESCRIPTION:** Spherical ettringite-filled air void spaces in thin section of concrete paste adjacent to the joint face; in thin section under plane polarized light. Note microcracking bisecting previously filled voids; mapped in red dashed line.
MAG: 200x
