Impact of Water/ Cementitious-Based Concrete Mix Design Specification Changes on Concrete Pavement Quality

July 2018

Research Project
Final Report 2018-25

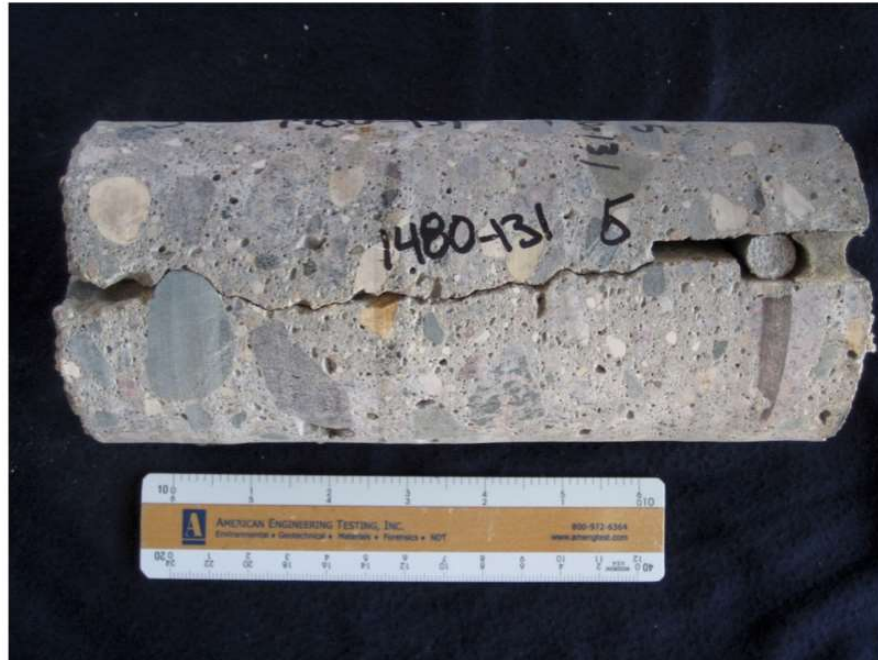
PHOTO: 7

SAMPLE ID: 1480-131, 5 **DESCRIPTION:** Jointed core sample utilized for petrographic analysis. The top surface is right.

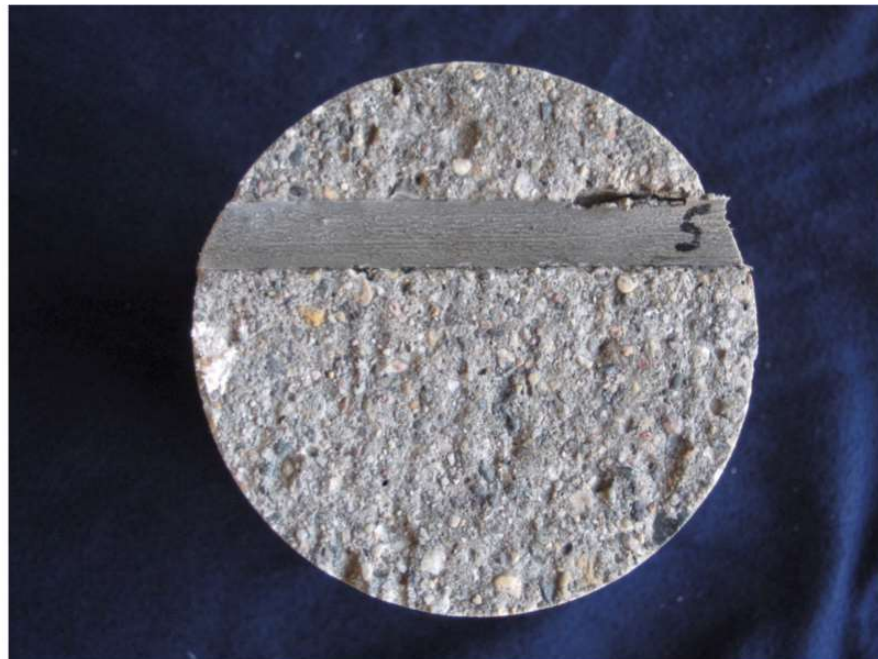
PHOTO: 8

SAMPLE ID: 1480-131, 5 **DESCRIPTION:** Rough screeded top surface of the core with mortar erosion. Note silicone joint sealant.

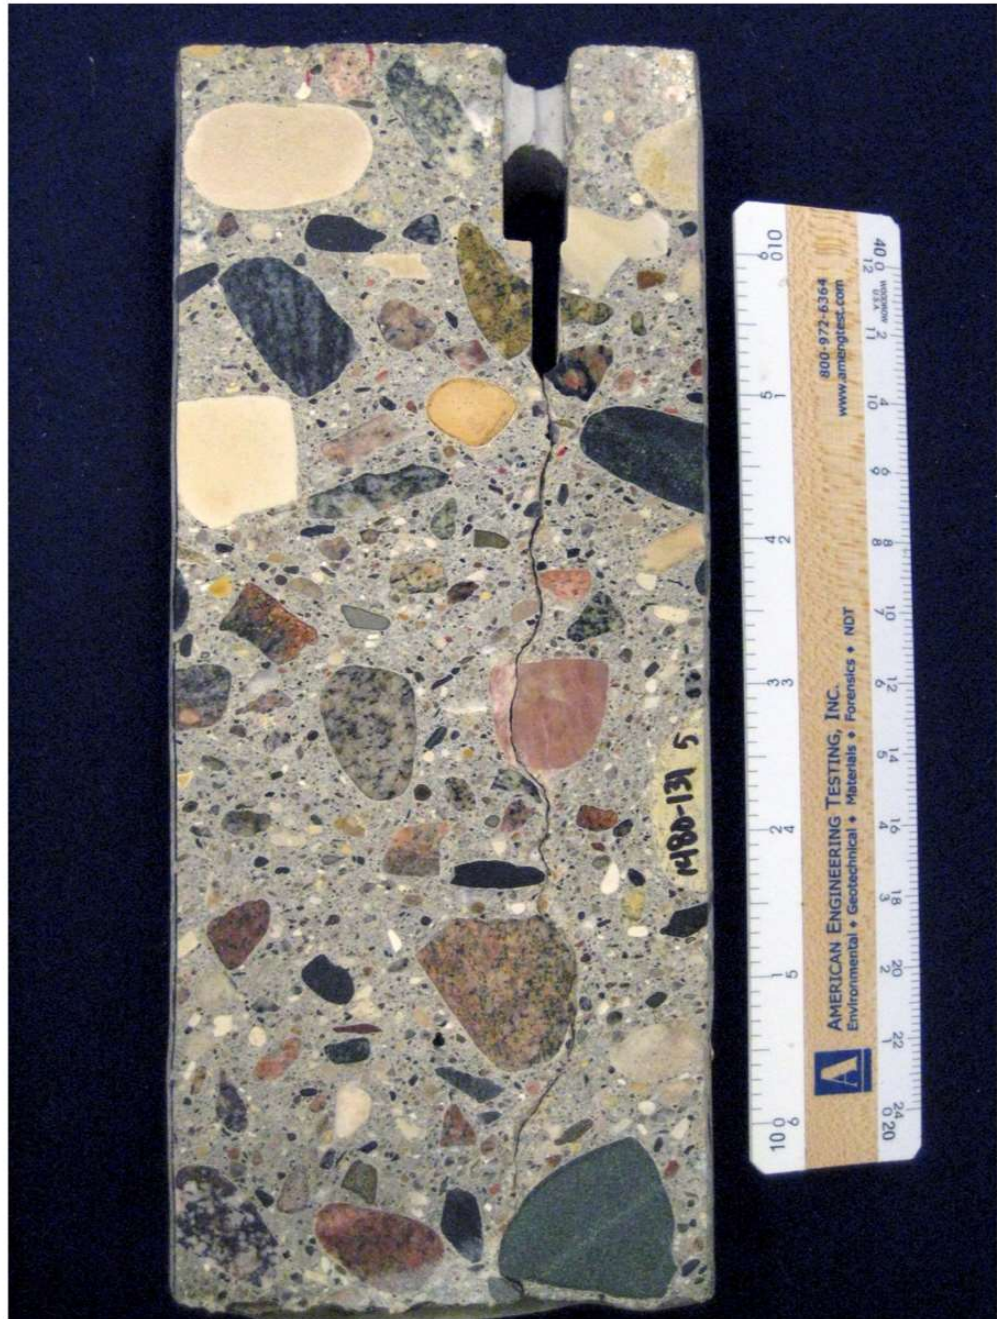
PHOTO:
59

SAMPLE ID: 1480-131, 5 **DESCRIPTION:** Sawcut and lapped cross section of core. The joint crack exhibits no distress.

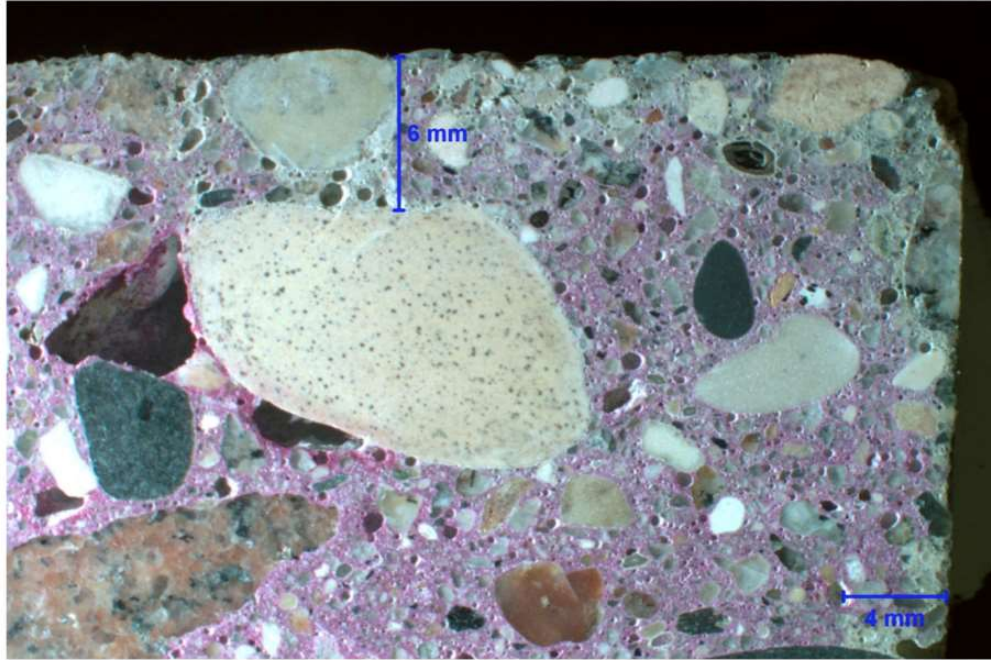
PHOTO: 84

SAMPLE ID: 1480-131, 5 **DESCRIPTION:** Carbonation (unstained) ranged from negligible up to 6mm depth from the top surface and from negligible up to 4mm depth), in this image, from the sawcut joint surface. A freshly sawcut and lapped cross section of concrete core exposed to phenolphthalein pH indicator.
MAG: 5x

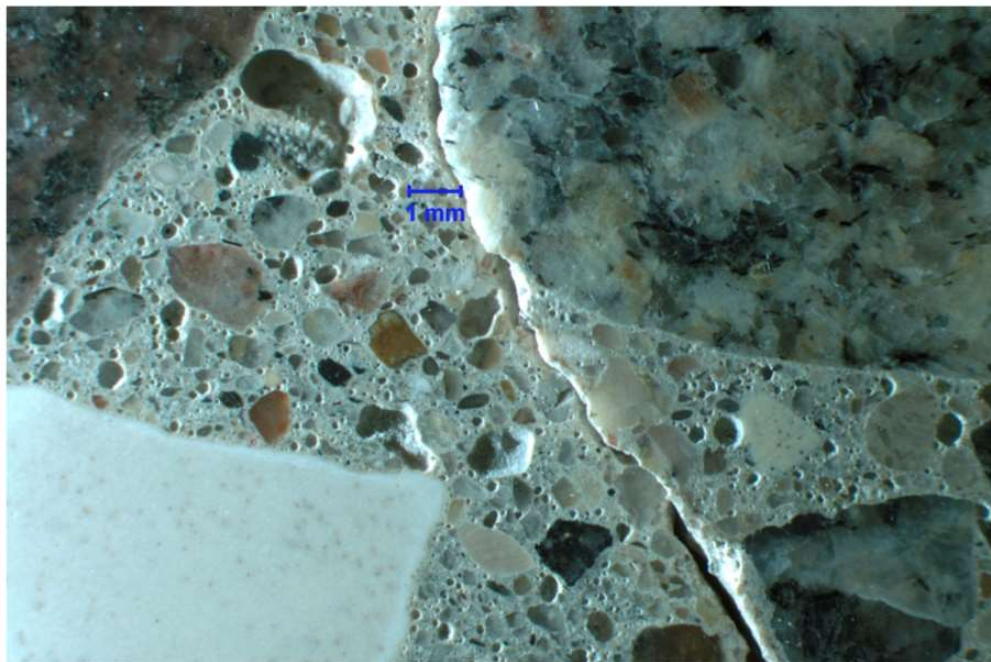
PHOTO: 85

SAMPLE ID: 1480-131, 5 **DESCRIPTION:** Tight residual interlock between the two core halves along the joint crack; below 145mm depth in this image. Note fine, unfilled, entrained sized air voidspaces.
MAG: 10x

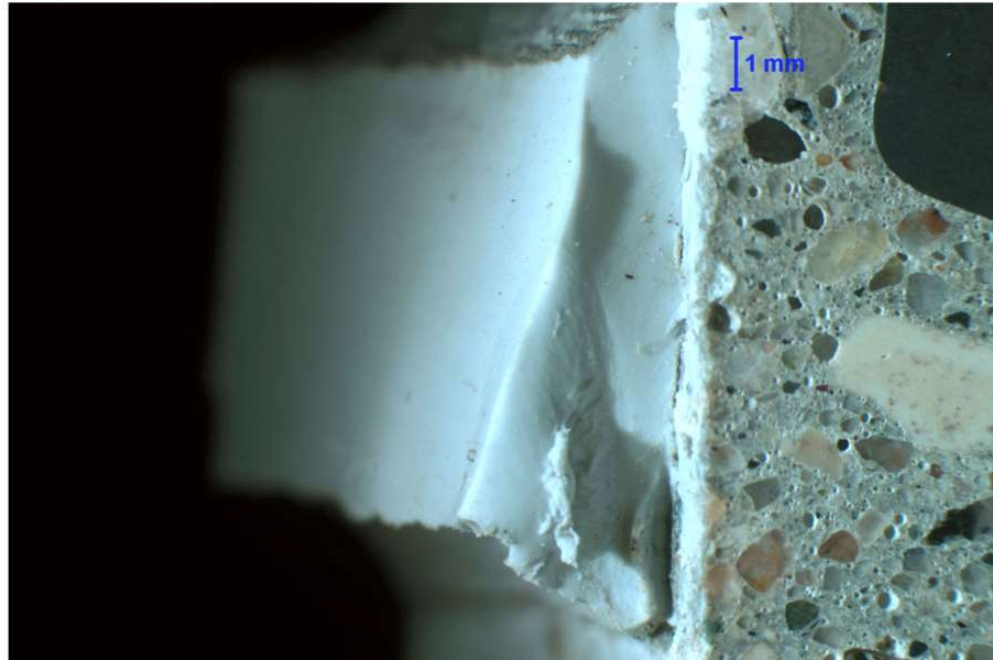
PHOTO: 86

SAMPLE ID: 1480-131, 5 **DESCRIPTION:** Well bonded silicone joint sealant was cut from the core half for preparation of the concrete surface.
MAG: 10x

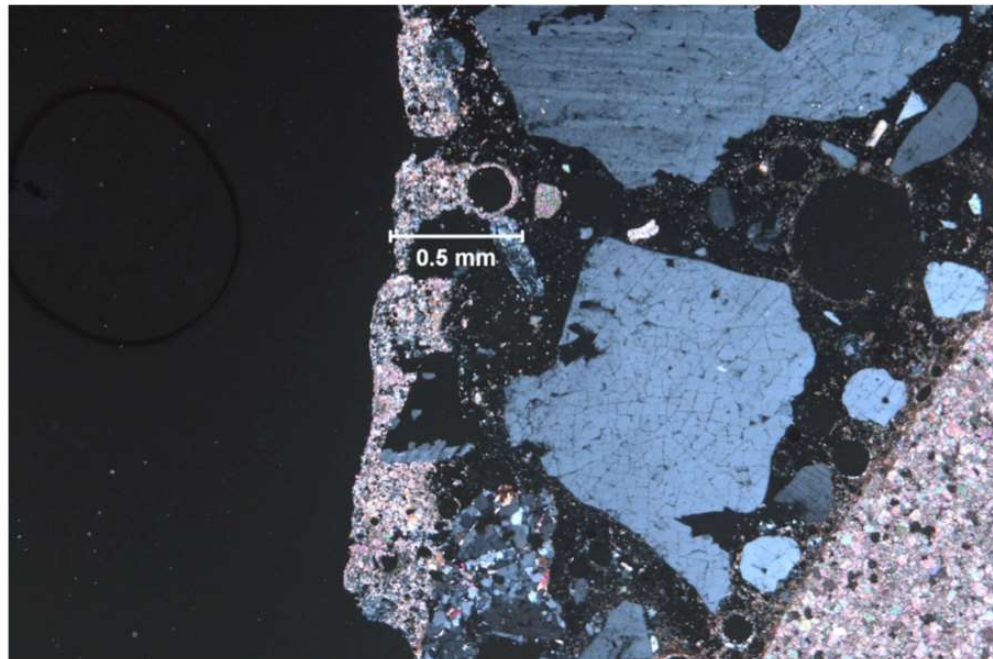
PHOTO: 87

SAMPLE ID: 1480-131, 5 **DESCRIPTION:** Brightly colored layer of carbonated paste along the joint crack plane; in thin section under cross polarized light.
MAG: 40x

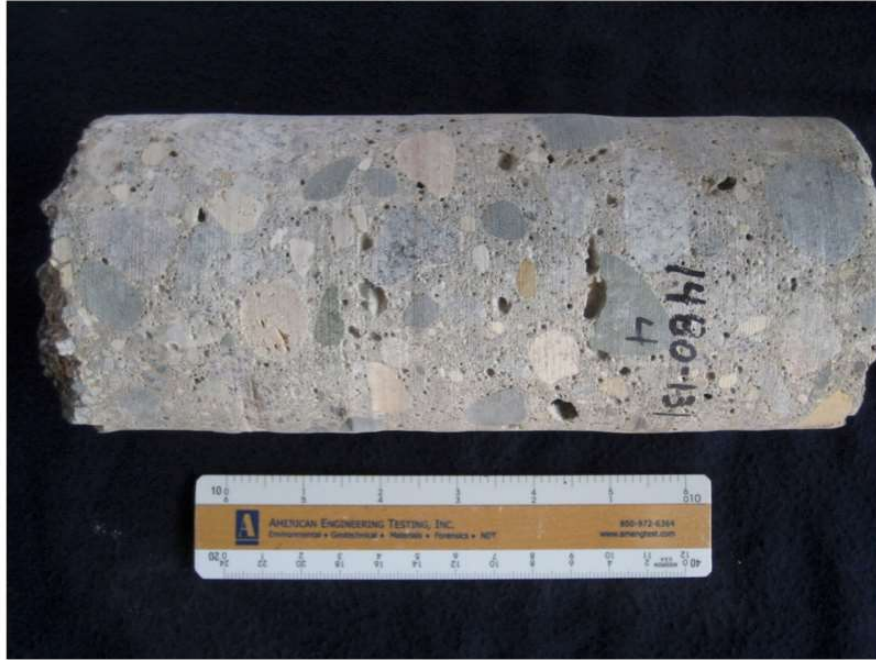
PHOTO: 5

SAMPLE ID: 1480-131, 4 **DESCRIPTION:** Mid-panel core sample utilized for rapid chloride permeability testing. The top surface is right.

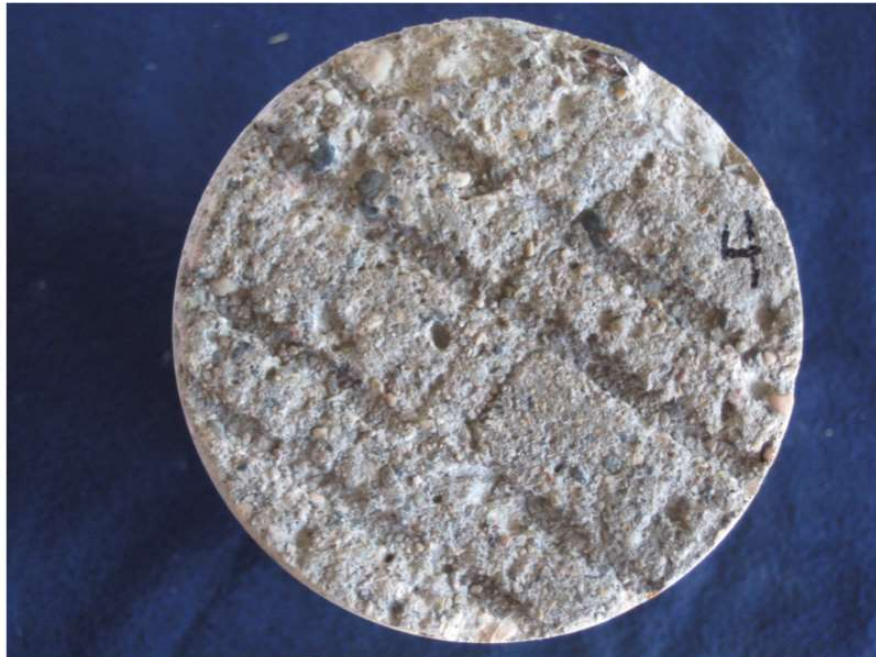
PHOTO: 6

SAMPLE ID: 1480-131, 4 **DESCRIPTION:** Rough screeded and tined top surface of the core with mortar erosion.

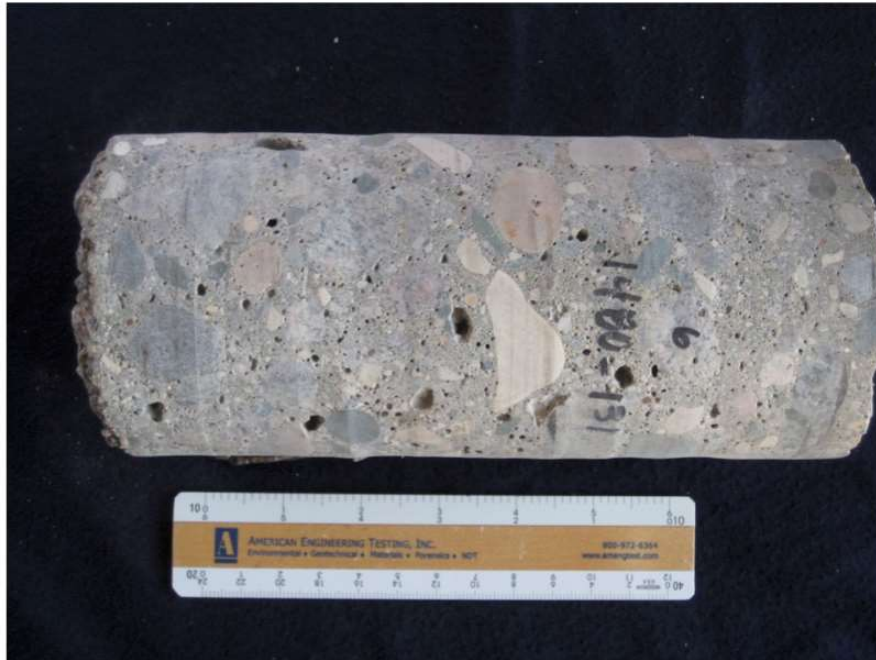
PHOTO: 9

SAMPLE ID: 1480-131, 6 **DESCRIPTION:** Mid-panel core sample utilized for rapid chloride permeability testing. The top surface is right.

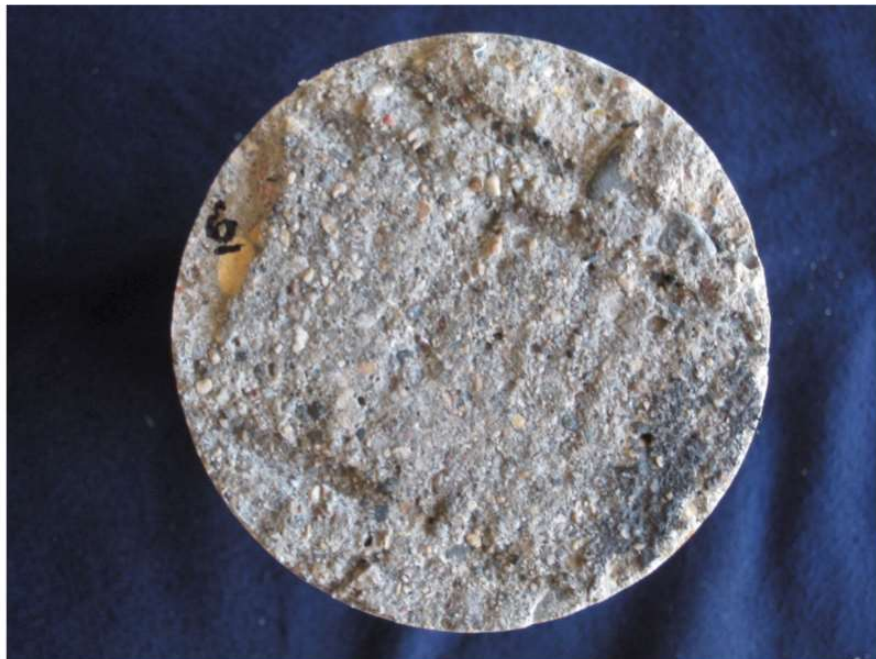
PHOTO:
10

SAMPLE ID: 1480-131, 6 **DESCRIPTION:** Rough screeded and tined top surface of the core with mortar erosion.

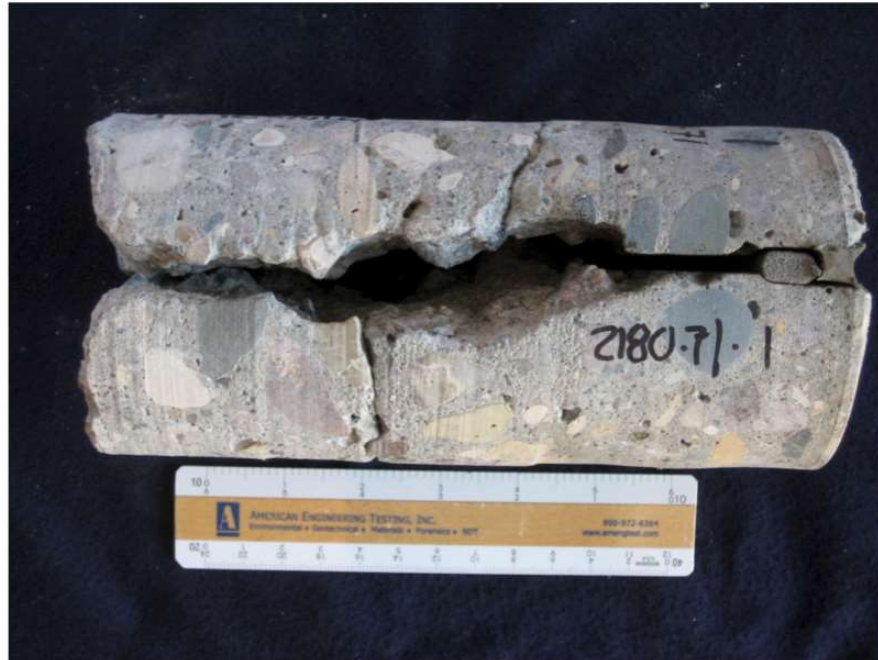
PHOTO: 17

SAMPLE ID: 2180-71, 1 **DESCRIPTION:** Jointed core sample utilized for petrographic analysis. The sealed top surface is right. Note mass lost along much of the length of the joint crack.

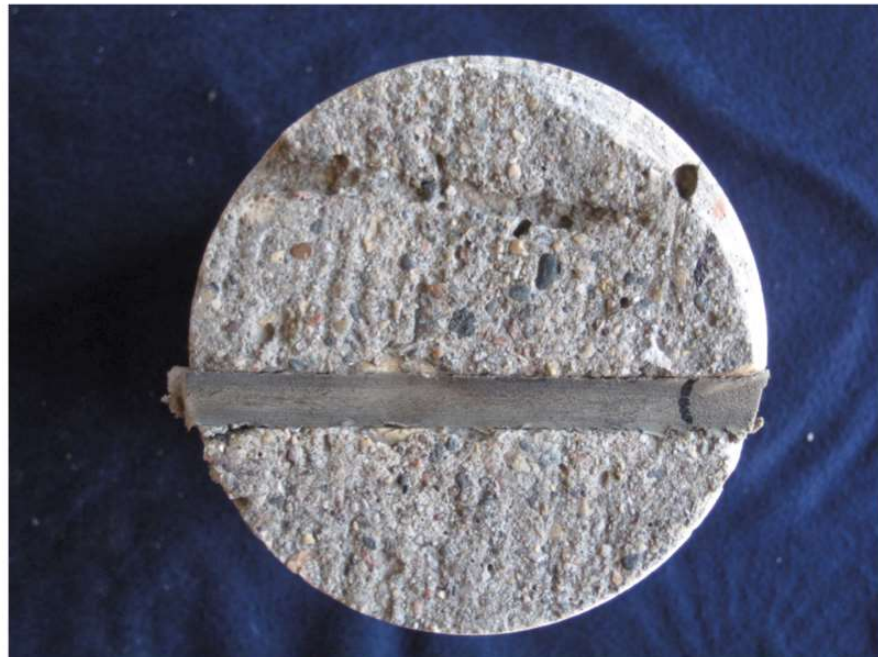
PHOTO: 18

SAMPLE ID: 2180-71, 1 **DESCRIPTION:** Rough screeded and tined top surface of the core with traffic wear. The sealant was completely de-bonded from one side of the joint.

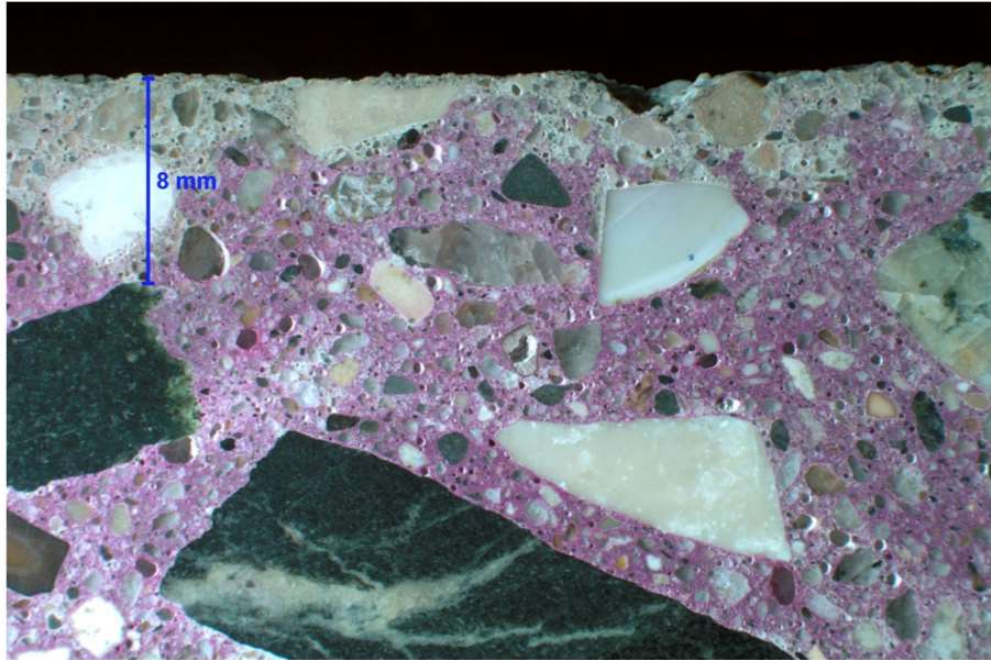
PHOTO: 98

SAMPLE ID: 2180-71, 1 **DESCRIPTION:** Carbonation (unstained) ranged from 1mm up to 8mm depth from the top surface.
MAG: 5x

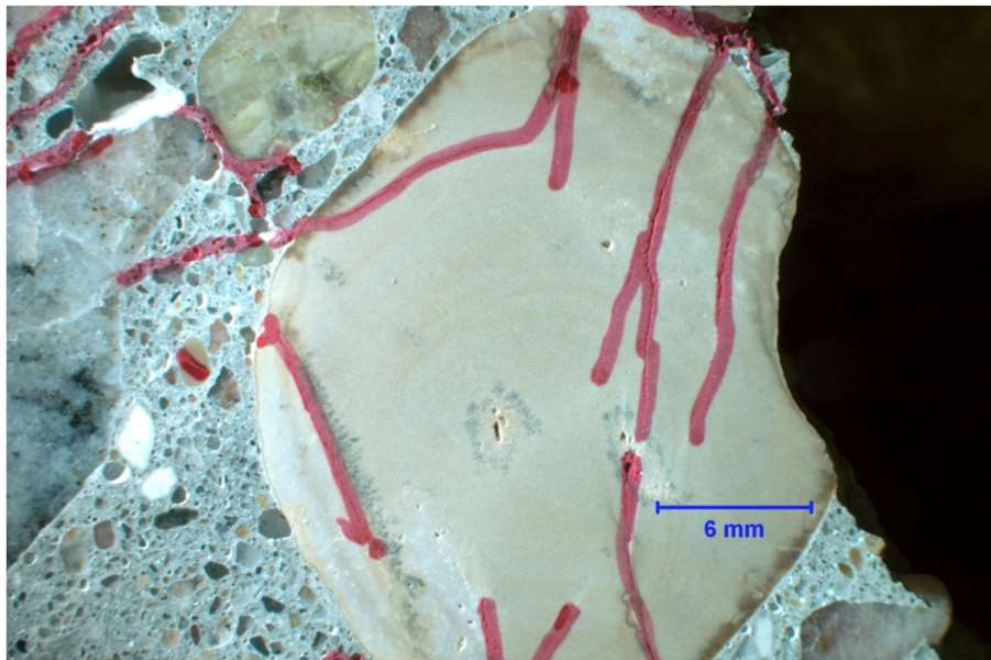
PHOTO: 99

SAMPLE ID: 2180-71, 1 **DESCRIPTION:** The coarse carbonate aggregate particle is participating in the incipient distress along the joint at below 140mm depth in the core.
MAG: 5x

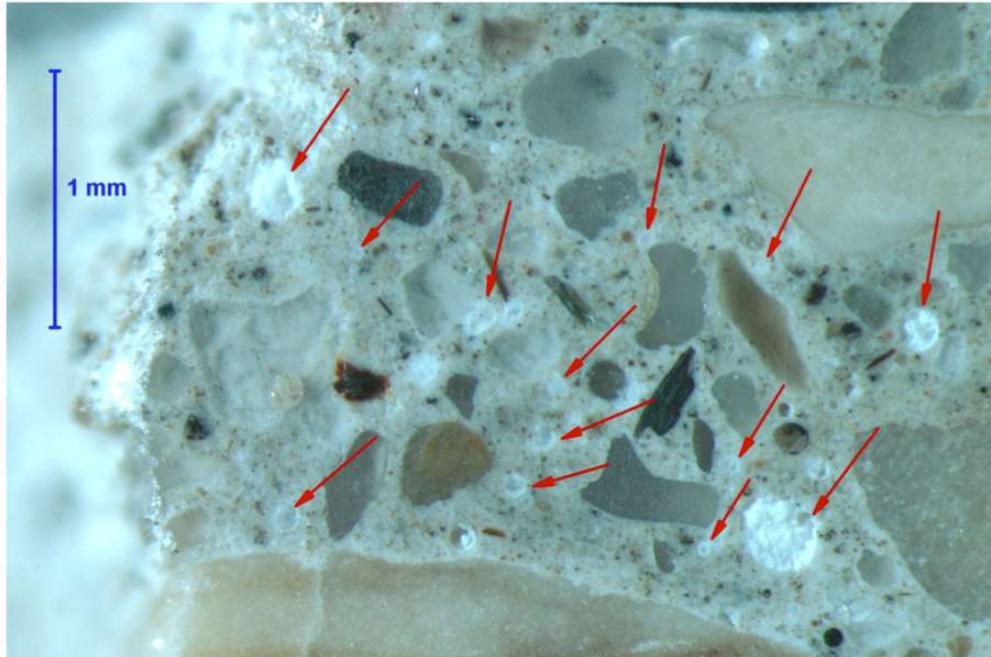
PHOTO:
101

SAMPLE ID: 2180-71, 1 **DESCRIPTION:** White to clear secondary ettringite-filled entrained air voidspaces adjacent to the distressed joint plane (left) at 108mm depth from the top surface.
MAG: 50x

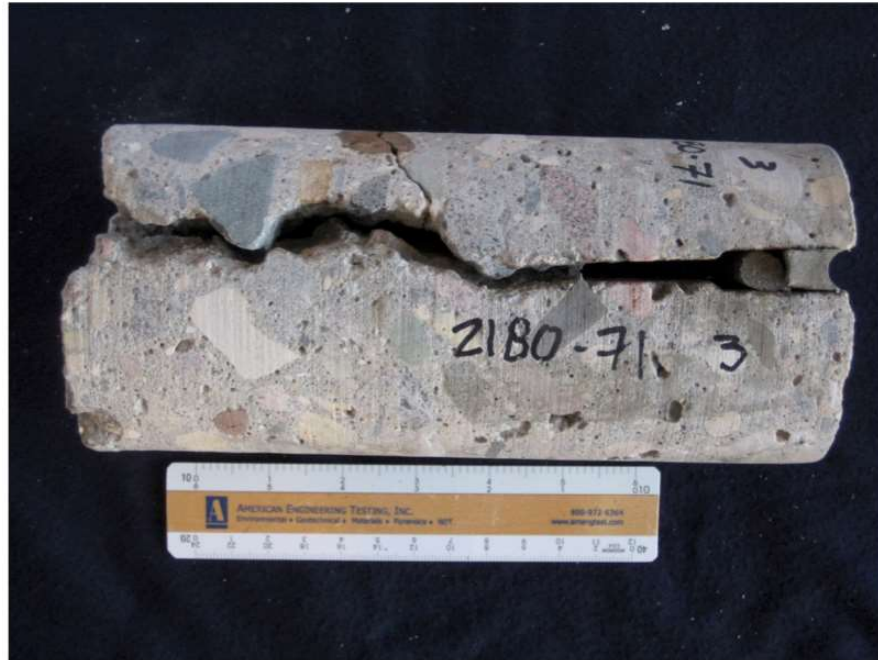
PHOTO: 19

SAMPLE ID: 2180-71, 3 **DESCRIPTION:** Jointed core sample utilized for petrographic analysis. The sealed top surface is right. Note mass lost along much of the length of the joint crack.

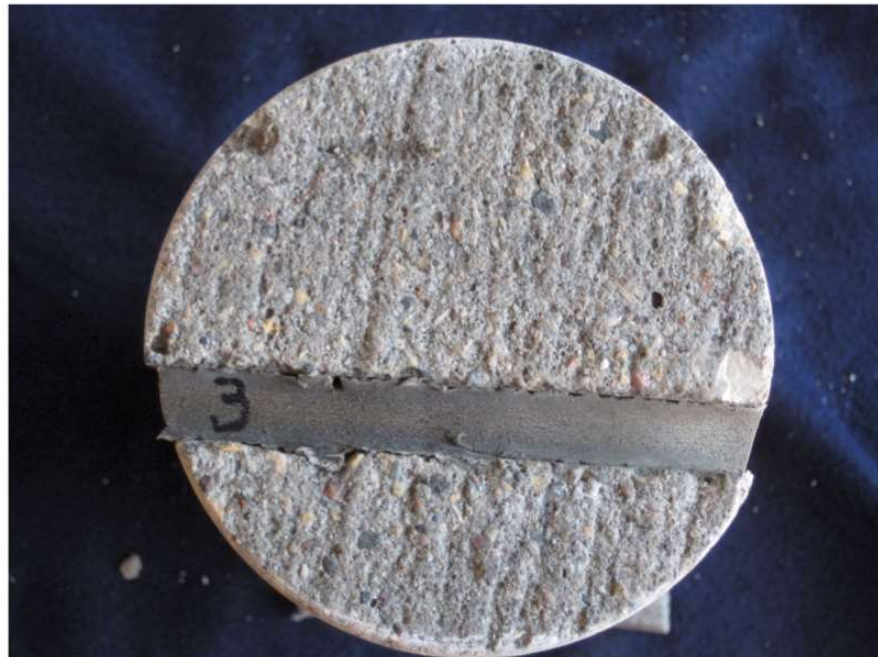
PHOTO: 20

SAMPLE ID: 2180-71, 3 **DESCRIPTION:** Rough textured top surface of the core with traffic wear. The sealant was completely de-bonded from one side of the joint and poorly bonded to the other.

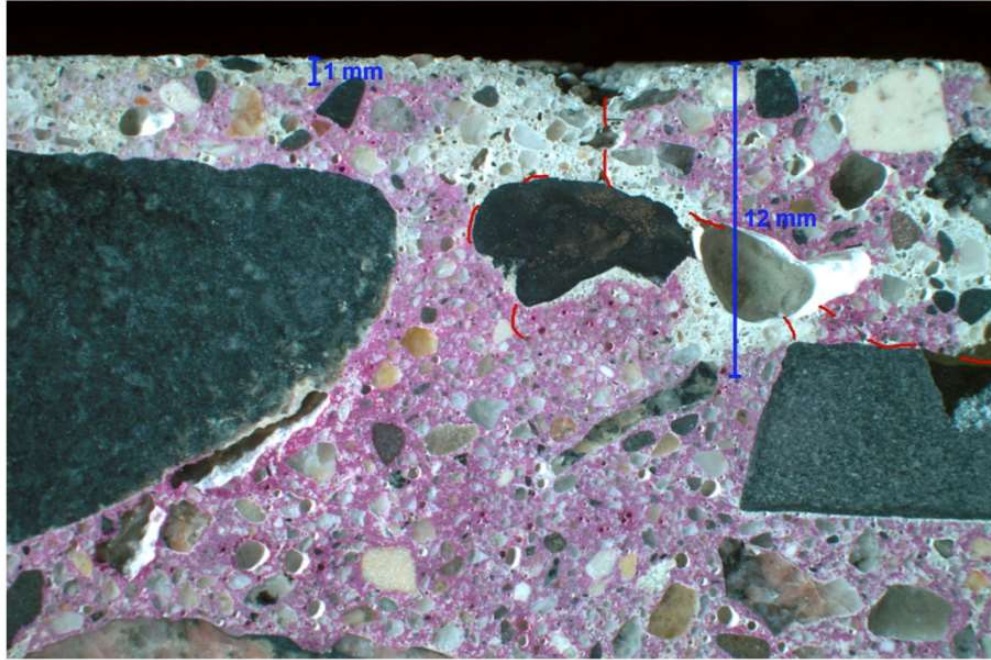
PHOTO:
102

SAMPLE ID: 2180-71, 3 DESCRIPTION: Carbonation (unstained paste) ranged from 1mm up to 12mm depth from the top surface; proceeding along microcracking mapped in red dashed line and consolidation void space.
MAG: 5x

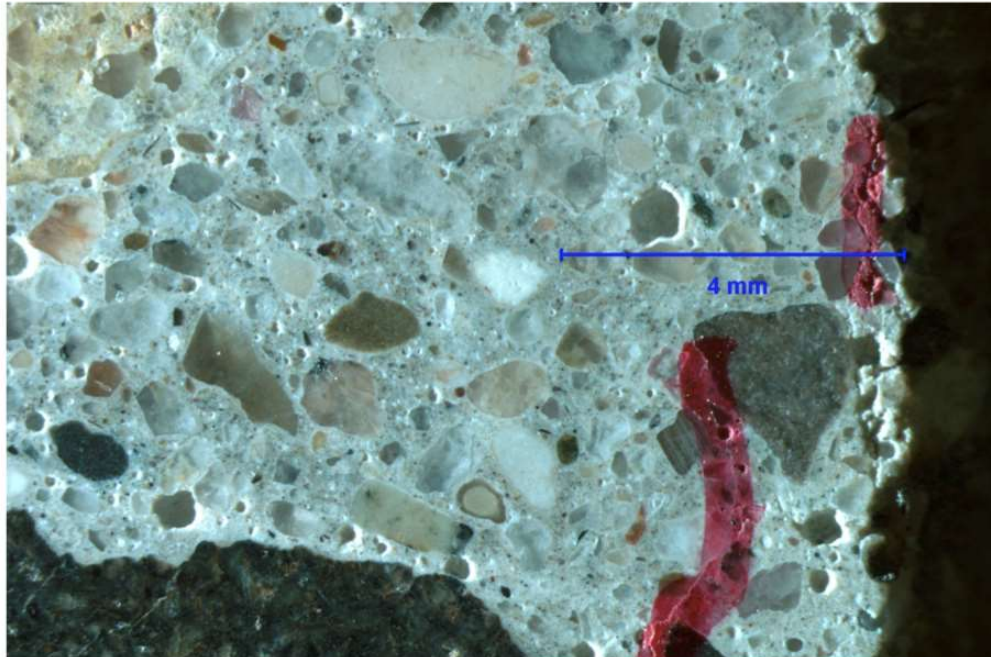
PHOTO:
103

SAMPLE ID: 2180-71, 3 DESCRIPTION: Note a significant loss of entrained air voidspaces within 4mm of the joint plane (right) at 90mm depth from the top surface. Incipient spalling is mapped in red ink.
MAG: 15x

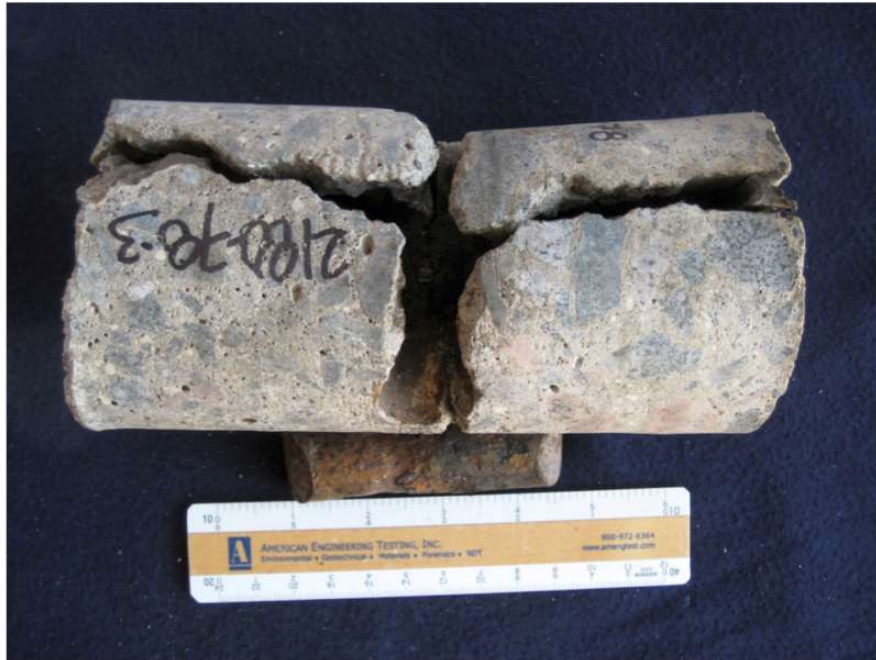
PHOTO: 21

SAMPLE ID: 2180-78, 3 **DESCRIPTION:** Jointed core sample utilized for petrographic analysis. The sealed top surface is right. Note mass lost along much of the length of the joint crack and the presence of a corroded rebar.

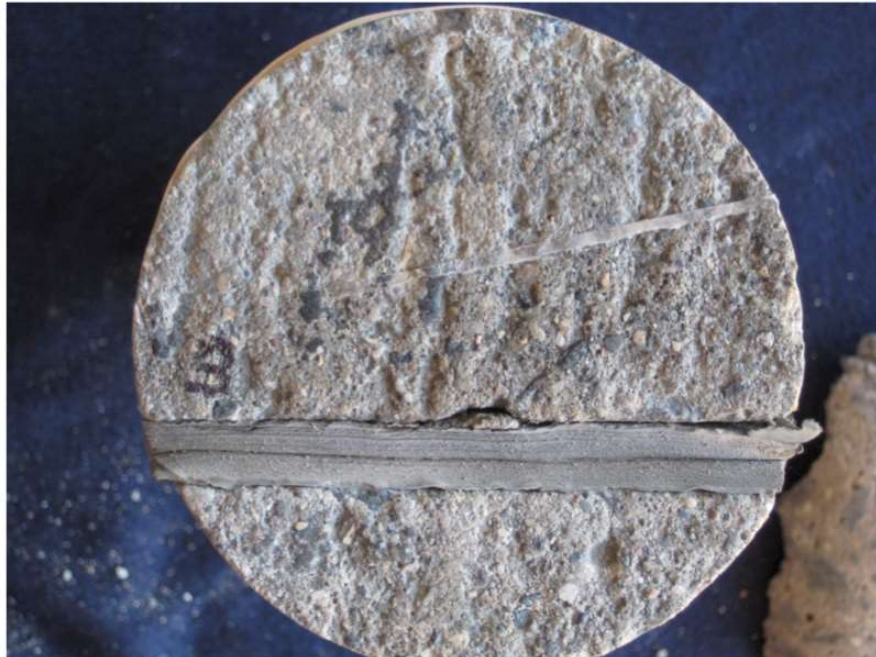
PHOTO: 22

SAMPLE ID: 2180-78, 3 **DESCRIPTION:** Rough textured top surface of the core with traffic wear. The silicone sealant was completely de-bonded from one side of the joint.

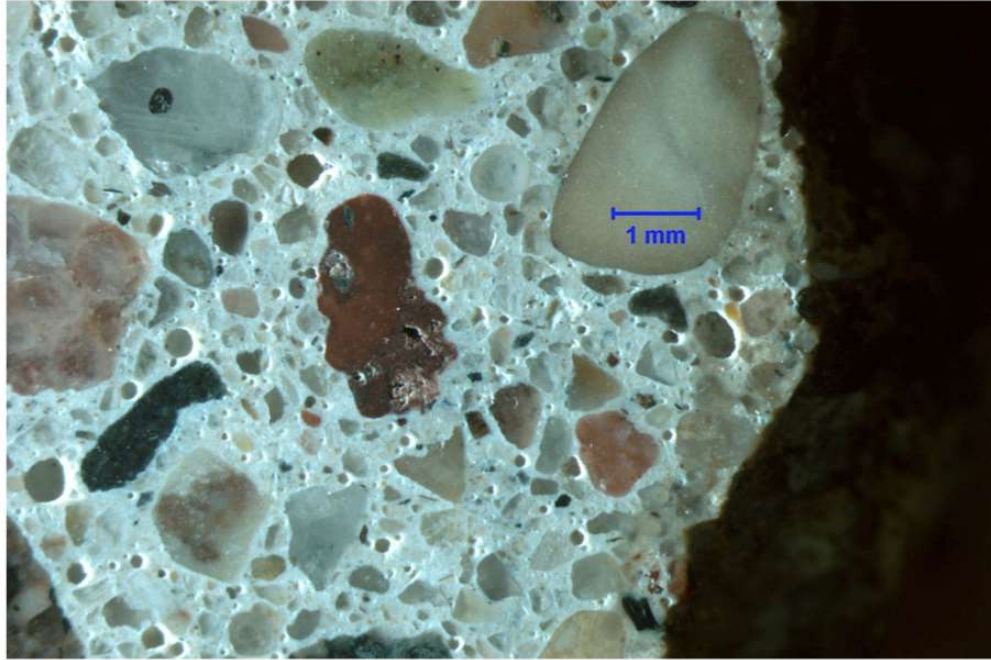
PHOTO:
104

SAMPLE ID: 2180-78, 3 **DESCRIPTION:** Fine entrained air voidspaces are obvious in the paste adjacent to the undistressed joint face at 70m depth in the concrete.
MAG: 15x

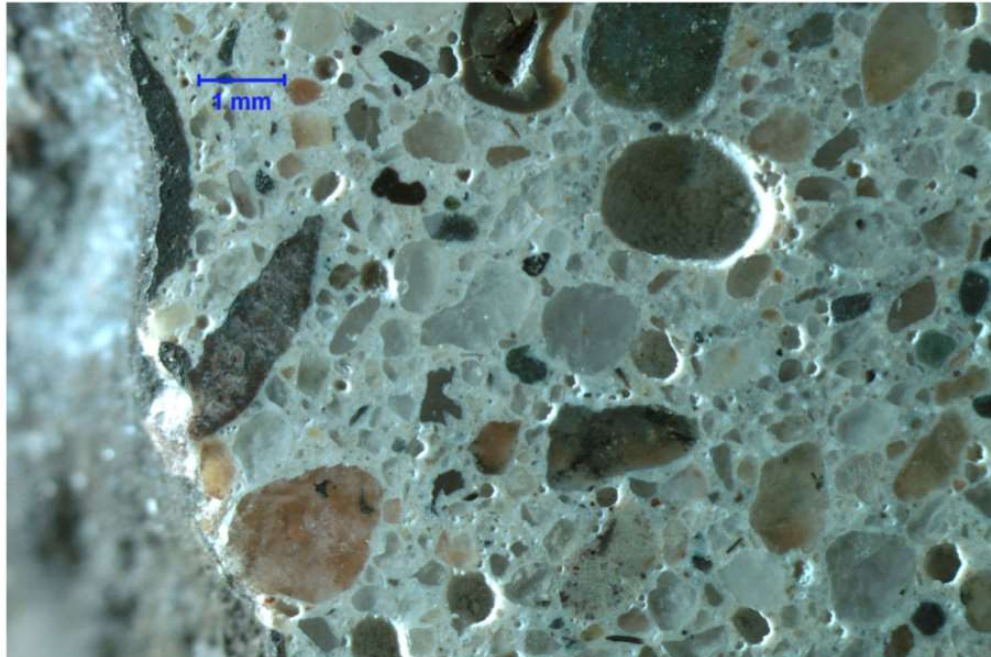
PHOTO:
105

SAMPLE ID: 2180-78, 3 **DESCRIPTION:** Note significantly less obvious entrained air voidspaces adjacent to the joint plane (left) at 148mm depth from the top surface.
MAG: 15x

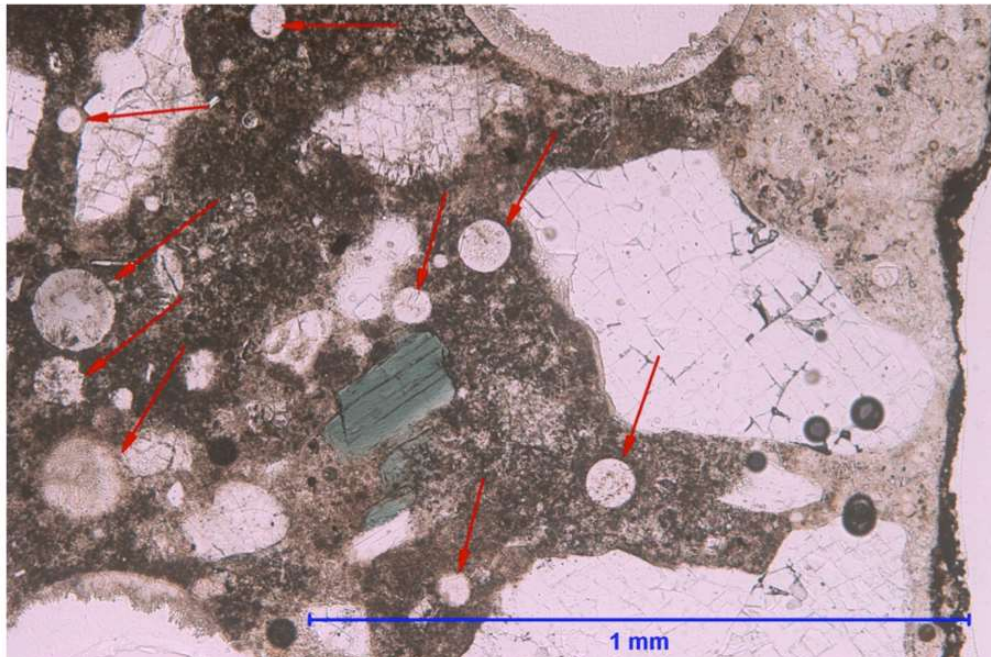
PHOTO:
107

SAMPLE ID: 2180-78, 3 **DESCRIPTION:** Ettringite-filled, entrained sized air voidspaces in the concrete paste directly adjacent to the distressed joint face (right) in thin section, under plane polarized light, at mid-depth in the core.
MAG: 100x

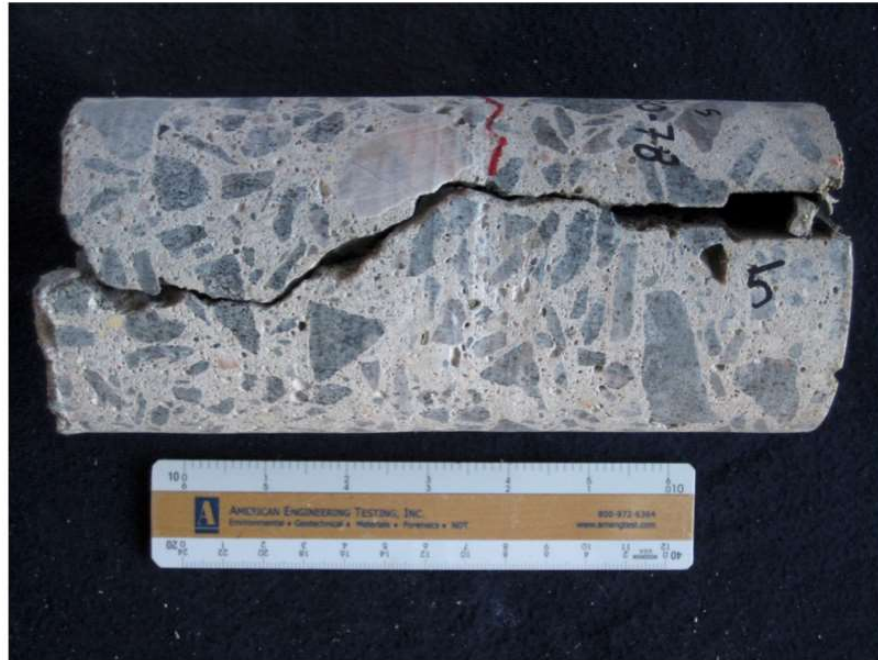
PHOTO: 23

SAMPLE ID: 2180-78, 5 **DESCRIPTION:** Jointed core sample utilized for petrographic analysis. The sealed top surface is right.

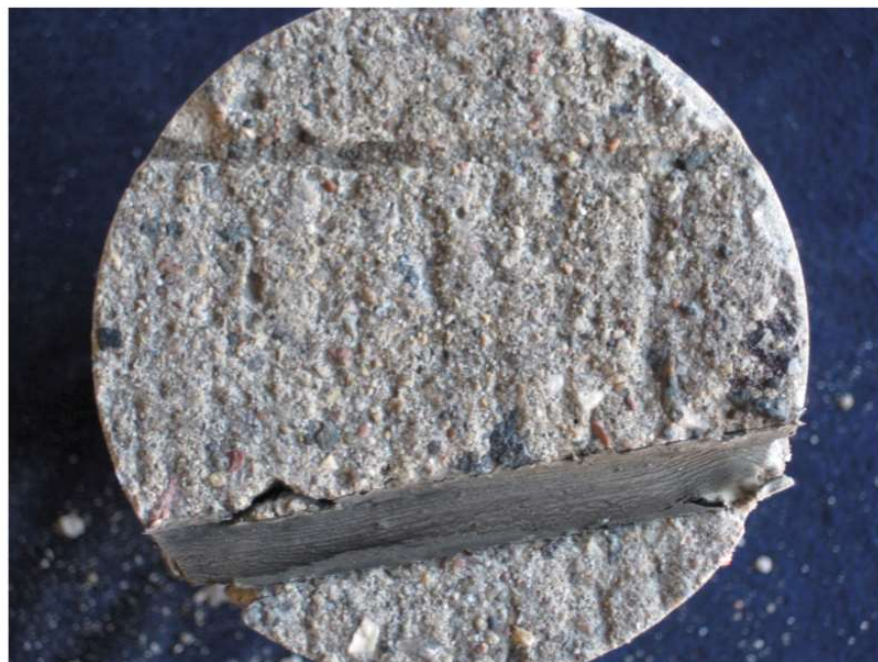
PHOTO: 24

SAMPLE ID: 2180-78, 5 **DESCRIPTION:** Rough textured top surface of the core with traffic wear. The silicone sealant was fairly well bonded to both sides of the joint.

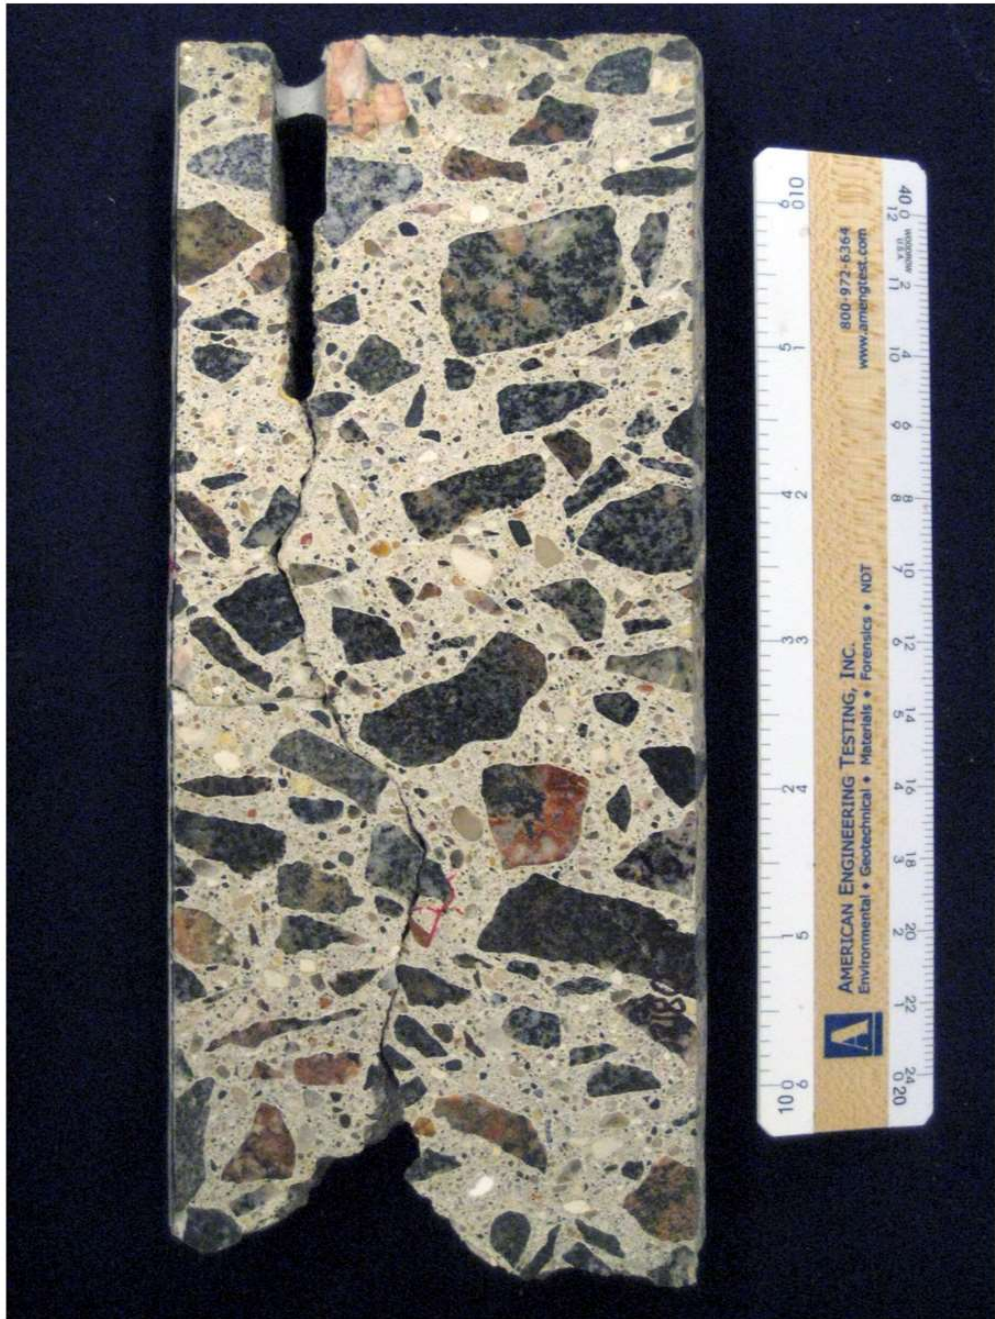
PHOTO:
66

SAMPLE ID: 2180-78, 5 **DESCRIPTION:** Sawcut and lapped cross section of core. The joint crack exhibited no distress. Note joint crack bisects two coarse aggregates in the lower third of the core.

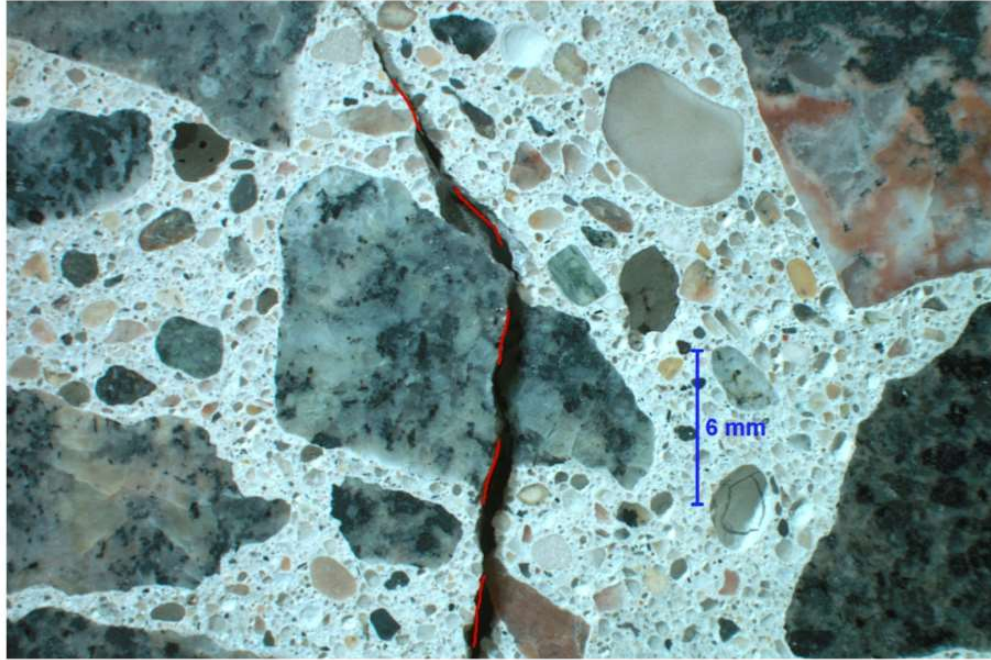
PHOTO:
108

SAMPLE ID: 2180-78, 5 **DESCRIPTION:** A coarse aggregate was bisected by the joint crack at below 131mm depth from the top surface.
MAG: 5x

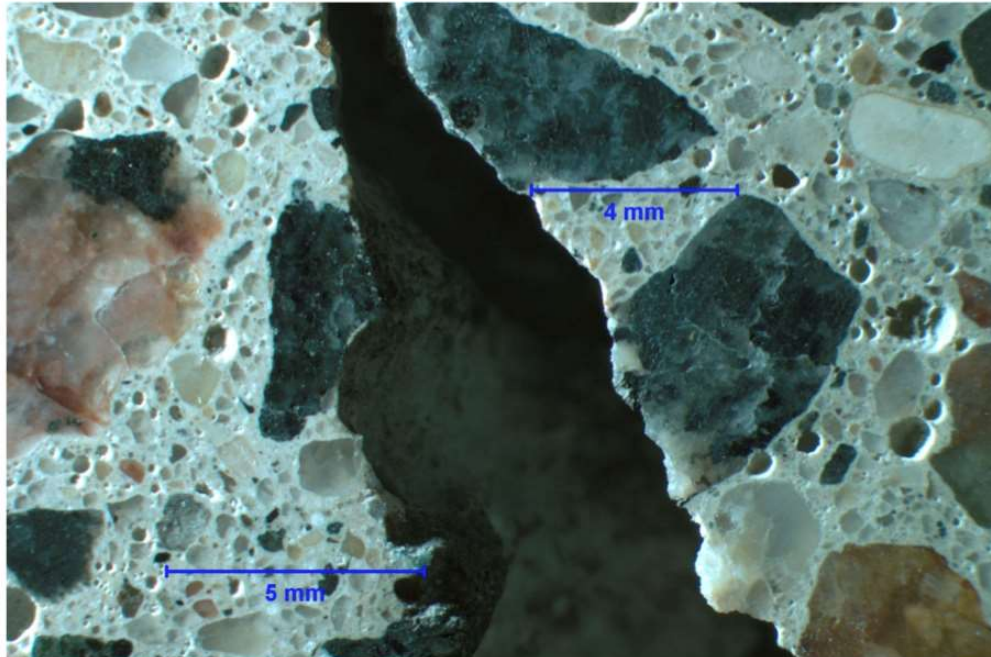
PHOTO:
109

SAMPLE ID: 2180-78, 5 **DESCRIPTION:** Significant air loss was documented in the concrete paste directly adjacent to the divergent joint faces at the bottom surface of the core.
MAG: 5x

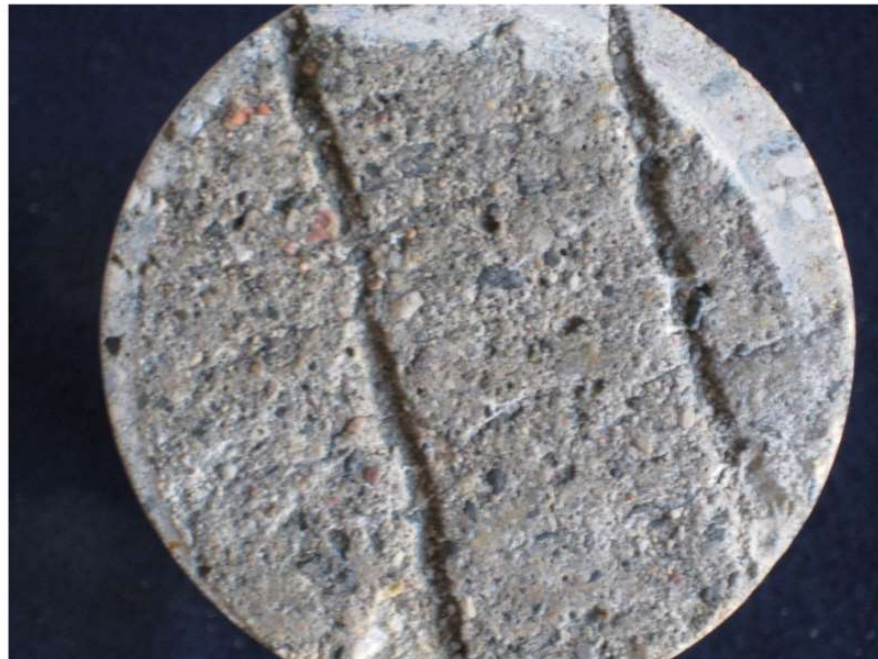
PHOTO: 26

SAMPLE ID: 2180-78, 6 **DESCRIPTION:** Rough textured top surface of the core with traffic wear.

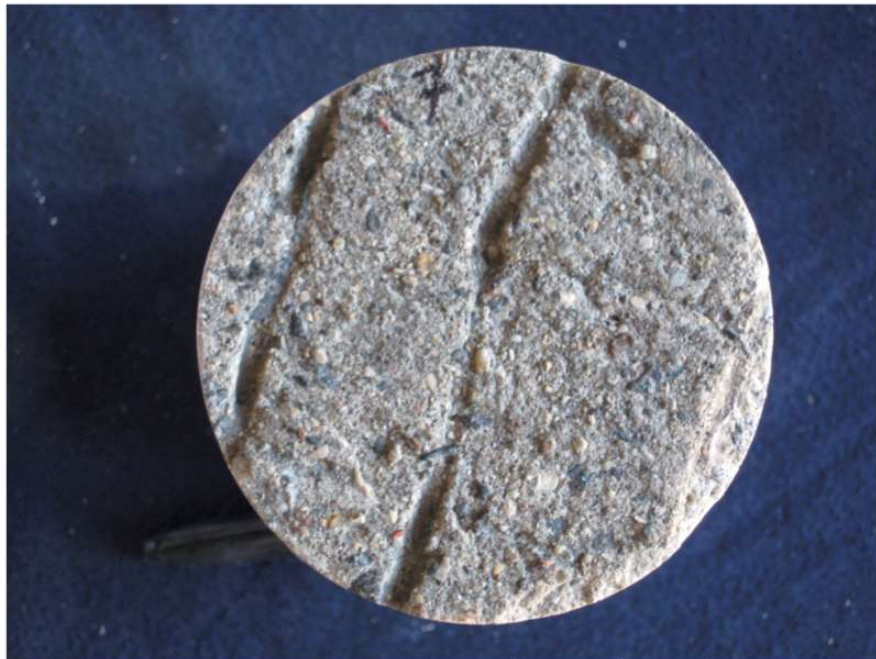
PHOTO: 28

SAMPLE ID: 2180-78, 7 **DESCRIPTION:** Rough textured top surface of the core with traffic wear.

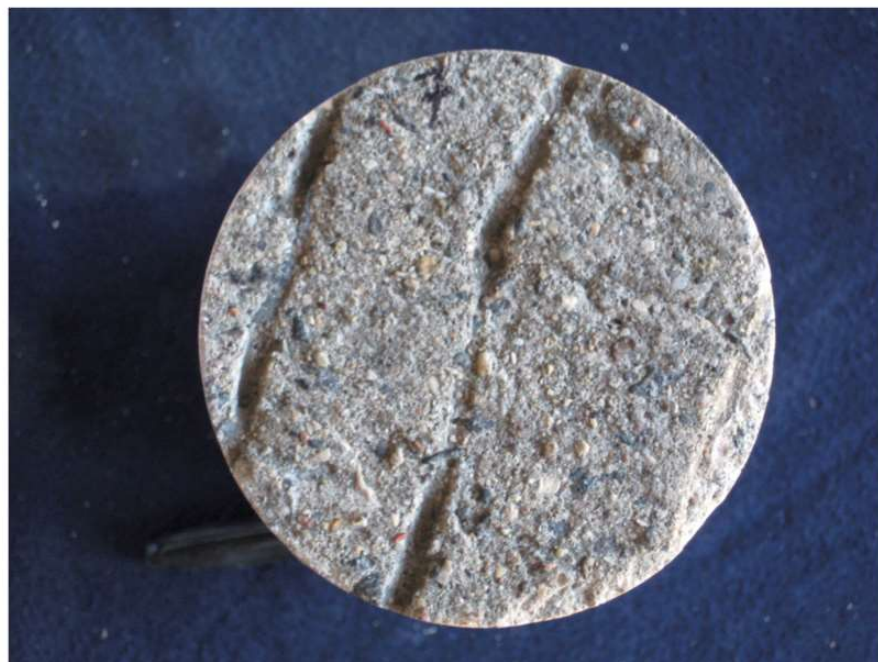
PHOTO: 28

SAMPLE ID: 2180-78, 7 **DESCRIPTION:** Rough textured top surface of the core with traffic wear.
