Impact of Water/ Cementitious-Based Concrete Mix Design Specification Changes on Concrete Pavement Quality

July 2018

Research Project
Final Report 2018-25

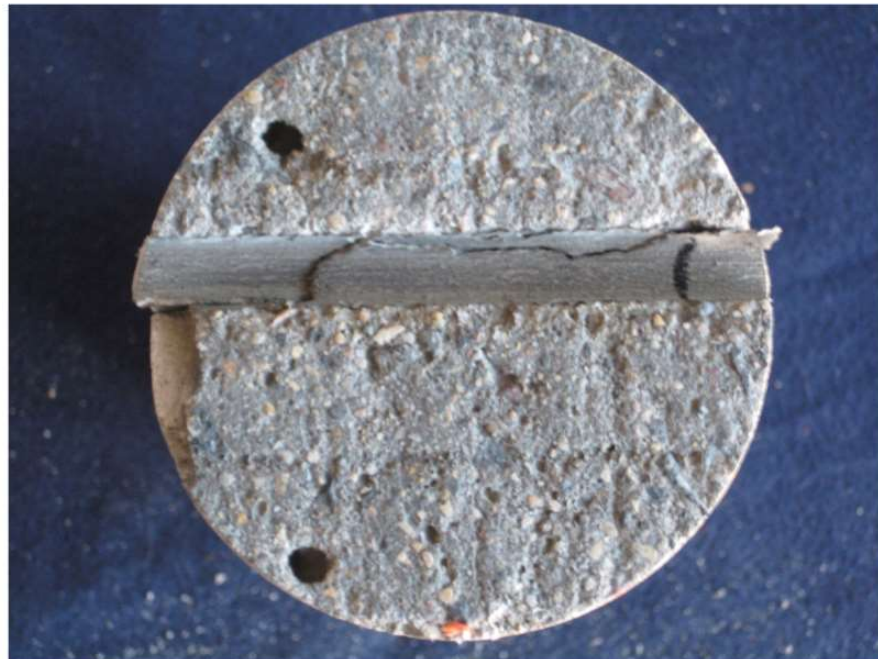
PHOTO: 30

SAMPLE ID: 2180-80, 1 **DESCRIPTION:** Rough textured top surface of the core with traffic wear. The silicone sealant was fairly well-bonded to both sides of the joint.

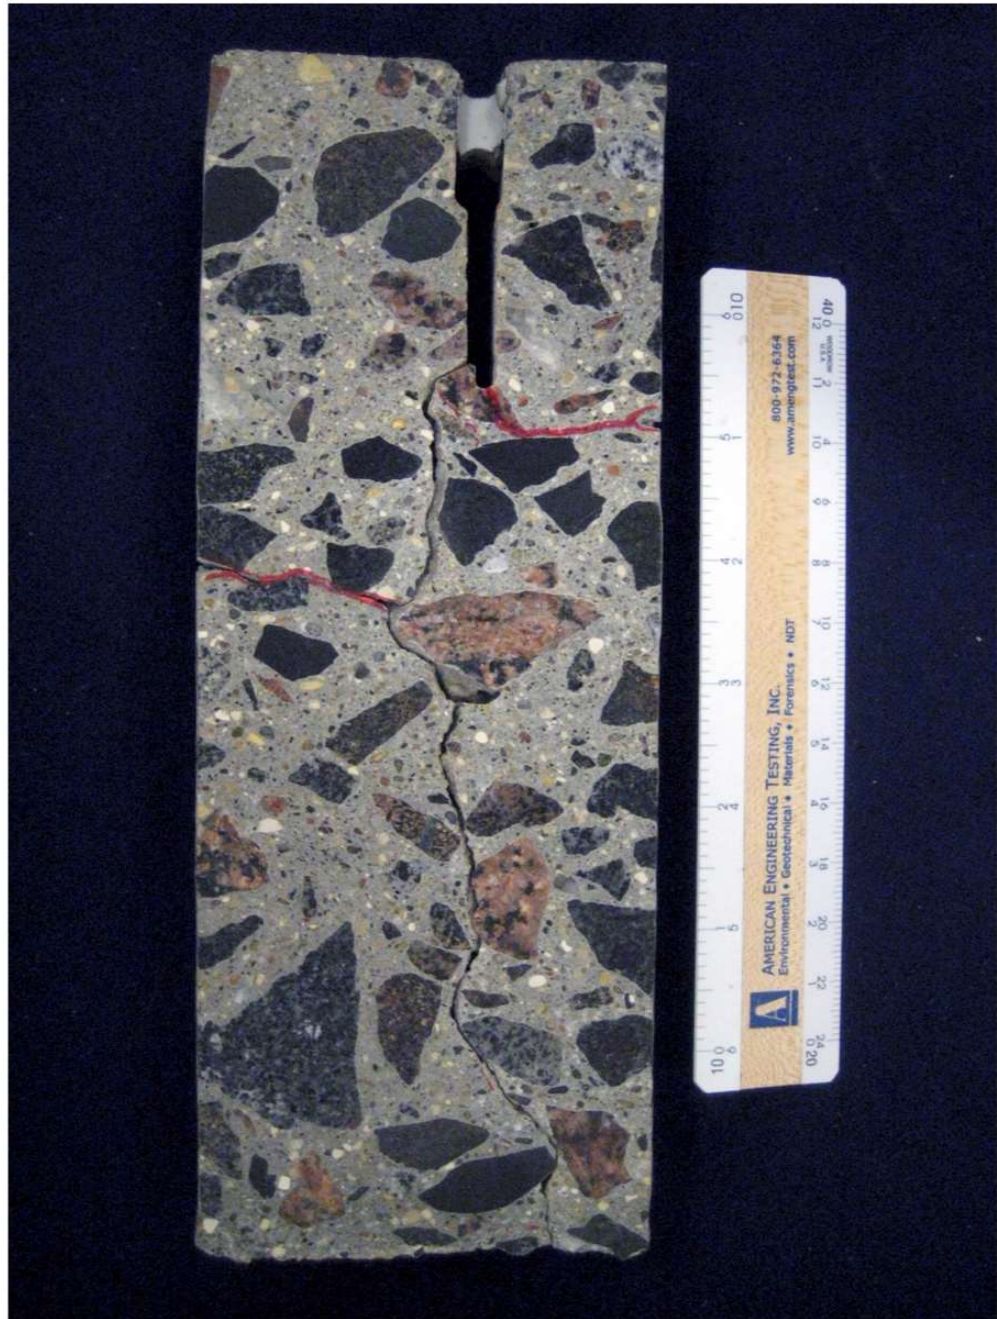
PHOTO:
67

SAMPLE ID: 2180-80, 1 **DESCRIPTION:** Sawcut and lapped cross section of core. The joint crack exhibited no distress. Sub-horizontal fractures are mapped in red ink.

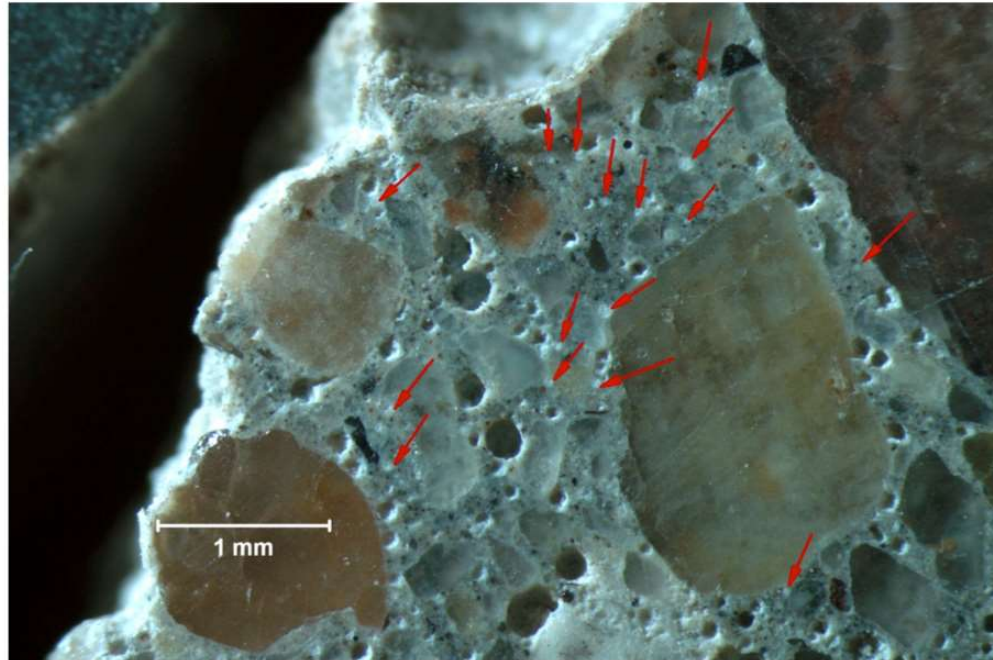
PHOTO:
110

SAMPLE ID: 2180-80, 1 **DESCRIPTION:** Much of the entrained air voidspaces within a few mm of the joint face at 222mm depth in the core are filled with secondary ettringite.

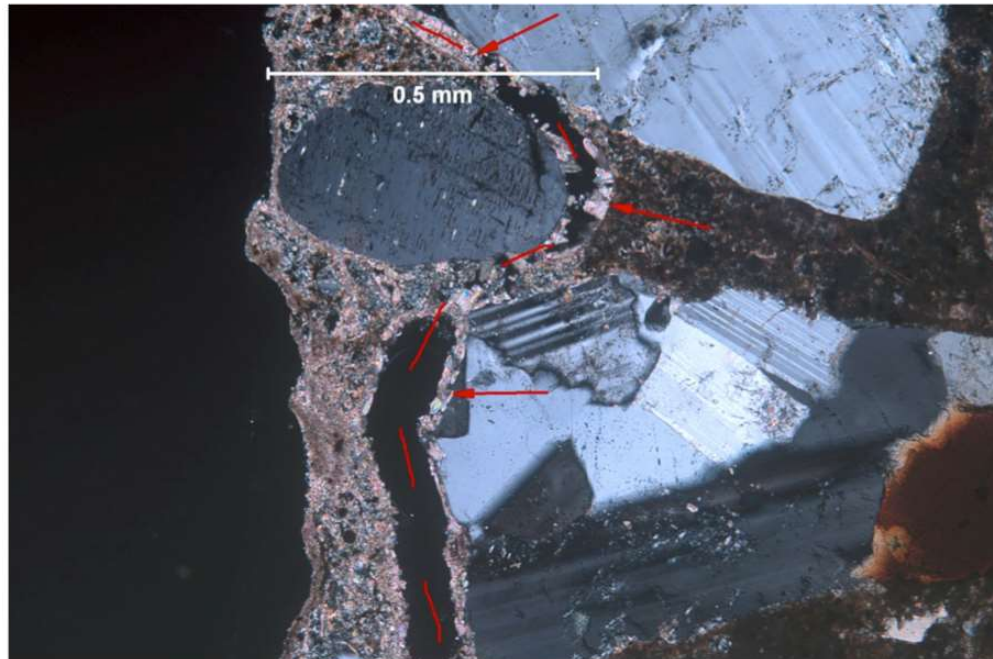
PHOTO:
111

SAMPLE ID: 2180-80, 1 **DESCRIPTION:** A sub-vertical microcrack in brightly colored, carbonated paste along the joint face; is mapped in red dashed line. Note secondary calcite crystals lining the microcrack (arrows).

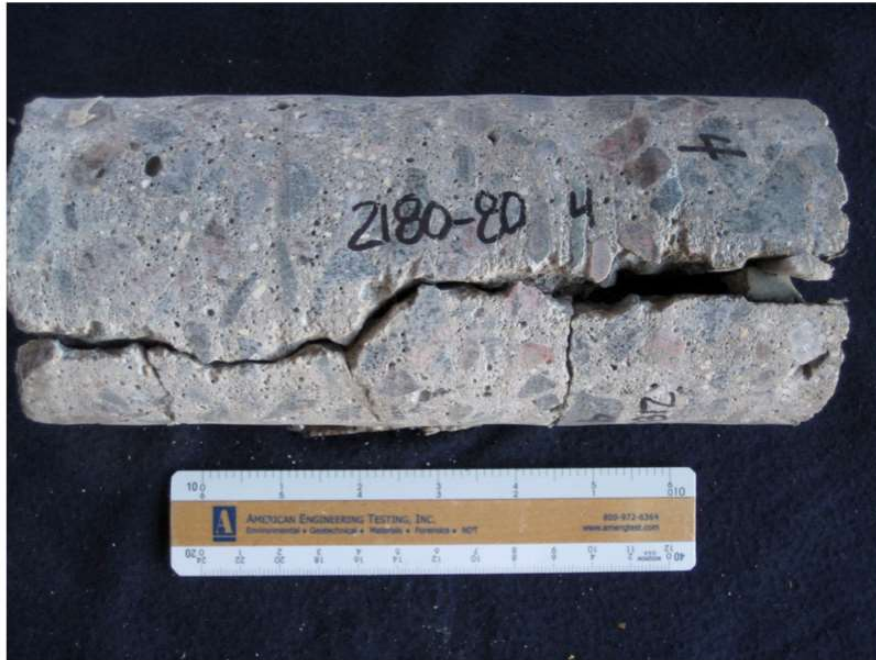
PHOTO: 33

SAMPLE ID: 2180-80, 4 **DESCRIPTION:** Jointed core sample utilized for petrographic analysis. The top surface is right. Note "tunneling" (mass lost) at base of sawcut.

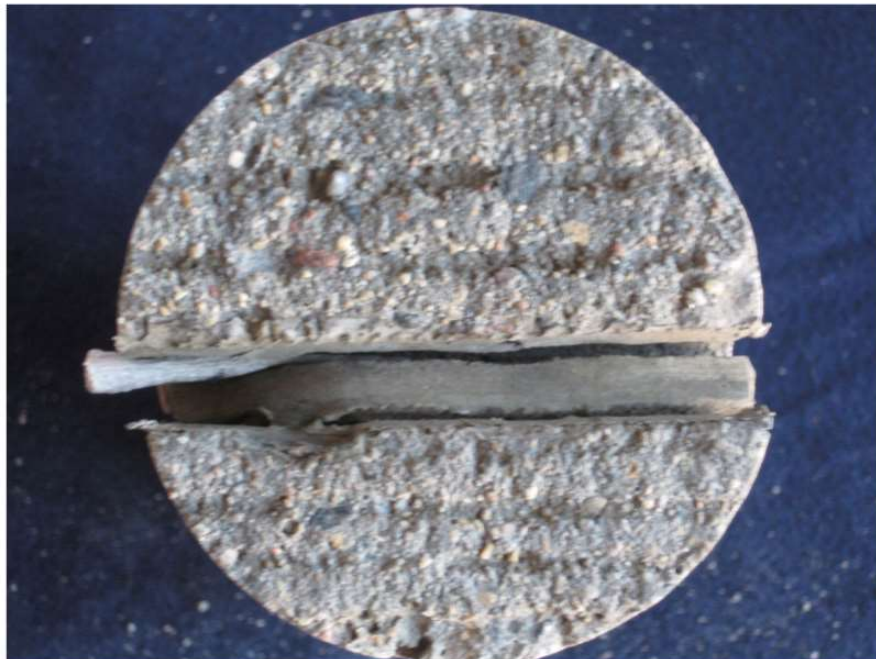
PHOTO: 34

SAMPLE ID: 2180-80, 4 **DESCRIPTION:** Rough textured top surface of the jointed core with traffic wear. The silicone sealant had been forcibly de-bonded from both sides of the joint.

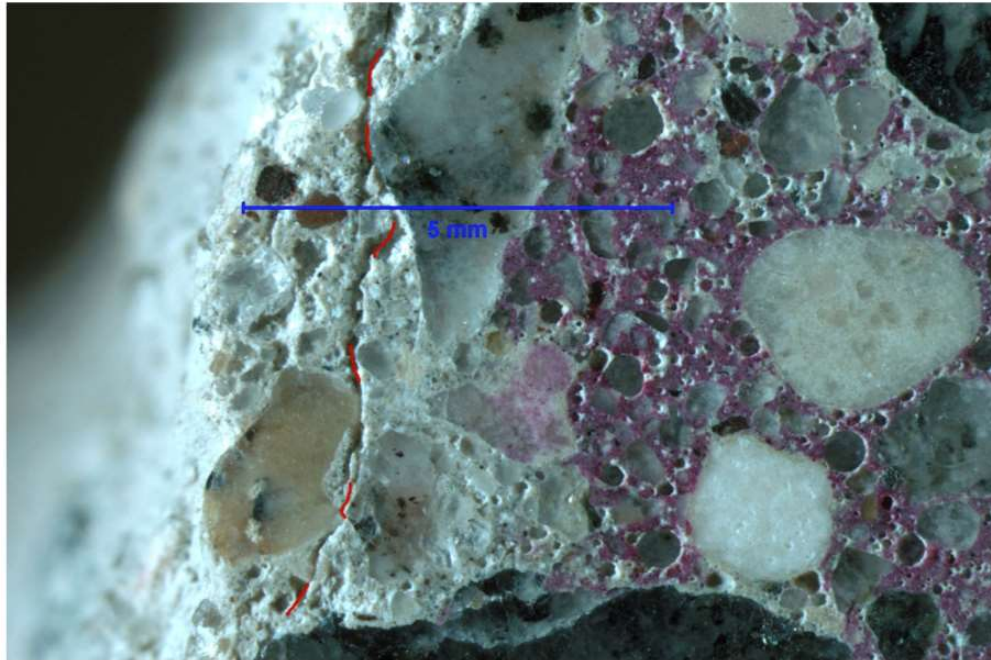
PHOTO:
112

SAMPLE ID: 2180-80, 4 **DESCRIPTION:** Much of the entrained air voidspaces within a few mm of the joint face at 145mm depth in the core are filled with secondary ettringite.
MAG: 15x

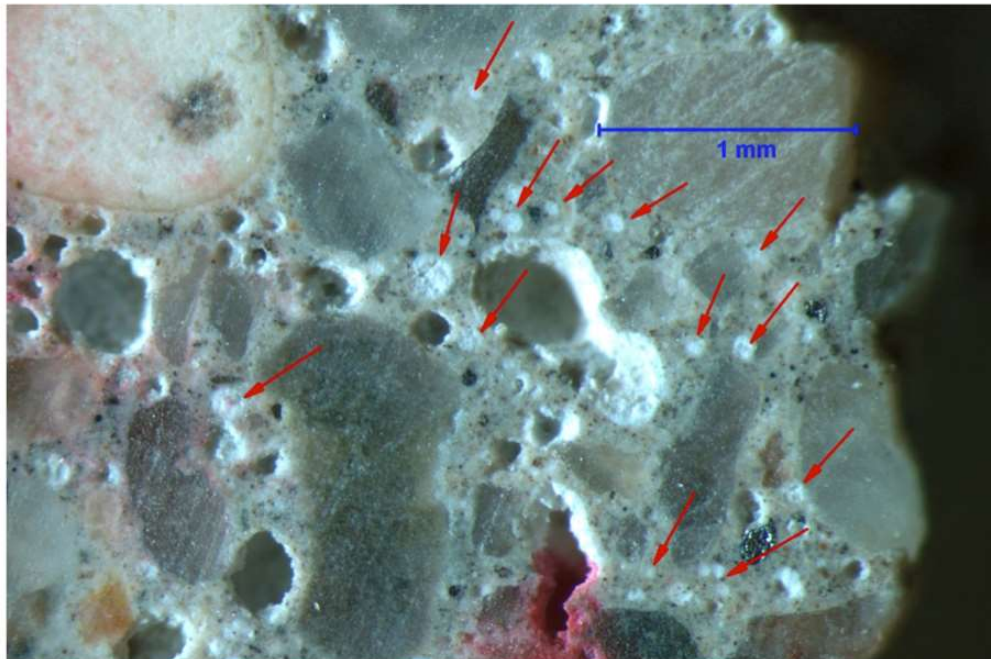
PHOTO:
113

SAMPLE ID: 2180-80, 4 **DESCRIPTION:** Secondary ettringite-filled entrained sized voidspaces in the paste within a few millimeters of the distressed joint face (right) at 210mm depth in the core.
MAG: 50x

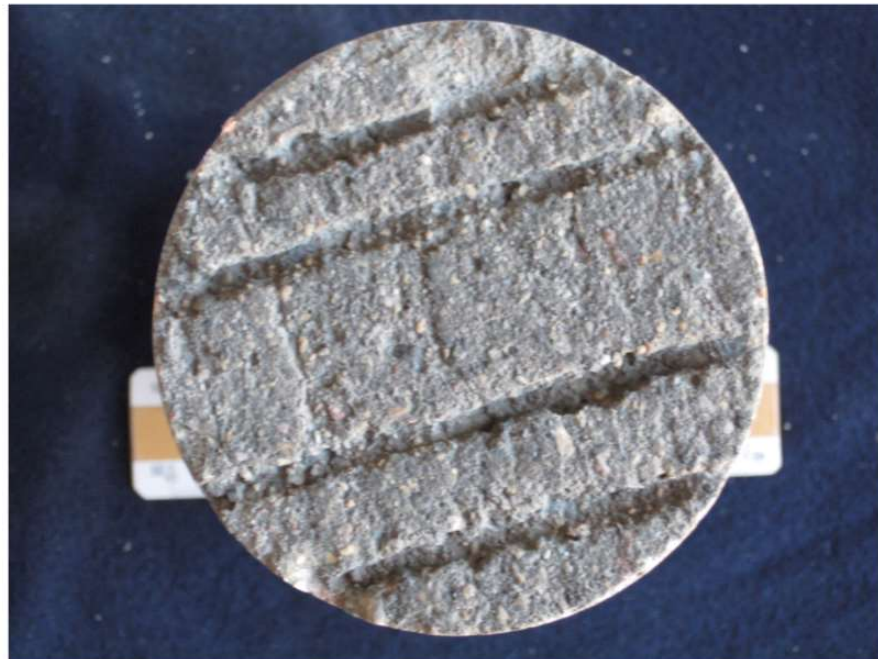
PHOTO: 32

SAMPLE ID: 2180-80, 3 **DESCRIPTION:** Rough textured top surface of the core with traffic wear. The silicone sealant was fairly well bonded to both sides of the joint.

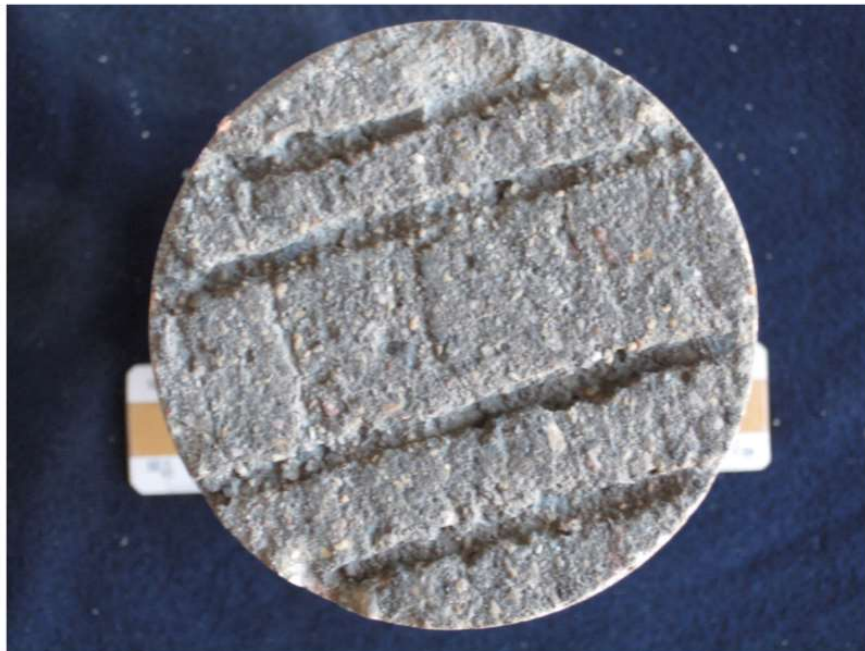
PHOTO: 32

SAMPLE ID: 2180-80, 3 **DESCRIPTION:** Rough textured top surface of the core with traffic wear. The silicone sealant was fairly well bonded to both sides of the joint.

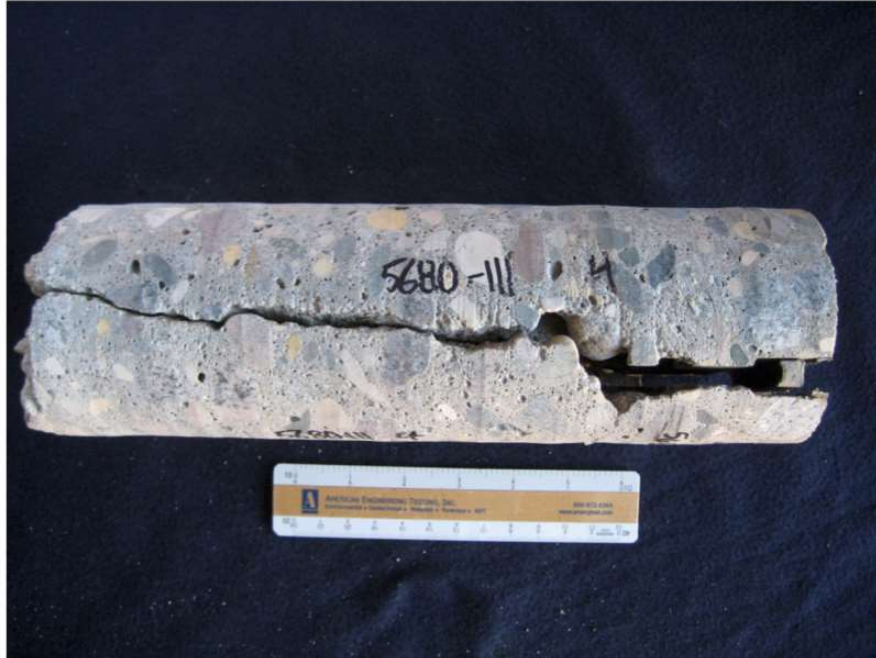
PHOTO: 37

SAMPLE ID: 5680-111, 4 **DESCRIPTION:** Jointed core sample subjected to petrographic analysis. The silicone sealed top surface is right. Note "tunneling" directly below the base of the sawcut.

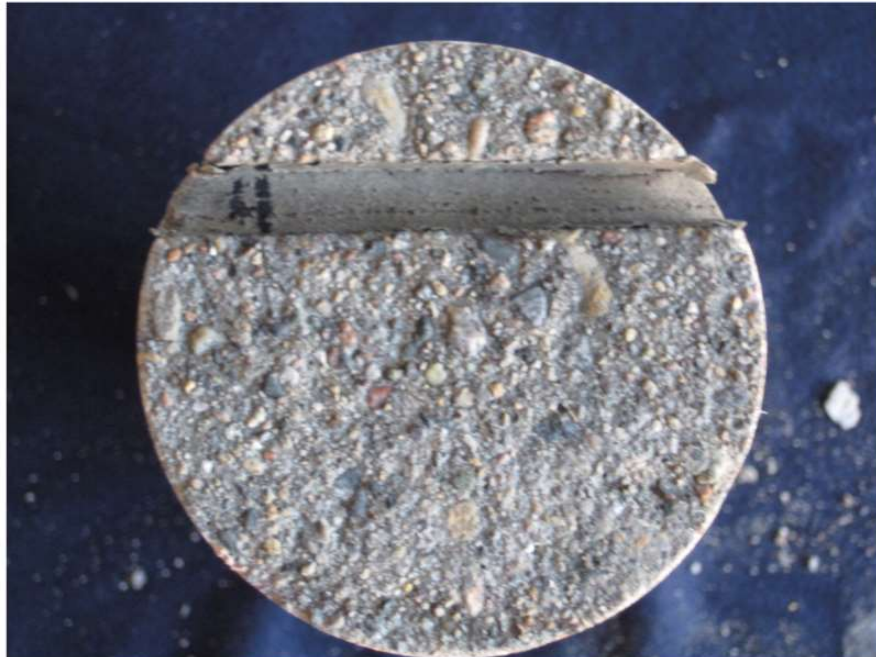
PHOTO: 38

SAMPLE ID: 5680-111, 4 **DESCRIPTION:** Rough textured and mortar-eroded top surface of the core. The silicone sealant was well adhered to one side of the joint, only.

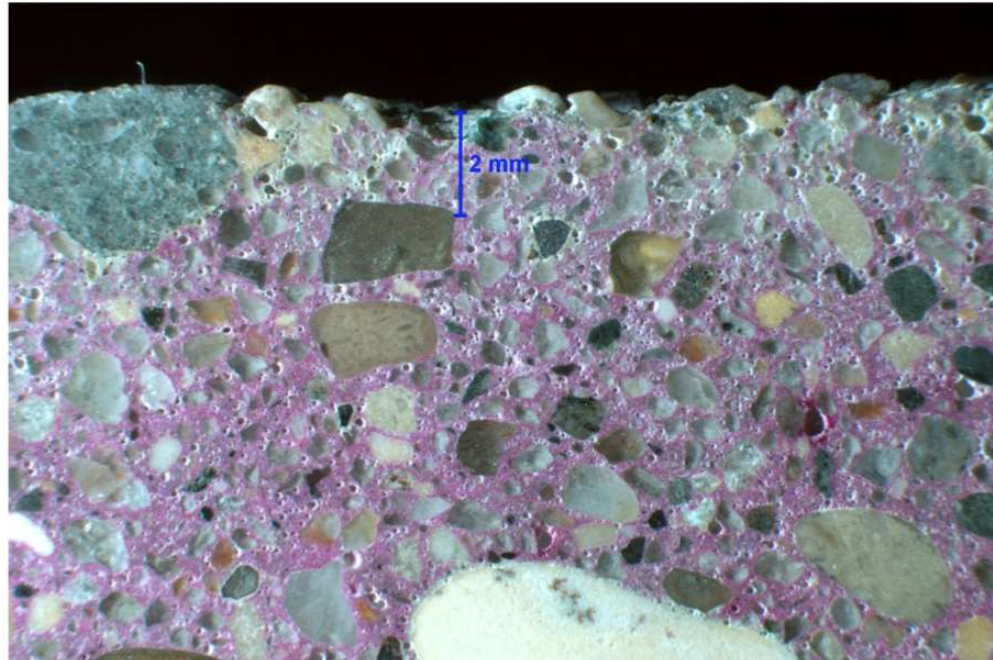
PHOTO:
114

SAMPLE ID: 5680-111, 4 **DESCRIPTION:** Carbonation (unstained paste) ranged from negligible up to 2mm depth from the top surface.
MAG: 5x

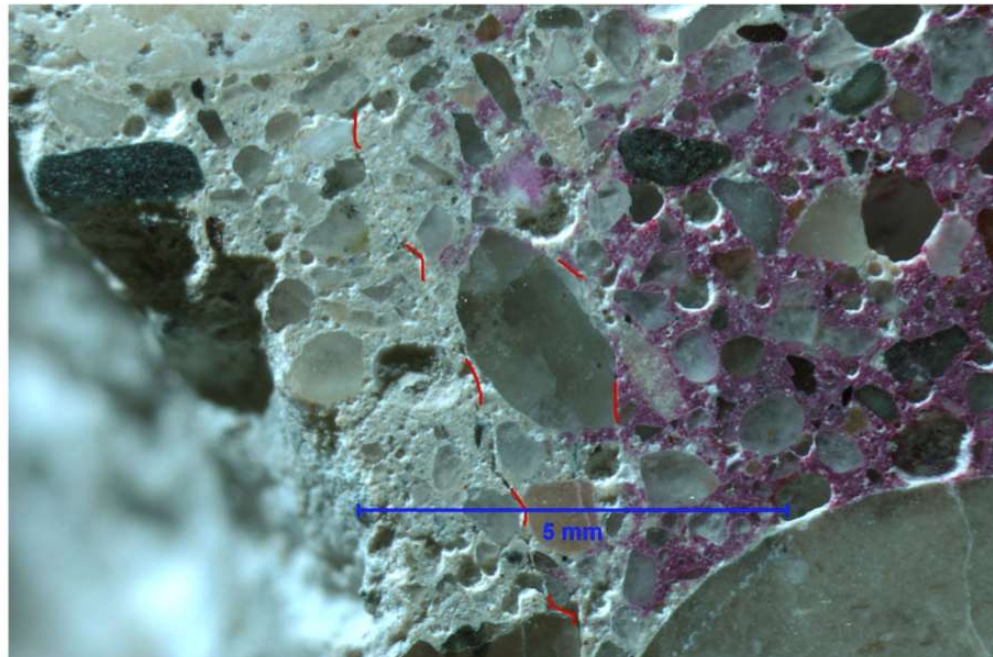
PHOTO:
115

SAMPLE ID: 5680-111, 4 **DESCRIPTION:** Secondary ettringite-filled entrained sized voidspaces in the paste within a several millimeters of the distressed joint face (left) at 228mm depth in the core.
MAG: 15x

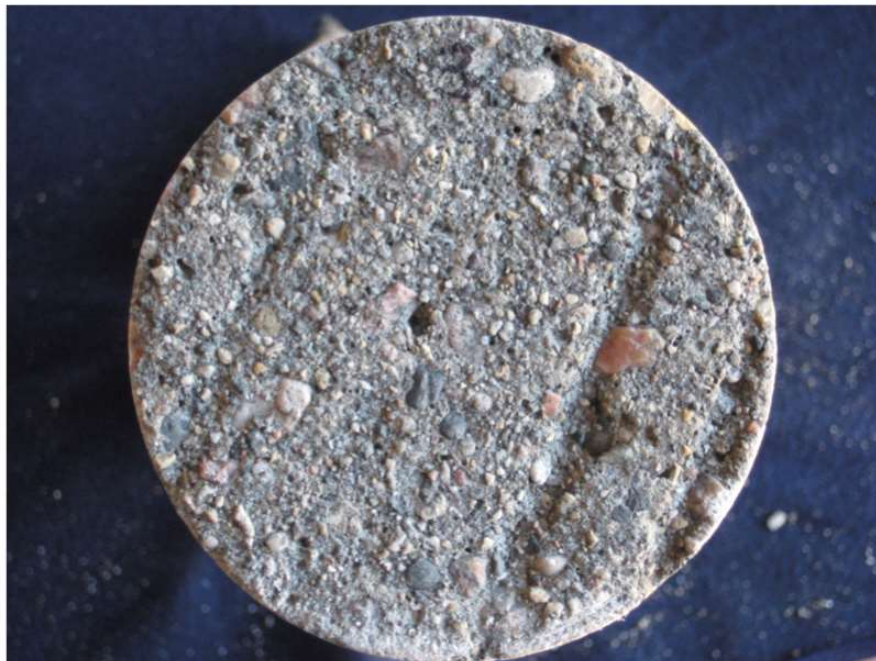
PHOTO: 36

SAMPLE ID: 5680-111, 3 **DESCRIPTION:** Rough textured and mortar-eroded top surface of the core.

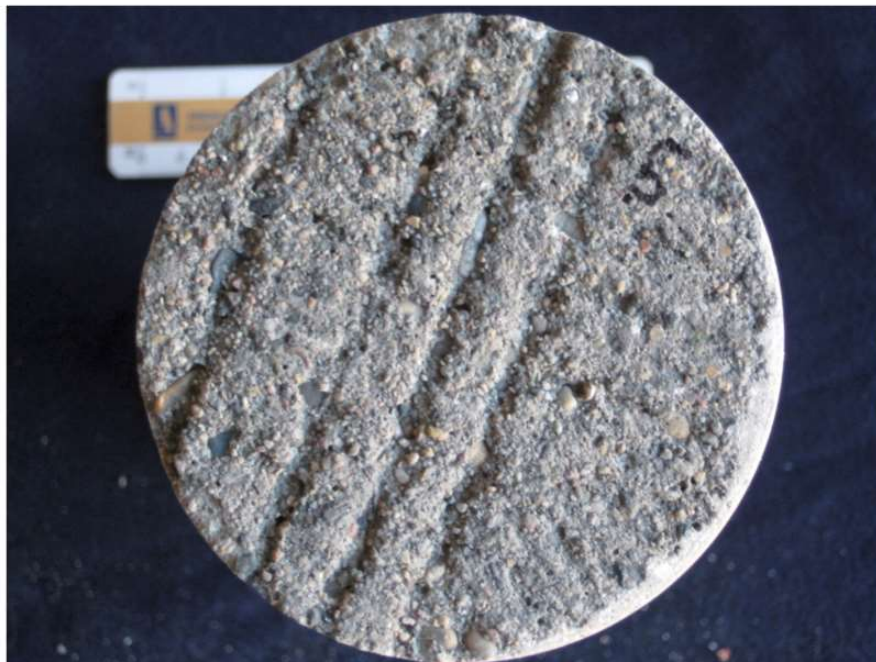
PHOTO: 40

SAMPLE ID: 5680-111, 5 **DESCRIPTION:** Rough textured and mortar-eroded top surface of the core.

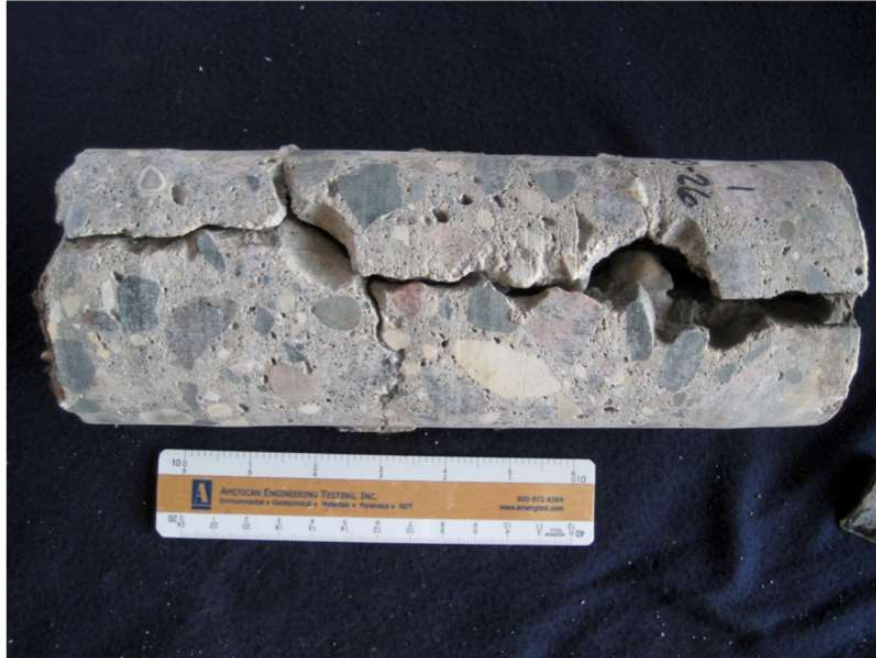
PHOTO: 41

SAMPLE ID: 8480-26, 1 **DESCRIPTION:** Jointed core sample subjected to petrographic analysis. The silicone sealed top surface is right. Note "tunneling" directly below the base of the sawcut.

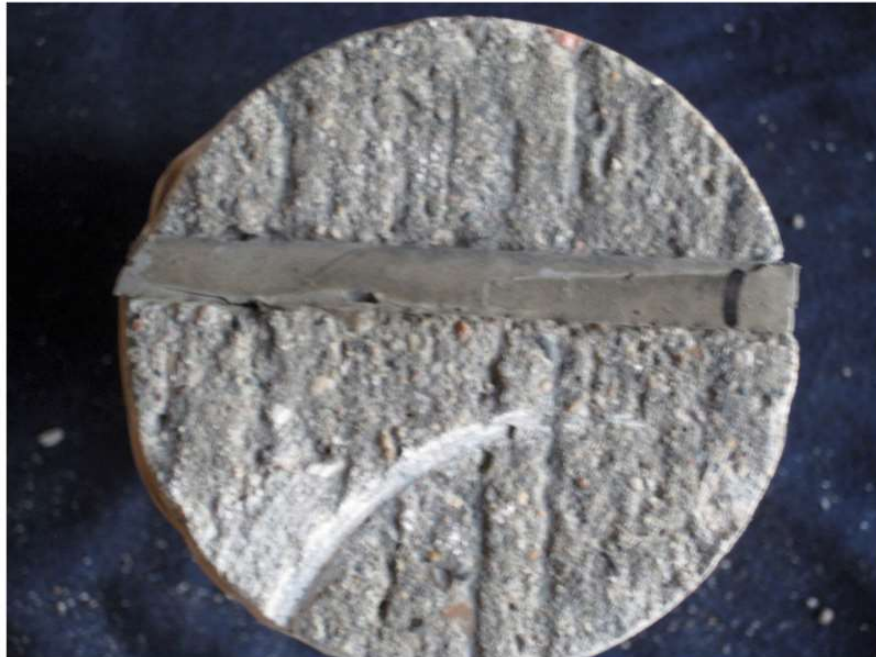
PHOTO: 42

SAMPLE ID: 8480-26, 1 **DESCRIPTION:** Rough textured and mortar-eroded top surface of the core. The silicone sealant was well adhered to one side of the joint, only.

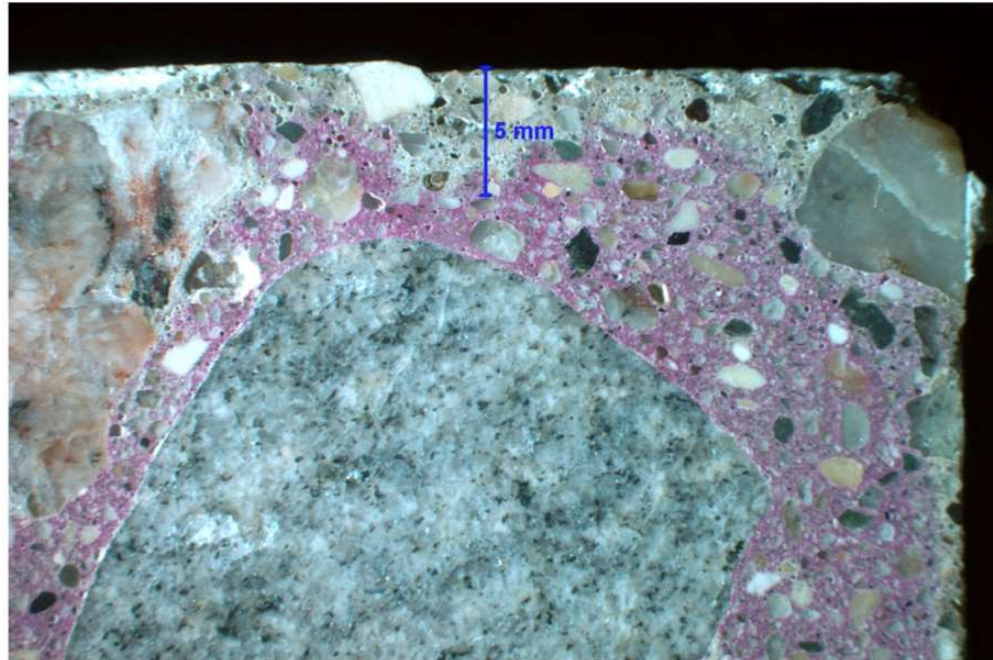
PHOTO:
118

SAMPLE ID: 8480-26, 1 **DESCRIPTION:** Carbonation (unstained paste) proceeded up to 5mm depth from the top surface.

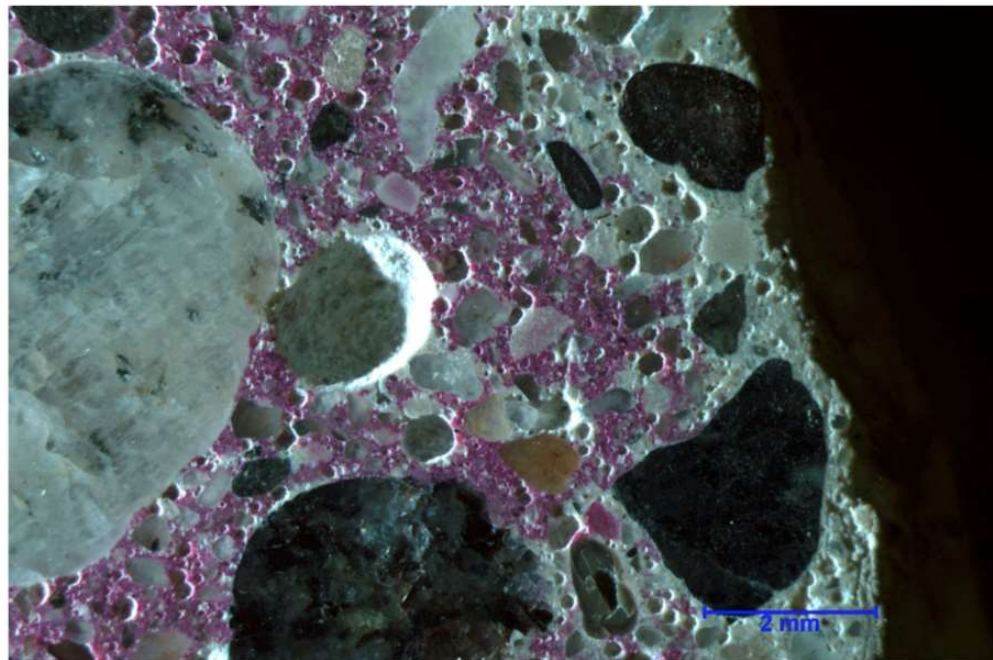
PHOTO:
119

SAMPLE ID: 8480-26, 1 **DESCRIPTION:** Carbonation (unstained paste) to 2mm depth from the joint face at 210mm depth in the core.

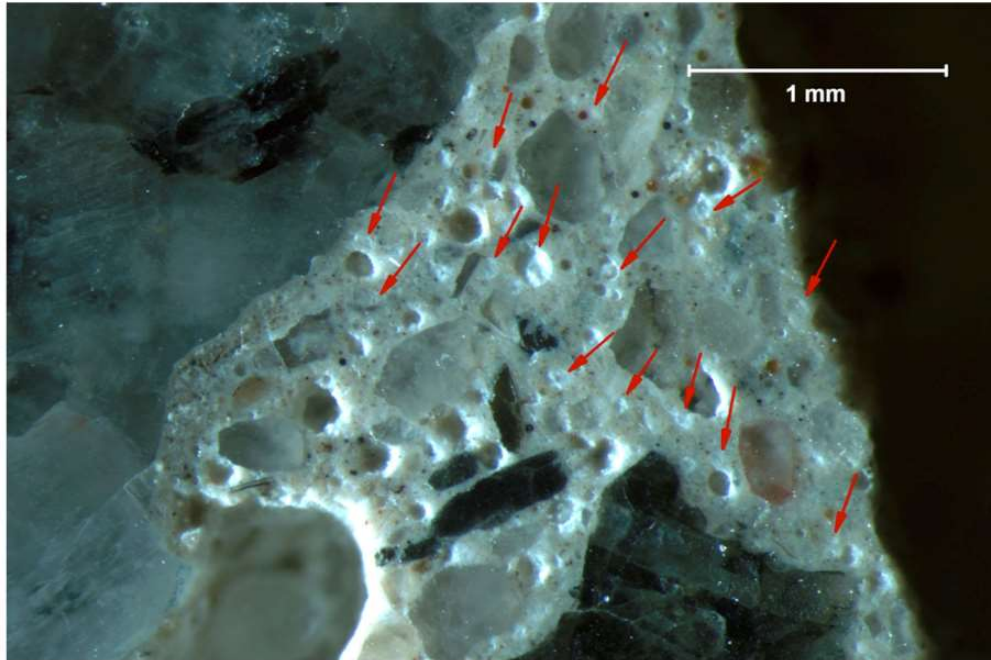
PHOTO:
120

SAMPLE ID: 8480-26, 1 **DESCRIPTION:** Secondary ettringite-filled voids within a few millimeters of the distressed joint face at 165mm depth from the top surface.
MAG: 50x

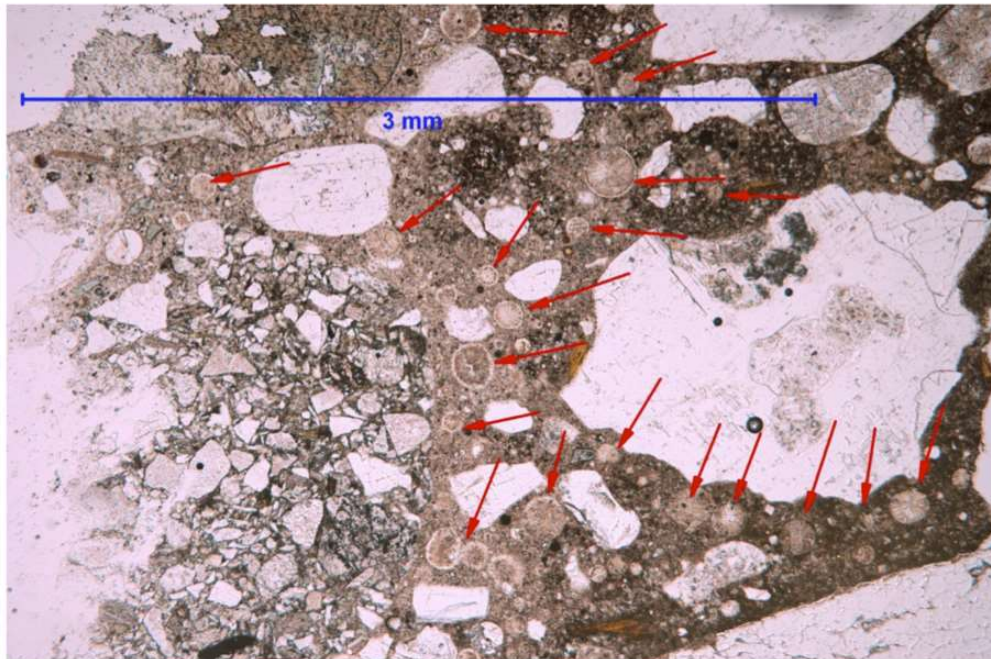
PHOTO:
121

SAMPLE ID: 8480-26, 1 **DESCRIPTION:** Secondary ettringite-filled voidspaces within a few millimeters of the distressed joint face (left); in thin section of concrete at mid-depth in the core, under plane polarized light.
MAG: 40x

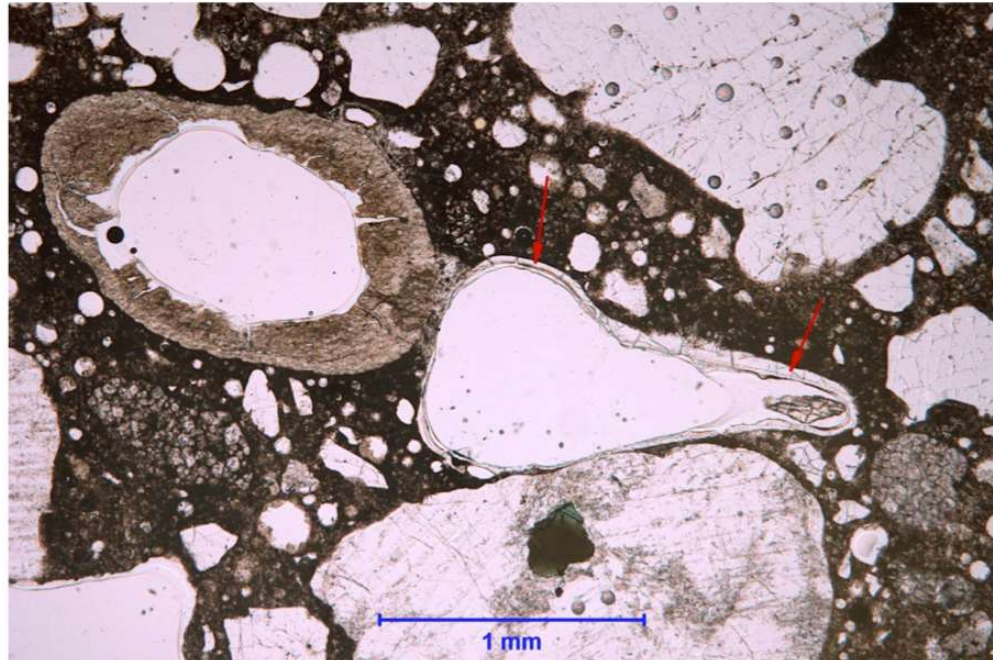
PHOTO:
122

SAMPLE ID: 8480-26, 1 **DESCRIPTION:** Brown reactive shale particle (upper left) and clear ASR gel product lining void space (center) in thin section of concrete under plane polarized light.
MAG: 40x

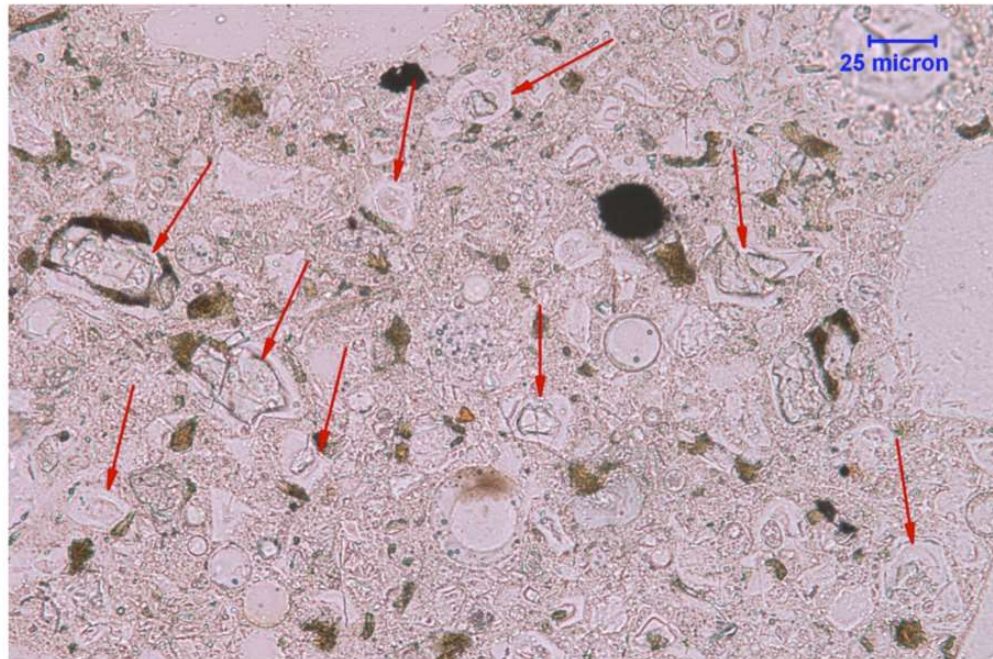
PHOTO:
123

SAMPLE ID: 8480-26, 1 **DESCRIPTION:** Well to fully hydrated alite portland cement clinker particles in thin section of concrete under plane polarized light (red arrows). Note abundant spherical flyash particles.
MAG: 400x

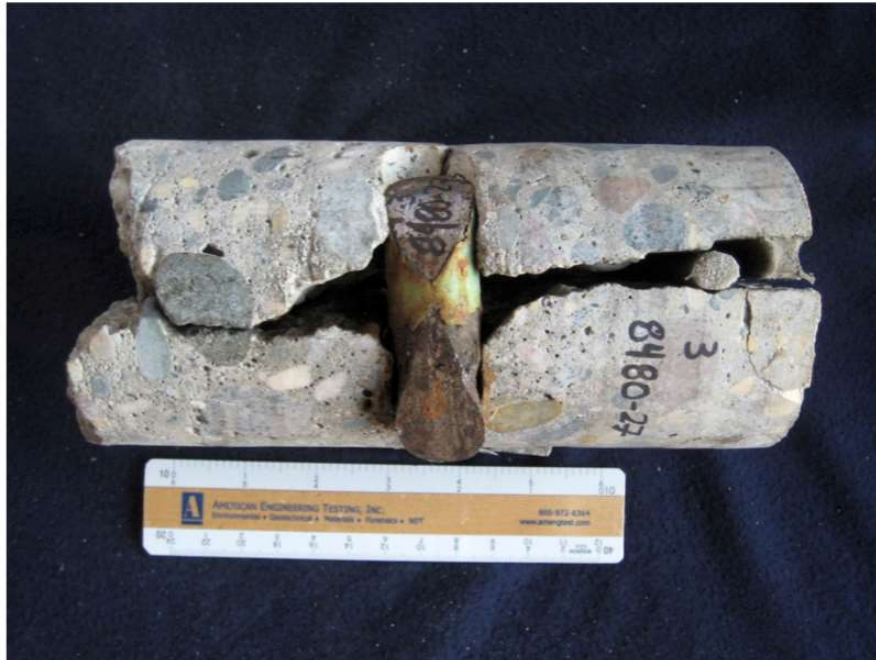
PHOTO: 49

SAMPLE ID: 8480-27, 3 **DESCRIPTION:** Jointed core sample subjected to petrographic analysis. The silicone sealed top surface is right. Note intersected dowel and loss of concrete along much of the length of the joint.

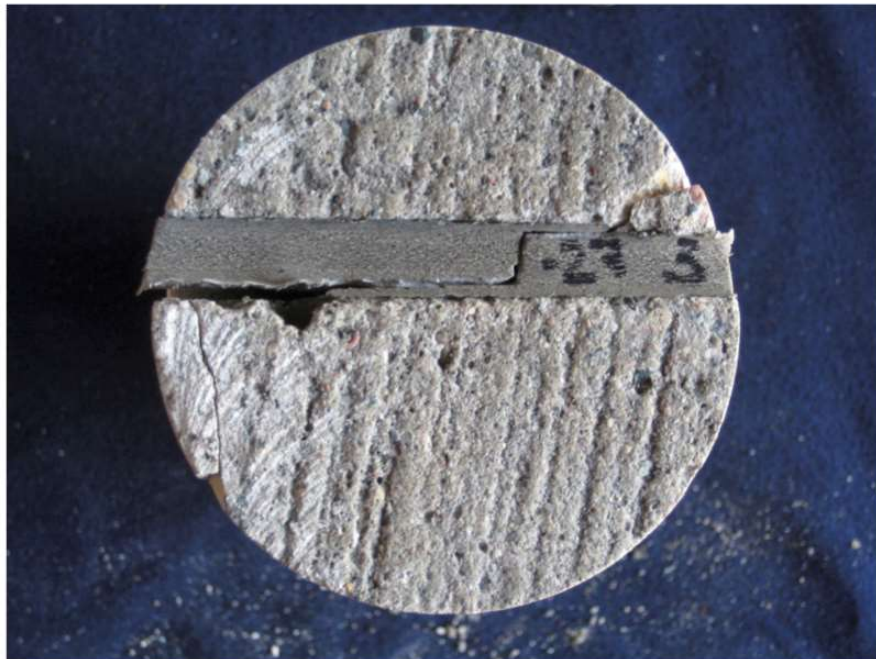
PHOTO: 50

SAMPLE ID: 8480-27, 3 **DESCRIPTION:** Textured and worn top surface of the core as received. Note the forcibly distressed silicone sealant.

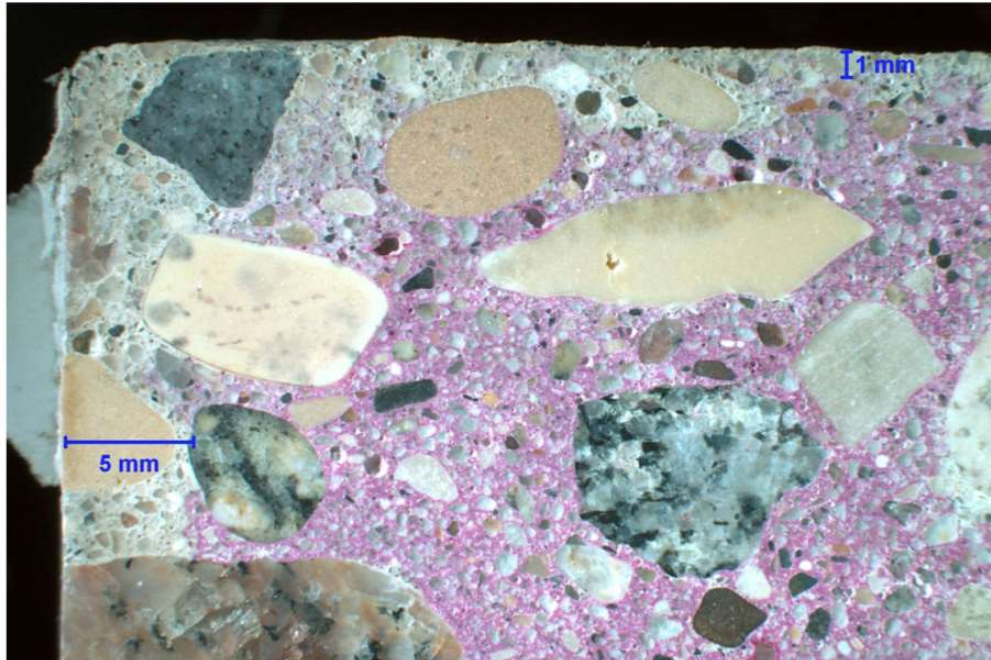
PHOTO:
130

SAMPLE ID: 8480-27, 3 **DESCRIPTION:** Carbonation (unstained paste) proceeded at least 1mm depth from the top surface and proceeded to 5mm depth from the sawcut joint; in this image.
MAG: 5x

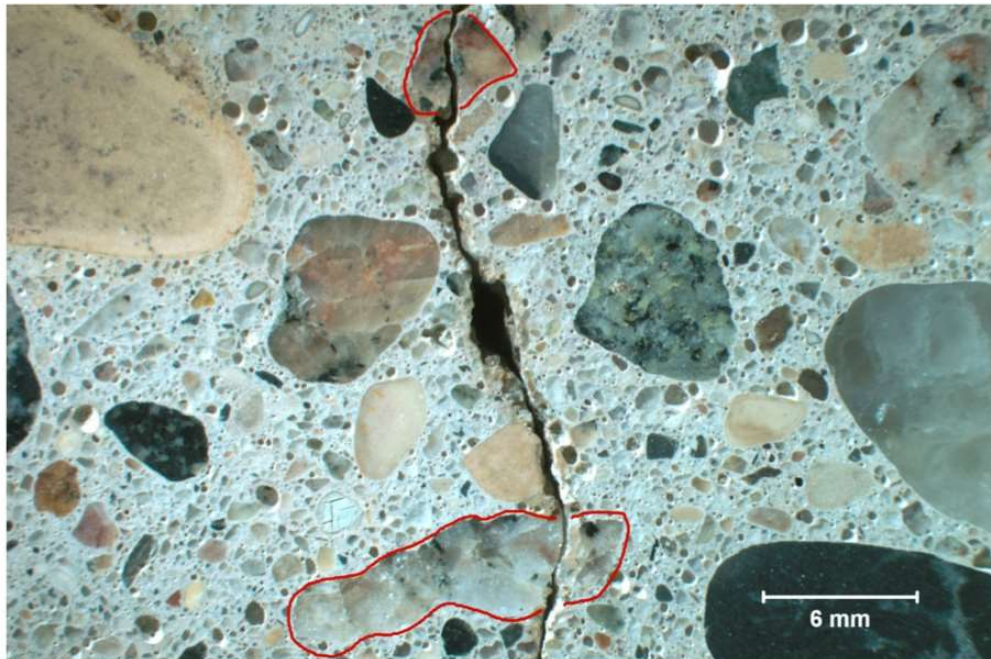
PHOTO:
131

SAMPLE ID: 8480-27, 3 **DESCRIPTION:** The joint crack bisects coarse aggregate particles, outlined in red, at depth in the core.

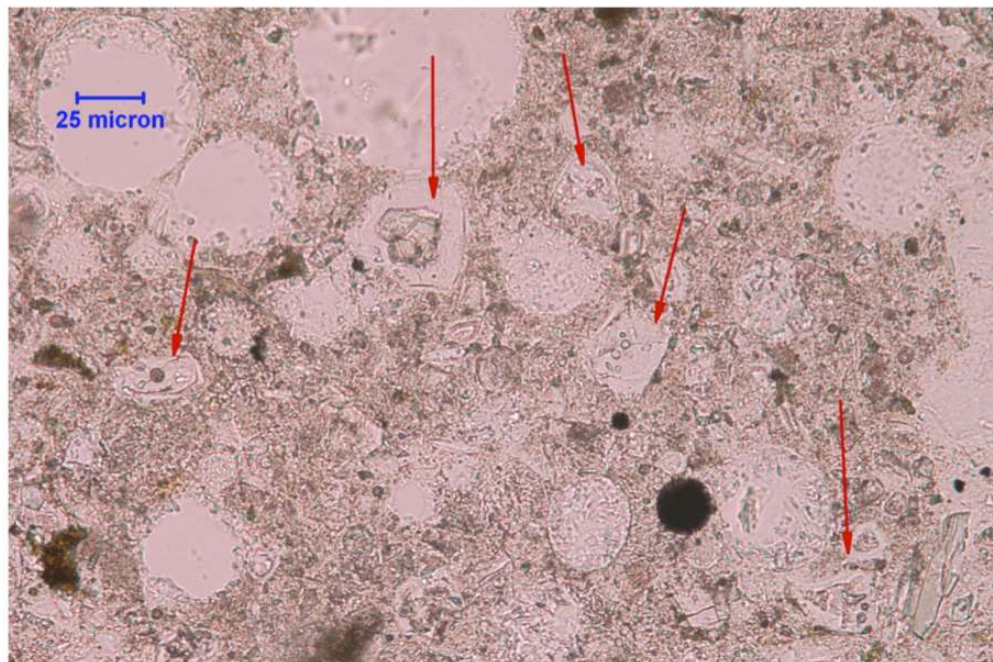
PHOTO:
133

SAMPLE ID: 8480-27, 3 **DESCRIPTION:** Well to fully hydrated alite portland cement clinker particles (arrows) in thin section of concrete paste under plane polarized light.
MAG: 400x

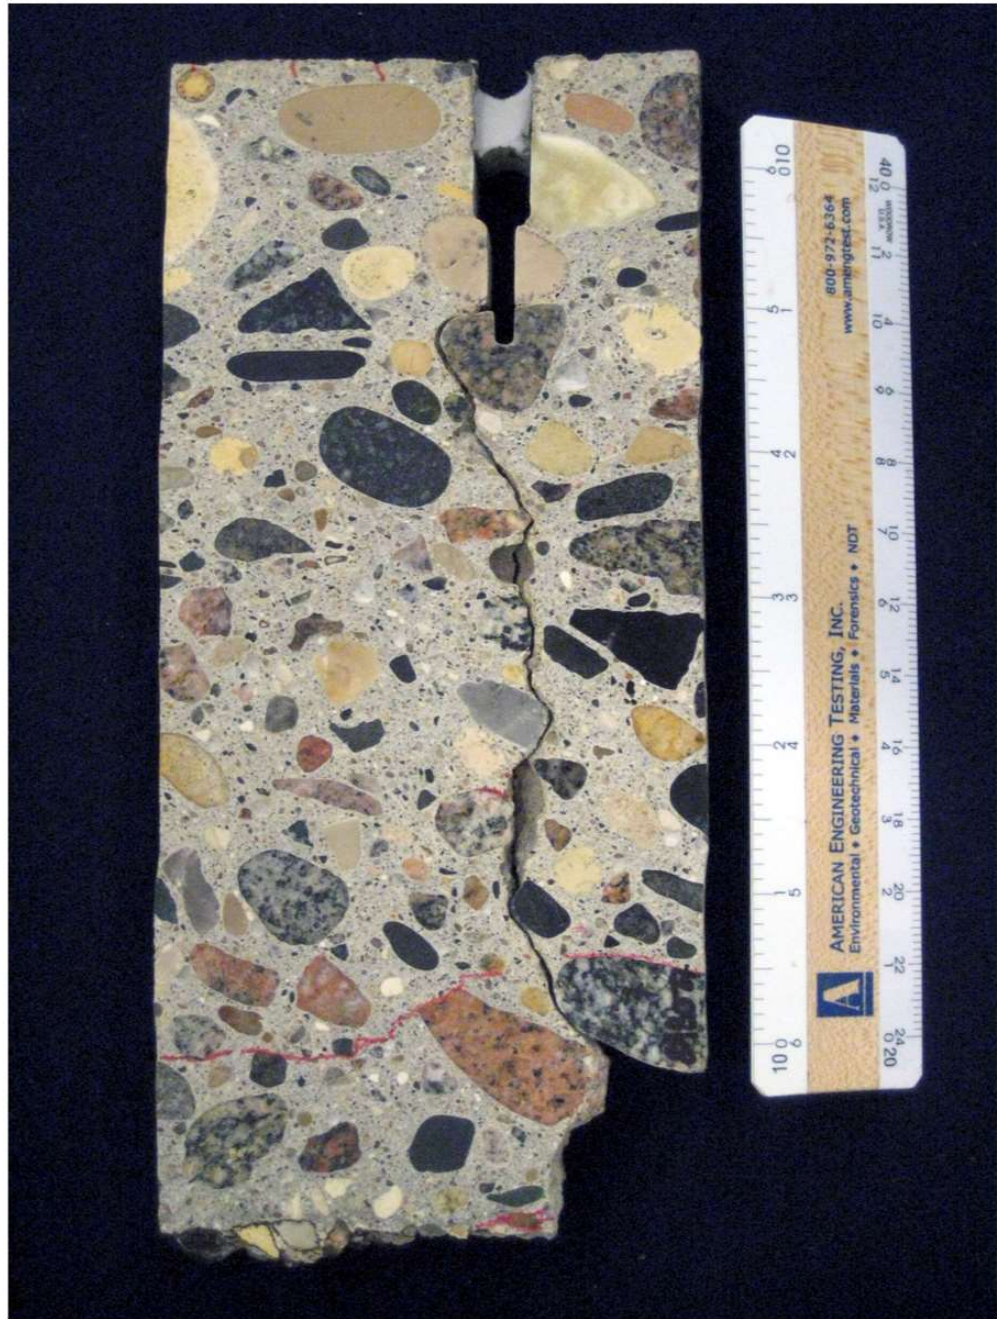
PHOTO:
74

SAMPLE ID: 8480-27, 7 **DESCRIPTION:** Sawcut and lapped cross section of core. The joint crack exhibited no distress.

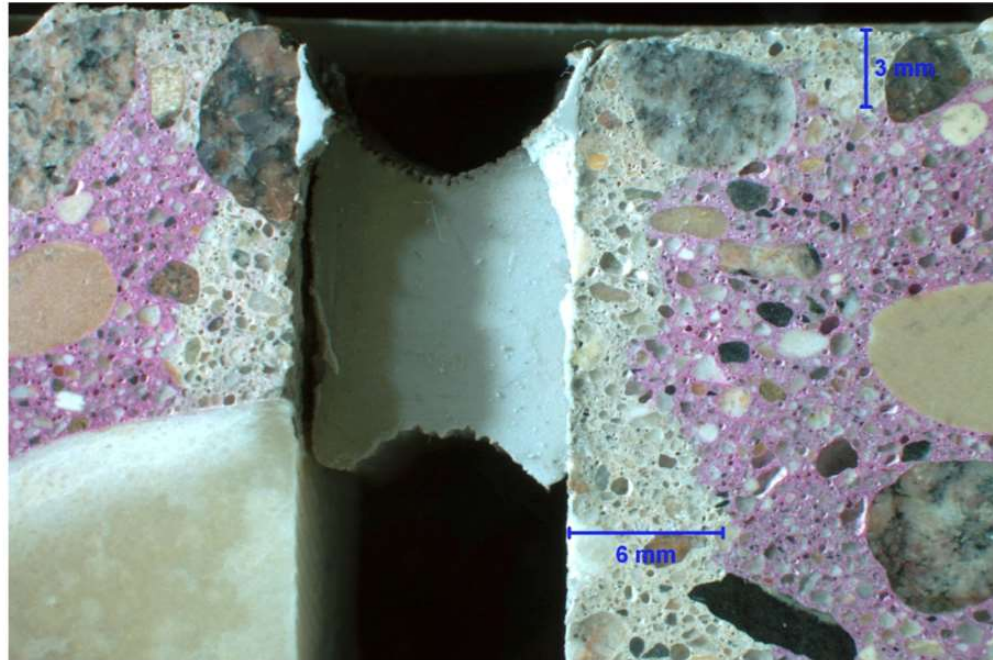
PHOTO:
134

SAMPLE ID: 8480-27, 7 **DESCRIPTION:** Carbonation (unstained paste) proceeded to 3mm depth from the top surface and to 6mm depth from the sawcut and sealed joint; in this image. The joint sealant was generally originally well bonded to both sides of the joint.
MAG: 5x

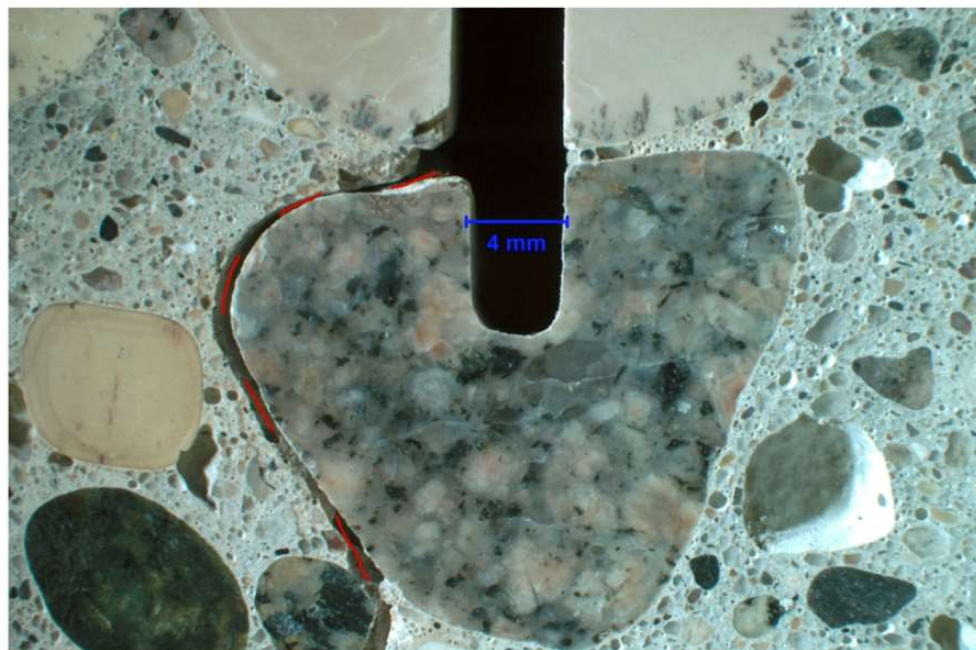
PHOTO:
135

SAMPLE ID: 8480-27, 7 **DESCRIPTION:** Image of the resulting joint crack proceeding around the sawcut-intersected coarse aggregate.
MAG: 5x
