Impact of Water/ Cementitious-Based Concrete Mix Design Specification Changes on Concrete Pavement Quality

July 2018

Research Project
Final Report 2018-25

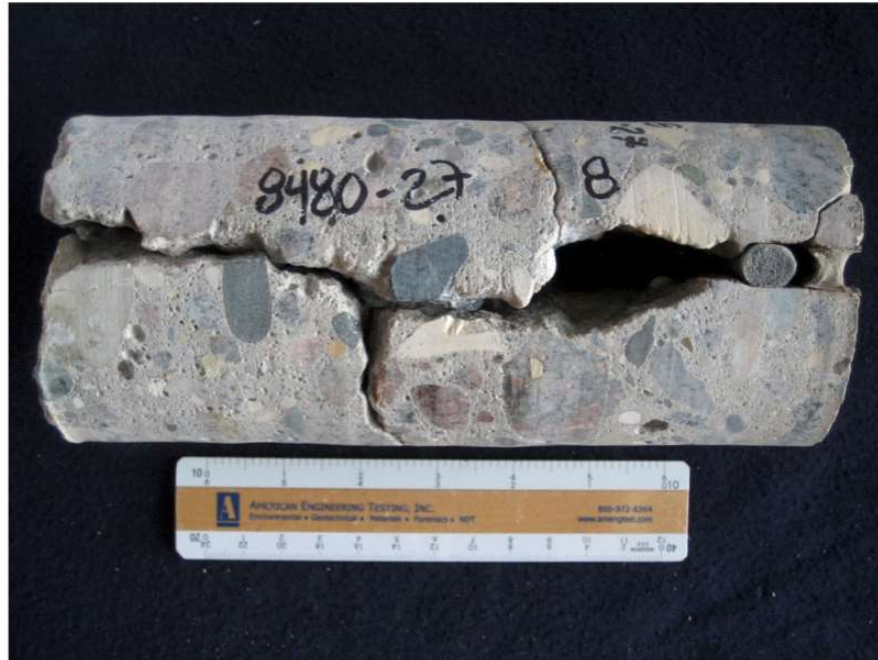
PHOTO: 55

SAMPLE ID: 8480-27, 8 **DESCRIPTION:** Jointed core sample subjected to petrographic analysis. The silicone sealed top surface is right. Significant "tunneling" was present directly beneath the sawcut joint.

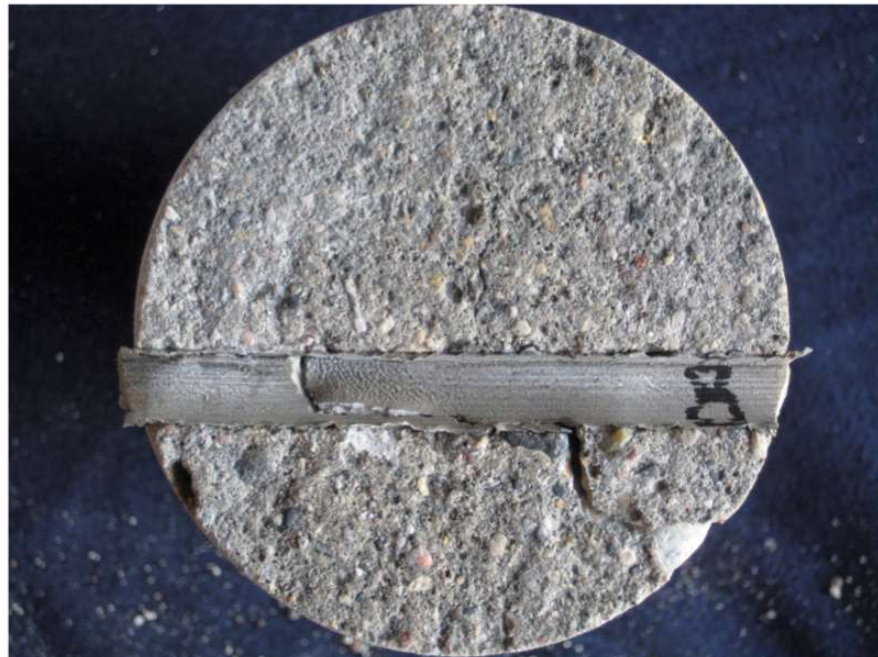
PHOTO: 56

SAMPLE ID: 8480-27, 8 **DESCRIPTION:** Textured and worn top surface of the core as received. Note the de-bonded silicone joint sealant.

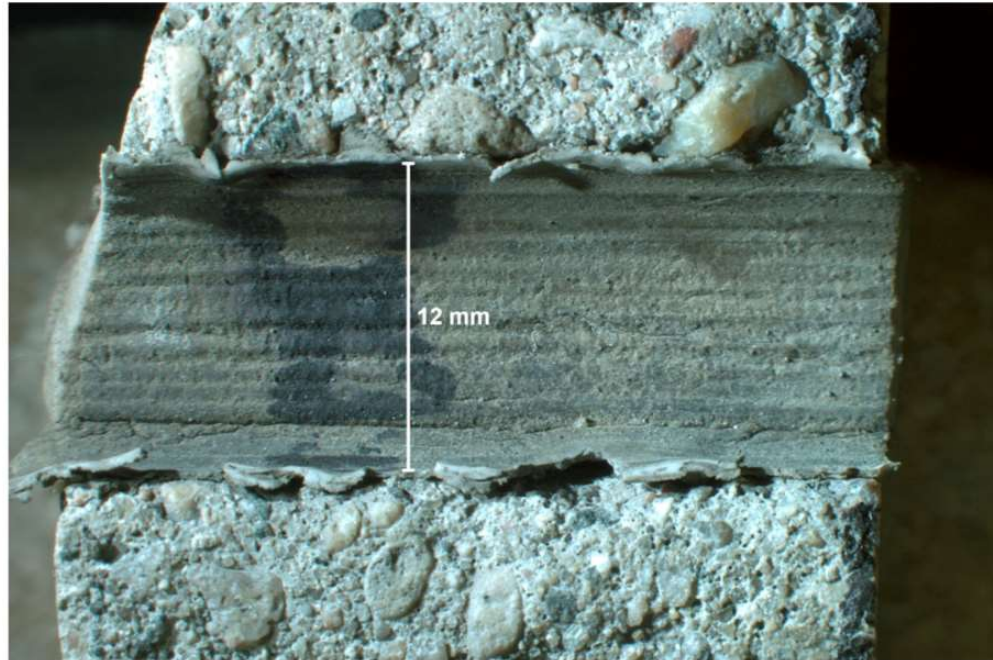
PHOTO:
136

SAMPLE ID: 8480-27, 8 **DESCRIPTION:** The joint sealant was intermittently bonded to the sawcut joint . Note mortar erosion of the top surface.
MAG: 5x

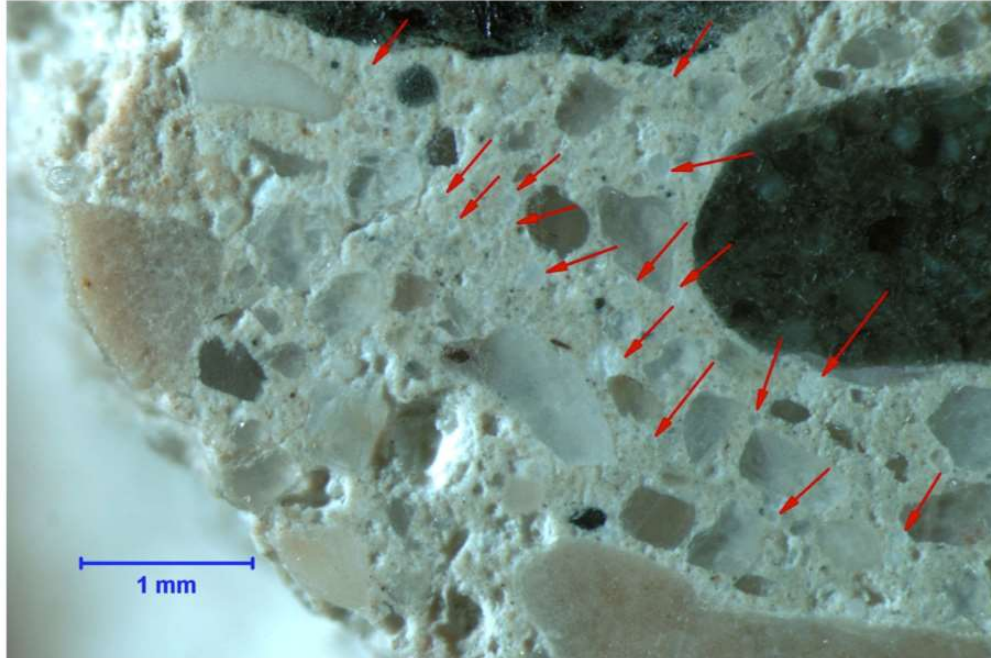
PHOTO:
138

SAMPLE ID: 8480-27, 8 **DESCRIPTION:** Ettringite-filled air voidspaces within 5mm of the distressed joint face (left); at 100mm depth in the core.
MAG: 30x

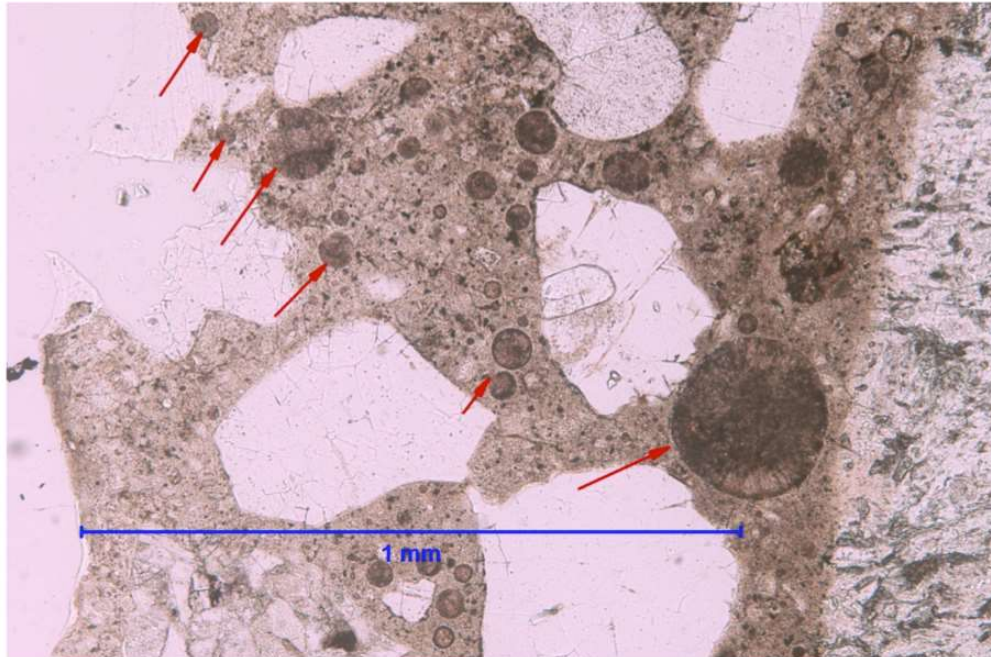
PHOTO:
139

SAMPLE ID: 8480-27, 8 **DESCRIPTION:** Stained, ettringite-filled, entrained sized air void spaces within 1mm of the distressed joint face (left); in thin section under plane polarized light.
MAG: 40x

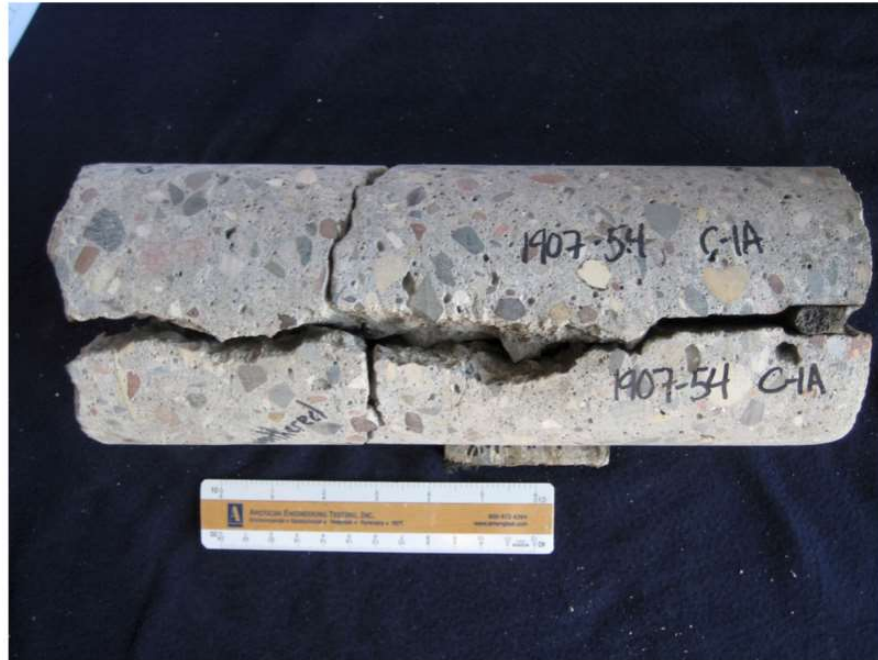
PHOTO: 11

SAMPLE ID: 1907-54, C-1A
top surface is right.

DESCRIPTION: Jointed core sample utilized for petrographic analysis. The sealed top surface is right.

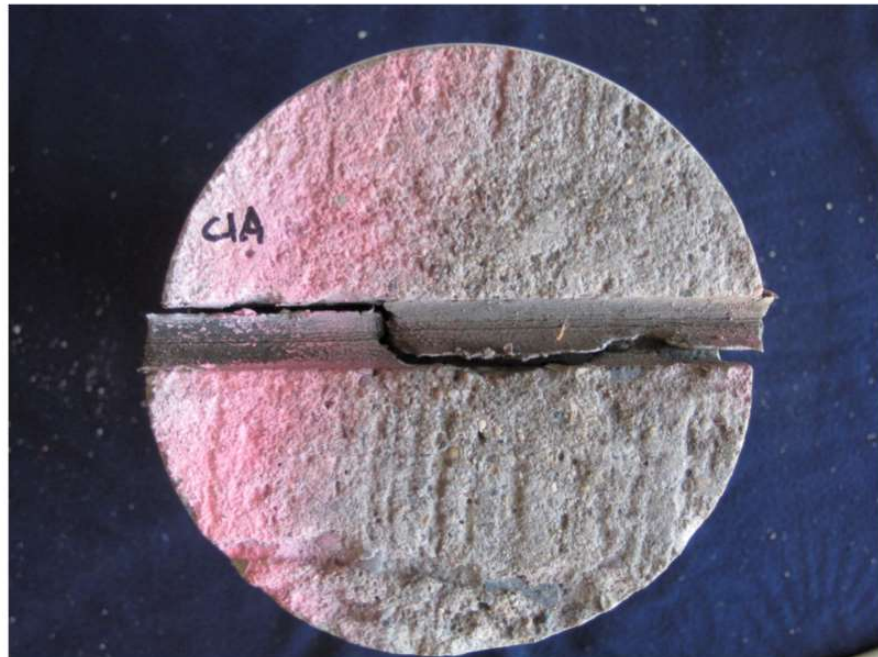
PHOTO: 12

SAMPLE ID: 1907-54, C-1A
erosion and compromised sealant.

DESCRIPTION: Rough screeded and tinted top surface of the core with mortar erosion and compromised sealant.

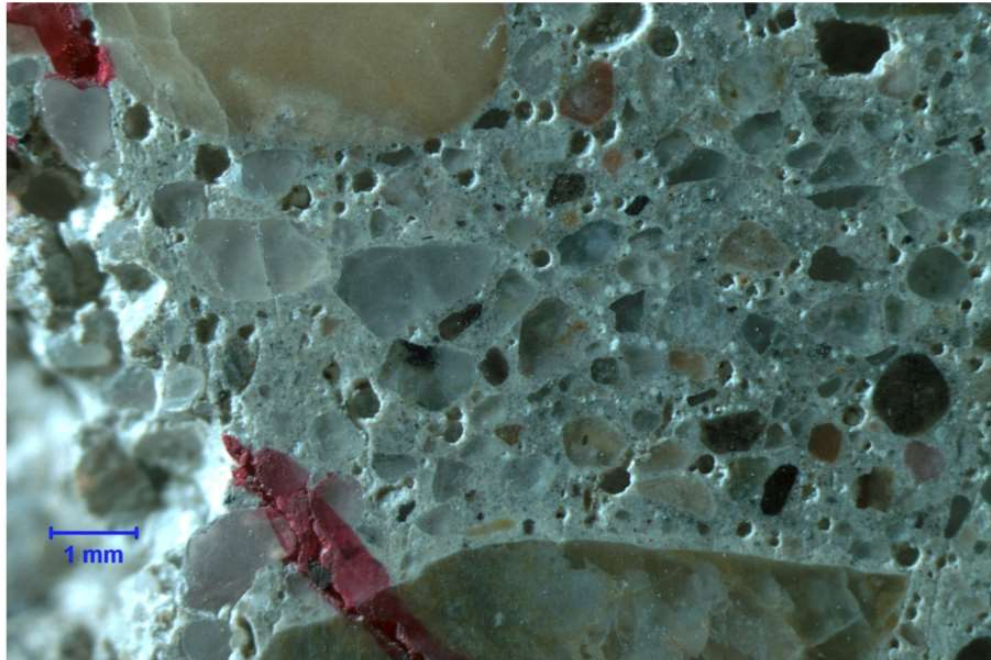
PHOTO: 90

SAMPLE ID: 1907-54, C-1A **DESCRIPTION:** Compromised air void system due to secondary ettringite fillings at the distressed joint (L) at 105mm depth in the joint.
MAG: 15x

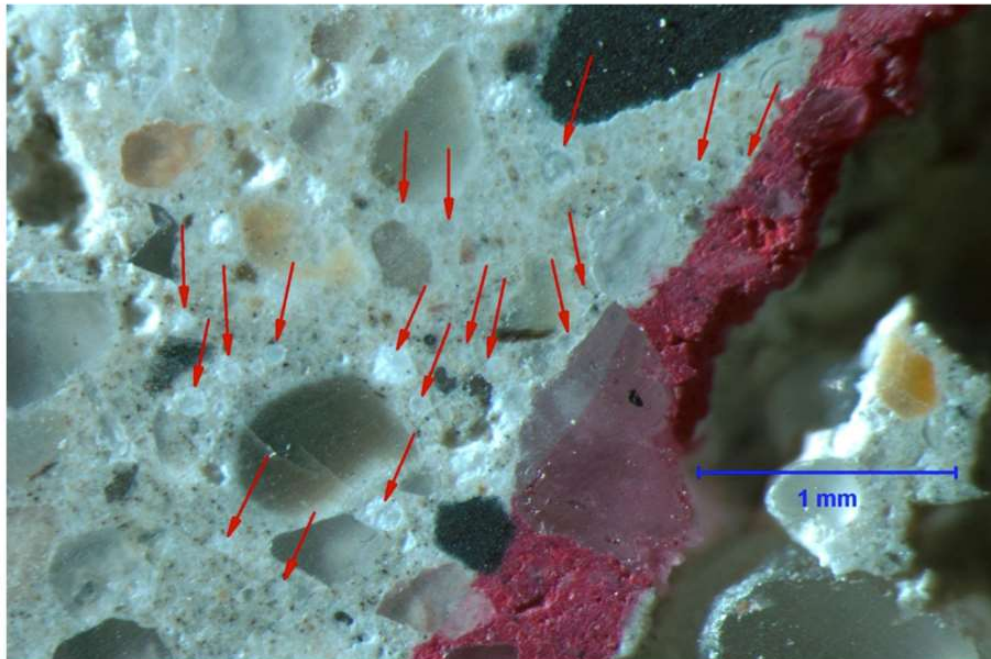
PHOTO: 91

SAMPLE ID: 1907-54, C-1A **DESCRIPTION:** Clear to white secondary ettringite fills fine entrained air voidspaces along the distressed joint at 175mm depth in the core.
MAG: 50x

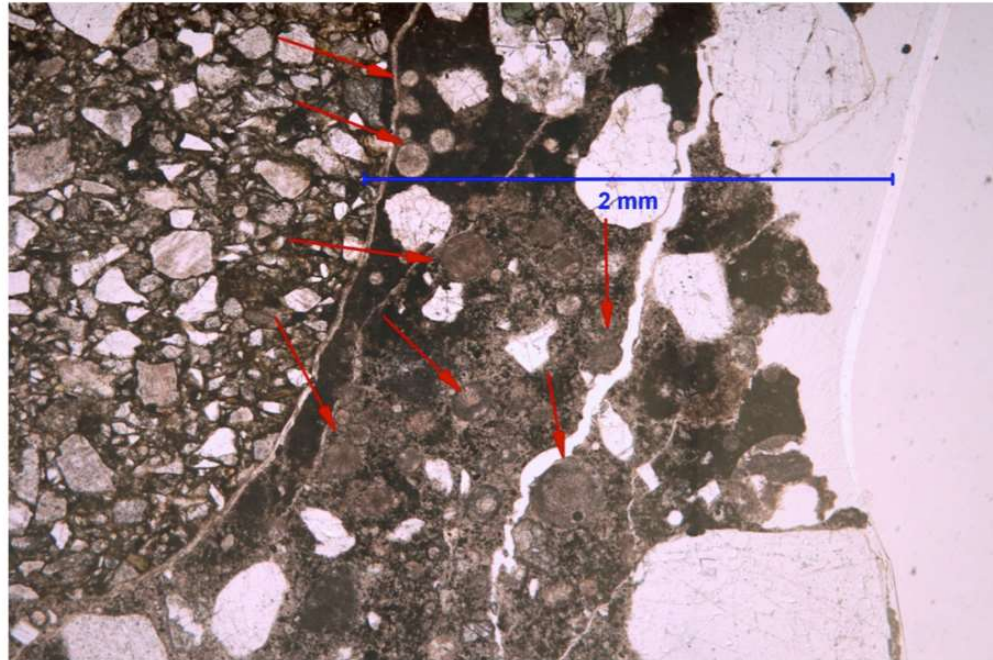
PHOTO: 92

SAMPLE ID: 1907-54, C-1A **DESCRIPTION:** Secondary-ettringite filled air voidspaces in the paste directly adjacent to the distressed joint face; in thin section at mid-depth in the core, under plane polarized light.
MAG: 40x

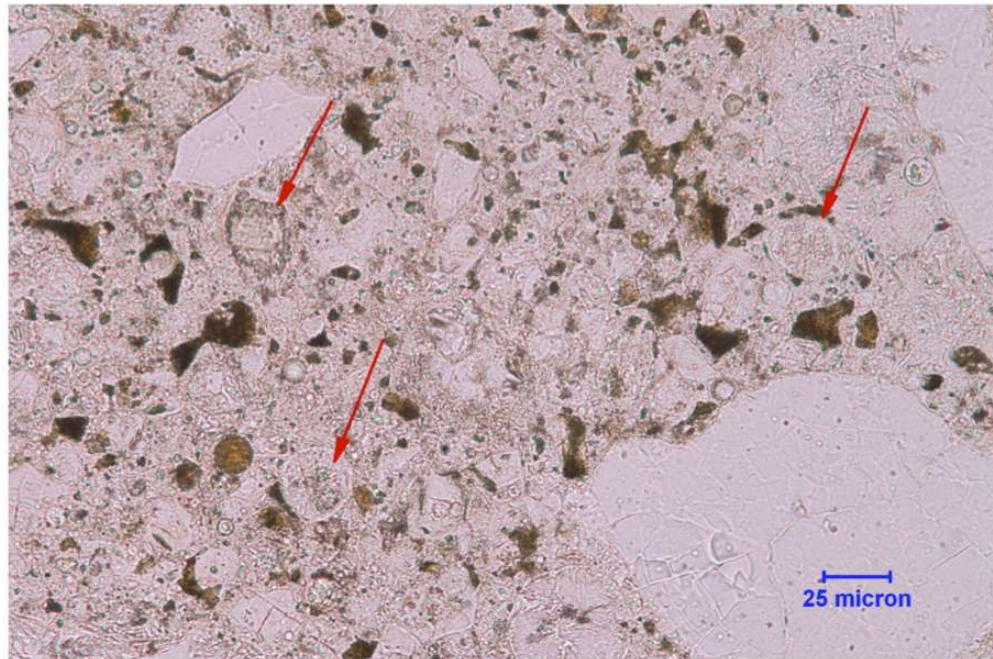
PHOTO: 93

SAMPLE ID: 1907-54, C-1A **DESCRIPTION:** Well to fully hydrated belite portland cement clinker particles in thin section of concrete paste under plane polarized light. Note abundant spherical flyash pozzolan particles.
MAG: 400x

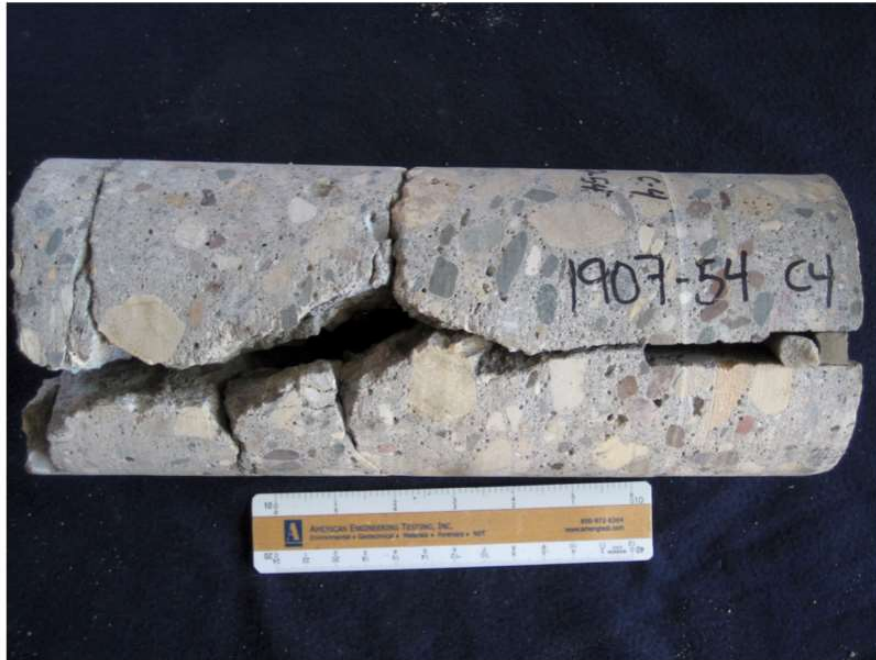
PHOTO: 13

SAMPLE ID: 1907-54, C-4 **DESCRIPTION:** Jointed core sample utilized for petrographic analysis. The sealed top surface is right. Note mass lost along joint crack.

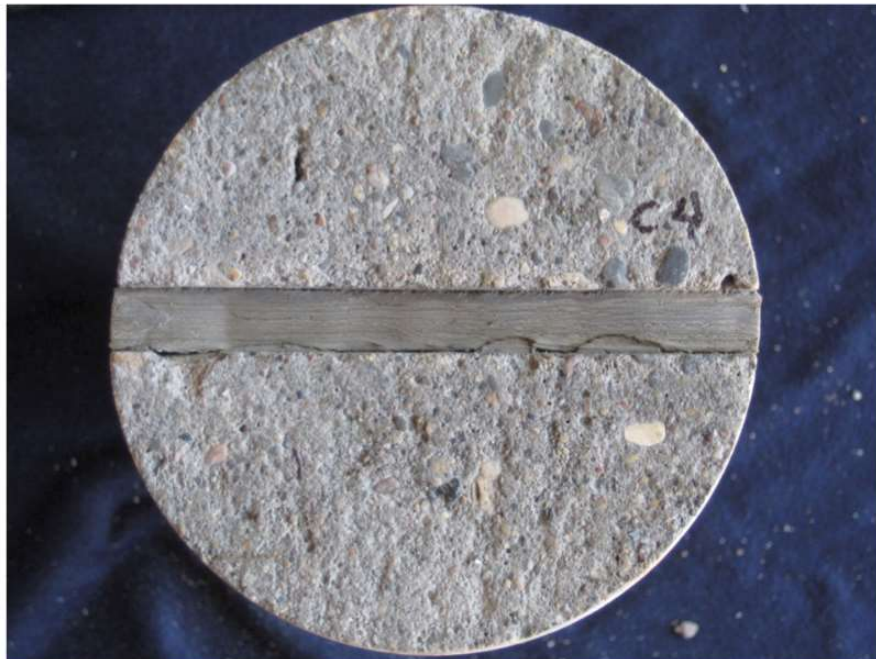
PHOTO: 14

SAMPLE ID: 1907-54, C-4 **DESCRIPTION:** Fairly smooth traffic-worn top surface of the core with compromised joint sealant.

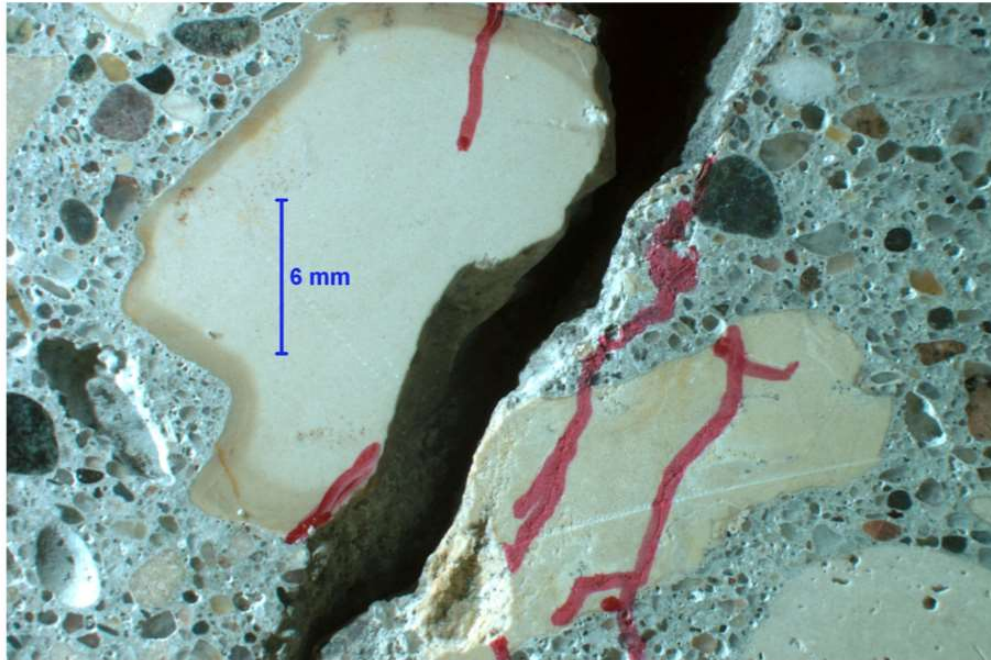
PHOTO: 94

SAMPLE ID: 1907-54, C-4 **DESCRIPTION:** Coarse carbonate aggregates at below 95mm depth in the core are participating in the incipient distress along the length of the distressed joint plane
MAG: 5x

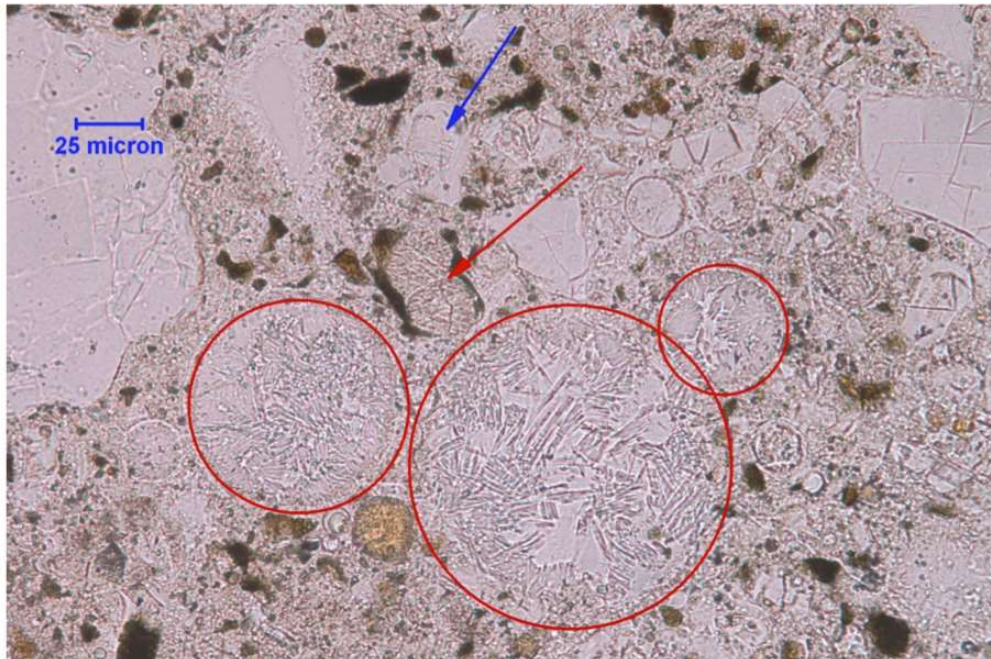
PHOTO: 95

SAMPLE ID: 1907-54, C-4 **DESCRIPTION:** Fully hydrated alite (blue arrow) and belite (red) portland cement clinker particle in thin section of concrete paste under plane polarized light. Secondary ettringite (mostly) filled air void spaces are outlined in red. Note abundant spherical flyash pozzolan particles.
MAG: 400x

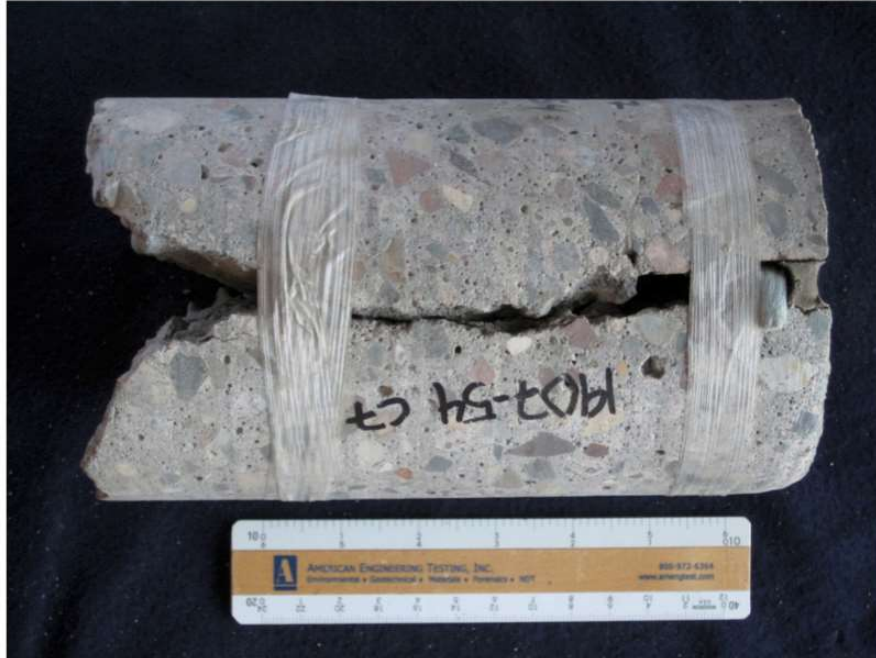
PHOTO: 15

SAMPLE ID: 1907-54, C-7 **DESCRIPTION:** Jointed core sample utilized for petrographic analysis. The sealed top surface is right. Note mass lost along joint crack at base of core.

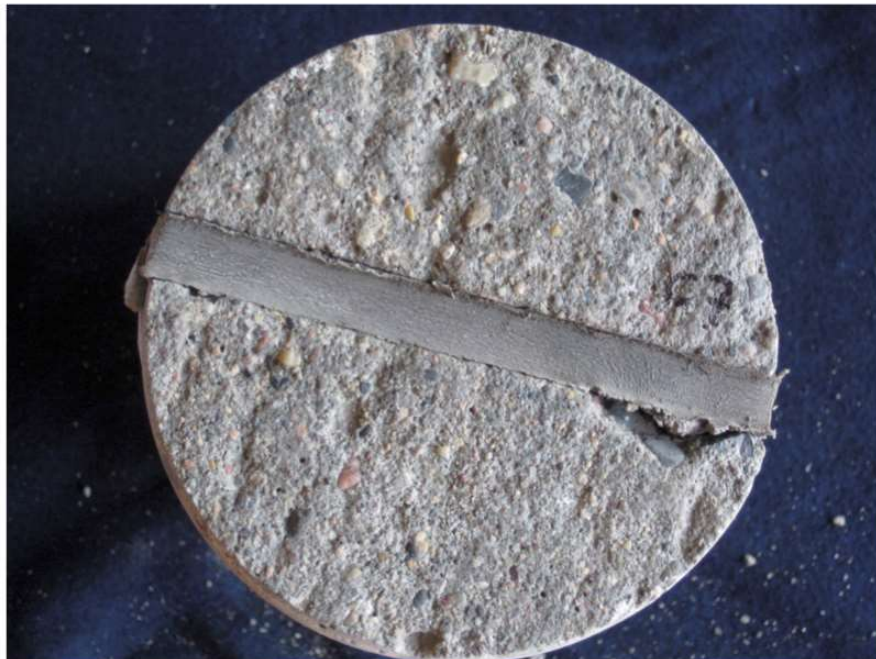
PHOTO: 16

SAMPLE ID: 1907-54, C-7 **DESCRIPTION:** Rough screeded and tined top surface of the core with traffic wear and compromised sealant.

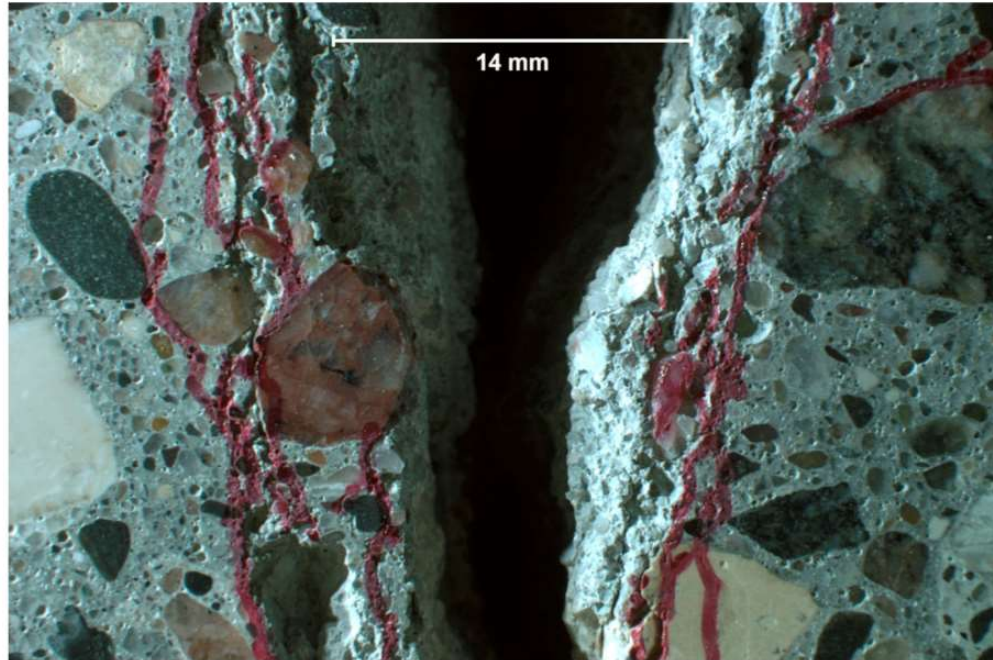
PHOTO: 96

SAMPLE ID: 1907-54, C-7 **DESCRIPTION:** Concentrated incipient distress along the length of the distressed joint plane at below 110mm depth in the core.
MAG: 5x

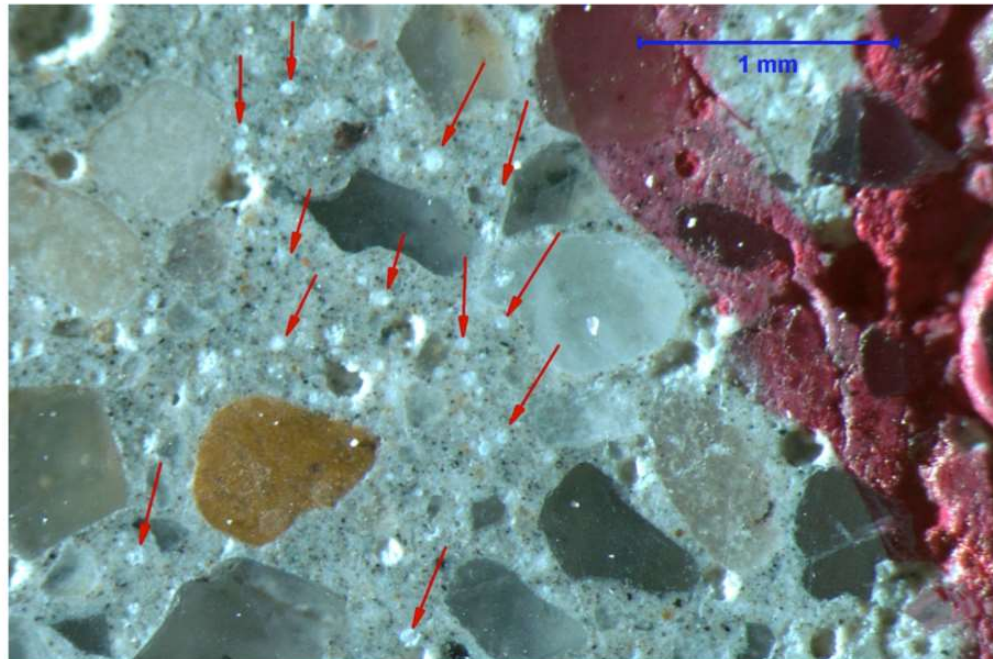
PHOTO: 97

SAMPLE ID: 1907-54, C-7 **DESCRIPTION:** Secondary ettringite filled air voidspaces at below 125mm depth in the core and 8mm depth from the joint.
MAG: 50x

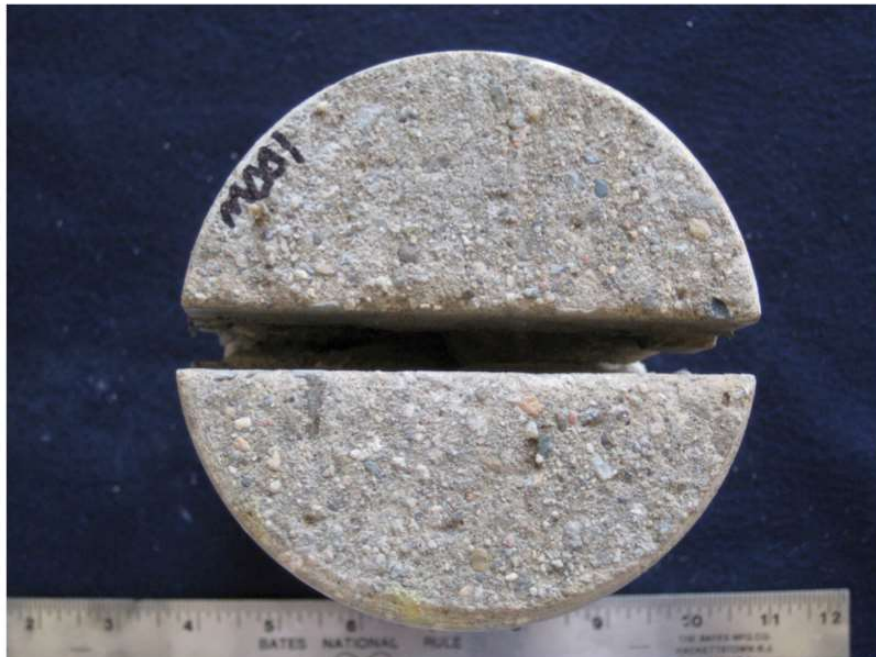
PHOTO:
20

SAMPLE ID: 2313-13, M001 DESCRIPTION: Rough mortar-eroded top surface of the core; with sawcut control joint.

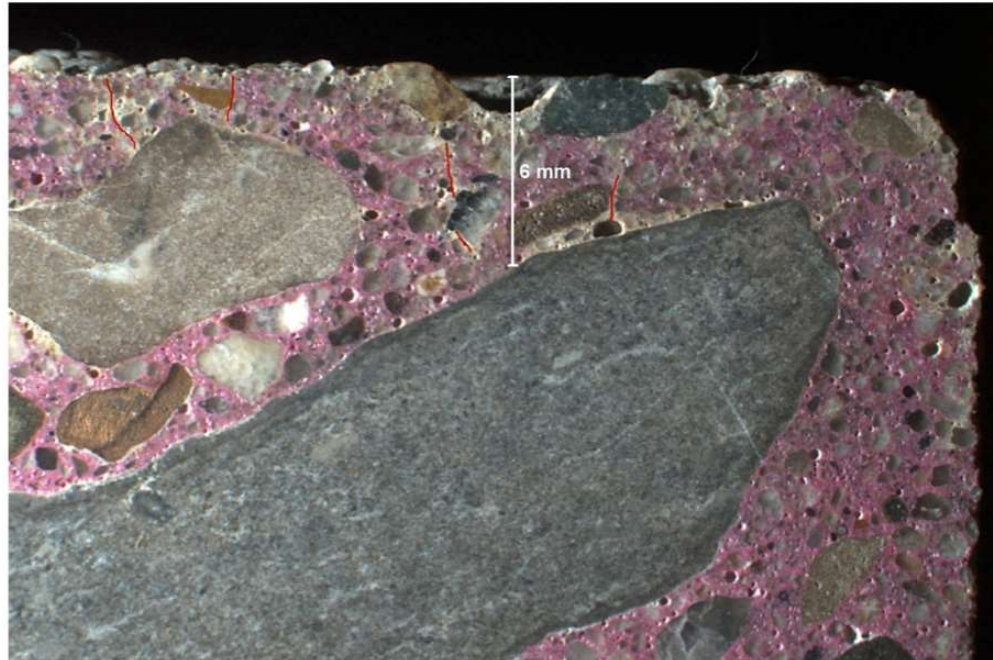
PHOTO:
106

SAMPLE ID: 2313-13, M001 **DESCRIPTION:** Carbonation (unstained paste) ranged from negligible up to 6mm depth, intermittently, and in this image, from the top surface. Freshly sawcut and lapped cross section exposed to phenolphthalein pH indicator
MAG: 5x.

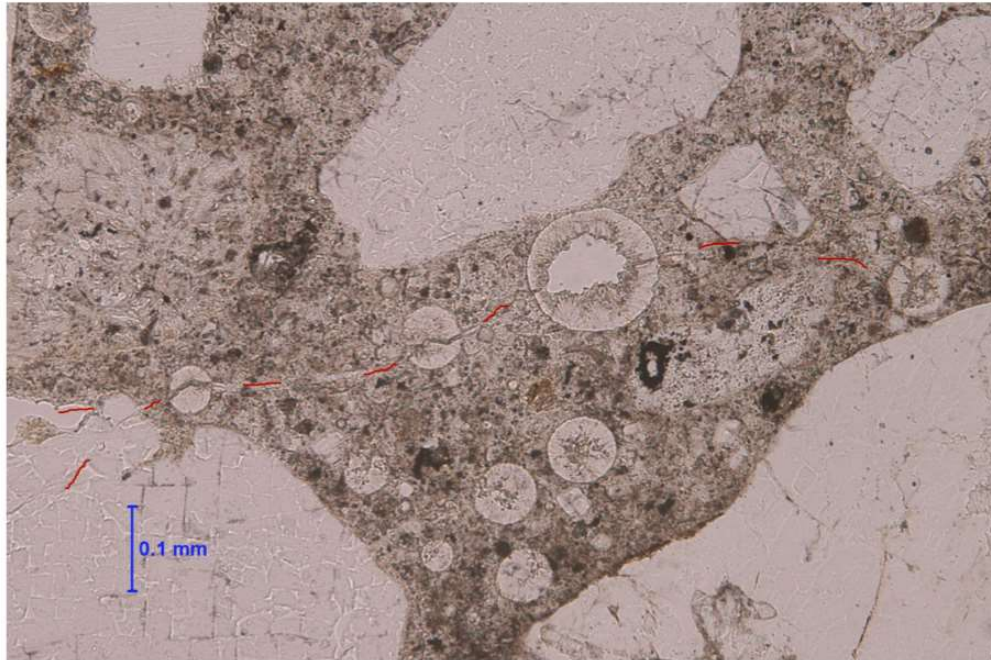
PHOTO:
108

SAMPLE ID: 2313-13, M001 **DESCRIPTION:** Ettringite filled and partly filled air voidspaces in thin section of concrete paste at approx. 70mm depth from the top surface and 12mm depth from the distressed joint plane. Note microcracking bisects fillings. Plane polarized light.
MAG: 100x

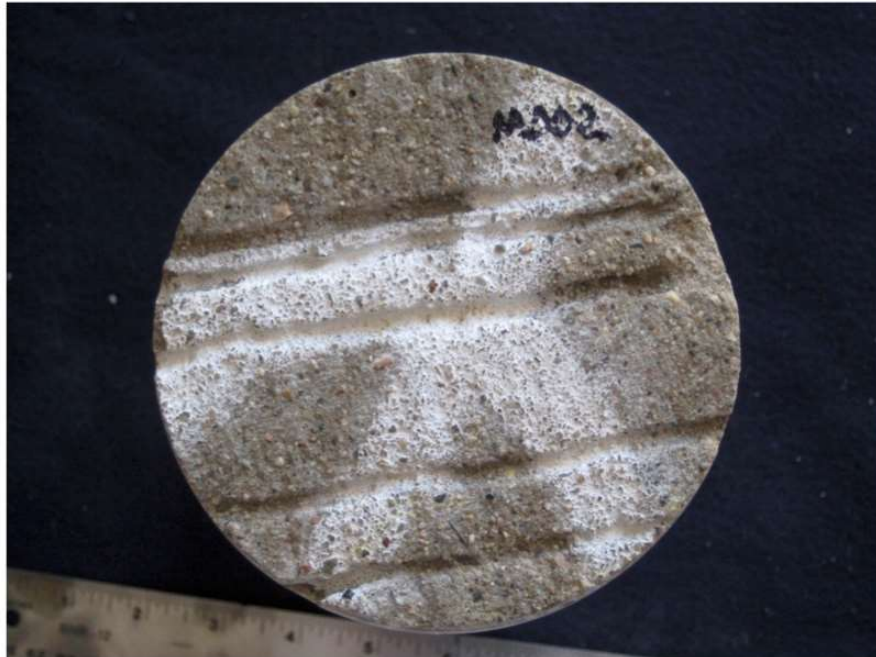
PHOTO:
22

SAMPLE ID: 2313-13, M002 **DESCRIPTION:** Rough screeded and tined surface with minor mortar erosion..

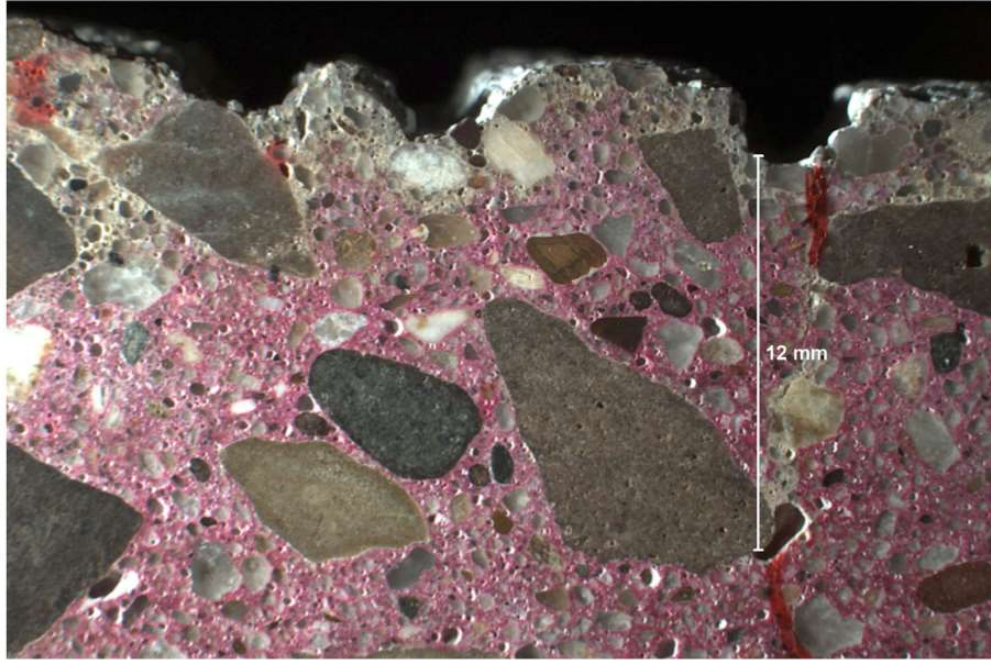
PHOTO:
110

SAMPLE ID: 2313-13, M002 **DESCRIPTION:** Carbonation (unstained paste) ranged from negligible up to 12mm depth from the top surface, intermittently along sub-vertical microcracking partly mapped in red ink.
MAG: 5x

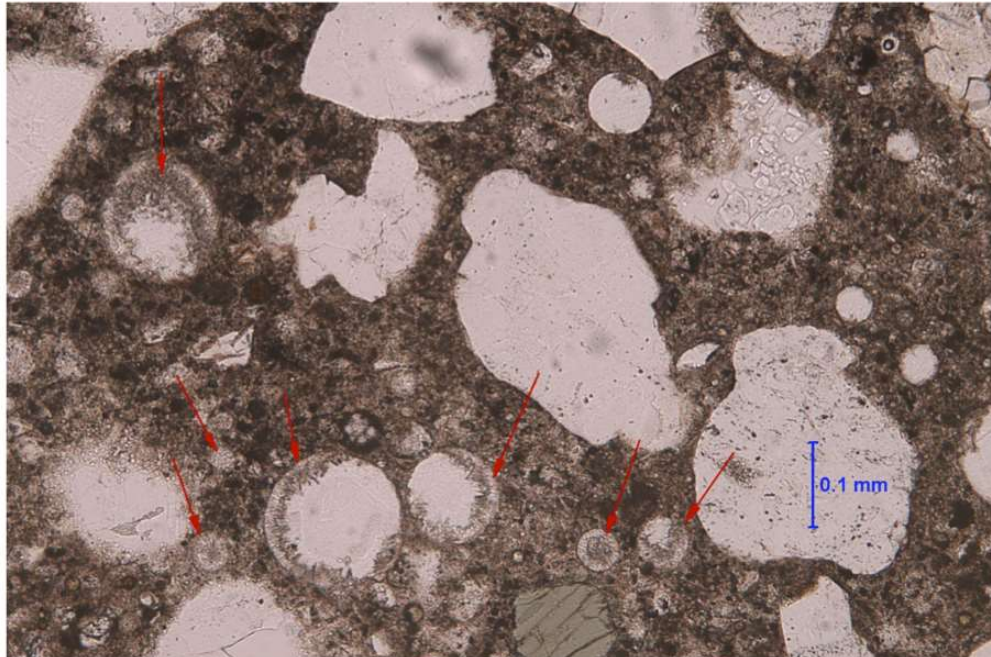
PHOTO:
111

SAMPLE ID: 2312-13, M002 **DESCRIPTION:** Very fine void fillings and large void linings by secondary ettringite in thin section of concrete under plane polarized light; at 170mm + depth in the mid-panel core.
MAG: 100x

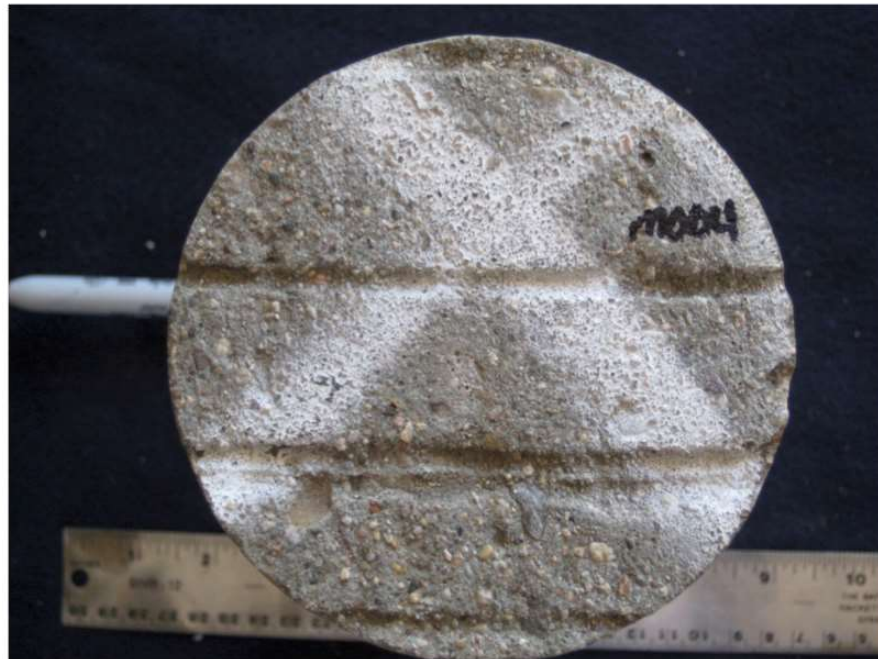
PHOTO:
24

SAMPLE ID: 2313-13, M004 DESCRIPTION: Rough screeded and tined surface with minor mortar erosion.

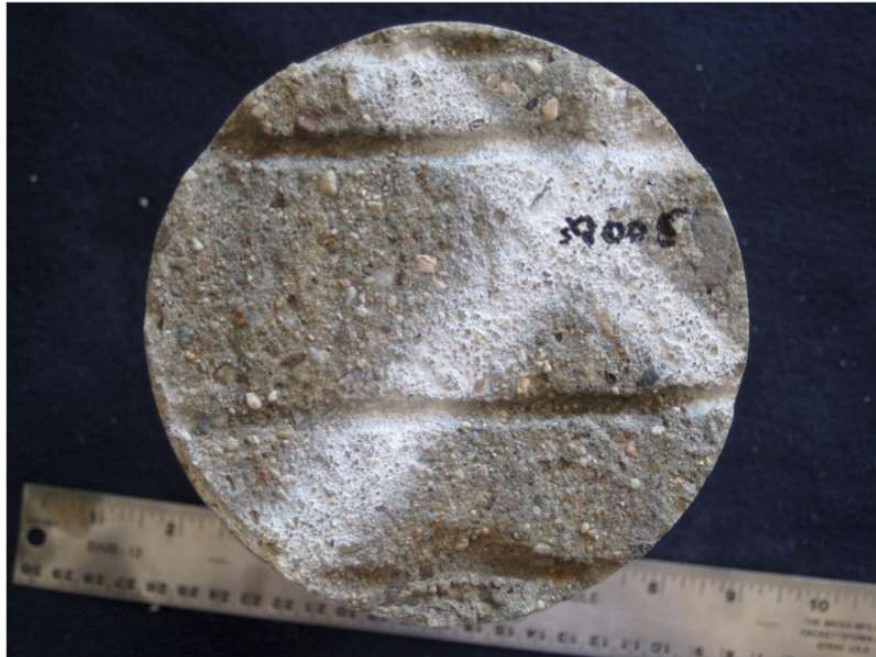
PHOTO:
26

SAMPLE ID: 2313-13, M005 **DESCRIPTION:** Rough screeded and tined surface with minor mortar erosion.

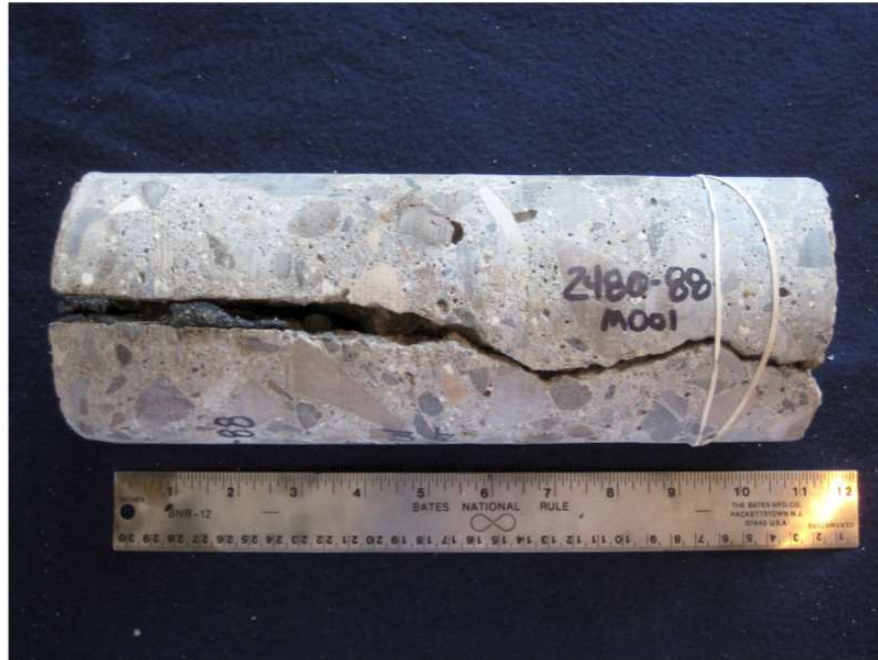
PHOTO:
27

SAMPLE ID: 2480-88, M001 **DESCRIPTION:** Overall view of the jointed core utilized for petrographic analysis. The top surface is left.

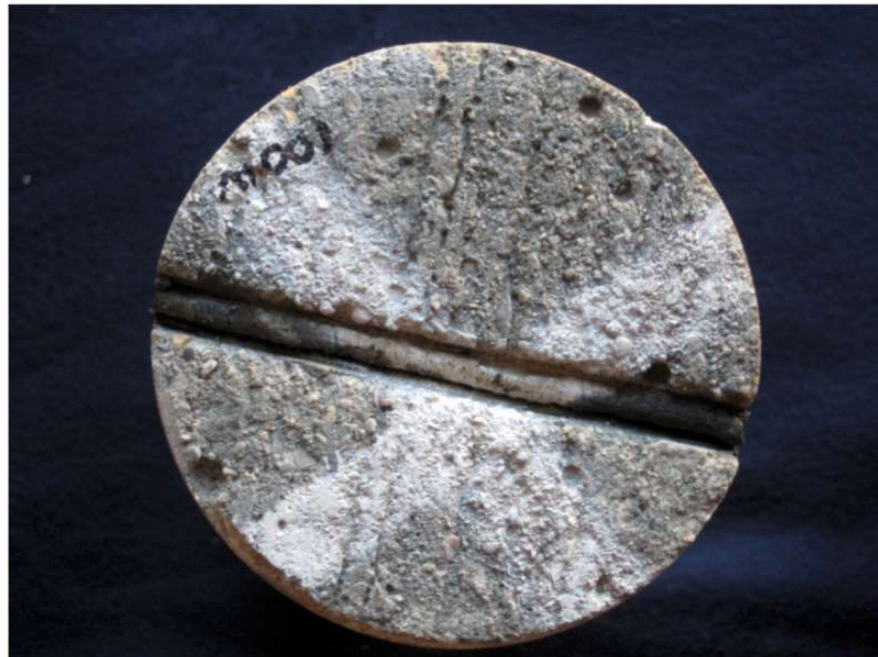
PHOTO:
28

SAMPLE ID: 2480-88, M001 **DESCRIPTION:** Rough screeded top surface with minor mortar erosion.

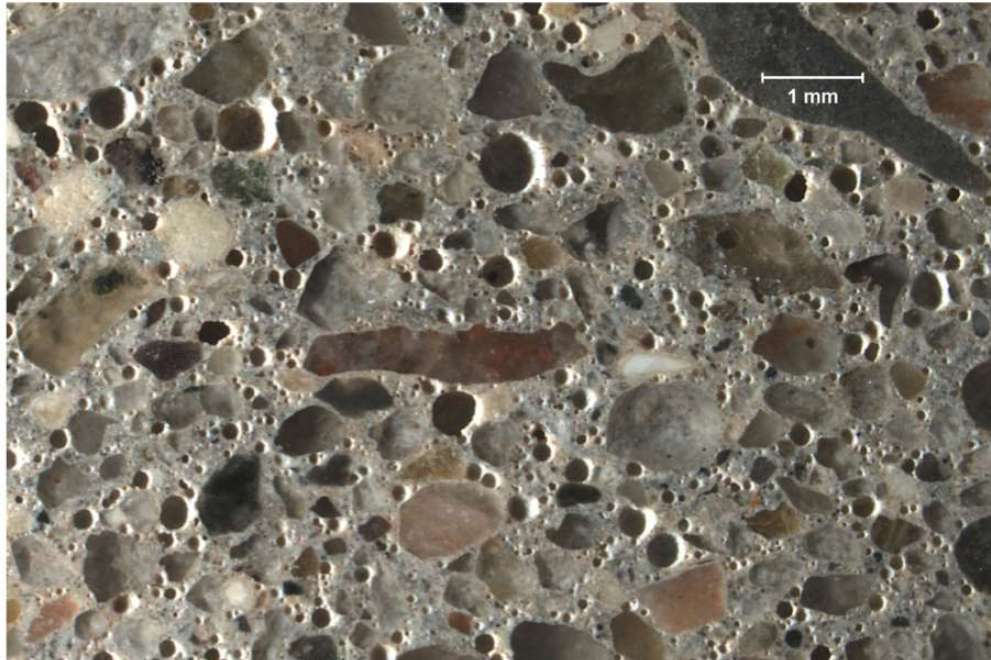
PHOTO:
112

SAMPLE ID: 2480-88, M001 **DESCRIPTION:** Overall hardened air content is relatively unfilled with secondary ettringite at 210mm from the top surface and 40mm depth from the distressed joint plane.
MAG: 15x

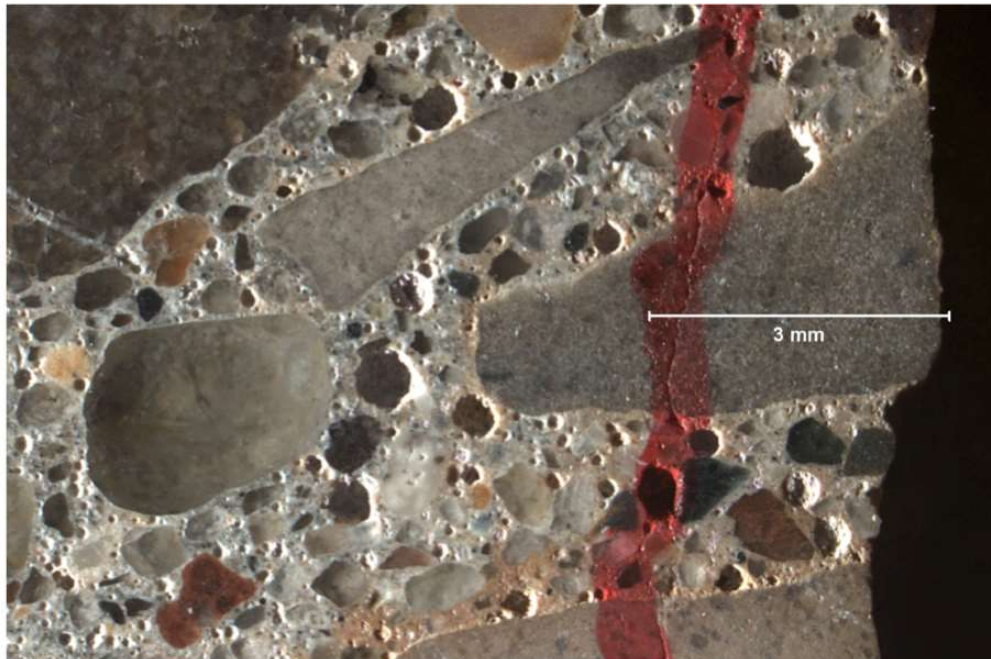
PHOTO:
113

SAMPLE ID: 2480-88, M001 **DESCRIPTION:** Most of the fine air voids within 3mm of the distressed joint plane and 225mm depth from the top surface are filled by secondary ettringite. Freeze-thaw microcracking is mapped in red ink.
MAG: 15x

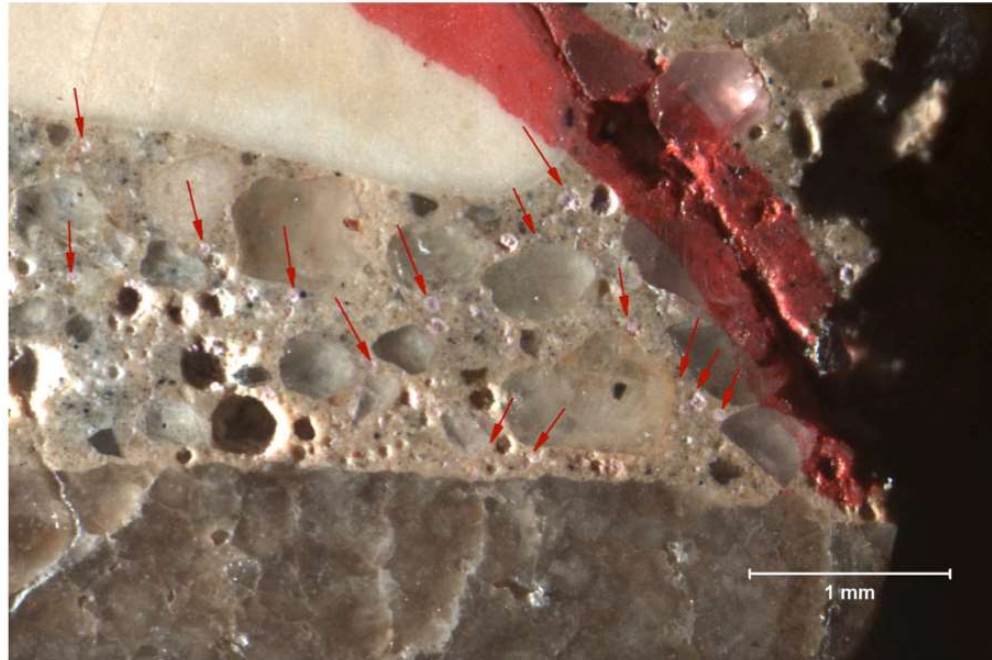
PHOTO:
114

SAMPLE ID: 2480-88, M001 **DESCRIPTION:** Fine ettringite filled voids are marked with arrows at the distressed joint plane (right).
MAG: 30x

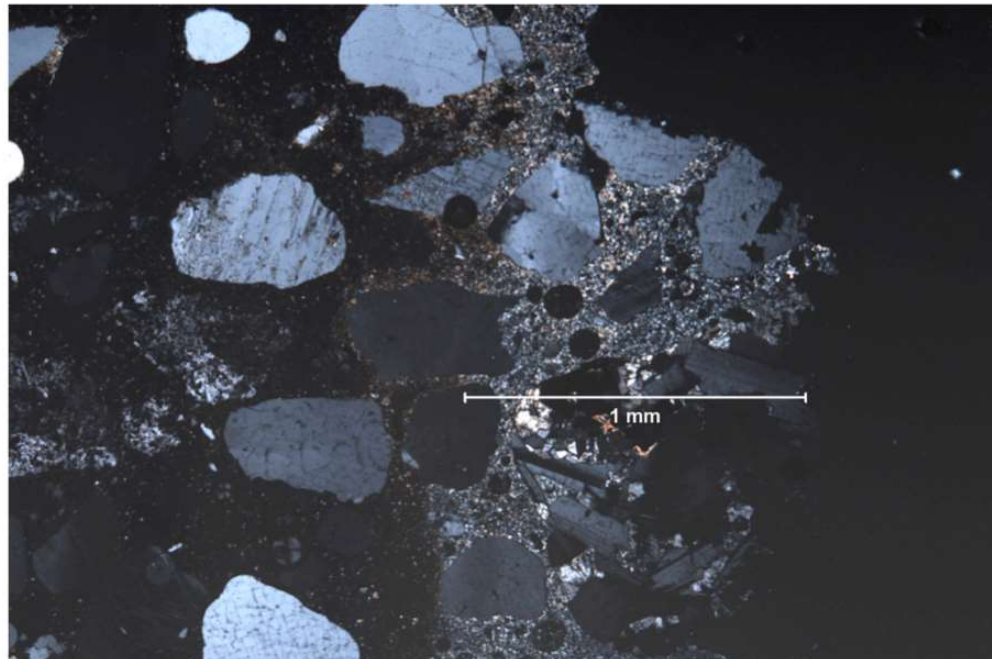
PHOTO:
115

SAMPLE ID: 2480-88, M001 **DESCRIPTION:** Brightly colored carbonated paste at the outer 1mm of the distressed joint plane (right); in thin section of concrete under cross polarized light.
MAG: 40x

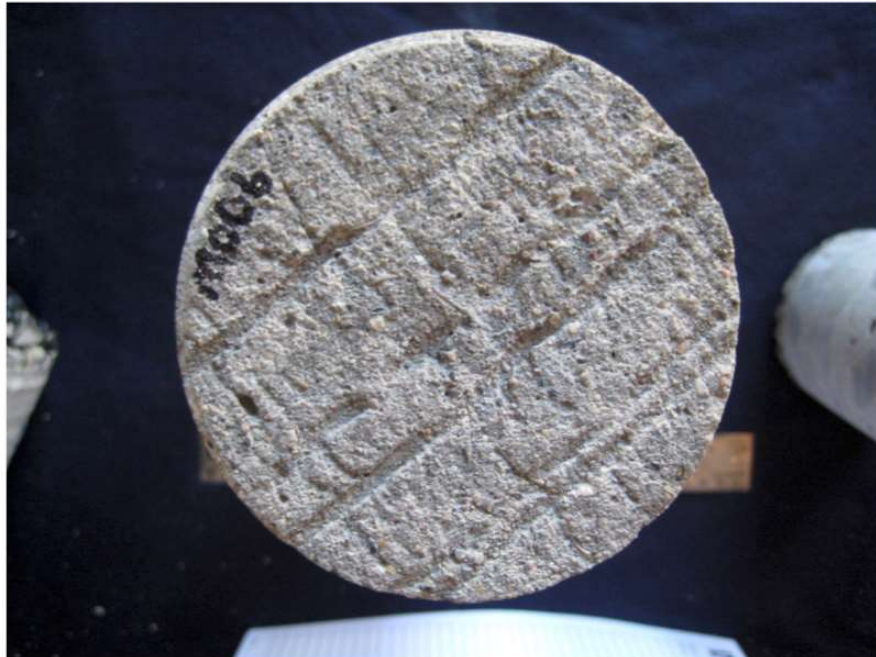
PHOTO:
30

SAMPLE ID: 2480-88, M006 **DESCRIPTION:** Rough screeded and tined top surface with minor mortar erosion.
