Impact of Water/ Cementitious-Based Concrete Mix Design Specification Changes on Concrete Pavement Quality

July 2018

Research Project
Final Report 2018-25

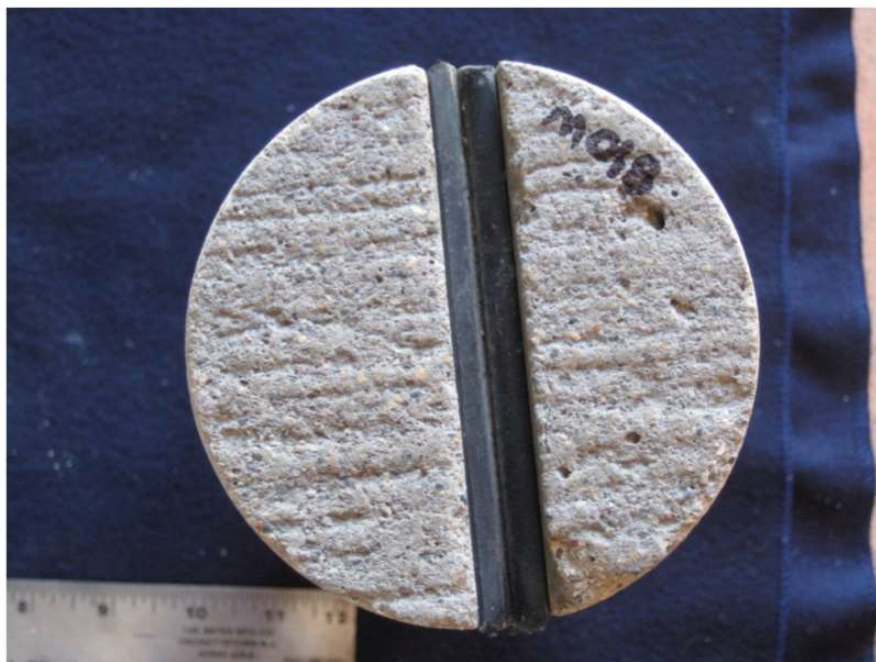
PHOTO:
34

SAMPLE ID: 2480-91, M018 **DESCRIPTION:** Rough screeded top surface of the core with neoprene-sealed control joint.

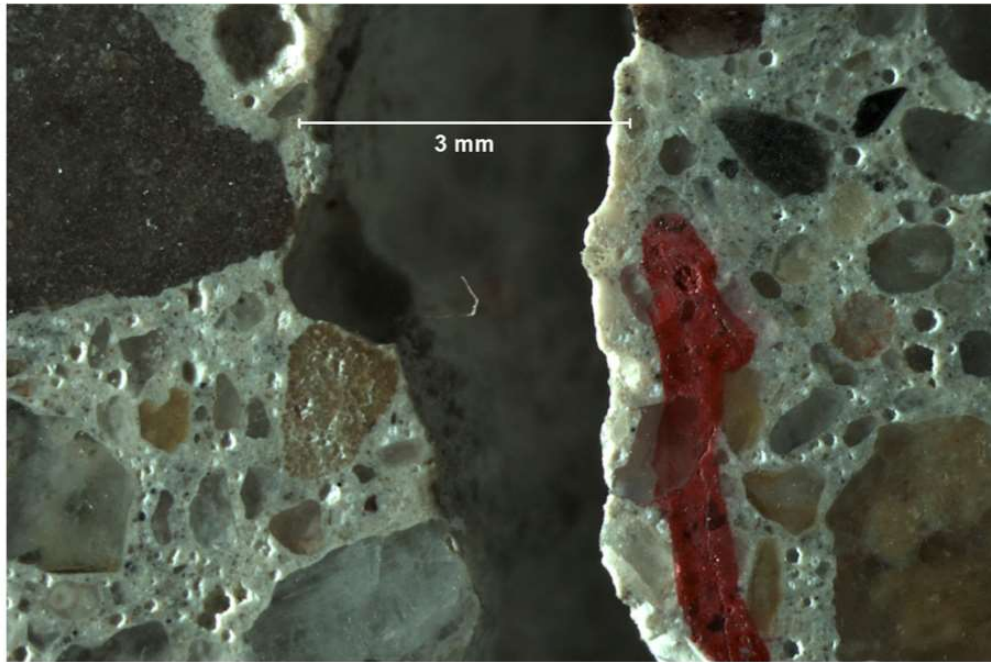
PHOTO:
116

SAMPLE ID: 2480-91, M018 **DESCRIPTION:** Note loss of air entrainment due to ettringite fillings adjacent to the distressed joint plane (center).
MAG: 15x

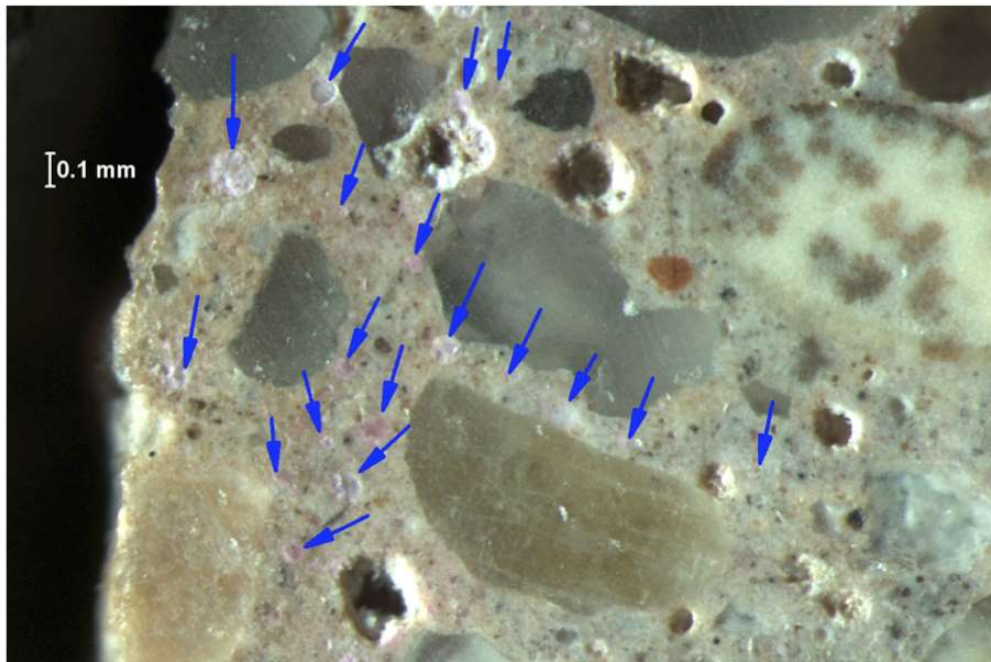
PHOTO:
117

SAMPLE ID: 2480-91, M018 **DESCRIPTION:** Nearly all of the finest entrained sized air voidspaces proximate to the distressed joint plane are filled with secondary ettringite. Image from 155mm depth from the top surface.
MAG: 50x

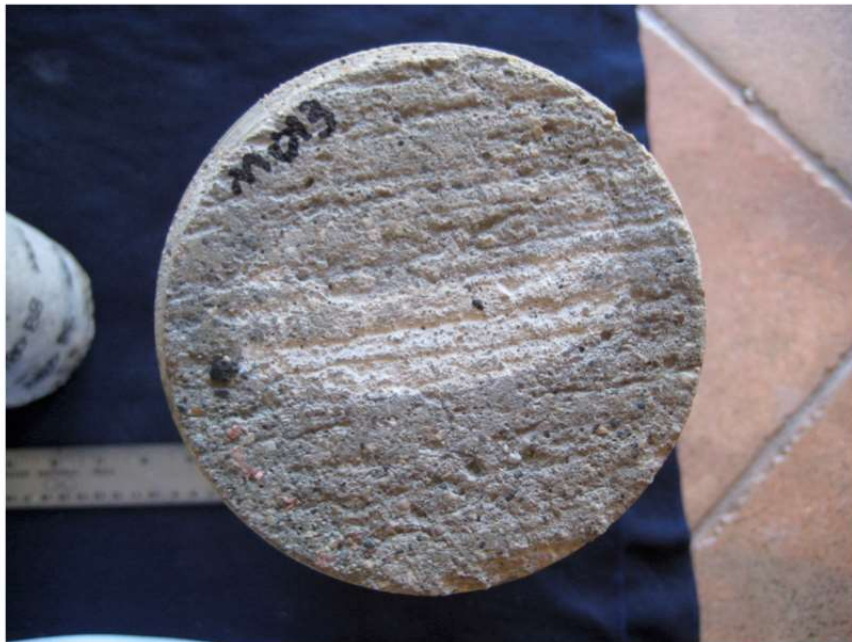
PHOTO:
32

SAMPLE ID: 2480-91, M013 **DESCRIPTION:** Rough screeded top surface with minor mortar erosion.

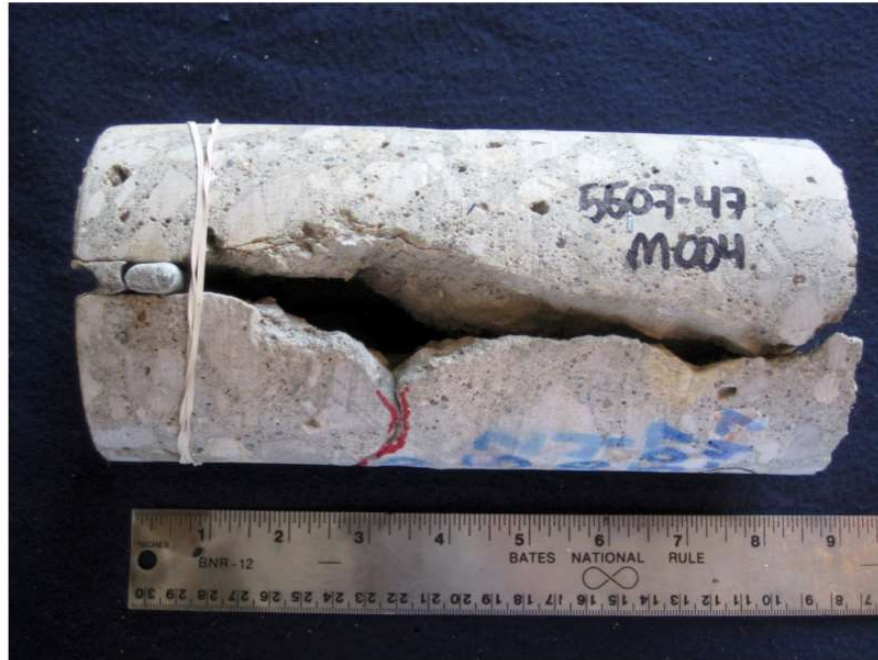
PHOTO:
49

3. **Reinforcement:** None observed.
4. **General Physical Conditions:** The core exhibits poor overall condition. The core was taken through a moderately to severely distressed pavement joint. The joint was characterized by an approx. 11mm wide sawcut proceeding at least 38mm (1 1/2") depth from the top surface. Evidence of a pilot cut was missing due to loss of concrete. An unattached 6mm thick light gray silicon joint sealant and light gray backer rod were included with the core. Incipient vertical scaling/spalling starts at as shallow as 24mm depth in the sawcut joint and incorporates between 8mm and 27mm of total concrete paste and dolostone aggregate between the two sides of the joint crack. The widest loss of concrete (15mm-27mm) occurs between approx. 40 and 120mm depth in the concrete; with the thinnest paste loss (8mm) generally below approx. 140mm depth in the core. Concentrated sub-vertical microcracks (incipient spalling) were observed generally within the paste and dolostone aggregates within 10mm of the distressed joint surface between the sawcut and bottom surface of the core. "Fresh" sub-horizontal fractures, most likely produced during coring, occur at approx. 75mm and 98mm depth from the top surface on one side of the joint and at approx. 117mm depth on the other side of the joint. Other sub-horizontally oriented microcracks were present at 43mm, 61mm, 97mm, 107mm, 137mm, 162mm, and 192mm in the core. This cracking and several other randomly oriented microcracks located below approx. 120mm depth, proceeds through most dolostone coarse aggregates it encounters.

SAMPLE ID: 5507-47, M004 **DESCRIPTION:** Overall view of the jointed core utilized for petrographic analysis. The top surface is left. Note "tunneling" distress.

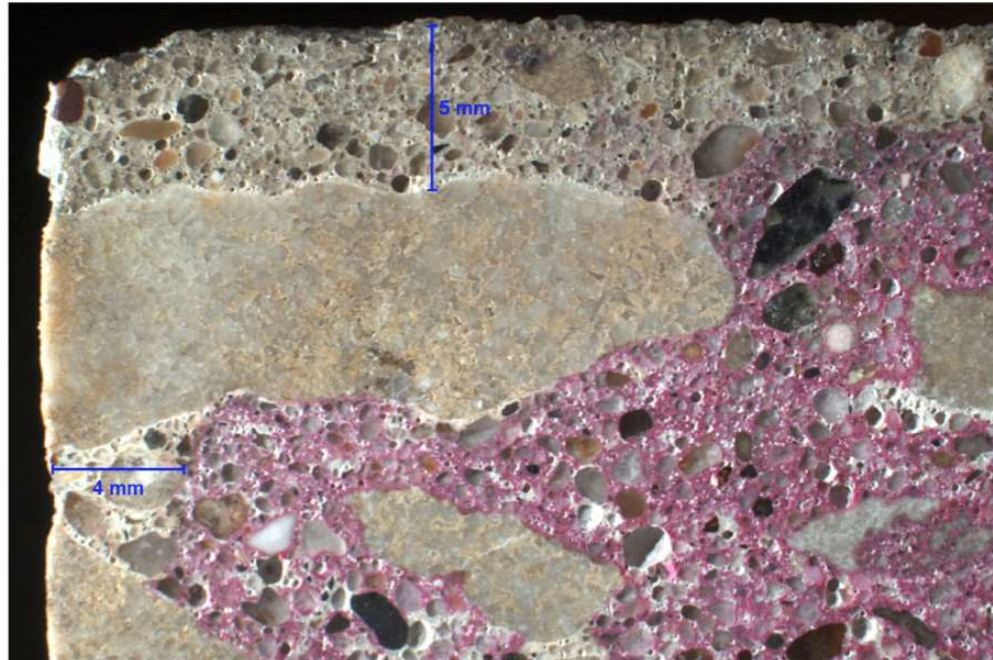
PHOTO:
134

SAMPLE ID: 5507-47, M004 **DESCRIPTION:** Carbonation (unstained paste) proceeded up to 5mm depth from the top surface (in this image).
MAG: 5x

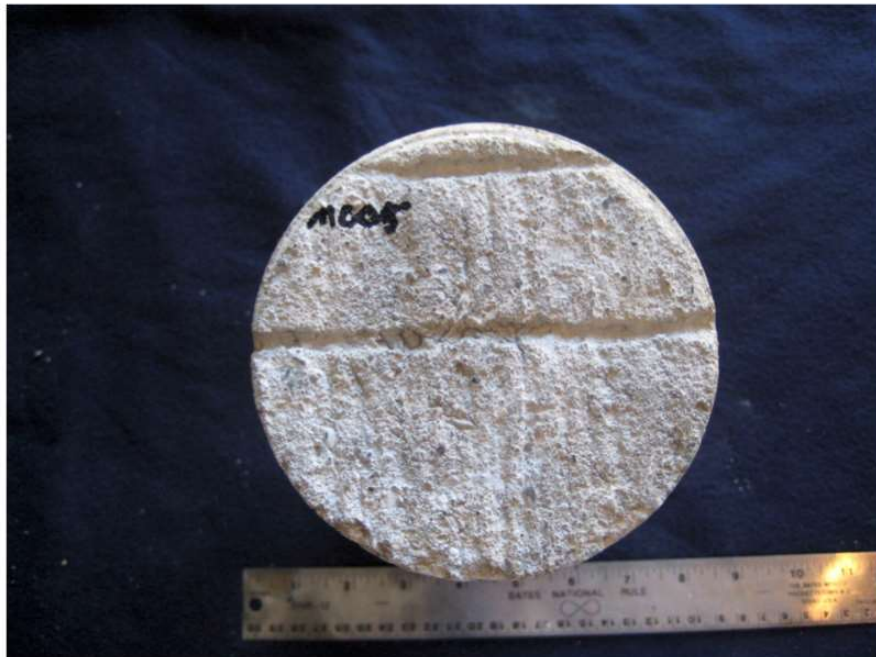
PHOTO:
52

DESCRIPTION: Rough screeded and tined top surface of the core with minor mortar erosion.

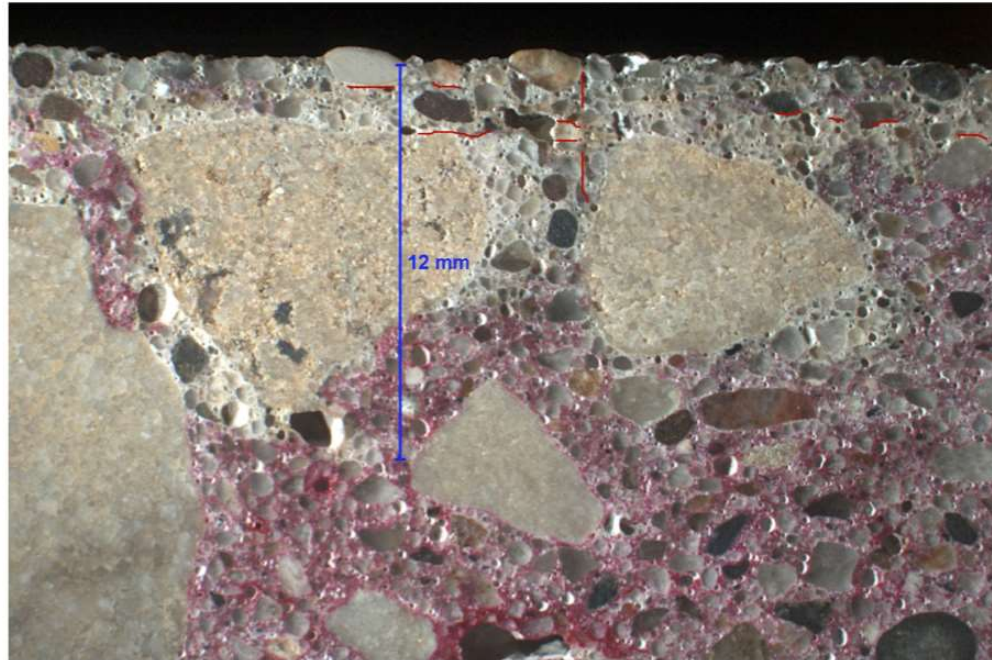
PHOTO:
136

SAMPLE ID: 5507-47, M005 **DESCRIPTION:** Carbonation (unstained paste) proceeded up to 12mm depth from the top surface; along porous dolostone aggregate particles.
MAG: 5x

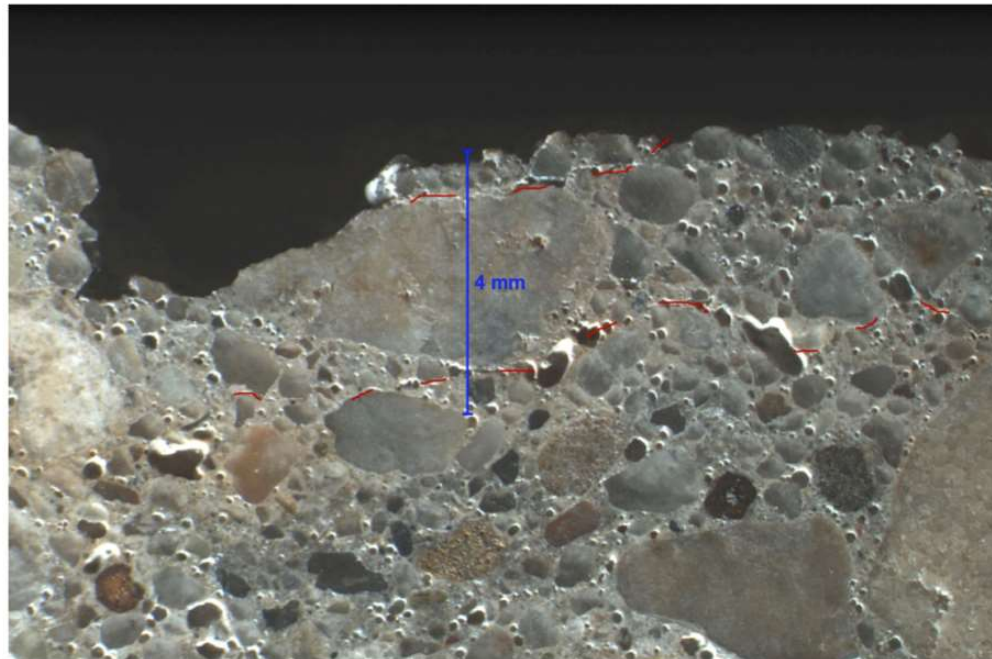
PHOTO:
137

SAMPLE ID: 5507-47, M005 **DESCRIPTION:** Sub-horizontal microcracking within 4mm of the top surface is mapped in red dashed line.
MAG: 10x

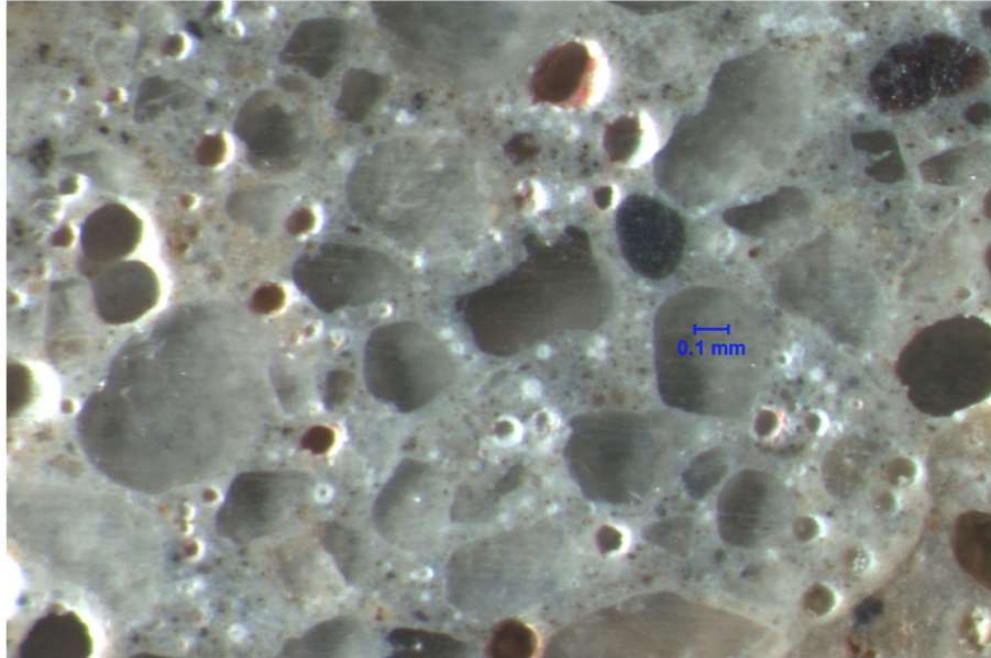
PHOTO:
138

SAMPLE ID: 5507-47, M005 **DESCRIPTION:** White ettringite fills many of the finest entrained air voidspaces at 125mm depth in the core in this image.
MAG: 50x

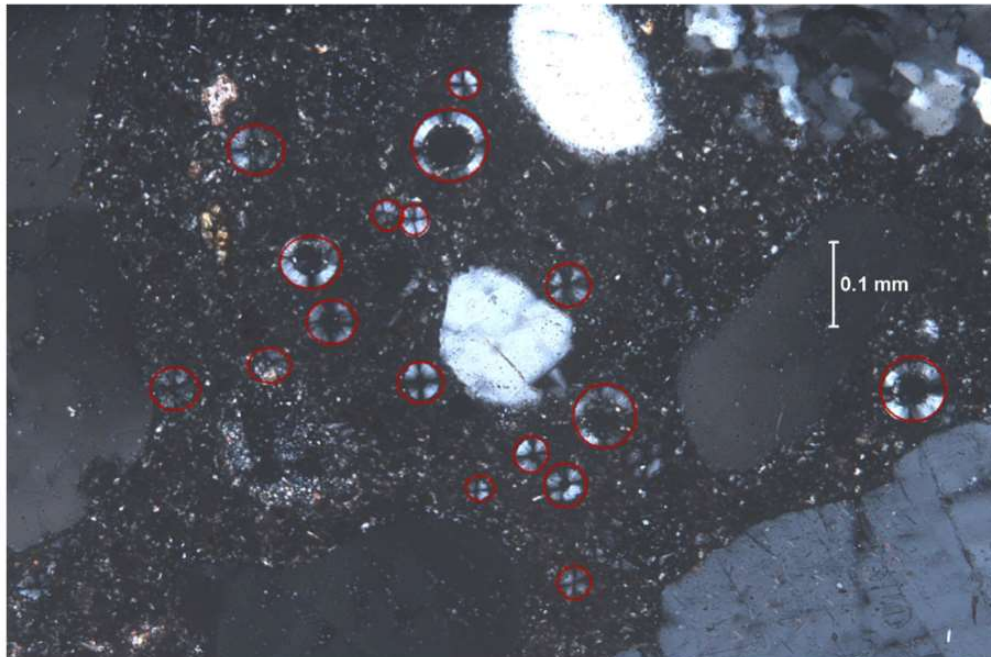
PHOTO:
139

SAMPLE ID: 5507-47, M005 **DESCRIPTION:** Ettringite lined or filled entrained air voidspaces are outline in red; in thin section of concrete at 150mm depth in the core.
MAG: 100x

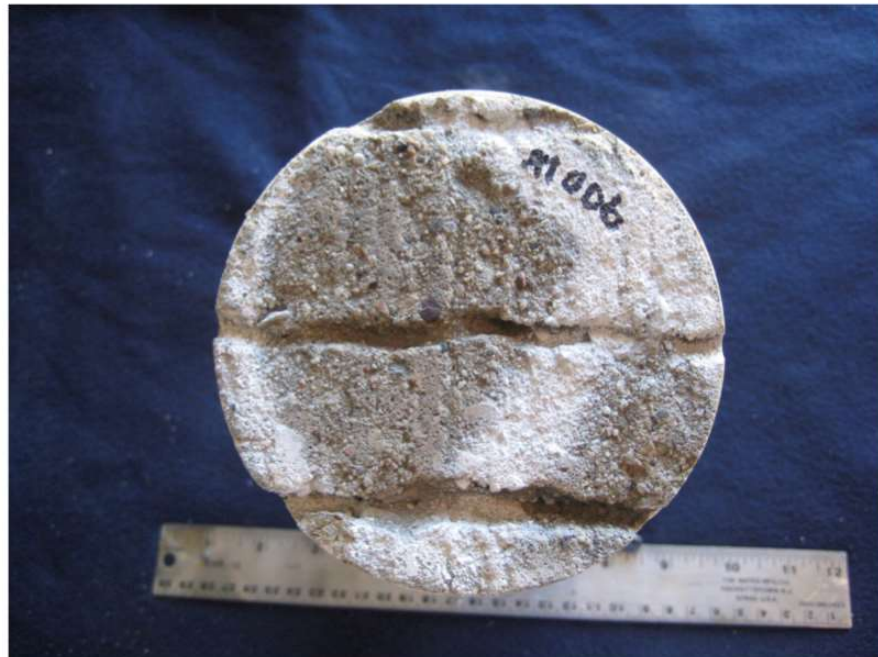
PHOTO:
54

SAMPLE ID: 5507-47, M006 DESCRIPTION: Rough screeded and tined top surface of the core with minor mortar erosion.

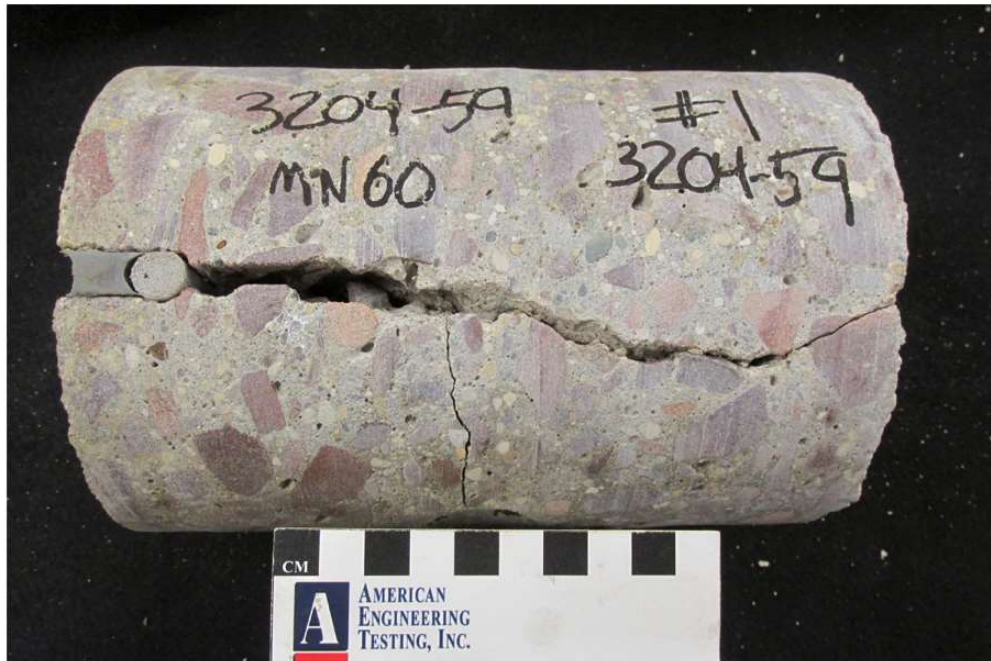
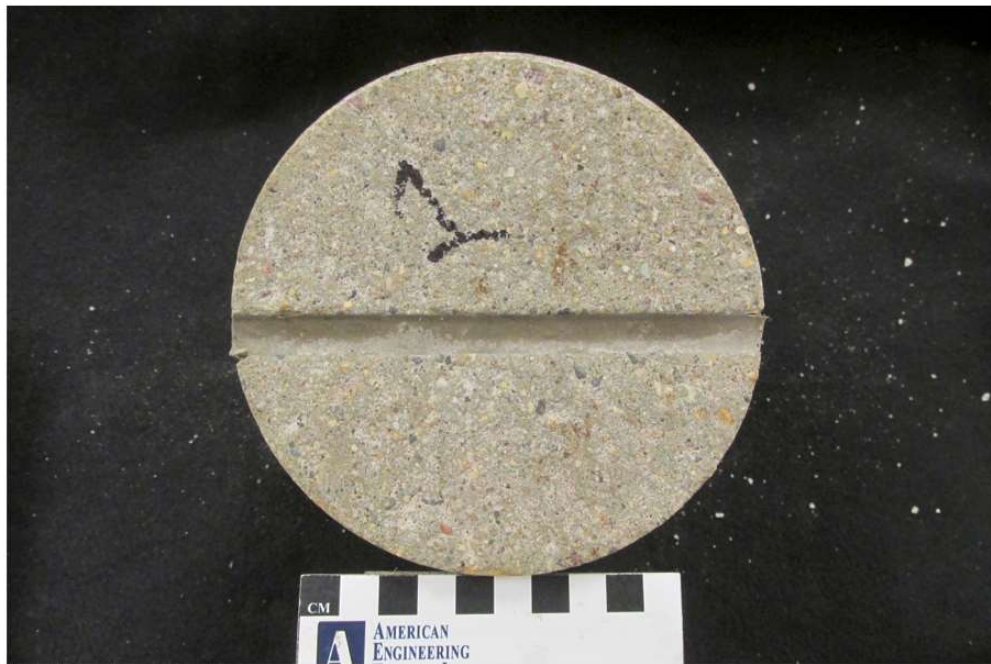
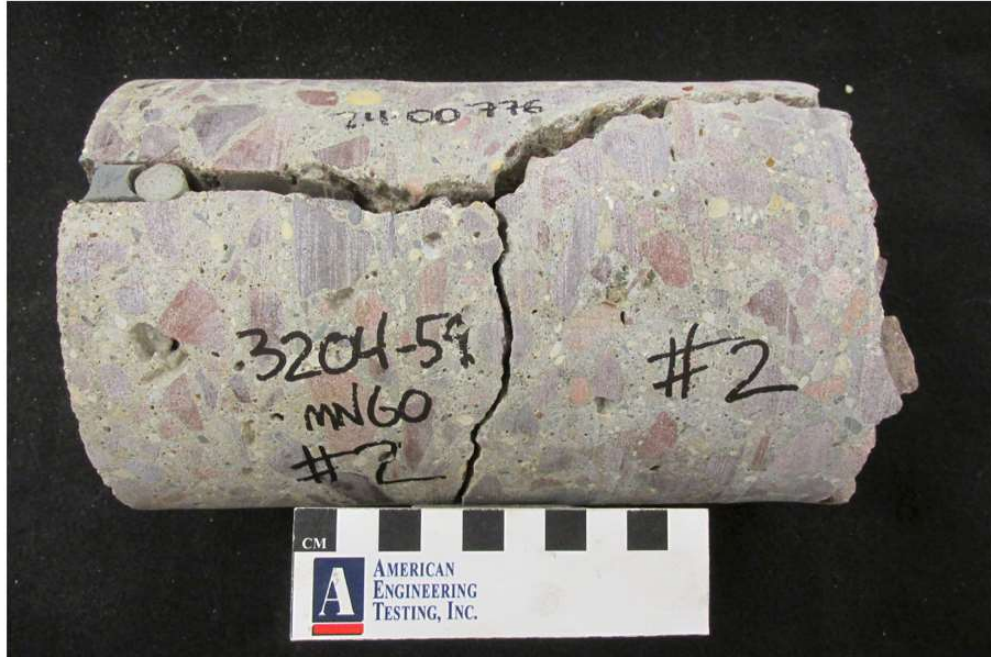
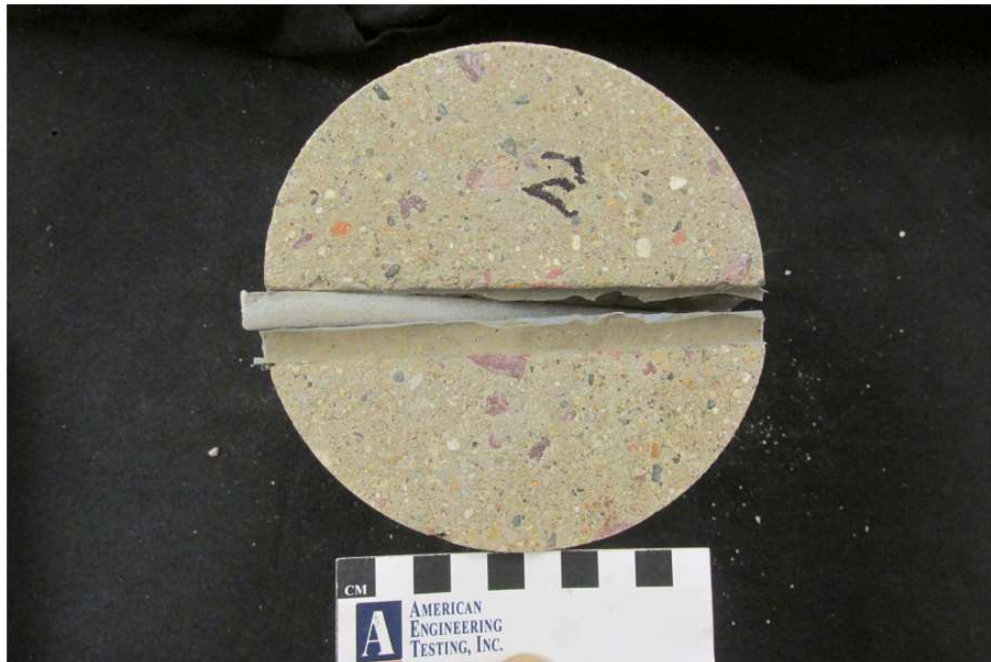
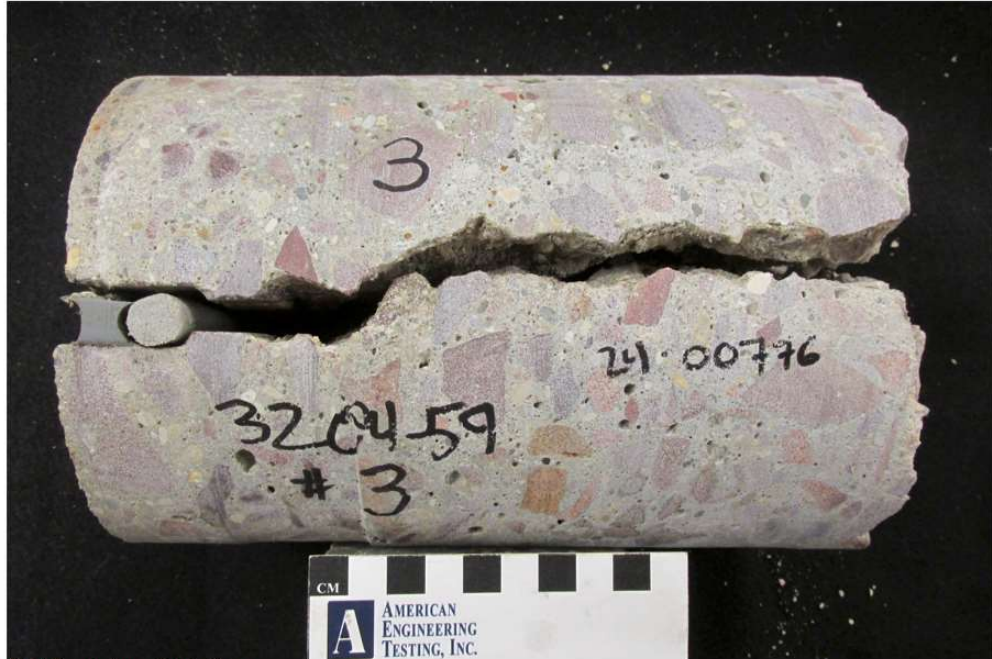
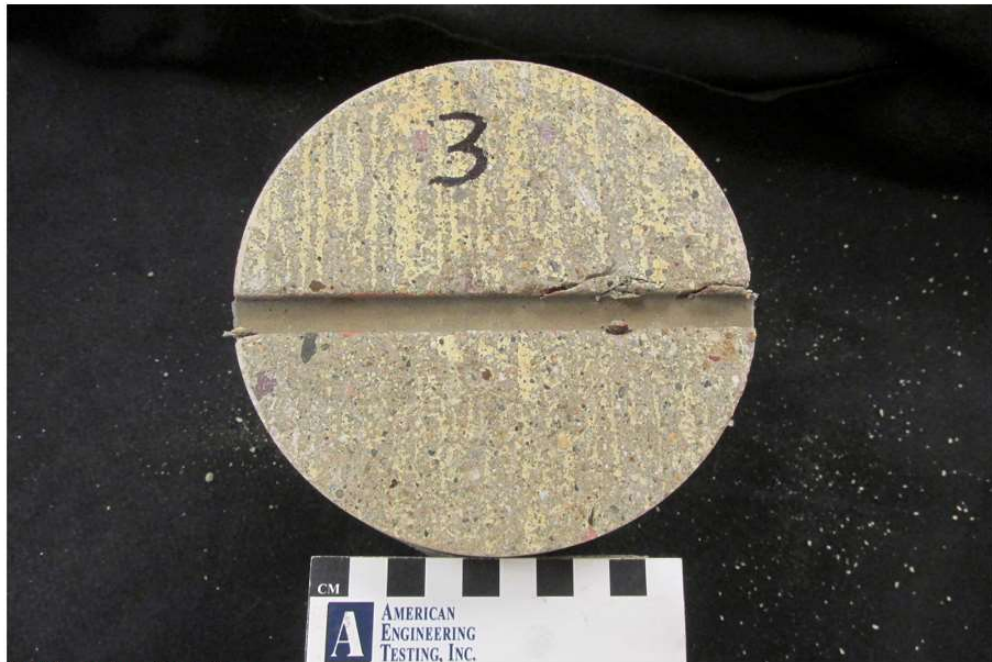
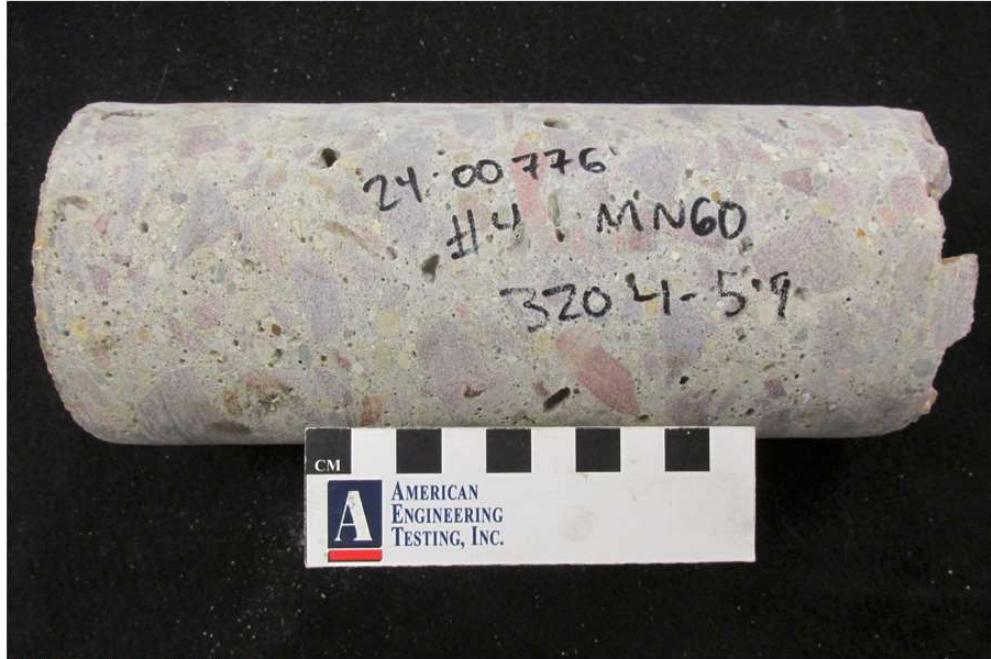
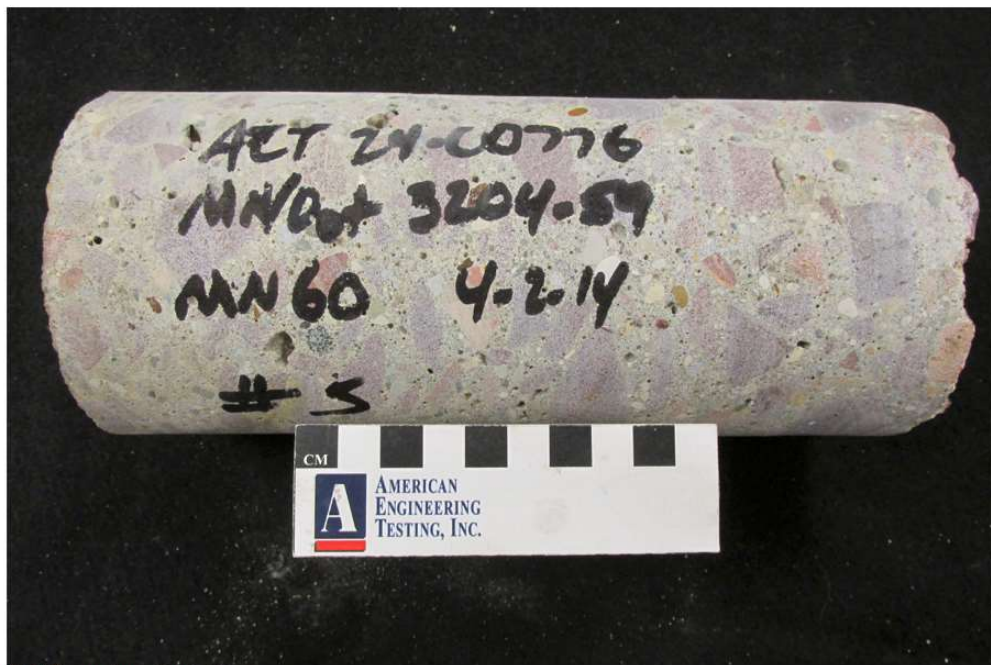
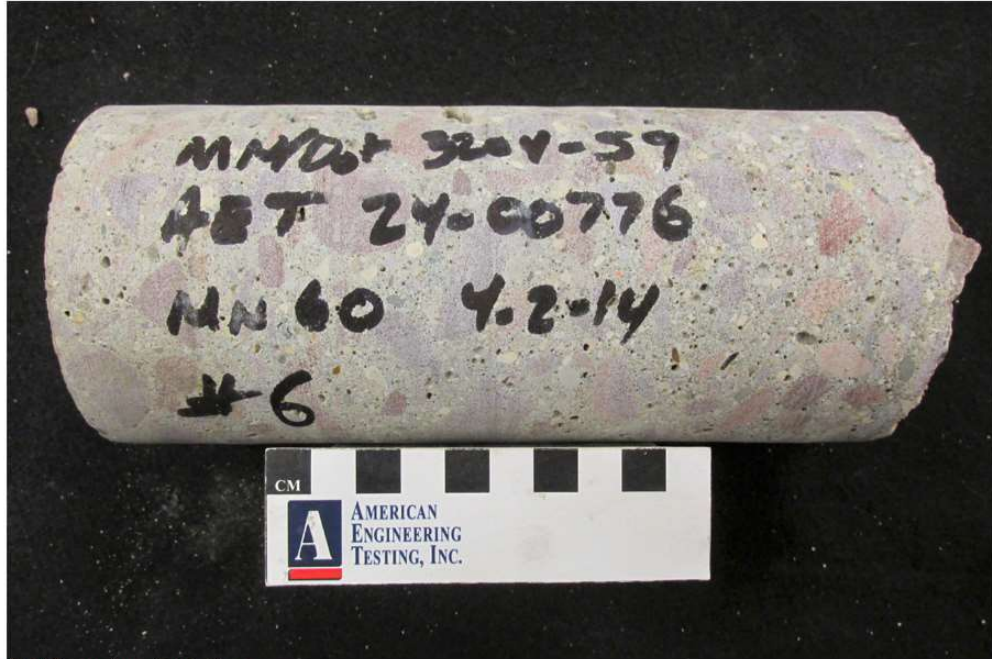
DESCRIPTION – Project 3204-59, core

1. **Sample Dimensions:** The core was taken directly through a sealed, sawcut and cracked pavement joint with paste loss at depth in the joint. Our analysis was performed on both lapped sides of a cross section (two pieces) of core sawcut "normal" to a sawcut and cracked joint measuring 229 mm (9") x 142 mm (5-9/16") x 32 mm (1-1/4") thick and one 76 mm (3") x 52 mm (2") wide thin section that was sawcut and prepared from the original 145 mm (5-11/16") diameter x 230 mm (9-1/16") long core. The thin section was located between 40 mm and 120 mm depth from the top surface; in cross section and along the sawcut and cracked and distressed portions of the joint.

2. **Surface Conditions:**
Top: Rough, mortar eroded surface; with several exposed coarse aggregate surfaces. Approximately 20% of the top surface was coated with a desiccated, pale yellowish orange (Munsell® 10YR 8/6) paint.
Bottom: Rough, irregular; spalled surface.

4. **General Physical Conditions:** The core was taken through a sealed pavement joint. The light gray silicone joint sealant was mostly de-bonded from both sides of the sawcut joint. Below the silicone joint sealant was a 12 mm (1/2") foam backer rod. The joint was characterized by an approx. 4 mm wide sawcut proceeding 58 mm (2-1/4") depth from the top surface and an approx. 11 mm wide reservoir cut to 30 mm (1-3/16") depth. Vertical scaling/spalling distress in the paste-only starts at as shallow as 30 mm depth in the sawcut joint surface and incorporates between a few mm and 15 mm of total concrete paste between the two sides of the joint crack. The joint plane is characterized by numerous relatively "clean" and un-distressed quartzite coarse aggregate protruding from the concrete. The widest loss of concrete (to 15 mm) occurs below 20 mm depth in the concrete from the top surface. The core does exhibit some residual interlock between the two halves. Sub-vertical microcracks (incipient spalling) were relatively rare in the intact paste. The coarse quartzite aggregate appeared sound. No evidence of ASR associated with the coarse aggregate was observed. No reaction rims were obvious. Internal, randomly oriented, empty micro-fractures appear to have been produced by the crushing procedure. Numerous alkali-silica reacted shale fine aggregate were present in the core.

The rough screeded top surface of the core exhibits moderate mortar erosion/traffic wear; exposing several coarse aggregate surfaces. The concrete was fairly well consolidated, with only a few entrapped voidspaces observed in excess of 12 mm in diameter in the mid-section of the core. The concrete was purposefully air entrained and originally contained a well-distributed air void system considered freeze-thaw resistant under severe exposure conditions. Original air void parameters include a 4.7% entrained-sized void volume and a 0.004" spacing factor. Secondary ettringite, with some portlandite, fills many of the smaller entrained sized voidspaces within approx. 21 mm of the distressed joint surface and approximately 15 mm from the bottom surface of the core. Void fillings decrease with depth from the joint plane. Actual measured air void parameters, which excludes the ettringite void fillings, in a band between approx. 0mm and at least 12mm (0-0.5") depth from the distressed joint surface (below 105mm depth in the core), are 2.8% entrained volume and a 0.011" spacing factor.

7. Microcracking: Sub-vertical microcracks (incipient spalling) were relatively rare in the intact paste.
8. Secondary deposits: White, generally acicular grown ettringite along with some clear platelets of portlandite fills many of the smaller entrained sized void spaces within approx. 21 mm of the distressed joint surface and approximately 15 mm from the bottom surface of the core. Void fillings become less abundant with distance from the joint.

9. w/cm: Estimated at between 0.43 and 0.48 with approximately 3 to 5% residual portland cement clinker particles and an amount of flyash visually consistent with a 20 to 30% replacement of portland cement.

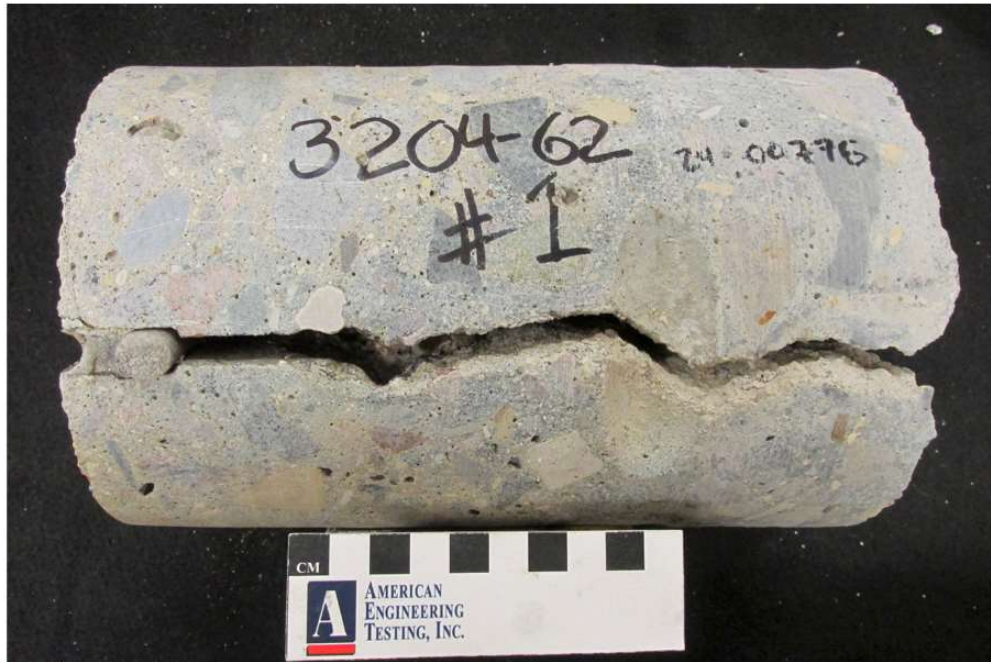
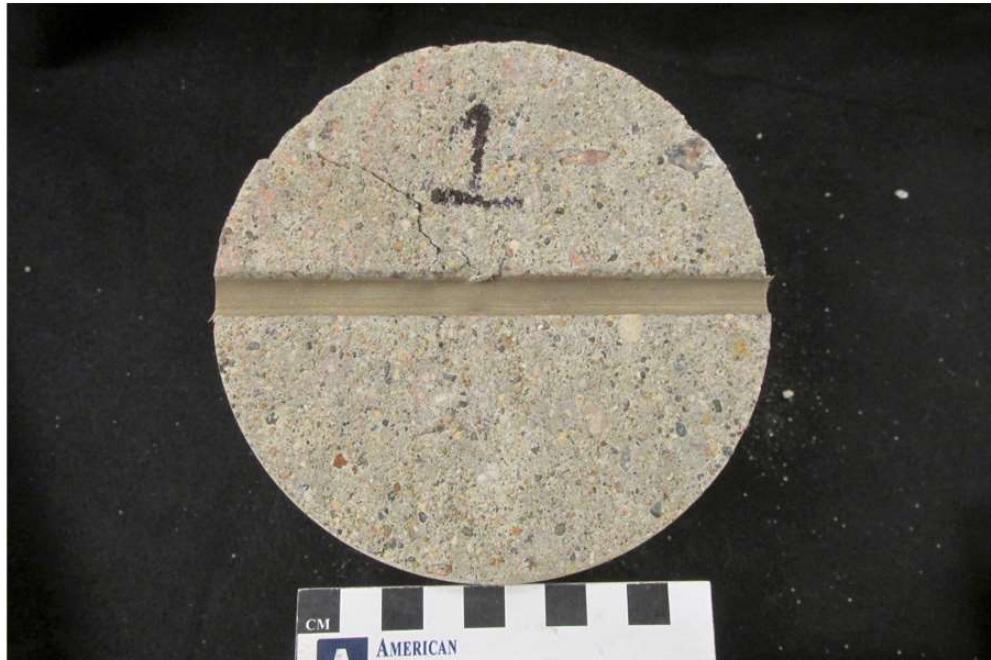
DESCRIPTION – Project 3204-62, core 1

2. **Surface Conditions:**
Top: Fairly smooth, traffic worn and slightly "gouged" surface; exposing several, traffic worn, fine aggregate surfaces.
Bottom: Rough, irregular, formed surface; placed on grade.

3. **Reinforcement:** None observed.
4. **General Physical Conditions:** The core was taken directly through a distressed pavement joint. A silicone joint sealant was observed well bonded to one side of the sawcut joint, only, between 1mm and 16mm depth from the top surface. The sealant was originally poorly bonded to the other side of the joint; with a little residual tooled meniscus remaining adhered to the sawcut surface. The joint was characterized by an approx. 4mm wide pilot sawcut, partially vertically scaled/spalled away, measurable to 68mm depth from the top surface, and an approx. 10mm wide reservoir cut to 27mm depth. The sawcut surface of the pilot cut was coated with a layer of pale brown debris. The resulting joint crack proceeded the depth of the core and passes around most coarse aggregate particles it encounters. Vertical scaling/spalling along the joint begins as shallow as approx. 55mm depth; with a significant loss of paste along a portion of the pilot cut between 55mm and 75mm. Up to approximately 15mm of paste loss occurs along the joint between 60mm and 110mm depth from the top surface. Thin paste loss with good residual interlock between the core halves occurs between 140mm and 230mm from the top surface. Areas of soft, friable paste were observed at between approximately 160mm and 195mm depth from the top surface; up to 1mm depth from the joint crack. In general, the widest loss of paste occurred between 60mm and 110mm depth from the top surface. This zone is characterized by several relatively "clean" and un-distressed coarse aggregates protruding from relatively clean concrete joint faces. Several sub-vertical microcracks (incipient spalling) were observed generally within the paste-only and within 3mm of the distressed joint surface between 77mm and 210mm depth from the top surface of the core. A few sub-vertical drying shrinkage microcracks proceeded up to 3mm depth from the top surface. A small, sub-vertically fractured section of concrete measuring approx. 19mm by 12mm was observed on the top surface of the core, adjacent to the joint and adhered to the silicone joint sealant. The fracture intersected the silicone joint sealant at approx. 6mm depth from the top surface. The coarse aggregate appeared sound. No evidence of ASR associated with the coarse aggregate was observed. A few alkali-silica "reacted" (ASR) shale fine aggregate particles were present in the core. The "reacted" shale particles exhibit internal cracking that propagates into the paste. ASR gel was observed partially filling an air void space.

The fairly smooth top surface of the core exhibits significant traffic wear; topographic highs have been worn smooth with exposed fine aggregate particles exhibiting worn surfaces. The concrete was well consolidated, with a few consolidation voidspaces observed up to 10mm in diameter in the core. The concrete was purposefully air entrained and contains a well-distributed air void system considered freeze-thaw resistant under severe exposure conditions. Original air void parameters include a 4.6% entrained-sized void volume and a 0.005" spacing factor. Secondary ettringite fills numerous entrained sized voidspaces within 3mm of the distressed joint faces; below 65mm depth in the core. Void fillings decrease with distance from the joint faces.

1. Air Content: 5.5% total original air void.
2. Depth of carbonation: Ranged from negligible up to 3mm depth from the top surface of the core; "spiking" up to 8mm depth along a paste/aggregate boundary and a cluster of air void spaces. Carbonation depth proceeding from the joint crack ranged from negligible up to 3mm.

6. Paste hardness: Hard (Moh's 3.5-4) with a few soft areas of paste (Moh's <2) within 1mm of the joint crack between 160mm and 190mm depth from the top surface of the core.

7. Microcracking: Several sub-vertical microcracks (incipient spalling) were observed generally within the paste-only and within 3mm of the distressed joint surface between 77mm and 210mm depth from the top surface of the core. A few sub-vertical drying shrinkage microcracks proceeded up to 3mm depth from the top surface. A small, sub-vertically fractured section of concrete measuring approx. 19mm by 12mm was observed on the top surface of the core, adhered to the silicone joint sealant. The fracture intersected the silicone joint sealant at approx. 6mm depth from the top surface.

8. Secondary deposits: Secondary ettringite fills numerous entrained sized voidspaces within 3mm of the cracked joint; below 35mm depth from the top surface. Void fillings decrease with depth from the joint faces. Alkali silica reaction gel was observed partially filling an air void space.

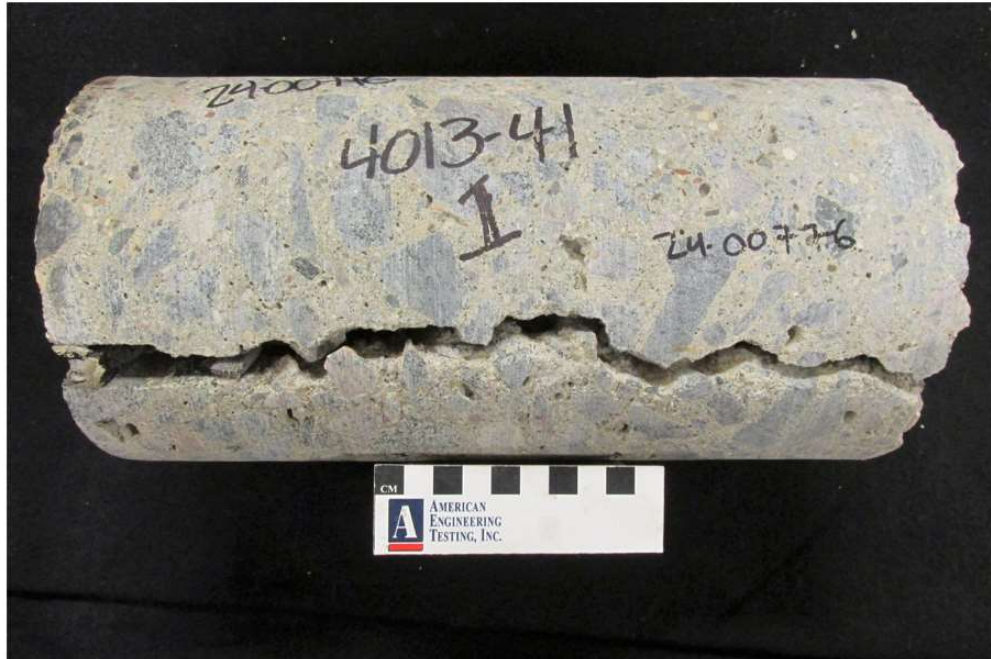
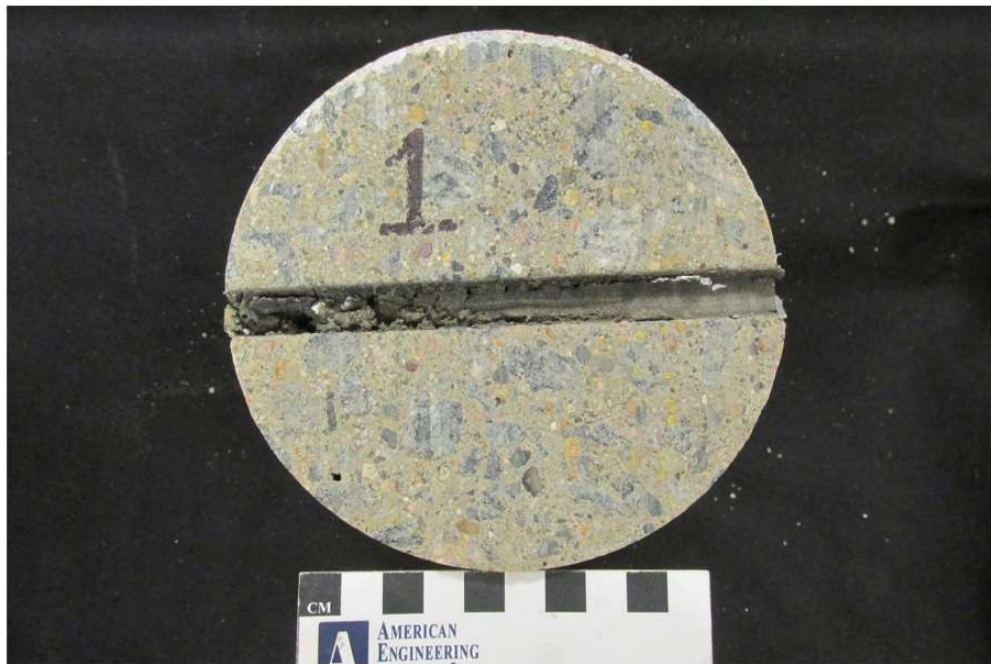
DESCRIPTION – Project 4013-41, core 1

2. **Surface Conditions:**
Top: Fairly rough, tined surface with traffic wear; exposing many traffic worn, fine and coarse aggregate surfaces.
Bottom: Rough, irregular; spalled surface.

3. **Reinforcement:** None observed.
4. **General Physical Conditions:** The core was taken directly through a distressed pavement joint. A neoprene pavement seal was observed in the joint. The joint was characterized by an approx. 5 mm wide sawcut proceeding 60 mm (2-3/8") depth from the top surface and an approx. 10 mm wide reservoir cut to 34 mm (1-5/16") depth. Vertical scaling/spalling distress in the paste-only starts at as shallow as 34 mm depth in the sawcut joint surface and incorporates between a few mm and 15 mm of total concrete paste between the two sides of the joint crack. The joint plane is characterized by numerous relatively "clean" and un-distressed granite coarse aggregate protruding from the concrete. The widest loss of concrete (to 15 mm) occurs below 130 mm depth in the concrete from the top surface. The core does exhibit some residual interlock between the two halves. Sub-vertical microcracks (incipient spalling) were relatively rare in the intact paste. The coarse granite aggregate appeared sound. No evidence of ASR associated with the coarse aggregate was observed. No reaction rims were obvious. Internal, randomly oriented, empty micro-fractures appear to have been produced by the crushing procedure. Numerous alkali-silica reacted shale fine aggregate were present in the core.

The fairly rough top surface of the core exhibits significant traffic wear; topographic highs have been worn down with exposed fine aggregate particles exhibiting worn surfaces. The concrete was well consolidated, with several consolidation voidspaces observed up to 20 mm in diameter in the core. The concrete was purposefully air entrained and contains a well-distributed air void system considered freeze-thaw resistant under severe exposure conditions. Original air void parameters include a 7.0% entrained-sized void volume and a 0.002" spacing factor. Secondary ettringite fills numerous entrained sized voidspaces within 5mm of the distressed joint faces; below 5 mm depth in the core. Void fillings decrease with depth from the joint faces.

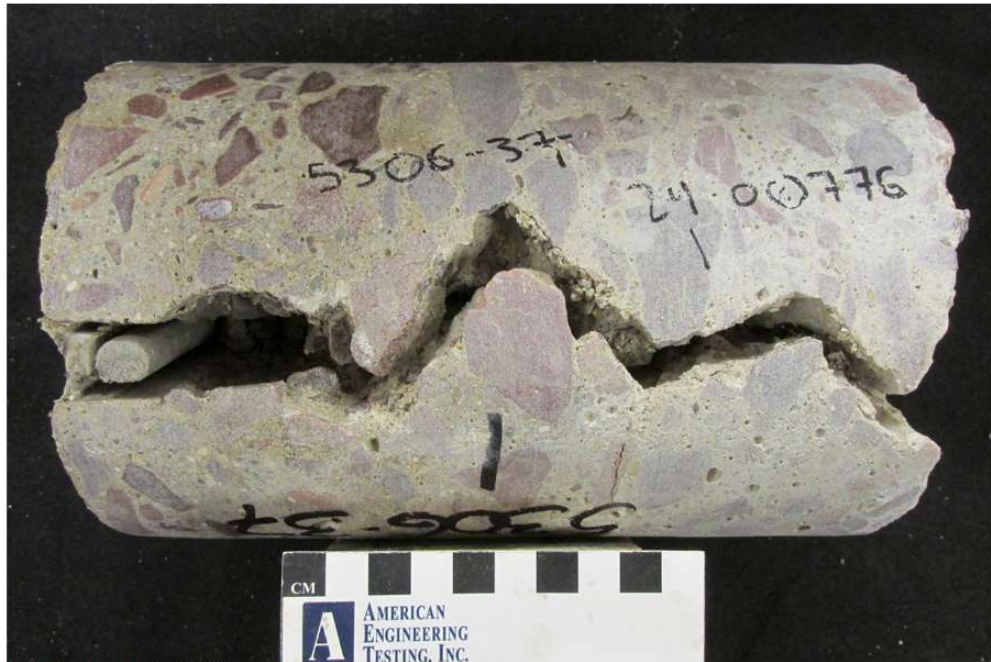
DESCRIPTION – Project 5306-37, core 1

9. w/cm: Estimated at between 0.43 and 0.48 with approximately 3 to 5% residual portland cement clinker particles and an amount of flyash visually consistent with a 20 to 30% replacement of portland cement.

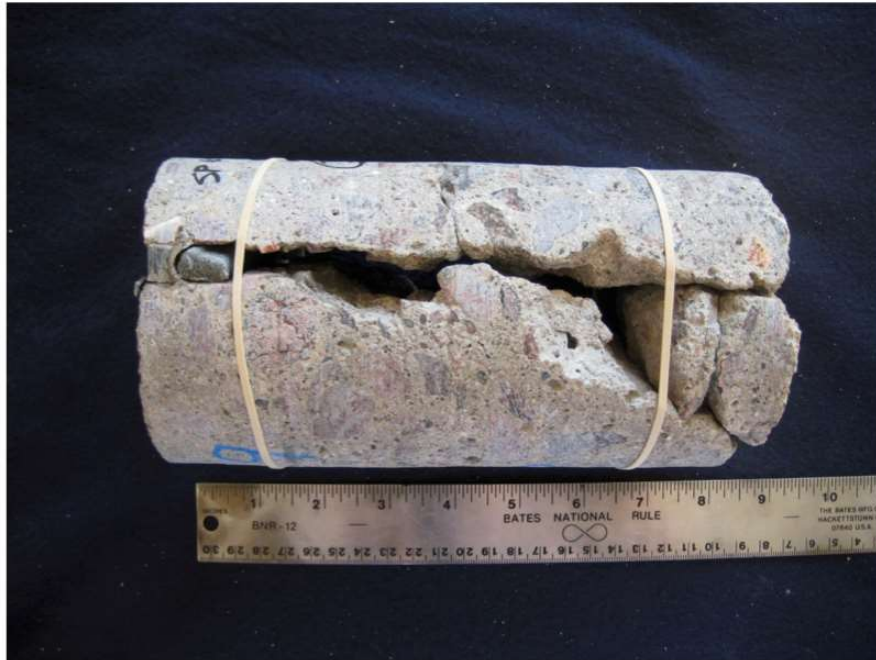
PHOTO:
67

SAMPLE ID: 6507-04, 22 **DESCRIPTION:** Overall view of the jointed core utilized for petrographic analysis. The top surface is left. Note "tunneling" distress at base of sawcut.

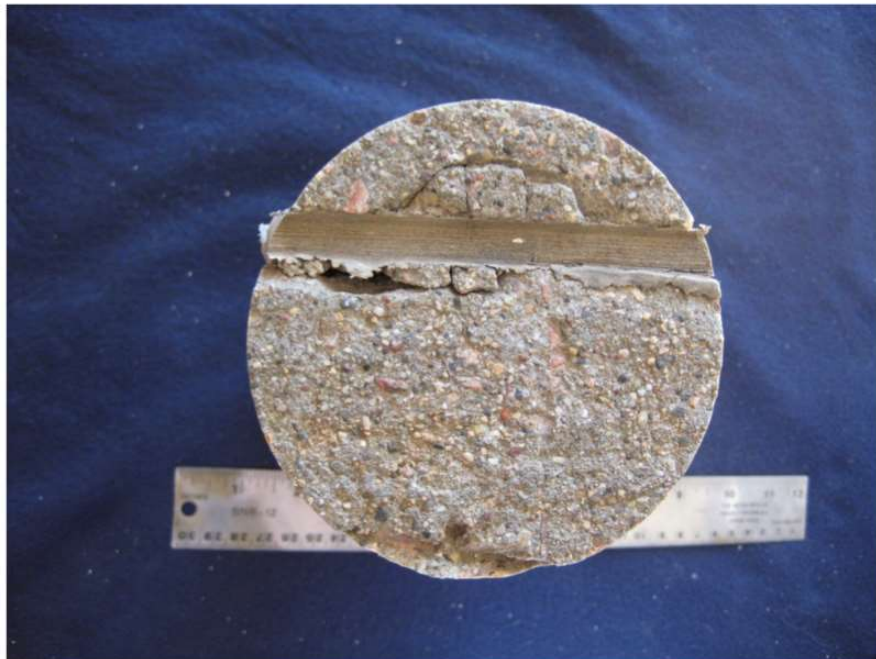
PHOTO:
68

SAMPLE ID: 6507-04, 22 **DESCRIPTION:** Top surface of the core exhibits silicone-sealed sawcut control joint.
