Impact of Water/ Cementitious-Based Concrete Mix Design Specification Changes on Concrete Pavement Quality

July 2018

Research Project
Final Report 2018-25

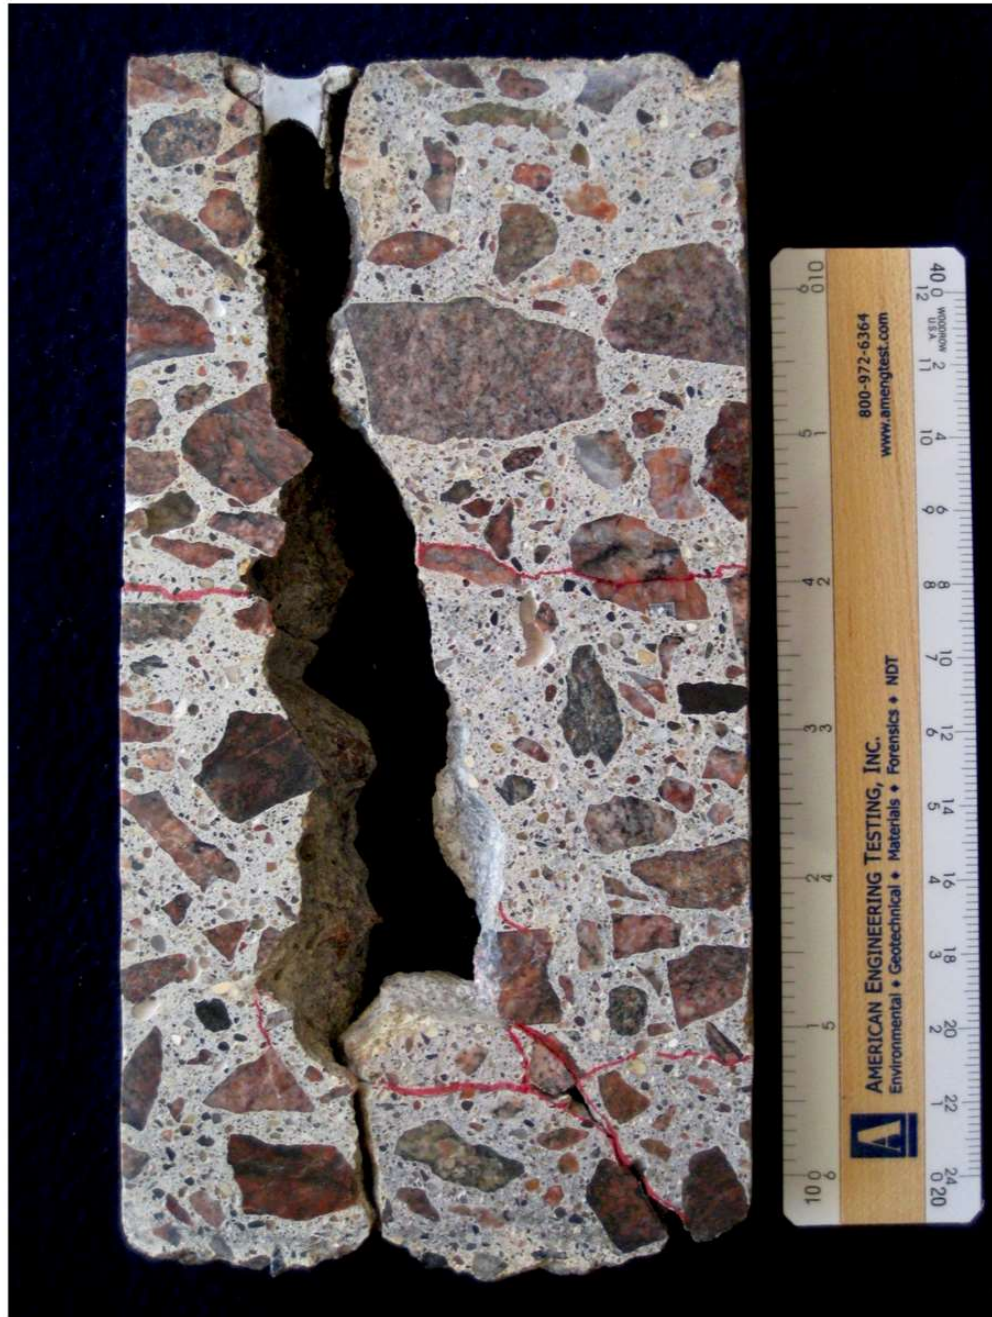
PHOTO:
94

3. **Reinforcement:** None observed.
4. **General Physical Conditions:** The core was taken directly through a severely distressed pavement joint. One side of the core exhibits evidence of the first pilot sawcut to 62mm depth. A second approx. 11mm wide "reservoir" cut is evident to 33mm depth. Vertical scaling/spalling and mortar erosion exposes coarse and fine aggregates along much of the sawcut. An apparently originally well bonded silicon joint sealant was present; placed upon a foam backer rod. The joint sealant was loosened along sliver spalling within the concrete joint edges intermittently along both sides of the joint. The resulting joint crack below the sawcuts appears to have splayed at a low angle into two crack planes. Apparent raveling of this thin section of concrete during coring has left an up to approx. 30mm (1 1/4") wide void in the core sample between approx. 65mm and 165mm depth from the top surface.

SAMPLE ID: 6507-04, 22 **DESCRIPTION:** Sawcut and lapped cross section of core. The silicone sealant was apparently well bonded to both sides of the now sliver-spalled joint. A sub-horizontal fracture and microcracks are mapped in red ink. Mass loss between the two sections appears to have been raveling of a splayed joint crack and not freeze-thaw.

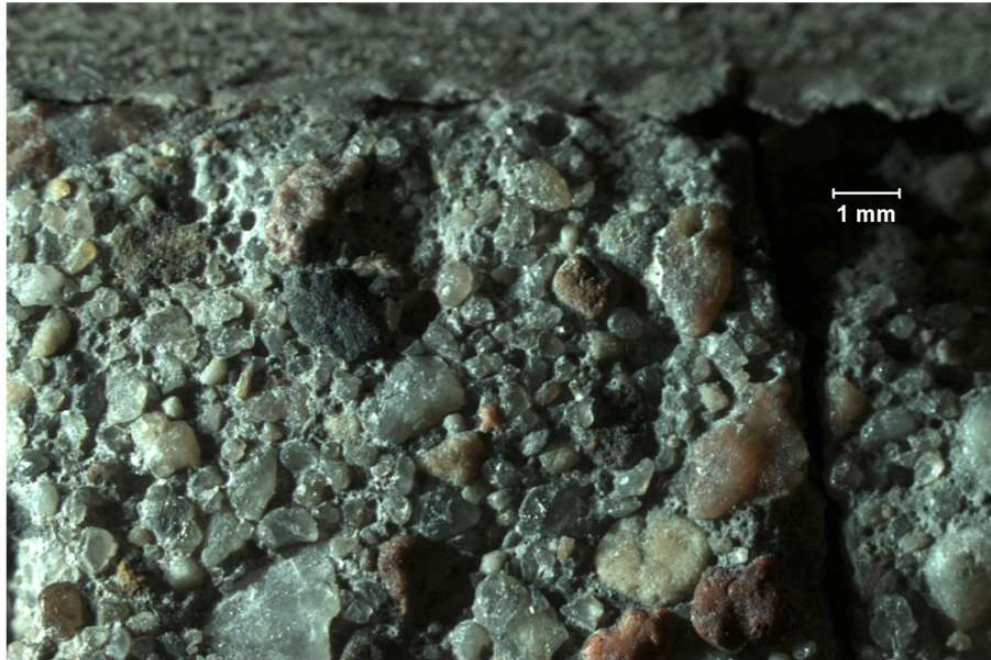
PHOTO:
148

6507-04, 22 **DESCRIPTION:** The top surface of the core exhibits significant traffic wear and/or mortar

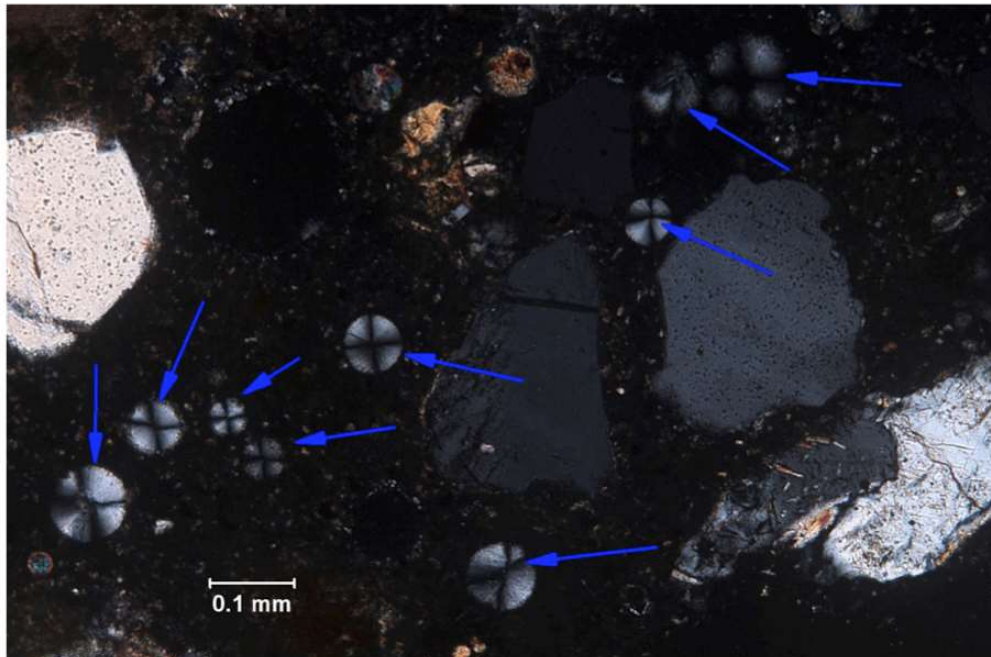
PHOTO:
149

6507-04, 22 **DESCRIPTION:** Fine entrained-sized air void spaces adjacent to the joint crack plane are filled with secondary ettringite (arrows); in thin section under cross polarized light.

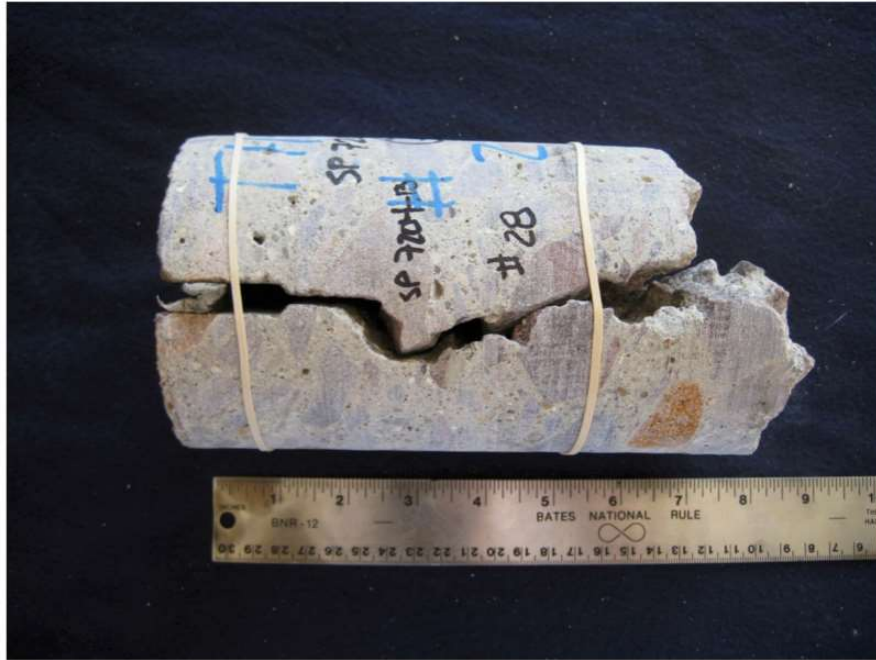
PHOTO:
71

SAMPLE ID: 7204-13, 28 **DESCRIPTION:** Overall view of the jointed core utilized for petrographic analysis. The top surface is left. Note loss of some concrete mass along the length of the joint.

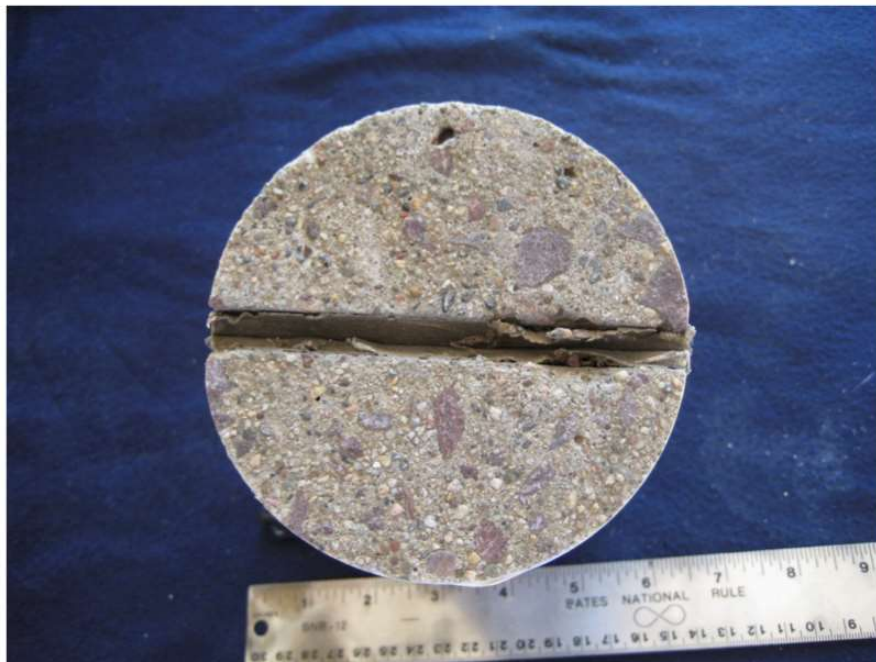
PHOTO:
72

SAMPLE ID: 7204-13, 28 **DESCRIPTION:** Mortar-eroded top surface of the core exhibits a sawcut and silicone sealed joint.

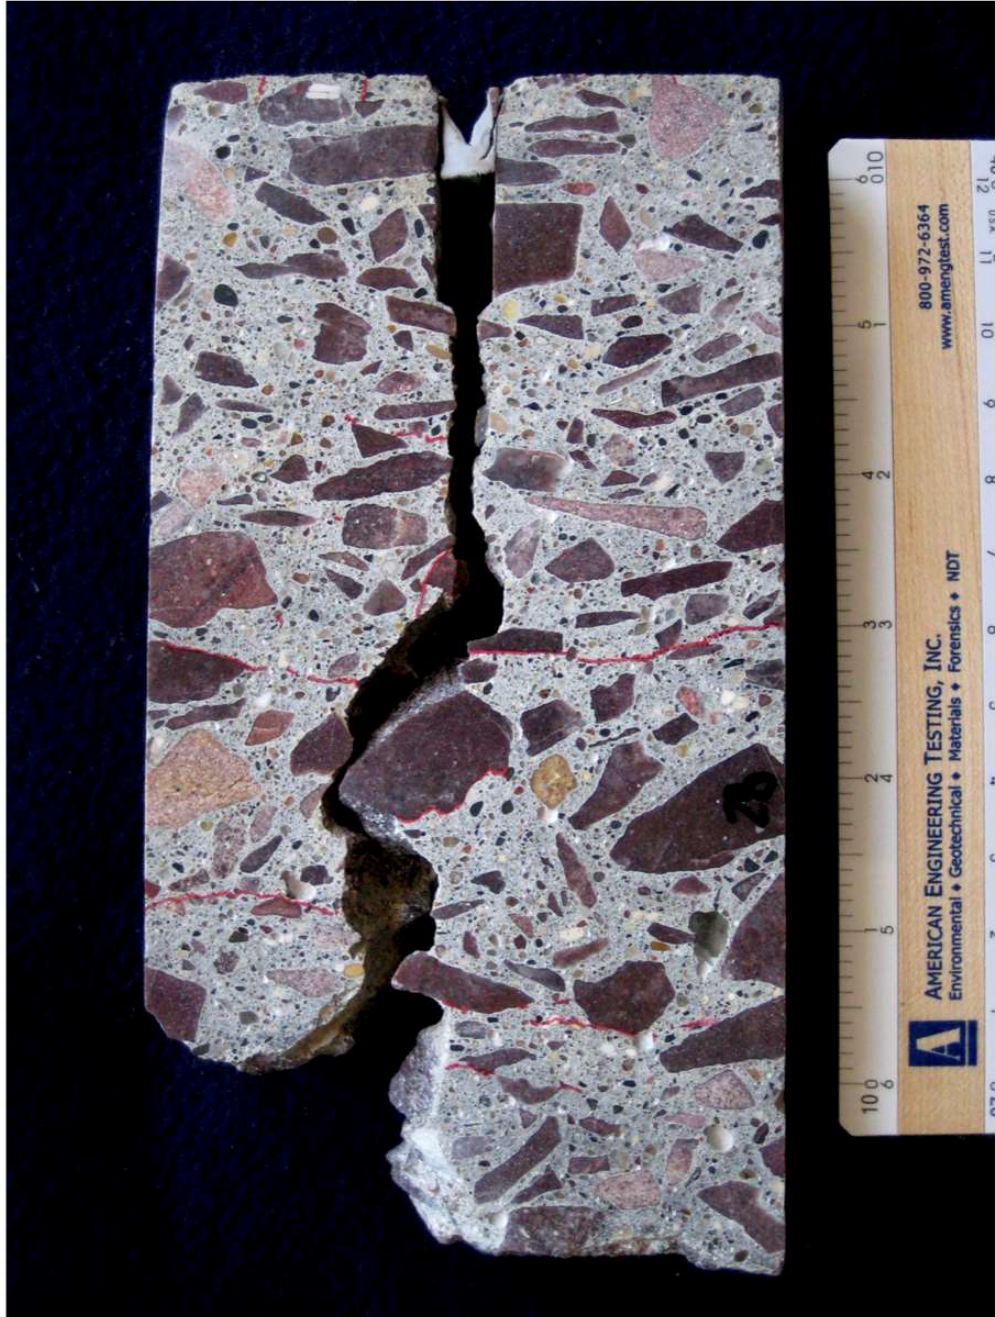
PHOTO:
95

4. **General Physical Conditions:** The core was taken through a sealed pavement joint. The light gray silicone joint sealant was mostly de-bonded from both sides of the sawcut joint. The joint was characterized by an approx. 4mm wide sawcut proceeding 63mm (2 1/2") depth from the top surface and an approx. 8mm wide reservoir cut to 36mm (1 3/8") depth. Vertical scaling/spalling distress in the paste-only starts at as shallow as 37mm depth in the sawcut joint surface and incorporates between a few mm and 19mm of total concrete paste between the two sides of the joint crack. The joint plane is characterized by numerous relatively "clean" and un-distressed quartzite coarse aggregate protruding from the concrete. The widest loss of concrete (to 19mm) occurs below 75mm depth in the concrete from the top surface. It is also apparent that there was loss of concrete paste and aggregates at the bottom surface. The core does exhibit some residual interlock between the two halves. Sub-vertical microcracks (incipient spalling) were relatively rare in the intact paste. Several relatively fine sub-horizontal microcracks occur at approx. 58mm, 91mm, 97mm, 130mm, and 150mm depth from the top surface on either side of the joint; proceeding through the paste only. The coarse quartzite aggregate appeared sound. No evidence of ASR associated with the coarse aggregate was observed. No reaction rims were obvious. Internal, randomly oriented, empty micro-fractures appear to have been produced by the crushing procedure. Numerous alkali-silica reacted shale fine aggregate were present in the core.

SAMPLE ID: 7204-13, 28 **DESCRIPTION:** Sawcut and lapped cross section of core. The silicone sealant was mostly de-bonded from both sides of the joint. Sub-horizontal microcracks are mapped in red ink. Mass loss of up to 19mm of concrete paste occurs along the length of the joint crack.

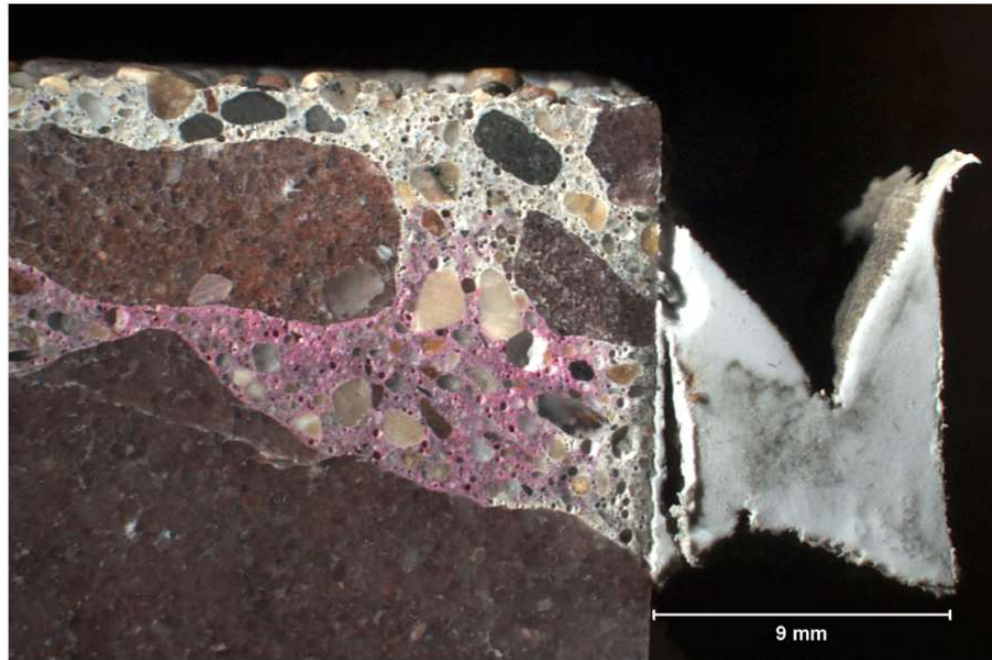
PHOTO:
150

SAMPLE ID: 7204-13, 28 **DESCRIPTION:** Silicone joint sealant was mostly de-bonded from both sides of the joint.
MAG: 5x

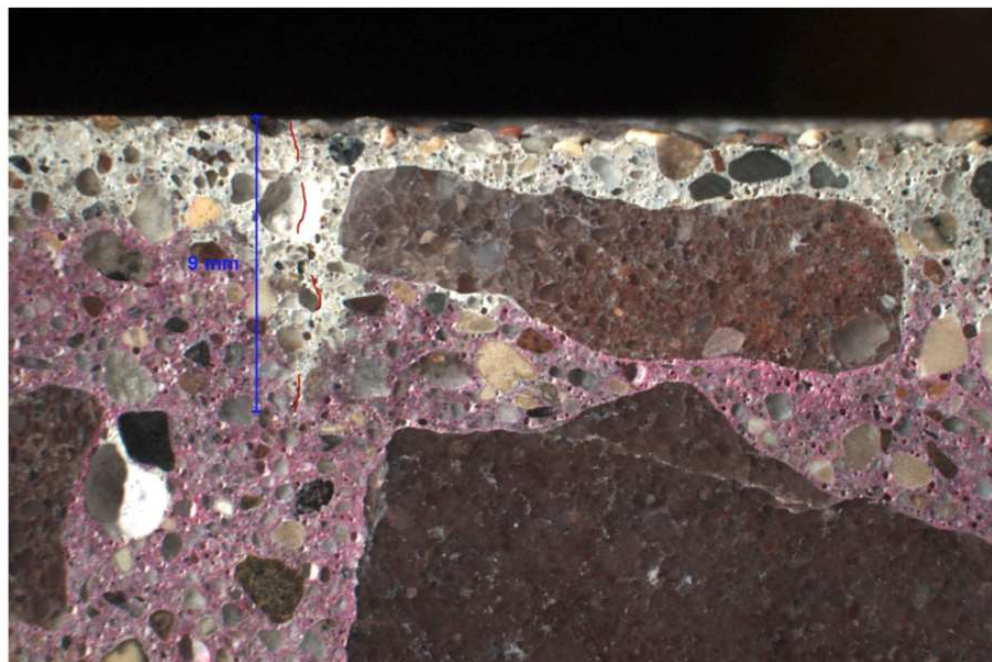
PHOTO:
151

SAMPLE ID: 7204-13, 28 **DESCRIPTION:** Carbonation (unstained paste) proceeded up to 9mm depth from the top surface; along sub-vertical shrinkage microcracking mapped in red dashed line.
MAG: 100x

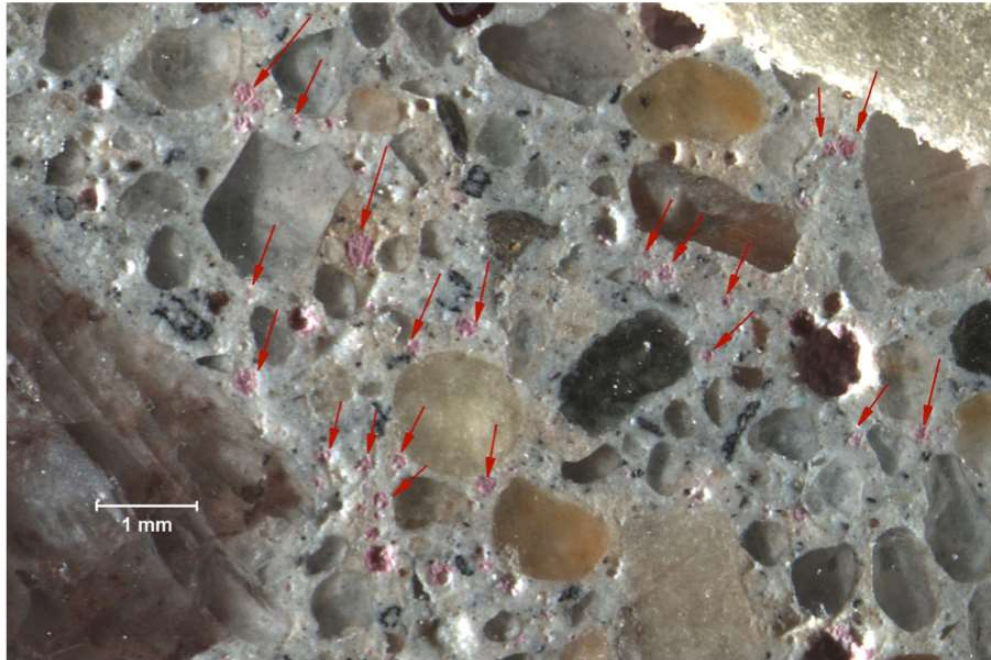
PHOTO:
152

SAMPLE ID: 7204-13, 28 **DESCRIPTION:** Abundant ettringite filled voidspaces (stained purple) at 10mm depth from the distressed joint crack and 105mm depth from the top surface.
MAG: 15x

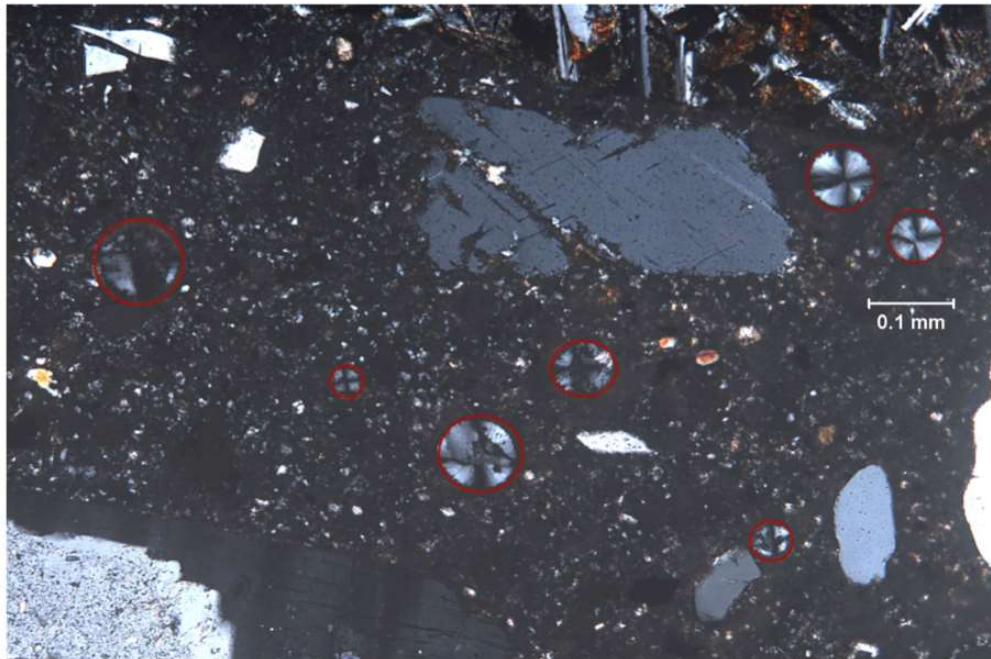
PHOTO:
153

SAMPLE ID: 7204-13, 28 **DESCRIPTION:** Fine entrained sized ettringite filled voidspaces within 3mm of the distressed joint plane; in thin section under cross polarized light.
MAG: 100x

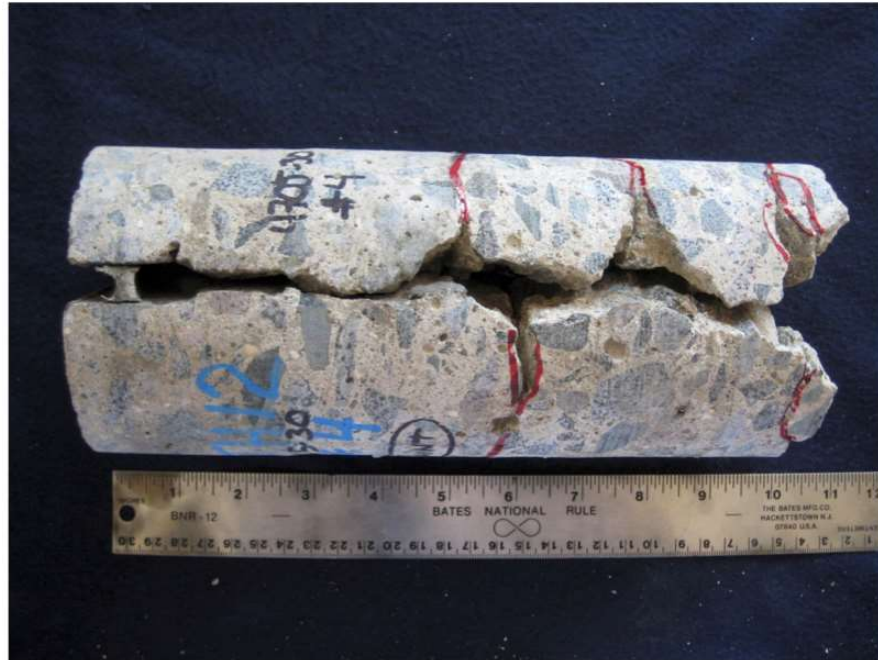
PHOTO:
43

SAMPLE ID: 4705-30, 4 **DESCRIPTION:** Overall view of the jointed core utilized for petrographic analysis. The top surface is left. Note mass lost along the joint.

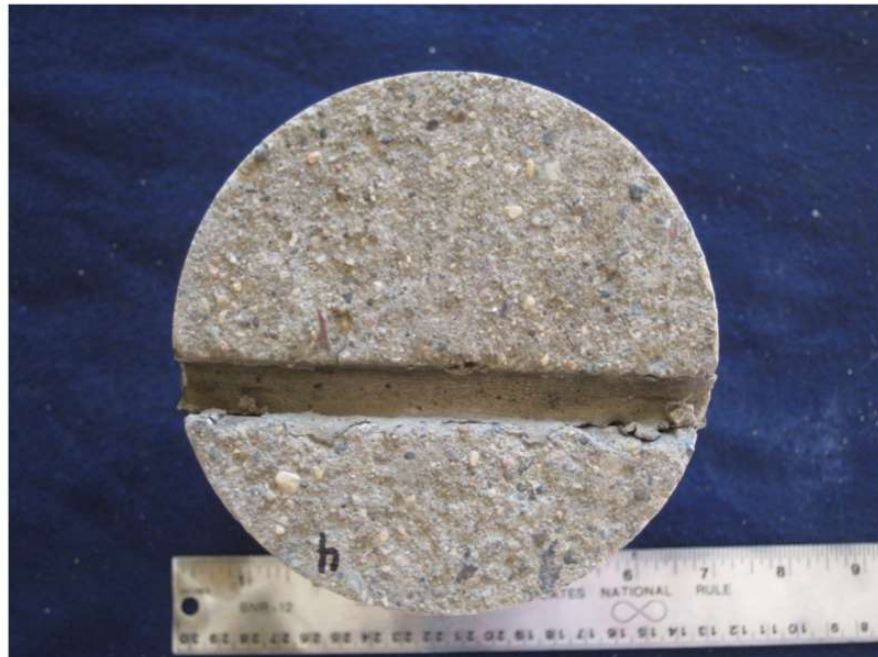
PHOTO:
44

SAMPLE ID: 4705-30, 4 **DESCRIPTION:** Rough screeded and jointed top surface of the core with minor mortar erosion. Note silicone sealant.

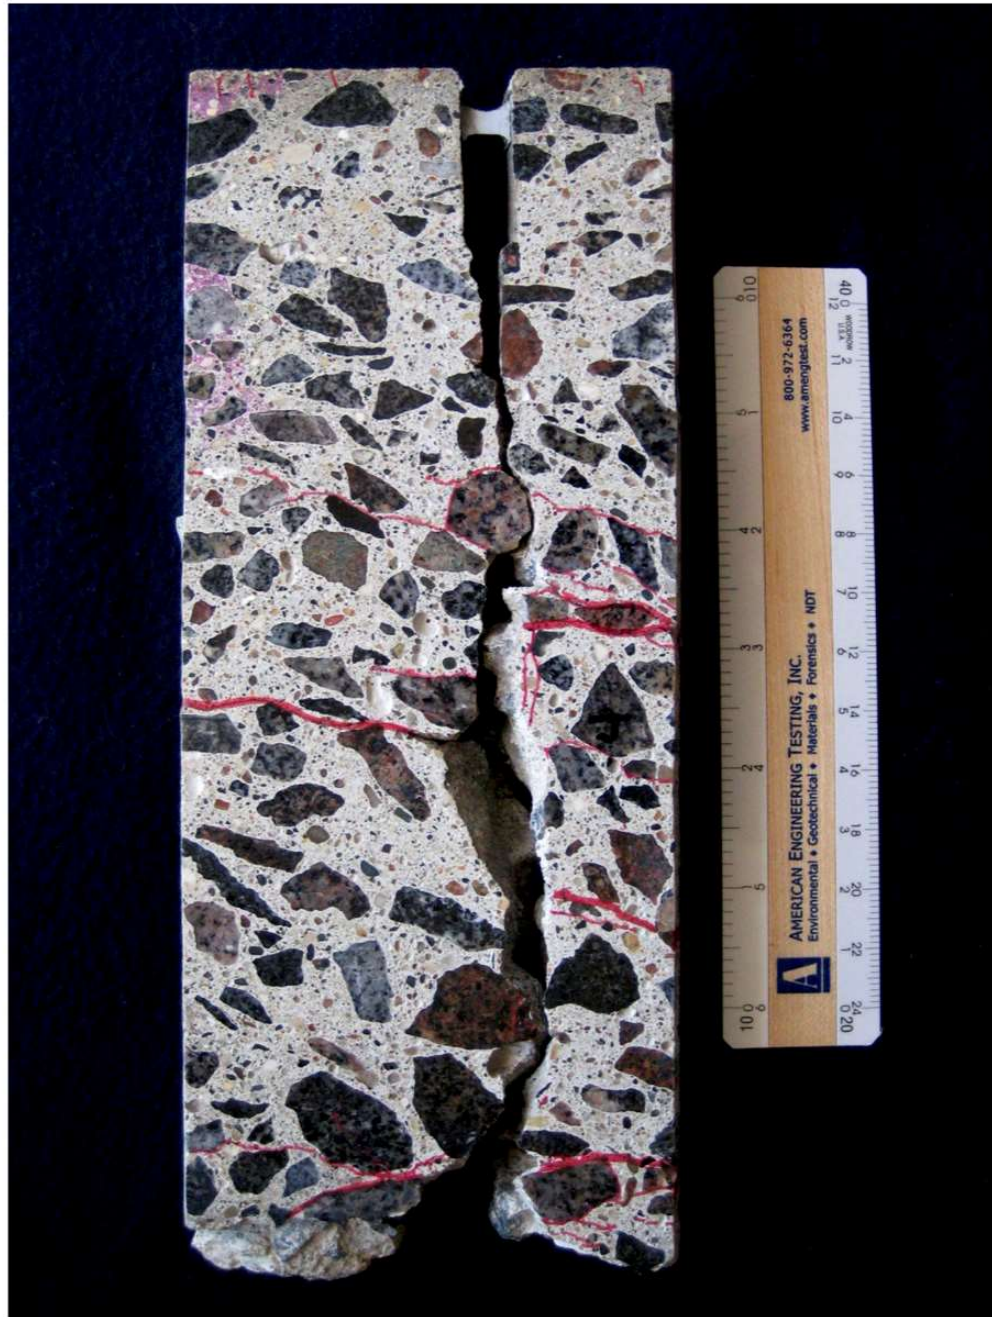
PHOTO:
89

7. Microcracking: Several fine sub-vertical microcracks (incipient spalling) were observed in thin section (in the paste-only) along the joint (cracked) surface between 150mm and 230mm depth from the top surface of the core. A few fine, sub-vertical drying shrinkage microcracks proceed up to 7mm depth from the top surface. Sub-horizontal microcracking, mostly in the paste and proceeding through a few reactive shale and chert fine aggregates, occur at approx. 95mm, 92mm, 122mm, 137mm, and several concentrated below 215mm depth in the cross section of core.

SAMPLE ID: 4705-30, 4 **DESCRIPTION:** Sawcut and lapped cross section of core. The core exhibits the most mass loss between 95mm and 182mm depth in the joint. Incipient vertical spalling was mapped in red ink. Sub-horizontal fracturing is also mapped in red ink. The silicone sealant is mostly de-bonded from both sides of the sawcut.

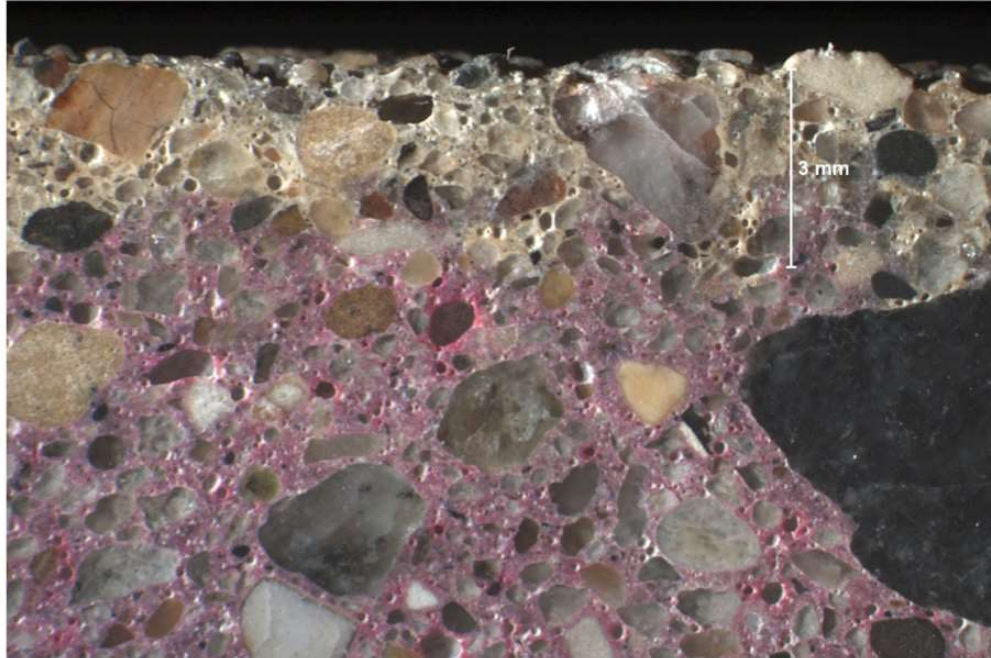
PHOTO:
124

SAMPLE ID: 4705-30, 4 **DESCRIPTION:** Carbonation (unstained paste) proceeded up to 3mm depth (in this image) from the top surface of the core.
MAG: 10x

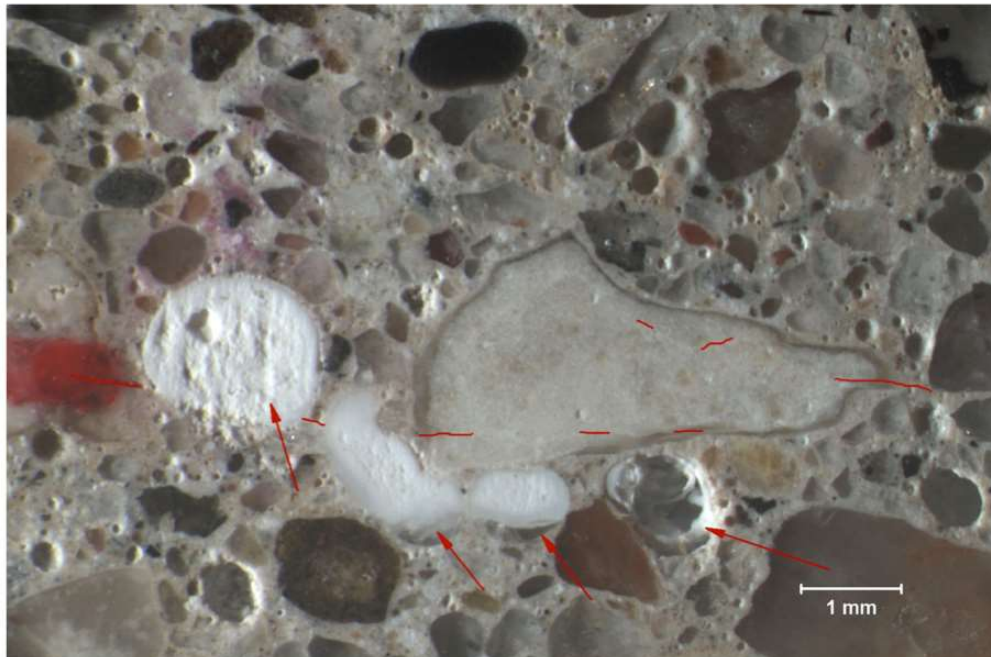
PHOTO:
125

SAMPLE ID: 4705-30, 4 **DESCRIPTION:** Isolated alkali-silica reaction (ASR) of a chert fine aggregate particles at mid-depth in the core. White to clear ASR fills or lines adjacent air voids (arrows).
MAG: 15x

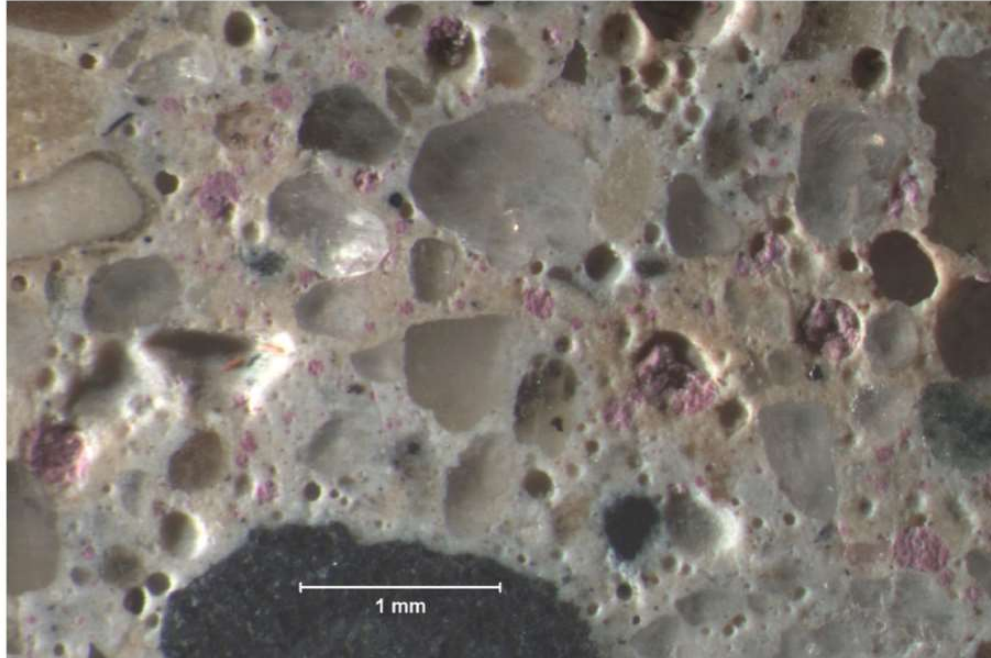
PHOTO:
126

SAMPLE ID: 4705-30, 4 **DESCRIPTION:** Abundant ettringite-filled fine entrained voidspaces (stained purple) at 155mm depth in the core and 20mm depth from the distressed joint plane.
MAG: 30x

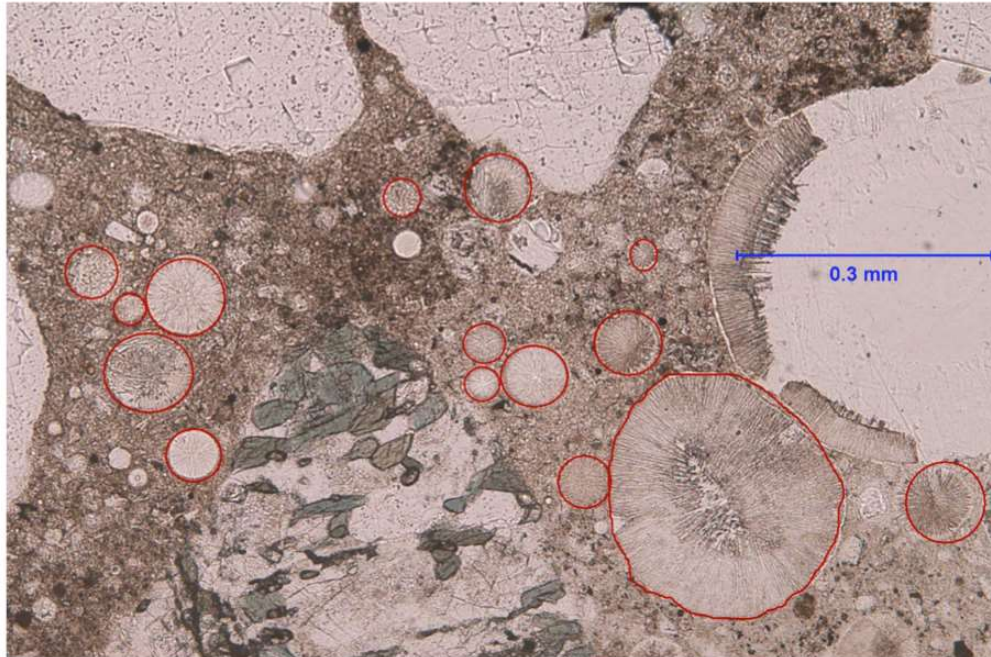
PHOTO:
127

SAMPLE ID: 4705-30, 4 **DESCRIPTION:** Nearly all of the finer entrained sized voidspaces are filled with secondary ettringite at 210mm depth in the core and within 5mm of the joint. Outlined in red and in thin section under plane polarized light
MAG 100x.

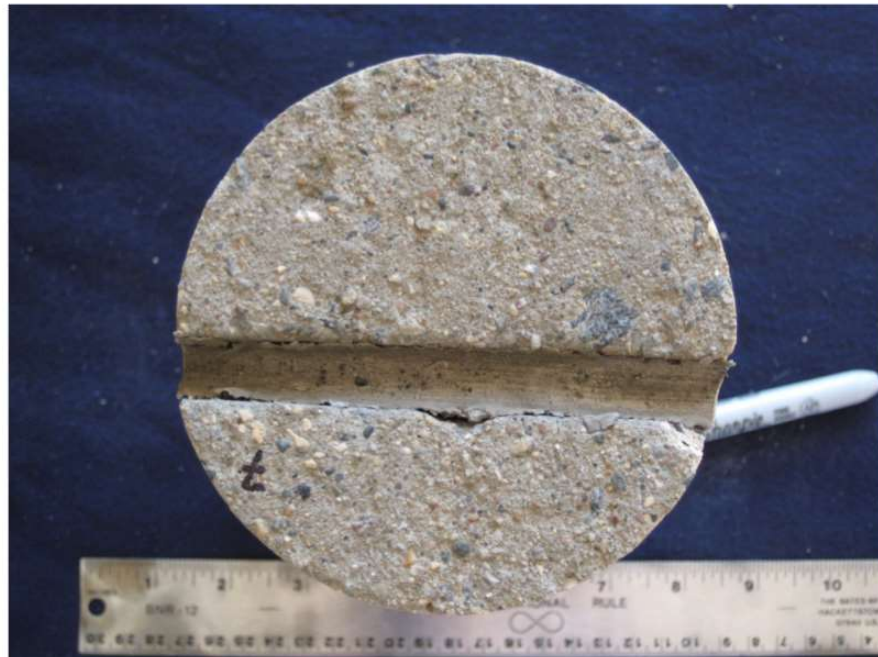
PHOTO:
48

SAMPLE ID: 4705-30, 7 **DESCRIPTION:** Rough screeded and jointed top surface of the core with minor mortar erosion. Note silicone joint sealant.

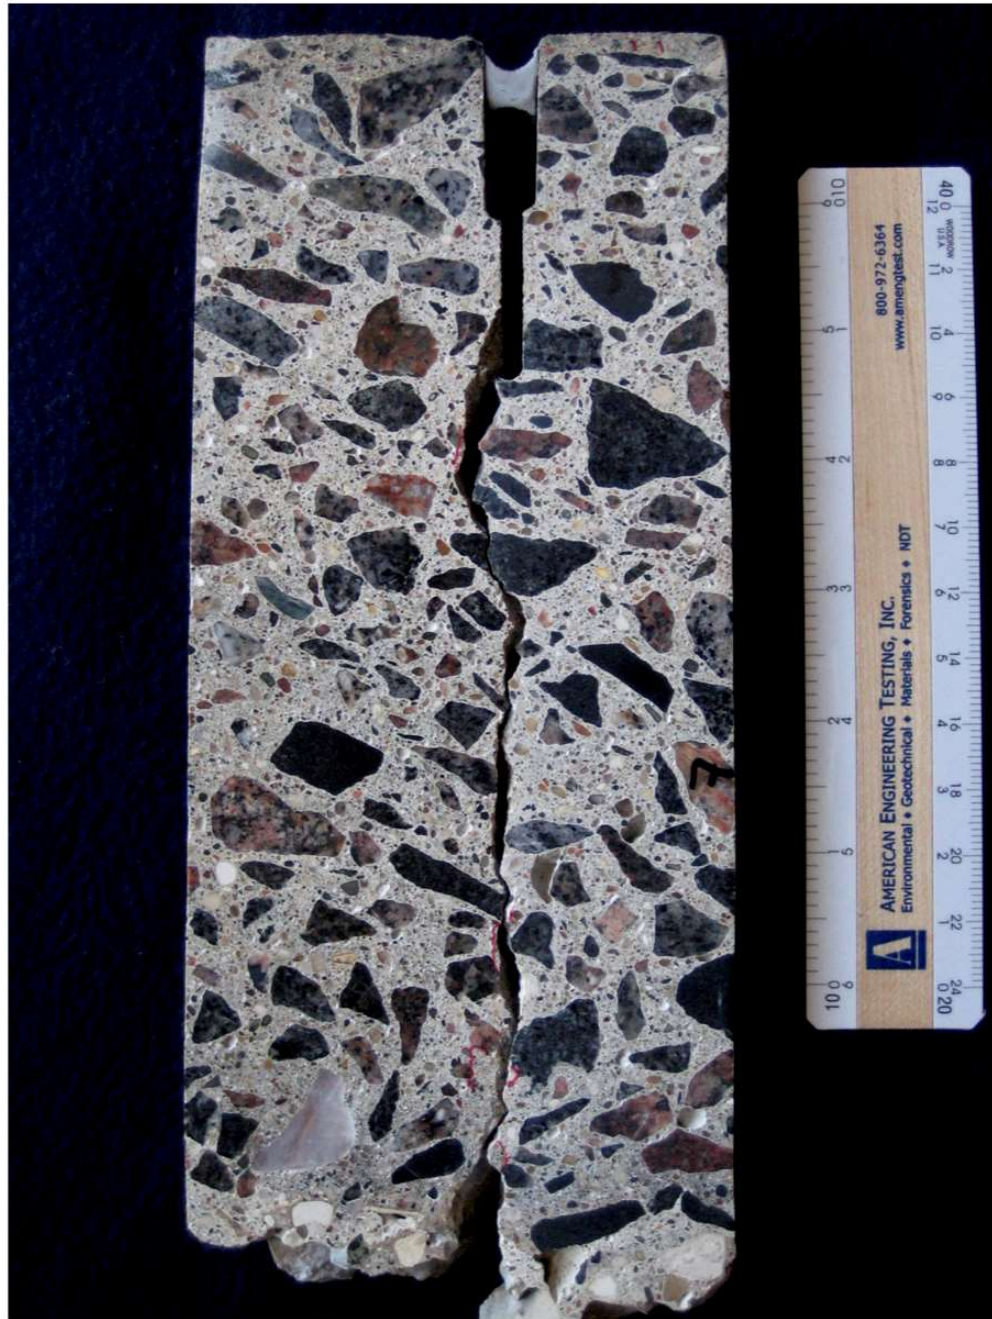
PHOTO:
90

7. Microcracking: Several sub-vertical microcracks (incipient spalling) were observed along the joint (cracked) surface between 75mm and 215mm depth from the top surface of the core. A few fine, sub-vertical drying shrinkage microcracks proceed up to 5mm depth from the top surface.

SAMPLE ID: 4705-30, 7 **DESCRIPTION:** Sawcut and lapped cross section of core. The silicone sealant was mostly de-bonded from both sides of the sawcut. The joint exhibits residual interlock and the crack bisects a few coarse aggregates. The widest loss of paste of 4mm to 7mm occurs between 65mm and 75mm depth in the core.

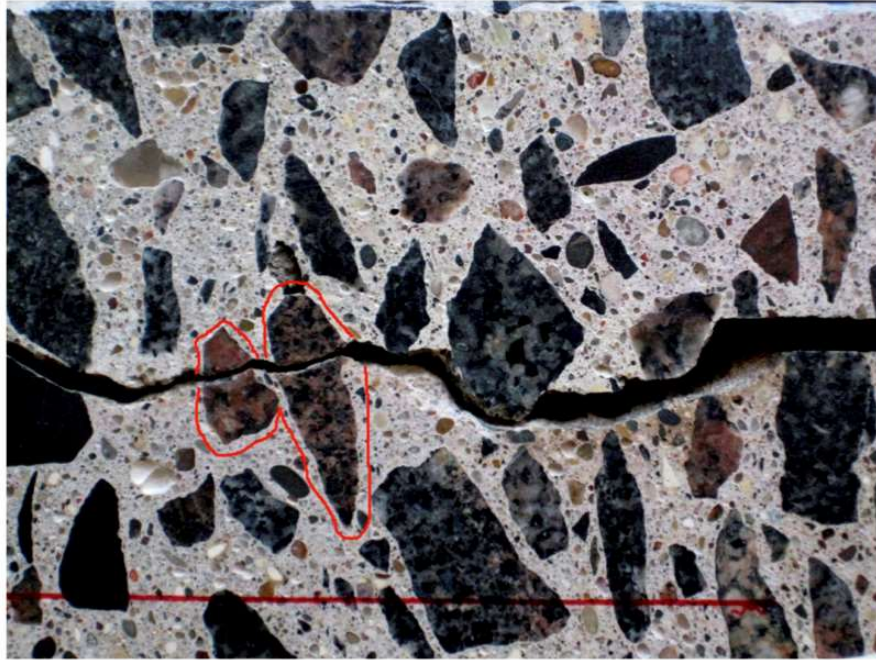
PHOTO:
128

DESCRIPTION: Coarse aggregates are bisected by the activated joint crack (outlined in red). Sawcut control is right.

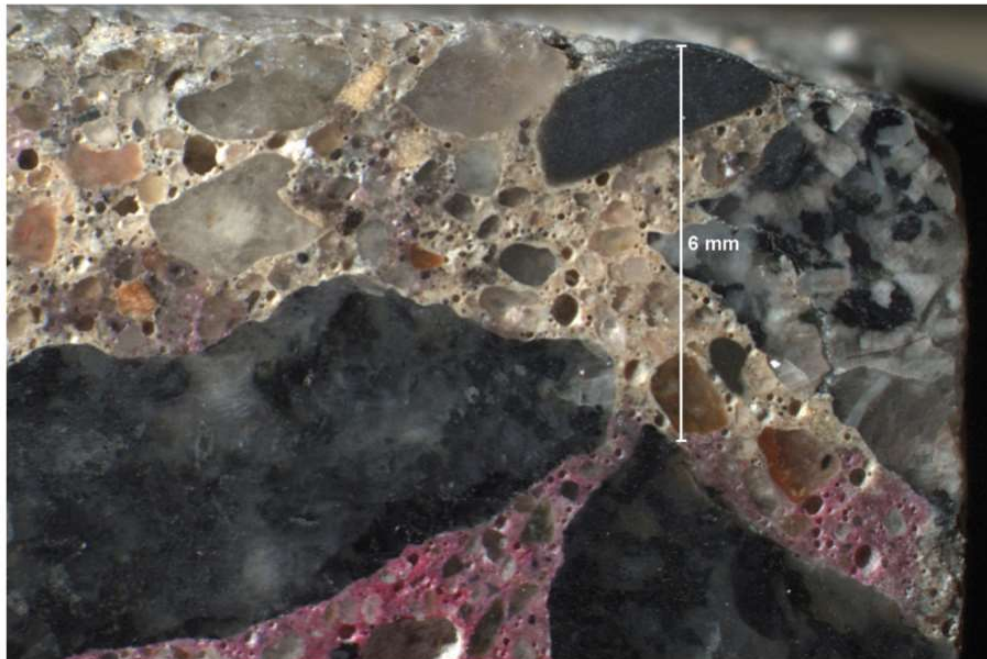
PHOTO:
129

DESCRIPTION: Carbonation (unstained paste) proceeded up to 6mm depth from the top surface of the concrete.

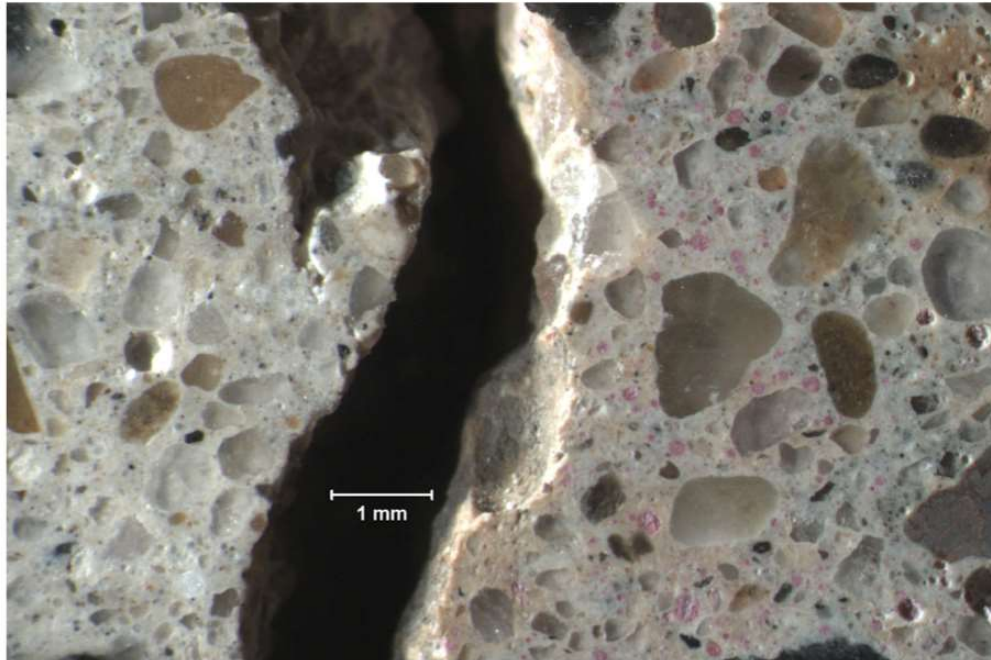
PHOTO:
130

SAMPLE ID: 4705-30, 7 **DESCRIPTION:** The concrete, adjacent to the joint crack at 130mm depth from the top surface, appears nearly devoid of entrained air voids due to fillings with secondary ettringite.
MAG: 15x

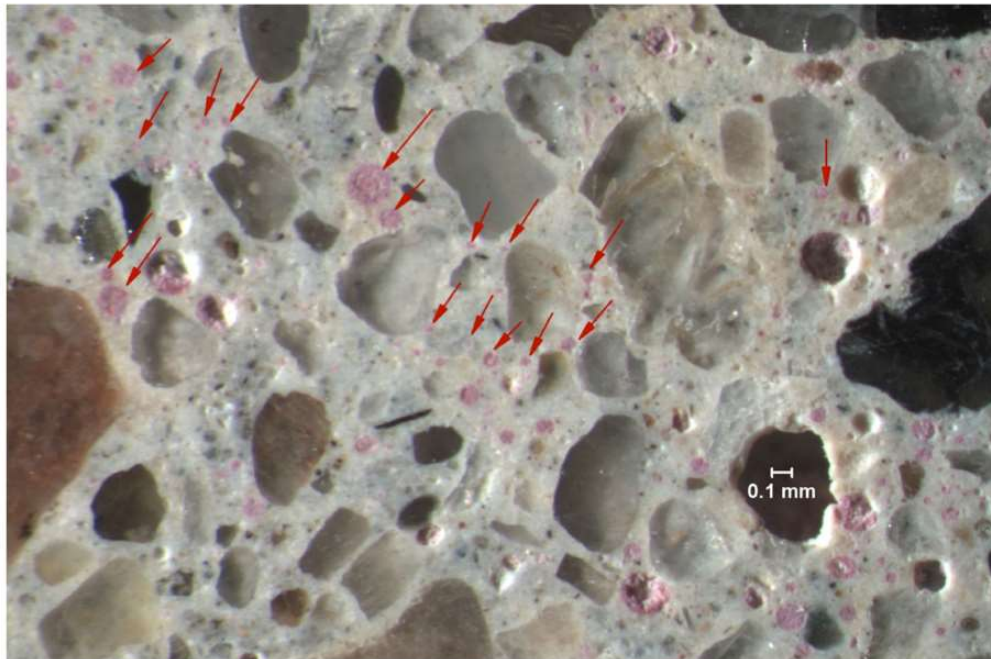
PHOTO:
131

SAMPLE ID: 4705-30, 7 **DESCRIPTION:** Ettringite-filled voids (stained purple) within 8mm of the joint plane at 120mm depth in the core.
MAG: 30x

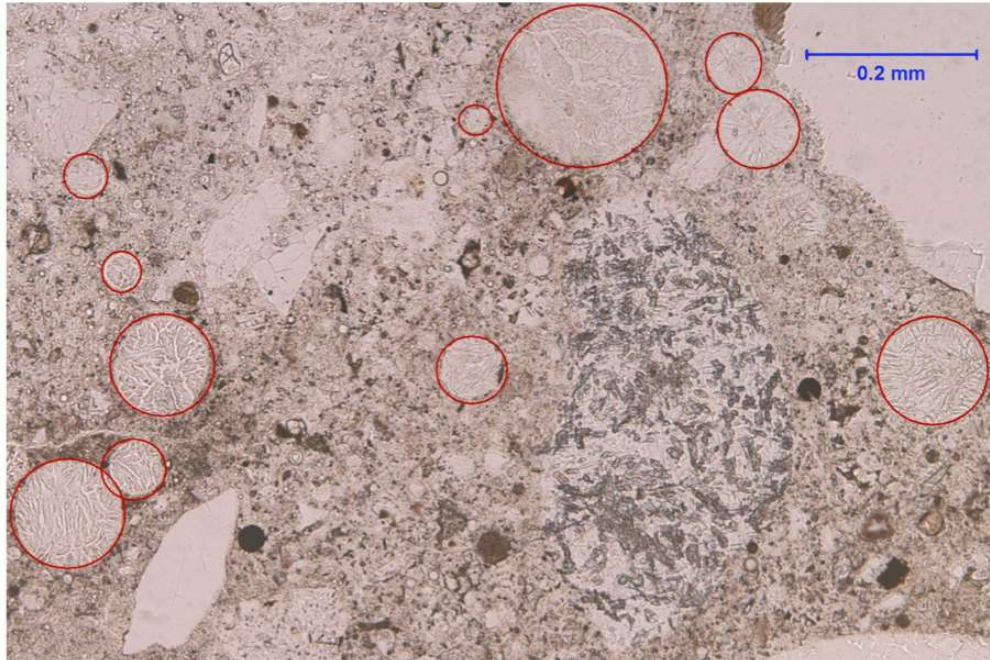
PHOTO:
132

SAMPLE ID: 4705-30, 7 **DESCRIPTION:** The entrained sized voids, adjacent to the joint crack at mid-depth in the core, are filled with secondary ettringite. In thin section under plane polarized light.
MAG: 100x

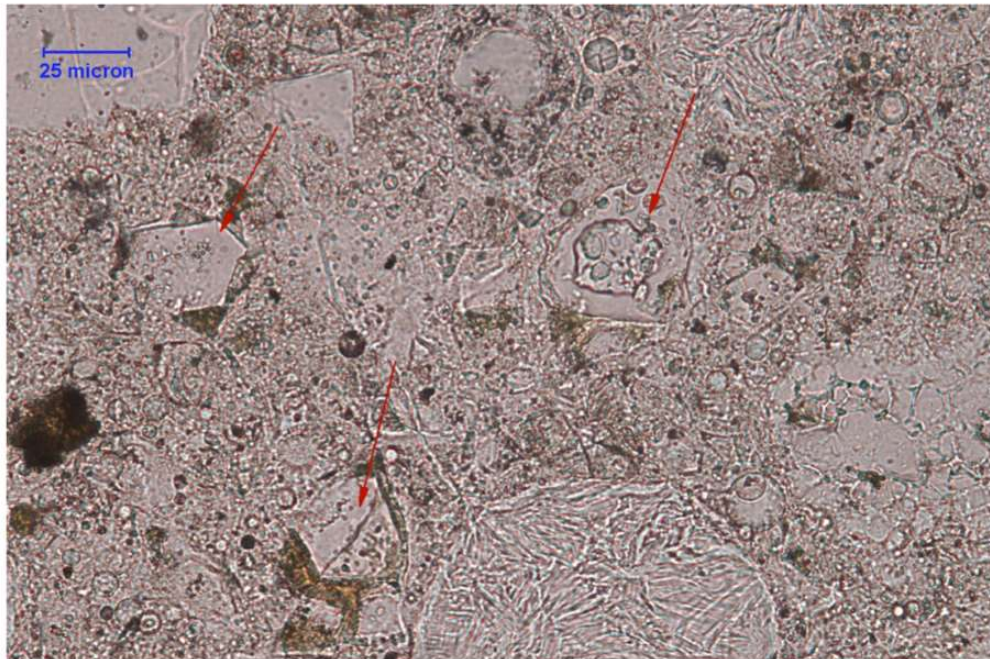
PHOTO:
133

SAMPLE ID: 4705-30, 7 **DESCRIPTION:** Well to fully hydrated alite portland cement clinker particles in thin section of concrete paste under plane polarized light.
MAG: 400x

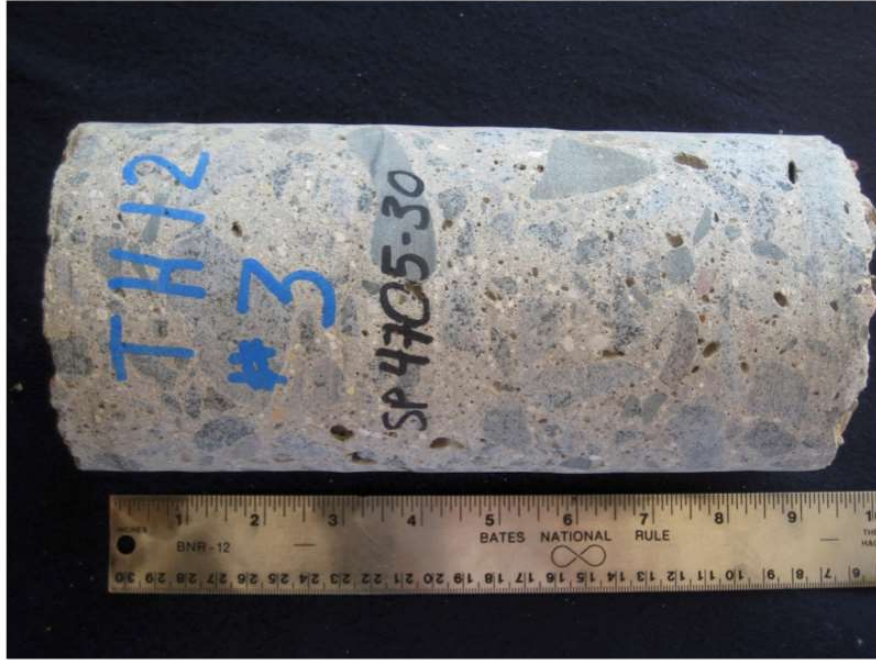
PHOTO:
41

SAMPLE ID: 4705-30, 3 **DESCRIPTION:** Overall view of the jointed core utilized for rapid chloride permeability. The top surface is left.

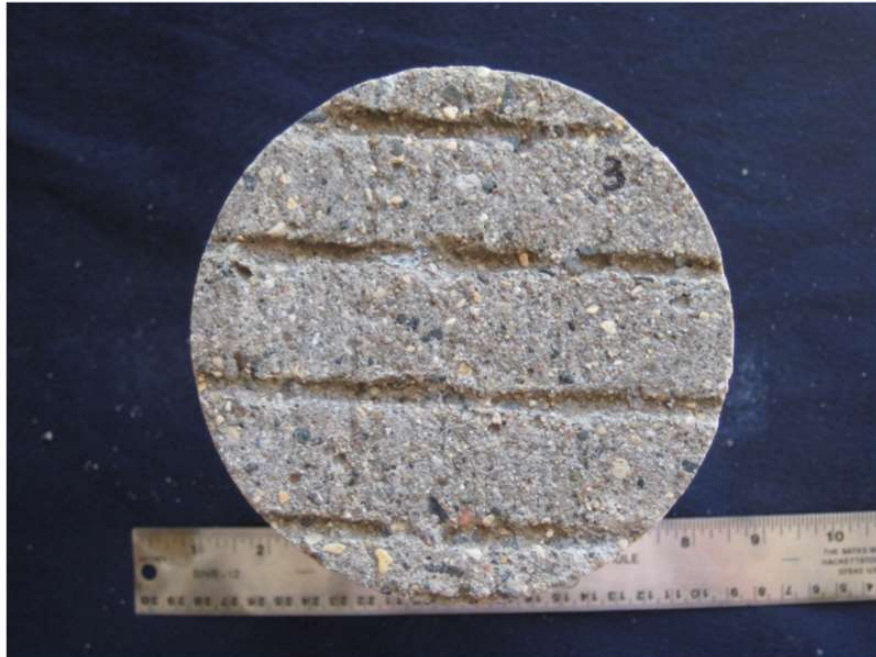
PHOTO:
42

SAMPLE ID: 4705-30, 3 **DESCRIPTION:** Rough screeded and tined top surface of the core with minor mortar erosion.

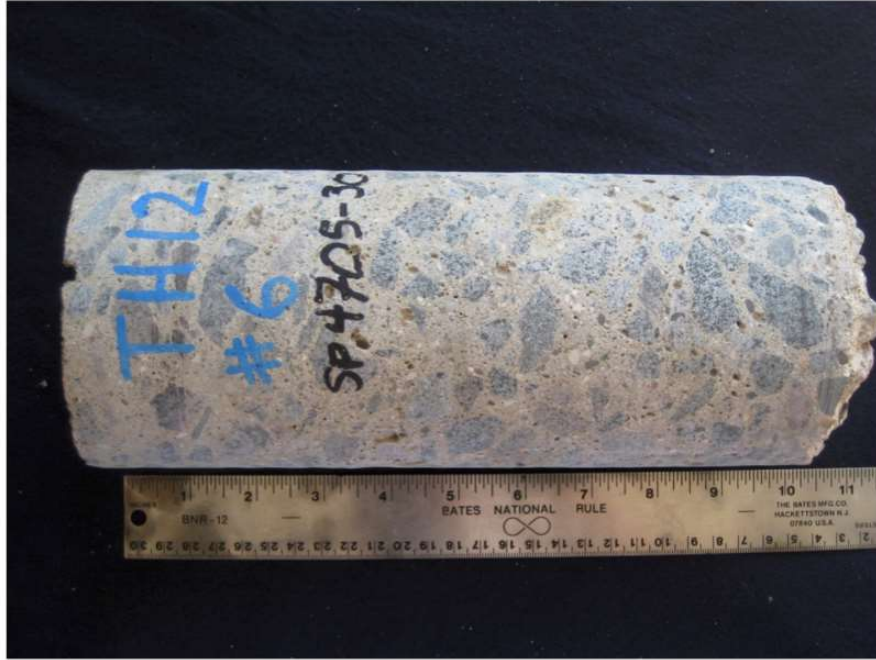
PHOTO:
45

SAMPLE ID: 4705-30, 6 **DESCRIPTION:** Overall view of the mid-panel core utilized for rapid chloride permeability. The top surface is left.
