Impact of Water/ Cementitious-Based Concrete Mix Design Specification Changes on Concrete Pavement Quality

July 2018

Research Project
Final Report 2018-25

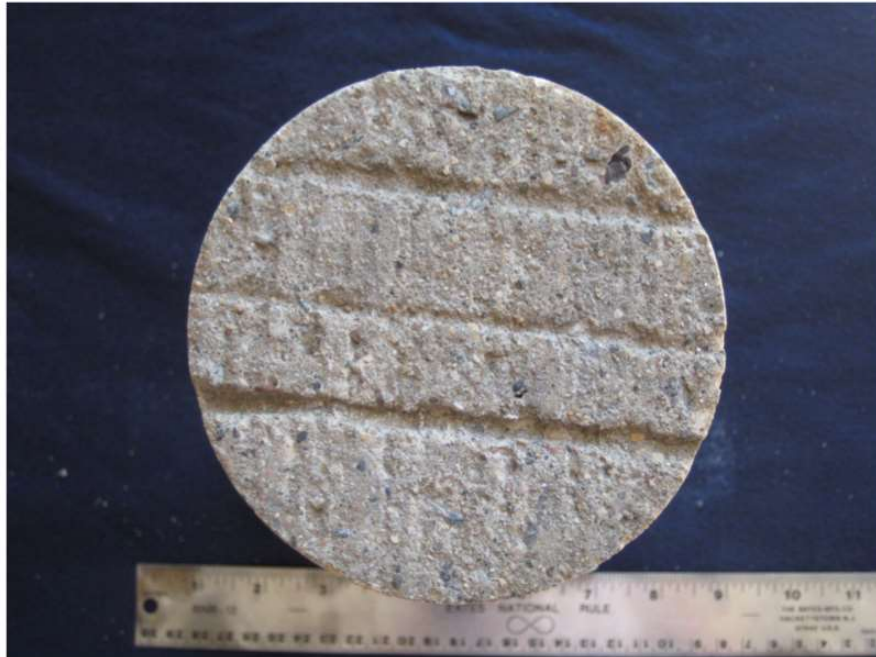
PHOTO:
46

SAMPLE ID: 4705-30, 6 **DESCRIPTION:** Rough screeded and tined top surface of the core with minor mortar erosion.
