Corrosion-Induced Durability Issues and Maintenance Strategies for Post-Tensioned Concrete Bridges

PUBLICATION NO. FHWA-HRT-22-090

SEPTEMBER 2022

U.S. Department of Transportation
Federal Highway Administration

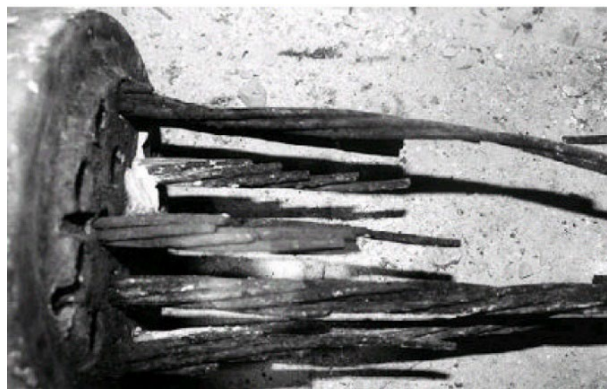
A. Failed strands.⁽¹⁷⁾

In 1999, bridge inspectors discovered that one of 234 external tendons on the Niles Channel Bridge had failed after 16 yr in service due to intensive corrosion in a grout void formed by bleed water. The void was located behind an anchor head at an expansion joint diaphragm. Recharging water contaminated with airborne chloride in the void was responsible for the corrosion. Inspectors speculated that the water leaked through the expansion joints and ran down the inner faces of the segment diaphragms onto the anchorage in question. Figure 1-A shows some of the damaged strands still attached to the anchor head, and figure 1-B shows the corroded interior condition of the anchorage trumpet associated with the failed tendon.

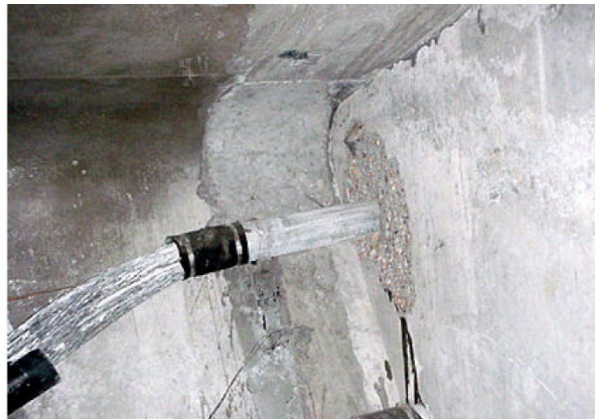
Figure 2. Photo. Failed tendon in the Mid-Bay Bridge.⁽¹⁷⁾

In August 2000, during a routine inspection, a failed tendon was pulled from an expansion joint diaphragm due to severe corrosion in the anchorage zone, as shown in figure 2. This incident was regarded as the second PT tendon failure by corrosion in the United States.

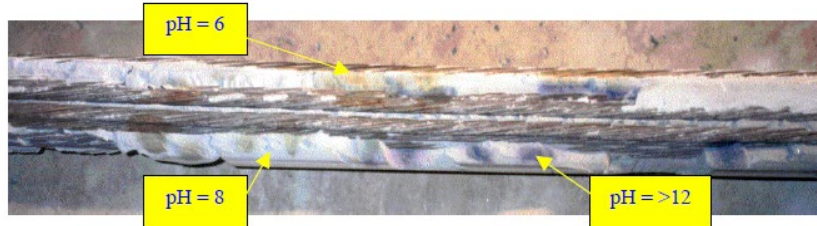
Figure 5. Photo. Variation of the grout pH.⁽²⁹⁾

The grout in two tendons revealed high pH values except within a thin top layer (16 mil). The white powdery deposit at the top of a tendon had a pH in the range of 8 ± 1 before cleaning with

a wire brush. The lowest pH was 6. After cleaning, the pH increased to 12 ± 1 . At the bottom, the 0.25-inch-thick grout was carbonated with $\text{pH } 8 \pm 1$. The broken wires were found in this layer. The deeper grout, which exhibited a dark gray color, had $\text{pH } 12 \pm 1$ again. Figure 5 shows a photograph of the grout after pH measurements were completed.

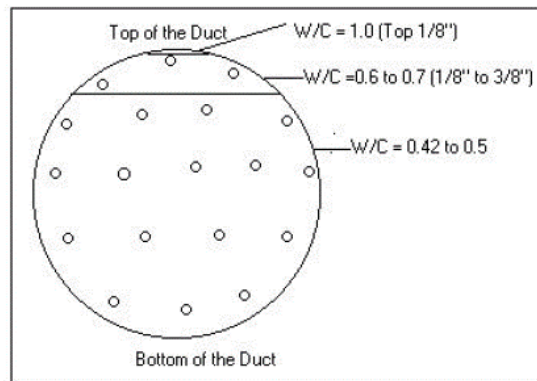
Figure 6. Illustration. Schematic representation of estimated water-cement ratios in segregated and normal grout areas.⁽²⁹⁾

Color differences in the grout samples were caused by variations in water-cement ratios and degrees of hydration. Stratification of cement paste was observed due to grout bleeding. Bleeding may have been promoted by high water-cement ratio, prolonged initial set, a long pumping range caused by single end injection, or a combination of two or more of these factors. In some areas, sedimentation of solid particles and movement of air bubbles had occurred during the grout's flowable state.

The highest water-cement ratio of 1 or greater was estimated within a 0.12-inch layer at the outer grout surface. This layer was highly porous, very soft, and weak. The second highest water-cement ratio of 0.6–0.7 was estimated within 0.12 to 0.39 inches from the duct surface. The hardened grout's water-cement ratio away from the duct surface was in the normal range of 0.42–0.50. Figure 6 illustrates the distribution of the estimated water-cement ratios in the segregated and normal grout areas.

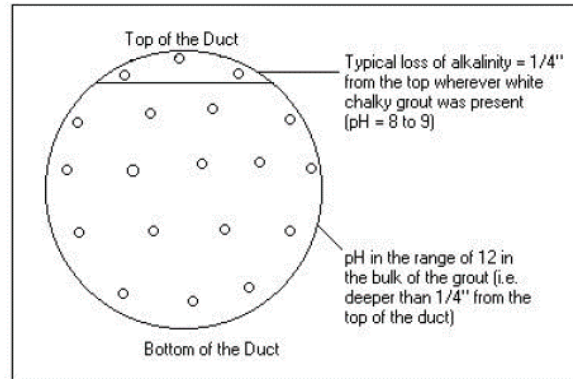
Figure 7. Illustration. Schematic of grout pH distribution.⁽²⁹⁾

In the cement paste with a high water-cement ratio and a porous layer, the pH was between 9 and 10. The grout was not carbonated at depths below 0.24 inches from the duct surface, where the pH values were between 12 and 13. The surfaces of the air voids also showed light carbonation

(pH between 9 and 10), suggesting that these voids might have been exposed to air containing CO₂. Figure 7 schematically illustrates the distribution of grout pH in the tendon's cross-section.

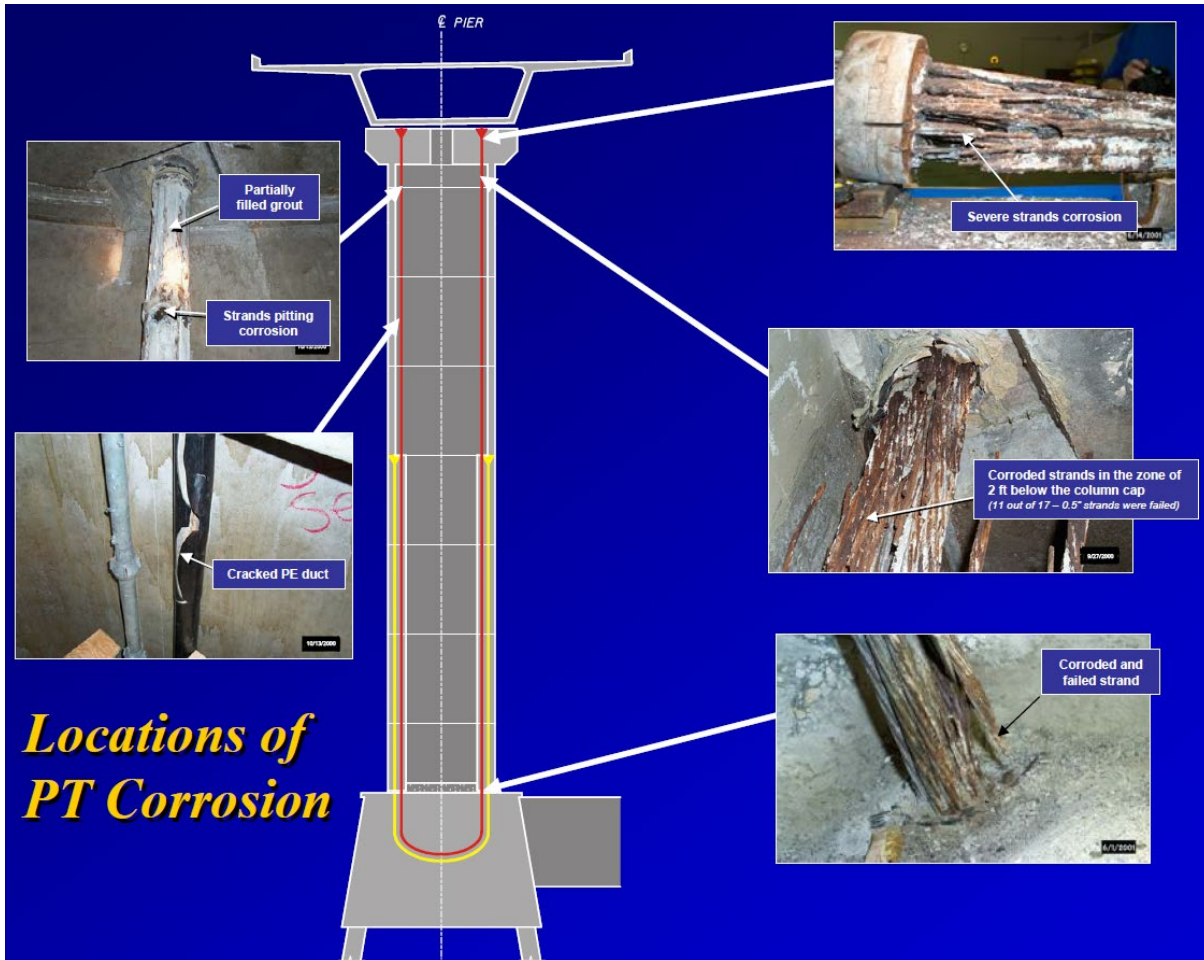
Figure 8. Schematic and photos. Column structure and locations of tendon corrosion.⁽¹⁴⁾

During a special inspection of the bridge in September 2000, severe corrosion was discovered in a tendon housed in a northbound column: 11 out of 17 0.5-inch strands were fractured at 2 ft below a column cap. As a result, further inspections were performed on all the other high-level approach columns (including comprehensive destructive testing on about 10 percent of the columns), the superstructure, and the cable anchorage of the main span. Figure 8 also shows the locations and actual conditions of the discovered tendon corrosion.

In addition, severe strand corrosion accompanied by partial or complete failures was discovered within the cap region at various locations. Three out of four tendons cored in the inspected column's cap showed severe corrosion (right middle and top left photos in figure 8) and failure in the trumpet areas (top right photo in figure 8).

- Severe duct splitting was found on 37 tendon legs in 21 columns (bottom left photo in figure 8). Portions of the ducts on 148 tendon legs in 57 columns were unsound and exhibited a hollow sound (indicating a grout void area) when tapped with a hammer. The neoprene boot duct coupler in the external tendon region contained grout voids with severe pitting and strand corrosion.
- No strand corrosion was observed at locations where the ducts were uncracked, regardless of voids, which appeared to be sealed from water and oxygen. Strand failure in the free length was identified only in the southeast tendon in a northbound column. Vibration tests showed that none of the external tendons had lost tension force in their free length except for the one shown in figure 8 and at a few locations where the test results were inconclusive, with no other critical deficiencies observed.

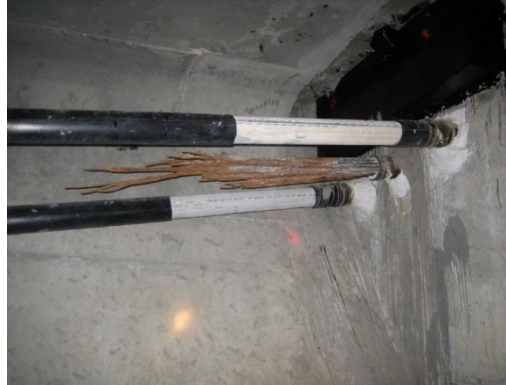
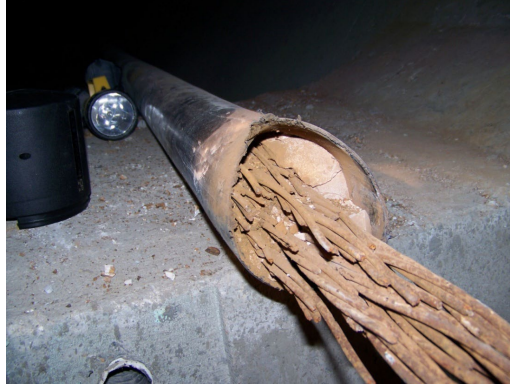
Figure 10. Photos. Failed tendon in the Varina-Enon Bridge.

In May 2007, a routine inspection discovered one failed tendon in the southbound bridge. Even though the tendon was regouted in 2004, it still failed by corrosion at a bridge age of 17 yr. Figure 10 shows the failed tendon.

A. Section attached to the diaphragm.

B. Opposite section on a deviation block.

Corrosion also damaged another tendon due to ponding water near a clogged drain hole in the bottom slab of a box girder. Both tendons were replaced in 2007. In late 2007, MFL testing was conducted on approximately 17 mi of external tendons (approximately 3,200 sections) and identified a severely corroded tendon. A closeup of its corroded wires is shown in figure 11.

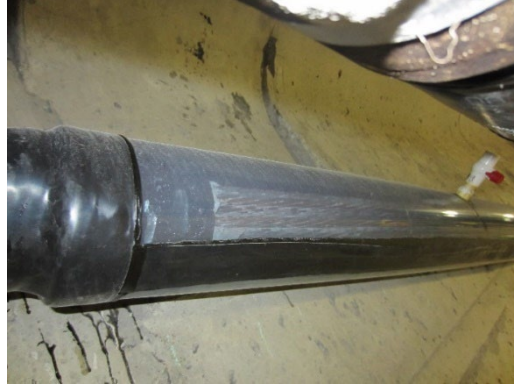
Figure 12. Photo. Condition monitoring section covered with a clear plastic tube.

Additional inspections were conducted after removing two-ft-long duct sections from the selected 20 tendons. Incomplete regrouting and broken wires were discovered in two tendons in the northbound bridge. Subsequently, clear plastic tubes with one or two plastic valves were installed over 11 opened sections, exhibiting different levels of corrosion. The transparent tubes allowed the inspectors to monitor the strand conditions. Figure 12 shows one of the tendon sections being monitored.

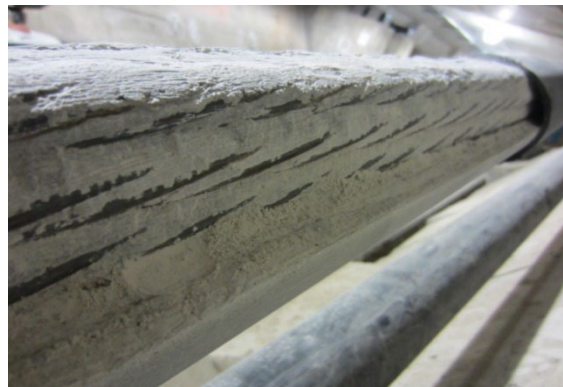
Figure 13. Photo. Typical condition of the segregated grout.

Large longitudinal grout voids were often discovered between 3 and 9 o'clock when the selected tendon sections were opened. Some strands were partially exposed without any recognizable corrosion. However, their bottom portions were filled with well-hydrated grout. The top section of the exposed grout appeared porous, weak, and covered with white powdery grout. The defective grout condition indicated that grout segregation had occurred during grouting. Figure 13 shows a representative condition of the segregated grout, including white powdery grout, sporadically exposed strands, and the grout void.

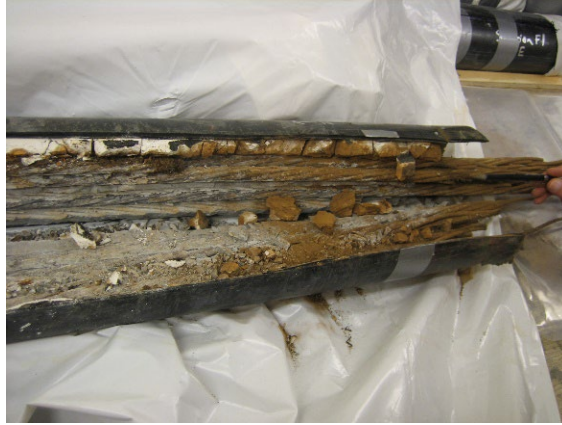
Figure 14. Photo. Interior condition of a failed tendon section.

In 2007, the Virginia Transportation Research Council (VTRC) and an independent laboratory investigated some of the retrieved tendon sections from the Varina-Enon Bridge. Figure 14 shows the interior condition of the failed tendon section shown in figure 10-B after it was opened with a circular saw.

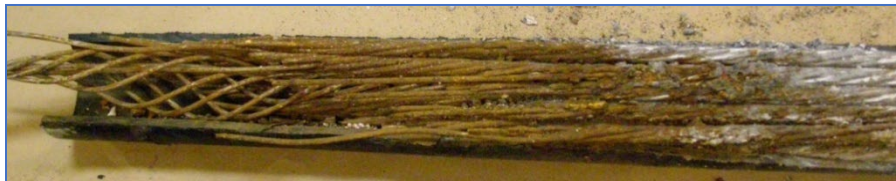
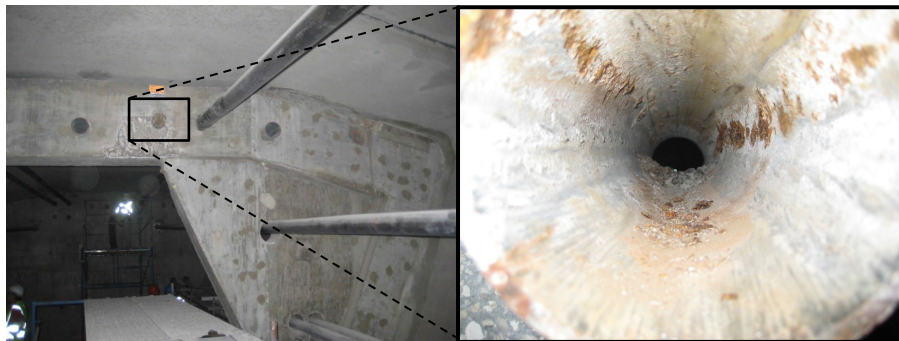
Figure 16. Photos. More photographs associated with the first failed tendon.⁽⁵²⁾

Figure 16 shows the other end of the failed tendon (see figure 16-A) and the upper deviator containing the steel pipe and the interior condition of the galvanized steel pipe that contained the failed tendon (see figure 16-B).

A. Closeup of the other end of the ruptured tendon.

B. Overview of the deviator and interior condition of the steel pipe.

This tendon exhibited severe corrosion mostly concentrated on the strands in the upper portion. Except for the heavily corroded strands there, the failure mode of the remaining strands appeared ductile, as evidenced by necking signs at the ruptured ends of the wires. The corroded-in-two wire tips suggested that the failed tendon must have been exposed to a very corrosive environment for some time. Corrosion was also observed in the upper portion of the galvanized steel pipe in the upper deviator (see figure 16-B). Although there is no initial photograph of the pipe's condition, two distinctive rust lines on the interior wall indicated that there was likely water or watery grout up to the rusty watermarks for an unknown duration after grouting.

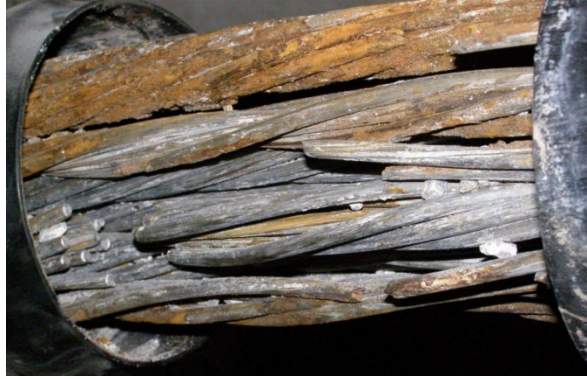
Figure 19. Photo. Closeup of the second failed tendon.

Figure 19 shows a close-up photograph of the failure location.

The condition of the failed section was inspected through the gap between the slipped HDPE duct and the galvanized pipe assembled with the neoprene coupler. Severe corrosion damage was not as localized as in the first failed tendon. Instead, corrosion and strand fracture were observed at several locations within a 20-ft section. The remaining strands showed a ductile fracture with necking. Severe corrosion of the strands within the galvanized steel pipe in the upper deviator was also observed.

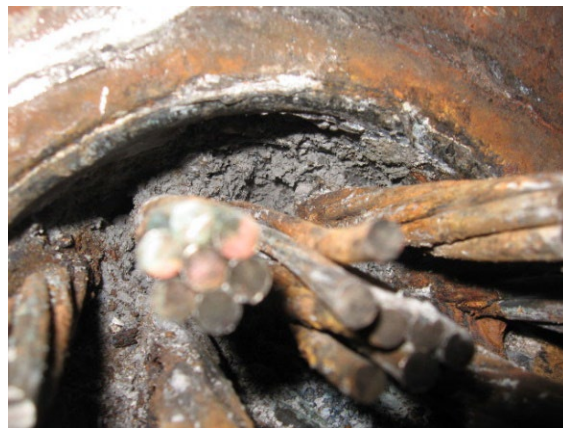
Figure 20. Photo. Interior of low-point anchorage of the second failed tendon.

Segregated soft/wet grout was observed throughout the region of corrosion failure. A large amount of segregated grout was also observed at a low point anchorage zone, where severe corrosion of the anchor head and strands occurred. Figure 20 shows the soft/wet grout inside the anchorage zone.

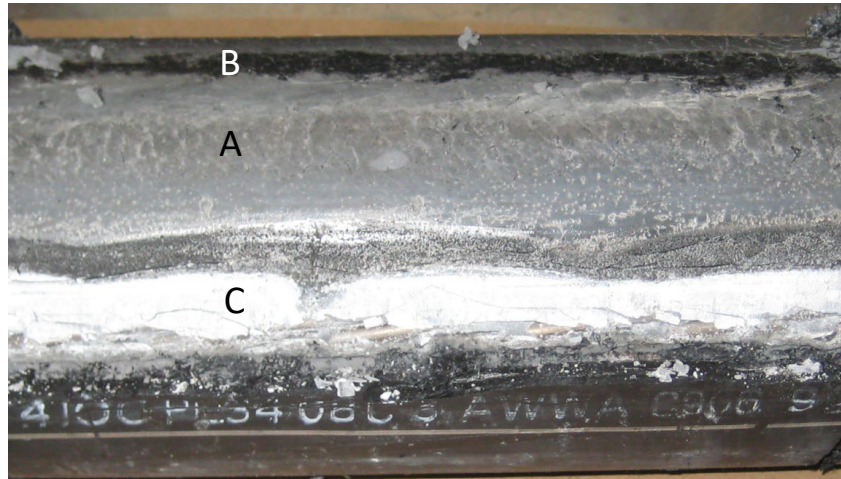
Figure 22. Photo. Stratified segregated grout.⁽⁵⁰⁾

The segregated grout was characterized as having a soft/wet—claylike—consistency (moisture content 50—80 percent), sedimented black layer with silica fume, and white chalky (moisture content 20—50 percent) appearance. Figure 22 shows three distinctively different areas of segregated grout.

A = soft/wet grout; B = sedimented silica fume; C = white chalky grout.

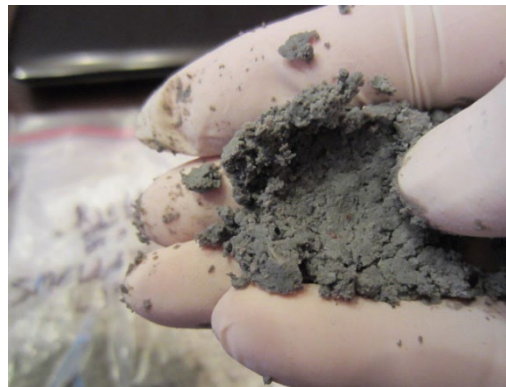
Figure 23. Photo. Claylike texture of a soft/wet grout sample.

Figure 23 and figure 24 show a soft/wet field grout sample that never hardened and chalky grout inside the corroded strands, respectively.

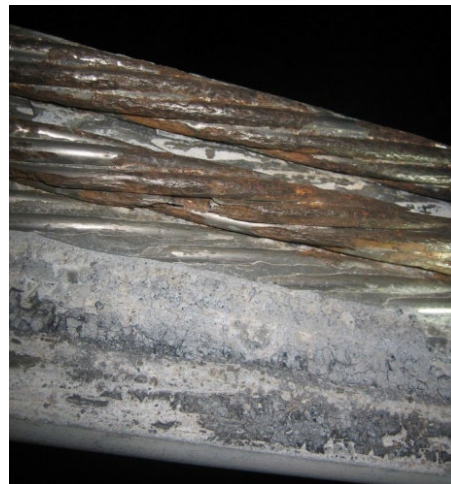
Figure 25. Photo. Closeup of segregated grout in a half-filled tendon.

Figure 25 shows an excavated area with four features commonly exhibited by many tendons filled with segregated grout, starting from top to bottom as follows: incomplete grout filling, i.e., a grout void; severely corroded bare strands surfaced above normally hardened grout; remnants of thin grout coating over some of the exposed strands; a layer of sedimented silica fume particles; and normally hardened grout.

The silica fume particles could surface on bleed water during grout pumping, moving through the duct, and during the initial plastic stage. When the bleed water evaporated or was reabsorbed into the segregated grout, lightweight particles such as silica fume clustered over the grout surface. A black deposit layer of silica fume particles was also present in the bleed channels. The normally hardened grout beneath the segregated grout preserved protective properties to maintain corrosion-free strands.

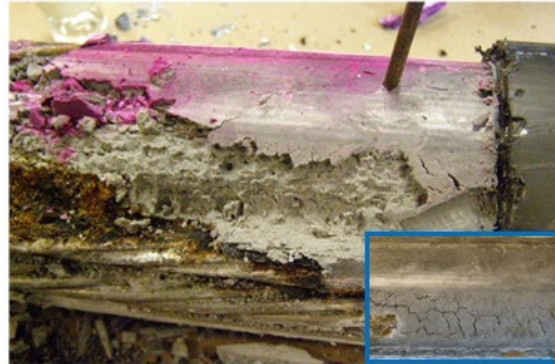
Figure 26. Photos. Severe corrosion associated with soft grout.⁽⁵⁰⁾

The observed corrosion problems were mainly associated with segregated grout, which was much more likely to develop strand corrosion than normally hardened grout. For example, figure 26 shows severely corroded strands embedded in the deficient grout, which was cracked, soft, and very thin. The inset at the right bottom corner shows the grout's initial condition exhibiting a network of grout cracking before it was removed.

Two interesting features observed from the photograph are the grout's softness (tested with a screwdriver) and the presence of the black-colored magnetite, which can form in the oxygen-starving environment.

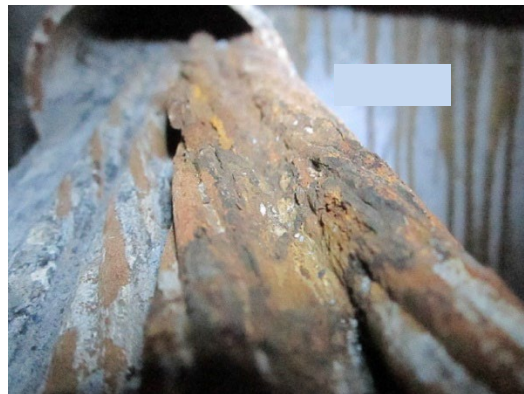
Figure 27. Photo. Closeup of severely corroded strands in a rejected tendon.⁽⁴⁹⁾

Figure 27 shows two significantly corroded strands covered with a thin grout coating; figure 28 shows a photograph taken from an undisturbed, inclined section upon opening, respectively.

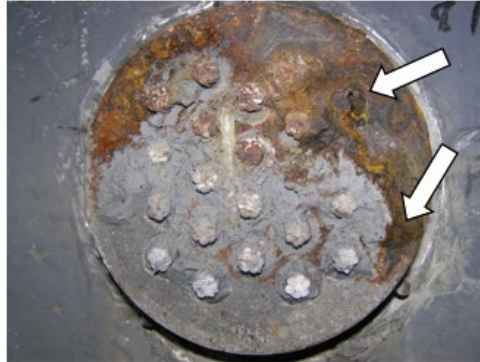
Figure 29. Photo. Exposed anchorage zone after a grout cap was removed.

Figure 29 shows an anchorage zone's interior condition after its grout cap was removed.

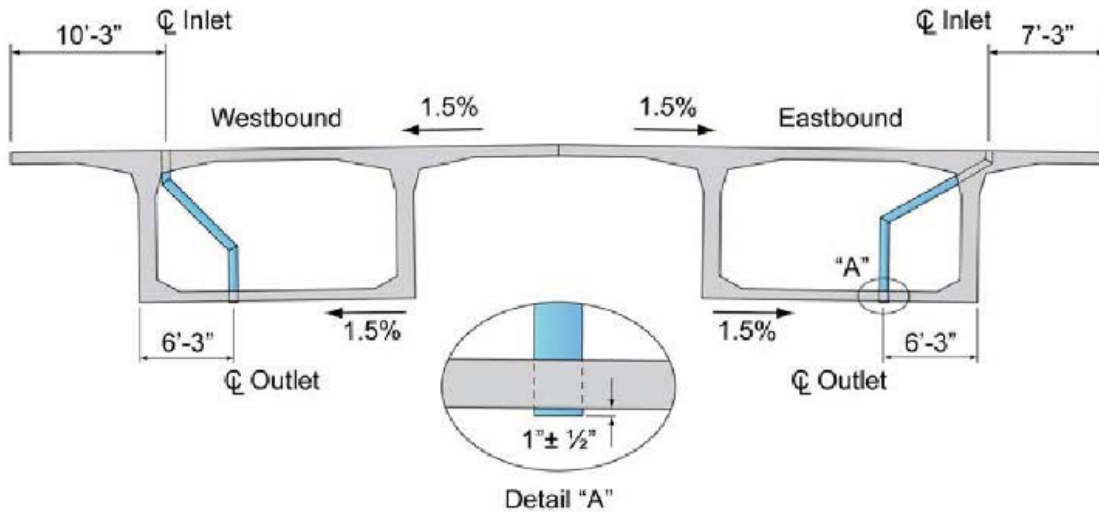
Figure 31. Illustration. Schematic of drainage system.⁽²⁸⁾

The investigation determined that chloride-bearing water from the deck was leaked through the misaligned drainage pipe sections inside the box girders and deicing salts accumulated in the bottom slab triggered corrosion of the internal tendons and adjacent reinforcing steel. A schematic of the drainage system is shown in figure 31.

The exterior bottom slab surface of the eastbound and westbound box girders also exhibited longitudinal cracks, efflorescence, rust stains, and concrete spalling. A very short drainage outlet pipe beyond the bottom slab (see detail “A” in figure 31) caused the corrosive water to wet the nearby bottom slab and initiated corrosion. Figure 32 shows an interior view of concrete damage and severely corroded tendons in the bottom slab (see figure 32-A) and an exterior view of another location experiencing similar damage (see figure 32-B).

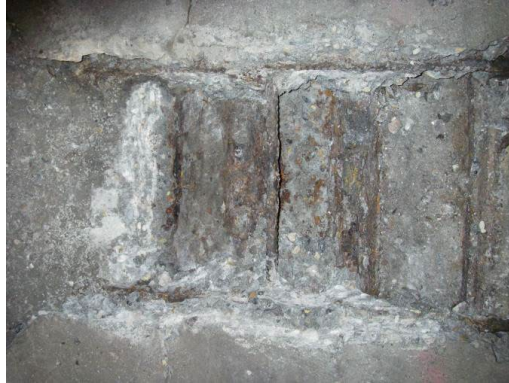
A. Corroded tendons exposed.

Figure 33 shows the as-excavated condition of three internal tendons beneath the delaminated concrete (see figure 33-A) and a closeup of a corroded tendon (see figure 33-B).

It was observed that the metal duct was corroded away, and grout and corrosion products mingled with severely corroded strands such that individual wires could not be distinguished. Nearby concrete contained a high level of acid-soluble chloride concentration (nearly 0.8 percent by weight of grout) at 0.8 inches deep.

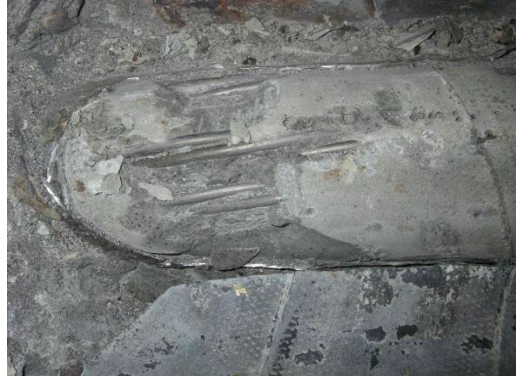
Figure 34. Photo. Exposed internal strands exhibiting excellent condition.⁽²⁸⁾

On the contrary, an internal tendon in excellent condition was uncovered in an area where a large crack was directly over the tendon. A representative condition is shown in figure 34.

A good quality grout without moisture was observed there. The grout contained 0.075 percent acid-soluble chloride concentration by weight of grout, which explained its corrosion-free condition.

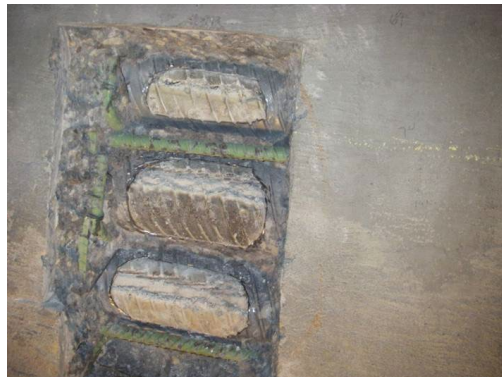
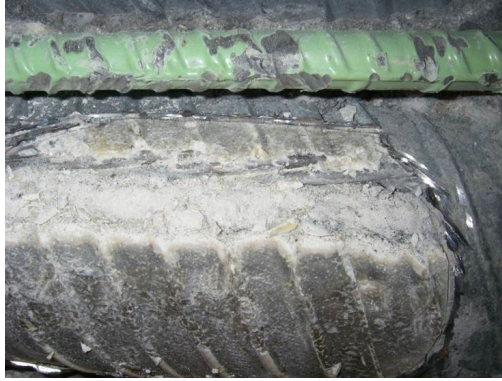
Figure 36. Photos. Exposed ducts at a low point of tendon profile on Coon Rapids Bridge.⁽²⁸⁾

Figure 36 shows a representative condition of internal tendons at low points.

They were filled with good-quality grout, and only some bleed channels could be seen on top of the grout. Acid-soluble chloride concentrations in two grout samples were 0.046 and 0.062 percent. The grout samples taken from other locations also contained acceptable levels of chloride.

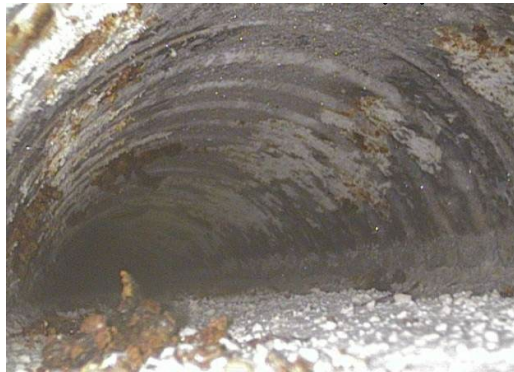
A. Corroded duct interior.

However, grout voids were discovered at 29 out of 90 high points (32 percent) inspected within three spans. A typical grout void occupied the roughly upper half of the duct's cross-section and was at least 10 ft long. The grout surface usually exhibited a white chalky texture. The poor condition suggested the grout segregation had occurred during grouting. Interior surfaces of the metal ducts showed light to moderate corrosion. Figure 37 shows two locations exhibiting moderate corrosion on the duct surface and chalky grout (see figure 37-A) and a smooth grout surface and little corrosion on the duct surface (see figure 37-B).

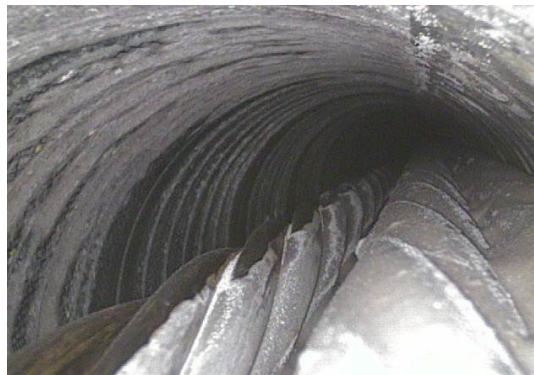
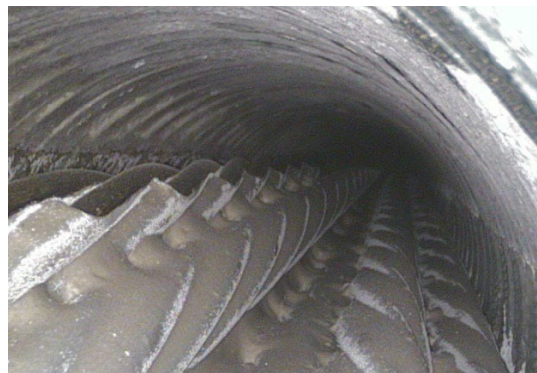
Figure 38. Photos. Exposed strands in the grout voids at high points.⁽²⁸⁾

The strands were exposed in approximately half of the grout voids, but significant corrosion or light surface corrosion was not observed at any of these locations. Figure 38 shows two locations at high points of the tendon profile, where the strands exposed above the grout surface were partially covered with grout coating (see figure 38-A) or fully covered (see figure 38-B).

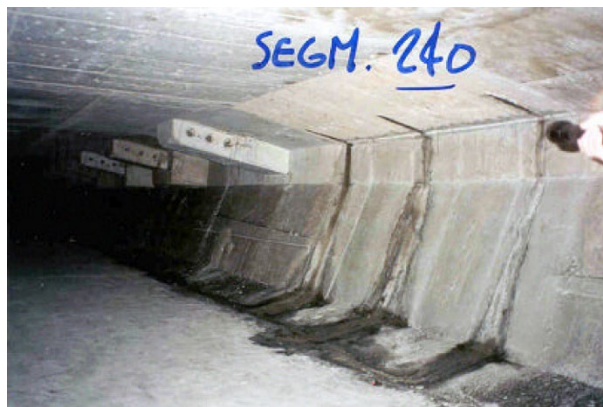
Figure 39. Photo. Interior view of water-leaking box girders at the Sawgrass Interchange.⁽¹⁷⁾

As briefly mentioned in chapter 1, some of the balanced cantilever PT bridges at the Interstate 75/Interstate 595 Sawgrass Interchange built between 1986 and 1989 experienced water-leaking problems through the segment joints. Efflorescence also came from the top slab continuity tendons. Figure 39 shows the interior condition of the water-leaking box girders.

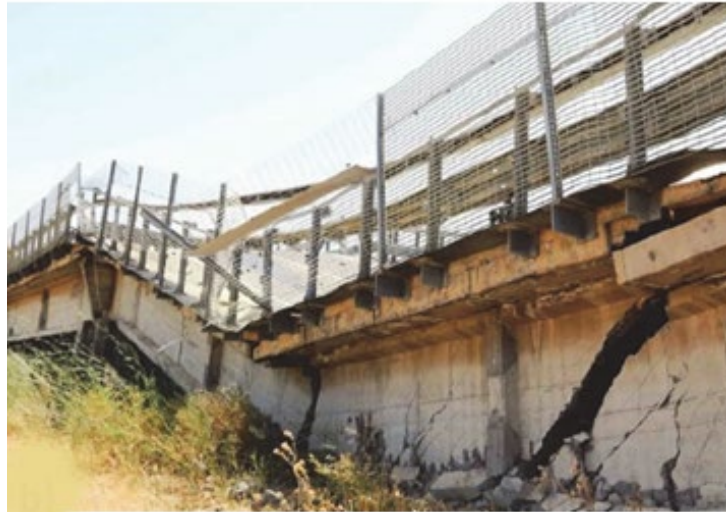
Figure 49. Photo. Petrulla Viaduct after its collapse.⁽⁸¹⁾

Petrulla Viaduct is situated along State Road 626 in the Salso Valley in Sicily. It was built in the mid-80s. The viaduct consists of 12 simply supported precast PT I-beams, each 131 ft long. Its 37-ft-wide deck was supported by four beams equally spaced at 9.4 ft. In July 2014, one span of the viaduct collapsed, injuring four people. The collapsed span is shown in figure 49.

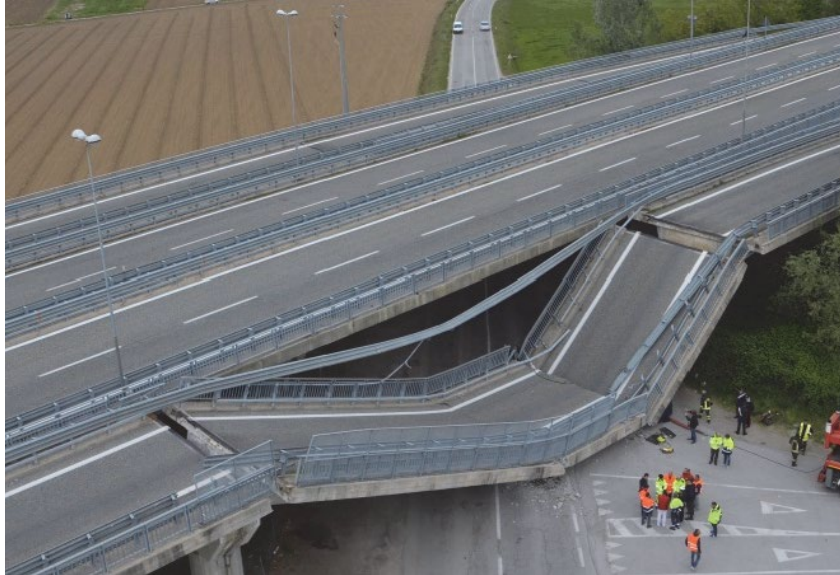
Figure 52. Photo. Collapsed La Reale Viaduct ramp.⁽⁸¹⁾

La Reale Viaduct, part of the Fossano bypass road, consists of simply supported PT box girders, each 101 ft long and 29 ft wide, and a cast-in-place concrete deck slab. Each of the eight parabolic tendons contains 19 0.8-inch strands. One ramp of La Reale Viaduct collapsed in 2017, as shown in figure 52.

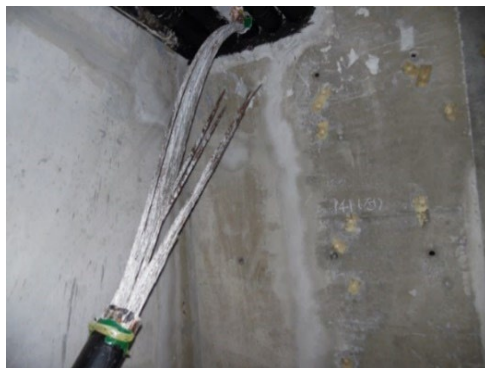
Figure 55. Photo. Cheong-Rung Creek Bridge's failed tendon as discovered.⁽⁸⁴⁾

All the tendons were filled with neat cement grout mixed at the construction site. Even though construction records indicated an expansive admixture was used in the grout mix, its presence could not be confirmed in petrographic analysis of several grout samples. One external tendon failed due to corrosion in February 2016. Figure 55 shows the failed tendon when discovered.

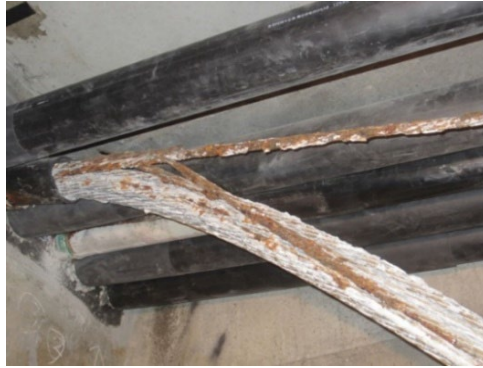
A. Severely corroded strands.

An immediate field investigation discovered that five other tendons adjacent to the failed one at the same pier were also severely corroded. Figure 56 shows an external tendon that was found to contain two strands that were severed by corrosion when the PE duct was removed (see figure 56-A) and water droplets (circled with yellow dashed lines) on a downward-sloped section of the failed tendon (see figure 56-B).

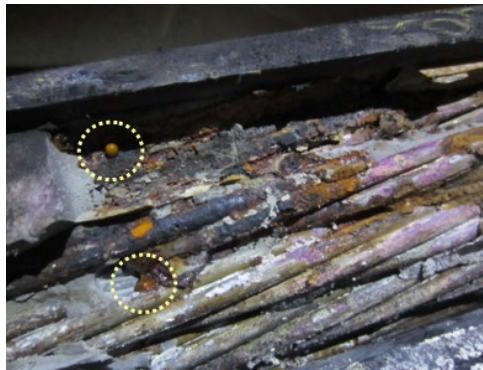
B. Water droplets on two corroded strands.

Since empty grout vent tubes could provide a water path from the deck surface to the high points of the external tendons inside the diaphragms, extensive efforts were made to locate empty grout vent tubes from the deck surface. As a result, it was determined that 44 out of 73 (60 percent) of the grout vent tubes identified from the deck were empty, and the water droplets shown in figure 56-B were remnants from water leaking before the tendon failure.

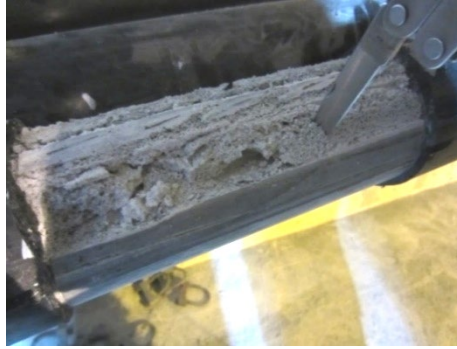
A. Porous and frosty grout.

Figure 58 shows the segregated grout exhibiting a porous and frosty texture (see figure 58-A) over the normally hardened solid grout at the bottom half (see figure 58-B).

The defective grout contained numerous tiny bubbles and had no strength, which allowed a knife to penetrate easily, as shown in figure 58-A. Large grout voids were also observed frequently in most of the opened tendons. They appeared to be formed by a violent grout segregation process assisted by entrapped air. Figure 59 shows the remnants of air (or gas) bubbles adhered to the interior surface of the duct with a matching condition on the segregated grout (see figure 59-A) and a closeup of segregated grout containing large air bubbles (see figure 59-B). Both conditions must have formed during watery grout's initial segregation process.

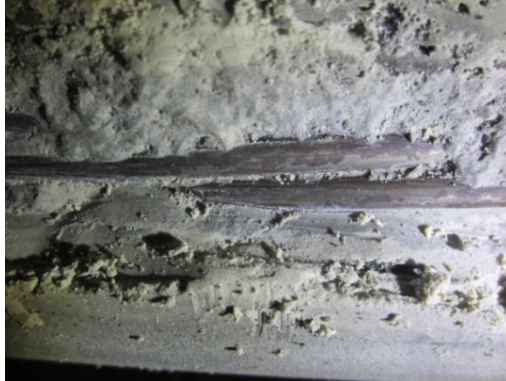
B. Exposed strand without corrosion.

Soft/wet grout was found in many opened tendon sections as well. Some grout samples contained more than 50 percent moisture content (mean moisture content = 38 percent). The cause or origin of the wet grout could not be determined. However, the wet grout did not result in corrosion of the strands. Figure 60 shows a thumbprint next to a spot cut out with a knife on a claylike soft/wet grout (see figure 60-A) and a freshly exposed strand showing no corrosion soon after the wet grout was removed with fingers (see figure 60-B). The latter condition reconfirmed that soft/wet grout itself does not always trigger corrosion.

Figure 60. Photos. Exposed soft/wet grout.⁽⁸⁴⁾

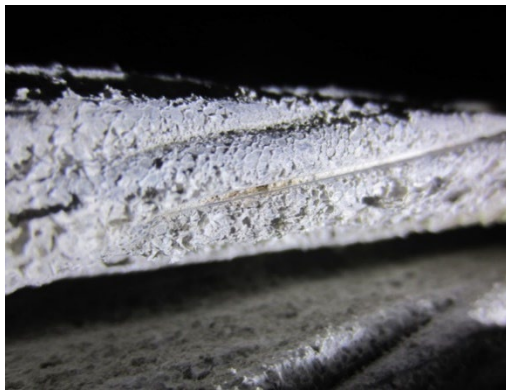
A. Thin grout coating.

As shown in figure 61, many sections of the examined strands were covered with a thin grout coating (see figure 61-A) or partially buried in porous, frosty segregated grout (see figure 61-B).

Figure 61. Photos. Strand conditions in deficient grout.⁽⁸⁴⁾

Neither condition—having a thin grout coating or being buried in porous, frosty segregated grout—induced corrosion damage aside from atmospheric surface corrosion. It was apparent that the segregated grout did not cause any corrosion—despite excessive moisture contents—probably due to low levels of chloride and sulfate ions. However, it was uncertain whether the bridge would remain corrosion-free throughout its lifespan.

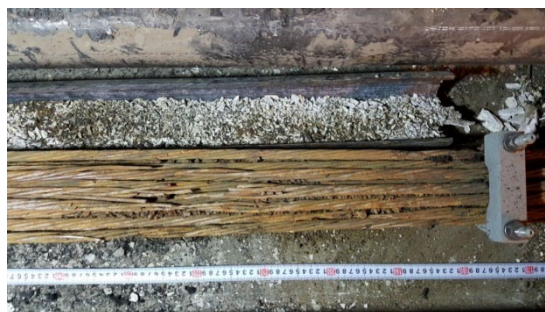
A. Chalky grout fragments.

The first corrosion problem involved an external tendon that suffered from severe corrosion damage where a 43-ft-long grout void formed across four deviation blocks in its bottom, horizontal section, running parallel to the girder floor. Such an abnormally large and extended grout void could likely be caused by excessive bleed water and entrapped air in the horizontal region during the grout injection. The corroded-in-two wires and other wires exhibiting significant section loss were mostly concentrated between two deviation blocks in the middle of the span. No water was found in the empty duct at the time of the investigation. Instead, many small pieces of the segregated grout were piled up in the form of chalky grout at the bottom of the duct. Figure 62 shows small fragments of chalky grout (see figure 62-A) and a closeup of the severely corroded strands in contact with the chalky grout (see figure 62-B).

Figure 62. Photos. Severely corroded strands exposed to chalky grout on Seo-Ho Bridge.⁽⁸⁴⁾

The presence of the chalky grout next to the corroded strands indicated that the segregated grout must have played a major role in the corrosion process.

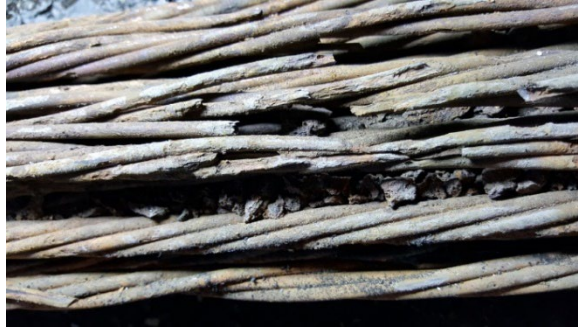
B. Severely corroded strands.

These photographs were believed to be snapshots of serious, ongoing corrosion, but they were not representative of the worst condition seen with this corrosion problem, which is shown in figure 62-B.

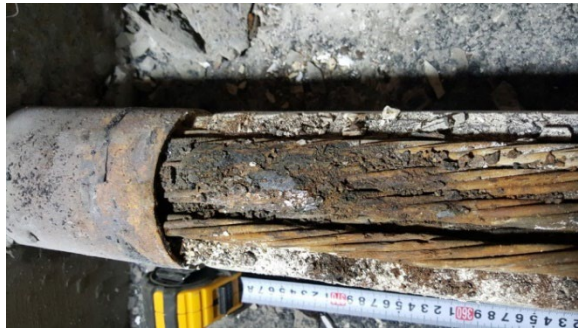
A. Before removal of corrosion products.

A neighboring tendon section also showed severe corrosion beneath thick corrosion products that were mingled with grout residue. Figure 63 shows the corroded strands upon duct opening (see figure 63-A) and the cleaned strands after the corrosion products were removed from the affected area (see figure 63-B).

Figure 63. Photos. Corroded strands before and after cleaning.⁽⁸⁴⁾

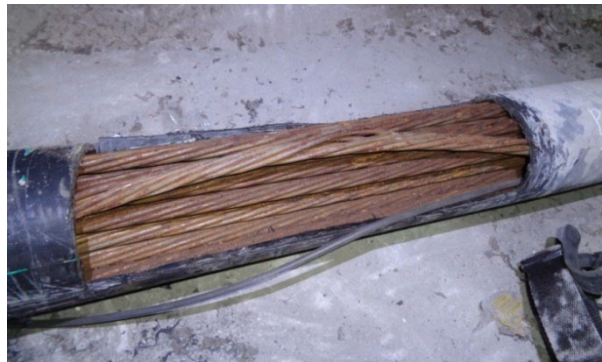
A. Loosened strands.

The second corrosion problem was discovered near a thick pier diaphragm in another span. When a suspicious-looking external tendon was opened, some loosened strands were observed, initially at one location. Later, entire strands completely severed by corrosion were discovered at a nearby location. This failure also occurred in a horizontal bottom section between a pier diaphragm and the third deviation block. An approximately 44-ft-long, virtually empty duct started from the anchorage zone inside the diaphragm. Figure 64 shows some loosened strands coming out of the diaphragm (see figure 64-A) and strands completely severed by corrosion near an anchor head inside the diaphragm (see figure 64-B).

Figure 64. Photos. Failed strands in the second damaged tendon.⁽⁸⁴⁾

Same as with the corrosion-damaged tendon shown in figure 63, no water was found in the empty duct section. While the physical conditions were very similar, this tendon must have failed in the voided area without intimate contact with the segregated grout. This speculation was based on the observation that no grout was found there.

At the end of the investigation, seven tendons were replaced, and an additional 132 extra tendons (each containing 16 0.6-inch 7-wire strands) were installed through reserved tendon holes to provide adequate structural redundancy.

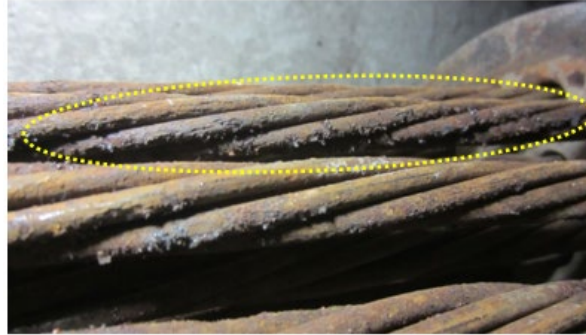
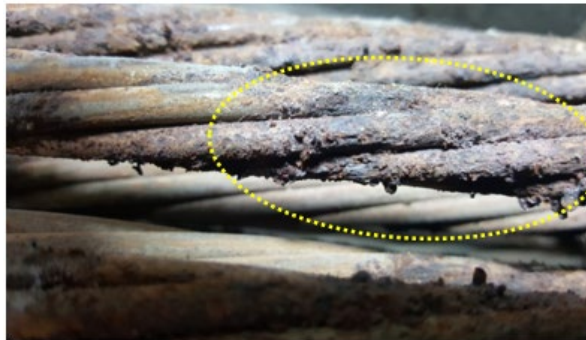
Another tendon in the same span had a similar condition, with an approximately 23-ft-long grout void. The majority of the strands extracted from the empty duct section inside a diaphragm did not have noticeable amounts of grout residue on the surface. Instead, they were covered with corrosion products that resembled those formed under atmospheric conditions. Figure 65 shows two close-up photographs of moderately corroded strands.

Figure 65. Photos. Closeups of corroded strands near anchor head.⁽⁸⁴⁾

Some strands had small droplets of solidified corrosion products, instead of grout, indicated by yellow dashed lines. A similar condition was observed in the Mid-Bay Bridge.⁽²⁹⁾

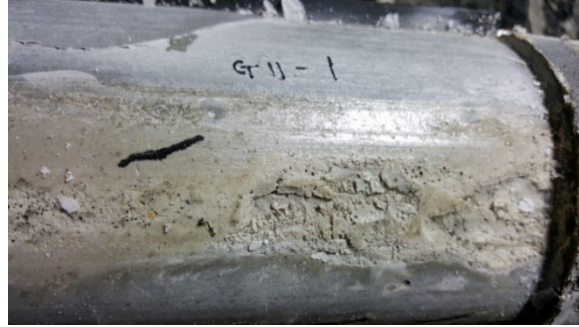
A. Localized soft/wet grout.

The failed tendon also had several forms of segregated grout along the tendon length. Figure 66 shows a small soft/wet grout band along the tendon length (see figure 66-A) and chalky grout (see figure 66-B).

Figure 66. Photos. Segregated grout in an opened external tendon.⁽⁸⁴⁾

Large bleed channels formed at 12 o'clock were also frequently observed in this tendon. The width of the bleed channels varied from less than 0.5 inches to wider than 2.5 inches. These grout conditions suggested that a significant bleeding problem took place during grouting.

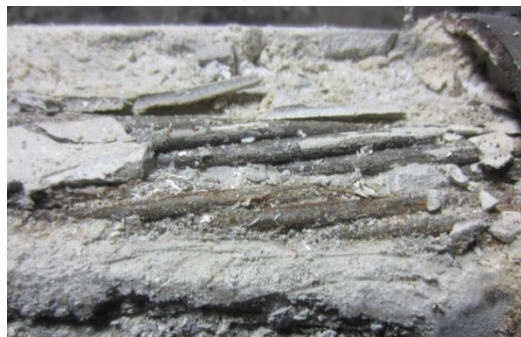
A. As-exposed condition.

Surface corrosion was observed occasionally on the strands partially buried in the segregated grout. Figure 67 shows the undisturbed condition of two exposed strands when a duct was removed (see figure 67-A) and the cleaned condition of the same strands after the segregated grout and surface rust were removed (see figure 67-B).

Figure 67. Photos. Exposed strands before and after removal of segregated grout and rusts.⁽⁸⁴⁾

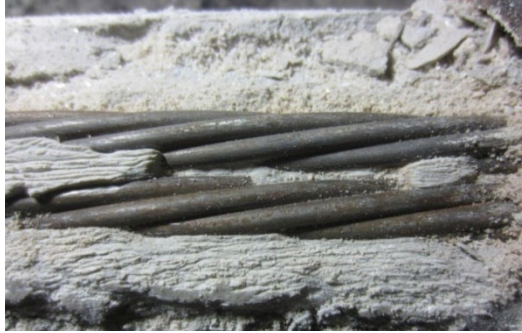
B. Cleaned condition.

Minor surface corrosion can be seen on the cleaned strands inside the opened external tendon. The grout around the cleaned strands exhibited a brush mark, indicating that it was soft, like clay. Laboratory investigations, including petrographic analysis of grout samples and corrosion products, revealed the following:

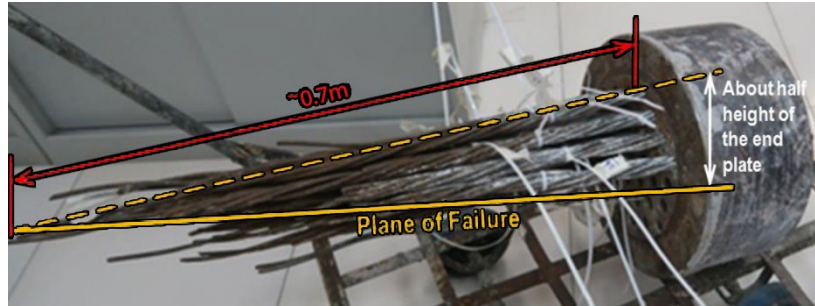
Figure 68 shows an overview of the failed P5 anchor head (see figure 68-A) and an end view of the anchor head (see figure 68-B).

A. Overview of failed P5 anchor head shows strands attached. Modified by FHWA.

Figure 68. Photos. Corroded P5 anchor head on Shenzhen Bay Bridge (Hong Kong).⁽⁸⁵⁾

About half of the upper portion of the strands attached to the P5 anchor head were failed and showed signs of serious corrosion—significant section loss and sharp wire tips—on most of the wires along a horizontal plane. The lower half of the strands on the same anchor head were embedded in the grout and mainly failed by overstressing. Most of the ruptured wires in this area exhibited a cup-and-cone fracture morphology, which indicated ductile failure by the necking process. No evidence of wire embrittlement and shear-type failure was observed.

White powdery paste, probably caused by grout bleeding, was observed on the strands near the P5 anchor head. The strands that were recovered from the mid-height section—between the upper and lower halves—of the P5 anchor head showed transitional corrosion morphologies from superficial corrosion to moderate corrosion without significant section loss. The strands at the opposite side (P1) anchor head were uniformly covered with whitish cementitious material, and all the exposed strands exhibited no sign of corrosion.

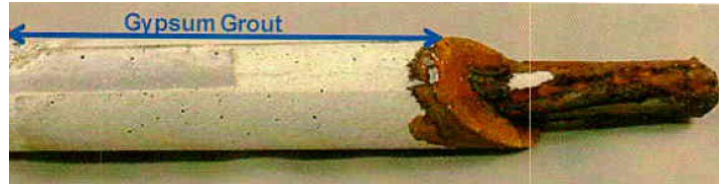
A. Corroded strand before removing gypsum grout.

No corrosion was observed on the specimens placed in the prepackaged grout, but significant pitting corrosion was observed at the inclined gypsum grout/void interface, after 2 mo of testing, in the sealed polyvinyl chloride tubes. The largest pits were approximately 1/16 of an inch deep. The strand section in the voided space above the gypsum grout interface was also corroded without direct contact with the grout. Figure 72 shows a corroded strand in gypsum grout (see figure 72-A) and the same strand after it was cleaned (see figure 72-B).

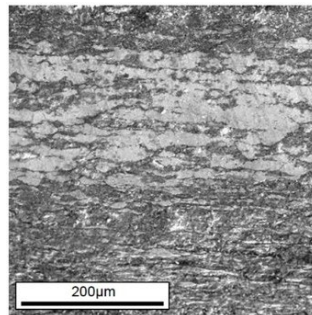
A photomicrograph shown in figure 74 shows the disturbed surface condition of the as-received zinc phosphate (ZnPO_4) surface coating on the prestressing steel, which contained flaws generated during cold drawing and subsequent thermomechanical processing during strand production.

Figure 74. Photomicrograph. As-received ZnPO_4 surface coating on prestressing steel.⁽¹⁰⁴⁾

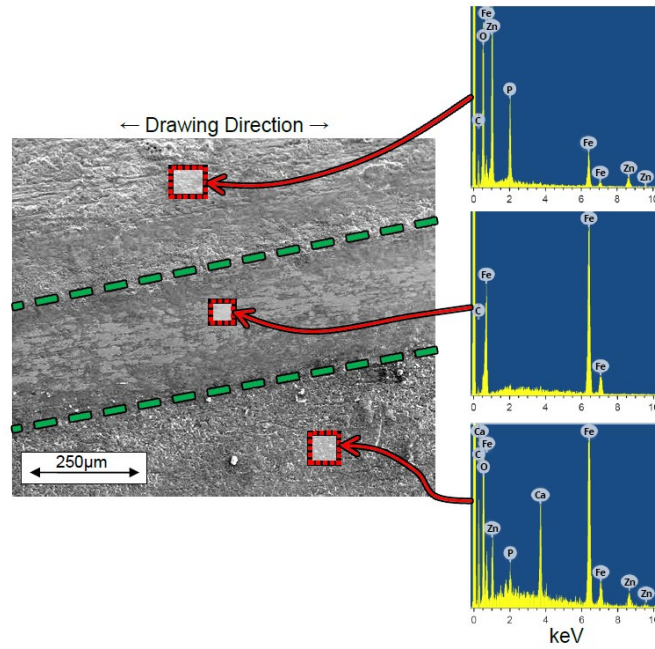
Scanning electron microscopy (SEM) and EDS analyses were performed on prestressing steel samples to characterize imperfections on as-received ZnPO₄ surface coatings. Figure 75 shows a photomicrograph highlighting the heterogeneity present in a 0.0016 in² area of the coating at an impingement site between two wires in a 7-wire strand sample. EDS results performed at three spots are also shown in figure 75.

Figure 75. Photomicrograph. Typical imperfect ZnPO₄ surface coating and energy dispersive X-ray spectroscopy results.⁽¹⁰⁴⁾

In the center of the backscattered image shown in figure 75, a bright diagonal imperfection band (marked by two dashed lines) shows a helical twist at the impingement site between the prestressing strand's outer wire and center wire. EDS analysis of this band indicated that most of the ZnPO₄ coating had been abraded off, as evidenced by the middle EDS spectrum showing only iron (Fe). Adjacent to this band of imperfection, the surface coating remained intact: Both zinc (Zn) and phosphorus (P) were present in the top and bottom EDS spectra. In many cases, trace amounts of calcium (Ca) were also detected in the surface coating. These Ca deposits were likely residual coatings from stearate-type drawing lubricants, which were not completely removed during postprocessing stress relief and cleaning treatments.⁽¹⁰⁵⁾

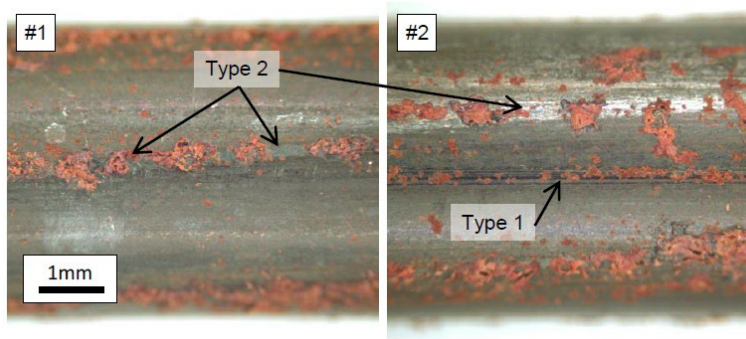
Figure 79 shows two specimens tested at passivity breakdown potential to determine preferential surface sites for corrosion initiation.

Figure 79. Photos. Corrosion initiation at surface imperfect sites: Type 1 and 2 defects.⁽¹⁰⁴⁾

Corrosion started at type 1 and type 2 imperfections before general corrosion of the ZnPO₄ coated surface. Corrosion was initiated on both specimens at type 2 defect sites where corrosion products were aligned with the helical twist of outer wires around the center wire. Corrosion is also shown at the type 1 defect on a carbon-rich black streak aligned in the drawing direction. These observations suggested that the surface coating's imperfections played an integral role in providing sites for corrosion initiation. Such effects would not be detected by experiments conducted on polished samples. Particularly, type 2 defects occurred at the crevices in the 7-wire prestressing strands and could aggravate the crevice corrosion process.

Crevice corrosion can occur at the interstitial site inside the 7-wire strand. Figure 79 shows the imperfect $ZnPO_4$ line (type 2 defect) along the spiral line formed by rubbing the wires with each other. Those interstitial sites can be filled with bleed water and a very lean grout mix in severely segregated grout and become a potential site for crevice corrosion. For example, figure 118 shows the origin of crevice corrosion in a corroding 7-wire strand.

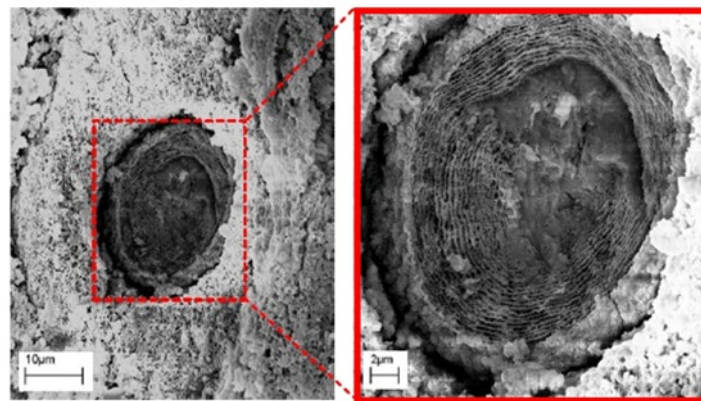
X-ray diffraction (XRD) analysis using post CPP specimens identified that whisker-type corrosion products in the pits were primarily goethite (FeOOH). Extensive pitting was observed at the base of the whisker formations. Figure 80 shows an SEM photomicrograph of a typical pit observed at the base of a whisker formation.

Figure 80. Photos. Typical pitting corrosion morphology: Pit mouth and closeup of inside of pit.⁽¹⁰⁴⁾

The diameters of the pits ranged from 0.2 to 0.8 mils and typically exhibited concentric circular deposits of corrosion products on the pit walls.

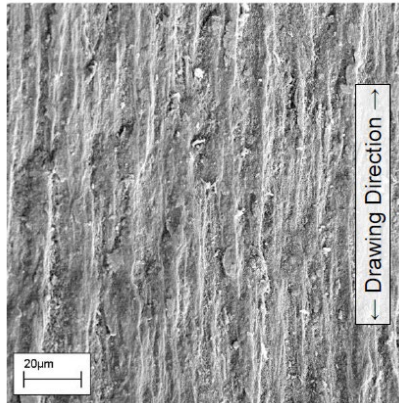
When corrosion products were removed in the uniform corrosion areas, corrosion damage was found to be preferentially aligned in the drawing direction of the prestressing steel, as shown in figure 81.

Figure 81. Photomicrograph. Uniform corrosion damage preferentially aligned in the cold drawing direction.⁽¹⁰⁴⁾
